# LAND at BRYONY HILL FARM WINKLEIGH DEVON

Results of a Desk-Based Assessment,  
Geophysical Survey, Walkover Survey &  
Historic Visual Impact Assessment

Report No.: 130930  
Date: 30.09.13  
Authors: S Walls  
E Wapshott

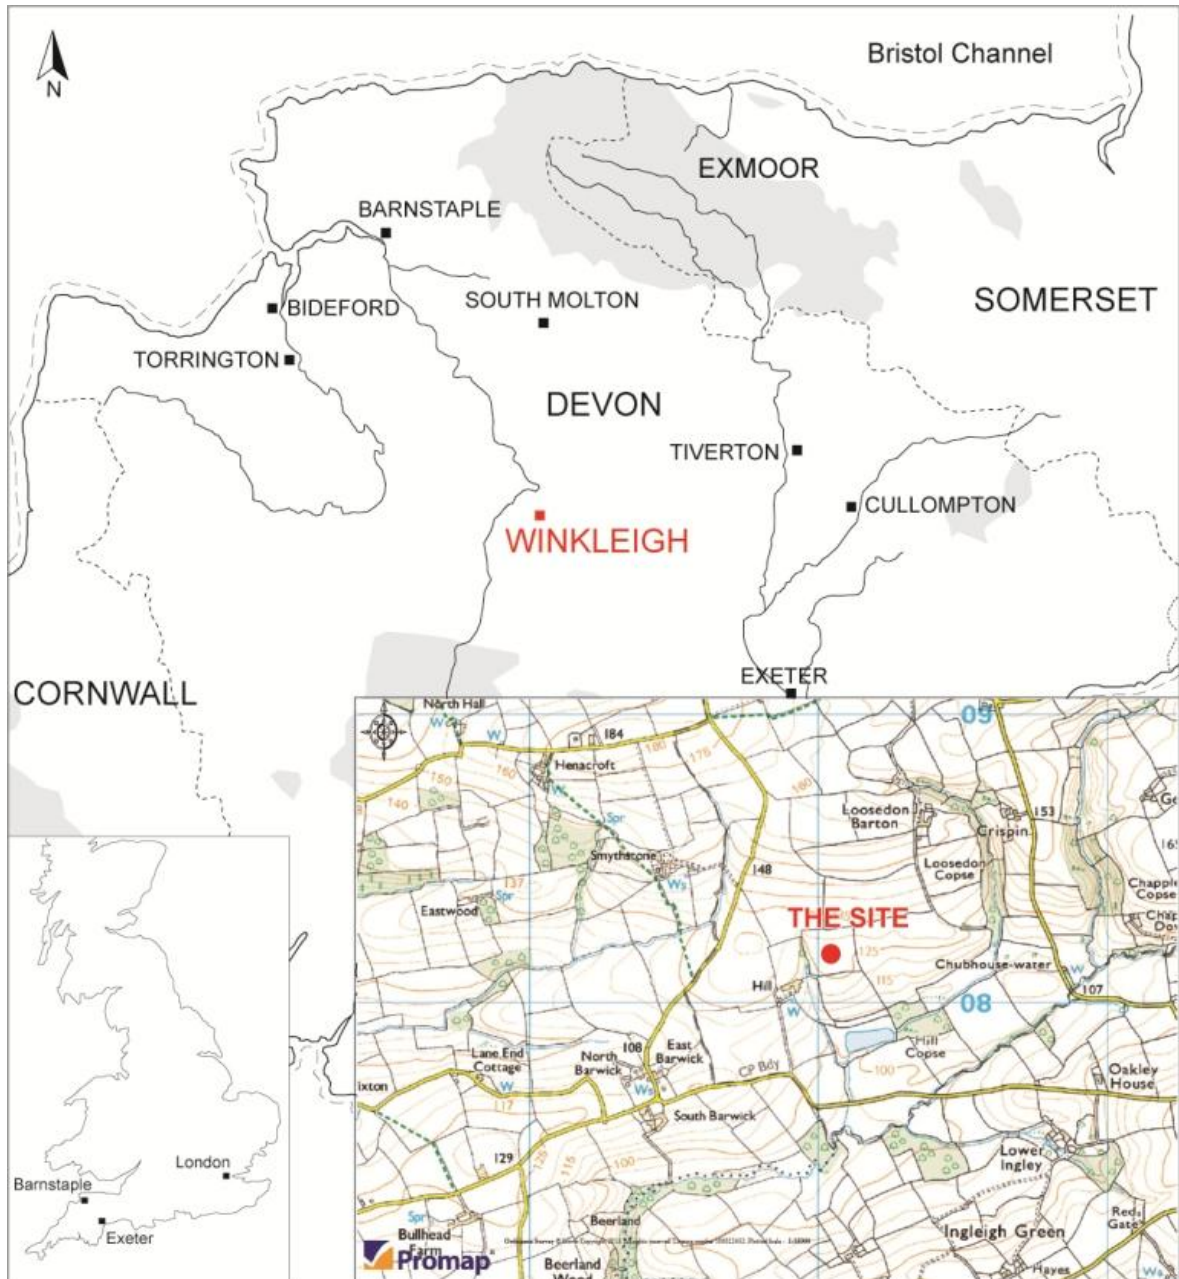
Figure 1: Site location (the site of the proposed turbine is indicated).

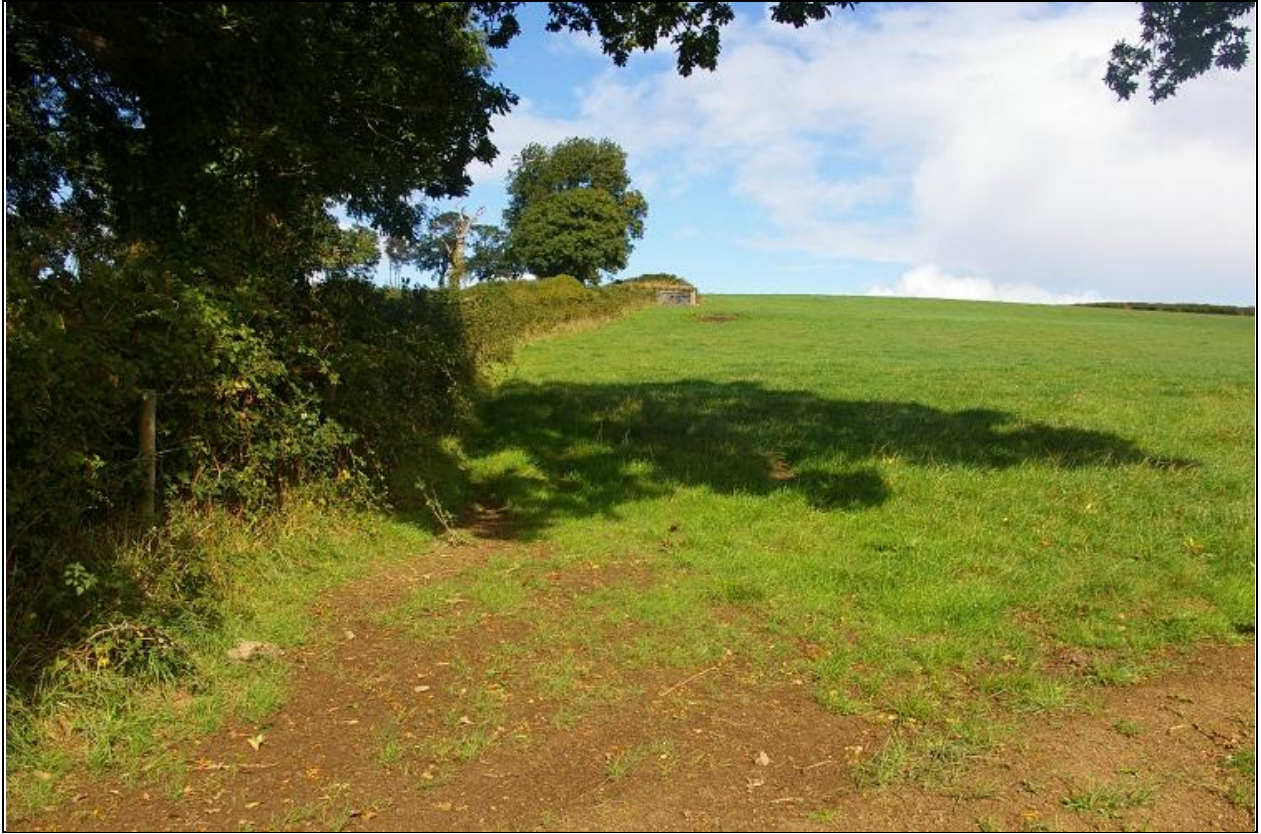
Shot of the hedge-bank along which the access track will run, parallel to the road; viewed from the south.

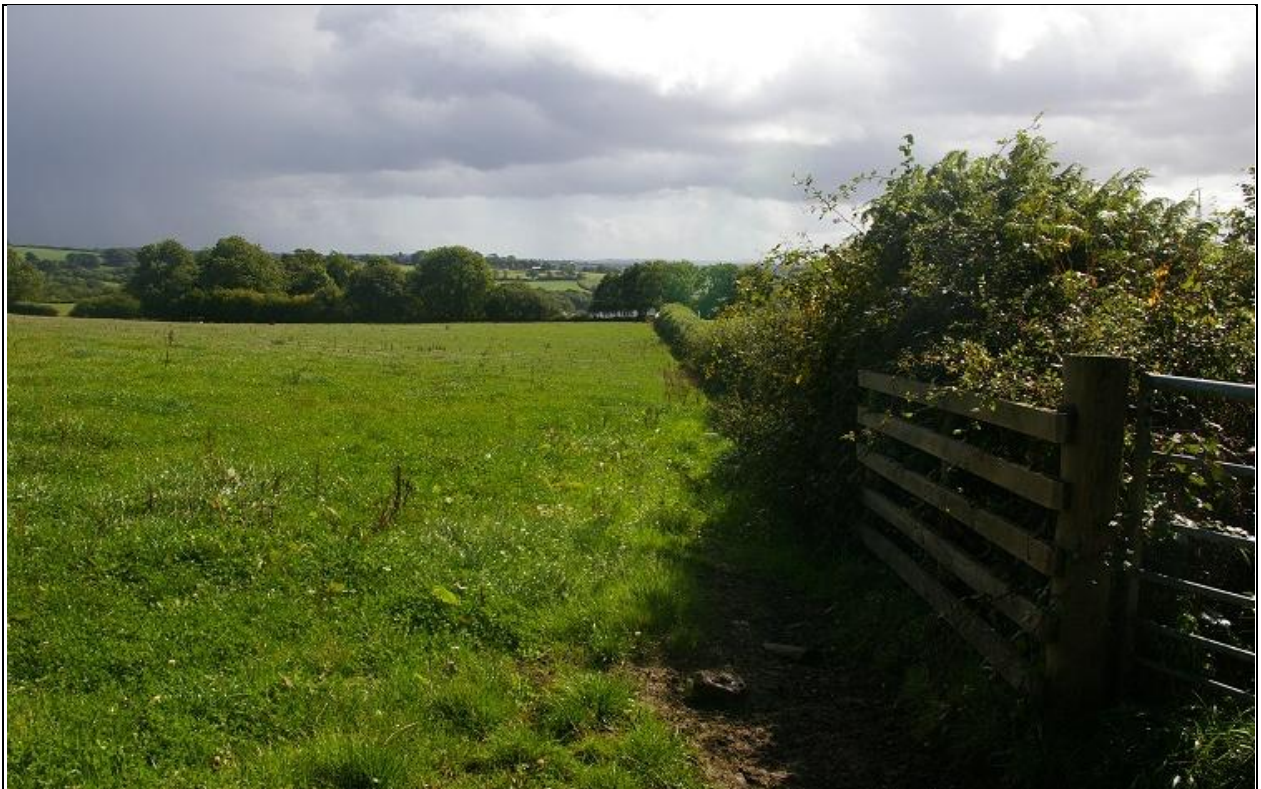
Shot of the long diagonal hedge-bank boundary, the access will run down this hedge-bank; viewed from the north-west.

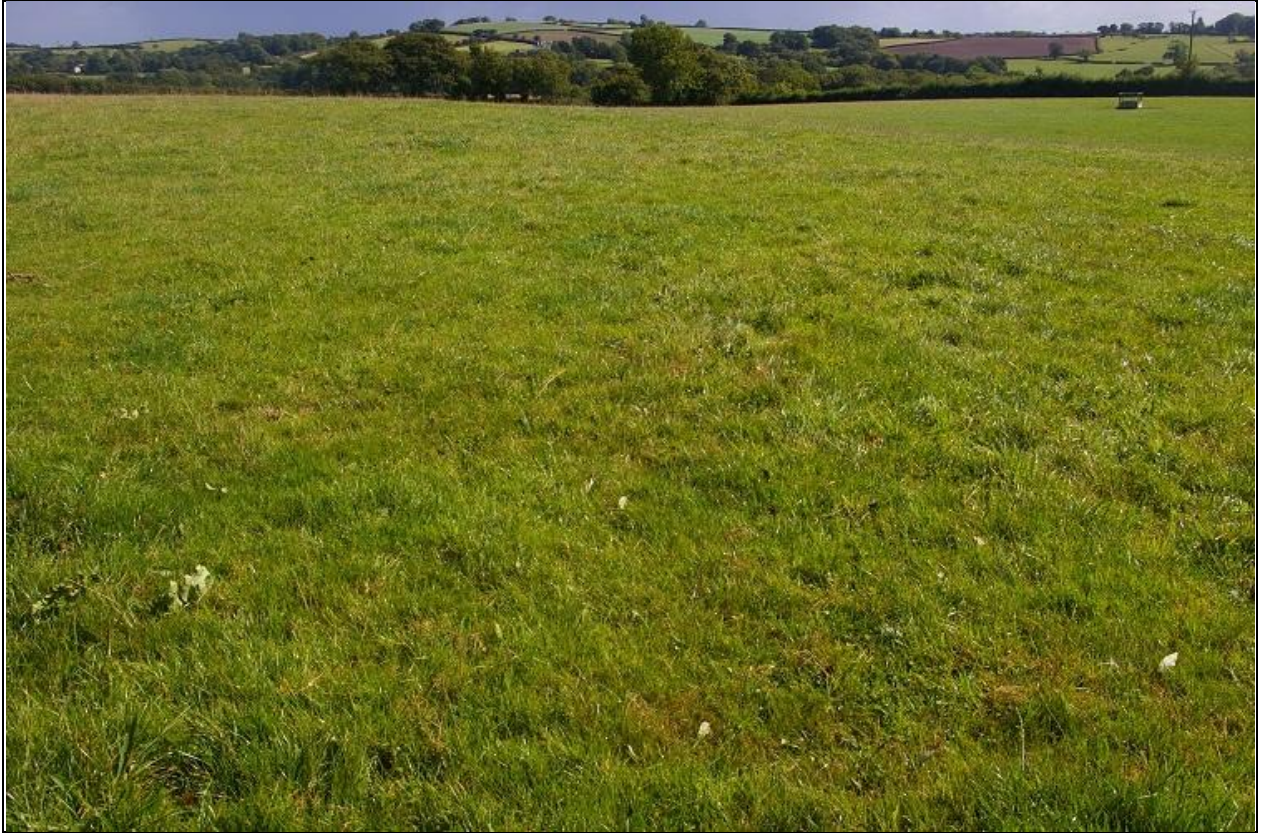
shot of the knoll on which the turbine will be situated; viewed from the north-west.

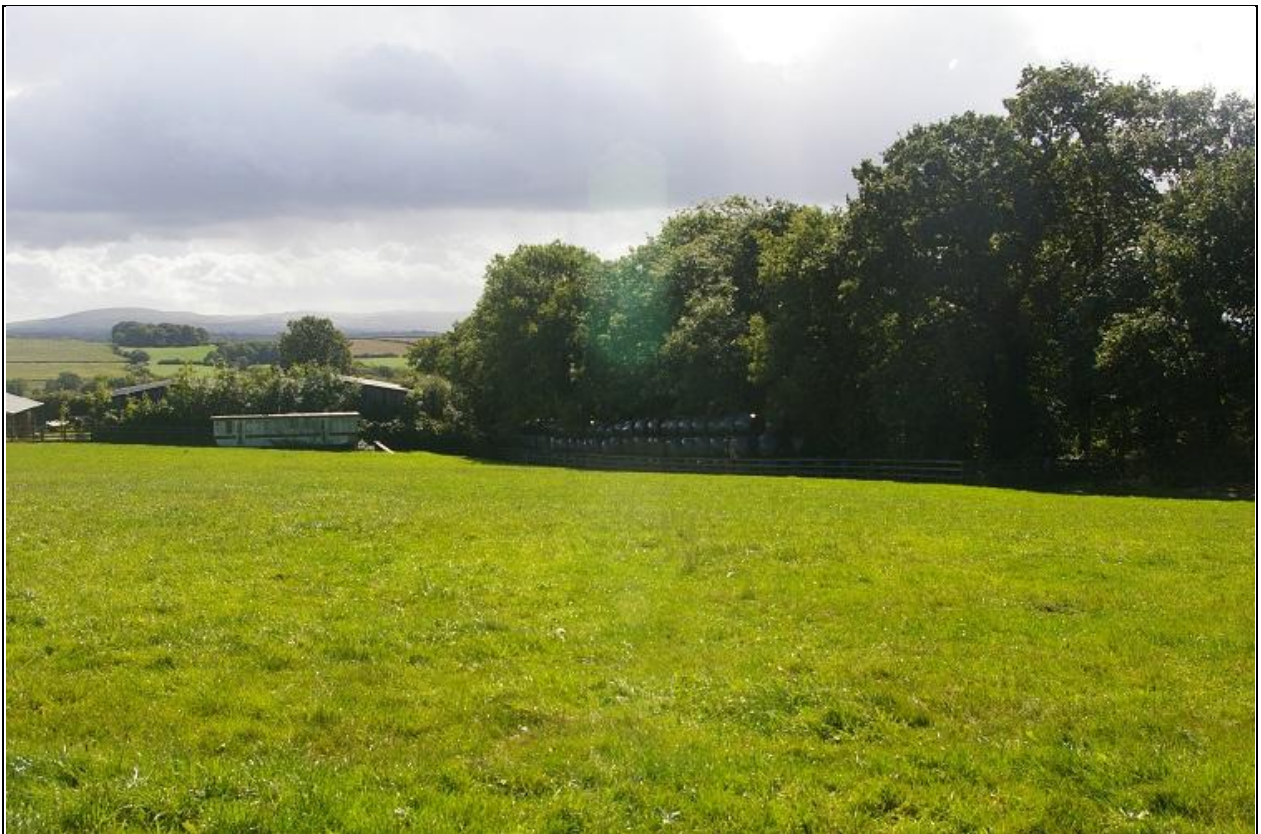
Shot of the trees between the turbine and the house, Bryony Hill; viewed from the north-east.

- Bryony Hill; medium significance; Grade II Listed; condition: excellent; the farmhouse is set back into the slope of the hill, with outbuildings and courtyard to the north and east. A plantation of trees to the north-east shields the building further, but this is seasonal. The focus of the building is to the south, away from the turbine, which will be located to the north-east; impact: **negative/minor**.

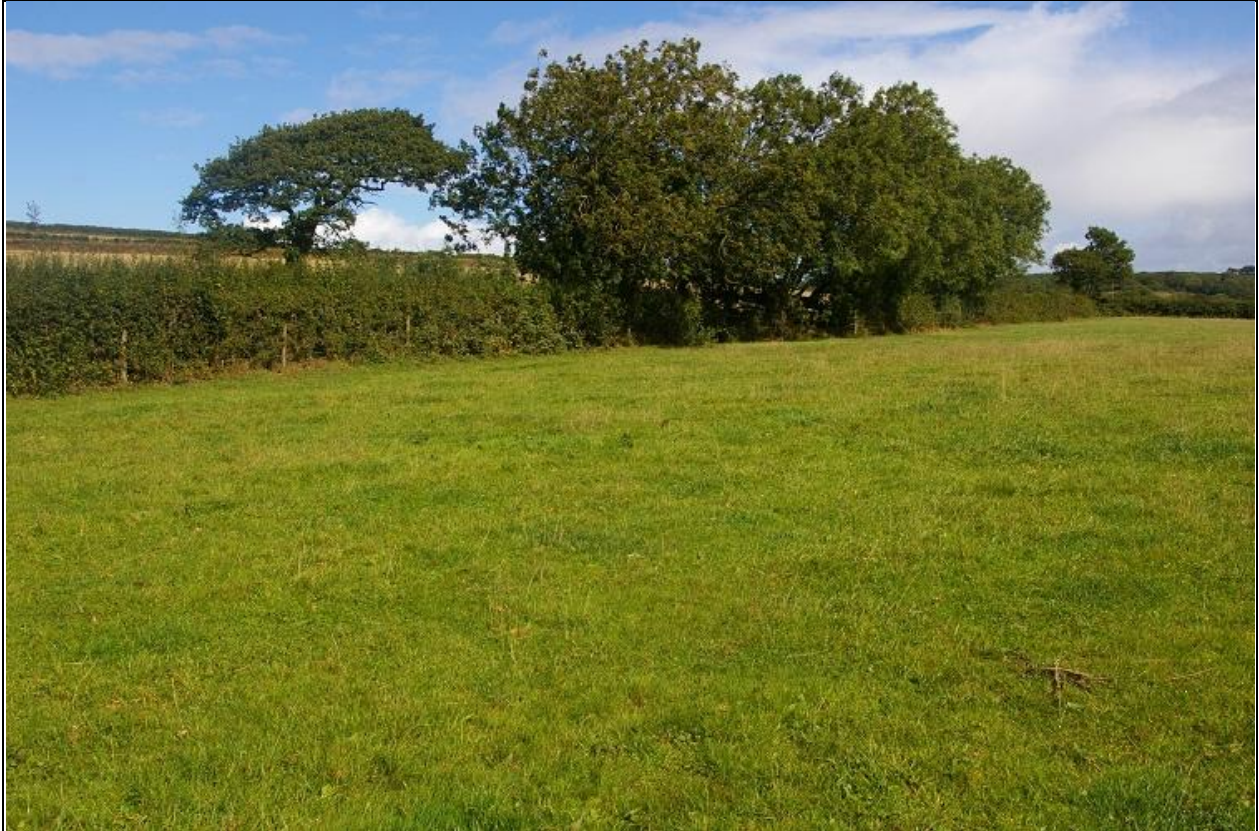
The northern field boundary, west of where the cable will run to the turbine; viewed from the south-west.

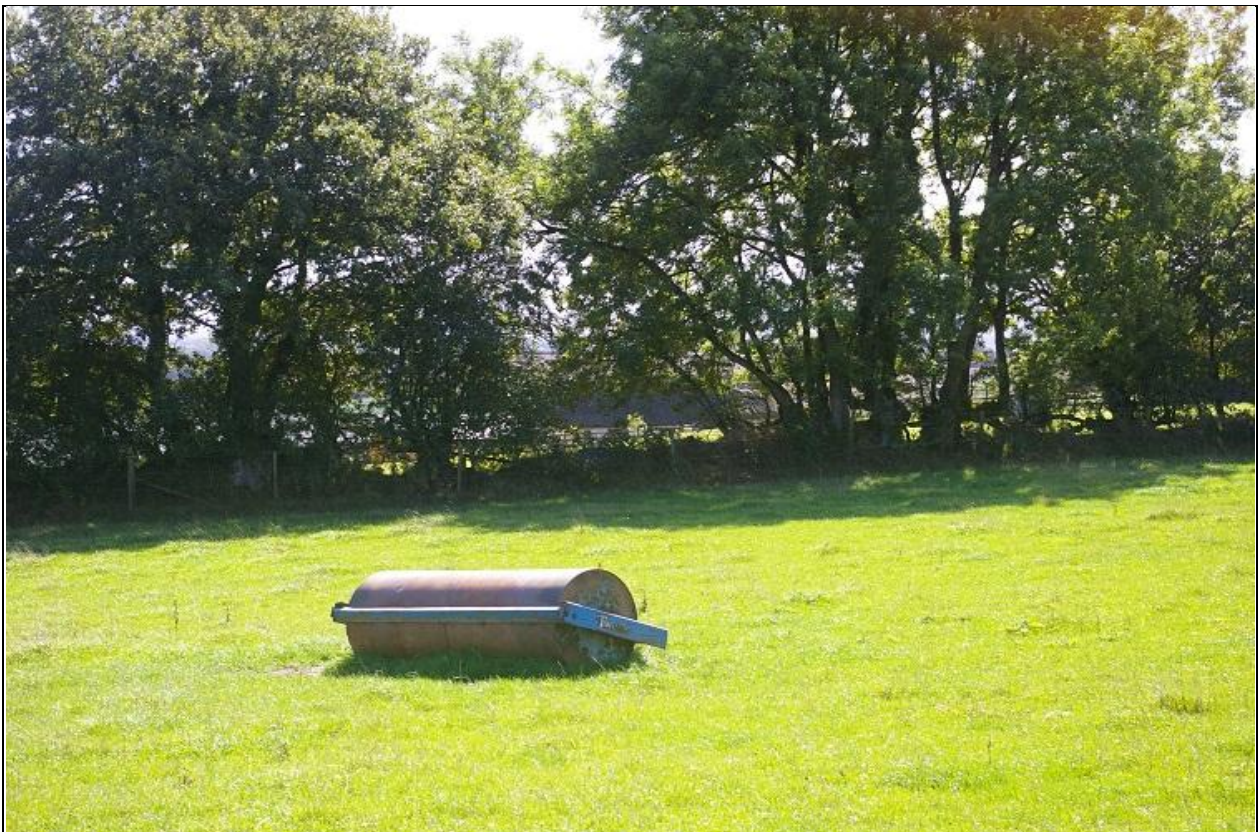
The house, Bryony Hill, set in a tree-fringed enclosure, which stands in the adjacent field to the north-east; viewed from the north.

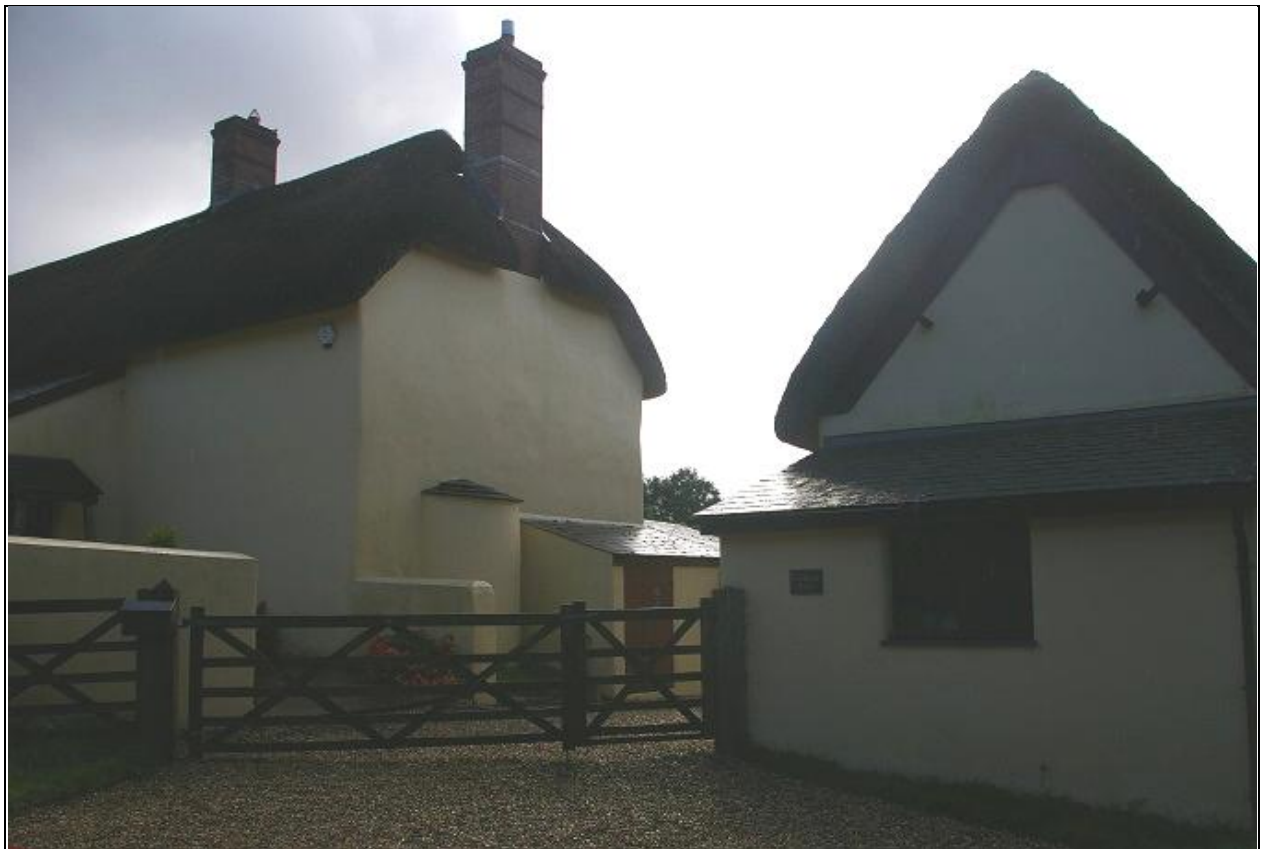
Corstone Farm and its courtyard of barns and buildings; viewed from the north-west.

- Corstone Farmhouse and outbuildings; medium significance; Grade II Listed, condition: excellent; set around a courtyard, focussed towards Dartmoor. The house and barns form a complete and well preserved group. The road passes to the north and west of the buildings, lined with tall hedge-banks and trees, blocking any views to the north and west; impact: **neutral**.

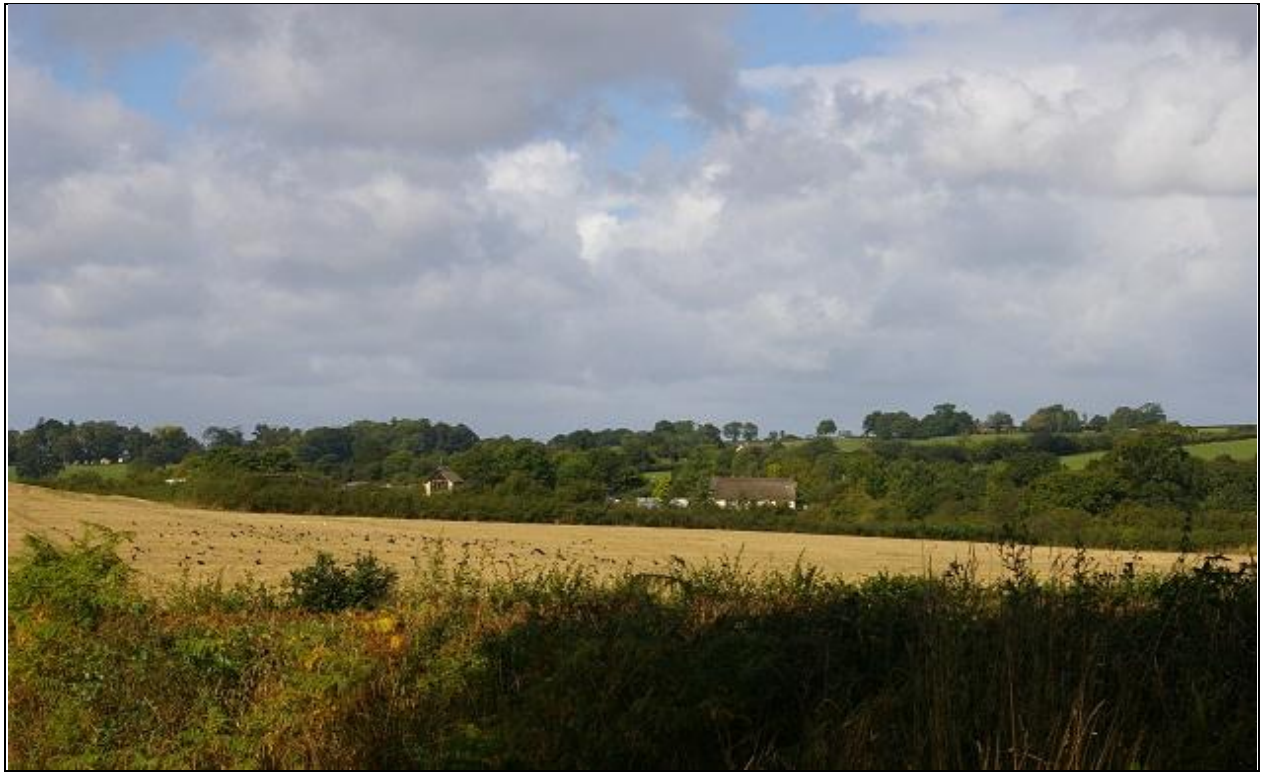
Burrow Farm, a Grade II\* listed farmhouse outside Monkokehampton; viewed from the south-east.

- Burrow Farmhouse; high significance; Grade II\* Listed; condition: good; substantially blocked by trees, hedgerows and topography. Views to the south-east across a small valley, some more limited views to Monkokehampton, to the west. No clear inter-visibility to the turbine; impact: **neutral**.

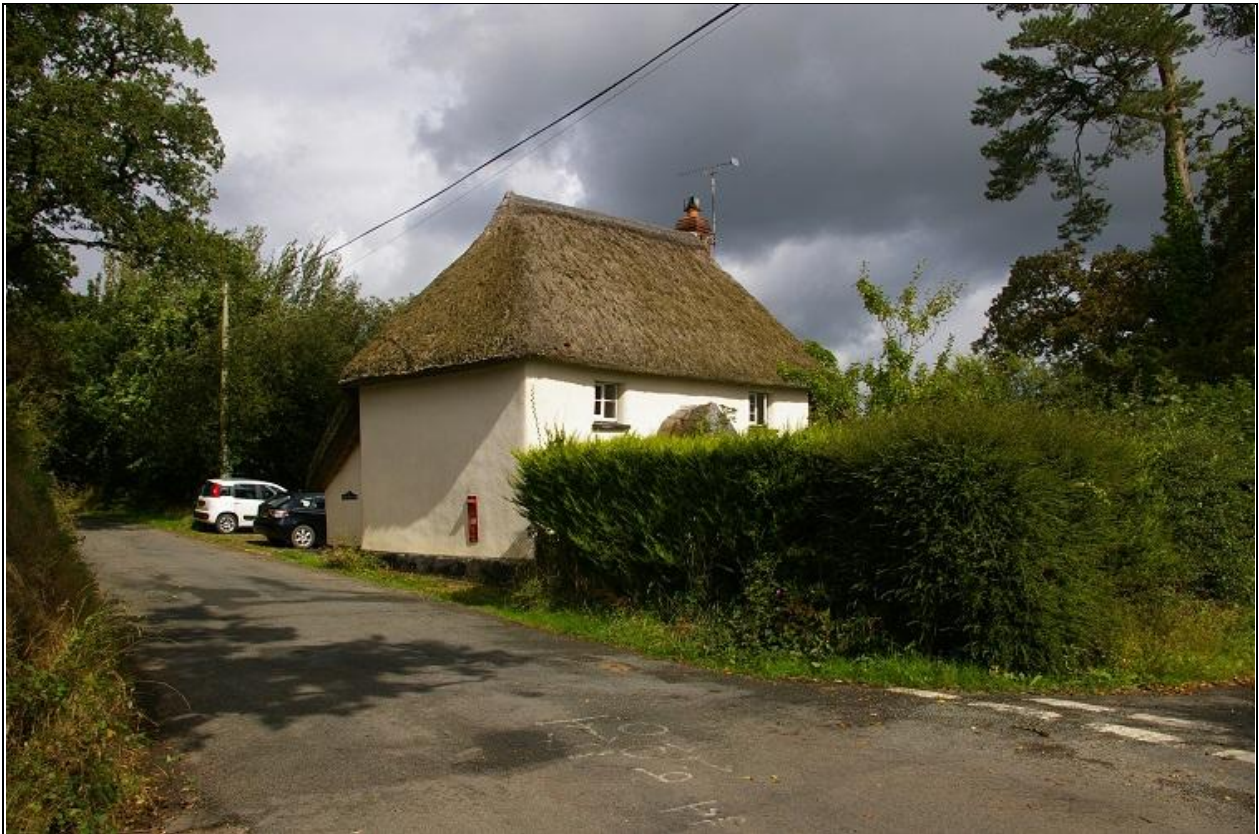
Weekmoor Cross Cottage, set in its wooded garden, at the crossroads; viewed from the south-west.

- Weekmoor Cross Cottage; medium significance; Grade II Listed; condition: good; lying north of a small crossroads. Set on a high knoll of land facing a shallow valley, views up the valley to the east, to the proposed turbine. Trees have been planted in and around the cottage, probably as a wind break and these will provide some local blocking; impact: **negative/minor**.

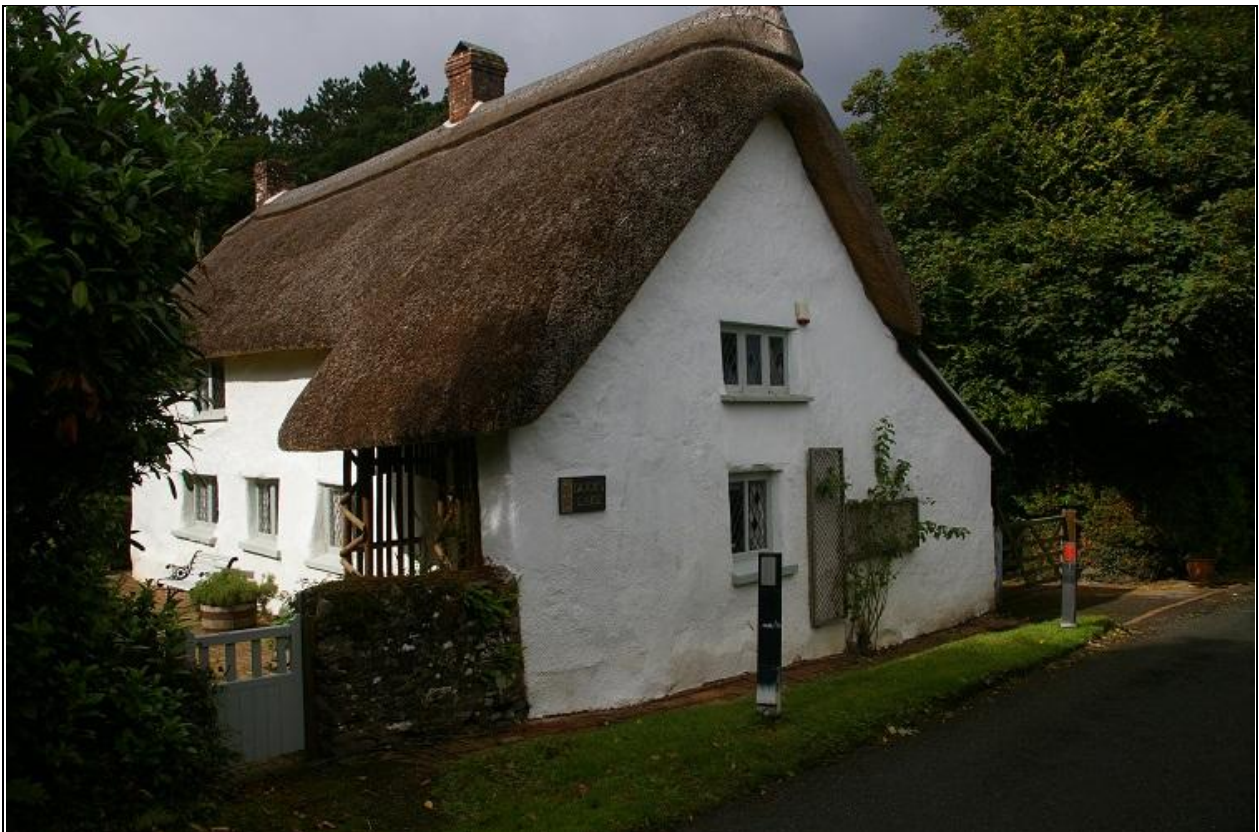
Duckslake Cottage, set in a wooded valley, south-west of Iddesleigh; viewed from the south-east.

- Duckslake; medium significance; Grade II Listed; condition: excellent; this lies in a steep little coombe. The cottage has a heavy stand of native and conifer trees to its north and a tall hedge-bank lining the road to the east, blocking any views; impact: **neutral**.

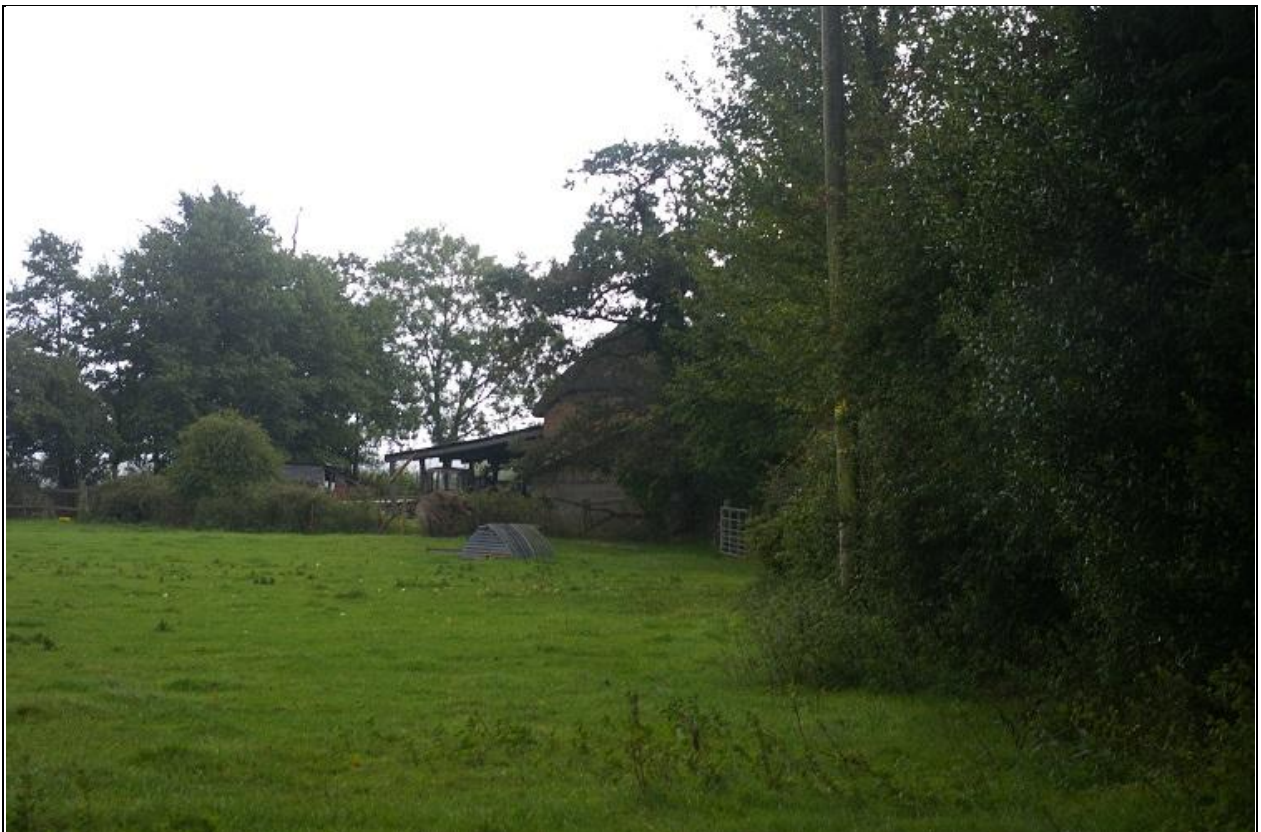
The outbuilding at BullHead Farm, with thatched roof; viewed from the north.

- Bullhead Farm outbuilding; medium significance; Grade II Listed; condition: good; set on a south-facing slope, the outbuilding is visible across a field from the public road. Some visibility to the turbine at the east end of the building, restricted by hedge-banks, impact: **negative/minor**.

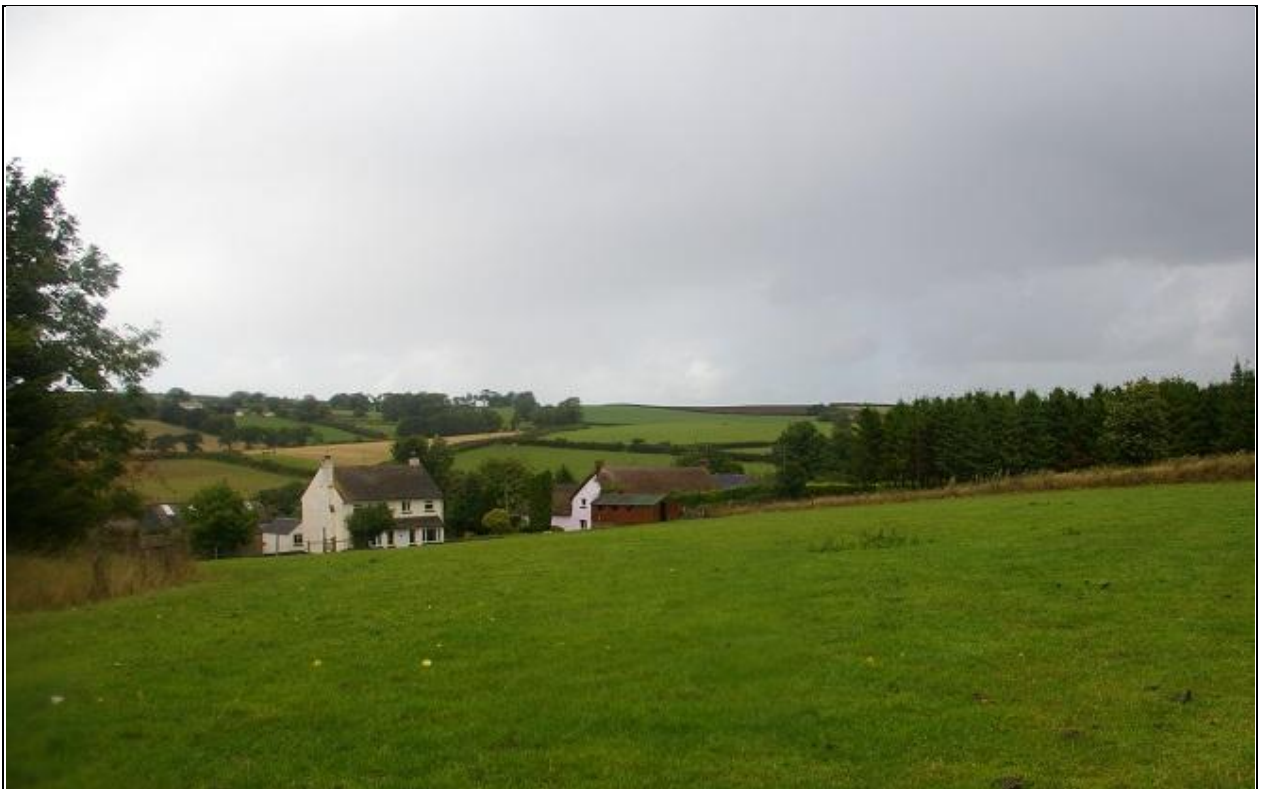
Little Barwick, on a north-facing slope, southwest of the turbine site; viewed from the south-west.

- Little Barwick; medium significance; Grade II Listed; condition: good; set to the north of the other buildings in the hamlet of Barwick. Located on a north-facing slope, some limited views to the north-east towards the turbine, partly restricted by trees in the garden, however the top of the turbine will probably be visible, at quite close proximity; impact: **negative/moderate**.

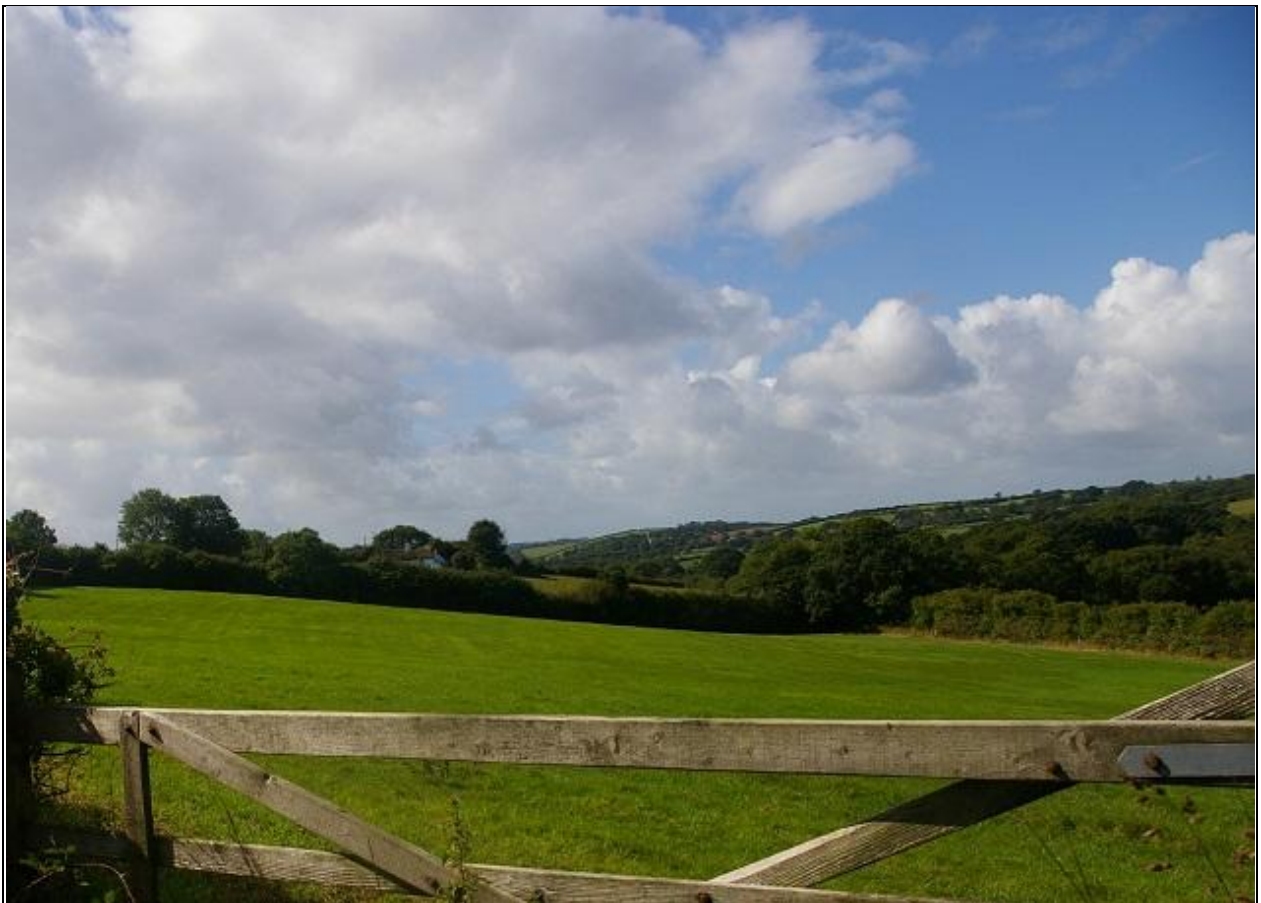
View from Lane End Cottages ; viewed from the east.

- Lane End Cottages; medium significance; Grade II Listed; condition: fair; these lie just down the road from Barwick, less than 1km from the turbine. The turbine will certainly be visible up the valley to the east, although there is some blocking from hedge-banks, but not to any great extent; impact: **negative/moderate**.

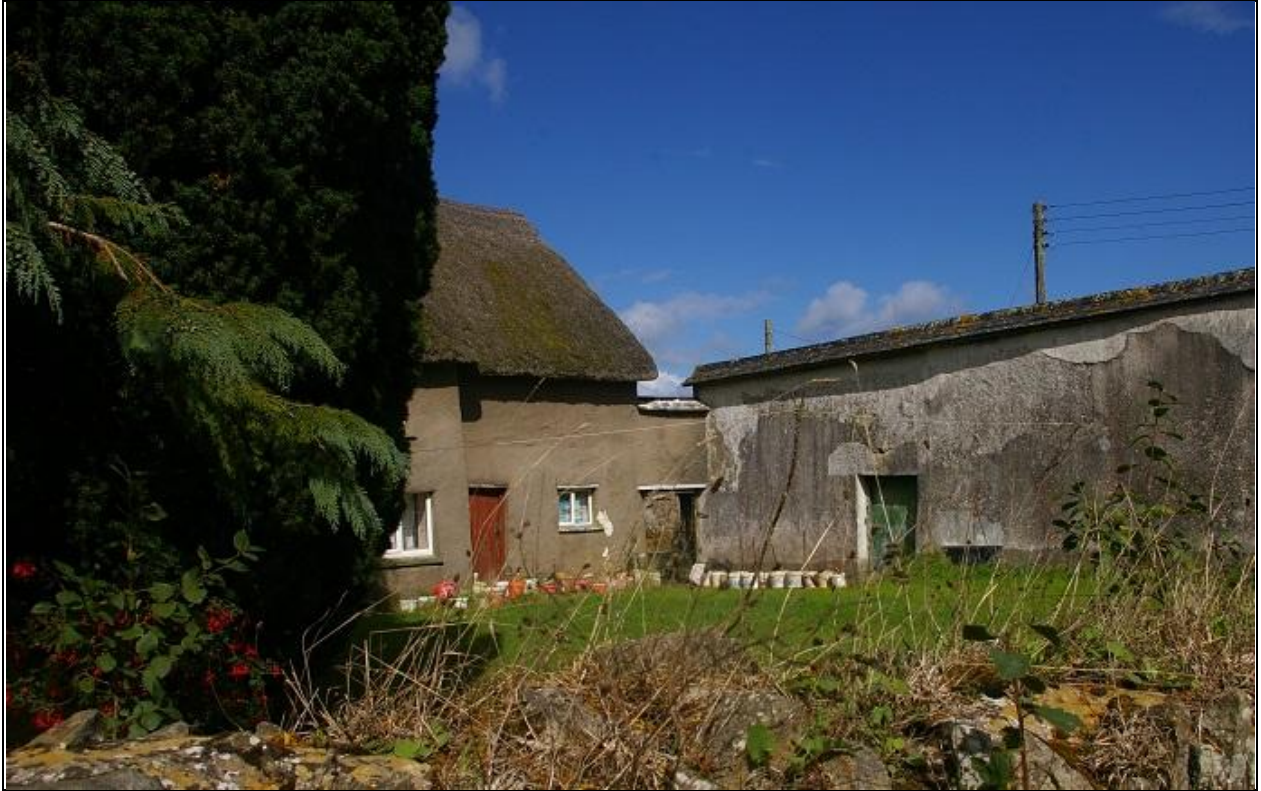
Pixton Farm, with its gardens walls and adjacent buildings; viewed from the south-west.

- Pixton; medium significance; Grade II Listed, conditions: excellent to poor. The farm lies on a north-facing slope, facing the village of Iddesleigh across a wide shallow valley. There are general views to the east towards the turbine. The large courtyard of barns and outbuildings will significantly limit these views however from the listed farmhouse there will be some views; impact: **negative/minor**.
