LAND at LESTOON FARM, LUXUYLAN, CORNWALL

Results of a Desk-Based Assessment
Walkover Survey, Geophysical Survey &
Historic Visual Impact Assessment

Report No.: 130907
Date: 07.09.13
Authors: B Morris
E Wapshott

This report presents the results of a desk-based assessment, walkover survey, geophysical survey and visual impact assessment carried out by South West Archaeology Ltd. (SWARCH) on land at Lestoon Farm, Luxulyan, Cornwall, in advance of the construction of a single 500kw wind turbine.

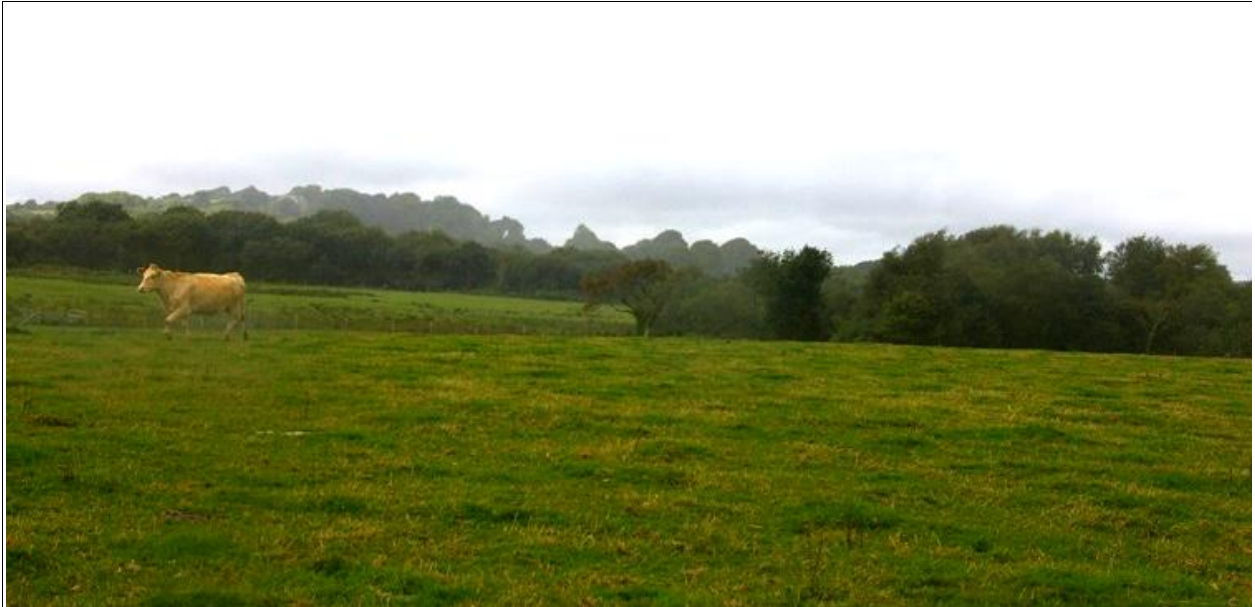
View to the north-west, where Great Lavrean Farm occupies the visible high ridge of ground, set within the thick woodland.

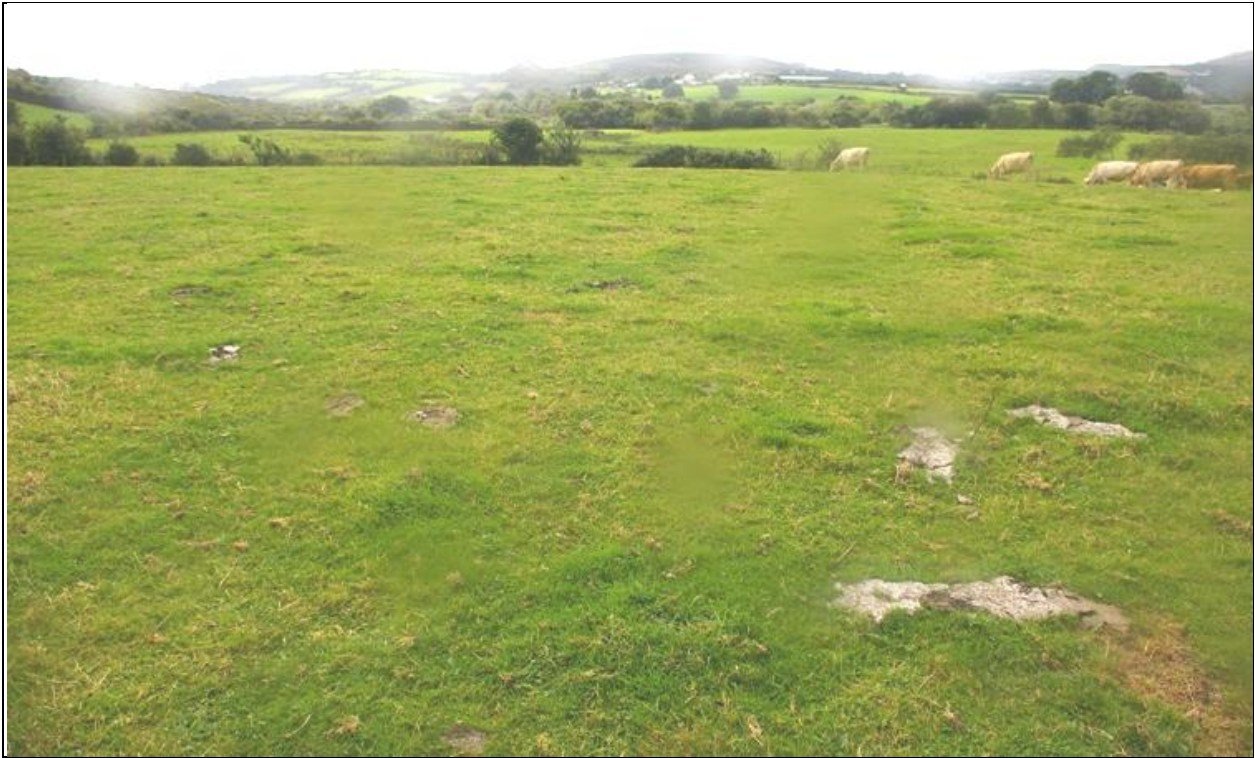
The field peaks at the centre, with some rock and granite showing through the grass pasture; from the south-east.

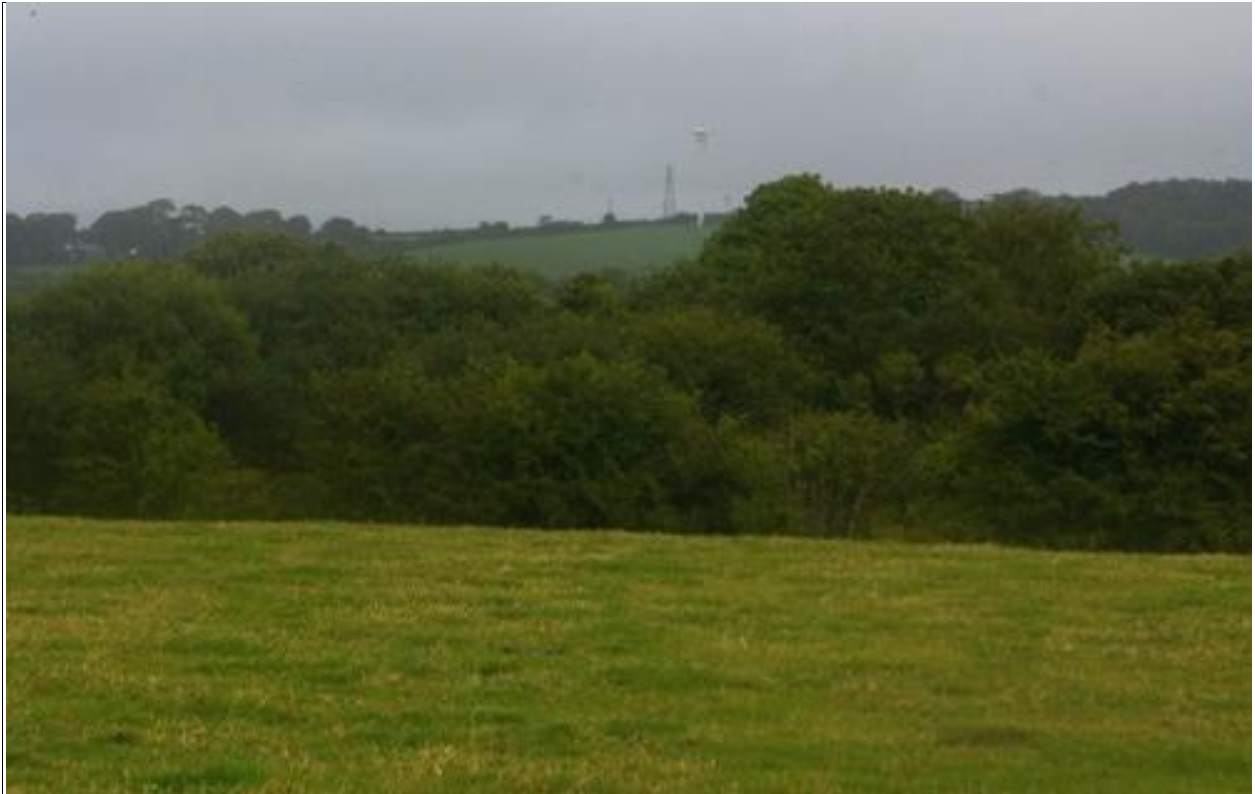
View of the large operational turbine that stands to the north-east, near Bodiggo Farm; from the south-west.

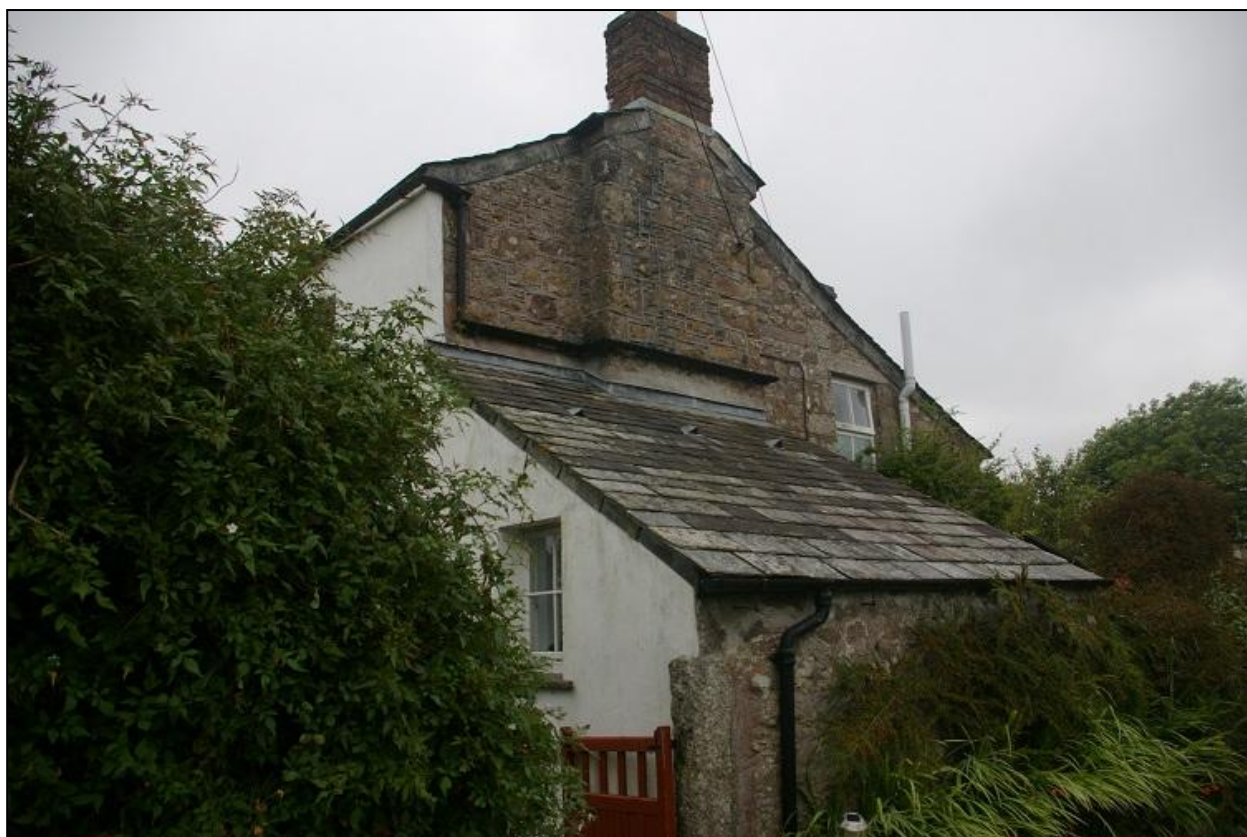
Ivy Cottage, at Bodwen; from the south-east.

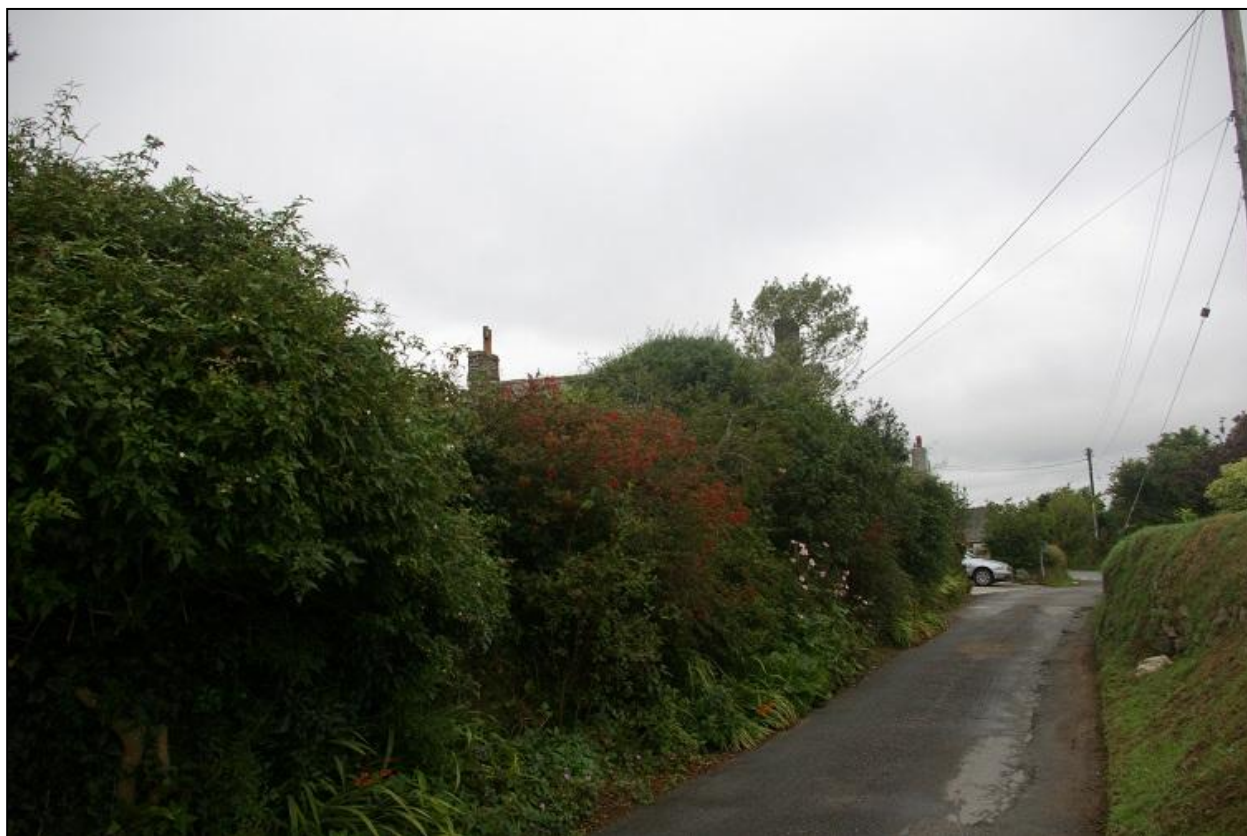
- Ivy Cottage, Old Farmhouse, Barns and Stables; medium significance; Grade II Listed; condition: good. Set in the small hamlet of Bodwen, just off a B road leading from the A391. The hamlet has been extensively developed, and lots of the small barns have been converted to dwellings. The settlement is shielded by mature trees in and around the buildings, and the houses provide local blocking to one another. The cottage is understood as a historic dwelling typical of the region, and this would not be affected by the proposed turbine. Some limited views might be possible, especially in winter, at a distance of only c.1.5km. The house, cottage and barns provide a cohesive unit; impact **negative/minor**.

Ivy Cottage, showing how its mature garden plants and tall hedge shield it from any views; from the south-east.

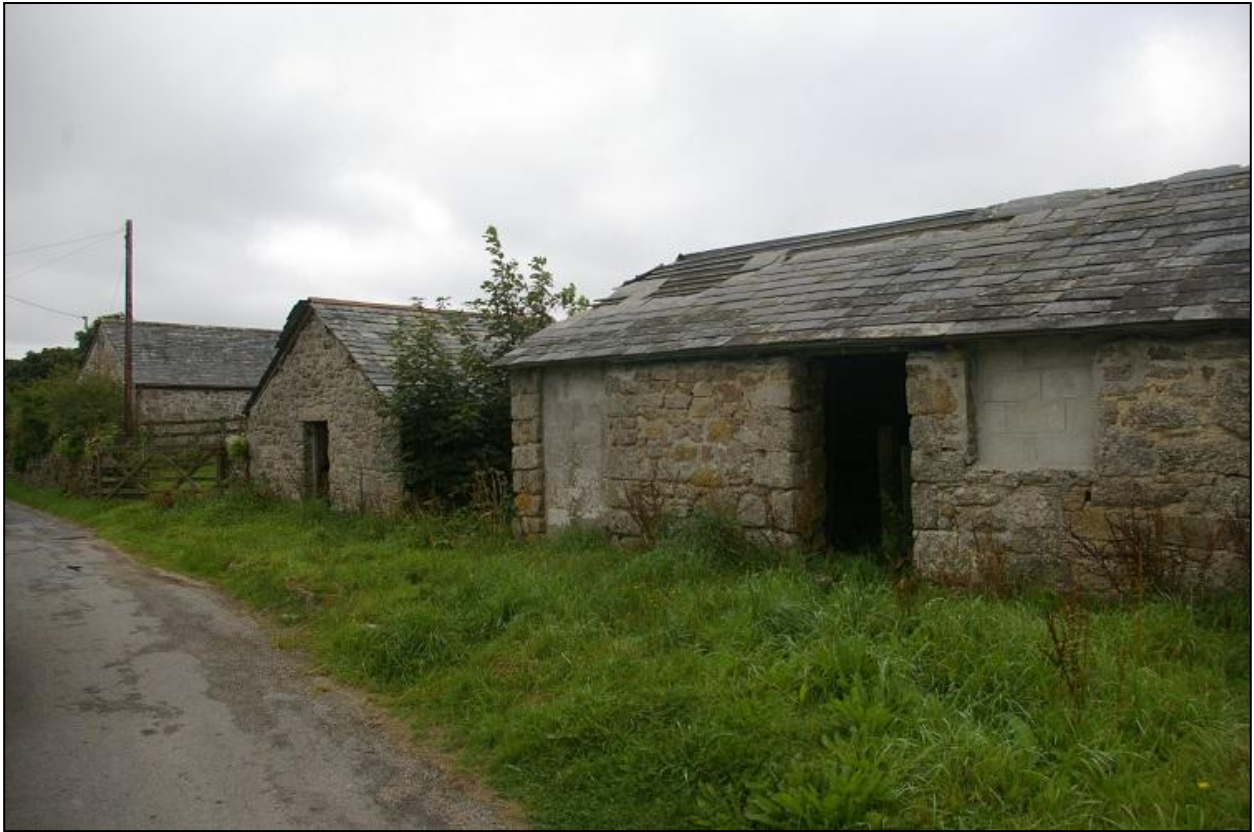
The barns and stables of the Old Farmhouse, in Bodwen, all Grade II listed buildings; from the north-east.

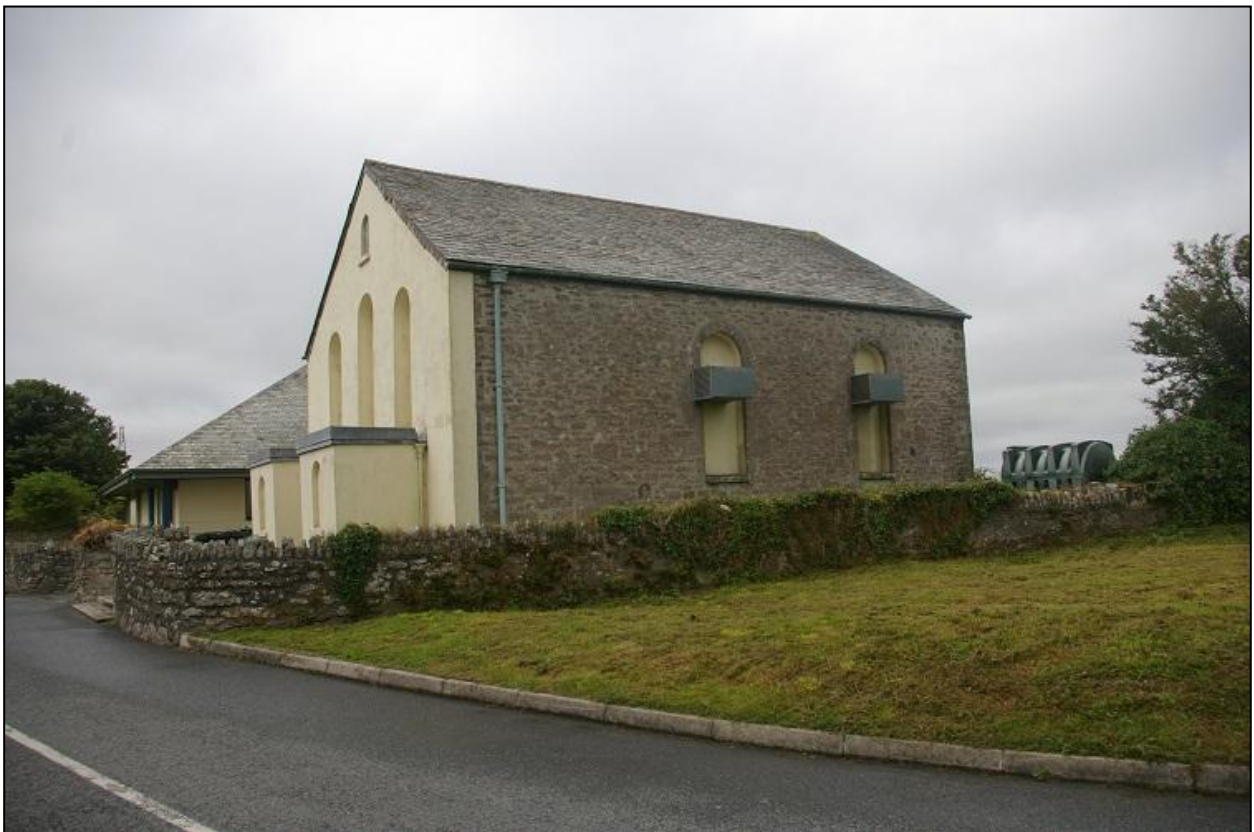
The Ebenezer Methodists Chapel, at Ebenezer, north of Luxulyan, showing its blocked windows and adjoining buildings; from the south-east.

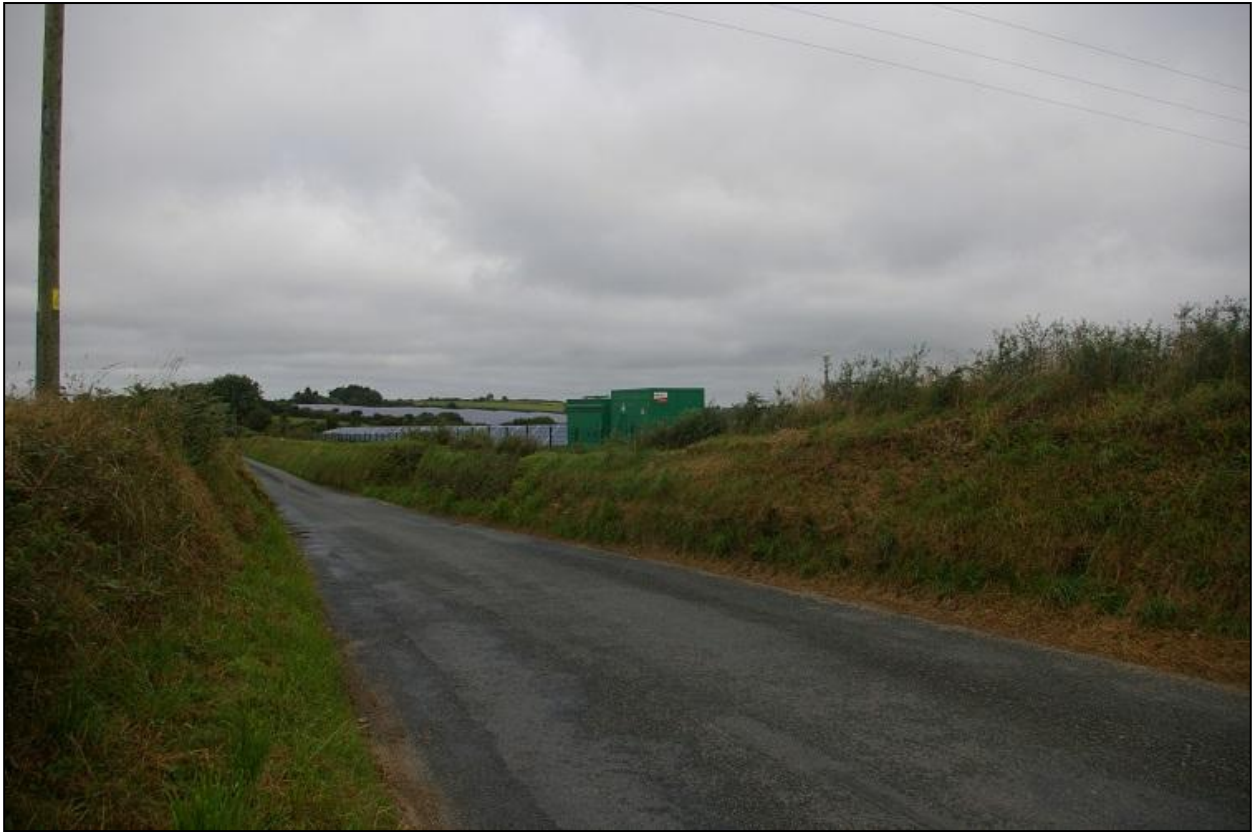
The large solar farm outside Luxulyan, near Bodiggo Farm, east, alongside the main road out of the village; from the south-west.

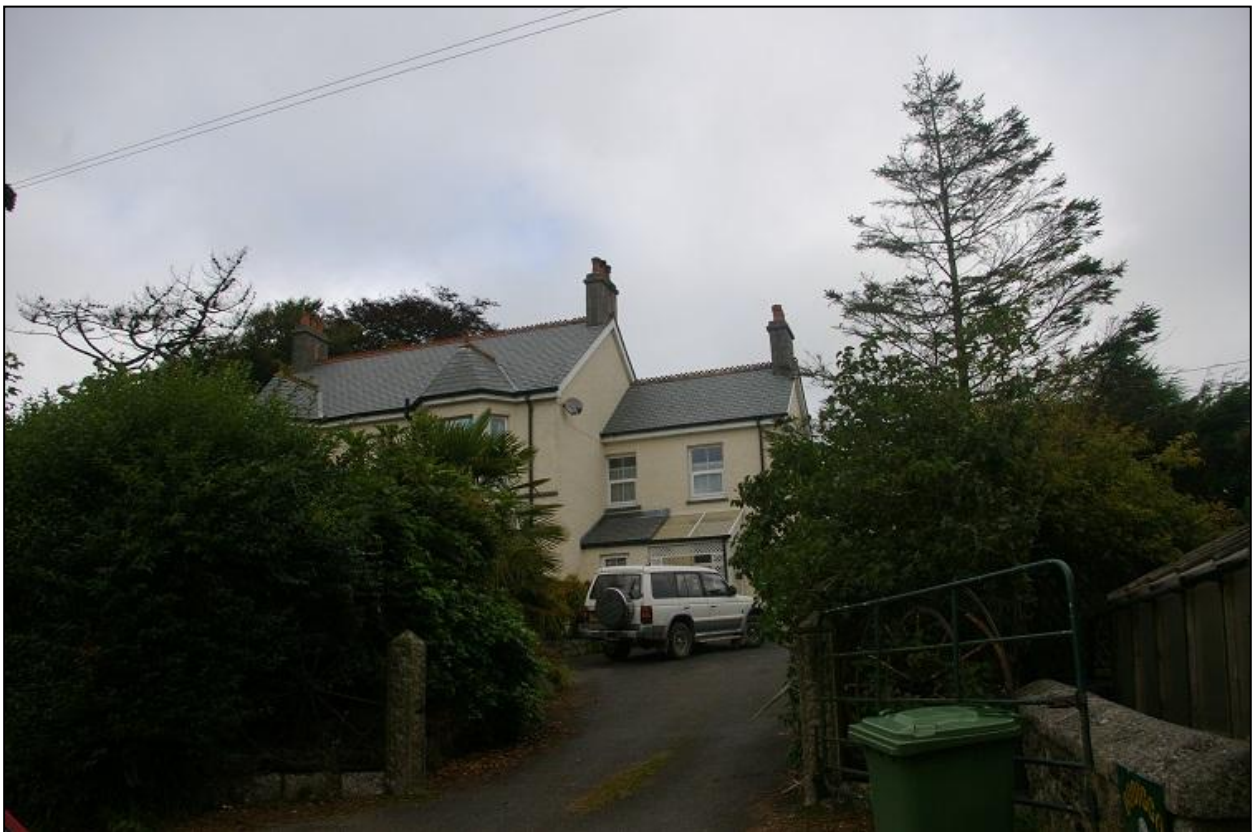
- Bodiggo; medium significance; Grade II Listed; condition: good. Situated just north of the village of Luxulyan, less than 1km from the proposed turbine. Two farmhouses and a range of modern, and historic barns, some having been converted into dwellings. East of the farm there are a number of large, very old conifer trees, and the lane that runs to the west of the farm buildings is lined by hedgebanks topped with mature trees. Just north-west of the farm, even closer than the proposed turbine, is another large wind turbine, and across the road to Luxulyan is a large solar farm. Some views to the turbine may be possible, through the trees, and it would certainly be visible from the farmland. However, the value of farm buildings is rarely defined by its wider setting; the buildings provide a context and setting for one another, which would not be affected by the proposed turbine. However, cumulative impact could be an issue here; impact **negative/minor**.

Bodiggo Farmhouse, with mature hedges to the garden; from the south-east.

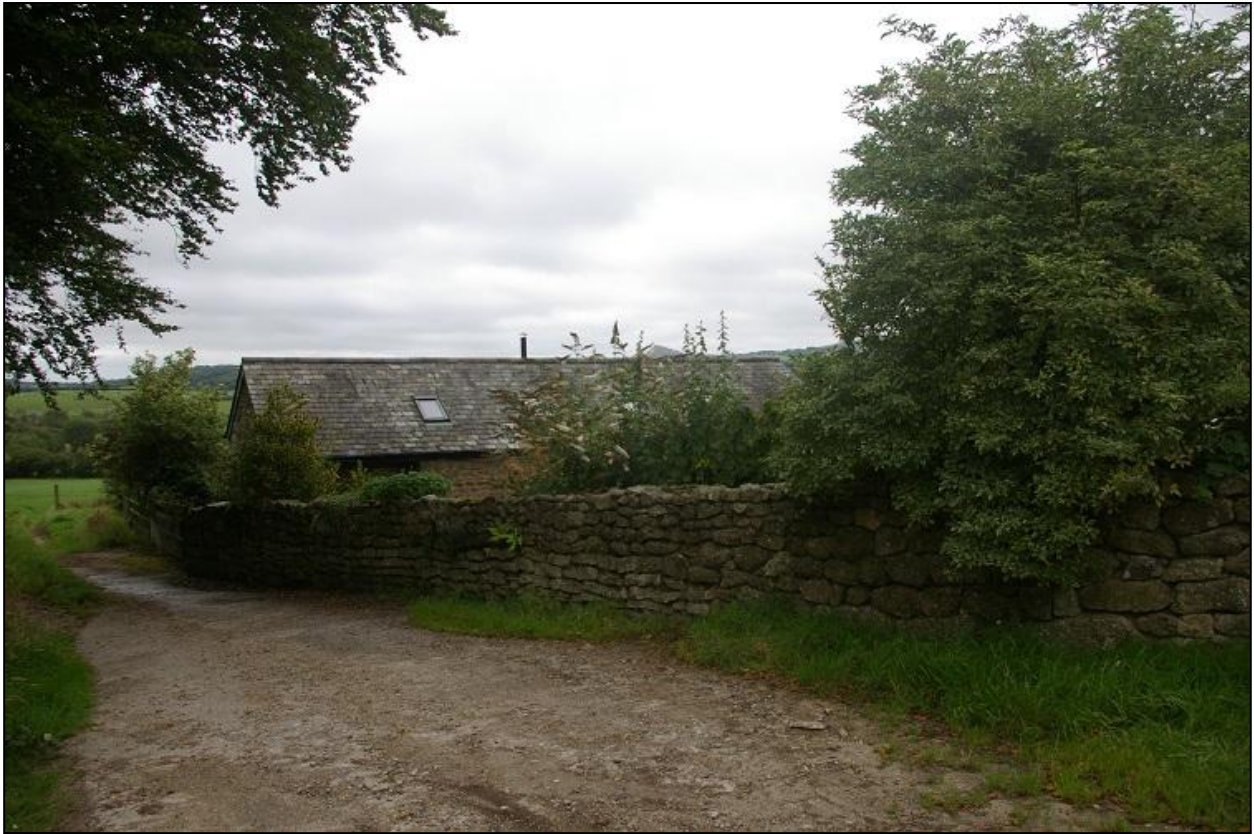
The barns at Bodiggo, in their own walled enclosure, having been converted for residential use; from the north-east.

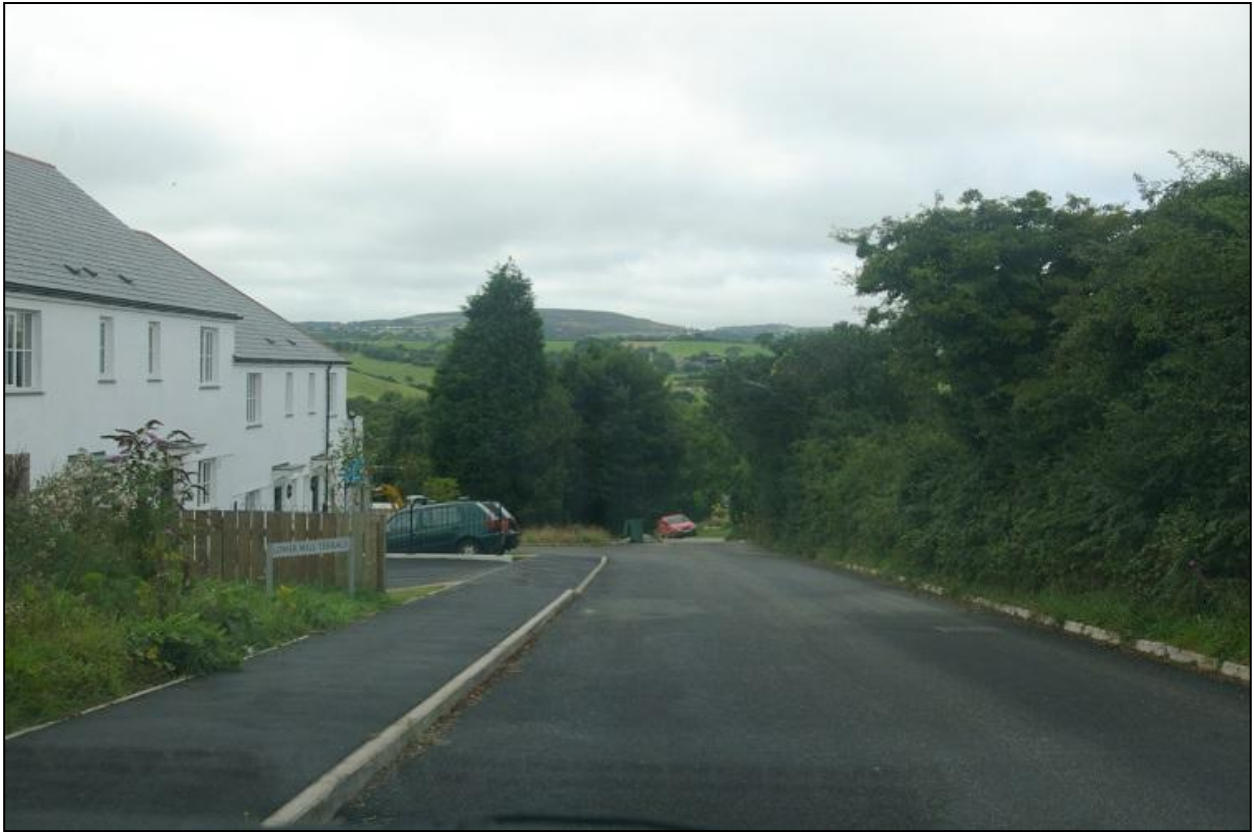
The clay works outside Luxulyan, to the north and adjacent to the railway line, now partially surrounded by a modern housing estate; from the east.

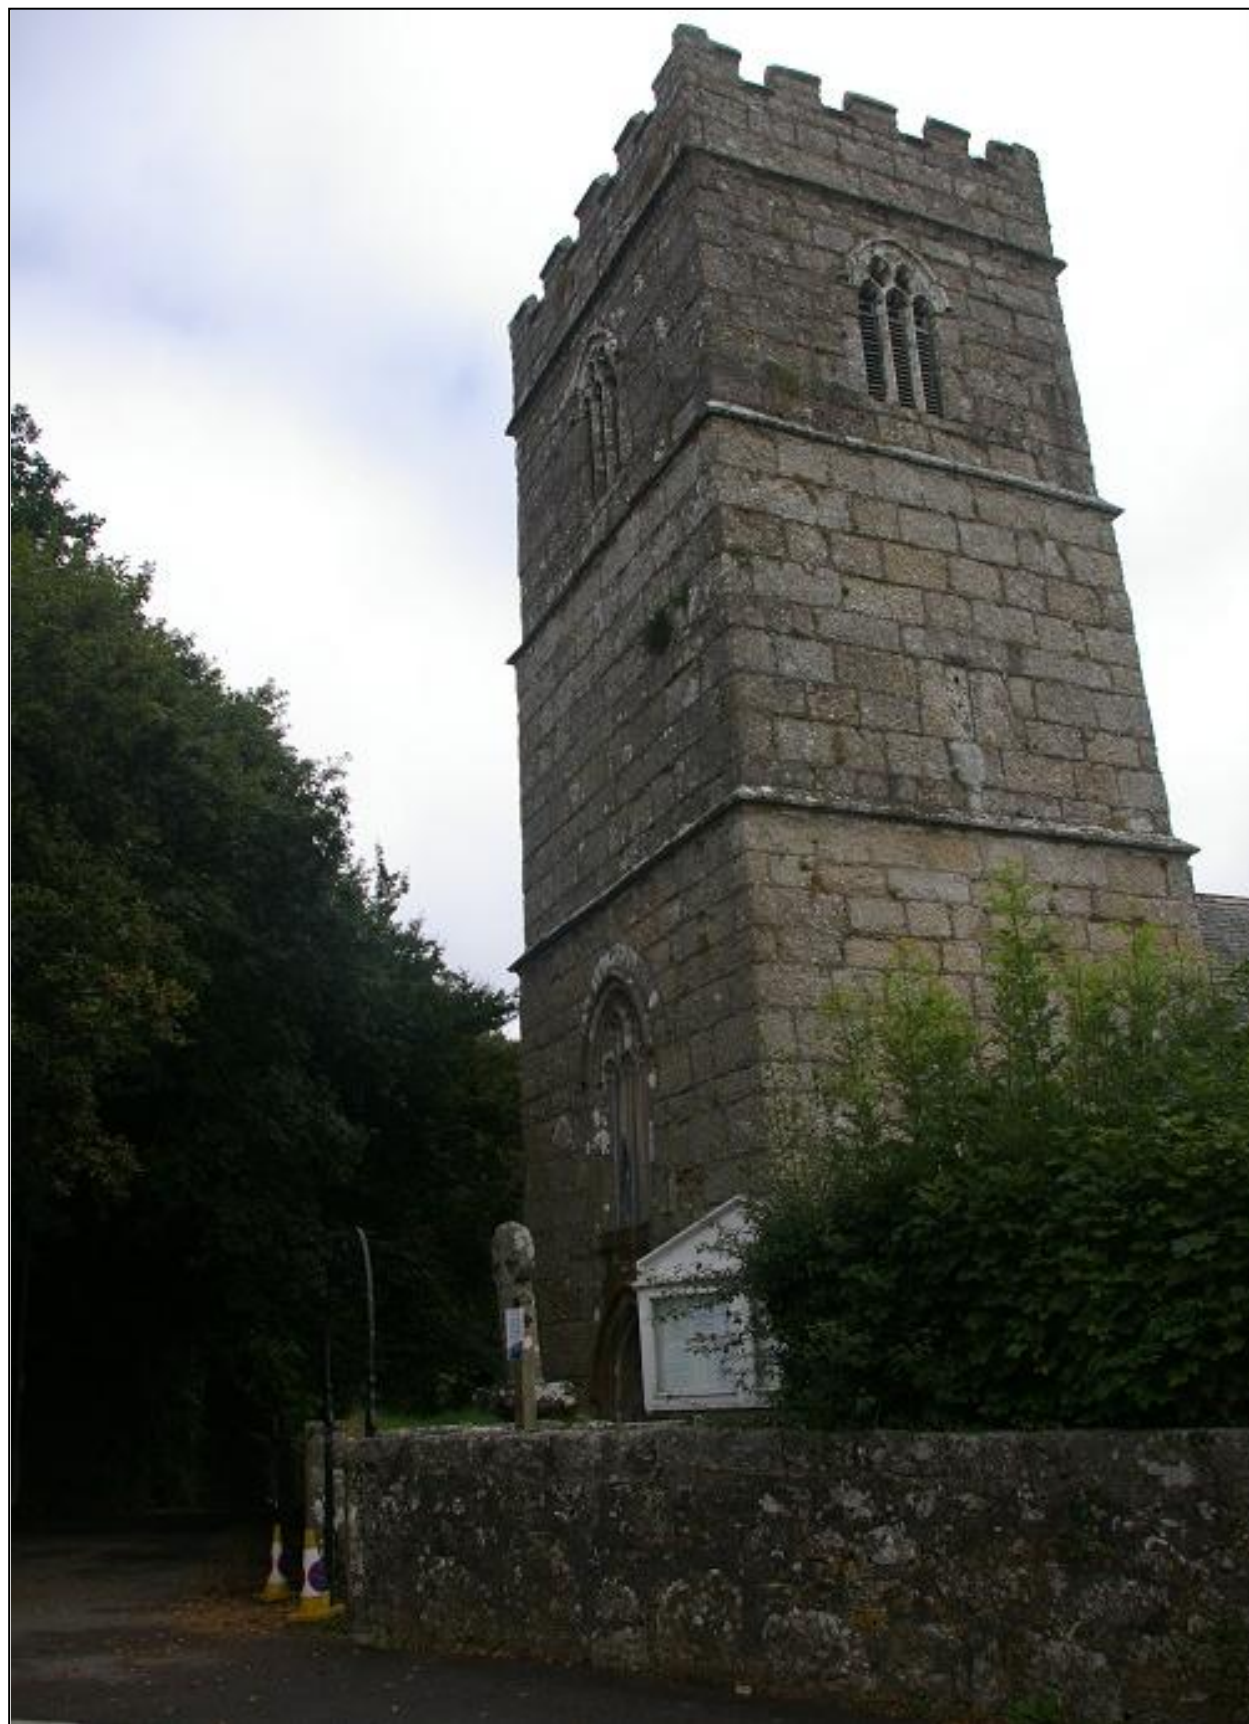
- Church of St Ciricius and St Julitta, at Luxulyan; high significance; Grade I Listed; condition: excellent. Tombchests, Gravestones, Crosses, Gates and other associated features; medium significance; Grade II Listed; condition: mixed, good to fair. The church and churchyard face across a narrow parish road to the heavily-wooded grounds of a large house that sits to the north-west. The block of woodland runs north along the parish road, shielding the church and churchyard from the majority of views towards the proposed turbine. The graveyard is also filled with scatters of decorative shrubs and small trees, with larger ones towards the edges, further shielding any monuments or churchyard crosses from any intervisibility. The church and its graveyard are defined by their relationships to one another, and in turn to the settlement they serve; many historic cottages and buildings surround the church. The tall square tower would have direct views to the wind turbine, but the church is not valued for its views and outlook, but for its architectural merit as an ancient place of worship, and both its exterior and interior fittings. Views to and from church towers are important (see above), as is the interaction between different churches throughout this landscape. This church tower is particularly important, however, as a landmark in a mining landscape due to its cultural associations: the local stannary records were said to have been stored in the tower in the post-medieval period. The proposed turbine would compete for landscape primacy; impact **negative/moderate**.

The church in Luxulyan, a Grade I Listed building, framed to the west, north and east by trees; from the south-west.

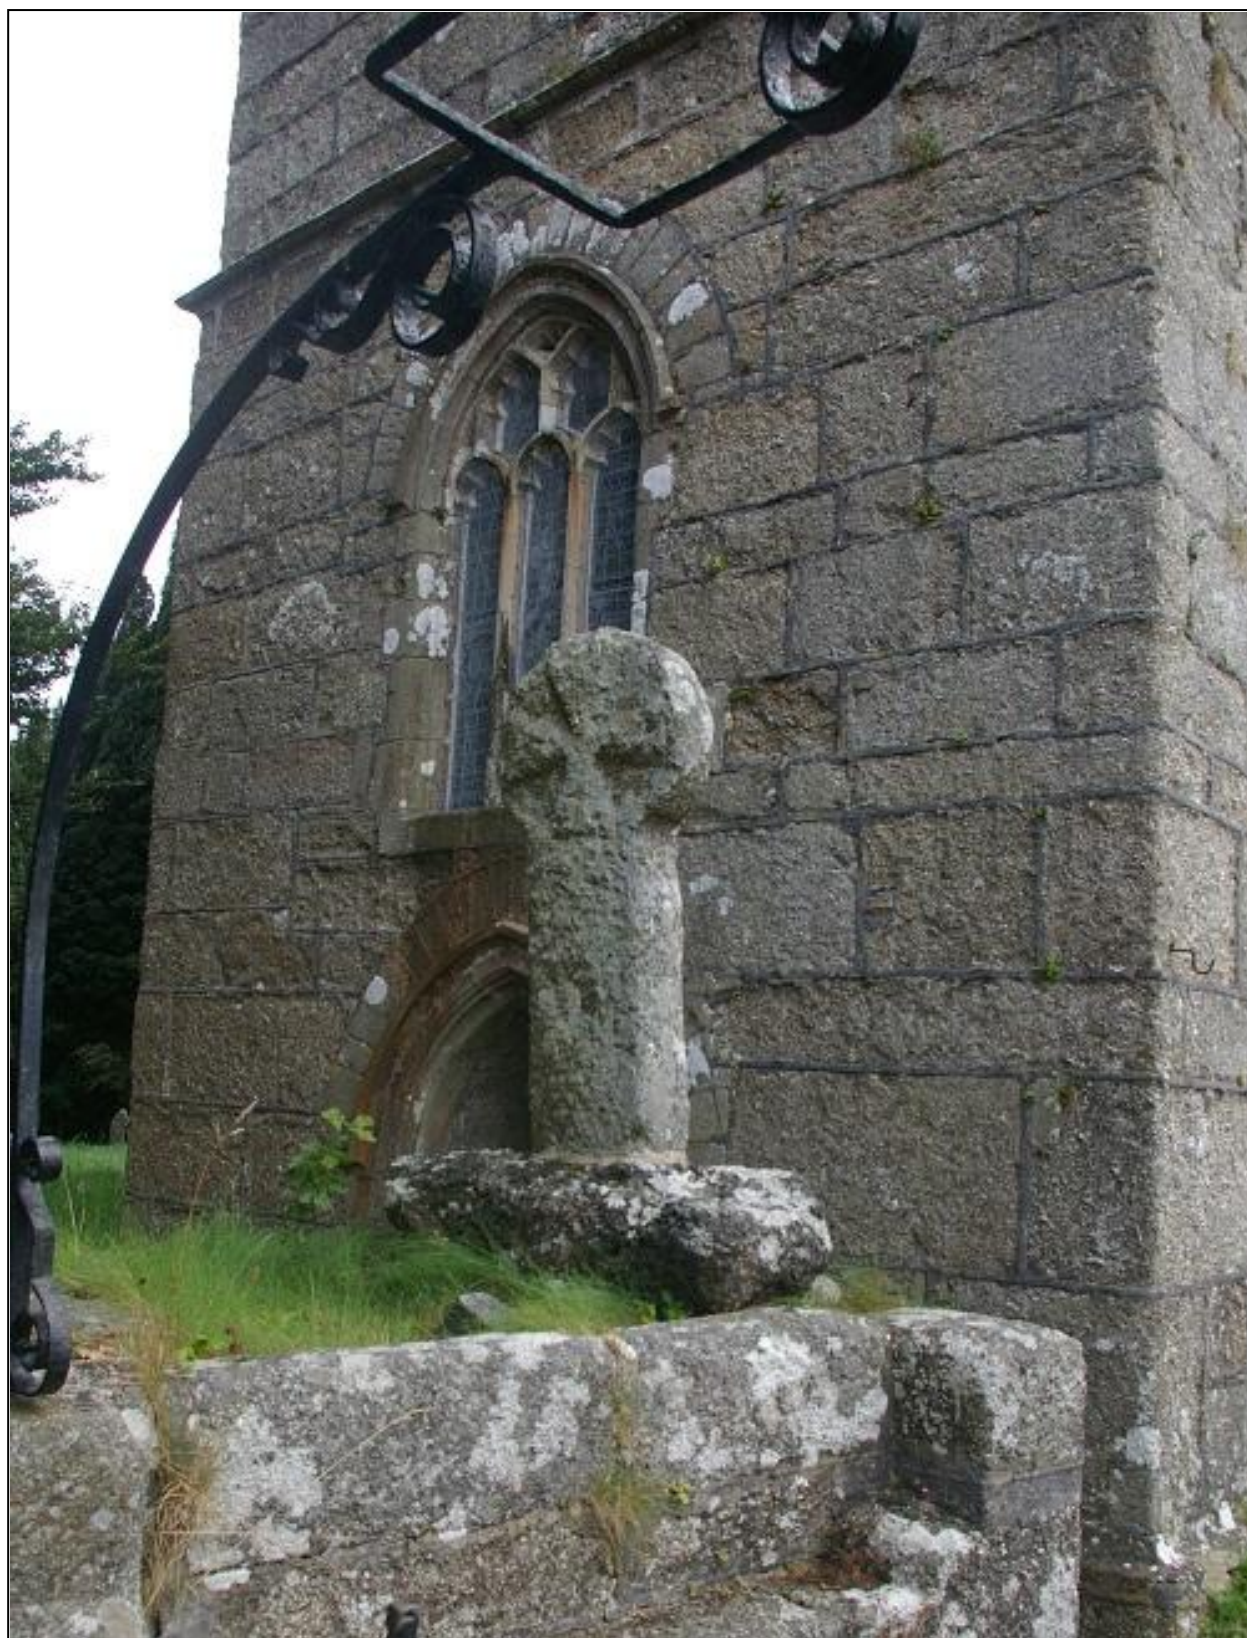
The medieval wayside cross in the churchyard, shielded by the walls of the churchyard, the buildings of the village and the trees; from the south-west.

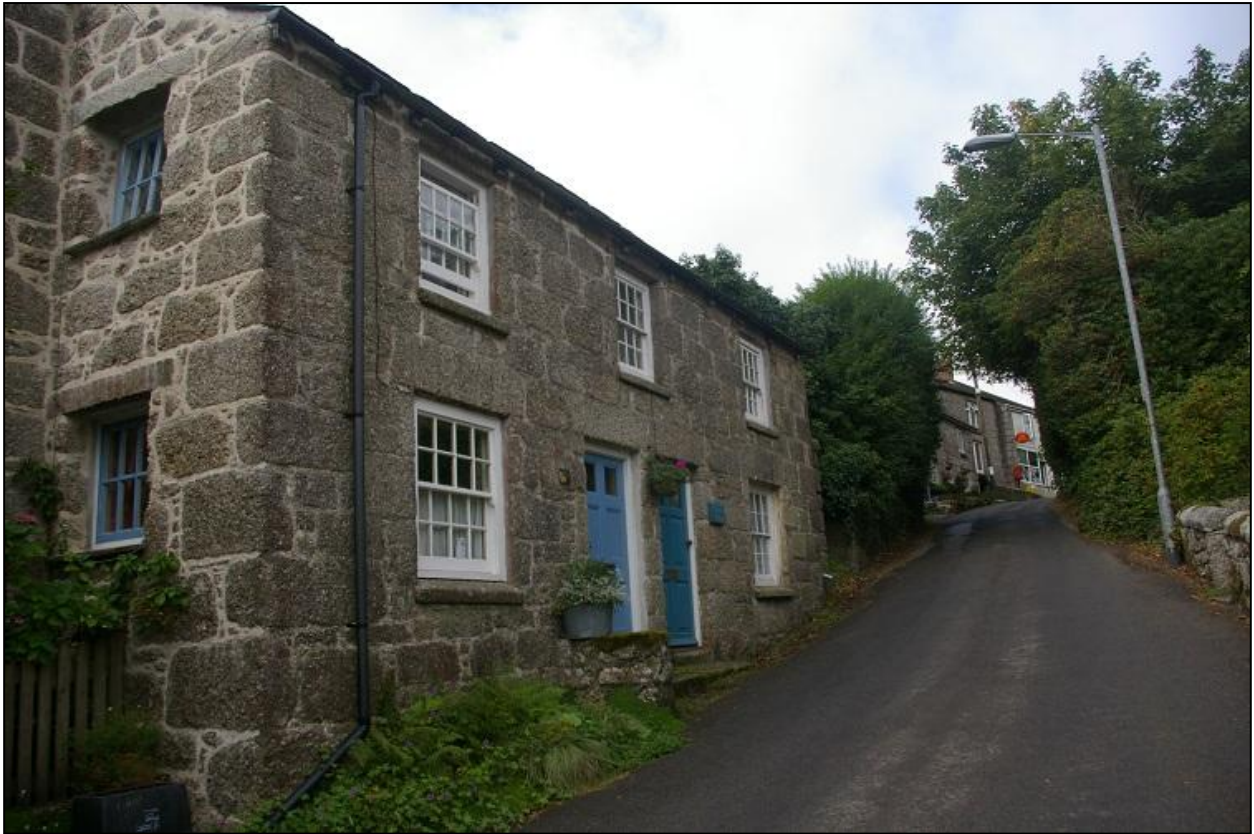
- Primrose Cottage and House attached to right; medium significance; Grade II Listed; condition: good. Set in the shallow valley east of the Church in Luxulyan. Surrounded by the other cottages and buildings in the village and blocked by the mature trees. The ground rises to the west and north, and the church and other village buildings also block any views; impact **neutral**.

Primrose Cottage, east of the church, local blocking from other houses and buildings in the village; from the south-east. .

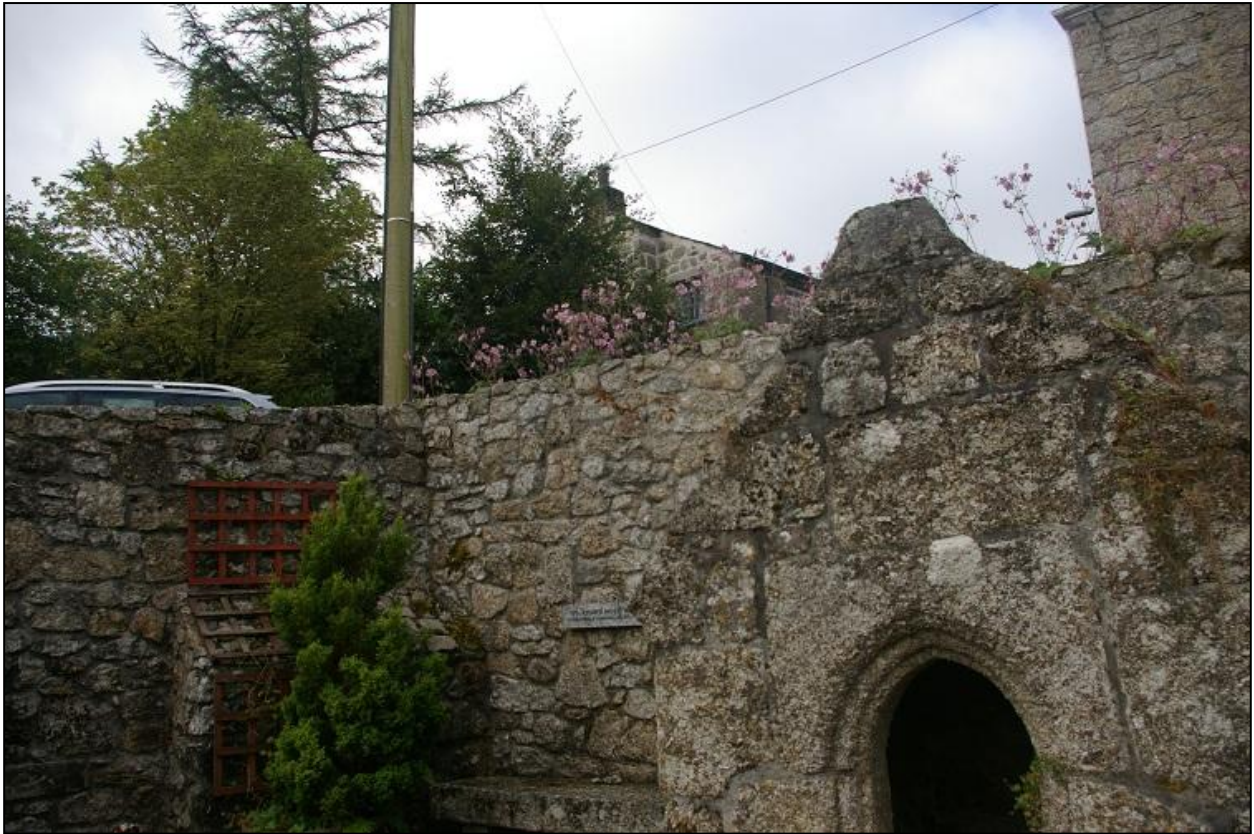
View from within the sunken stone enclosure that contains the small arched well house building, showing no views to the north or the west, only limited views to the east and south; from the east.

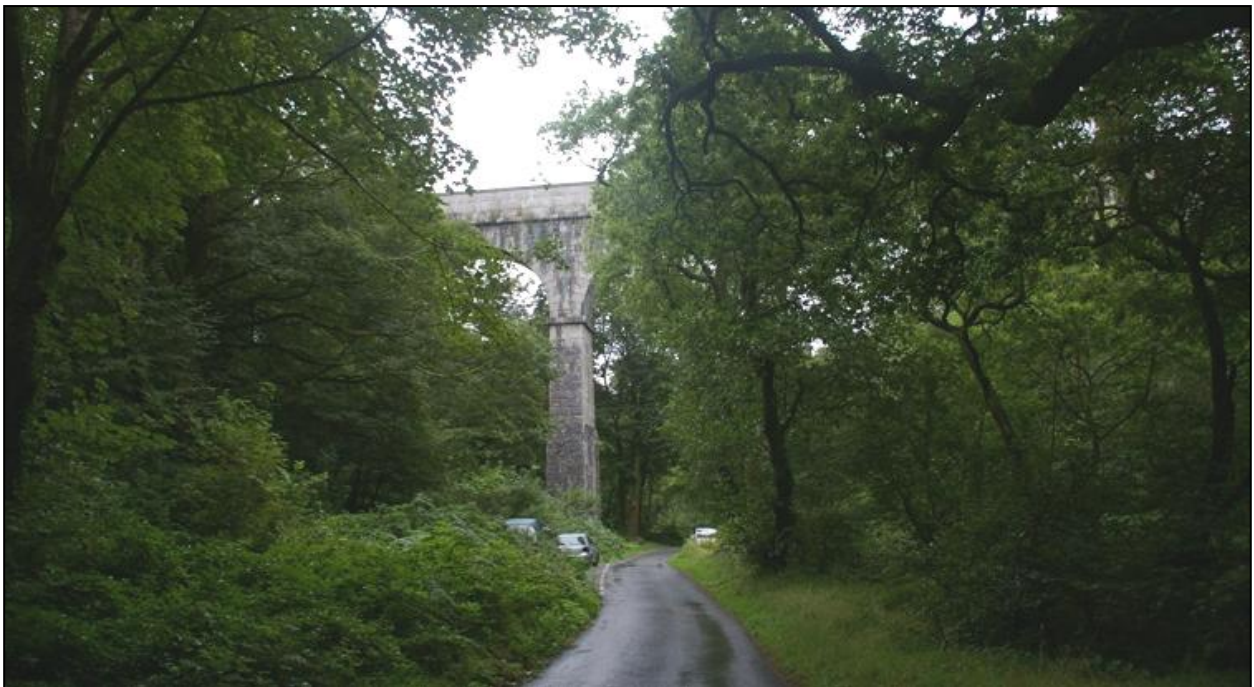
The Treffry Aqueduct within the Luxulyan valley, surrounded by the trees of the valley; from the north.

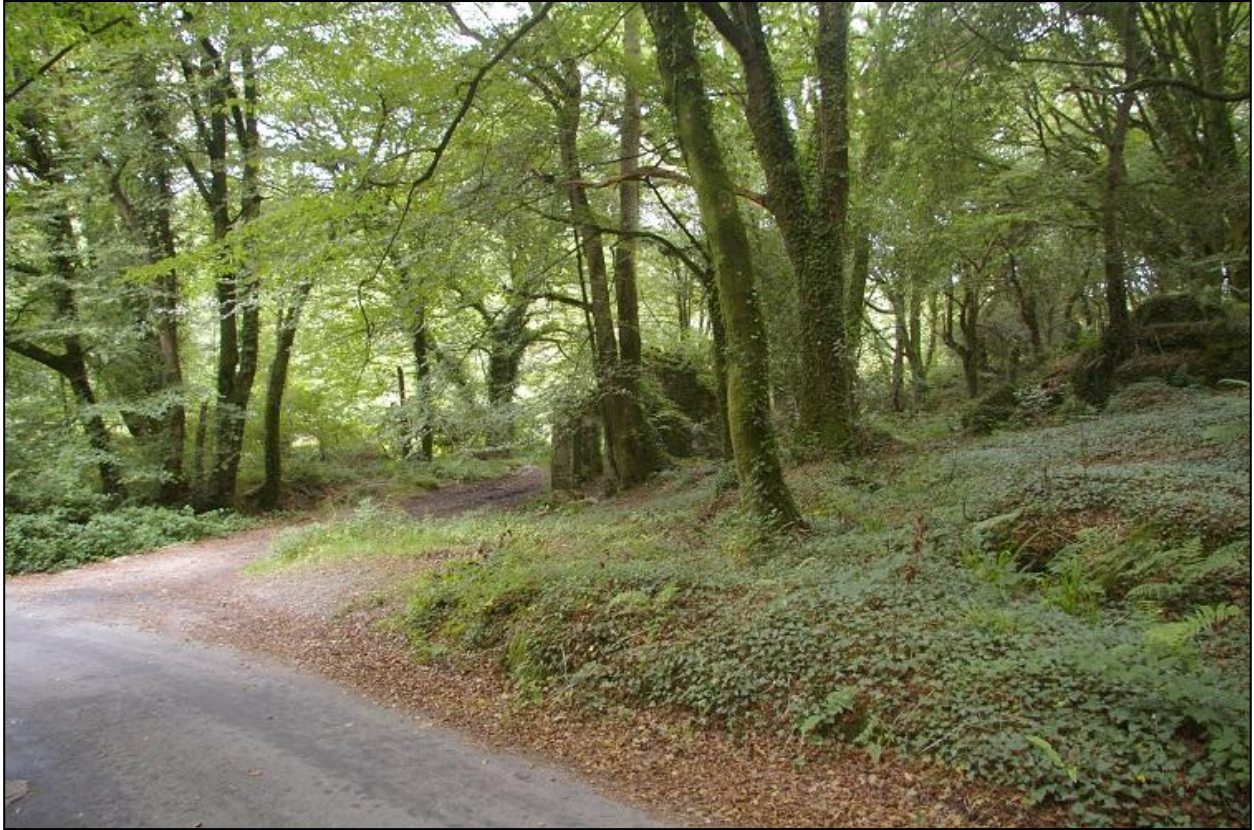
The remains of the mine buildings that line the valley are shielded from any impact by the trees that dominate the area; from the west.

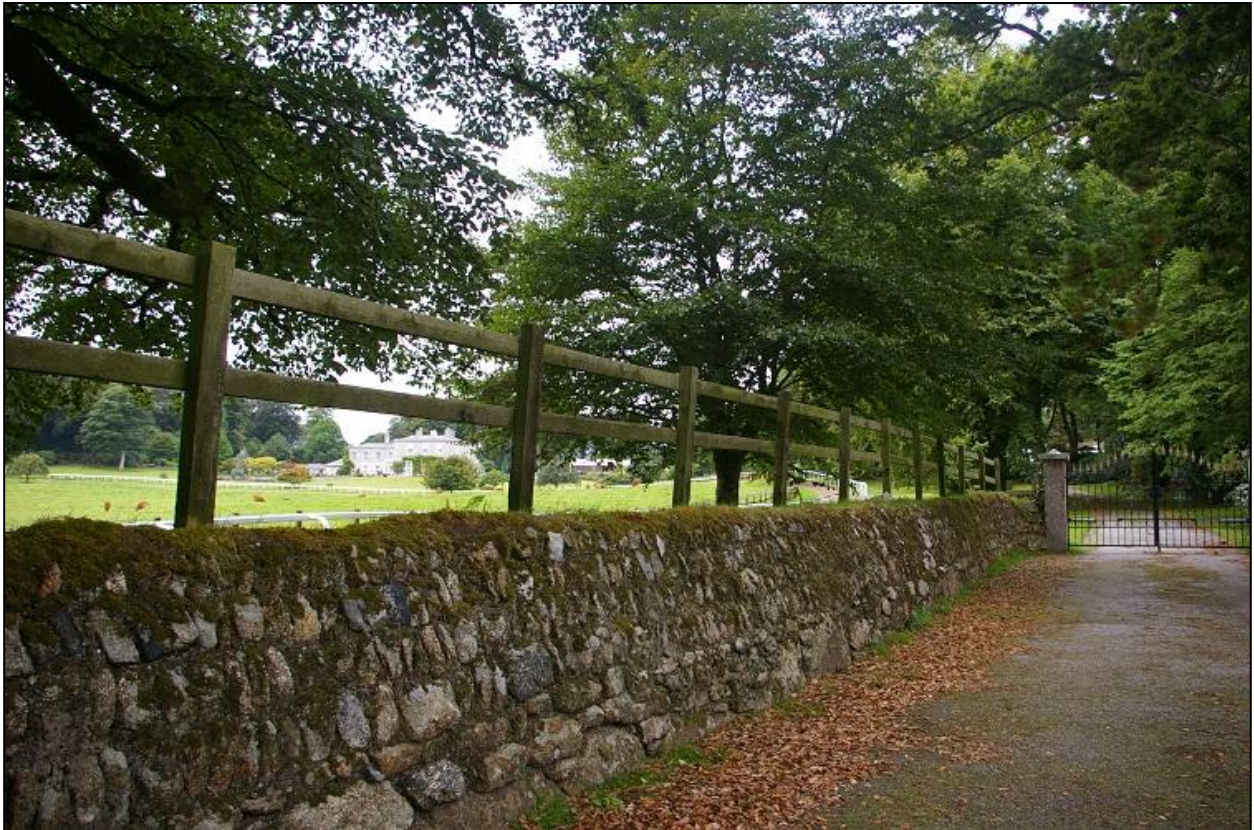
condition: excellent. A country house in landscaped parkland, which lies mostly to the south, with banks of trees to the north and agricultural farmland beyond. There would be some views towards Luxulyan and the proposed turbine, although these views would be limited by the topography of the hill. Despite these restricted views, the impact on the house should be **neutral**, as it takes its setting from its landscaped grounds. We would still understand the house as an important gentry residence, with its associated service and outbuildings and home farm, which all lie to the north and north-east along the parish road. Setting, context and understanding would be largely unaffected; impact **negative/minor**.

Prideaux House, which lies south of the turbine and to the west of the Luxulyan valley at its southern end. The house sits in its landscape parkland and there is no impact from the turbine; from the south-east.
