LAND at LESTOON FARM, LUXUYLAN, CORNWALL

Results of a Desk-Based Assessment
Walkover Survey, Geophysical Survey &
Historic Visual Impact Assessment

Report No.: 130907
Date: 07.09.13
Authors: B Morris
E Wapshott

This report presents the results of a desk-based assessment, walkover survey, geophysical survey and visual impact assessment carried out by South West Archaeology Ltd. (SWARCH) on land at Lestoon Farm, Luxulyan, Cornwall, in advance of the construction of a single 500kw wind turbine.

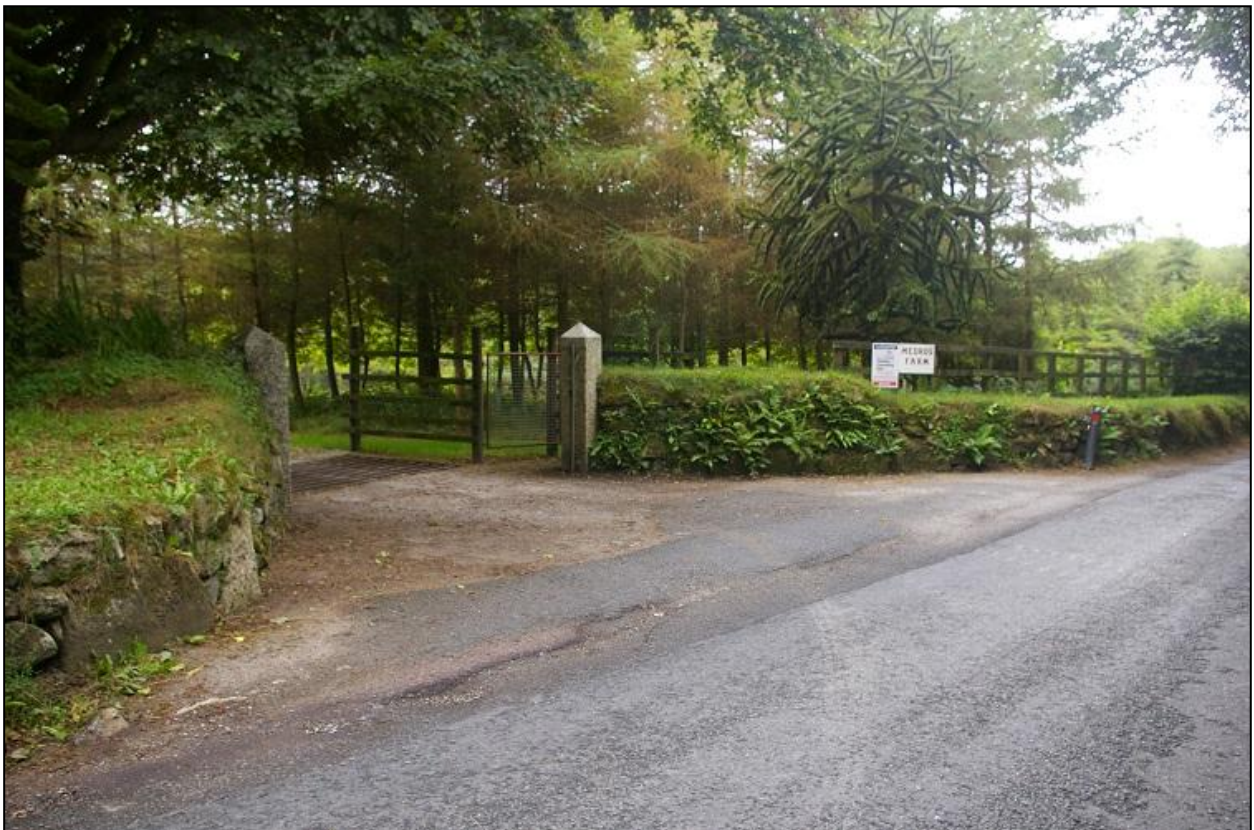
- Medros Farmhouse and Methrose Farmhouse, attached walls and courtyard; high significance; Grade II* Listed; condition: unknown. Located down a long private drive off a busy road; trees have been planted around the entrance and along the field edges, restricting vehicle noise and views. From the nearest point of public access the land was observed to slope gently to the top of Luxulyan valley, and thus it is possible these buildings would have some views to the turbine. These are farmhouses, and not necessarily constructed with long views in mind; they are currently defined by their association with the land-holding, their barns and agricultural buildings, and those buildings may provide local blocking. The buildings are Listed for their architectural merit – in this case very high – and their surviving fittings and former functions; impact **negative/unknown**, but probably **negative/minor**.

The wide gateway to the private drive down to Medros Farmhouse, showing the small plantation of trees that block views to the farm; from the north-west.

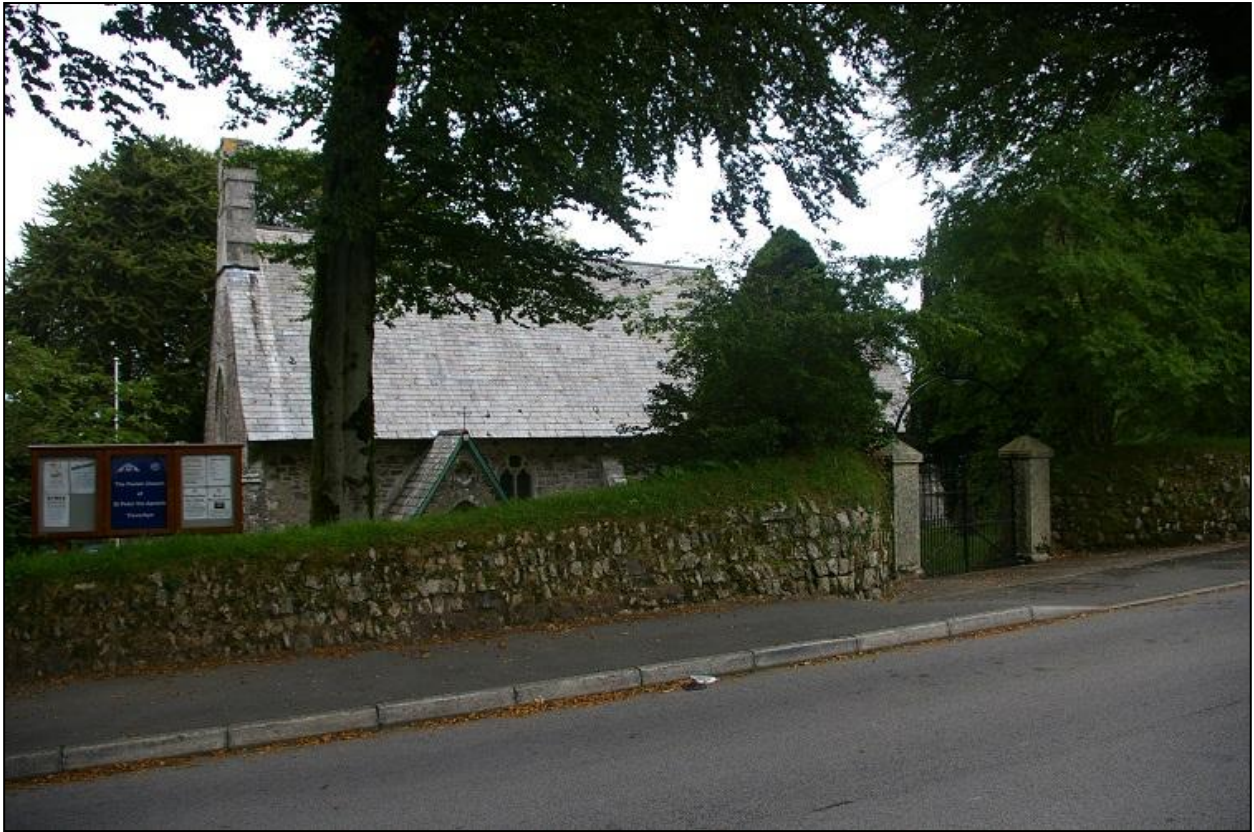
- Church of St Peter, at Treverbryn; medium significance; Grade II Listed; condition: good. Set in a heavily-wooded churchyard, this is a small 19th century church without a tower. The churchyard is enclosed by a wall, and the trees add to the introverted nature of the enclosure. Significant local blocking is provided by two houses built to the north of the church, and the school that stands to the north and east. The setting and context of the church remains unchanged at the heart of the community; impact **neutral**.

The small 19th century church of St Peter, showing it surrounded by trees; with no views out to the surrounding countryside; from the south.

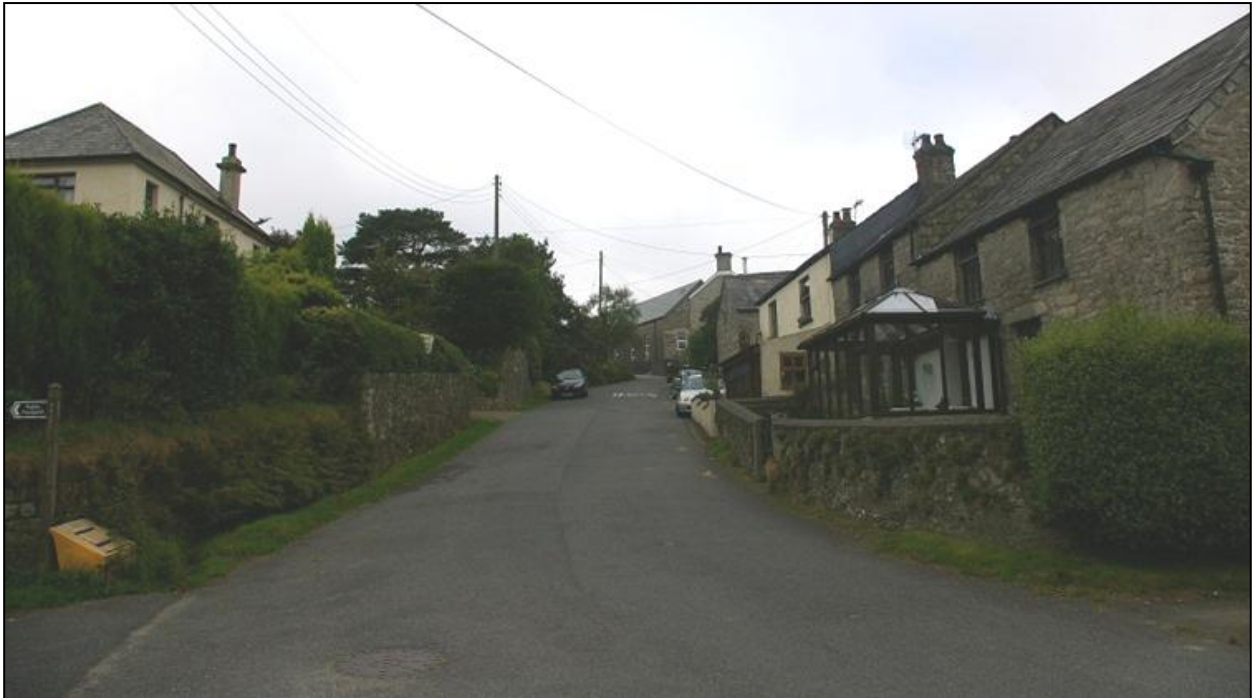
- Rescorla Farmhouse and cottage; medium significance; Grade II Listed; condition: good. Located in the small settlement of Rescorla, the farmhouse and cottage lie close to the centre of the hamlet, surrounded by other stone-built buildings. Set on a high knoll of land, the farmhouse will most definitely have some views across to the north-east to the turbine. There are already a number of operational turbines in the area, and these are also visible from the farmhouse. The farm has a large range of buildings, and the cottage also enjoys local blocking from the other buildings in the settlement. Impact **negative/minor**.

View up the main street in the small settlement of Rescorla, showing to the left, the farm house and to the right the cottages; from the east.

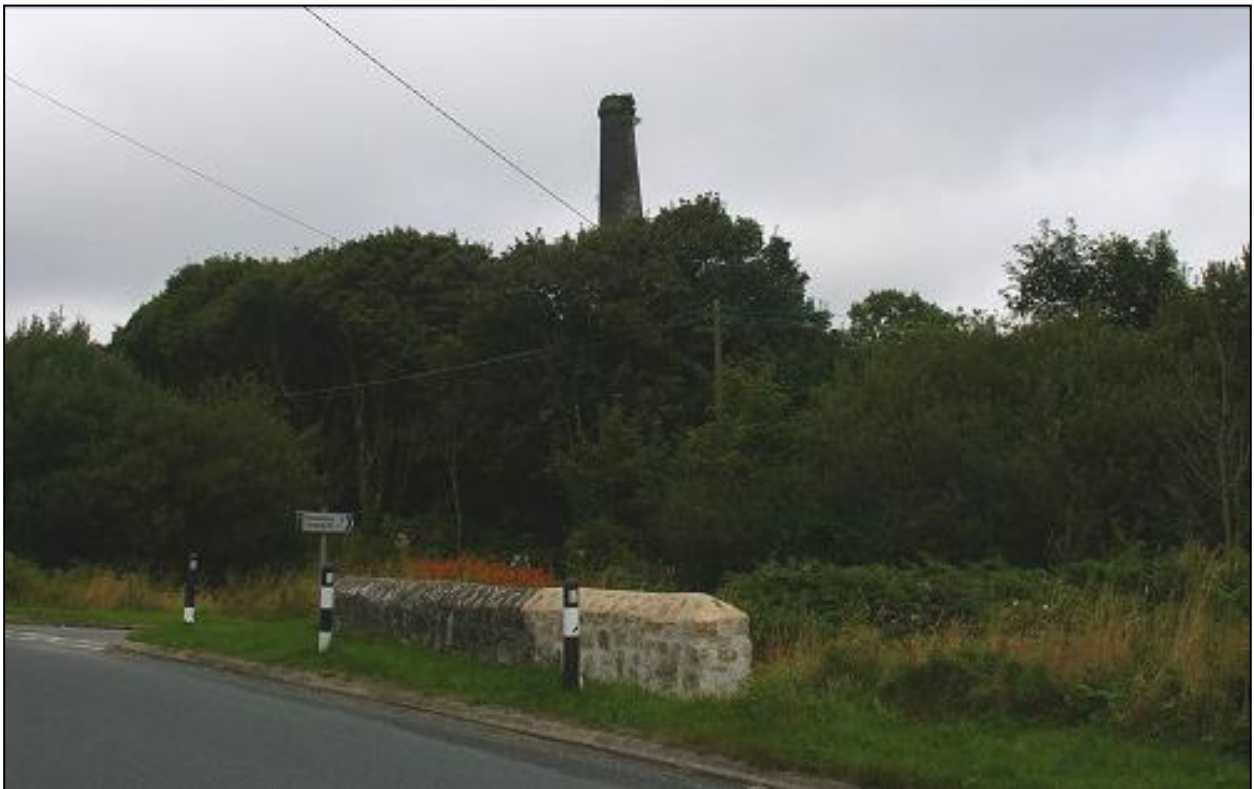
The top of one of the kiln chimneys, showing above the trees; from the south-west.

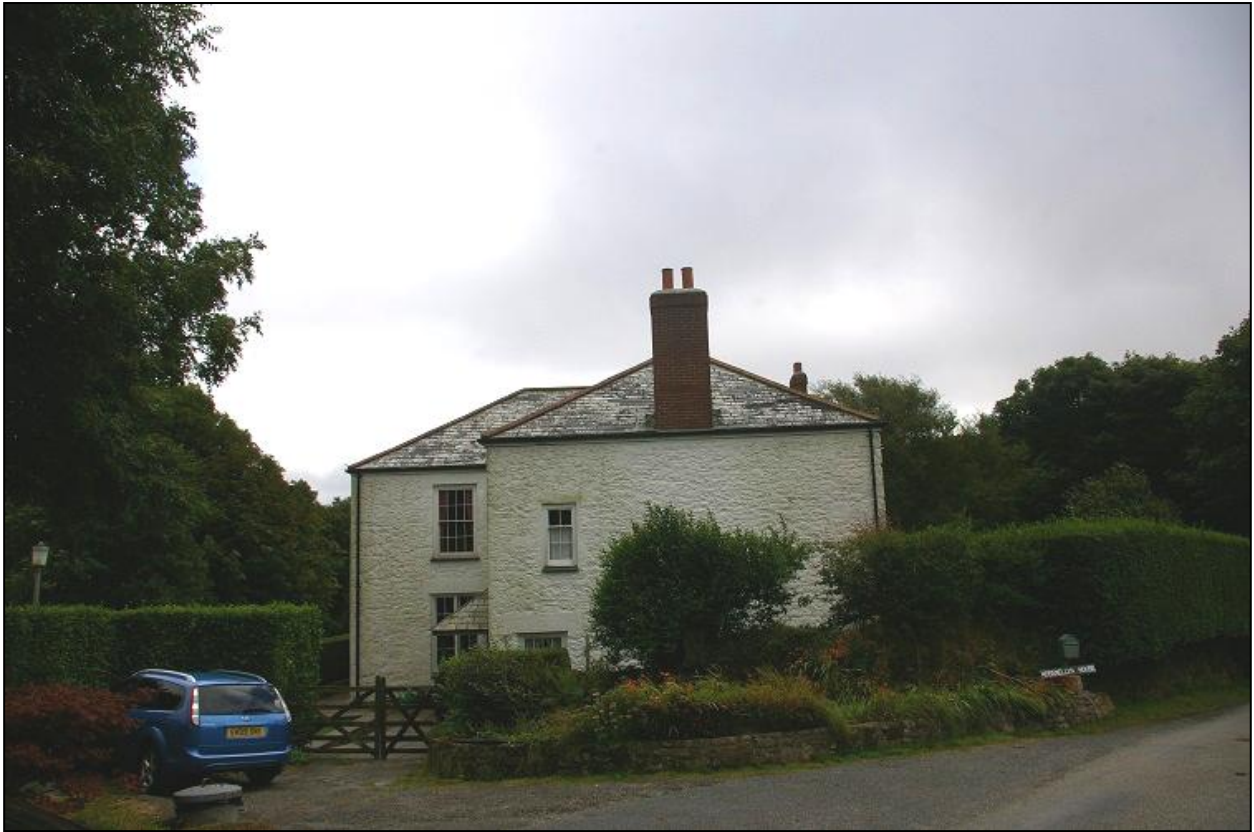
- Rosemellyn Farmhouse; medium significance; Grade II Listed; condition: good. Located within the heavily-wooded landscape of the various clay works, comprehensive local blocking is provided by these woods. The various industrial structures to the south also provide an element of local blocking; impact **neutral**.

Rosemellyn Farmhouse, set in the woodland, between and around the various clay works and adjacent to the Rosemellyn Clay Works; from the north.

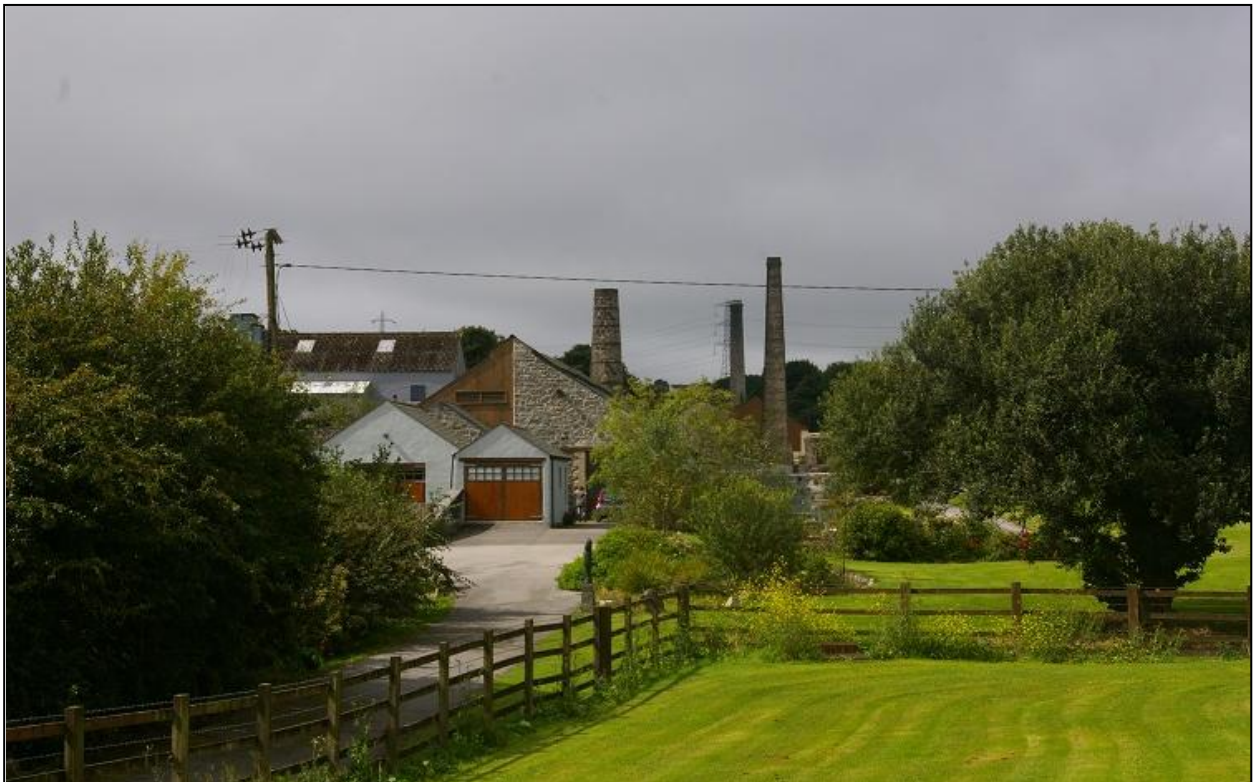
View west along the valley north of the main china clay quarries, along the road between Bugle and Roche. All of the various china clay works, brick works and kilns provide each other with a cohesive context, also being shielded by the trees of the surrounding woodland; from the east.

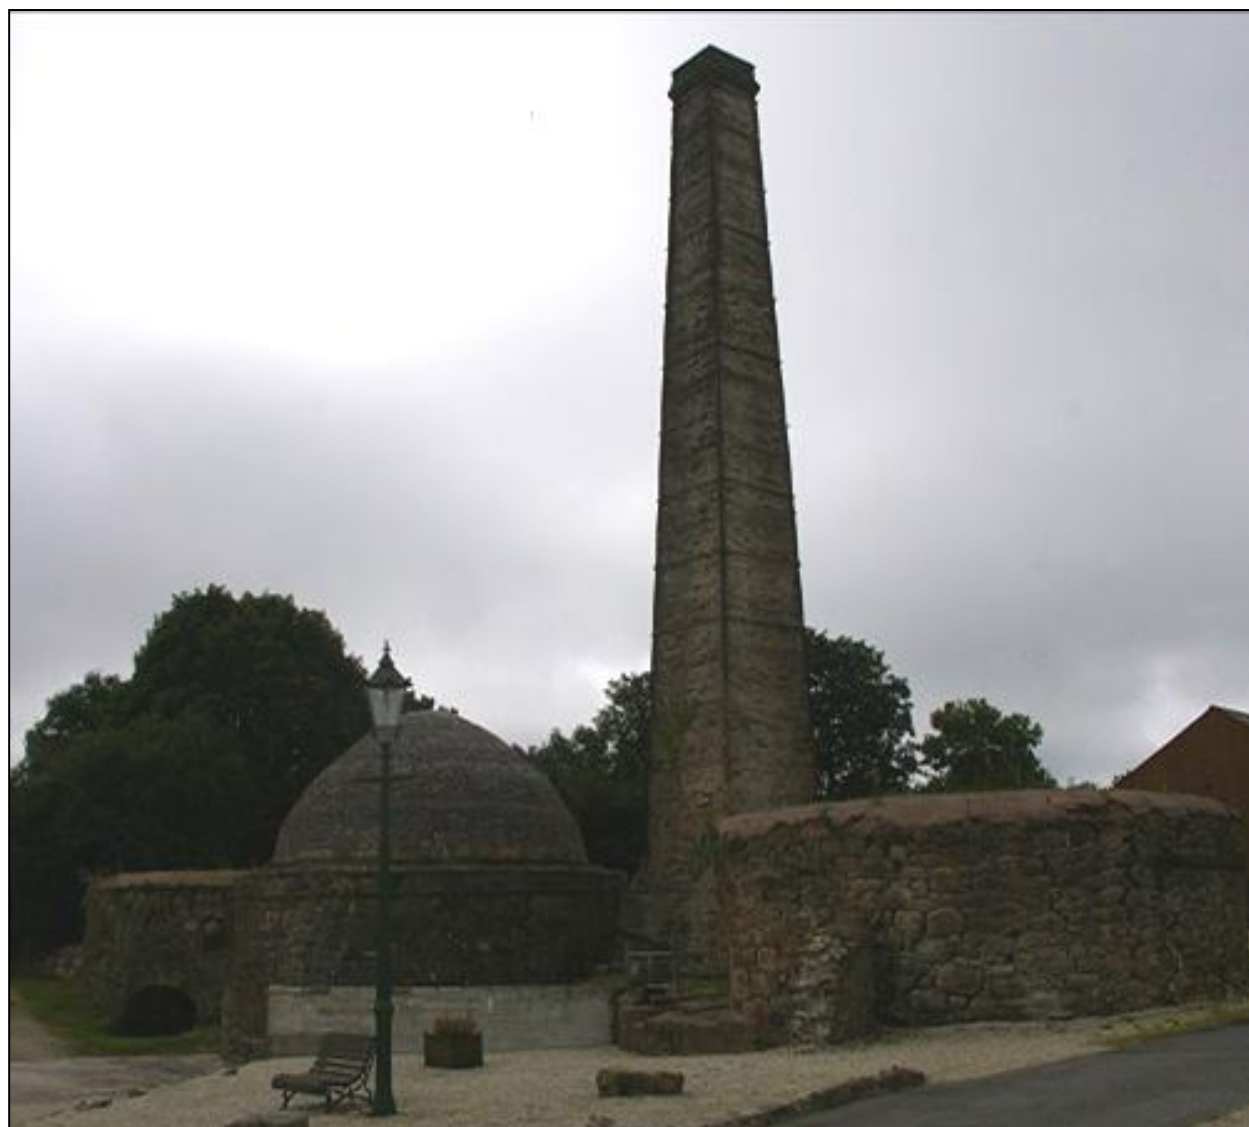
The Carbis Brick Works, with beehive kilns and chimney; from the north-east.

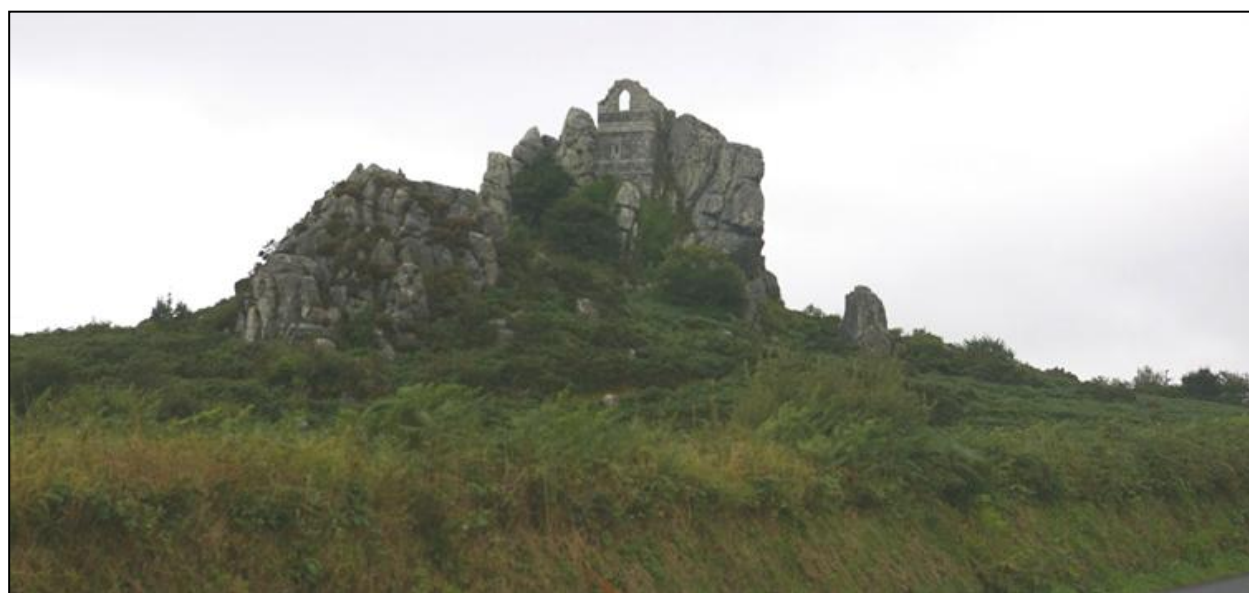
The medieval chapel of St Michael, at Roche, set into the high rocky outcrop; from the north-east.

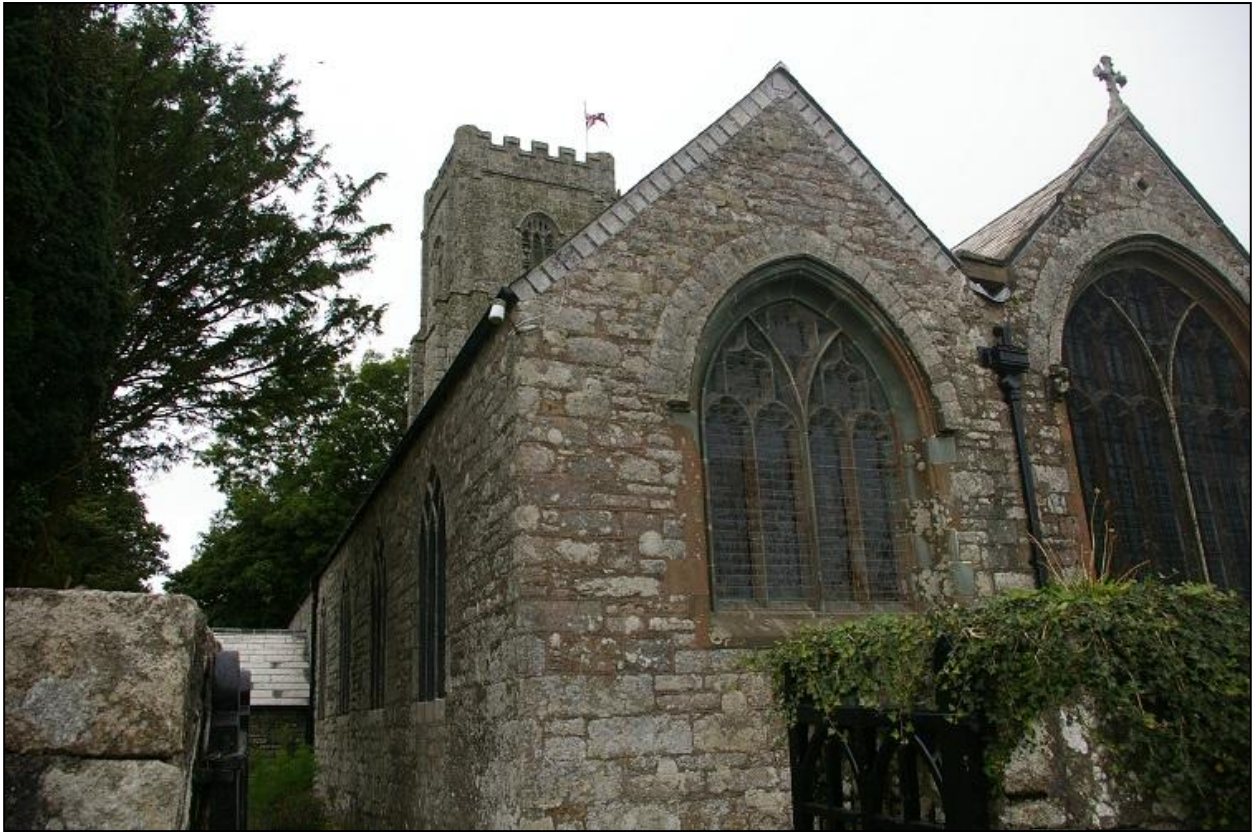
- Church of St Gomonda, at Roche; high significance; Grade II* Listed; condition: good. The churchyard includes monuments, crosses and churchyard features; all medium significance; Grade II Listed structures; condition: mixed, generally good. Set in a heavily-wooded churchyard, but one that is open to the east, within a walled enclosure framed by the main road on the eastern side. Opposite the church, to the south-east, lies the village war memorial, with a playground and then the open countryside beyond. A line of large electricity pylons runs south-east of Roche, but the most obvious intrusive elements in this landscape are the large china clay quarries and spoil tips; the tips provide comprehensive local blocking and severely diminish the potential impact of the proposed turbine; impact **neutral**.

The Church of St Gormonda, a Grade II* Listed building in Roche; from the south-east.

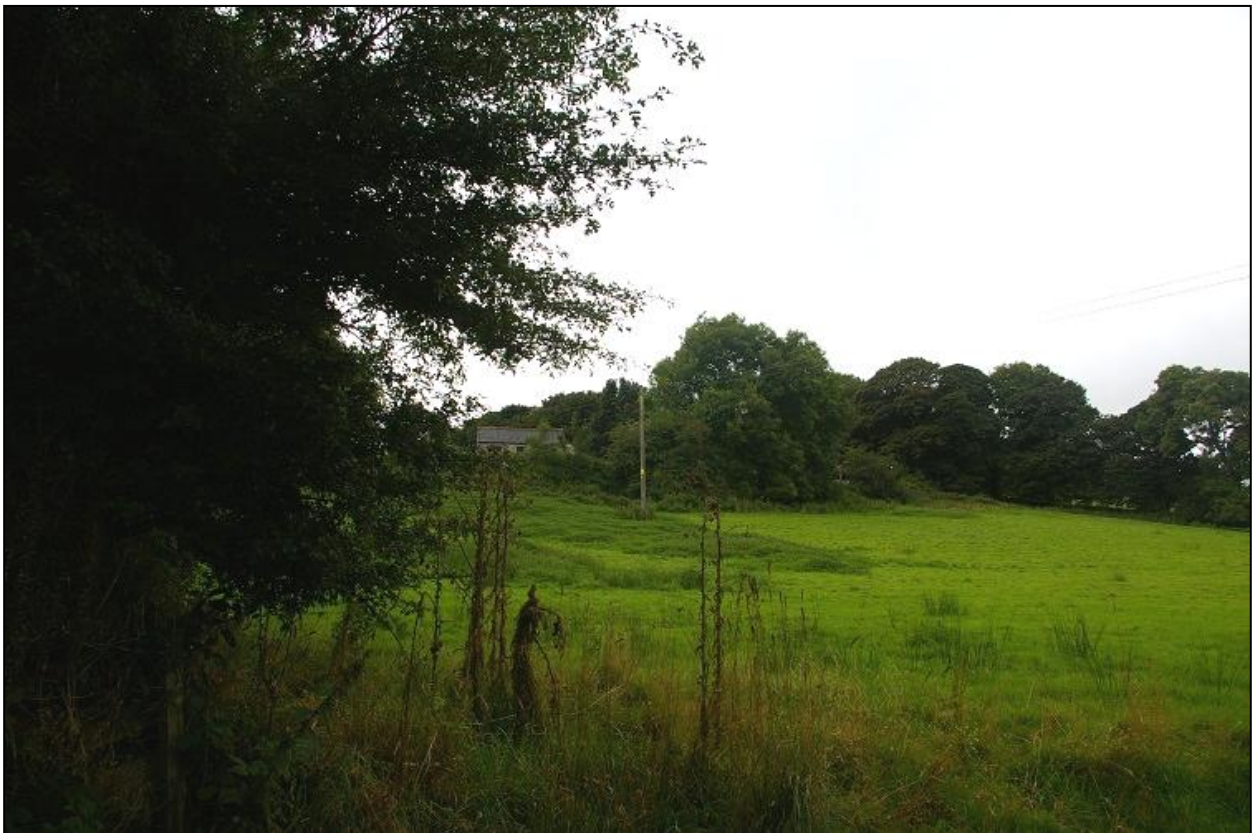
- Barn east of Great Lavrean Farmhouse; medium significance; Grade II Listed; condition: unknown. Located on a hill, facing towards the proposed wind turbine site, the farm is surrounded by thick stands of mature trees. There is a break in the trees around the farmhouse, but this is not Listed. The barns lie to the east; they were not designed for their views, which have little relevance to their value, being Listed for their local

Views up to the barns set into the trees at Great Lavrean Farm; from the south-east.

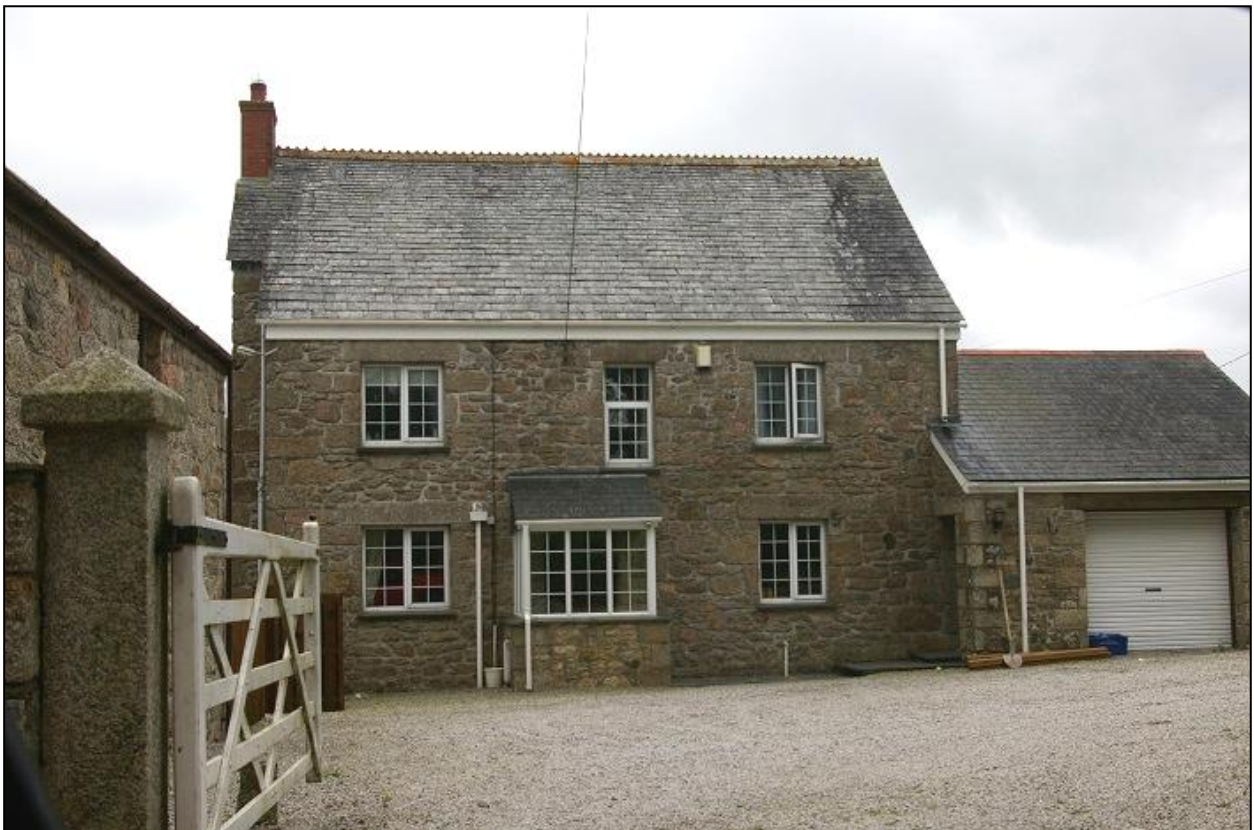
- Trevillyn Farmhouse; medium significance; Grade II Listed; condition: fair, but converted. Terraced into an east-facing slope, the farmhouse has some views to the south and to the south-west, limited by rising ground to the south of the building. The house and barn have been newly converted, but still provide the context and setting to each other. This age of house was built with larger windows to light the rooms, and views were considered more important. For a farmhouse, however, its primary function was agricultural, and thus the contribution of its wider setting to its value is more limited. It is Listed for its architectural merit, and that would not be affected by the proposed turbine; impact **negative/minor**.

Trevillyn Farmhouse, showing the excellent condition of the newly restored building, with a barn to the west converted to a garage and another barn to the east; from the north.

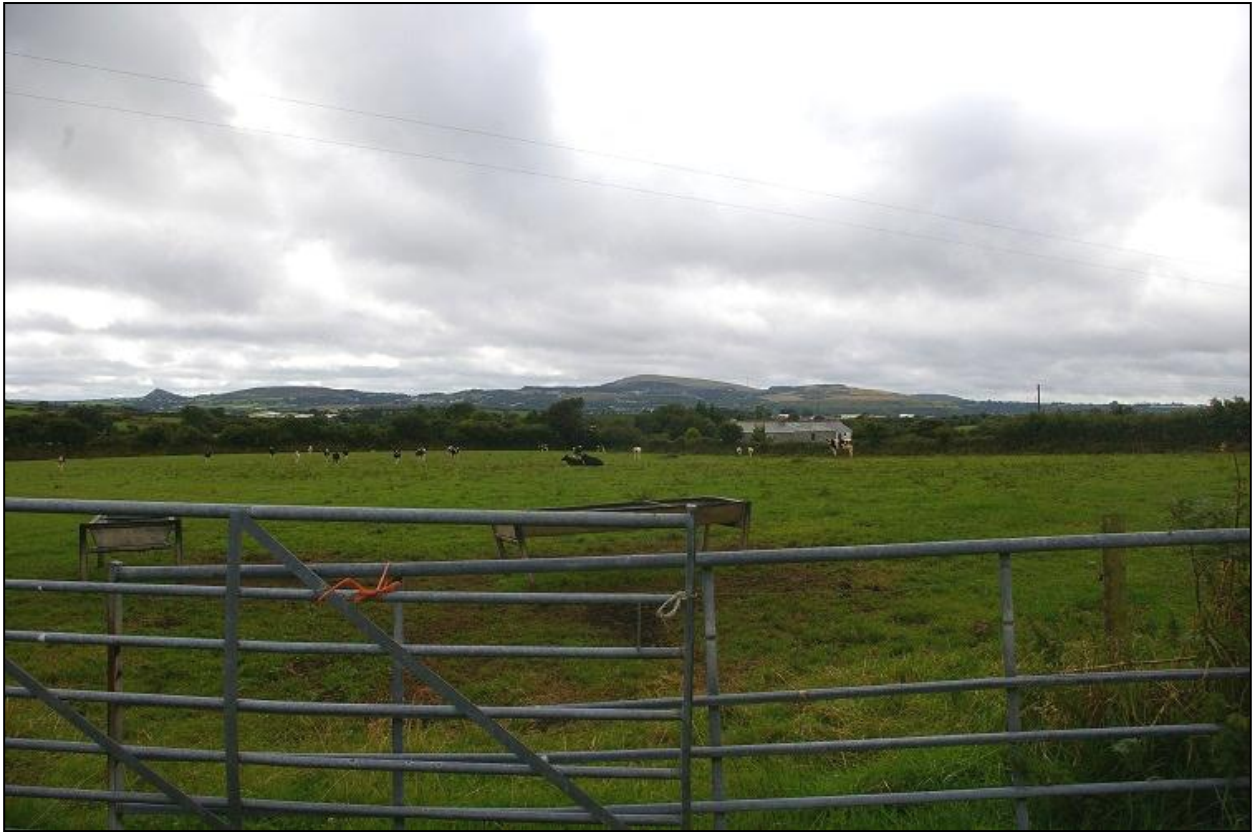
Views towards the proposed turbine location from a gate just above Trevillyn Farmhouse, confirming views from the general area of the farmhouse; from the north-east.

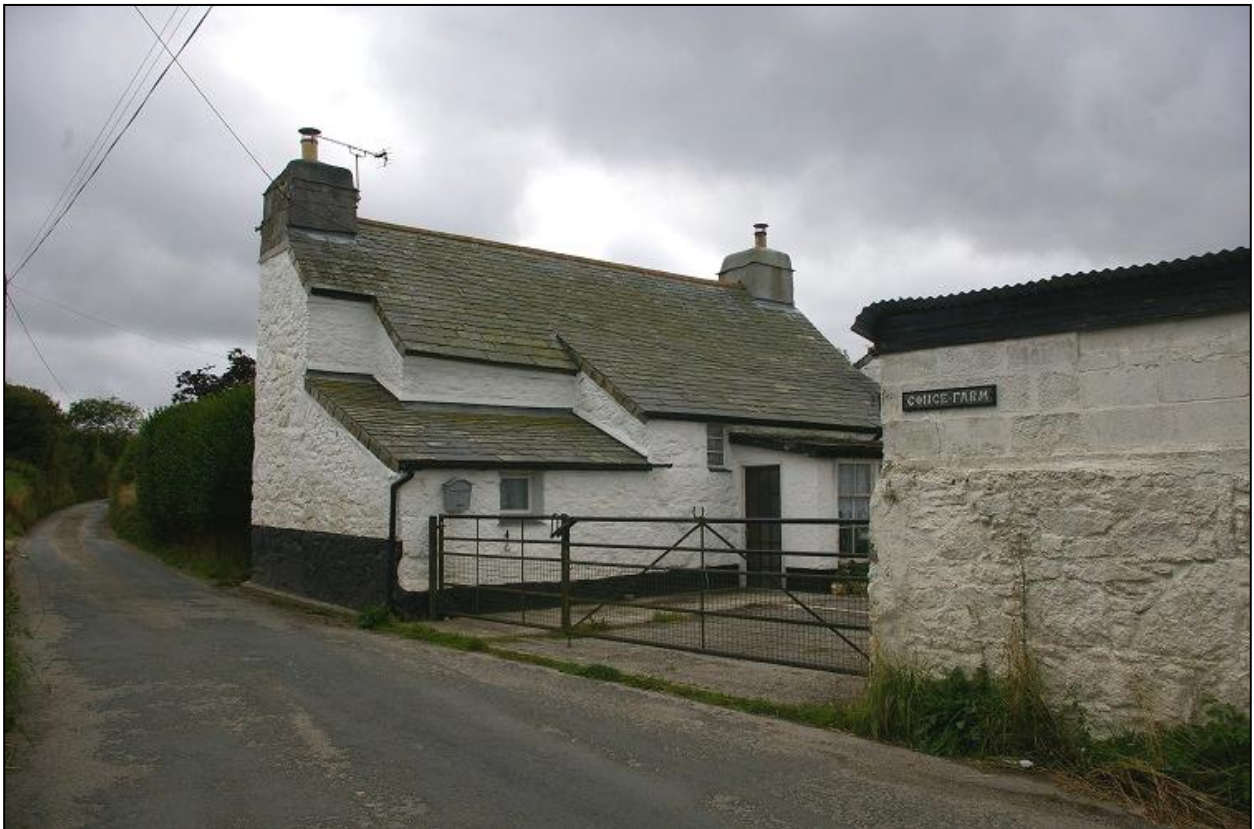
- Conce Farmhouse; medium significance; Grade II Listed; condition: fair. Located alongside a narrow parish road, north of Luxulyan, this small low farmhouse stands to the south of a farmyard and group of outbuildings, across the road from a cottage of later date. The windows of the farmhouse are small, and there are none of the northern side. The frontage is almost totally obscured by the mature garden and tall hedge, which surrounds a small square garden to the south of the house. The house has been built for an agricultural purpose, not for views or outlook. It is Listed for its architectural merit as an example of an older vernacular style of farmhouse, very different from the 19th century houses that dominate the area. The turbine may just be visible across the fields to the south-west, but due to the low height of the farmhouse the hedgebanks that surround the agricultural fields west will significantly limit these views; impact **neutral**.

Conce Farmhouse, on the side of the road, showing its low roof height and the tall hedges to its garden at the front; from the north-east.

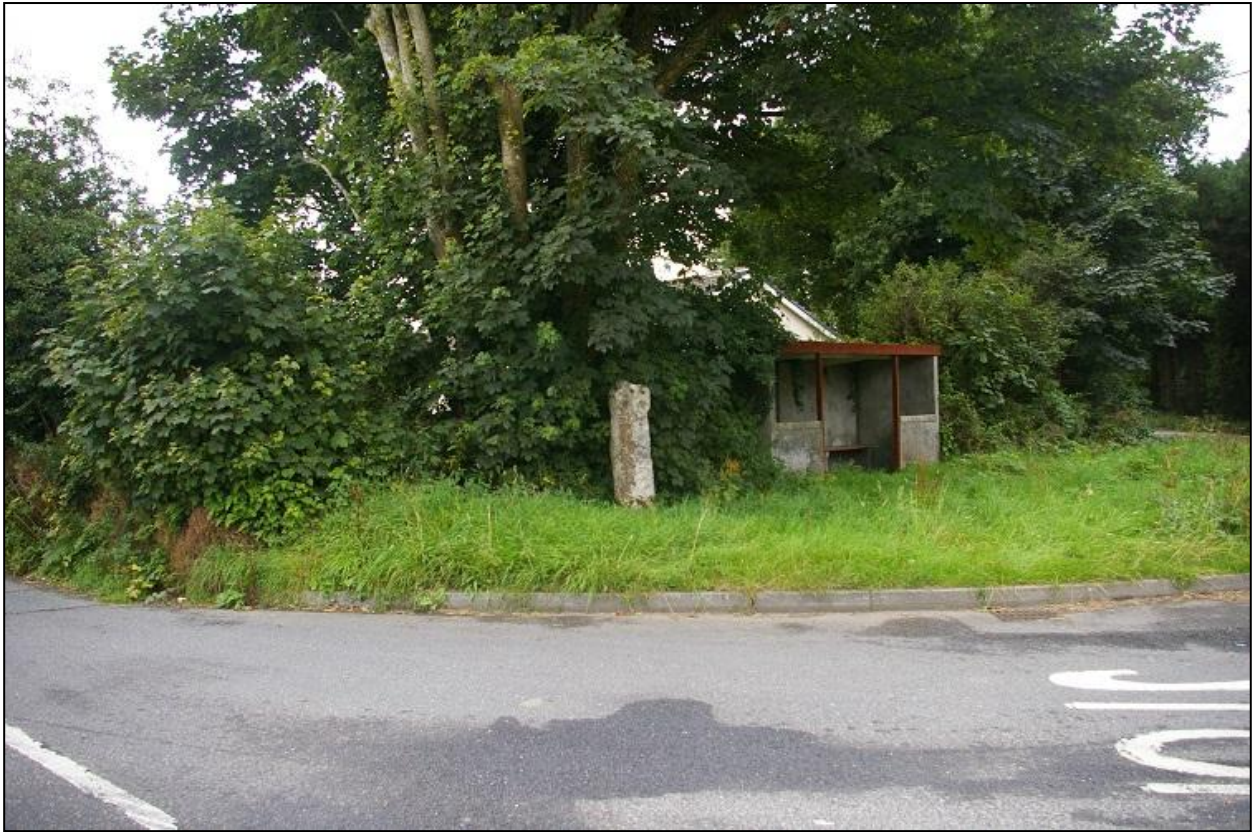
The medieval wayside cross, still standing in its intended location at the road junction in Lockengate, shielded to the south and east by tall mature trees and the houses behind; from the north-west.
