# STAPLETON FARM BERRY NARBOR DEVON

Results of a Desk-Based Assessment,  
Walkover Survey  
&  
Historic Visual Impact Assessment

Report No.: 130902  
Date: 020913  
Authors: D Laing-Trengove  
B Morris  
E Wapshott

**SWARCH project reference:** CMS13  
**OS Map copying Licence No:** 100044808  
**National Grid Reference:** SS 5606 4376  
**Planning Application Ref:** 52968  
**Planning Appeal Ref:** APP/X1118/A/12/2171663  
**Project Director:** Colin Humphreys  
**Fieldwork Managers:** Brynmor Morris  
**Project Officer:** Brynmor Morris  
**Desk Based Assessment:** Brynmor Morris  
**Fieldwork:** Emily Wapshott  
**Report:** Deb Laing-Trengove; Emily Wapshott  
**Report Editing:** Brynmor Morris  
**Research:** Brynmor Morris  
**Graphics:** Brynmor Morris

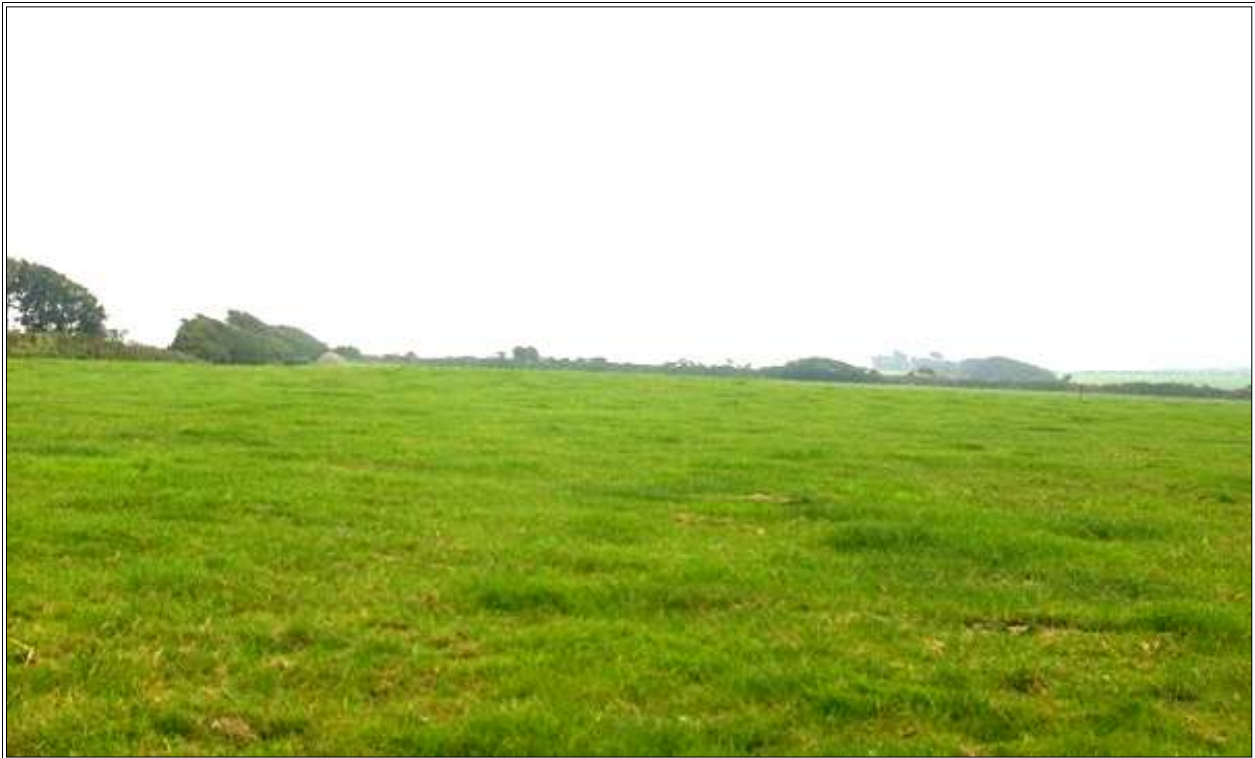
Grassy mound within the proposed turbine field; from the north.

The field is currently under pasture. Some very minor undulations were noted within the field, but these appeared to be natural, following the contours of the south-facing slope of the hill. One significant mound was observed, close to the southern end of the eastern hedgebank. This appeared to be abutted by a slight linear bank running across the length of the field; this may represent an earlier hedgebank. No obvious cropmarks were noted, although a small difference in grass colour to either side of this shallow linear feature may indicate a ditch or double ditch.

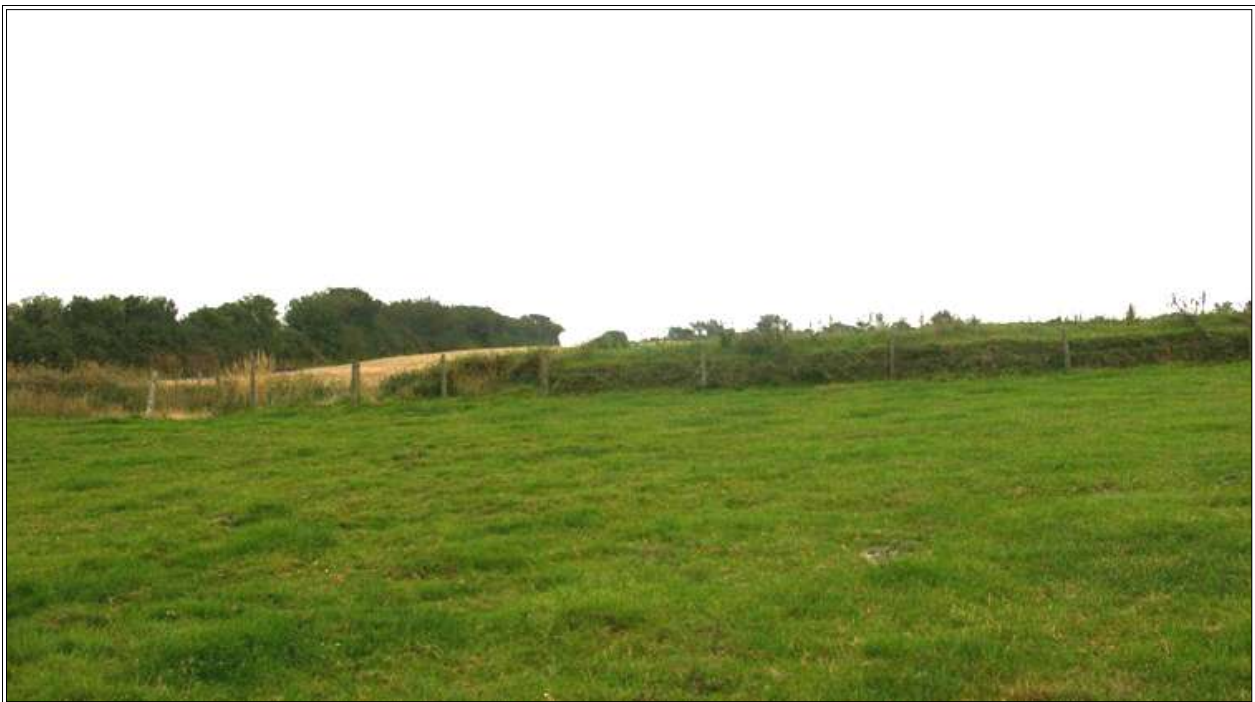
View from the location of the first proposed turbine, towards the barrows and barrow cemetery at Berry Down Cross, showing local blocking provided by the terrain; from the south-west.

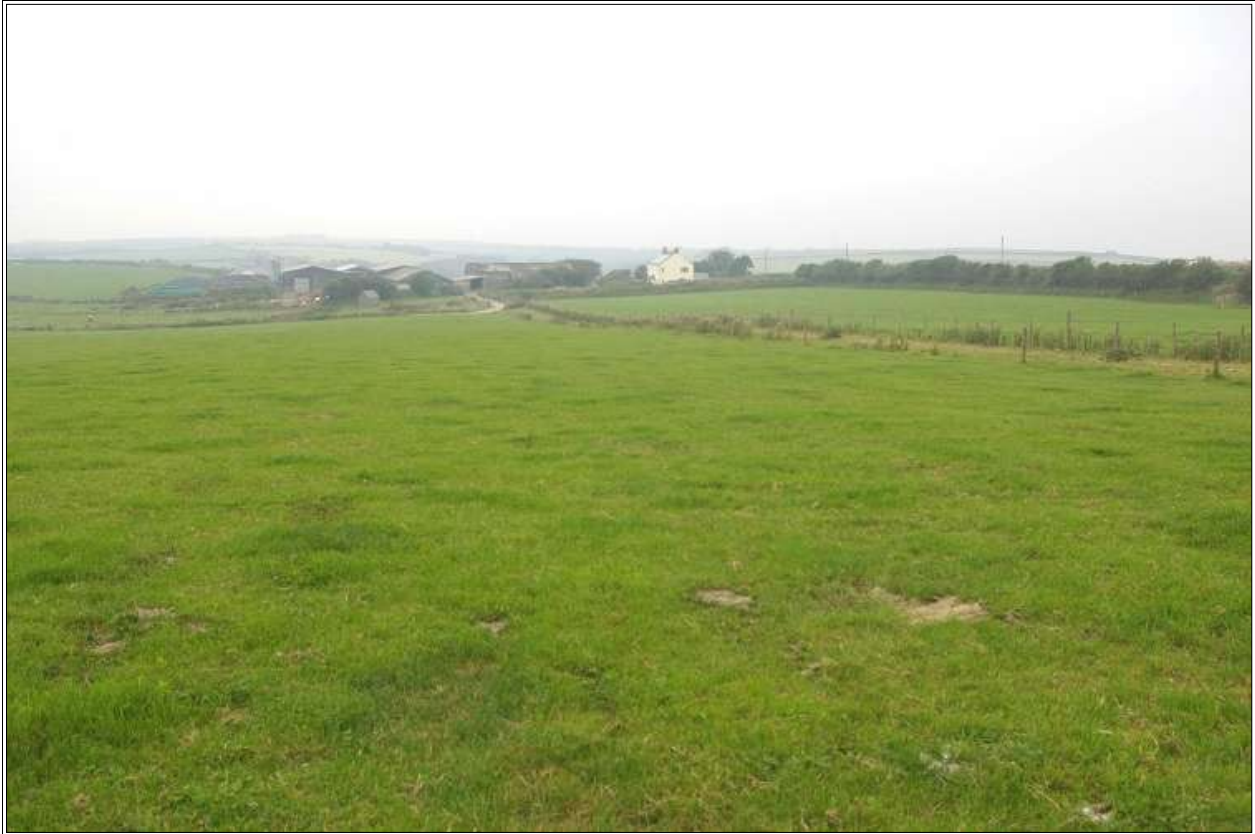
View across the field to the Stapleton Farm to the west, with the hilltop enclosure and barrows beyond; from the east.

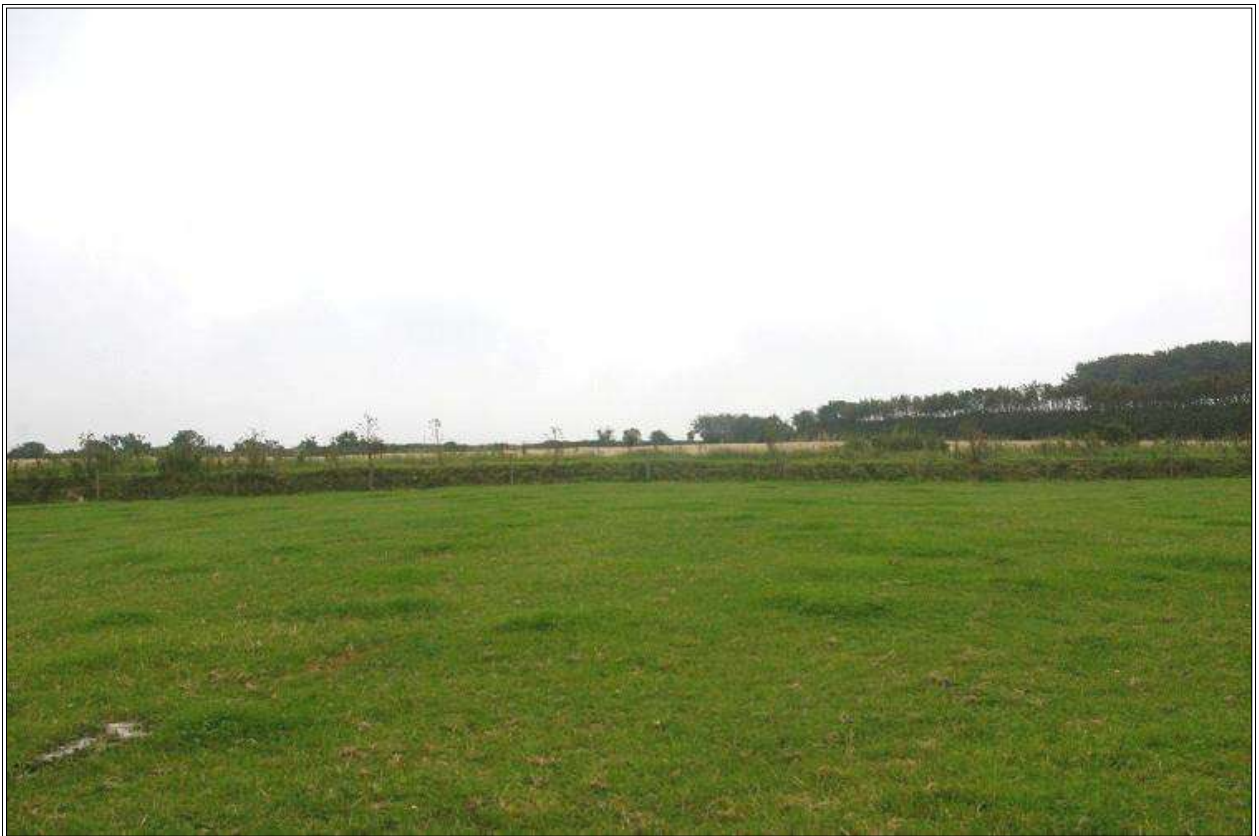
View to the eastern boundary of the field, from the approximate position of the second turbine, showing elements of local blocking; from the west.

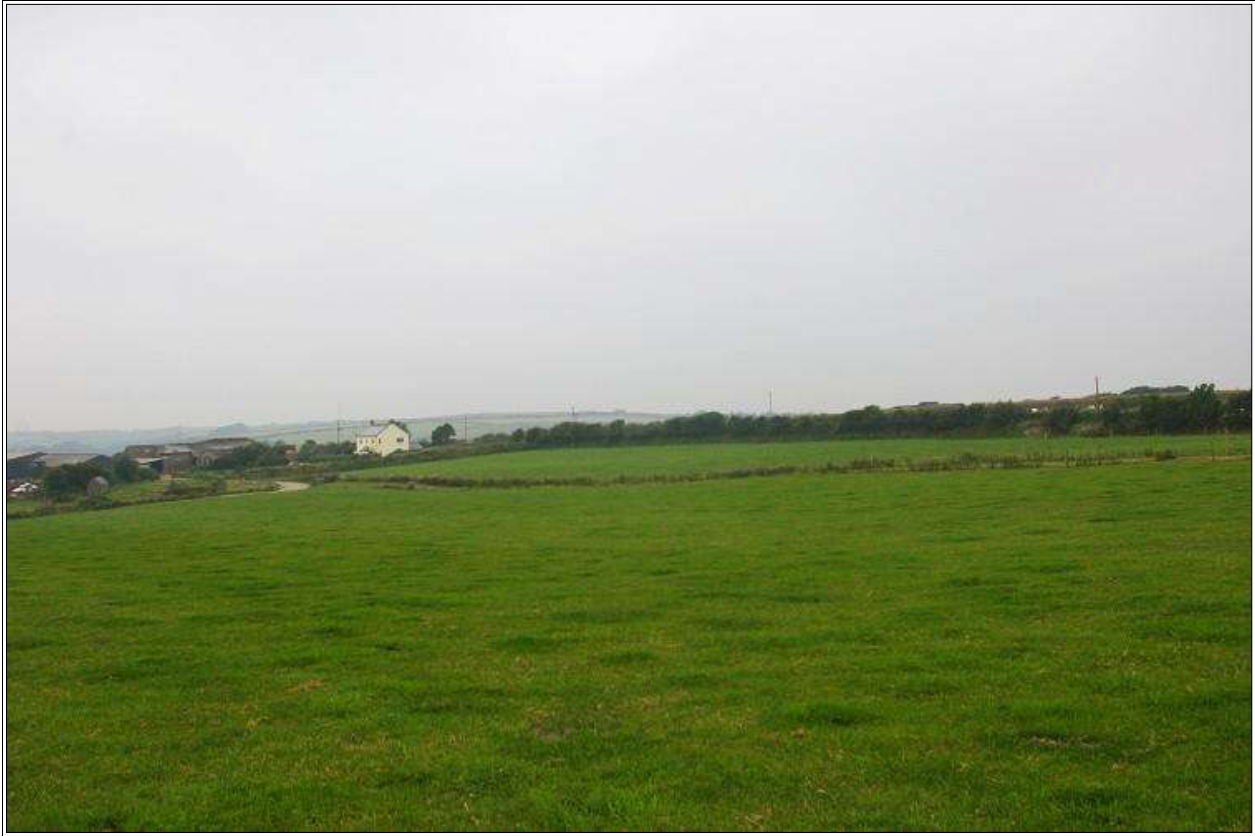
Views to the north-west and Hill Barton, East Hagginton House and the barrow at Ettiford, showing local blocking with some limited views beyond; from the south-east.

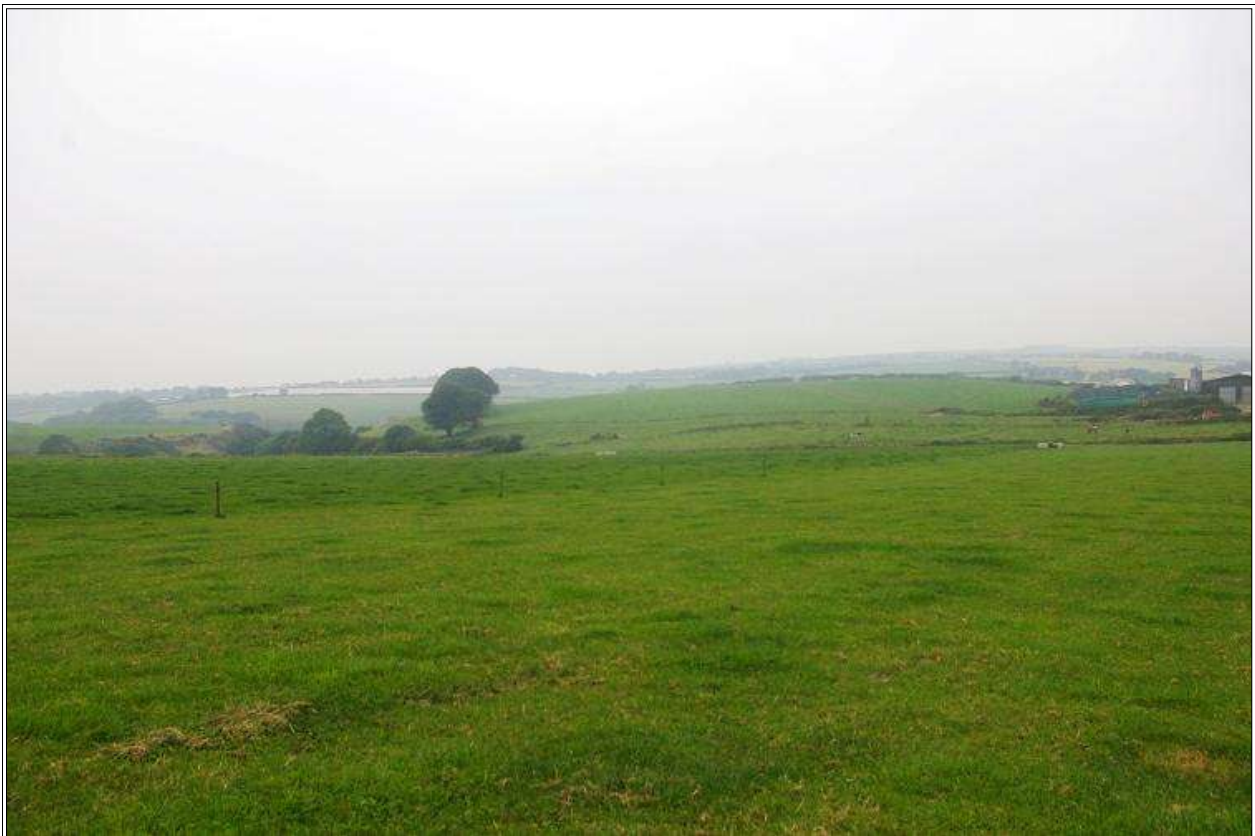
View down the field from the west, showing the long slight linear mound; from the north-east.

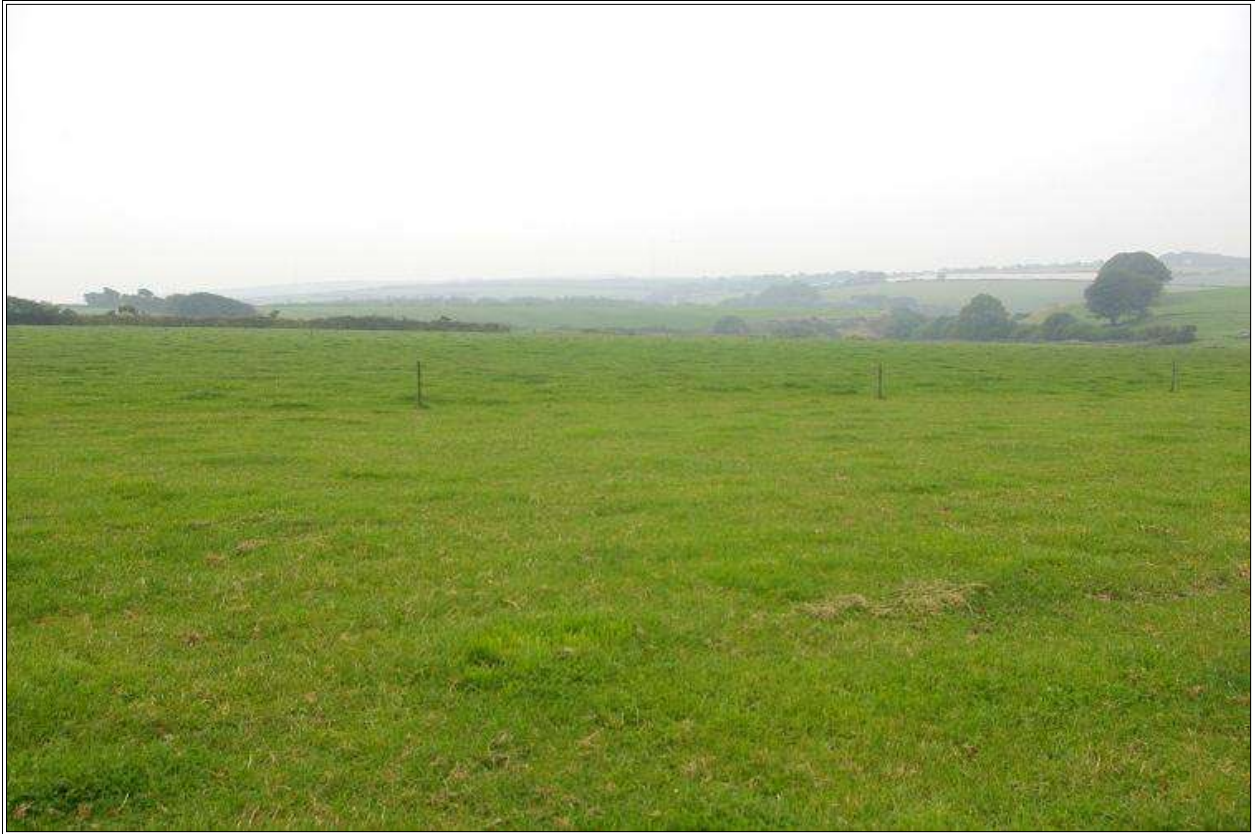
The wire fence boundary to the south of the turbine field; from the north-east.

The modern Stapleton Farm lies adjacent to the busy A3123 between Lynton Cross and Berry Down Cross. The turbines are to be situated within a field away from and to the south of the road, on a shallow south-west facing slope. The fields in the immediate area are large and regular straight-sided enclosures dating to the early 19<sup>th</sup> century. The field boundaries are generally stone-faced hedgebanks, but on Stapleton Farm and the immediate area of the two proposed turbines some of the boundaries have been removed. Where these boundaries have been reinstated, it is as post-and-wire fencing.

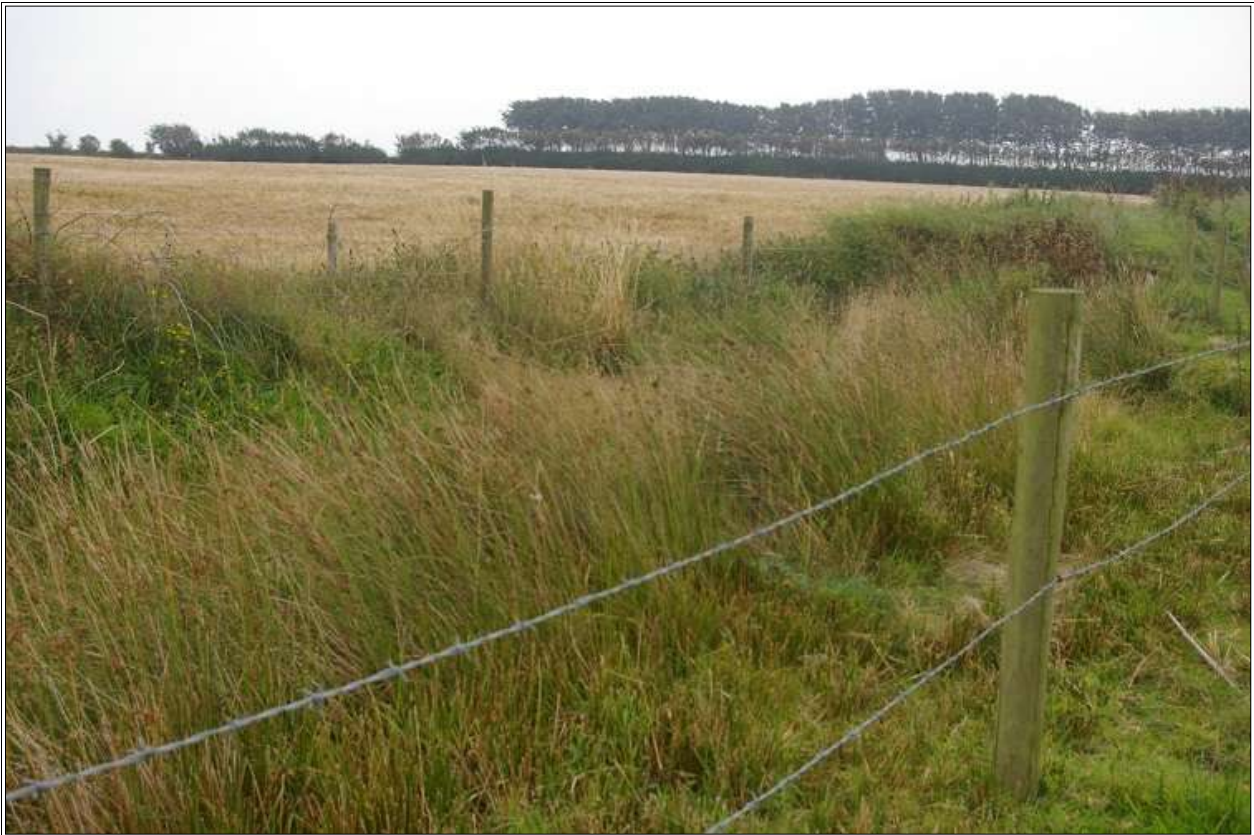
The open boggy area in the north-eastern corner of the field; from the north-west.

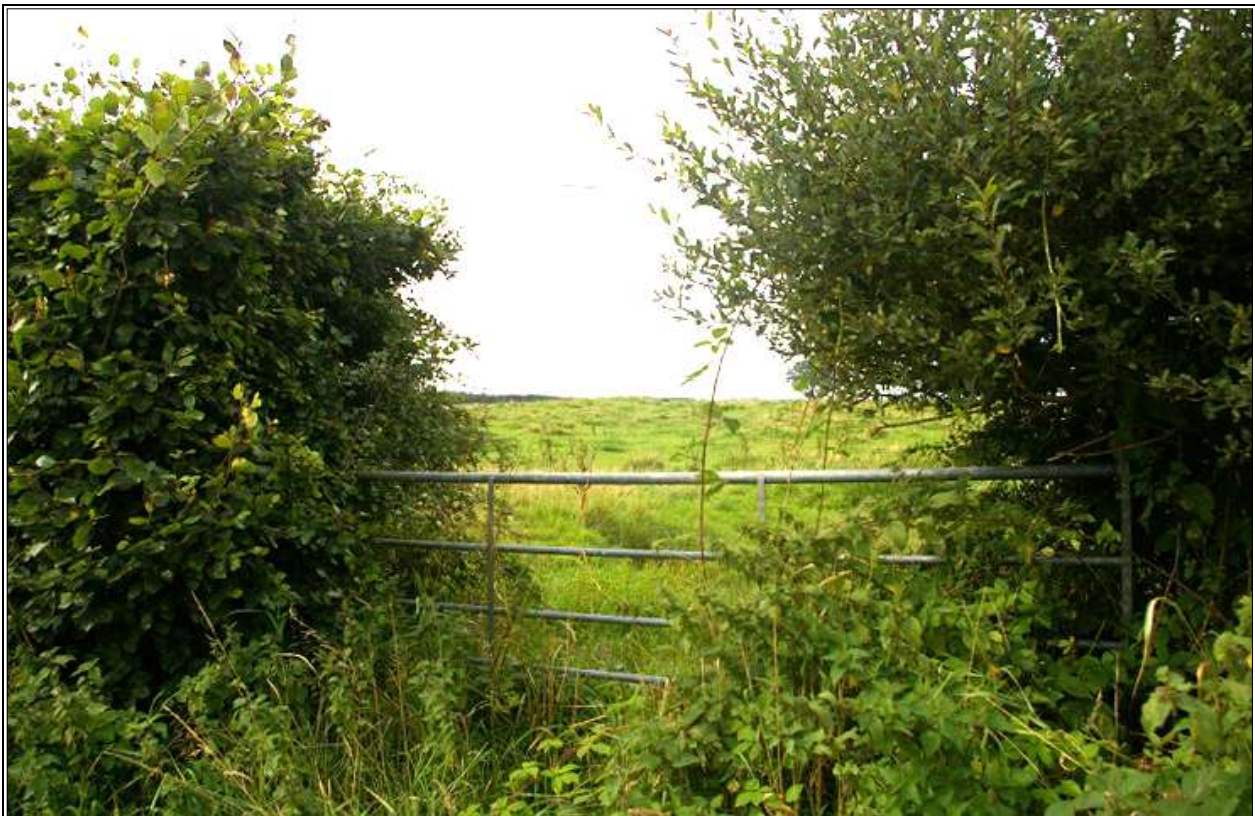
Shallow barrow in field south of Berry Down Cross, within 3km from the turbine but comprehensively blocked by the tall hedgebanks that surround the field; from the north-east.

- Two bowl barrows, to the west and south-west of Berry Down Cross; high significance; Scheduled Monuments; condition: good. Two upstanding earthen mounds set within an agricultural field south of the A3123. The field is on a shallow east-facing slope, and the ground rises to the west towards Smythen Cross. The site of the proposed turbines is not currently visible from the barrows, although the turbines themselves might just be visible to the west once constructed. The barrows can still be understood as part of a funerary landscape, despite the enclosure and subdivision of that landscape. Many of the surrounding barrows are upstanding and therefore have a

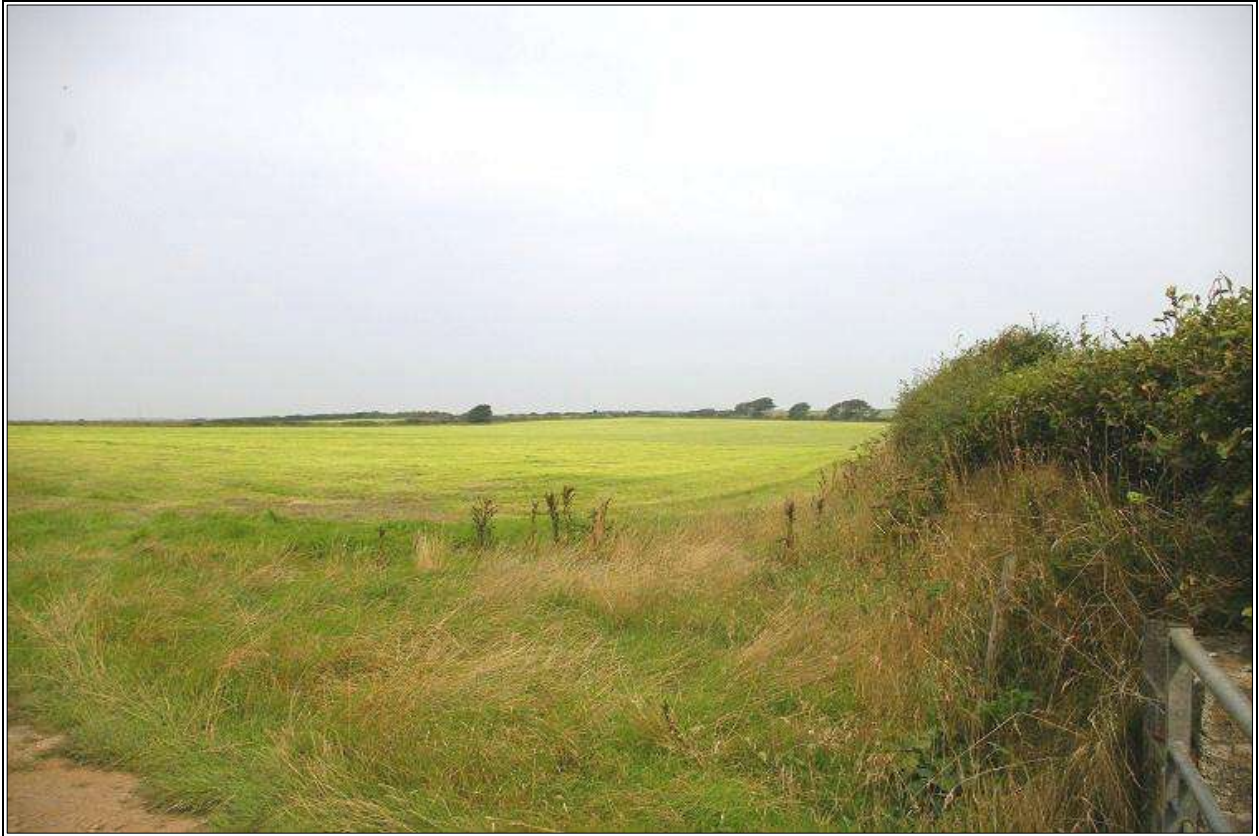
View across a large field to the three shallow barrows just south of the main group along the A3123, from Berry Cross, demonstrating that despite their elevated position, local blocking is provided by the short hedgebanks; from the south-east.

- Three bowl barrows, 470m south-west of Berry Down Cross; high significance; Scheduled Monuments; condition: fair. The extant barrows are now reduced to slight earthen mounds, and one may survive only as a trace. Set further to the south, although within the same group of agricultural fields as a number of other barrows, these three barrows are set on high ground, overlooking the turbine locations to the north-west. These barrows have group value, but the importance of local blocking is more pronounced as they are much-reduced in height. Therefore, and despite their location, the impact of the proposed turbines would be limited; impact **negative/minor** due to local blocking by adjacent hedgebanks.

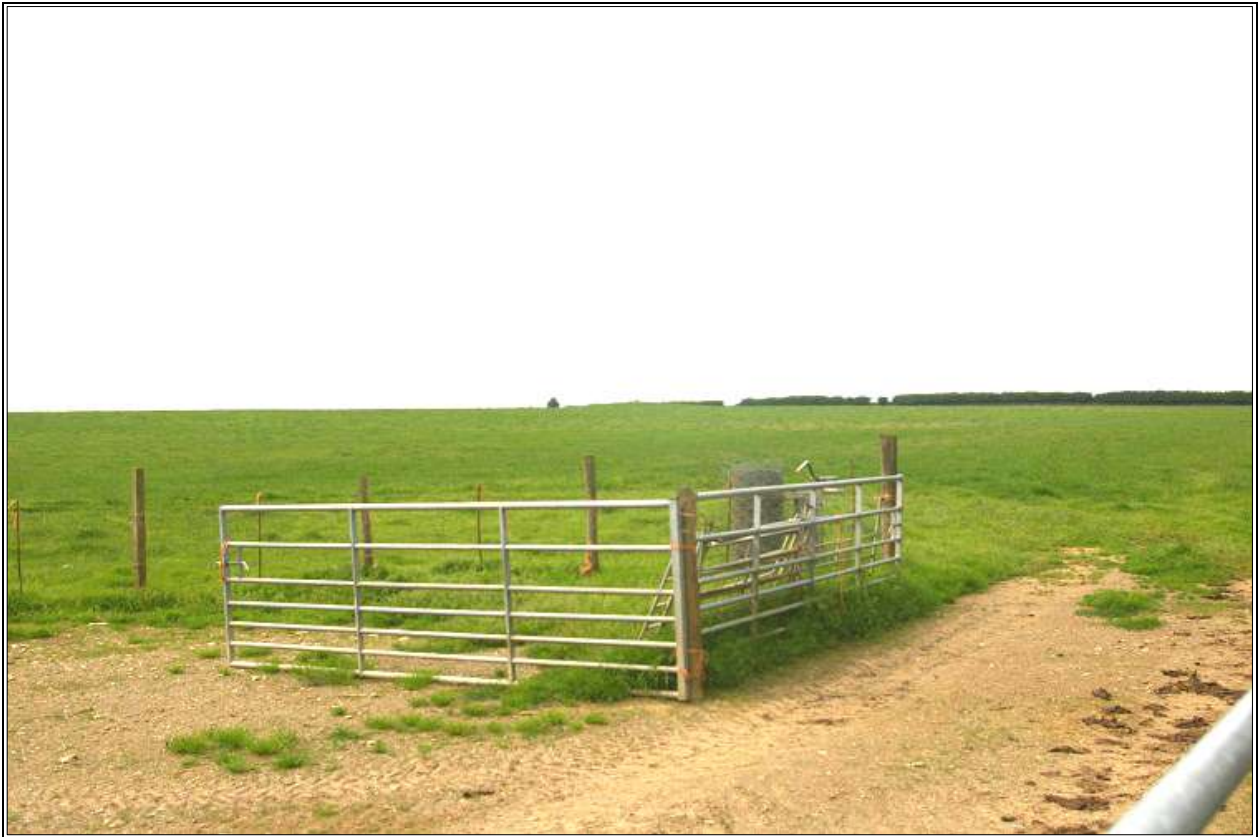
A large barrow west of Berry Down Cross, showing how it looks out of the field, over the hedgebanks; from the north-east.

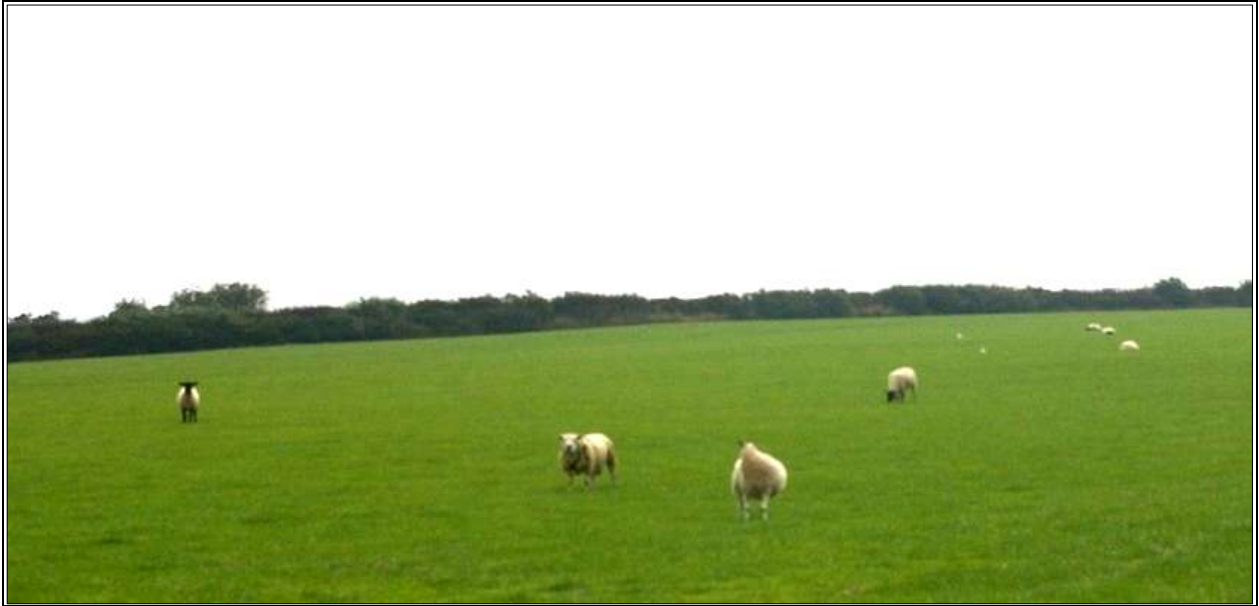
One of the two barrows south-west of Berry Down Cross, which survives as shallow mound, with local blocking provided by the hedgebanks of the field; from the north-west.

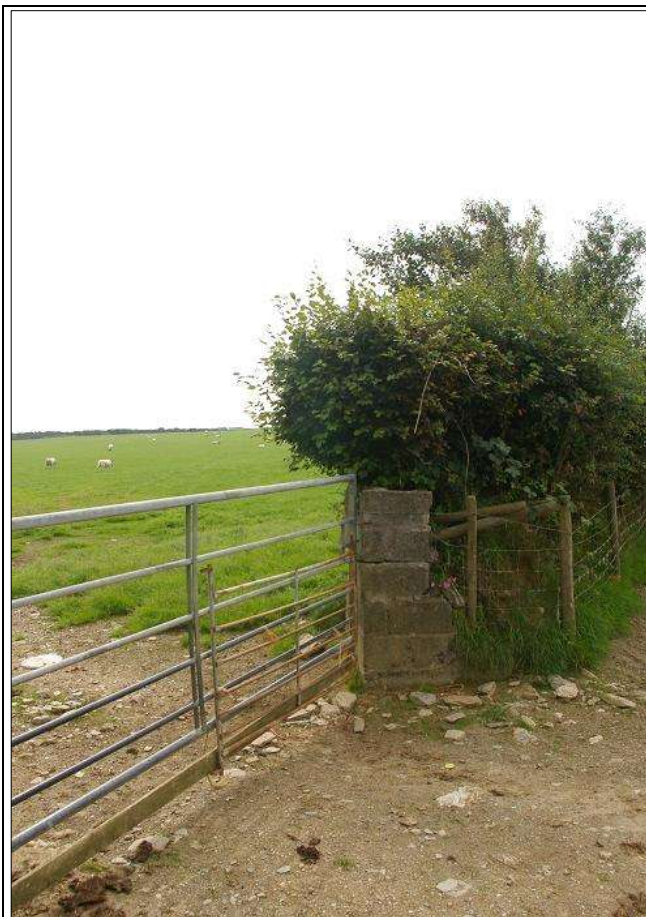
The second of the two barrows south-west of Berry Down Cross, showing how it is immediately against the hedgebank, to its west side, locally blocked by this field boundary from the turbines proposed to be to the west; from the north-west.

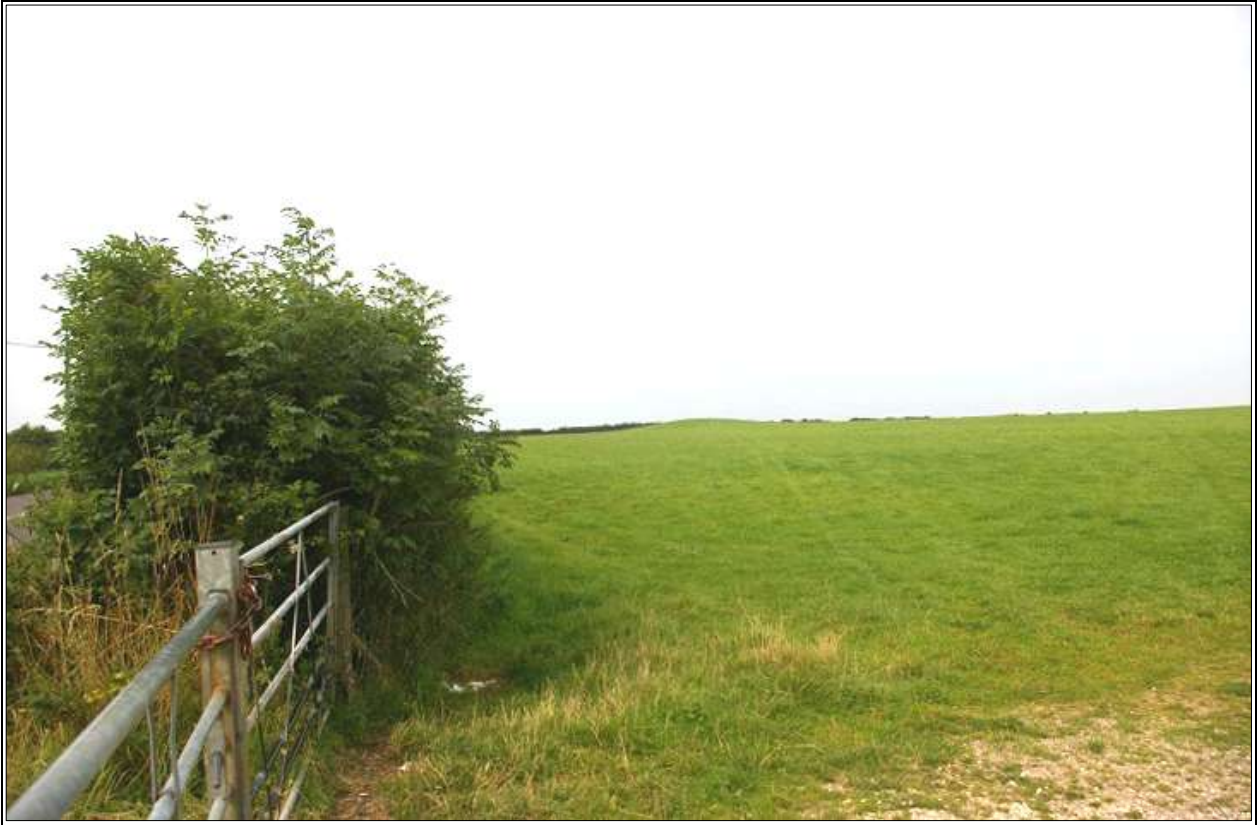
Large barrow east of Smythen Cross, showing how it overlooks the adjacent hedgebanks and retains its landscape presence; from the east.

- Bowl barrow 420m east of Smythen Cross; high significance; Scheduled Monument; condition: excellent. Surviving as a large upstanding mound, with views over the field hedgebanks to the landscape beyond; as a result, the monument has retained a significant landscape presence. The barrow would have clear views to the two proposed turbines, although limited local blocking would be provided by field and road hedgebanks. However, views to the monument are just as important and from the north, south and east these would be largely unaffected. Line-of-sight to the monument from the south-west would, however, be interrupted. The two turbines would also draw the eye and provide a visual distraction. A former area of open ground, these barrows are now divided from one another by hedgebanks and this has affected their context and how they are experienced. This particular barrow is, however, set on higher ground to the north and has views to the barrows to the south of the A3123, which increases the value of its outlook and the significance of the monument. Impact **negative/moderate**.

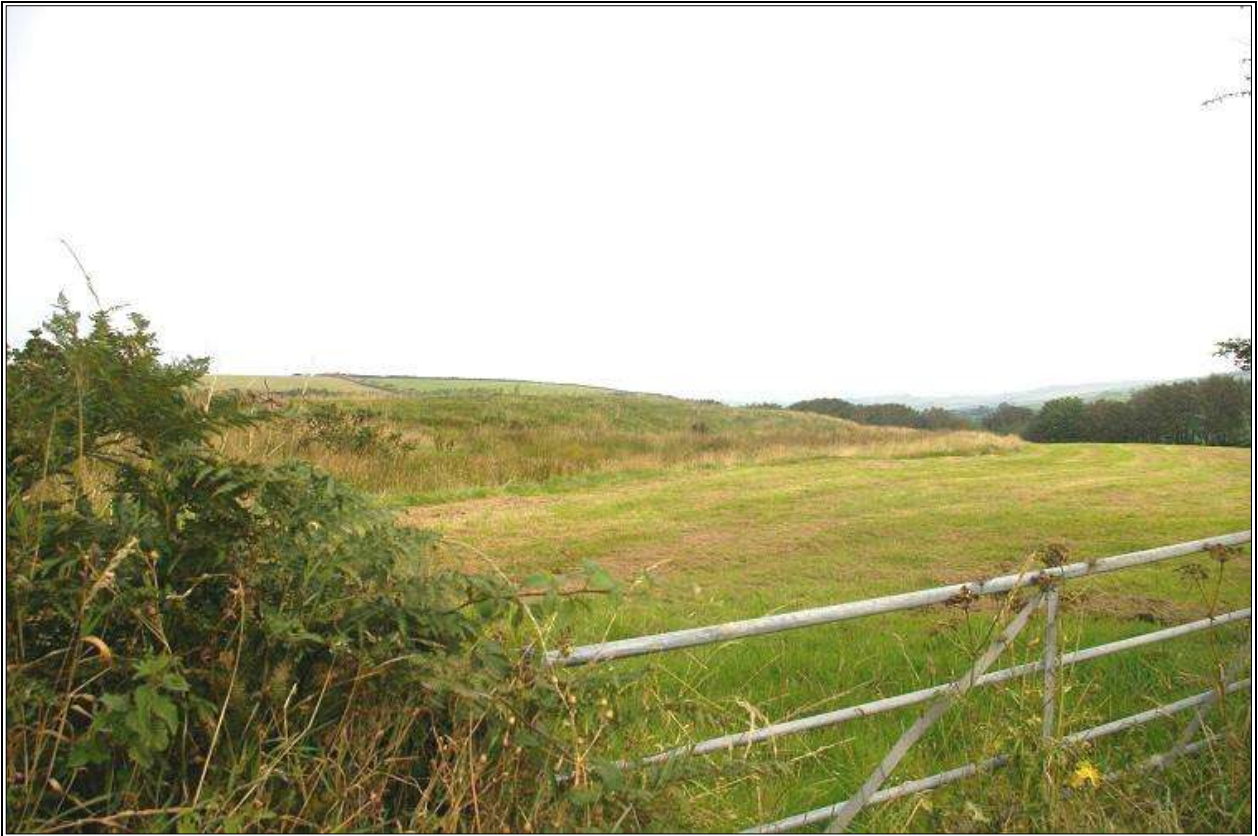
The large hill-top enclosure, north-west of the location of the proposed turbines, with views down the valley to the north-east; from the south-west.

- Hilltop enclosure 400m north-east of Outer Narracott Farm; high significance; Scheduled Monument; condition: excellent. The monument has upstanding earthwork banks and associated trackway remains, but is somewhat compromised by the adjacent road. The field in which the monument is located has a mature hedgebank to the east, and this wraps around to its southern boundary against the road. This hedgebank is topped by tall trees, providing seasonal local blocking. The modern farm buildings at Stapleton Farm would also provide limited local blocking. The enclosure lies on a north-facing slope, with views to the north and north-east, with more limited views to the north-west. It ‘faces’ north, overlooking the valley below the enclosure, into which the associated trackway extends. This Iron Age enclosure is defined by its views both to and from itself, as it is a feature intended to be the focus for the immediate area, as a protective enclosure, a place of collection, a ‘community hub’. Whatever its specific original function, it retains a presence within the modern landscape. The presence of four extant barrows very close to the enclosure (although one is now separated by the road) is evidence of further Prehistoric activity within the immediate area and line-of-sight to these monuments will be retained, unaffected by the turbines at Stapleton. The turbines are small in size and will not impact on the key visual relationships between the monument and the valley to the north, therefore despite its proximity impact is assessed as **negative/minor**.

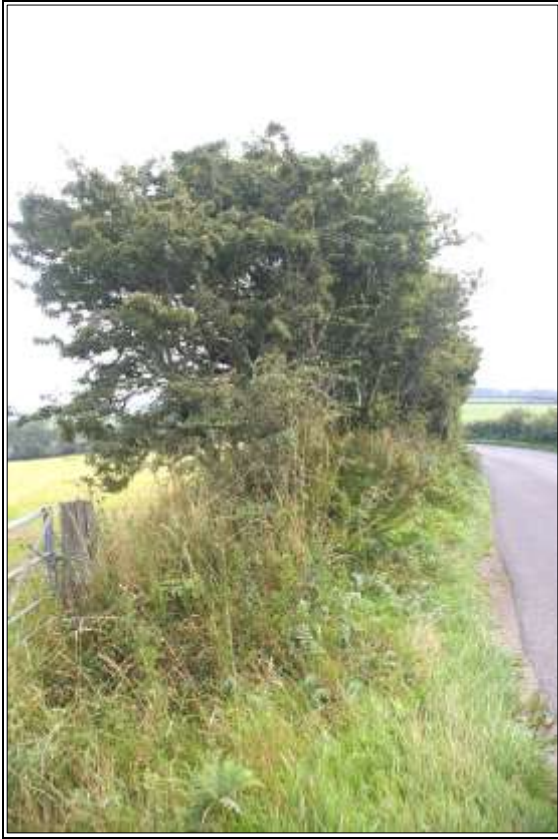
The tall hedgebank along the road edge, shielding the hilltop enclosure from views of the proposed turbines, which would lie to the south-east behind this hedge; from the west.

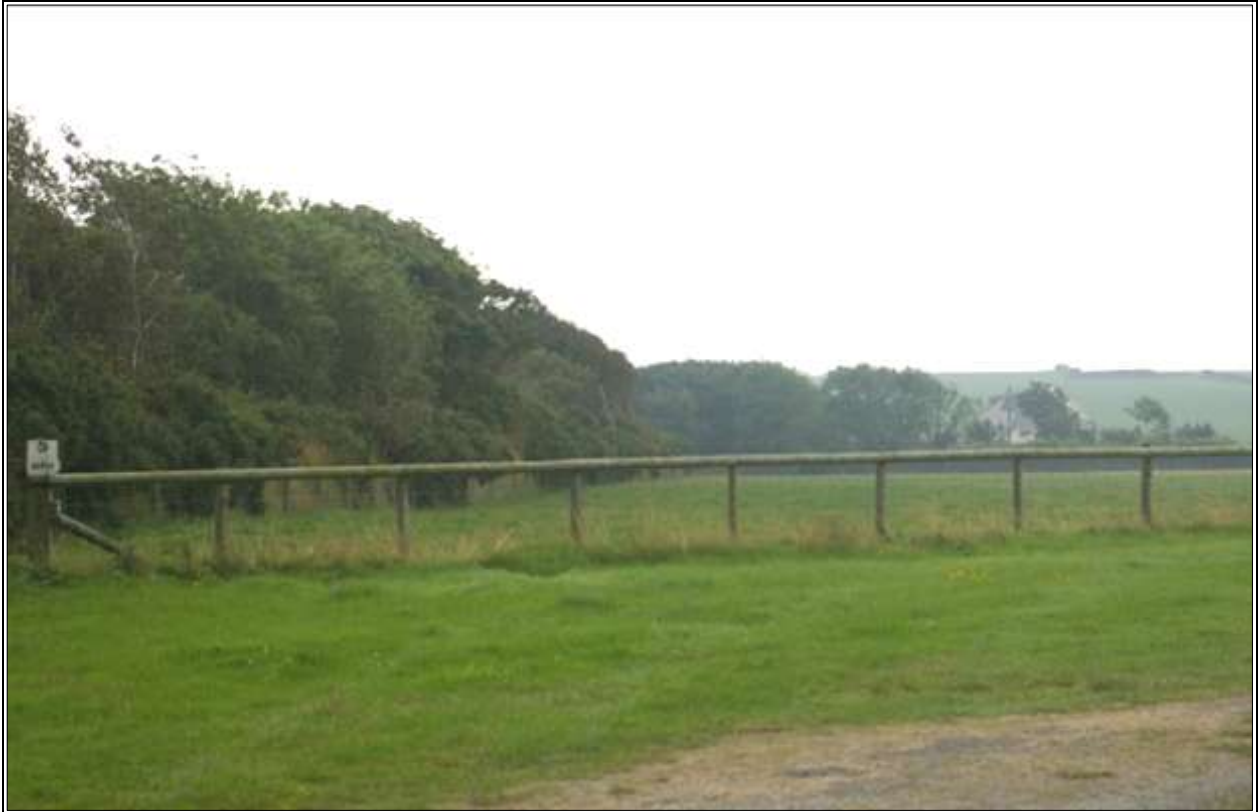
View across the field to the heavily wooded grounds of Narracott Farm. The tall 19<sup>th</sup> century farmhouse is visible through the trees at the north-west end of the farmyard, but the older farmhouse lies further in the trees to the east; from the west.

- Narracott Farmhouse; medium significance; Grade II Listed; condition: fair to poor (from the listing description) otherwise unknown. The building is upstanding and was used at the time of Listing as a farm store, with walls and some elements such as windows surviving but with some, such as the roof, replaced. It is located down a long private farm track off Centery Lane and surrounded by hedgebanks topped with tall mature trees, which shield the farmhouse and provide local blocking. The enclosure in which the farmhouse is set has a relatively dominant place within the landscape, although a later 19<sup>th</sup> century house to the north-west is now the main focus. Farmhouses were not built for their views and this building has numerous outshuts on its north and south sides which would be expected to further block and reduce any views. An impact of **neutral** is anticipated, as its architectural merit is not impacted by

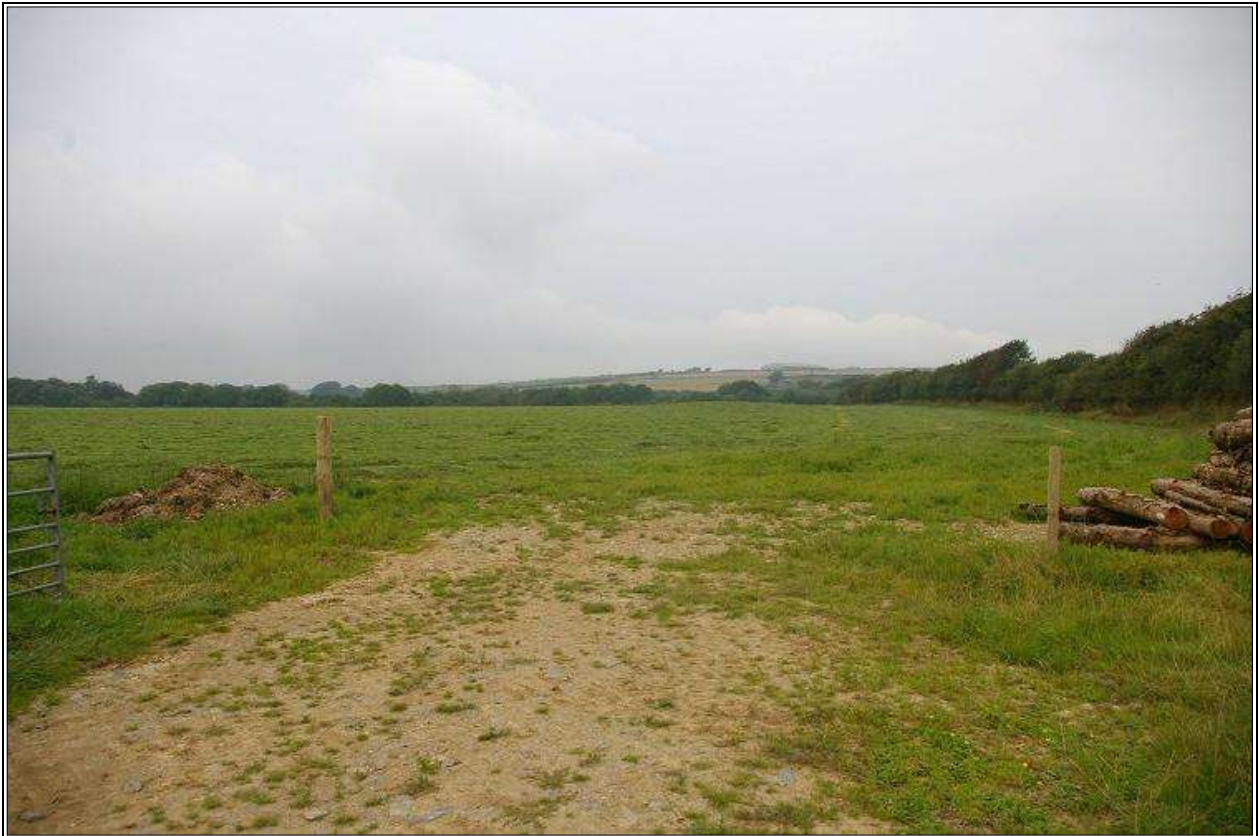
The northern end of the barrow cemetery at Hillcrest Farm, showing the tall mature hedgebank that runs along the northern boundary of the field in which the majority of the barrows are found; from the east.

- Round barrow cemetery, 210m south-west of Hillcrest; high/very high significance (group value): condition: mixed. Four survive to a height of 1m+, a few others are visible as shallow mounds, but the majority survive only in poor to trace condition. However, the group can still be understood and experienced together as a whole, the few better examples giving an indication of the wider group; there are also visible differences within the vegetation of the field, indicating the presence of significant buried archaeological features. The barrows sit on high ground and there are certainly views to the north towards the location of the proposed turbines, which might be visible from the general area around the cemetery. However, the mature hedgebanks that surround the field preclude any intervisibility. The house and buildings of Hillcrest Farm across the road to the north-east also provides additional local blocking. There are also a group of very large wind turbines on high ground just to the south and directly visible at a much closer distance. Within 300m on the opposite side of the parish lane is a small two-bladed grey farm turbine. In comparison with these visual elements, and in consideration of the evidence for local blocking, the two turbines at Stapleton will have a **neutral** impact.

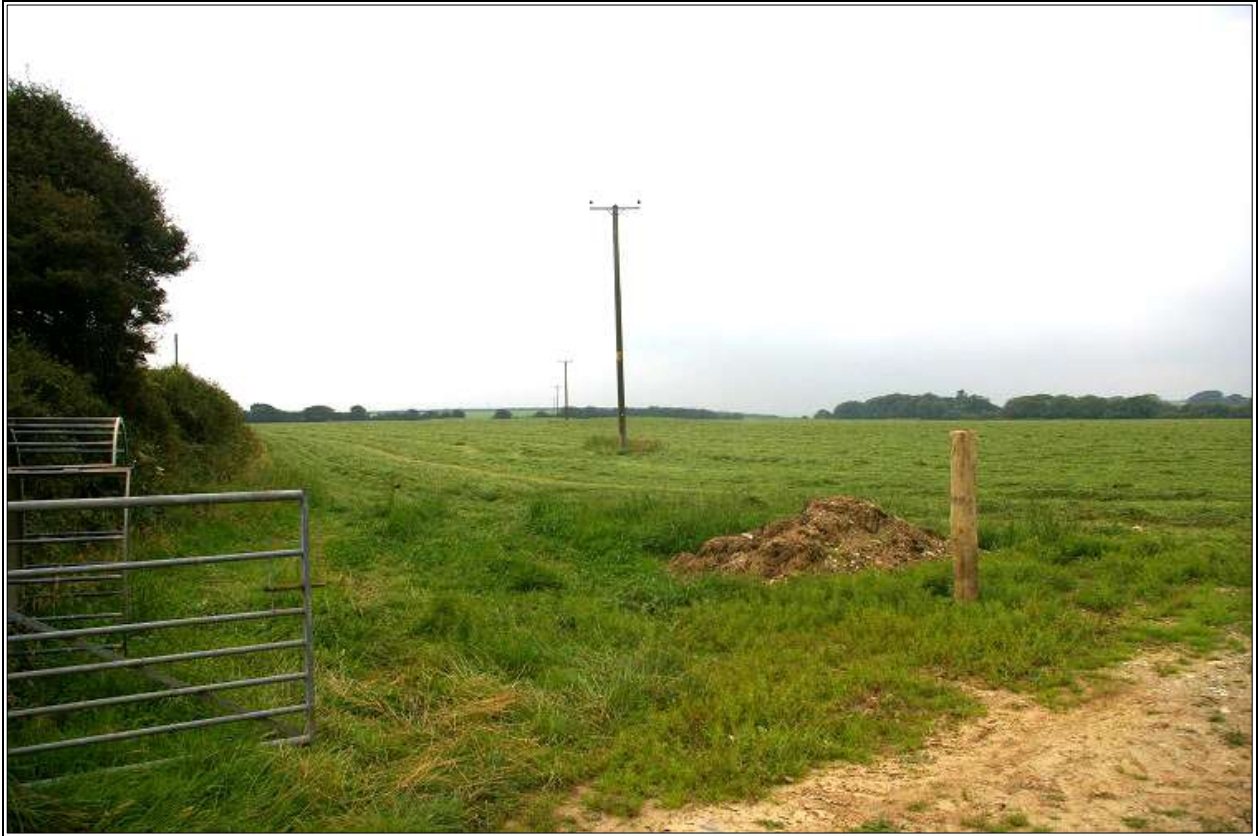
View down the field, showing a range of shallow mounds of various heights; local blocking is provided by hedgebanks. From the north-east.

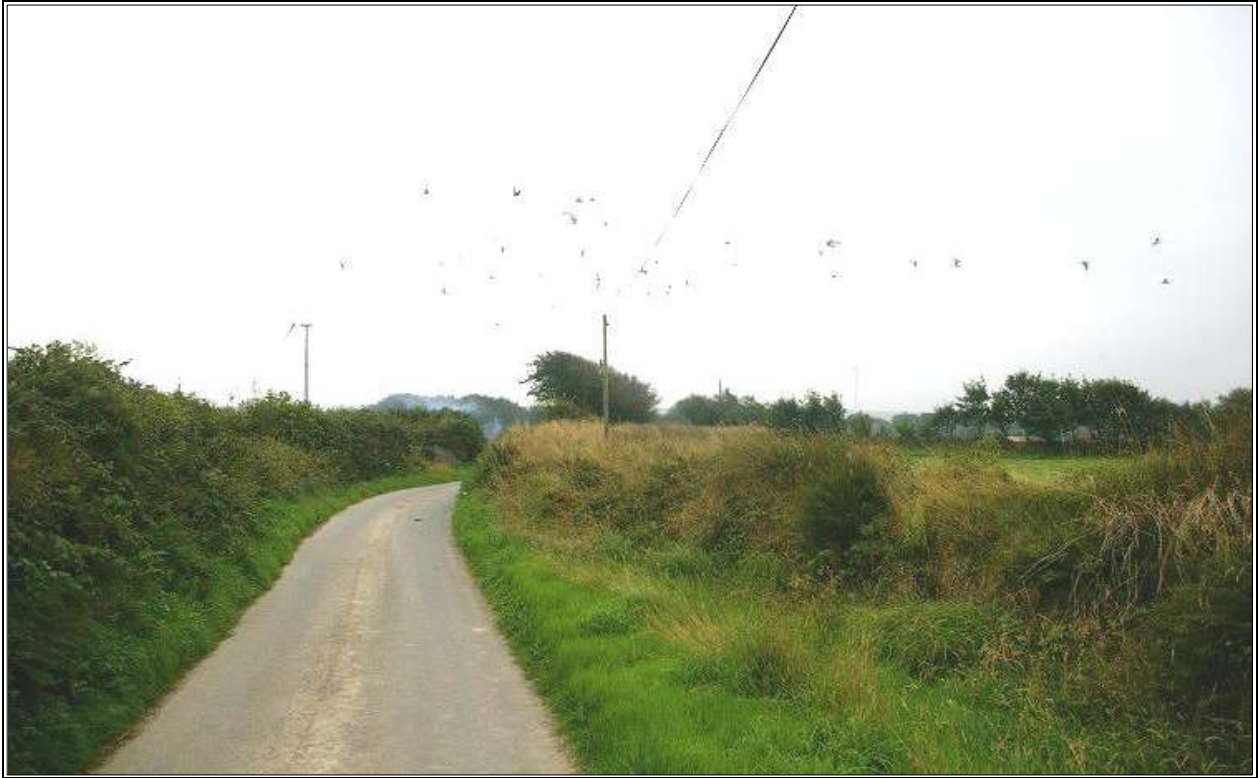
The southern end of the barrow cemetery, showing clear views to the operational turbines to the south and south-east; from the north.
