# STAPLETON FARM BERRY NARBOR DEVON

Results of a Desk-Based Assessment,  
Walkover Survey  
&  
Historic Visual Impact Assessment

Report No.: 130902  
Date: 020913  
Authors: D Laing-Trengove  
B Morris  
E Wapshott

**SWARCH project reference:** CMS13  
**OS Map copying Licence No:** 100044808  
**National Grid Reference:** SS 5606 4376  
**Planning Application Ref:** 52968  
**Planning Appeal Ref:** APP/X1118/A/12/2171663  
**Project Director:** Colin Humphreys  
**Fieldwork Managers:** Brynmor Morris  
**Project Officer:** Brynmor Morris  
**Desk Based Assessment:** Brynmor Morris  
**Fieldwork:** Emily Wapshott  
**Report:** Deb Laing-Trengove; Emily Wapshott  
**Report Editing:** Brynmor Morris  
**Research:** Brynmor Morris  
**Graphics:** Brynmor Morris

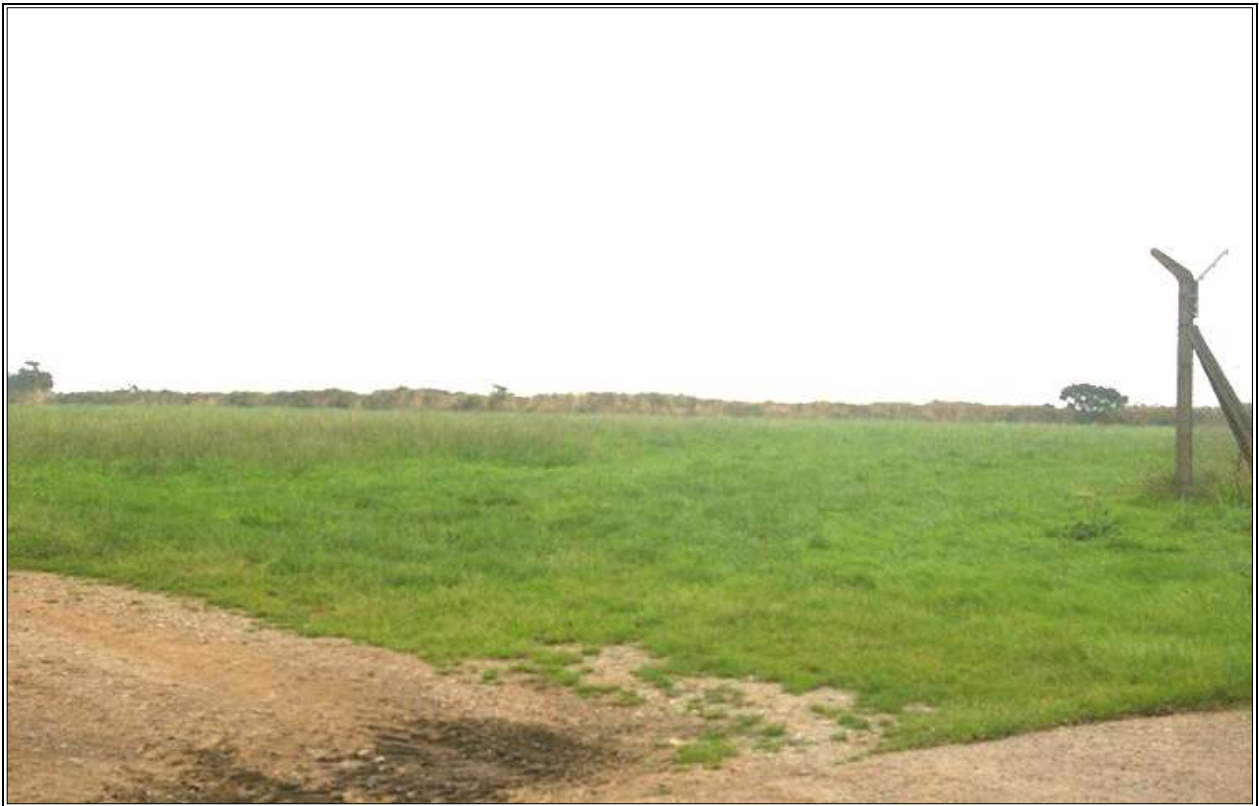
The barrow north of Ettiford, showing how a hedgebank clips the northern edge of the barrow. There is also an electricity tower and substation, the perimeter of which is just visible on the right. From the north-west.

- Bowl barrow 440m north-west of Ettiford; high significance; Scheduled Monument; condition: good. An upstanding earthwork set within a field, possibly truncated to the north by a hedgebank and track. With general views across the steep curving valley to the south-east, towards the location of the proposed turbines. Adjacent hedgebanks, the hilltop enclosure, and various trees limit views, as do the farm buildings of Stapleton Farm. However the turbines might yet still be visible, although the impact on the monument would be minimal as line-of-sight to the other barrows and features on the ridge of land opposite (see above) would not be affected. There is also a very large electricity mast and substation immediately adjacent the barrow, as well as large operational turbines visible directly to the south. Impact **neutral** to **negative/minor** impact.

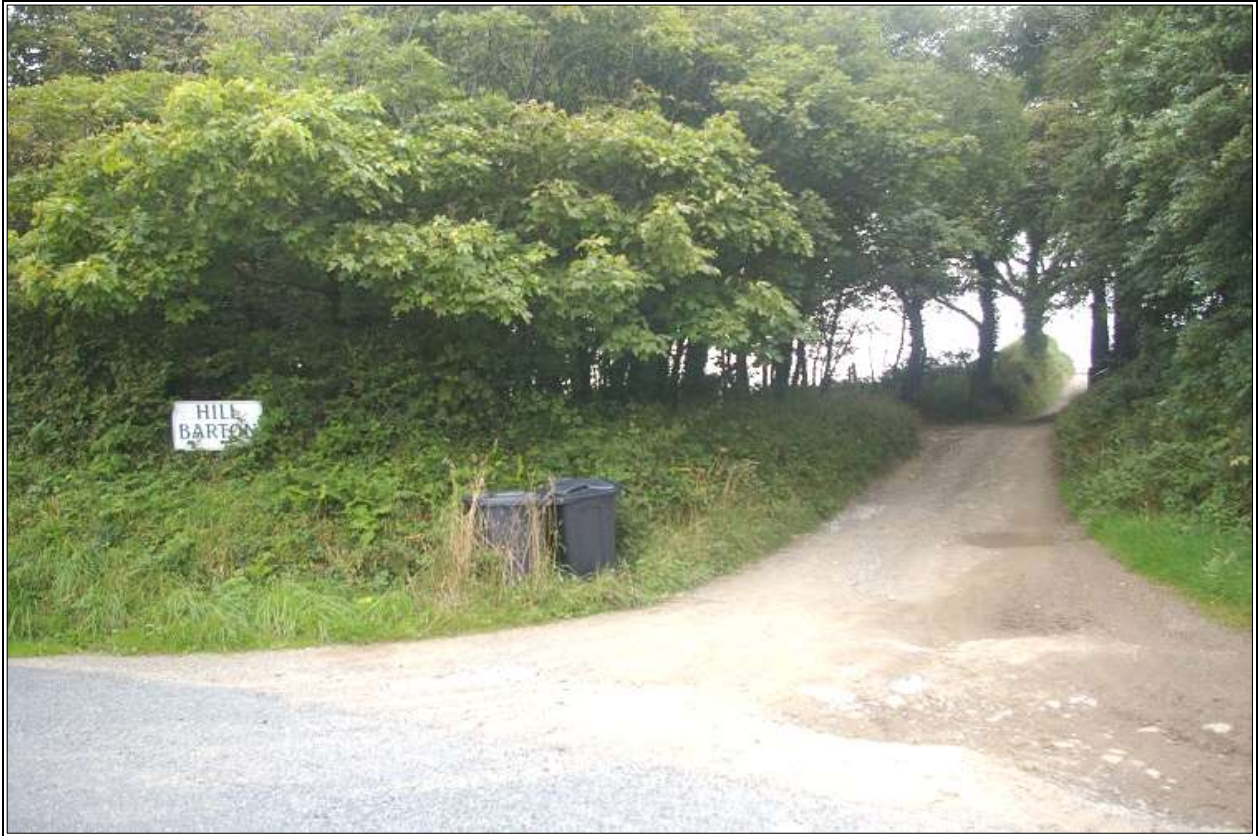
The long private track to Hill Barton; the plantation wind break blocks any views to the farm. From the west.

- Hill Barton; medium significance; Grade II Listed; condition: unknown. The farm is located down a long private track; this runs through a small section of woodland, probably a wind break, and then drops over the crest of the hill into the valley below. From the Listing we know the farmhouse is a 17<sup>th</sup> century stone-built building, set within its own land, on the west side of a valley, with general views south and south-east to towards the location of the proposed turbines. A farmhouse is not defined by its outlook, but by its former function, its association with the land and the relationships between the farmhouse and outbuildings and the setting within the farmyard. Therefore, despite the possibility of views, which would in any case be partially blocked by modern farm buildings or the historic outbuildings around a yard, the impact would be neutral or negative/minor because the turbines cannot affect the architectural value of the farmhouse, and the building is understood and experienced within its intended setting. Impact **negative/unknown**, but probably **negative/minor** at worst.

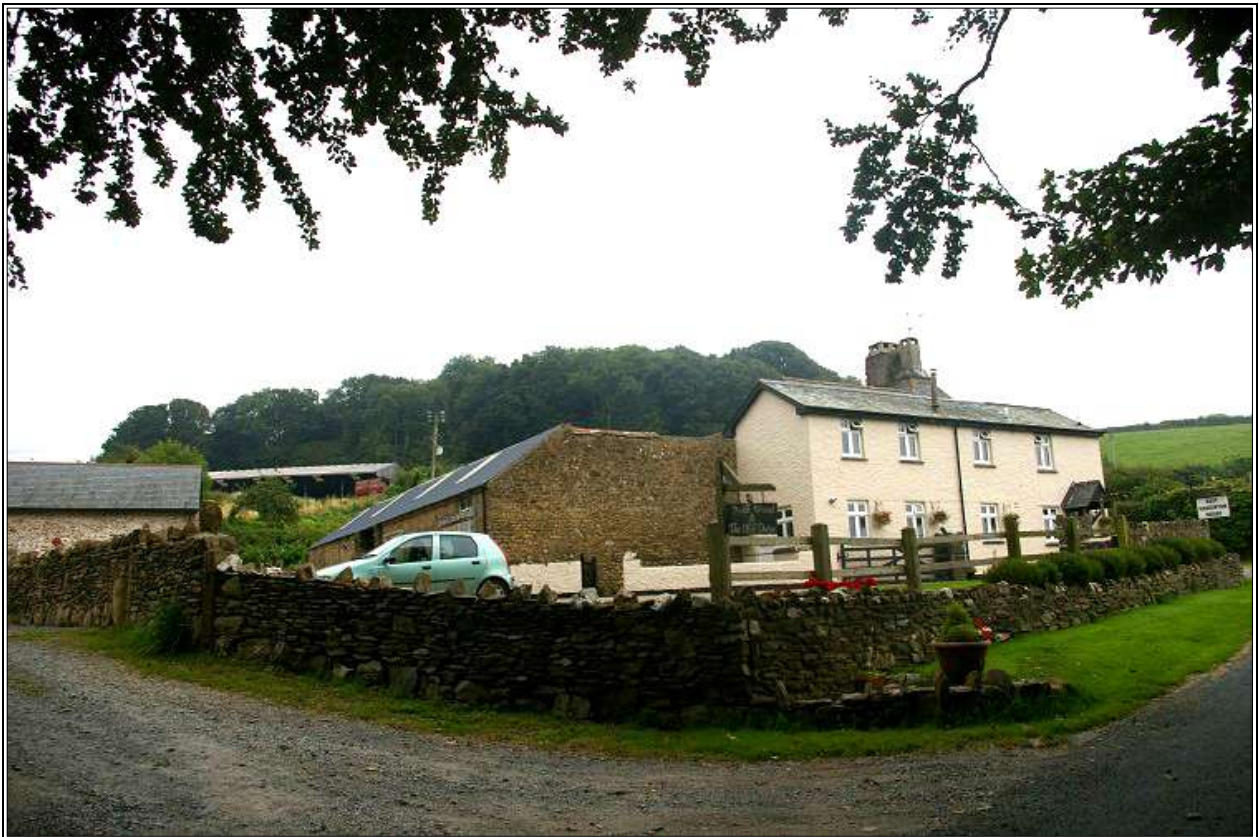
East Haggington Farm, showing the courtyard of buildings and converted outbuildings, also showing the steep slopes to the south, which shield the farm from any views to the turbines; from the north-east.

- East Hangington/Hagginton Farm, associated outbuildings and attached courtyard farm buildings; medium significance; Grade II Listed; condition: excellent, though the outbuildings have been converted to dwellings and the attached courtyard buildings appear to have been converted in part. The buildings and the farmhouse are focused inward on the enclosed courtyard. The farmhouse does have some views to the west, and there would be some distant views to the two proposed turbines from the adjacent hill to the south, which rises steeply above the farm, but there would be no views to the proposed turbines from the rest of the farm, which is also shielded by a stand of mature woodland of native trees to the south on the upper slopes. Impact **neutral**.

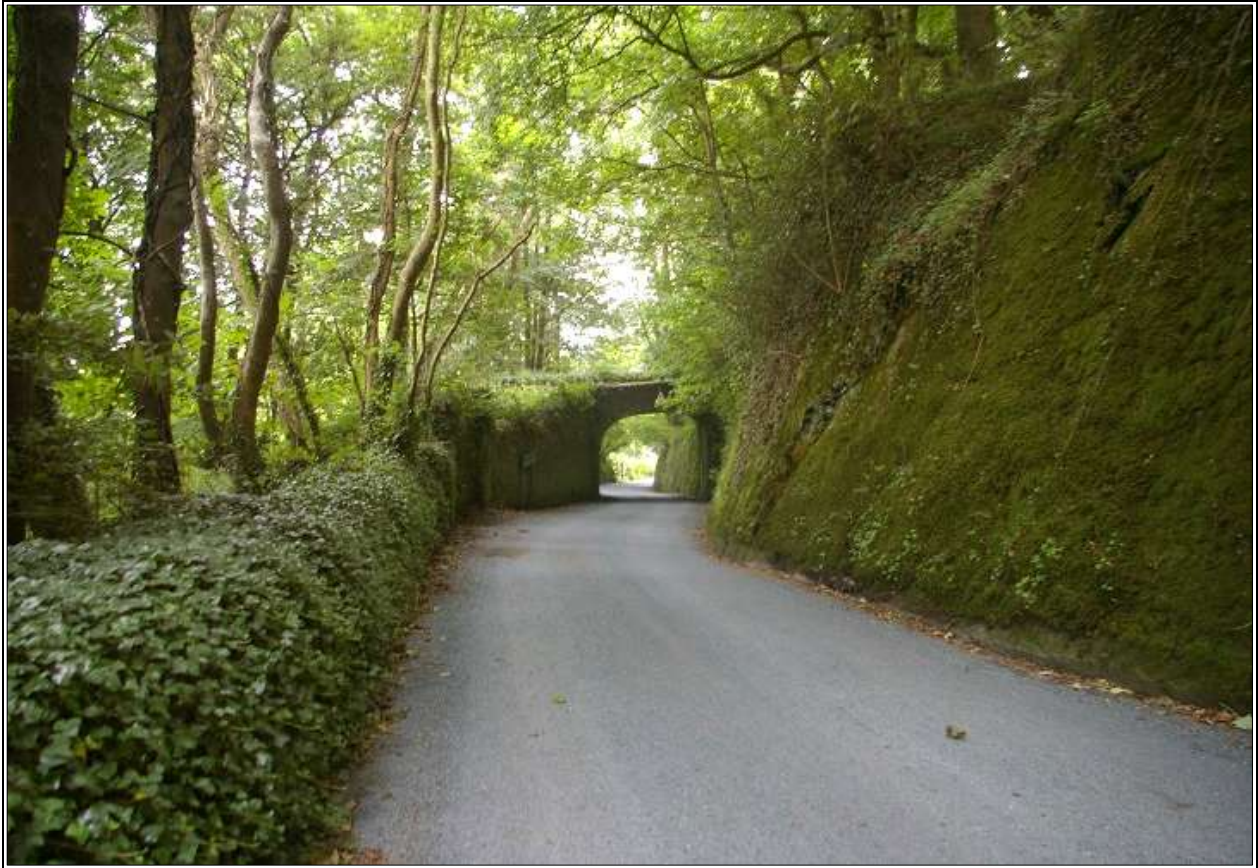
View of Haggington Bridge, set on the wooded slopes of Pit Hill, in Pit Wood; from the west.

- Bridge on Hagginton Hill, 150m east of East Hagginton/Hanginton Farmhouse; medium significance; Grade II Listed; condition: good. The bridge is largely intact and appears well maintained, although no longer in use. It appears to be associated with stone walls, gated entrances (now blocked) and other possible parkland features. There is no intervisibility with the turbine as it is situated in dense woodland, with no views out to the surrounding countryside. The outlook from a bridge is irrelevant to its value, being listed for its architectural merits. Impact **neutral**.
