LAND ADJACENT TO TRECARRACK ROAD CAMBORNE CORNWALL

Results of a Cartographic Desk-Based Assessment
&
Walkover Survey

Report No.: 130426
Date: 26.04.13
Author: D. Laing-Trengove
S. Walls

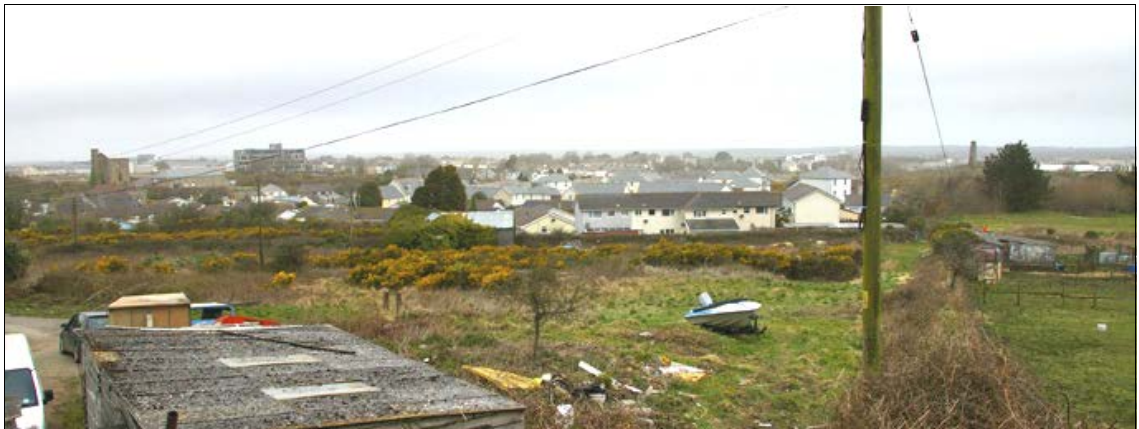
Figure 6: The site from the south-eastern corner of the central field, with views to the housing estates to the north-east and former mine workings of the Dolcoath Mine.

The central field (Figure 6) is bounded to the west and north-west by an overgrown hedgebank flanking the path, with a metal gate in the north corner. To the east the field is bounded by a stone-faced hedgebank with modern concrete buildings to the north. The southern boundary consists of scrubby evergreen trees; there are a number of modern concrete buildings to the south-west, much overgrown by vegetation. Just north of the houses to the south-east there is an open area for car parking and a garage. Most of the rest of this field was inaccessible due to scrub and gorse growth.

Extant housing provides local blocking from the north and west; however, the area to the north-east will be visually impacted by the development, but this will be **negative/minor** given the partial blocking offered by the railway embankment, the topography and existing housing (see Figure 6).

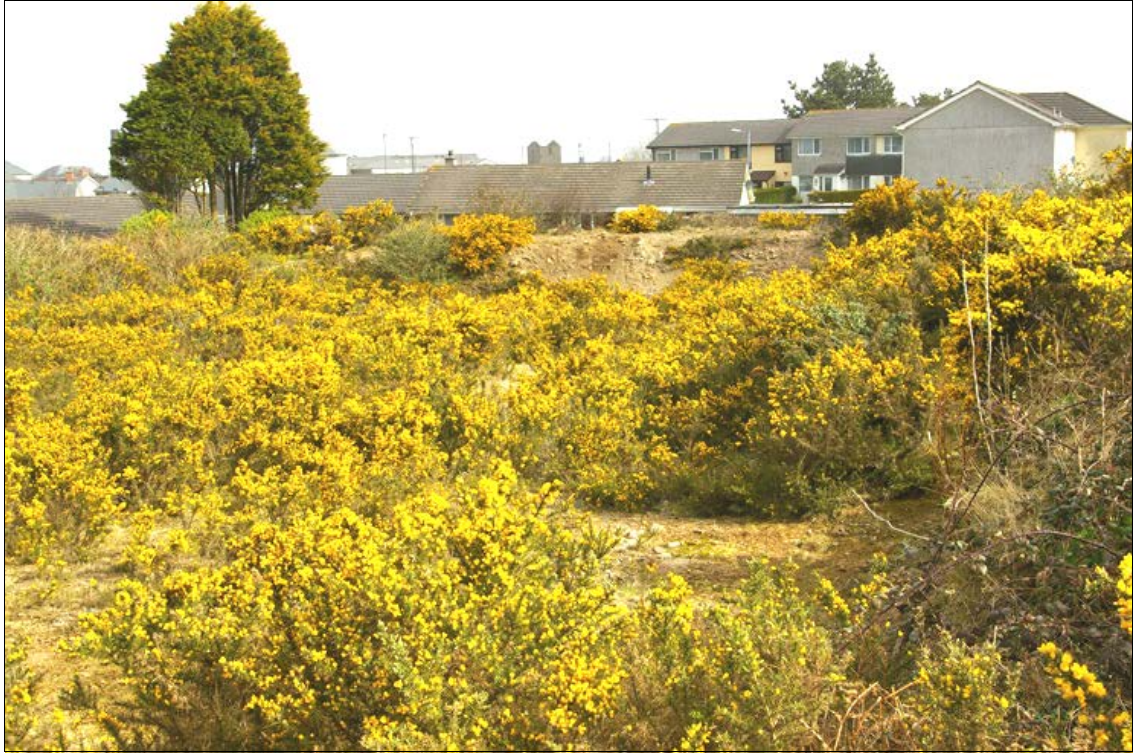
The small irregular field to the west is surrounded by a high and wide continuous bank of stony gravel (sugar granite?), enclosing a central area with a gently undulating surface (Figure 7). The whole area is covered with vegetation, predominantly gorse, and has the appearance of having been grubbed up from the centre and the material dumped around the perimeter to form the large banks. A shaft cap to the north of centre is marked on the ground by three metal stakes. No surface finds were observed or collected. The fact that the central area had been reduced appears to run contrary to the cartographic sources, as both the 1st and 2nd Edition OS maps are hachured to suggest the central area functioned as a raised spoil heap.

Figure 7: The western field, with the houses of Trecarrack Road in the background; viewed from the south-east.

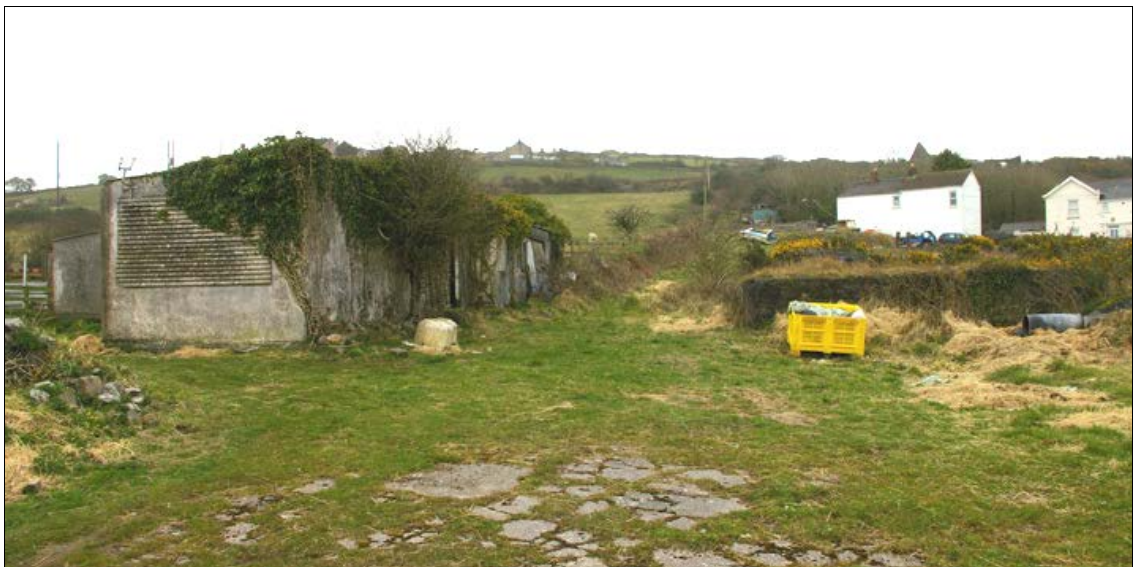
The accessible part of the central field was limited to the eastern edge and northern corner. From here a number of raised concrete platforms and cement surfaces were noted within the central and north-eastern portions of the field, all heavily overgrown by grass and gorse (Figure 7).

Figure 8: The eastern edge of the central field, viewed from the north.

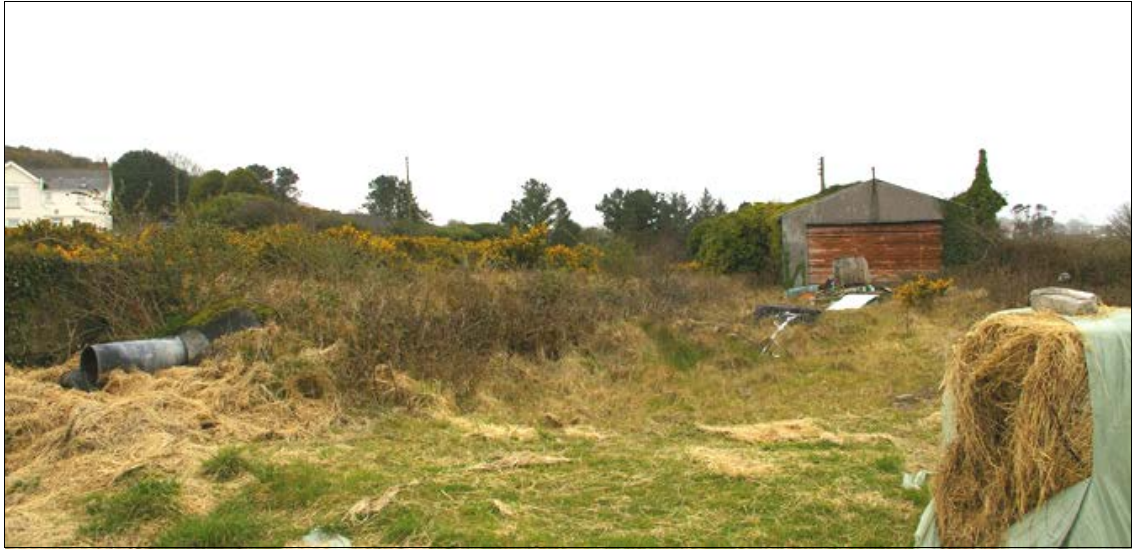
The large concrete shed stands close to the western boundary, but could not be accessed (Figure 9). All observed features and surface finds appeared to be modern.

Figure 9: The central area and western edge of the central field, showing the disused building on the north-western boundary; viewed from the north-east.

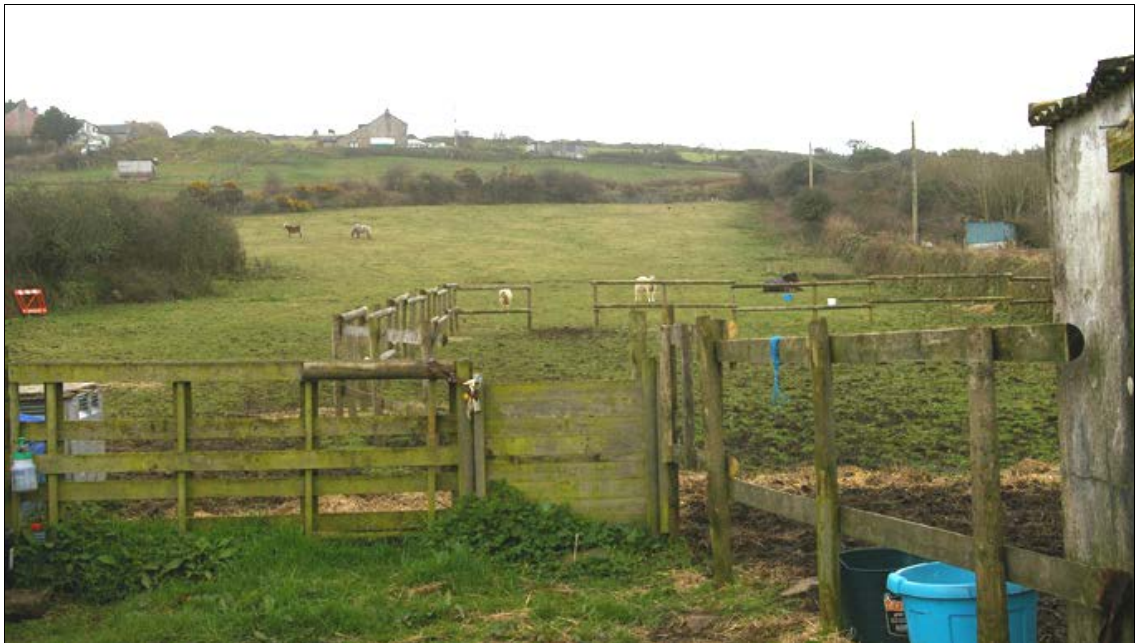
The eastern field is subdivided at the northern end by a timber fence and crude earth bank; the area to the south contained livestock, including goats and horses (Figure 10). The main body of the field to the south is bounded by stone-faced hedgebanks to south, east and west. These are slightly eroded or collapsed to the south-west and east. The only earthwork observed within this portion of the field was a recently-removed straight modern boundary, bisecting the field east-to-west.

Figure 10: The upper south portion of the eastern field, viewed from the north.

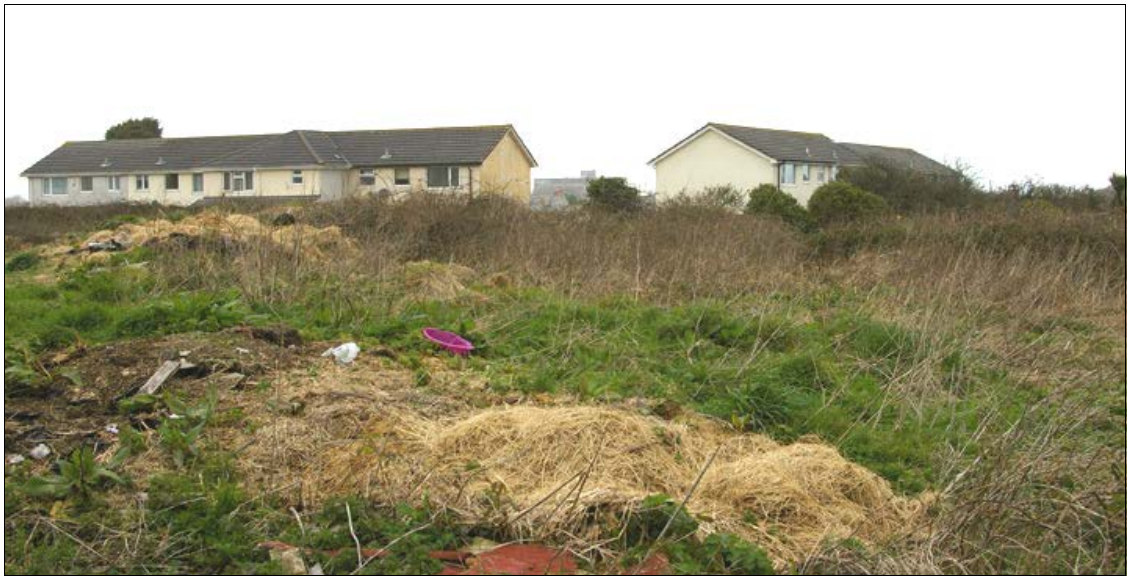
The northern part of the east field is overgrown with grass and weeds; the interior of this portion of the field is raised up from the edges where waste from the stables has been dumped on top of earlier waste and rubble (Figure 11). There is a small group of conjoined buildings in the south-west corner of this portion of the field, all of modern concrete block and cement (Figure 12). One part of these buildings – the element projecting to the north – appears to be built up from a rubble stone and cement plinth, suggesting that it could be constructed on the remains of an earlier structure.

Figure 11: The north-western boundary of the north portion of the east field, viewed from the south-east.

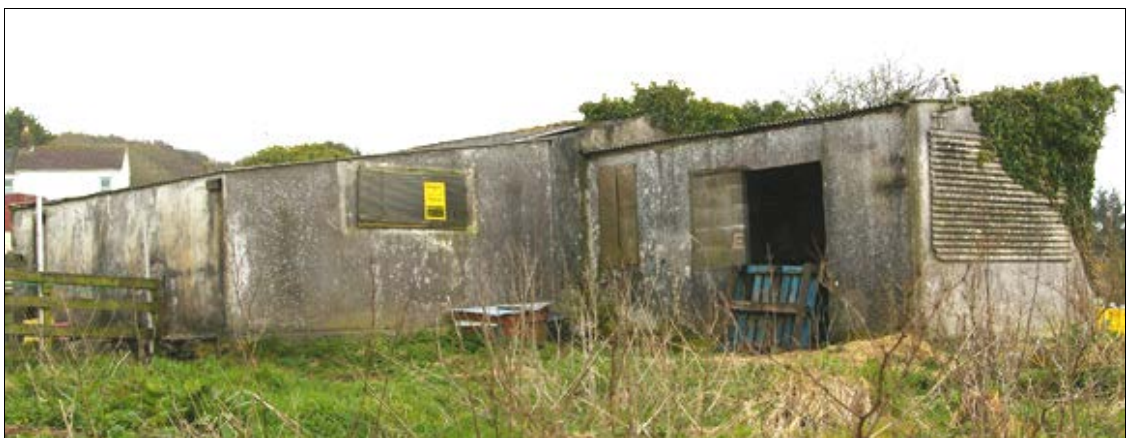
Figure 12: The buildings in the south-west corner of the northern portion of the eastern field, viewed from the north-east.
