# ST MARGARET'S CHURCH NORTHAM DEVON

## Results of a Desk-Based Study Historic Building Assessment & Archaeological Monitoring

### Revised Report

Report No.: 130711  
Date: 11.07.2013  
Authors: D. Laing-Trengove

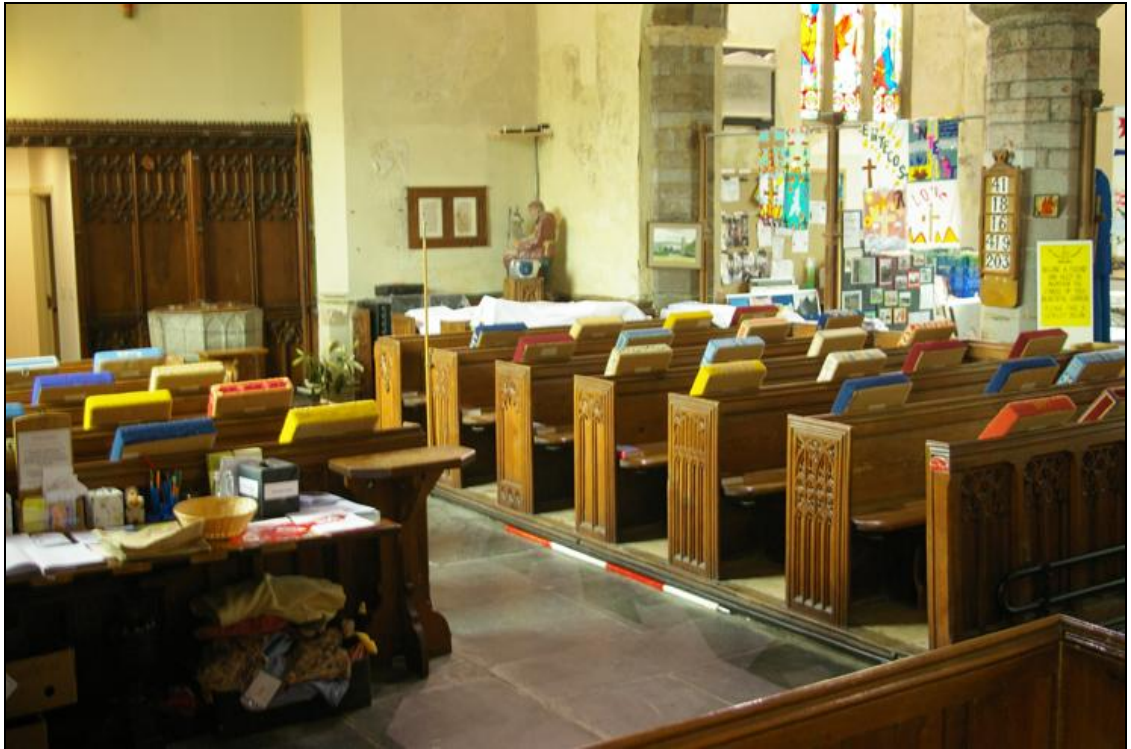
Figure 5: The south-west corner of the nave (south aisle), showing the pews to be removed under the current proposals, viewed from the south-east.

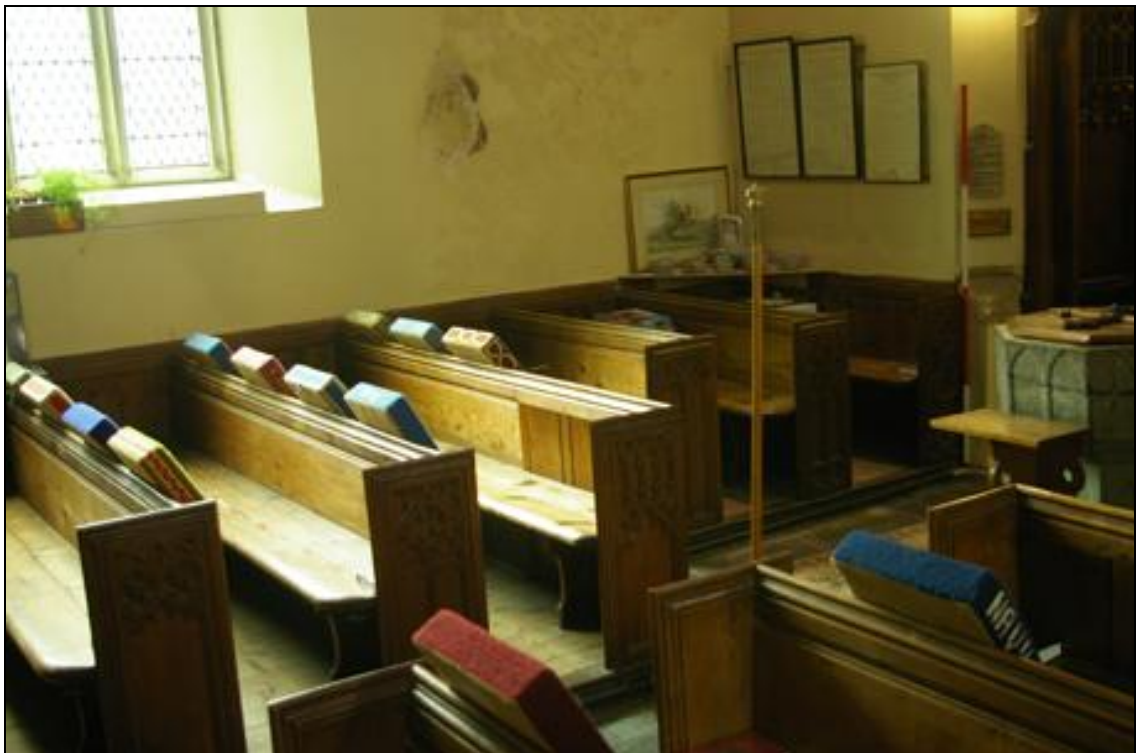
Figure 6: The south-west corner of the nave (south aisle), showing the pews to be removed under the current proposals, viewed from the north-east.

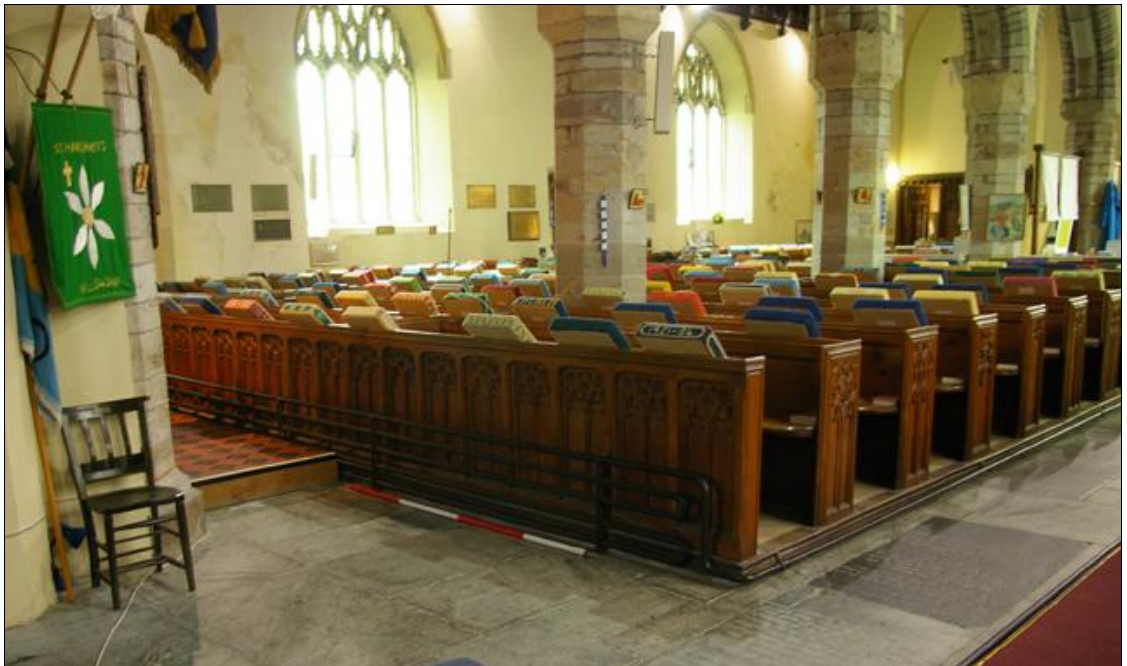
Figure 7: The pews to the front of the central area of the nave, with the northern edge of the raised platform against the chancel to the south, viewed from the north-east.

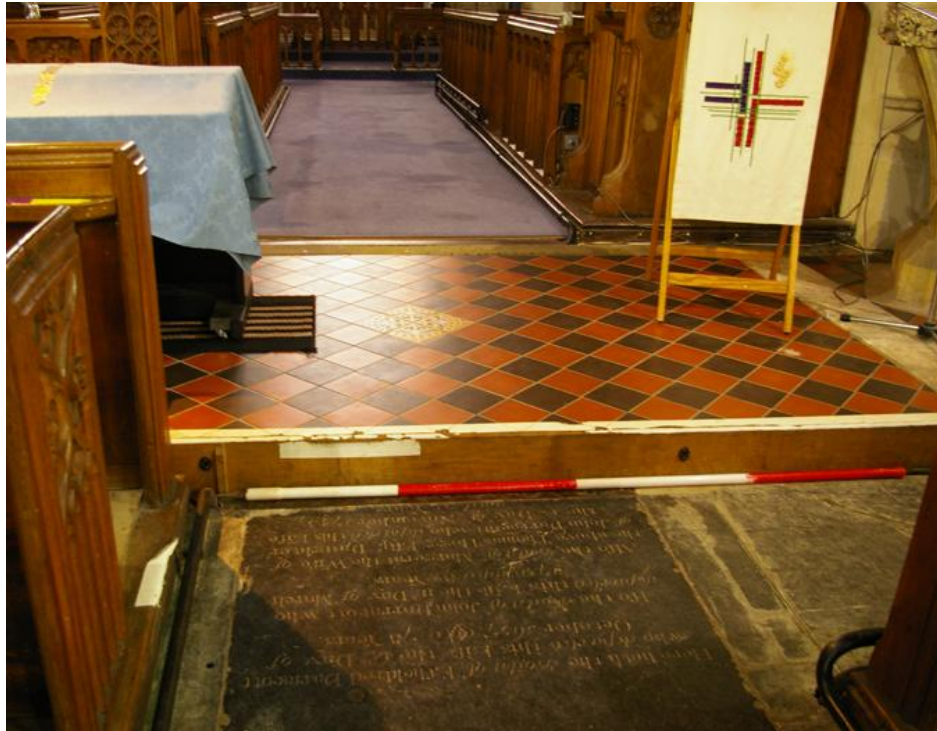
Figure 8: The south-east end of the nave, with plinth and reset gravestone, viewed from the west.

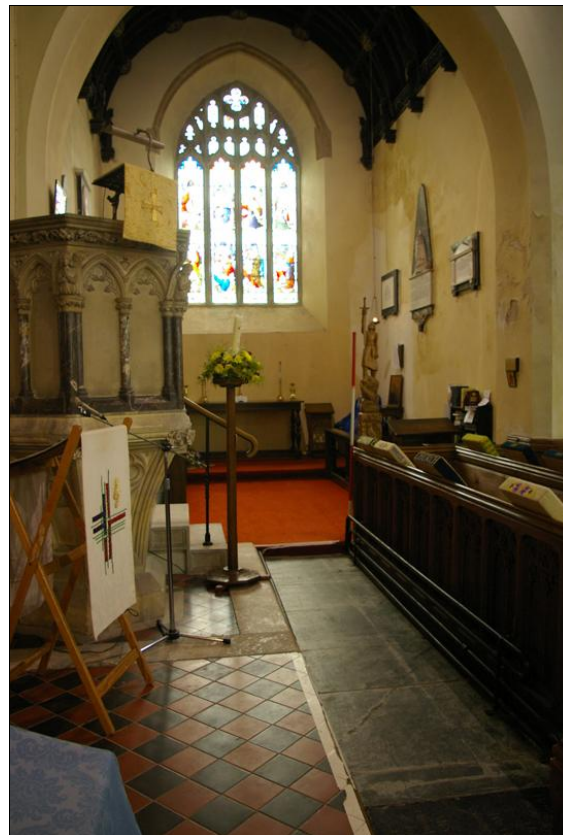
Figure 9: View into St Georges Chapel, showing the raised 19<sup>th</sup> century pulpit platform and the modern structure alongside, also the serpentine pipes fixed to the frontal of the pew block, viewed from the north.

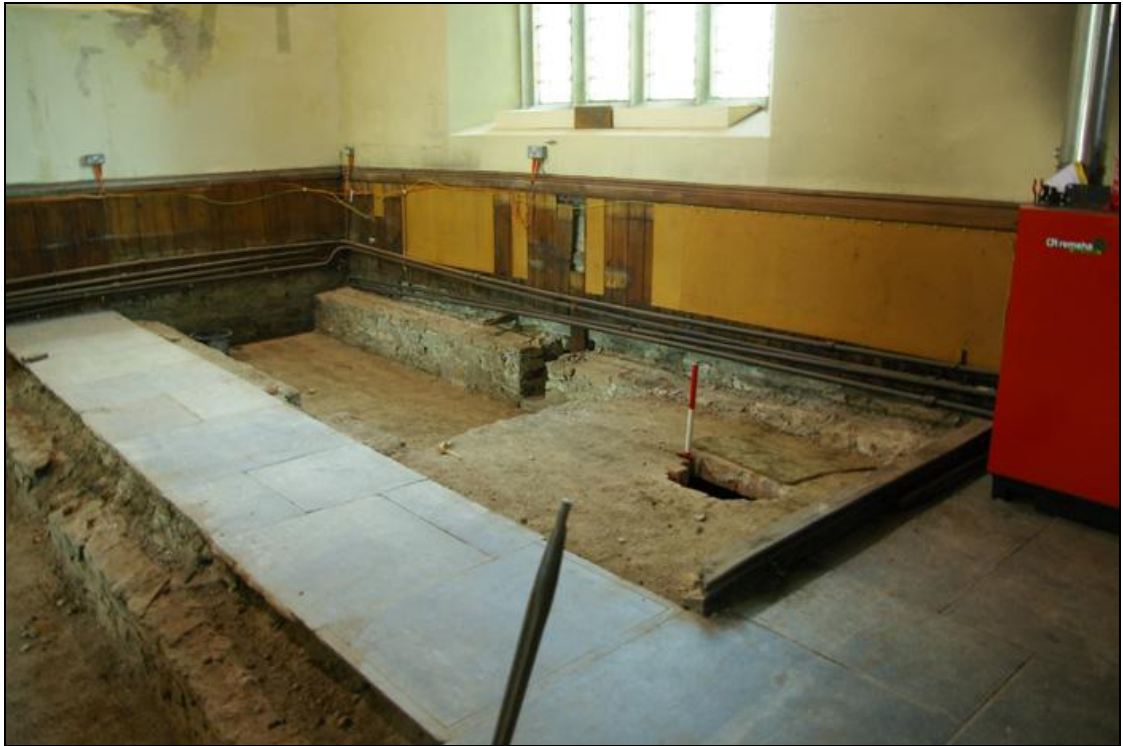
During the removal of the base of the former seating area within 'Martha's Corner', just to the west of the current heating boiler, a brick vault was uncovered containing a number of burials (Figure 11 & 12).

Figure 11: The raised arch of the vault below the seating areas within 'Martha's Corner', viewed from the south-east (2metre scale).

The discovery of a small mid 19<sup>th</sup> century vault, containing three coffins within 'Martha's Corner', just to the west of the current boiler, was recorded. The top of the vault was then repaired, resealed and the new flooring placed on top.

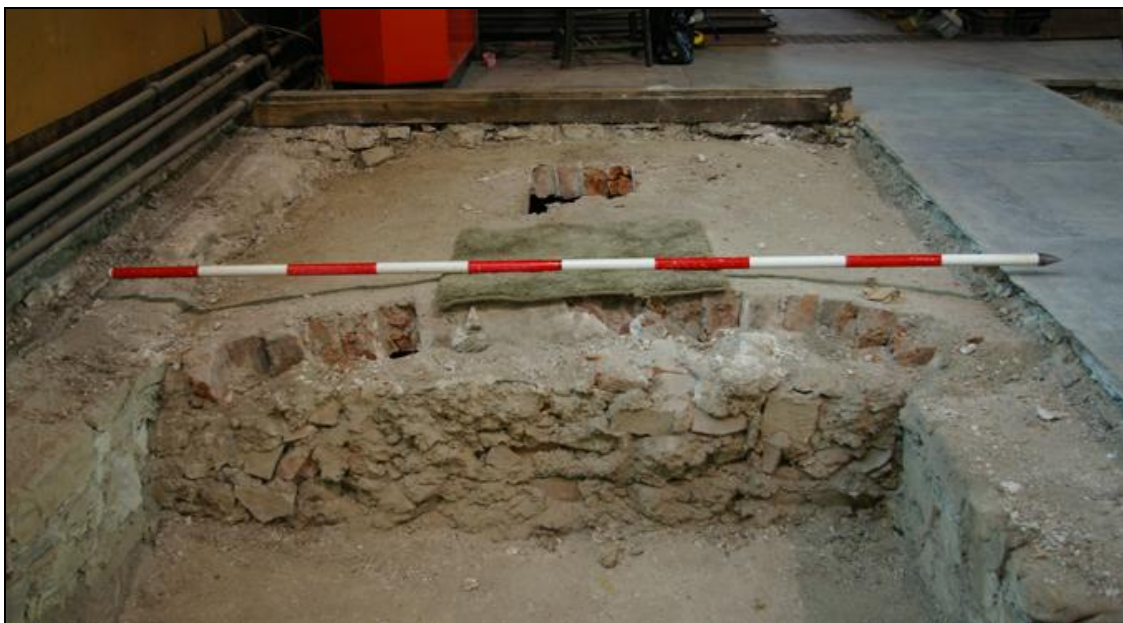
Figure 12: The top of the brick vault, viewed from the west (2 metre scale).

The top of the arch of the vault was impacted during removal of the joists supporting the plinth on which the pews within this area formerly sat. A small hole in the top of the vault then allowed the interior to be inspected. The vault was found to contain members of the Wren family, who are remembered in a number of memorials within this, the west end of the north aisle. An engraved slate headstone was fixed to the west wall of the vault with four names engraved upon it.

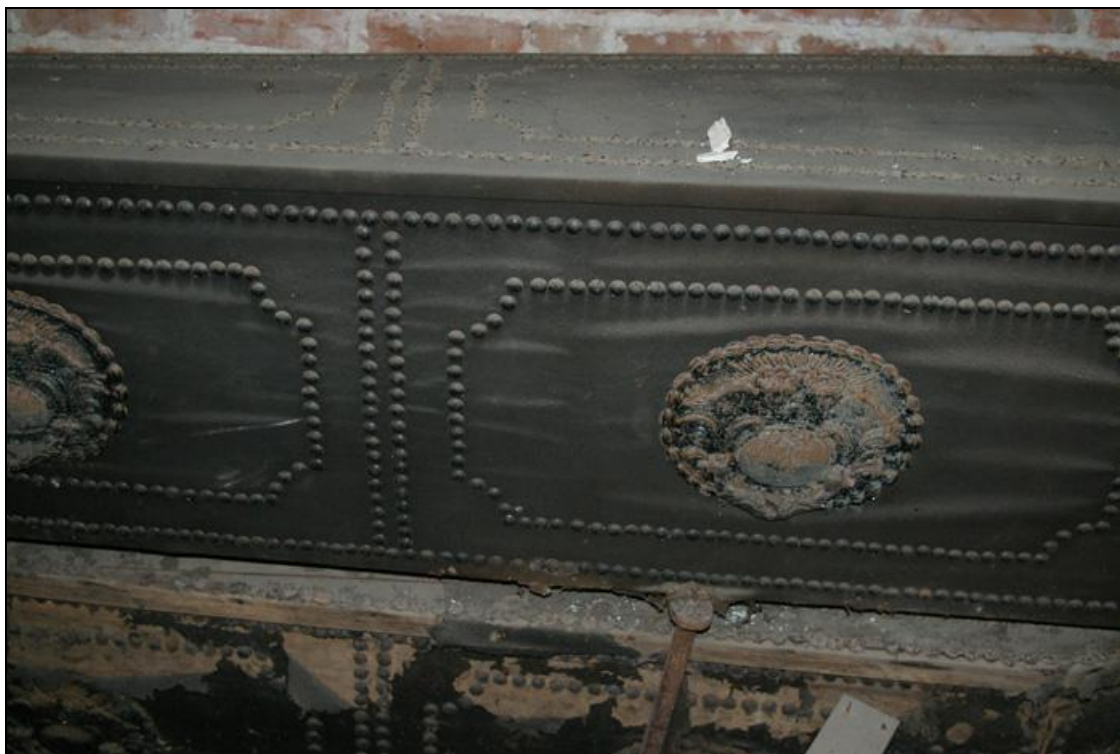
Oddly only three coffins were observed within the vault, two to the south, set one above the other on a metal frame, both identically covered in leather and with studwork and decorative bosses (Figure 15). The third, to the north appears to be of plain timber but with the remains of floral tributes still in place upon the coffin (see Figure 13). Three of the named individuals are also commemorated within this corner of the church, including Margaret Wren who appears to have had a window installed at the west end of the north aisle in her memory (Figure 14).

Figure 15: The two stacked coffins within the southern area of the vault, viewed from the north.
