# LAND at EAST BALSDON FARM, PYWORTHY PARISH, DEVON

Results of a Desk-Based Assessment,  
Walkover Survey &  
Historic Visual Impact Assessment

Report No.: 130708  
Date: 08.07.2013  
Authors: B Morris  
E Wapshott

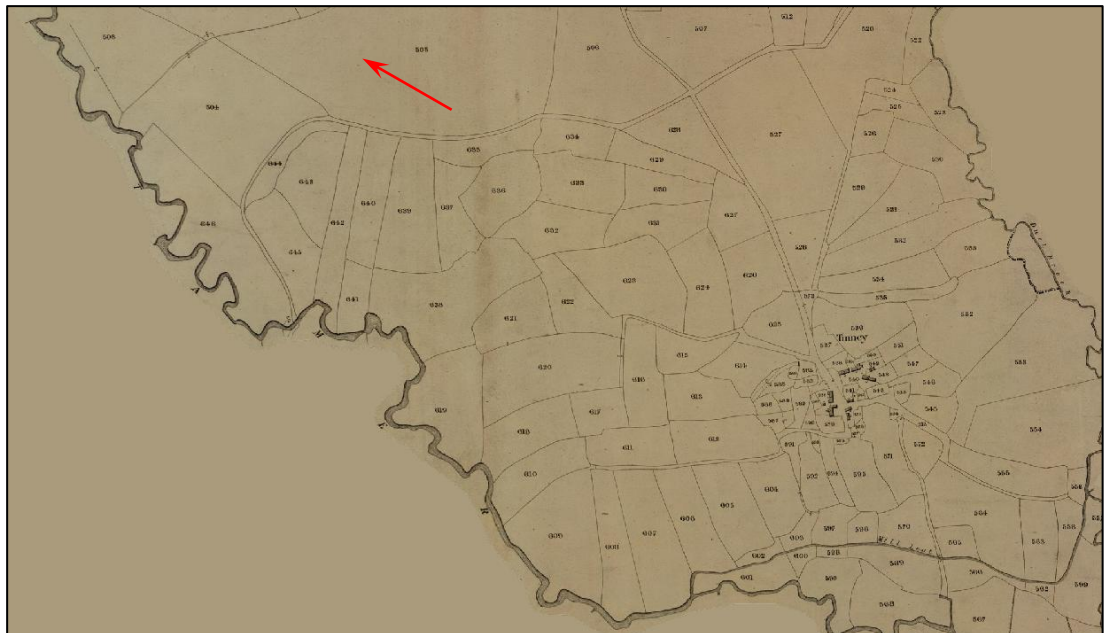
Figure 3: Extract from the 1843 tithe map (DHC) (the approximate location of the site is indicated).

## 2.3 The 1843 Bridgerule (east) Tithe Map

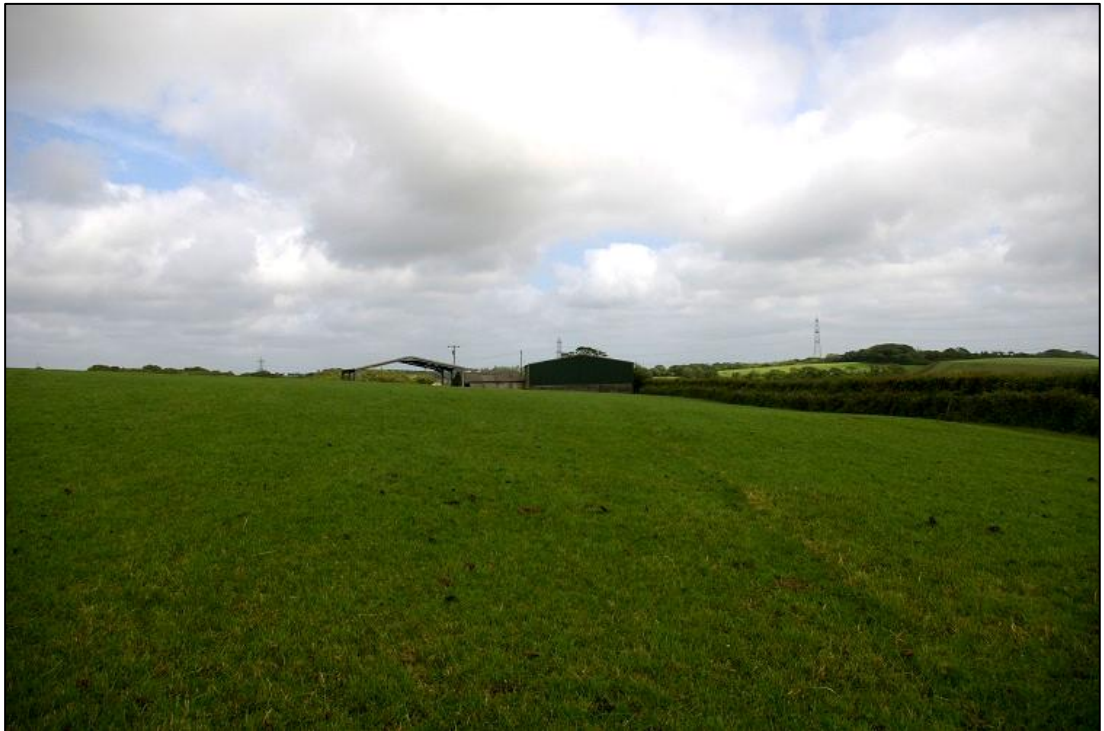
Figure 5: View east along the straight southern boundary towards the small group of barns and enclosed secondary farmyard; from the west.

The field in which the turbine is to be located is large and irregular in shape. It is bisected by a wire fence which enclose a small complex of barns. The field is bounded by tall hedgebanks; the northern boundary is topped with mature trees that show evidence of wind damage. The western and southern boundaries are more closely trimmed grassed banks; to the east the field is framed by native woodland. The ground rises up from the road quite sharply, and the hill peaks close to the northern field boundary. The field is laid to pasture with the small fenced area seeming to be more intensively worked. There were some minor undulations within the pasture section of the field enclosure, but these appeared to be natural as they followed the contours of the south-facing slope of the hill. There were no obvious cropmarks or earthworks visible on the ground. Intervisibility with Whitstone was confirmed (Thorne Farm) and some limited intervisibility was confirmed for the group of barrows on Affaland Moor to the east.

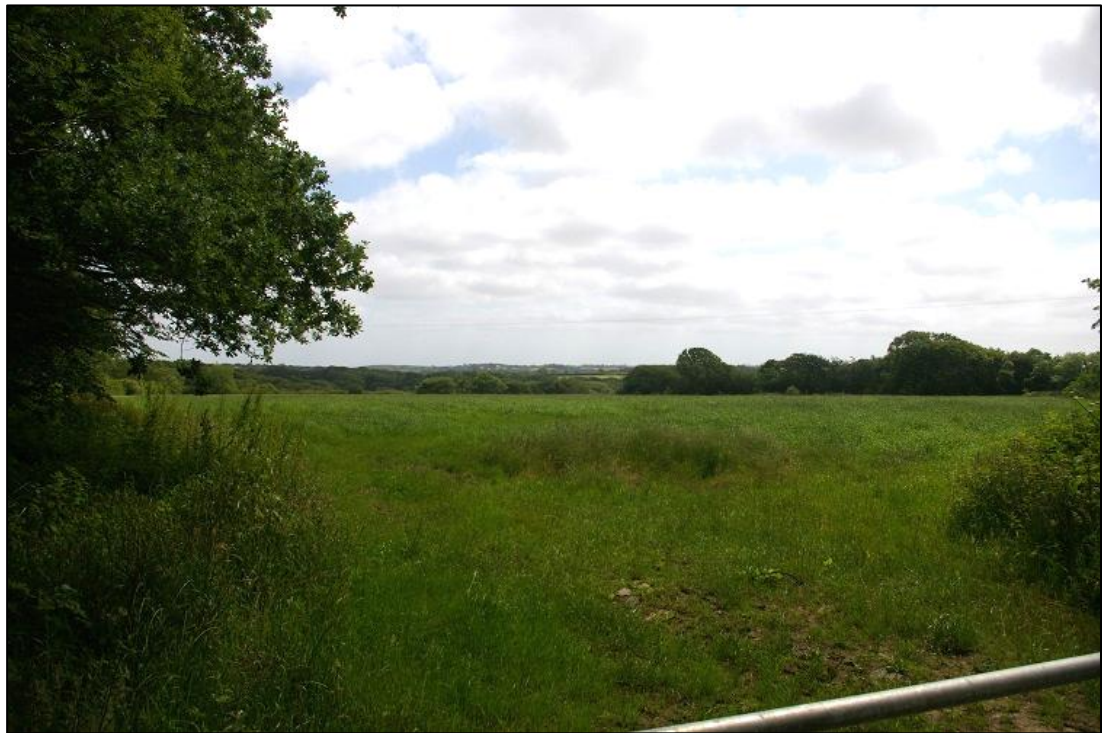
Figure 9: View south-west towards the proposed turbine from the Old Rectory and its grounds; views would be limited by the mature trees within the wider parkland-style landscape surroundings of the house. Viewed from the north-east.

- The Old Rectory and Coach House; medium significance; Grade II Listed; condition: excellent. This stands south-west of Pyworthy within its own grounds. There are some landscaped views to the south; the western side of the grounds are fairly open, to the east the views are framed by trees; high hedgebanks limit views to the south-west. The Rectory and Coach House provide the setting for the other and are experienced as a historic grouping within the landscaped grounds. Impact **neutral** as the majority of the important vistas are directed to the south, so the setting and outlook remains unaffected.

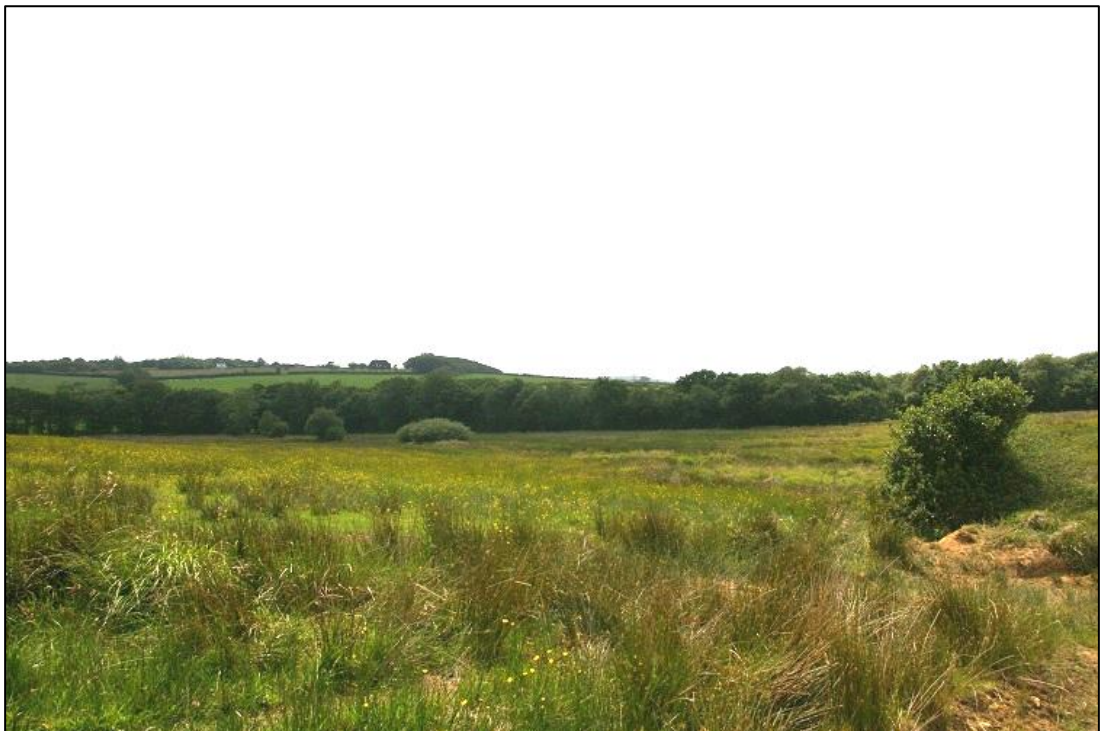
Figure 10: View towards the proposed turbine from St Bridget's Churchyard in Bridgerule, north-east of the main village; viewed from the north

- Church of St Bridget; high significance; Grade I Listed; condition: excellent. Located north-east of Bridgerule village, within a small churchtown settlement comprised of two historic farmsteads. This setting would not be affected by the proposed turbine. The church sits within its churchyard, which is framed to the south by mature trees and enclosed by a wall; this creates the backdrop for experiencing the church. The adjacent farms comprise a lot of modern farm buildings, over which the church tower has some wide views to the south, east and west. A number of extant turbines are visible at a distance from around the church building. On this basis, the impact is assessed as **negative/minor**.

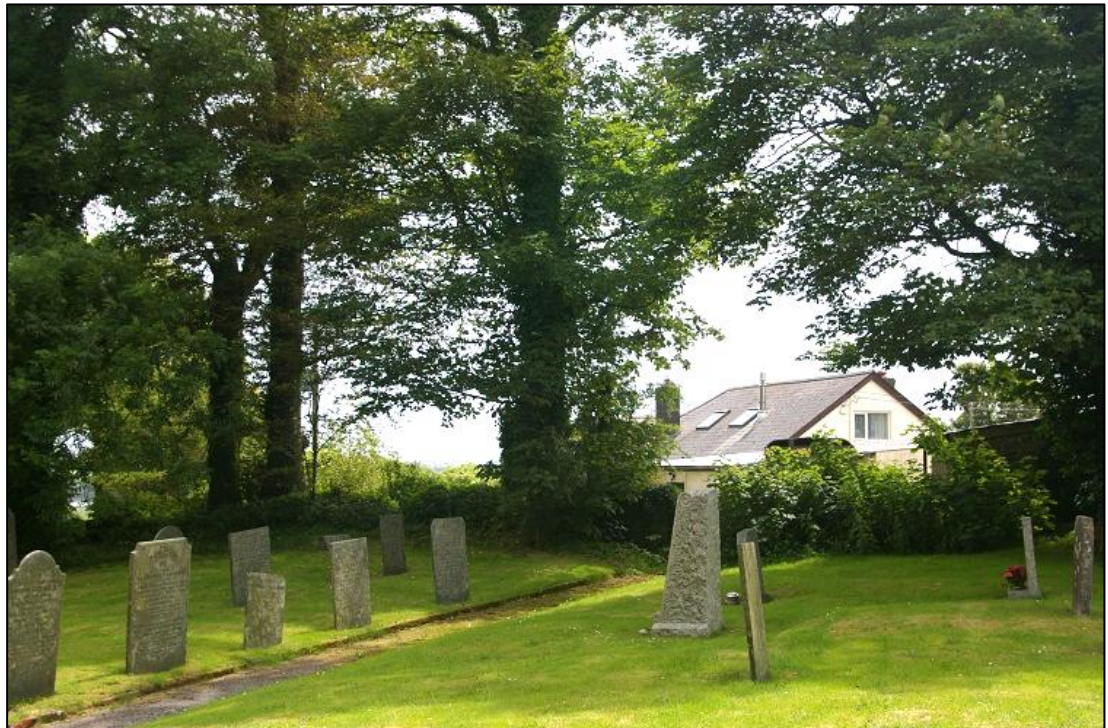
Figure 11: View south towards the proposed turbine from St Pancras Church in Pancrasweek, showing local blocking from the adjacent farm and trees; viewed from the north.

- Church of St Pancras; high significance; Grade II\* Listed; condition: good. Located in the village of Pancrasweek and surrounded by a walled churchyard. This is framed by trees to the south, and the setting of the church and the experience of the heritage asset would remain unchanged. There is some local blocking from a farm and outbuildings that stand adjacent to the southern boundary of the churchyard. The church sits on a high ridge of land with 180° views to the south. Numerous turbines are already visible within this landscape, and the proposed turbine would be in addition to these, but at a distance of c.6-6.5km. Impact **negative/minor**, despite the distance, as the visual connection to churches further south, such as Luffincott, Whitstone and Tetcott, would be interrupted.

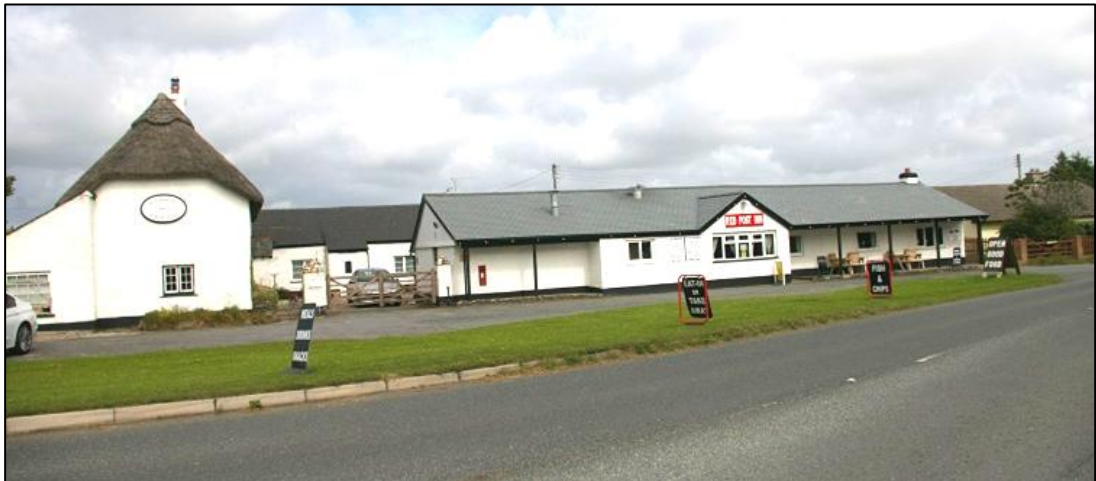
- The Red Post Inn; medium significance; Grade II Listed; condition: good. Located within the small settlement of Red Post, set around a crossroads on the main road between Stratton and Holsworthy. The immediate area around the Inn and crossroads has been developed as a modern caravan holiday park, and outbuildings have been built up against the south elevation of the historic building. The modern structures and caravan park provide local blocking, and have substantially altered the original wayside setting. Impact **neutral**.

Figure 12: View towards the proposed turbine from Red Post and Red Post Inn; viewed from the north-west.

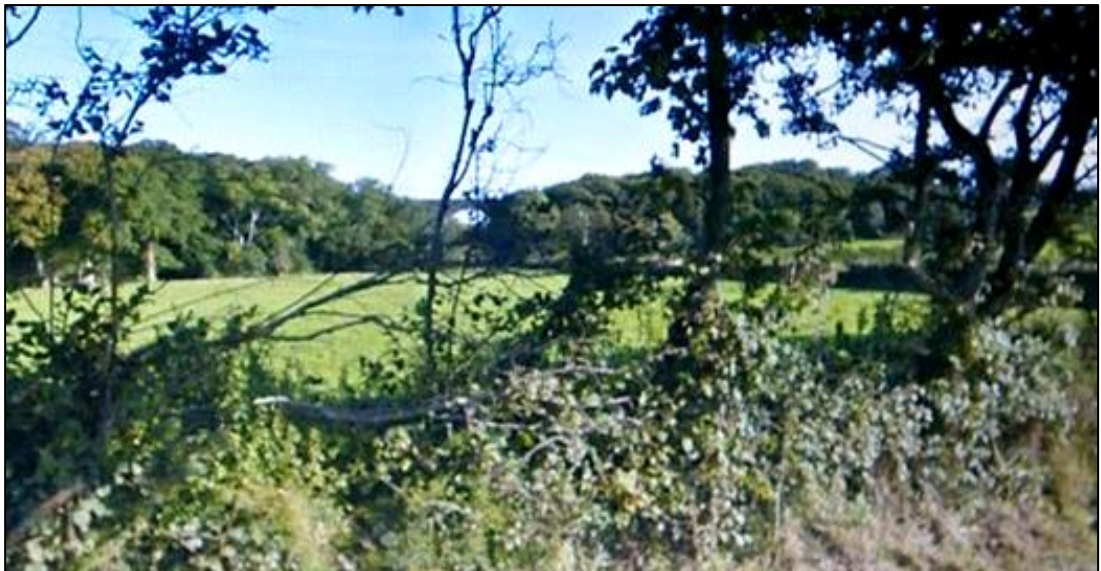
- Viaduct near Woolston Farm; significance high; Grade II\* Listed; condition: good. Set into a narrow valley that widens to the south, the slopes are covered with mature woodland. The proposed turbine will probably be visible from the top of the hill, but there would be no intervisibility to the turbine from the actual heritage asset; impact **neutral**.

Figure 13: View towards the Woolston Viaduct, showing steep wooded slopes of the valley and comprehensive blocking; viewed from the south-west.

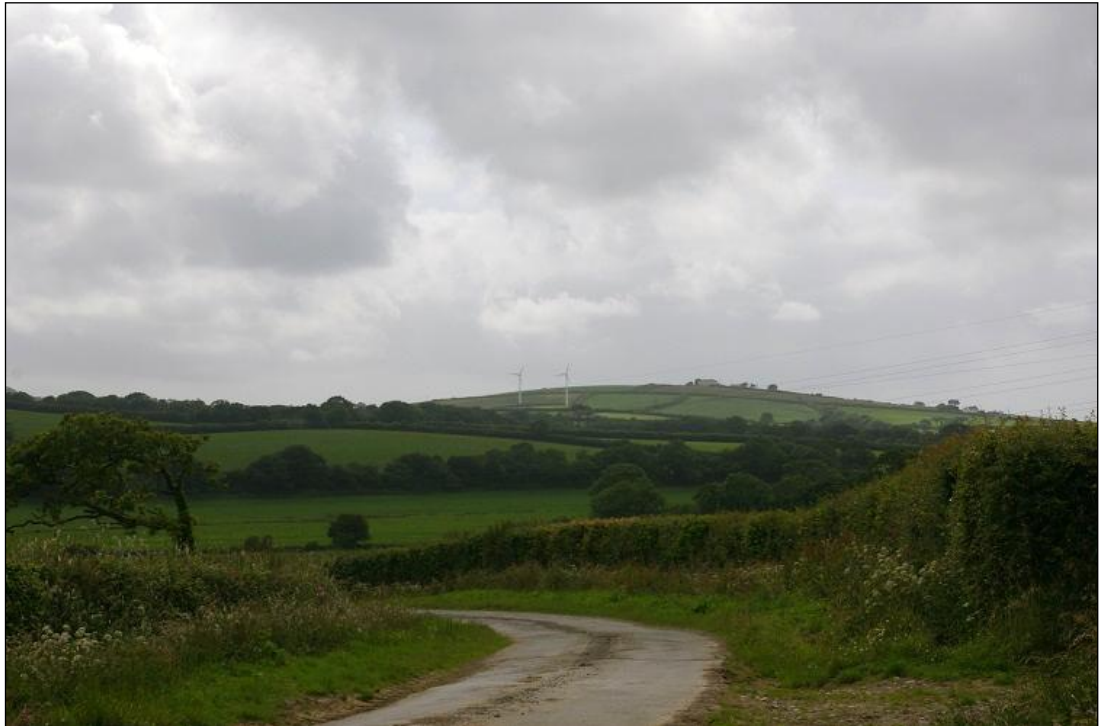
View west from the location of the proposed turbine, showing open views across the valley to two extant turbines; from the north-east.

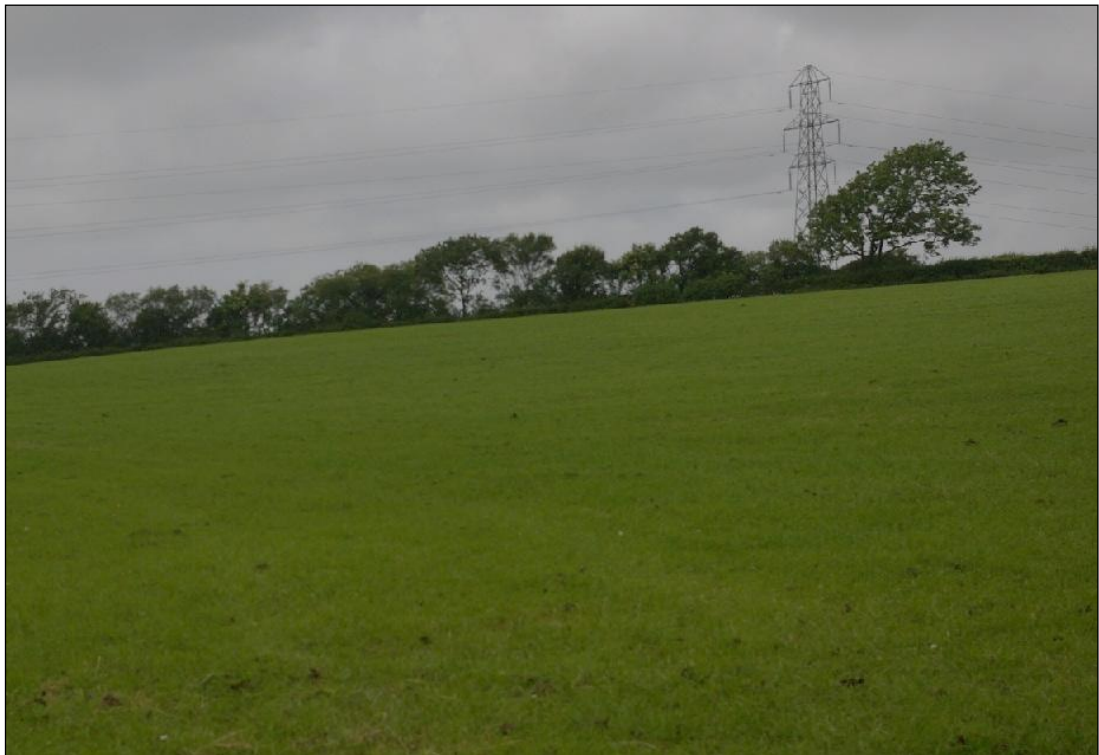
View up the field to the northern boundary with mature hedgebanks and trees; from the south.

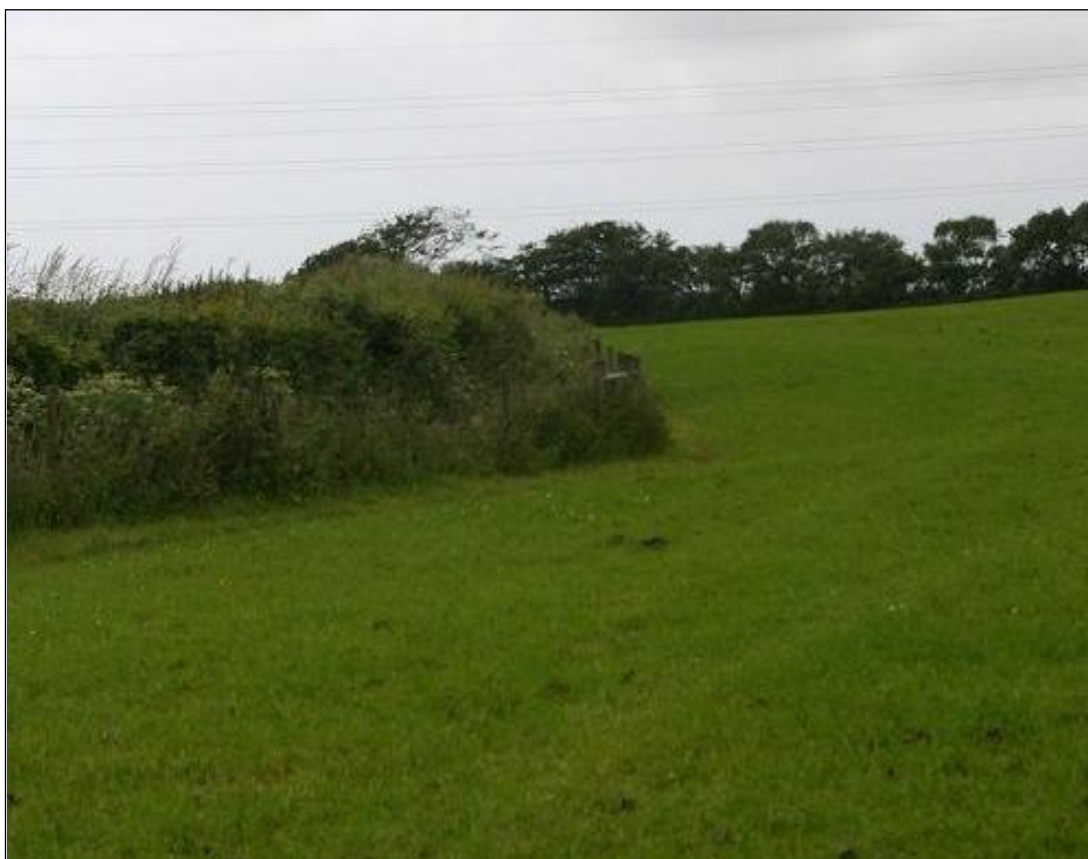
The irregular western boundary, with fenced banks; from the south-east.

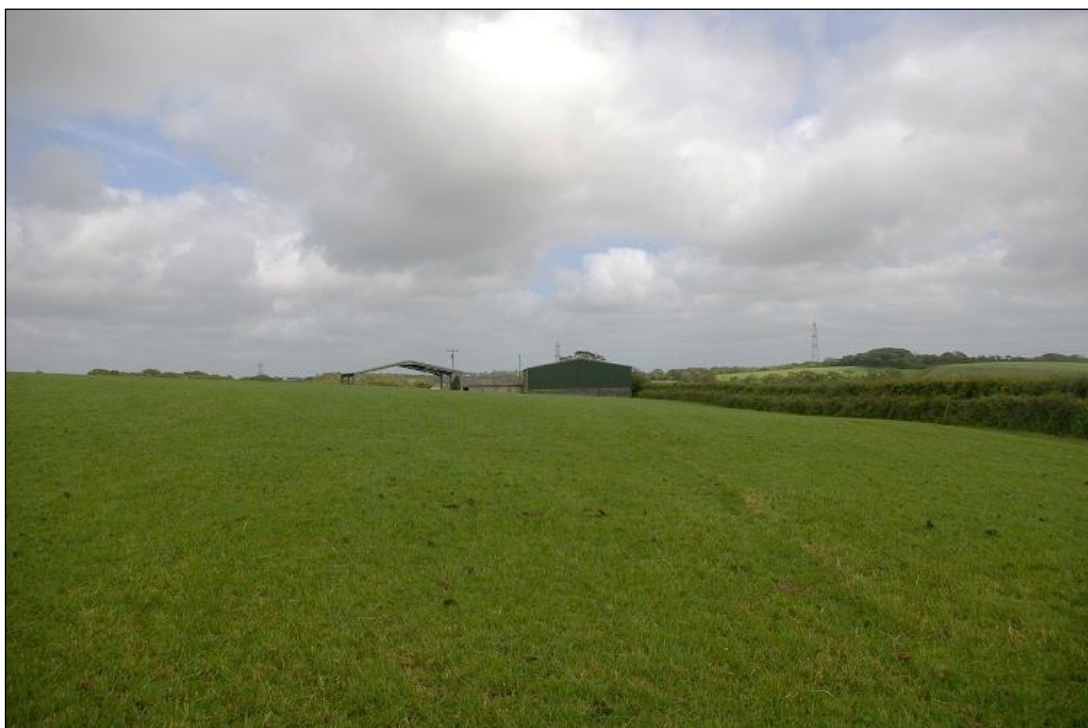
View east to the straight southern boundary, and the small group of barns and secondary farmyard; from the west.

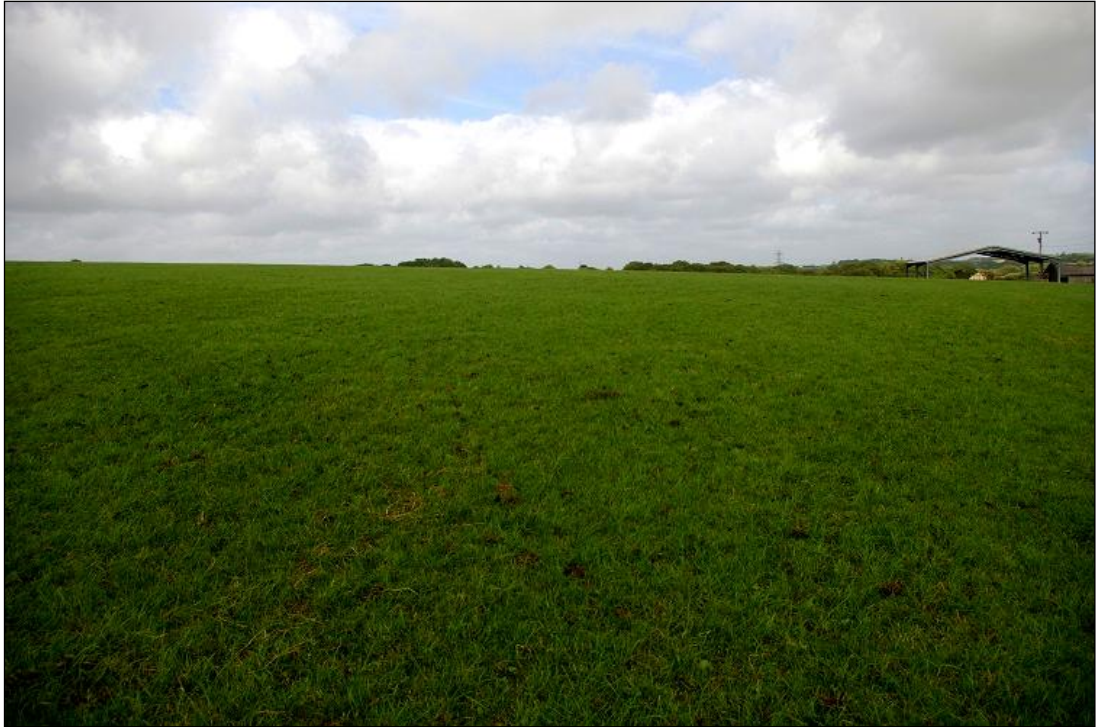
View up and across the pasture field; from the south-west.

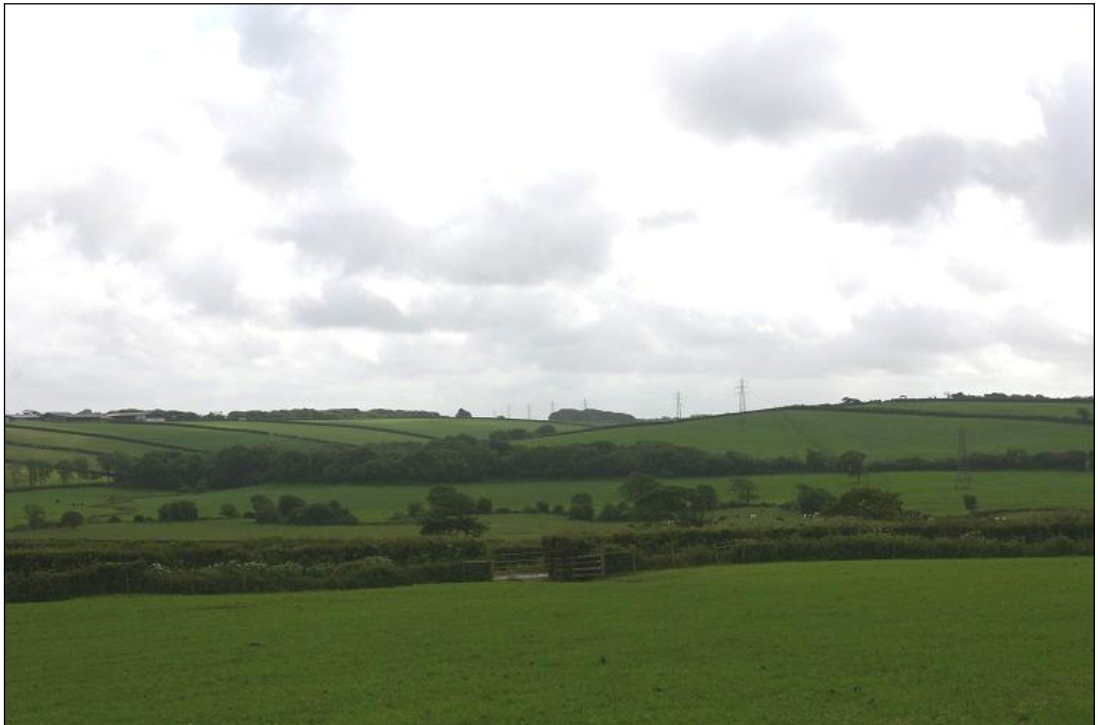
Open views to the south from the location of the proposed turbine, showing the pylons which cross the landscape; from the north.

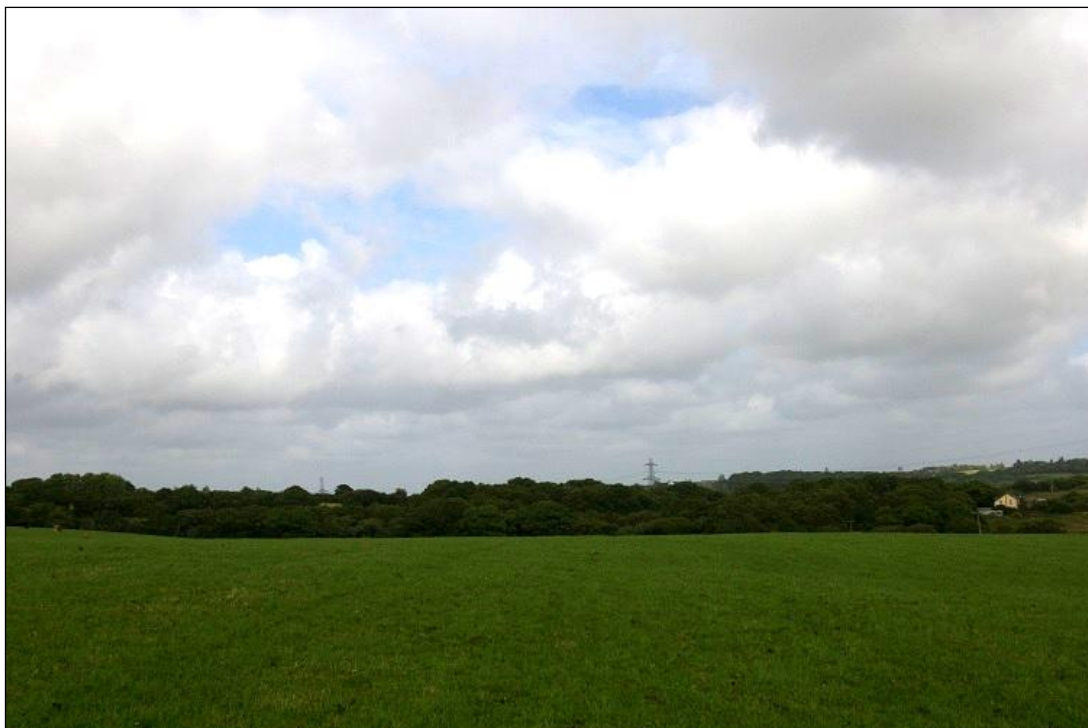
View showing the woodland which frames the field to the east; viewed from the west.

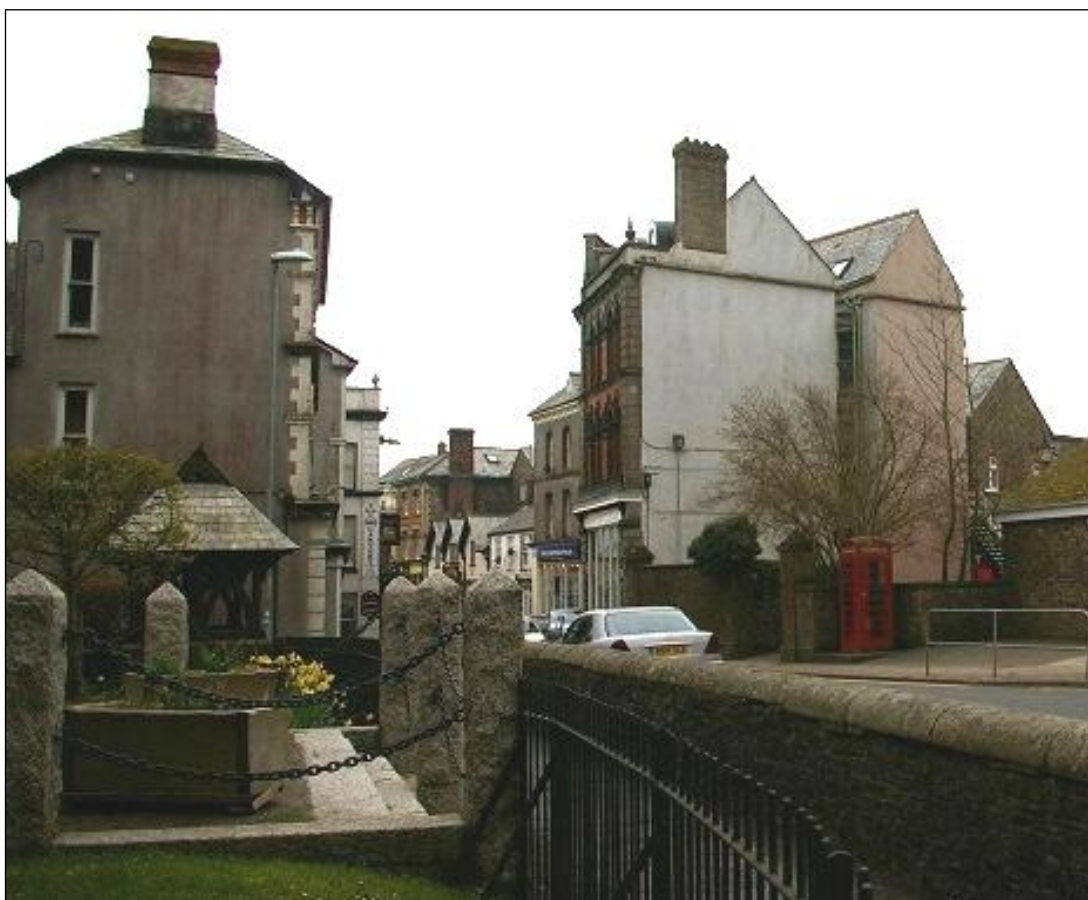
- Church of St Peter and St Paul; high significance; Grade II\* Listed; condition: good. Located at the heart of the market town of Holsworthy. Local blocking from the surrounding buildings is such an extent that the setting of the church is wholly defined by its town location and the experience and outlook are also defined by the historic town buildings which surround it and therefore despite some limited views from its tower the assessment of impact for this heritage asset is **neutral**.

View of the historic buildings in Holsworthy town centre that provide both setting and blocking to St Peter and St Paul, the Grade II\* Listed church; viewed from the north-east.

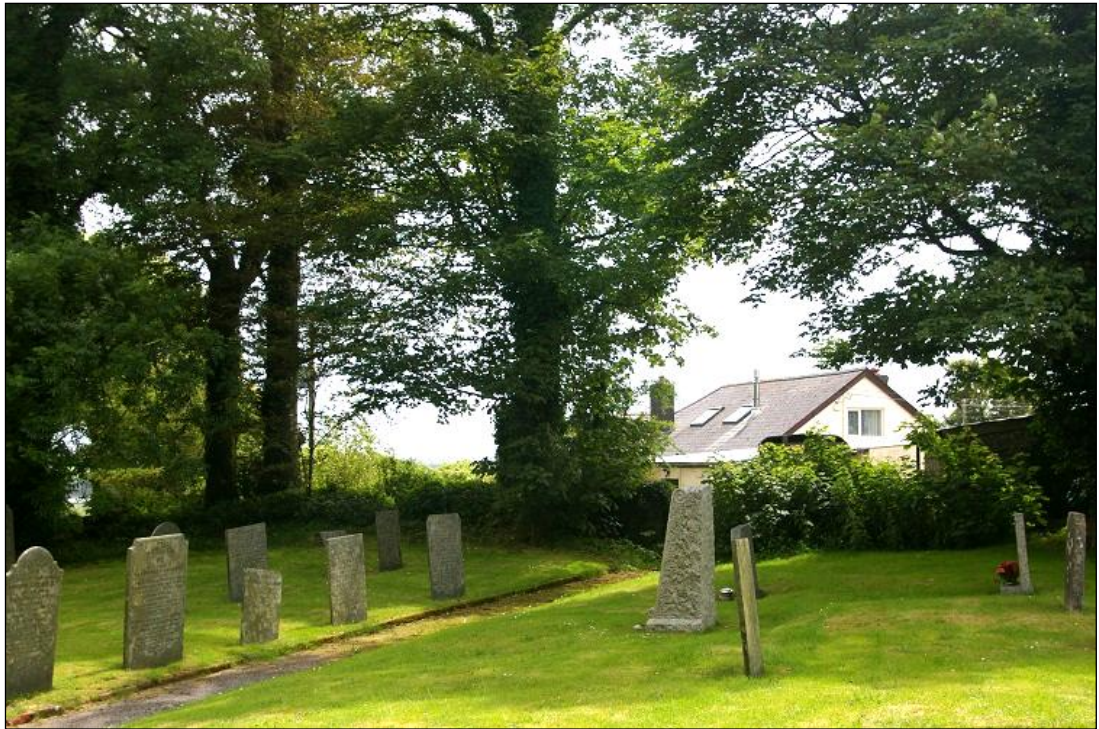
View south towards the site of the proposed turbine from St Pancras Church in Pancrasweek, showing some local blocking from the adjacent farm and trees; viewed from the north.

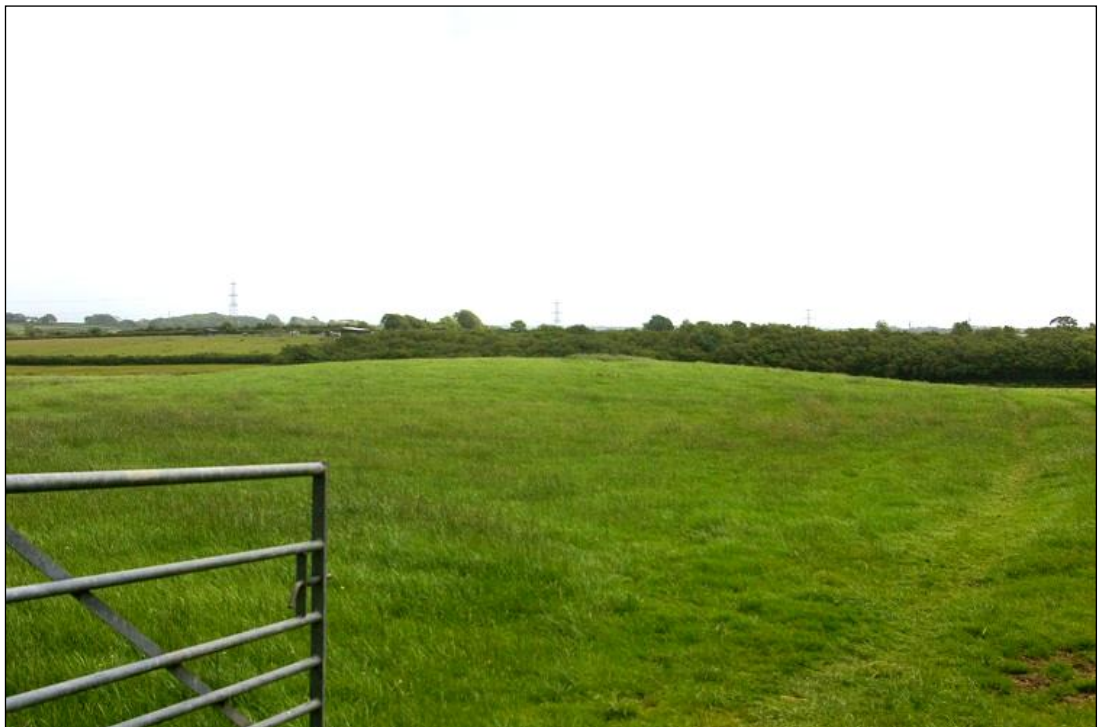
- Barrow east of Bridgerule, near Dux; high significance; Scheduled Monument; condition: excellent. Located on a shallow ridge with some views to the south, intervisibility would be somewhat limited by the intervening topography. Seasonal local blocking would be provided by trees to the south and hedgebanks; impact: **neutral**.

View south from a large barrow east of Bridgerule; viewed from the north.

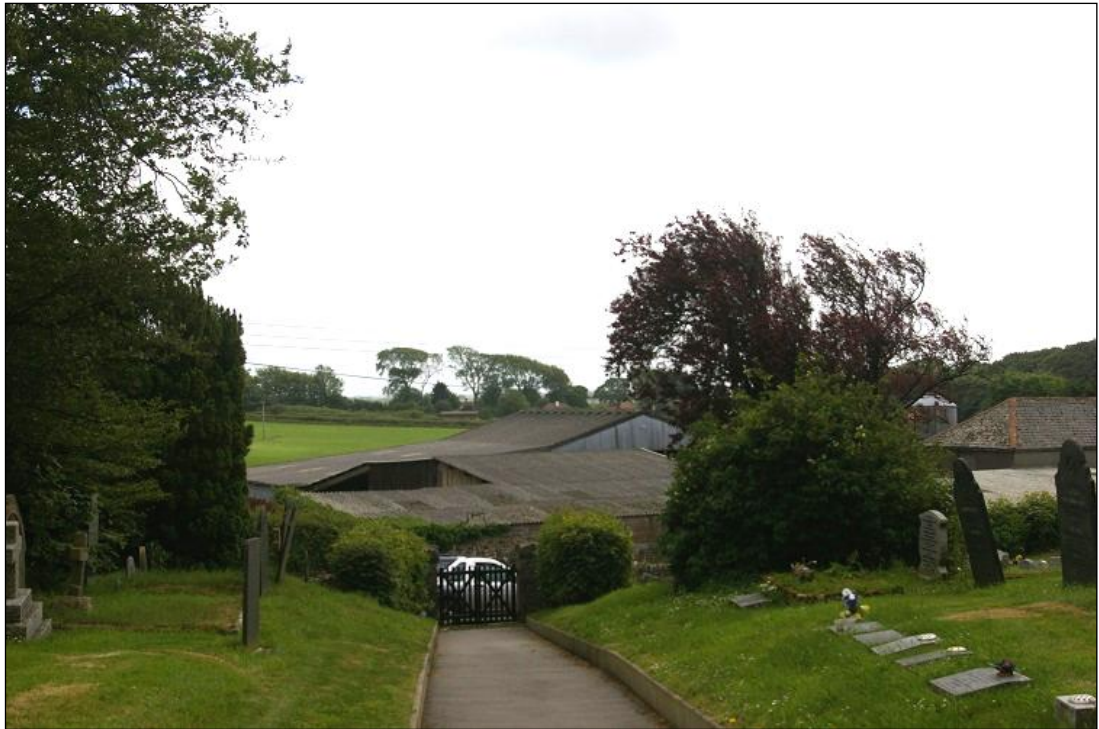
Views south from St Bridget's churchyard in Bridgerule, north-east of the main village; viewed from the north.

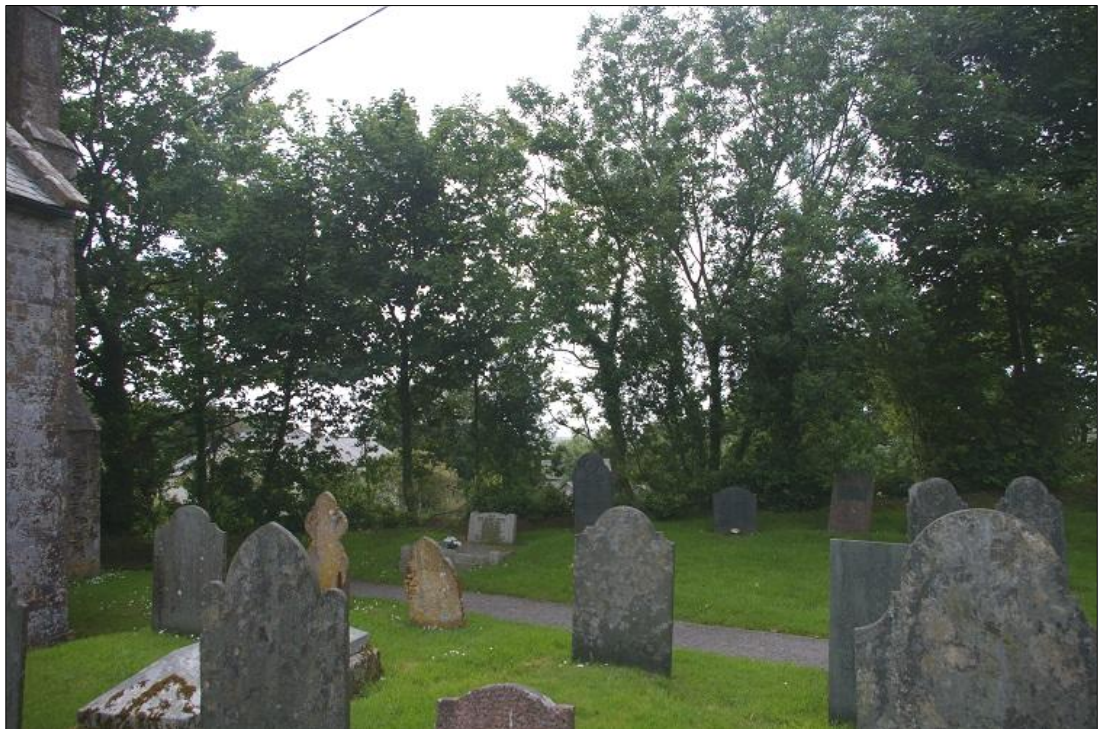
- Church of St Swithin; high significance; Grade II\* Listed; condition: excellent. Located in Pyworthy village, the church lies at the centre of the settlement. To the west and north of the church stands the Molesworth Arms PH, as well as various other historic and modern houses, including the Rectory. The setting would not be affected, and the experience of the church and its immediate surroundings would not be compromised. The turbine would be visible from the church, but those views would be limited; impact **neutral to negative/minor**.

View south-south-west from St Swithin's Church in Pyworthy, showing the trees that surround the churchyard, with cottages and houses beyond; from the north-east.

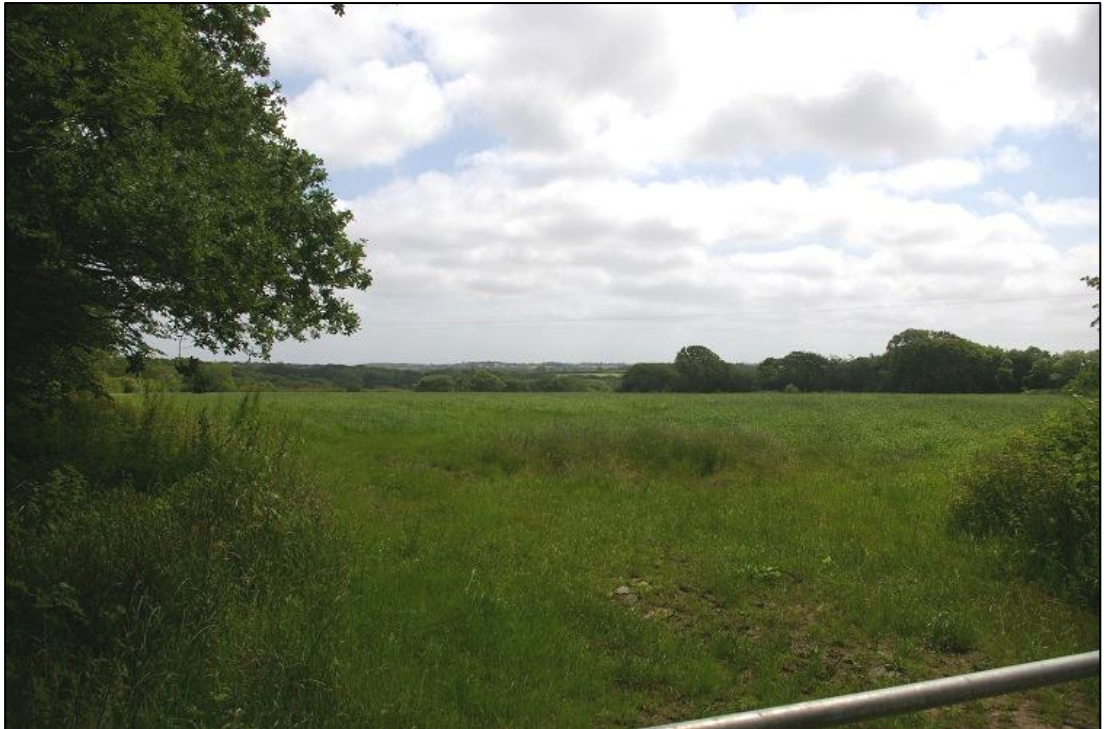
View south-west towards the proposed turbine from the Old Rectory and its grounds; views are limited by the mature trees within the wider parkland-style landscape surrounding the house. Viewed from the north-east.

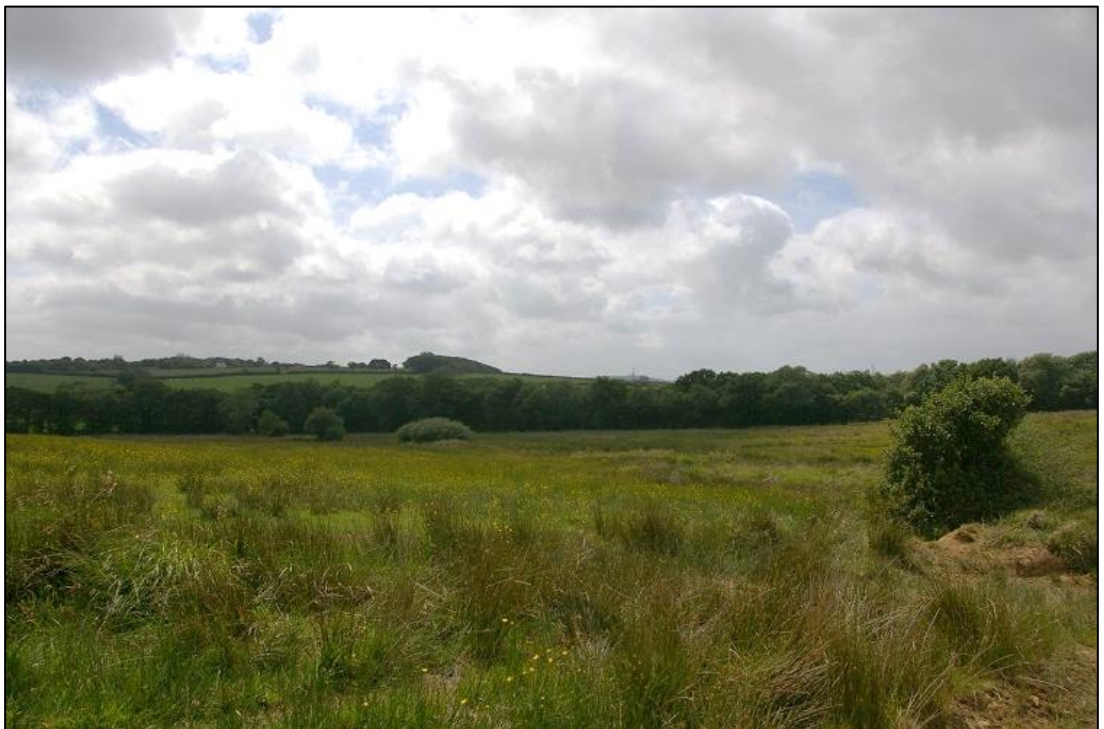
- Bowl barrows west of Leworthy and on Affaland Moor; high significance; Scheduled Monuments; condition: varies, most fair to good condition, those in ploughed fields fair to poor. This group comprises of a large number of upstanding bowl barrows spread across open ground and within the surrounding enclosed fields. The setting of the barrows in the fields is now defined by the field hedgebanks, which provide comprehensive local blocking; their intended setting on high open ground has been substantially altered. For these barrows the impact assessment is **neutral**. The barrows on Affaland Moor survive in an area of open unenclosed land; the ground does rise to the north, but there would be direct views to the proposed turbine at a distance of c.3km. As a group, the impact is assessed as **negative/moderate**, as views to and from these memorials is a key element of their significance. Therefore, any change within their landscape will be inherently negative, if minimal.

View north-west from Affaland Moor and the various groups of barrows that it contains; from the south-east.

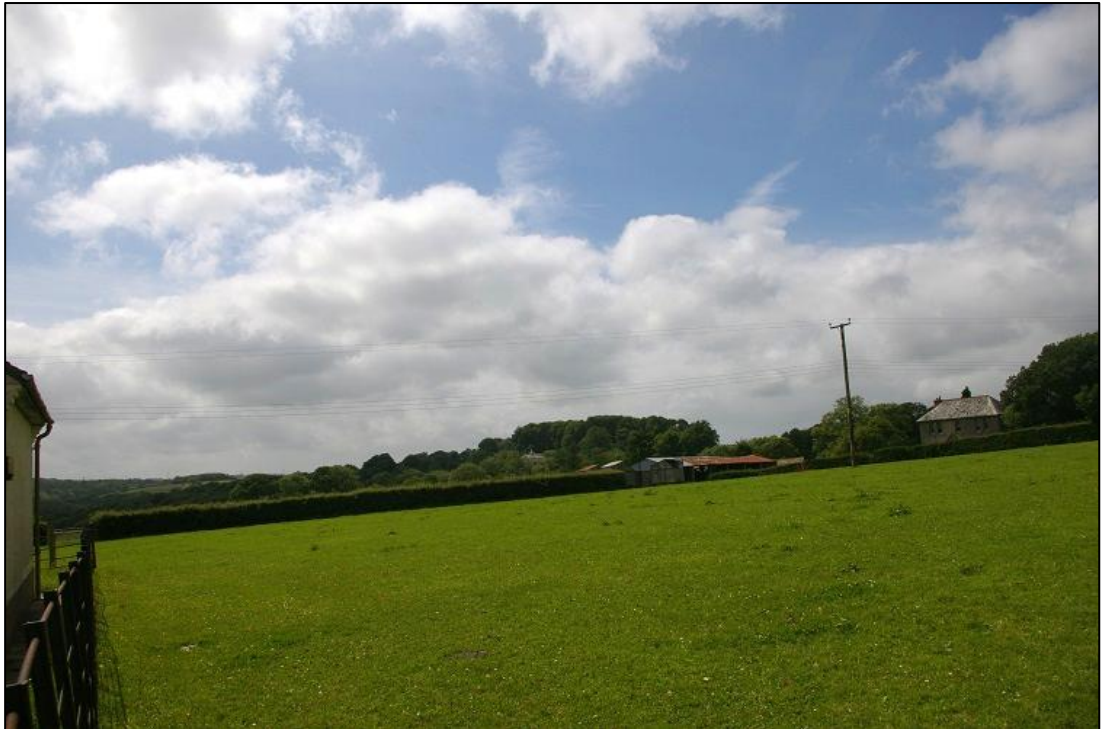
- Vacye Farm, granary and an outbuilding at Davies Farm; medium significance; Grade II Listed; condition: unknown. Both farms have views up the valley towards the location of the proposed turbine, and both are surrounded by mature trees, probably

planted as wind breaks. However, an assessment of **negative/unknown** is recorded as these buildings lie on private land accessed by long private drives.

Davies Farm and Vacye House. Looking up the valley towards the site of the proposed turbine, showing the open views but also the wooded grounds; viewed from the south-east.

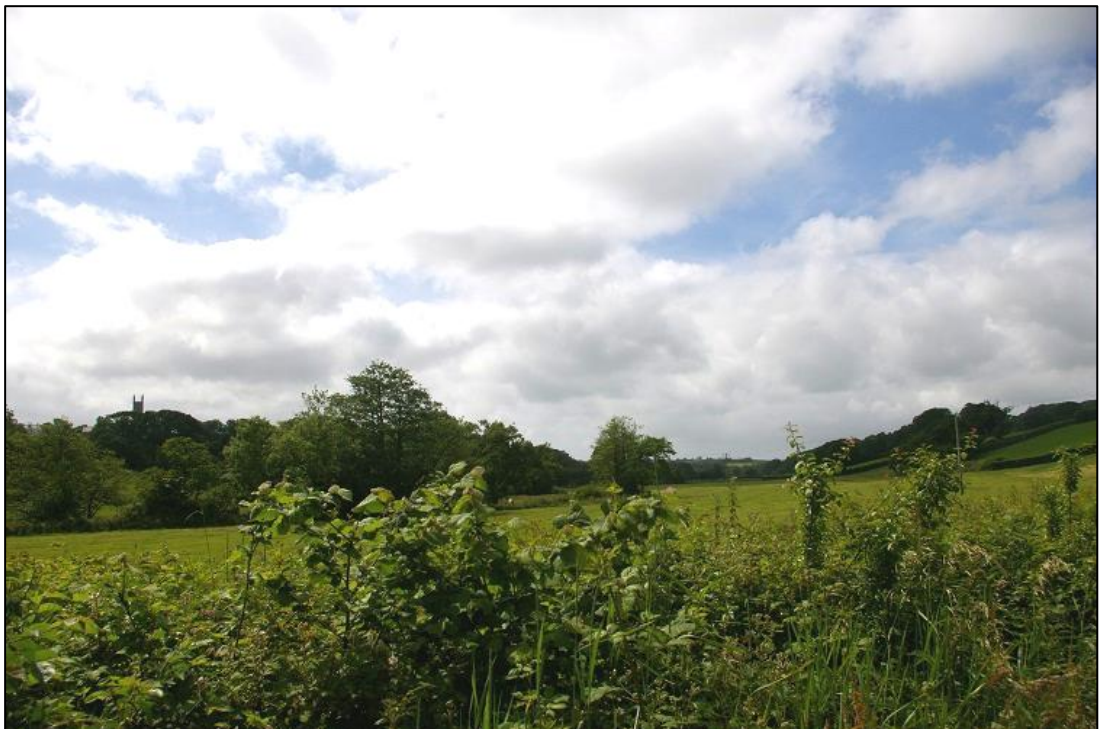
View up past North Tamerton, with its various Grade II Listed buildings and Grade I Listed church, to the site of the proposed turbine; viewed from the south-east.

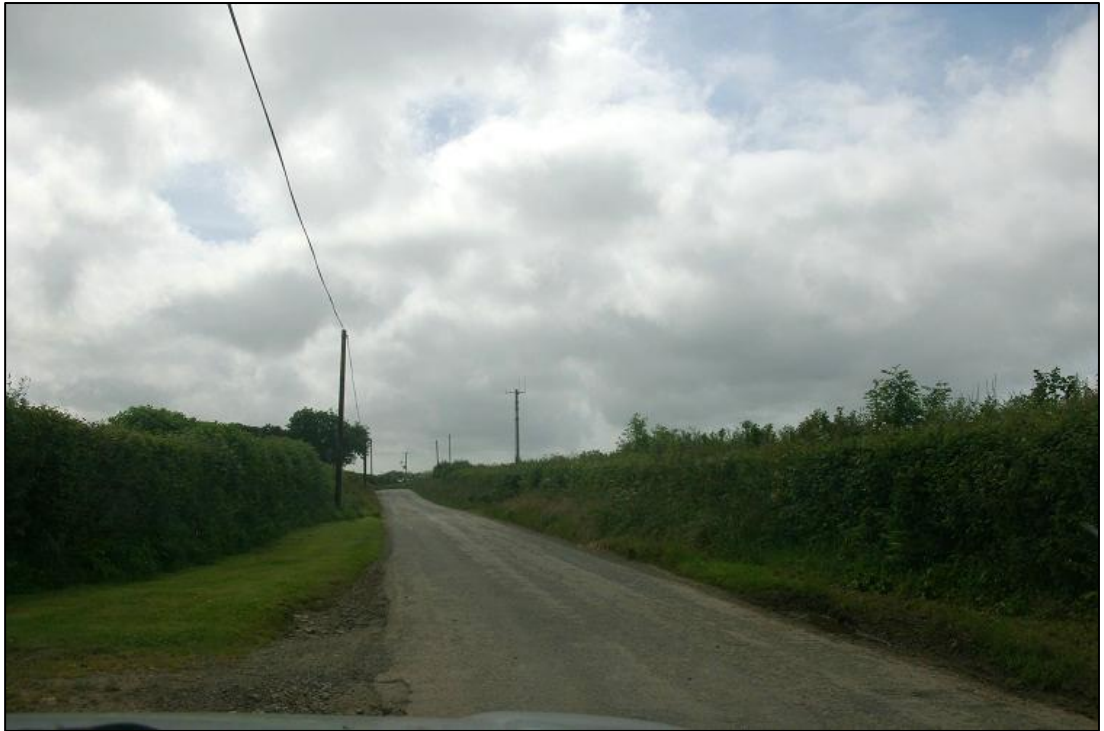
View north-west from Down Farmhouse to the site of the proposed turbine; viewed from the south-east.

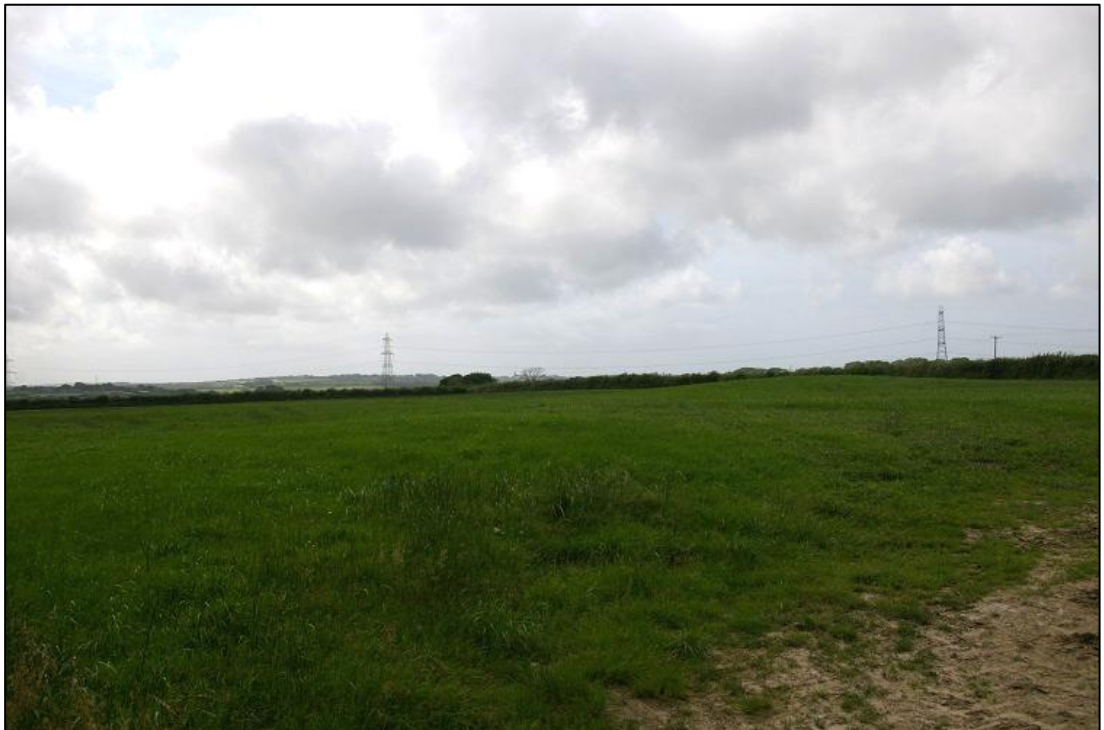
- Two groups of bowl barrows near Wilsworthy, at Cherry Cross and Wilsworthy Cross; high significance; all Scheduled Monuments; condition: varies, some in fair condition, other merely trace. The monuments are located on a high ridge of land, and the ground falls away to the north and to the east. Set within pasture fields, and divided from one another by hedgebanks which impede views both to and from the former monuments, the original context has been lost. Impact **neutral**.

View across the barrows near Wilsworthy Cross, showing the view towards the site of the proposed turbine; viewed from the south-west.
