# LAND at EAST BALSDON FARM, PYWORTHY PARISH, DEVON

Results of a Desk-Based Assessment,  
Walkover Survey &  
Historic Visual Impact Assessment

Report No.: 130708  
Date: 08.07.2013  
Authors: B Morris  
E Wapshott

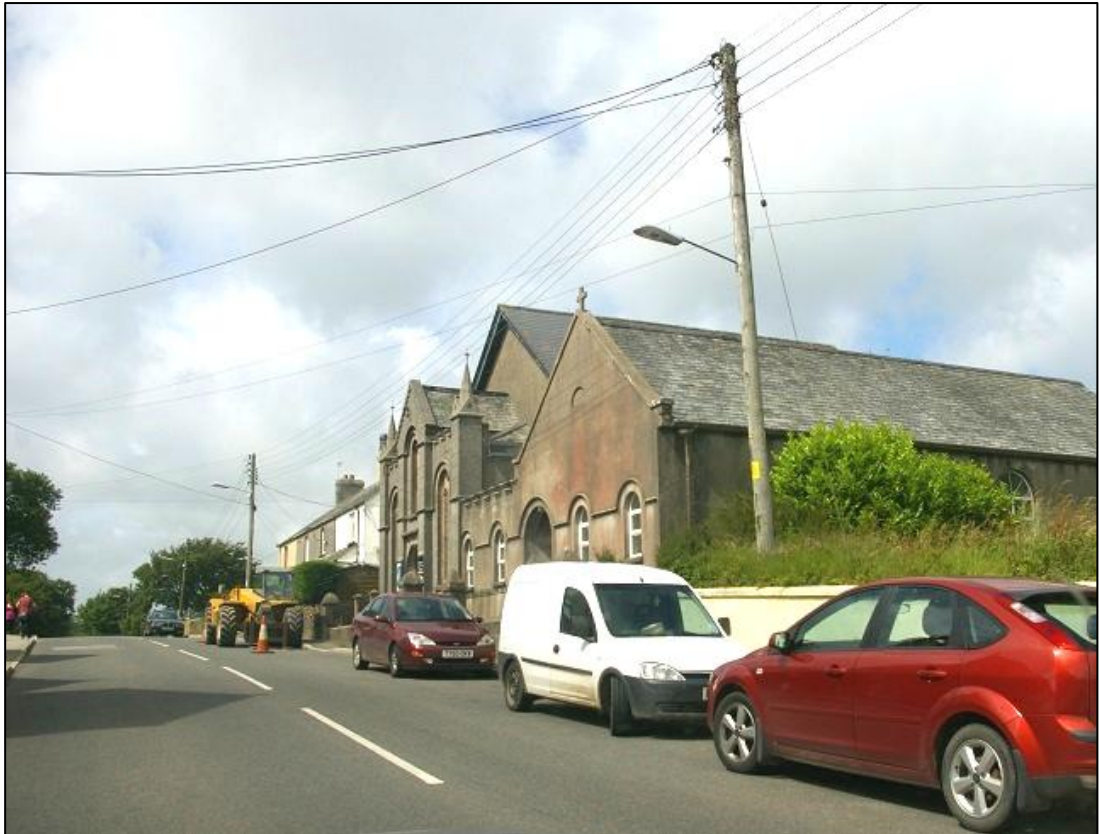
- The Bible Christian Chapel, wall and gate piers; medium significance; Grade II Listed, condition: poor. Located in Whitstone, the building stands on the eastern side of the B3254. To the east, views are effectively blocked by the heavily wooded and overgrown section of the walled plot behind the chapel. The chapel is designed to be experienced within its walled plot and was intentionally set within the heart of the later 19<sup>th</sup> century ribbon development along the main road; neither of these important factors is affected by the proposed turbine, impact **neutral**.

Whitstone village, and the views towards the site of the proposed turbine which would lie to the north-east; the chapel and other houses do provide local blocking views. Viewed from the south-west.

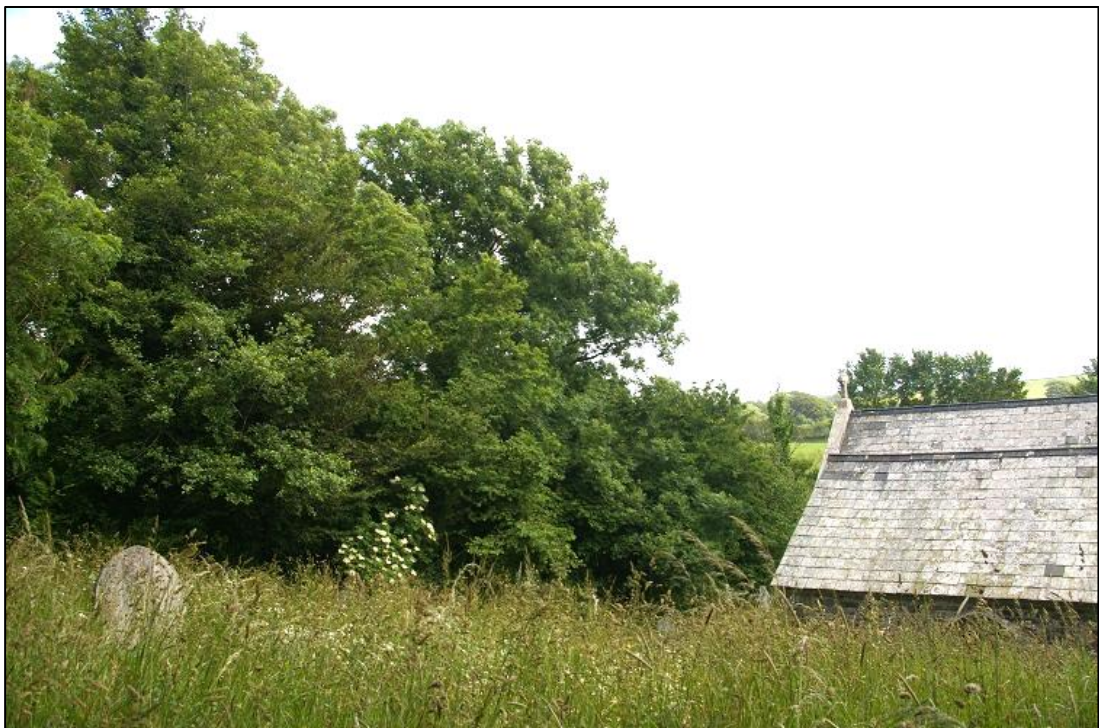
- Church of St Anne; high significance; Grade I Listed; condition: good. Located north of the village of Whitstone and set within a heavily-wooded churchyard enclosed by a large stone wall. The tower of the church does rise above the trees, but the church is set on a south-facing slope and the ground rising sharply behind. This blocks some or all views to the site of the proposed turbine. The visual links with the other Grade I churches of St Denis and St Bridget would also remain unaffected. Impact **neutral**.

St Anne's churchyard in Whitstone, which lies within heavily wooded grounds, showing local blocking; viewed from the west-south-west.

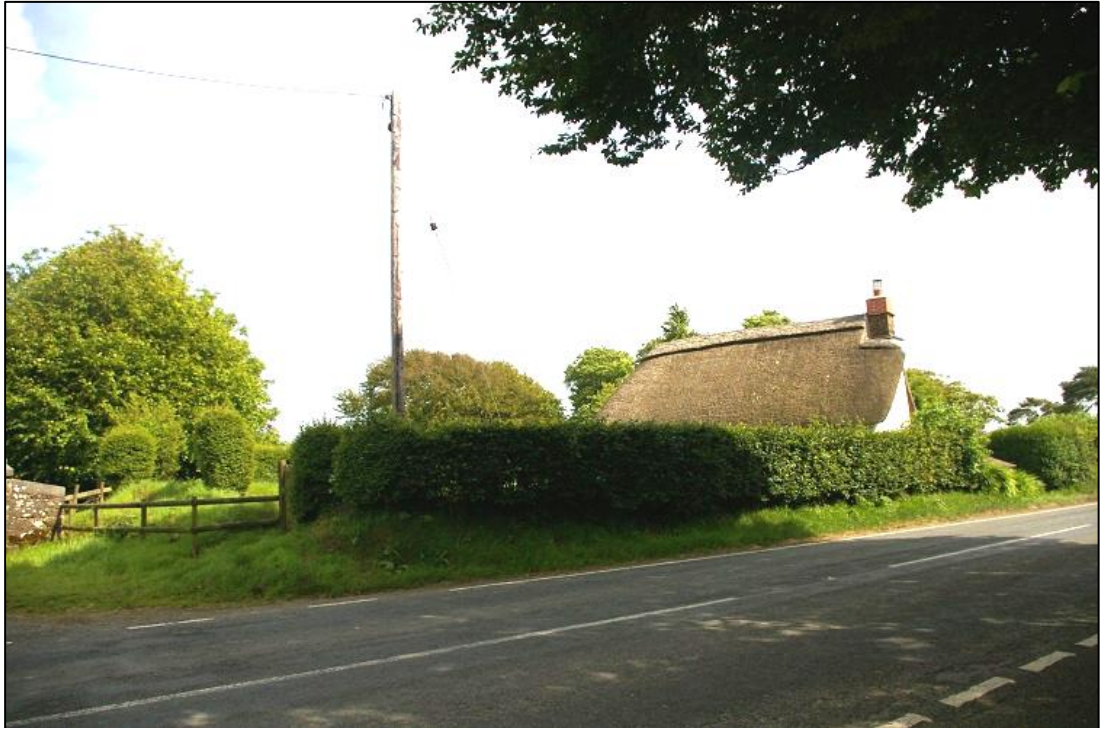
- Cottage 30m east of Bevill's farmhouse; medium significance; Grade II Listed; condition: excellent. Located to the east of a small junction on Tackbeare road. To the west is Bevill's Farm, a large stone farmhouse with courtyard of outbuildings. The cottage sits on a small plot of land surrounded by a hedgebank and trees. There are views to the south-east, across the fields to where the proposed turbine will be located, slightly restricted by the trees. An assessment of **negative/minor** has been applied as despite potential views to the turbine, the visitor experience of the heritage asset in its context at the former crossroads, together with other historic buildings, will not be affected and the setting of the cottage within its garden is also unaffected.

View of cottage east of Bevil's Farm, showing mature gardens around the Listed building, with views to the south-east towards the site of the proposed turbine.

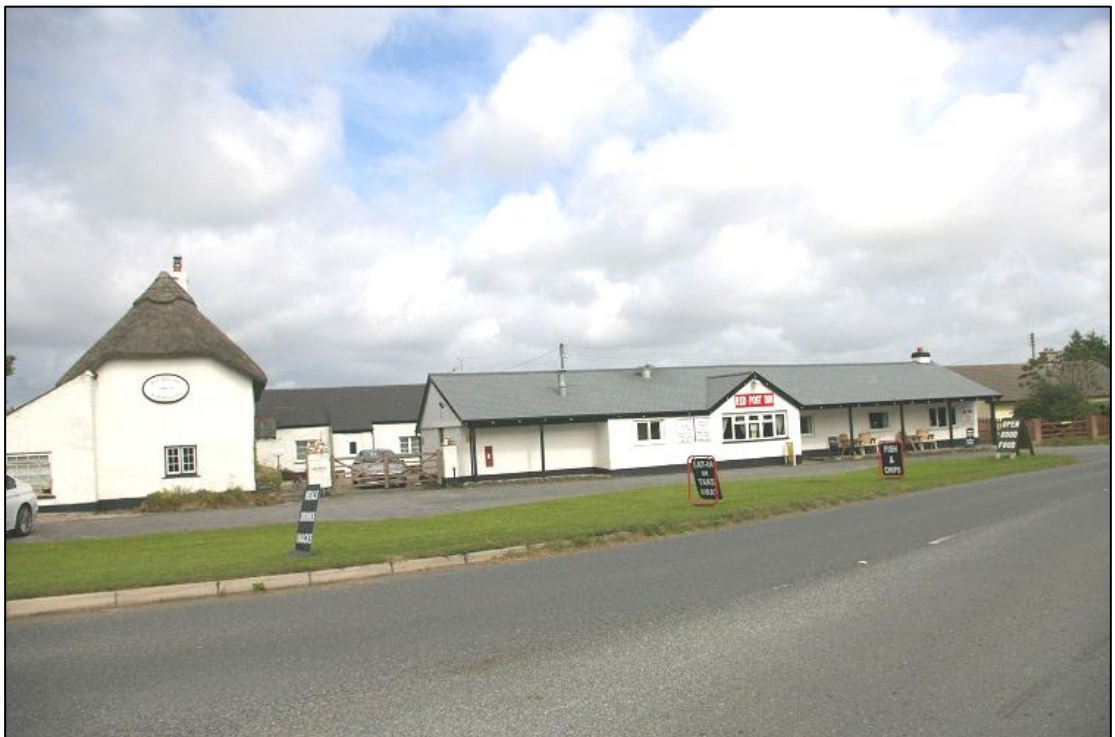
View towards the proposed turbine from Red Post and the Red Post Inn; from the north-west.

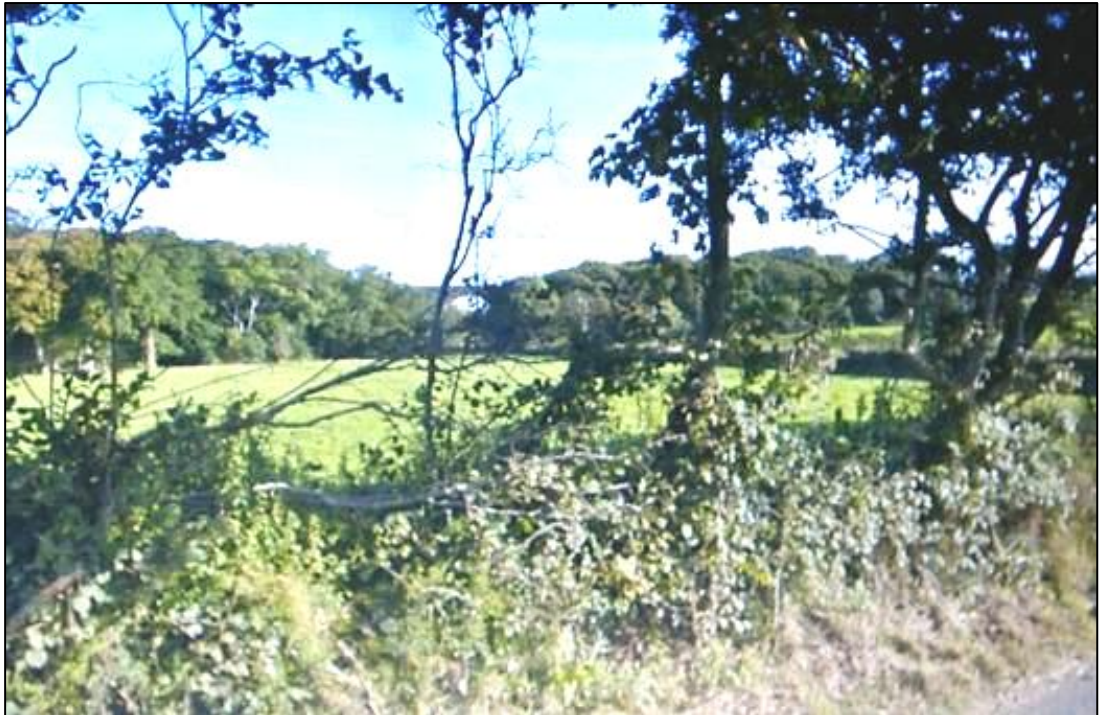
View towards the Woolston Viaduct, showing steep wooded slopes of the valley and comprehensive blocking; viewed from the south-west.
