# LAND at SALTERS FARMHOUSE St ANN'S CHAPEL, CALSTOCK CORNWALL

Results of a Desk-Based Assessment,  
Geophysical Survey, Walkover Survey &  
Visual Impact Assessment

Report No.: 130729  
Date: 29.07.13  
Authors: B Morris  
E Wapshott

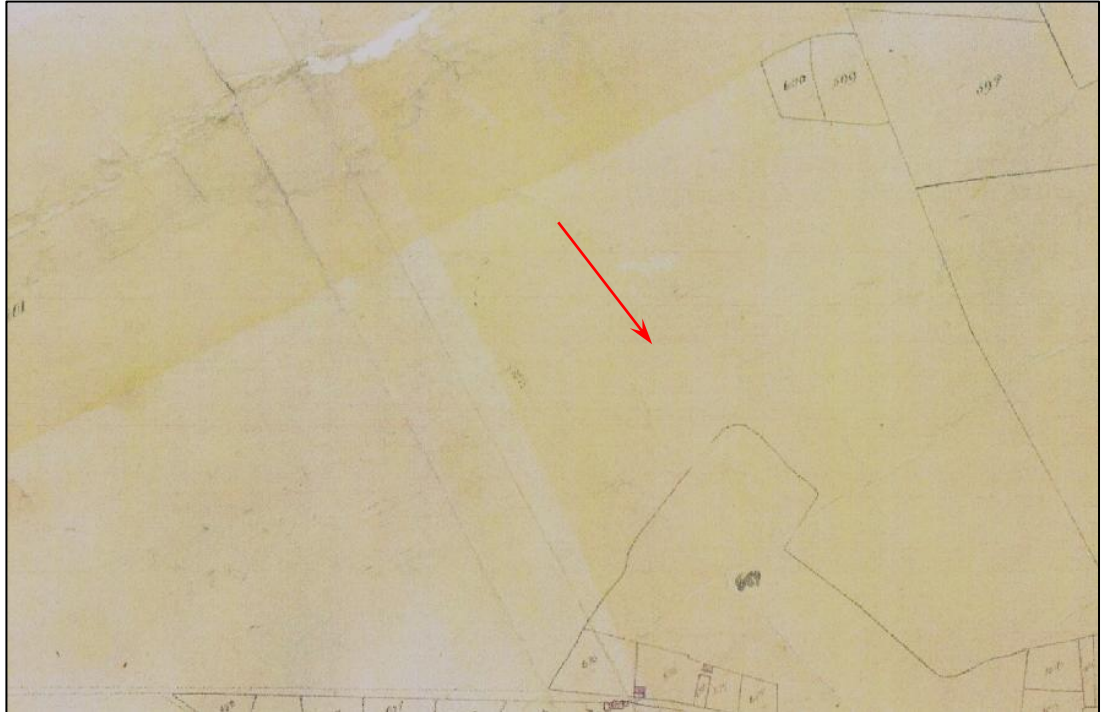
Figure 3: Extract from the 1840 tithe map (CSL) (the approximate location of the site is indicated).

The earliest large-scale mapping of any value is the 1802 Ordnance Survey surveyor's draft map of the area (Figure 3); earlier maps do not show any relevant detail. The surveyor's draft shows Hingston Down as entirely unenclosed.

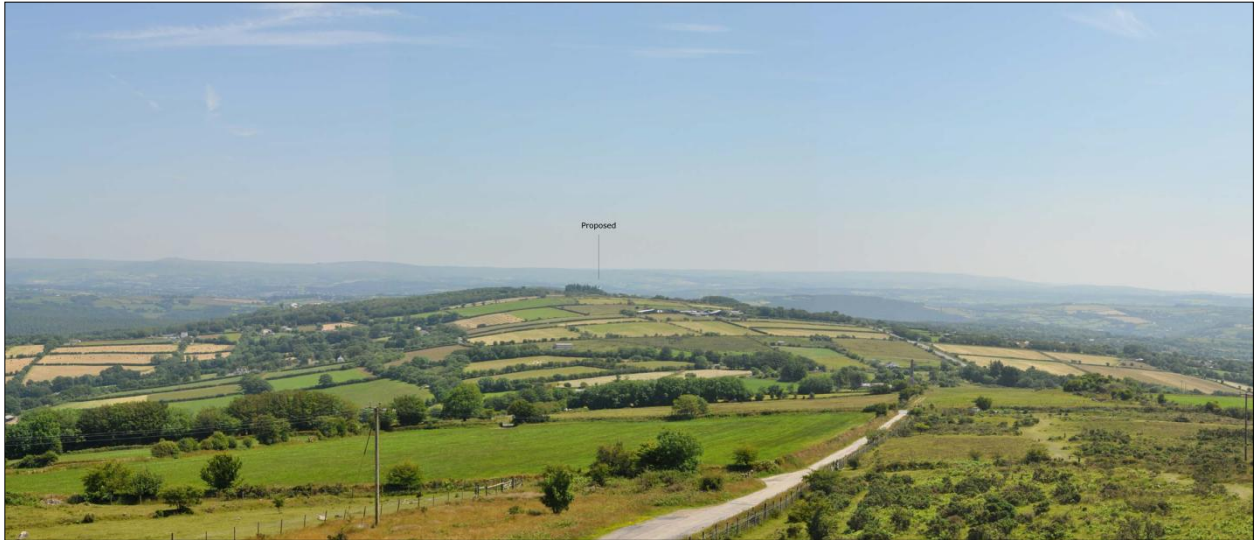
Figure 11: Verified photomontage: the proposed turbine from the summit of Kit Hill (NGR: SX3802071446); viewed from the west (provided by Amalgam Landscape and Plumedia, Figure 12c-Photomontage-Viewpoint 6).

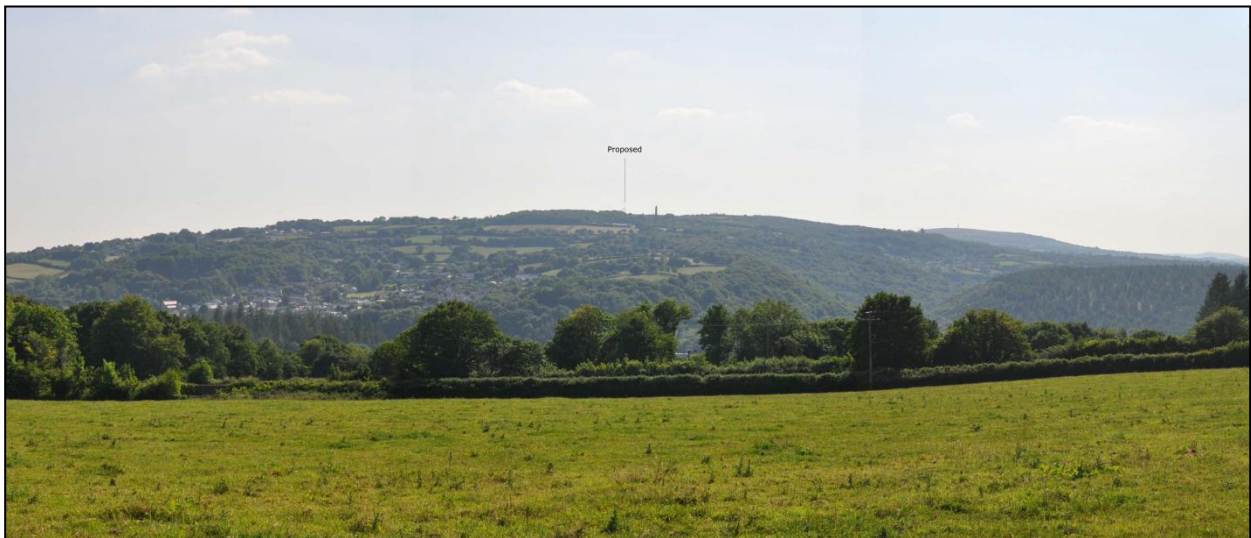
Figure 12: Verified photomontage: the proposed turbine from near Gulworthy Cross (NGR: SX4436172951); viewed from the east (provided by Amalgam Landscape and Plumedia, Figure 10c-Photomontage-Viewpoint 5).

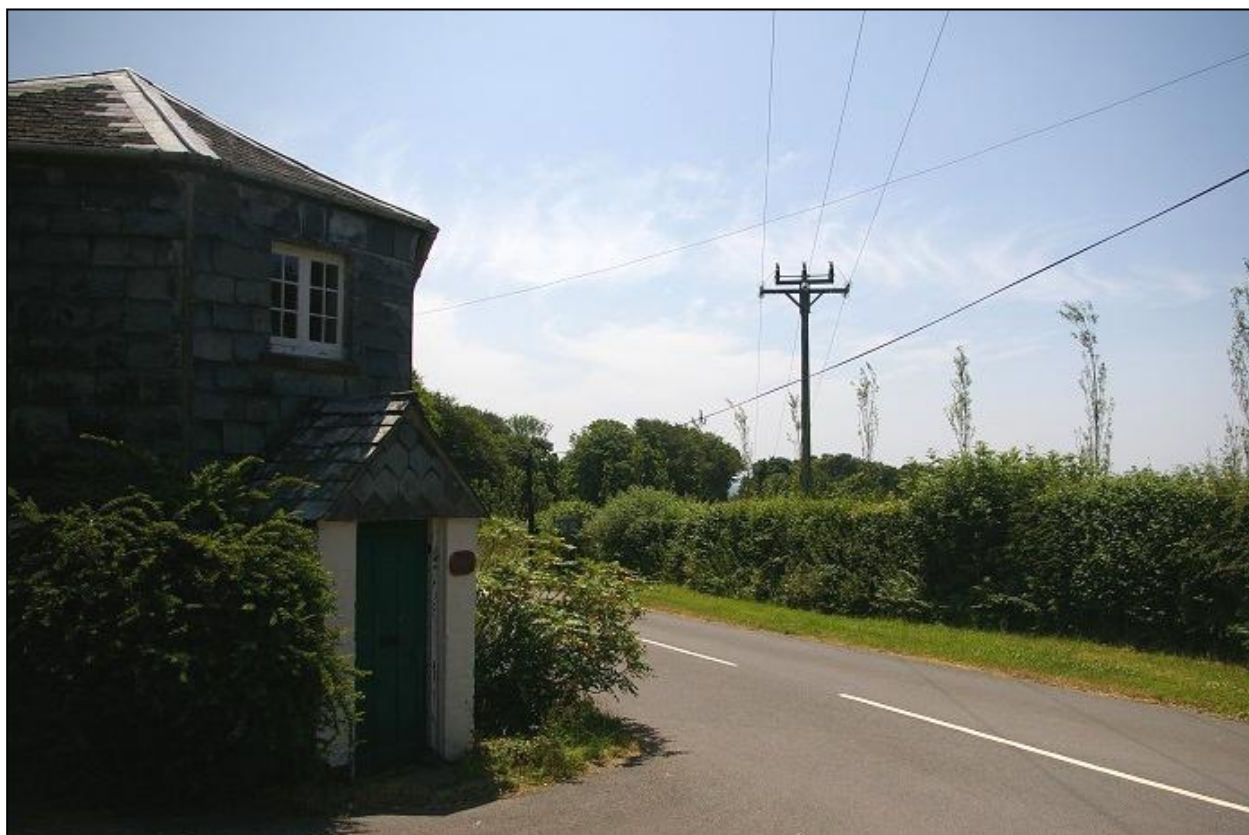
Rock Cottage, a former toll house, set at a road junction with views west to the turbine; from the north-east.

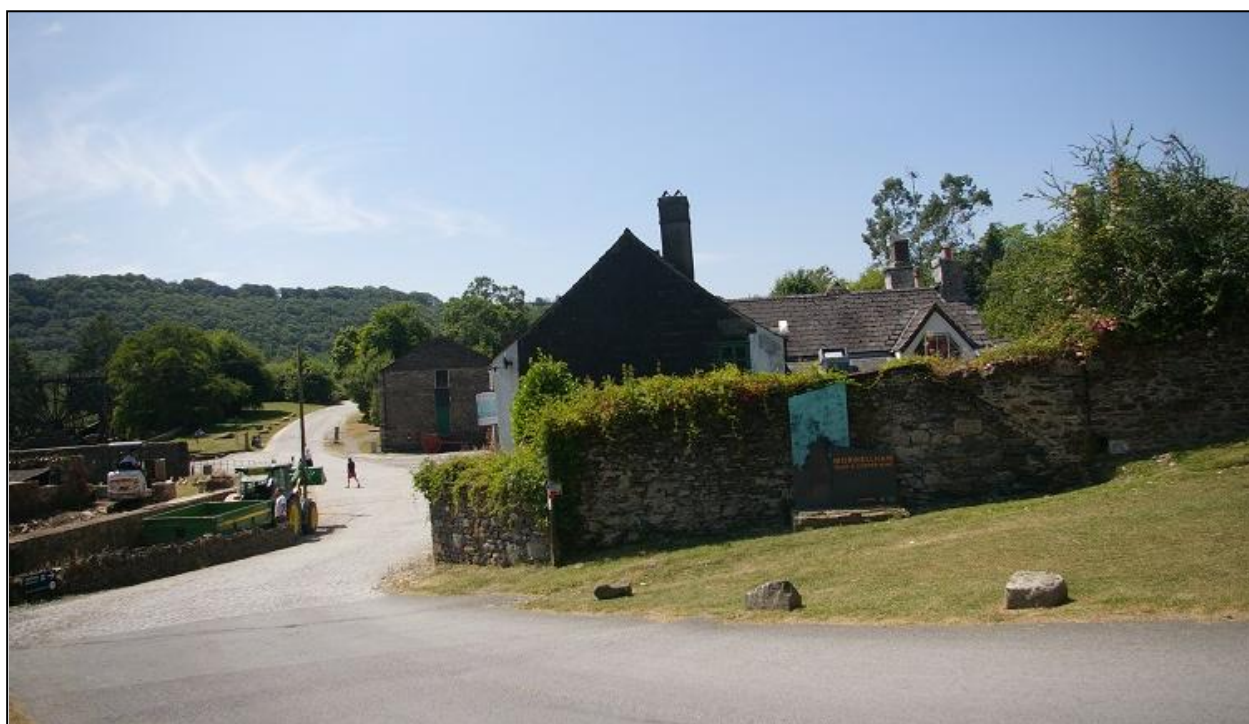
Morwhellam Quay and the various heritage assets it encompasses, showing little to no views out of the location; from the south-east.

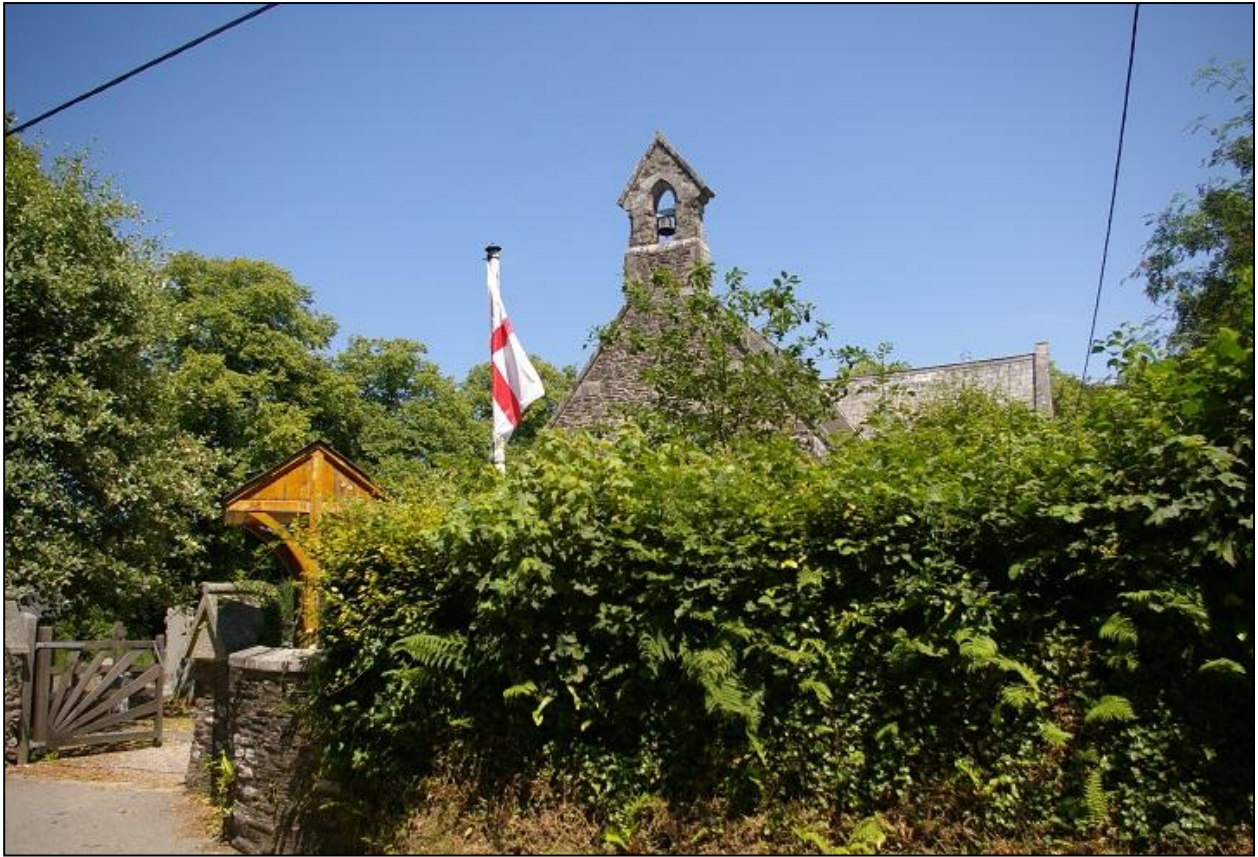
Gulworthy church, St Paul's, set in its wooded grounds and churchyard, with no tower, merely a bell-housing; from the north-east.

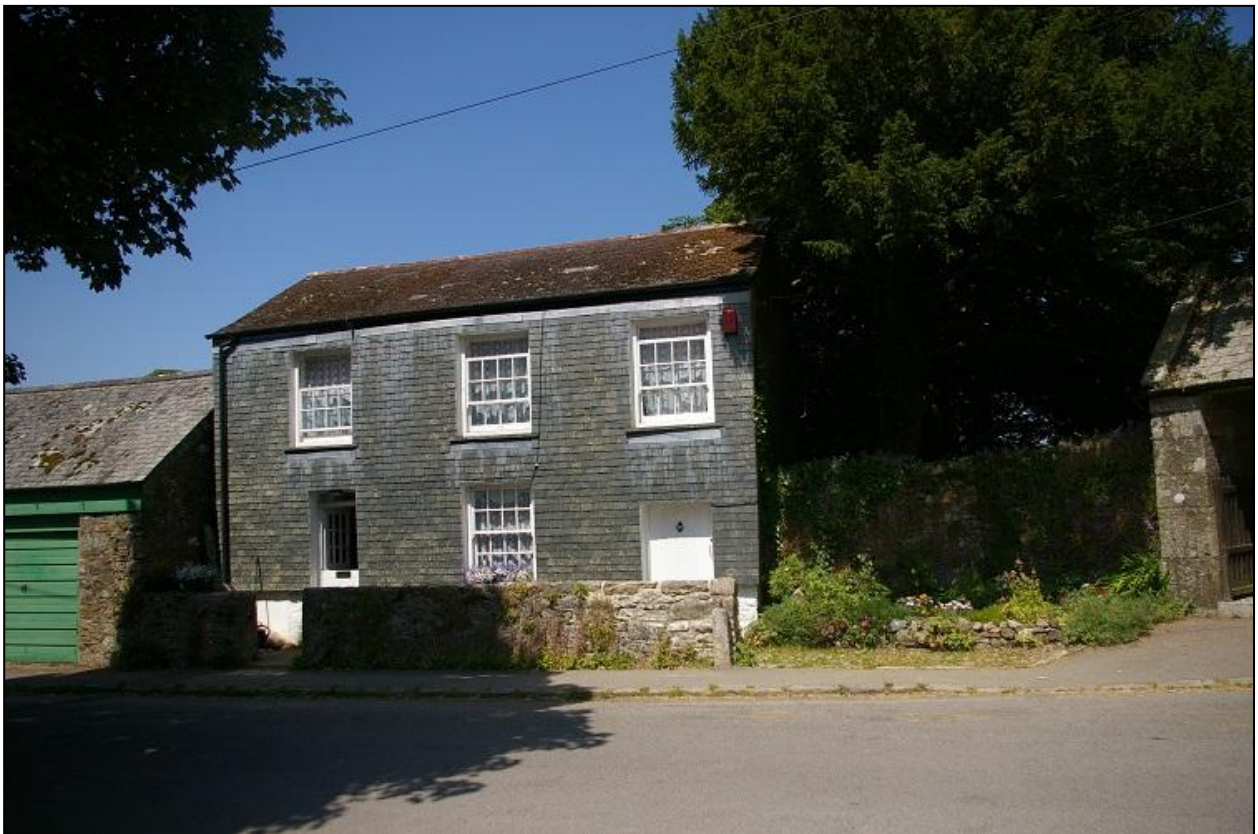
Church House, adjacent to the churchyard and church of St Andrew, wrapped around by the churchyard and its extensions. Also visible, the edge of the stone lychgate, a Listed structure; from the south.

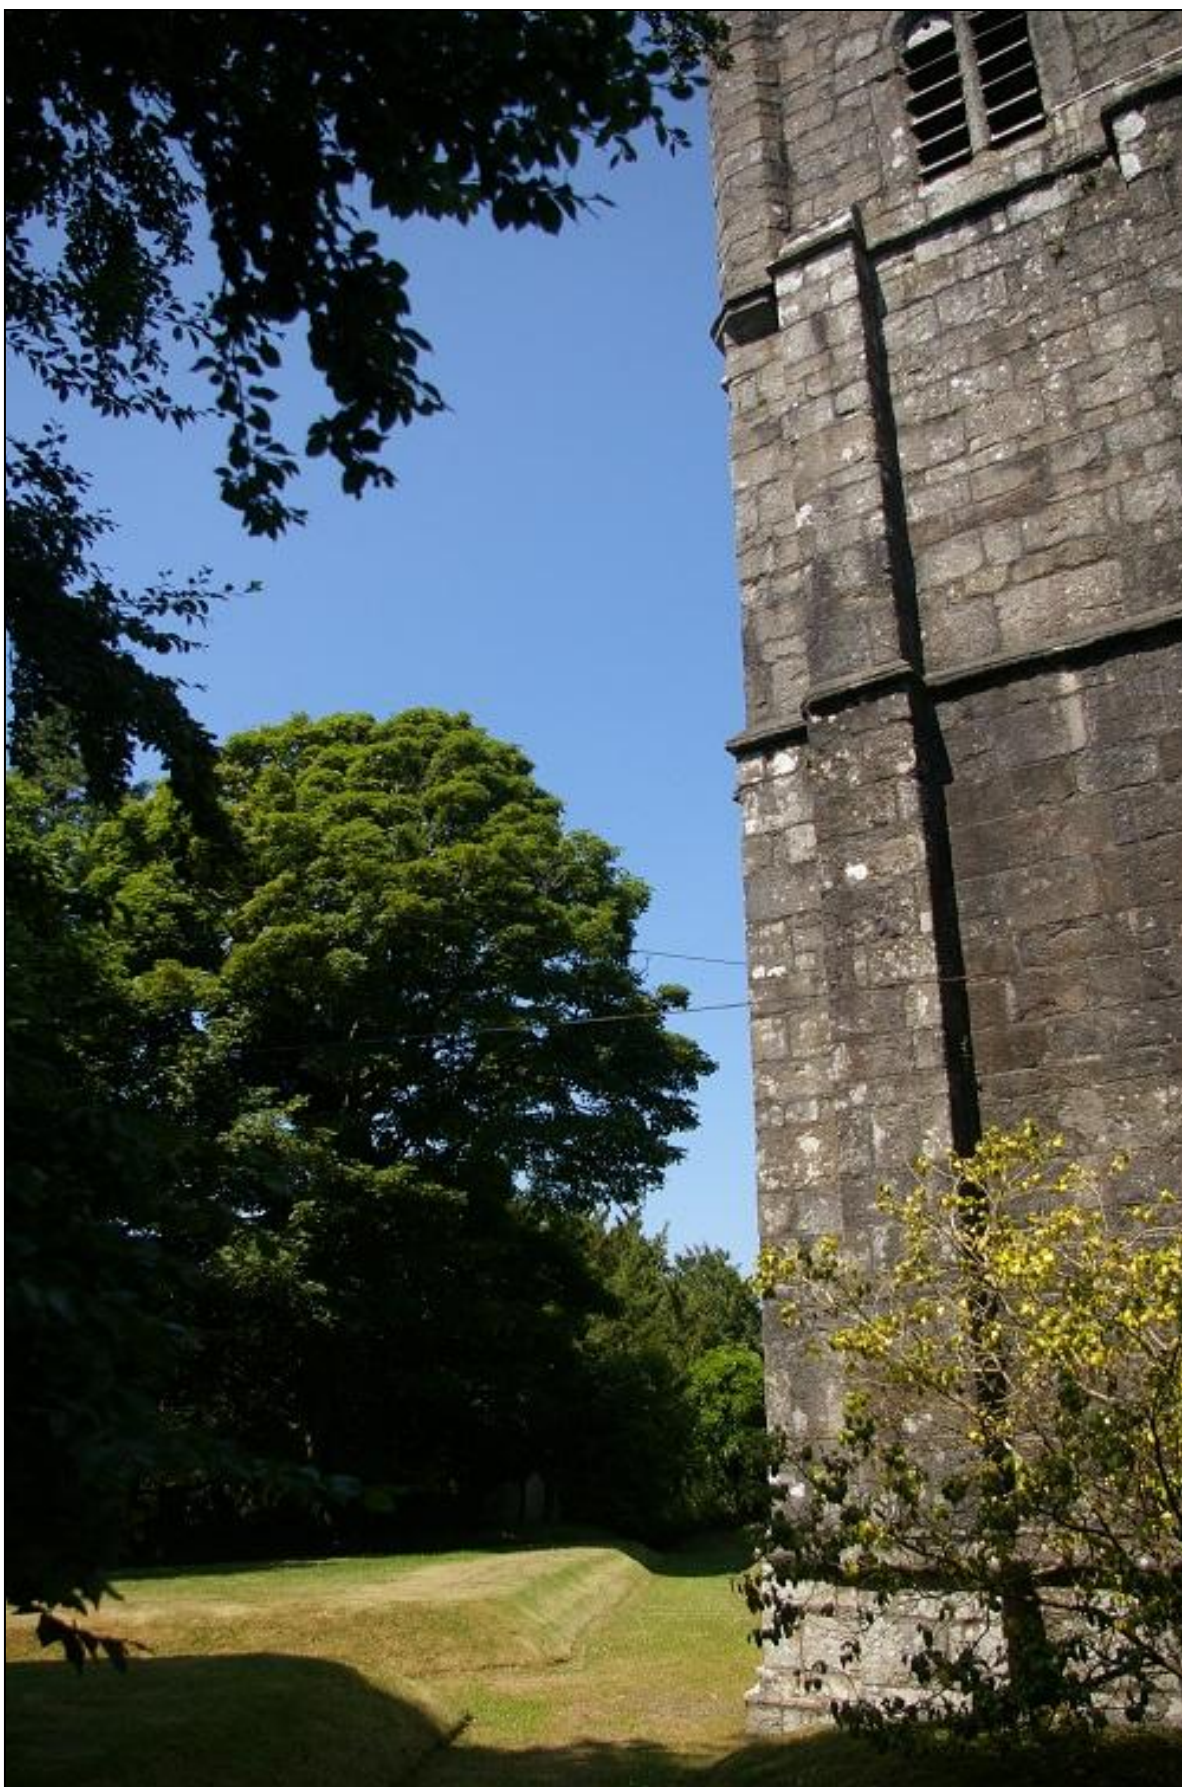
Views to the north-west, from the west tower of St Andrew's church in Calstock; from the south-east.

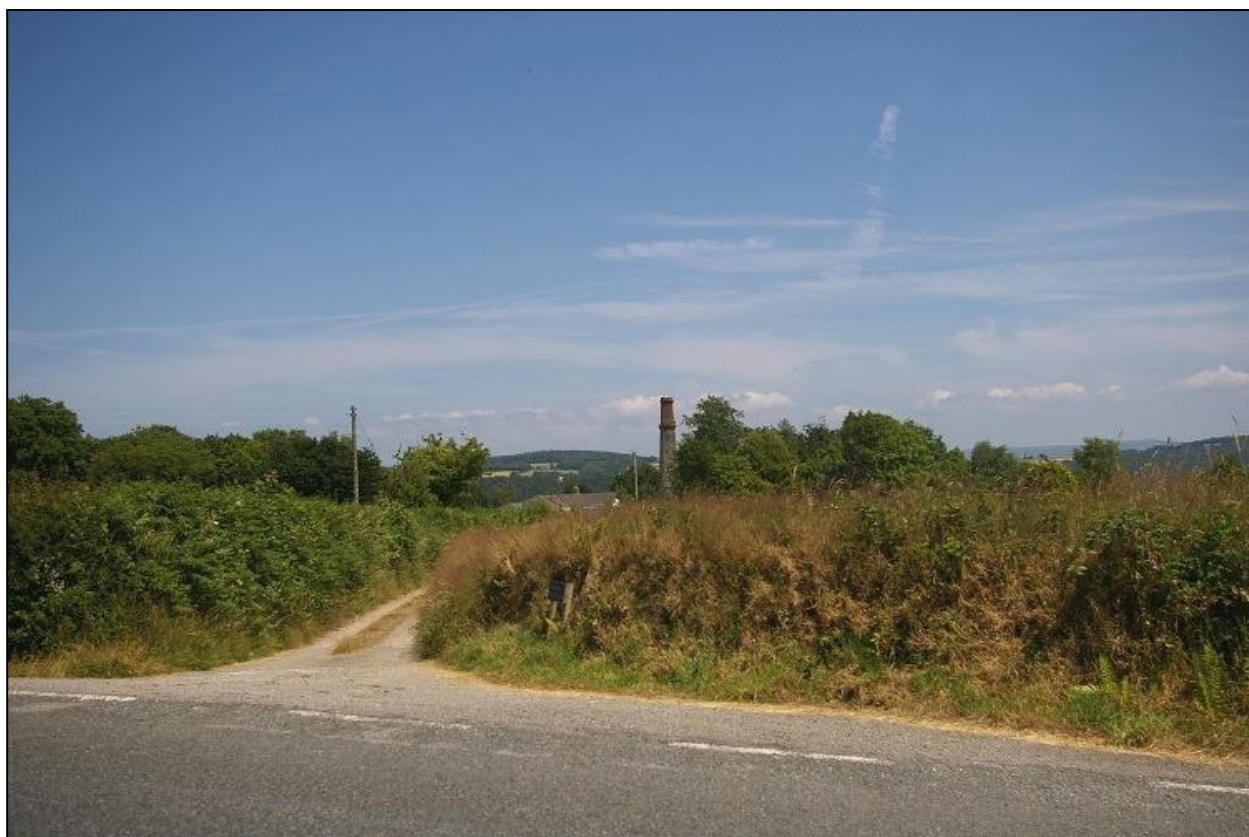
Mine chimney, outside of Calstock, showing upstanding remains and views north; from the south-east.

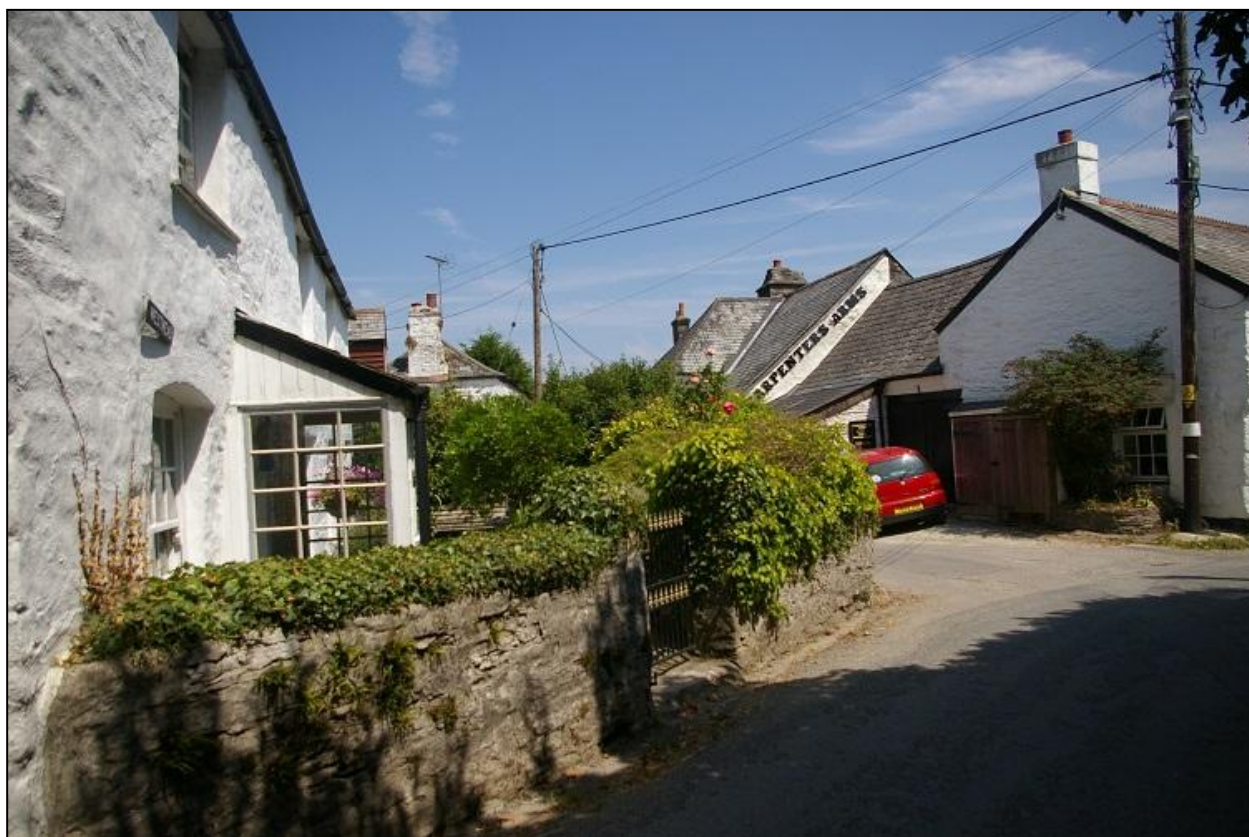
Westmead and The Carpenter's Arms, in Methereil, showing how the various heritage assets create local blocking elements to each other; from the west.

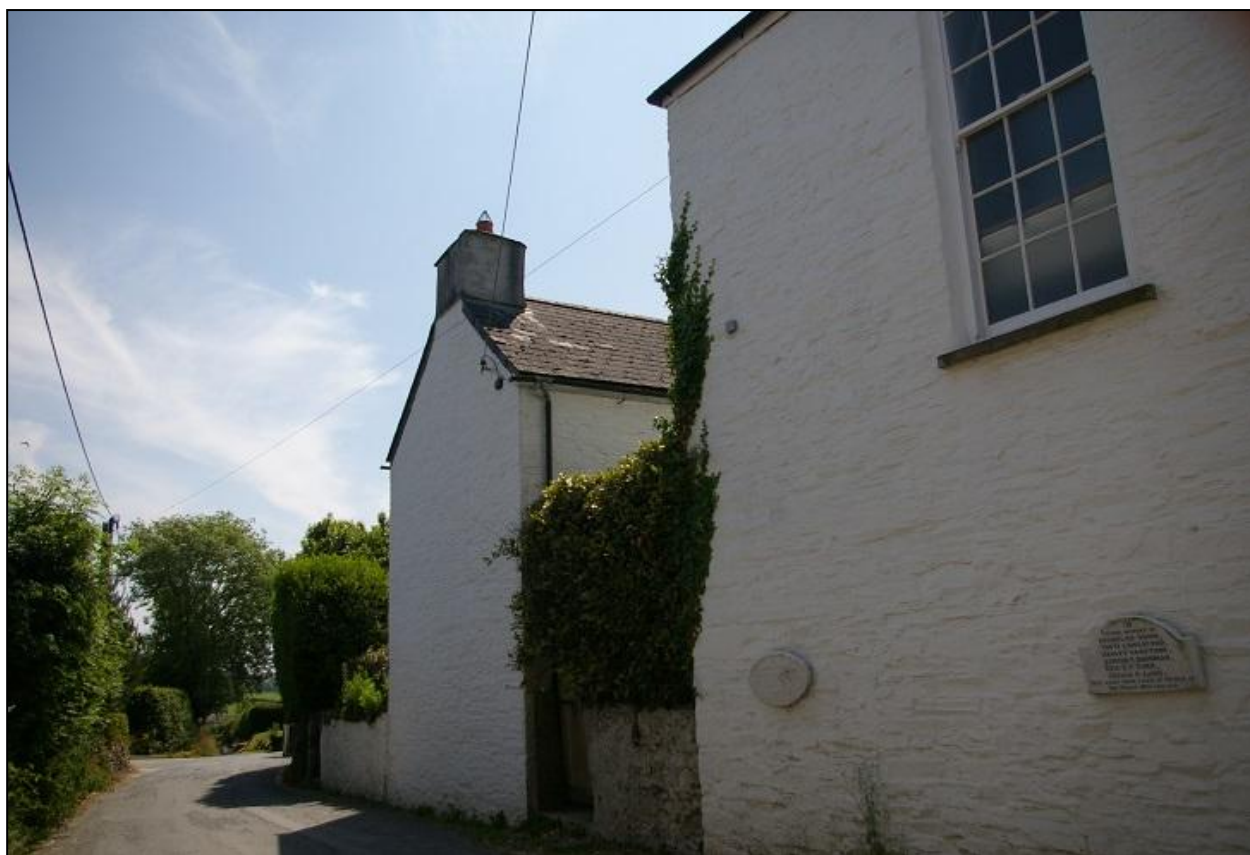
Metherell Baptists Church with attached Sunday school, showing local blocking; from the south-west.

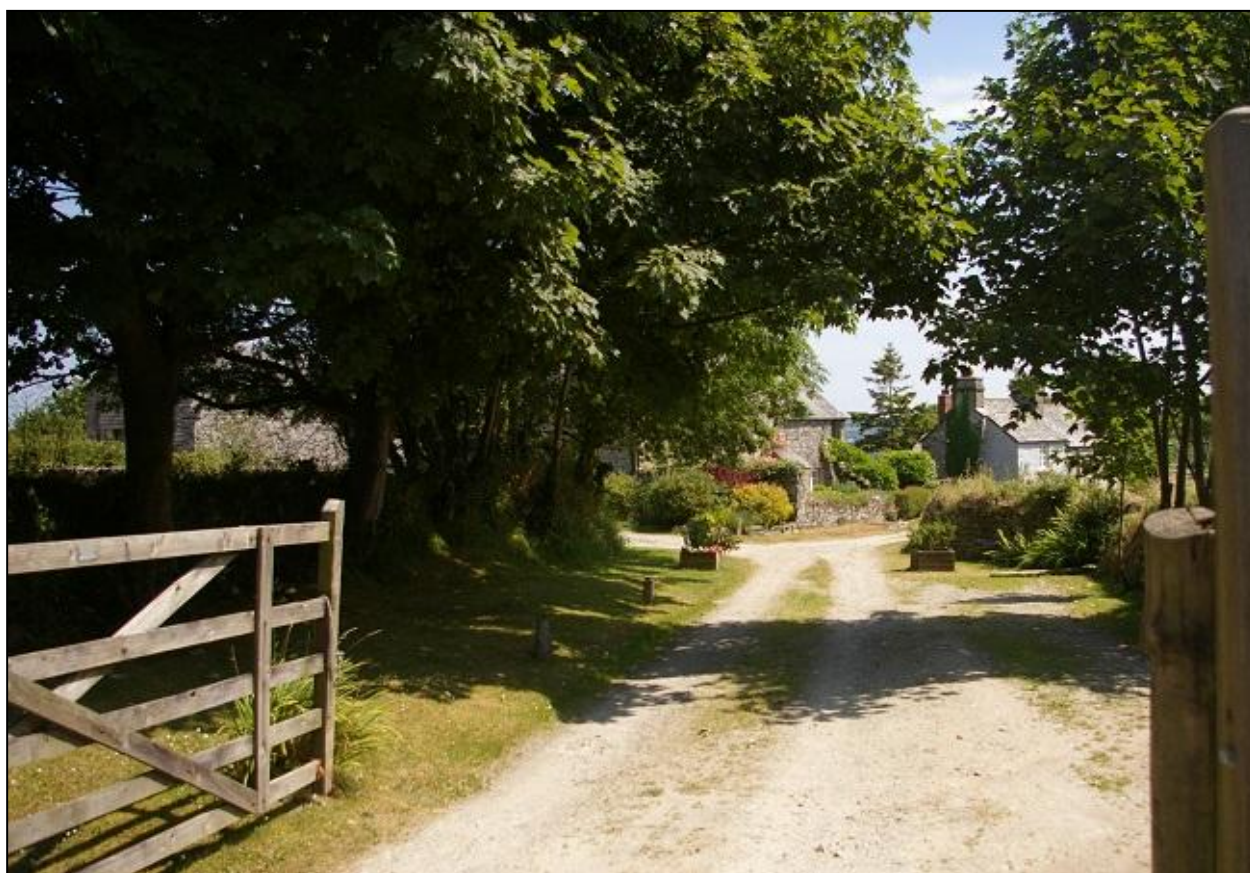
East Trehill Farm, showing the setting of the farm in its farmyard with historic farm buildings, and of local blocking; the setting of this site would be unaffected by a proposed turbine at 2km distance; from the north.

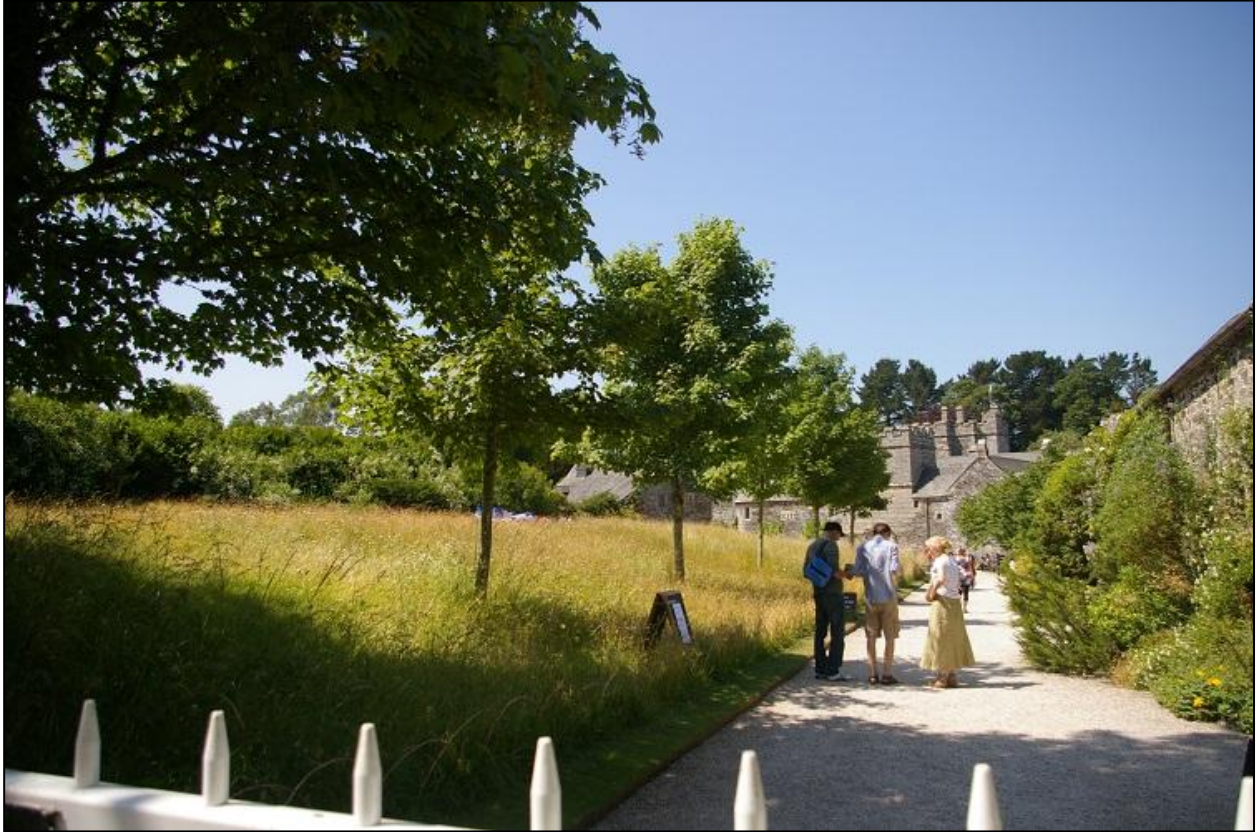
The wooded grounds of Cotehele, showing the local blocking provided by adjacent service buildings and highlighting the introverted nature of the estate, focused on the house; from the south-west.

- Cotehele House, retainers court and screen wall, all of high significance, Grade I Listed, condition: excellent. Surrounded by the wooded grounds of its estate, the

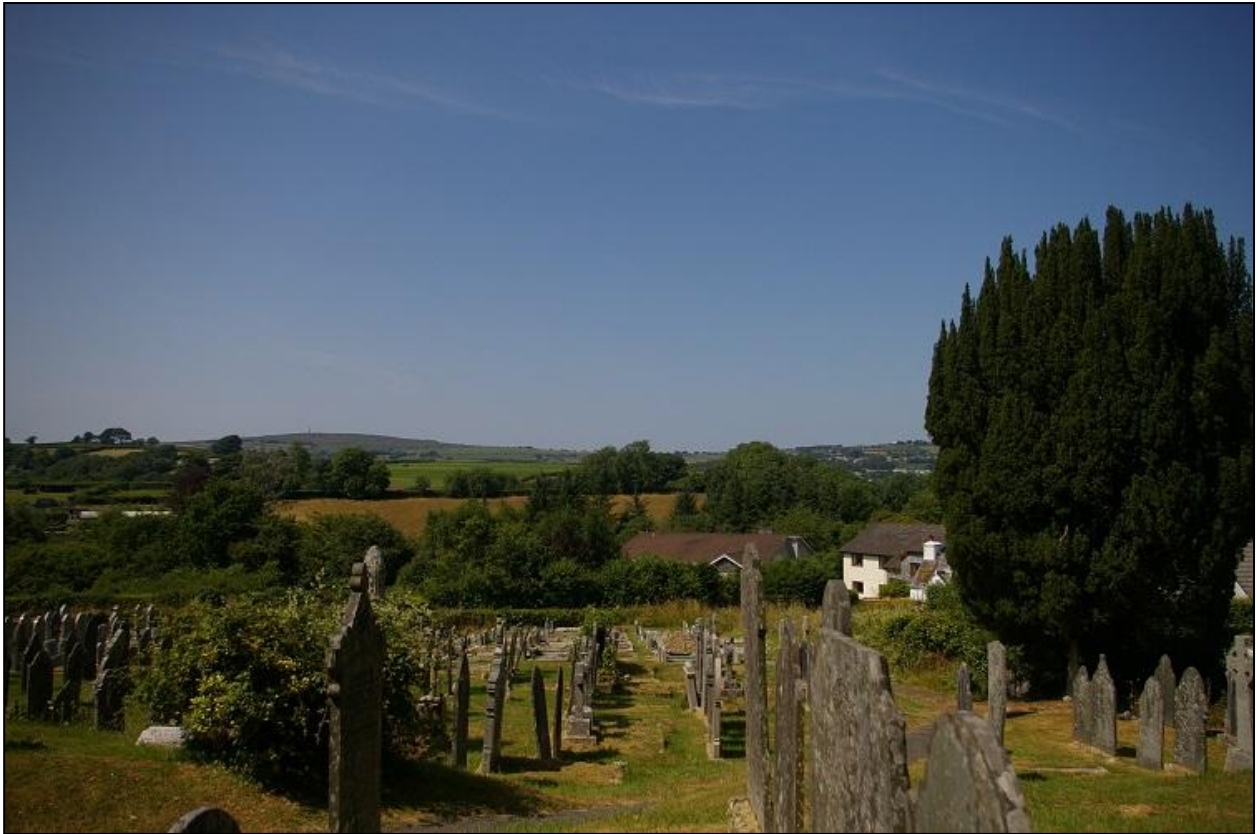
Views towards the proposed turbine site on the high ridge of land at St Ann's Chapel, from St Dominica's graveyard; from the south-west.

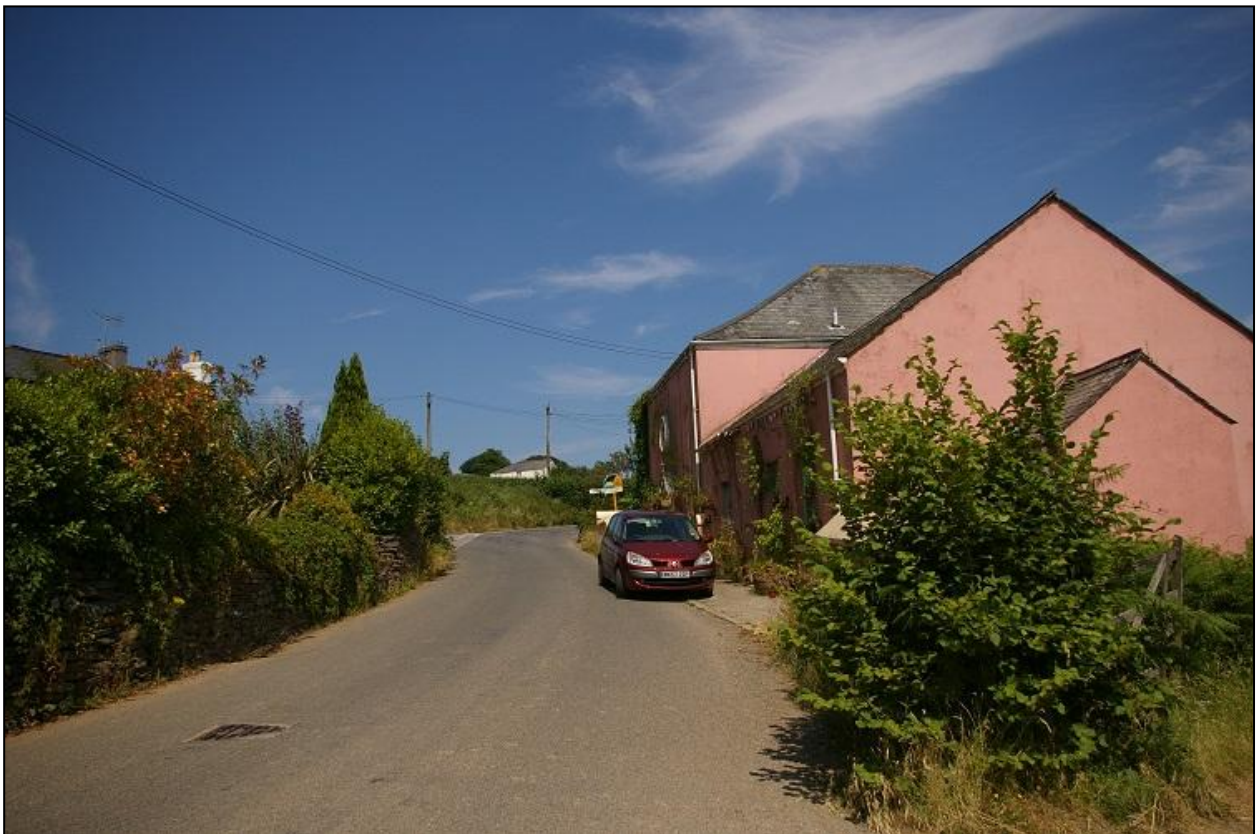
Harrowbarrow Methodists church, showing local blocking from trees, topography and hedgebanks; from the south-west.

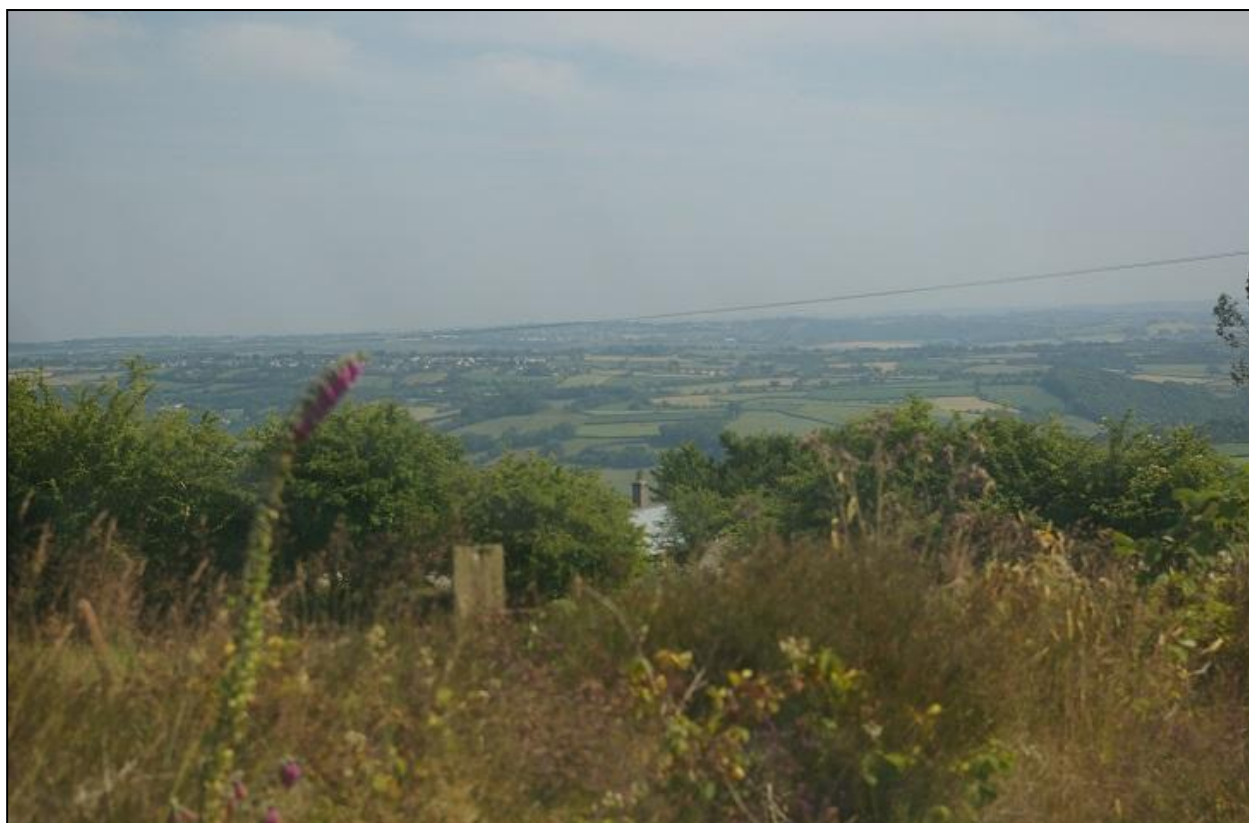
Salter's Farmhouse, set in its wooded and overgrown grounds, showing local blocking; from the north.

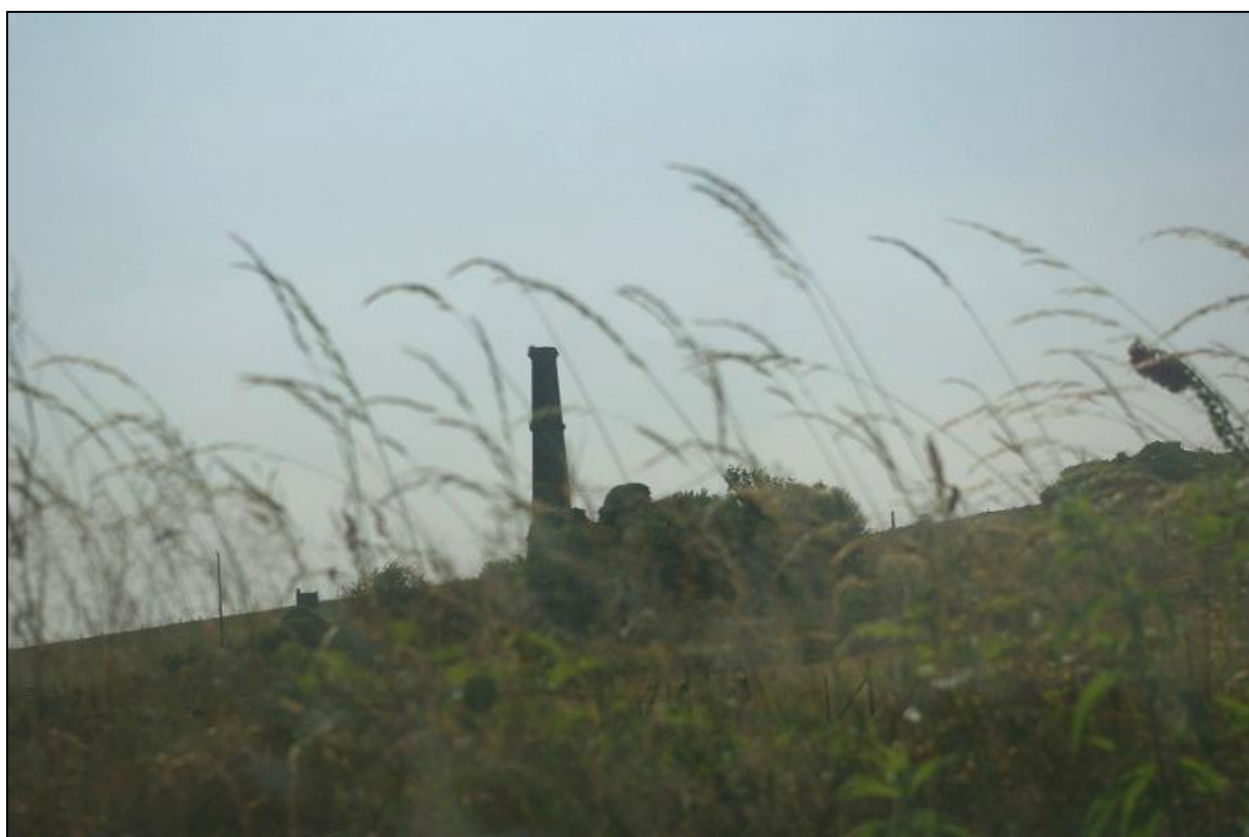
View of one of the tall upstanding chimneys of the Kit Hill mine, on Kit Hill; from the south-east.

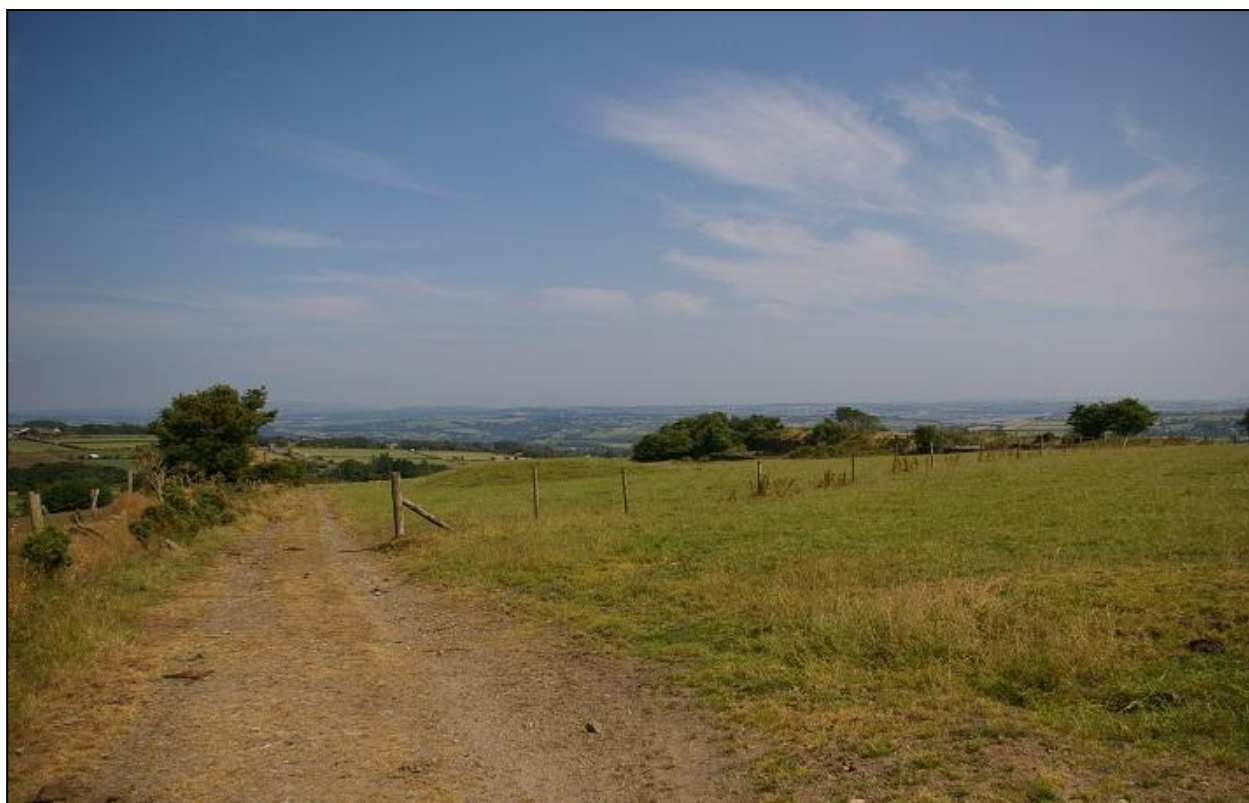
View towards the proposed turbine location from the collection of barrows on the eastern slopes of Kit Hill; from the west.

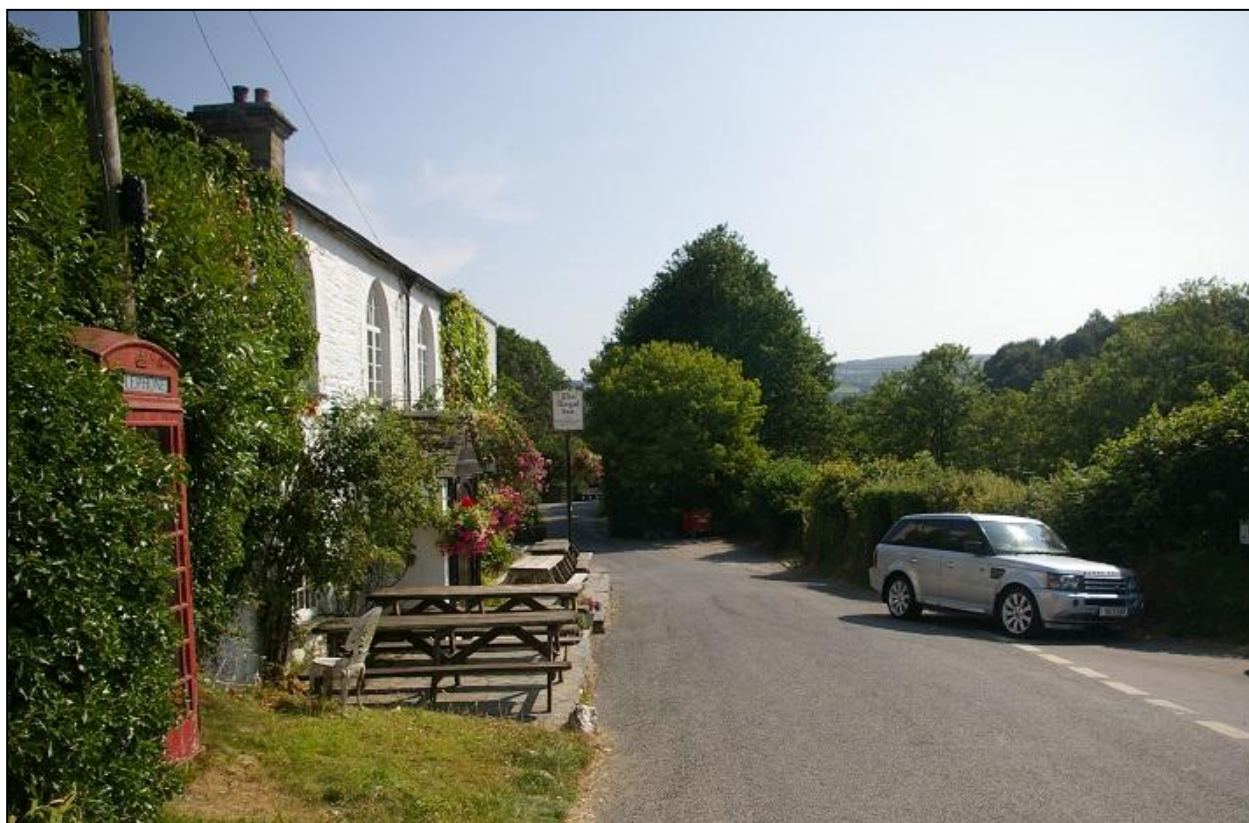
The Royal Inn, at Horsebridge, showing some limited views down the valley towards the proposed turbine, but with extensive local blocking from trees; from the north-west.

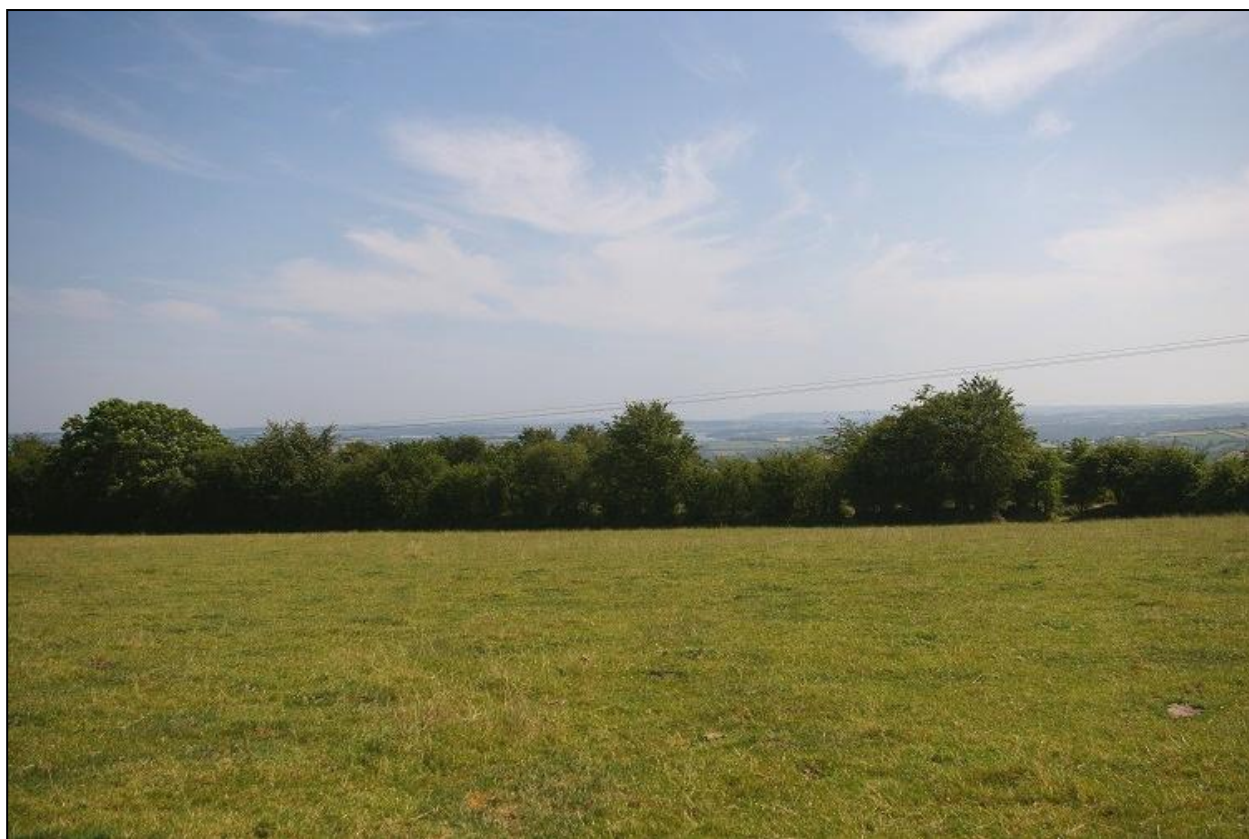
Views south, over the mature hedgebank of the field in which the turbine is to be situated; from the north.

The field in which the turbine is to be located is large and has with straight sides. The field boundaries are comprised of tall mature hedgebanks, and the southern boundary contains a number of trees. The enclosure is currently laid to pasture. Some very minor undulations were noted within the field, but most of these appear to be natural and follow the contours of the south-facing slope of the hill. No obvious cropmarks or earthworks were noted.

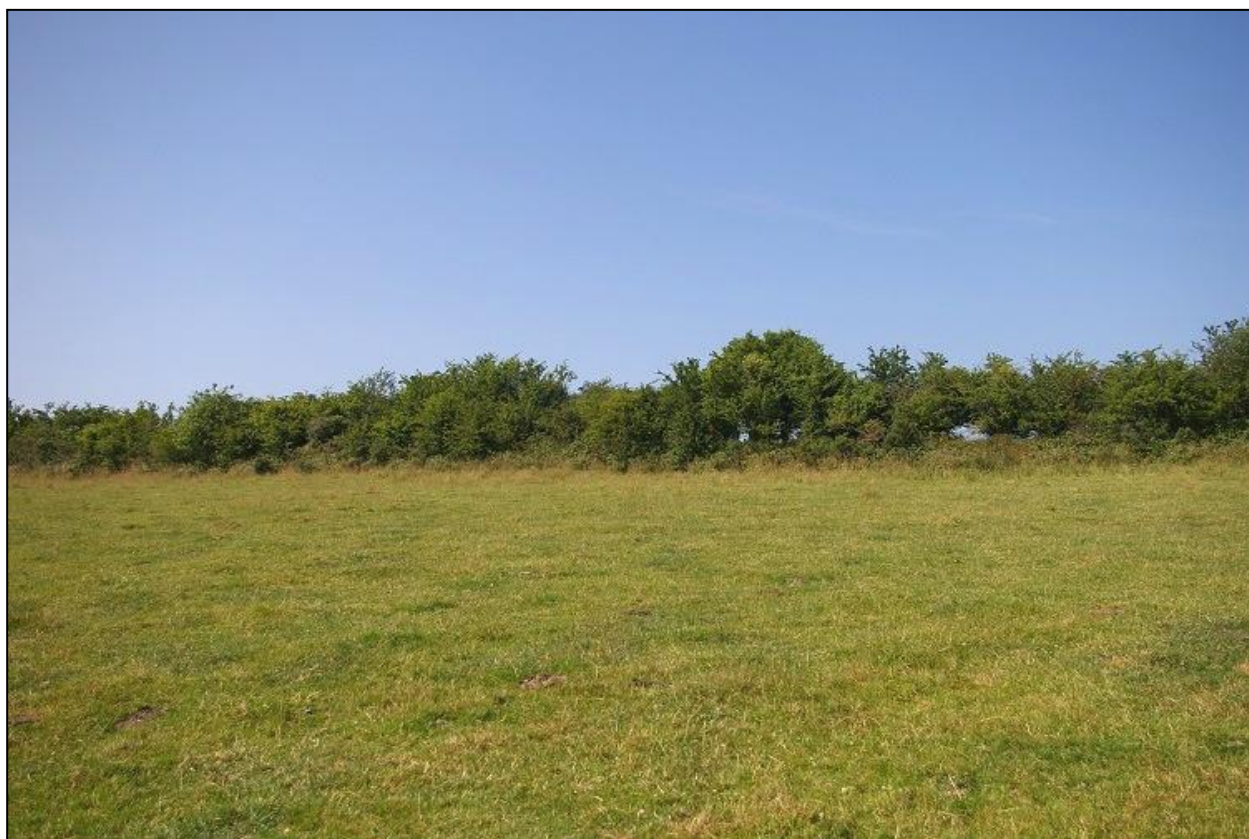
View up the field, towards the northern hedgebank boundary; from the south.
