# LAND at SALTERS FARMHOUSE St ANN'S CHAPEL, CALSTOCK CORNWALL

Results of a Desk-Based Assessment,  
Geophysical Survey, Walkover Survey &  
Visual Impact Assessment

Report No.: 130729  
Date: 29.07.13  
Authors: B Morris  
E Wapshott

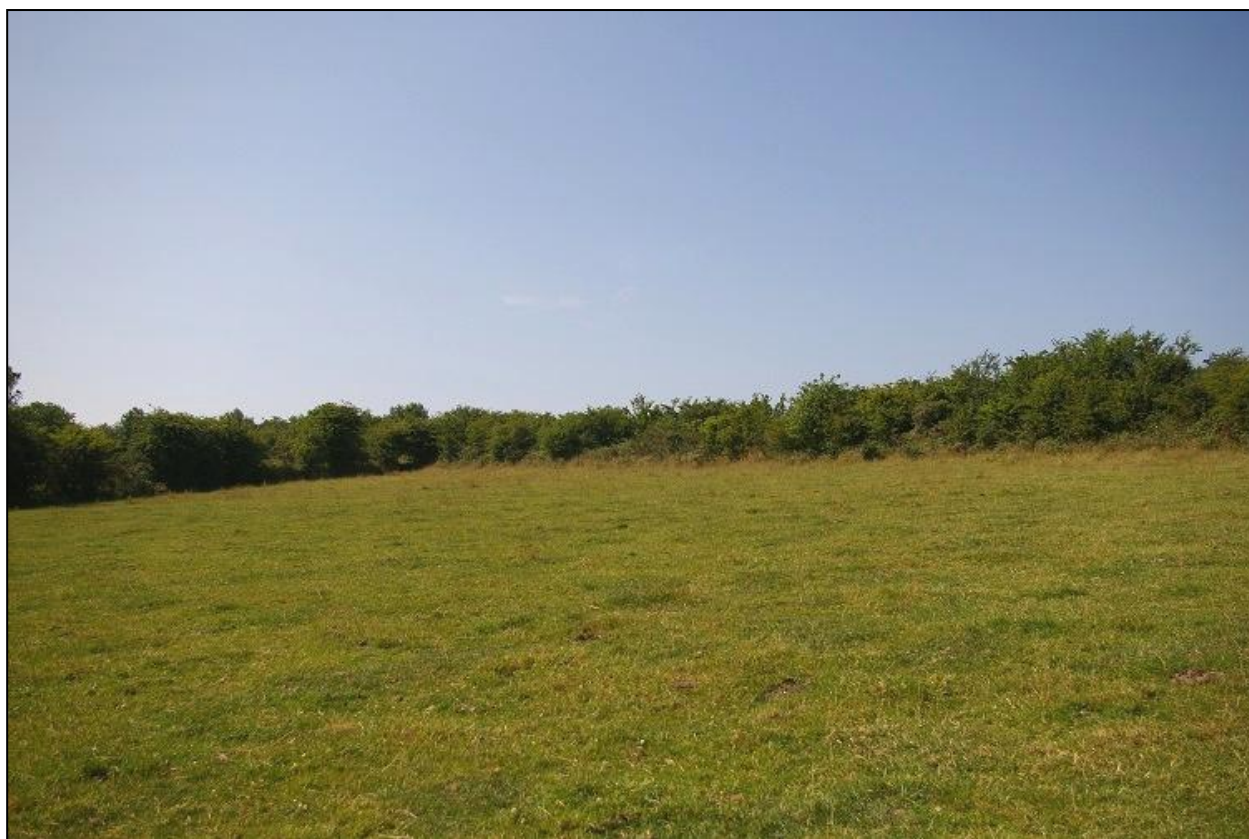
View up to the north-west corner of the field, showing the diagonal western boundary; from the south-east.

The field in which the turbine is to be located is large and has with straight sides. The field boundaries are comprised of tall mature hedgebanks, and the southern boundary contains a number of trees. The enclosure is currently laid to pasture. Some very minor undulations were noted within the field, but most of these appear to be natural and follow the contours of the south-facing slope of the hill. No obvious cropmarks or earthworks were noted.

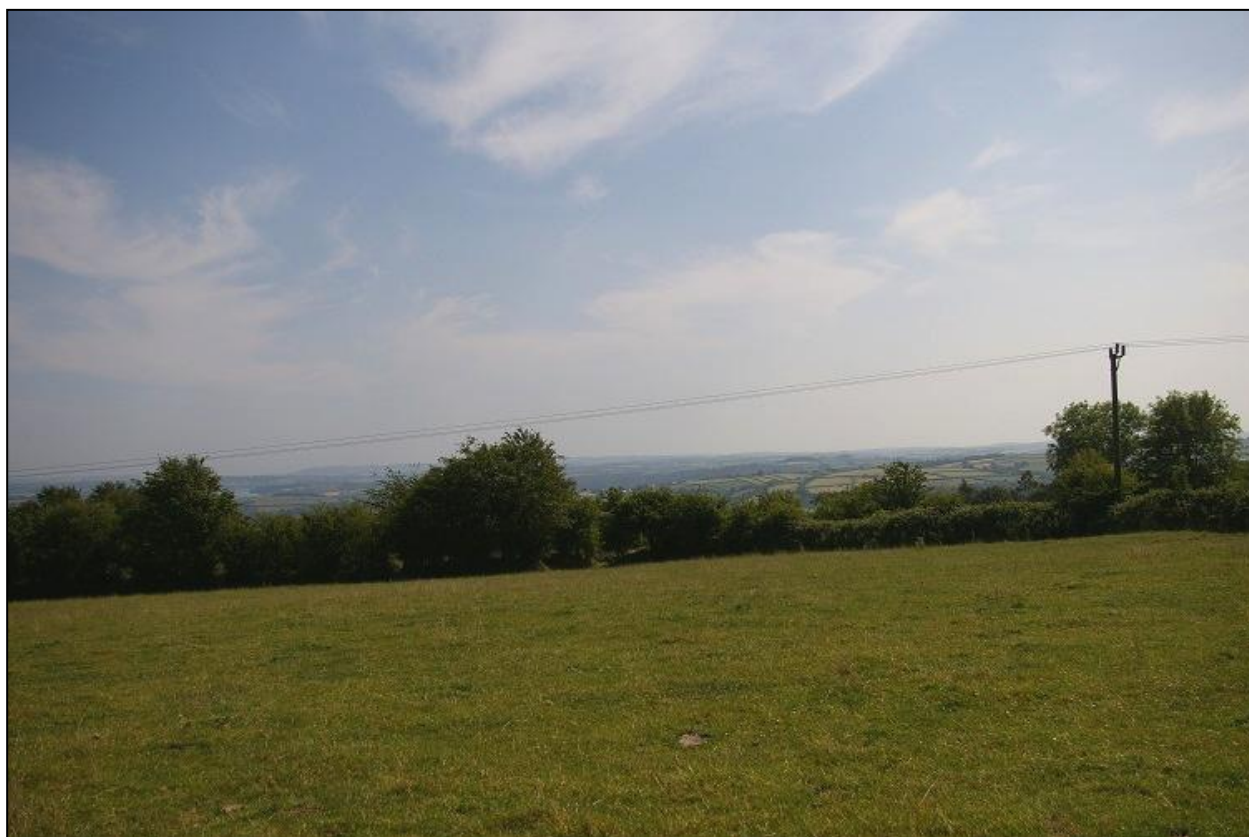
Open views south-west from the field in which the turbine is to be situated, showing an element of local blocking towards Salters Farm, which is shielded by the trees and hedgebanks; from the north-east.

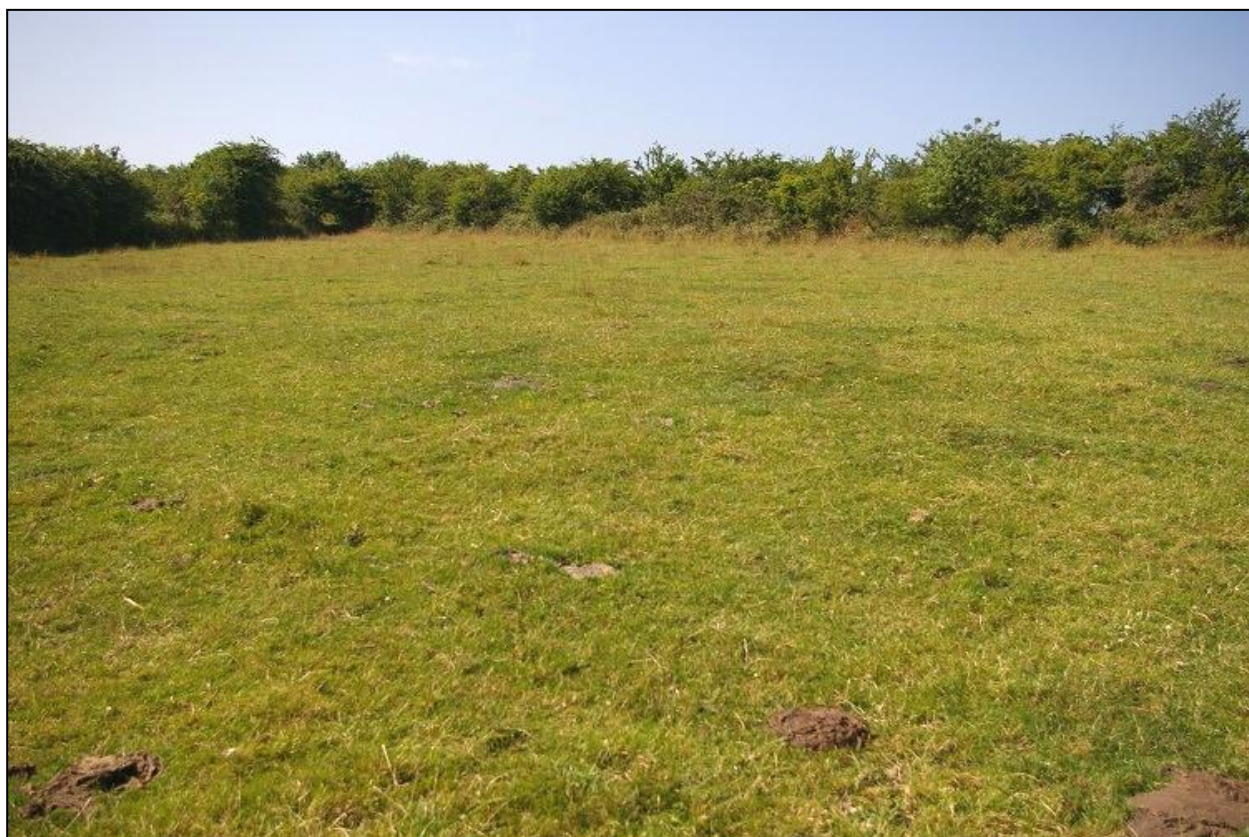
View across the pasture, showing slight undulations, which may be natural or possibly a former hedgebank; from the south-east.

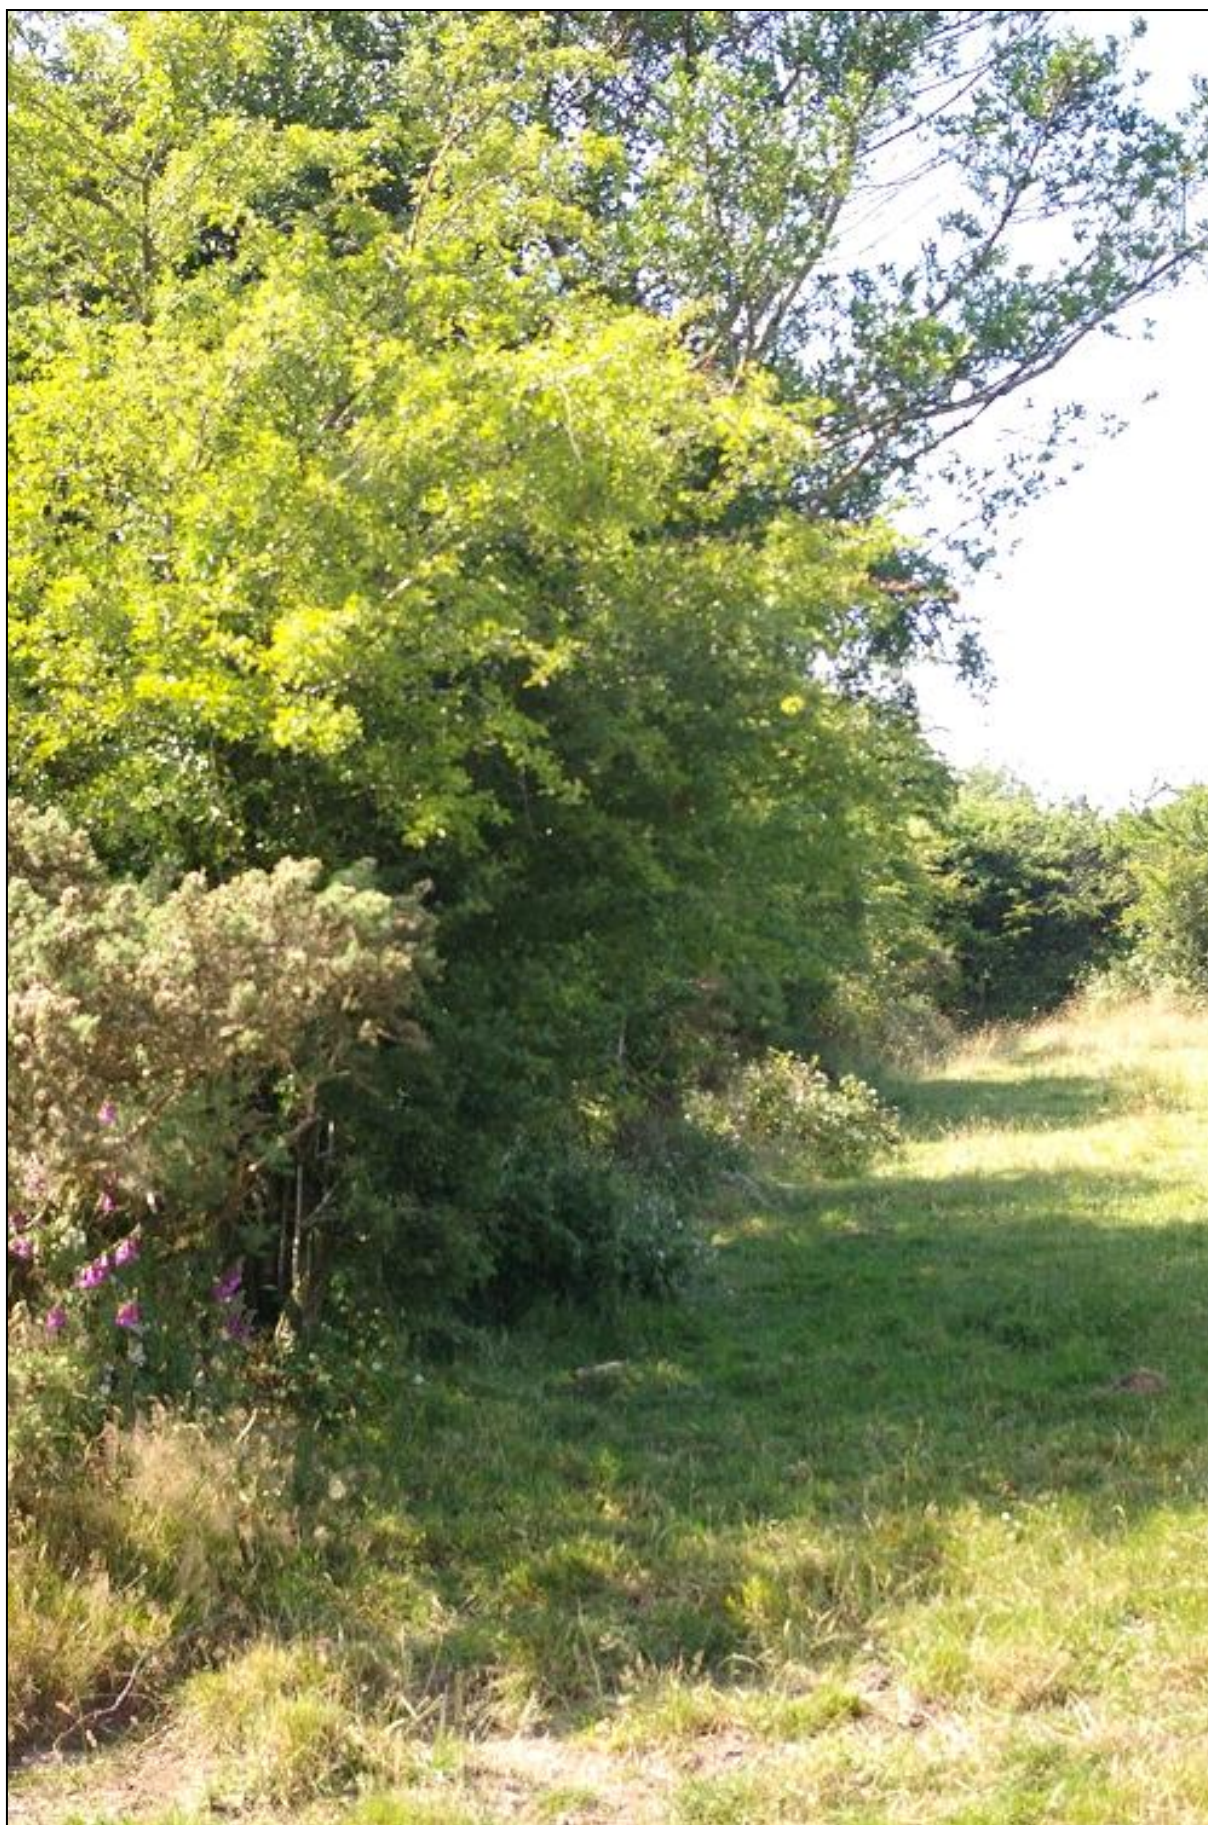
View up the western boundary hedge-bank; from the south.

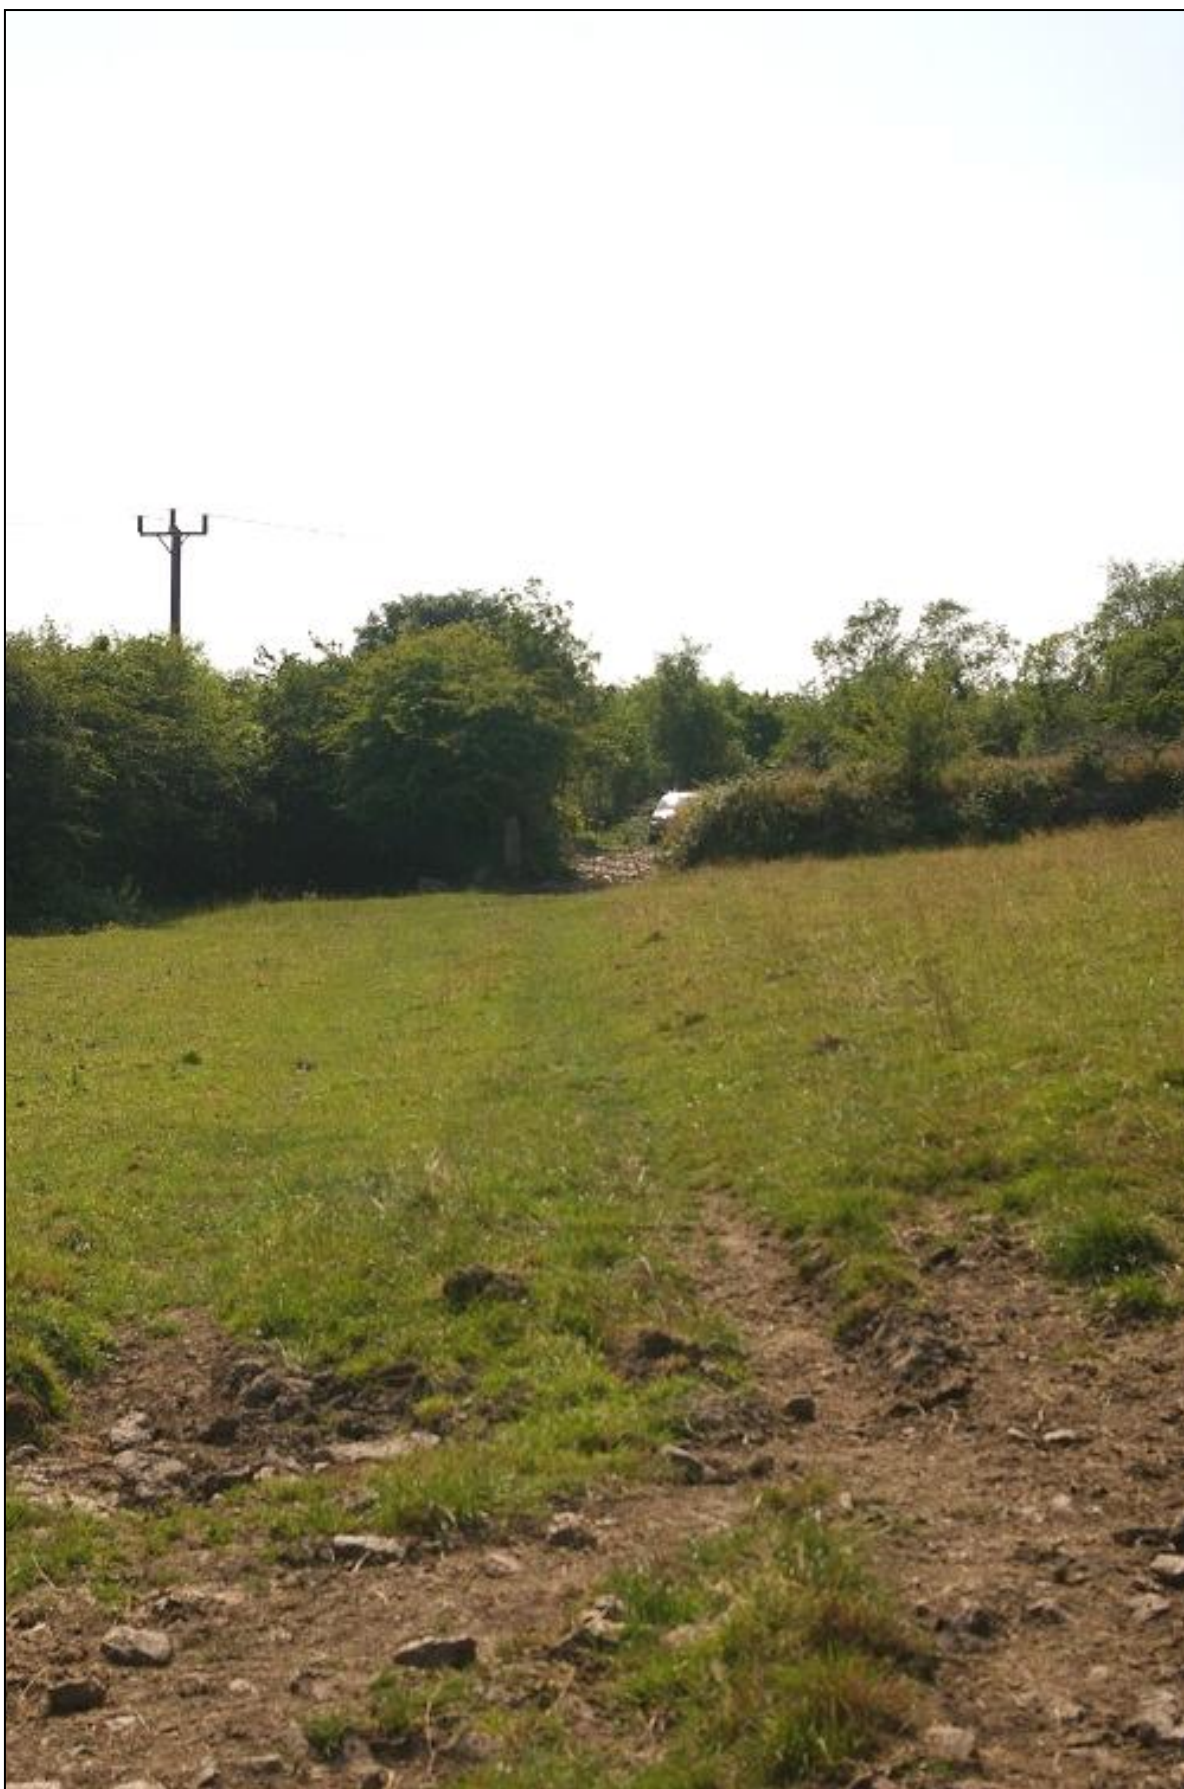
View from the turbine field in, through the western gateway into the next field, showing the route of the proposed access track; from the east,
