A FORMER MILL at WILTON MILL FARM PELYNT CORNWALL

Desk-Based Assessment
&
Historic Building Recording

Report No.: 131219
Date: 19.12.13
Authors: D. Laing-Trengove

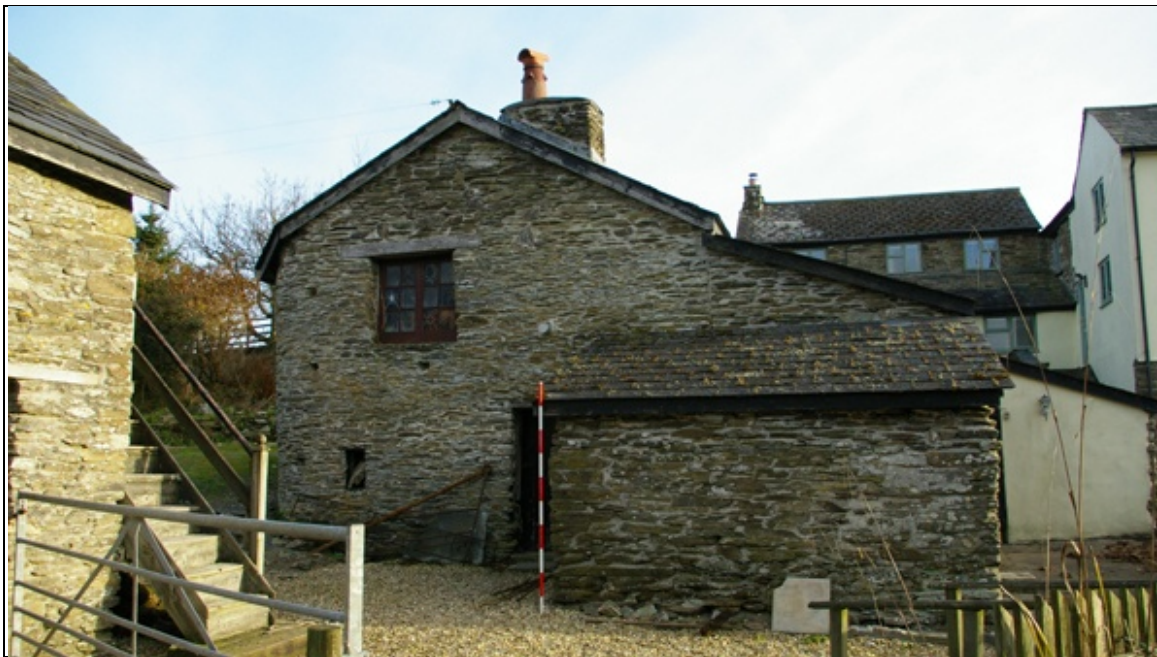
Figure 2: The west elevation of the mill (B1) and lean-to B1c, from the south-west (scale 2m).

The former mill building (B1 – Figure 2), with lean-tos B1a, B1b & B1c, represent four phases of construction, with B1a clearly abutting B1, B1c clearly abutting B1 and B1a, and B1b abutting B1a. There are few clues as to the age of the building within the fabric, except that the masonry of the upper portions of the building appears blockier than that to the lower, and the wall thicknesses at ground floor level suggest that perhaps the lower portion of the building may be earlier and possibly contain 18th century fabric.

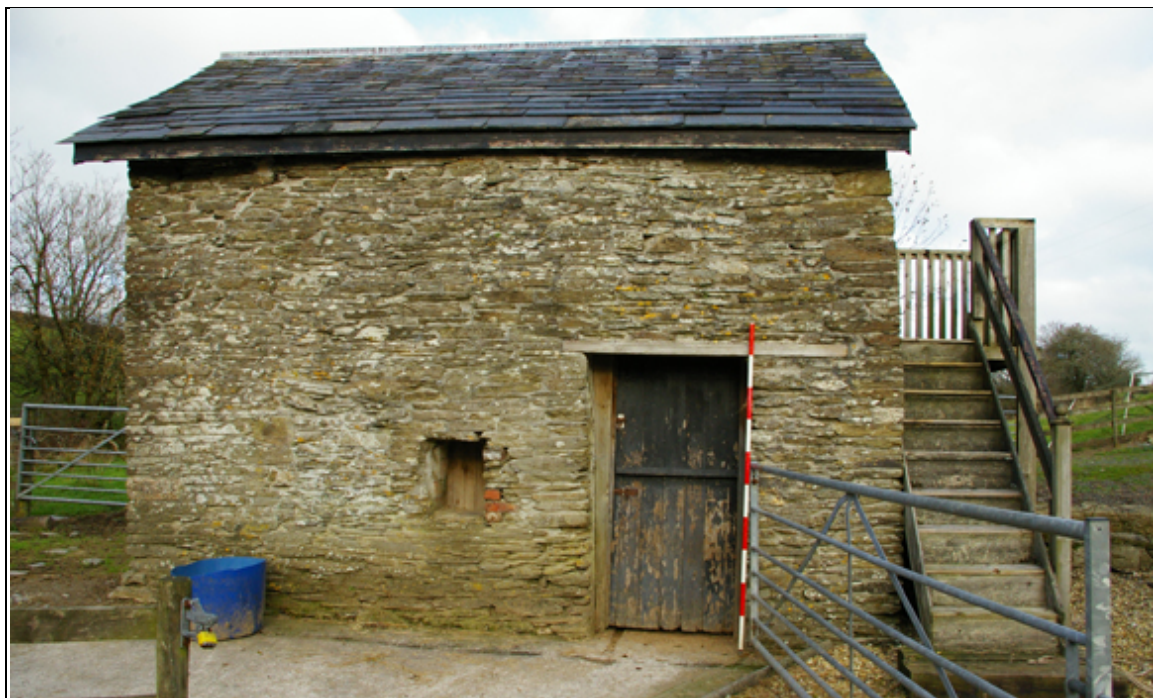
Figure 3: The south elevation of the granary (B2), from the south (scale 2m).

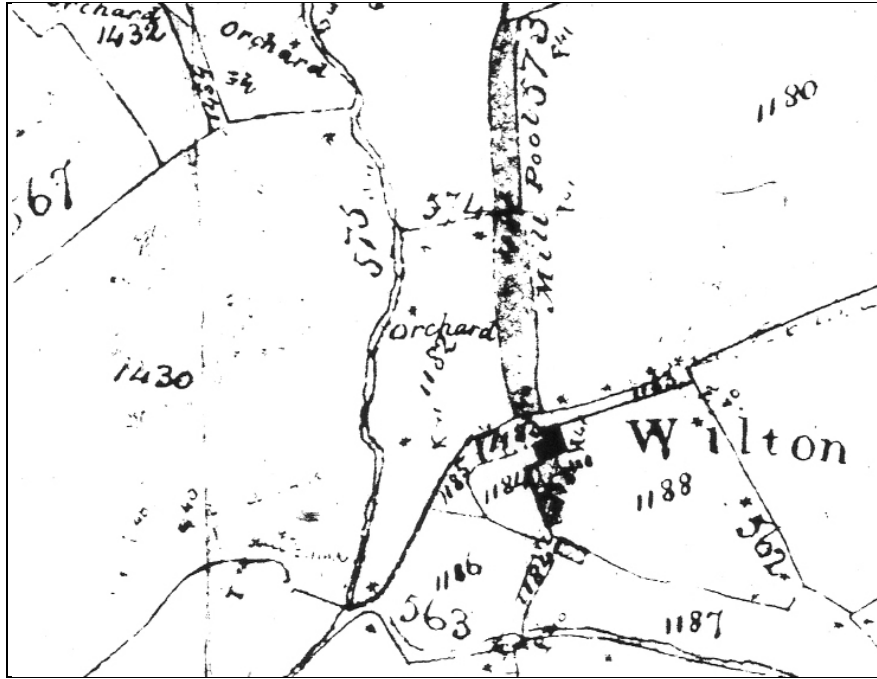
Figure 4: Extract from the 1840 Pelynt tithe map (CSL).

The earliest source available to this study is the 1840 tithe map for Pelynt. Figure 2 is an extract from the map, unfortunately not particularly clear, but it is still possible to identify the mill building, positioned to the west of the farmhouse which is coloured solid black. The small building or granary to the west of the mill is not marked. The long mill pond to the north-east of the mill is clearly marked and is numbered 1181 on the Apportionment, and mill race is probably represented by the line located just above 1185 from the pond to the mill wheel and to the stream to the west from the mill. The apportionment gives the holding at Wilton Mill as comprising of just over 2 acres, including the mill pool, the road & mill (numbered 1183) and houses and yards etc. (numbered 1184), as well as pasture and garden.

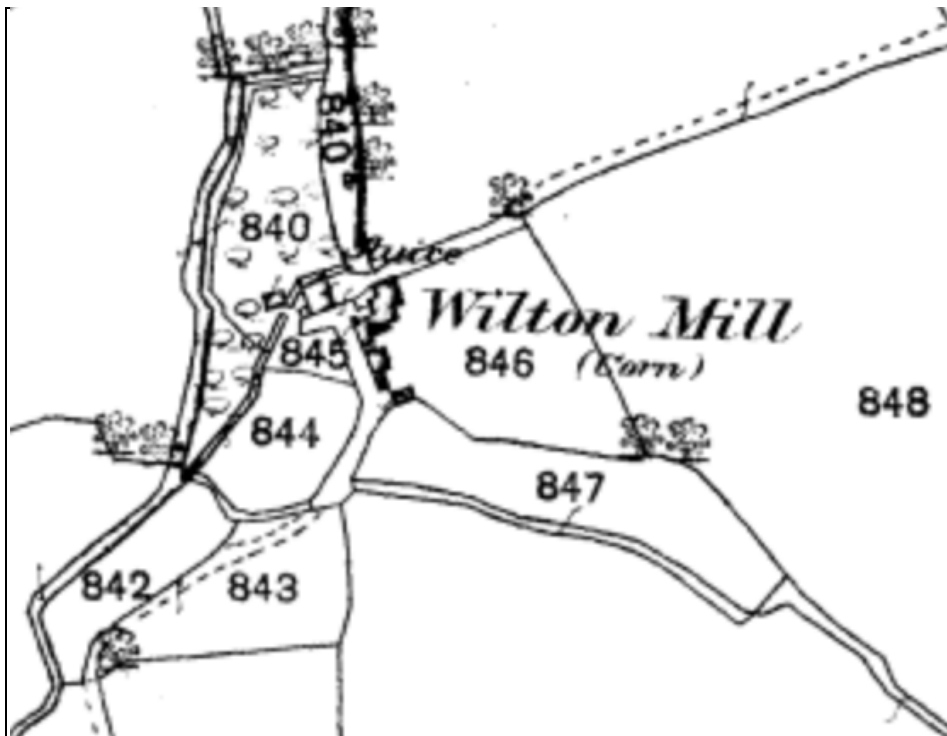
Figure 5: Extract from the 1st edition Ordnance Survey map.

The 1st Edition Ordnance Survey map of c.1888 (Figure 3) clearly shows both buildings, including the lean-tos to the south and west (B1a and B1c). The size of the building depicted is similar to that of the tithe which suggests that the southern lean-to was in place at this time. The mill pool, sluice and route of the launder and leat are marked with a break in the leat to the south-west of the mill, suggesting a bridge across it to allow access to the granary to the west. The leat flows to the south-west and joins the stream. The map also clearly states that the mill is at this time grinding corn.

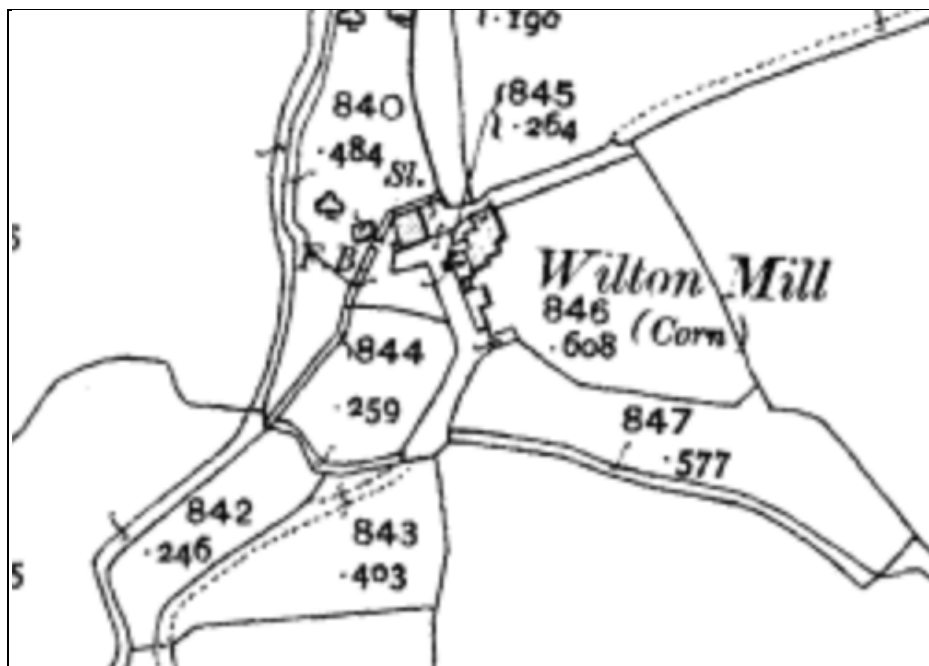
Figure 6: Extract from the 2nd Edition Ordnance Survey map of 1905.

The 2nd Edition Ordnance Survey Map (Figure 4) appears to show little or no change to the landscape or buildings.

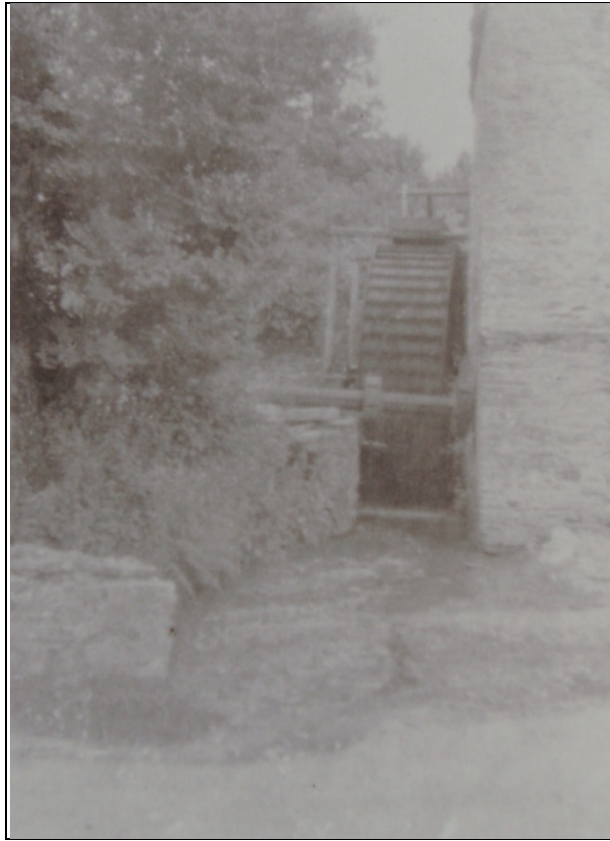
Figure 7: A photograph of the mill at Wilton, dating from c.1905.

A number of 20th century photographs of the mill and granary buildings have been made available to this study (courtesy of Mr & Mrs Axon). The earliest photograph dates to c.1905, and shows the overshot mill wheel, apparently affixed to the north elevation of the mill building, with the wheel pit, launder and the broad leat flowing down to the west (Figure 7).

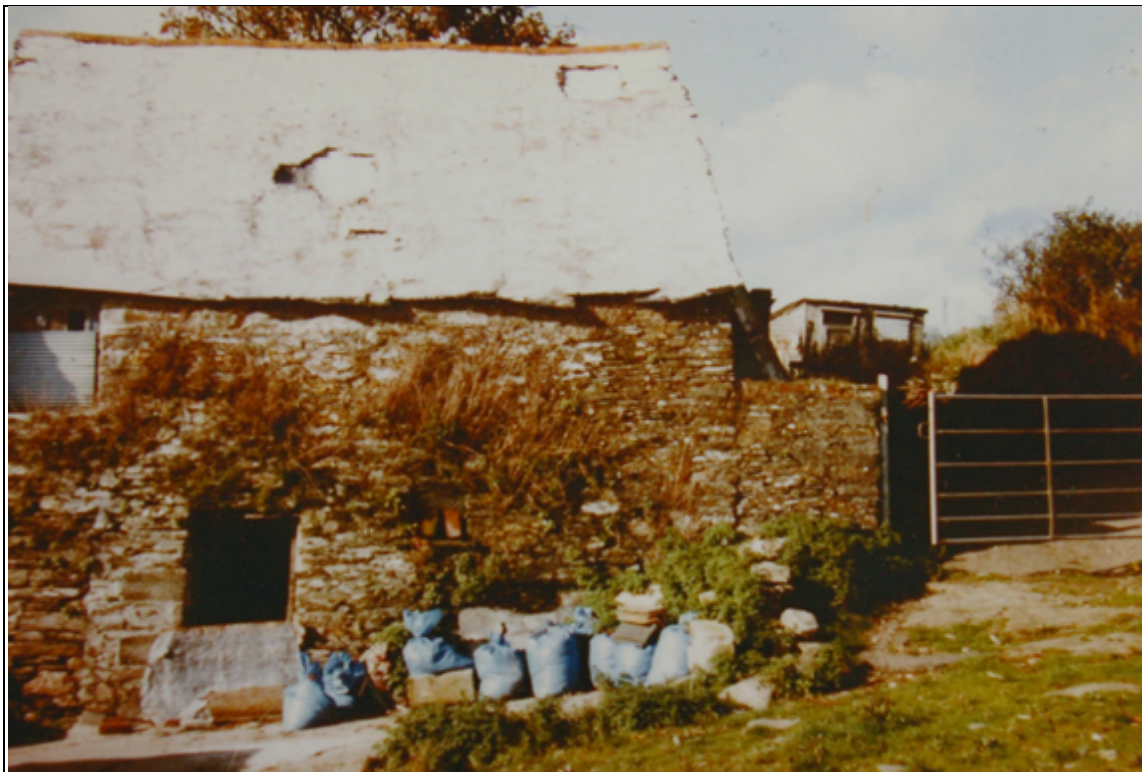
Figure 8: The south elevation of the mill photographed during the 1980s.

The other photographs date to the later 20th century and show the mill building as it was in the middle of the century when it fell out of use (Figures 8 & 9). The stone rubble south elevation is pictured, or rather the south elevation of the southern lean-to (Building 1a), with a reduced opening in the position of an extant ground-floor door into the building, a small window opening to the east and a first floor opening to the west. The roof, although in very poor condition and roofed with slates coated with bitumen, appears higher, with a catslide roof from the apex of the mill building forming a two storey lean-to rather than the one-and-a-half storey building extant today. Figure 8 also shows a small low structure against the east elevation of the lean-to, possible simply a yard wall enclosing the area to the south.

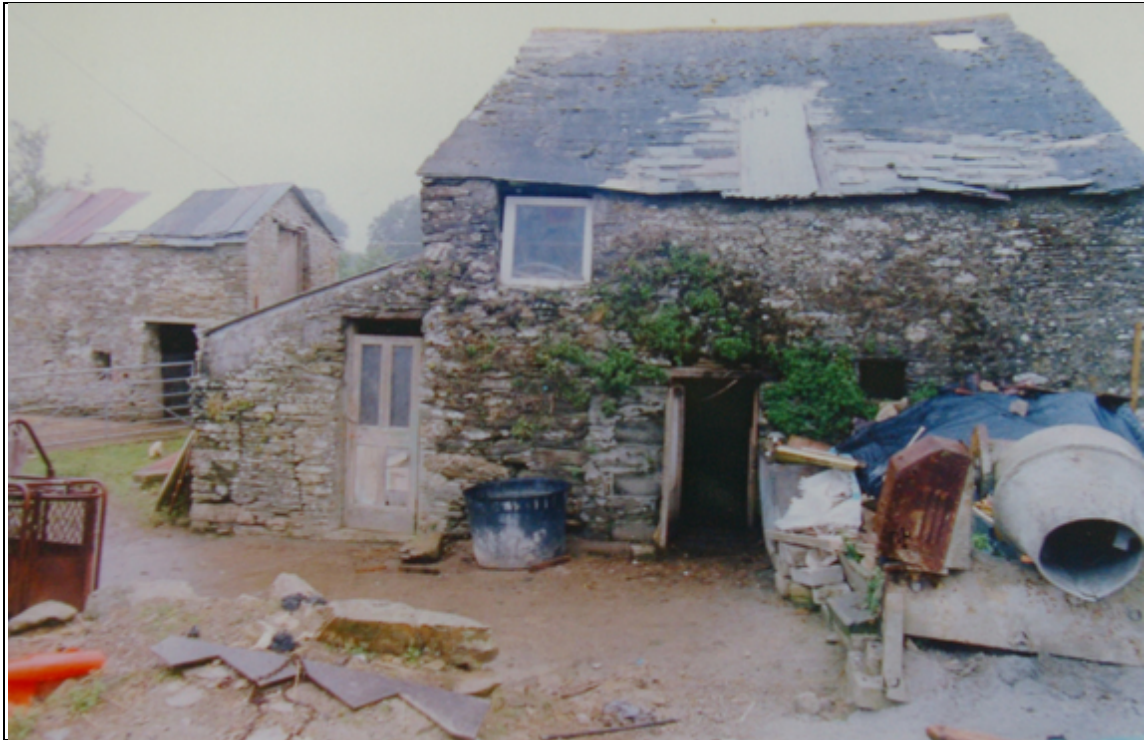
Figure 9: The south elevation of the mill, during the 1990s, with the granary visible on the left.

Figure 9 shows the south elevation of the western lean-to (B1c), which appears much as it does today. Figure 9 also shows the granary to the west of the mill; the south elevation and the upper portion of the east wall appear much as they do today. However, the roof is clad with sheet metal at this time. Figure 10 is a photograph of a similar date depicting the north and east elevations of the granary.

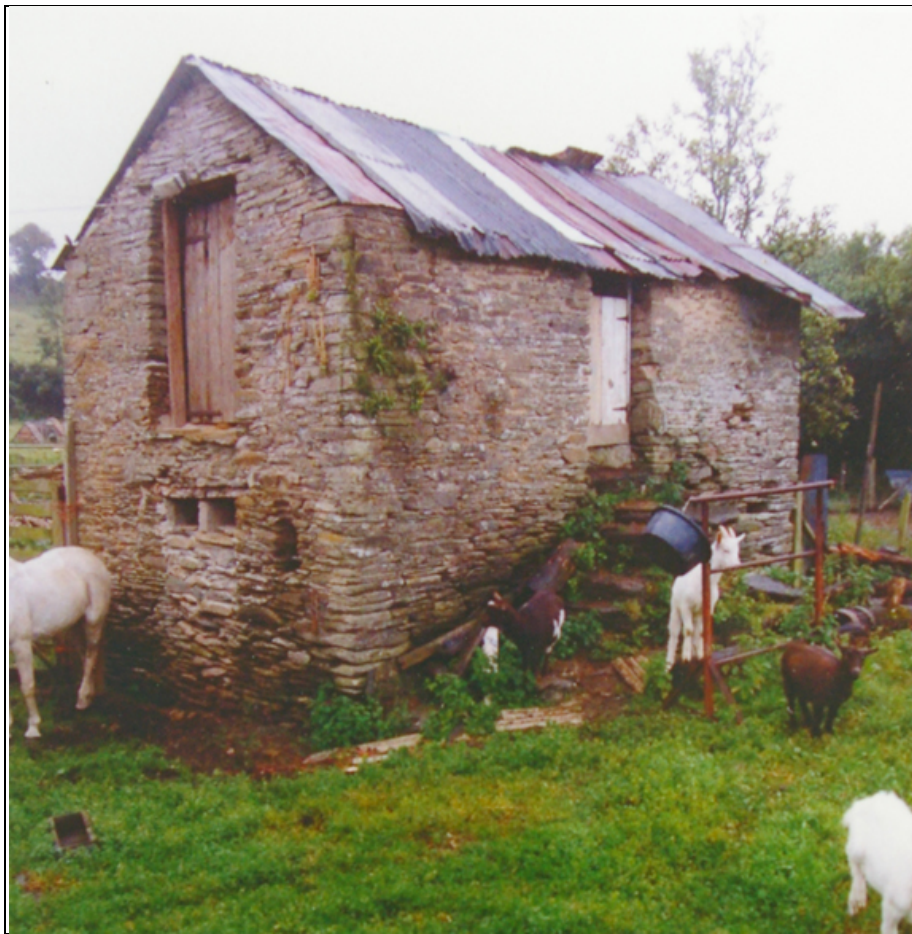
Figure 10: The north and east elevations of the granary, during the 1990s.

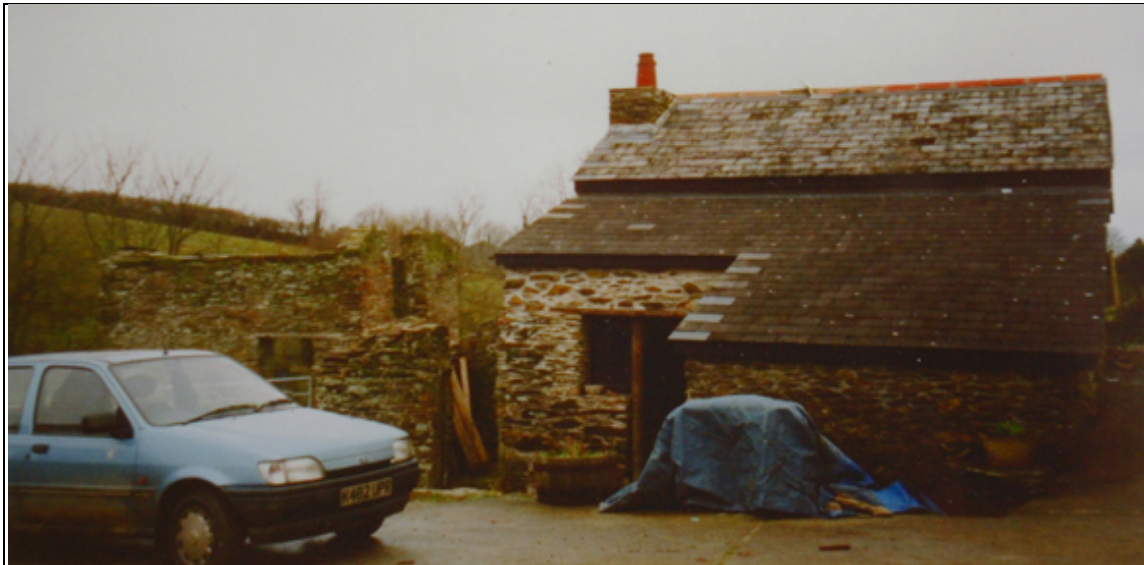
Figure 11: Photograph of the south elevation of the mill dating to 2002, with the roofless granary in the background to the west.

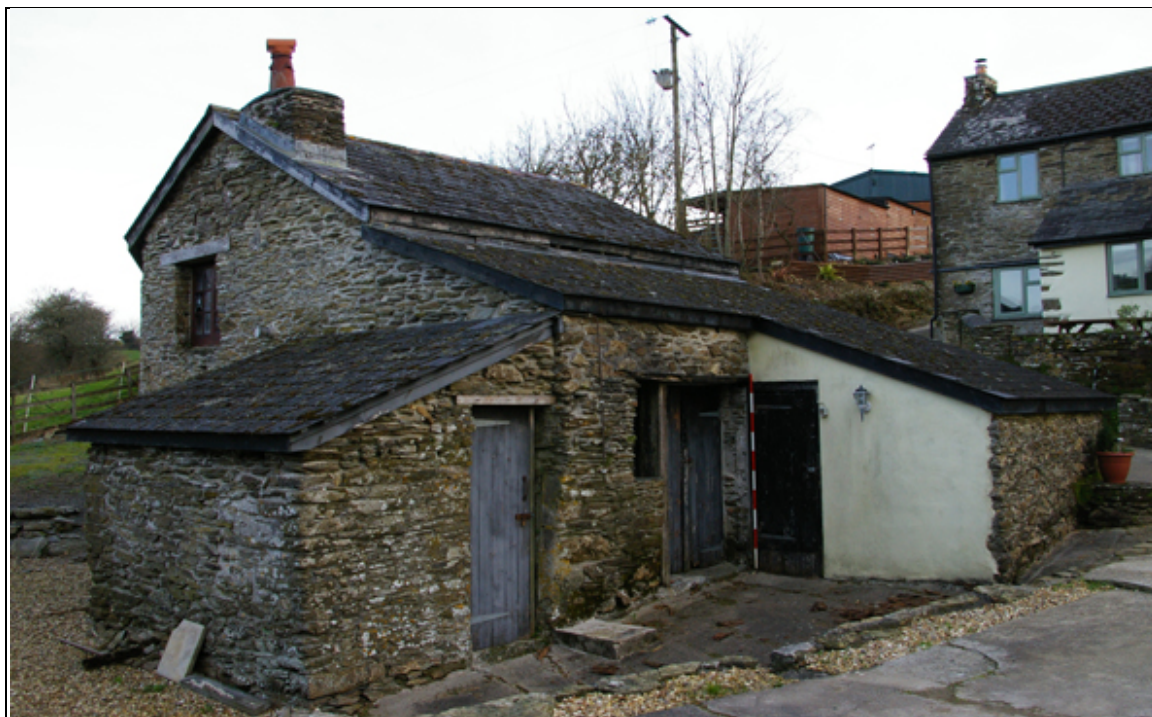
Figure 13: The mill, with lean-tos B1a, B1b & B1c built against the south elevation, from the south-west (scale 2m).

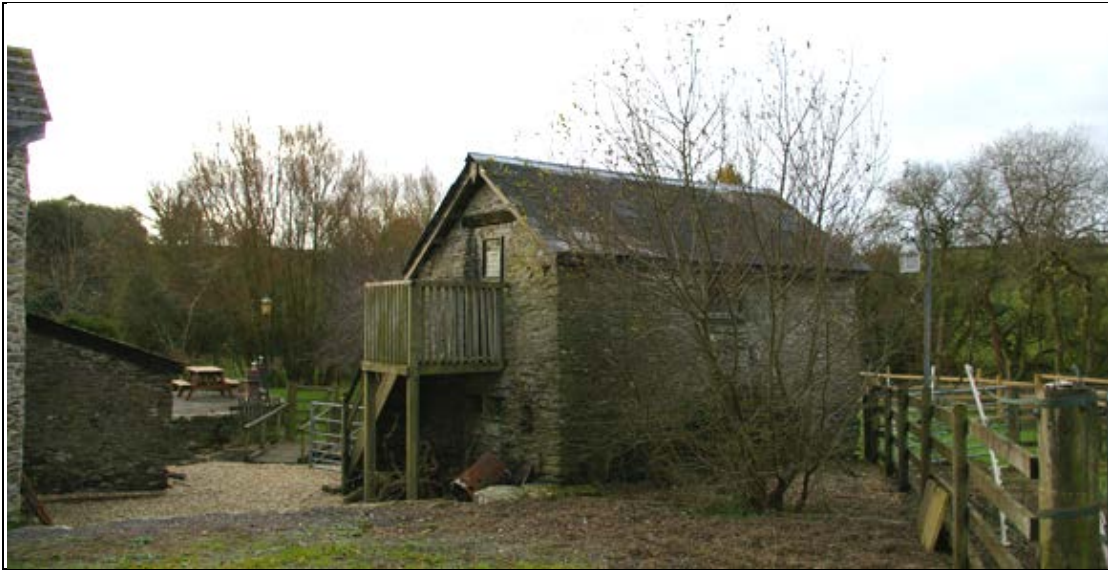
Figure 14: The Granary, Building 2 (B2), from the north-east

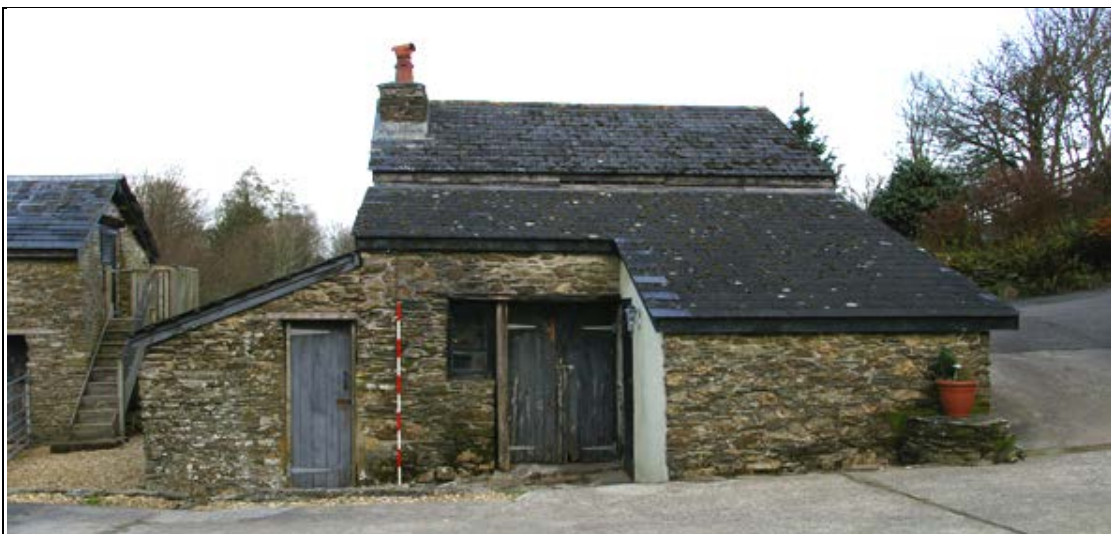
Figure 16: The south elevation of the mill (B1) with lean-tos B1a, B1b & B1c in the foreground, from the south (scale 2m).

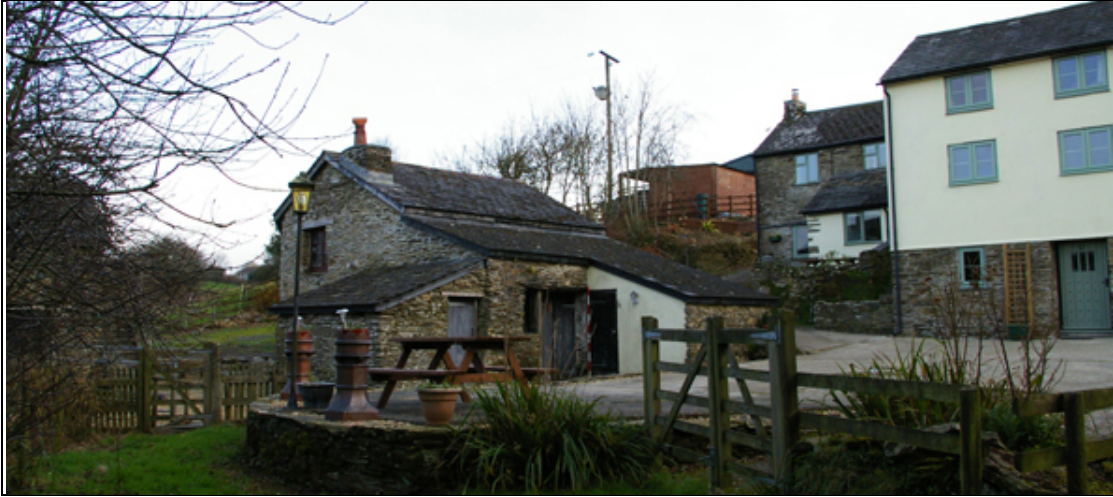
Figure 17: The mill and lean-tos, from the south-west (scale 2m).

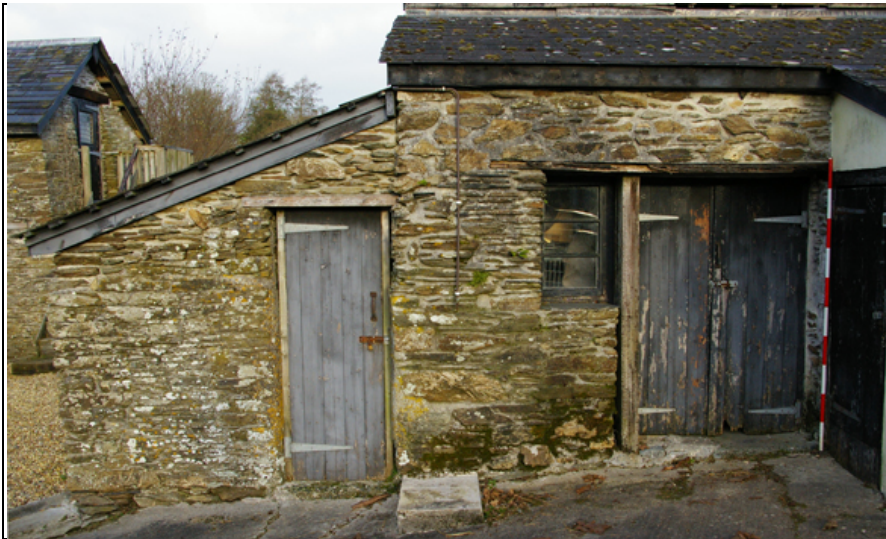
Figure 18: The south elevations of B1a and B1c, from the south (scale 2m).

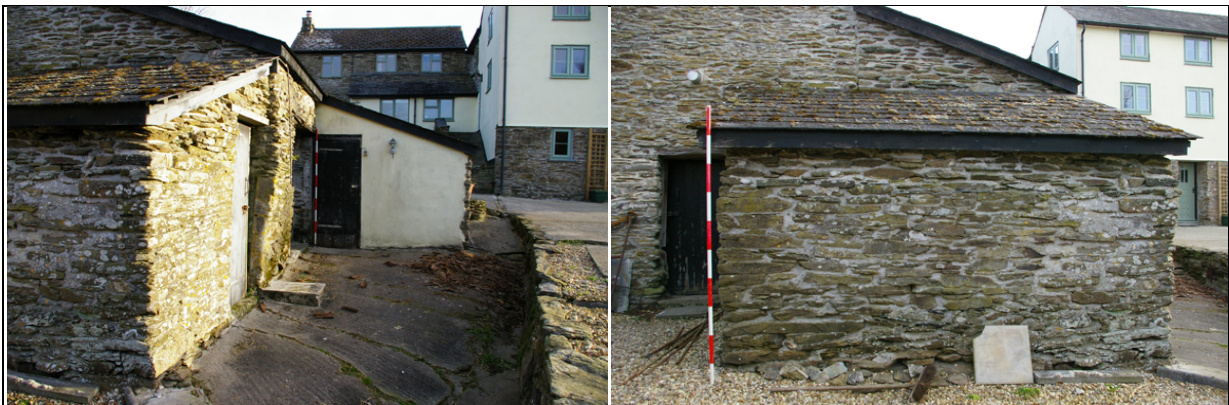
Figure 19: B1b west wall, with B1c in foreground, from the west (scale 2m).

Figure 20: The west elevation of B1c, from the west (scale 2m).

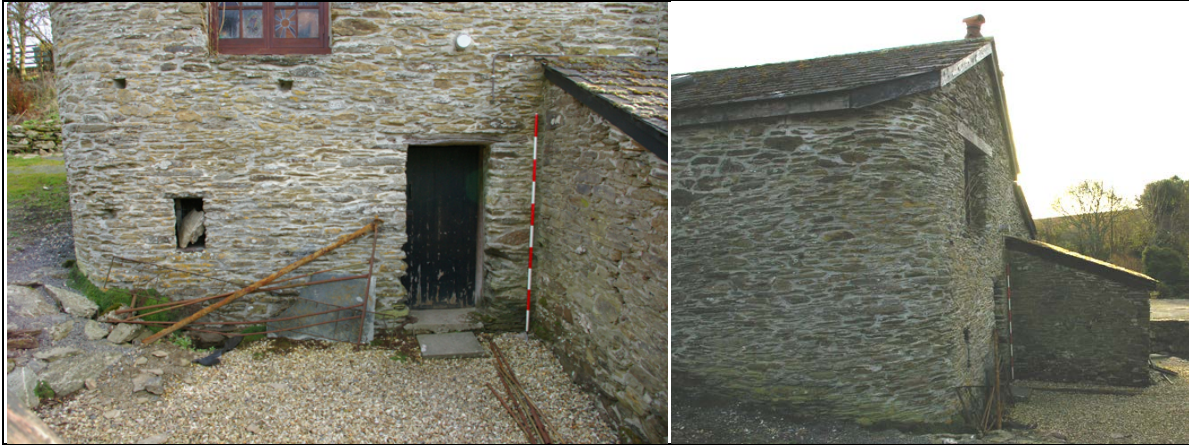
Figure 21: The ground-floor west elevation of the mill (B1), from the west (scale 2m).
Figure 22: The north-west corner of B1, with north wall of B1c, from the north.

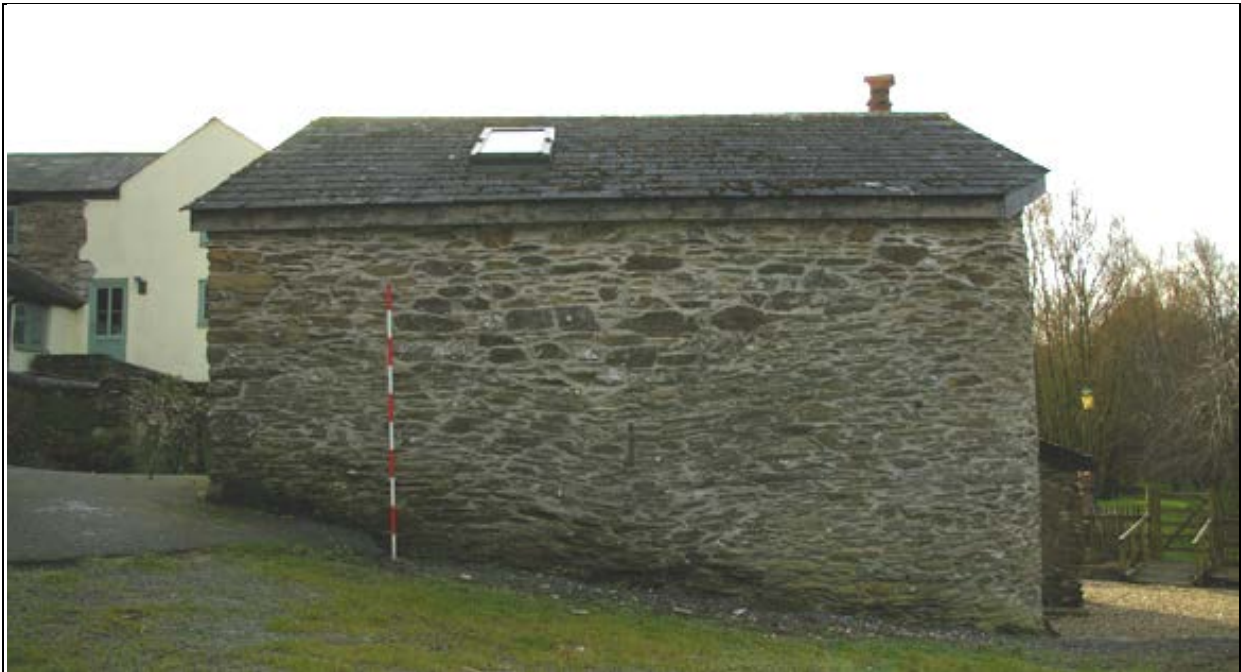
Figure 23: The north elevation of the mill (B1), from the north (scale 2m).

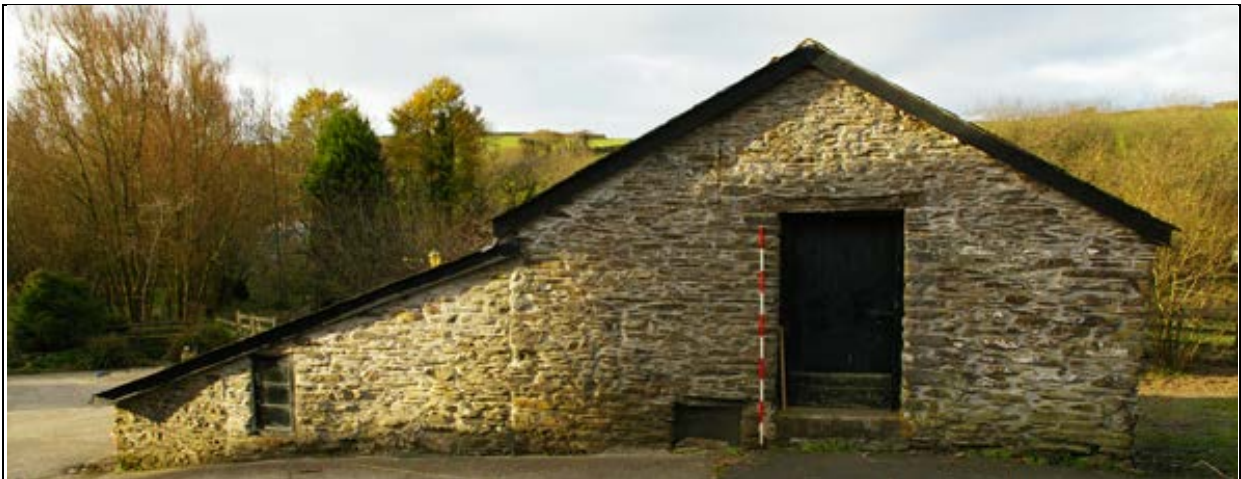
Figure 24: The east elevation of B1, from the east (scale 2m).

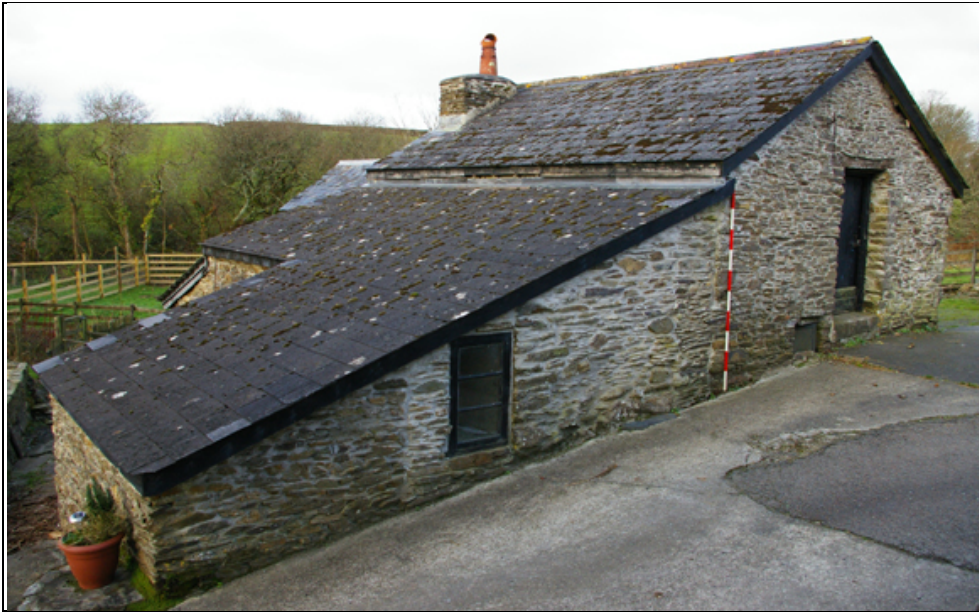
Figure 25: The east elevation of B1, from the south-east (scale 2m).

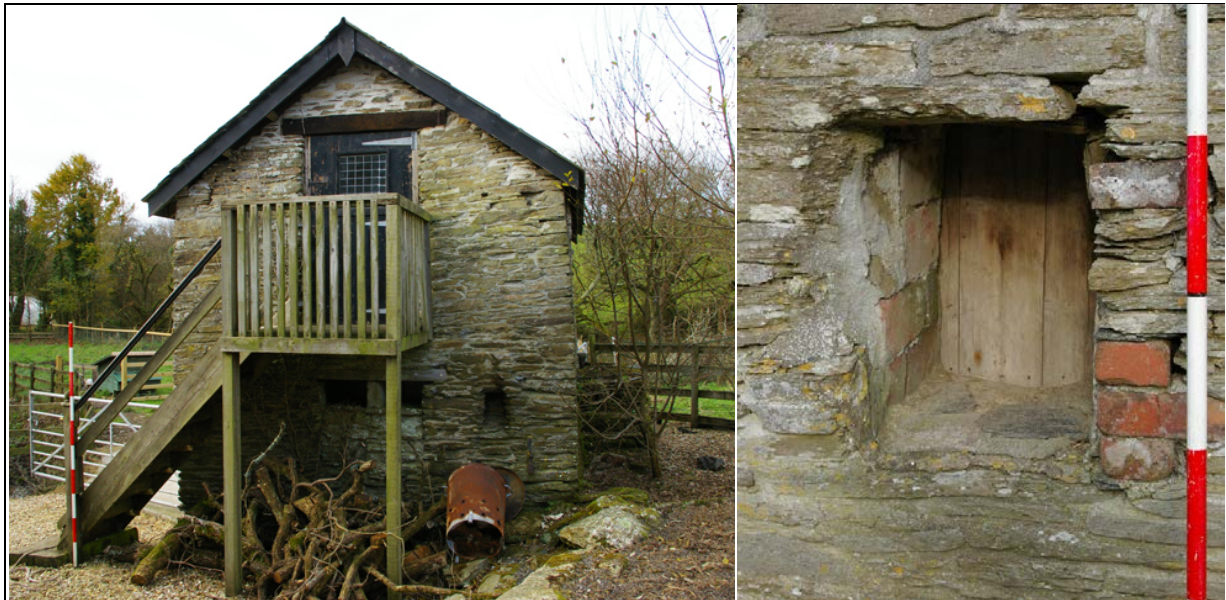
Figure 26: The east elevation of the granary (B2), from the east (scale 2m).

Figure 27: Detail of the opening to the west of the door in the south wall of B2, from the south (scale 2m).

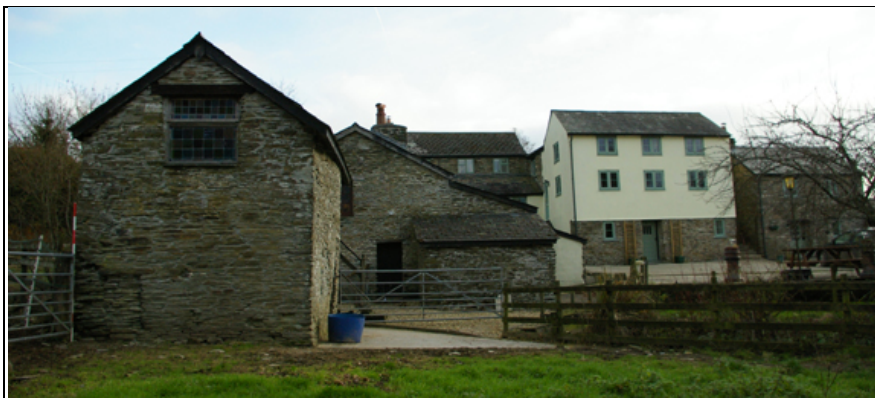
Figure 28: The west elevations of B2, B1 & B1c, from the west (scale 2m).

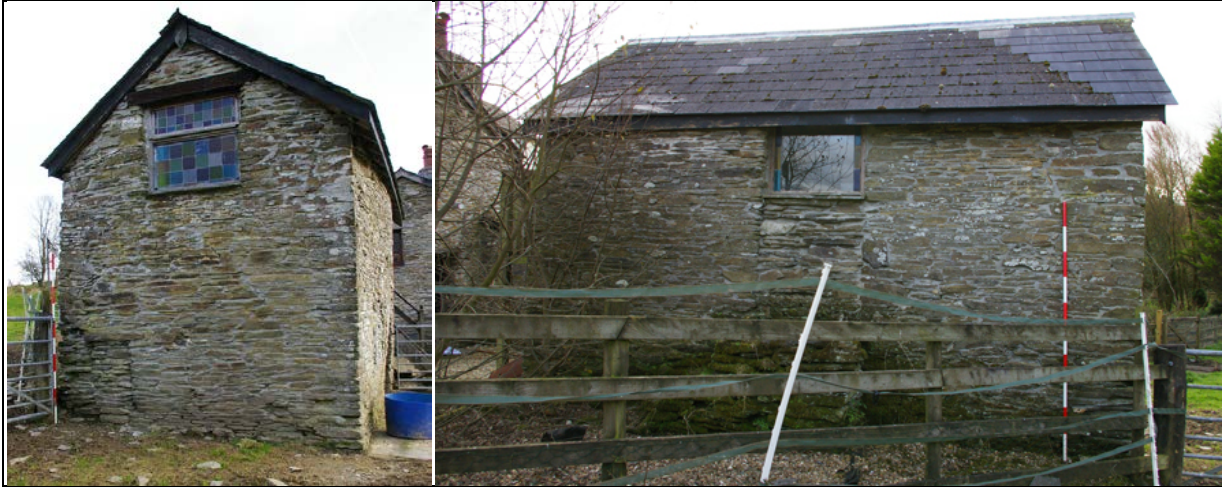
Figure 29: The west elevation of B2, with blocked opening bottom left, from the west (scale 2m).
Figure 30: The north elevation of B2, with partly-blocked loading door, from the north (scale 2m).

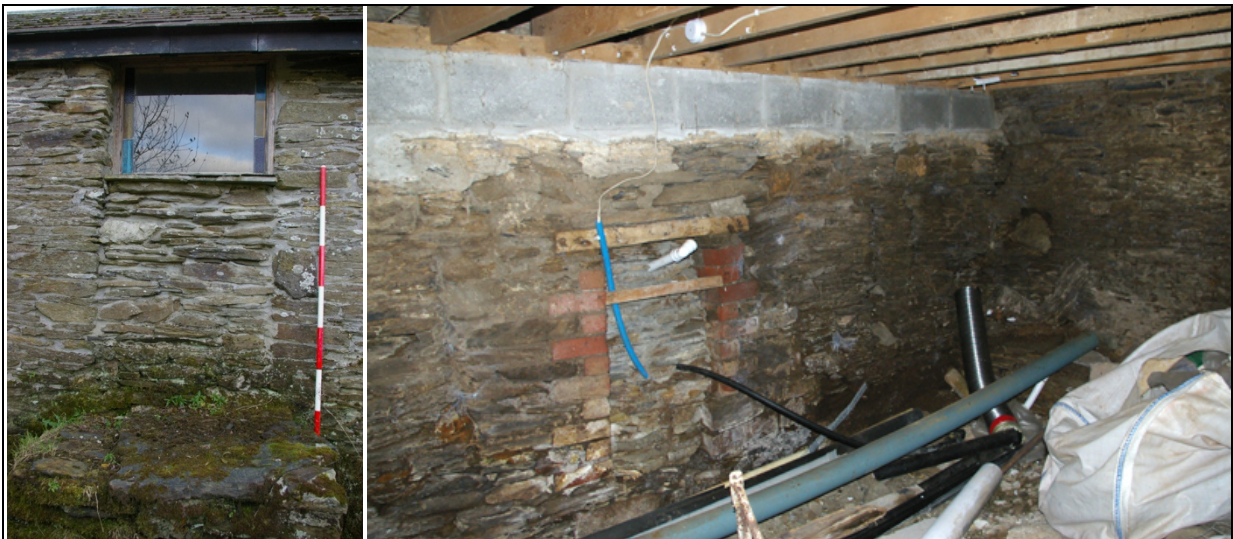
Figure 31: Detail of the blocked opening in the north wall of B2, from the north (scale 2m).
Figure 32: The interior ground-floor north wall of B1, with blocked opening, from the south-west.

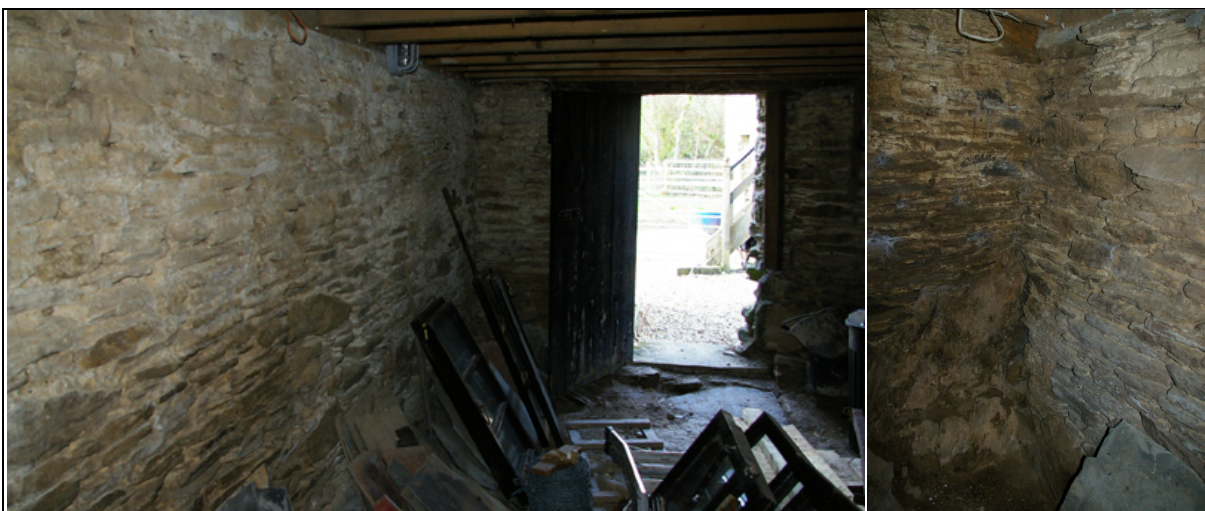
Figure 33: The interior ground-floor south wall of B1, from the east.
Figure 34: The interior ground-floor south-east corner of B1 built into the bedrock, from the north-west.

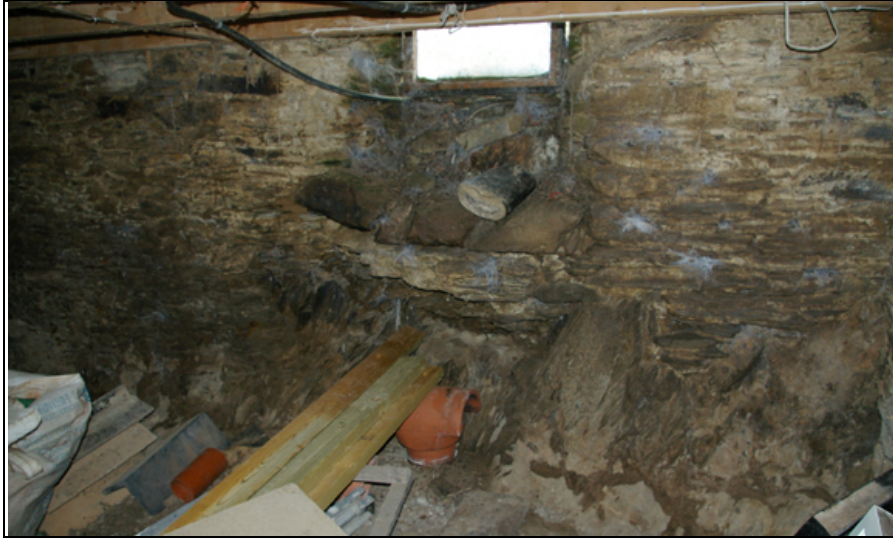
Figure 35: The interior ground-floor east wall of B1, with stone sill and window opening.

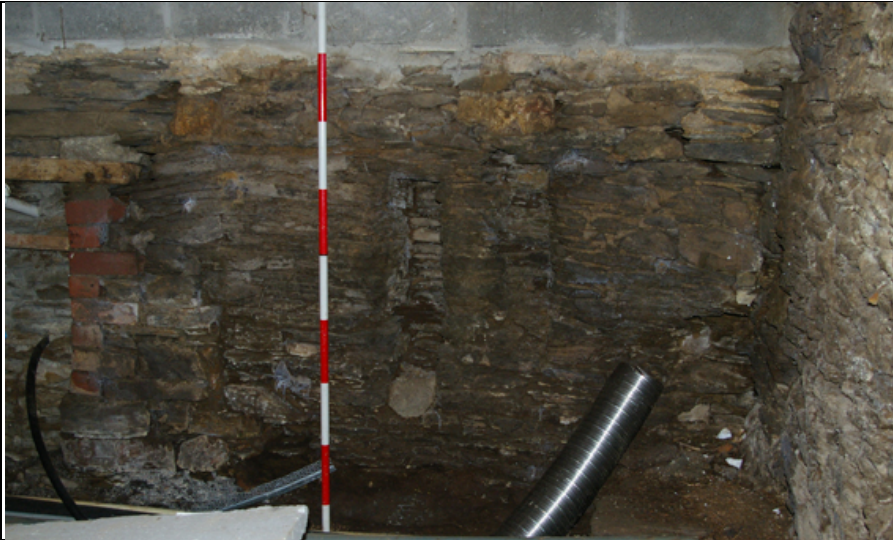
Figure 36: Ground-floor interior north-east corner of B1, with blocked openings; from the south (scale 2m).

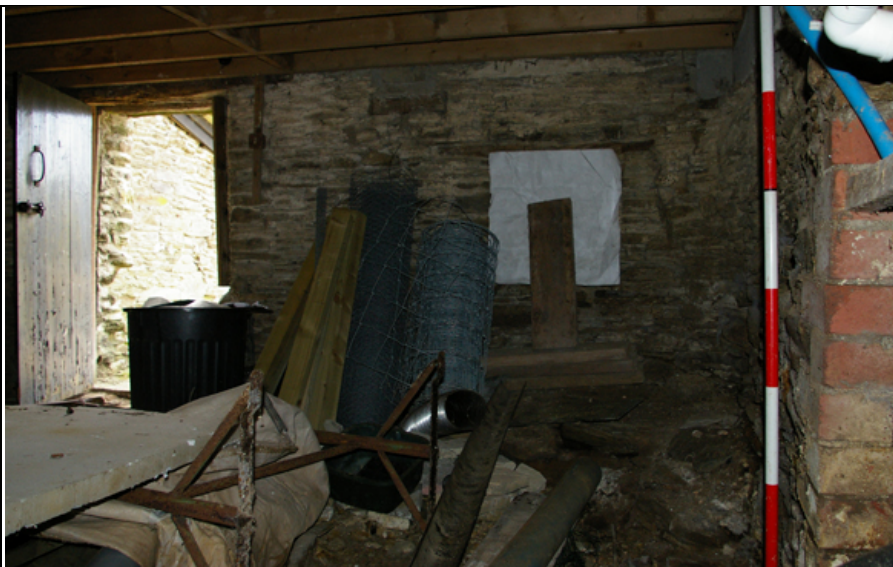
Figure 37: Ground-floor interior north-west corner of B1, from the east (scale 2m).

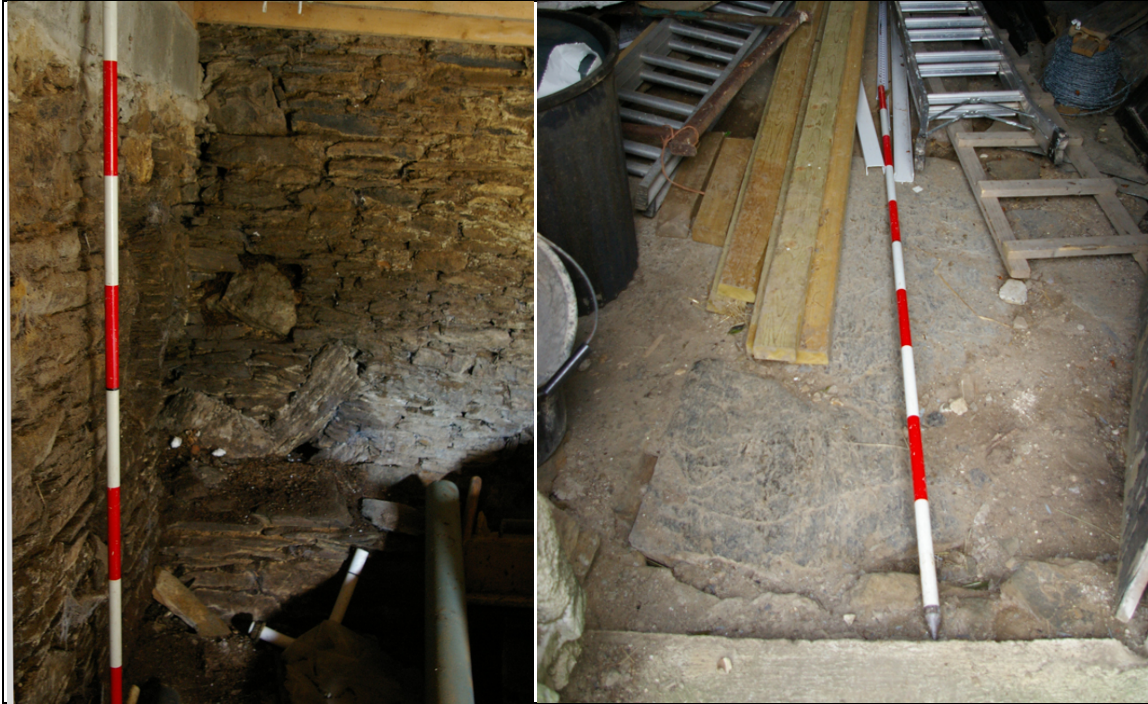
Figure 38: Detail of the interior north-east corner of B1, built on the bedrock, from the west (scale 2m).

Figure 39: The remaining stone slab floor to the ground-floor interior of B1, from the west (scale 2m).

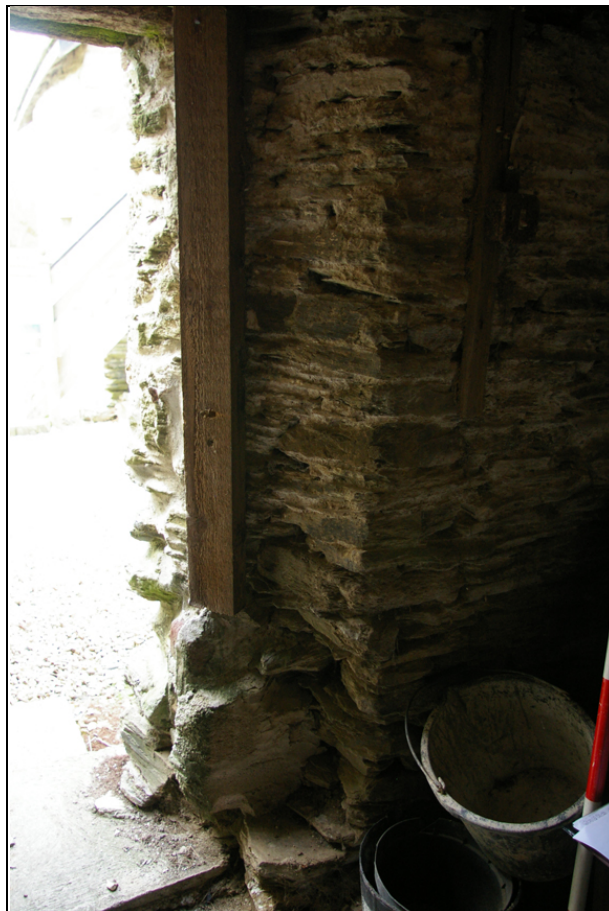
Figure 40: The ragged northern jamb of the ground-floor door opening in the west elevation of B1, from the south-east.

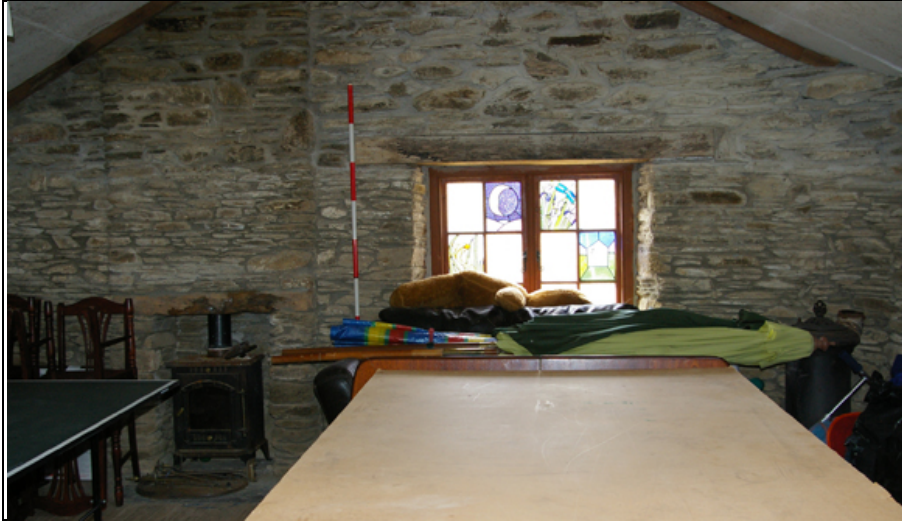
Figure 41: The interior first-floor west wall of B1, from the east (scale 2m).

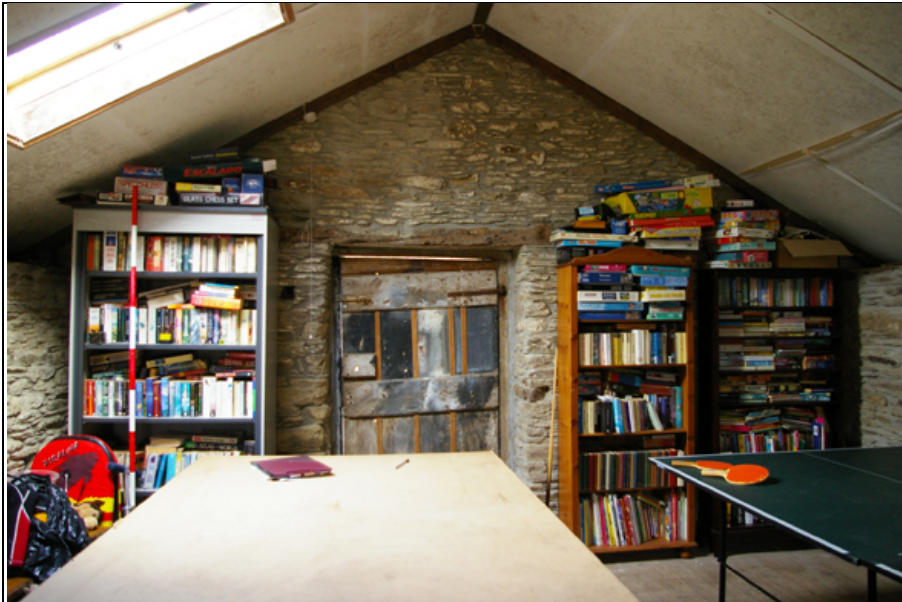
Figure 42: The interior first-floor east wall of B1, from the west (scale 2m).

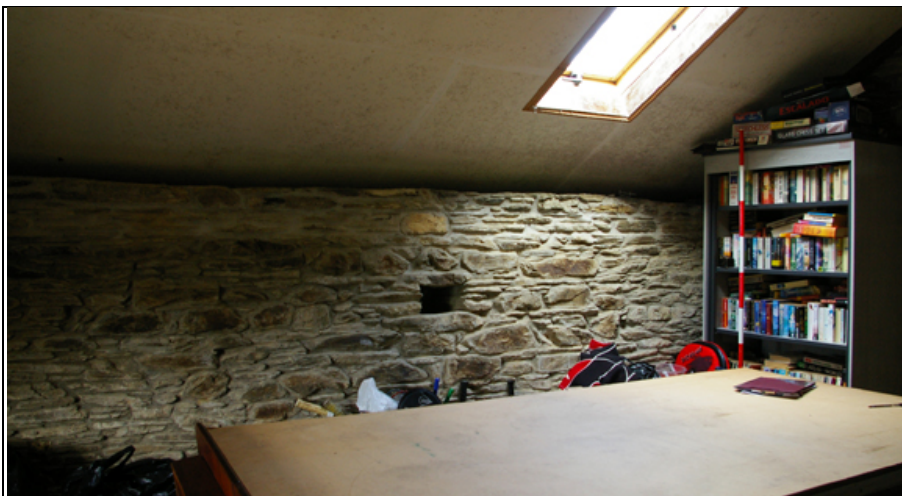
Figure 43: The first-floor interior north wall, with small opening, blocked to the exterior, from the south (scale 2m).

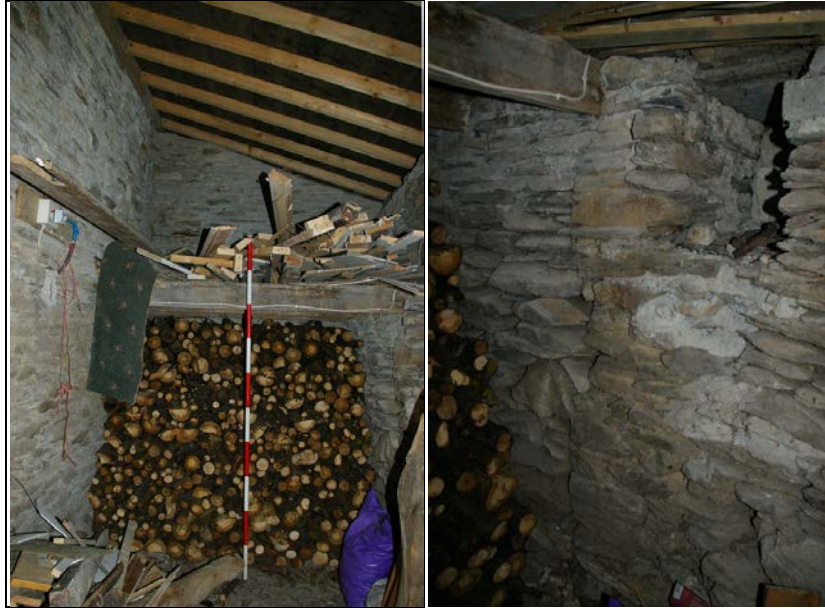
Figure 44: The interior eastern end of lean-to B1a, from the west (scale 2m).

Figure 45: The possible former openings in the south wall of B1a, from the north-west.
