A FORMER MILL at WILTON MILL FARM PELYNT CORNWALL

Desk-Based Assessment
&
Historic Building Recording

Report No.: 131219
Date: 19.12.13
Authors: D. Laing-Trengove

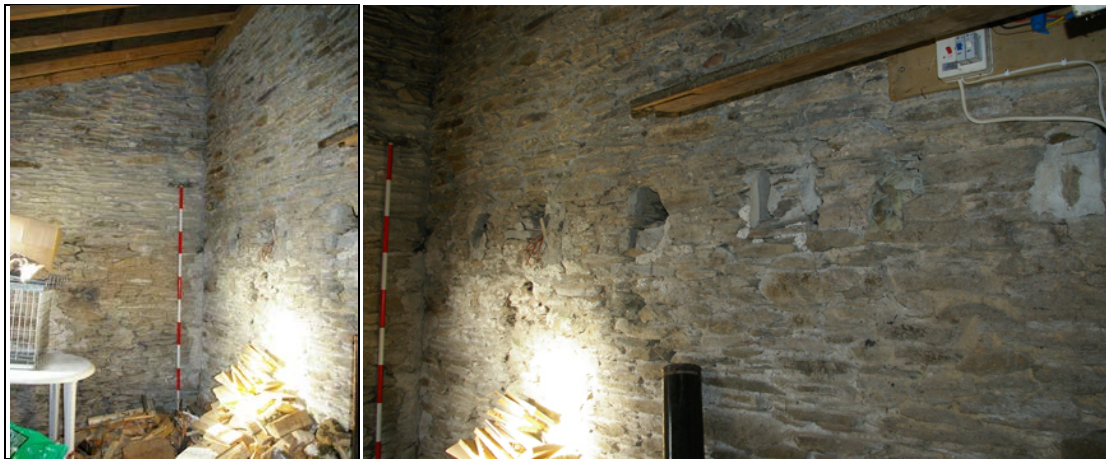
Figure 46: The western interior of B1a, from the east (scale 2m).

Figure 47: Socket holes in the interior north wall of B1a (exterior south wall of B1), from the south-east (scale 2m).

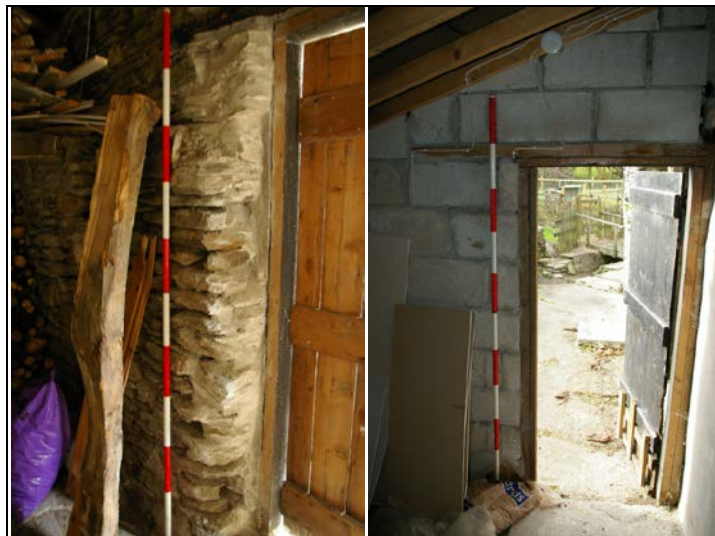
Figure 48: The ragged eastern jamb of the door opening in the south elevation of B1a, from the north-west (scale 2m).

Figure 49: The west wall of modern lean-to B1b, from the east (scale 2m).

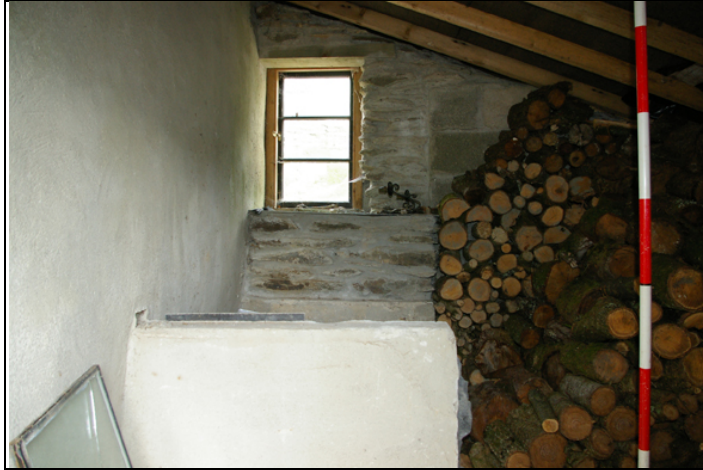
Figure 50: The interior north-east corner of B1b, from the west (scale 2m).

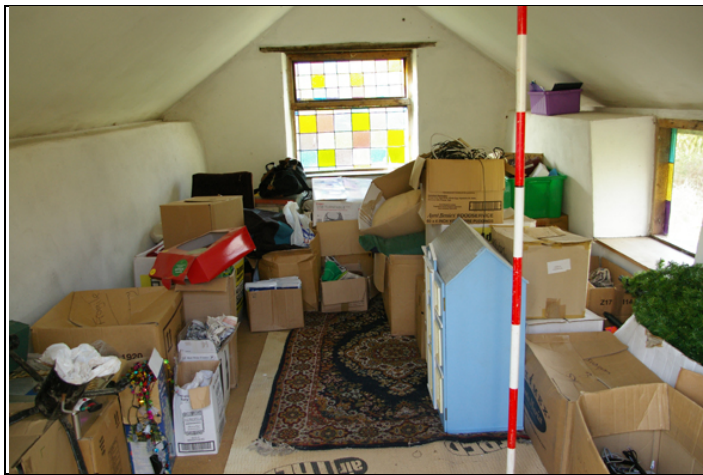
Figure 51: The first-floor interior of B2, from the east (scale 2m).

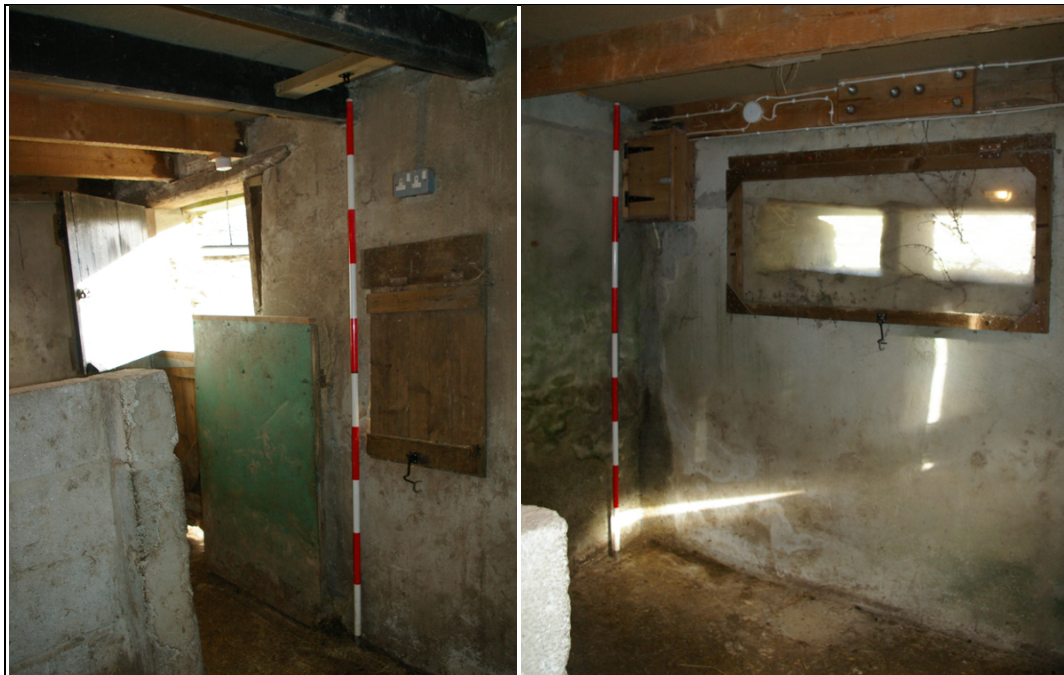
Figure 52: The ground-floor interior south-east corner of B2, from the north-west (scale 2m).

Figure 53: The ground-floor interior north-east corner of B2, from the south-west (scale 2m).

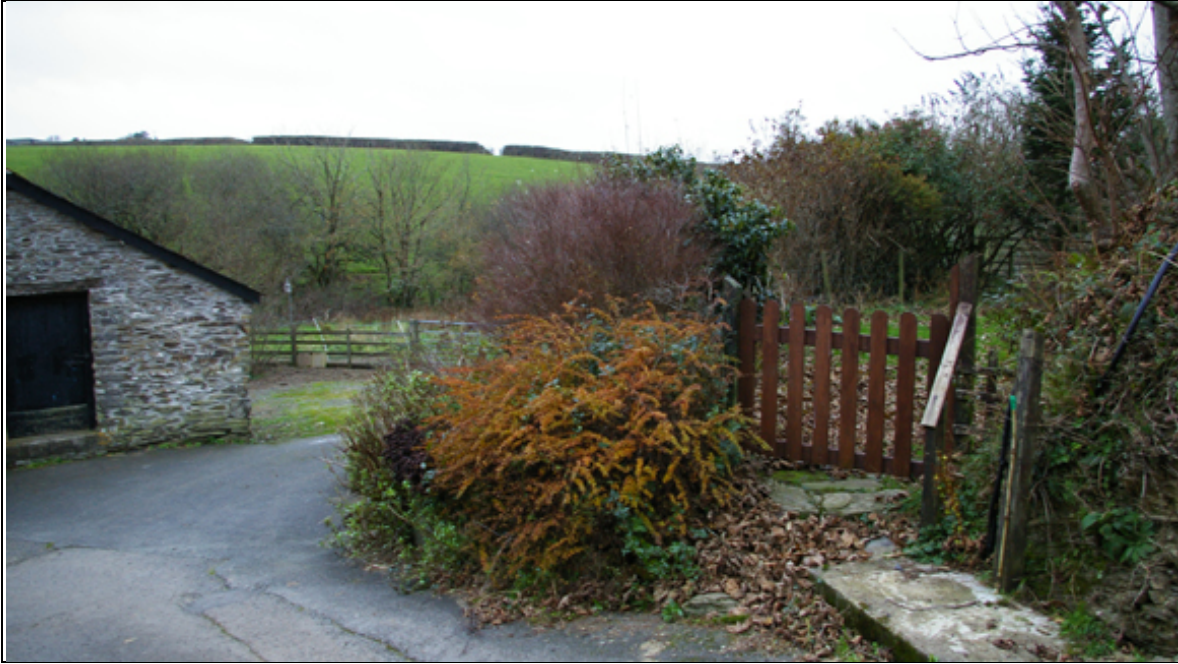
Figure 54: The point from which the water from the mill pond was formerly channelled into the head race of the mill, from the east.
