# **BARN at KNOWLE FARM BROADHEMPSTON DEVON**

## **Results of Historic Building Recording**

Report No.: 291013  
Date: 29.10.2013  
Authors: D. Laing-Trengove

**Historic Building Record**

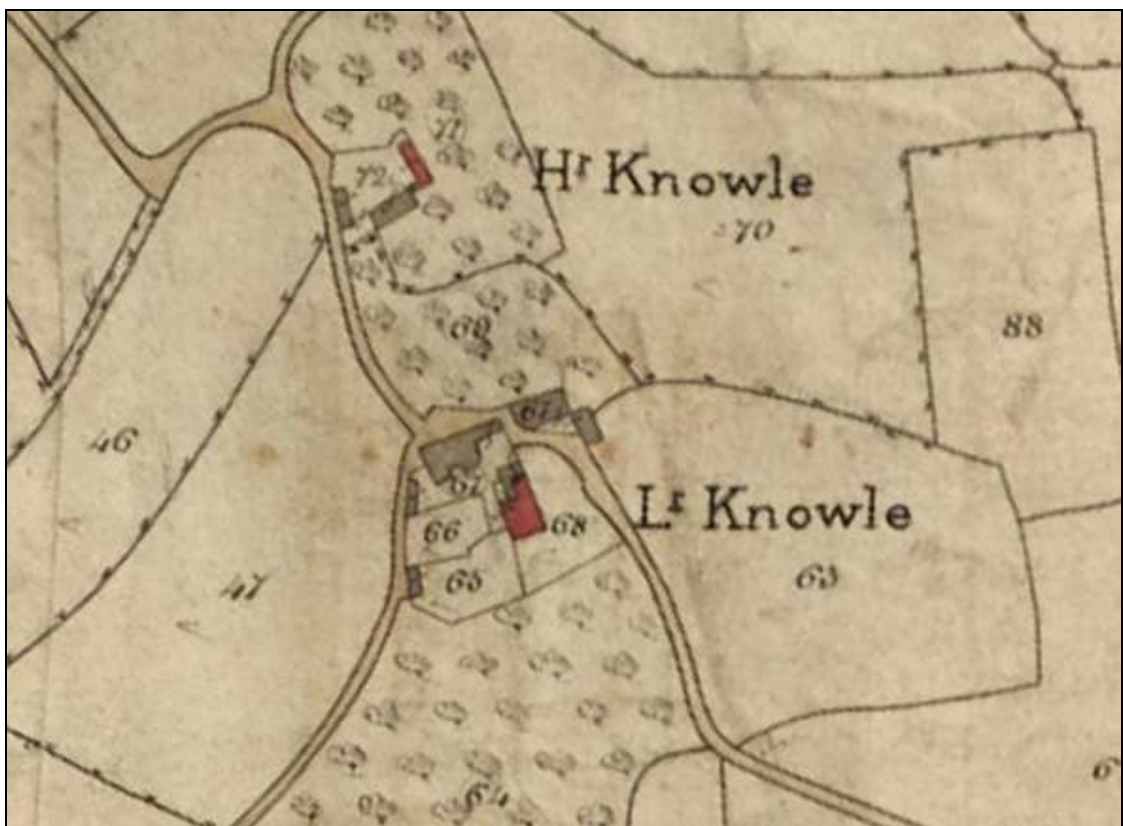
The first cartographic source available to this study is the Broadhempston tithe map of 1841 (Figure 2). The settlement now known as Knowle was at this time listed as *Lower Knowle*, owned by one *John Skinner*. The house is marked in pink, denoting a domestic structure, whilst the farm buildings are marked in grey/brown illustrating buildings with a non-domestic function. Interestingly the northern element/s of the house are coloured grey/brown indicating that the use and function of this part of the building was non-domestic.

Figure 2: Extract from the Broadhempston tithe map of 1841.

The barn and both the shippon and piggery are depicted, the piggery positioned in a small orchard, but all appearing basically as they are today in plan. However, the barn itself appears to be slightly larger; the foot of the L-shape is present at this date but there is also a curvilinear structure on the south elevation, presumed to be a roundhouse for a horse engine. The east end of the building also appears slimmer than the extant building, although this illustration may not reflect the dimensions of the actual building at this time.

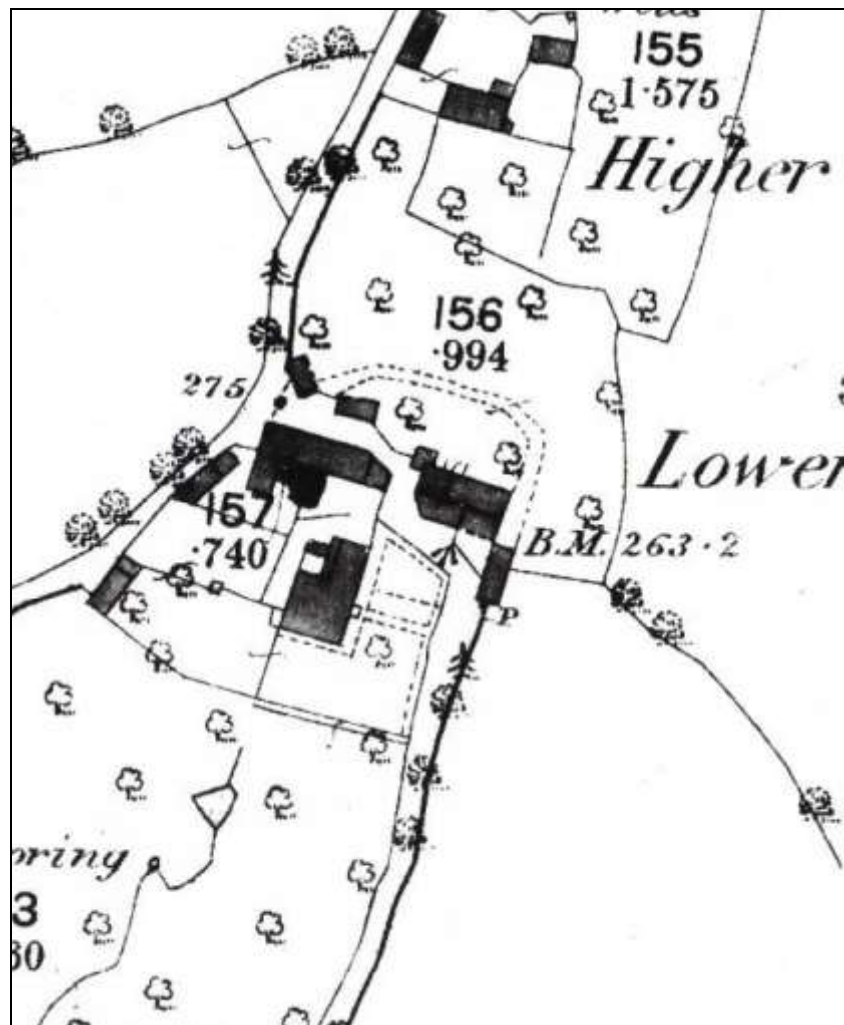
The First Edition Ordnance Survey map depicts the barn and the associated agricultural buildings at Knowle with little change from the 1841 map. The layout of the barn, particularly its association with the yard wall at the east end of the building, is almost exactly as marked on the tithe map. This suggests that the eastern lean-to was extant in 1841. However, the difference in the width of the eastern half of the building as represented on the tithe, could suggest that by the time of the First Edition map this end of the building has been enlarged and/or rebuilt during the mid 19<sup>th</sup> century.

Now, as well as the boundaries enclosing the paddocks to the west of the house, there appear to be two new boundaries marked within the yard to the south of the barn. One of these is an extension of the wall to the west of the house; this now separates the western end of the barn and the shippon from the eastern portion of the yard. A second boundary, aligned east-west, separates the eastern portion of the yard into two areas, both accessed from the gateway into the yard from the east. The southern portion now appears associated more with the service end of the house, the northern area with the eastern elements of the barn. To the north and north-east of the barn, across the lane, some additional small agricultural buildings have been constructed, with a new track to the north of these; the garden to the south-east is now represented with a planned layout.

Figure 3: Extract from the First Edition OS Map of 1889.

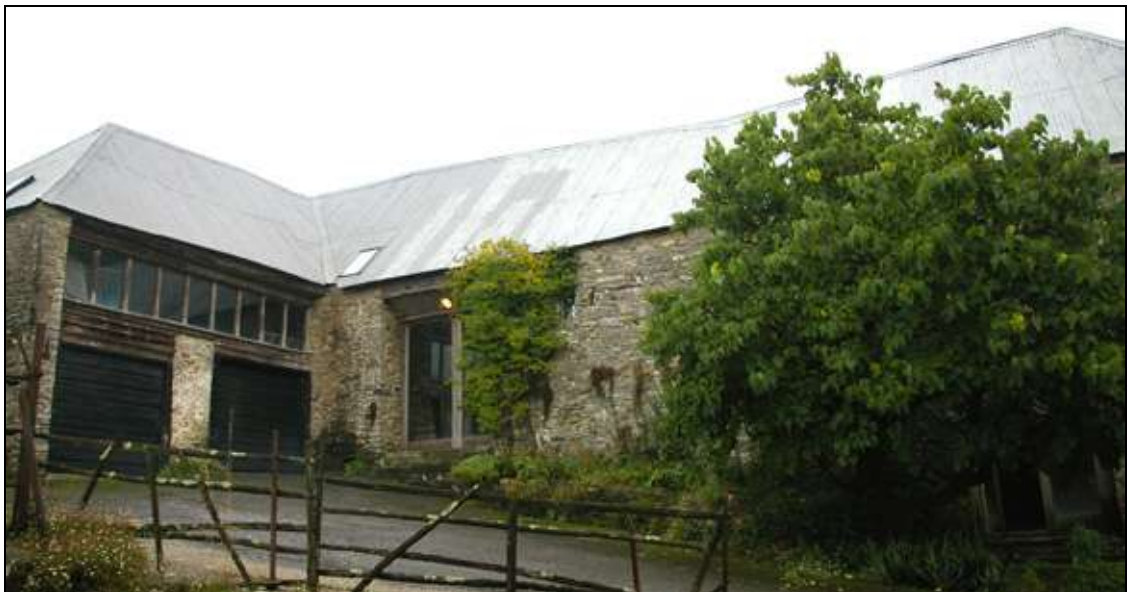
Figure 5: The south elevation of the barn and east elevation of the south projecting linhay to the west, viewed from the south-east.

The south front of the barn faces onto the former yard situated to the rear (north and west) of the 18<sup>th</sup> century house and orchard (Figure 5). To the east end of the building is a two storey

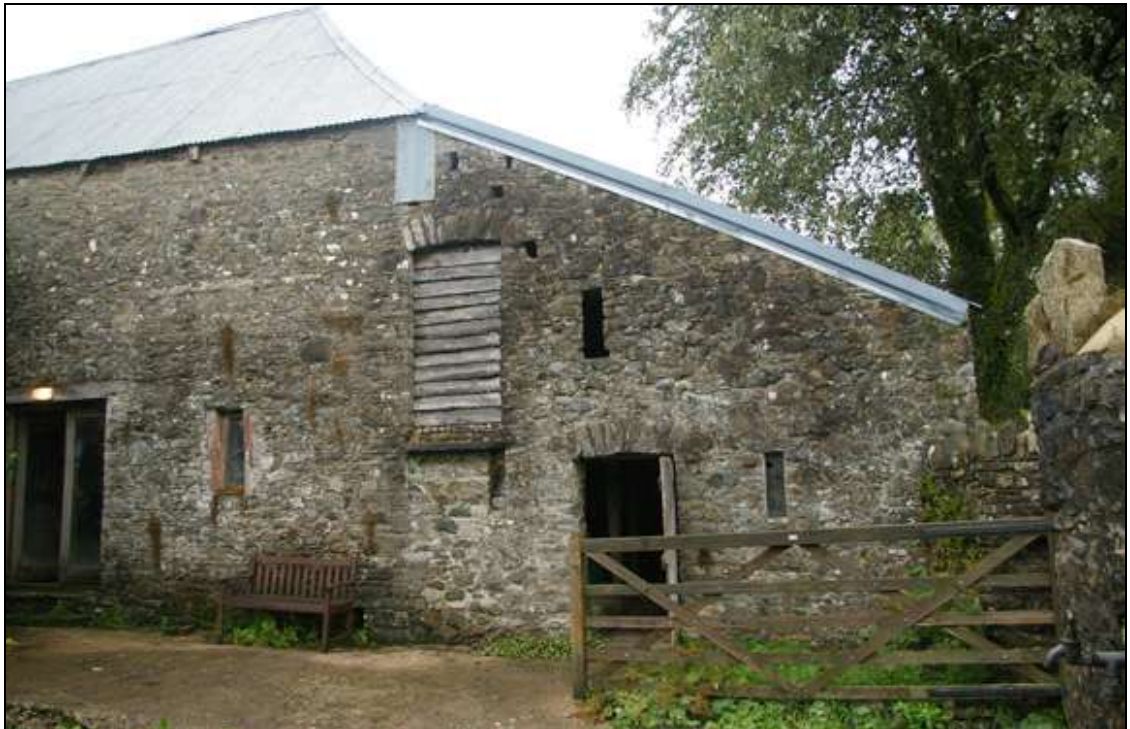
The south face of the lean-to has a central door opening on the ground floor with a pair of flanking slit windows, the door opening has rubble stone jambs and segmental stone arch above, with a timber lintel to the interior (Figure 6). The slit windows have stone lintels, that to the east is glazed, that to the west is blocked with modern bricks and cement. At first floor height, just to the west of centre is a larger open slit window with a stone lintel. To the west end just below first floor level is a loading door, also with segmental arch above and a stone slab sill. The sill has been cut to the shape/size of the opening with the east side cut to be flush with the wall face and forming the lintel of the western slit window below the east reveal. Above and to the upper right of the loading door are a number of squarish holes for doves.

Figure 6: The south elevation of the eastern lean-to and the east end of the barn, with the entrance gate into the yard to the right; viewed from the south-east.

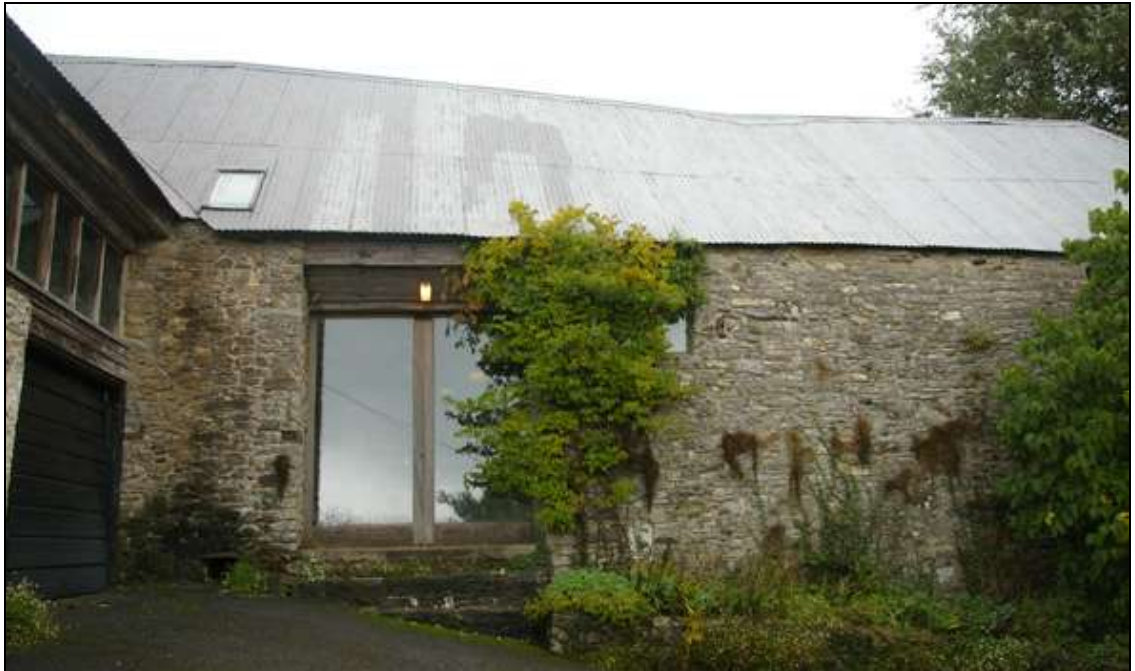
The main south elevation of the barn has two large door openings, one at the west end, accessing the higher level former threshing floor, and one to the east, accessing the lower level of the building. Both now have modern timber and glass double doors. All window openings are glazed to the interior.

To the west of the door the ground level rises quite steeply and there is a raised flower bed against the base of the wall that runs up to the upper (threshing) door opening at the west end of this south elevation (Figure 7). There are no further openings in this section of the south elevation, but just to the east of the upper western door opening quite a large timber projects from the wall and there is a blocked opening just to the right with the remains of a timber lintel set in the wall above (Figure 8). The threshing door opening to the west has three steps up, with a straight joint down to the east side of the steps but a ragged sort of tie-in to the west. The top step is modern cement; the lower two are fairly uniform coursed stone rubble with modern cement mortar pointing. To the east of the opening, at the top of the wall is a window, probably an enlarged former slit window, now glazed as elsewhere. The full height threshing door opening has slim blocky quoins to the opening, with modern glazed doors and modern timberwork above. To the west at the base of the wall is a broad drainage hole with stone lintel, now blocked to the interior. Where the wall is abutted by the (formerly open) modern timber elevation of the south projecting foot of the L, the west end of the south wall is also finished in blocky rubble quoins as to the door opening. There is a modern skylight in the roof to the west of the door opening.

Figure 7: The central western portion of the barn with the southern threshing doors, viewed from the south.

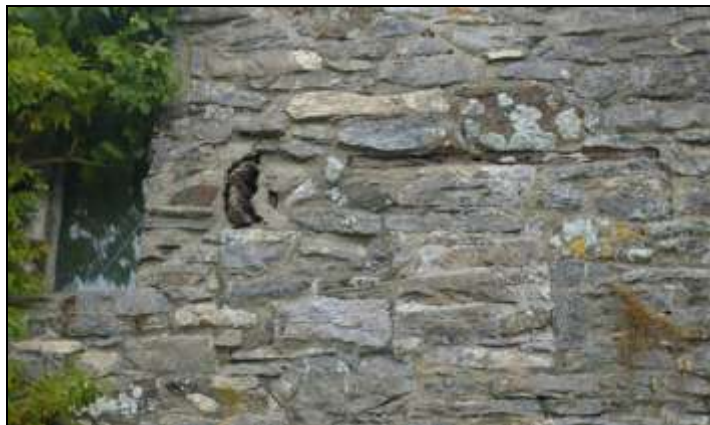
To the eastern end of the barn is a single slit window opening at the lower ground floor level, between the east end of the barn and the door; this opening has been forced and has composite block reveals and utilises an existing stone above as a lintel and has thin roof slate sill. To the west the door opening has a step up that appears tied in to the wall to the east but not to the west, and a modern timber lintel above. At roughly 0.75m above first floor level there is a line of cement on the wall face above the eastern window opening, suggesting the roof line of a former building (see Figure 6). The ground below this section is concreted so there are no clues on the ground. Just to the west of the door at first floor level is a double length slit window which is also glazed and which appears forced, as the reveals are jagged and rough.

Figure 8: Detail of the blocked opening in the south wall.

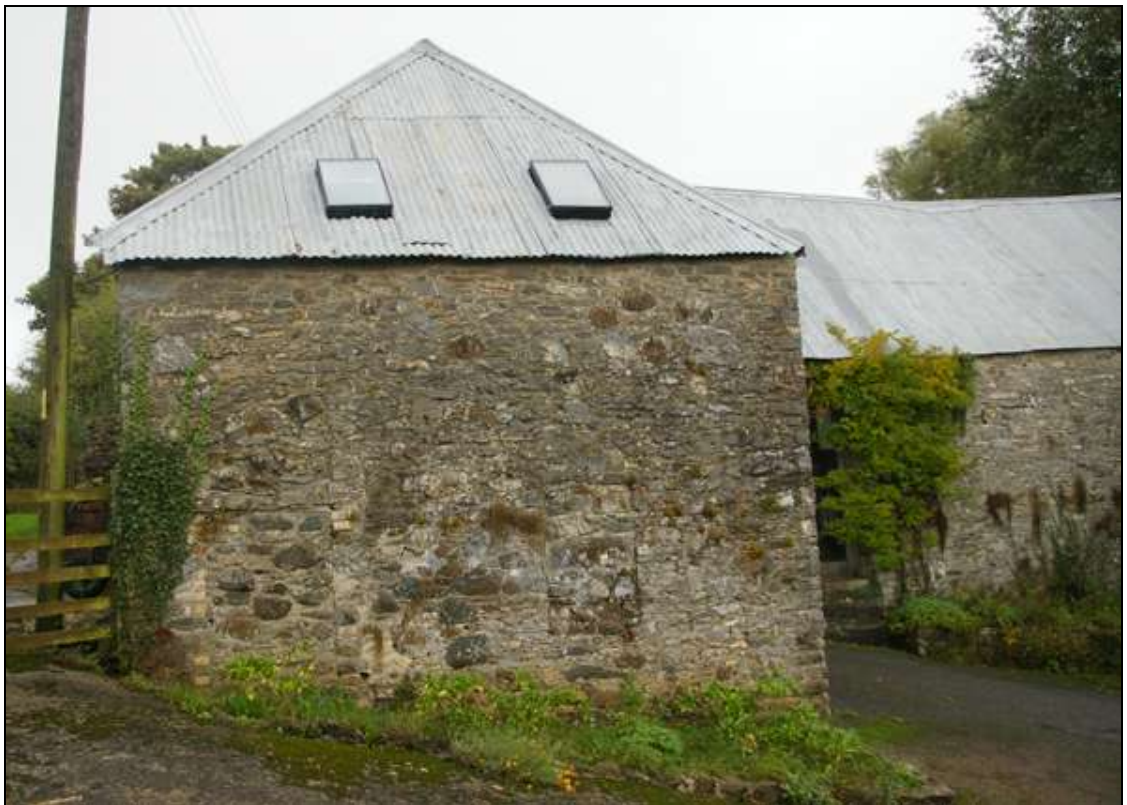
The west end of the barn is built into the slope to the west and the ground level is raised against the west wall and drops down along the south elevation of this western element. This south wall has been repaired/repointed in a number of phases in cement and the former cob uppers of the wall have been rebuilt in stone rubble. The quoins to the west end are large and blocky and the elevation contains two blocked openings at ground floor level: a former door opening to the west and a former window opening to the east (Figure 9). The blocked door opening is forced, with creamy (local ball clay) brick quoins to the jambs and a slim timber lintel, with a rubble stone blocking set in hard creamy cement mortar and with a pintle surviving to the upper right hand jamb. Above the remaining lintel the opening appears to continue but with no brick in the reveals apparent. Possibly a former loading door? The window opening has stone reveals and no lintel remaining, and is also blocked in stone rubble. There are two roof lights in the sheet metal hipped roof above.

Figure 9: The south elevation of the linhay, viewed from the south.

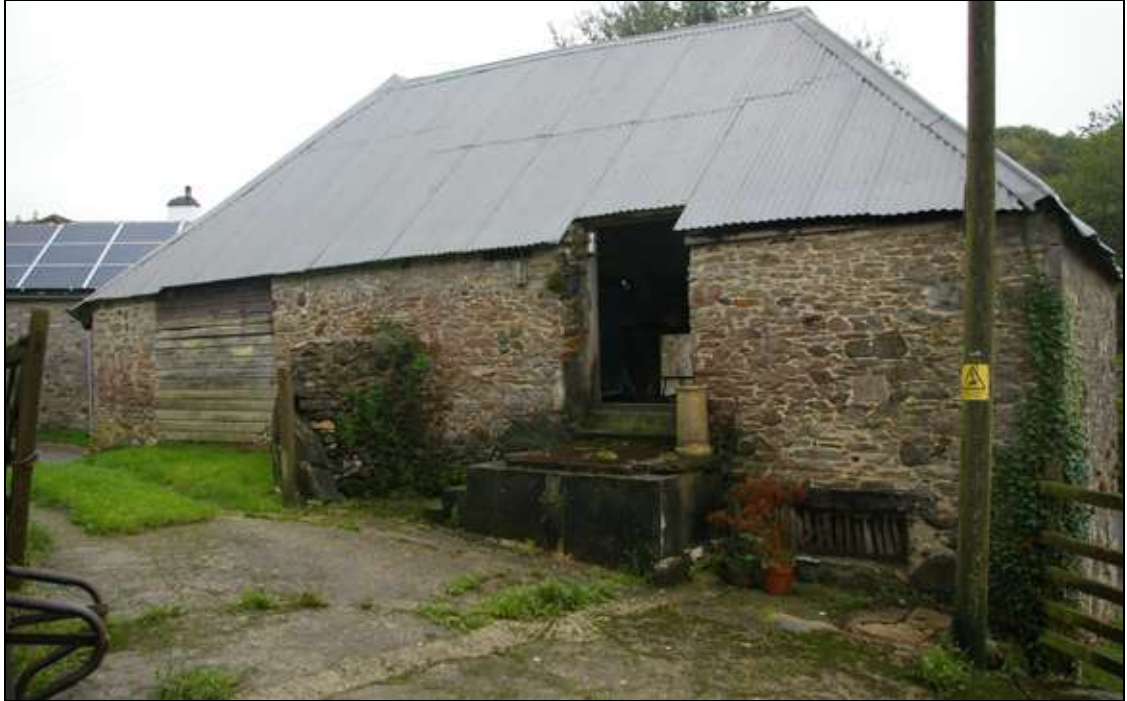
The west elevation has blocky quoins to the south, as before, but the much of the elevation is constructed of smaller, slimmer semi coursed stones (Figure 10). A rubble stone yard wall abuts roughly centrally on the elevation with gateway to the west into this upper western portion of the yard. The north end of the west wall is rounded above the base, and the southern portion, toward the end of the building, contains a small timber window with a timber lintel in a reduced opening at the base of the wall. This appears to be a door sized opening now blocked below and filled in to ground level, which has probably been raised and is now cemented. The

wall around the opening has been partially rebuilt and repointed. To the north of this opening is a concrete plinth with three steps up to the north to a first floor door; probably a former loading door now with modern timber door and framing and with modern repairs and repointing to the jambs and part of the upper of the wall just below the eaves for a couple of metres to the north.

Figure 10: The west elevation of the linhay at the west end of the barn, viewed from the south-west.

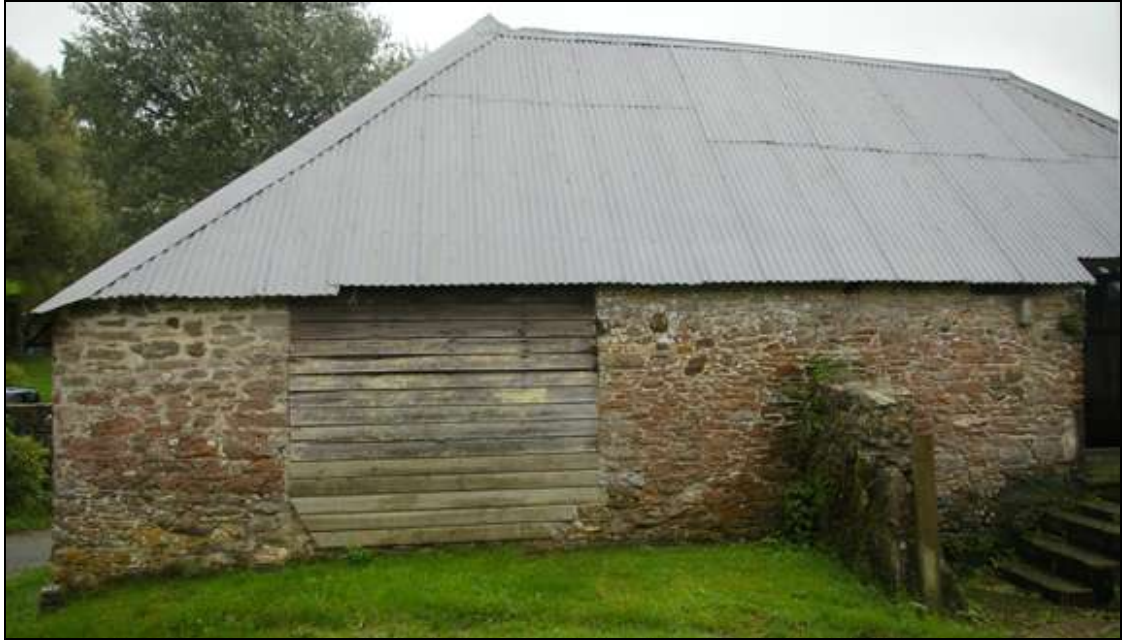
To the north of the yard wall is a further large former opening, with some timber lacing to the upper right (southern) door jamb and concrete block to the upper left (north) and with the wall repaired and repointed in cement to the north end (Figure 11). The opening is now boarded with vertically laid planks almost down to the base of the wall; the base of the opening is set *c.*25m above ground level.

Figure 11: The north end of the west elevation of the barn and linhay, viewed from the south-west.

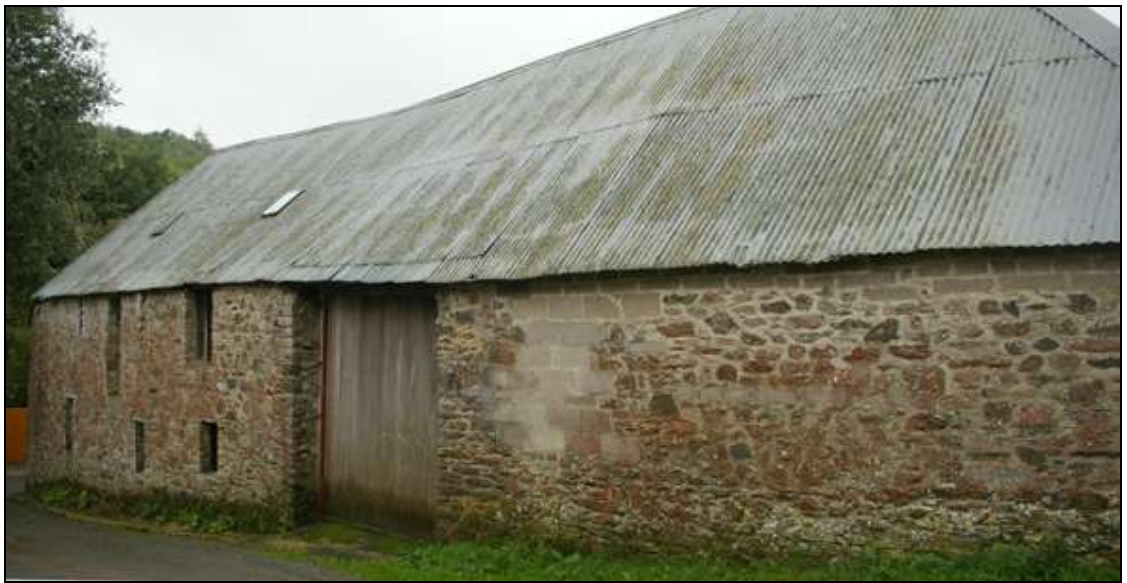
The western end of the north elevation has been heavily repaired above *c.*1m in height with concrete block, rubble stone and cement, probably replacing a former cob upper (Figure 12). Approximately 8m to the east is a very large double door opening as to the south, now with modern plank doors in a ridged steel frame. The opening retains its large timber lintel and some rotten timber lacing to the east jamb; the quoins are good to the east but have been rebuilt to the upper of the eastern jamb. The wall to the east of the door opening is composed of large rubble stones in a creamy mortar and contains two window openings. The wall face of this roughly 5-6m section is much more regular than to the east or west and the upper portion, above approximately 1m from the base, appears to have been rebuilt. To the east this type of stonework terminates at a clear ragged joint in the masonry (Figure 13). The two windows within this section (one to first floor, one to ground floor) both have chunky plain timber frames set within openings with limestone quoins as before. That to the first floor has a timber lintel with a timber frame, central timber mullion, diamond-set bars to the exterior and is glazed to the interior. The opening at ground floor level has a stone lintel and a mix of replaced slight timber and metal mullions/bars set into a plain frame, repaired at the base (see Figure 13).

Figure 12: The north elevation of the barn, viewed from the north-west.

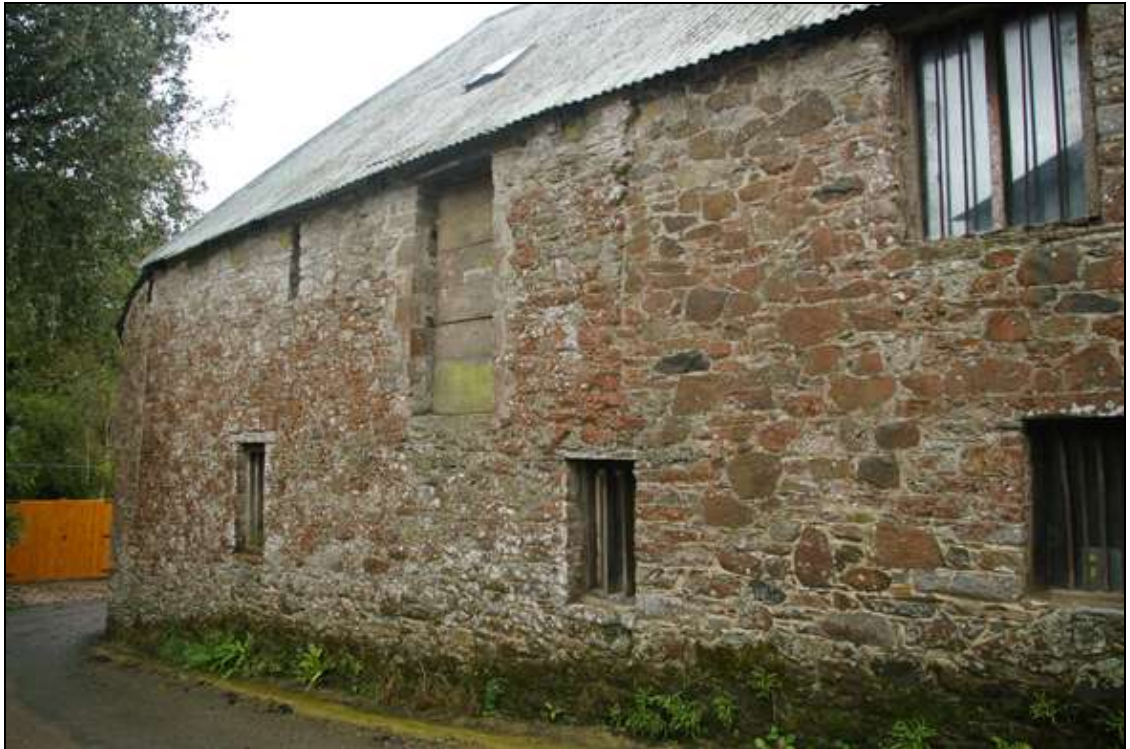
To the east, *c.* 1m from the joint in the masonry is a forced first floor loading door, with modern concrete block reveals and sill and a timber lintel, now blocked with timber planking. Just to the east is a slit window under the eaves and a further window opening at ground floor level with an unmolested frame as to the opening to the east, with a timber lintel and single stone sill. Approximately 3m to the east is a further joint in the masonry of the elevation, with the

quoins of the former return of the wall clearly visible to the upper portion but with the masonry of the lower portion tied into the masonry continuing to the east, which suggests a former single storey structure or wall formerly continued to the east of the barn prior to the addition of the lean-to at the east end. At the top of the joint in the wall, under the eaves, is a slim hole lined with slate.

Figure 13: The east end of the north elevation of the barn, showing the clear joint in the masonry, viewed from the north-west.

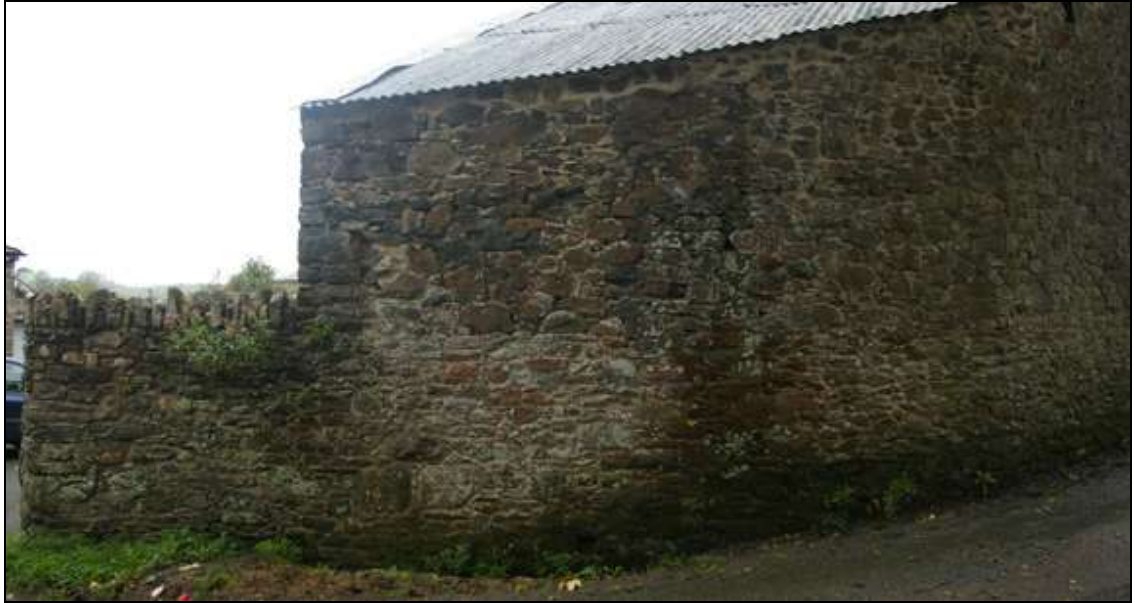
The wall then curves around to the east, with two further slim openings, set just below the eaves and a small slit window at ground floor level. This north-eastern elevation of the lean-to to the east of the barn is set on three planes and the yard wall to the south, with the rounded gate pier terminal, is a single continuous build (Figure 14).

Figure 14: The polygonal north/east wall of the lean-to, the lower portion of the wall is of a continuous build to the gate pier, viewed from the north-east.

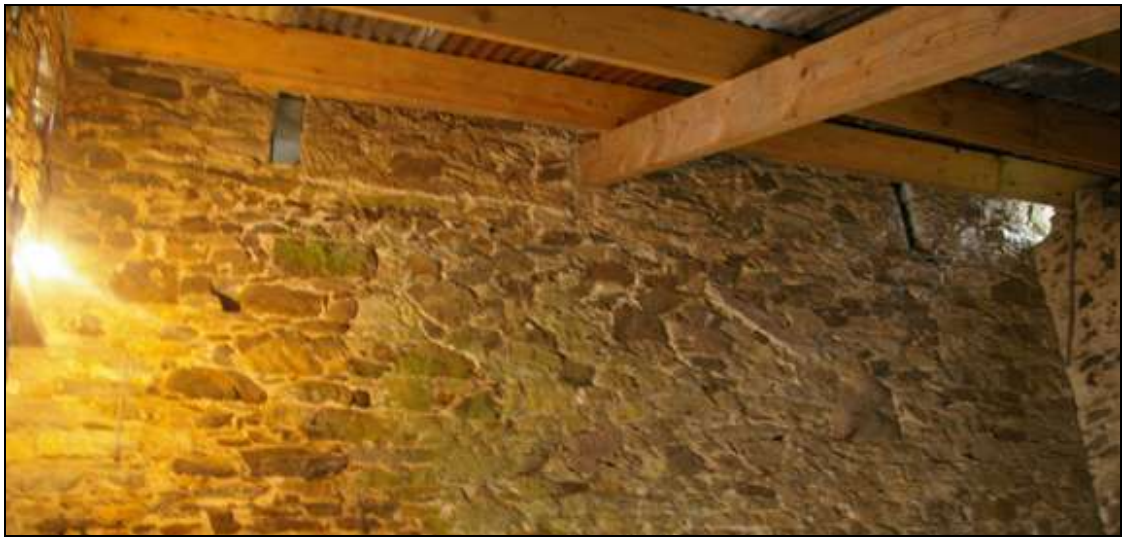
The south wall of the lean-to abuts the barn to the west as does the rear north wall. The former east wall of the barn, now inside the lean-to, has two narrow slit openings just under the eaves, to the north and south ends of the wall. There are also traces of mortar adhering to the upper portion of the wall marking a former roof line, straight across at the top and sloping down to the north, which suggests an earlier, lower roof line with a single storey wall to the north (Figure 15). The wall fabric of the north-eastern elevation(s) retains the line of an earlier wall height, roughly 1.5m in height, above which the masonry of the later structure is very roughly pointed.

Figure 15: The west wall of the lean-to, with scars of a former roof line, viewed from the east.

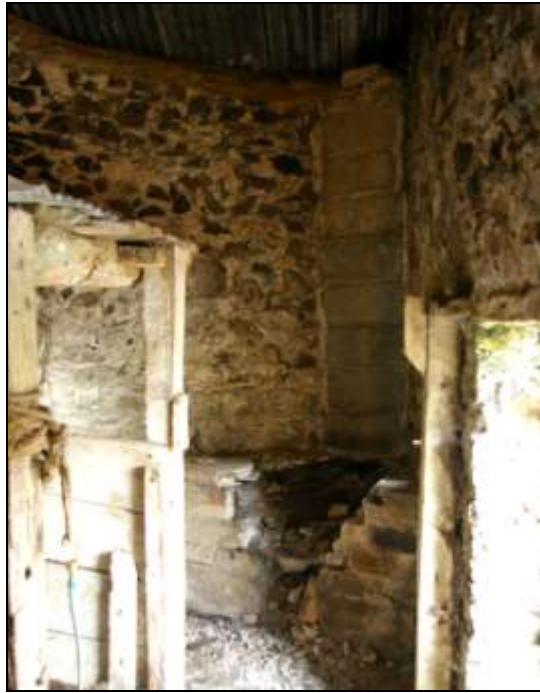
The floor of the lean-to is raised by approximately .25m *c.* 1m into the buildings to north, east and west, and now cemented over. The interior retains the remnants of timber stalls and first floor loft to the centre. In the south-east corner is a formerly heated base for a copper, with concrete blocks filling the corner of the building up to ceiling height, presumably forming a

flue (Figure 16). Below, the concrete block and cement structure fills the corner to roughly 0.75m height, with a brick lined central space, rounded at the base, still partially remaining and an opening below for a fire.

Figure 16: The copper in the south-east corner of the lean-to, viewed from the west.

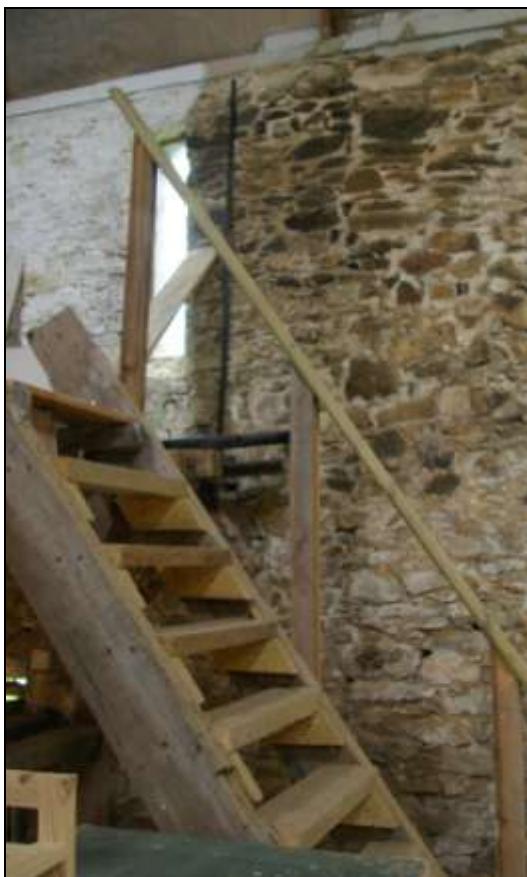
The south wall of the east end of the barn is of a single phase, up to the point to the west where the structure is disrupted in the position of a former east wall of the barn (Figure 17). The south wall has a double door opening with a modern door, and a forced or enlarged slit window to the east, with very ragged reveals. The wall is tied into the east wall at the corner, which itself is tied into the north wall. The north wall appears, like the north wall of the lean-to to the east, to have different fabric at the base, for roughly 1-1.5m in height, and a line in the masonry can be seen. The north wall contains a single window, east of centre with a timber lintel, blocked to the interior. To the west, in the south-west corner, are modern timber steps up to the main body of the barn which is raised in relation to this eastern element. The steps are set against a rubble stone wall, c. 1m in height, the height of the current floor of the threshing barn to the west. This wall, or rather base of a former east wall of the threshing barn, appears to be tied into the north wall in the north-west corner and is now topped with a haphazard timber structure.

Figure 17: The disturbance in the south wall of the barn in the former position of the return of the east wall, viewed from the north.

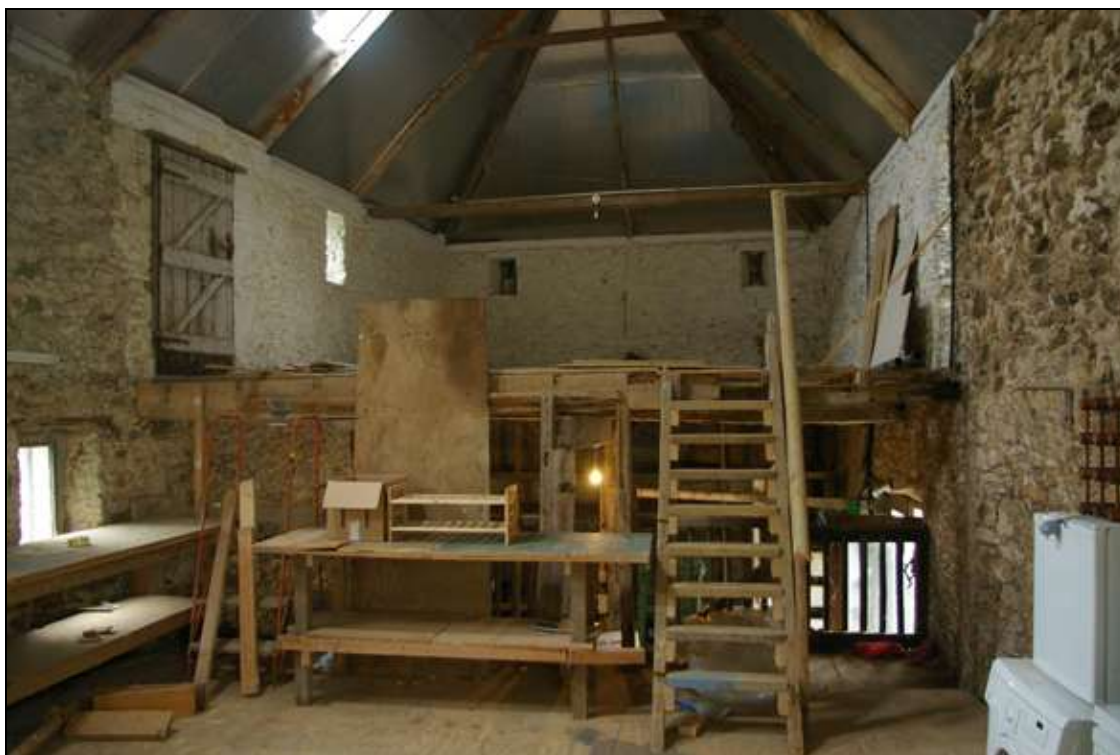
The floor is cemented, and the ceiling of the ground floor element is supported by three half round transverse pine timbers, reinforced to the south-west corner by an RSJ, and running north-south through the building with the axial joists set into the wall to the east and the main ceiling beams set into the walls to north and south, with pine boards above. Above at first floor level the walls are uniform of build and painted white, with two slit windows at the east end and a small window and modern loading door to the north. The first floor is accessed via rough timber steps nailed to the dividing partition to the south side of eastern end of the threshing barn (Figures 17 & 18). There is no wall separating the space from the main body of the building at first floor level. The roof structure is included with the main threshing barn description below.

Figure 18: The partition between the barn and the lower eastern element with first floor loft above, viewed from the west.

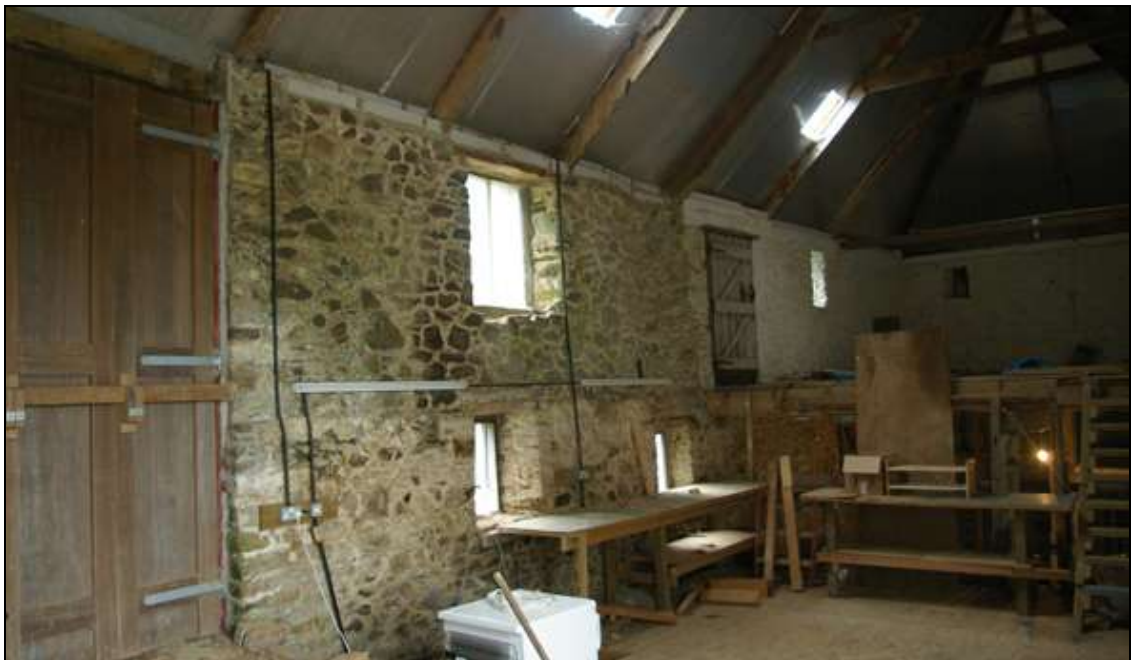
The east end of the main barn has a lower floor level than the central threshing floor to the west; the floors have all been replaced and apparently raised with modern boarding (Figure 19). Where the floor level rises to the west the dwarf wall against the threshing floor abuts the walls to north and south (see Figure 16). The masonry walls, as elsewhere, are mostly unplastered internally and the walls to north and south have modern thermolite blocks to the tops, probably replacing earlier cob. The east portion of the north wall steps in at first floor height to the east of the central threshing doors, and the stonework above has a smoother flatter face than that below, suggesting that it has been rebuilt (Figure 19). Further to the east the wall is disturbed where the former east end wall would have stood prior to the addition of the current lower east end. The wall in the same position to the south is similarly disturbed where the later eastern element has been attached and the former east wall demolished.

Figure 19: The eastern portion of the north wall of the barn, viewed from the south-west.

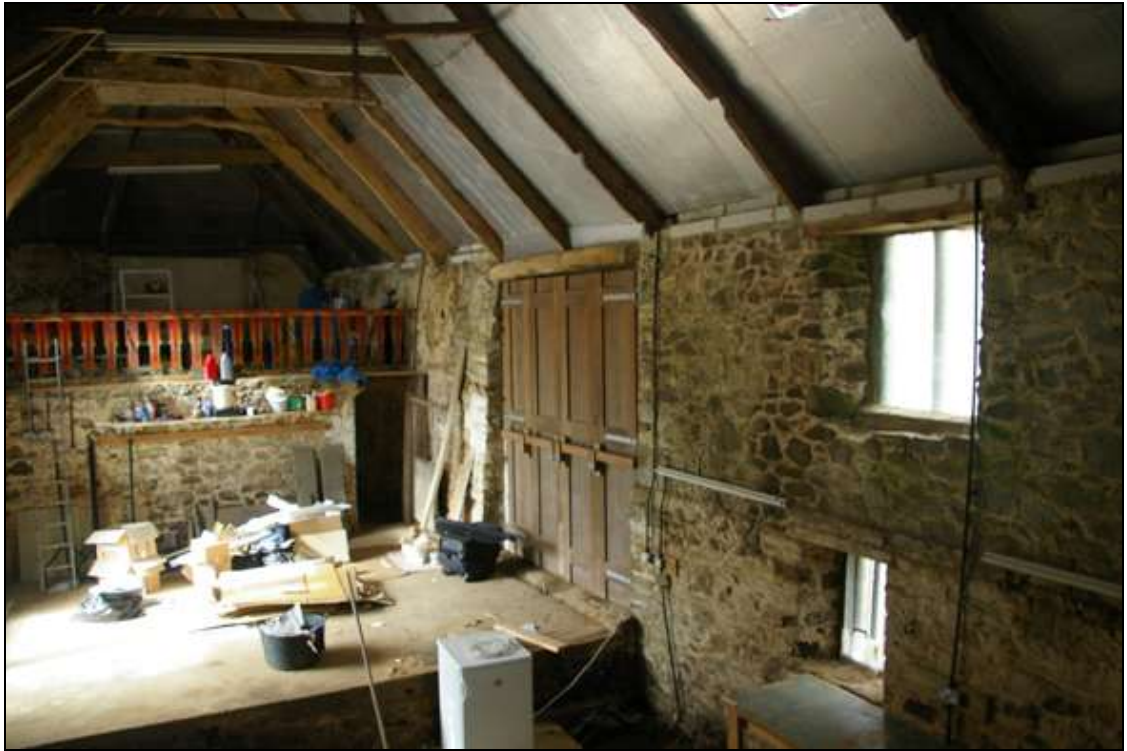
The three windows in the eastern section of the north elevation all have timber lintels and plain timber frames with secondary interior glazing. The large threshing door opening in the north wall retains the earlier timber lintel above the modern door structure, the quoins are disturbed to the west (left) and the upper appears to have been rebuilt (see Figures 20 & 21). To the west of the doors the wall has a cob upper, plastered in a thick layer of lime plaster, upwards of an inch thick, with a rubble stone plinth below. At the east end of this section, adjacent to the door, the north wall has been rebuilt using grey cement (see Figure 17). Within the ground floor area at the west end there is possibly a former opening in the north wall just inside the western compartment, but this is probably simply patching where the cob has failed. The north

Figure 20: The north wall of the barn and western single story partition, with raised threshing floor, viewed from the east.

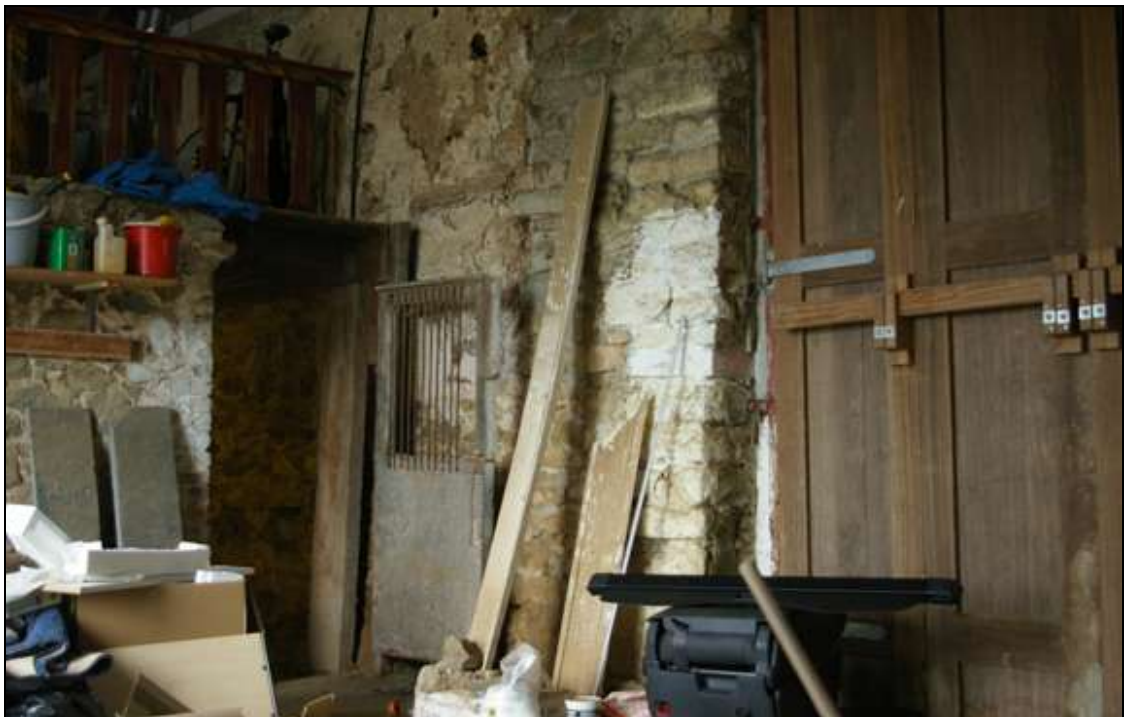
wall appears tied in to the west wall at the north-west corner. The east wall is single storey with a forced door opening at the north end, with brick quoins in the jambs, suggesting that there was formerly no access into this area from the threshing floor.

Figure 21: The cob portion of the north wall of the barn and north end of the single storey internal wall, viewed from the south-east.

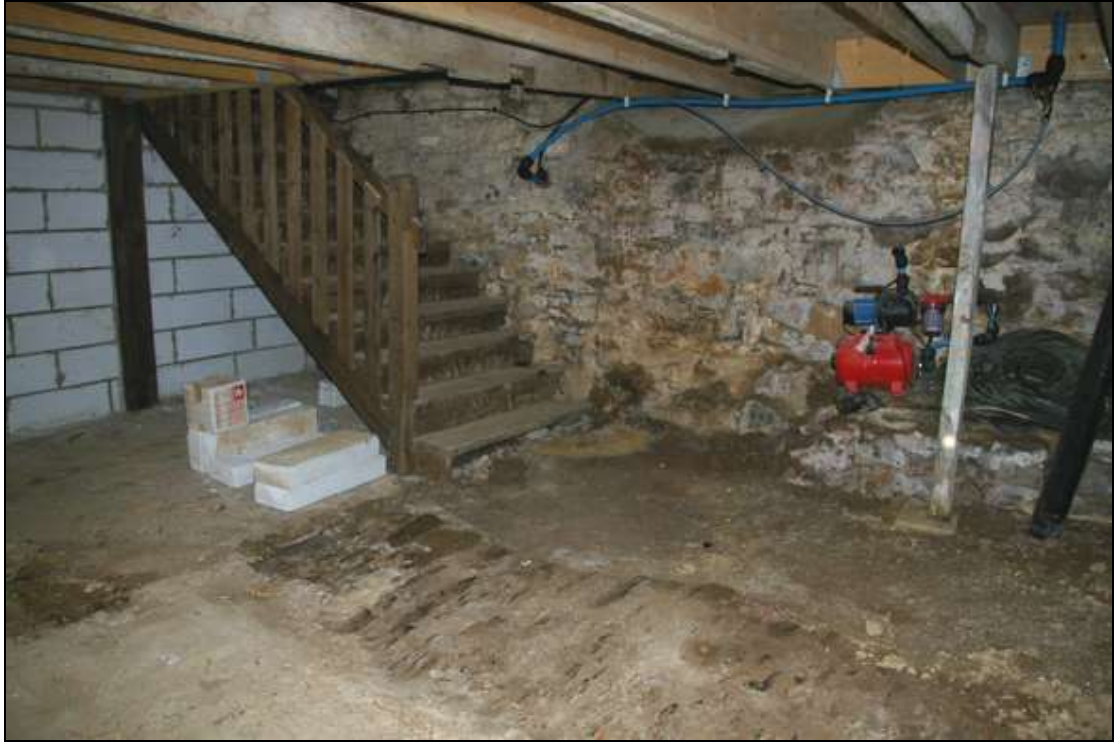
Within the ground floor western end compartment the floor is partially covered with cement but with some patches of cobbling remaining. There are modern timber steps up to the first floor of the linhay and east end of the barn in the south-west corner and a rubble stone plinth in the north-west corner (Figure 22). The rubble stone west end wall steps back at first floor height and is topped with cement below the blocked opening toward the north end, in the former position of the sill which now slopes inward. Above, at first floor level there is a double size opening with a straight jamb/reveal to the south but slightly ragged cob reveal to the north-although the opening is plastered to the interior. The wall to the south is significantly thinner at this level. Below the steps in the south west corner of the compartment and just below this section of wall, the masonry is disturbed and cuts back suggesting a former return and therefore an earlier wall formerly closing this south-western end of the building.

Figure 22: The west wall and north-west corner of the ground floor western element of the barn, viewed from the north-east.

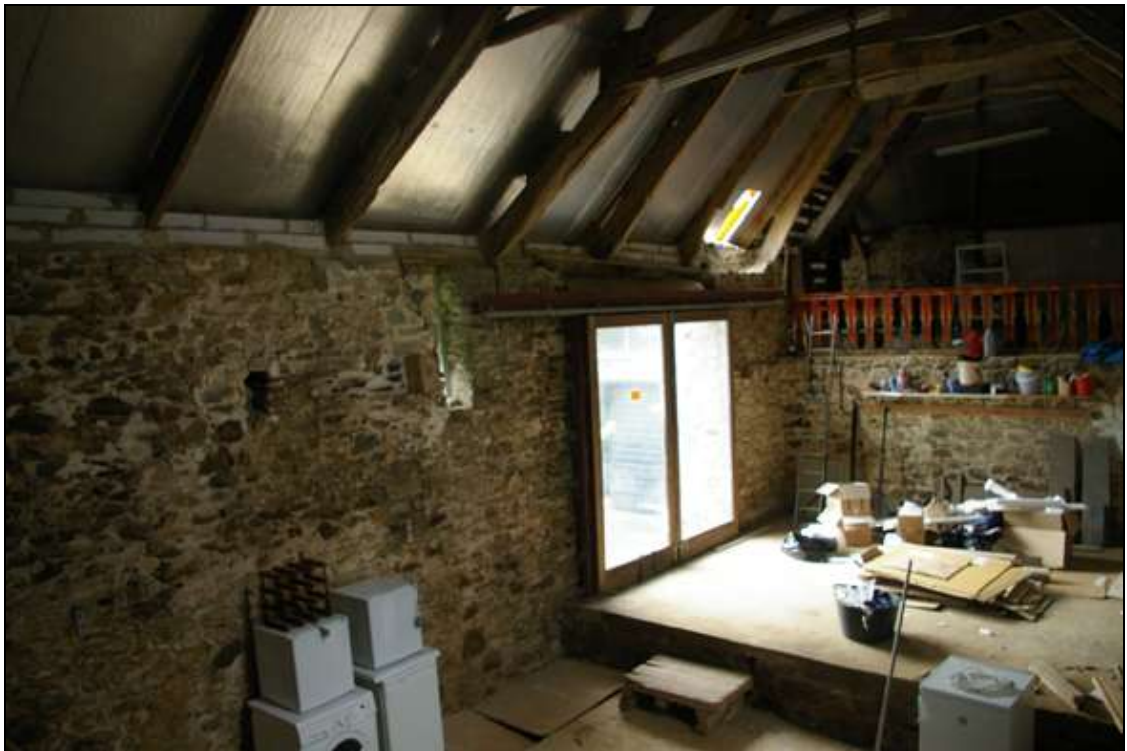
Figure 23: The south wall of the barn and western single story partition, viewed from the north-east.

To the east the upper end of the south wall is visible and is slightly ragged at the top. Potentially this wall could have originally continued to the west, closing this end of the barn. To the north, the upper west end of the building is cob to the interior, now topped with thermolite blocks and patched with cement, although with much of the thick skin of haired

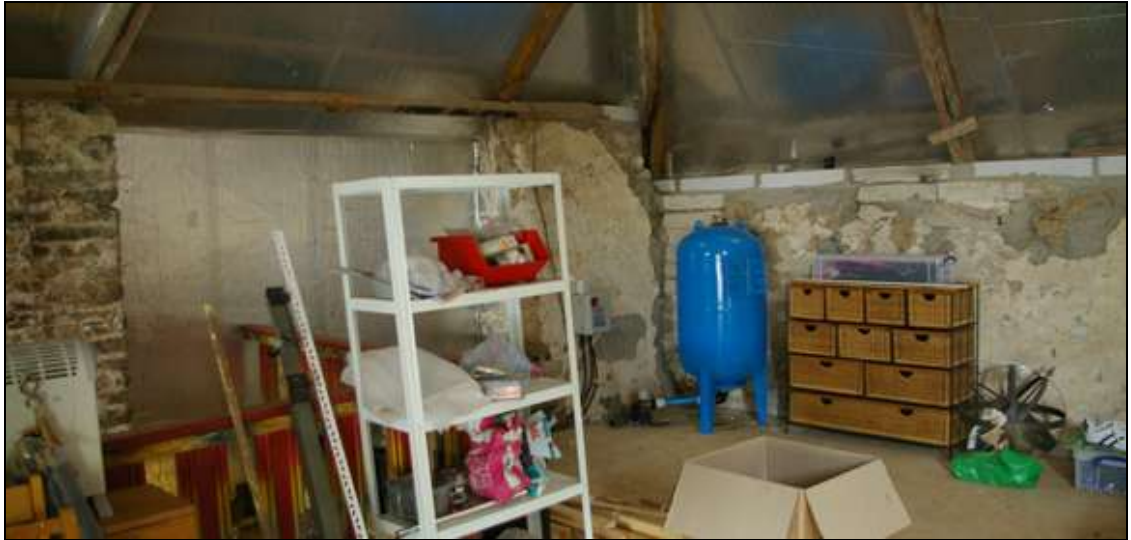
plaster still surviving (Figure 24). There is a modern balustrade across to the east, above the single storey wall; the timber stubs in the walls to north and south suggest that this upper floor was formerly extended into the barn to the east. The floor throughout this element is boarded with plywood.

Figure 24: The cob built north-west corner of the barn, viewed from the south-east.

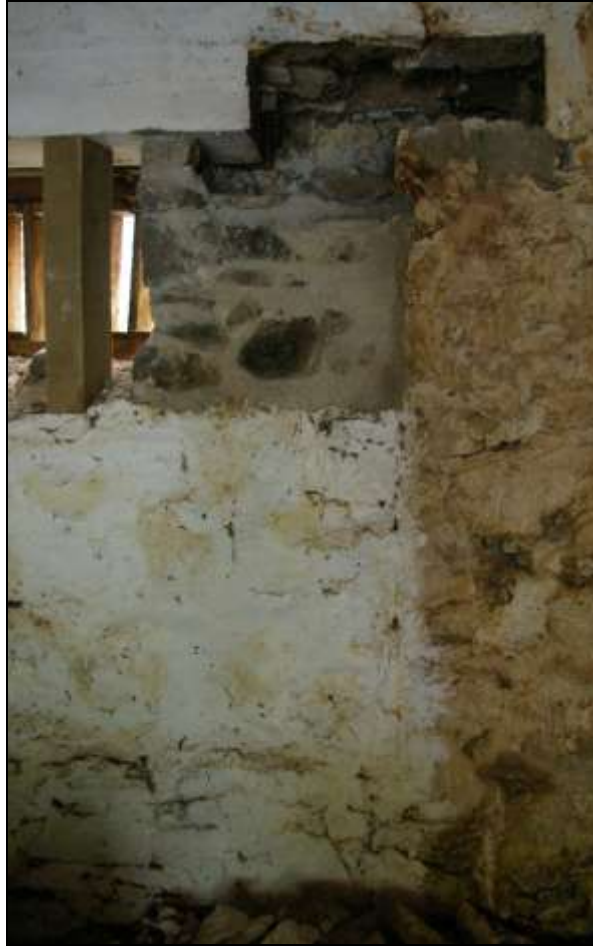
To the south-west the west wall appears to have formerly contained a larger opening than the present slim opening, which has been partially blocked with rubble stone below, and the truncated modern cement set lintel to the north above (Figure 25). The floor is cement, slightly raised to the north with two uprights and a raised plinth to the centre, roughly 1m east of the west wall.

Figure 25: The partially blocked opening in the west wall of the Linhay, viewed from the east.
