THE PARISH HALL EAST WORLINGTON DEVON

Results of a Desk-Based Assessment
&
Historic Building Survey

Report No.: 130215
Date: 15/02/2013
Authors: T. Green
D.Laing-Trengove

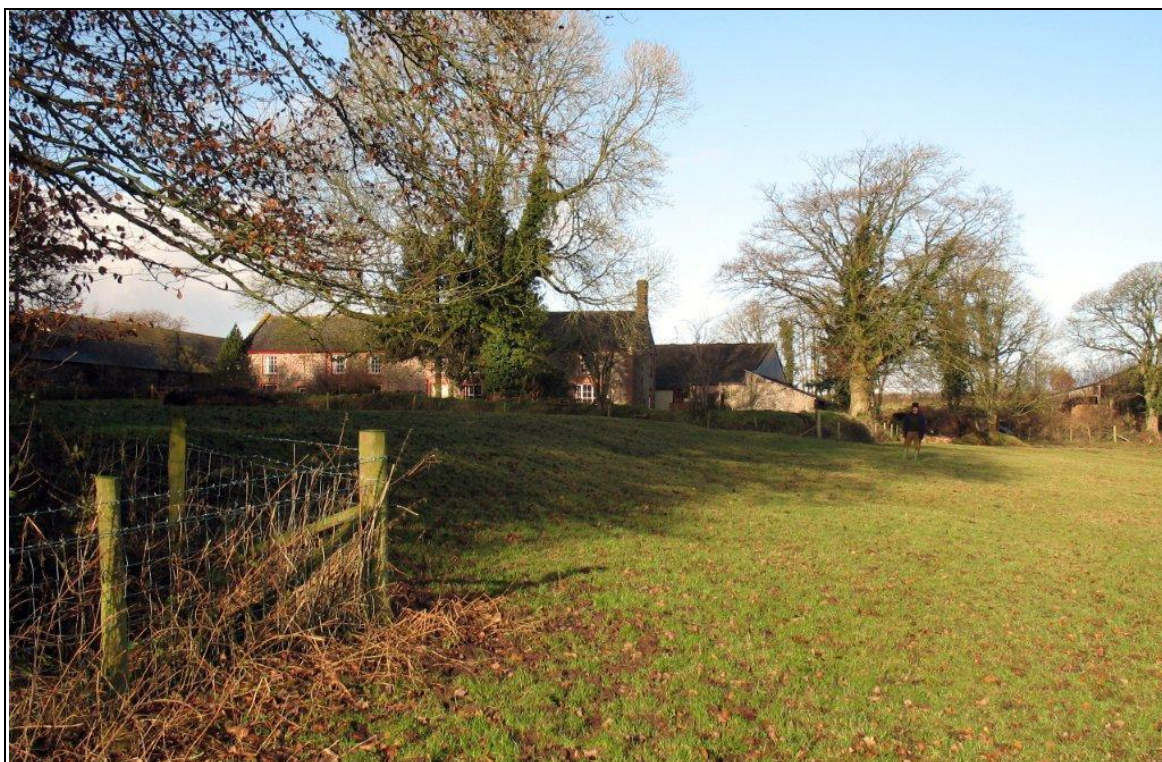
Figure 3: Photograph of the low bank, part of the ‘manorial enclosure’ boundary?

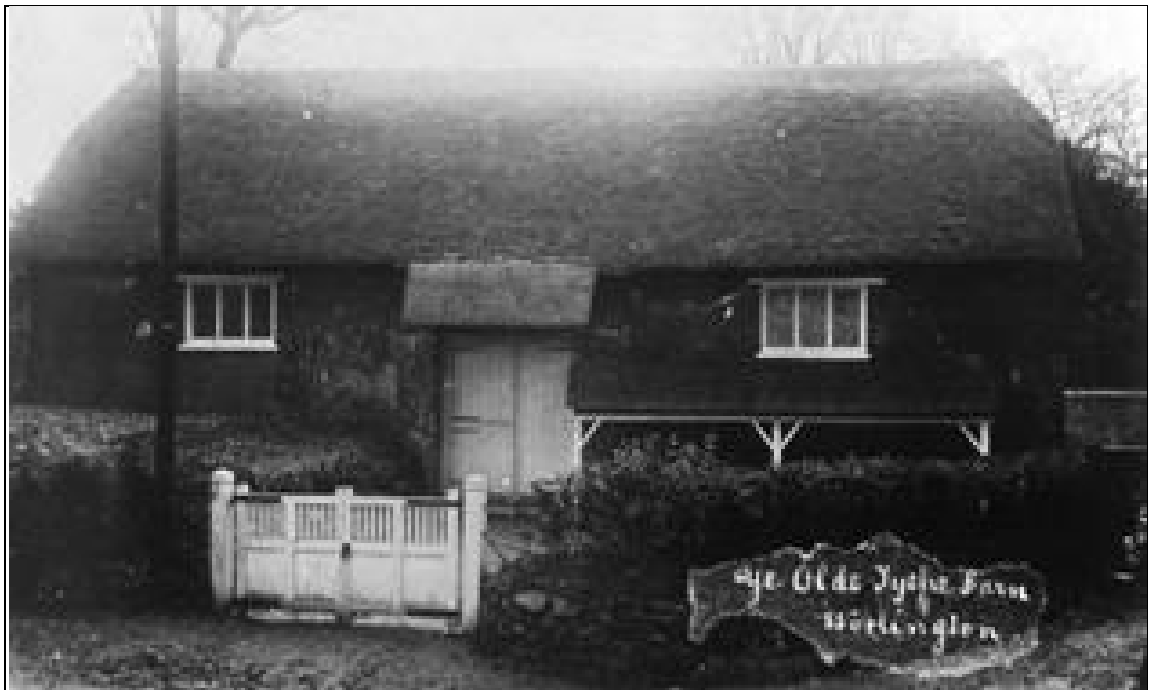
Figure 4: Photograph of the building dating from the early part of the 20th century, showing the mullioned windows, ‘pent house’ and verandah.

Writing his ‘East Worlington Kalendar of Quotidian Quotations’ in 1910, Rev. H.A.Hill was happy to accept that the barn of 1727 – and presumably also that of 1679 - was the very same that had recently been converted into a Parish Room. In 1910 the fabric, he tells us, ‘is the same as that described in the terrier of 1727: “built of mudd and consisting of five bays.” The old cob walls,’ he continues, ‘are good and of a soft and matured hue: the roof is of thatch and a pent-house over the doorway has been added and a verandah. Everything has been done in the restoration to preserve the rustic appearance and effect. An old oak window frame with deep moulded mullions was rescued from one of the village cottages, and inserted in the north wall; and two others of similar design have been put in and filled with diamond leaded panes. The courtyard in front has been paved in the old Devonshire fashion...’

This description fits nicely with an undated photograph of the building from the early part of the 20th century (Figure 4).

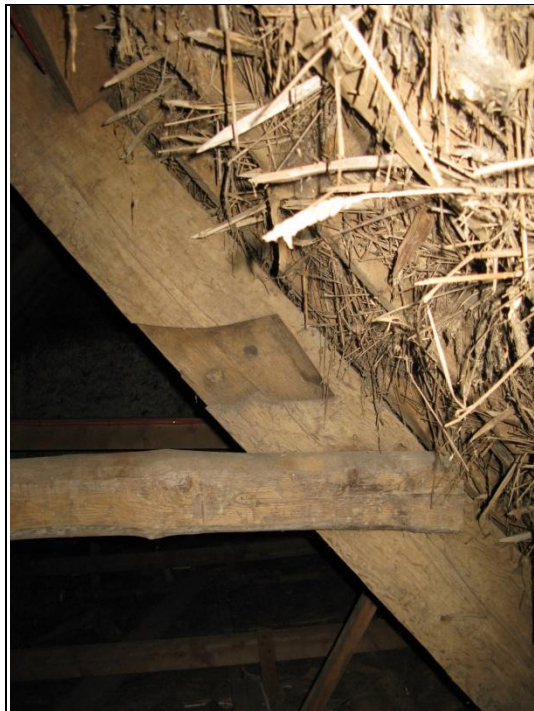
Figure 8: The former collar joint above a later spiked timber on an early roof truss.

The remaining original oak timbers are confined to the northern end of the building and are comprised of the two blades of a roughly south of centre truss (Figure 9, T3), the western blade of the truss to the north of this (T2) and the eastern blade of the next most northerly truss (T1). All original purlins on both the east and west pitch of this north end remain, trenched into the backs of the earlier truss blades, and scarfed together at this point. The truss blades are set into the wall tops to east and west. All common rafters, battens and the ridge pole are modern and have been replaced during the 20th century, appearing contemporary with most of the replaced roof trusses to the south. The structure is now covered with a seemingly thin layer of thatch, with the feet of the spars protruding through for up to 0.15m (see Figure 8). All collars and tie beams on the remaining early truss blades are replacements, bolted or spiked to the faces of the blades. The single remaining complete A-Frame truss is lapped and pegged at the apex and the former collar was affixed via face pegged notched lap-joints (Figure 8).
