**BARNS at
HIGHER TREGARNE FARM
MAWNAN SMITH
CORNWALL**

Historic Building Record

Report No.: 231013
Date: 23.10.2013
Authors: D. Laing-Trengove

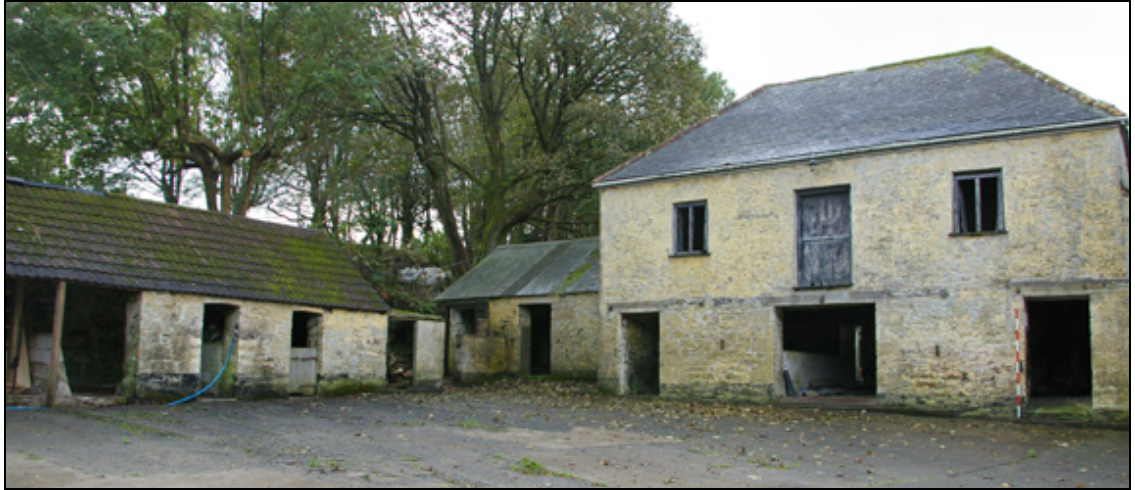
Figure 6: The south-east corner of the yard, with B1, B1a, plus B2, viewed from the north-west.

The former chall barn is the most dominant building of the complex and it sits a story higher than the others on the site (see Figure 6). The building and associated structures (B1a & B1b) form the south side of the yard, with the north elevation fronting onto the yard. The building is of random granite rubble construction, with dressed granite quoins to the corners and openings, with the masonry bonded in a creamy brown lime mortar; with a pitched roof, hipped to the east and west, slated and with terracotta ridge tiles and now with modern plastic guttering to the eaves. The roof slates are mortared into place. The barn is accessed at ground floor level to the north via a central double door opening or by either of the flanking double door openings in the north elevation, or through either of two openings in the single storey building to the east. To the south is a central opening at first floor level. To the west the barn is abutted by a single storey granite built lean-to, and to the east by a single storey pitched roof building.

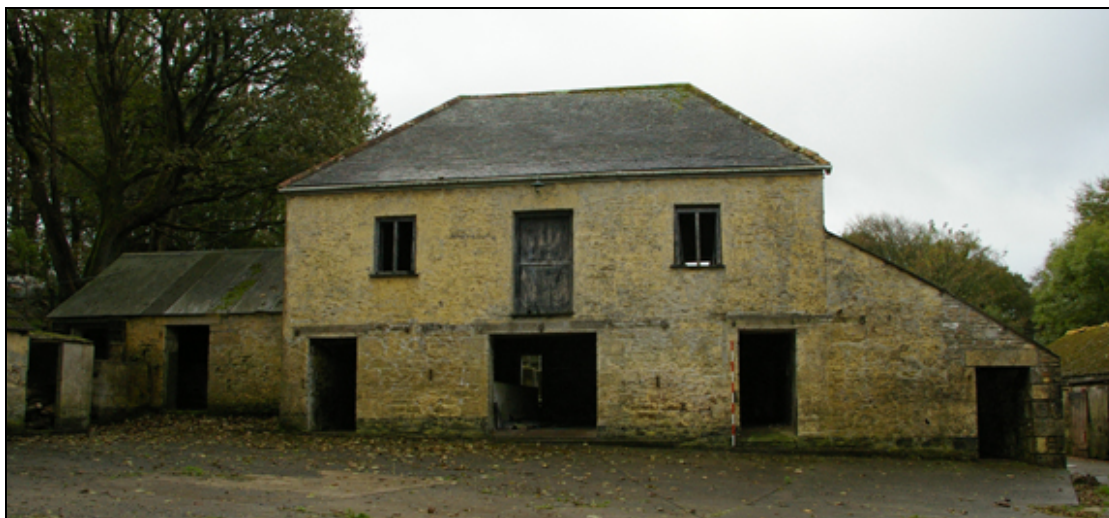
The north elevation has a symmetrical facade (Figure 7), with large dressed granite block quoins to the corners and with three door openings to the ground floor, one to either end of the elevation and a central double sized door opening, all with integral granite lintels and large dressed granite block quoins to the straight jambs. Above at first floor level are two window openings offset to the door openings to the east and west, with a central loading door above the ground floor double sized opening. The ground floor door openings formerly had exterior sliding doors with the metal brackets above and below still remaining. Above, the western openings have beaded timber frames, slate sills and internal shutters. The loading door has a chamfered timber frame and stable type door. The north wall was formerly whitewashed on the exterior with an overcoat of pale creamy orange paint.

Figure 7: The north (front) elevation of the chall barn (B1) with associated structures B1a (shippon) & B1b (lean-to) to east and west, viewed from the north.

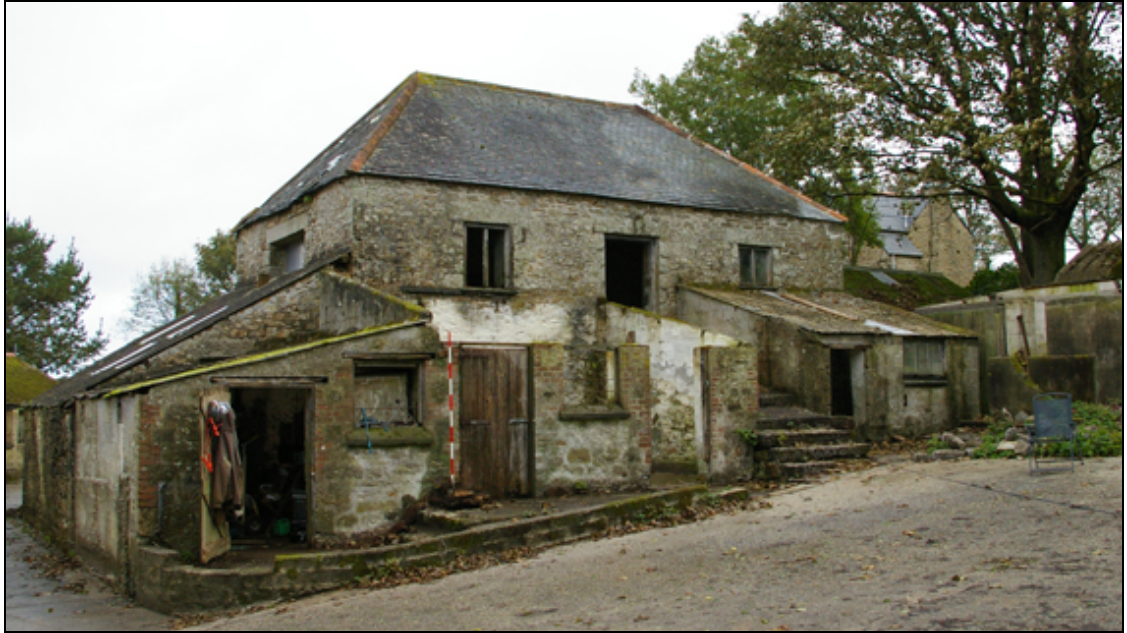
The south elevation of the barn has a central loading door and flanking windows to the east and the west at first floor level, with a range of small single storey modern buildings abutting at ground floor level (see below). There is also a later forced opening at ground floor level to the east, now within a concrete block lean-to abutting the eastern portion of the ground floor south elevation. To the east of this opening the former exterior south wall of the barn is ragged and uneven suggesting that it was also dug into the side of a formerly steeper slope to the east. Centrally, between the lean-tos, is a flight of granite built steps, now partially built up in stony concrete, with concrete block walls to either side. To the interior of the western flanking lean-to the line of the steps is preserved, with the modern block wall built up from the masonry of the steps. To the east a modern block wall has been constructed against the steps. The first floor openings all have dressed granite lintels and quoins as to the north, with beaded pegged frame and shutters to the west, but not the east, where the opening has been reduced at the base where the later lean-to roof formerly abutted.

Figure 8: The south (rear) elevation of the main chall barn (B1), with later associated structures (and the former farmhouse in the background), viewed from the south-west.

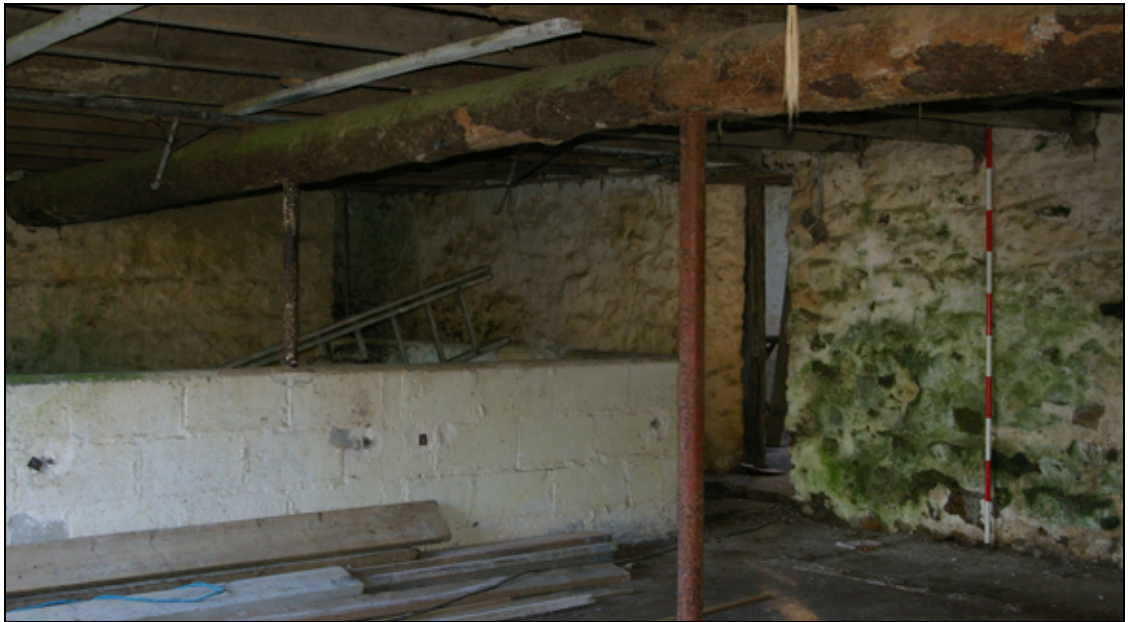
Figure 9: The south-east corner of the ground floor of B1, viewed from the north-west.

The ceiling rests on transverse joists supported on a later inserted pair of axial round pine timbers, resting on metal acrow props cemented into the ground and into the central partition wall (see Figure 9 & 10).

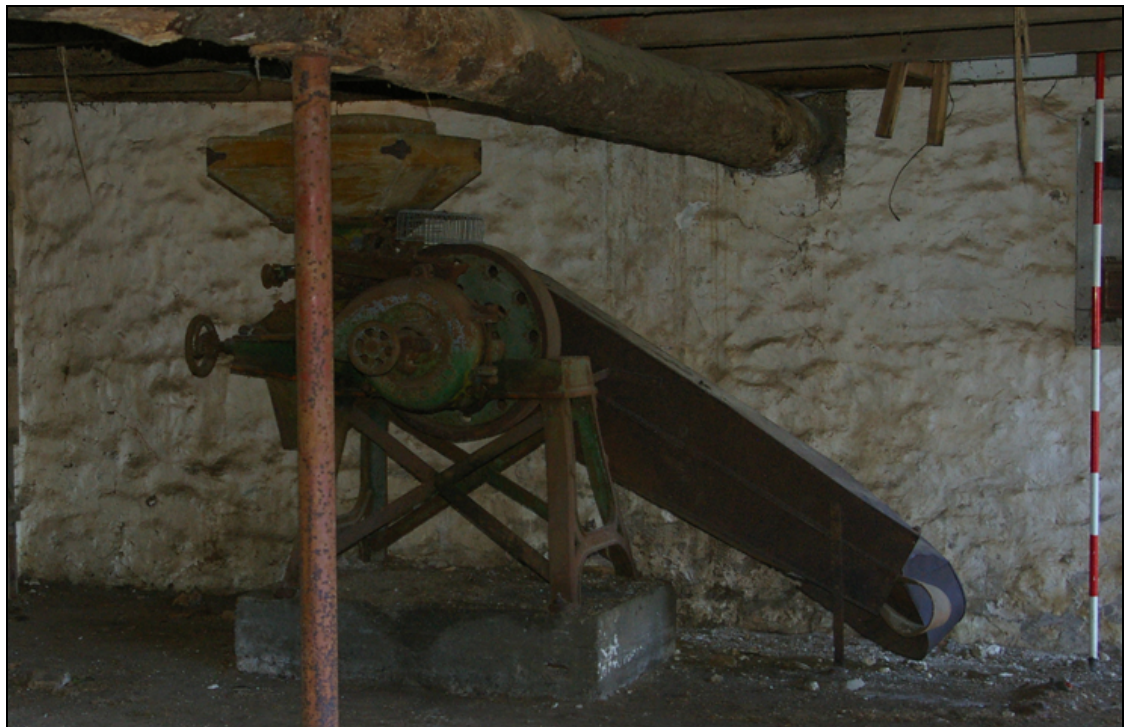
At ground floor level the cement floor slopes upwards to the interior within all three openings. With concrete block built stalls to the east, partitioned from the west side and the rear (north) by a concrete block dwarf wall, with a feed passage to the south with a forced door opening into B1a to the east and another opening into the lean-to to the south (Figure 9). All walls are white washed. To the west, in the south west corner is a Bentall Grinding Mill positioned on a concrete plinth and with a forced opening in the ceiling above (Figure 10). This model was advertised in the 1935 Bentalls catalogue and the various models would require between 10 and 14 horse power to drive (www.oldengine.org/members/diesel/bentall/machine.htm). There

Figure 10: The ground floor south-west corner of B1, with the Bentall Grinding Mill, viewed from the north-east.

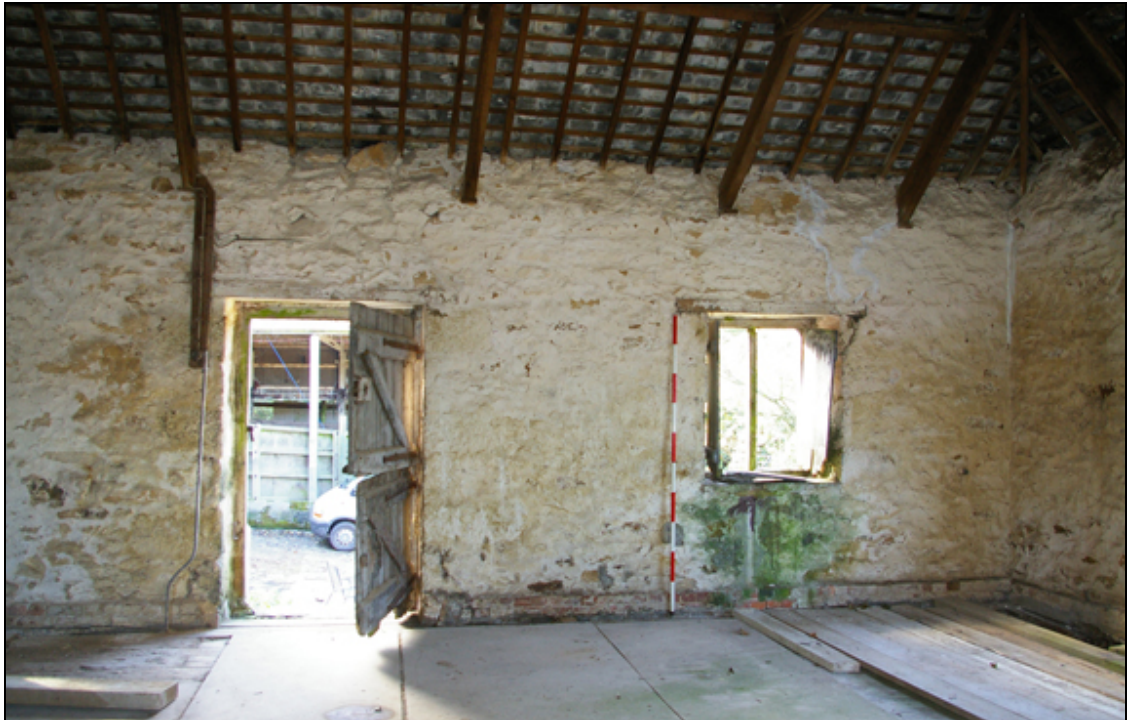
Figure 11: The western portion of the first floor south elevation of B1, viewed from the north.

To the south (Figure 11) the openings are as to the north, but the upper leaf of the loading door has an attached timber stock lock. The ledging and bracing timbers are chamfered (as to the north), and to the east, the window opening is reduced, to accommodate the roof of the lean-to on the exterior, with concrete block at the base (Figure 12).

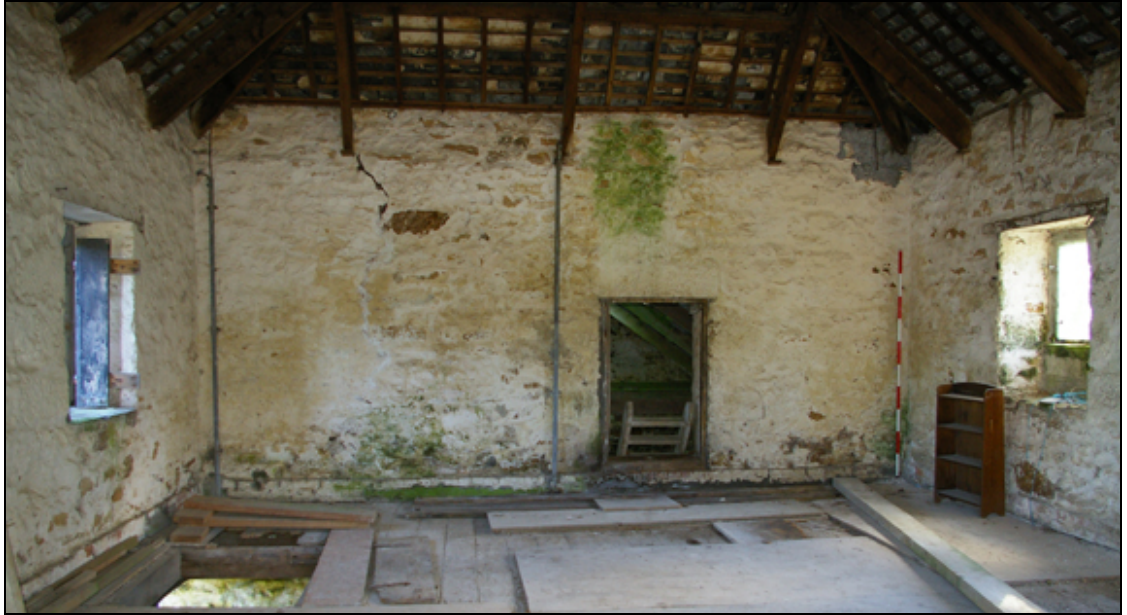
Figure 12: The eastern end of the first floor of B1, viewed from the west.

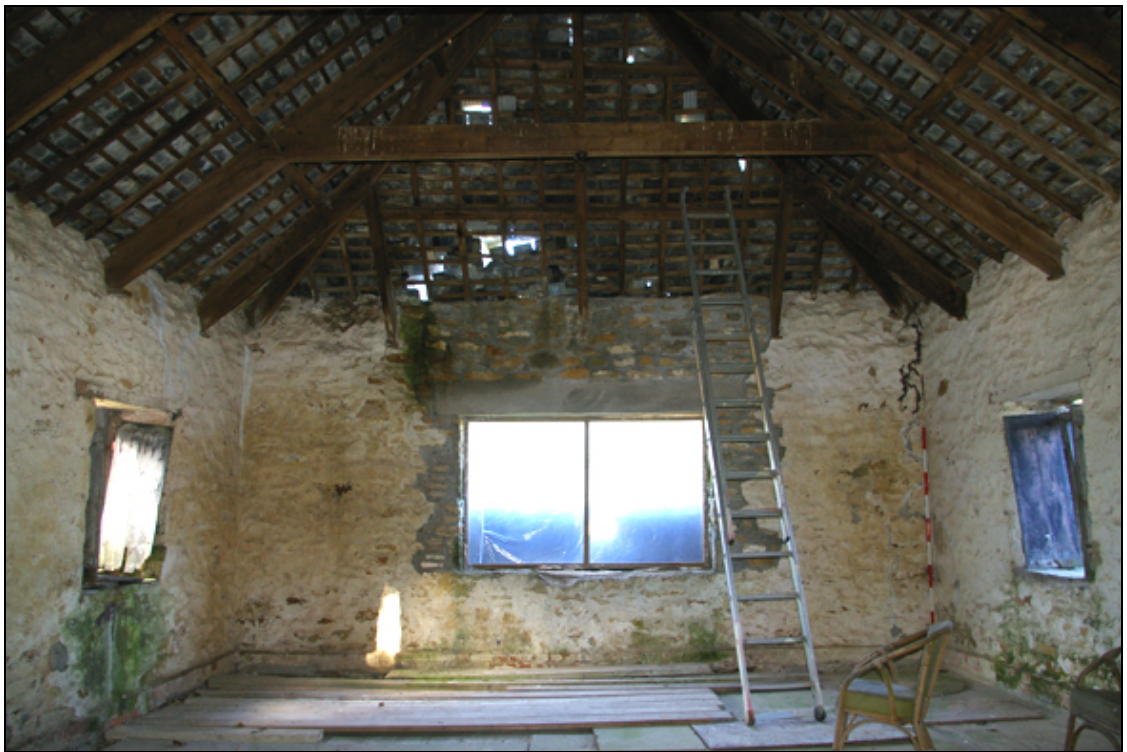
The roof is of five bays, hipped to the east and west (see Figure 13), with 4 A-frames with lapped, spiked collars, lapped and spiked at the apex, where the ridge pole is clasped by the truss blades, with the purlins resting on the backs of the truss blades and slight rafters and battens, slated above and with additional integral supporting timbers to each corner. The slates are mortared in place and have a coat of lime mortar on the eastern hipped pitch. The truss blades are set into the wall tops on timber pads, the wall above batters outward (see Figures 12 & 13) which suggests that the roof trusses were originally set onto the wall tops, as in B1a to the east, which were later extended up to the level of the slates to seal the space.

Figure 13: The interior west end of the first floor of the chall barn (B1), with central inserted window, viewed from the south-east.

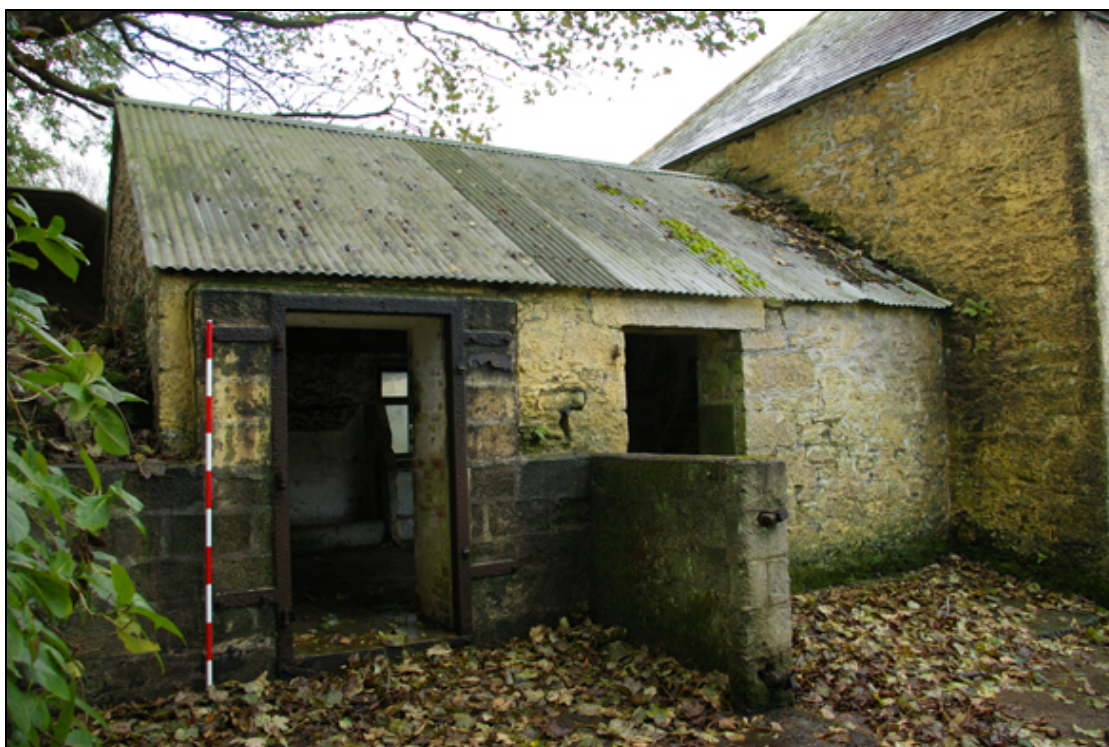
east of the opening) with a similar granite lintel and quoins as the main barn, all bonded in a creamy brown lime mortar (Figure 14). To the east end of the north wall is a later door opening with a chunky metal frame bolted to an applied skin of concrete block to the exterior wall face and with brick jambs to the interior. B1a is roofed with modern metal sheeting, set at a slightly lower level than an earlier roof. The building now has an abutting exterior concrete block wall between the two openings. To the south, to the east of the central steps, the granite rubble south wall of B1a is tied into the barn, and has been repointed in modern cement. With a central window opening with granite quoins, no sill, a chamfered frame, timber glazed casement, with a timber lintel and cemented surround. The east end of the wall has the long and short granite quoins as elsewhere. The east gable of B1a has been repointed in cement, as to the south, and is built into the slope to the base.

Figure 14: The north elevation of B1a, viewed from the north

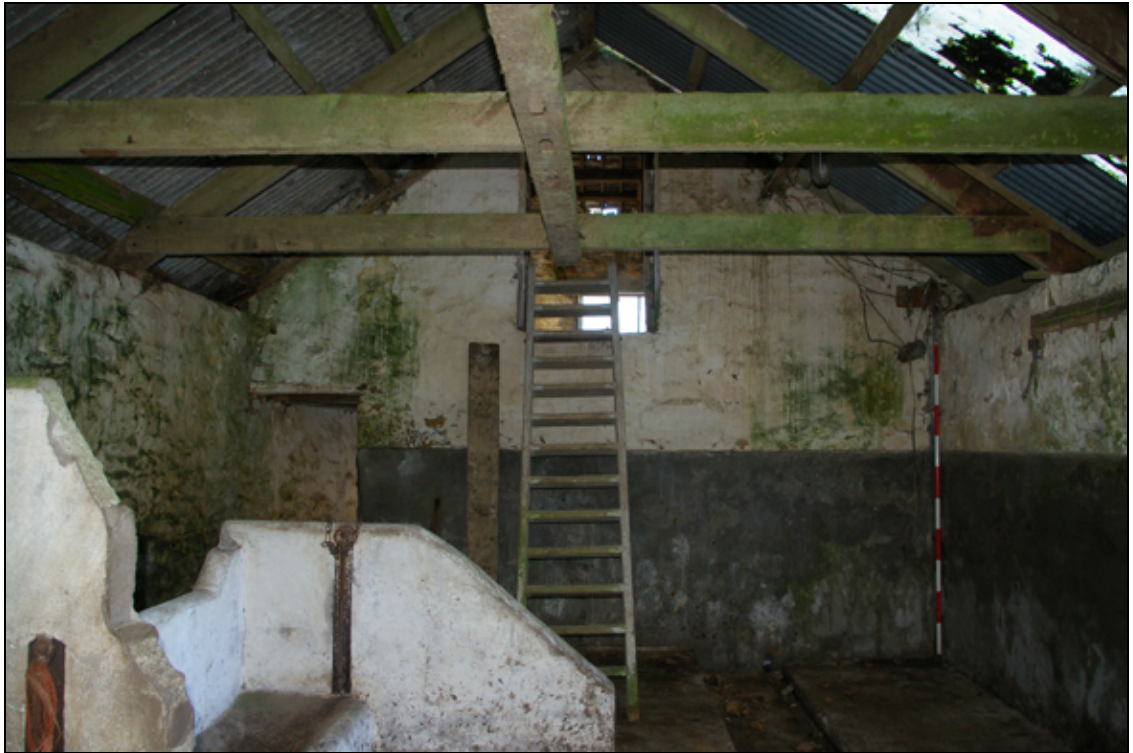
To the interior the building now has a modern concrete floor, with the walls also cemented to the lower portion, and three concrete built cattle stalls with a feed passage to the rear (south) of the building. This building was formerly accessed through a central door opening in the north wall, now with a later reinforced opening to the east end, with modern red brick jambs and a concrete lintel to the interior. The walls are all of granite rubble as before, single storey to the south and north and gabled to the east and west. To the south with a central window opening with splayed reveals, with a later hopper window inserted and a cement sill, formerly sloping to the interior but now built up with concrete block. Also with a central first floor loading door opening in the west wall (the east wall of B1) with straight jambs and a plain timber frame remaining, and a more recent opening at the west end of the southern feed passage, forced through from B1 (Figure 15). The four bay roof structure has three timber A-frames trusses (as to B1), with the truss blades resting on the wall tops to north and south, the purlins resting on the backs of the truss blades and with the lapped and spiked apex clasping the ridge pole.

Figure 15: The west wall of B1a (east wall of B1), with original loading door and forced door opening in the south-west corner, viewed from the east.

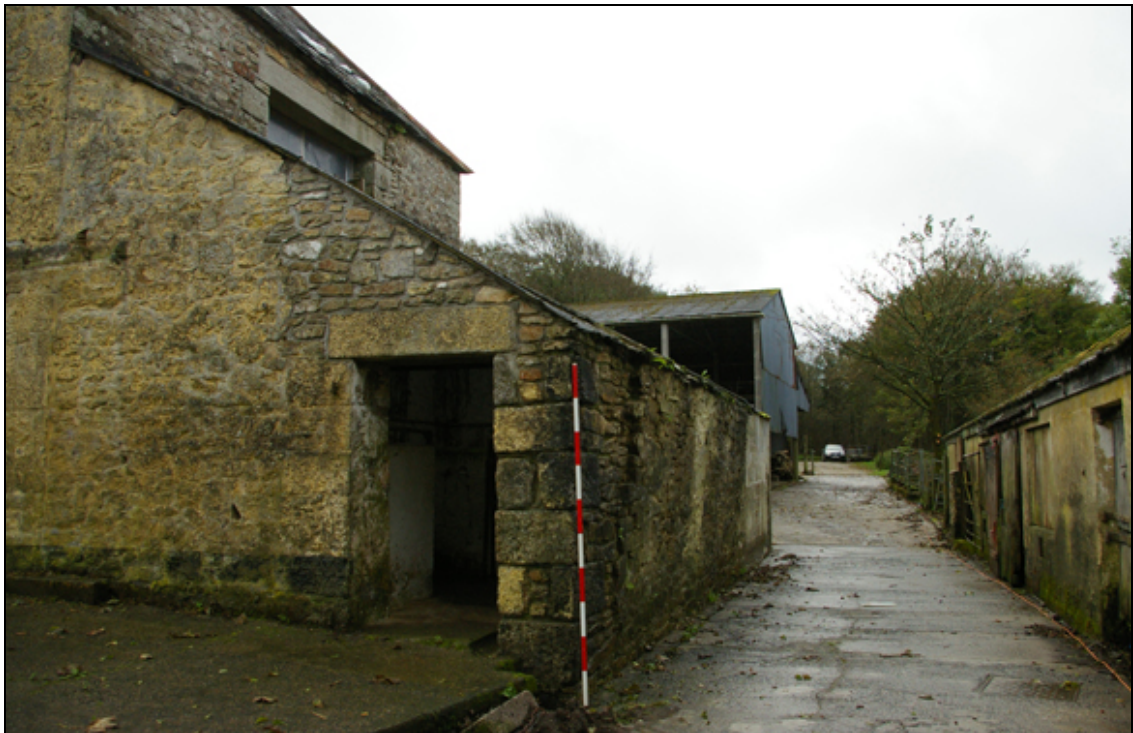
Figure 16: Lean-to (B1b) against the west wall of the chall barn (B1), viewed from the north.

The north wall has been rebuilt around the opening in at least two modern phases, both in cement (Figure 16). Elsewhere the masonry of the building is mortared in an orange earth bond. The west elevation of the lean-to is ragged to the exterior but with large dressed granite quoins to the north and south ends. The south elevation of the lean-to abuts the west elevation of the main barn and is now inside a further lean-to to the south. The south wall has a single window opening, central in the elevation, with chamfered timber frame, formerly glazed and now cut to the top by the sloping roof of the further lean-to (see Figure 17). To the interior there is a partition to the east, effectively creating two areas or stalls, with a raised cement trough built up against the east wall, and a window roughly central in the south wall. The walls in the north-west corner have been rebuilt. The floor is cement and slopes down to the west, with a drainage channel against the west wall.

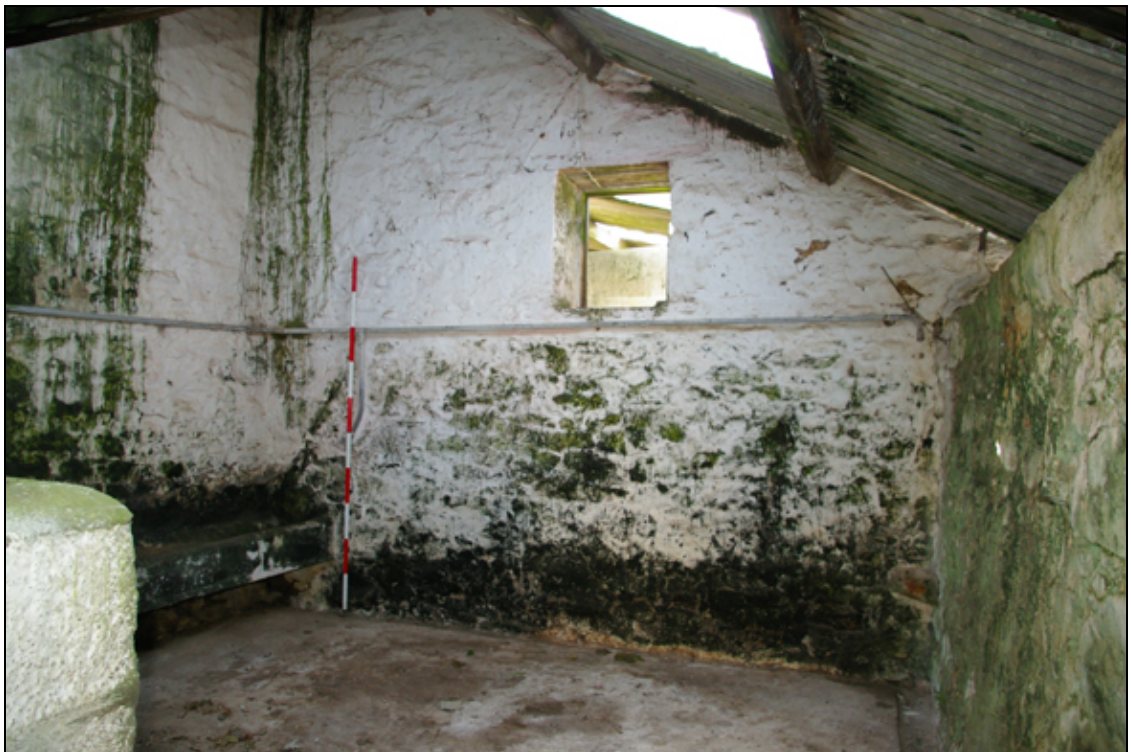
Figure 17: The interior of the south wall of B1b, viewed from the north.

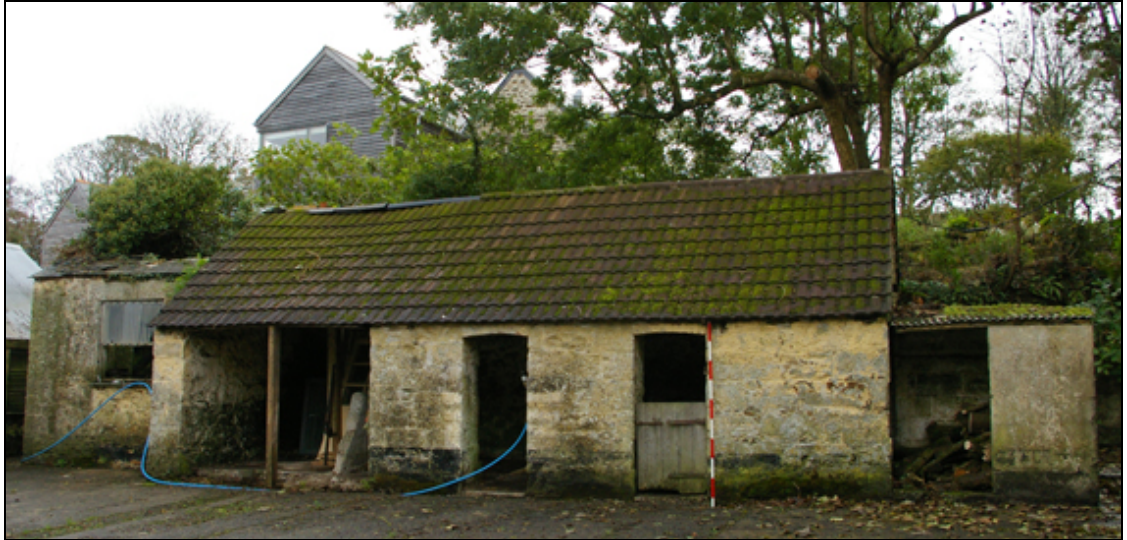
The west elevation has two door openings to the south and a large double opening to the north, formerly with two openings as to the south but with the central block of masonry now removed. The random granite rubble masonry is bonded as the chall barn (B1) with a creamy lime mortar. With granite quoins to openings and segmental brick arched lintels above to the

Figure 18: The west elevation of B2, viewed from the west.

south, all formerly with stable type doors, with pintles and sockets for bolts remaining. The openings to the south also have granite stone thresholds. To the north end of the west front the roof over the enlarged opening is supported by a timber upright.

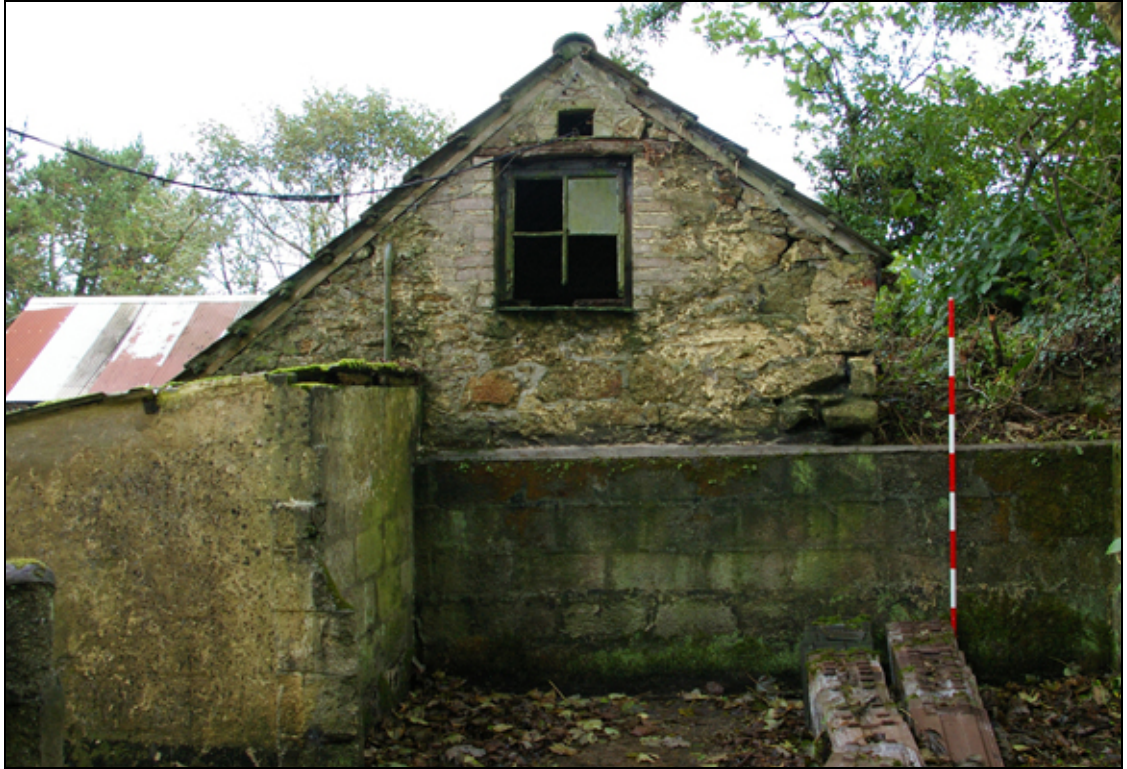
The south wall is abutted to the west at ground floor level by a modern log store and has a modern concrete block wall built up against the lower portion to the east of this that continues beyond to the east (Figure 19). The east end of the south wall has ragged masonry projecting above the modern wall top, which is tied into the east wall of the building and which probably represents the remnant of a former yard and retaining wall against the slope to the east. In the centre of the south gable is a single inserted opening, with a timber lintel, slim slate sill and four light casements. The reveals and wall around the opening are pale pink-orange brick (as to the interior first floor of B1) which also fill the gap between the opening and the apex of the roof where there is a small square opening.

Figure 19: The south gable of B2 with associated modern structures to the south, viewed from the south.

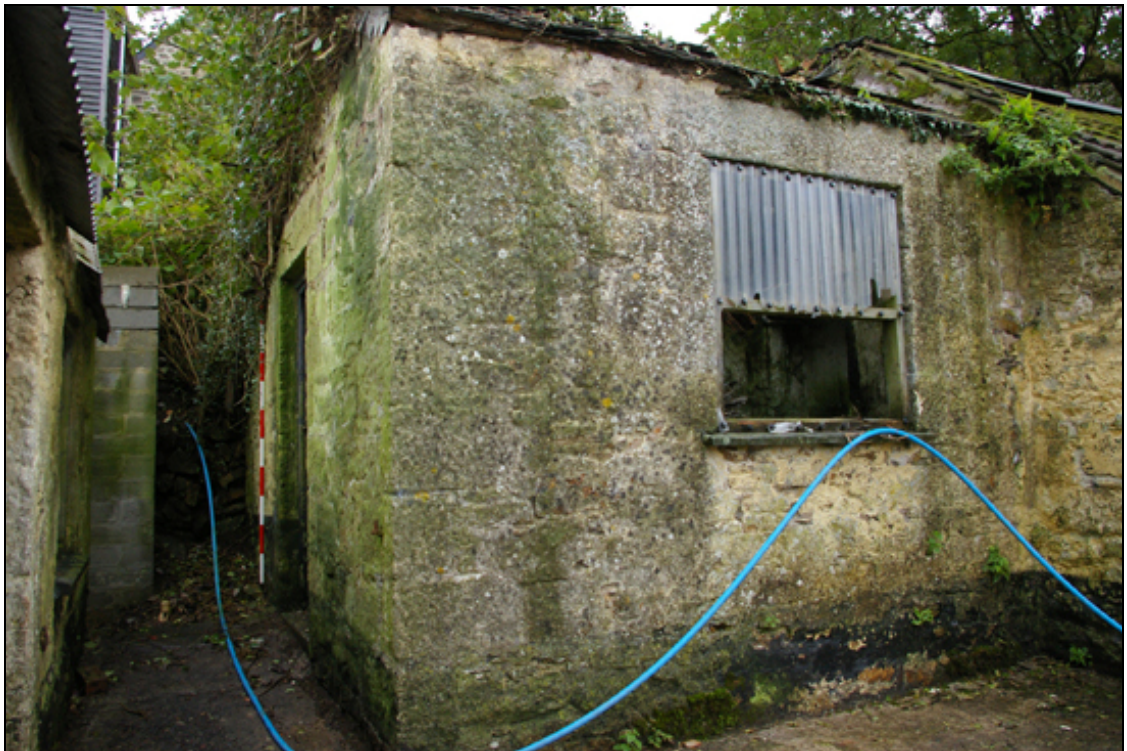
To the north of B2, a small single cell, single storey granite rubble built structure is set back *c.* 1m from the west elevation of B2 (Figure 20). The small square structure is built into the slope to the east, gabled to north and south, with a pitched slated roof, now partially remaining.

Figure 20: B2a, viewed from the west.

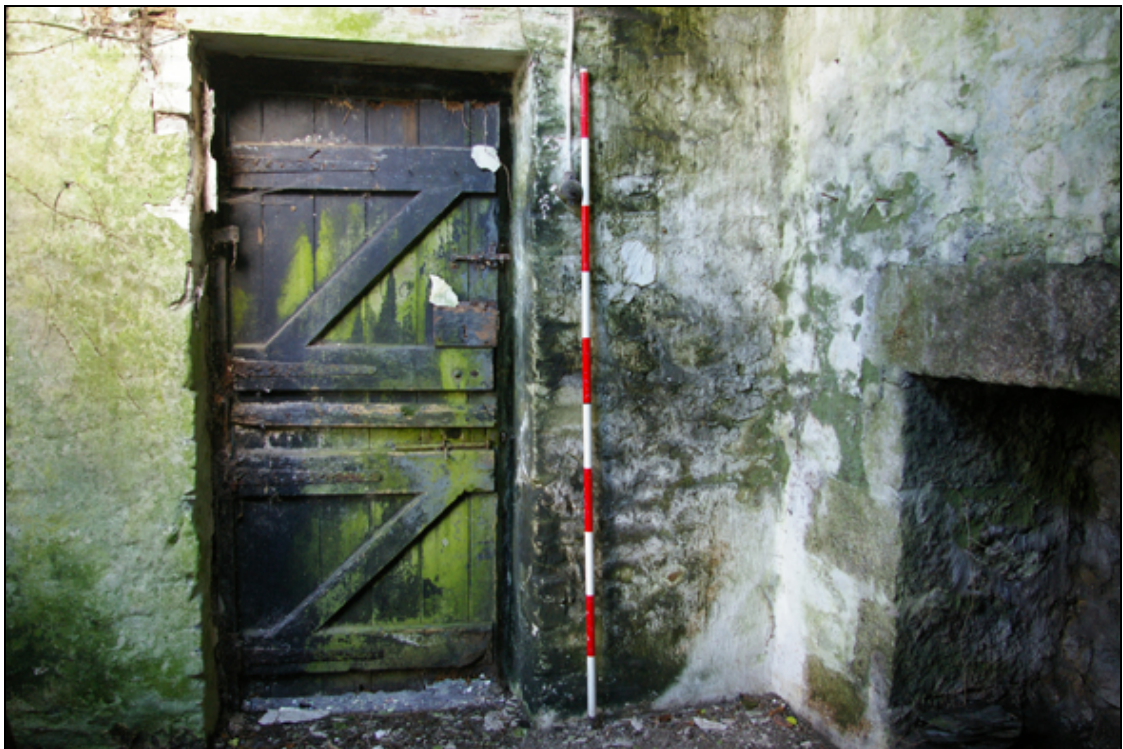
To the interior, all walls are heavily whitewashed. The south wall has a blocked door opening into B2, with what appear to be a dressed granite lintel and quoins as elsewhere. This suggests that the opening formerly accessed the exterior rather than the interior of B2a, as elsewhere the openings have timber lintels to the interior. Now the opening is blocked flush to the wall face within B2 with concrete block. To the north, the door opening has a ledged and braced stable type door, hung on strap hinges and with a metal latch and bolt and timber stock lock (Figure 21). To the east there is a fireplace projecting from the north-east corner of the small room (see Figure 19). To the exterior the ground level is almost to the eaves of the roof and when investigating the chimney opening from the exterior, a secondary flue was visible from above, leading down in a southerly direction toward the recessed south-east corner of the building (Figure 22). This suggests a secondary heated structure, either for something like a boiler for heating water or for fodder preparation. The walls appear to be earth bonded as B1b, which suggests that this is a secondary structure, added after B2 and B3, and set back so as to not impede access to B3 to the north. The roof had collapsed and there was not enough remaining to record the type of structure.

Figure 21: The interior north-east corner of B2a, viewed from the south-west.

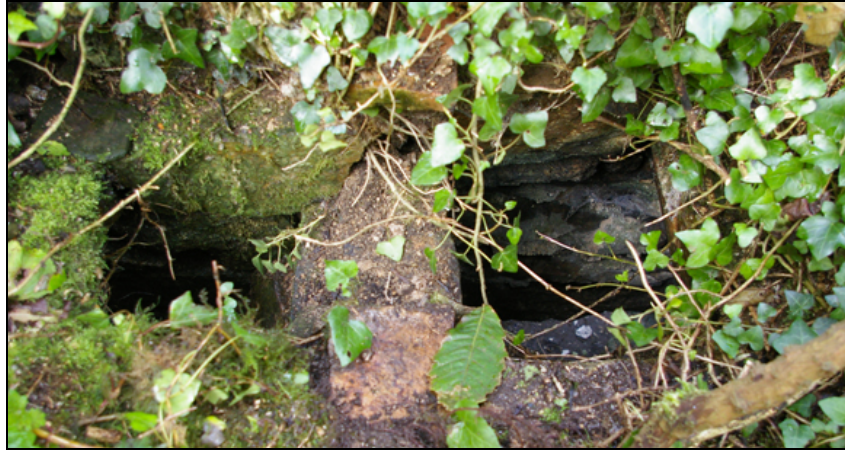
Figure 22: The flue from the fireplace in the east wall of B2a, showing smaller flue leading up from the south, now blocked, viewed from the east.

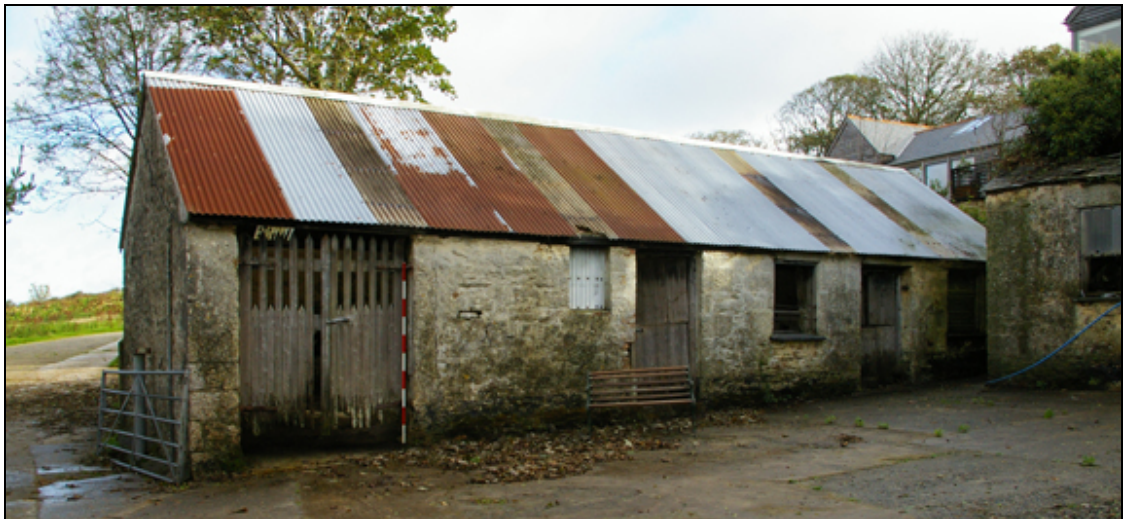
Figure 23: The south elevation of B3 and B3a (to the left), viewed from the south-west.

The south wall has a central double door opening and flanking windows. The window opening to the east has a chamfered timber frame, is slatted to the lower part and with a hopper window to the upper, and a slate sill. The window to the west has a frame as to the opening to the east, only partially remaining, with a slate sill. The central door opening also has a chamfered frame and with a hinged four leaf door. The three openings all have dressed granite lintels and quoins as before. The granite rubble east elevation has a window opening in the upper part of the

Located to the west of B3, with a pitched roof now covered with sheet metal (see Figure 23). The south elevation of B3a is of granite rubble construction with a forced window and door opening to the east and larger double sized opening, now filled with lightweight timber gates to

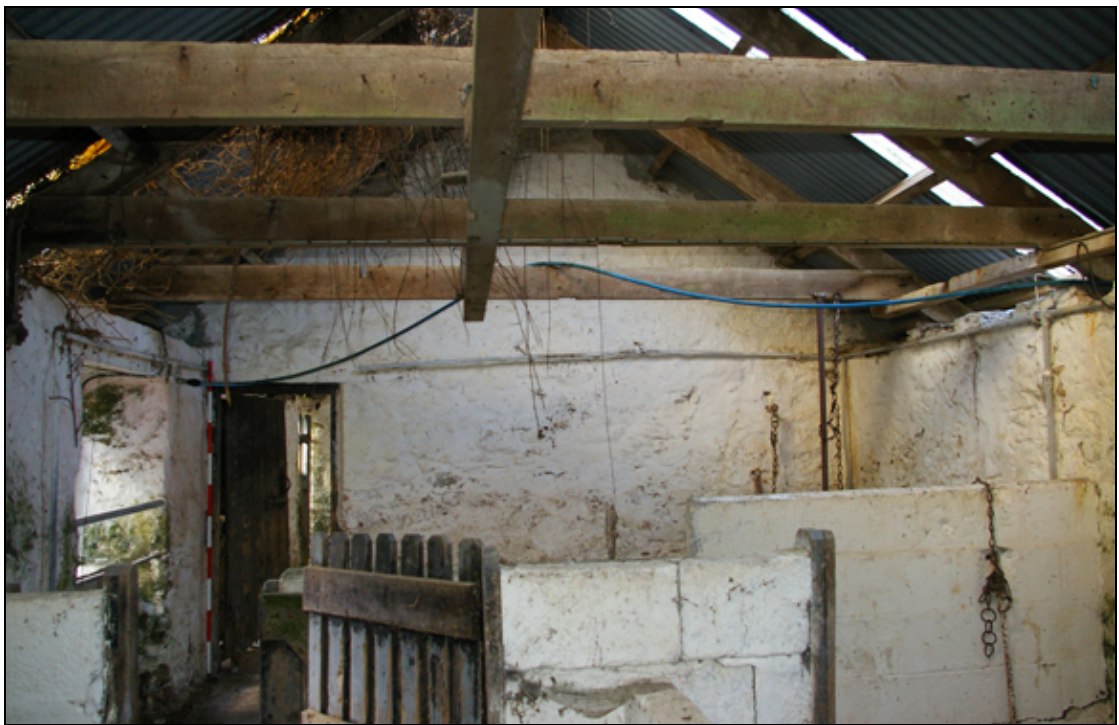
All walls are whitewashed to the interior and there are a number of dwarf concrete block walls, with associated timber gates portioning the space (Figure 24). The walls to north and south are single story and the east wall has a forced window in the east gable, with a four pane casement as to B2. To the south, the two window openings have splayed reveals down to floor level but are blocked with an inset of granite rubble stone below sill level, and internally with concrete block to the east, both have internal timber lintels. The central double door opening has a chamfered frame with run out stops and stable type doors with centrally folding leaves. To the west the wall has a forced door at the south end, with a brick jamb to the north and a slim timber lintel, and brick in the west face of the wall to both jambs. The floor is modern cement and the roof structure is as B1, B1a and B2, with the four trusses resting on the wall tops, although here the purlins are notched into the backs of the truss blades and set into the gables to east and west.

Figure 24: The interior west end of B3, viewed from the east.

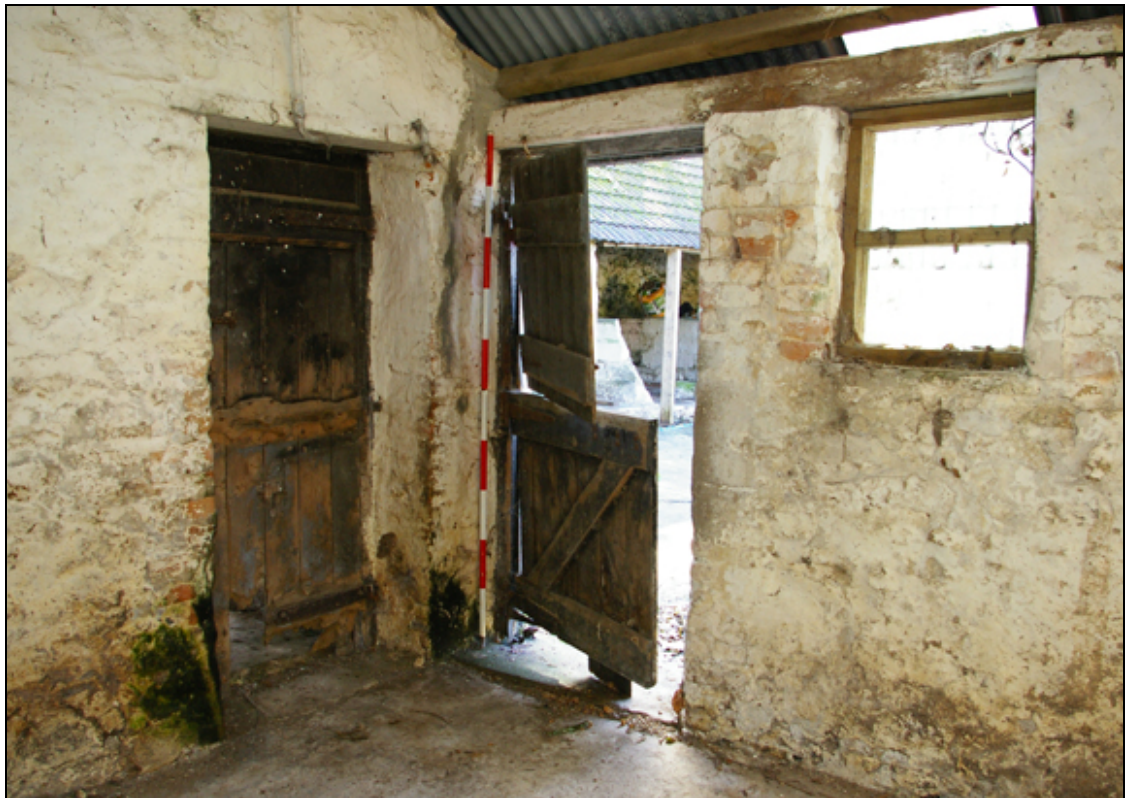
On the interior B3a has a concrete floor which slopes down to the double doors to the west, and a modern concrete trough against the base of the north wall. The openings in the south-east corner to the exterior and from B3 to the east are all forced, with bricks to all openings (Figure 24). The roof structure comprises a single modern timber A-frame to the centre, with modern purlins set into the walls to east and west.

Figure 25: The forced openings in the south-east corner of B3a, viewed from the north-west.

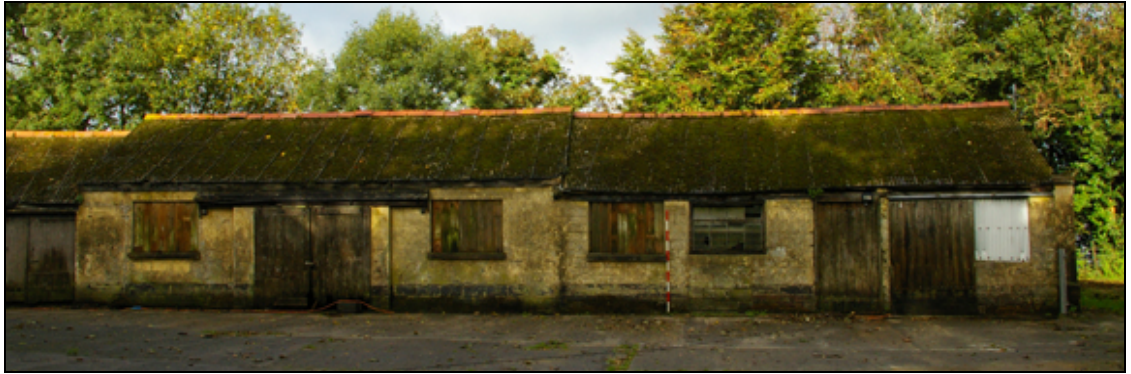
Although this range of buildings to the western side of the yard appears in keeping with the rest of the agricultural complex at Higher Tregarne, this is only because of the modern pale orange paint finish and mossy covering of the roofs. Formerly at least three separate units, with differing roof lines, now mostly open to the interior; this building is of completely modern construction, with concrete block walls, cement floors and modern sheet roofing (Figures 26 & 27).

Figure 26: The northern portion of the east elevation of modern building B4, viewed from the east.

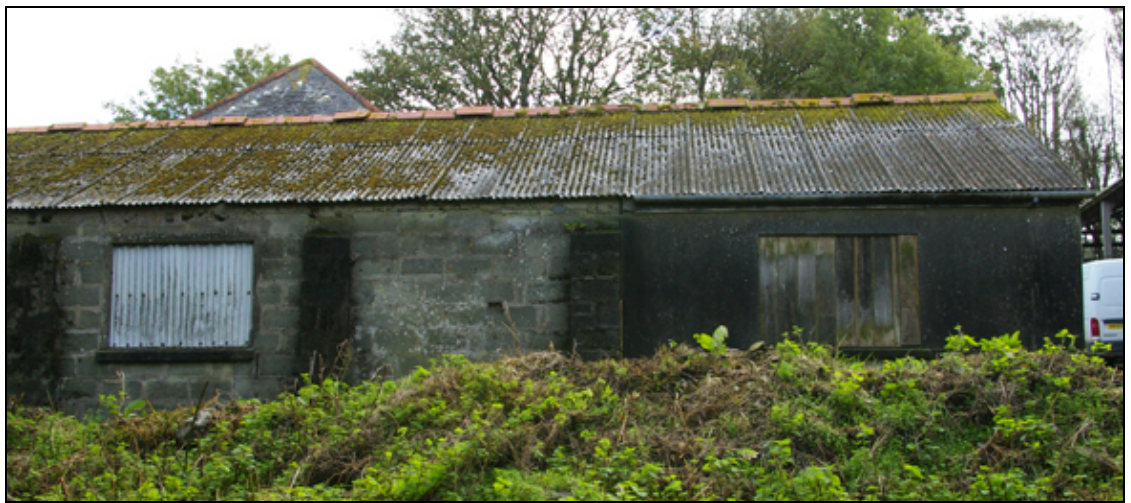
Figure 27: The south end of the west elevation of B4, viewed from the west.

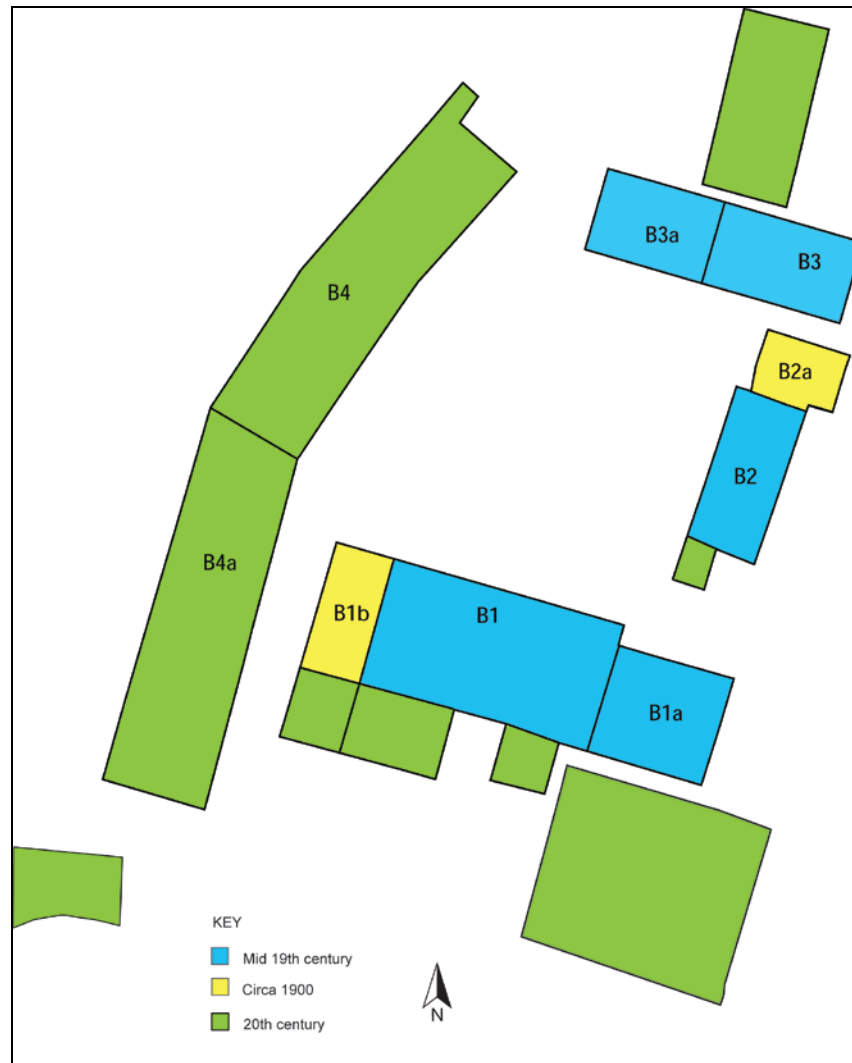
The major buildings in the agricultural complex at Higher Tregarne appear to have been constructed in the mid 19th century, after the production of the tithe map (see Figure 28). The early range comprised: to the south, a Chall Barn (B1), for animal housing and the processing and storage of grain and fodder, with an associated Oxen House or perhaps a further storage Barn to the east (B1a); a Calf House or Piggery to the east side of the yard, and with a Stable or Oxen House and Cart Shed to the north.

Later, perhaps around the turn of the century (*circa* 1900), these buildings were added to or extended; B1 gained a lean-to to the west, most likely a Root Store, B2 saw the addition of a Meal House or Killing House (depending on the specific function of B2), (B2a) set back to the north, and a building of two elements was constructed to the south-west of the yard which is no longer extant. These later structures are constructed of the same granite rubble with dressed block quoins and lintels, but are set in an earthen bond rather than the lime mortar of the earlier structures.

Figure 28: Site plan with phasing of the buildings at Higher Tregarne (not to scale).
