POLVELLAN MANOR WEST LOOE CORNWALL

Results of a Historical Assessment

Report No.: 130821
Date: 21/08/2013
Authors: D. Laing-Trengove
S. Walls

SWARCH project reference: WLP13
OS Map copying Licence No: 100044808
National Grid Reference: SX25005377
County Planning Reference: PA13/00130/PREAPP
Project Director: Colin Humphreys
Project Officer: Colin Humphreys
Building Assessment: Colin Humphreys; Deb Laing-Trengove
Desk-Based Assessment: Terry Green; Dr. Samuel Walls
Report: Deb Laing-Trengove; Dr. Samuel Walls
Report Editing: Colin Humphreys; Dr. Samuel Walls
Research: Terry Green
Graphics: Colin Humphreys; Dr. Samuel Walls

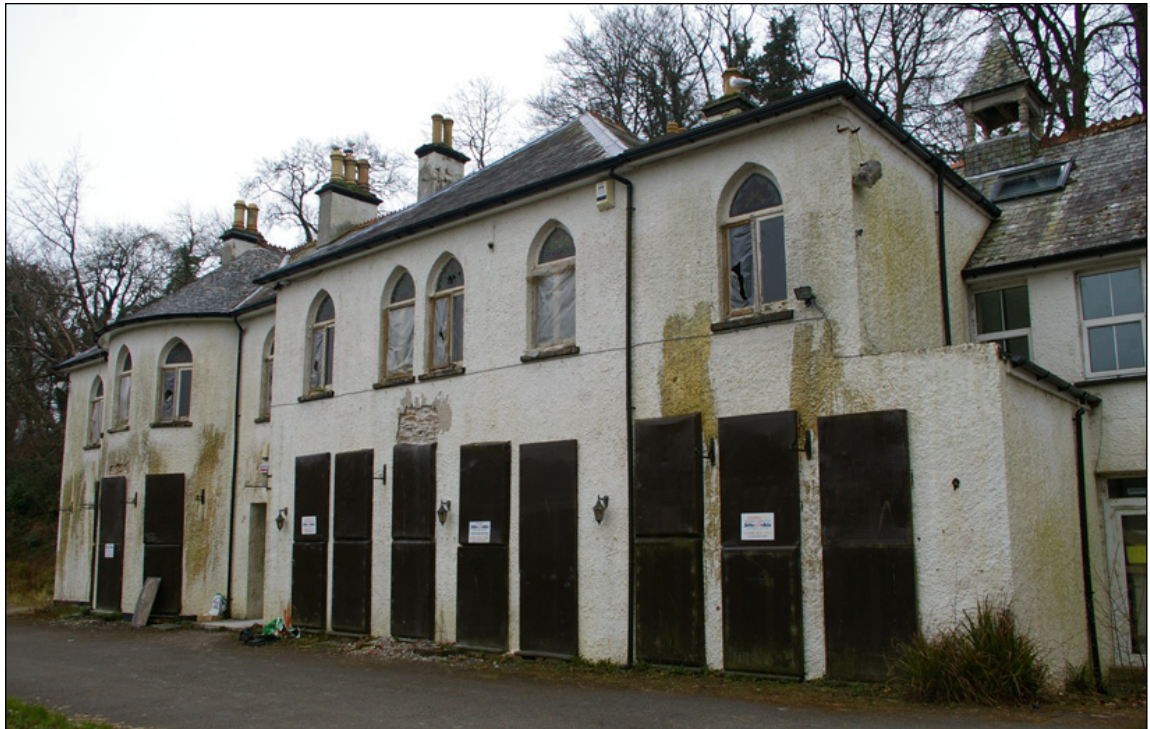
Figure 6: The north elevation of Polvellan Manor, viewed from the north-west.

The building (Figure 6) sits on a level platform of ground, cut into the north facing slope overlooking the estuary, with levelled areas of former garden to the east and west of the house. The presentation facade of the house is to the east, looking toward the town of Looe. To the east and west the ground slopes steeply away to the north and the modern car park, formerly a larger mill pond. These areas are wooded.

The building comprises a relatively large irregular plan rubble slate stone and brick house, with modern cement render over, with a multi faceted slate roof with terracotta cockscomb ridge tiles to the main ridge, lead to the gables and hipped elements, with ball and leaf finials, and four brick rendered chimney stacks with Victorian buff coloured octagonal chimney pots. All ground floor openings were covered for security at the time of the survey but comprise full length versions of the first floor window openings; Gothic arched windows with late 19th – 20th century coloured glass in a floral motif forming the top light of each. Each ground floor opening has a brick step with slate tread.

The eastern elevation (Figure 7) has a double bow front, each bow with three full length arched windows at ground floor level and three smaller three light windows above. The roofs of the bow elements sit slightly uncomfortably with the hipped gables, suggesting they may be later. To the south is a single storey flat roofed crenellated former entrance porch, with a modern exterior stair. The south elevation is connected to a later ballroom structure to the west of this, positioned on a raised rubble stone platform giving access to a pathway up to the south-east and with a walkway around the south and west sides of the ballroom accessing the rear of the house and service elements to the west. The north elevation has a single bow at the east end (Figure 6),

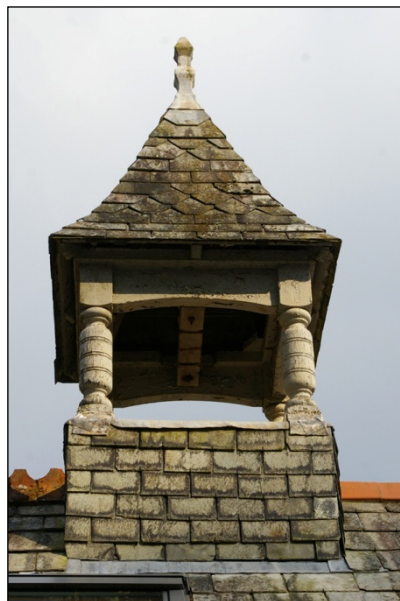
Figure 8: Wooden bell tower.

This elevation then steps back to a probable former service block set back and to the west (mostly inaccessible at the time of the survey), with a double door opening and three window openings (all with modern plastic windows) and a modern velux roof light. The only visible exterior feature of any merit being a small wooden bell tower on the ridge of the roof of this element, with turned timber supports, decorative slate roof and lead finial but with no bell remaining (Figure 8).

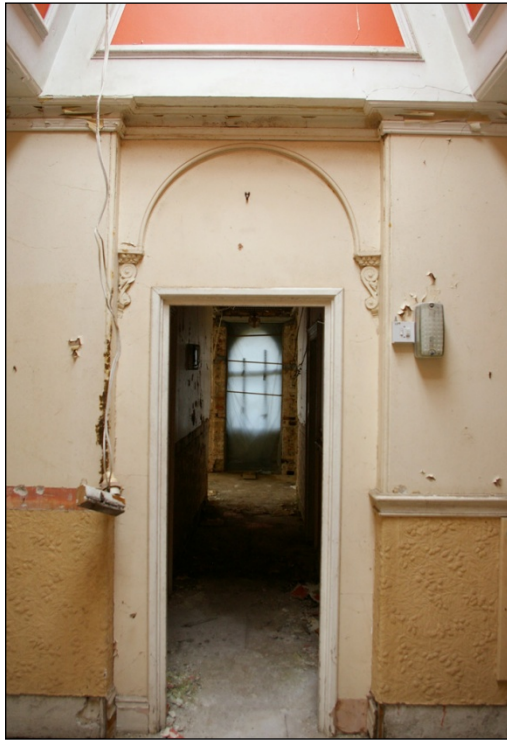
Figure 11: Early 19th century detailing.

Most, if not all of the decorative architectural features pertaining to this phase of the development of the building have been removed or replaced by later detailing or recent works. However, some of the less elaborate detailing may date to this period such as the concave moulded coving, which is less decorative and ornate than much of the later 19th century mouldings. This type of moulding was found in R3 and a number of the bedrooms over this eastern range (R16 & R17). The first floor landing (R10) also dates to this first recognisable phase (Figure 11); it is easily accessible from the stair, which would have risen in R14, and it has the concave moulded coving as well as a decorative arched opening into a small corridor leading to the former principle bedrooms with the bow windows on the east front (R16 & R17) – now a single room but formerly two.

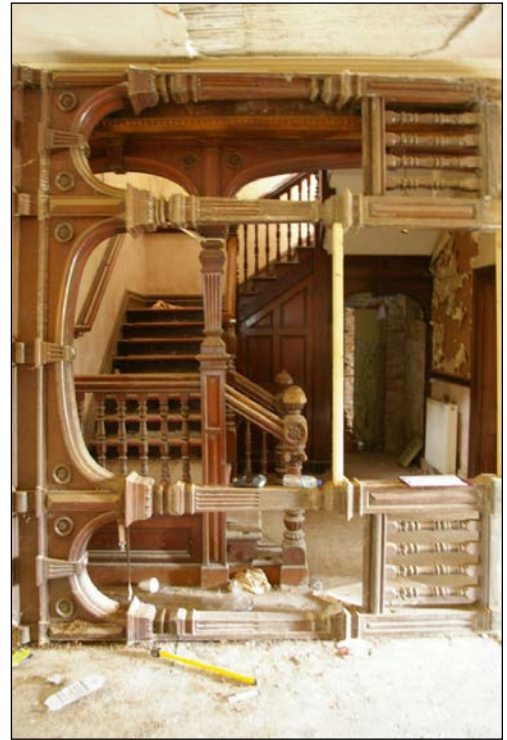
Figure 12: Late 19th century timberwork.

A new imposing staircase was installed into the centre of the building and a heavy dark stained timber framing was positioned in the eastern entrance to the stair lobby from the entrance hall, and another at the south end of the current entrance hall where the former exterior wall had been removed (Figure 12 – confusingly the removed timber arch is resting on its side in front of the stair). At first floor level the stairwell was decorated with elaborate plaster friezes (Figure 13) and at the head of the stair the wall between the new stairwell and the existing landing was

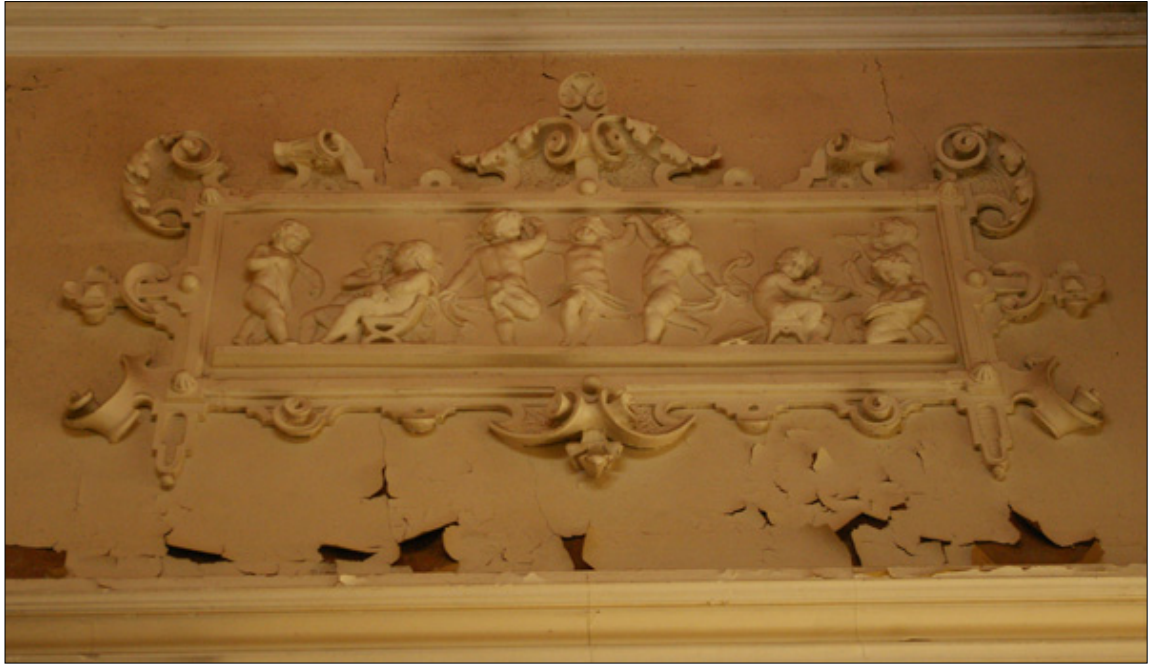
Figure 13: Plaster decoration within the stairwell.

removed and new mouldings added to the soffit, the earlier former stairwell was converted – possibly to a nursery, and a large master bedroom was added to the west.

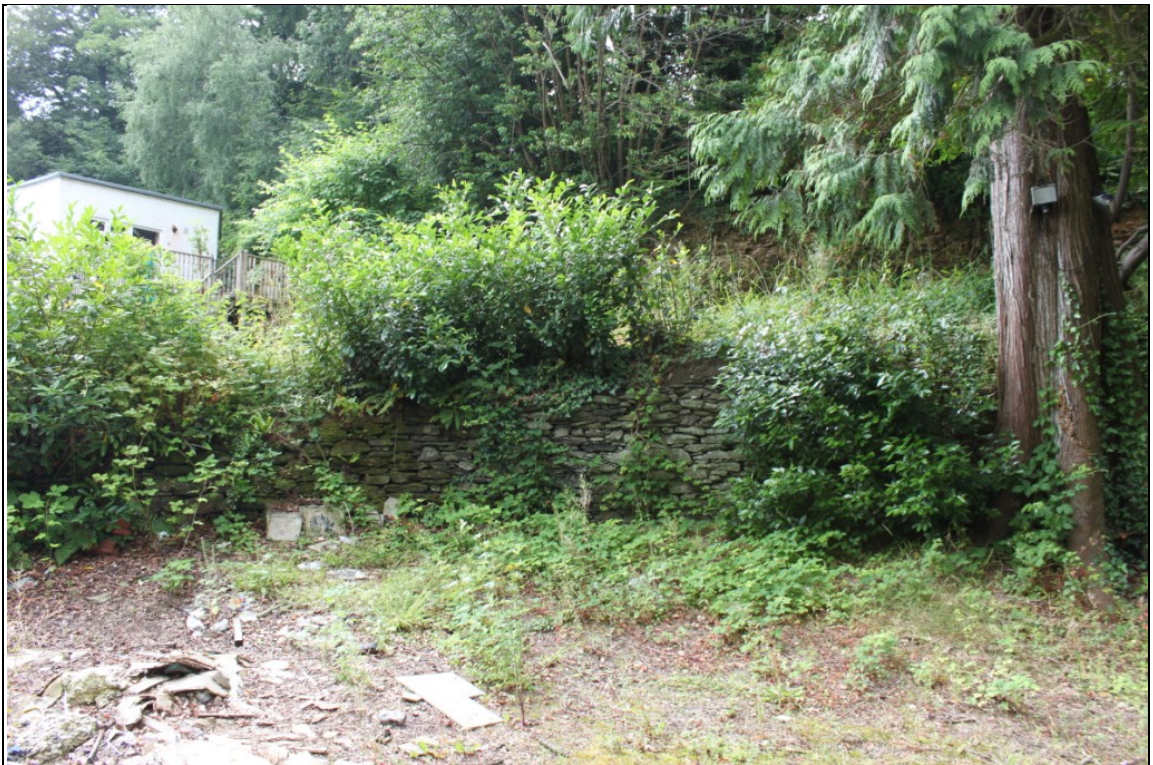
Figure 14: Stone retaining wall along the eastern edge of the southern edge of the oval platform to the west of the house, viewed from the north.

Immediately to the west of the building is a large oval shaped levelled area, with large dumps of spoil and rubble to the northern edge and a rock cut bank to the south. Along the eastern part of the rock cut southern edge is a 0.5-2m high stone retaining wall, and it is likely that this represents the earlier dimensions of the platform (c.12m wide), with a subsequent expansion (the rock cut portion) occurring probably in the early 20th century. To the south of this platform a wide (c.8m) track runs up slope to the west toward a random rubble stone garage and a tradesman's entrance to the grounds. There is a further footpath located to the north of the platform which is now largely obscured by the rubble and spoil which has been dumped along the platforms northern edge. The levelled area has no significant features except for the partial stone revetment to the eastern end of the southern edge (Figure 14).

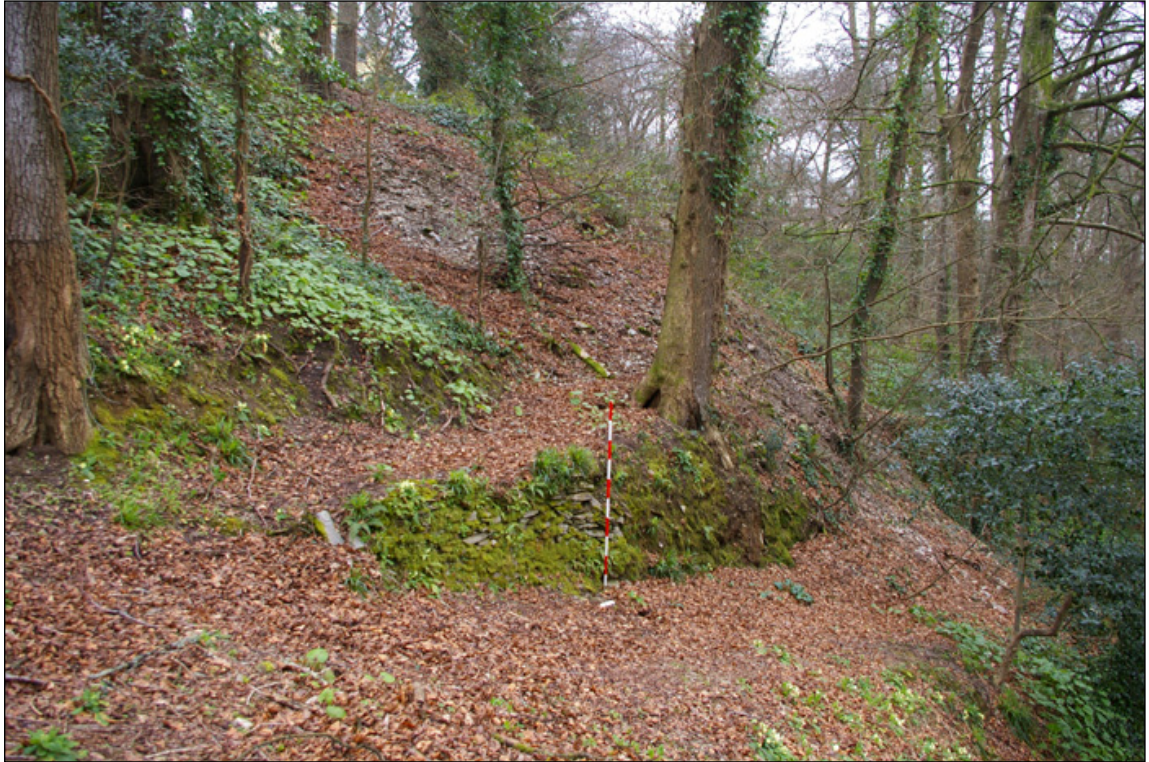
Figure 15: The paths leading west below the levelled area to the west of the house, partially blocked by dumps of shillet, viewed from the east (2m Scale).

Below the western end of the platform, the track which runs along the northern edge of the platform splits with one path extending to run along the northern edge of the gardens and a further path running up slope to the south. There is a small length of rubble stone revetment wall to the north-eastern extent of this upward path. Both paths have been partially blocked or disrupted to the west by dumps of spoil and shillet from up slope (Figure 15). Immediately to the north of this junction in paths is a small quarry, which may be associated with the construction of the mill pond to the north.

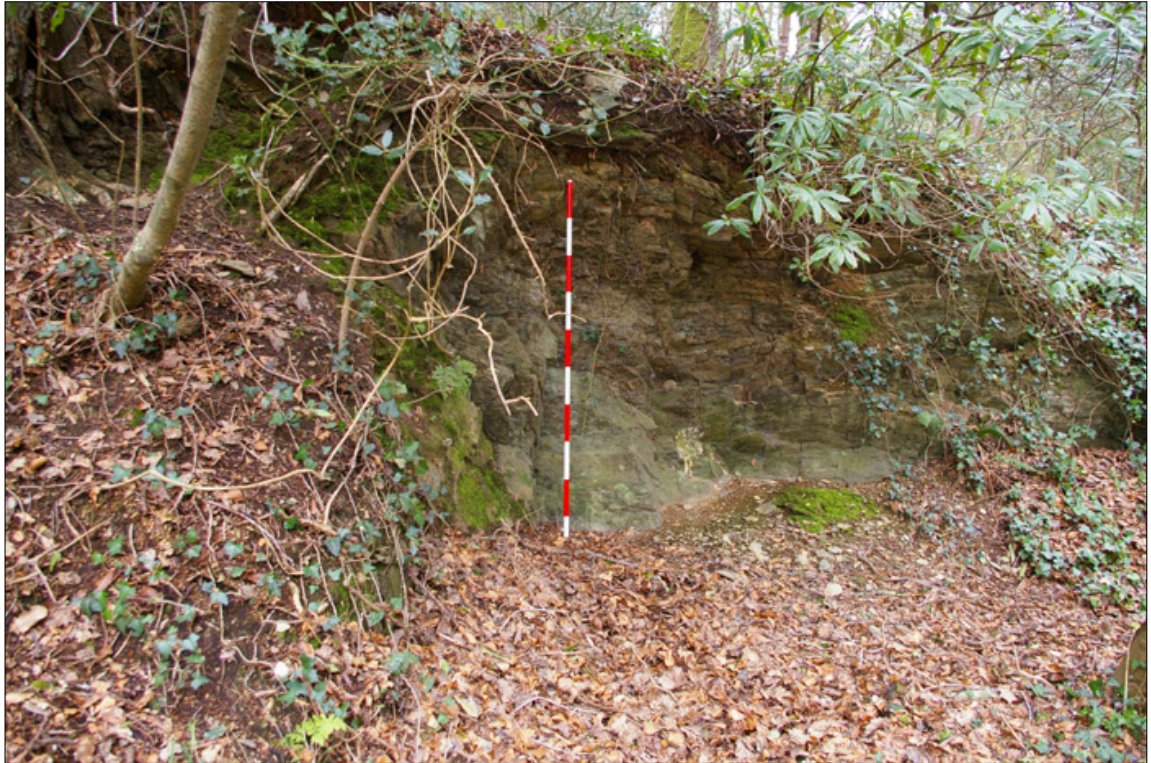
Figure 16: The possible rock-cut grotto or quarry, viewed from the north (2m scale).

The lower (northern) path continues around the northern edge of the gardens to the western extent of the property. At the point where the boundary cuts inward (south) and curves around forming a small semicircular inlet, now used as a bus-turning area (see Figures 2-5), there is a possible rock cut grotto (see Figure 16). The feature may be a product of a more mundane activity such as quarrying, but the location would formerly have given pleasant views out across the estuary and the mill pool, as well as a sheltered position from which to watch the wildlife and activity on the water.

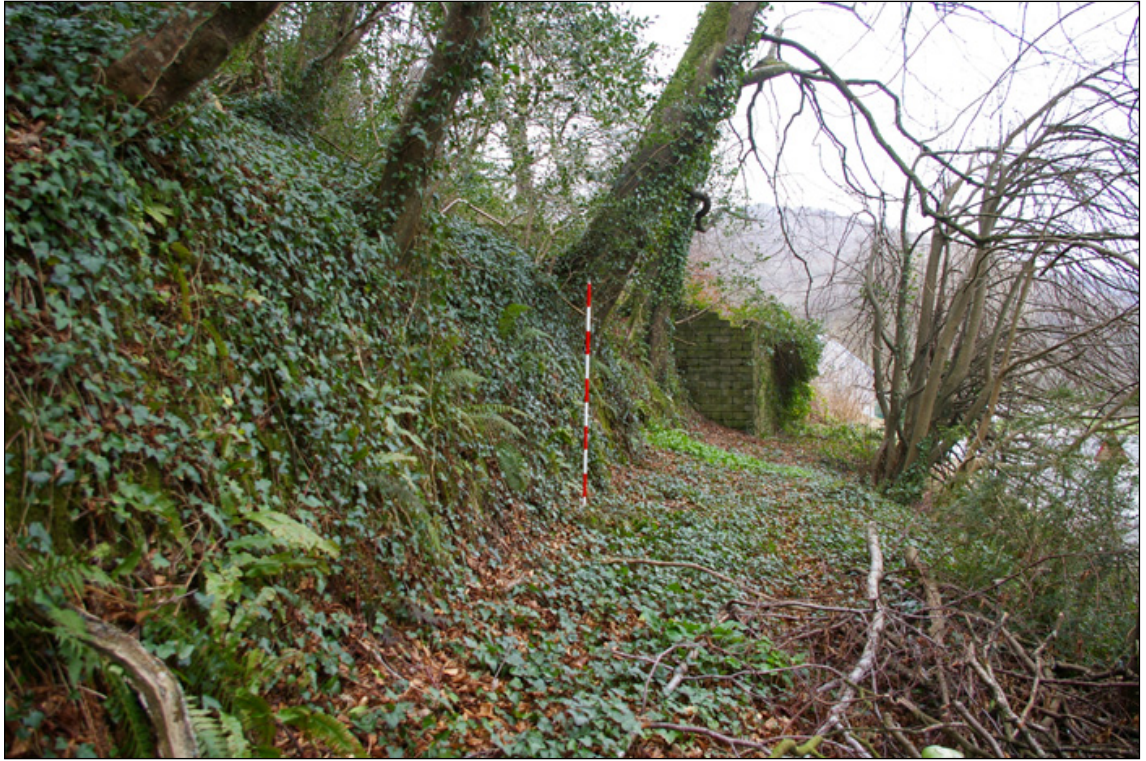
Figure 17: The end of the lower northern pathway to the west of the house, now blocked by a modern concrete block building, viewed from the east.

The lower (northern) track continues to the current north-western extent of the property to a modern concrete block built building (Figure 17), here a narrow probably modern pathway runs upslope to the south-west and to the southern path that borders the southern boundary to the site. It is likely that the lower (northern) path may have formerly led to a boathouse, although there is no physical trace of this, or cartographic evidence to support the suggestion.

The footpaths further west and north will not be impacted by the proposed works although some clearance work could be done to reinstate these, especially the lower northern path. The garage will also not be part of the development works, but some repairs, clearance and re-roofing would stabilise this structure which could then be used as a useful store on the site.

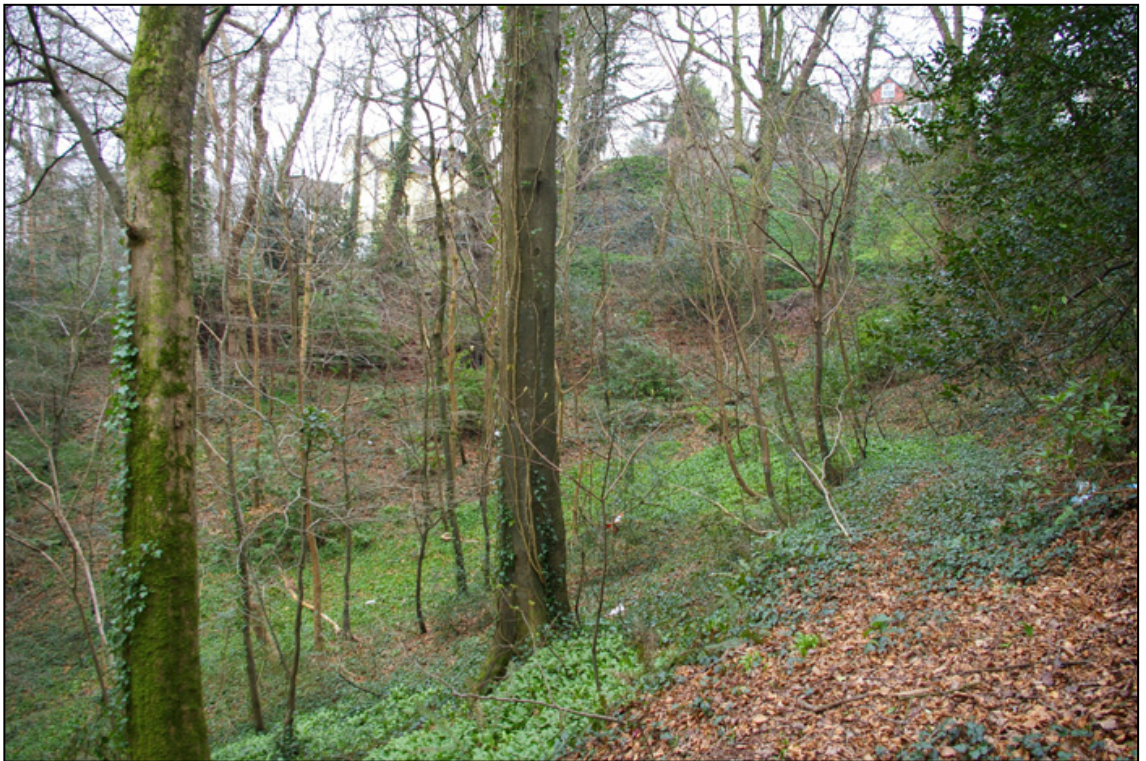
Figure 18: The upper southern pathway to the west of the house, curving around to the south-east, viewed from the north-west.

The upper (southern) pathway follows the southern edge of the grounds, positioned at a distance of approximately 5-8m to the north of the property boundary (Figure 18). There are a number of mature late 19th century beech trees lining the route where the path sweeps around to the south-west.

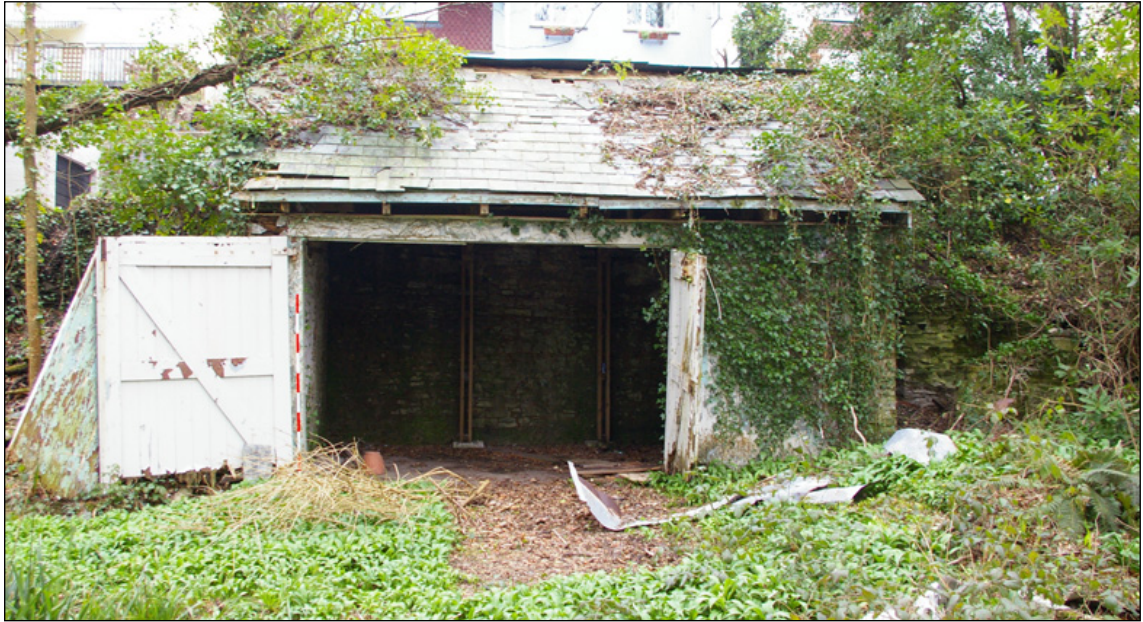
Figure 19: The former garage against the southern boundary, viewed from the north (2m scale).

The upper pathway joins with the wide trackway running south-west from the house, meeting at a levelled area associated with and just to the north of a former garage and rear access (Figure 18). The garage is a semi coursed rubble stone built structure is built into the bank to the south, with a slated roof (with sheet covering to the south) and large timber double doors to the north. The structure is currently in poor condition. To the west is an associated rubble stone built structure, also built into the southern bank, with an odd curvilinear south-east corner and a later brick flue built into the south-east end of the south wall (Figure 19).

Examination of the map evidence suggests that the building and the small associated structure were present by 1907 (see Figure 4), previous to this, a square building is marked in this position (Figure 3), probably representing a larger former coach house.

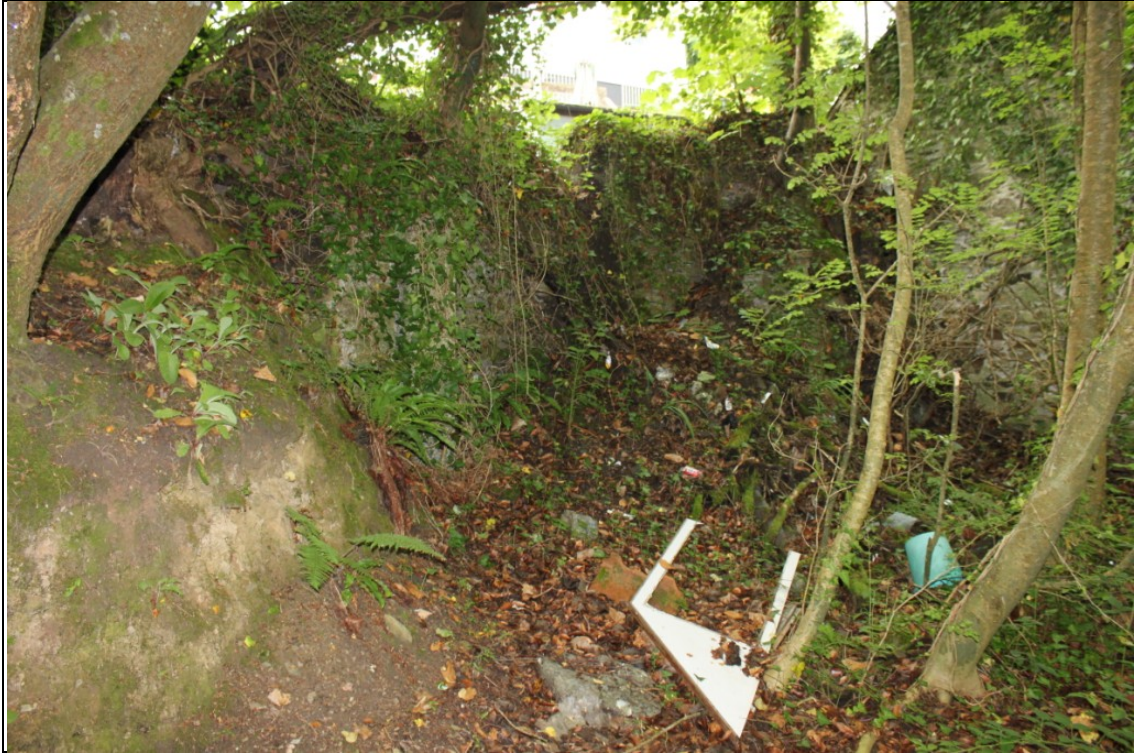
Figure 21: Blocked former opening to the east of the garage, viewed from the northeast.

To the east of the garage is a blocked former entrance, with rubble stone and brick gate piers, and with a granite gate post with pintles remaining inside the former opening, against the western face of the eastern pier. The former opening is blocked with rubble stone facing (Figure 21) and the road beyond has presumably been built up since the closing of the opening, as the level of the lane to the south is now at the level of the roof of the garage. An opening is marked on the Second Edition OS map of 1907 (Figure 4), and was associated with the earlier layout of this area (see Figure 3) where it seems to have formed another entrance – possibly for tradesmen etc. The dramatic increase in level of the public road may suggest that it was formerly a sunken hollow-way, possibly of some antiquity.

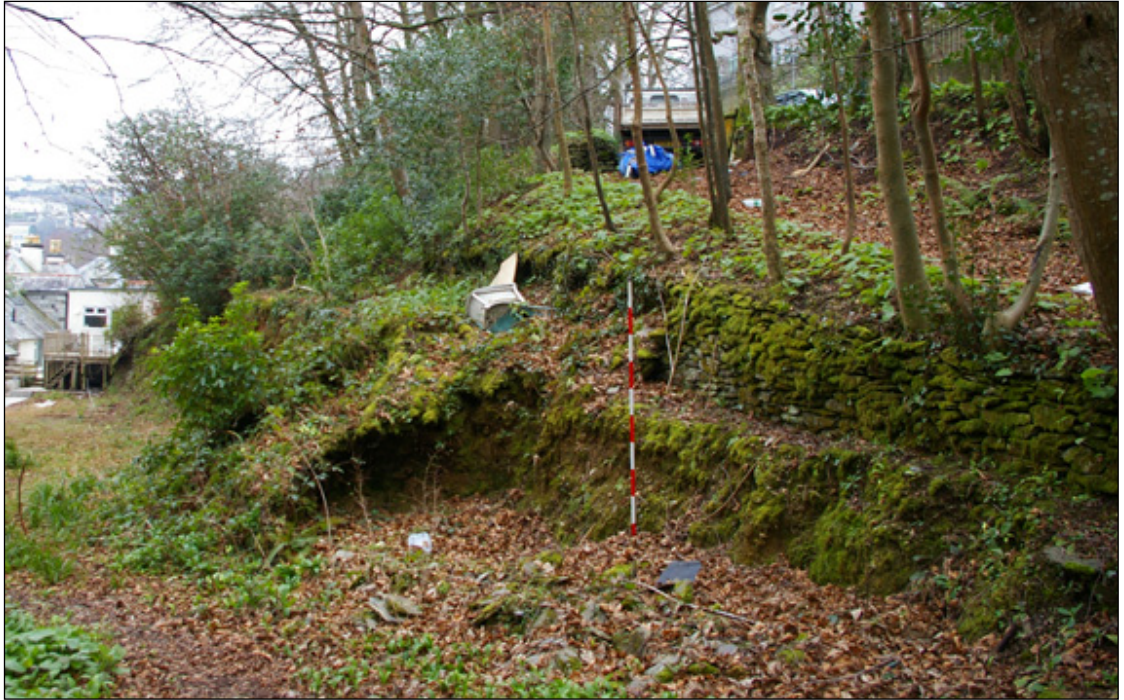
Figure 22: The modern access track to the east of the former garage (van positioned in entrance), with a partially truncated pathway beneath, and the wider path further below, viewed from the west (2m scale).

To the east of the former opening, a modern access track rises to the south-east and joins the public road to the south. This access track is marked on the later 20th century maps and replaced the earlier access through the lower (blocked) opening to the west. Running alongside and below this, a pathway leads off to the east toward the rear (south) of the house, but this has been partially truncated where the slope below it has been dug away (see Figure 22). The bank to the south between it and the track above is stone faced and to the north is the lower track or former drive up to the garage – the spoil from where the path has been partially dug away is dumped to the north of the lower drive. It was not possible to follow the central pathway for any distance as vegetation growth and modern buildings to the south-east of the main house have obstructed it.

The cartographic sources (Figures 3-5) suggest that to the east of the garage and between the two pathways (shown in Figure 22) was a small sub-rectangular building. There was no physical trace of this structure, although it appears that there may have been some further modern truncation of the bank between the two paths, which may have removed some/all trace.

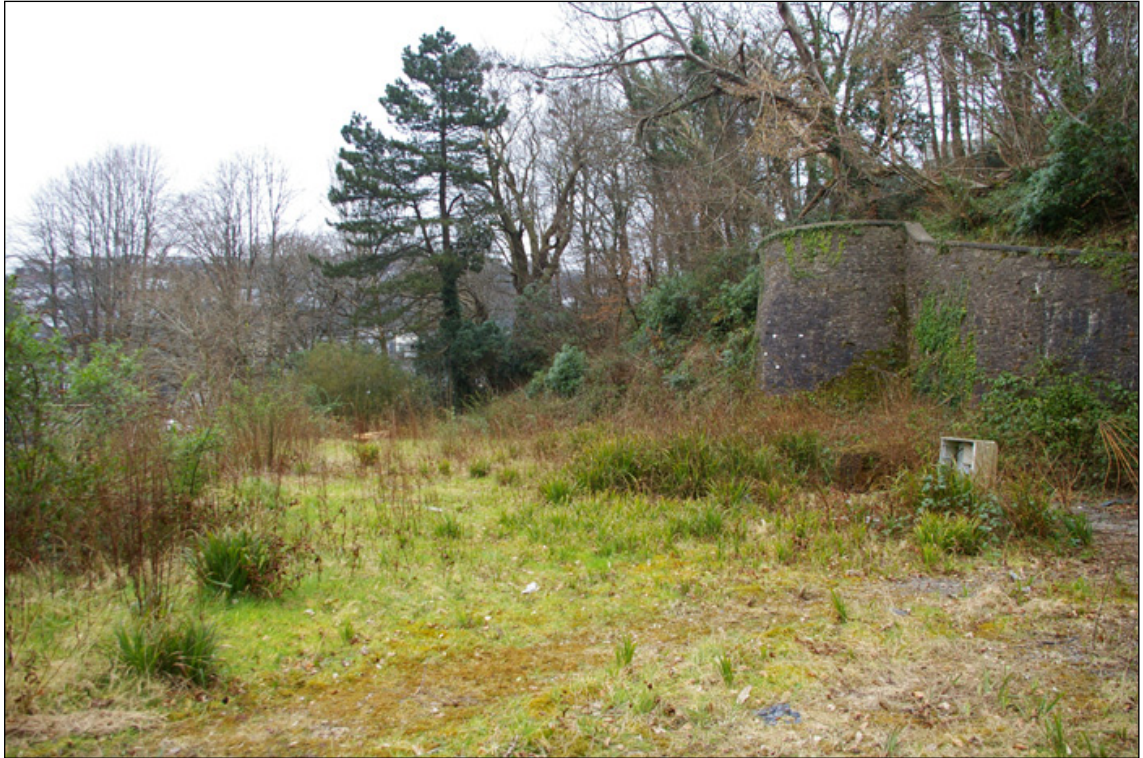
Figure 23: The levelled garden area to the east of the house, viewed from the west.

Immediately to the east of the building is a levelled area of former garden, with further sloping woodland to the south, east and north and with an imposing three tier sequence of rubble stone retaining walls and paths to the south (see Figure 23).

The levelled area contains remnants of concrete paths, chippings and cemented areas and to the east, the base and foundations of a possible (modern) former summer/green house set in modern cement. No historic garden features or planting were observed.

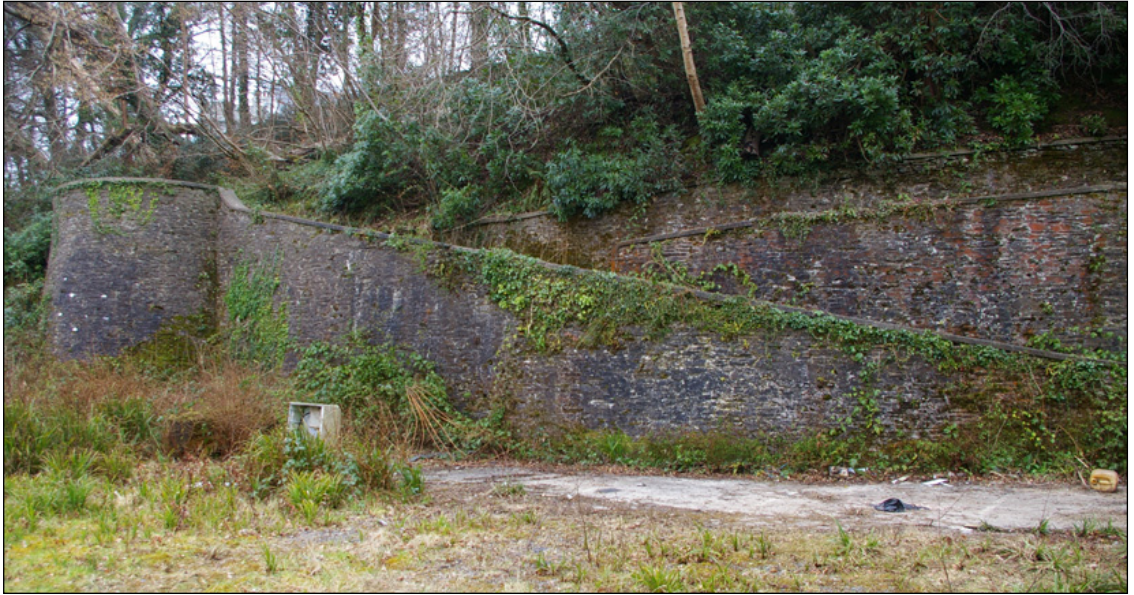
Figure 24: The tiered retaining walls and viewing platform tower to the east of the house, viewed from the north-west.

To the south-west of this levelled area, a semi coursed rubble stone wall with cement slab capping rises up to the east to form a semicircular viewing platform. A ramped path to the south of the wall rises from a ground level rubble stone platform associated with the ballroom, to the west giving access to the viewing tower, formerly planted with a central tree (now just the stump remaining), and a further path, set between the central retaining wall and a higher structure joins it just to the west of the platform. This path possibly formerly linked with the truncated path to the west of the house (see Figure 22). To the west, at the south-west corner of the ballroom structure, at the level of the path and below at ground level, dripping lead water pipes project from the wall forming a possible former water feature or possibly marking the route of a former water supply? At ground level a brick arch has been constructed over the corner as if to make a feature of it.

To the east of the viewing platform tower the path continues eastward into the woodland, but has no obvious structural component, is overgrown and appears to peter out toward the eastern extremity of the property. No further garden features were observed during the survey.
