25 SOUTH STREET GREAT TORRINGTON DEVON

Results of a
Historic Building Assessment

Report No.: 140109
Date: 09.01.2014
Author: Colin Humphreys

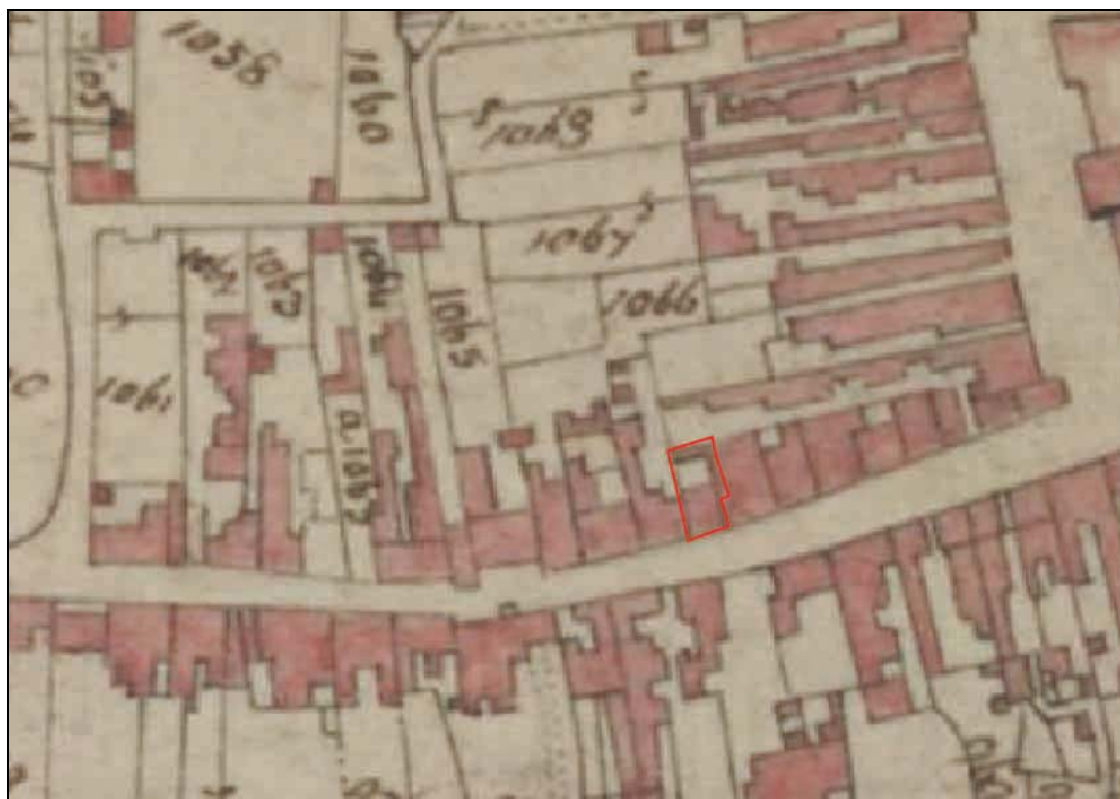
The tithe map of Great Torrington (Figure 2) illustrates the rectangular plot of Number 25 with the building set against the road. The tithe map suggests that at this time the building probably only consisted of rooms R1, R2 & R3 (see Figure 6 for room numbers) with a yard to the north and outbuildings to the rear of the plot. The rear of the plot (and the adjacent buildings are accessed from a back lane running from an opening to the east in South Street.

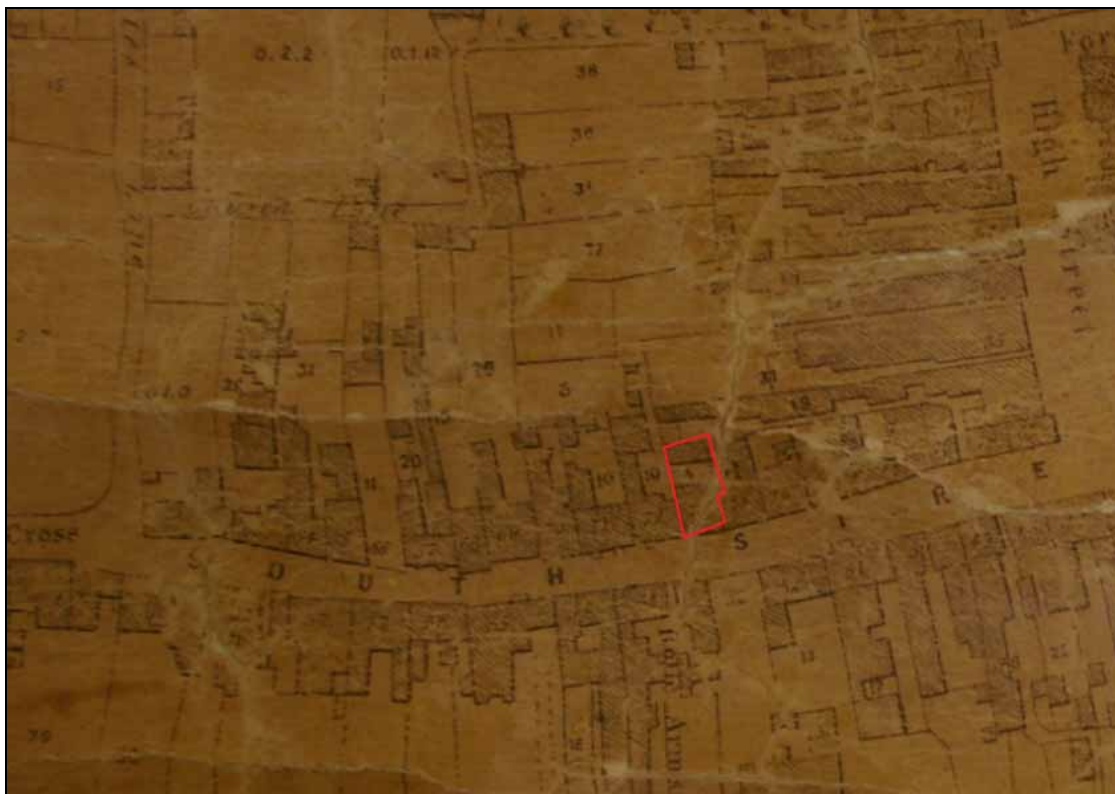
This 1843 map shows the property in similar detail to that shown on the tithe (Figure 3).

Figure 3: Extract from Browns Torrington Town map of 1843, the site is indicated.

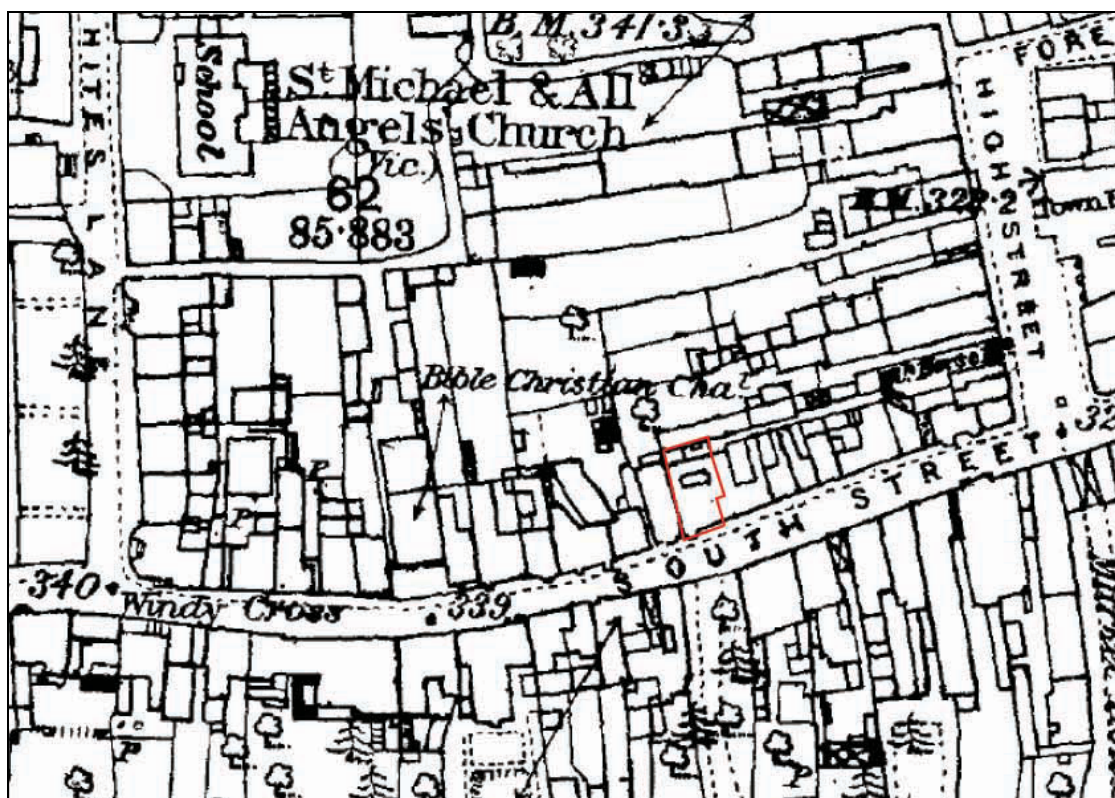
The First Edition OS map shows alterations to both the front and the rear of the building (Figure 4). A detail marked on the map on the left hand road side of the building suggests a porch/doorway; if this is the case it is likely to have been inserted when the side passage (R1) was built to give independent access to the rear of the building and the first floor. It also appears that the yard is mostly built over leaving only a small open area at the rear of the building rather than the former yard.

Figure 4: Extract from the First Edition Ordnance Survey map of 1888, the building is indicated.

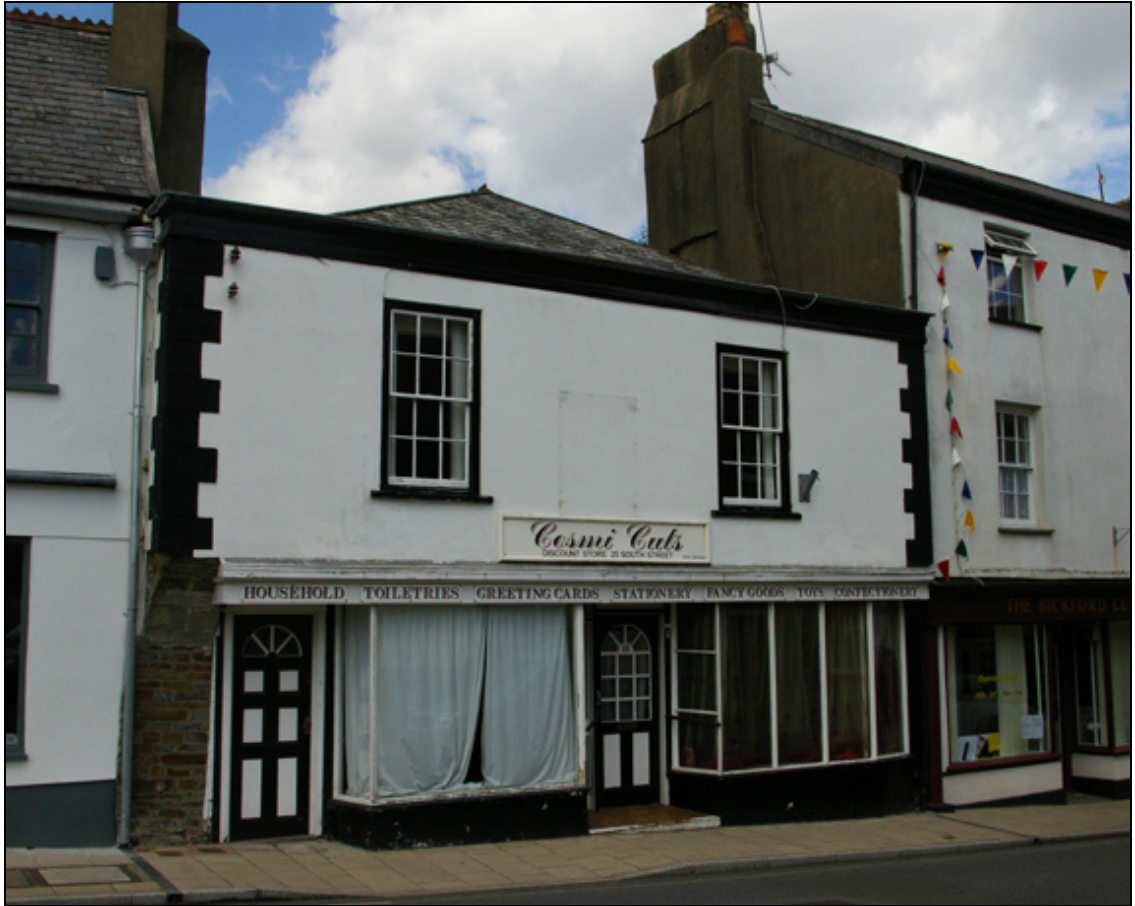
The street elevation (south) consists of a mid-20th century shop front with a central door and a second door to the left (west). The first floor is slightly jettied and supported on corbelled side walls with a pair of forward fixed hornless sash windows. Mock quoins have been added to the first floor to left and right (Figure 7). Above, large chimney stacks project from the walls to left and right. The doorway in the centre of the elevation gives access into the shop (R2 & R3), that to the left accesses a passageway that leads to the rear of the building (R1).

Figure 7: View of the building from South Street.

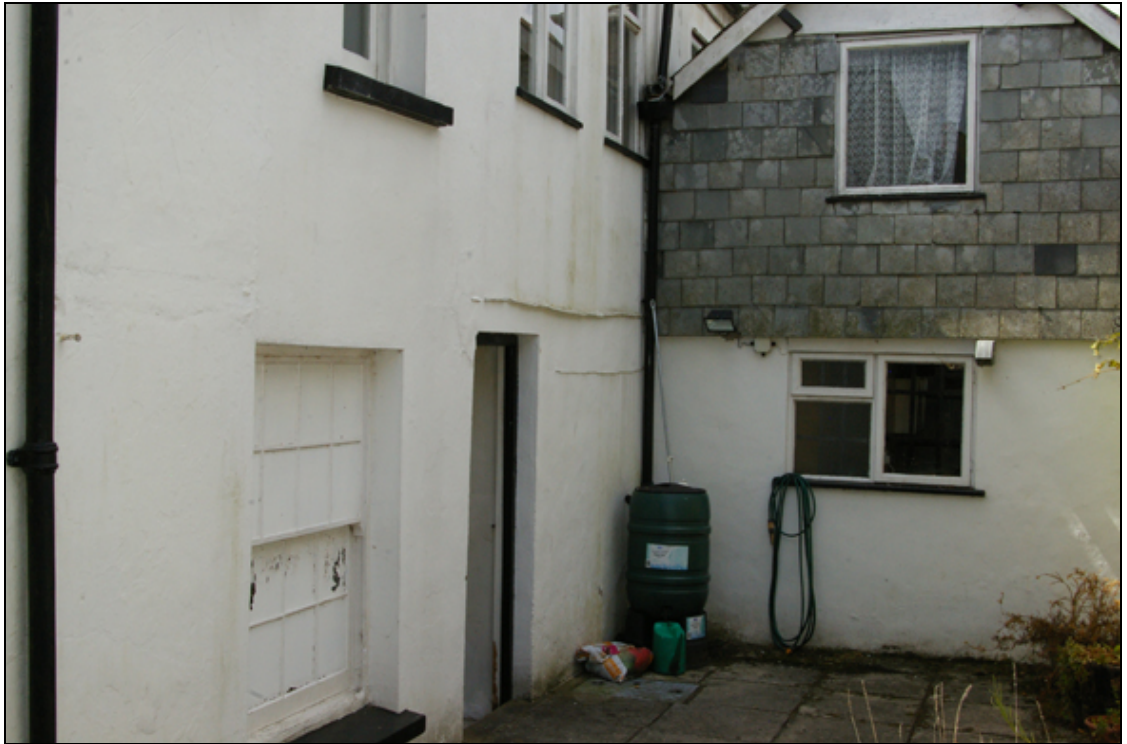
To the rear (north) of the building is a small yard, to the left (west) of which is a two story extension with a pitched roof (Figure 8). To the right (east) there is another similar extension, but not as deep, that overlaps the former plot boundary (Figure 9). Between these extensions is a more modern two storey build with a flat roof.

Figure 8: View of the left hand (western) part of the yard.

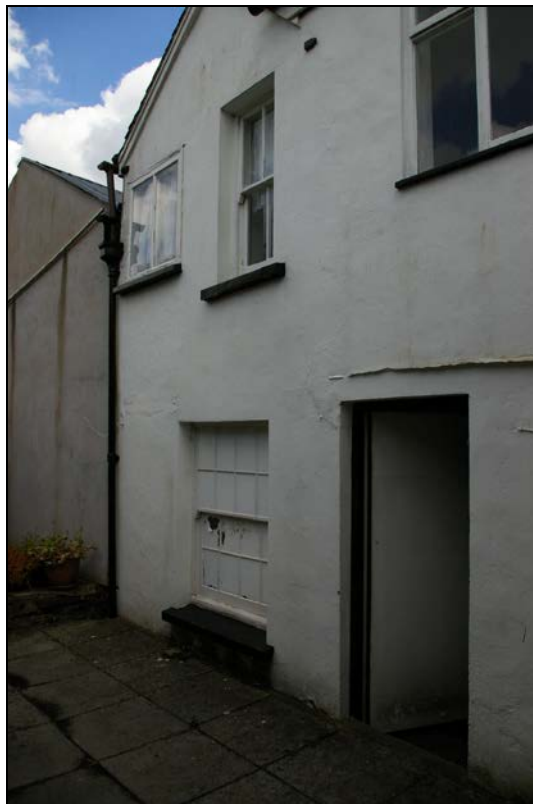
Figure 9: View of the right hand (eastern) part of the yard.

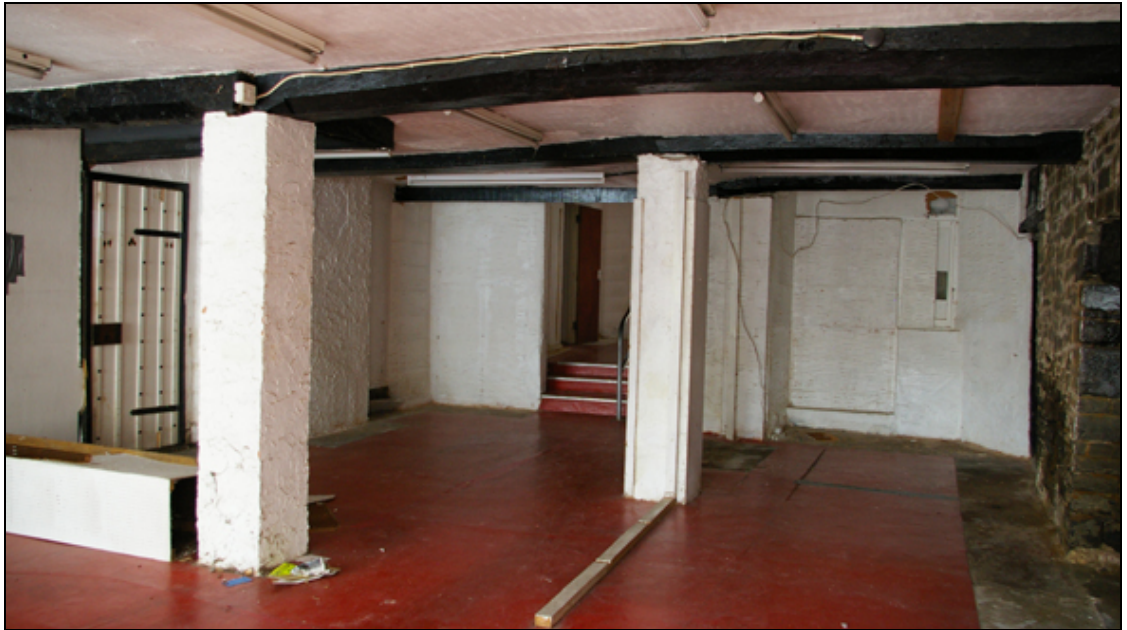
The ground floor shop interior is now a large open space (R2 & R3 - see Figure 6), broken only by a series of modern pillars which support the ends of the heavy timber chamfered and stopped ceiling beams (Figure 10).

Figure 10: General view of the shop interior (R2 & R3) from the street doorway.

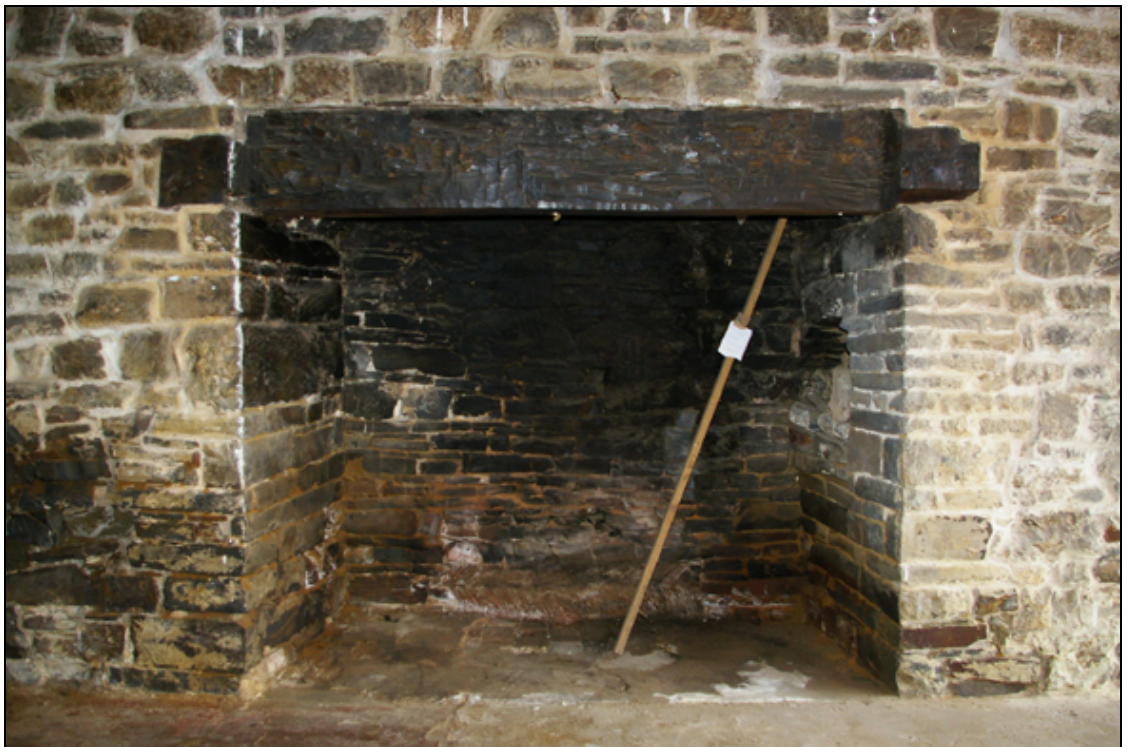
To the right (east) is a large open fireplace (Figure 11) and to the left of the fireplace is a doorway, with a cupboard above (Figure 12). The door and the cupboard are of mid 17th century date but are likely to have been reset. The door passes through the original eastern boundary wall, into the adjacent property and to an extension at the rear (north) of the building (R4, R6 & R7). Within R4 is a blocked alcove, with a relieving arch above, set into the left hand side of the chimney stack in R4 (Figure 13)

Figure 11: The fireplace to the right (east wall) of Room 3 (R3).

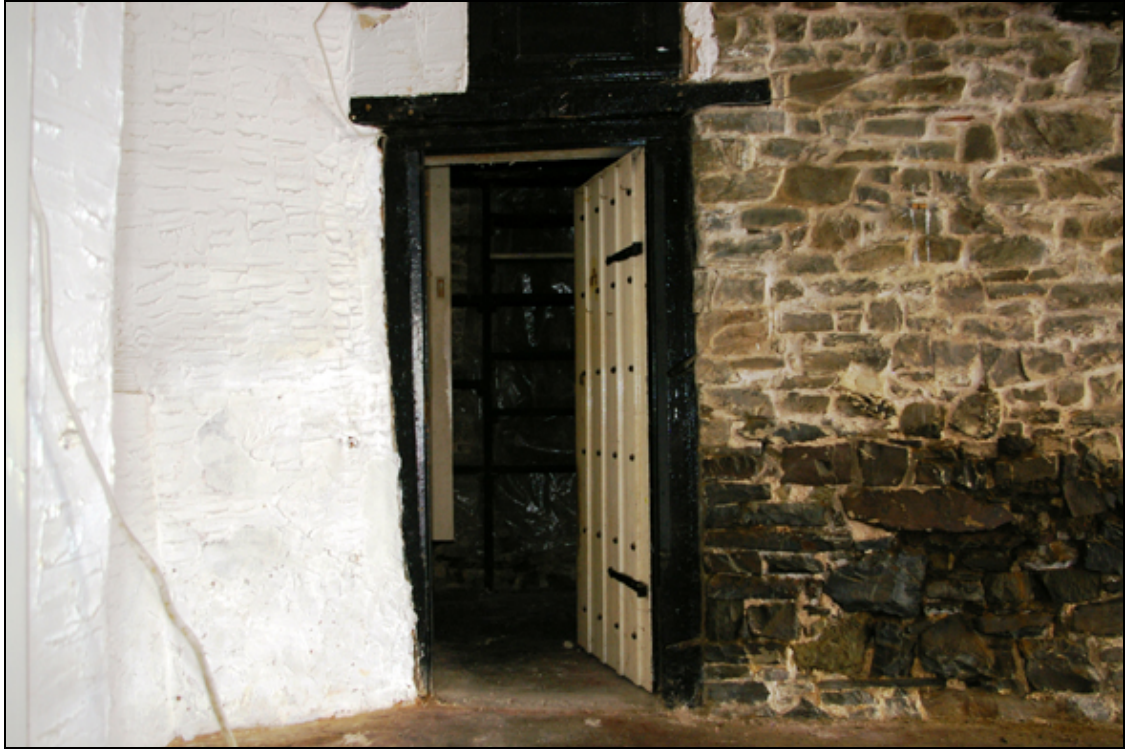
Figure 12: The doorway and cupboard to the left of the fireplace in the east wall of R3.

The door and frame to the left of the fireplace are of 17th century date, but most likely these have been reset, possibly from elsewhere in the building, as this doorway is forced through the (burgage plot) boundary wall to form a small room in the neighbouring plot to the east.

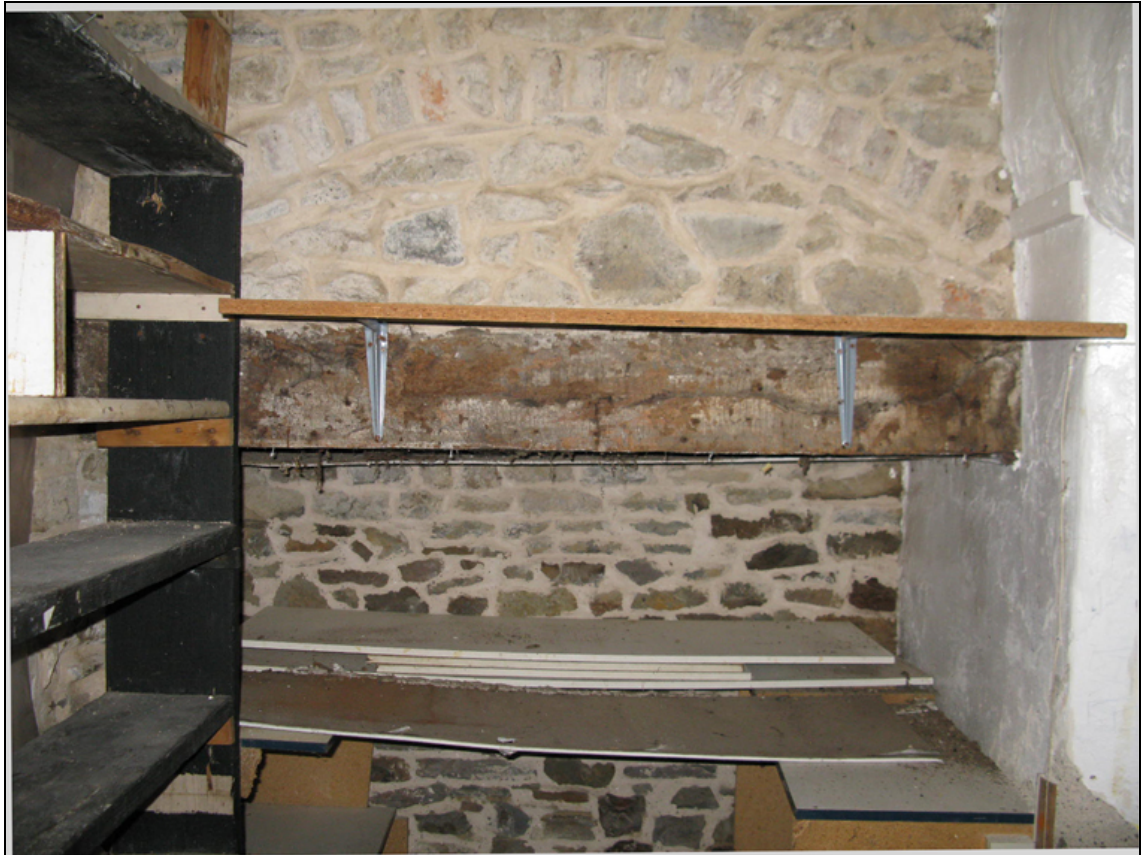
Figure 13: The arched feature in R4, set into the back of the chimney stack in R3.

It has not been possible to give a function for the alcove with relieving arch in R4, which is set into the left hand side of the chimney stack in R3 (Figure 13). Recent repairs may have removed detail, however it would appear likely that this was part of the 19th century remodelling works.

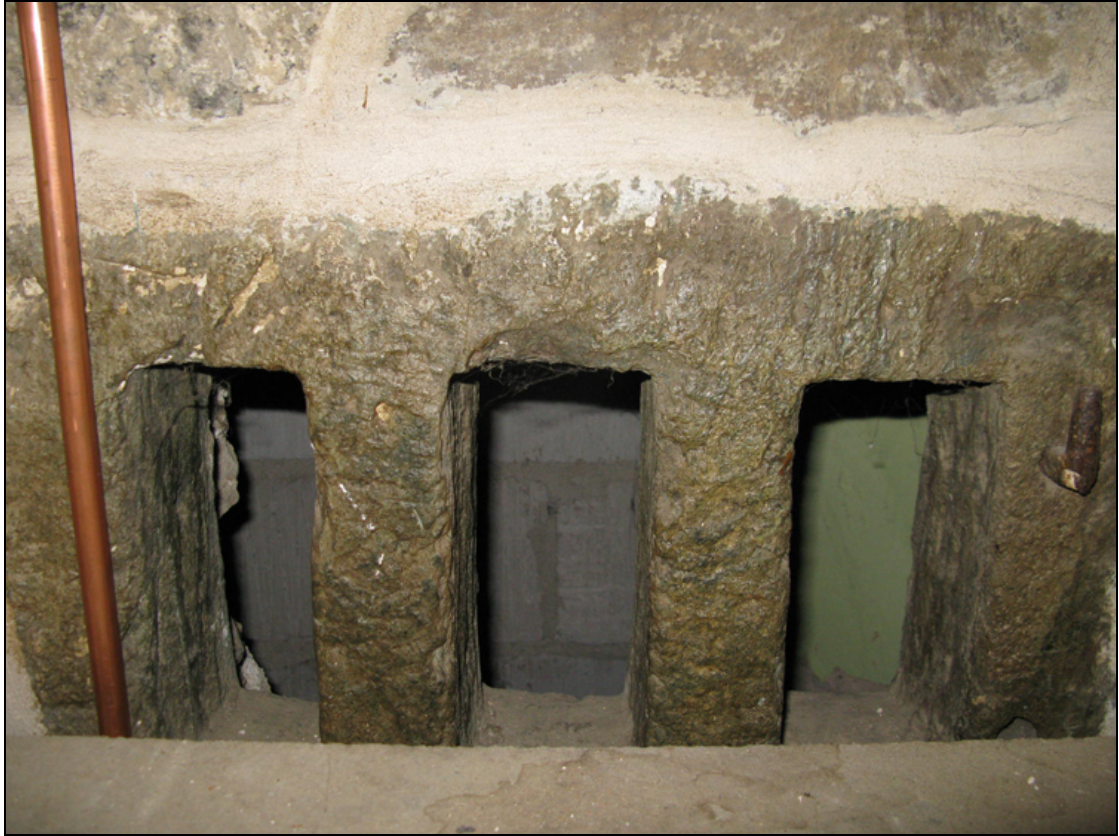
A large chimney stack projecting upward from the boundary wall to the left (west) may indicate that the left hand room was formerly also heated. However, if it was, the evidence has been mostly lost when the passage (R1) was inserted on this side of the building. The stone grate (Figure 14) set into this boundary wall, that vents a closed cupboard/fireplace in the adjoining property, may be indicative.

Figure 14: The stone grate set into the left (west) boundary wall.
