THE RED LION 56 EAST STREET ASHBURTON DEVON

Historic Building Recording
&
Archaeological Monitoring

Report No.: 140527
Date: 27.05.14
Authors: S.Walls
D. Laing-Trengove
J. Bampton

**The Red Lion
56 East Street, Ashburton
Devon**

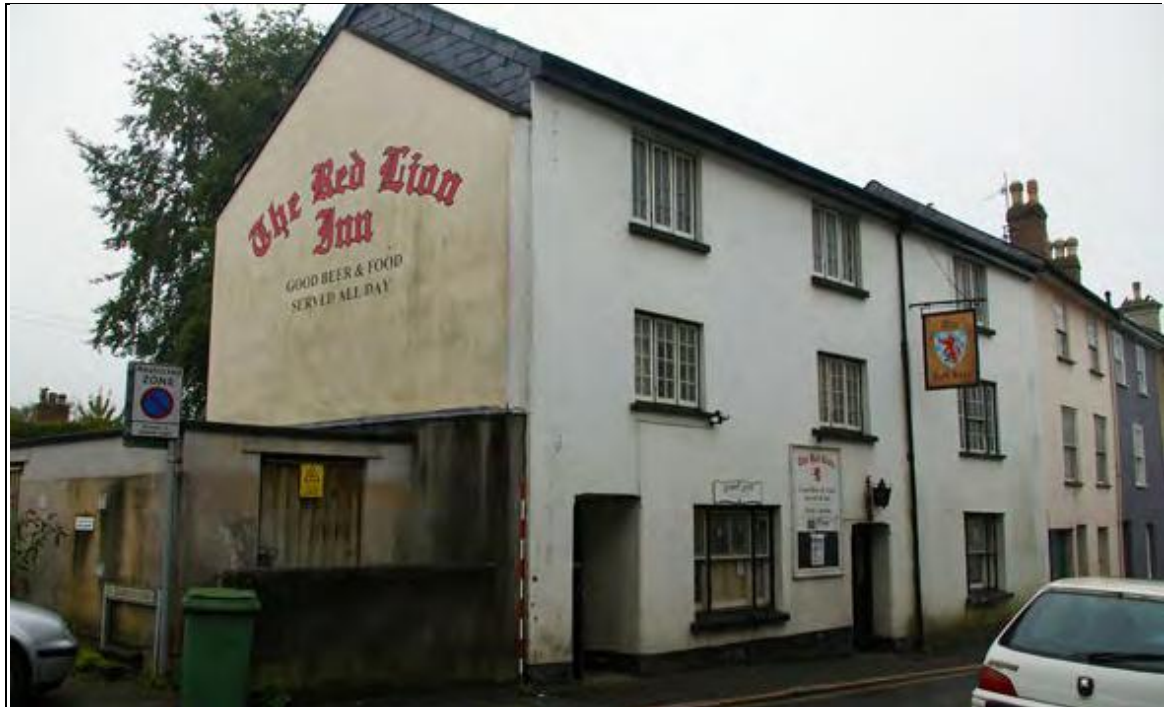
Figure 7: The north and east elevations of the building, from the north-west (2m scale).

The east elevation has an apparent secondary gable wall, with a lower roofline, against the higher east wall of the building which is slate hung above the line of the lower secondary gable (Figure 7). This probably represents the remnants of a former two storey building located here in

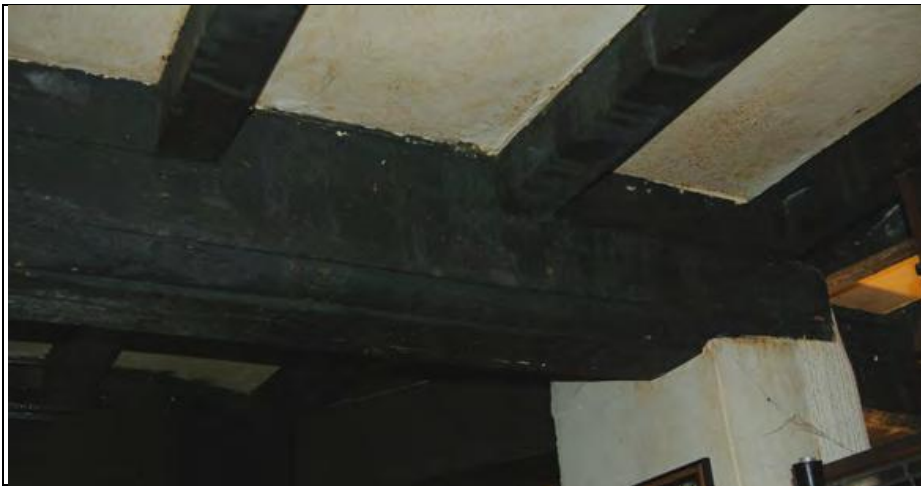
Figure 8: The truncated 17th century moulded beam in G3, from the south.

Much of the remaining interior detail of the original main range, on the ground floor comprising rooms G1, G2 and G3, with F1-4 and S1-4 above, appears to date from the 19th century (see Figure 11) . Historic elements and detail are minimal with some 19th century elements on the ground floor such as boarded panelling and a chamfered transverse beam within G2. The beam appears to continue through the partition to the east to straddle the passageway (G1), where the chamfer also fits the space. There is an earlier truncated large ovolo moulded beam straddling the former cross passage in G3 that probably dates to the 17th century (Figure 11).

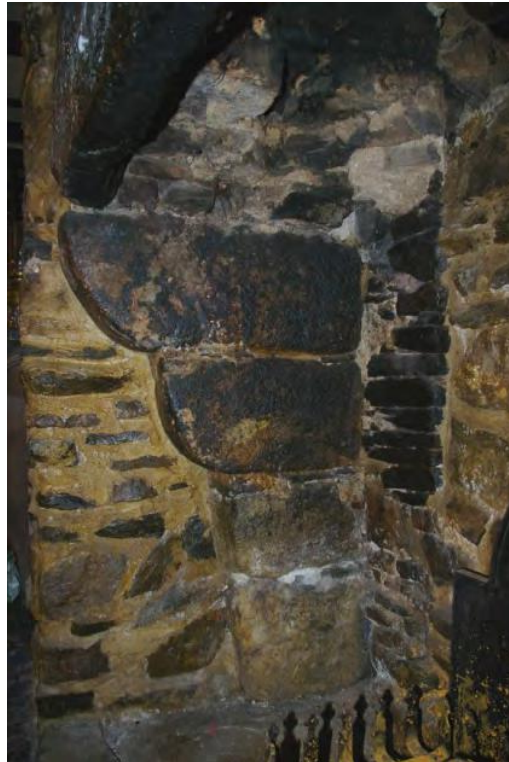
Figure 9: Detail of the corbels to the west of the opening within the fireplace in room G2, from the west.

The most notable historic feature of room G2 is the fireplace in the south-east corner. The opening has a large granite lintel supported on pairs of rounded granite corbels that step back into the fireplace to either side, and are supported on large stone blocks (Figures 9 & 10). The stonework to either side above the opening projects outward leaving a recessed space, and the large bressemer stone contains a number of pairs of holes, some with plugs remaining. This suggests that the fireplace formerly had a decorative plaster overmantle. To the interior of the opening there are two straight joints in the masonry edged with blackened stones, suggestive of a former opening in the back of the fireplace into a chamber (oven?) to the south.

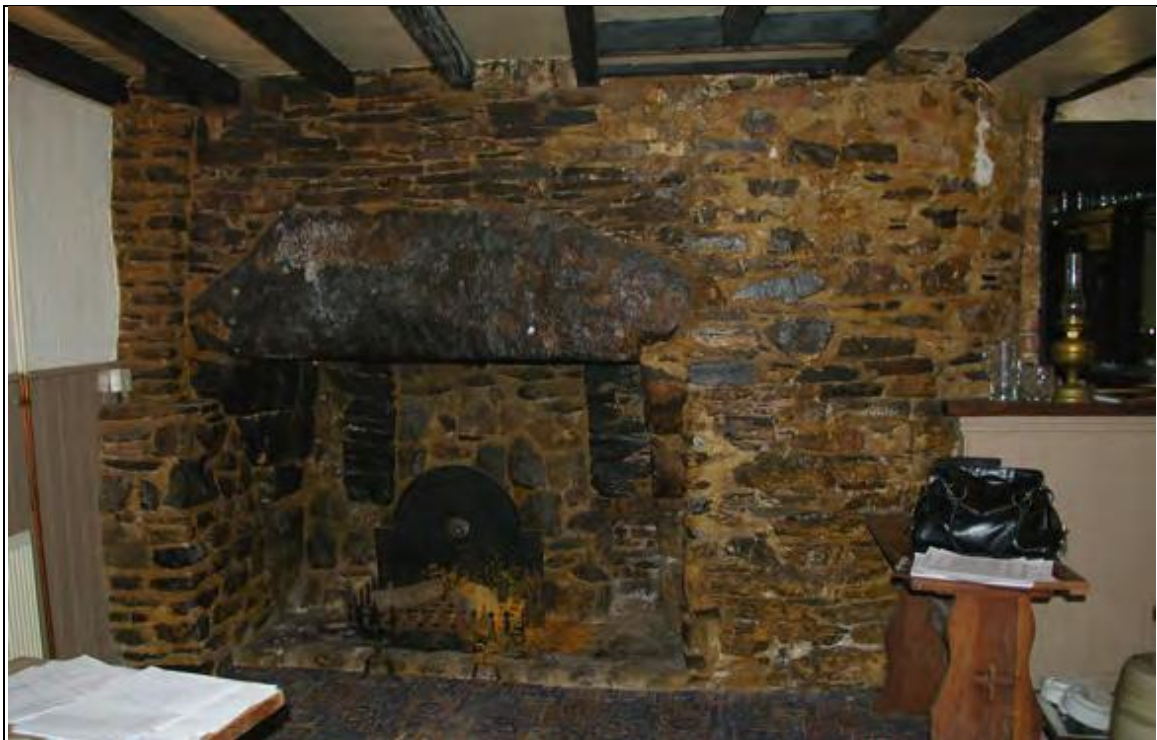
Figure 10: The fireplace in the south wall of G2, from the north.

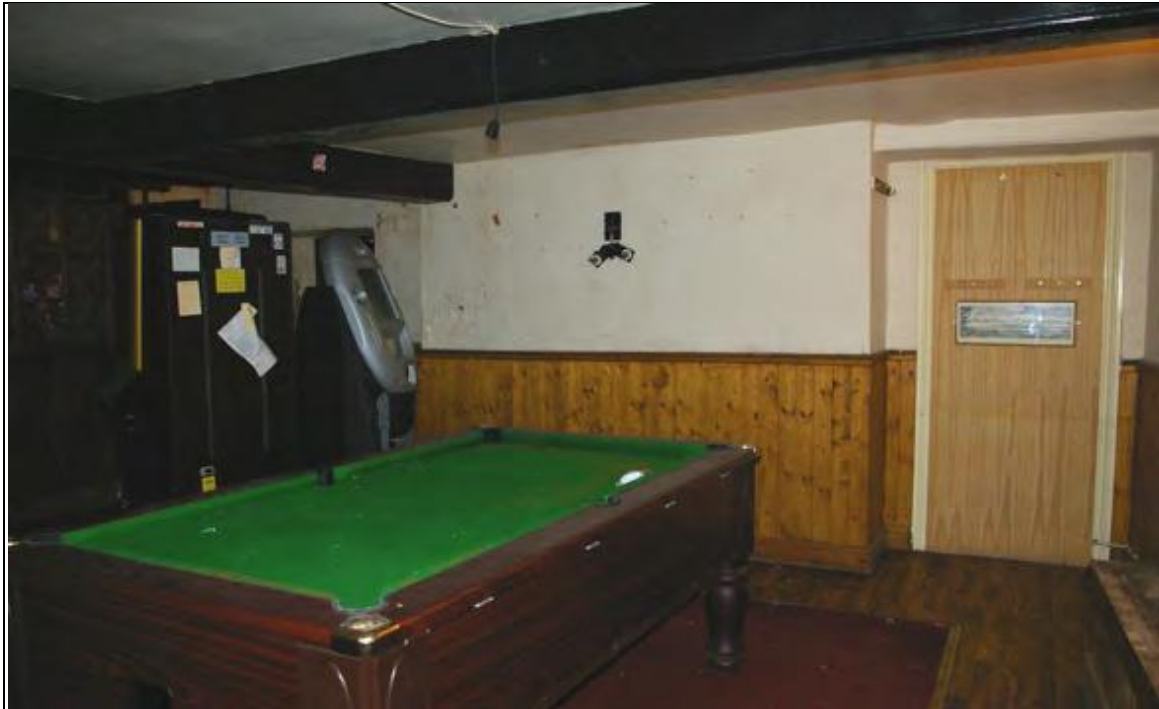
Figure 11: The interior south wall of the former games room (G3), with fireplace projection to the centre and forced opening to the right, with former cross passage to the left; from the north-east.

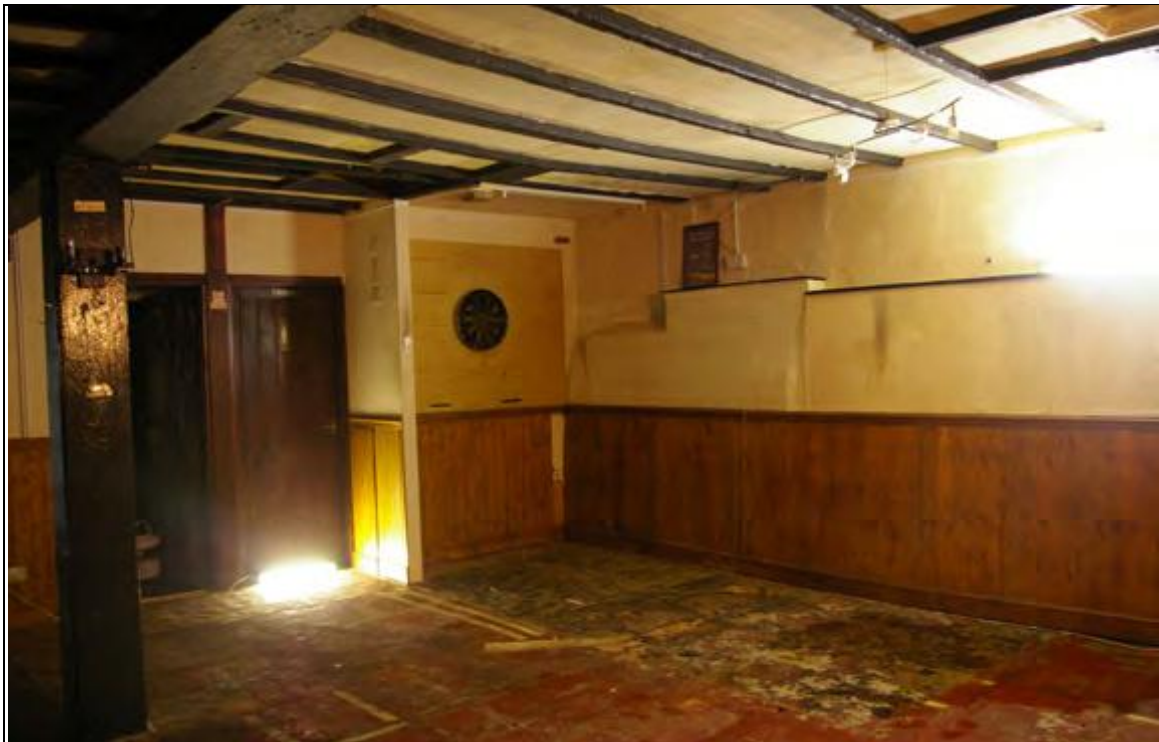
Figure 12: The south-west corner of room G4, with irregular west wall and toilet block to the west, from the north-east.

To the rear (south) of the main range little of historic merit was noted, with most elements such as walls, ceilings etc being relatively modern in appearance. However, the west wall has significant changes in width which suggests that this is a phased structure (see Figure 12). During the subsequent monitoring these different phases became more apparent.

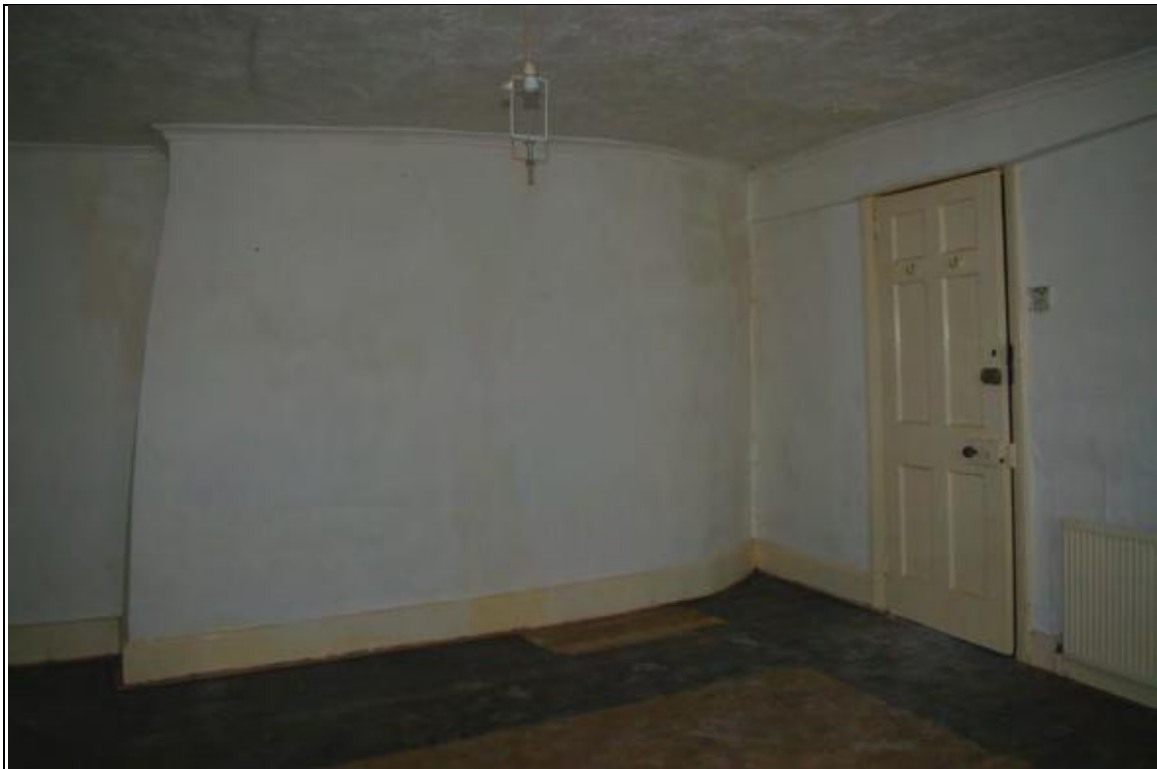
Figure 13: The chimney projection within the south-west corner of room F2, from the north-east.

In bedroom F2, located above G2, the south wall projects into the western part of the room, curving to the south-west in the same way as in G2 below (Figure 13). There are no opening for a fireplace but there is probably a blocked opening within the projection as the dark stain on the floor boards delineates a rectilinear patch against the base of the wall. To the west the wall has what appears to be a timber projecting from and running along the top of the wall – possibly a former roof timber? The floor level is slightly raised in rooms F4 and S5 to the west which suggests that the insertion of the first floors to the east and west was of different phases. This may be used as very tentative evidence to suggest that the original layout of the building may have been similar to 5 East Street, with a solar and open hall, and with flooring over the hall added as a later date (17th century?).

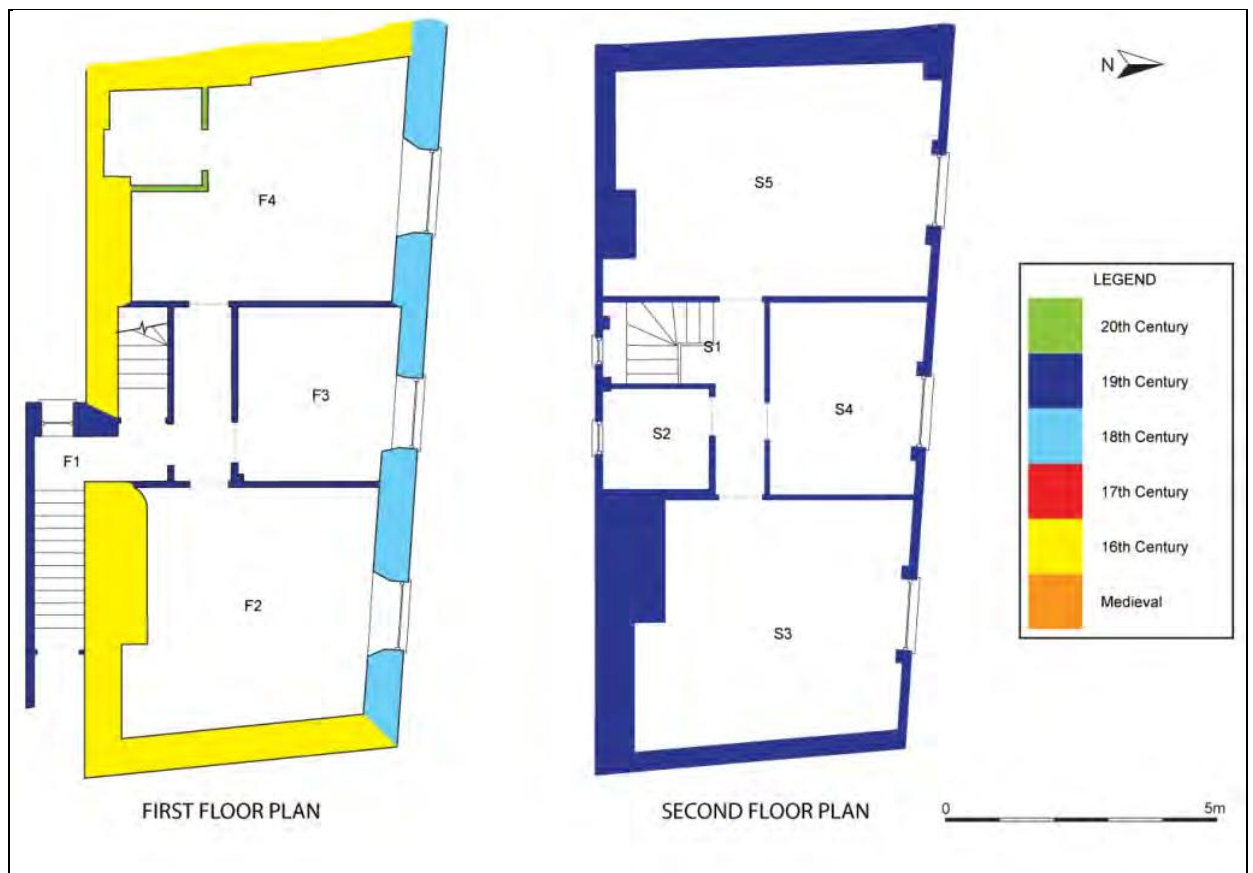
Figure 15: Phased first and second floor plans of The Red Lion, Ashburton.

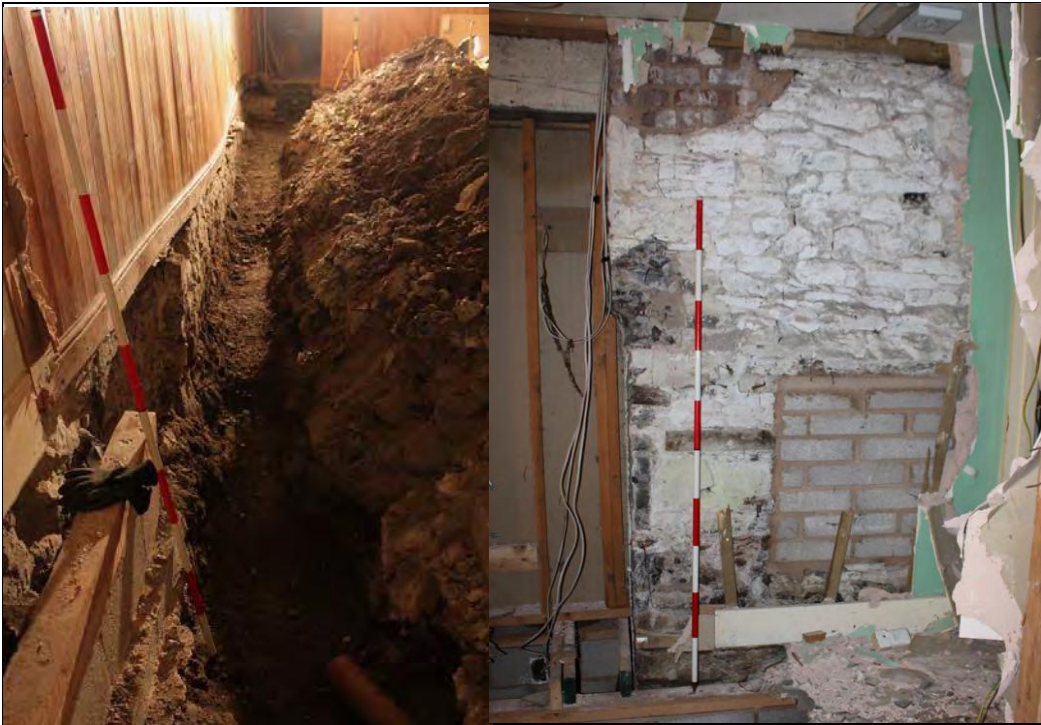
Figure 16: Sewer trench in G4, showing change in the build of the west wall, from the south.

Figure 17: The east wall of toilet block G5, from the south-west.

The service trench ran along the west wall of the bar and roughly 5.90m from the north wall of the front range a change of build was noted in the west wall, with the wall face set back slightly from that to the north and which it appeared to abut (Figure 16). Of the 5.90m length of the west wall, up to 9 of the lower courses were viewed. Exposed up to 1m high, the upper courses were bonded with a creamy yellow mortar, which was quite soft, with no apparent inclusions, and were composed of blocky rectangular stones, 0.30 x 0.12m, slightly rounded and smooth. The lower c.5 courses were bonded with gritty dark grey earth with roots, with smaller, thinner and more angular stone c.0.10m x 0.06m. This wall abutted the north-west corner of the front range, although the earth bonded courses were not exposed here.

The plaster was partially removed from the east wall of the toilet block (G5) exposing the remnant of a former back block wall (Figure 17). The terminus of the wall appeared correct, but disturbance in the masonry in the upper portion suggests a possible door opening here. The wall contains what appears to be timber lacing (with forged nails and spikes apparent) to this potential opening and has had several repairs, with brick to the upper of the north end,

supporting the modern ceiling. A low former opening was exposed to the south, with a slim timber lintel set on timber pads, blocked with concrete block.

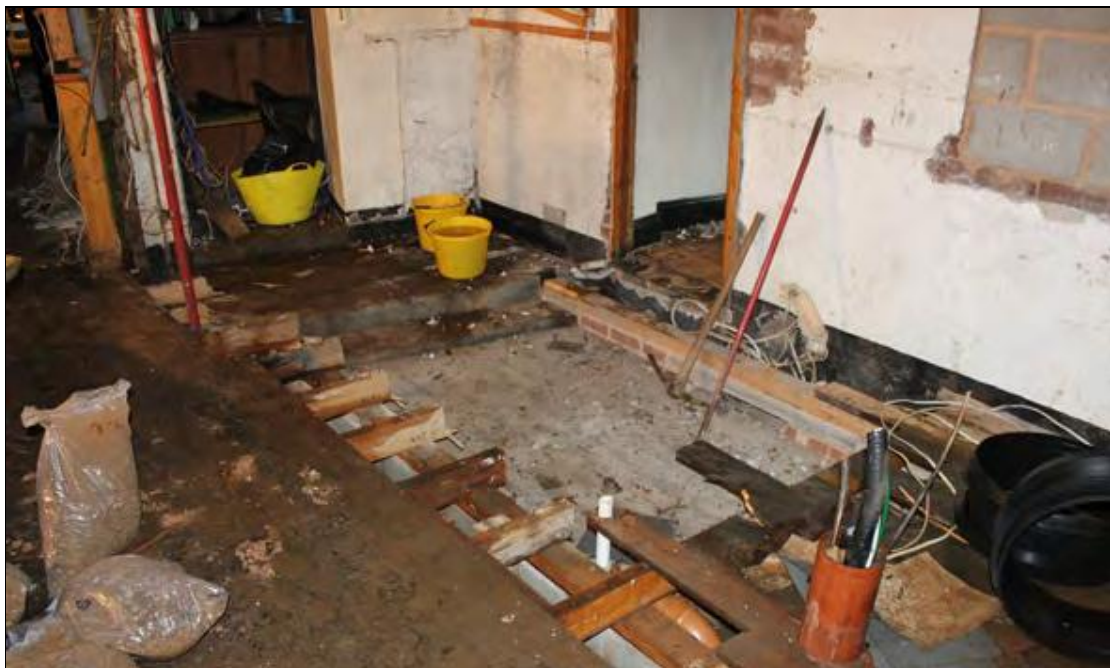
Figure 18: The removed bar area in the north-west corner of G4, from the south-west.

The modern bar structure in the north-east corner of G4 was removed, revealing a modern cement floor beneath (Figure 18). The wall to the east against the kitchen (G8) was revealed to be of modern brick construction with concrete block.

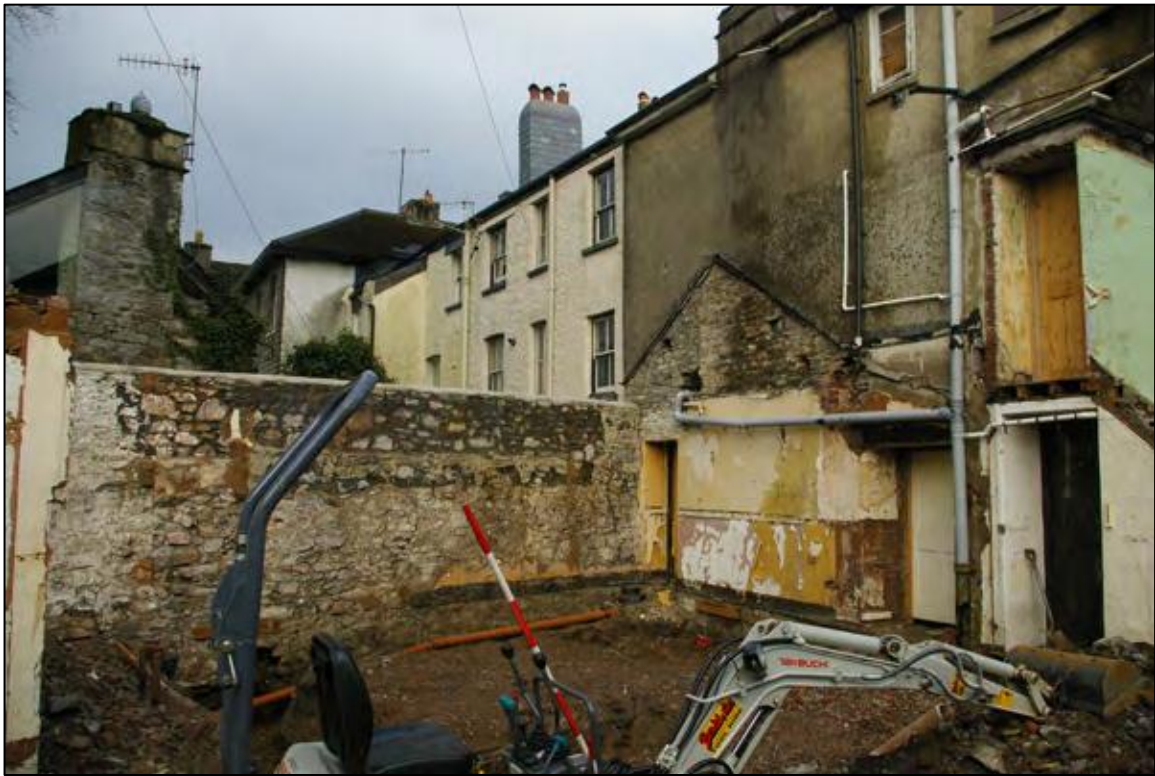
Figure 19: Site shot post excavation, viewed from the south-east.

The second phase of monitored groundworks consisted of the excavation of footing trenches within the former bar area (G4) and former kitchen (G8) following their demolition. These were excavated in a rough 'E'-shape (Figures 19 and 25). These footing trenches were excavated to a depth of c.1.30m below the original floor level, but c.0.60m below the reduced floor level post removal of standing structures and concrete floors.

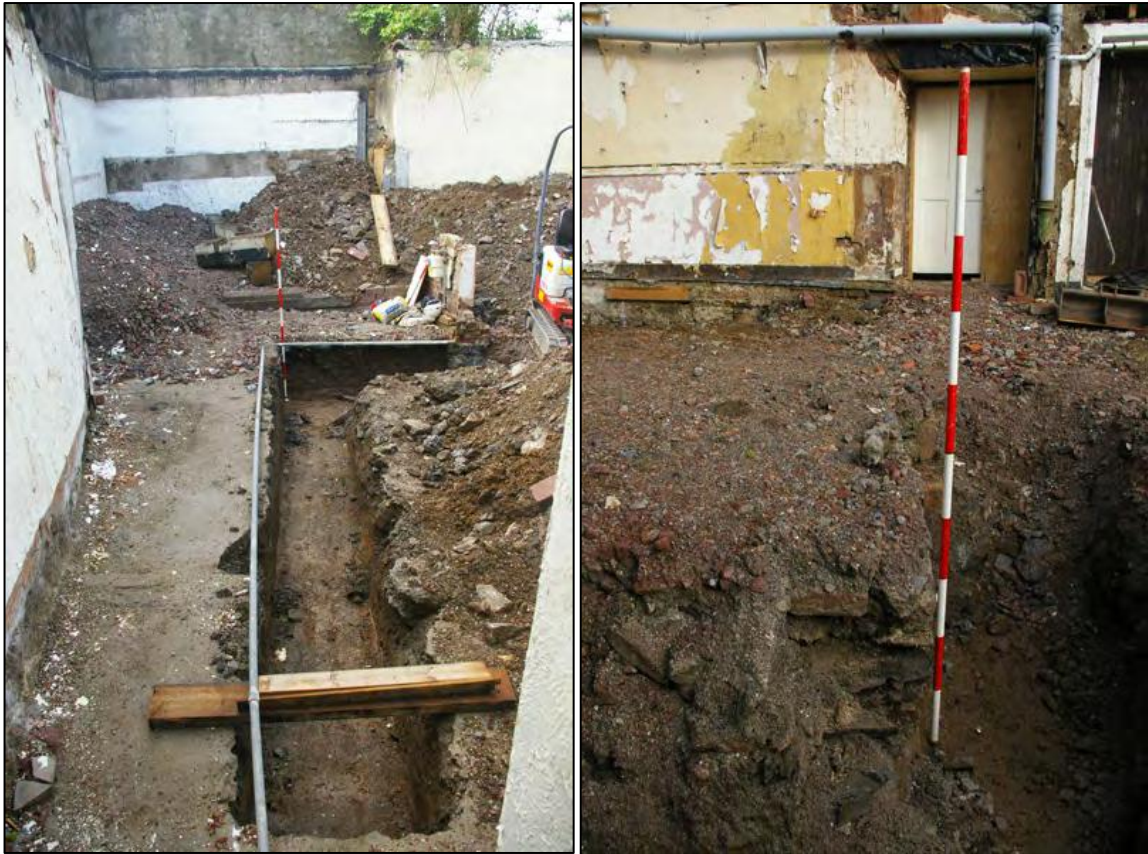
Figure 20: Eastern footing trench, viewed from the north (2m scale).

Figure 21: Middle section of footing trench showing Wall {108}, viewed from the south (2m scale).

The eastern portion of footing trench consisted of a reverse 'L'-shape running north-south for c. 5.50m before turning westward at its southern end for a further 2.50m. It cut through 20th century footings and rubble layers of 19th and 20th century date (made-ground layers (101), (102) and (103)) and Natural (104) (Figure 20). The natural comprised a yellow-buff, sandy loam. No archaeological features or deposits were encountered in this portion of the footings.

The middle section of footing trench cut through modern concrete foundations and rubble and natural. The footing trench did cut a c.0.50m wide historic wall footing, Wall {108} (Figures 21 and 22). Wall {108} was comprised of sub-angular to sub-rounded stones and granite fragments with a single hand-made brick noted. It was lined by a concrete block wall on its east side. This wall is aligned roughly-north-south in the middle of the former bar area (G4). Concrete block wall footings for the former toilets (G5) had disturbed and truncated the majority of the southern extent of the middle and western part of the footing trench. This concrete ground was also visible beneath the toilets in the south end of the earlier excavated drainage trench.

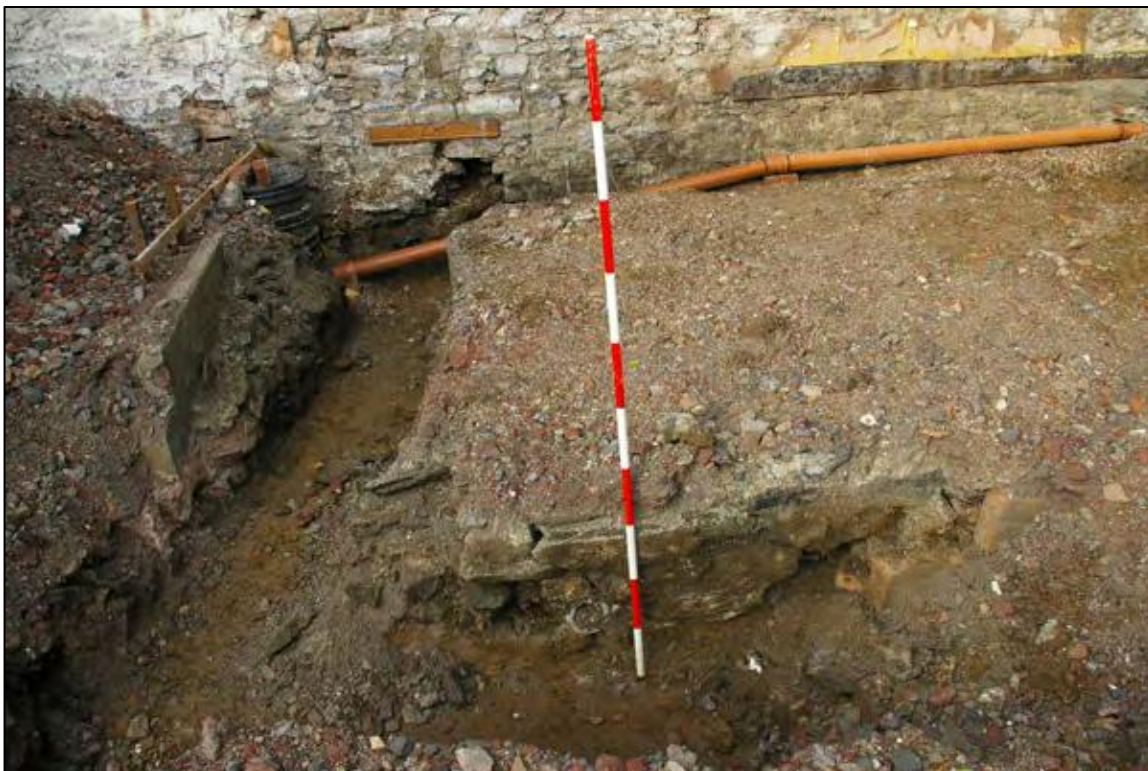
Figure 22: Middle and south end of footing trench showing wall {108}, viewed from east (2m scale).

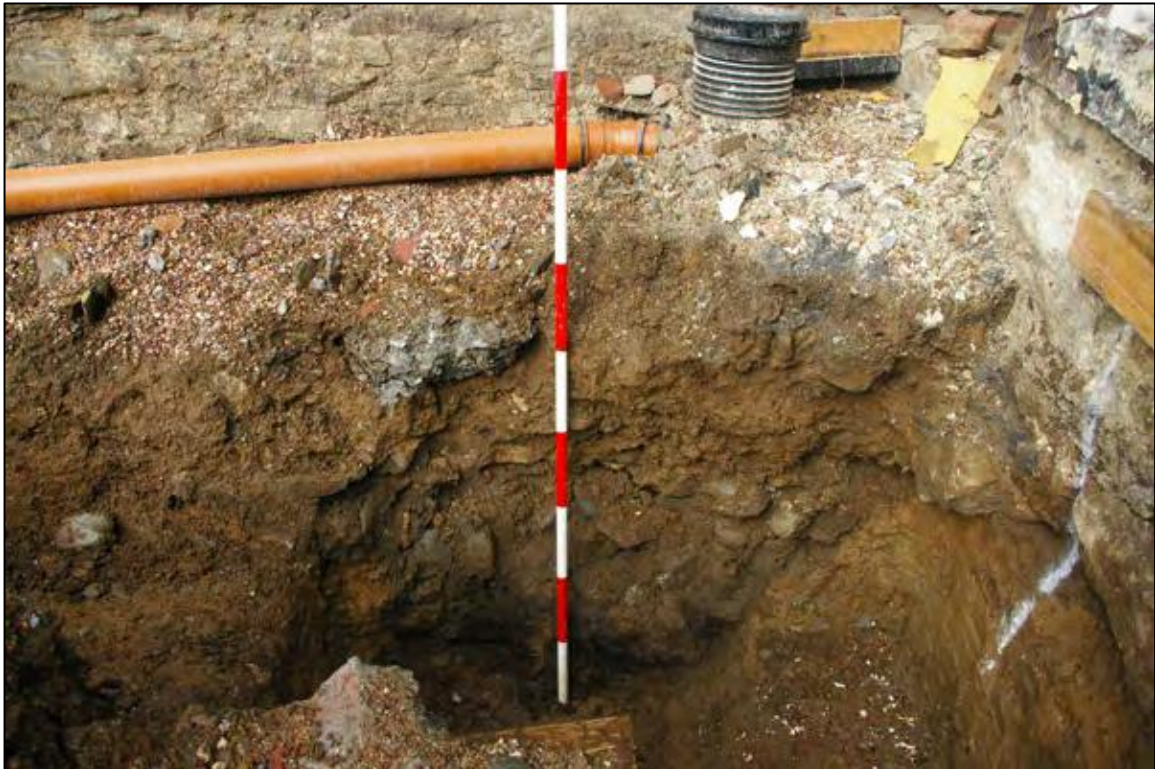
Figure 23: Pit [105] viewed from east (2m scale), note the modern drain is that lain during the 1st phase of monitoring.

The western segment of the footing trench cut through the same layers as those above. A single feature, Pit [105], was cut by the footing trench in the far north-west corner of the former bar area (G4) (Figures 23 and 24). Pit [105], c.1.60+m dia. and 0.76m deep, was an ovoid pit with moderate-steep concave sides and a gentle concave base located against the south wall of the main range (G3). It contained two fills, (106) and (107), lower and upper respectively. Fill (106), 0.24m thick, was a dark subtle green-brown grey, moist and soft fine clay-silt that produced no finds. Fill (107), 0.51m thick, was a light grey-brown, loose-soft silt-clay with common sub-angular stones. It produced no finds. The blocky sub-angular stones within fill (107), being generally towards the top of the fill may be suggestive of a remnant flat stone surface/consolidation of the pit. The feature appears to have been truncated by the overlying rubble made-ground layer (103), which suggests that there has been reduction in the levels within this former courtyard.

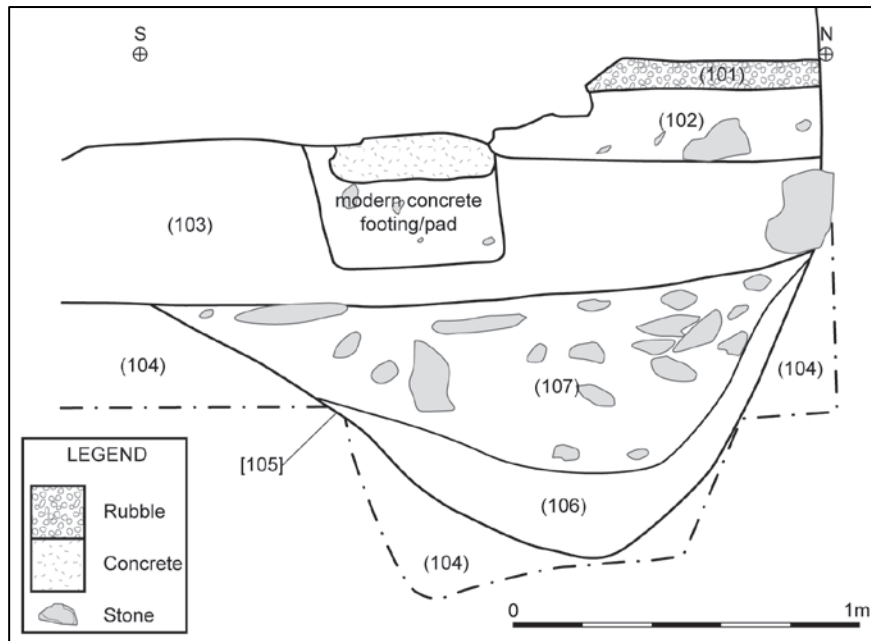
Figure 24: East facing section of Pit [105] and footing trench.

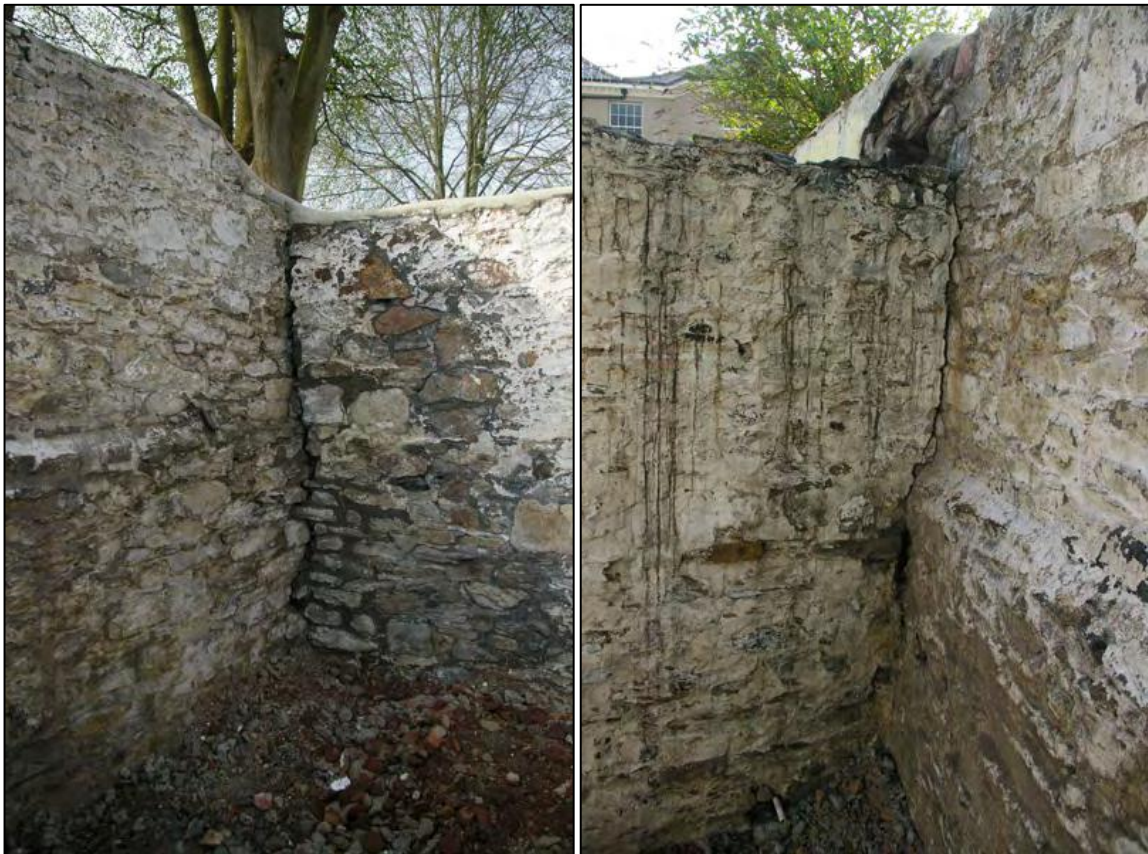
Figure 26: Abutting wall in south-west corner of toilet block (G5), viewed from the north-east.

Figure 27: Abutting wall in south-east corner of toilet block (G5), viewed from the north-west.

Prior to the excavation of the footing trench the demolition of the interior structures south of the main range allowed for a clearer view of a number of the standing walls. A rough phasing of these standing walls can be seen in Figure 14. The west wall of the bar (G4) (Figure 19) abutted the medieval west wall of the main north range (G3) and its build suggests it is probably of an early post-medieval phase, being raised in the 19th century. Its south end was abutted by the west wall of the toilet block (G5). The west wall of the toilet block also abutted the south elevation of the site (Figure 26) as did the east wall of the toilet block (Figure 27). The south elevation of the site and the east wall of G7 all appear to be of the same build quality and fabric, although with some later repair work (Figure 28). It appeared later than the east wall of the bar and was then abutted by later, probable 18th century walls and was thus phased to the 17th century. The east wall of the kitchen/hall (G8 and G1) appeared to then overlap and abutt the east wall of G7 (Figure 29); and the 17th century east wall of the hall by the main range (G1). These walls are all post-medieval and are phased relative to one another and based on relative comparisons of characteristics and similarity of build, although most had undergone significant 19th and 20th century modification and repair.

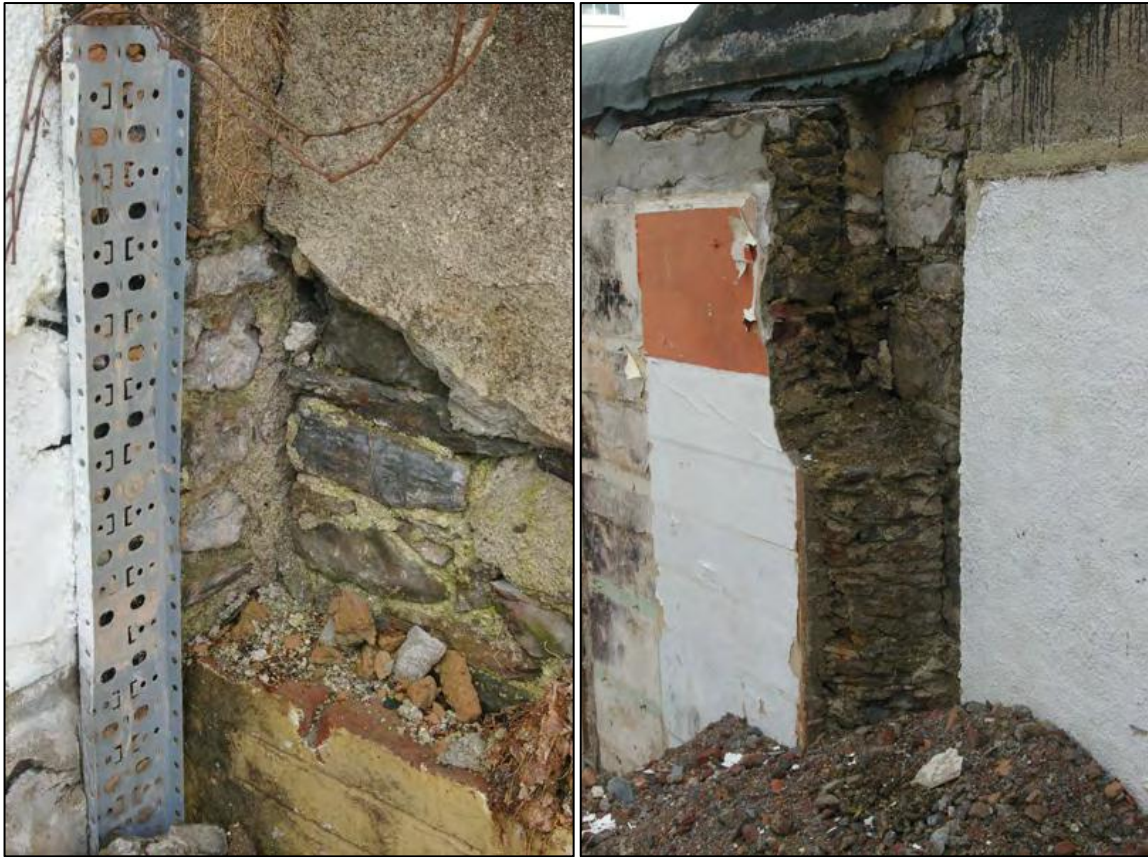
Figure 28: Build of east wall of kitchen/hall (G8/G1) abutting east wall of G7, viewed from south-west.
Figure 29: Kink in wall of south elevation, in south-west corner of G7), viewed from the north-east.

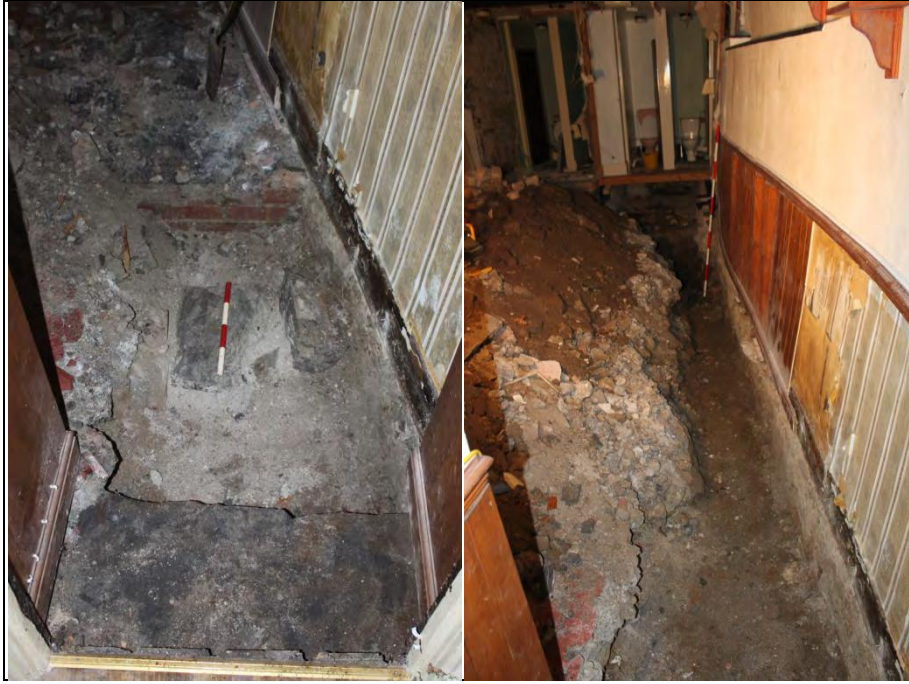
Figure 71: Dwarf wall noted in sewer trench in G4, from N.
Figure 72: Fully excavated sewer trench as above.

The service trenches were excavated to a depth of c.0.80m in the north-west corner of G4 through the modern concrete floor (Floor layer (100)), which overlaid rubble (Made-ground layer (101)) and a single coursed modern brick dwarf wall, 1.20m south of the dividing wall of the front (north) range. This dwarf wall suggests that there was formerly a (19th century) suspended wooden floor in this area, which was replaced in the 20th century by a mixture of concrete and timber floors. Within the rubble layer were several large unbonded stones, some worn as if they were former floor slabs, others sub angular and blocky (c.0.60m x 0.30m x 0.12m). Beneath the rubble layer was a dark grey yellowish-brown gritty silt clay with common sub angular stones and animal bone but no other finds (Made-Ground layer (102)).

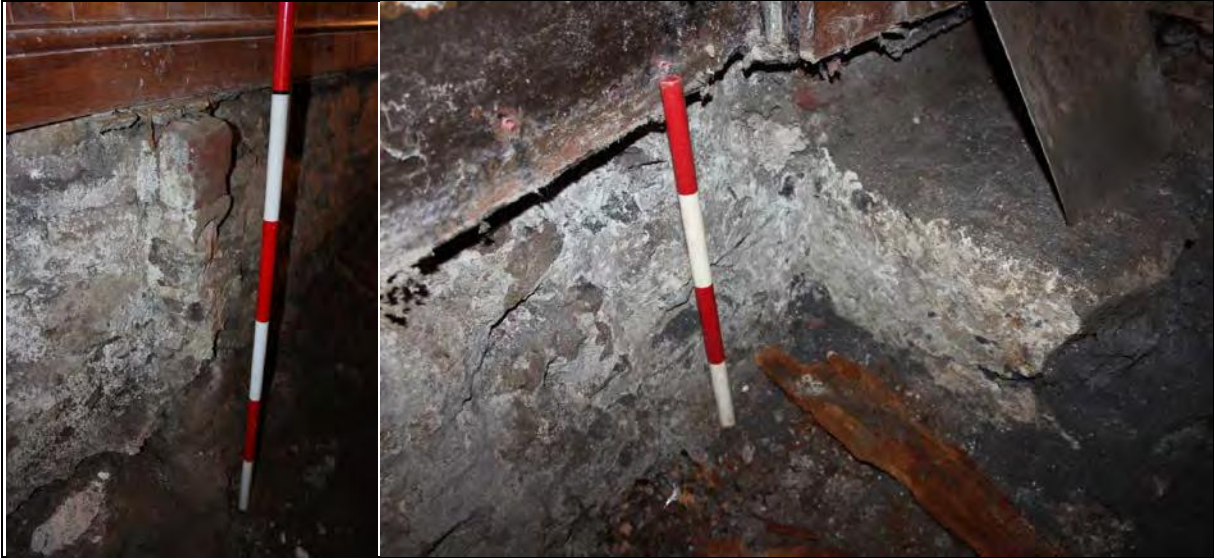
Figure 75: Left: close up of change of build in W wall of G4, from S-W.
Figure 76: Right: W wall of G4 abutting G3 N-W corner, from S-E.

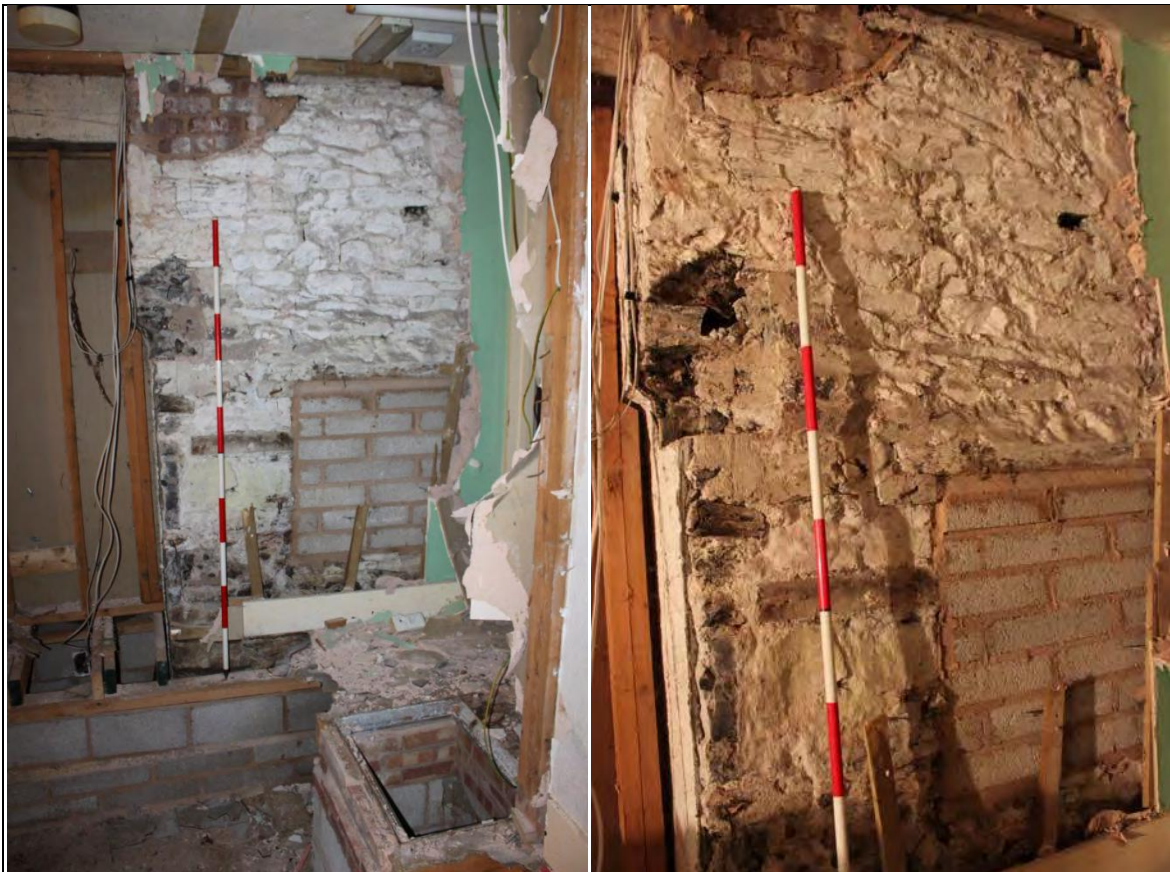
Figure 77: Left: E wall of toilet block G5, from N-W.
Figure 78: Right: close up of above.
