**LAND AT EAST STOWFORD BARTON
BERRYNARBOR
NORTH DEVON
DEVON**

Results of Archaeological Monitoring and Recording

South West Archaeology Ltd. report no. 300418

Land at East Stowford Barton, Berrynarbor, North Devon, Devon Results of Archaeological Monitoring and Recording

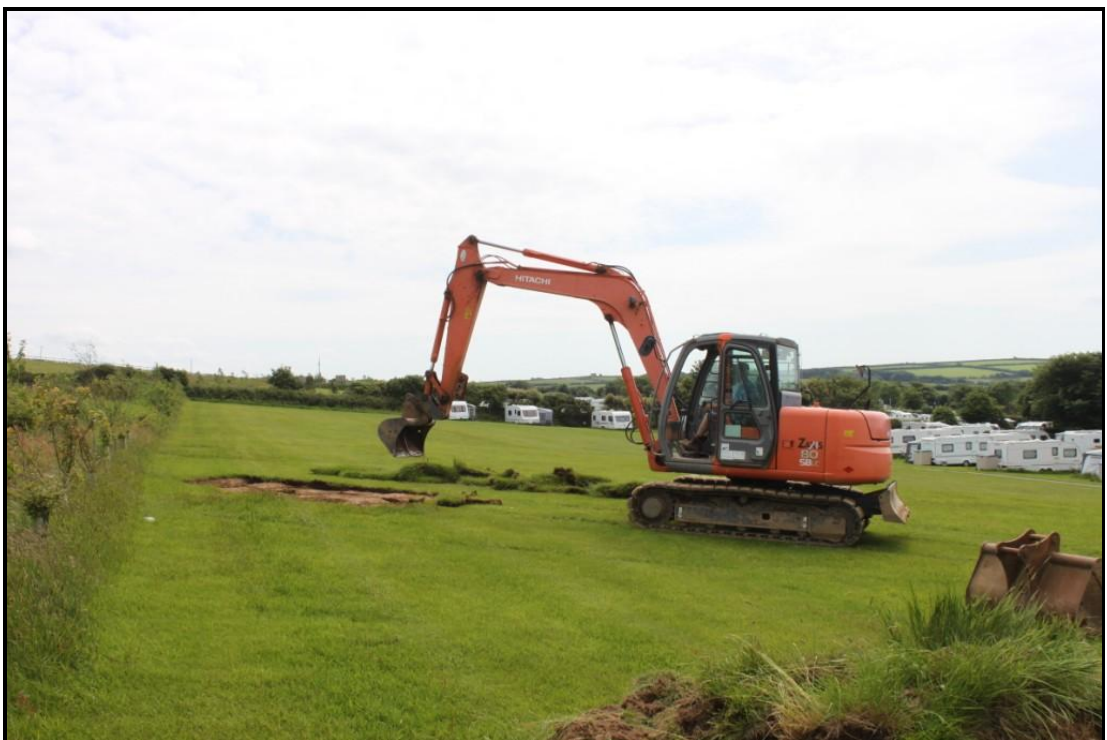
COVER PLATE: SHOT OF PLOT C MID-EXCAVATION; VIEWED FROM THE WEST (NO SCALE).

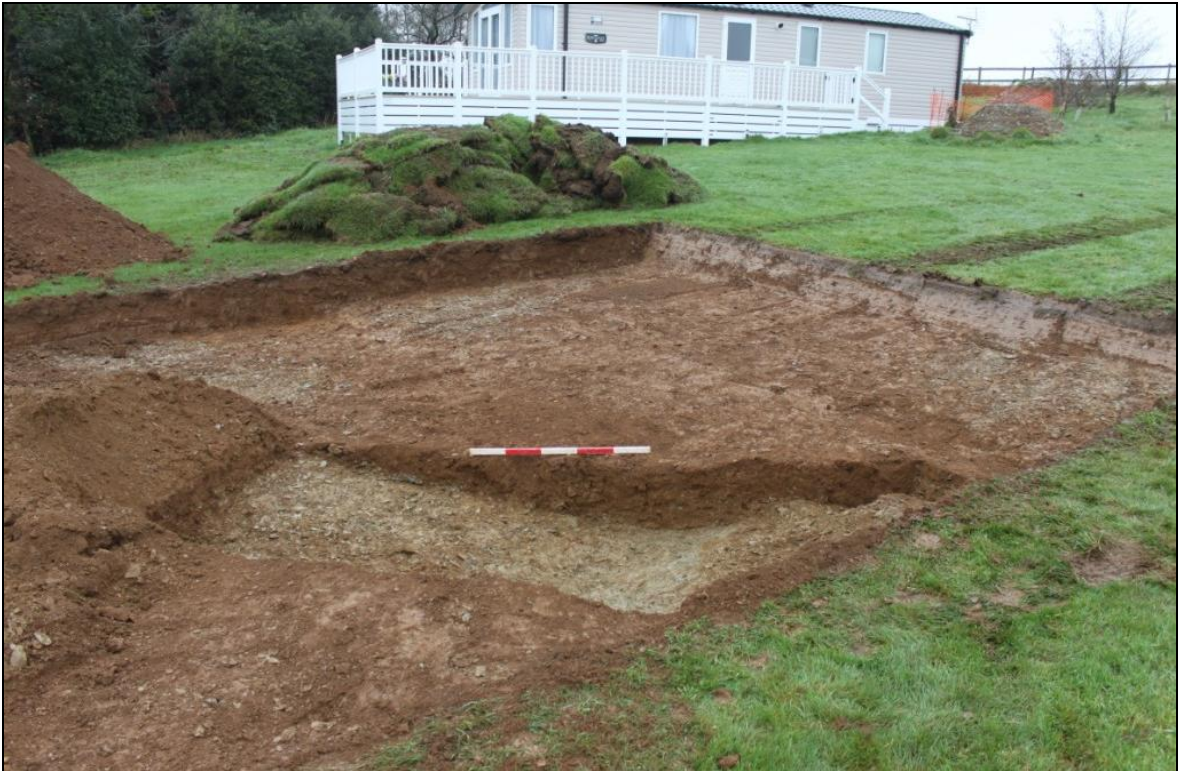
FIGURE 3: SOUTH-FACING SECTION OF DITCH [022]; VIEWED FROM THE SOUTH (1M SCALE).

Ditch [015] cut the fills of Ditch [022]; this was orientated north-south, 3-3.5m wide but only 0.35m deep with very gently-sloping sides and a broad slightly concave base (Figure 4). It contained multiple very clean fills. It is possible this feature may form part of a relict fieldsystem of Prehistoric date, but without secure dating evidence or additional geophysical survey it would be very difficult to be conclusive.

The 14 static-caravan pitches monitored cover less than 6% of the total area of the field, and thus the conclusions of the work are necessarily partial and tentative. However, the dating of ditch [015] to the medieval period, and a general absence of material culture, would argue against the existence of a Prehistoric or Romano-British enclosure. The long gentle arc of ditch [015] can instead be interpreted as a medieval strip-field boundary, rather like those that survive around West Down c.3.5km to the west-south-west. Ditch [015] does cut an earlier feature, ditch [022], and this may well be Prehistoric in origin; however, further survey work would be required to confirm this.

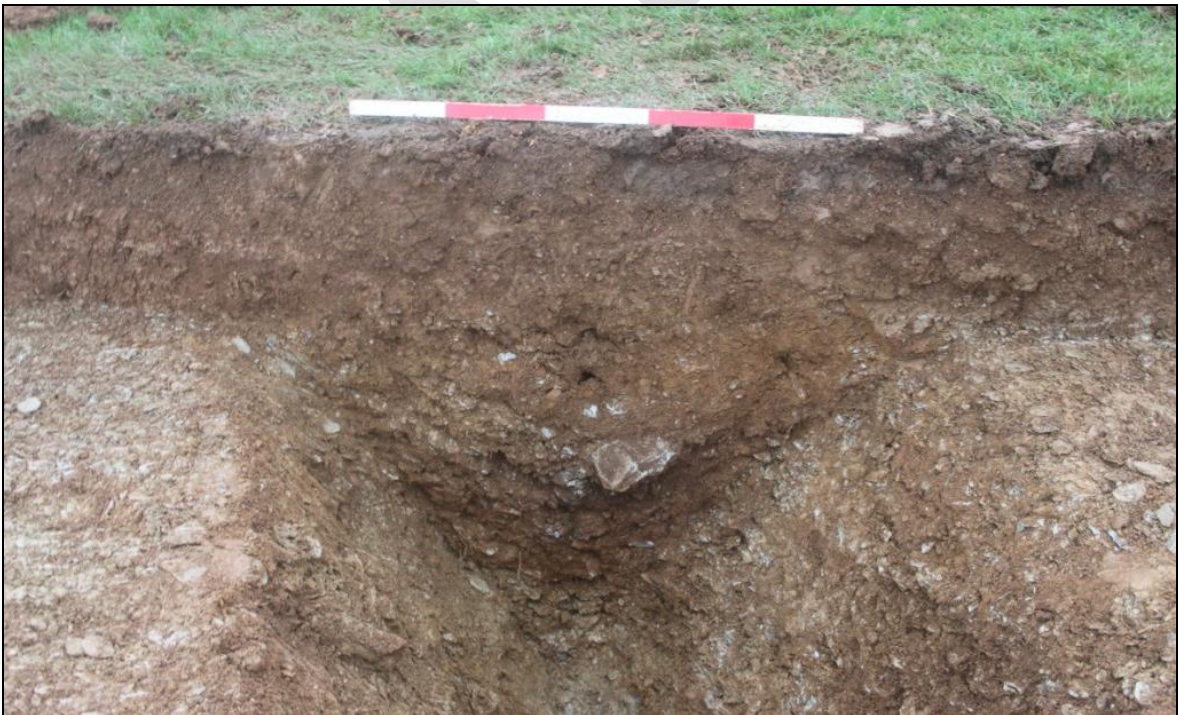
FIGURE 4: EAST-FACING SECTION OF DITCH [015]; VIEWED FROM THE EAST (1M SCALE).

Plot N proved to be the most interesting; located by happy coincidence at the intersection of two linear features [015] and [022] (Figure 7). Ditch [015] was orientated broadly east-west, c.1.4m wide and c.1m deep (Figure 4). It had steep sloping sides, with a slightly steeper southern face, and a steep and sharply concave base. There were multiple fills, most of which appeared to have slumped into the feature from the south, thereby perhaps representing a collapsed/removed bank on this side. The upper fill contained a single sherd (16g) of 13th-15th century North Devon medieval coarseware (NDMC).

The stratified assemblage consisted of a single sherd (16g) of 13th-15th century North Devon medieval coarseware (NDMC), from Ditch Fill (016) probably manufactured in Barnstaple. The finds from the topsoil (001) included a NDMC handle (71g), 3 sherds (78g) NDGT and 1 sherd (2g) NDGF post-medieval ware, 1 sherd (1g) of white refined earthenware (post 1720), and 1 fragment (39g) of C19 green bottle glass.

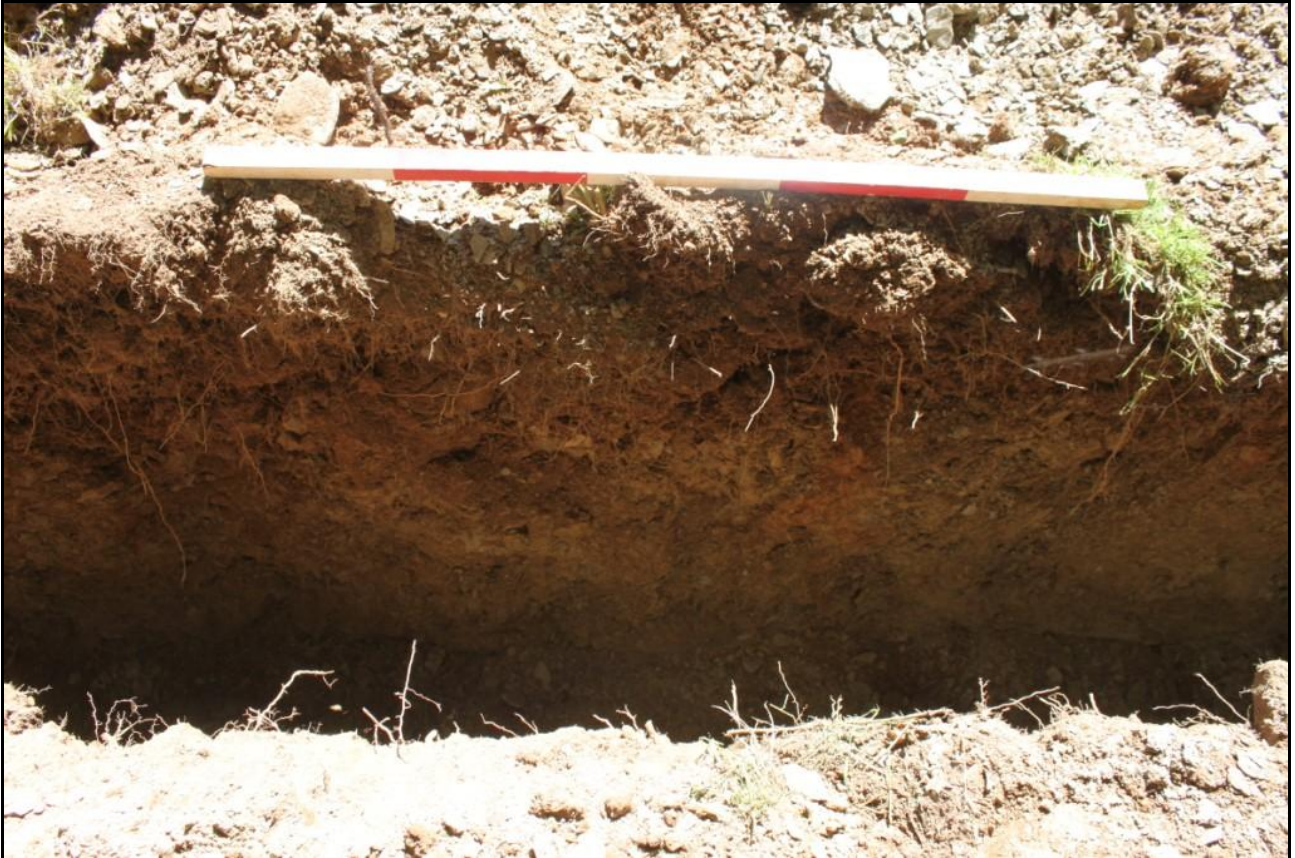
13. SOUTH-EAST FACING SECTION OF DITCH [007], NOTED IN THE SERVICE TRENCH FOR PLOT A; VIEWED FROM THE SOUTH-EAST (1M SCALE).

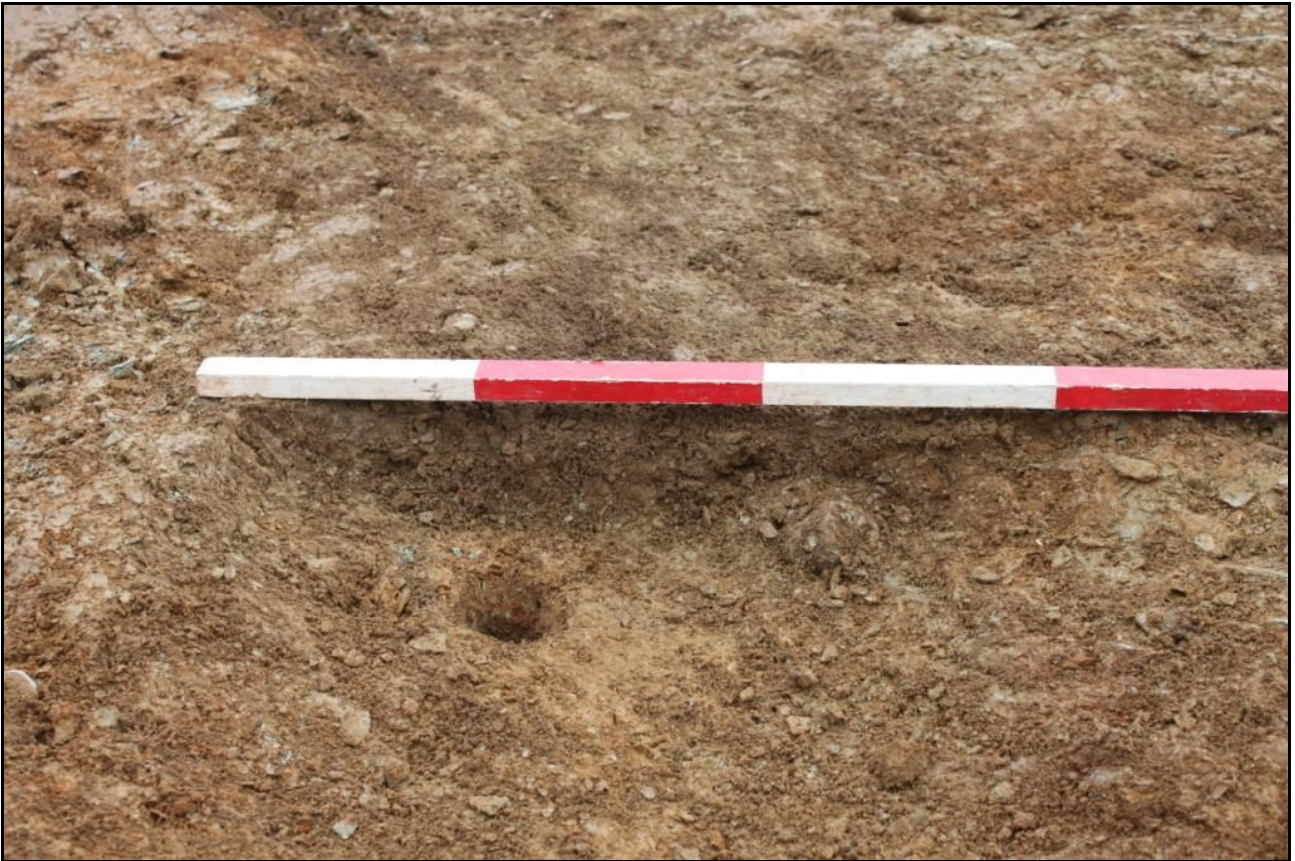
20. EAST-FACING SECTION OF DITCH [011]; VIEWED FROM THE EAST.

Monitoring at Plot G recorded a very shallow (>0.05m) ditch [011] (Figure 6). This was 0.55m wide with a flat base and slightly sloping sides, orientated east-west. It was filled by (012), a soft very clean greyish-brown silt-clay, with rare small sub-angular shillet fragments. The feature may be fairly recent in date, although it did not appear to cut the subsoil. It was located very close to Evaluation Trench 8.

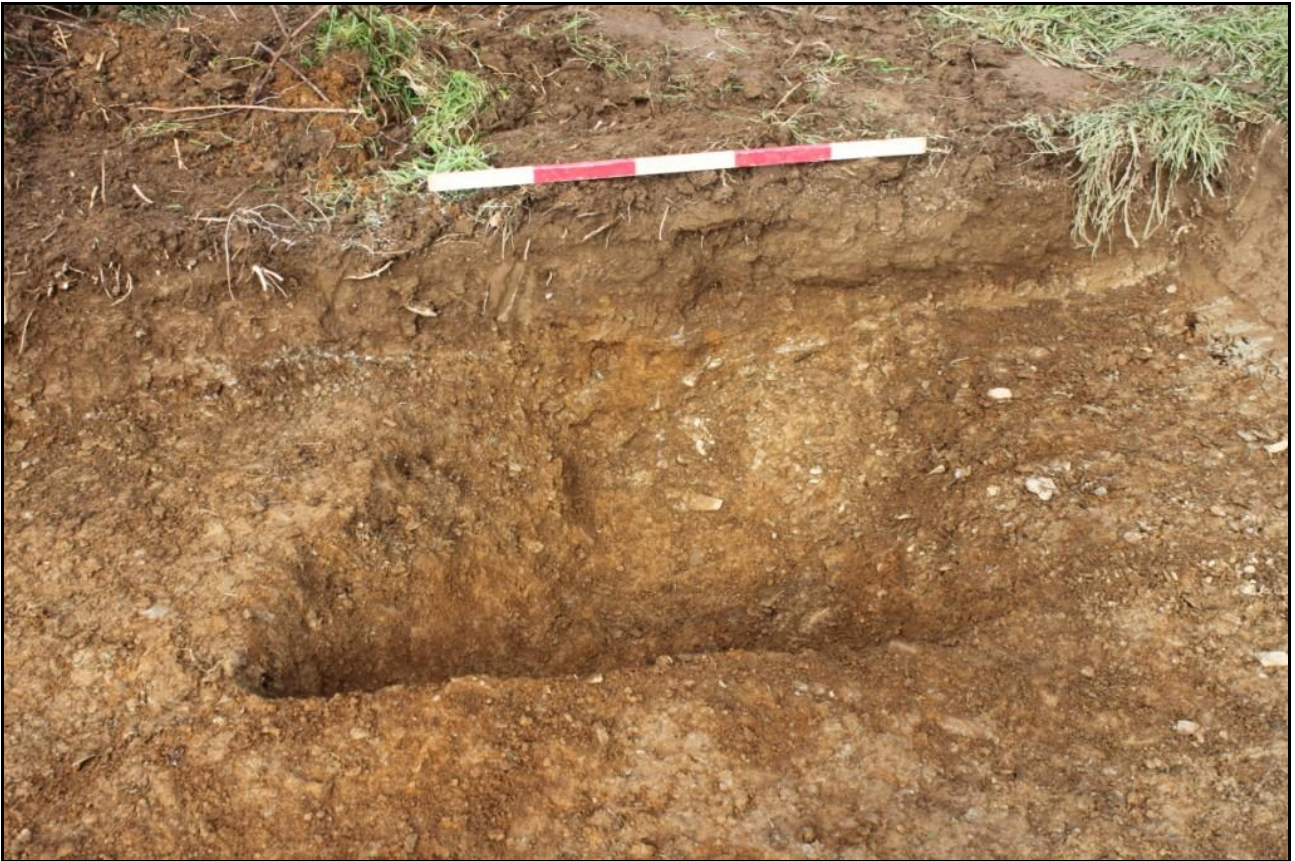
25. SOUTH-FACING SECTION OF DITCH [009; VIEWED FROM THE SOUTH (1M SCALE).

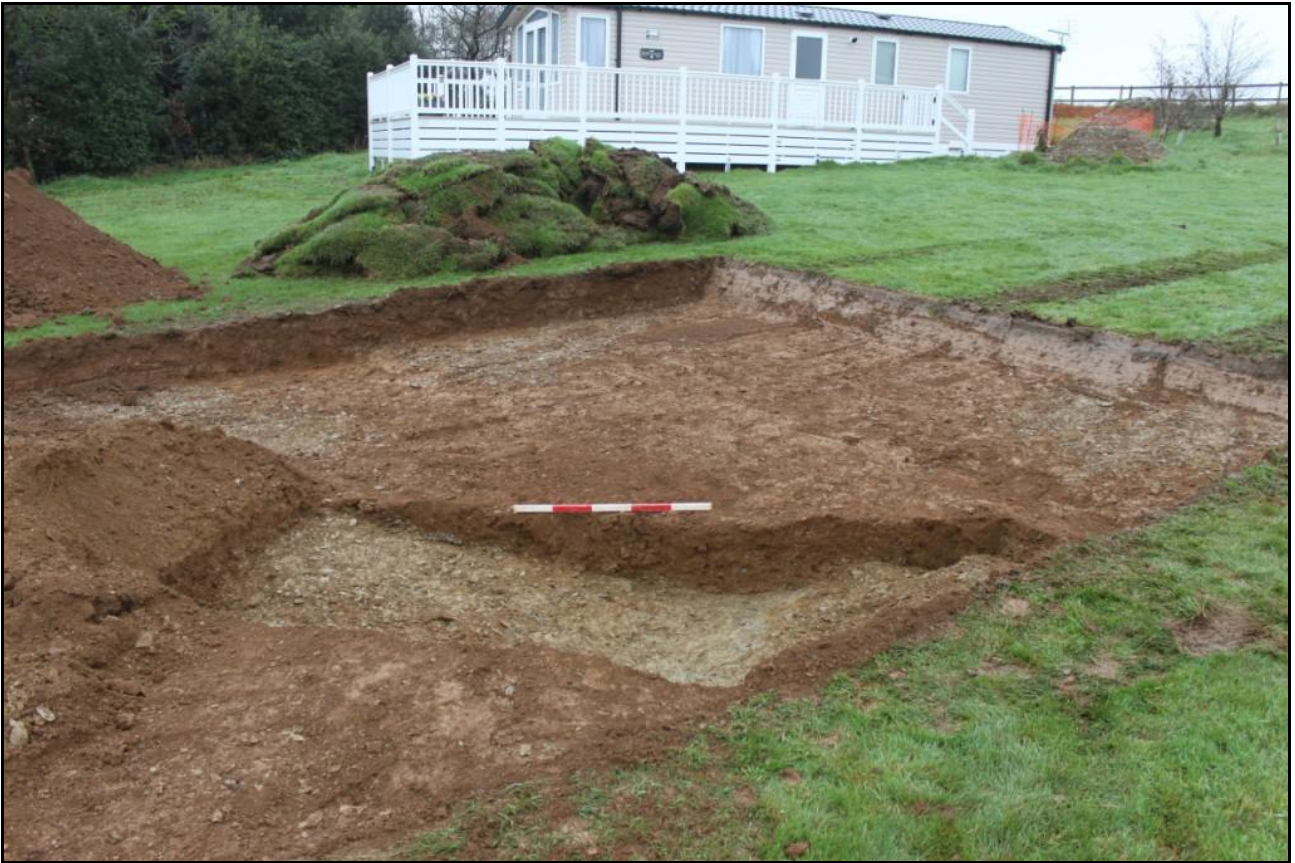
31. SOUTH-FACING SECTION OF DITCH [022]; VIEWED FROM THE SOUTH (1M SCALE).

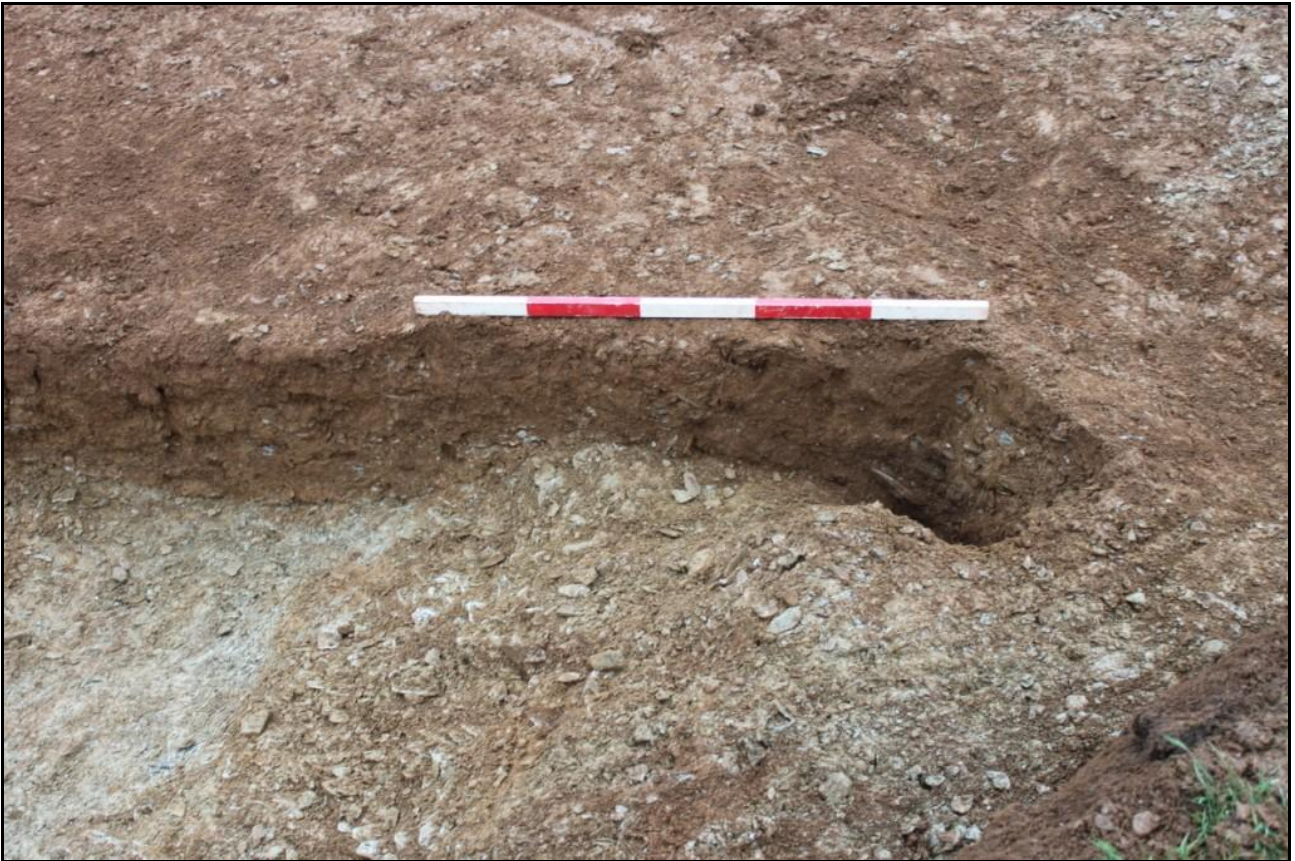
33. AS ABOVE; DETAIL OF THE RELATIONSHIP WITH DITCH [015]; VIEWED FROM THE SOUTH (1M SCALE).

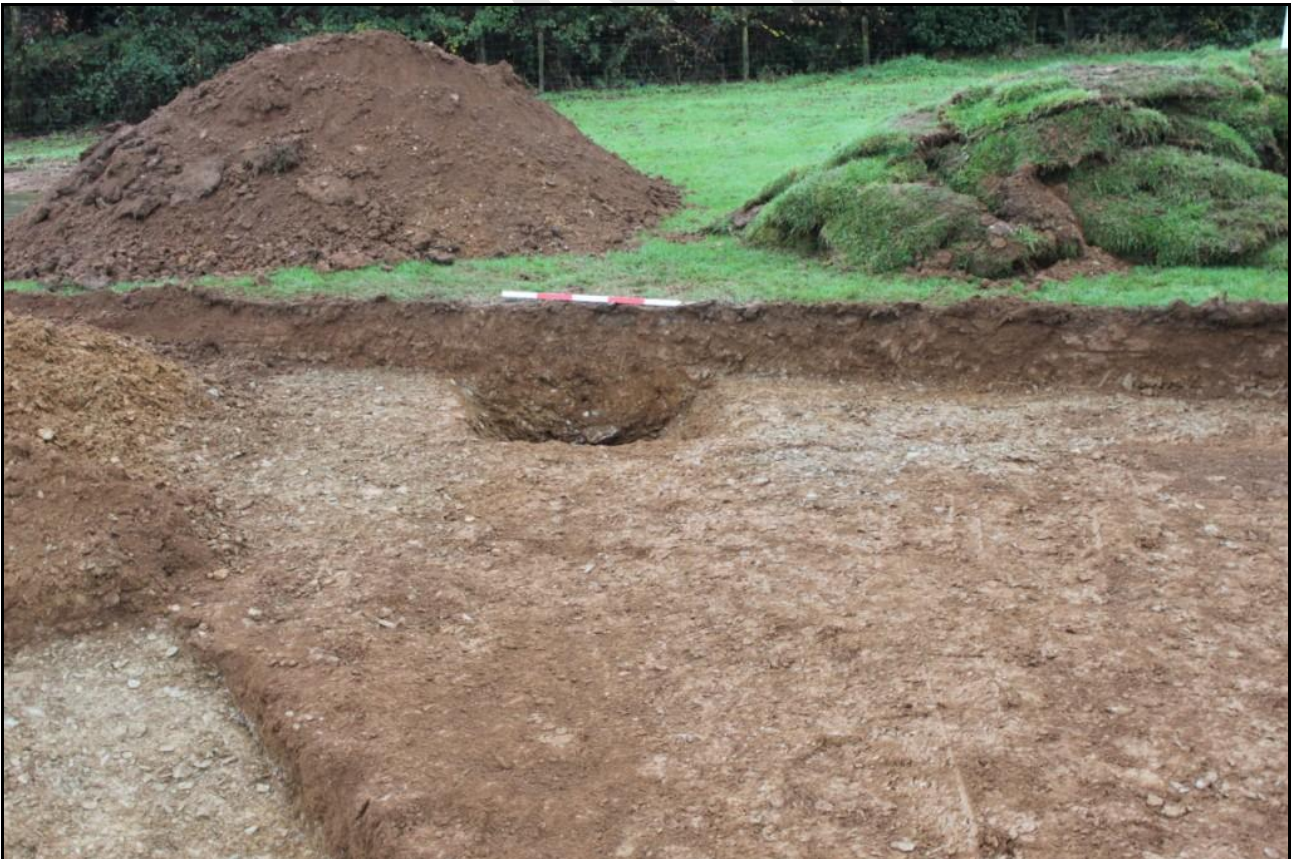
34. POST-EX SHOT OF DITCH [015]; VIEWED FROM THE EAST (1M SCALE).
