THE LUTTRELL ARMS DUNSTER SOMERSET

Results of an Archaeological Evaluation

> Report No.: 150901 Date: 01.09.2015 Authors: Peter Webb Samuel Walls

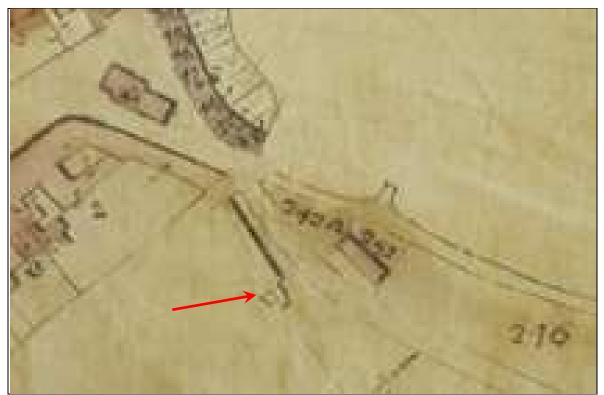
Figure 7: Detailed extract of the Dunster tithe map of 1842.

The first cartographic depiction is shown on one of the two surviving versions of the Dunster tithe map (1842). This shows a small square building to the south of the long range (coach house, stables and workshops) fronting onto the road. If it is the kiln, it is shown as square, not circular, although this may reflect the kiln being located inside a small building to enable undercover working (as depicted in the 1768 painting).

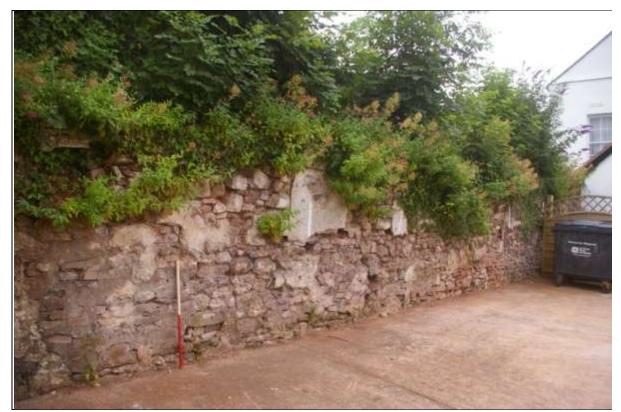
Figure 11: Retaining wall to the yard to the north of the Skittle Alley, viewed from the north (1m scale).

The north-facing elevation of the (south) retaining wall to the north of the Skittle Alley was recorded by photographic survey (see Appendix 6). This was the south wall of a structure shown on this site from 1888. It shows phases of re-building and repair (Figure 11), including four blocked window openings, all dating to the 19th and 20th centuries. The wall is comprised of poorly-coursed and poorly-sorted sub-angular reddish-purple sandstone blocks in a weak and crumbly off-white lime mortar. There are areas of surviving plaster and traces of lime- or white-wash.

The bulk of the structure will be of mid-19th century date (post-1842, pre-1887), and it would have been constructed when the former road/footpath that crossed this area was blocked. At that time the footprint of the former building was terraced into the slope. The upper window opening in the western elevation of the coach house appears to have reveals on this side, and this may have been the eastern gable wall of the demolished structure.

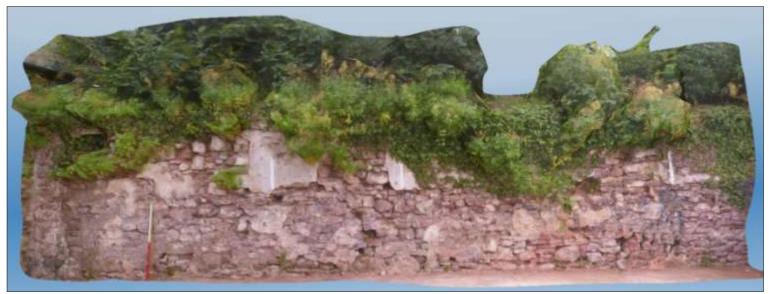
Figure 12: The north-facing elevation of the wall (rectified image produced using Autodesk 123D Catch imaging software).

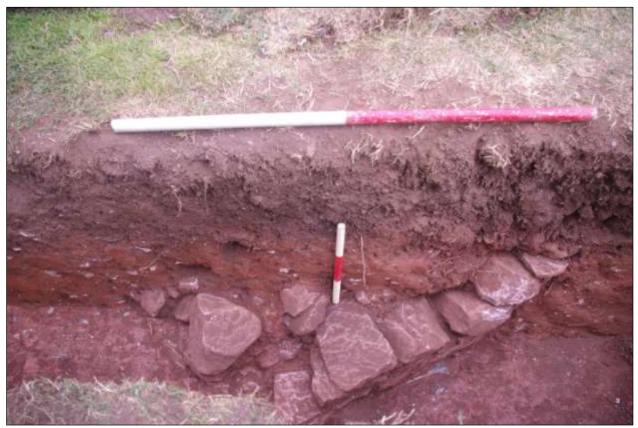
Plan view of wall {207}; viewed from the south-east (scales 0.3m and 1m).

A single feature was identified in this trench: stone wall {207} and robber cut [208]. Wall {207} was constructed of medium-large angular stones in an earth bond, and survived to $0.9m \times 0.5m$ wide and up to four courses high. It was set within a near-vertical foundation cut [206]. The southern end of the wall was truncated by a robber cut [208] filled by re-deposited material (209). The wall was associated with four sherds (35g) of handmade, hard-fired medieval coarseware ($13^{th}-14^{th}$ century), but it is not clear whether the structure is medieval in date.

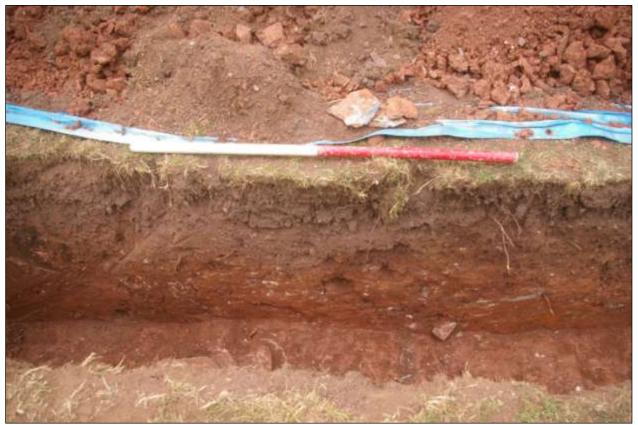
West facing section of robber cut [208]; viewed from the west (scale 1m).

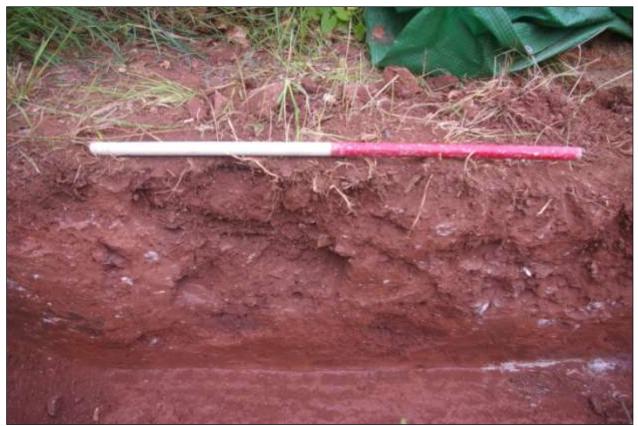
South facing section of robber cut [303]; viewed from the south (scale 1m).

A single possible archaeological feature was identified within the trench: robber trench [303]. This was a north-south orientated cut with steep to moderate sides measuring $0.6m + \times 0.7m$ wide, and filled by (304) and (305), brown silt-clays with frequent sub-angular stone.

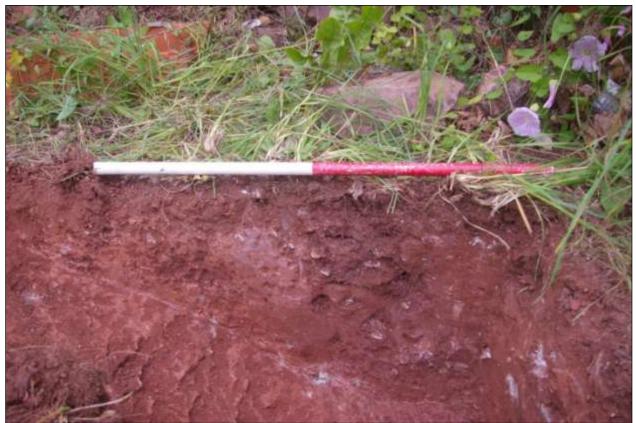
East facing section of trench#3, showing slope of natural down towards the north; viewed from the east (scale 1m).

The other aspect of note is that the coach house (to the north) has been terraced (c.1.5m) into the slope. The natural within the north-south orientated part of Trench #3 suggests that there has been other terracing events, as the natural appears to slope gently up to the north with at least one levelled area; this may correspond with the location of the road/path shown on the 1746 map.

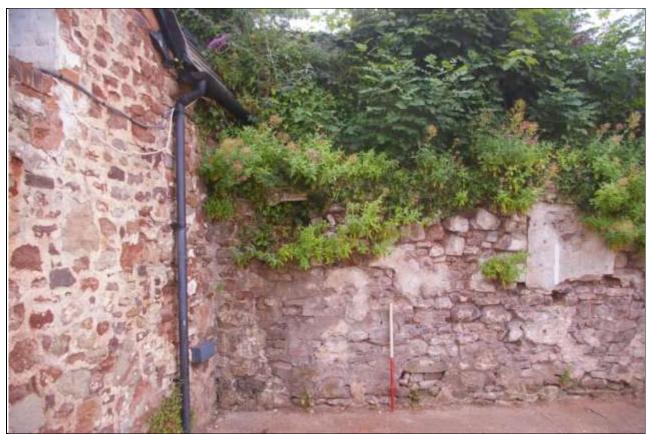
Western end, where it abuts the workshop/tack room of the coachhouse, viewed from the north (1m scale).

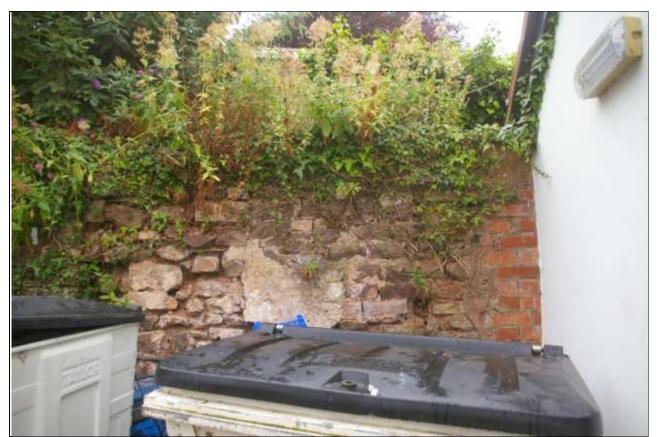
Eastern end of the wall, where it has been abutted/re-built in the 20th century in brick, at time building to the east was constructed.
