LAND at HEANE FARM, HATHERLEIGH, DEVON

Results of a Desk-Based Assessment
Walkover Survey &
Visual Impact Assessment

Report No.: 140117
Date: 12.03.2014
Authors: S. Walls
E. Wapshott
B. Morris

SWARCH project reference: HHF13

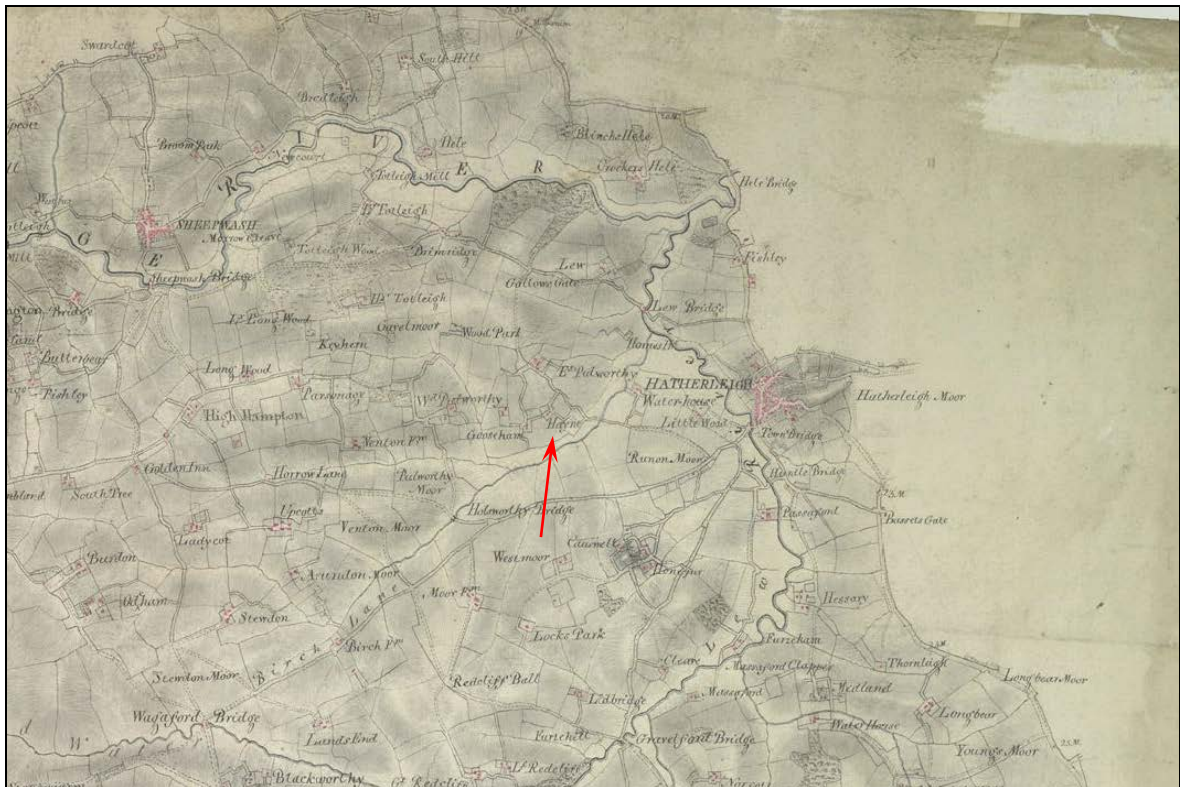
Figure 2: Ordnance Survey Surveyors Draft 1803 (BL) (the location of the site is indicated).

The earliest large-scale mapping of any value is the 1803 Ordnance Survey surveyor's draft map of the area (Figure 2). The Draft is not particularly reliable with regard to the field boundaries, but does usually show the difference between enclosed and unenclosed land with some accuracy. South-east of *Hayne Farm* lies *Runon Moor* (*Renden* 1551); the tithe data (below) indicates this formerly extended some distance along the southern side of Pulworthy Brook, and was probably largely enclosed in the later post-medieval period. The Donn (1765) and Greenwood (1827) maps provide no additional detail.

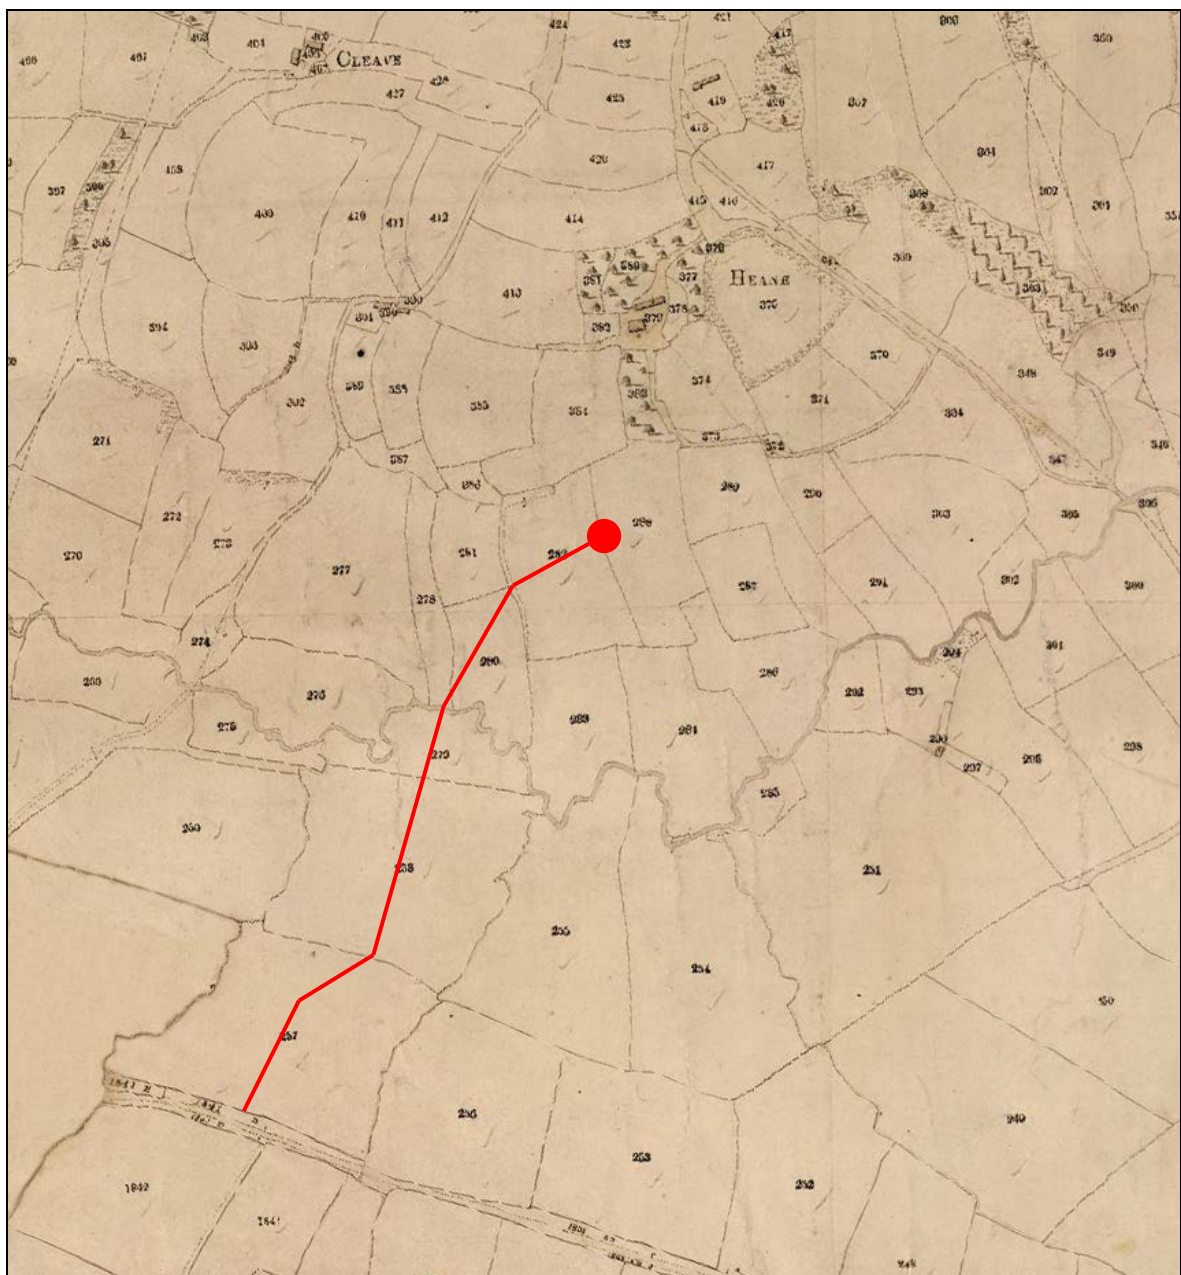
Figure 3: Extract from the 1839 Hatherleigh tithe map (DHC) (the location of the proposed turbine and access track is indicated).

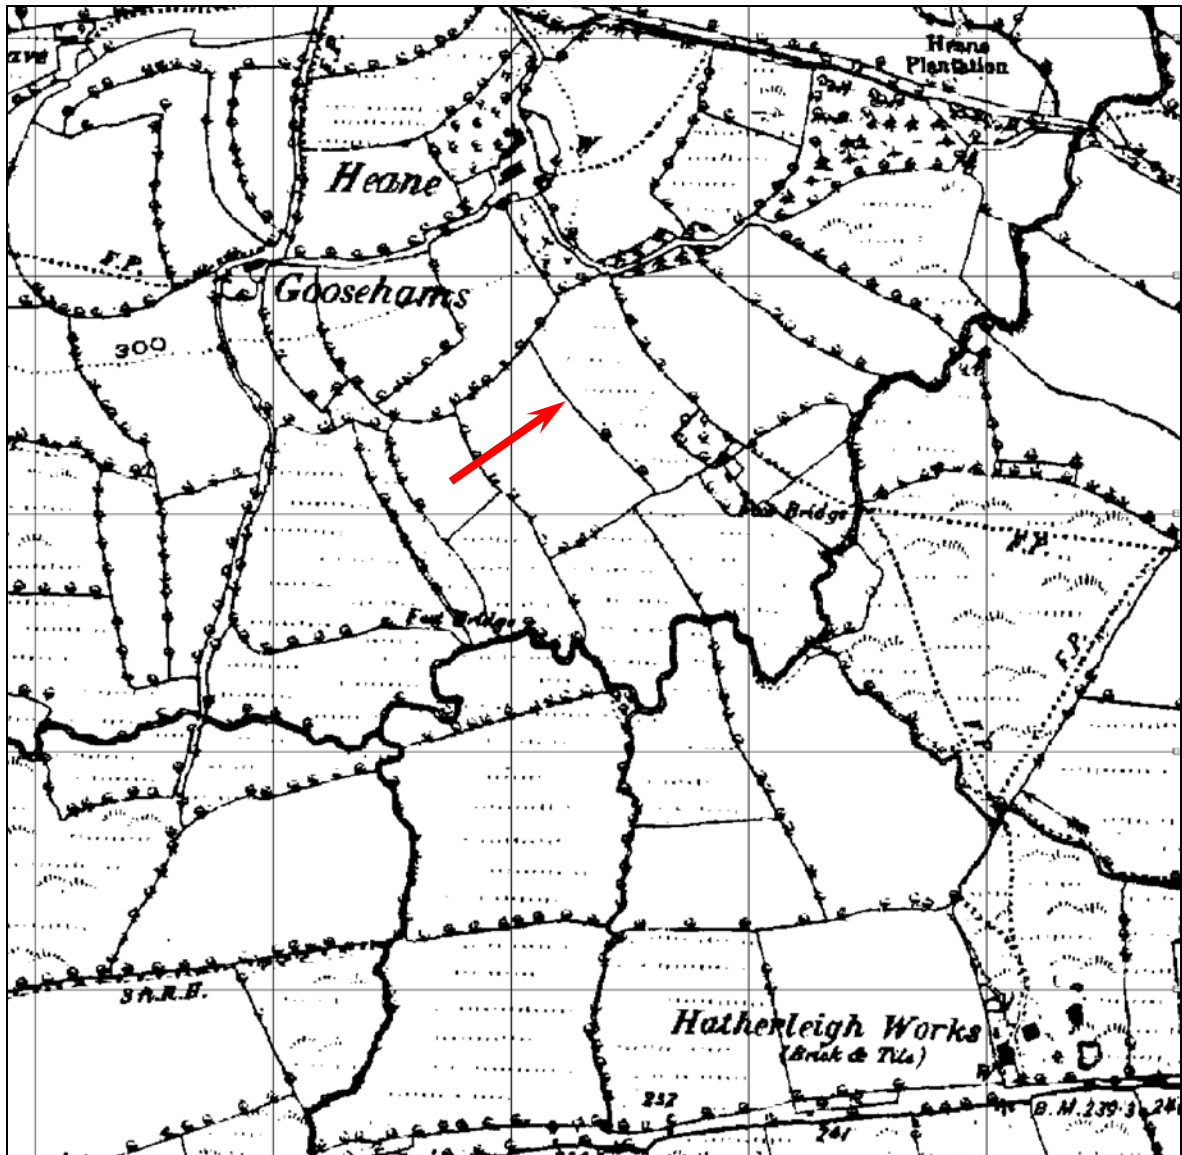
Figure 5: The 1890 1st Edition Ordnance Survey map (Promap) (the site of the proposed turbine is indicated).

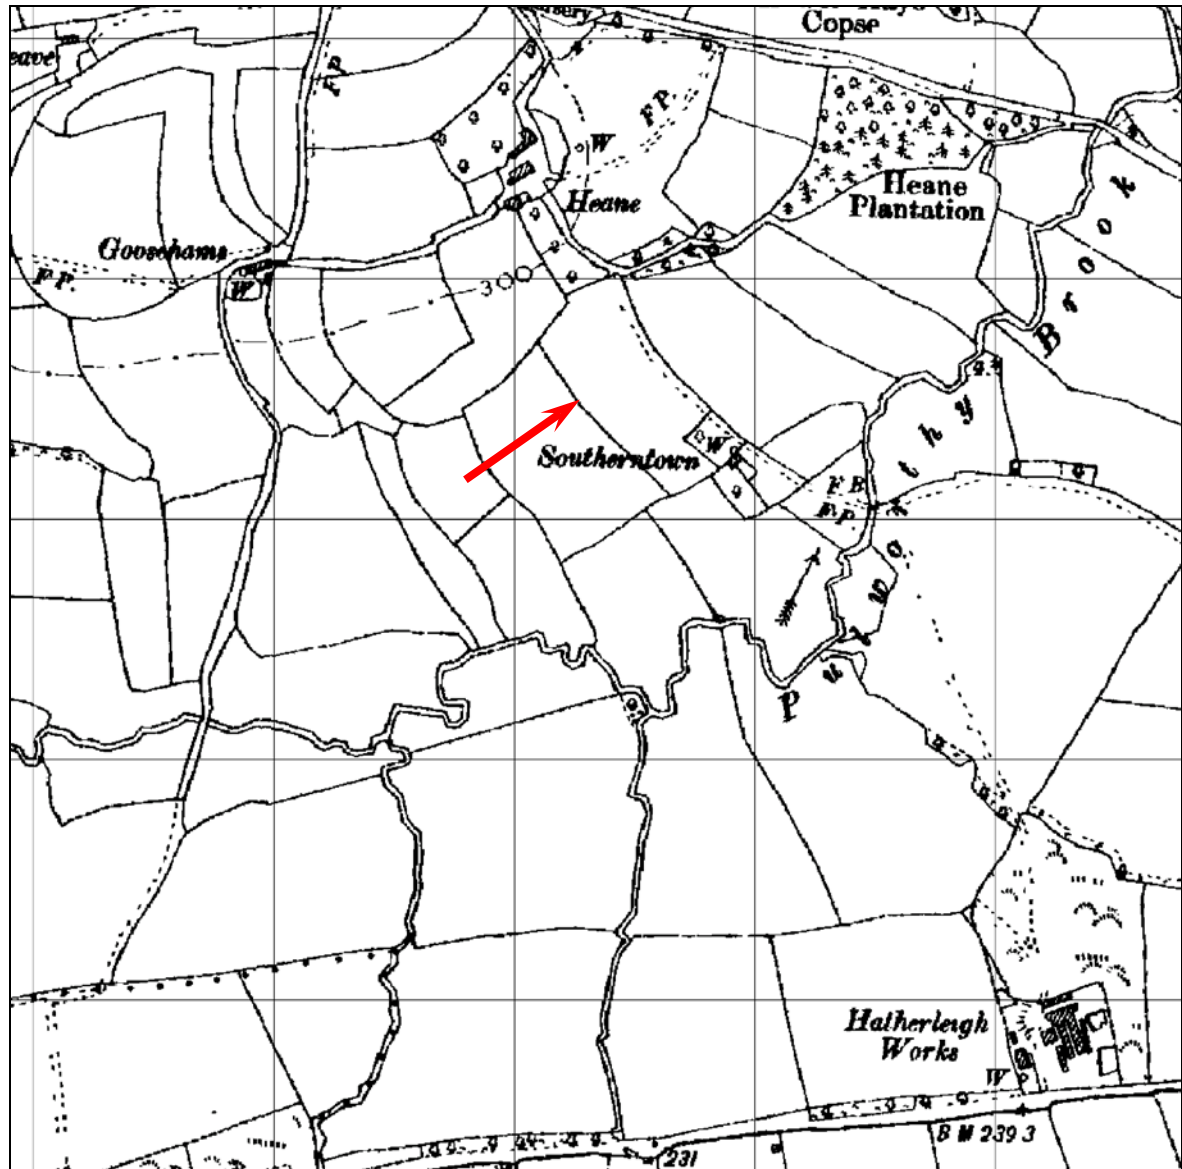
Figure 6: The 1906 2nd Edition Ordnance Survey map (Promap) (the site of the proposed turbine is indicated).

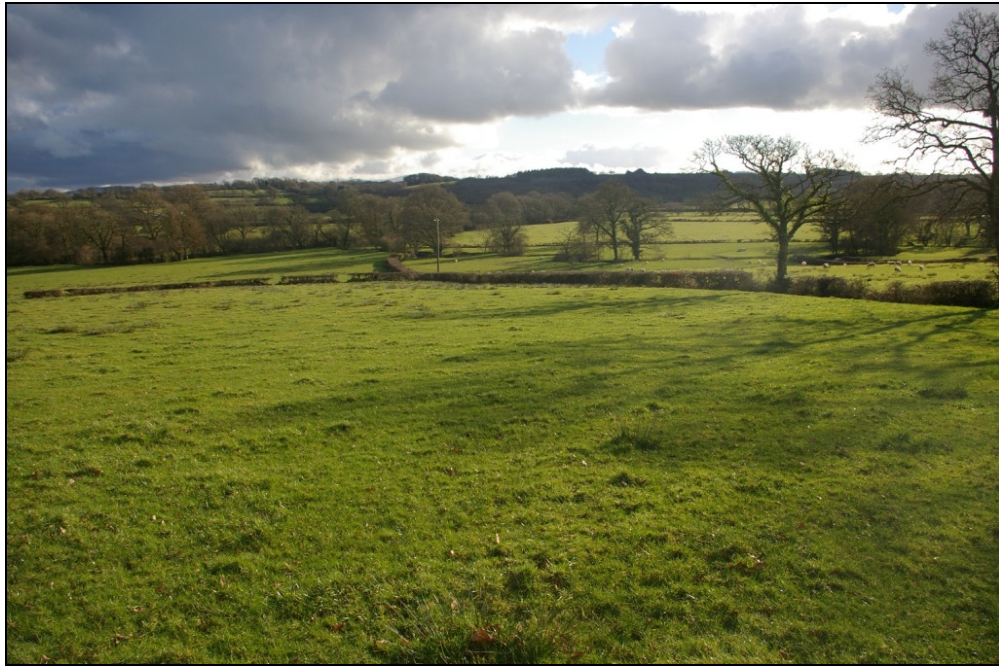
Figure 7: View to the south-west across the field in which the turbine is to be situated, showing Dartmoor in the distant background and the south and west boundaries of the field; from the north-east.

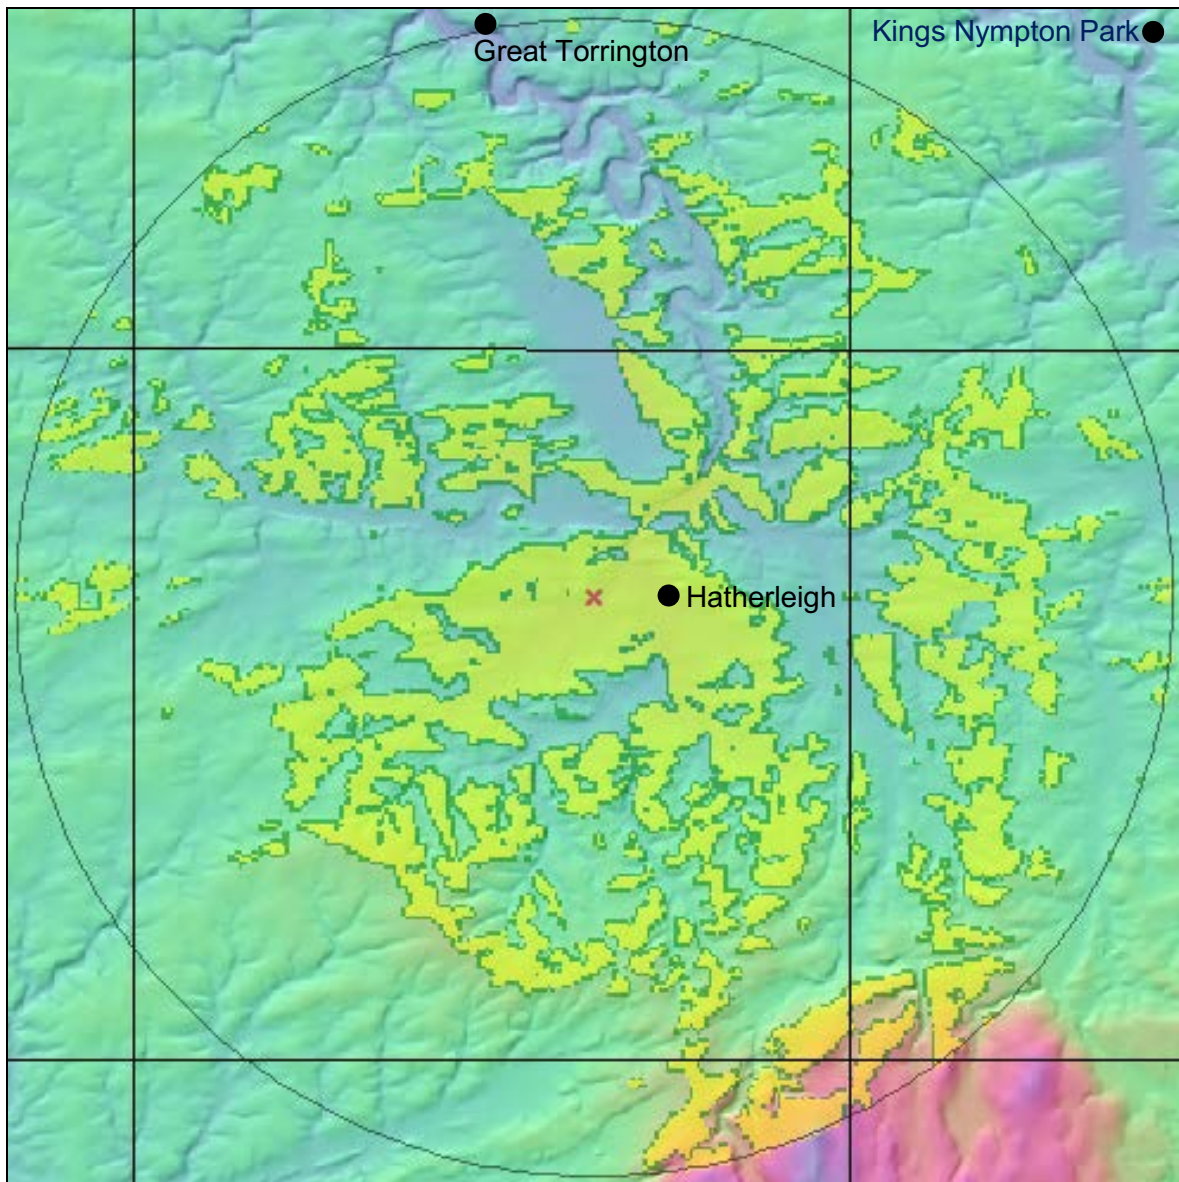
Figure 11: 15km ZTV: distribution of designated heritage assets within the ZTV (to tip) of the proposed turbine; the areas in yellow are those with theoretical intervisibility with the proposed turbine (based on a ZTV generated by SWARCH). This is a bare-earth ZTV, generated by MICRODEM (ver 2010.11.5.2) using OS Opendata Panorama DTM data (Ordnance Survey data © Crown copyright and database right 2014). The closest Registered Park and Garden is at Kings Nympton, at c.20km.

On the whole, the ZTV mapping was found to be a fairly accurate representation of the likely inter-visibility between the proposed turbine and the surrounding landscape out to 1km, 5km and 10km, together with the heritage assets that the landscape encompasses. The areas mapped on the ZTV as having inter-visibility are very wide close to the wind turbines location, especially to the east and west, running out to the south-west, with a high ridge to the south having extensive hypothetical views towards the proposed turbine. Clear visibility from much of the foothills of Dartmoor, around Inwardleigh, Folly Gate and Northlew. The steep valley of the River Lew where

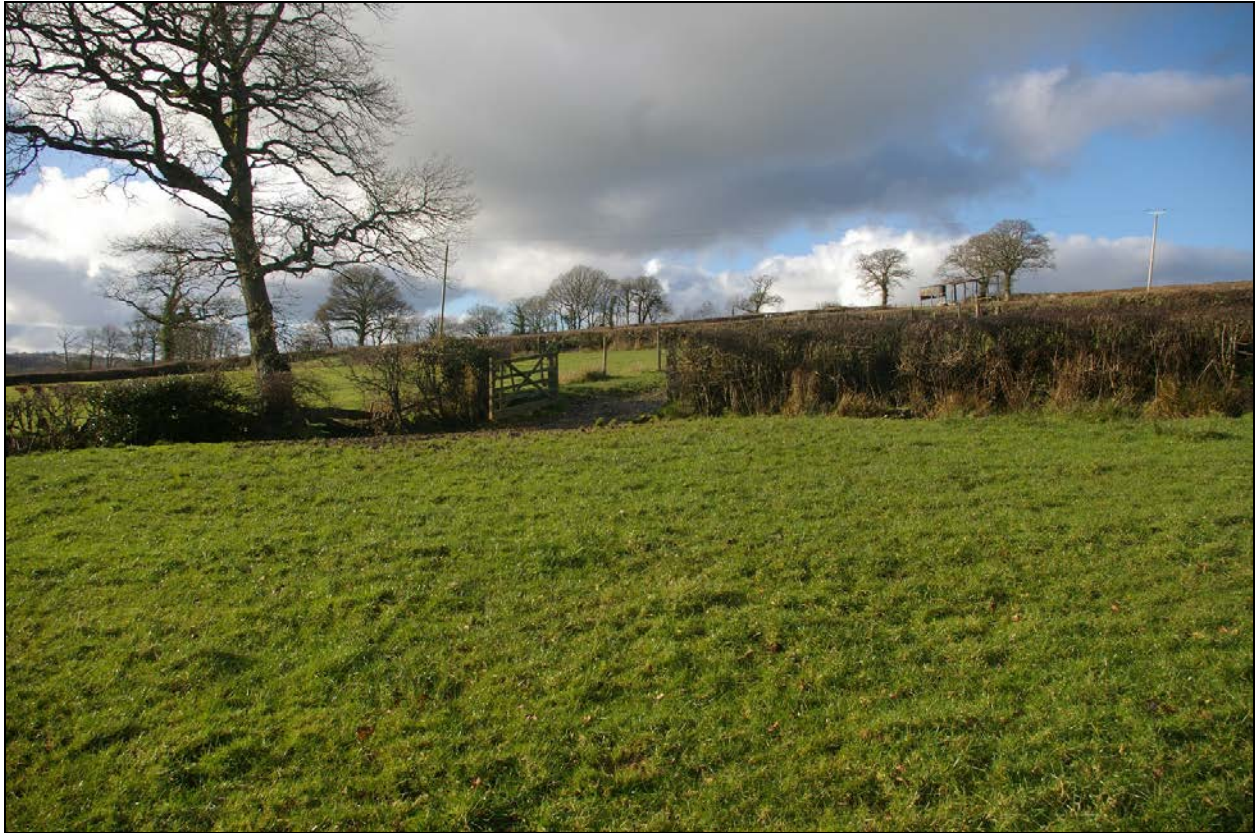
View to the north-west from the turbine site, where the ground rises; from the south-east.

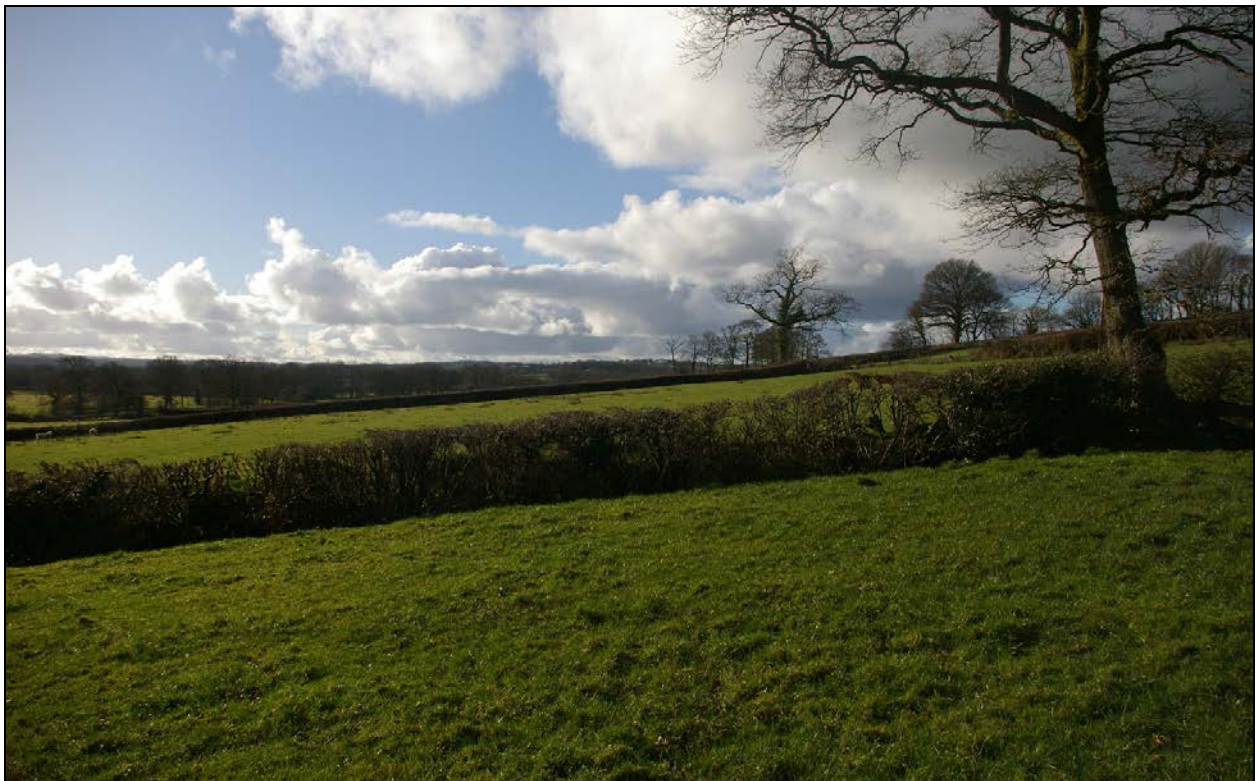
View to the west from the turbine site, showing the neatly trimmed hedge, and views to Highampton; from the east.

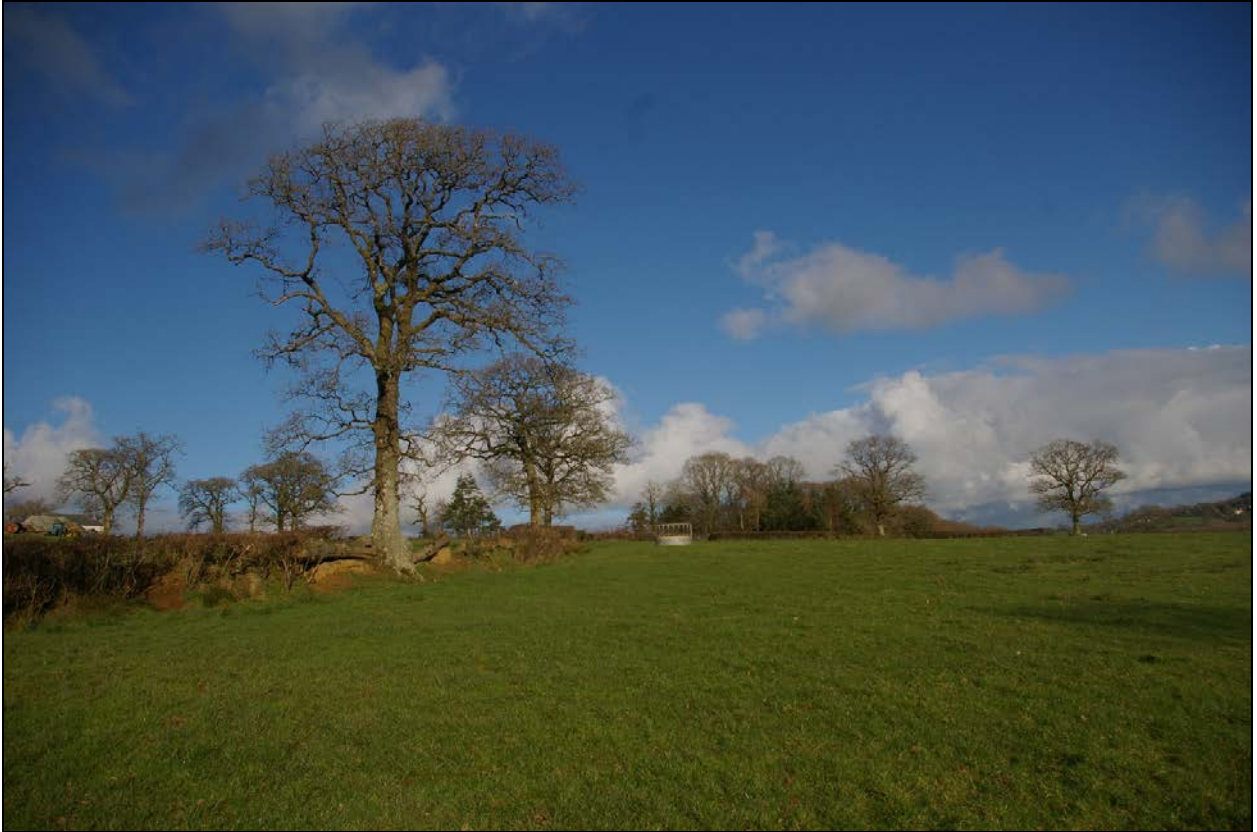
View from the top of the field in which the turbine is to be located, showing the northern boundary, again with some mature trees; from the west.

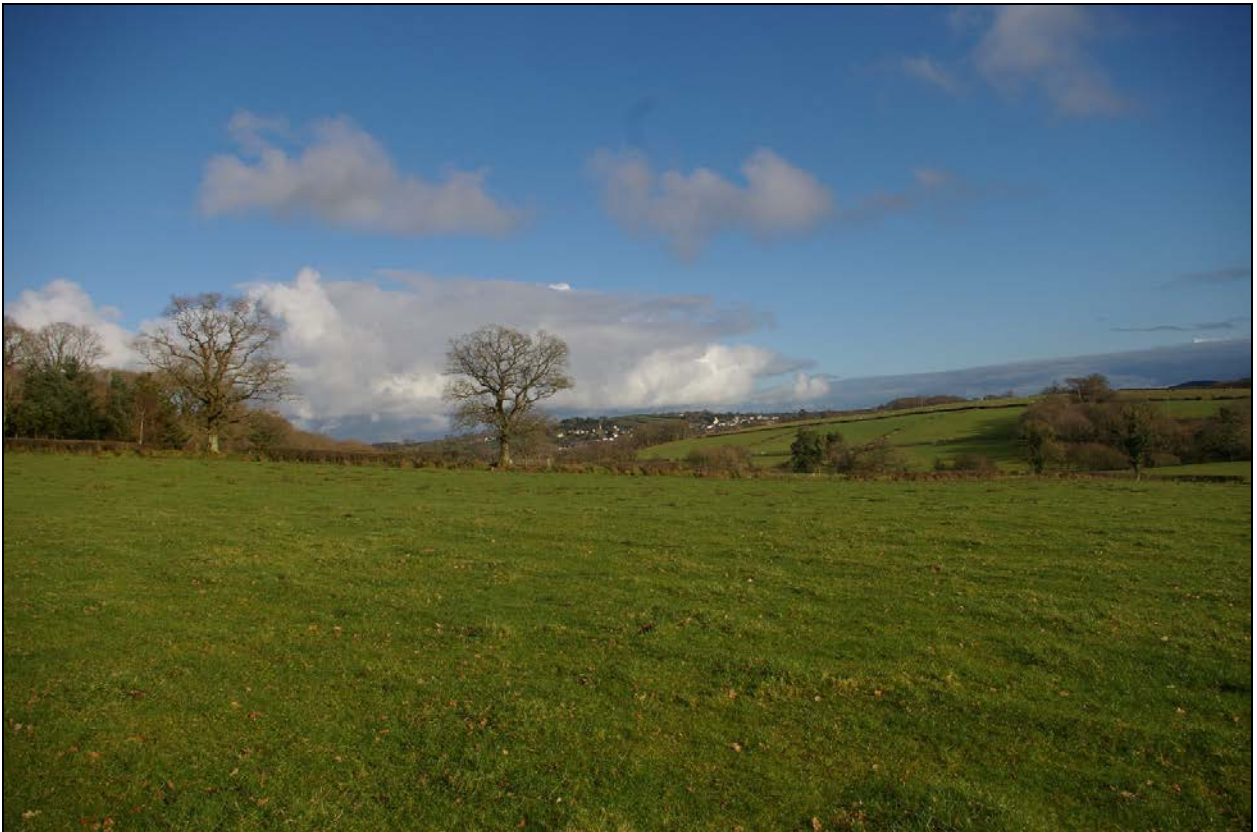
View east from the turbine site, showing the church tower and town of Hatherleigh, clearly in sight; from the west.

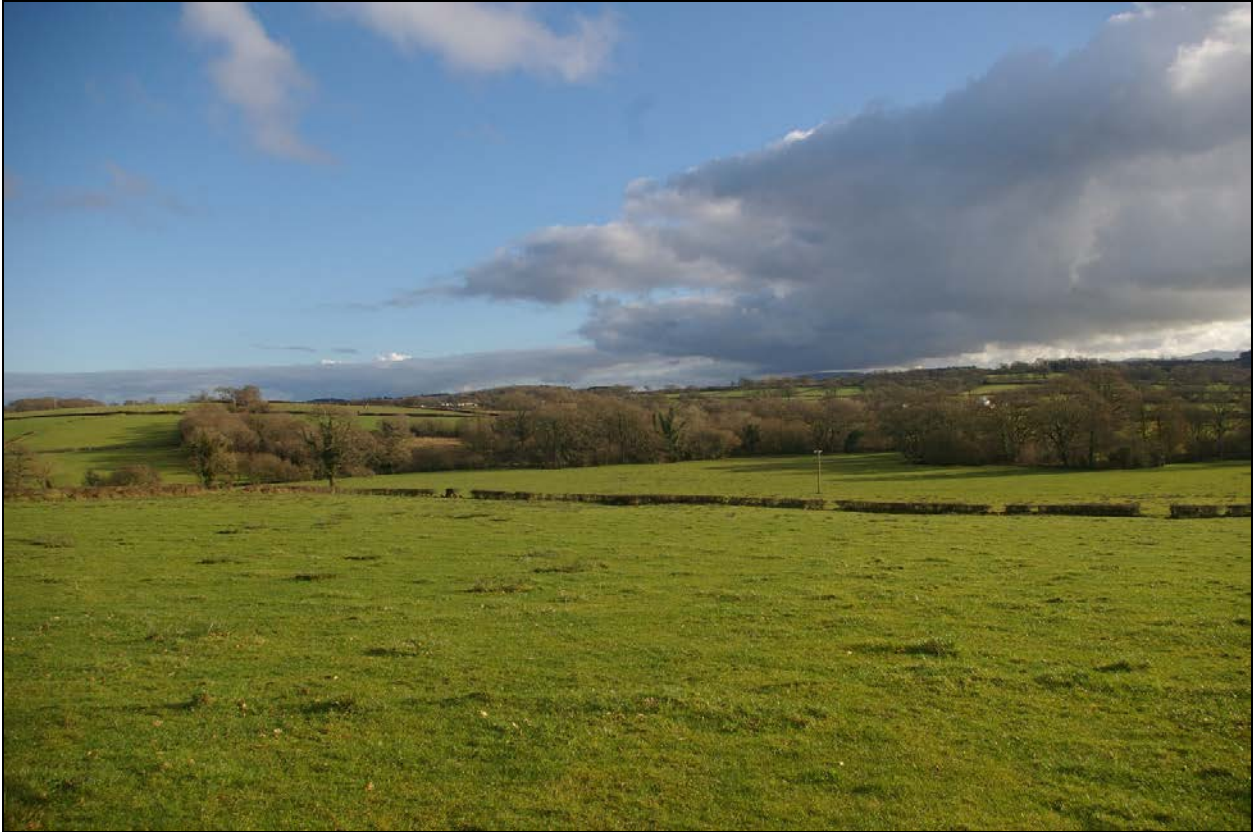
View to the south-east from the turbine site, to the valley of Pulworthy Brook; from the north-west.

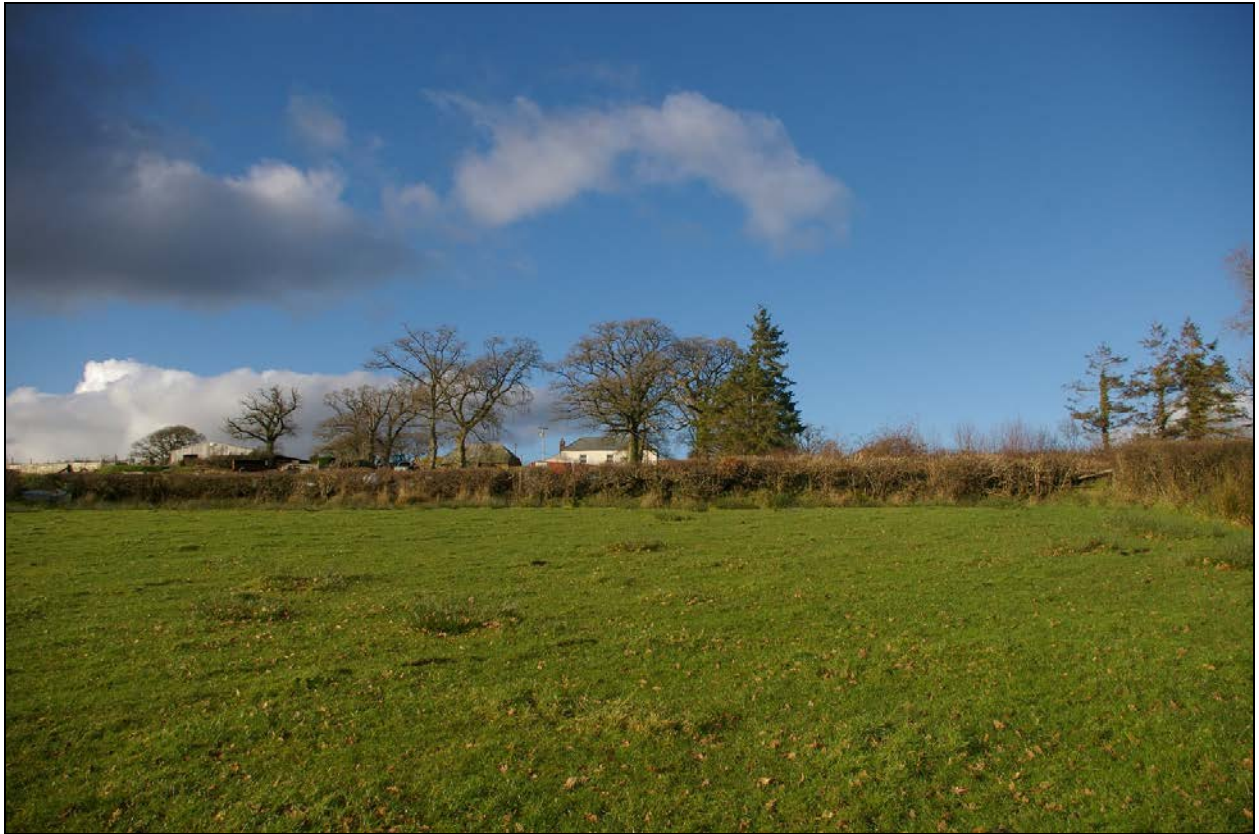
View from the turbine site to the north, to the farmhouse and farmyard of barns; from the south.

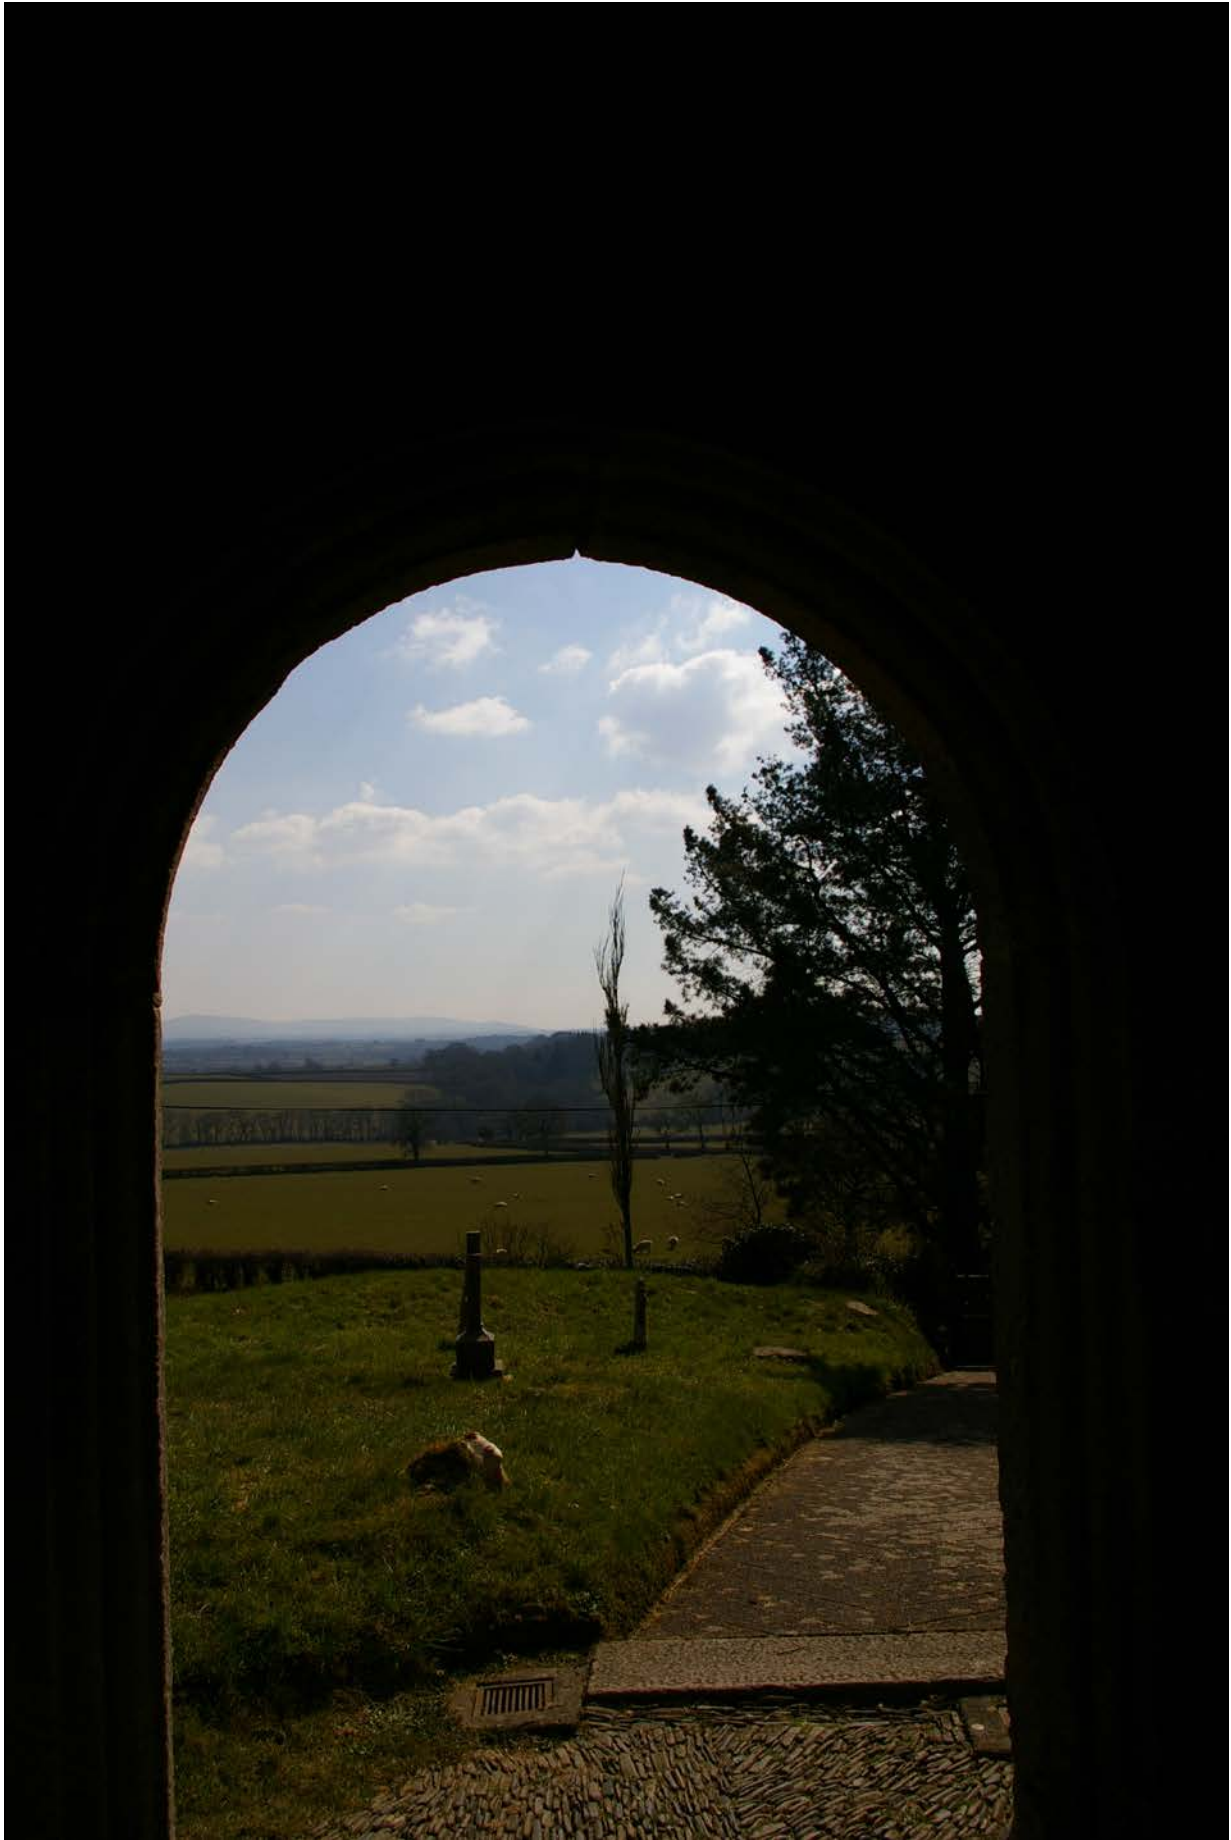
St James, Iddesleigh, showing views from the porch of the church to the lower ground to the south, and the local blocking of the trees to the west of the church; from the north.

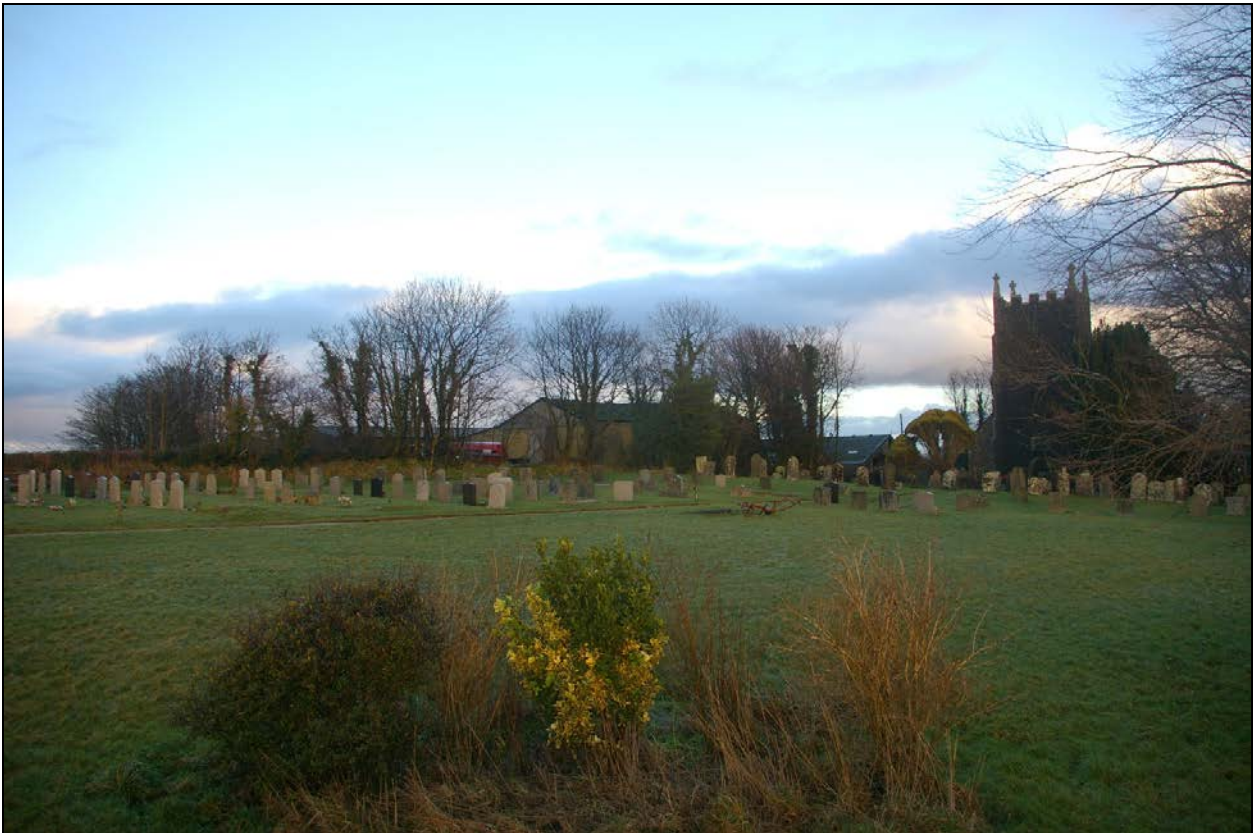
Inwardleigh church, set to the south of a large modern farm building complex, with a short squat tower, some very limited views over the roofs of these buildings from the top of the tower; from the south-west.

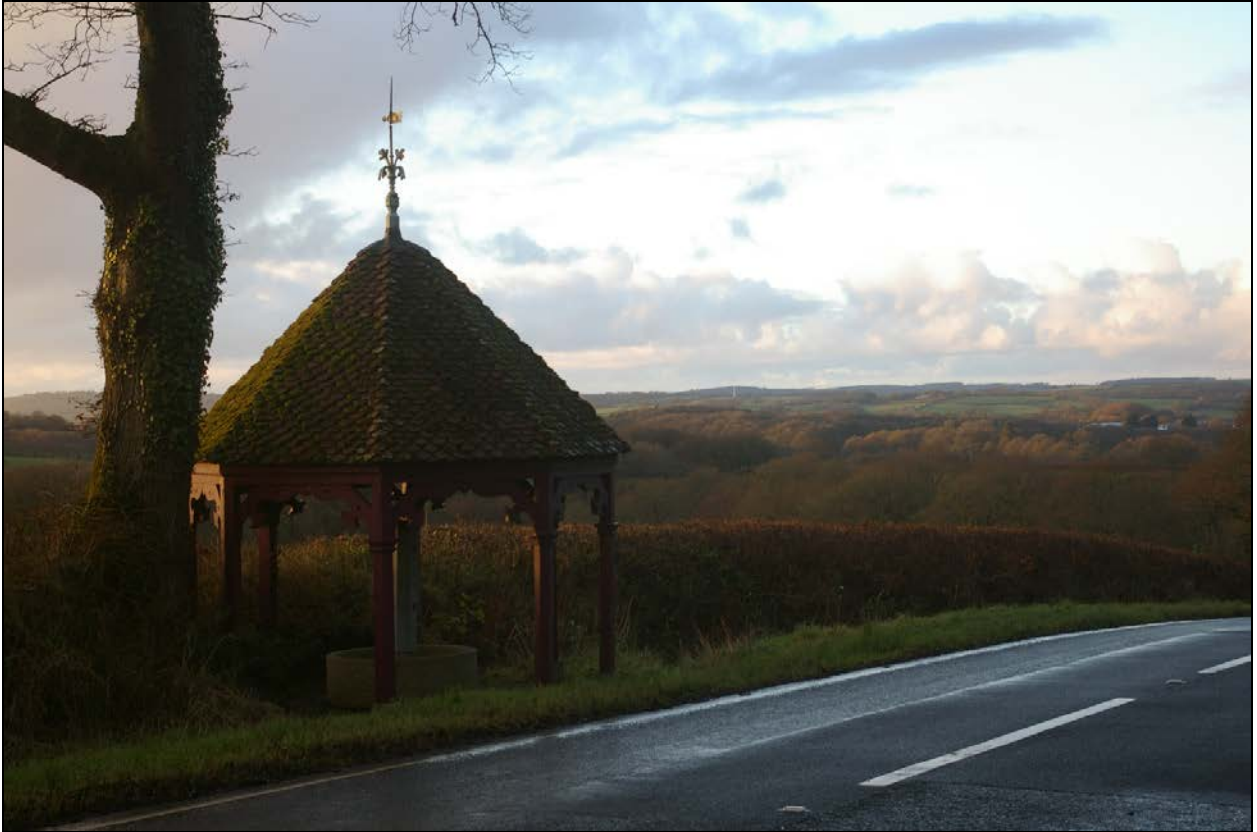
IMG8751 – Well house and shelter at Pressland Farm, showing wide views to the north and north-west, as well as the sensitivity to the views due to the nature of the shelter; from the south-east.

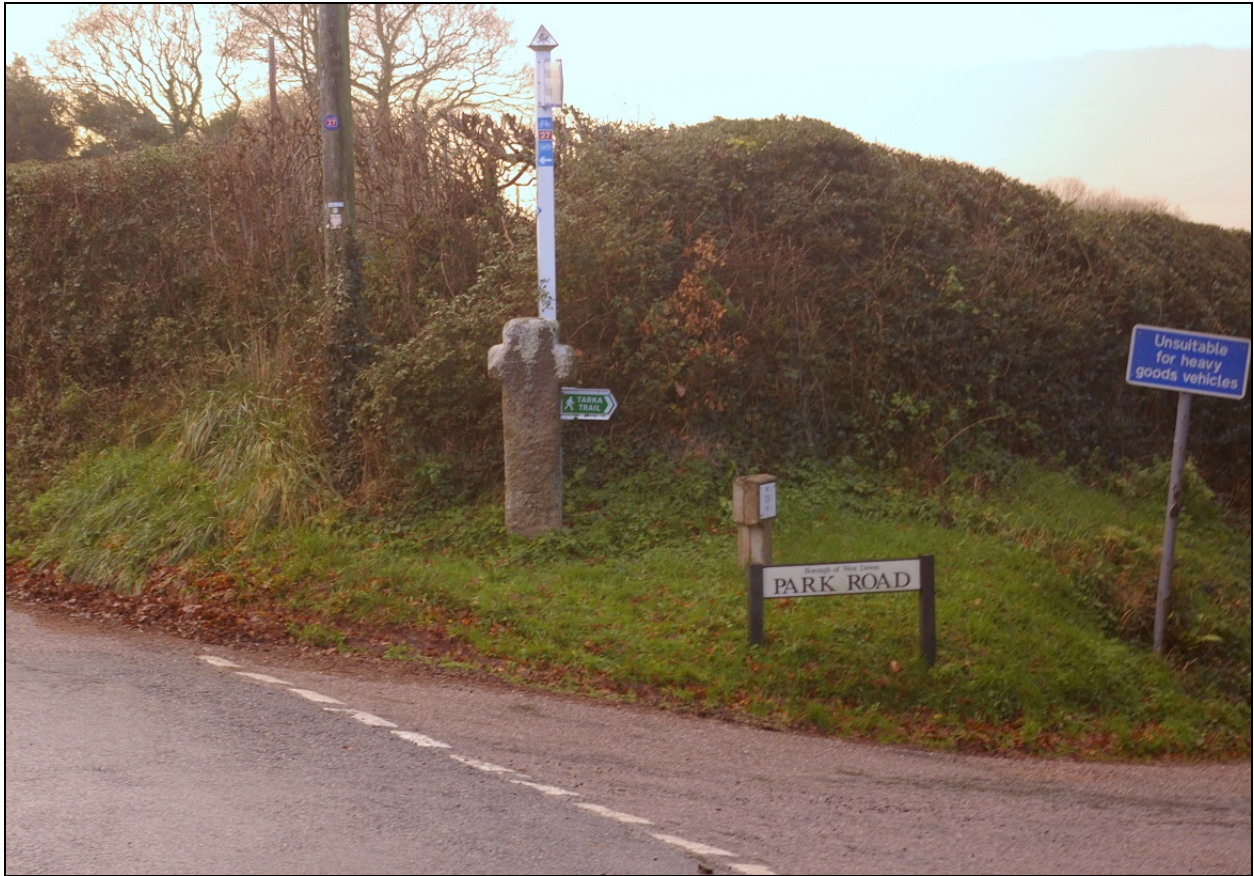
Wayside Cross east of Park Road, Hatherleigh. Set against a tall hedge-bank which blocks all views to the proposed turbine, local blocking applies, as shown; from the east.

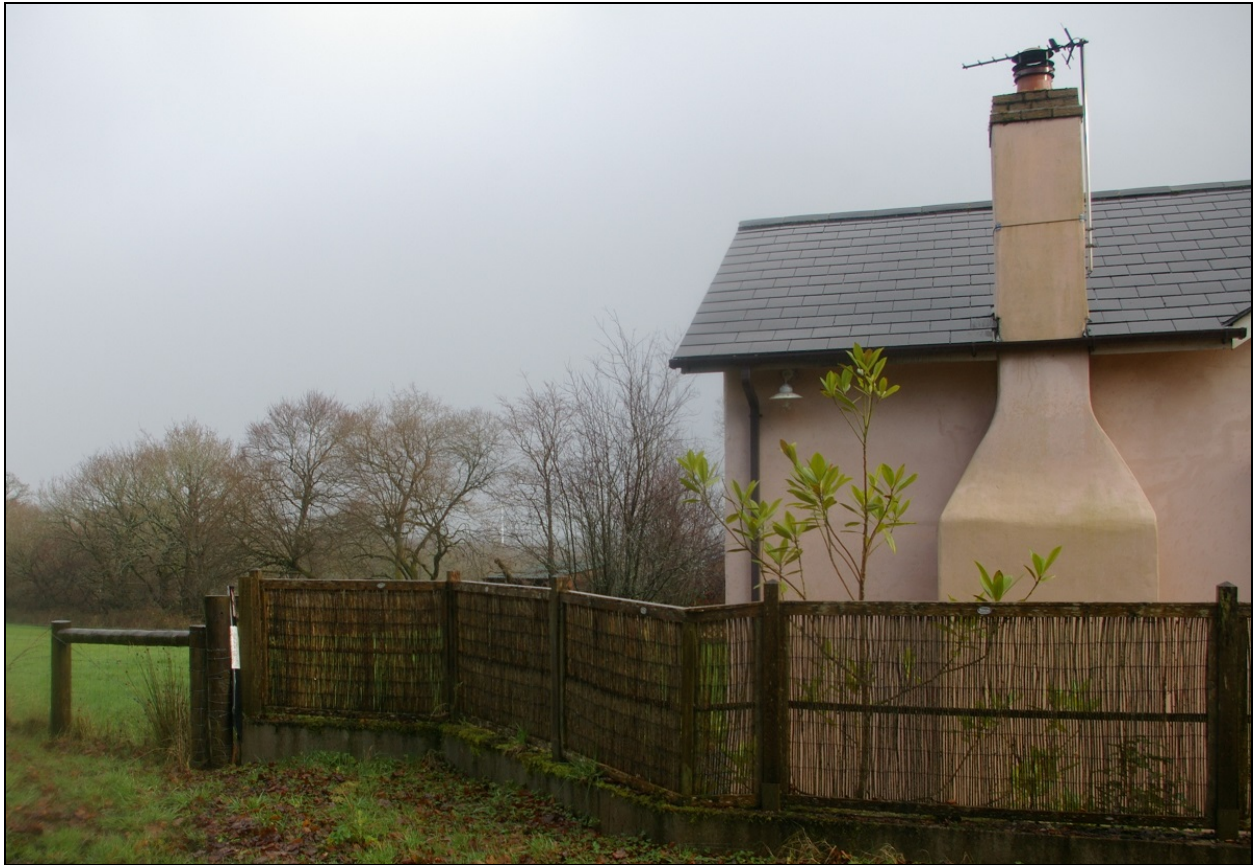
Legge Farmhouse, with views through the trees to the north-east, where a large extant turbine is to be found; from the south-west.

- Legge Farmhouse, Highampton; medium significance; Grade II Listed; condition: good. Set alongside the parish road this low building is comprehensively blocked from views to the south and south-east by the tall mature trees of shelter belt planting and hedge-banks. There is also an unlisted farmhouse to the south-east, set within a wooded enclosure which will additionally block views to the turbine. An extant turbine is visible to the north-east through the trees; impact: **negative/minor**.

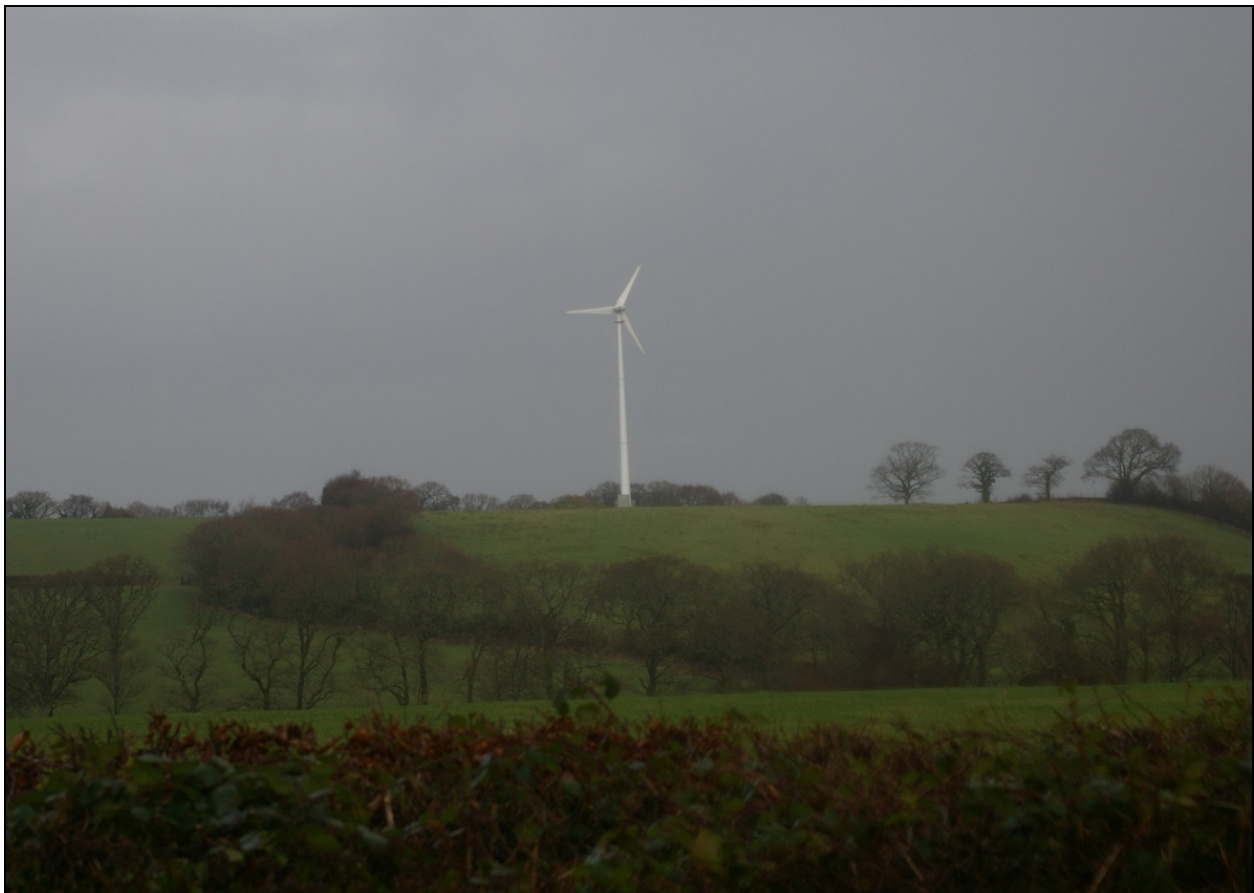
The extant turbine just north of the proposed turbine site; from the south.
