LAND at HEANE FARM, HATHERLEIGH, DEVON

Results of a Desk-Based Assessment
Walkover Survey &
Visual Impact Assessment

Report No.: 140117
Date: 12.03.2014
Authors: S. Walls
E. Wapshott
B. Morris

SWARCH project reference: HHF13

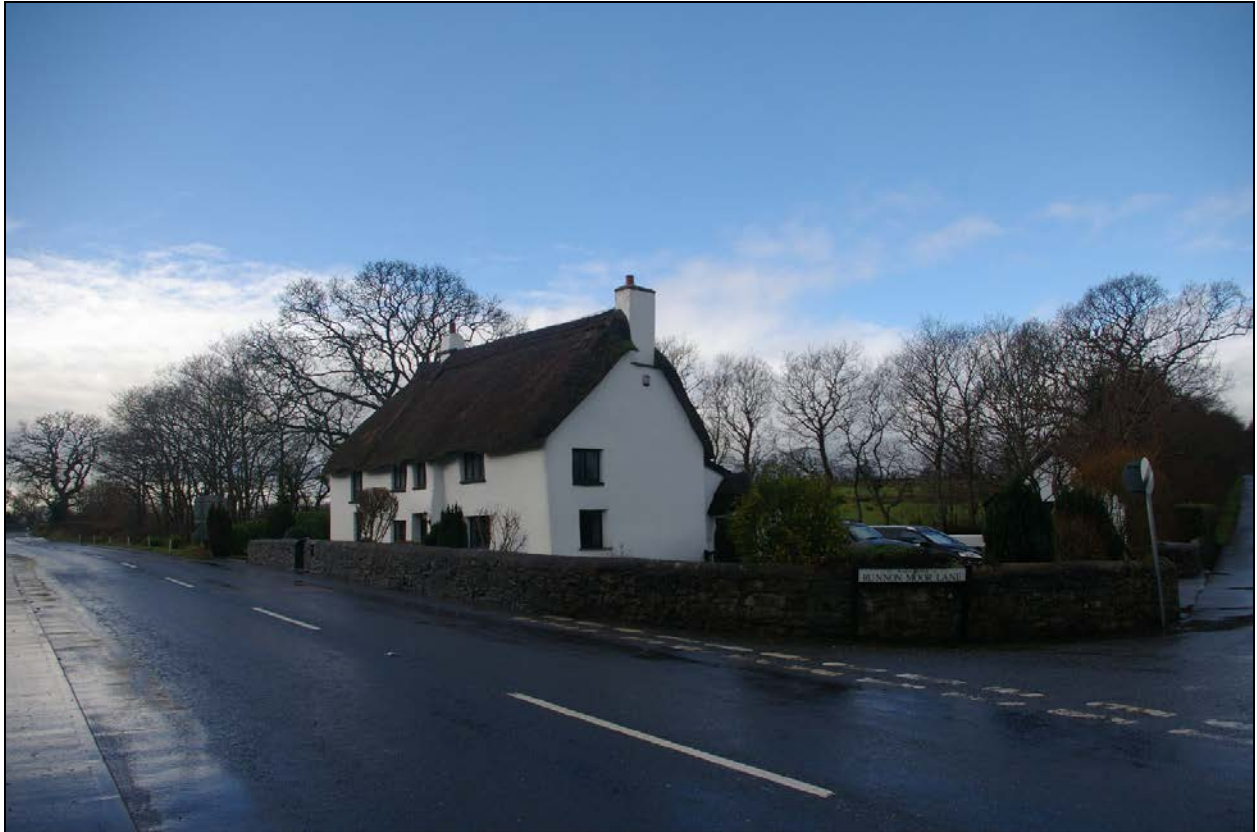
Handon Pen Cottage, west of Hatherleigh, on the A3072; from the south-east.

- Handon Pen Cottage, Hatherleigh; medium significance; Grade II Listed; condition: excellent. Set to the west of Hatherleigh, in a small corner plot alongside the A3072, a historic roadway between Hatherleigh and Holsworthy. The historic field system respects the small corner of land on which the cottage is built. Designed as an out-of-town agricultural cottage, probably associated with the grazing rights on Runnon Moor, the house was not built with views in mind, but for its position, near the road and moorland. It is now almost wholly consumed within a council estate and industrial site, facing across to a large nursing home. The only surviving views which give the asset some context in which to understand its intended setting are to the west and north west, through the trees. The adjacent hedge-bank does somewhat break up these views (seasonally), topped with densely packed mature trees. The wind turbine will be within these views and although it will not interrupt the views between the house and fields, it will be another modern impact on the asset, reducing its setting slightly further. The effect on the asset is cumulative here, as it has already lost all real sense of its intended function and place. The architectural value of the asset however will not be affected and its immediate setting in its small grounds aren't affected and its primary facade to the south, will not have any views to the wind turbine; impact: **negative/minor**.

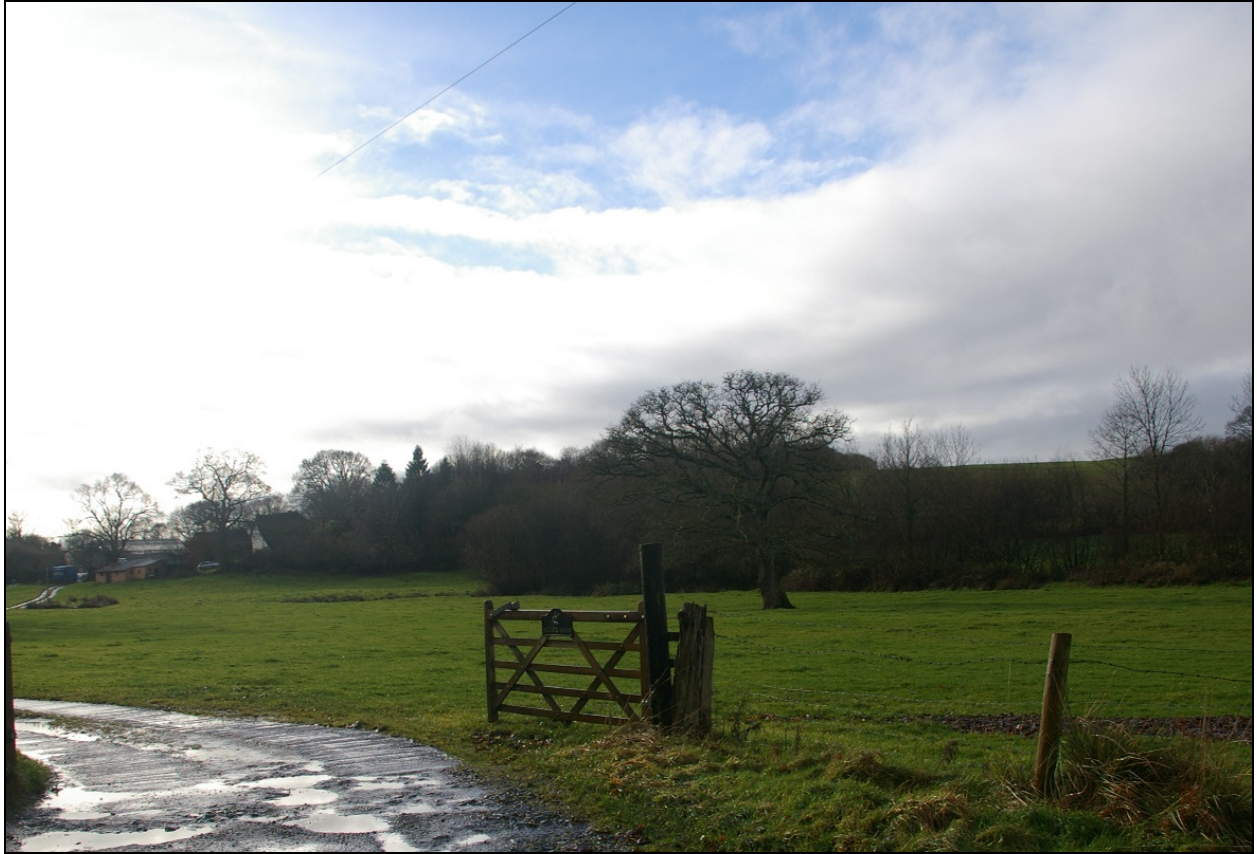
Holmes Farmhouse, north of Hatherleigh, set to the west side of valley, some local blocking from trees set around the house but limited views to the south and west towards the proposed turbine; from the north.

- Holmes Farmhouse, Hatherleigh; medium significance; Grade II Listed; condition: good. Visible across agricultural fields this small thatched building sits to the west of a wide shallow river valley, nestled into the edge of the slope, which then rises sharply. The valley turns and the ground therefore rises sharply to the south as well. The west slopes of the valley are dominated by woodland which would be expected to block all views to the turbine. The house also sits amongst trees. Despite being able to assess condition at a distance across the fields, the actual level of impact was harder as the house was only accessible down a long gated driveway. **Negative/unknown** impact should accurately be applied but neutral impact is expected due to the woodlands, despite being in the dominant zone.

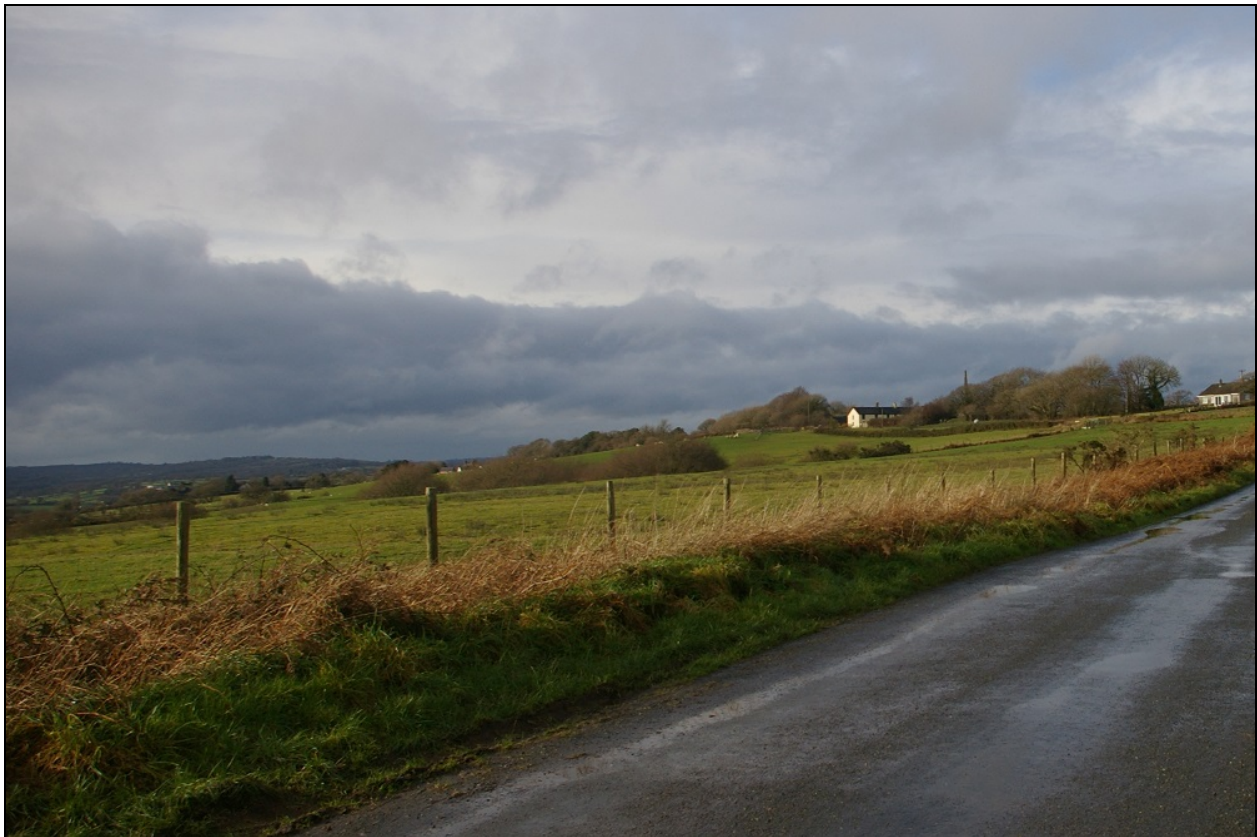
View from Hatherleigh Moor across towards the proposed turbine site, including the Morris Monument and showing how the monument stands tall in the landscape; from the south-east.

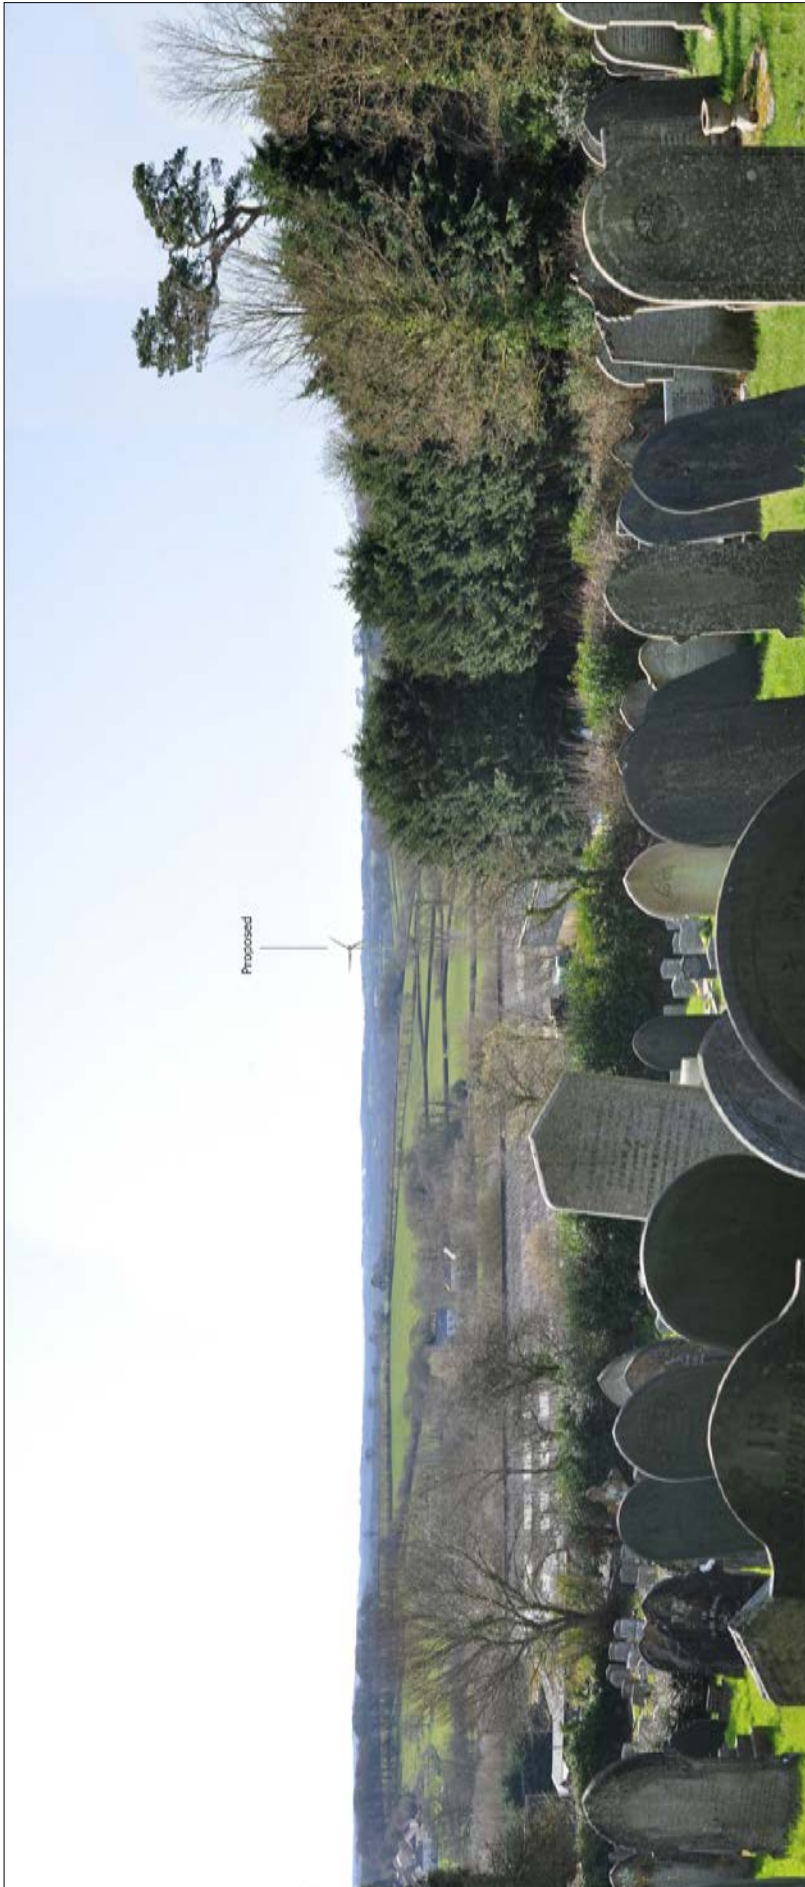
Photomontage, showing the view from the Church in Hatherleigh (photomontages produced by Amalgam Landscape/Plumedia for Mi-Grid – see LVIA for the original photomontages and methodology of production).

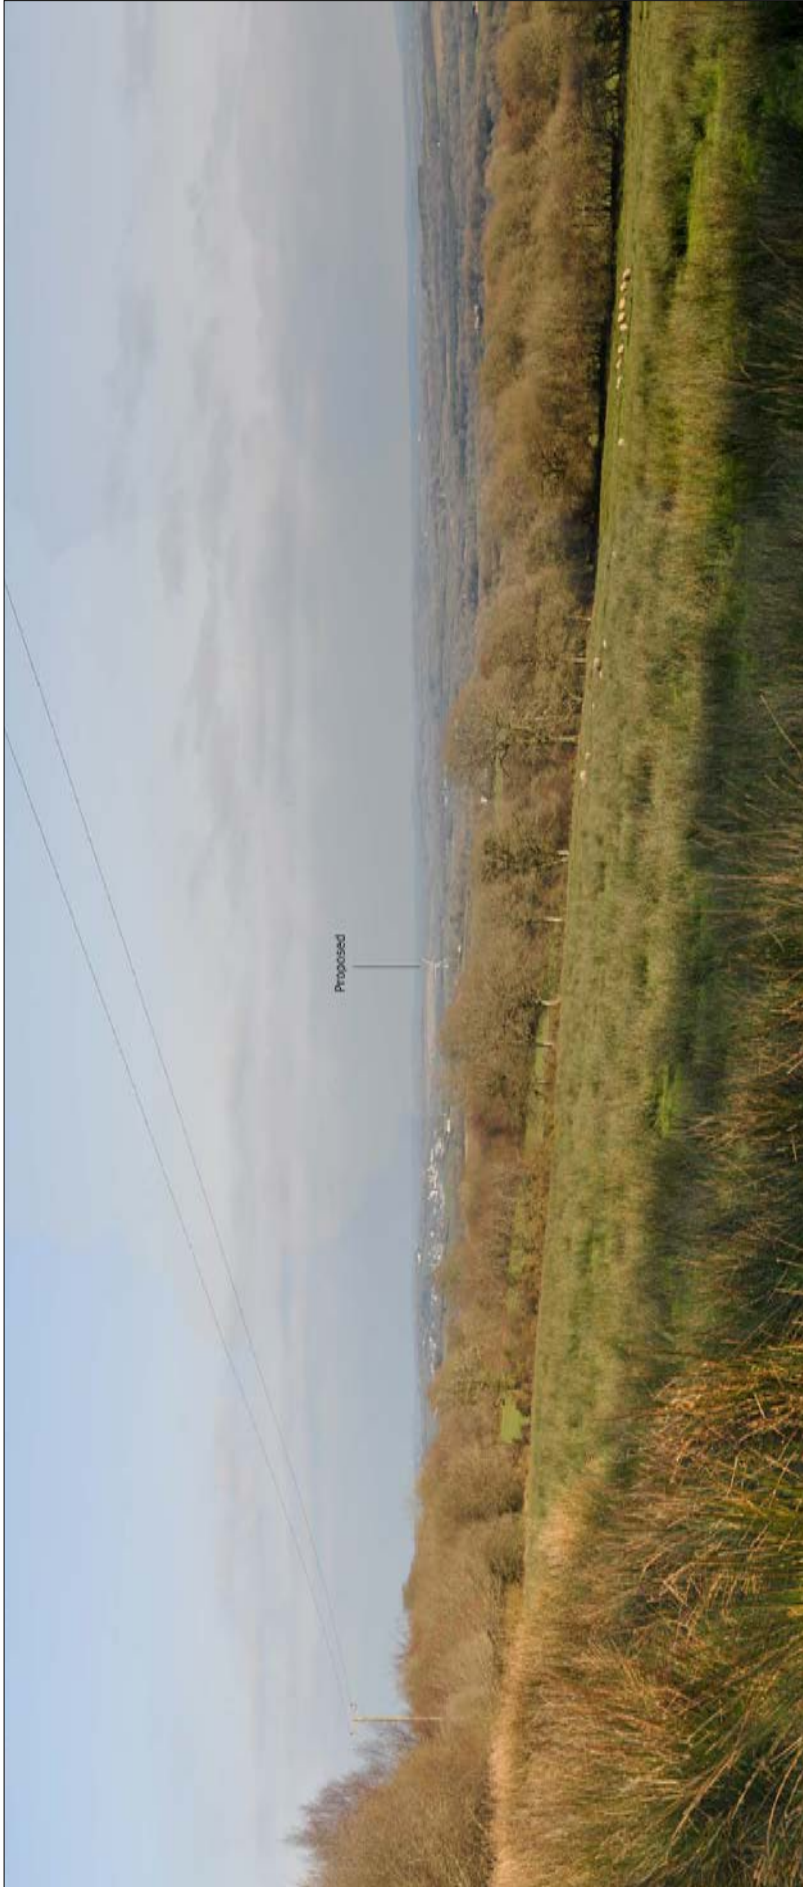
Photomontage, showing the view from close to the Church in Highampton (photomontages produced by Amalgam Landscape/Plumedia for Mi-Grid – see LVIA for the original photomontages and methodology of production).

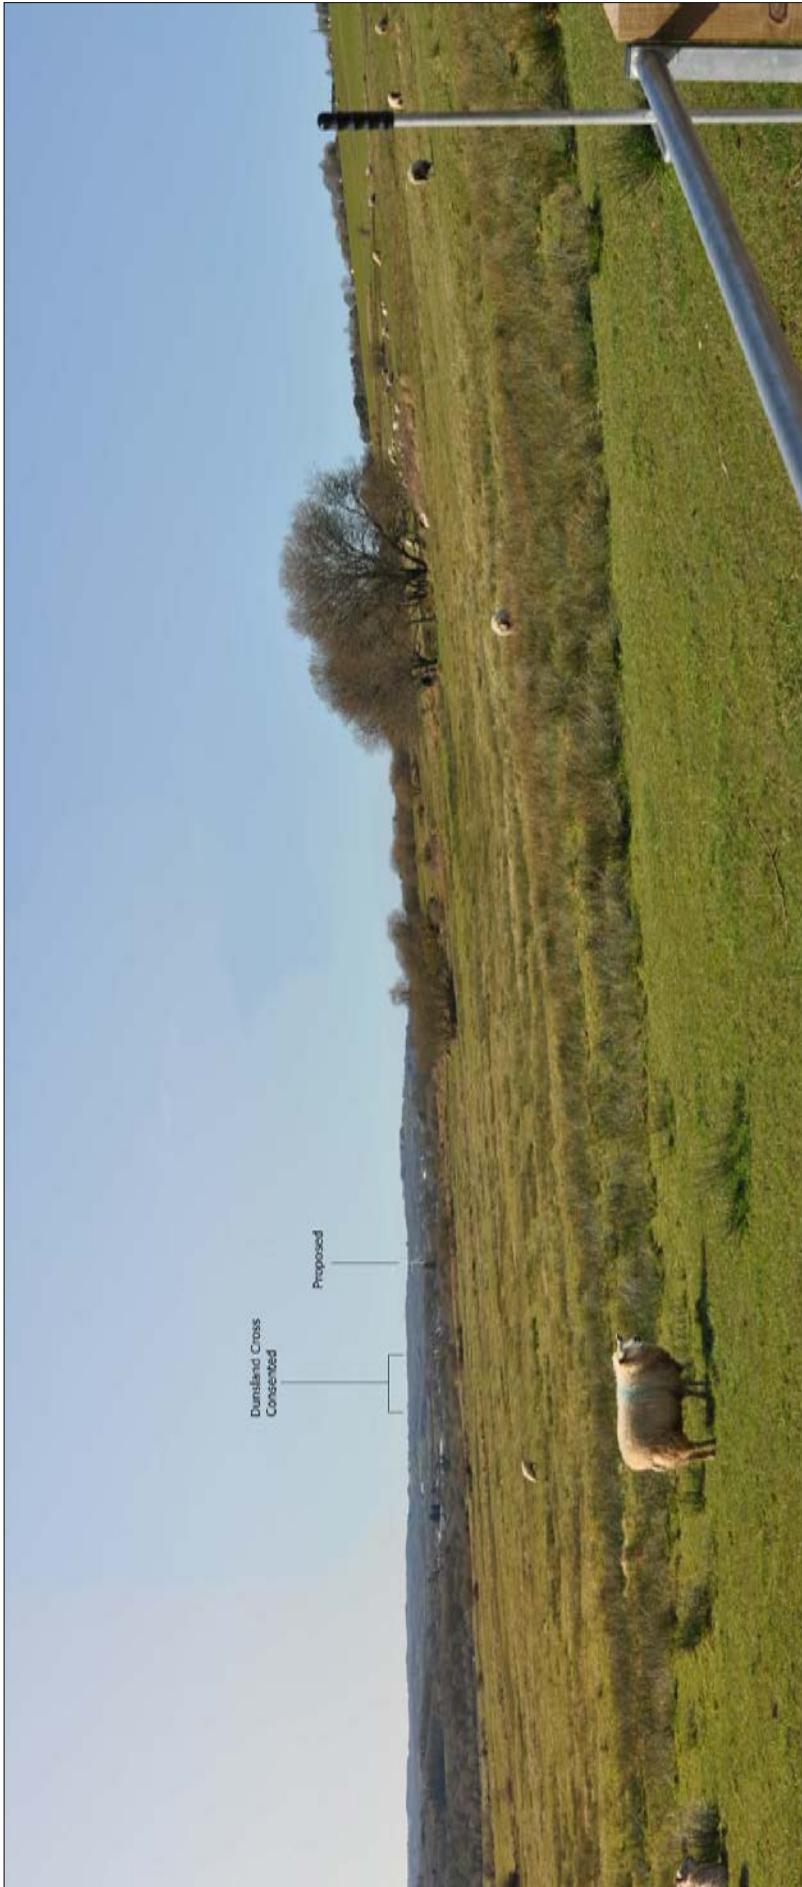
Photomontage, showing the view from the top of Hatherleigh Moor (photomontages produced by Amalgam Landscape/Plumedia for Mi-Grid – see LVIA for the original photomontages and methodology of production).
