OCCOMBE HOUSE PRESTON DOWN ROAD PAIGNTON DEVON

Historic Building Assessment

Report No.: 140110
Date: 10.01.14
Authors: D. Laing-Trengove
S. Walls

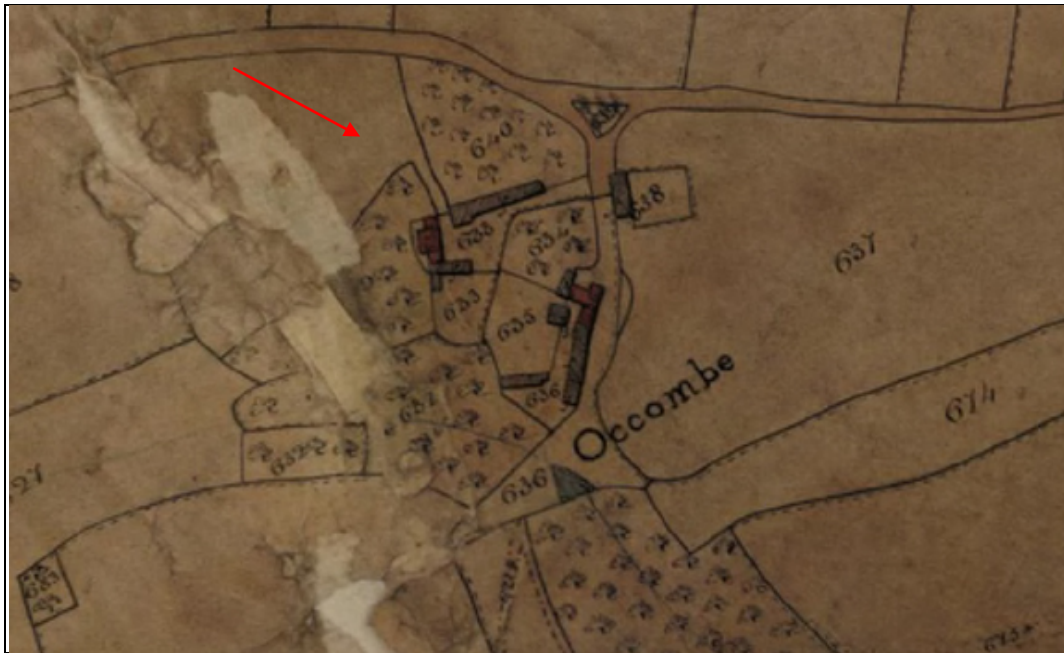
The earliest known source available to this study is the 1840 tithe map for Marldon. Figure 2 is an extract from the map, showing that at this time there is no building in the position of the current Occombe House. The small settlement of *Occombe* at this time appears to comprise two domestic buildings (coloured pink on the map) both with associated ranges of outbuildings located within plots numbered 633 and 636. These two houses reflect two separate Holdings (both named Occombe in the apportionment). Number 633 is listed in the apportionment as a *house, yard & outhouses* occupied by a Thomas Northcott and owned by Montague Edmund Newcombe Parker (1807-1858). M.E.N. Parker who lived at Whiteway House, Chudleigh, was M.P. for South Devon between 1835 and 1841 and High Sherriff of Devon in 1849. Number 636 (*house, yard & outhouses*) was leased by a Charles Pook from a Robert Butland (of Preston) who was one of the largest landowners in Paignton at this time.

The area in which the present Occombe House is located is shown as a single large enclosure at this time, and although the number is illegible, it is likely to have been numbered 629 (Orchard Park) given the surrounding fields. part of the land owned by M.E.N. Parker. The only feature of

Figure 2: Extract from the Marlton tithe map of circa. 1840. The approximate location of Occombe House is indicated.

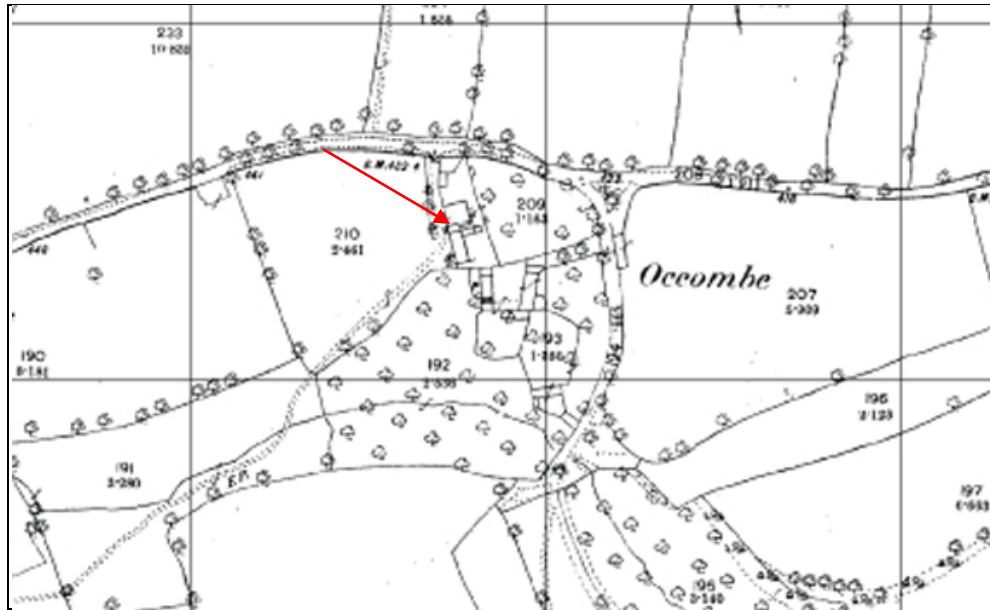
By the time of the First Edition Ordnance Survey Map of 1887 (the next available cartographic source), there is a very different settlement layout at Occombe (Figure 3). Many of the earlier buildings that made up the two separate farmsteads in the early 19th century have been removed. The former domestic building located to the south of the current Occombe House appears to have been truncated to the west and the long non domestic range to the east has gone. The other farmstead further to the south appears to have been almost completely removed, with just a single building remaining of the former range of buildings in this location. There is also some amalgamation of smaller enclosures (orchards) primarily to the south of the settlement.

Figure 3: Extract from the Ordnance Survey First Edition Map of 1887.

These developments are almost certainly associated with the building of Occombe House which by this time had been constructed on the high ground to the north of the two former farms, within a rectangular enclosure taken in from the former field to the north-west. The house appears to comprise a square main range with a very small projecting element on the east elevation and possibly two projecting elements on the west elevation (coloured black?). To the south are what appear to be a number of small outbuildings and a large north-south orientated range to the south-west with a small compartment linking this with the main house. The house appears to be accessed at this time from a lane to the west of the house, which may suggest that the front elevation and entrance into the building was located on the west side of the building originally.

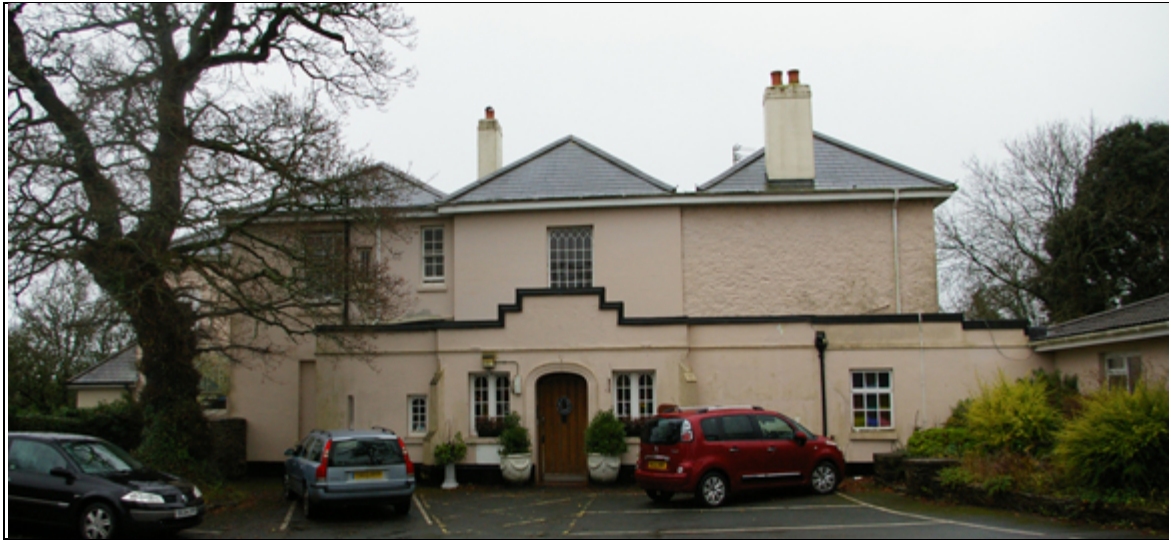
Figure 5: The north front of Occombe House, viewed from the north.

The north front, triple gabled elevation of Ocombe House retains a symmetrical façade with an early 20th century ground floor porch or vestibule with short flanking corridors. The western (right) corridor has been extended to the west in the late 20th century. The decorative metal windows flanking the arched door opening appear correct with the single storey entrance but the windows above at first floor level in the gables are inconsistent with the apparent symmetry of this facade. The western gable is un-rendered and projects northward in comparison with that to east. To the north-west and south-east of the primary building modern single storey ranges have been added and to the west the projecting bays in the west walls of rooms G23 and F18 above have been constructed in the late 20th – early 20th century. The rendered and painted rear south and east elevations of the building retain little of historic interest (see Appendix 1).

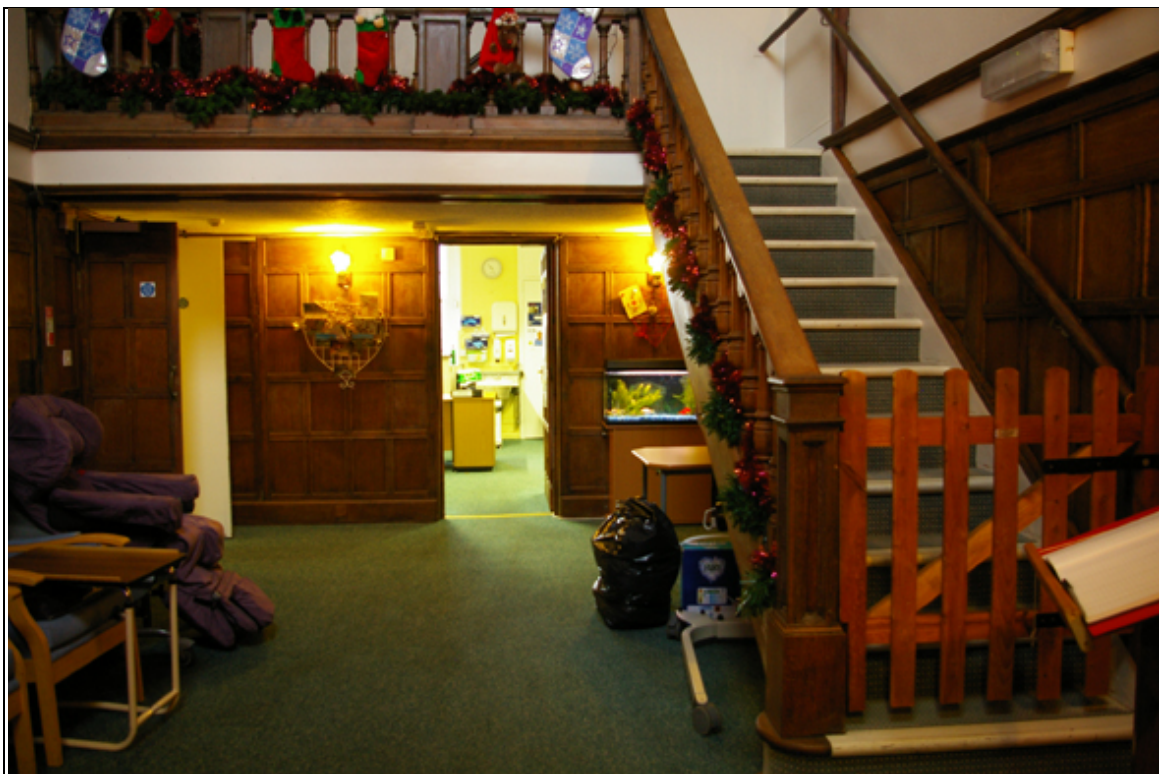
The interior ground floor retains a significant amount of historic detailing, although large parts of the earlier building have been altered and adapted for use other than as a private house. The main entrance/stair hall (G17), along with the south wall of the entrance porch (G16), is completely panelled at ground floor level, including the doors and underside of the stair (Figure 9).

Figure 9: The panelled entrance and stair hall (G17), viewed from the north.

This panelling appears to be older than the building and of 17th century date; worn, with simple moulding and plain panels and with decorated carved and reeded pillasters. The panelling

appears well set but some elements appear uncomfortable and the timberwork is clearly reused here. The stair is also of a late 17th century style; a closed string with chunky balusters. The course of the stair has been altered just below first floor level, now with a modern flight rising to the west from the intermediate landing to first floor level. There is a 19th century neo-gothic fireplace in the centre of the east wall with a large decorative cast iron fireback cemented into the back of the opening.

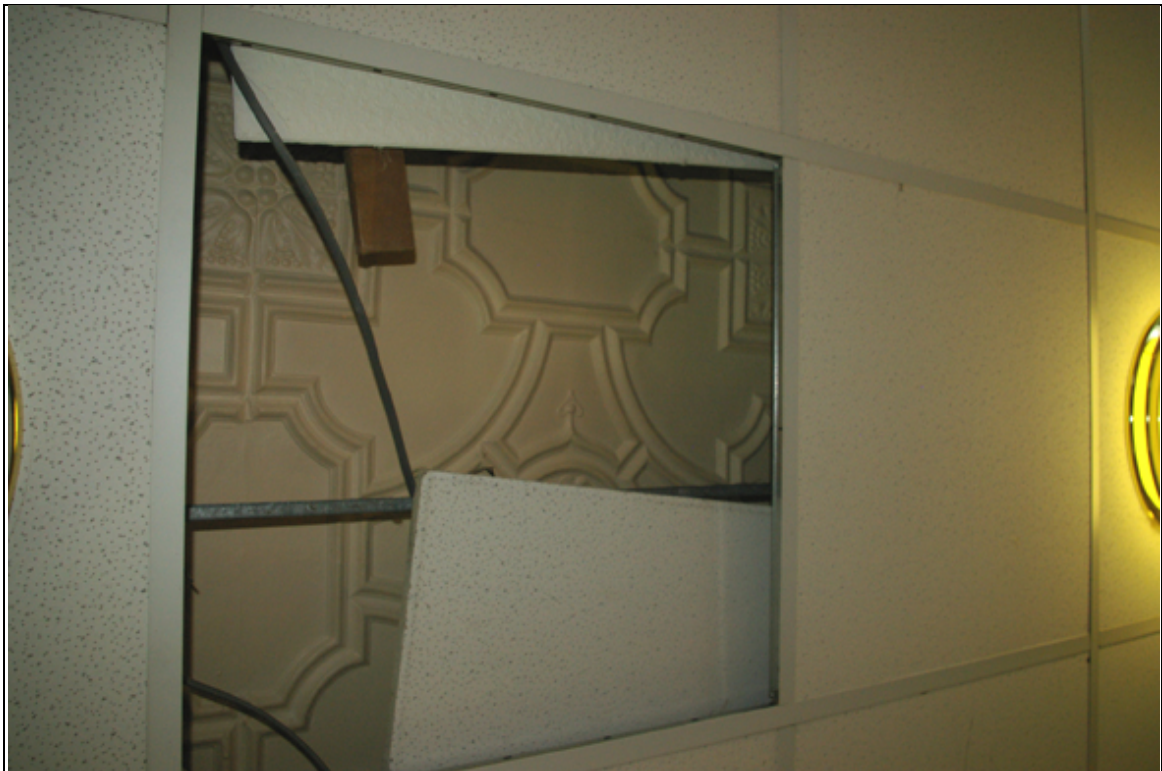
Accessed via a panelled door in the south-west corner of the entrance hall, the current dining room (G22) retains unremarkable panelled window cases but an apparently intact decorative plaster ceiling above the lower modern ceiling panels (Figure 10).

Figure 10: A small portion of the moulded plaster ceiling, above the modern ceiling in G22.

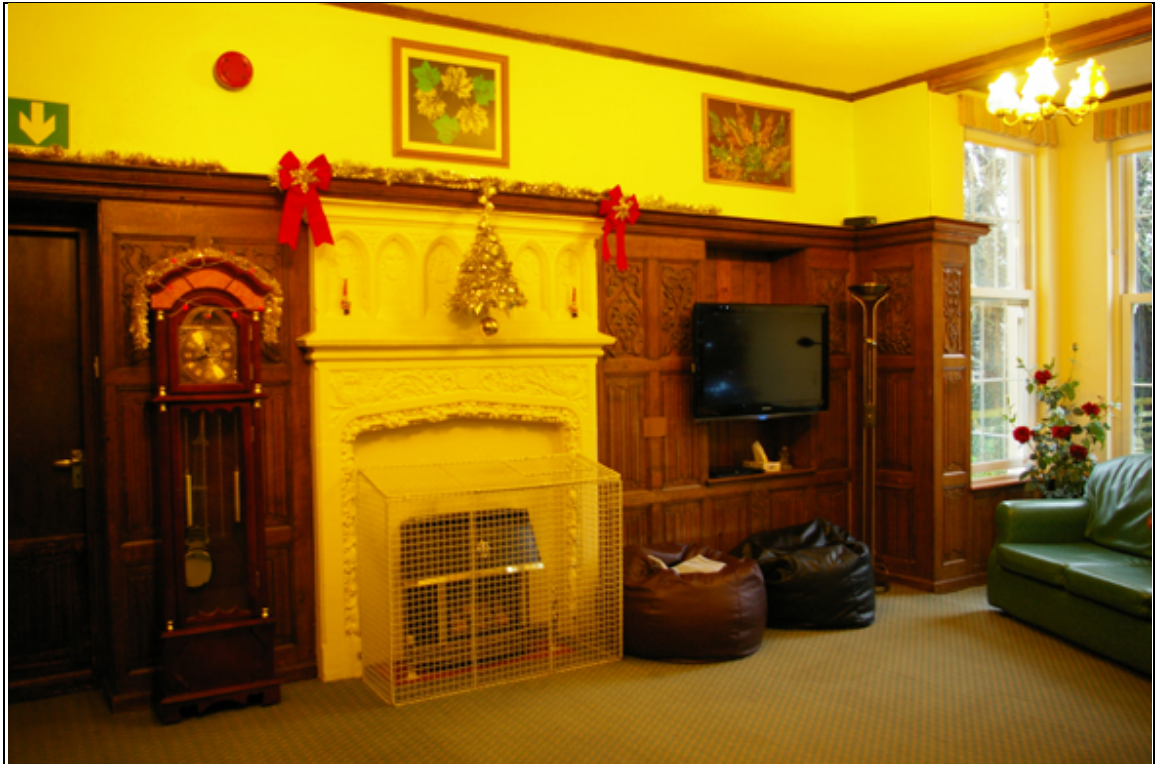
The room to the south (G23) is also panelled and has an elaborate fireplace with integral overmantle (Figure 11). The panelling is linen fold to the lower portion and with a vine relief to the upper panels. These elements appear to form a cohesive whole and are in the late 19th century neo-gothic style. One of the panels on the north wall is carved with a monogram that apparently includes an 'S' denoting a Singer family connection (Occombe House care assistant *pers. com*), although this is not very decipherable (Figure 12). It is possible that this scheme has been reset as some of the jointing is untidy. The stair to the basement (G19) is accessed via a panelled door in the north-east corner of the room; this is probably a later development as the stair is predominantly constructed of modern cement and concrete block.

Figure 11: The elaborate fireplace and panelling on the south wall of room G23, from the north-east.

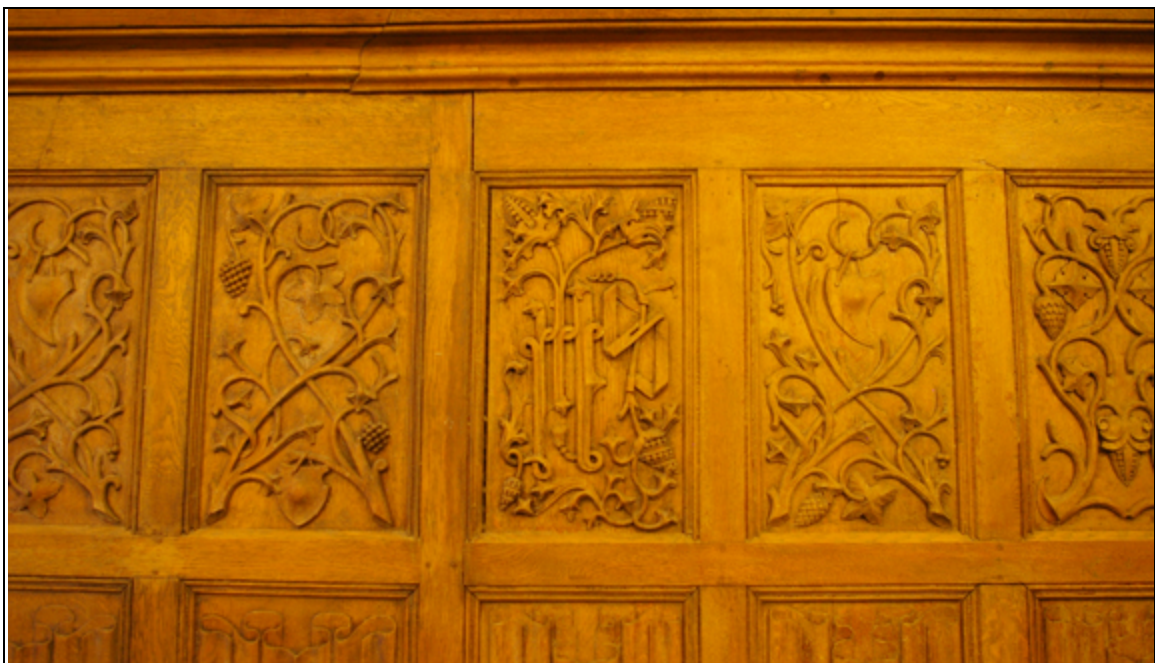
Figure 12: Detail of the panelling on the north wall of G23 with central monogram, from the south.

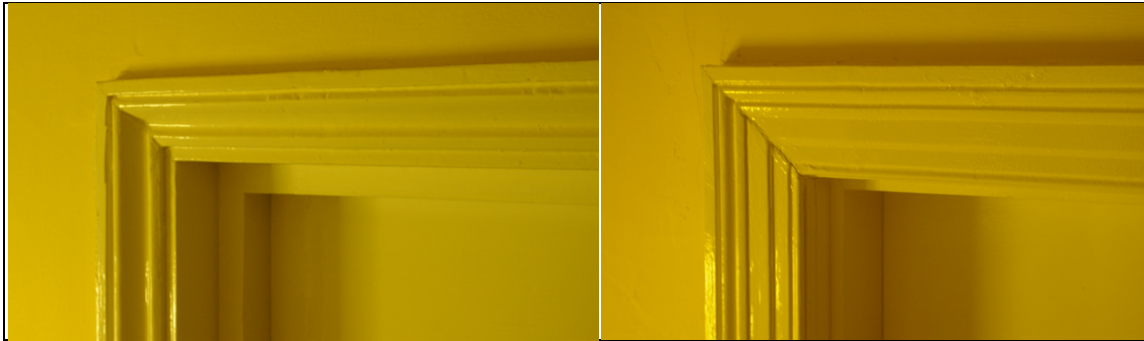
Rooms G7-G14 appear to comprise the original service end of the building. Most of the interior however has been modernized to create ground floor accommodation and little detail remains besides the architrave around some of the door openings which matches that of rooms F14-F16 (see Figure 13). Room G9 has this type of architrave to the interior and a 1930s cupboard door in the north-east corner.

At first floor level the remaining detailing consists primarily of moulded door frames, architrave and skirting. There appear to be two distinct types of moulded architrave used, with the most elaborate being the most common. The less common moulding is present around the door openings into F14, F15 & F16 (Figure 13), all within the north-west corner of the building, whereas the other is present throughout the rest of the first floor (Figure 13) excluding the east end of corridor F1, rooms F2 & F3 and F18, all of which are modern.

Figure 13: Left – The architrave type of door frames to rooms F14, F16 and F17 (interior). Right - The architrave type of door frames to rooms F01, F04, F07, F08, F10, F12 & F17 (exterior).

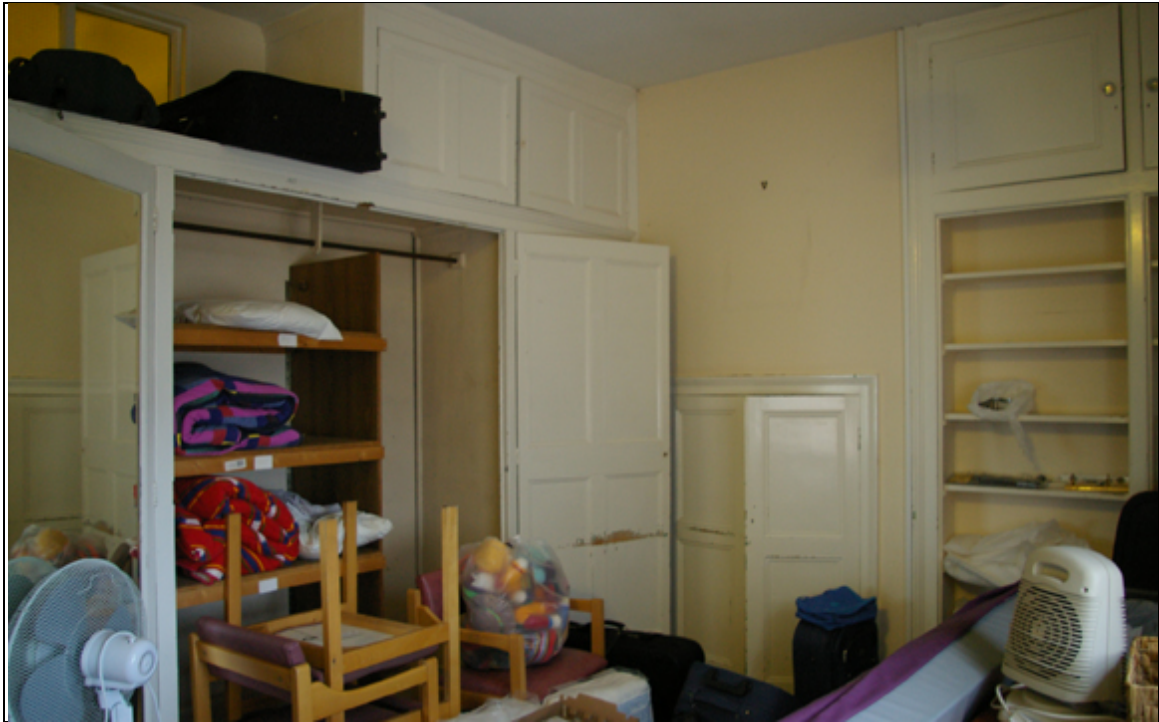
Other 19th century elements found include hornless sash windows, with 2x3 panes per sash, in the west wall of rooms F14 & F15. G14 has a decorative cast iron fire surround, with a blocked arched opening, in the centre of the north wall. F12 is a former dressing room with surviving 19th century built-in cupboards and wardrobes (Figure 14).

Figure 14: The north-east corner of former dressing room F12, from the south-west.

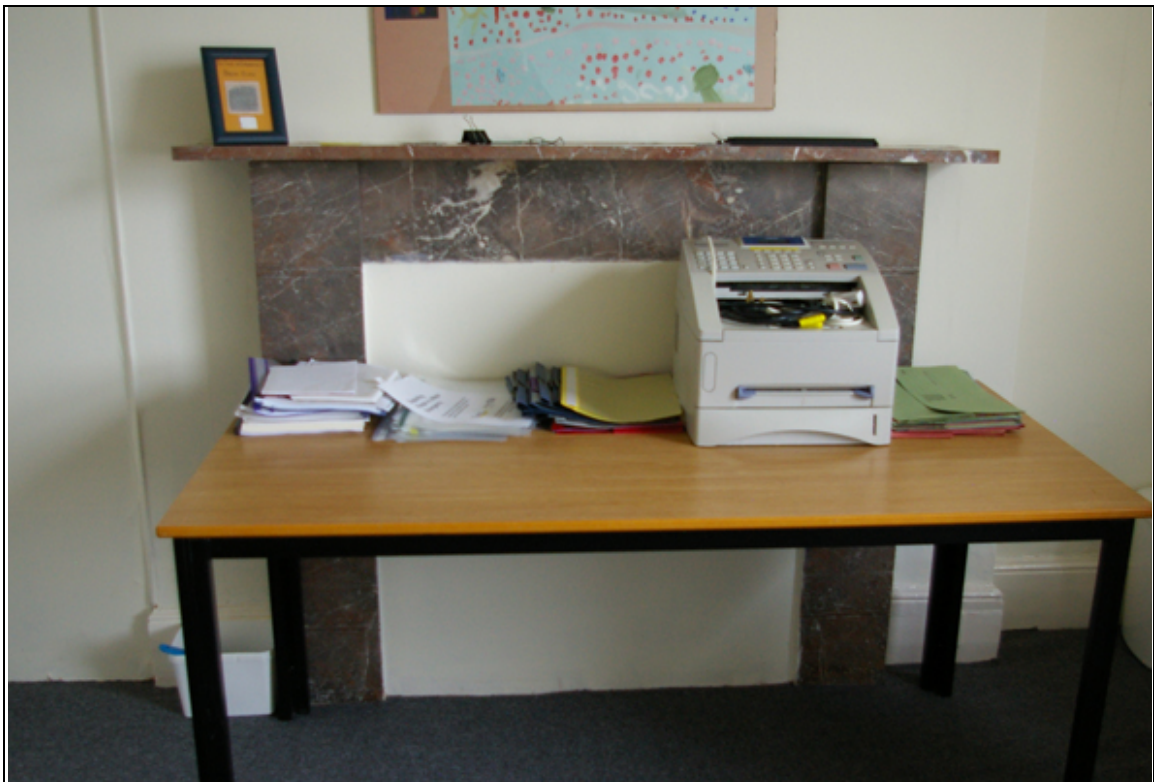
Room F13, in the south-east corner of the main building, retains a (probably local) marble fire surround (Figure 16), with a blocked opening, in the east wall.

Figure 15: Fireplace in the east wall of room F13, from the west.

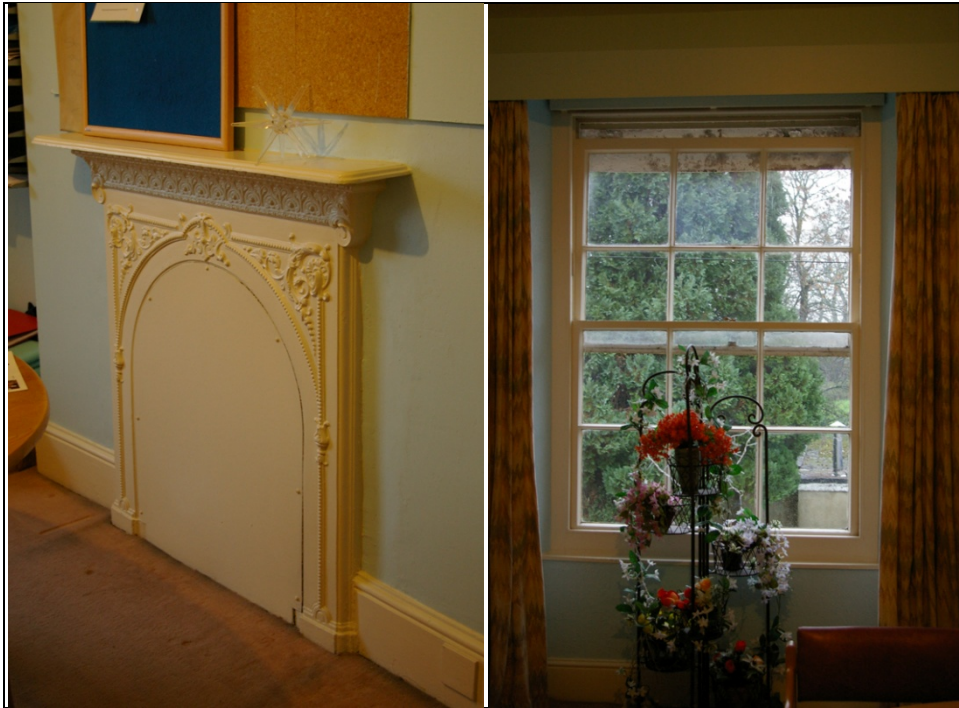
Figure 16: The fireplace in the north wall of Room F14, from the south-east.

Figure 17: The hornless sash window in the west wall of F14, from the east.

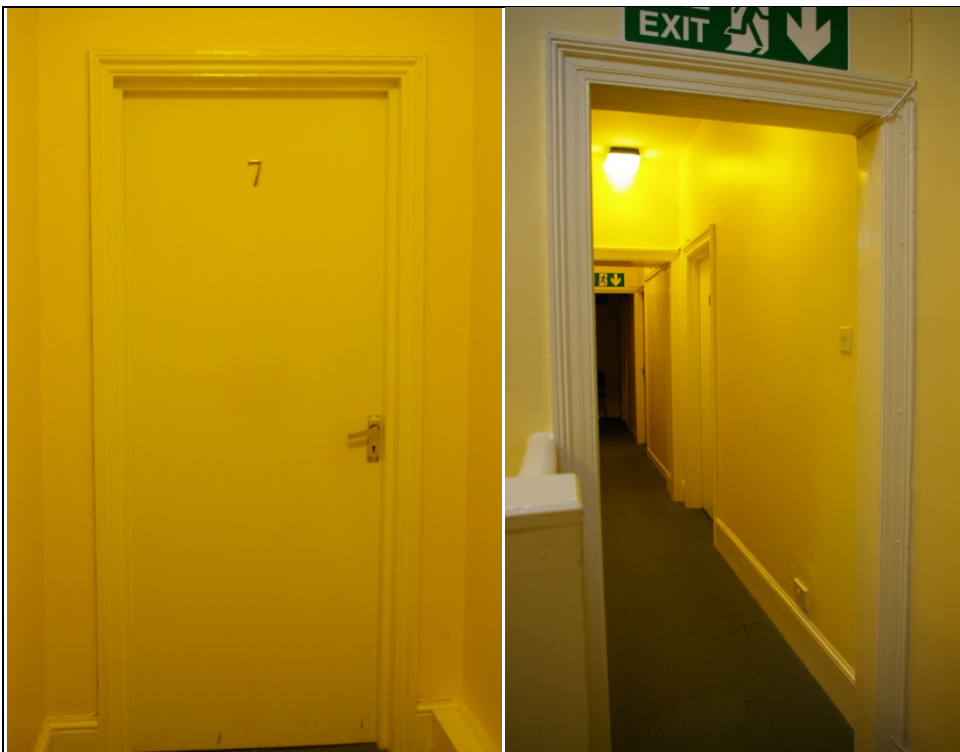
Figure 18: The door into F14, with moulded architrave as to rooms F15 & F16, from the south.

Figure 19: Opening in corridor F01 to the east of F13, from the west.

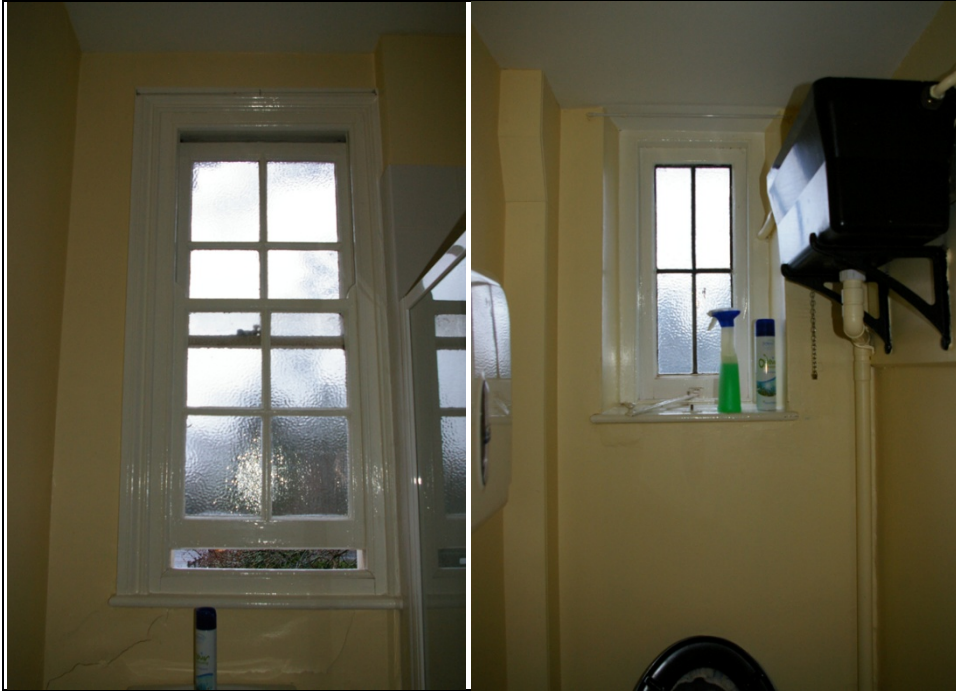
Figure 20: Window in toilet F08, from the south.

Figure 21: Window in toilet F07, from the south.

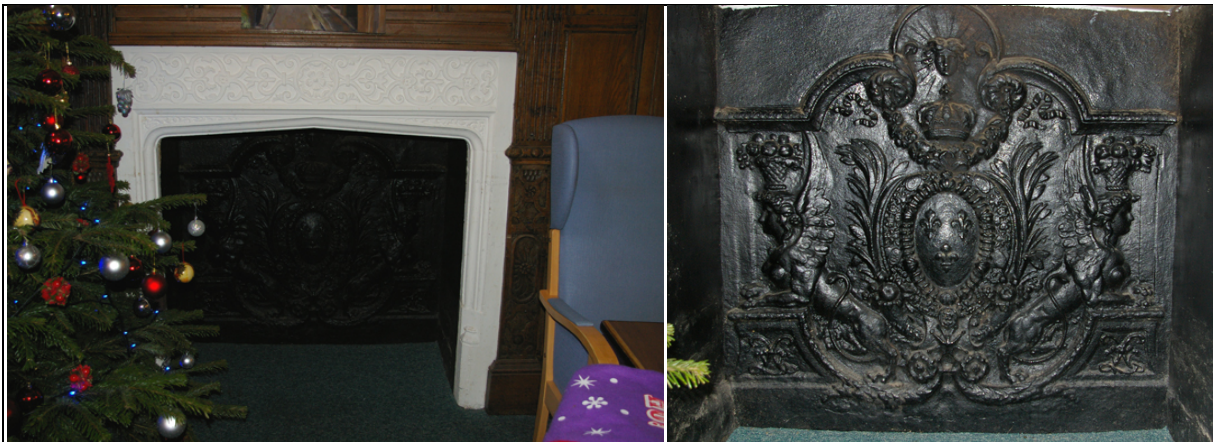
Figure 22: Fireplace in the east wall of the ground floor entrance/stair hall G17, from the west.

Figure 23: Elaborate cast iron fireback cemented into the fireplace in G17, from the west.

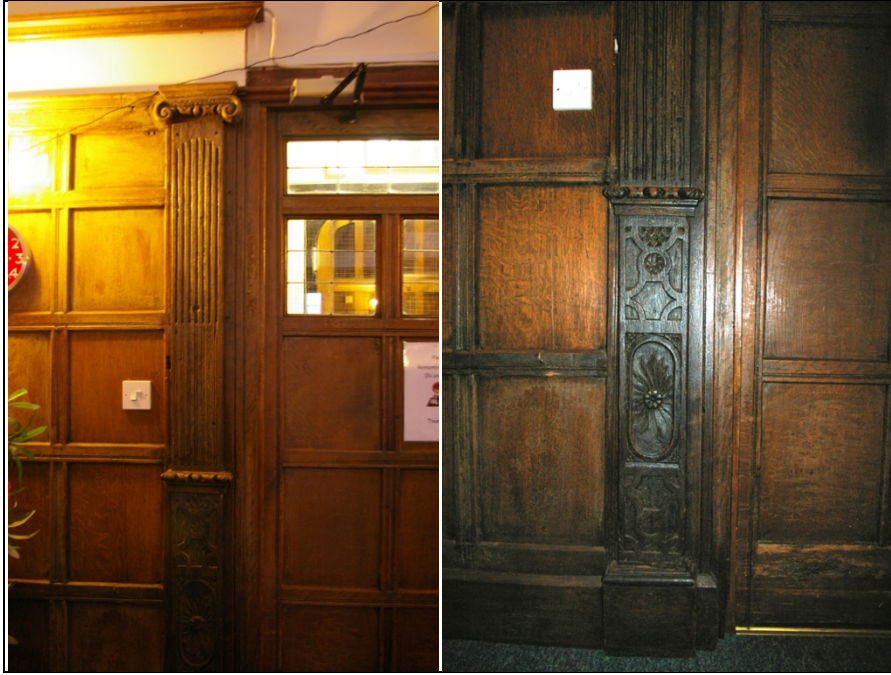
Figure 24: Upper portion of timber pilaster to west of the entrance door in north wall of G17, from the south.

Figure 25: Detail of the lower portion of pilaster as above.

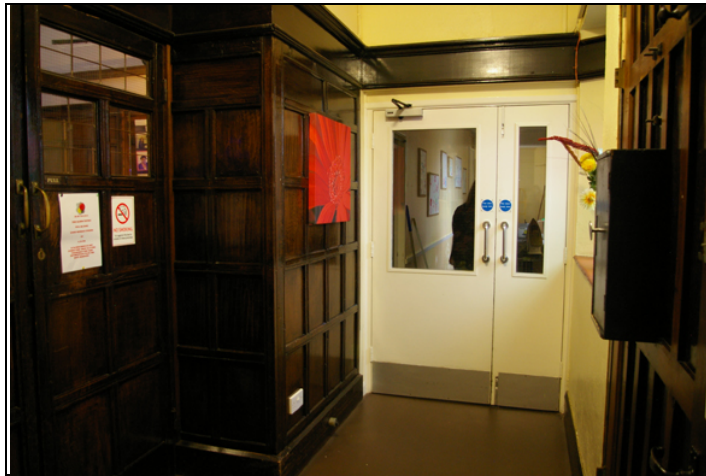
Figure 26: The western door leading from the entrance porch G16, with panelled cupboard to north, from the north-east.

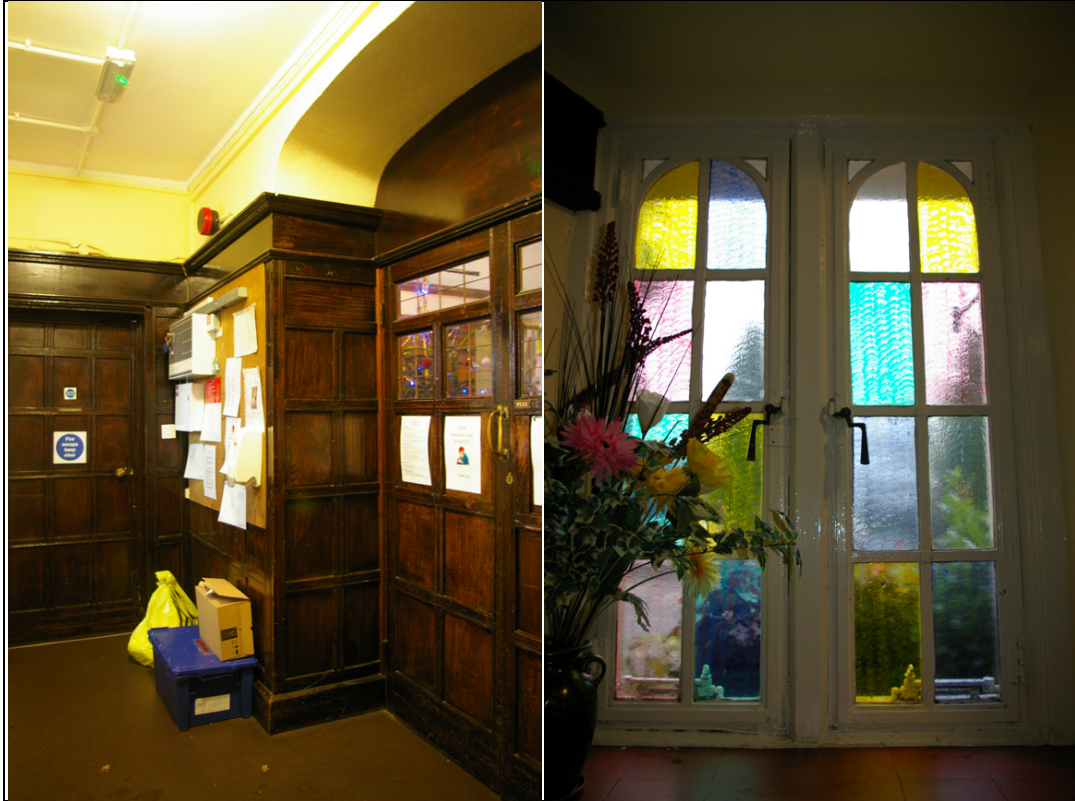
Figure 27: The panelled cupboard, door into lobby G13 and door into G17 from G16, from the south-west.
Figure 28: Window to the west of the front door opening in G16, from the south.

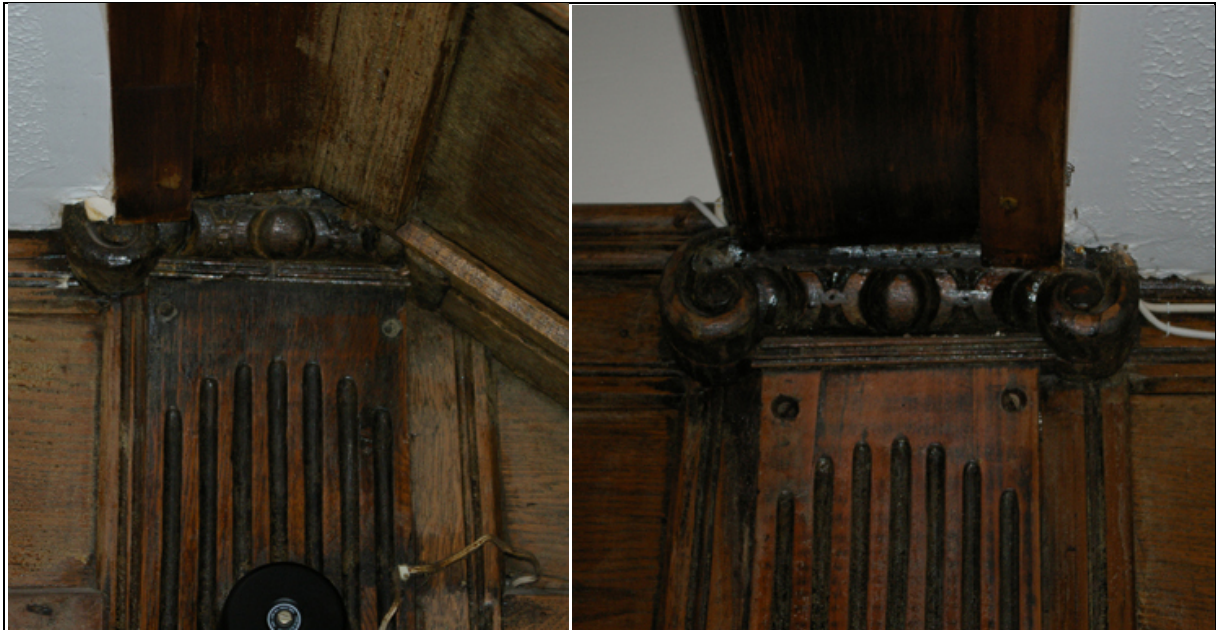
Figure 29: Detail of ionic capital of pilaster beneath the stair and landing on the west wall of G17, from the east.
Figure 30: Detail of ionic capital of pilaster below the landing rail on the east wall of G17, from the west.

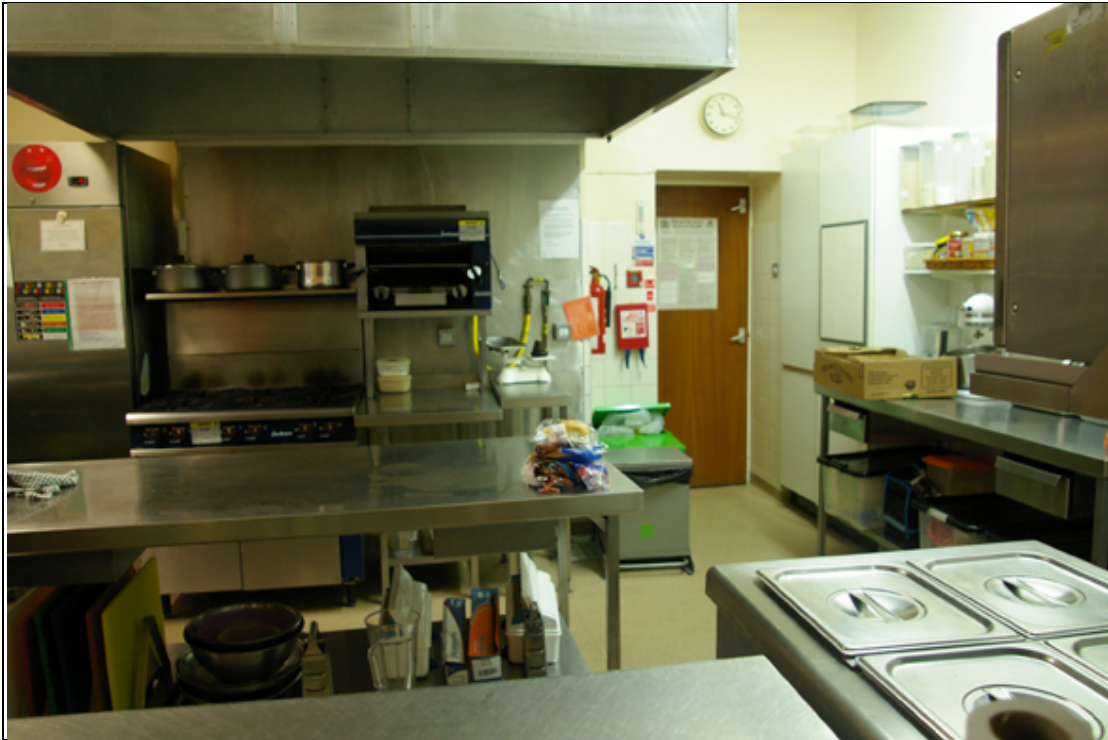
Figure 31: The current kitchen, G21, from the modern opening in the north wall of G22.

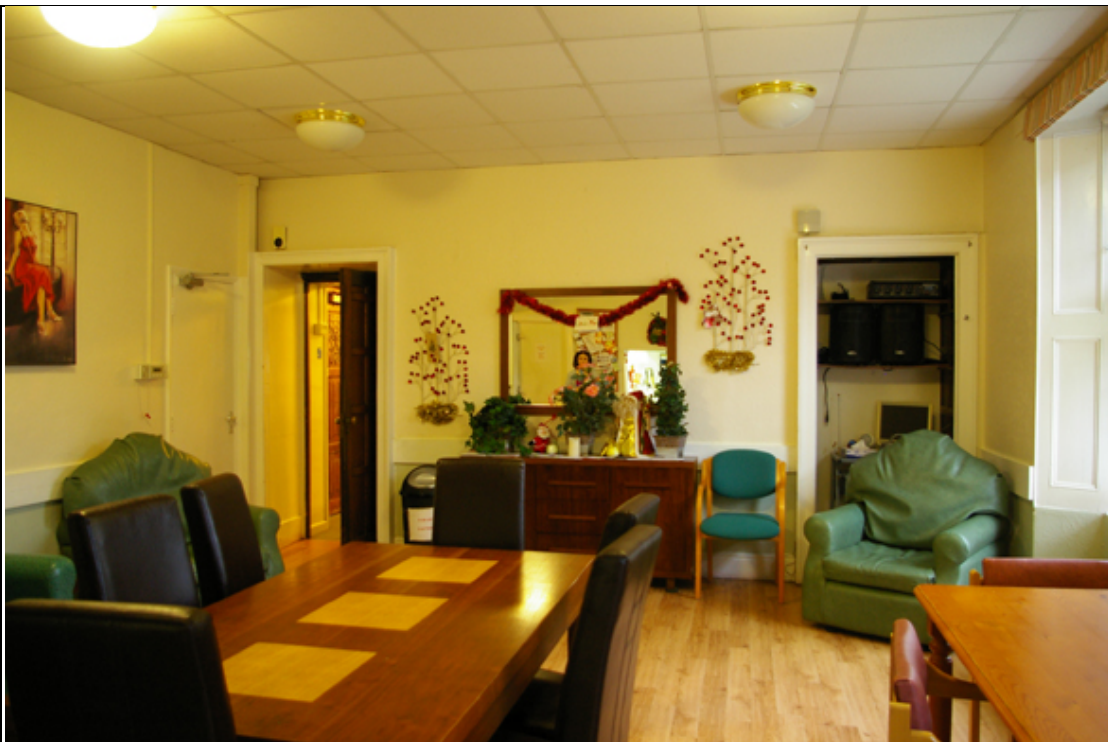
Figure 32: The south wall of G22, with framed, panelled alcove to the west and door opening into G23 to the east, from the north.

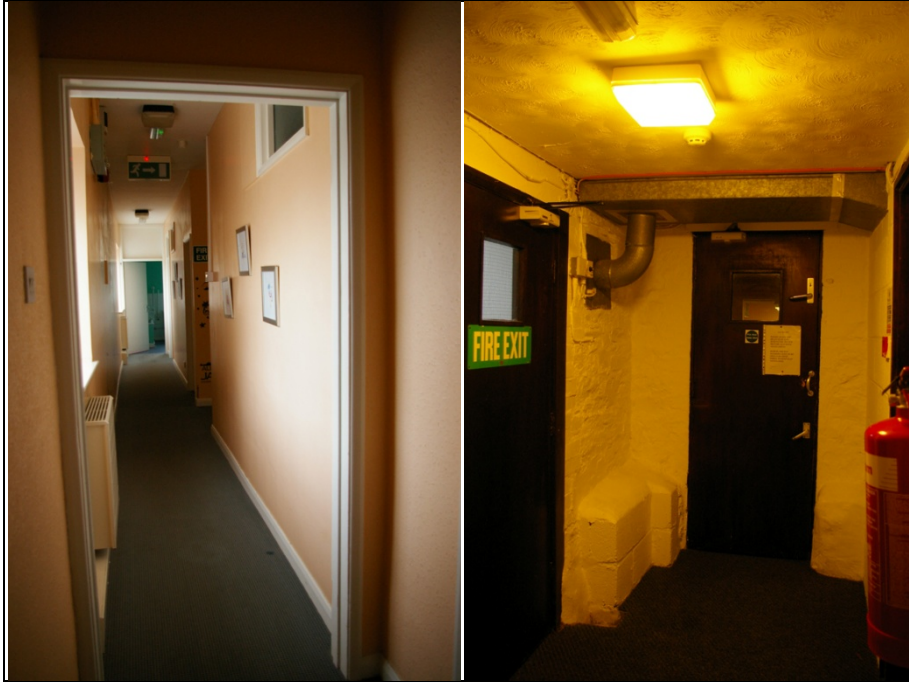
Figure 33: Corridor G26, from the north.

Figure 34: B11, with doors from stair B09 & corridor B12, from the north.

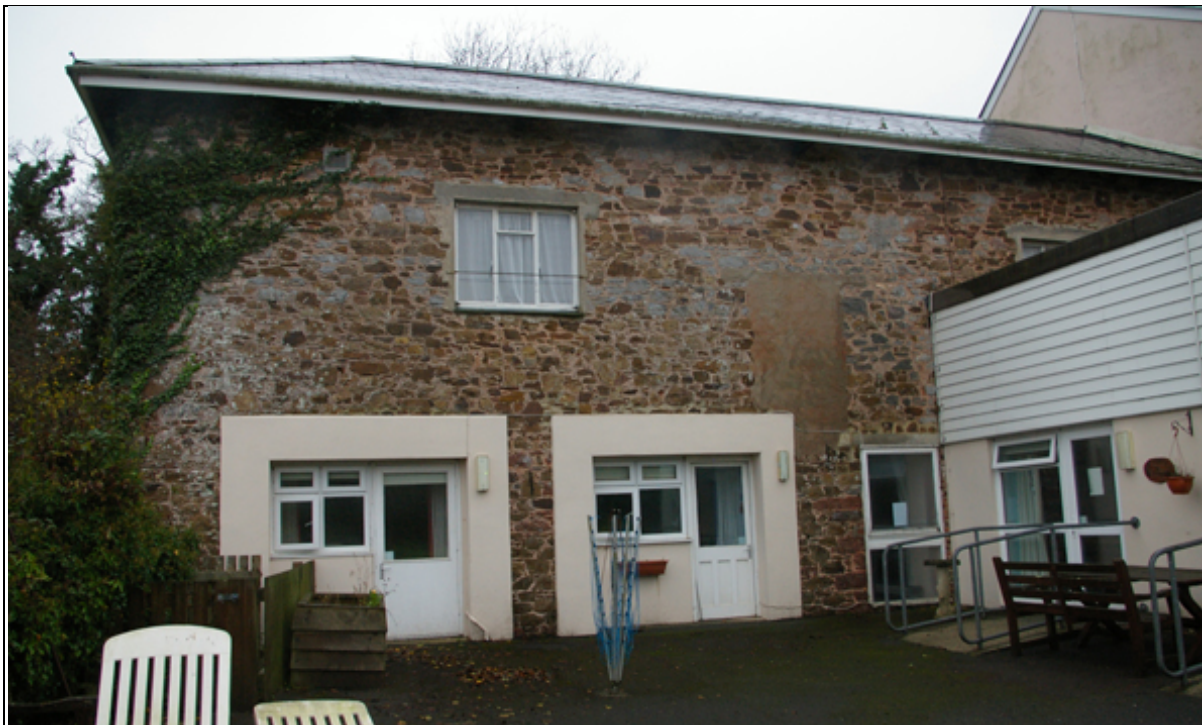
To the rear (south) of the main range, down slope to the south-west, is a stone-rubble built range un-rendered to the east, which retains some evidence of former use, with a blocked opening in the east elevation of a former first floor loading door which suggests that this range

probably functioned as stables/carriage house/garages. The south elevation of this element was not viewed (unable to access) and the west elevation is modern.

Figure 35: The east elevation of the former stable block to the south of the house, from the east.

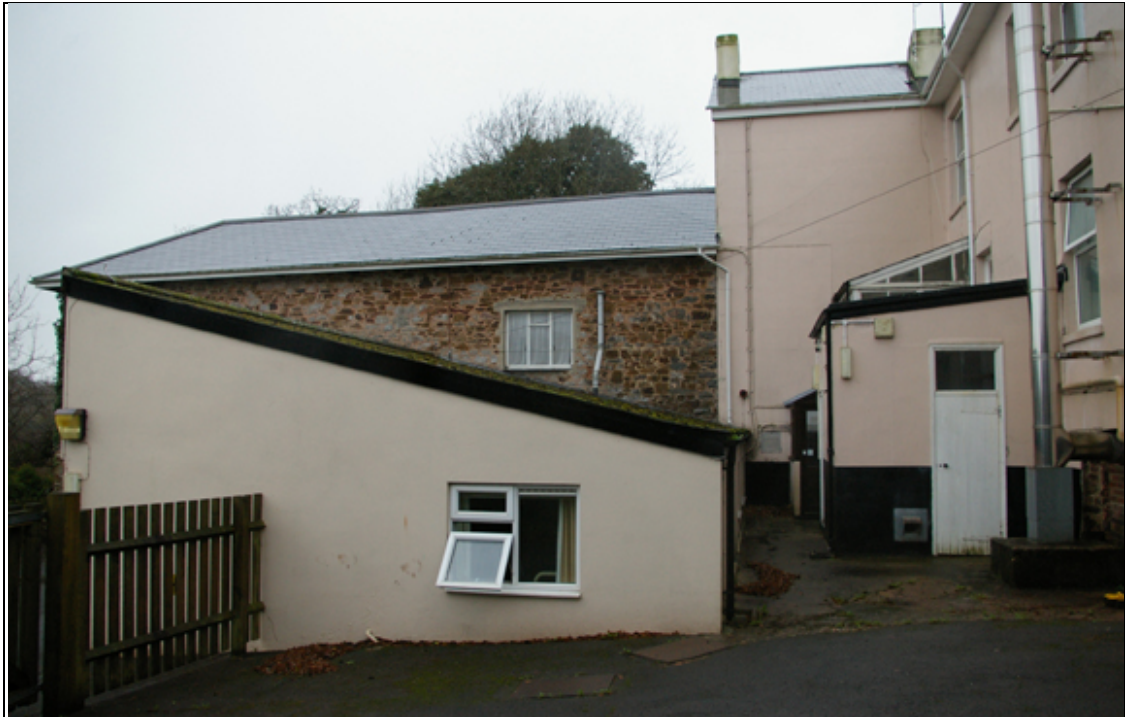
Figure 36: The east elevations of the southern elements of Occombe House, from the east.

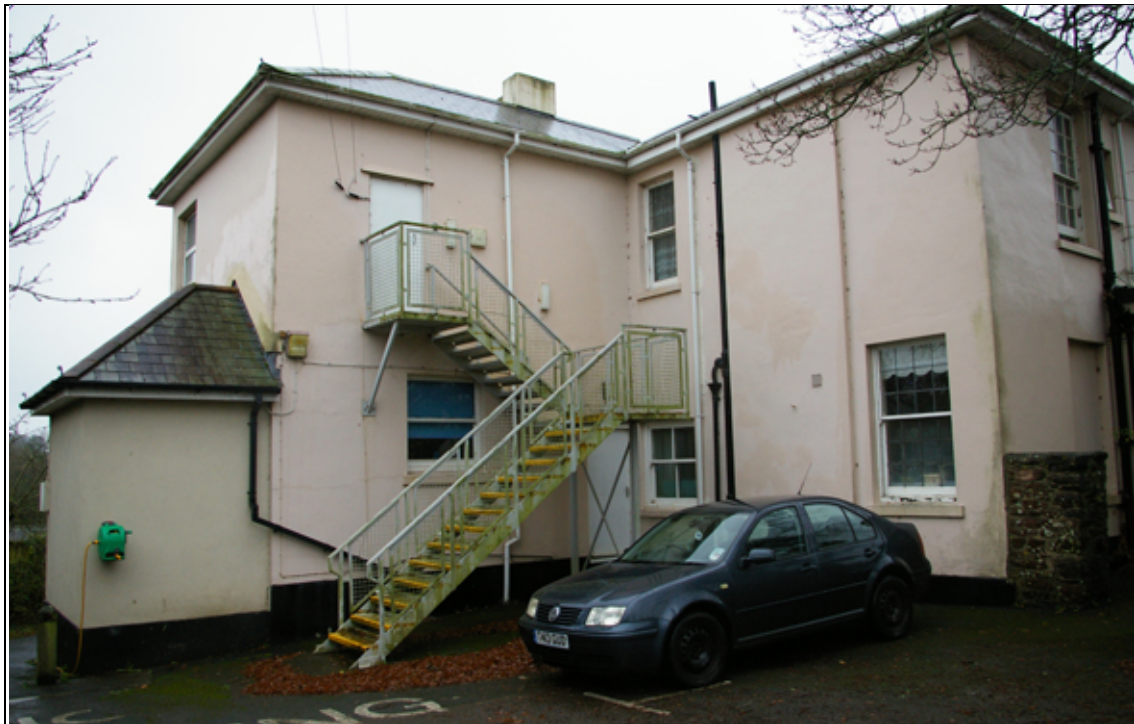
Figure 37: The north-eastern end of Occombe House, from the north-east.

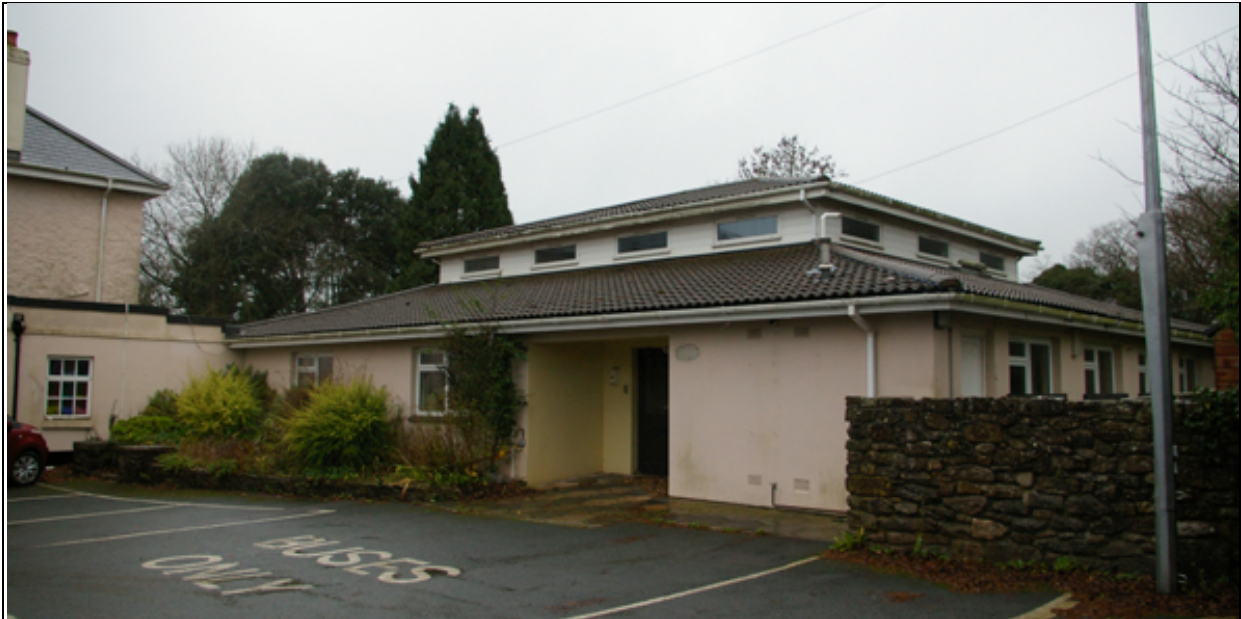
Figure 38: The north and east elevations of *Fairwinds*, from the north-east.

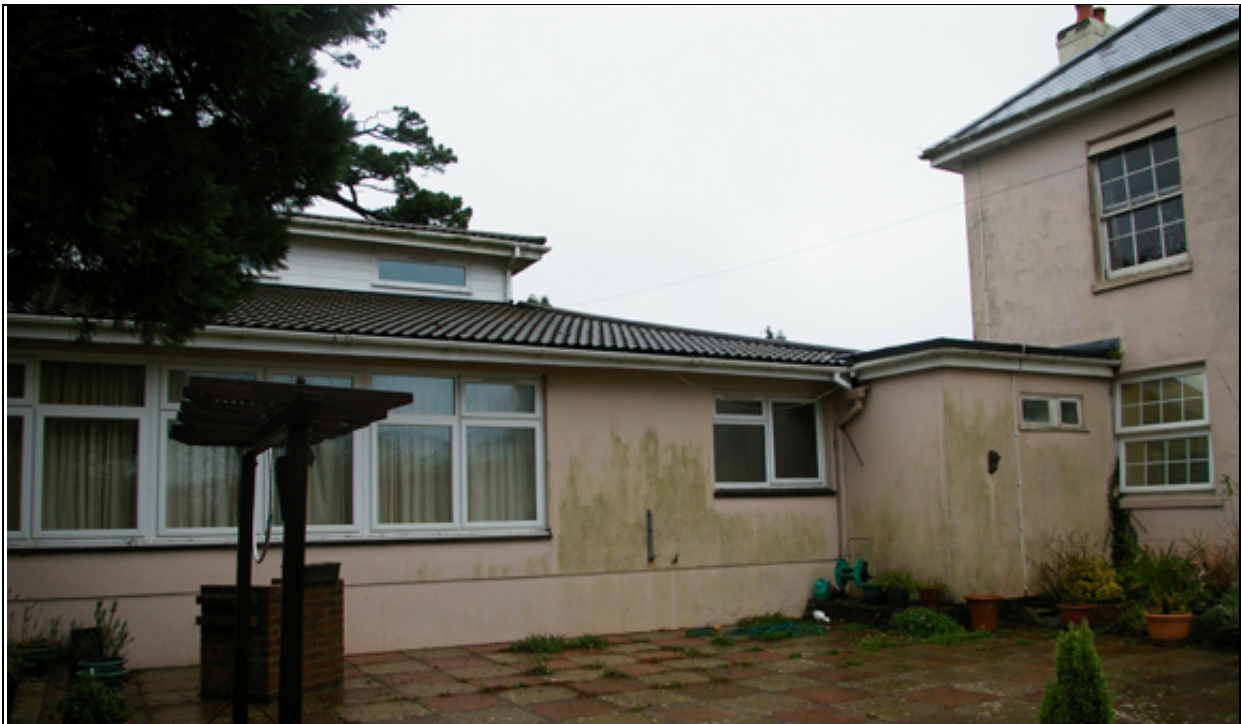
Figure 39: The south elevation of *Fairwinds* adjoining the north-west corner of Occombe House, from the south.
