OCCOMBE HOUSE PRESTON DOWN ROAD PAIGNTON DEVON

Historic Building Assessment

Report No.: 140110
Date: 10.01.14
Authors: D. Laing-Trengove
S. Walls

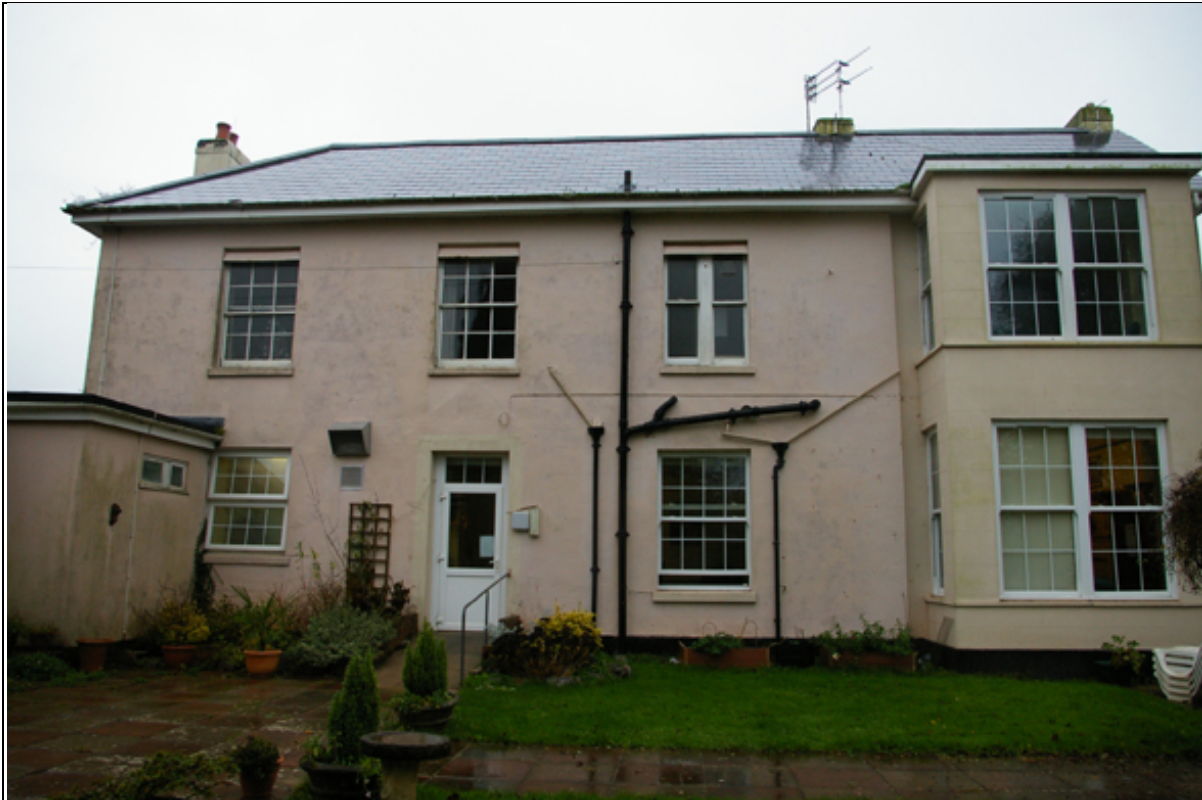
Figure 40: The west elevation of Occombe House, from the west.

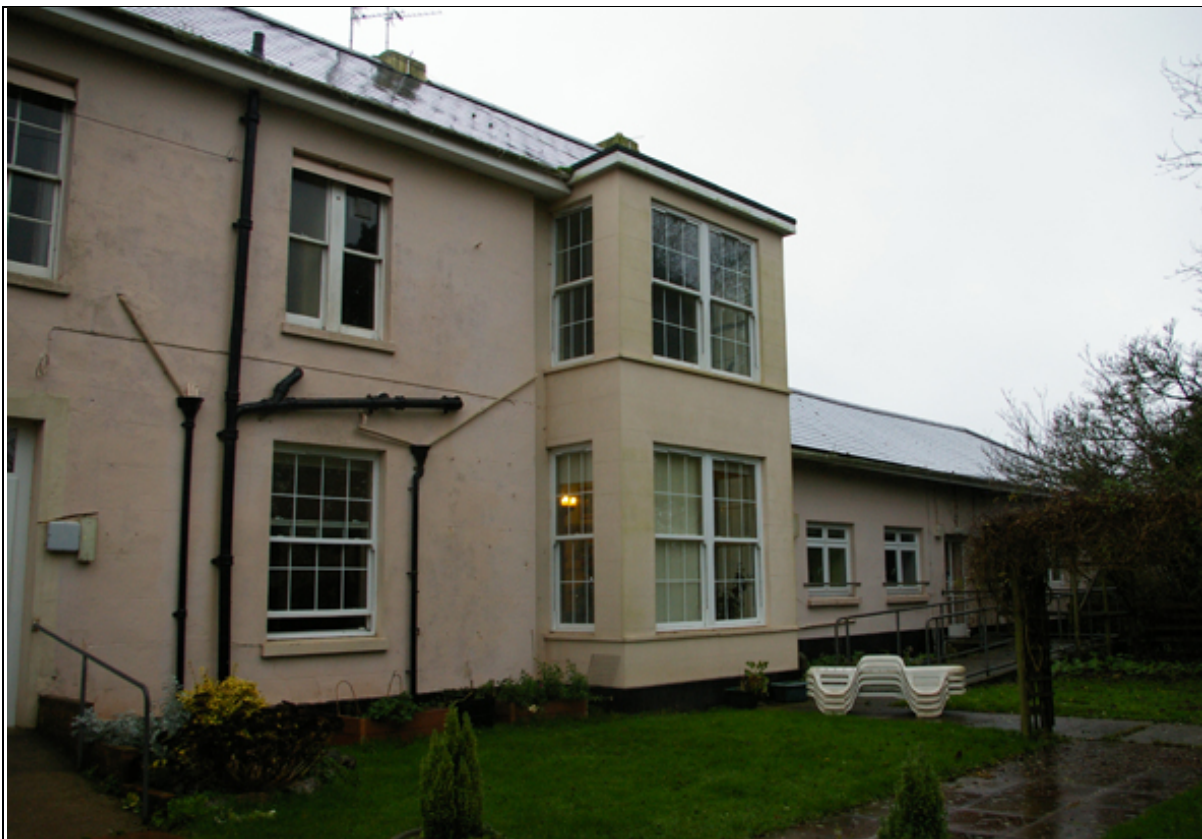
Figure 41: The west elevation of Occombe House, with modernized former stable block to south, from the north-west.
