# THE ENGINE HOUSE RUDDLE FARM ST AUSTELL CORNWALL

## Results of Historic Building Recording & Archaeological Monitoring

Report No.: 160308  
Date: 08.03.2016  
Authors: D. Laing-Trengove

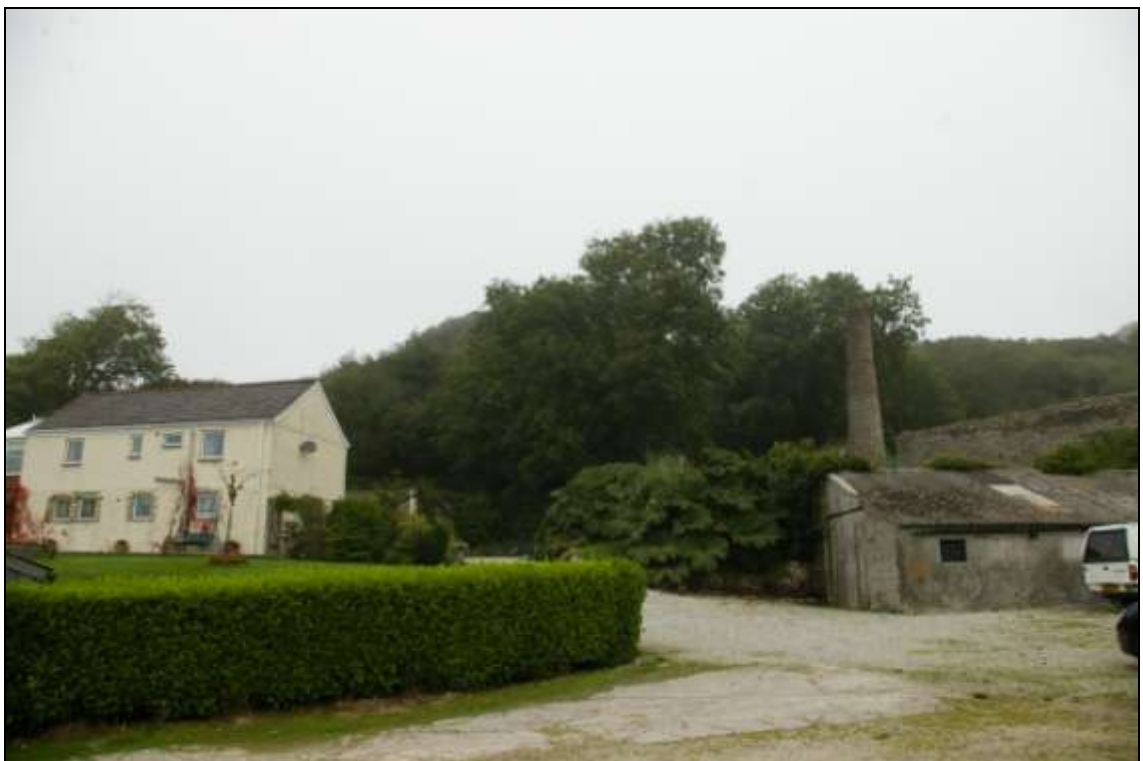
The engine house is situated upslope to the north-east of the earlier farmhouse and associated farm yard and buildings on a platform terraced into the south facing slope (Figure 5). The walls of the substantial granite built engine house survive, single storey except to the south where the lower portion of the two storey wall acts as a retaining wall against the slope to the north. The associated chimney to the west also survives and the foundations and base of further auxiliary structure/s to the south end of the east elevation are present. The building, roughly oriented north-south, formerly housed a horizontal steam engine, but now is only partially complete and has a square modern concrete block building to the north end, which was formerly attached to the north wall of the engine house. The site and building was found at the time of the survey to have been subject to recent clearance, repair and stabilisation, prior to recording.

Figure 6: The position of the engine house in relation to Ruddle Farm, viewed from the south (no scale).

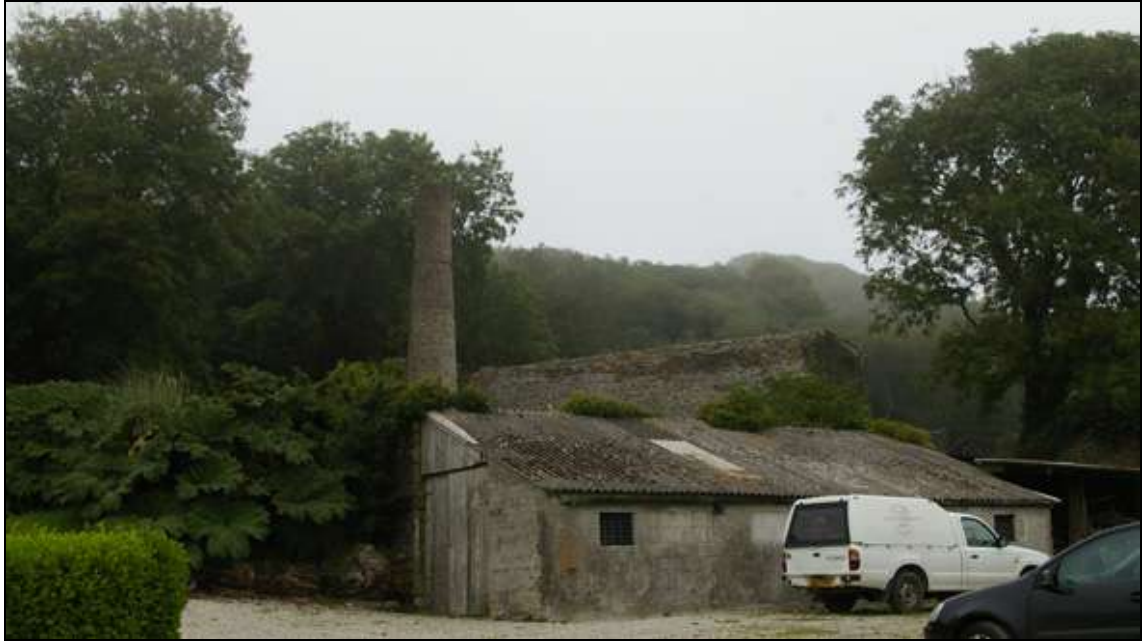
The building is single storey, has no roof remaining and almost all fixtures, fittings and features have been removed. The floor of the building had been levelled and covered with blue plastic membrane prior to cementing; no evidence of former plinths or machine beds remains. To the interior much of the original fabric of the building remains, although most elevations have been repointed in modern cement and some walls appear to have been substantially repaired; for example, concrete blocks have been added to the interior walls above the openings.

Figure 7: View of the engine house from the yard to the south-west of the building; viewed from the south (no scale).

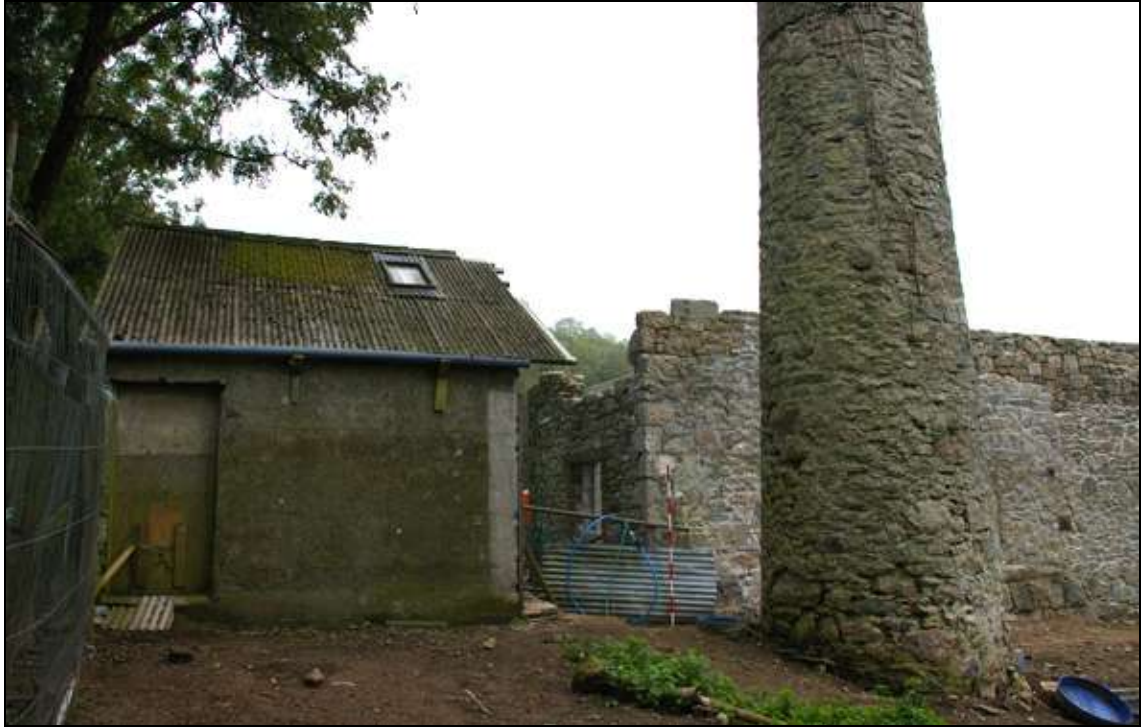
The single storey north elevation of the engine house was formerly abutted by a modern single storey (agricultural?) building to the north, constructed of concrete block and cement with an asbestos sheet roof, now with the ends of the formerly abutting walls removed. This modern extension has a window opening in the east wall, now with a reused window and planks filling the opening, and a door opening to the west (Figure 6). The east and west walls have been truncated to the south where formerly they abutted the north wall of the engine house, and where the ground has been levelled between the two, a layer of burnt material and clinker is visible beneath the cement floor of the remaining modern building (Figure 7).

Figure 8: The modern building to the north of the engine house, the north end of the engine house and the base of the chimney, viewed from the north-west (2m scale).

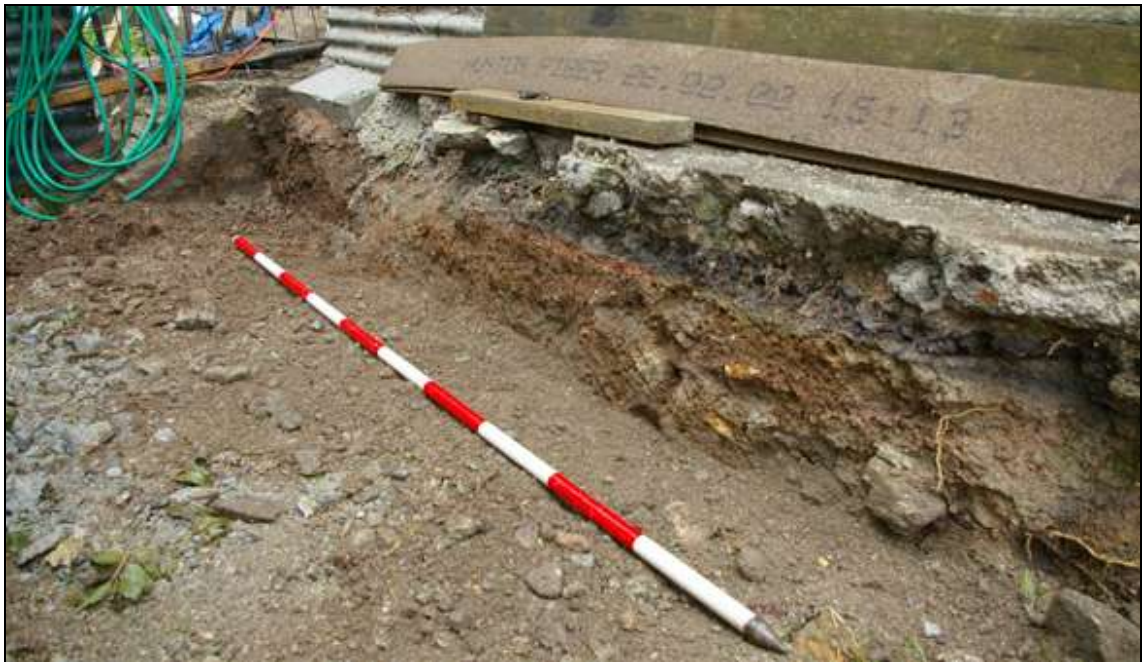
Figure 9: Section revealed between the engine house and the modern building to the north; viewed from the south-east (2m scale).

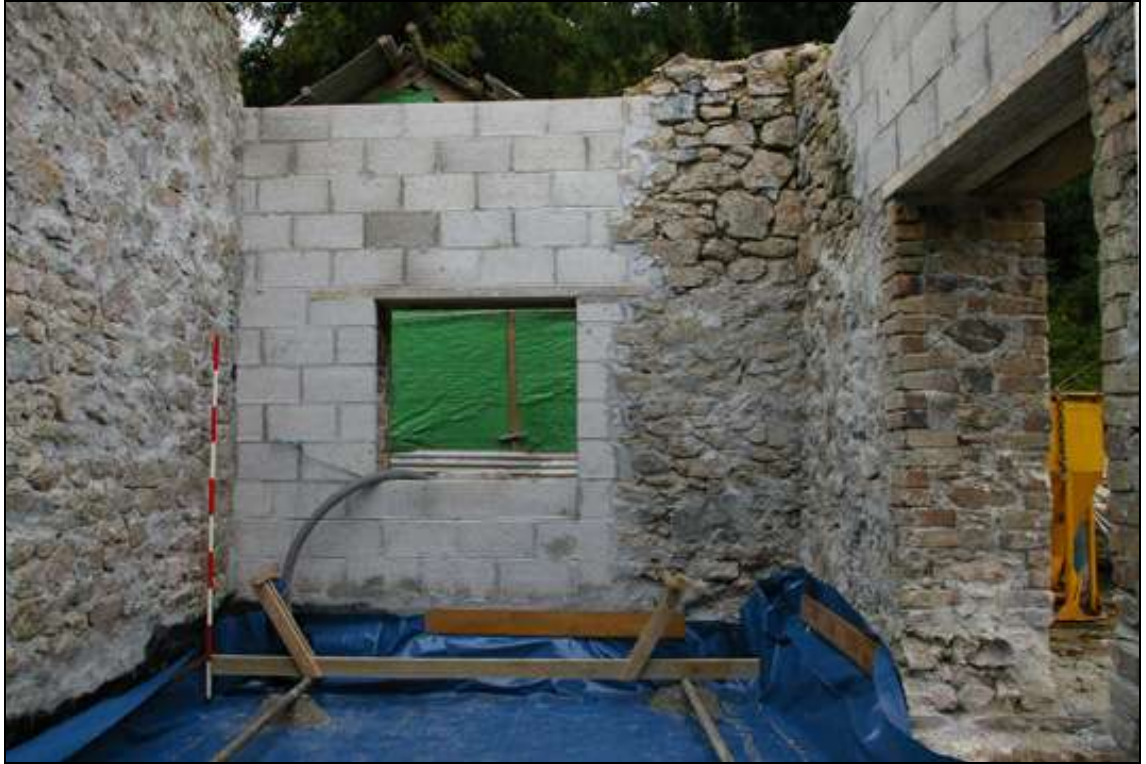
The short single storey north elevation of the engine house has been almost completely rebuilt to the west, in granite rubble with modern cement bonding to the exterior and with modern concrete block to the interior. The exterior wall is of semi coursed granite rubble with large granite rubble block quoins to the east and west corners and with a central original window opening, now with the earlier pale creamy orange to brownish orange bricks only to the interior

of the reveals, and with a replaced timber lintel above the opening and modern brickwork to the exterior reveals. There is a further, modern opening at the base of the wall to the west of the window, with a cement lintel and protruding modern plastic pipework. At the west end of the exterior elevation is a slight projecting (c.15cm) plinth at the base. To the east the original build remains, with hard gravelly grey cement mortar bonding between the granite rubble.

Figure 10: The repaired interior north end of the engine house and northern jamb of the double door opening at the north end of the east elevation; viewed from the south (2m scale).

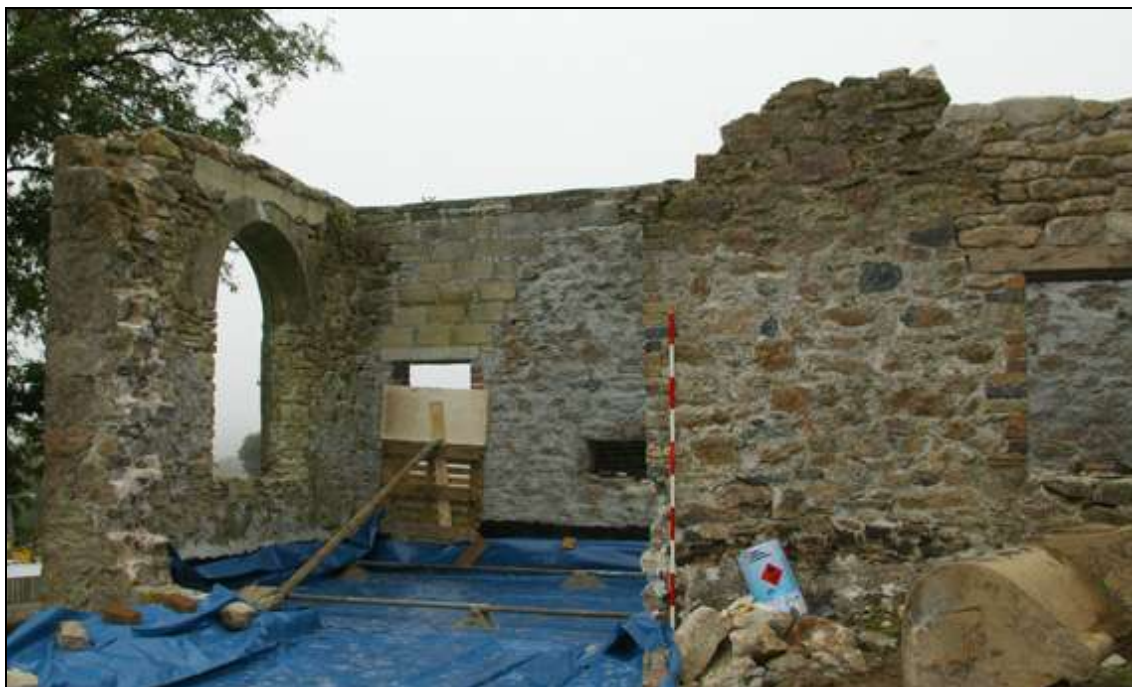
The masonry of the south end of the east elevation is no longer extant adjacent to the position of a former machine house, just to the east of the elevation (see Appendix 3). The remaining south end of the wall is ragged to the upper but tied into the south wall down below the level of the engine house floor at the south-east corner of the building where the ground level is much lower. The remnants of an opening formerly within this portion of the building remains in the east wall, with brick quoins to the northern edge of the extant opening marking the extent of the former opening at this end, but lost to the south (Figure 9). To the north of these brick quoins the section of wall, containing a central window opening, projects from the position of the wall to the south, with granite quoins to the return and with brick quoins to reveals of the window opening. The reveals are splayed to the interior, but the opening now has no sill and a new replaced lintel. The wall has been rebuilt above the opening with coursed granite rubble in smooth grey cement mortar. The walls to the north, south and below the opening are of random semi-coursed granite rubble with some brick to the north of the window opening. The original mortar is hard grey gravelly cement, as to the east end of the north wall.

Figure 11: The southern end of the east elevation of the engine house; viewed from the north-east (2m scale).

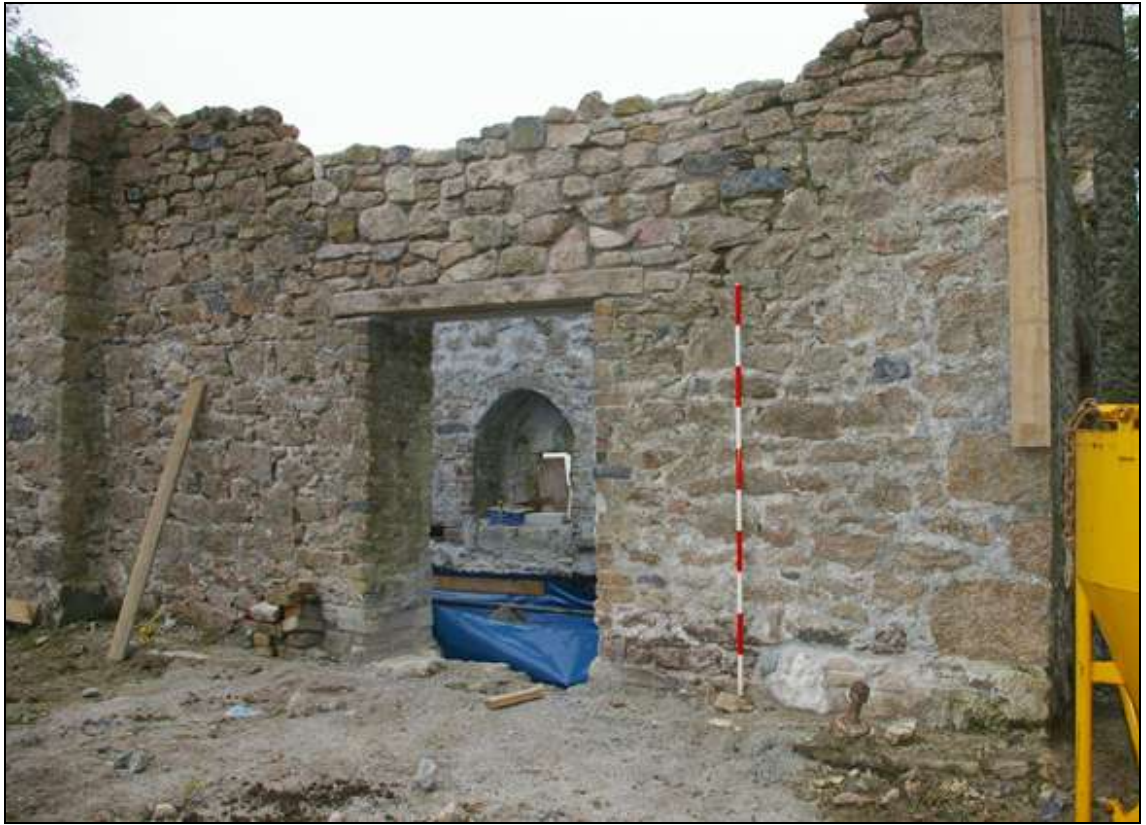
To the north of the projecting face, the east wall steps in, although there appears to be a cement plinth projecting at the base that aligns with the wall face to the south (see Figure 10). To the interior this northern portion of the east wall also steps in, perhaps suggesting that it has been rebuilt to the west of an earlier wall line that aligns with the portion of the wall to the south. In the centre of this northern portion of wall is a double width door opening, with a new replaced timber lintel. The wall above has been rebuilt using modern cement and mortar, with earlier bricks to the jambs and an interior rubble stone core (see Figure 8). The bricks must be reused, or were 'seconds' rejected for their original intended use, as a number are voussiors for an arch and many have what appear to be the marks from firing where they were laid in across each other. The brick fabric is a creamy pale yellow with quartz/mica inclusions. To the north of the opening, at the base of the wall, a small section has been rebuilt, possibly a former opening (?). Two metal pipes or rods protrude here from the ground through the aforementioned plinth (Figure 10).

Figure 12: The north end of the east wall of the engine house; viewed from the south-east (2m scale).

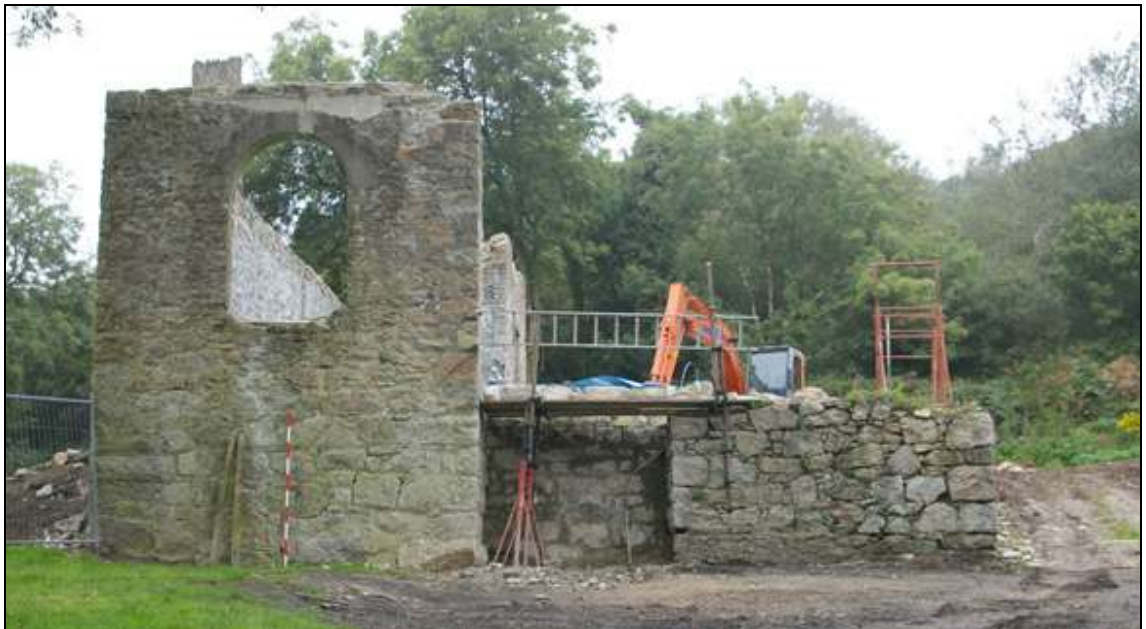
The south wall is constructed of granite rubble as before, but with very large blocks to the corners and to the base of the wall for the lower c. 3m portion where the elevation is built up against the slope to the north (Figure 11). The wall has a large central arched window opening at first floor level with brick quoins to the reveals, with cement over the arch to the exterior. To the interior the reveals of the opening are splayed with no sill remaining, and the wall fabric contains some brick to east. The retaining wall to the east of the south-east corner of the building is set back from the exterior face of the south wall; is battered and slopes back to the north up to ground level. The stonework appears tied into the build of the east wall of the engine house, which suggests that the structure is contemporary with the building. To the east is a further structure, the face of which is aligned with the south wall of the engine house. This appears to abut the battered wall, suggesting it is a later addition, and creates a recessed space between it and the engine house. This abutting wall is also of granite rubble construction, with large blocky quoins and bonded in a slightly greyer and more gravelly mortar.

Figure 13: The south elevation of the engine house and associated structures to the east; viewed from the south (2m scale).

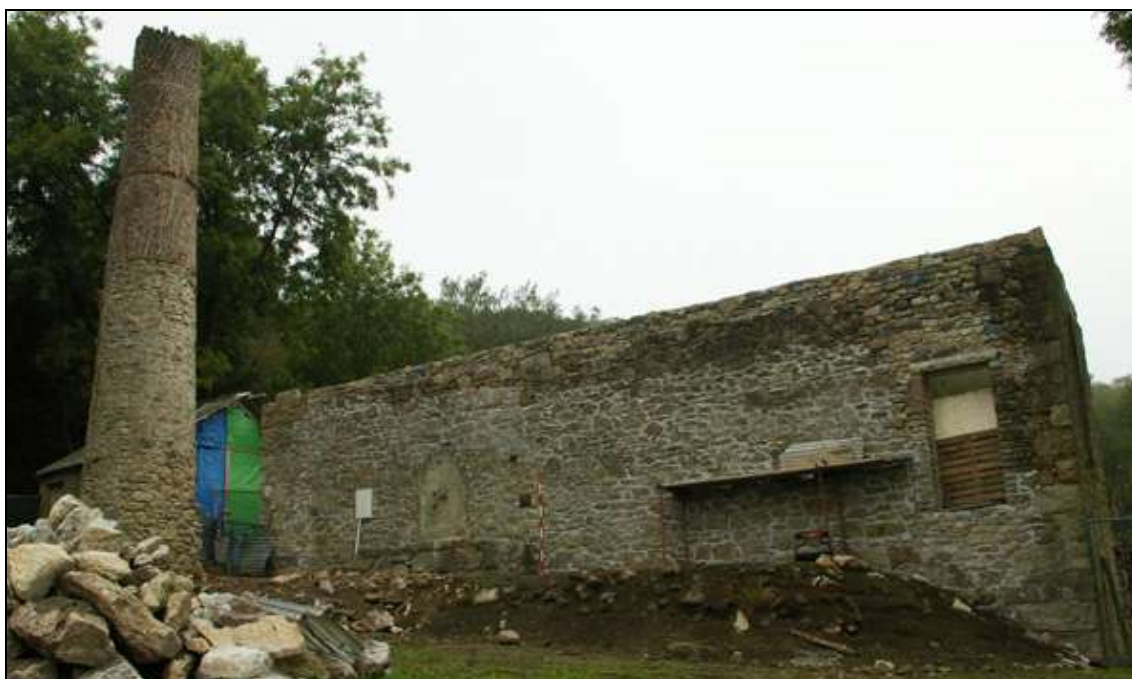
The west wall of the engine house is a long elevation; it is two stories at the southern end, where the south wall returns to the west, but single storey upslope (Figure 11). Three (former) openings are evident along its length and there is a granite plinth apparently tied into the elevation to the north below the northernmost opening. At the southern end is a door sized opening with brick reveals (and possibly some cement block) as before, rebuilt or extended upward with red modern brick, a granite lintel and no sill. The wall above, below and to the north of the opening has been rebuilt or completely repointed in modern cement to the exterior and to the interior the wall has been rebuilt above the opening in concrete block. To the north of the opening the ground surface rises up toward the north and appears to have been recently built up against the wall to the west with soil and granite rubble. To the north of the door opening is a slim horizontally aligned opening of unknown function. To the interior the opening appears to have formerly contained a metal or timber framework, but no lintel or supports remain.

Figure 14: The west elevation of the engine house and the chimney; viewed from the north-west from downslope (no scale).

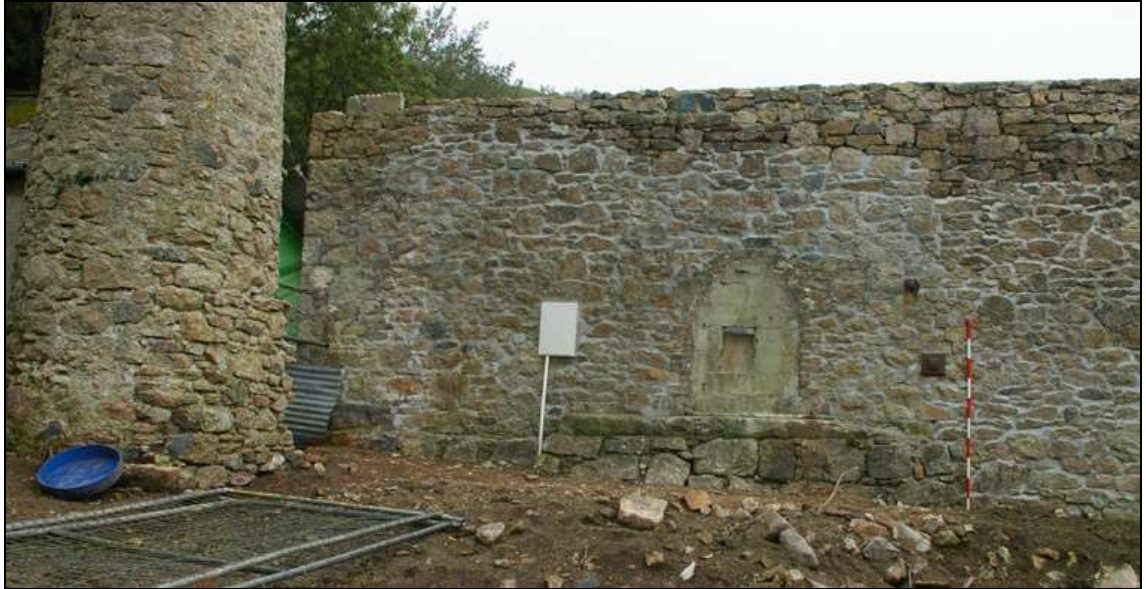
Towards the north end of the west elevation is a projecting narrow platform of large granite blocks apparently tied into the wall, with a central arched opening above, with straight brick reveals and blocked with concrete blocks and cement (Figure 12 & 13). To the interior the reveals of the opening have the voussiors bricks as to the opening to the east, the sill has been raised with concrete block, but there remains a line of bricks in the wall to either side of the opening that appear to mark a position just above the earlier sill height (Figure 14). Below this, to the north, the wall has been rendered in modern cement and to the south of this opening at the height of the horizontal line of bricks associated with the southern opening reveal, is a small rectangular recess in the wall with an internal cast iron frame and lintel and a large projecting bolt and nut.

Above the recess three large threaded bolts project from the wall face just to the north of the change in the face of the elevation. The wall face steps out slightly just south of the position of the plinth on the exterior face. The interior edge has brick quoins (the brick as before) but

appears to be contemporary with the rest of the wall, however, the masonry of the exterior wall appears slightly disturbed, although most of this elevation has been repointed and repaired, obscuring any breaks or differences in the masonry of the build. On the exterior face of the wall, to the south of the arched opening, two square-set metal rods project through squared cast iron plates set against the wall face (see Figure 13), which must be associated with the projecting bolts on the interior wall face.

Figure 15: The northern end of the engine house, showing the blocked opening in the west elevation of and truncated masonry at the base of the chimney; viewed from the south-west (2m scale).

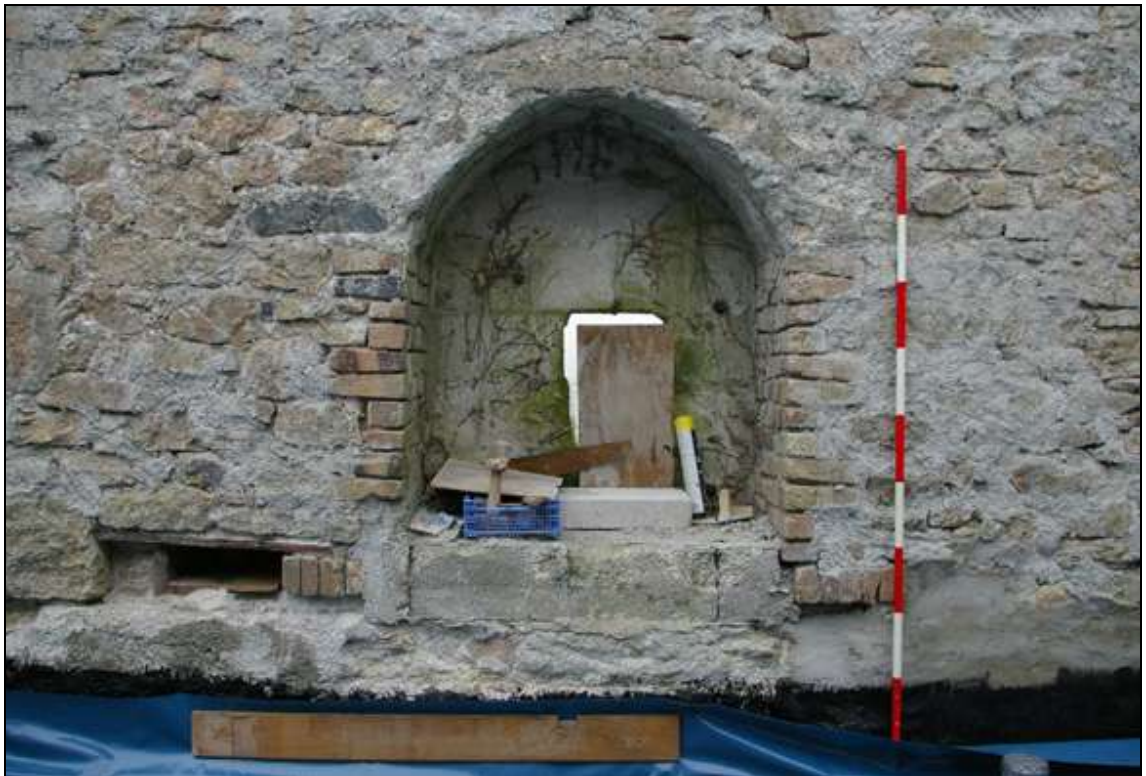
Figure 16: The blocked arched opening in the west wall of the engine house; viewed from the east (2m scale).

To the north of the projecting plinth/platform on the exterior face of the west wall is a lesser projection set low on the elevation at the base of the wall, above, at the north end, the wall has been repaired/repointed in modern cement. The ground between the engine house and the chimney to the west has been dug away and cleared. The granite rubble chimney is of a similar construction to the engine house with similar mortar to the base. The upper is built in brick with two metal ties. On the south face of the structure at the base, the wall face is flat indicating the former presence of an integral structure, in the position of a former wall most likely associated with a former boiler house (see Figure 13). The masonry of this portion of the structure is truncated to the east, and the north end of the engine house may have been reconstructed where these walls formally joined.

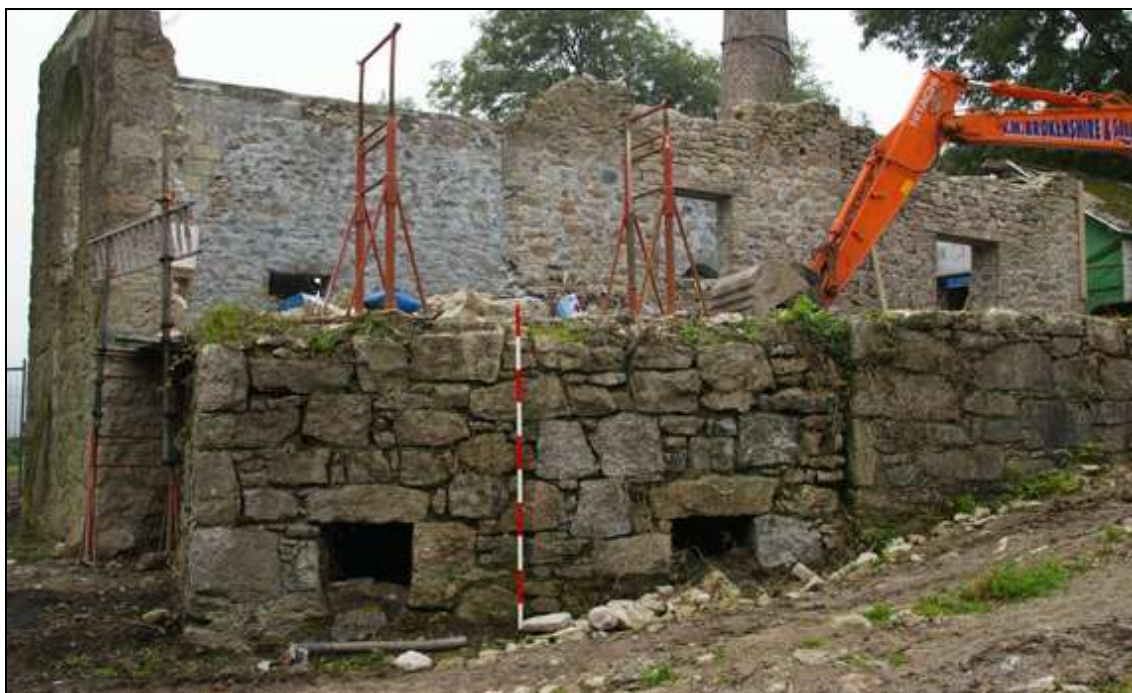
The east end of the south elevation of the engine house has an abutting structure (see the south wall described above) that fills the south-east corner of the platform on which the engine house sits. The south wall of this structure has no openings but the elevation to the east has two built-in openings to the base, with granite quoins and lintels to the openings and with internal metal lintels and horizontal rods. These are possibly access points for spanners to tighten up the long vertical bolts which held down either the engine or its flywheels/axels onto the masonry block. This section of walling has a clear joint between it and the granite wall structure further to the north.

Figure 17: The structures to the south-east of the engine house; viewed from the south-east (2m scale).
