Hartland Higher Brownsham House

Hartland

Devon

Introduction

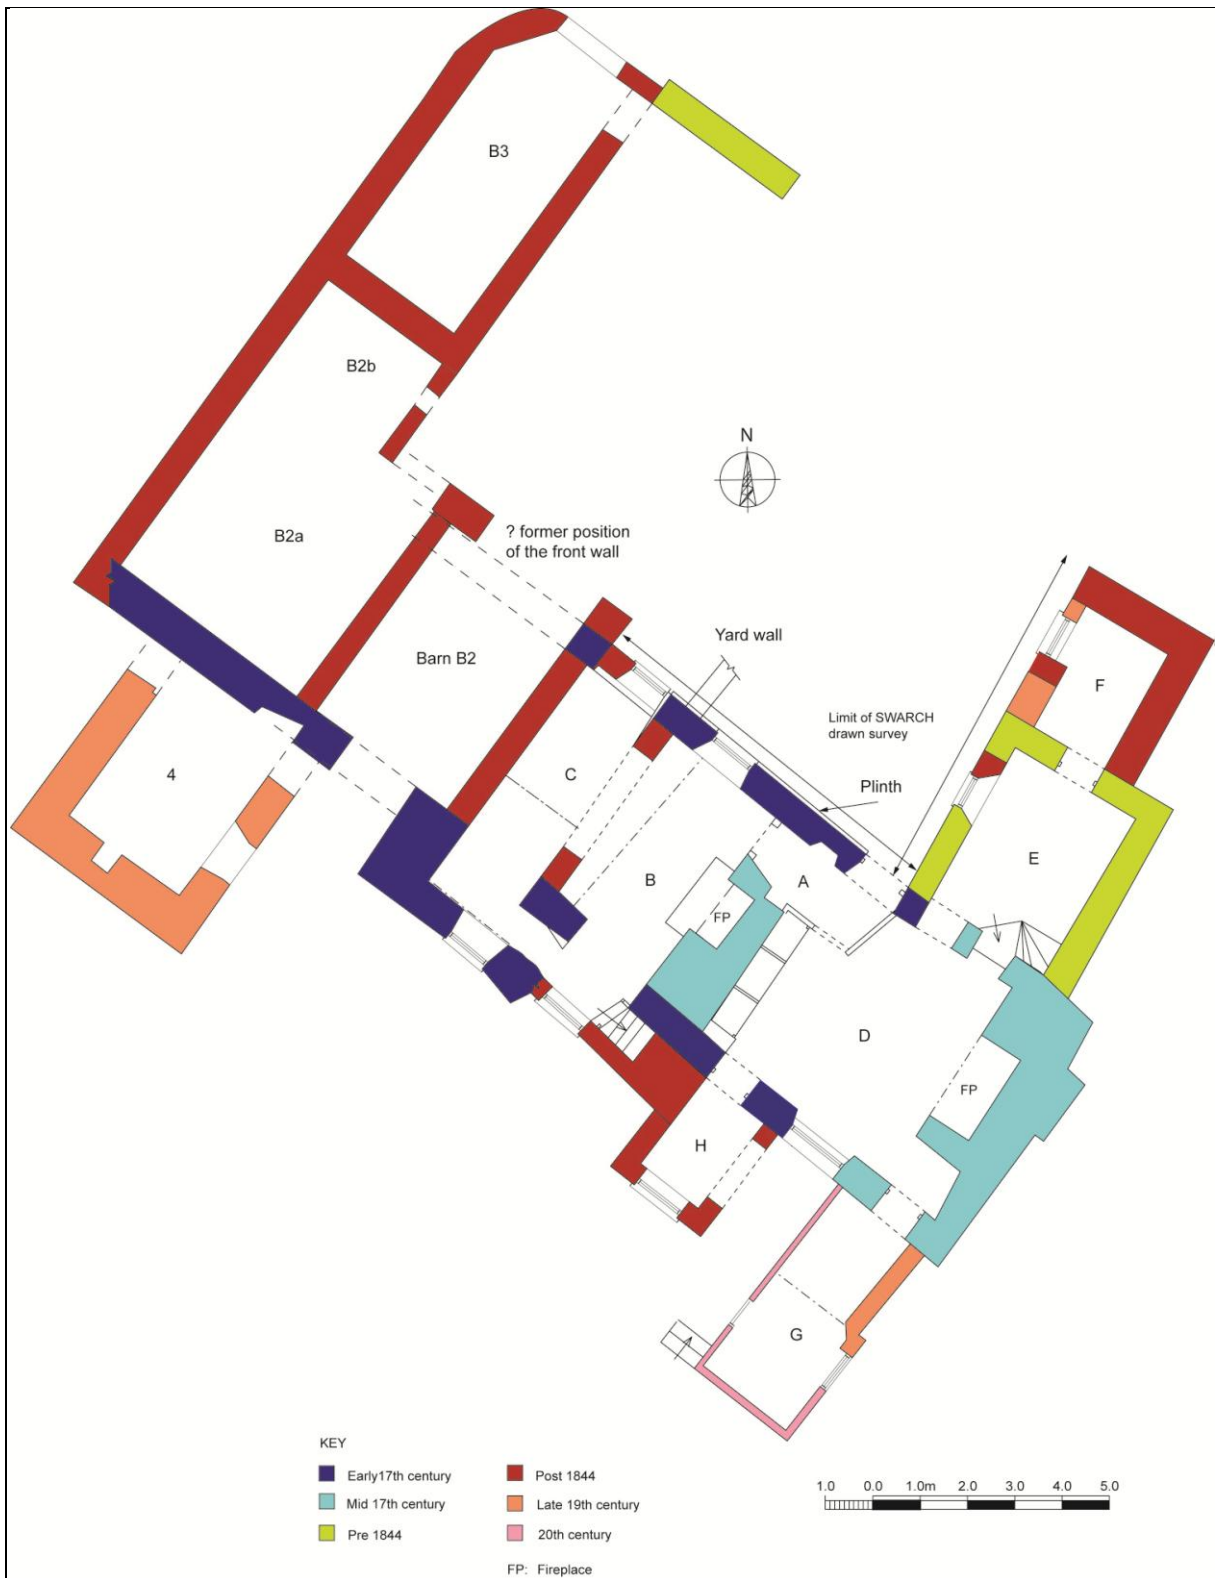
Figure 1: Phased plan of ground floor and barn.

The phased plans included in this report (figs 1 & 2) are based on survey plans supplied by the National Trust and plans contained in the earlier reports but only shows the recent re-interpretation of the development of the building.

Phase 1: Early 17th century

Rectangular building with stair turret at the south west end of room C (the cross-passage) and adjacent lateral stack with the extant structure representing the lower end of the building, the hall and inner room having been rebuilt as a barn in the 19th century (see below).

Phase 2: Mid 17th century

The lower end of the building is extended, heated and the decorated first floor ceiling is inserted.

Phase 3: Early 19th century

The wing added to the north east side of the building.

Phase 4: Mid 19th century (post 1844)

The upper end of the house is rebuilt as a barn. The position of the truss adjacent to the wall in room J suggests that the earlier building extended further to the north west. This is supported by the tithe map that shows all of the building up to the lane in domestic use. This would date the conversion of this end of the building to a barn after 1840. The barn shown behind this end of the building adjacent to the lane partially survives as a ruin.

A mural stair is inserted replacing the stair turret (now part of the barn).
