THE NORTHERN END OF THE LUTTRELL ARMS COMPLEX DUNSTER SOMERSET

Results of a Historic Building Assessment

Report No.: 140610
Date: 10.06.2014
Author: Emily Wapshott
Colin Humphreys

South West Archaeology Ltd. was instructed to undertake a historic building survey of the northern end of the Luttrell Arms building complex ahead of development works. The complex is made up of buildings from a range of dates, associated with a number of development phases of the Luttrell Arms and charting its history as a hotel and inn. The northern end is the only area due to be affected by the insertion of a tunnel, underground store and new 'garden bar' and as such was the focus of this study.

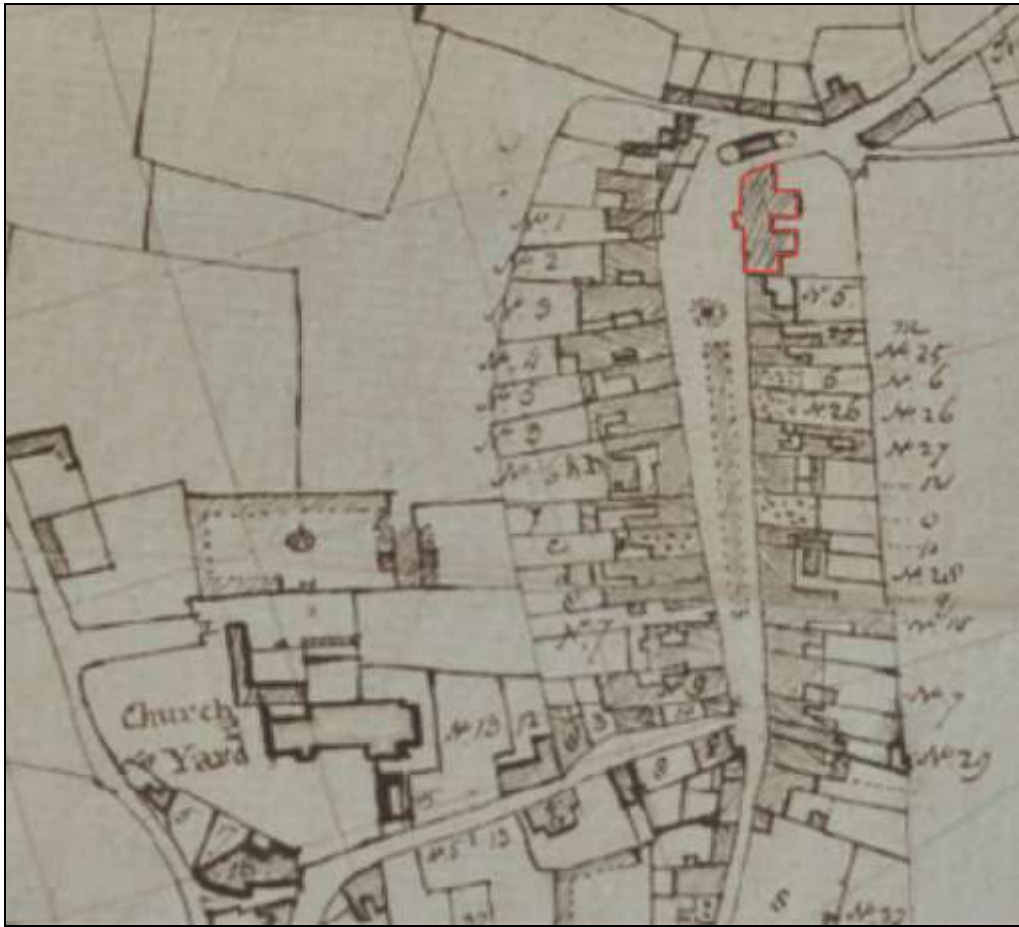
Figure 2: Detail of a Plan of Dunster dated 1746. The Luttrell Arms outlined in red.

Although this map can be only considered to be a sketch it clearly shows the Luttrell Arms (outlined in red) with a main block addressing the street, the projection presumably being the existing porch. To the north of the main block a long range can be seen running up to the north end of the street, this represents the development of the service buildings, within the complex. Projecting wings are shown to the rear of the building; that to the north contains the medieval building and that to the south, possibly redeveloped from earlier rear service ranges.

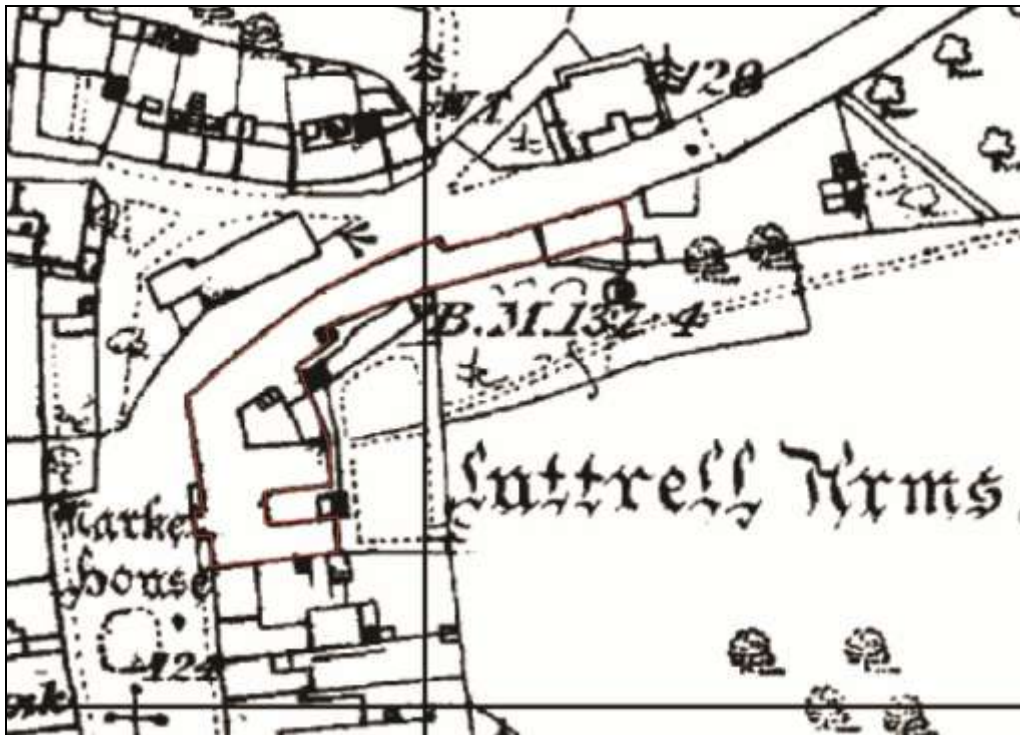
Figure 5: Extract from the First Edition Ordnance Survey map of 1887.

The plan shown on the First Edition Ordnance Survey map is of similar layout to the tithe map however the coach house and stables along Dunster Steep now appear to be connected by a long linear structure, built up against the retaining wall to the south, and the skittle alley appears to have been constructed within the gardens. Steps have also been built providing access to the first floor, in the north-east corner of the service courtyard.

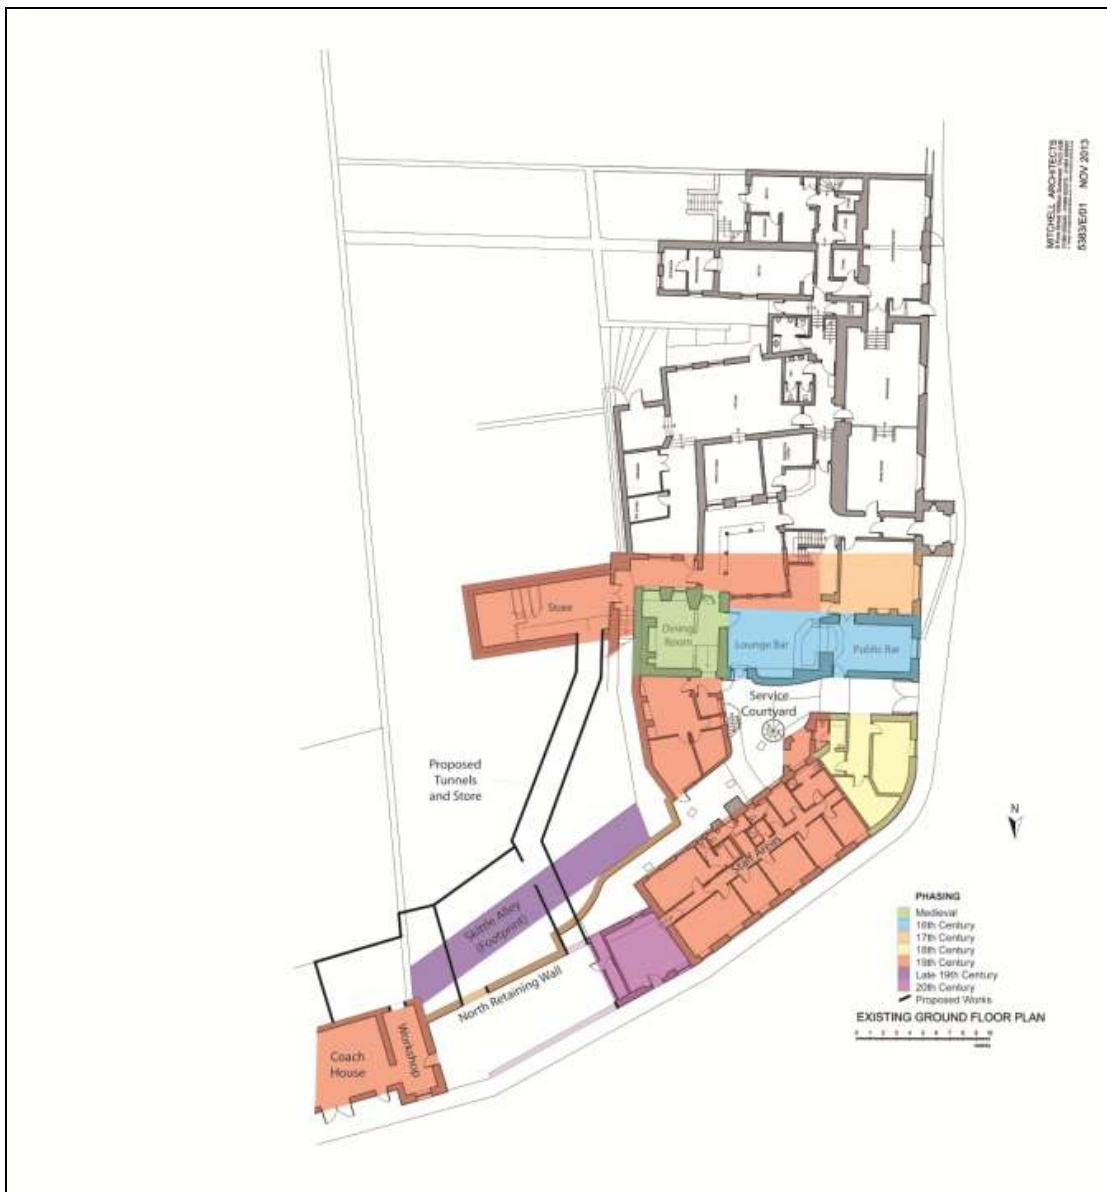
The proposed development will affect a number of structures in the northern end of the complex. Figure 7 shows a plan of the complex, with the affected buildings coloured according to their phase of construction. It also shows in black the proposed new tunnels and store, showing where they will breach the existing structures.

Figure 6: Plan of the building complex, showing the developmental phasing and proposed plans.

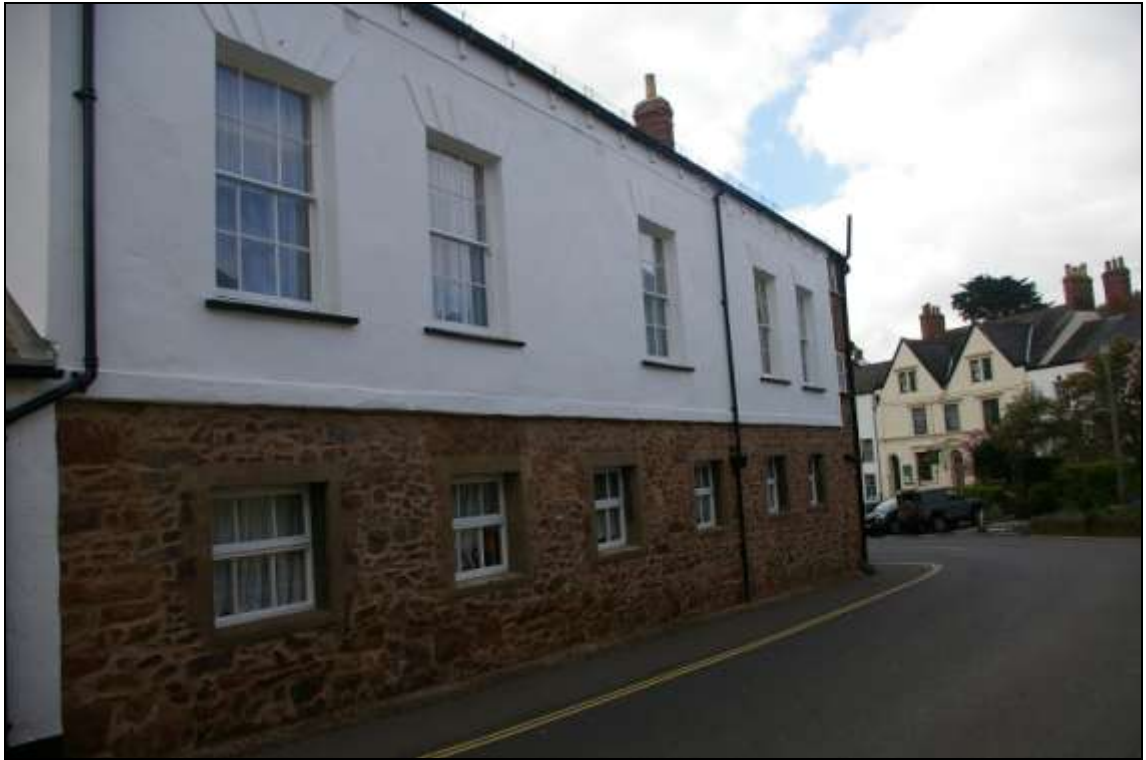
A long, stone, mixed phase, 18th century building with long 19th century building extension. Lies to the north of the complex, where the street turns and runs east. The building is long and narrow, two storeys for the majority of the length of the building, three storeys to the west end. The building has a pitched slate roof and modern guttering. The eastern elevation is the gable end of the building and has been rendered, obscuring all historic details within the stonework. It has one small 19th century sash window to the south side, at first floor level. A brick gable end stack appears to have been rebuilt in the 20th century and serves the rooms at this end of the building. The elevation is abutted by a single storey service building, which opens onto the courtyard to the east and is of 20th century date, also rendered externally. The north elevation is rendered to the east end, from the first floor up to the eaves. The first floor is the principal floor of this 19th century section of the building, built as a ballroom with high ceilings. The render obscures any historic details of the stone build for the upper part of the elevation. There are five, off-set, sizeable 19th century large paned sash windows, with plaster detailing over the lintels, of keystone style, with slate sills. The ground floor can be seen to be of rubble construction, with stone quoins to the east end. There are six identical windows inset into the stonework, all of hopper casement form; in openings with cement rendered reveals. There is some localised disturbance within the stonework at ground floor level, but the elevation has recently been heavily re-pointed and any clear breaks in the wall line are not visible. There is a brick stack to the west end of the main section of the building, roughly positioned at the point where the 18th century and 19th century sections meet.

Figure 7: View of the 19th century building which housed the dancehall/ballroom; from the north-east.

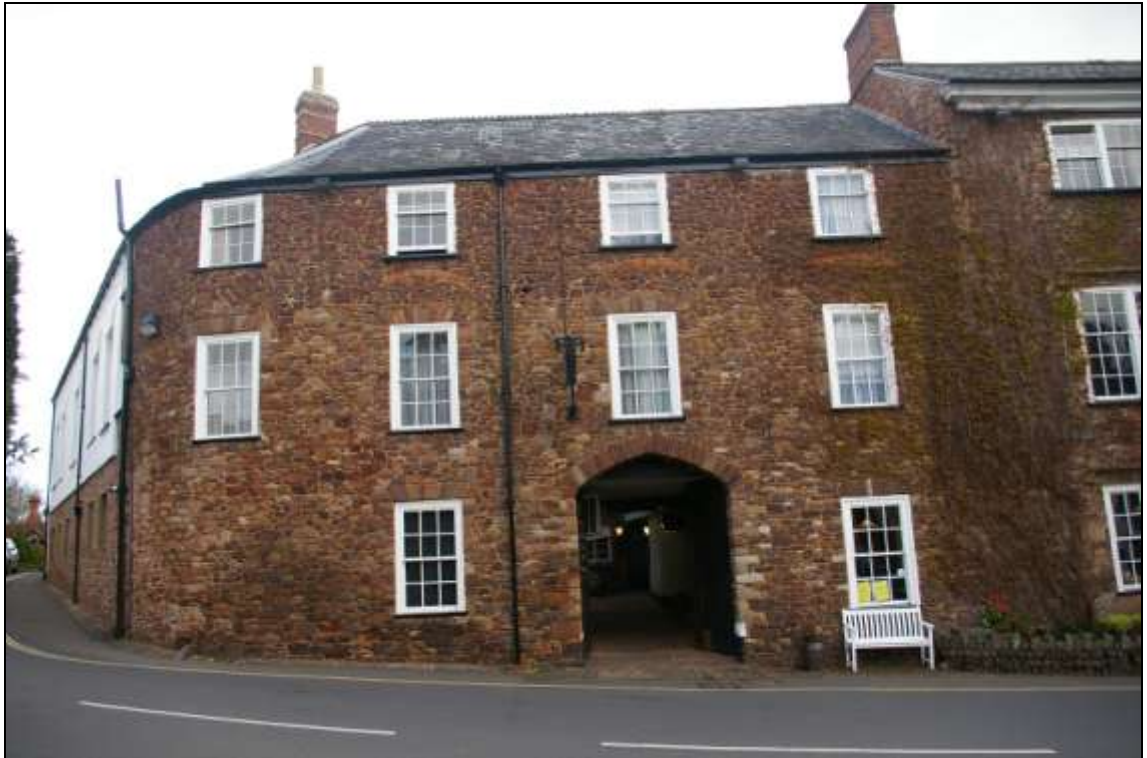
The building flanks the High Street, forming the western elevation of the complex. There is considerable disturbance on the curving corner of this building which has two causes, the corner being cut off or reduced when the road was widened for cars and the disturbance resulting from the truncation of the 18th century building. Within this area there is a window on the first floor, which is a small four-paned casement, set into a ragged section of wall where another window opening may have been blocked and reopened. The casement has been inserted at the top, as there is a good quality stone segmental flat lintel. Above this is another narrower, longer opening set into the eaves under the roofline, with a slate sill and a six-paned narrow sash. The wall between these windows is of rubble construction and appears to have been completely rebuilt. The windows are within the ragged join between the two phases. The western end of the building range is of rubble stone and is three stories high. An additional eaves floor has been added to this originally lower building, bringing it in line with the 19th century roofline to the east. There is a clear build line just above the first floor windows, between larger blockier semi-coursed stonework, with fine quality dressed stone segmental flat lintels to the ground and first floor windows, raised by tightly packed rubble construction stone, with additional brick relieving arches added above three of the first floor windows. The building is built around and over a large flat three-centred segmental dressed stone block arch, which is the entry to the service courtyard. This fine work is older than 19th century and this section of the building appears to abut the 17th century main block. A number of build lines visible within the stonework suggest this was built as an 18th century service wing or accommodation extension. There are two ground floor windows which frame the arch, with four evenly spaced windows to the first floor, and four second floor windows directly above. All of the windows sit in wide moulded frames, with slate sills, being hornless six over six pane sashes; these are the same as the hornless sashes on the ground floor of the main building and probably of later 18th century date.

Figure 8: View of the west front of the 18th century or early 19th century section of the buildings to the north, with earlier segmental stone arch over the entrance to the service courtyard; from the west.

The south end the long building range appears to abut the main block, with some quoins on the second floor and partly on the first, although there appears to be disturbance to the stonework at ground floor level. The rear, south and eastern elevations of the curving building range face into the service courtyard and are rendered and whitewashed, obscuring any historic details within the stonework. The courtyard is cobbled, patched extensively with cement and concrete where services and trenches have been dug. This area has been converted to public toilets and before that was heavily altered in two phases of works in the 19th century. It is likely this was a service/domestic area of the building. There is an early 20th century corner extension within the north-west corner of the courtyard which has been built on brick pillars. This serves the first and second floors only, with a narrow moulded sash window to the first floor and a smaller sash directly above on the second floor at the roofline. The structure is abutted by a disproportionately large spiral fire escape of the mid to late 20th century. This early 20th century extension appears to have been intended to provide a small service room to the hotel bedrooms to the west. This structure is still currently used by hotel housekeeping today. This extension obscures almost all of the 18th century structure within this courtyard. Some of the 18th century structure may survive above the archway through which the courtyard is entered - there is a small decorative oval window here which lights the corridor on the first floor. One large early 19th century hornless large paned sash can be seen in the wall of the 19th century building to the north of the courtyard, but on the ground floor the windows are all modern.

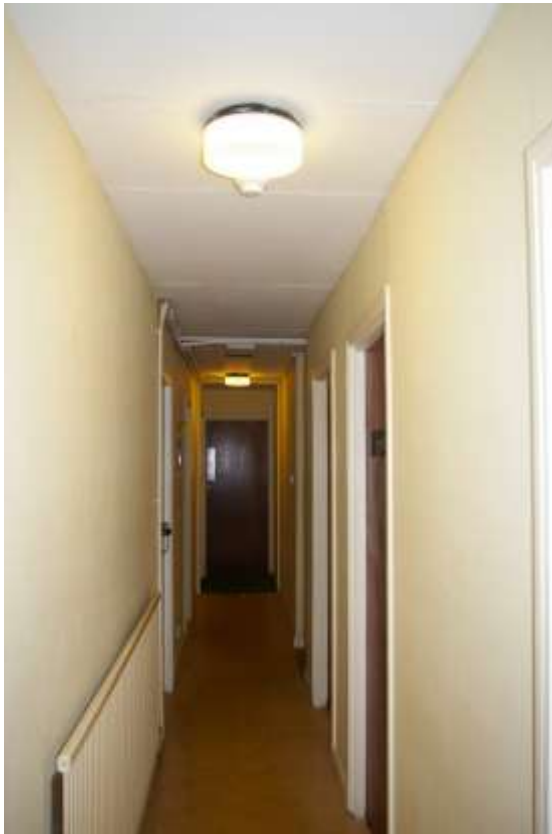
ground floor is now divided to provide a spine corridor which runs roughly east-west, with rooms leading off to the north and the south. This is accessed via a locked secure door in the south wall, leading directly into the main service courtyard, with the passage to the coach house and barns running away to the south-east. The ceiling within the area is of plaster board; this may be a false ceiling, covering or obscuring an older structure. All of the partitions within this area appear to be modern, of plaster- and chipboard, with modern timber doors. The partitions form small rectangular rooms, often quite narrow, each with one door to the corridor. These are divided into bedrooms and bathrooms, with stores for personal belongings between. Many of the narrow windows on this ground floor level are set high in the wall. Some, on the north, street side of the building, look to be potentially 19th century in date, being hopper opening casements. Many look replaced (20th century) within the service courtyard, although several hopper casements also survive here. Any internal details which provide clues to the function of this space appear to be obscured by the later partitions; nothing of any note was viewed during the fieldwork. The floor of the corridor was covered in lino sheeting and therefore could not be viewed however it appeared uneven and it may be possible that a historic floor surface survives beneath.

Figure 9: View down the main hallway to the west end within this modern converted space; from the east.

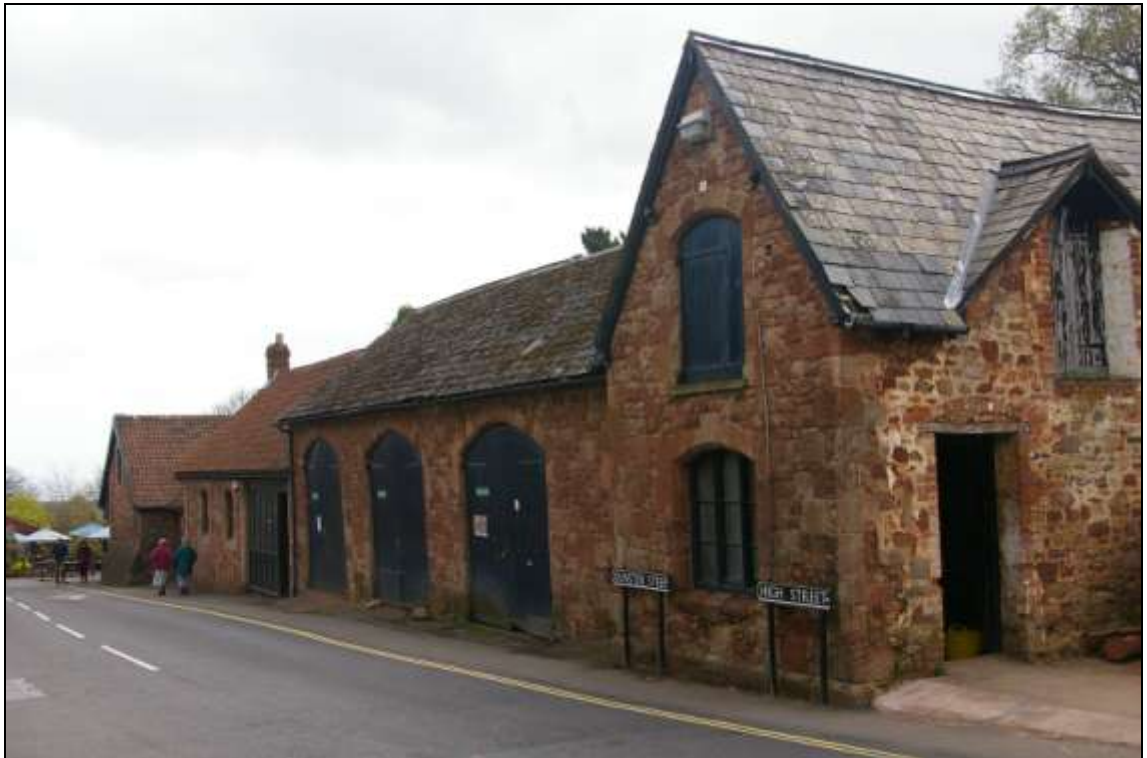
19th century range of outbuildings built along Dunster Steep, where it adjoins the north end of the High Street. The range is long and narrow, with its long north elevation facing the road and the long south elevation set back into the retaining wall, which delineates the terracing into the hill to the south. The range is attached to further buildings to the east; a forge, workshop, stables etc, with barns to the east and south-east which have been converted to an information and tourist centre and shops. The one storey coach house lies to the east of

the range, under a slate roof, with black glazed terracotta ridge tiles and modern guttering. The north elevation is of dressed, faced stone blocks, semi-coursed style, forming a presentation front onto the road. There are three large, dressed stone segmental arches with arched double doors; boarded, braced and ledged, with large iron door fittings, such as strap hinges and bolts, of original 19th century date. There is a small single door to the west end in a dressed stone arched opening of the same style as the larger double doors, also of 19th century date. All of the openings have stone slab thresholds and evidence of the original sloping cobbled surface in front of the building survives although most is covered by the tarmac of the road and heavy patching with concrete. The coach house is integrated with the workshop to the west, which projects slightly and has the same presentation front, of faced stone blocks with dressed stone quoins to the corners. The roof is of slate, with glazed terracotta ridge tiles and modern guttering. The workshop is of one and half storeys, with a loft over and a loading door, symmetrically positioned over a central window on the ground floor. Both openings have the same arched dressed stone reveals as the coach house to the east. The loading door is set in a sharply pointed gable, with wide plank barge boards to the eaves. The west elevation of the workshop has a pitched slate roof with small pointed dormer over another loading door at eaves height, which appears to have been forced into the elevation at a later date, with brickwork patching the sloping ragged reveals. There is a narrow doorway forced into the north side, with brick reveals and a narrow timber lintel and a small brick relieving arch above. The elevation is of rubble stone construction, although it includes some dressed blocks of stone and has stone quoins to the corners, in a similar style to the north elevation. It has been whitewashed and rendered or plastered at some point. It is likely another later structure abutted this elevation and has since been removed. The building has a dressed stone block chimney to the south side, which appears to serve the ground floor of the workshop. In construction style this is similar to the north elevation, but is unusual as it appears to be built into the earlier retaining wall.

Figure 10: View down the main presentation front of the coach house range as it faces onto Dunster Steep; from the north-west.

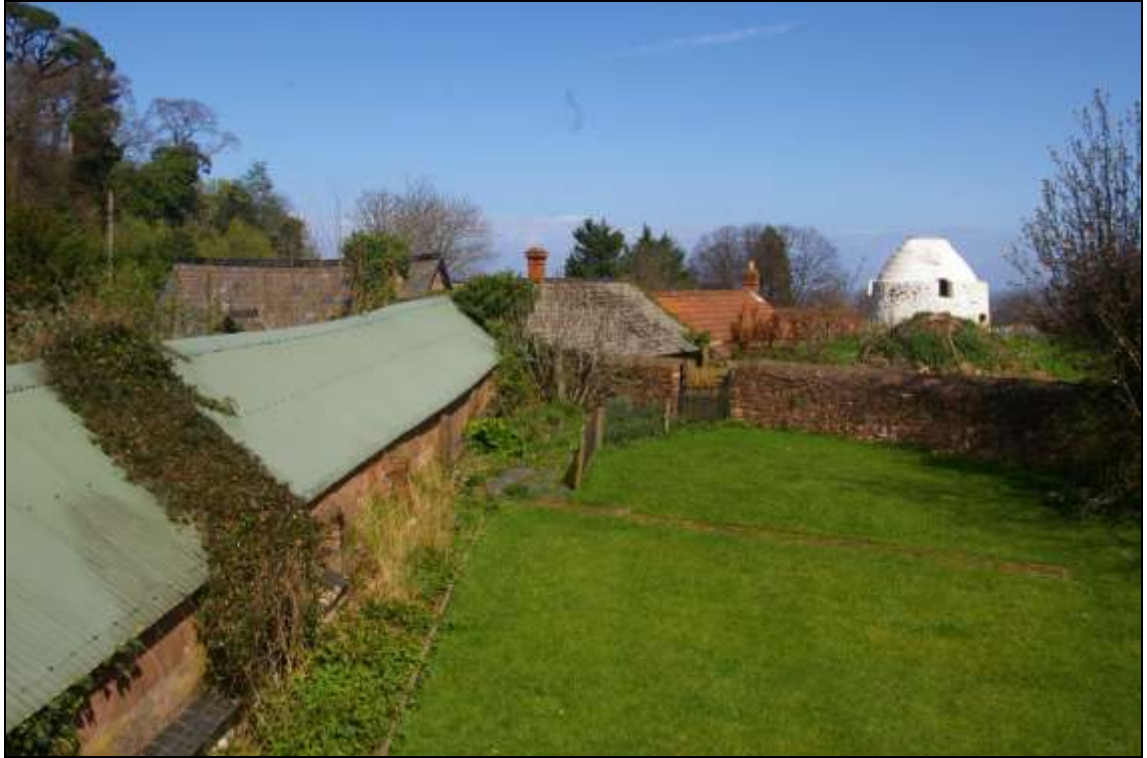
The Skittle Alley is a very late 19th century building built onto the bank created by the retaining wall and terracing of the hillside. It lies to the east of the complex and is a long, low, single storey structure. It has a corrugated iron sheet roof over a basic A-frame timber roof structure. The south wall is brick, rendered externally above an exposed brick base with small buttresses. The north wall has some brick and stone, to the west and east, but also a section of corrugated iron, timber and possibly concrete block. The east end of the building is built into the ruins of another service building, of rubble stone, with a cob/earth core. This building has a forced opening with brick reveals and lies at an angle, abutted by both the 19th century garden boundary wall and the 19th century coach house and workshop range. The south wall of the building survives in part, running west; and the brickwork of the south wall of the Skittle Alley appears to be built over and into this stonework. The west end abuts the small structure built to the north of the early 19th century cottage, which stands to the east of the main service courtyard, possibly built for staff. The Skittle Alley is accessed via the first floor of the 19th century linking structure and the possible 17th century retaining wall has been truncated to gain access to the Skittle Alley, creating a step as you enter into the building through a narrow modern doorway. This western end of the Skittle Alley has been divided and converted into a laundry room. The building is used partly as a store and is partly derelict; the floor could not be properly examined but was partly concrete.

Figure 11: The skittle alley in relation to the coach house, stone garden walls and other features, taken from the first floor of the 19th century cottage built to the north-east of the main building complex; from the south-west.

The skittle alley is a late 19th or early 20th century structure in very poor condition. The walls are a mixture of brick patched with concrete block and in some sections to the north, boarded or corrugated sheeting. The exterior walls are mostly rendered in a cement render. It has a shallow pitch roof of bolted A-frame trusses, with raised collars, with through and through purlins and a thin on-edge ridge pole. The roof is covered in corrugated sheeting. The building holds little to no significance.

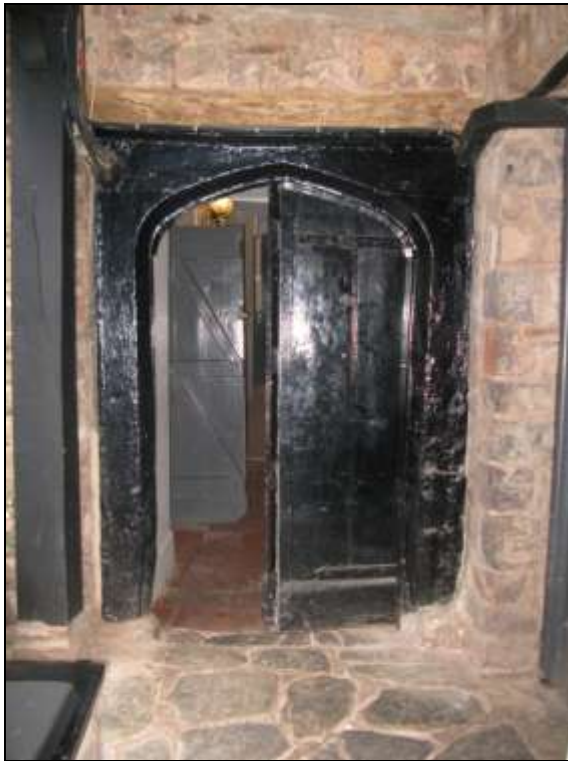
The Medieval structure is built into a late Medieval or 16th century building, which contains wide chamfered beams and 16th century moulded three-centred arched door frames; including a fine example which leads from the main bar dining area into the open central courtyard. The fine quality door frame mentioned above has an opposing door in the north wall, only the stone jambs at the base of which survive; this is suggestive of a cross passage. This linear range runs between the medieval structure to the east and the road to the west, perpendicular to the street, facing south. A fine quality 16th century fireplace survives within the first floor of this range which may have been a first floor hall. The main fireplace on the ground floor has been altered in the 18th or 19th century. The ground floor rooms have been so heavily altered in the intervening 17th -19th centuries that very little of this phase survives.

Figure 12: 16th century possible former cross passage door

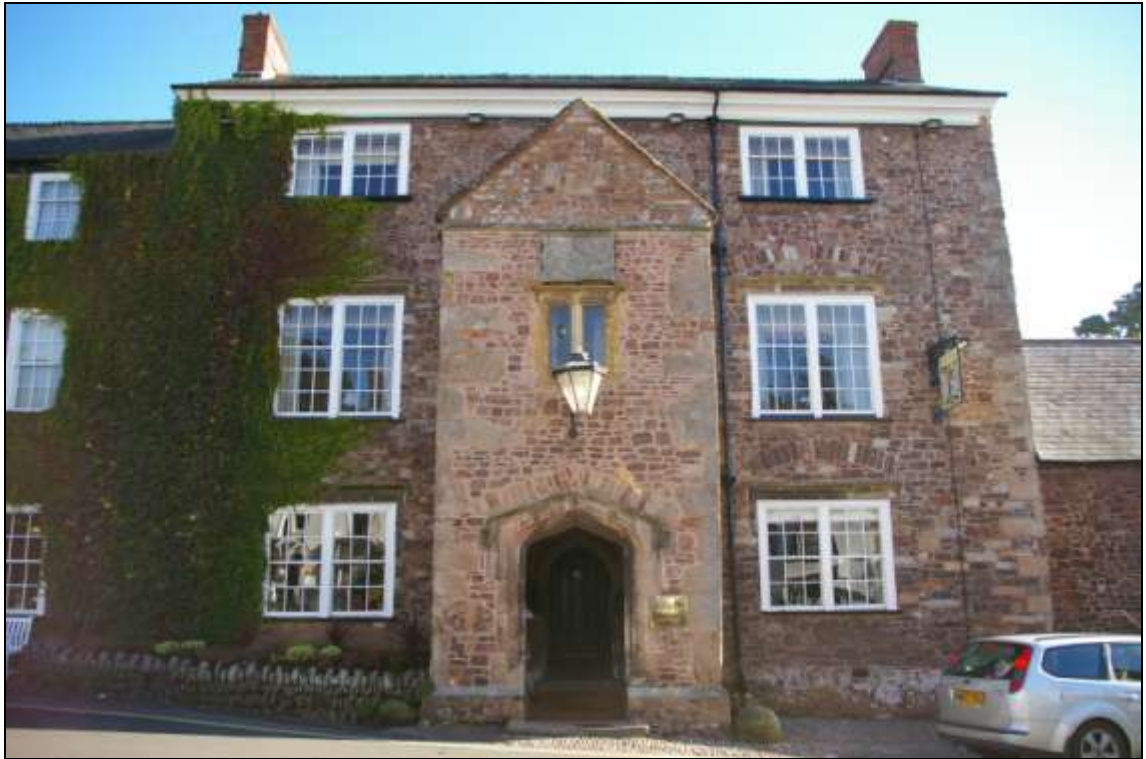
The largest and most significant changes to the building complex which survives today took place in the early 17th century. The main front block, to the west of the complex, facing onto the high street was wholly constructed in this period. We cannot know if this was built around, out of, or replacing an earlier structure, however the internal features and exterior architectural details on the ground and first floor are cohesive and point to a single phase structure. The plaster ceilings and decorative fireplace overmantles in some of the rooms in the front range, such as the small dining room at the north end of the ground floor and room 12, to the south of the first floor, are of fine quality and point to a date of the first decades of the 1600s, possibly the 1620s. The crest of George Luttrell, a gentleman of that time and related to the family who owned Dunster Castle, can be found in room 14. The building to the south of the main block which appears cohesive with the structure has a large blocked arched opening and may have originally led through to the rear of the complex to the service areas

Figure 13: West elevation of main block with projecting porch; from the west.

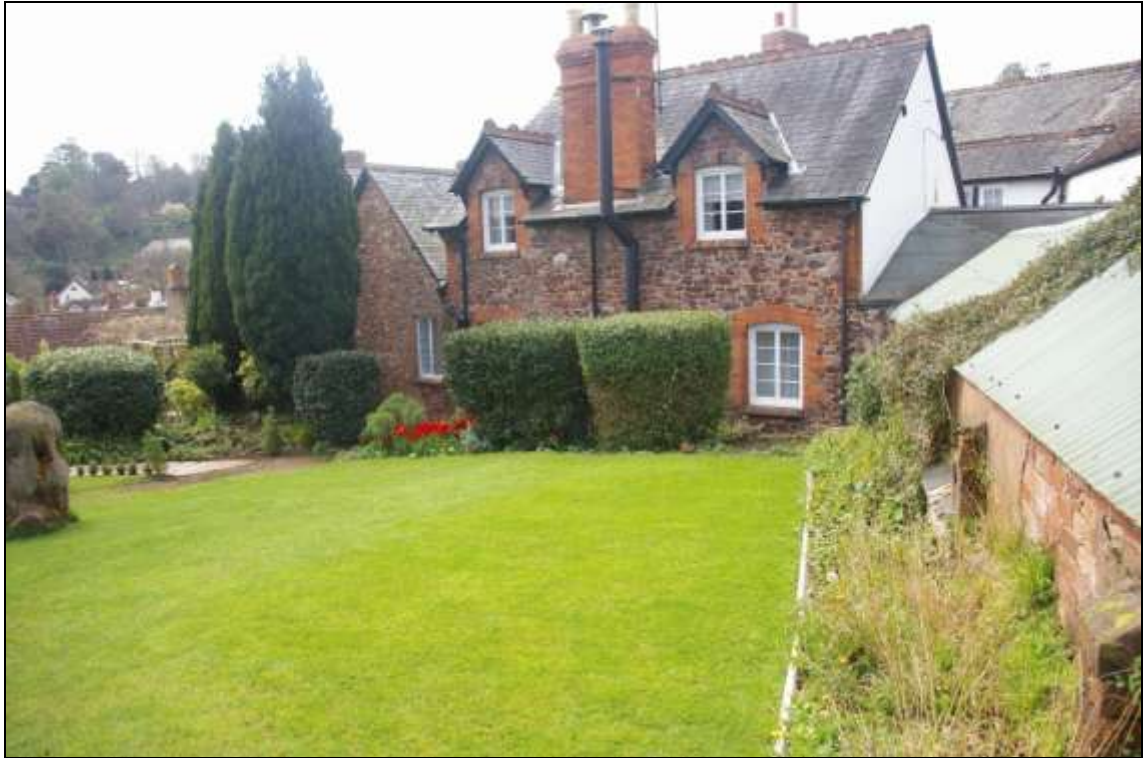
Figure 14: View across the garden showing the area to be disturbed by the service tunnel; from the north-east.

The structures that will be altered as part of the proposed works are of varying dates and levels of significance. However, it is recommended that where walls will be breached or the ground will be excavated, a program of archaeological monitoring should take place.

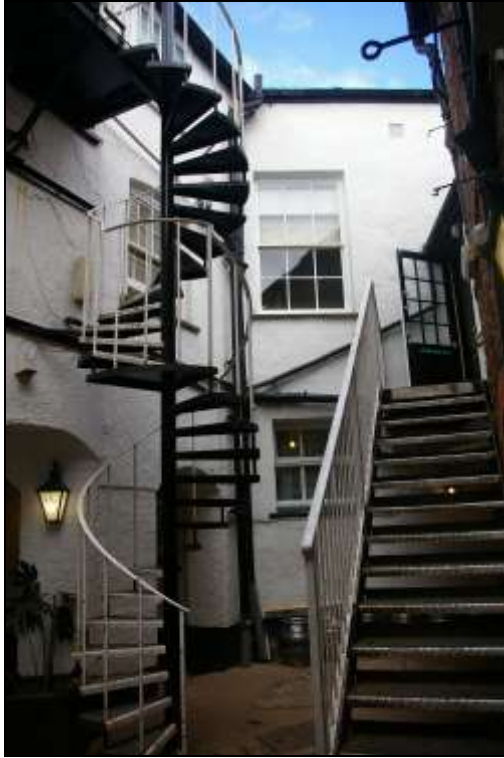
Figure 15: View north within the courtyard, showing the 19th century building; from the south.
