LAND at BEARA FARM CHULMLEIGH DEVON

Results of a Historic Visual Impact Assessment

Report No.: 140507
Date: 07.05.14
Authors: B Morris

This report presents the results of an archaeological evaluation and historic visual impact assessment carried out by South West Archaeology Ltd. (SWARCH) at Beara Farm, Chulmleigh, Devon, in advance of the construction of a single 50Kw wind turbine.

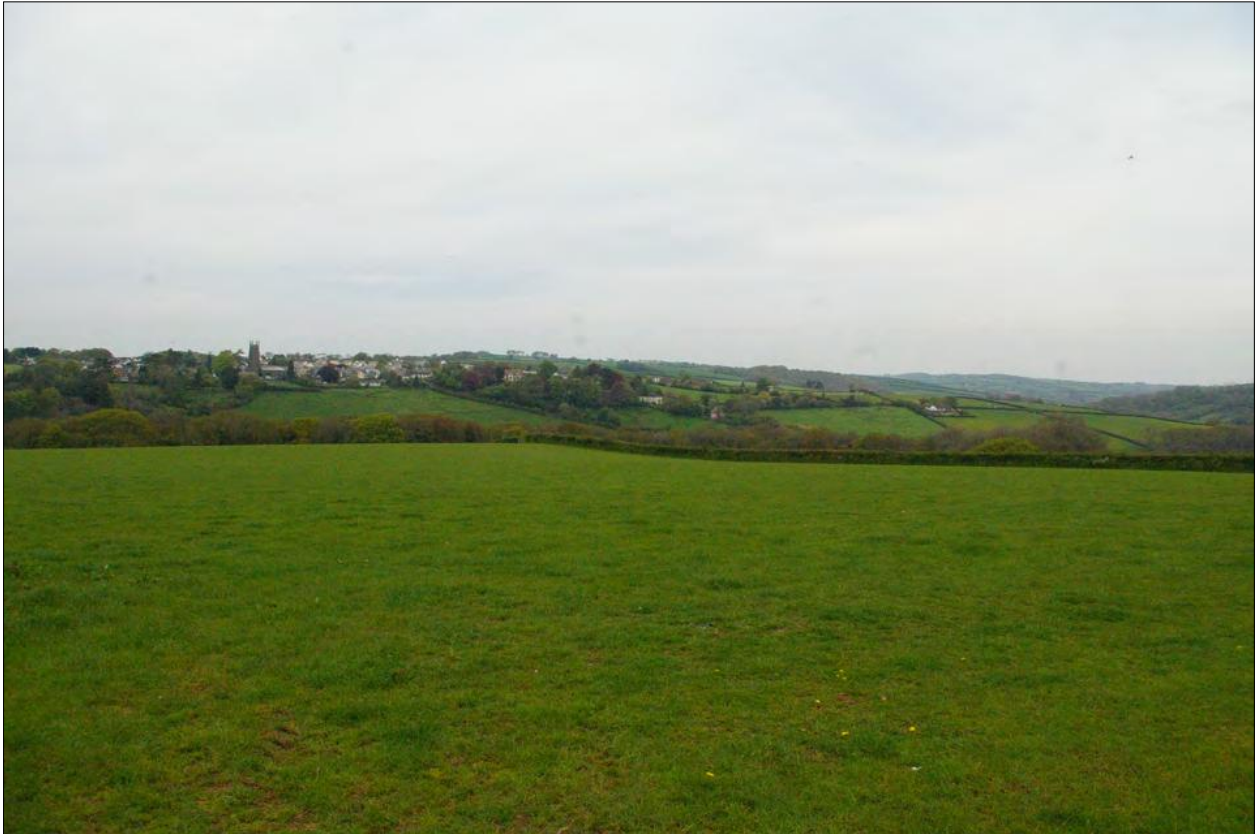
View of Chulmleigh from the south [SS686132]; the proposed turbine would be located in the hills to the right of the town.

- Chulmleigh; high significance; multiple Grade II structures and Conservation Area; condition: varies. Distance to turbine c.3.1km. A small historic town containing multiple Listed historic structures. Chulmleigh does not fall within the ZTV, and the proposed turbine would be located outside the wider landscape context of these assets. Impact: **neutral**.

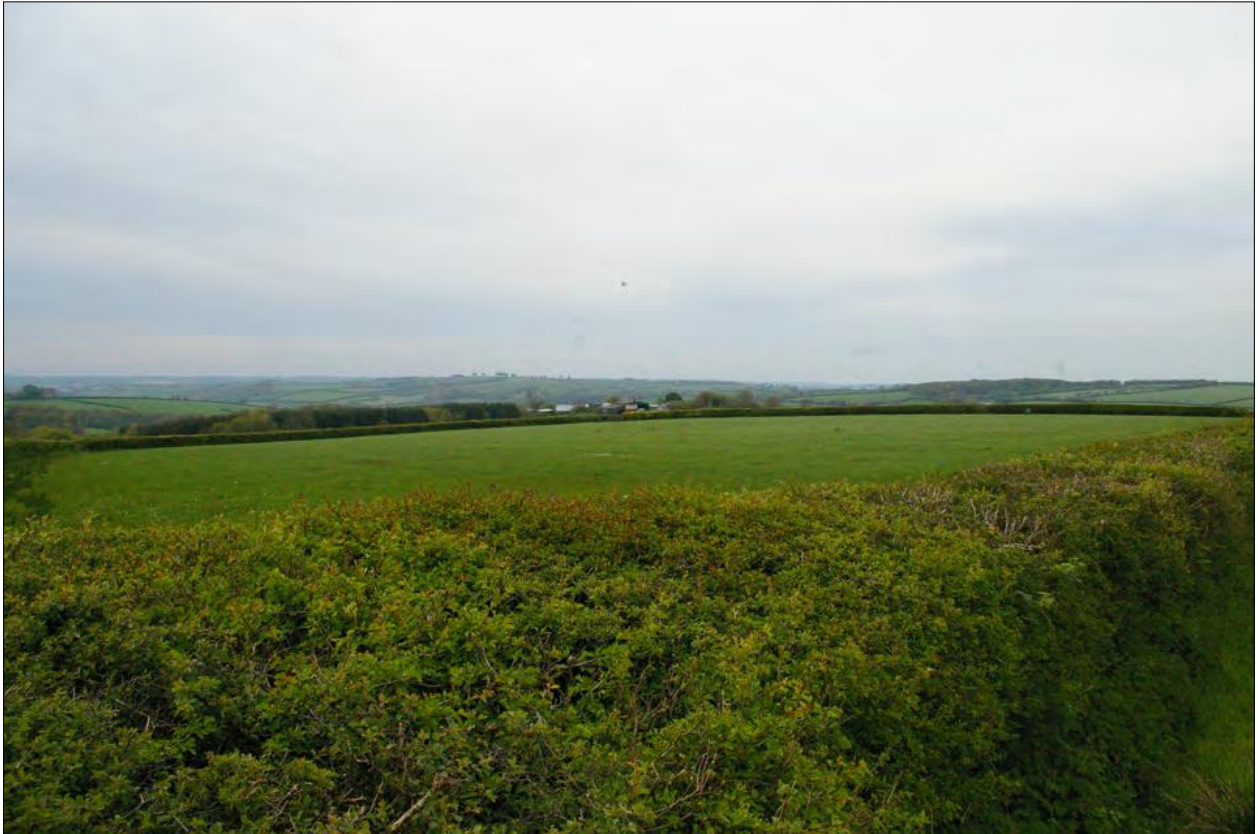
Higher and Lower Sheepsbyre Farm, viewed from the east-south-east [SS734156]; the proposed turbine would appear in the background directly behind the farms.

- Lower and Higher Sheepsbyre Farmhouses; medium significance, Grade II Listed; condition: unknown, accessed via long private tracks. Distance to the turbine c.2.9km. Located on the upper south slopes of a wide valley, on a narrow ridge projecting into the valley. The two farmhouses are early post-medieval in date and retain relatively well-preserved farm outbuildings. Both farmhouses face south across a narrow coombe. The proposed turbine

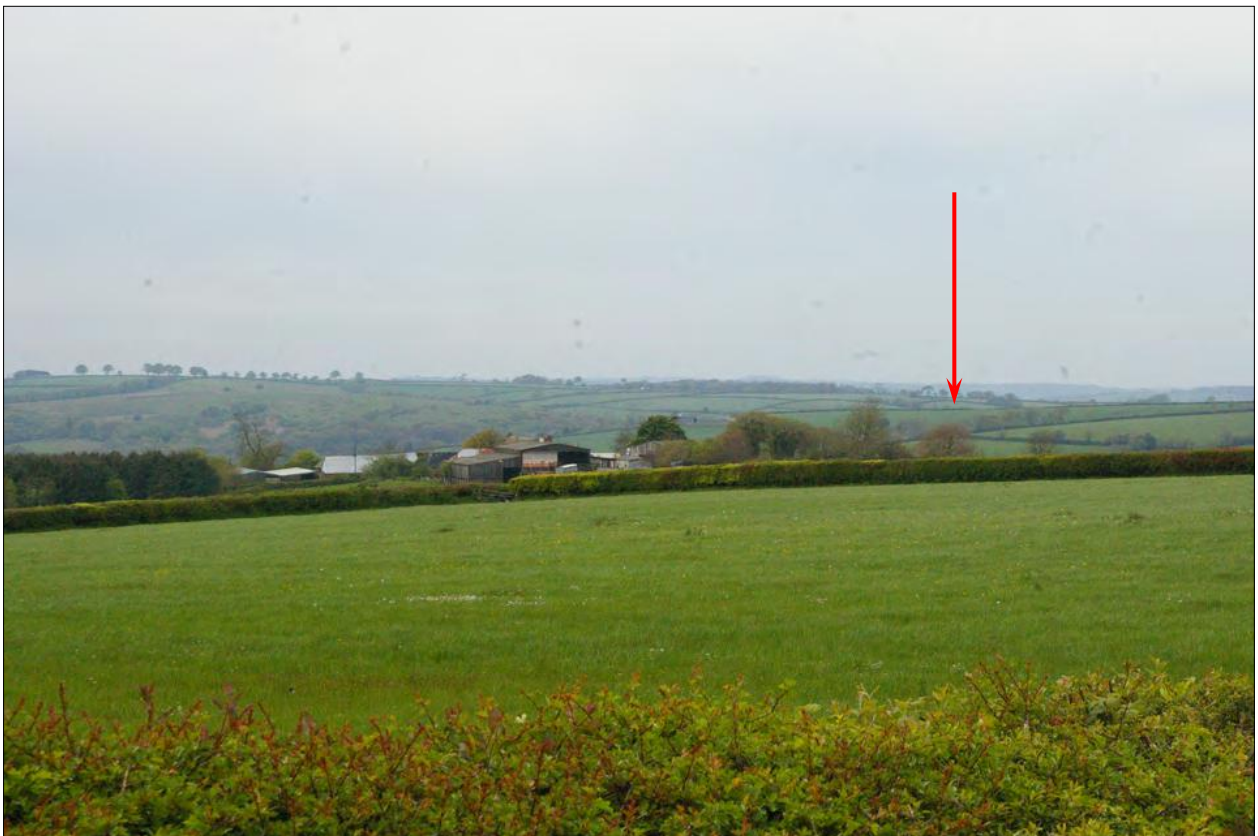
Detail of the above; the approximate location of the turbine is indicated.

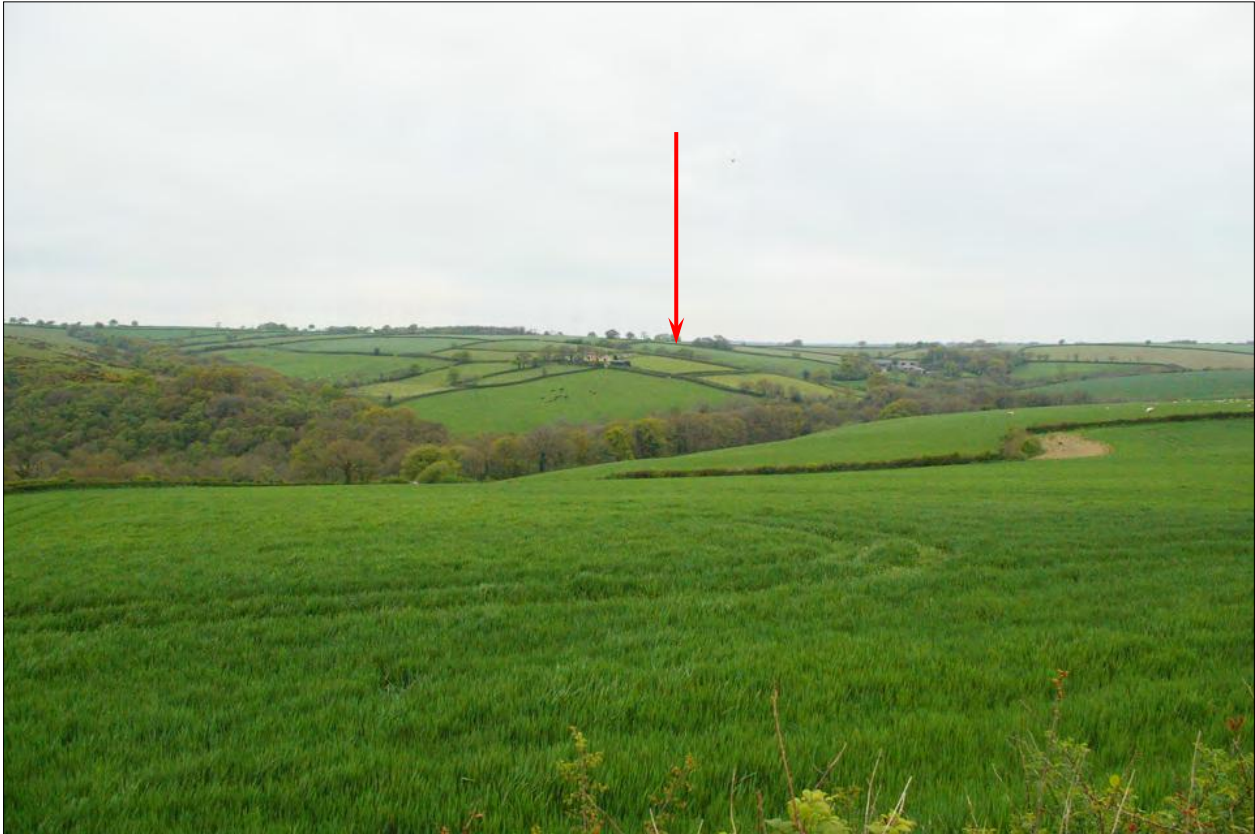
View from above Higher Dodyard [SS712164], looking across to the location of the proposed turbine; from the east-south-east. The approximate site of the turbine is indicated.

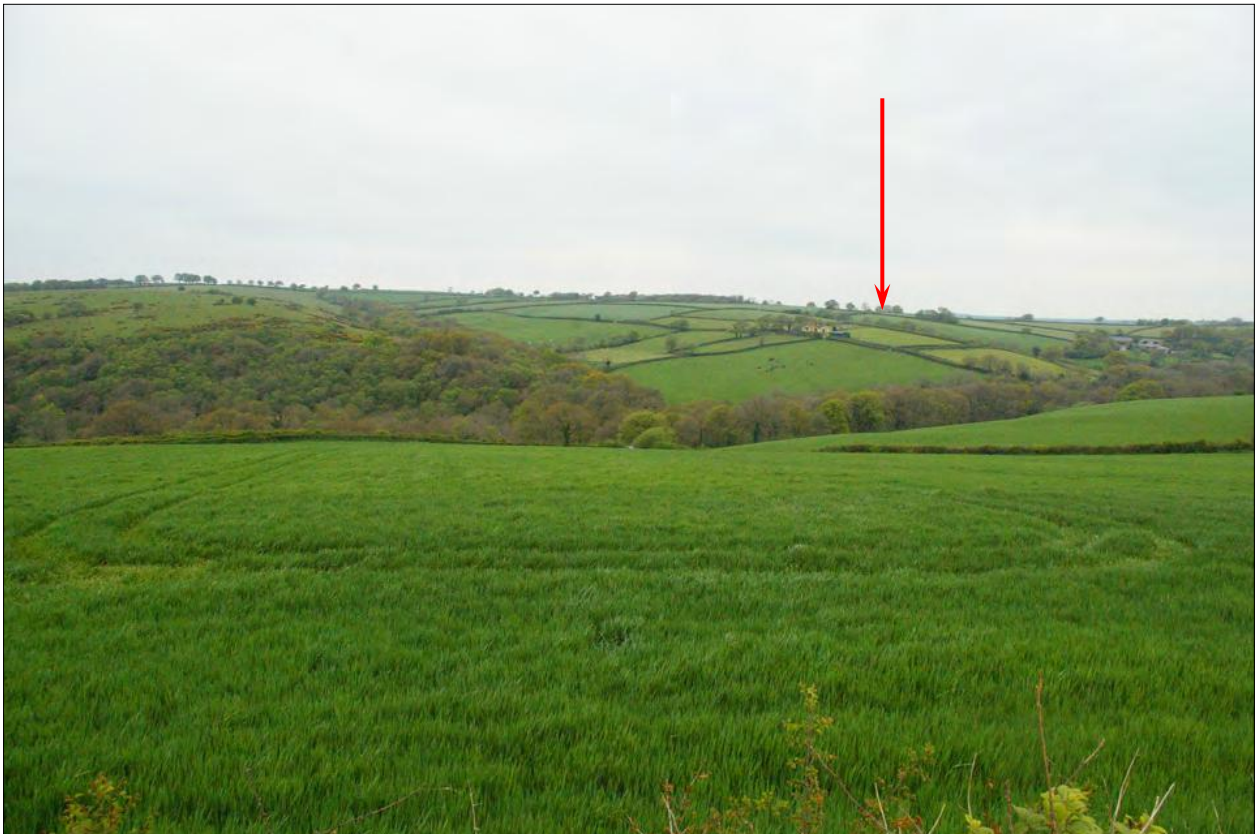
As above, showing the relationship to Horridge Moor; viewed from the east. The approximate site of the turbine is indicated.

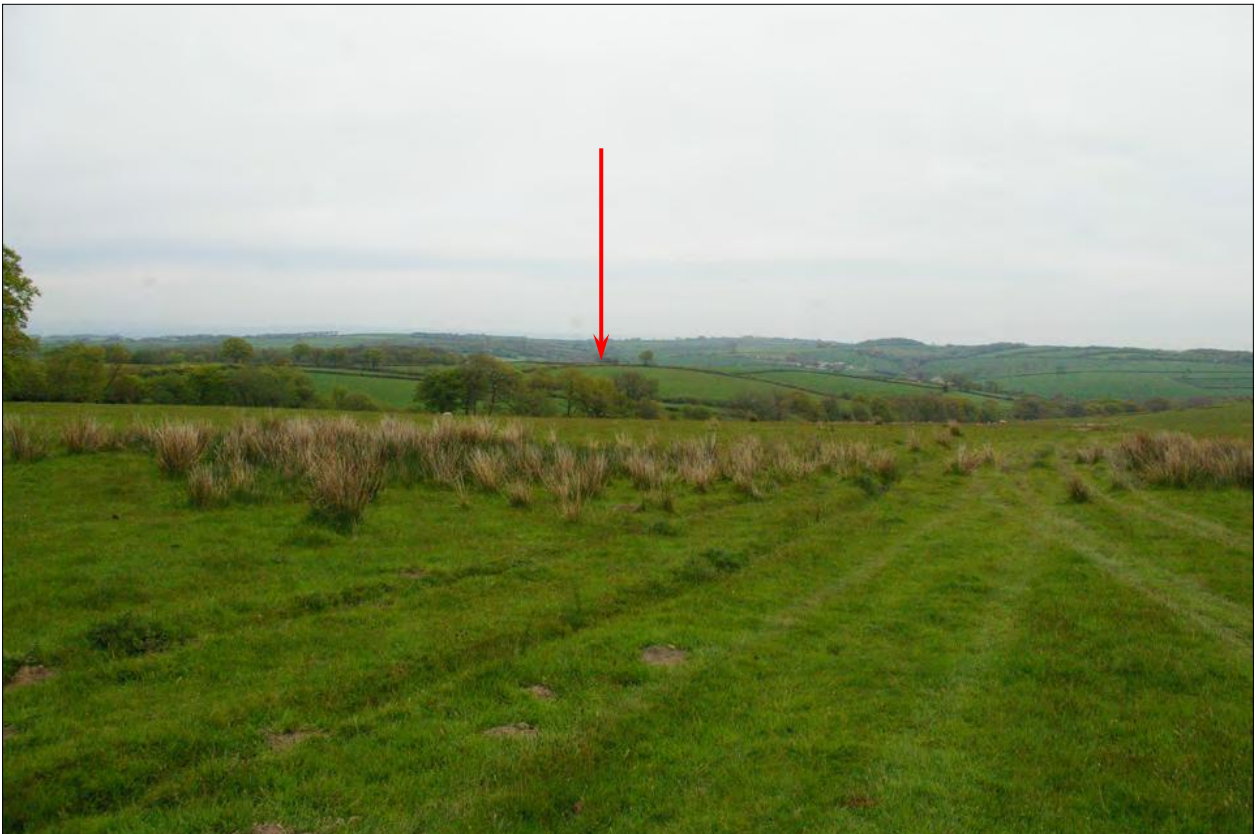
View from the western edge of Horridge Moor, looking east-north-east. The approximate location of the proposed turbine is indicated.

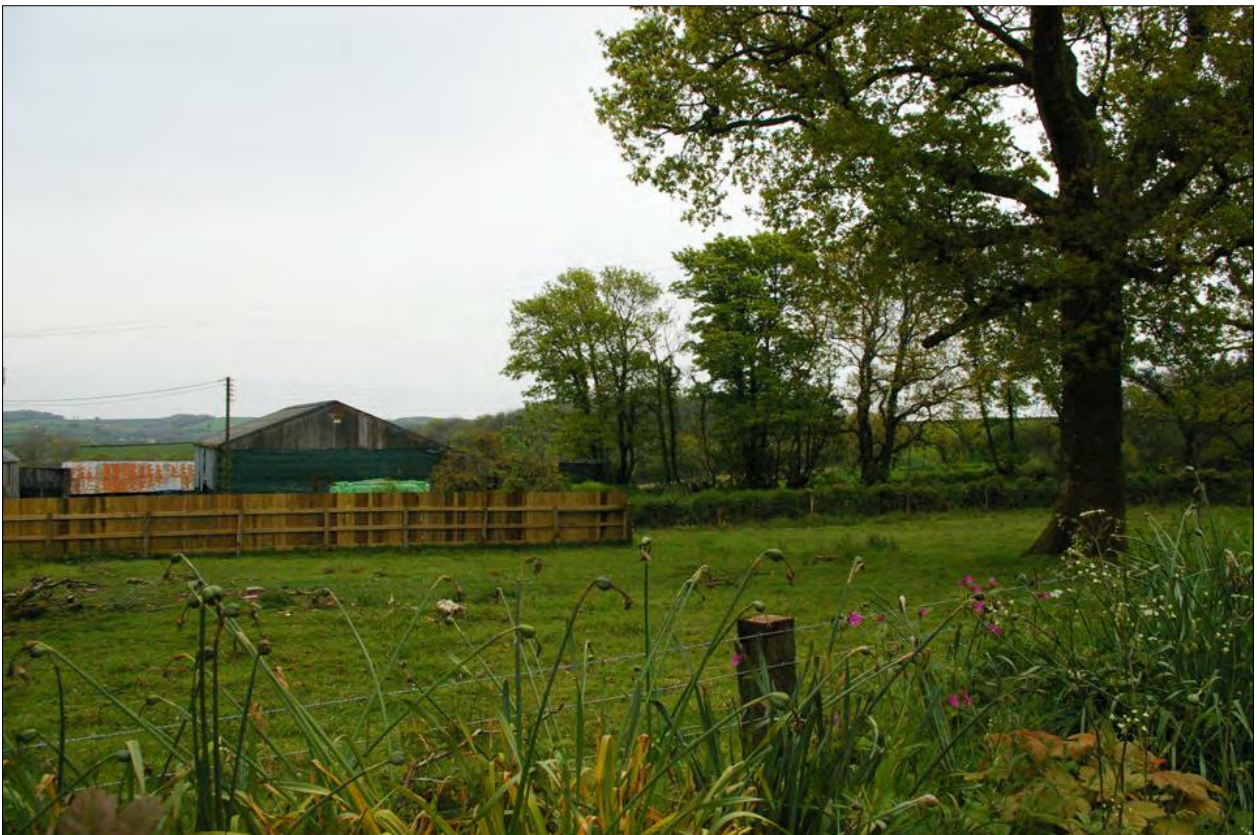
As above; the turbine would be located behind the woodland in the background.

- Cadbury Barton Chapel; medium significance, Grade II Listed; condition: unknown. Distance to turbine: c.750m. Located within a complex of rubblestone farm buildings at Cadbury Barton and not readily distinguishable from the public road. Local blocking from the other farm buildings, and some screening from trees nearby, are likely to be relevant factors. The immediate landscape context is provided by the farm, and while the proposed turbine would stand within its wider landscape context, is not likely to significantly detract from its setting. Impact: **negative/minor**.
