WAYFORD MANOR, WAYFORD, SOMERSET

Results Archaeological Monitoring

Report No.: 140808
Date: 08.08.14
Authors: P. Webb

This report presents the results of archaeological monitoring carried out by South West Archaeology Ltd. (SWARCH) at Wayford Manor, Wayford, Somerset during the excavation of pipe trenches for the installation of a biomass boiler system.

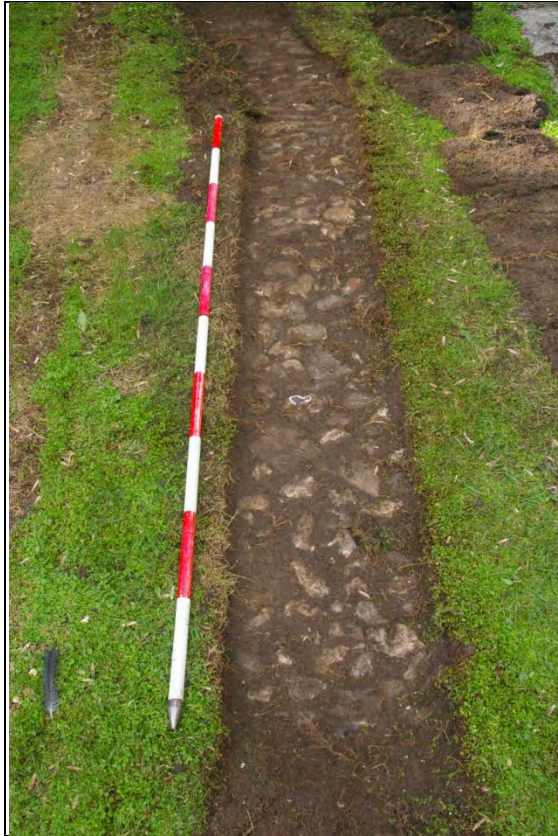
Cobbled surface {101} was situated immediately beneath the topsoil and covered the full length, extending beyond the limits, of Trench 01 (Figure 4), and comprised sub-rounded irregular stones

and angular sandstone fragments c.100mm to a depth of c.0.1m (one course) within a matrix of dark brown friable silt loam. Beyond the confines of the trench, evidence of cobbles protruding through the topsoil suggests that the surface covers the entire area occupied by the grass to the south of the extant garden wall [108].

Figure 4: Shot of Trench 01 showing coble surface [101]; looking south (2m scale).

The three cobbled surfaces, {101}, {201} and {215}, likely all form the remains of a single cobbled yard truncated by the insertion of the paving slab paths and garden wall, probably in the 20th century. The yard surface is likely to have been laid during the period of the manor site's use as a farm during the 19th century, and it was probably during the creation of this surface that the series of dump deposits, located at the southern end of Trench 01 were added, to create a level base for the surface to site upon.

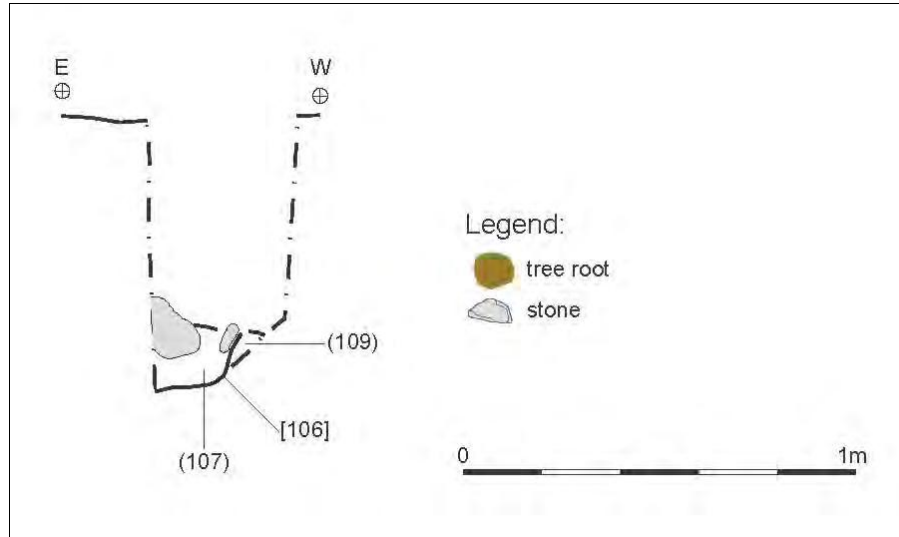
Approximately 0.2m south of garden wall [108], at a depth of c.0.5 was a possible wall [106] (Figures 5-7) comprising a single course of three large angular stone blocks orientated north – south within a matrix of firm-plastic red-brown clay (Figures 5-7). The feature has the appearance of being the remains of a predominantly robbed out wall.

Figure 6: North facing section of cut through wall cut [106].

The earliest feature stratigraphically was the remains of a possible wall {106}. This consisted of a line of three substantial stone blocks, with a slightly irregular appearance suggestive of them being the remains of a robbed-out wall, and potentially relating to the original medieval house. However, no dating evidence was recovered from the construction cut, and it may be a later feature relating to the 16th century remodelling of the manor.

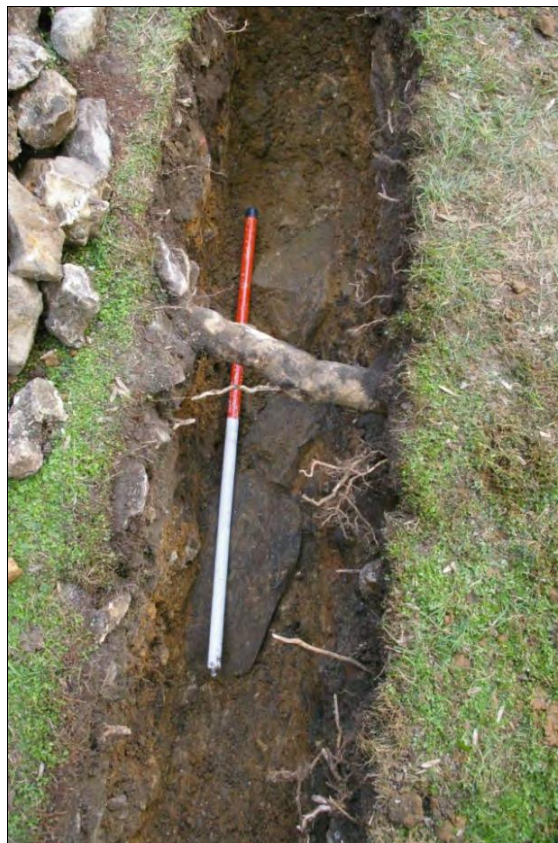
Figure 7: Shot of Trench 01 showing possible wall [106]; looking north (1m scale).

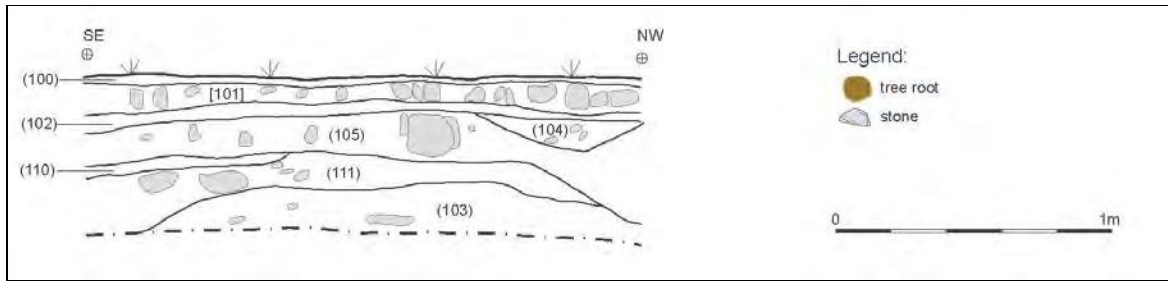
At the southern end of Trench 01 were a series of dump deposits (Figures 8-9) consisting of grey-brown silt clays (105) and (111) interspersed with deposits of green sand (104) and (110), overlying the re-deposited natural.

Figure 8: East facing section of Trench 01, showing dump deposits.

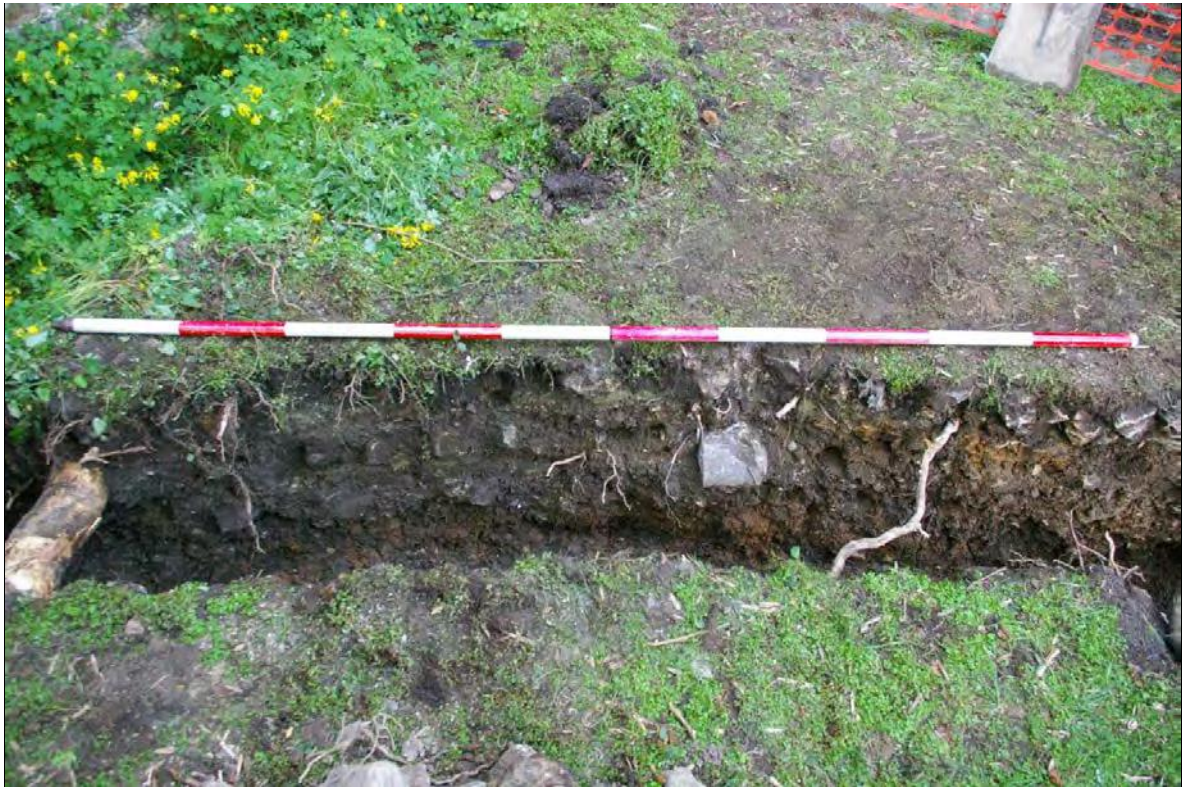
Figure 9: East facing section of Trench 01, south end, showing dump deposits; looking south-west (2m scale).

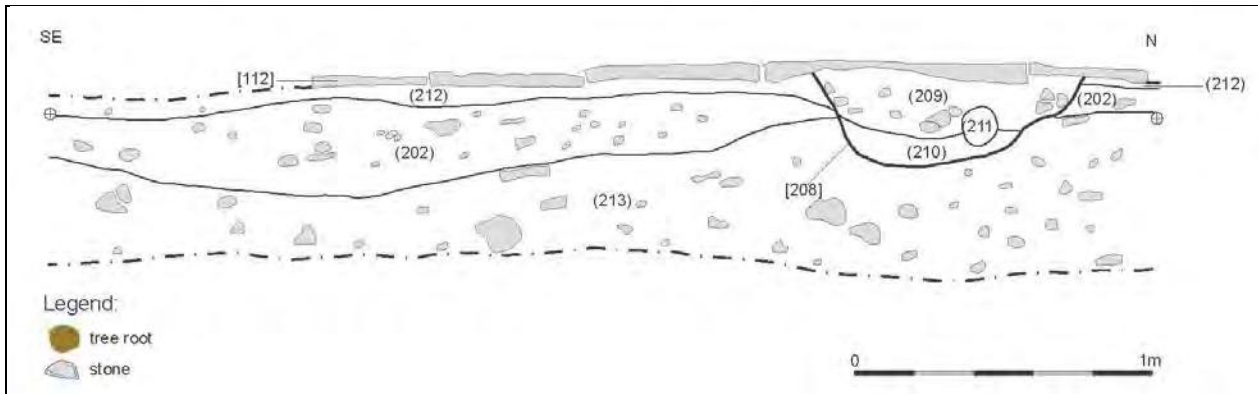
Trench 02, located in the northern half of the service yard and orientated approximately north to south, measured 6m before turning 45° and continuing a further 4m on a south-east to north-west alignment. Trench 02 was 0.5m wide and was excavated to a depth of c.0.7m. The southern and northern ends comprised a dark brown friable silt loam topsoil (200) c.0.05m thick overlying cobbled yard surfaces {201} and {215}. These cobbles overlay c.0.1m thick layers of re-deposited natural, an orange-brown sand-clay (202) and (213) (Figure 10). The central portion of the trench comprised areas of rectangular stone paving slabs {109} and {112} and associated bedding layers (212) overlying re-deposited natural (202).

Figure 10: Representative south-east and east facing section of Trench 02.

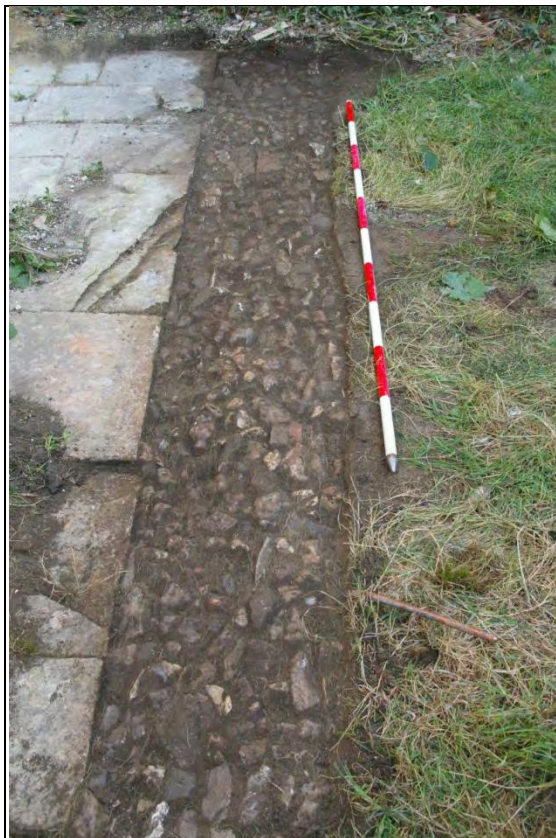
Cobbled surface {201}, located at the southern end of Trench 02, measured 1.5m north–south and extended beyond the width of the trench. It comprised sub-angular to sub-rounded stone 50-200mm to a depth of c.0.1m within a matrix of dark brown-grey friable silt clay. Cobbled surface {215} (Figure 11) similarly comprises sub-angular to sub-rounded stone 60-150mm to a depth of c.0.1m within a matrix of dark brown silt loam.

Figure 11: Shot of northern end of Trench 02, showing cobble surface {215}; looking north (2m scale).

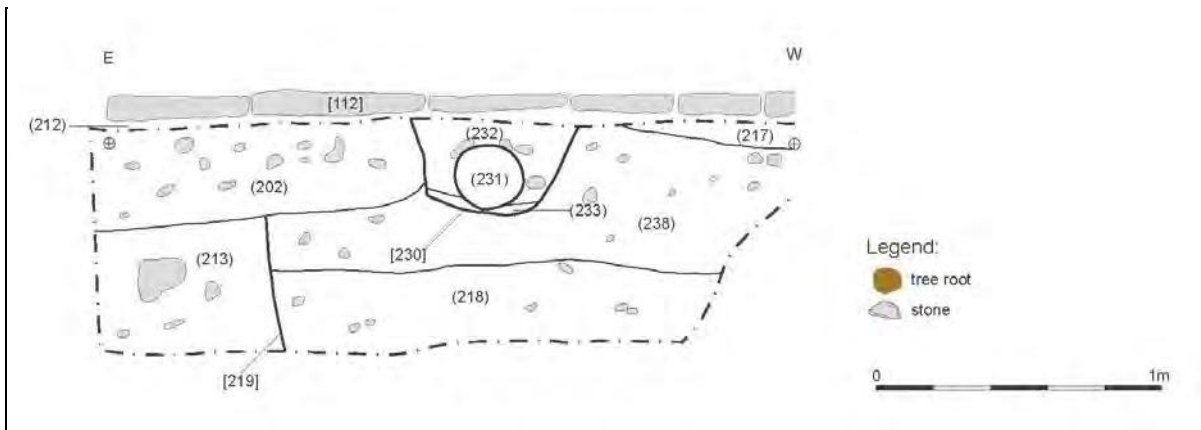
Cut [219] was present in the south-western corner of the trench, orientated north-west to south-east, was a linear feature running c.1.7m into the trench from the western end, x c.0.6m wide and excavated to a depth of 0.9m (Figures 13-16). It had a stepped profile with the upper 0.4m with northern side sloping at c.45° to a flat base 0.2m wide, before dropping with a near vertical edge to the base of the trench. It was filled by loose friable green sand (218) overlain by brown soft silt clay (238) and mixed loose-friable green-white silt-sand with 20% angular – sub-angular stone 100-150mm. This feature is likely to represent the construction cut for the extant well.

Figure 13: North facing section of Trench 03, showing well construction cut [219].

The position of cut [219], c.1m north of the well, suggests that it is likely to form the construction cut for the extant well servicing the manor. As with wall {106}, no dateable artefacts were recovered and it is not possible to establish which phase of the manor complex it relates to. Photographic evidence, however, shows that it had been constructed by c.1910 (Cox and Thorp 2013: 24).

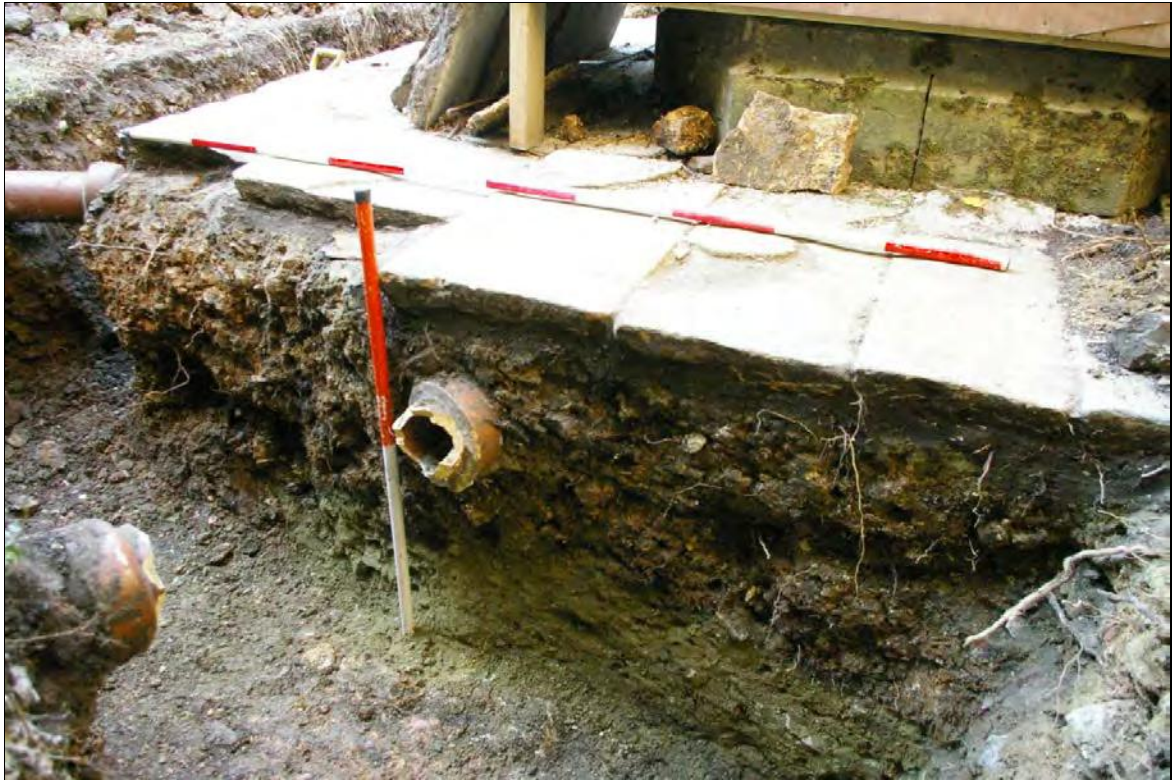
Figure 14: North facing section of Trench 03 showing construction cut [219]; looking south-east (1m and 2m scales).

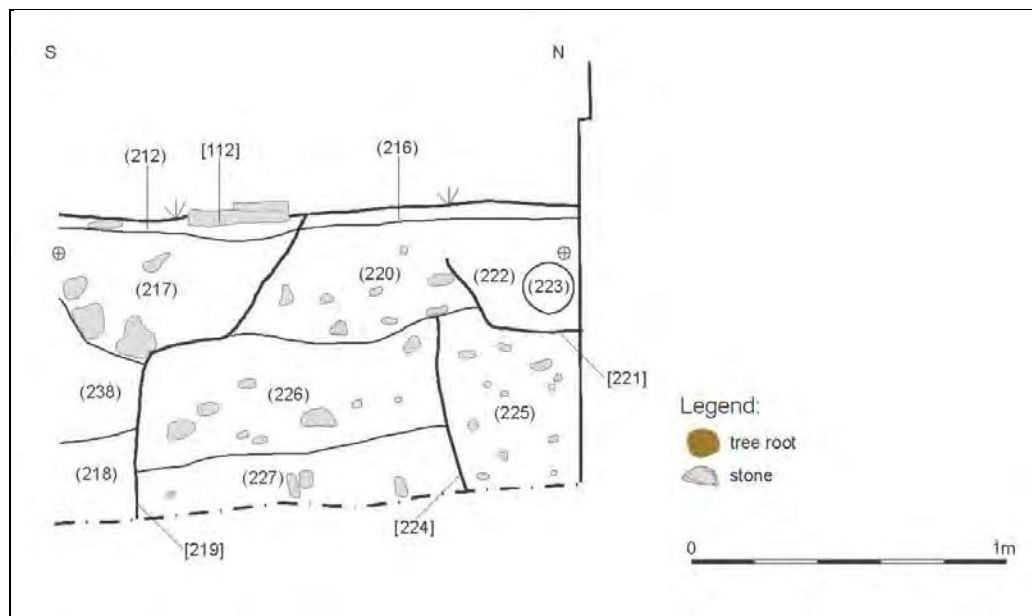
Figure 15: East facing section of Trench 03, showing well construction cut [219] and building construction cut [224].

Immediately to the south of the north range, along the northern edge of the north-south protrusion of Trench 03, was a second linear cut [224], orientated north-west to south-east measuring c.0.6m+ x 0.5m+ wide and extending beyond the limits of excavation. It was excavated to a depth of c.0.6m, with a near vertical southern edge. The fill comprised mid brown silt-clay with 20% sub-angular stone 20-50mm (225). This feature is likely to represent the construction cut for the foundations of the extant north range of buildings.

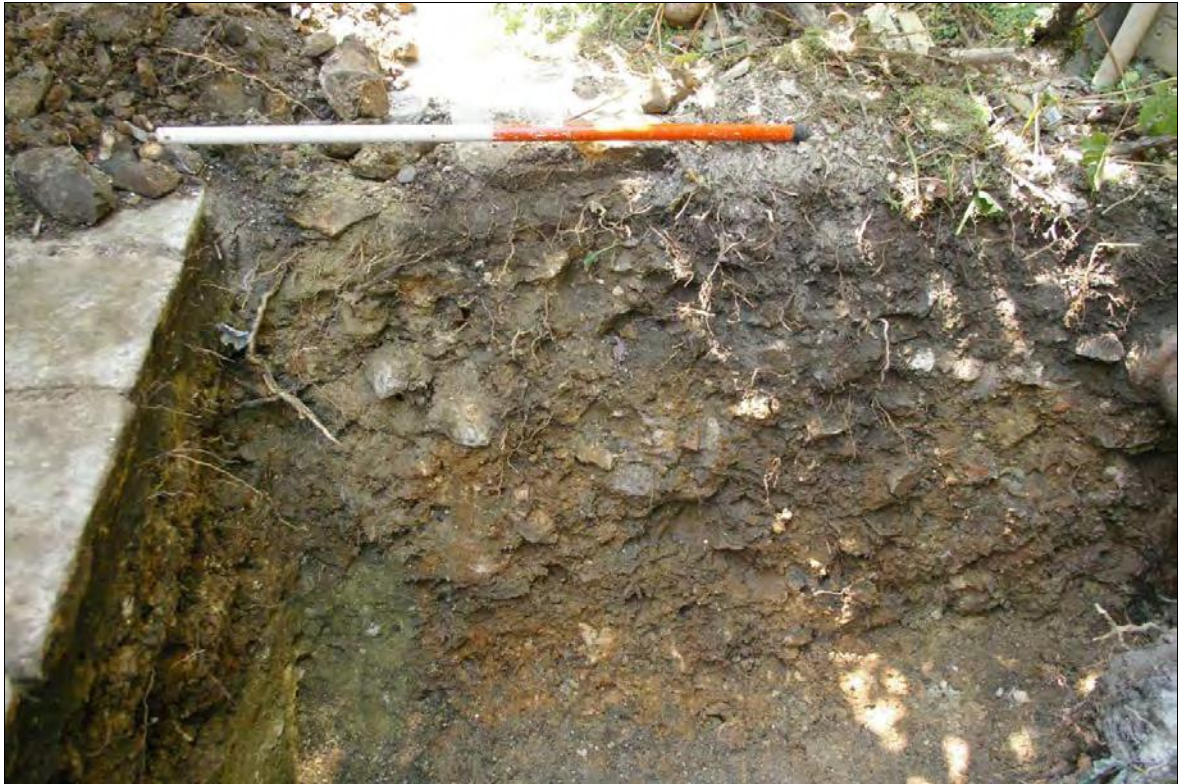
Figure 16: East facing section of Trench 03, showing possible construction cuts [219] (left) and [224] (right); looking west (1m scale).

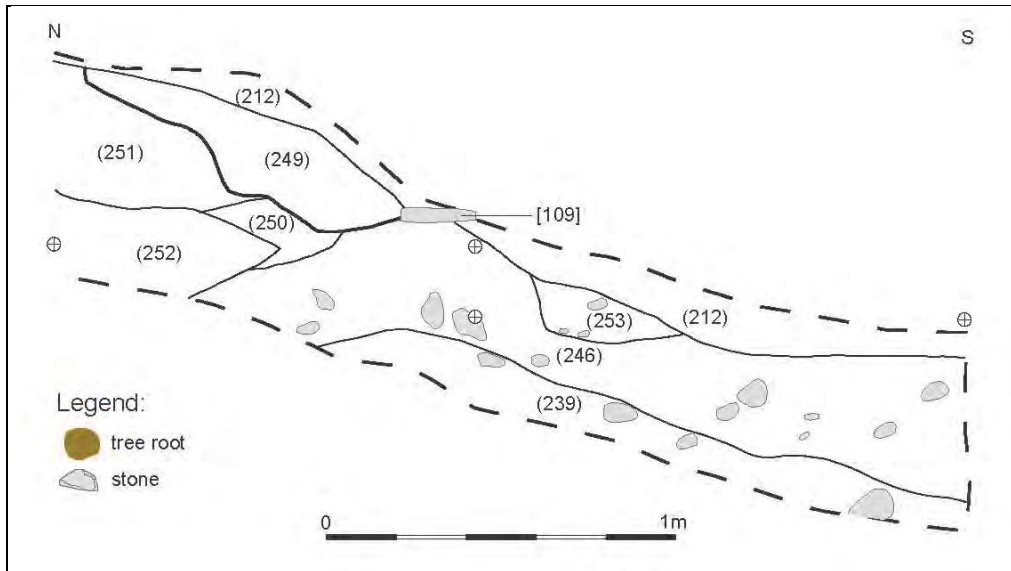
Trench 04, orientated north-west to south-east, measured c.19.5m x 0.5m and was excavated to a depth of c.0.6m, along the eastern side of the north range. The stratigraphy consisted of a continuation of the paving slab surface {109}; overlying bedding deposits (207) and (212); a series of re-deposited layers (246), (250), (251), (252) and (253); and natural (239) (see Figure 17). The entire length of this trench was affected by a series of modern ceramic drains, water pipes (Figure 18) and brickwork manhole chamber (Figure 19).

Figure 17: Representative section of Trench 04, showing modern disturbance layers.

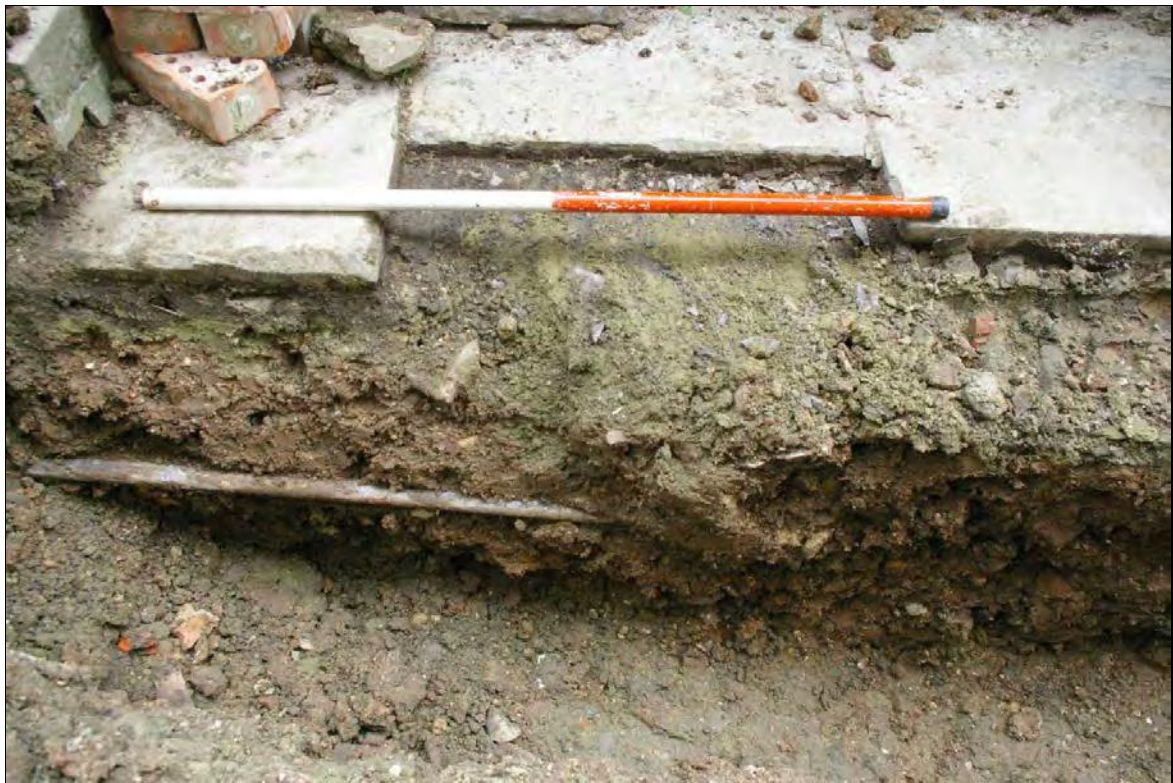
Figure 18: West facing section of Trench 04, showing modern water pipe [256]; looking north-east (1m scale).

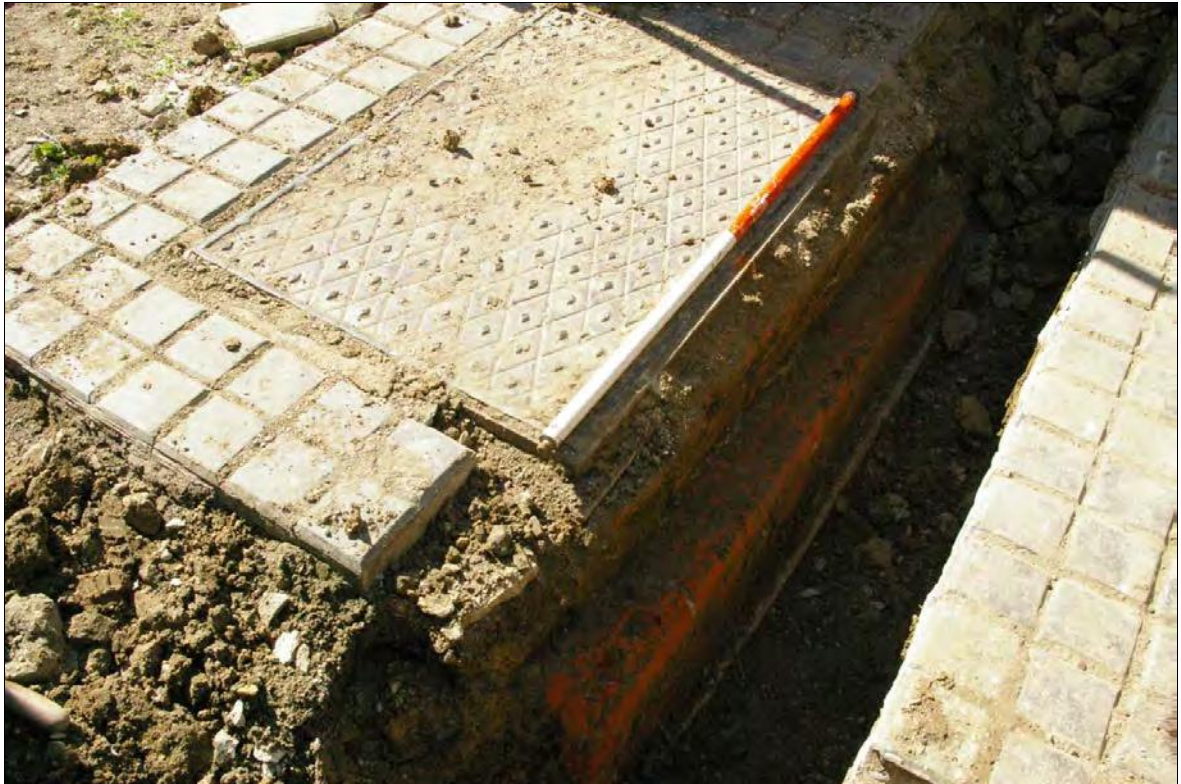
Figure 19: Shot of Trench 04, showing brick manhole chamber; looking north-west (1m scale).

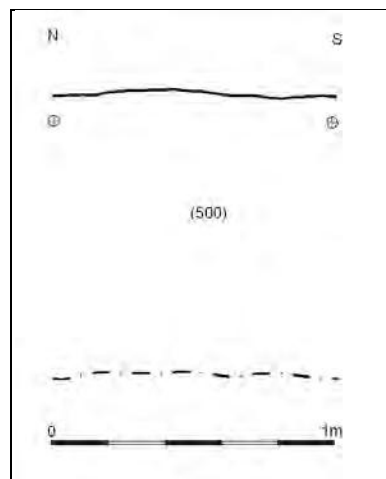
Trench 05, orientated north-west to south-east for c.5m before turning to run c.5m north – south, measured c.0.8m wide and was excavated to a depth of c.1m. Its fill comprised angular to sub-rounded stone and brick 70-200mm within a matrix of loose yellow-brown sand (Figures 20-21). No archaeological features were identified within the exposed area of this trench.

Figure 20: Representative section of Trench 05.

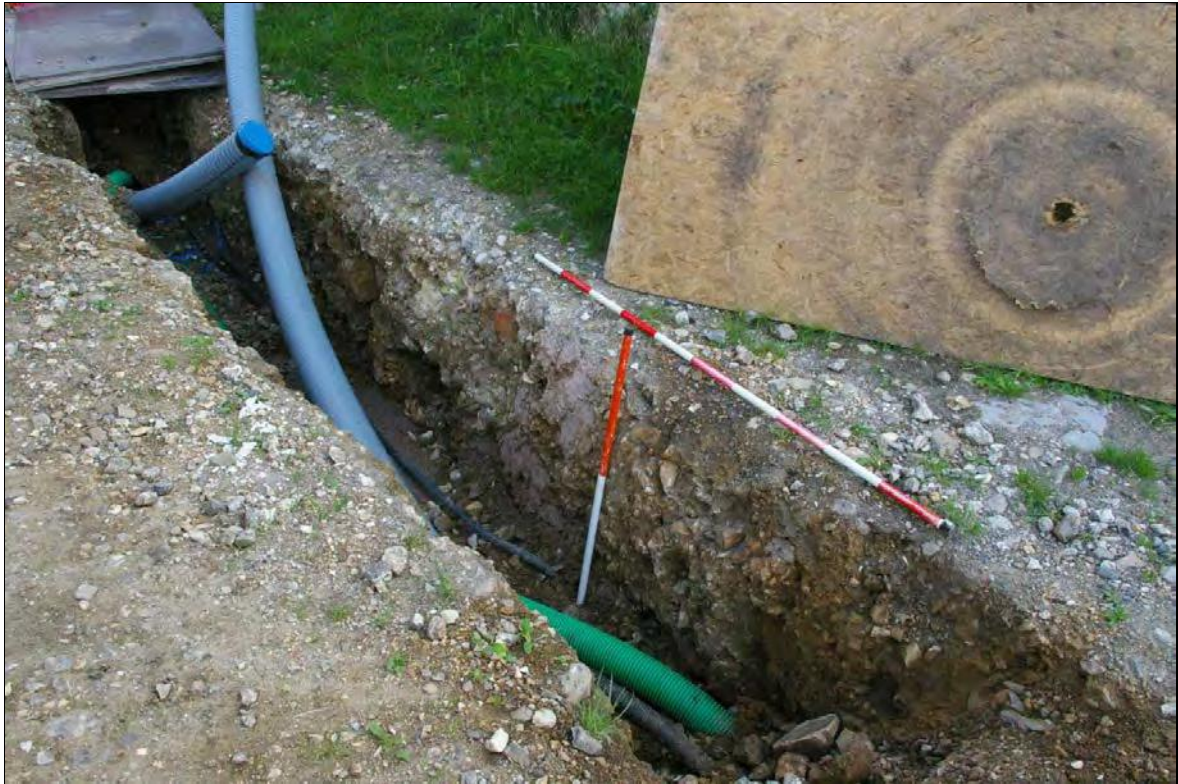
Figure 21: West facing section of Trench 05, showing disturbance layer; looking north (1m and 2m scales).

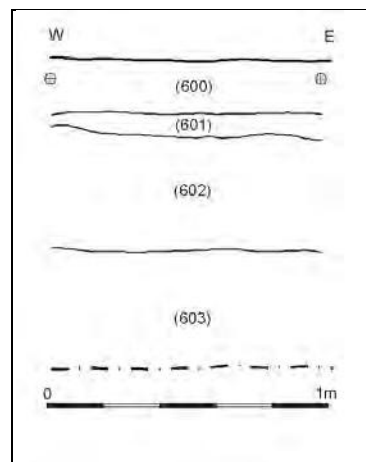
Trench 06, orientated east to west for c.40m before turning to run c.5m north-west to south-east, measured c.0.8m wide and was excavated to a depth of c.1m. Its fill comprised a series of stone and silt layers (600-603) which form the construction layers for the modern road (Figures 22-23).

Figure 22: Representative section of Trench 06, showing construction layers of modern road.

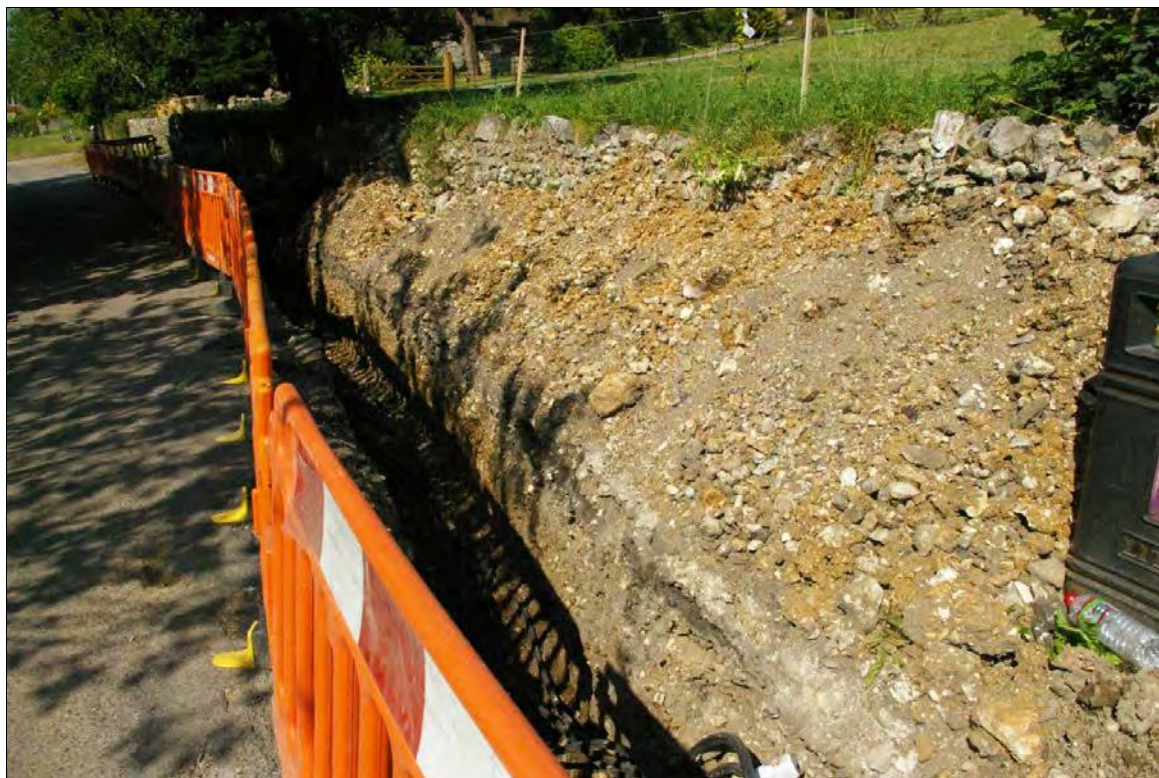
Figure 23: South facing section of Trench 06, showing modern road build-up layers; looking north-west.
