LAND at WINSHAM CROSS, BRAUNTON, DEVON

Results of a Historic Visual Impact Assessment

Report No.: 140527
Date: 27.05.14
Authors: E. Wapshott
S. Walls

National Grid Reference: SS5040139615 and SS5051139516

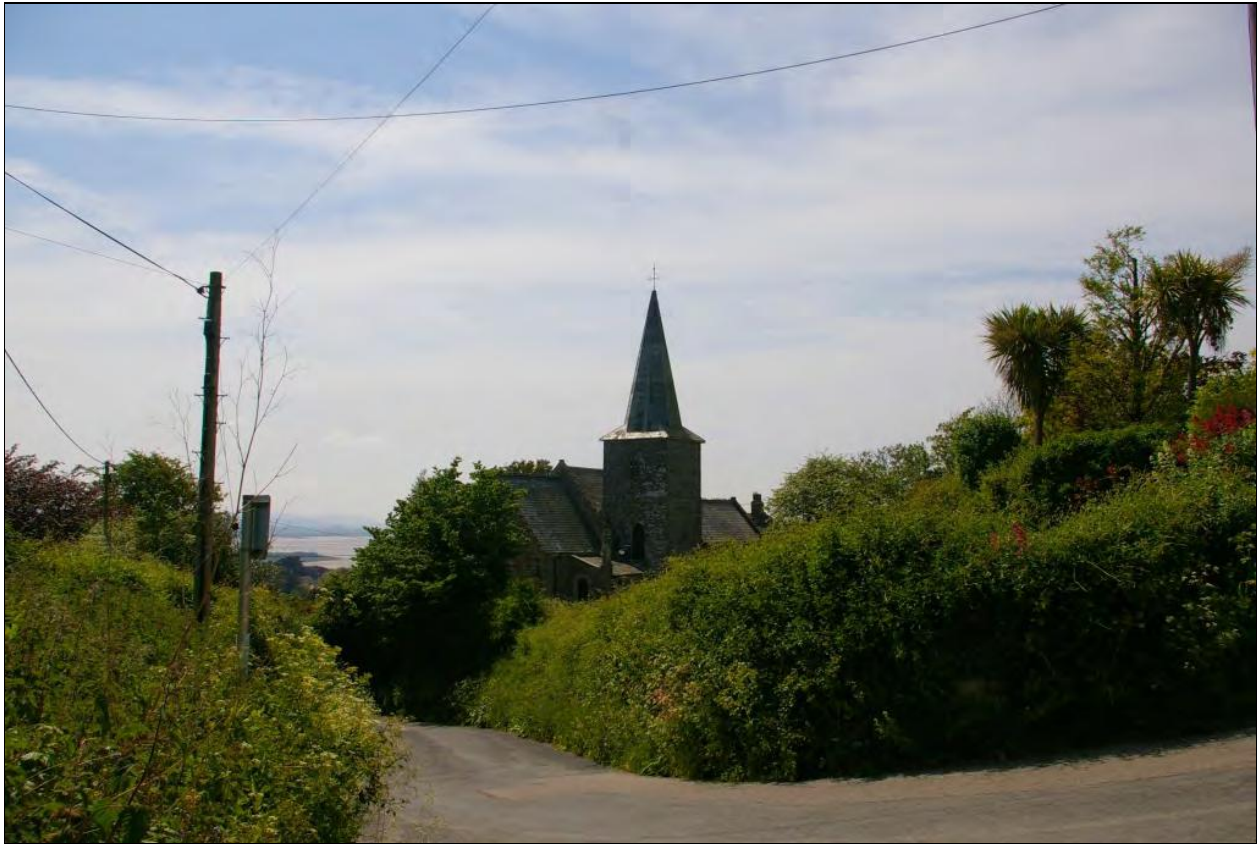
Ashford Church, set on the south and western slope, overlooking the Taw estuary; from the north-east.

- Church of St Peter, Ashford; high significance; Grade II* Listed; condition: good. Distance to turbine c.5.2km. This church has a spire, dating from the late 18th century which has wide views across the estuary. The church sits on a south-south-west facing slope. The churchyard is heavily wooded, and the church is framed by trees. The houses in the village and tall hedges and walls along the road will provide an element of local blocking to the churchyard and body

of the church. The ground peaks to the north behind the village, and as with Heanton Punchardon the landscape context of this church is the estuary, not the landscape to the north in which the turbine will be found. Despite the technical wide views, a spire has a lot less landscape primacy than a tower. A significant number of turbines stand behind the church to the north and north-west at Fullabrook and the proposed turbines will stand on the opposite hill, at a similar proximity. The turbines will not impact this church to any great extent, in no way intruding upon the village context or wider estuary setting; **negligible** impact.

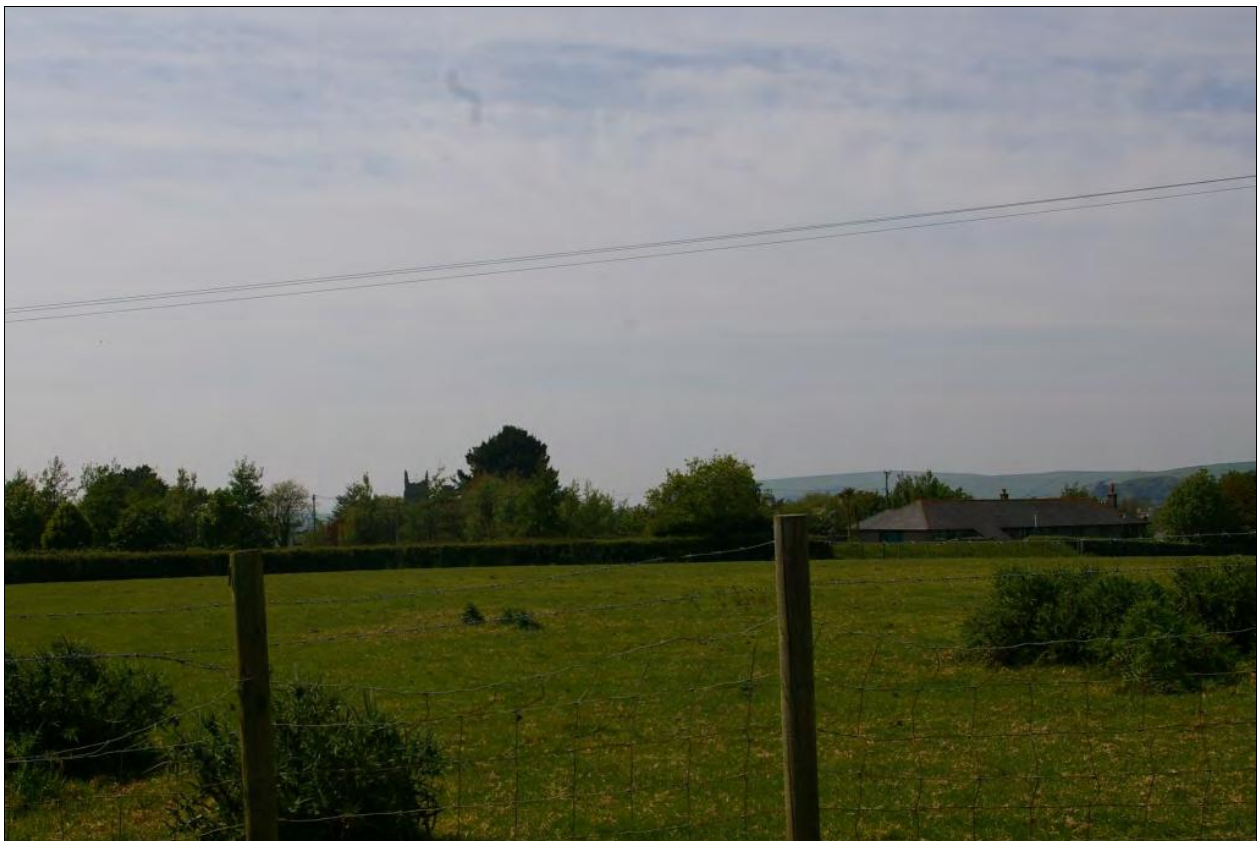
Landscape view of Heanton Punchardon church, set amongst the trees showing local blocking; from the east.

- Church of St Augustine Heanton Punchardon; high significance; Grade I Listed; condition: excellent. Distance to turbines: c.4.1km. Set on a shallow southern and south-western slope, at the peak of the slope, just off the top of the hill, with the ground rising immediately behind the church. Wide views across the estuary, the church tower is a key landscape feature within the wider estuary area, from the west, however the church is less visible, blocked by trees. Key views are along the river estuary, east to Barnstaple and across to Instow, Appledore and Bideford, the turbine will not appear in or affect these views. The turbine will stand to the north outside of the landscape context of the church of the south-facing slopes and estuary. A significant number of turbines stand behind the church to the north and north-west at Fullabrook, and the proposed turbine will stand on the opposite hill, at a similar proximity. There may be some limited views to the turbine from the top of the tower but the asset is not usually experienced from this angle and views will not affect our understanding of this asset; **negligible** impact.

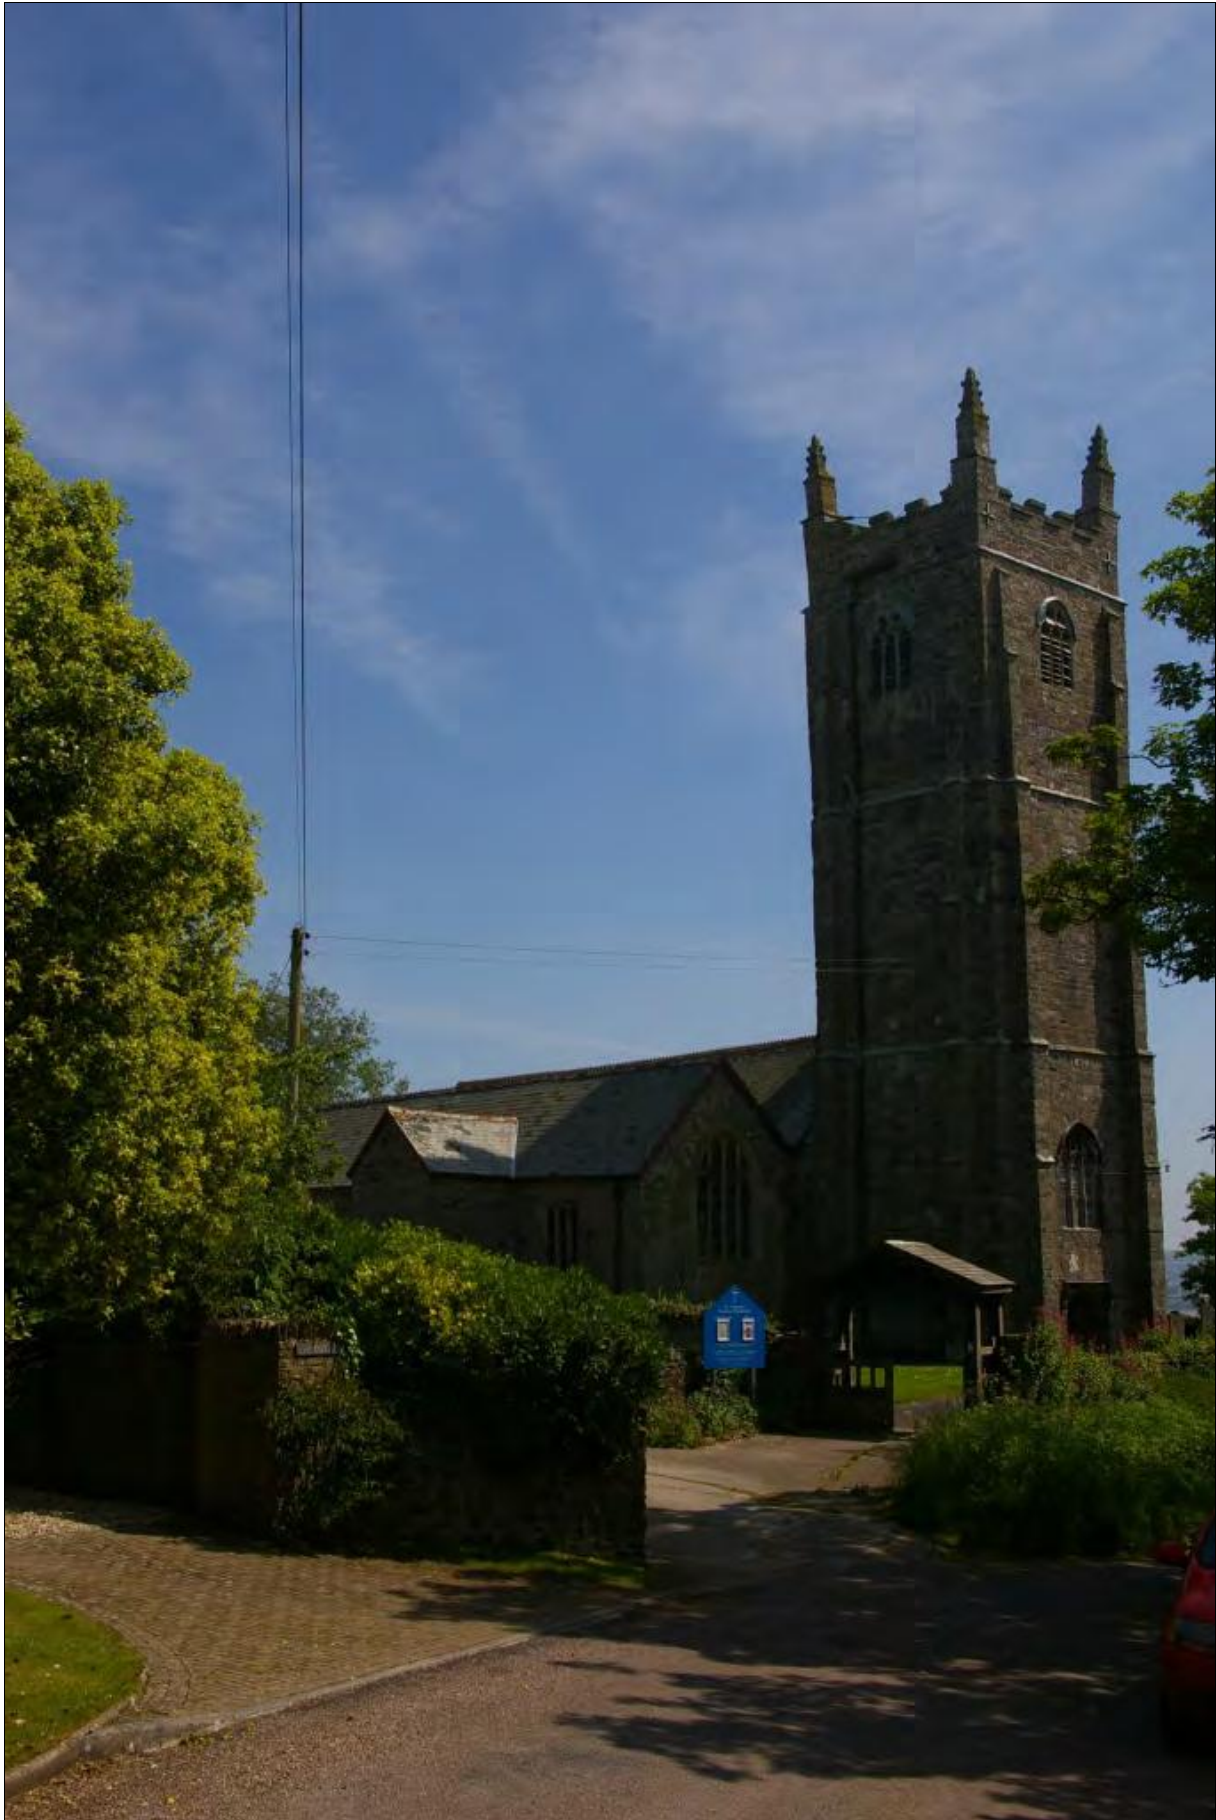
Heanton Punchardon church showing the tall tower, its the village setting and trees obscure it; from the north-west.

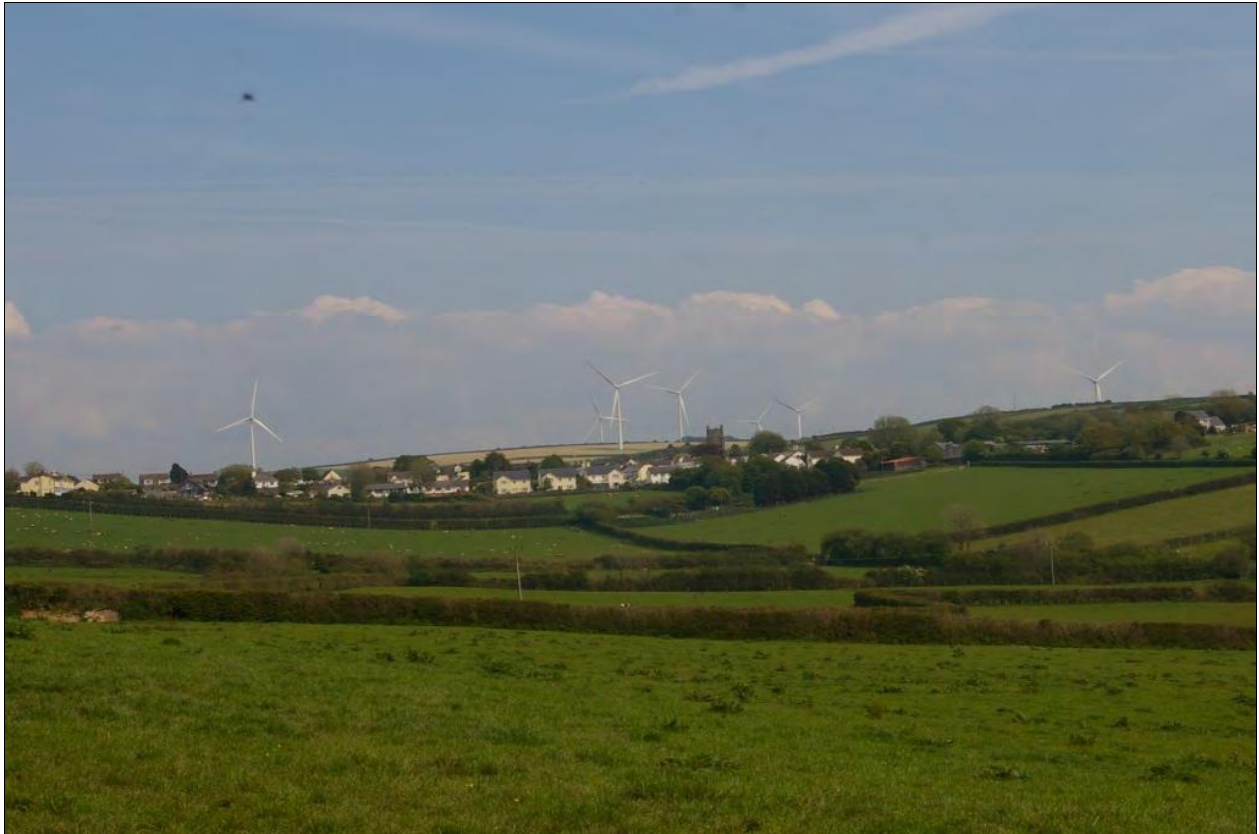
Landscape view of West Down Church , with Fullabrook wind farm behind; from the north-west.

- Church of the Holy Trinity, West Down; high significance; Grade I Listed; Condition: good. Distance to turbines: c.2.8km. Set in the wide open valley, on a north-facing slope, in a landscape of simple rural character. The context of the church is this valley and its immediate village setting. The historic and modern houses provide both setting and local blocking to the body of the church and the churchyard. The Fullabrook wind farm stands to the south-east and a single turbine stands to the north-east, within the landscape context of the church. The open nature of the valley is such that despite the enclosed cultural boundary of the village, the church and its tower are quite significantly affected as a landscape feature by the already extant turbines. Cumulative impact is expected to make this situation worse, although in comparison the proposed turbines will not directly affect the church as they will stand outside of the crucial valley landscape context, over a ridge of ground to the south. The blades or upper section may still be visible however; **negative/moderate** impact due to cumulative impact, little direct impact.

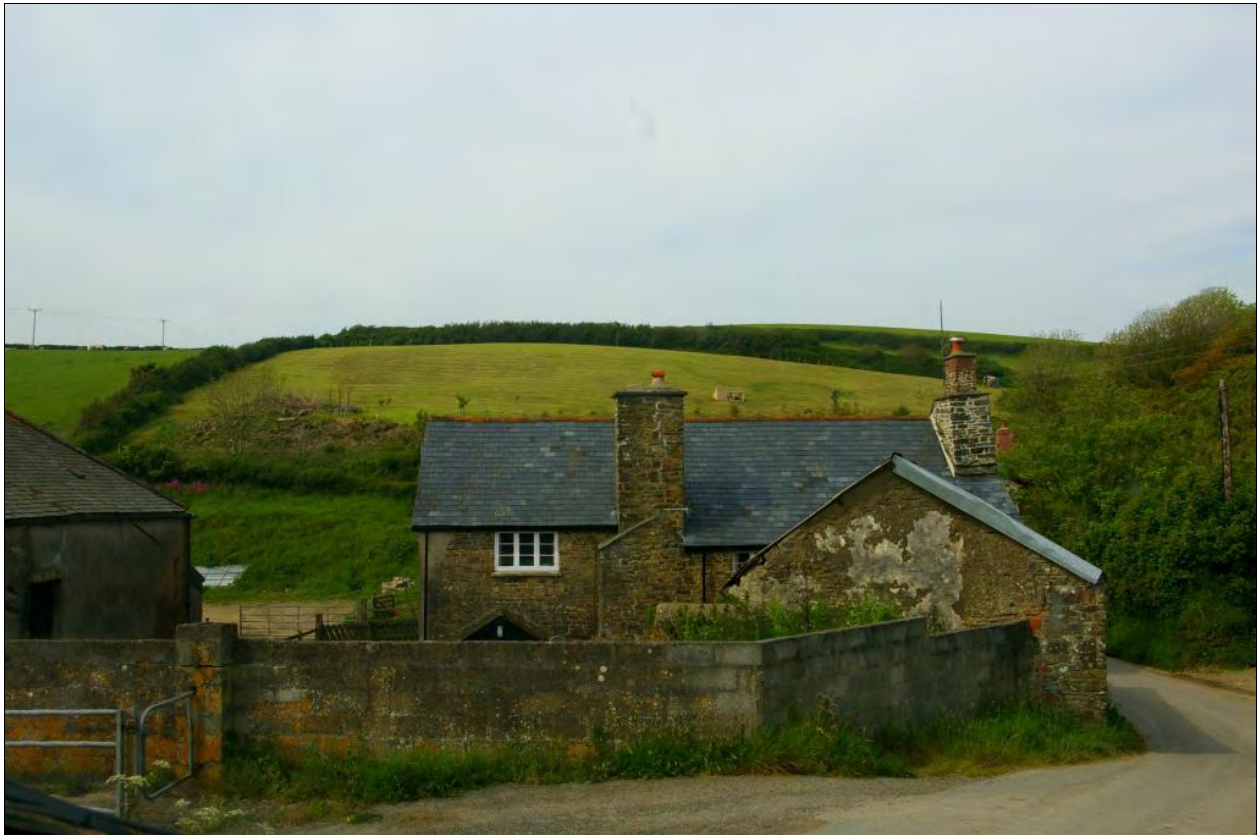
Middle Winsham Farm set in the small combe/valley, with its barns to the east, west and south; from the south.

- Middle Winsham Farmhouse and adjoining stables; medium significance, Grade II Listed, condition: fair. Distance to turbine: c.0.7km. Farm set in a deep wedge shaped east-west valley. The farm sits in the base of the valley, with buildings to the south and west, it is very enclosed with trees and hedgebanks to the western side, and modern buildings to the east. The valley curves and the ground rises to the north-east, where there are mature gardens of Higher Winsham Farm. There are wider views down the valley to the west, however the landform scale is small the setting of the farm enclosed, intimate within its immediate surroundings. Although the turbine lies just up the top of the valley, it does lie outside of the key section of the valley in which the farm is viewed. Some local blocking also occurs here with the trees to the north-east; **negative/minor** impact.

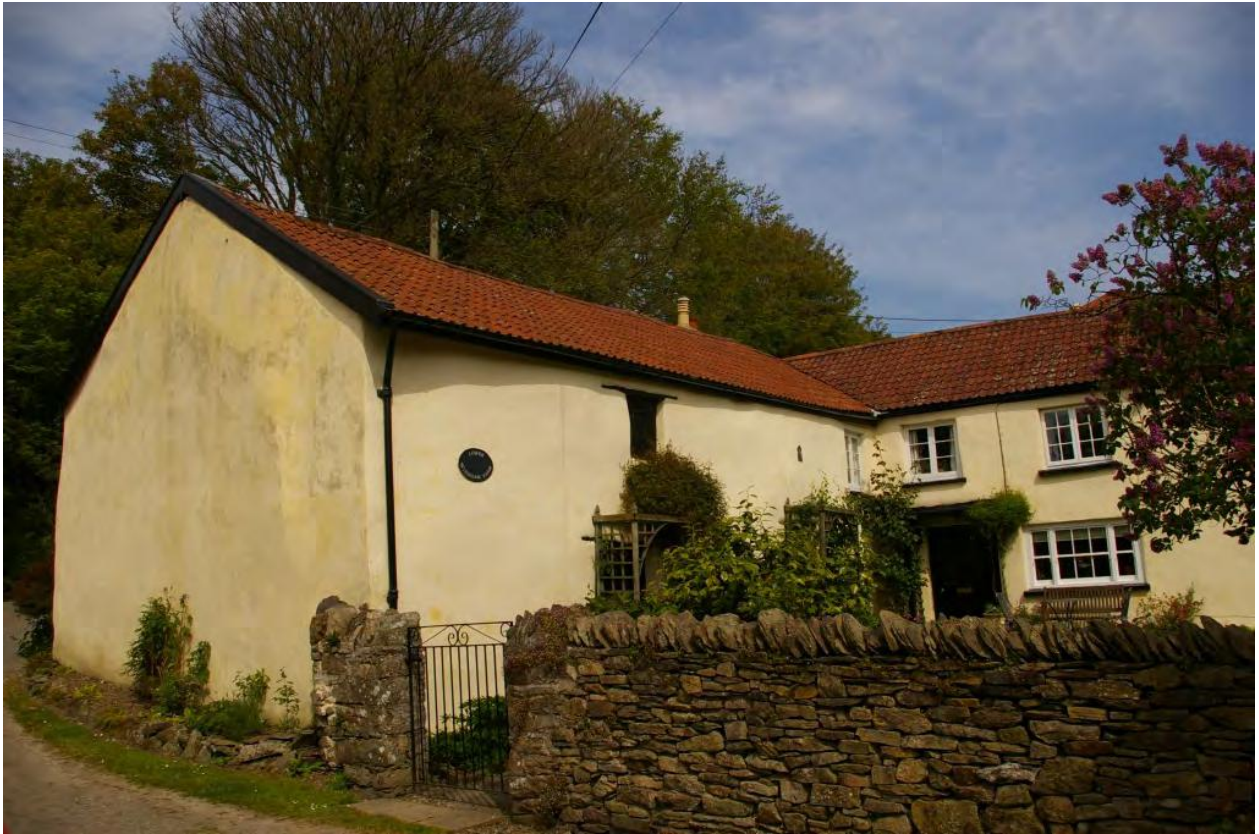
Lower Winsham Farm, set into the bank, within the steep valley; from the south-west.

- Lower Winsham Farm; medium significance, Grade II Listed; condition: good. Distance to turbine: c.0.9km. Set into a bank to the north-east, in an east and north-east orientated valley,

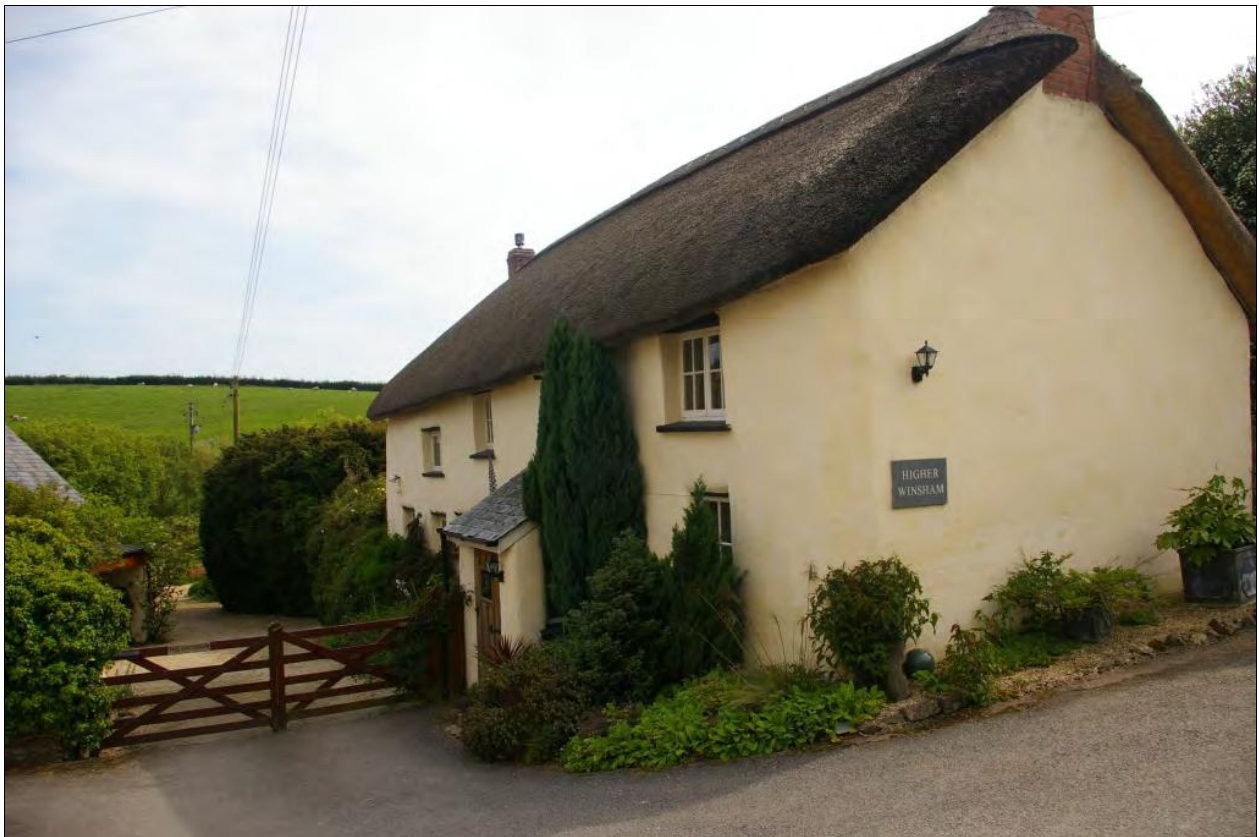
Higher Winsham Farm, set into the side of a southerly slope; from the north-east.

- Higher Winsham Farm & Higher Winsham Cottage; medium significance, Grade II Listed; conditions: excellent. Distance from turbine: c.0.5km. Two thatched buildings on an east-facing slope, at the top of a narrow valley, with the ground falling away to the east. The landform scale is quite small and enclosed; the valley narrow and focussed, the landscape context of this farm is limited to the valley, in which the proposed turbines will also appear, to the north-east. The hedgebanks in the area are tall and mature and may provide some local blocking. The rural simple character of the setting of the farm and cottage will be significantly impacted by the proximity of the turbine. The key views and relationship between the house and cottage will also be affected, as the turbine will appear in all views east and the experience of both will be impacted; **negative/substantial** impact.

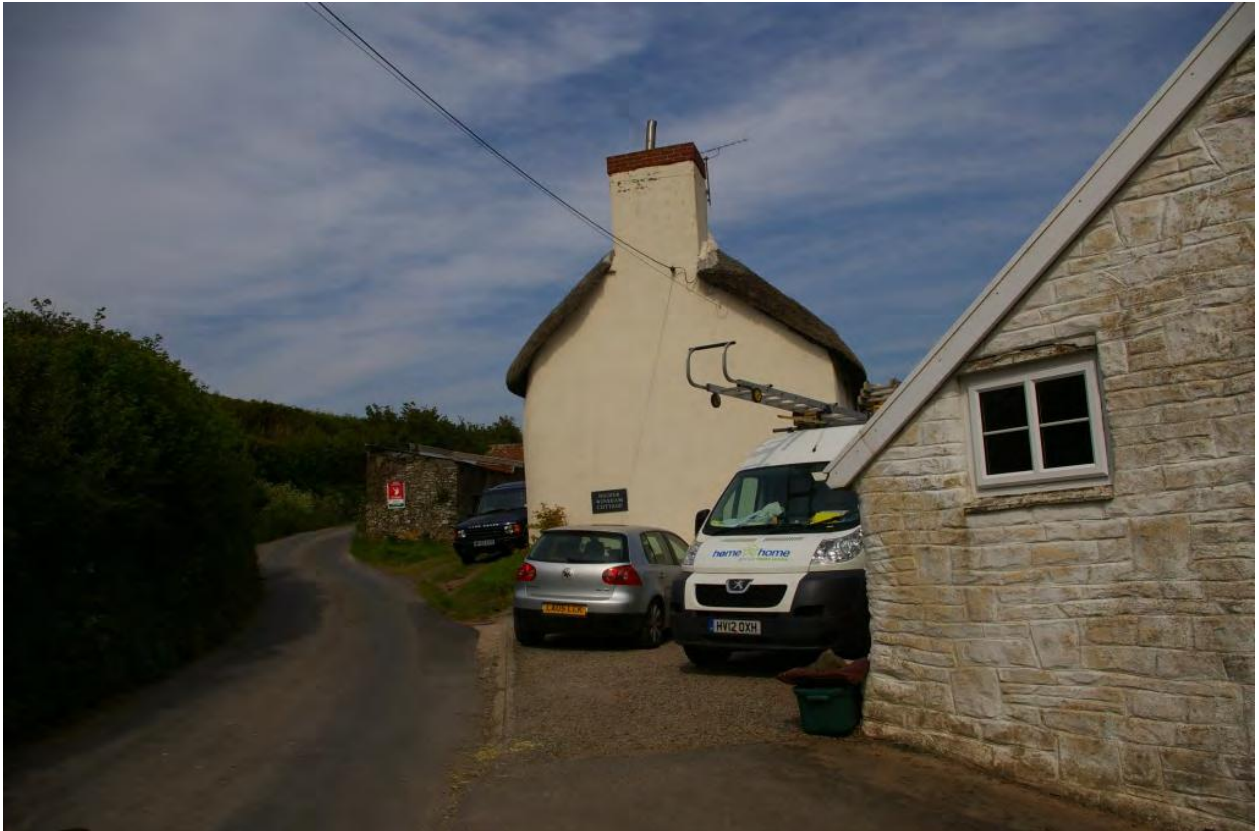
Higher Winsham Cottage, set just to the north-east of Higher Winsham Farm, on a south-facing slope, within a shallow valley; from the south-west.

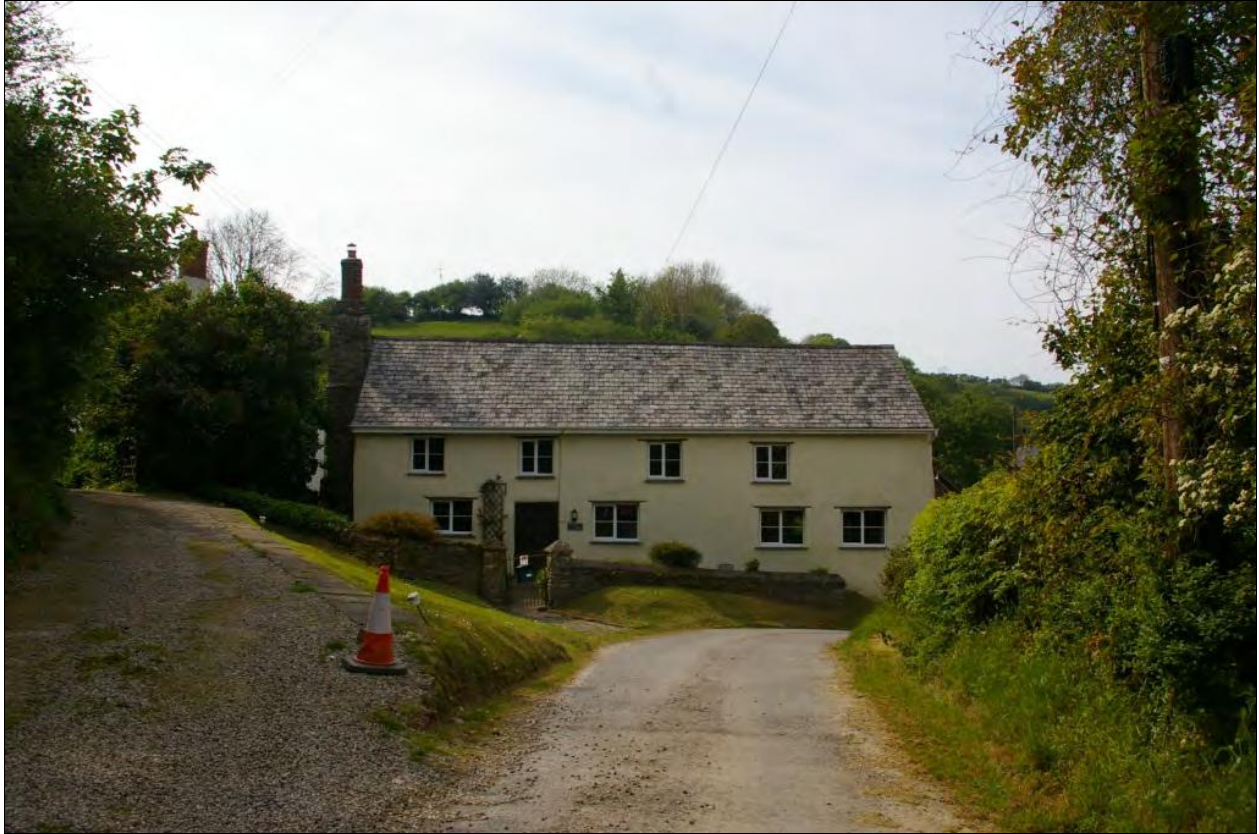
Dyers Farmhouse and Stanburys, set in the trees to the south, on a north-facing slope; from the east.

- Dyers Farmhouse and Stanburys, in Nethercott; medium significance; Grade II Listed; condition: good. Distance to turbine c.1.9km. Stanburys is compressively blocked, being set down into the steep bank of the combe, surrounded by hedges and trees with limited views; **neutral** impact. Dyers Farmhouse, set to the south side of a combe which leads into the Caen valley to the east. Some limited views generally down the valley, but less so from the farm, which is set lower than later 19th century buildings located immediately to the south, by the road. Other historic buildings within the hamlet provide a cohesive historic rural context. The combe is a small enclosed landscape context for the farm, with the hamlet forming the setting in which it is experienced. The turbine stands outside of this context and despite some very possible limited views to the east there is no quantifiable effect on the setting or our experience of the asset; **negligible** impact.

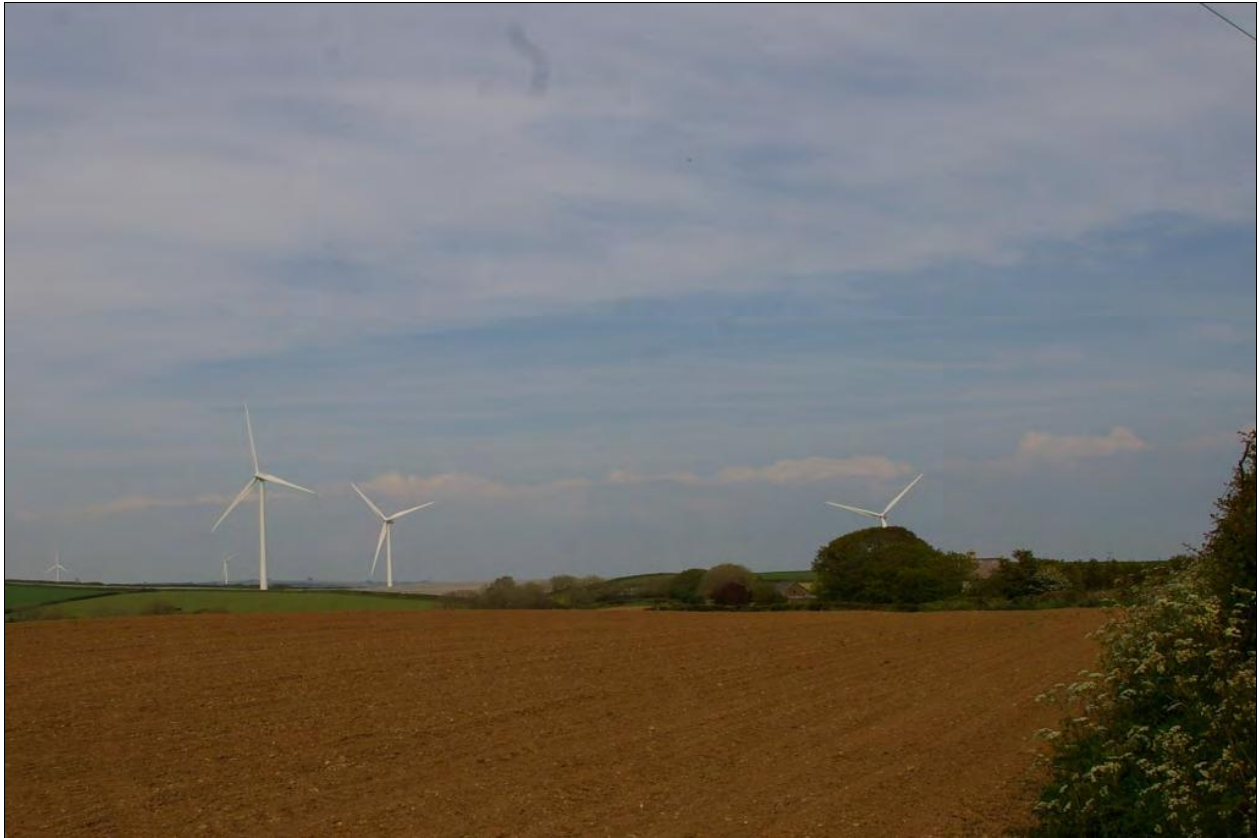
Ash House, viewed across the fields, set amongst the trees, with Fullabrook wind farm behind; from the south.

- Ash Barton; high significance, Grade II* Listed, condition: good. Distance to turbine: c.2.7km. Large house, former manor house, on south and east slope, with principal elevations to the south and west. Has wide views across the estuary to the south and to Heanton Punchardon and Fremington. The landscape context of the house is the wooded valley to the south, of which it sits at the head, with the woods to the western side. It stands on the edge of the high rolling downs in which the turbine is to be constructed. Within that landscape, and in close proximity to the asset, lies the Fullabrook wind farm, which completely dominates the wider landscape. These extant turbines are much closer than the proposed, and the main impact from this proposal will be cumulative, as the only open views left to the north are to the north-west and the turbines will appear in these views. The impact on setting for the north is already compromised and our primary intended experience of the house is from the south; **negative/moderate** impact.
