Report No.: 140605
Date: 05.06.2014
Author: Emily Wapshott
Colin Humphreys

**31 Bridgeland Street
Bideford
Devon**

**Results of a
Historic Building Assessment**

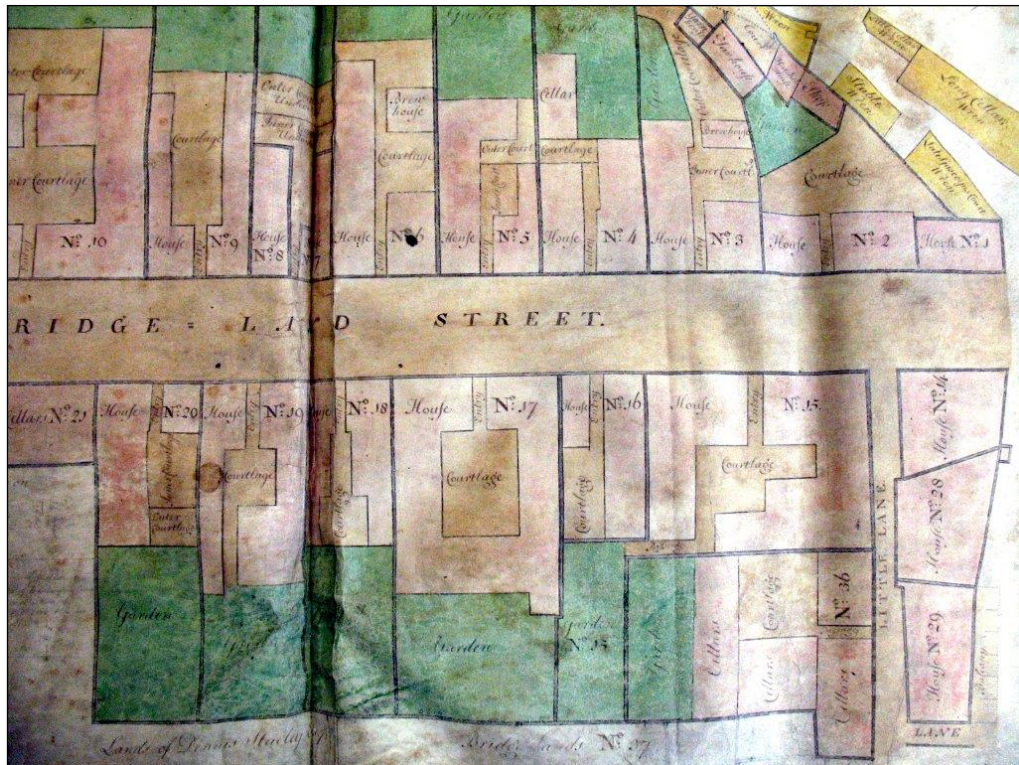
Figure 2: Extract from the Bridge Trust plan of 1745.

The plan shows the building (No 15) extending to the corner of Little lane; renamed Queen Street by 1886, and although the plan layout is similar to that shown on the later Ordnance Survey map the corner plot to the east and the plot to the west are separated from the main building by 1886.

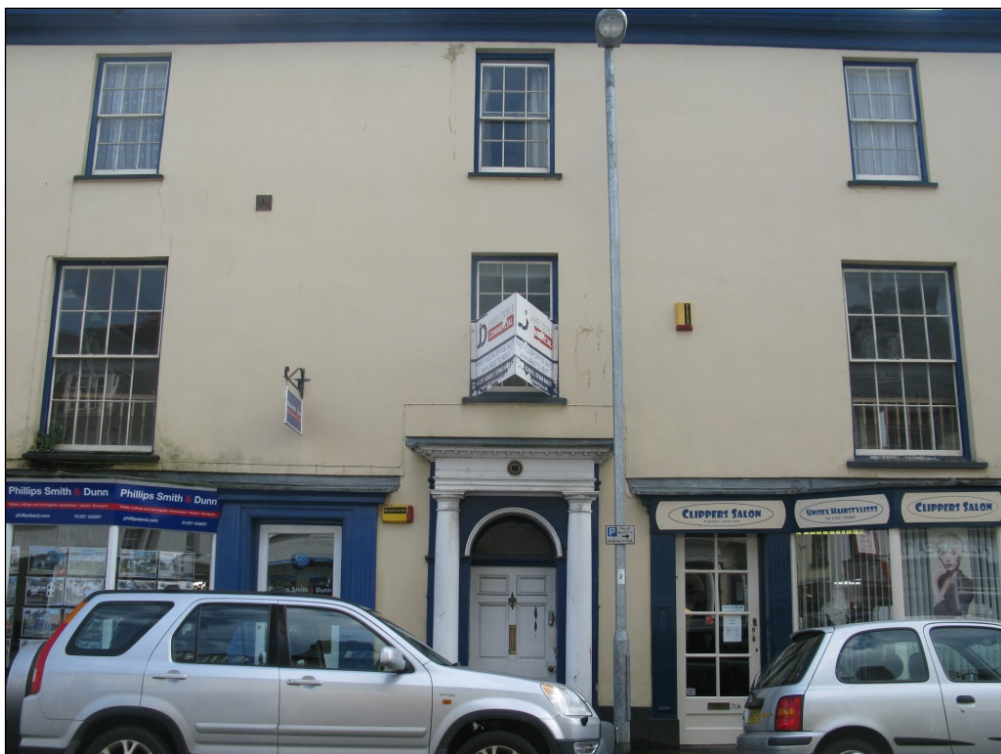
The street elevation (south) consists of a mid-20th century shop front with a central door and a second door to the left (west). The first floor is slightly jettied and supported on corbelled side walls with a pair of forward fixed hornless sash windows. Mock quoins have been added to the first floor to left and right (Figure 7). Above, large chimney stacks project from the walls to left and right. The doorway in the centre of the elevation gives access into the shop (R2 & R3), that to the left accesses a passageway that leads to the rear of the building (R1).

Figure 4: View from Bridgeland Street

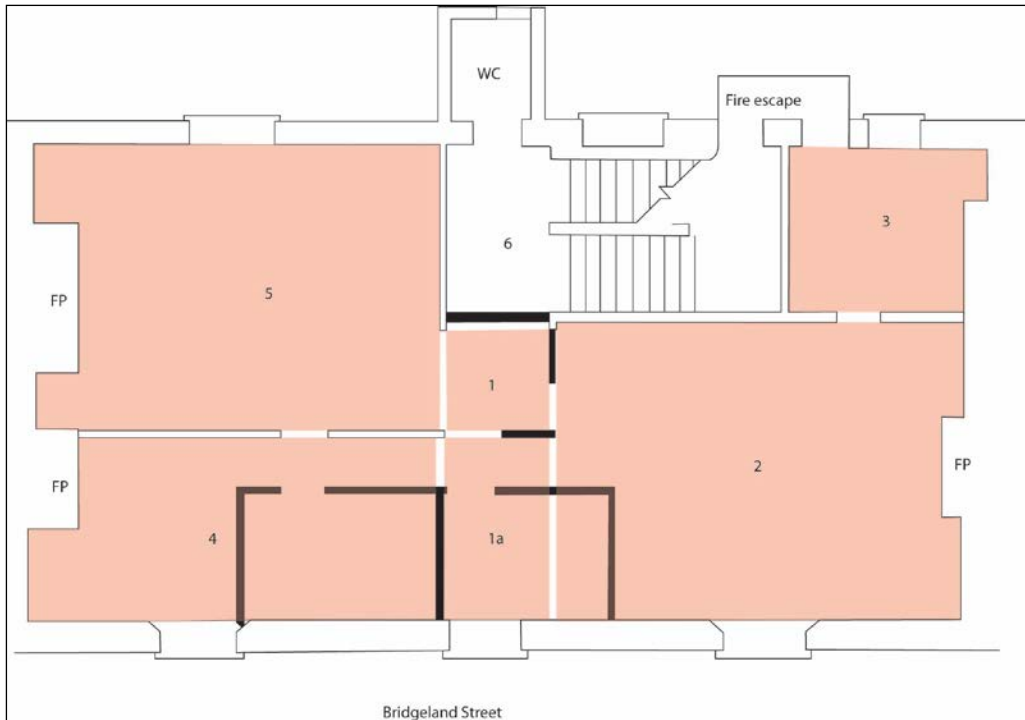
Figure 5: Plan of the first floor of the building.

The flat assessed occupies the entire first-floor, accessed directly off the main stair through a lobby. It comprises five main rooms, with the majority of the space lying to the north side of the building, overlooking the street, and one small WC to the north side also leading off the stair. The space was used as an office in the later 20th/21st century and several of the rooms have been divided by modern plaster board/chipboard partitions. The space is now empty.

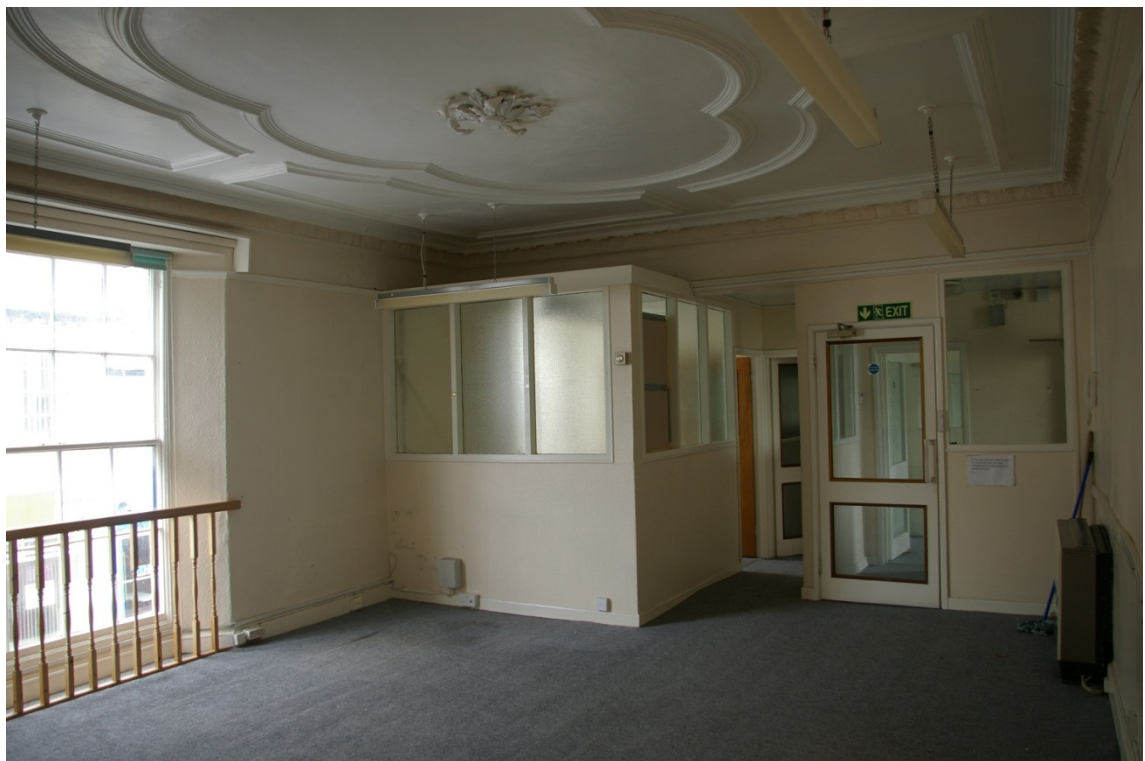
Room 2 is the largest within the flat; high status, formerly the grandest of the first floor reception rooms, overlooking the street. The ceiling is 17th century, with a large central scalloped panel and four panels, one to each corner, with scalloping mimicking the central panel on their inner sides. Two small rectangular panels lay within the alcoves either side of the stack to the western end of the ceiling. The panels are defined by deep beaded and bolection mouldings. The central panel has a later 19th century addition of a central 'acanthus leaf' style ceiling rose, with ventilation and an attachment for a gas light. There is also a deep moulded plaster cornice. The lower part of this cornice has been altered, in the 19th century, with the lower part being cut out and appliqué acanthus leaves being overlaid into the created cavetto space. These appear to have been pre-made plaster shapes which have been curled over at the end and project down slightly from the square section of surviving moulding. Both the work to the cornice and the ceiling rose are of 19th century date but appear to take inspiration from the original elaborate 17th century leaf moulded cornice in the ground floor reception room to the east of the hallway, which is now a retail unit. A 19th century moulded narrow picture rail has been applied to the top of the walls. Modern office strip lighting has been attached to the plaster ceiling.

Figure 6: View across Room 2, towards Room 1 and Room 1A, showing how the historic wall of the original lobby has been removed and modern partitions inserted, also showing the large 19th century window in the north wall; from the south-west.

The wall to the main stair should be reinstated with a centrally positioned doorcase, leading into the flat. It is expected that the surface mounted partitions will be fairly simple to remove, opening up the space (room 1). The stubs of wall which survive to the west of the former historic lobby (room 1A) could be reinstated, creating a central hall. A doorway could be centrally positioned leading to the west into the large reception room (room 2), opposite the fireplace. This makes a large and light living area, retaining the current window but during the renovation works if the boarded up windows are revealed they could be recorded as part of a monitoring program, in order to make a full record. Room 3 would make a suitable kitchen space, with considerable 20th century works having already been conducted converting it to provide services. This also has a fire escape and rear access to the yard, providing an additional access, which should/could be retained. The partitions within room 4 could be removed and then partially reinstated, this area having been more heavily altered in the 19th and 20th centuries than anywhere else within the current space. This therefore means it is less sensitive to a reorganisation of the space and provided protection is given to the historic features which do survive, the 19th century cast-iron grate and the 17th century cornice, there is considerably more flexibility with this space than elsewhere. This room could provide either one large bathroom and a bedroom or two small ensuite bathrooms and one small bedroom. The large reception to the south-east (room 5) cannot be partitioned without compromising the important historical details and losing an understanding of the space and fundamentally changing the experience of the building; whether this is used as additional living space or as a large bedroom, the proportions of this room must be maintained. As stated above this reception room and the reception room to the west are the areas most sensitive to change and development. The door to the west wall should be retained as access off the main lobby and the doorway to the north wall could be retained providing access to the bathroom or possibly a short corridor and ensuite, minimising any breaches to the historic fabric within this room. The fireplace could be opened up and may be suitable for reinstatement depending on the state of the chimneystack, the fireplace and surround and cupboard to the north must all however be retained, as they are all important 17th century details. It is

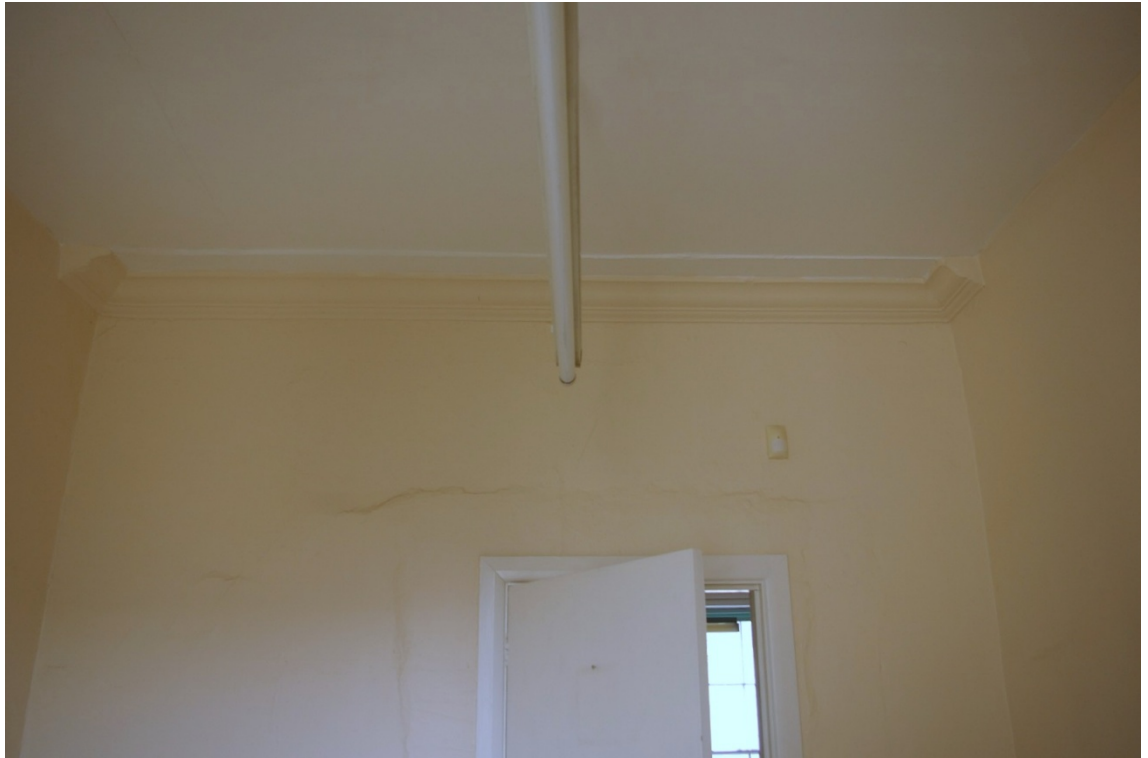
Room 3 is the smallest historic room within the flat, lying to the south side of the building, west of the stair and overlooking the yard areas to the rear. The only historic detail in this room is a short section of 17th century cornice, of simpler style than in the large rooms, with a large curving bolection mould and some bands of simple beading. This runs along the north wall of the room and turns around the corners to the west and east where it is cut off. This shows the space is correct for the original plan although the south wall may have been replaced in the 19th century. This wall includes a large window opening with a forced opening and appears to be of 19th century date. There is also an opening forced into this wall from which a small fire escape leads down to the yard below. The walls are all solid, plastered and wall-papered. In the west wall there is a shallow cupboard, with replacement doors and the wall is fitted with a sink and units. The skirting is all of 20th century date. The floor was viewed in one loose corner and is lino over boarding which is of 19th century date, with 20th century alterations.

Figure 7: Room 3, the north wall showing the surviving section of cornice and the scar around the door opening; from the south.

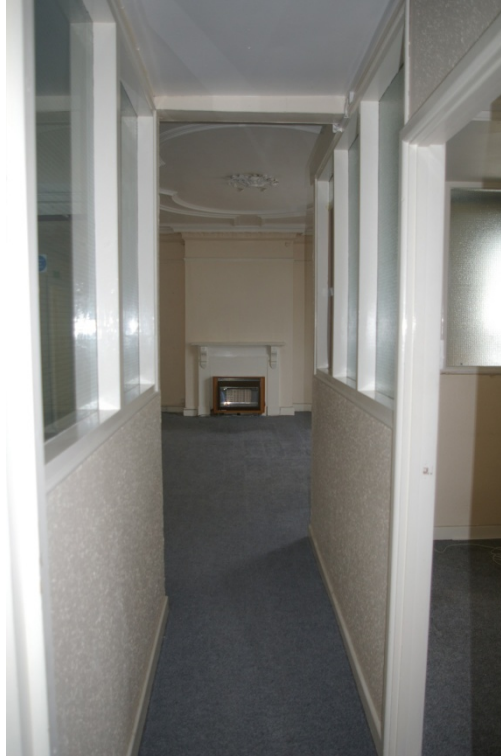
Room 4 is accessed via the former lobby space, where another small partitioned room (room 1A) and short section of open corridor have been created by forcing the historic wall between the lobby and the reception room to the west (room 2). There is a false plasterboard ceiling here and a section of this allowed a view into the space above which showed the 17th century plaster ceiling survives intact here. Upon the conversion works this may be exposed and can be fully recorded. No other historic details appear to survive here apart from a stump of the original historic wall, there is a large boxed in section below the 19th century window which has been created out of the original 17th century window opening. The walls are plastered and wall-papered, the floor carpeted, the south and west walls are modern partitions, the wall to the east is solid. A single modern door in the south partition leads out into the corridor area. A door in the historic east wall of the lobby leads into Room 4.

Figure 8: View through the open corridor between rooms 1 and 1A, back into room 2; from the east.

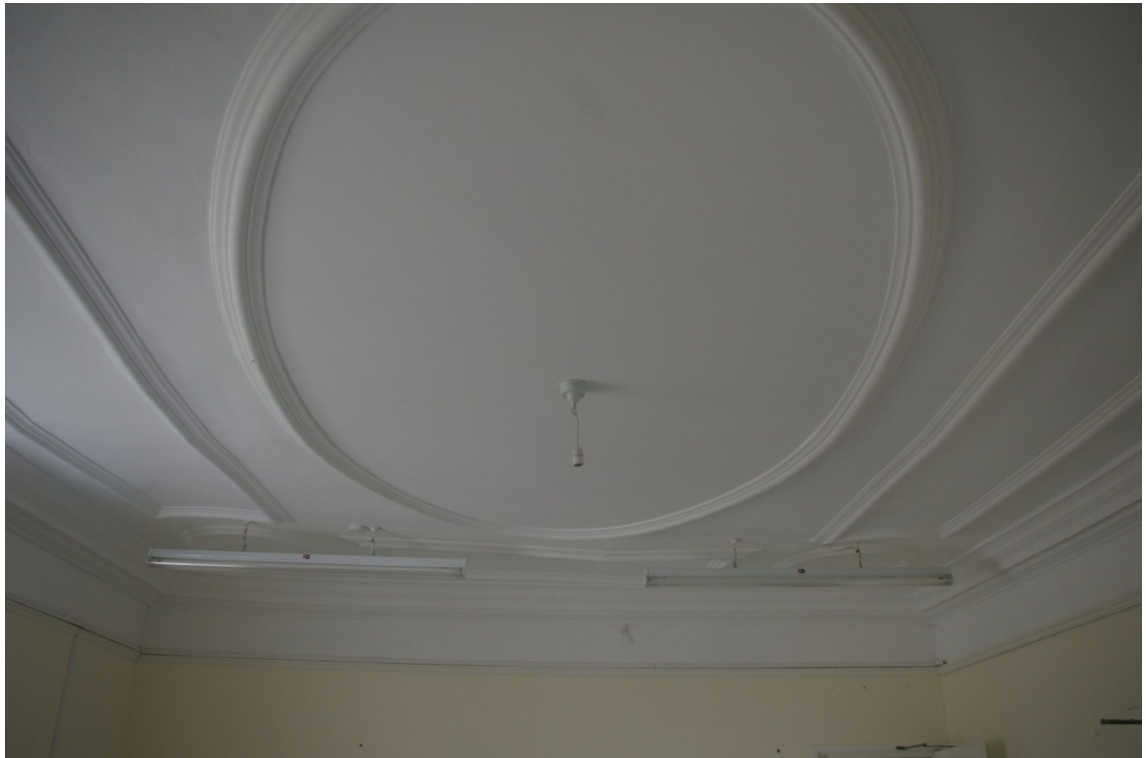
A door back in the lobby leads into room 5. This is the second of the large receptions on this floor, but lies to the south side, overlooking the yard to the rear of the building. The room has elegant proportions, like room 2 and has an elaborate 17th century plaster ceiling, although it is less detailed than its western counterpart. There is a central oval panel and long rectangular panels run down the length of the room on the north and south sides. A short rectangular panel lies at both the west and east ends of the ceiling, with a small oval panel in each corner of the room. The rectangular panels echo the oval corner panels, with relieved curving ends. There is a small alcove to the south of the fireplace and this has its own small rectangular moulded panel, as seen in room 2.

Figure 9: Room 5, the 17th century plaster ceiling; from the east.

The panels have the same deep beading and bolection mouldings. The room also has the same deep moulded cornice in its original 17th century form. This cornice has an off-set corner to the south-west, where the ceiling may not have been straight. Here, the cornice running along the south wall drops down and runs under that along the west wall. Above the window to the south the cornice dips, where there has been some historic damage to the former lintel and water damage. This ceiling has recently been restored after some extensive water damage. The walls are solid, plastered and wall-papered with surviving, very simple, 17th century skirting, deep with a small cut bead moulding, along the north and east walls. The south wall has 19th century skirting and the west has modern skirting, of an old style. There is one central window to the south wall; a 19th century replacement, of hornless sash form. The opening here is shallow and no shutters or panelling have survived. The brick stack is on the east wall, contiguous with the structure in room 4. There is an original 17th century timber surround, with shallow relieved classical pilaster-style jambs to the side and wide beading to the mantle, with a cornice and corner panels. This fits around the large square firebox, which is boarded but may be brick. The fireplace is slightly offset with the wall to the south side of the stack which slopes. This area does appear disturbed and possibly reduced in width towards the base. It may be that the fireplace, which is slightly wider, is of the correct period but has been removed here from elsewhere in the house, as no other 17th century fireplace

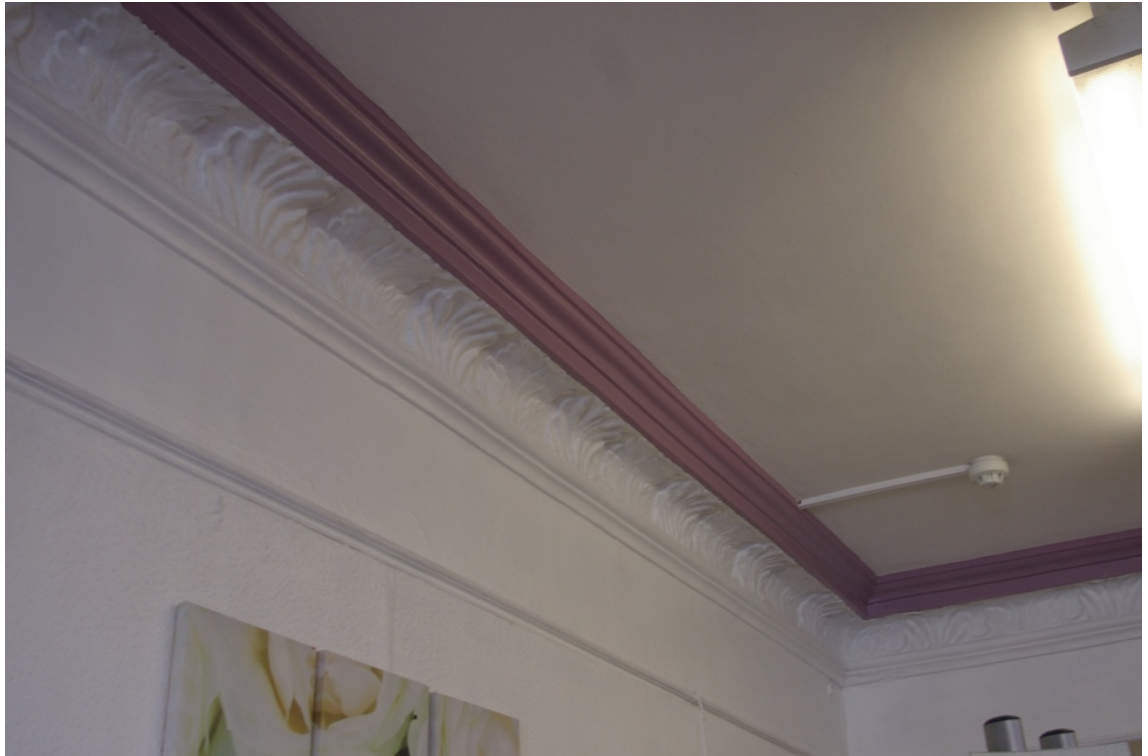
Figure 10: View of the high status 17th century cornice in the front ground floor room to the west, now a retail unit; from the north-west.

This is an original 17th century leaf moulded cornice, with additional banks of beading. This cornice has acanthus style leaves which are clearly formed by hand from the plaster; an earlier form of work, irregular in shape and original to the cornice, obviously a sign this room was of increased status compared to the rest of the house. The first floor rooms retain their surviving plaster moulded ceilings with decorative panels. It is not clear if the ground floor rooms also had decorative ceilings, if so, these have not survived and only the cornices remain. The ground floor rooms to the east of the hallway have retained their 17th century wide plank panelling, with shallow chamfered panels. There are also surviving arched alcove cupboards either side of the fireplace in the north-east front room, with modern replacement doors; the stack being encased in panelling, but with no surviving fireplace surround. Another identical cupboard is now to be found on the second floor in the largest room to the west; this was probably moved here in the 19th century and may come from the ground or first floor of the building.

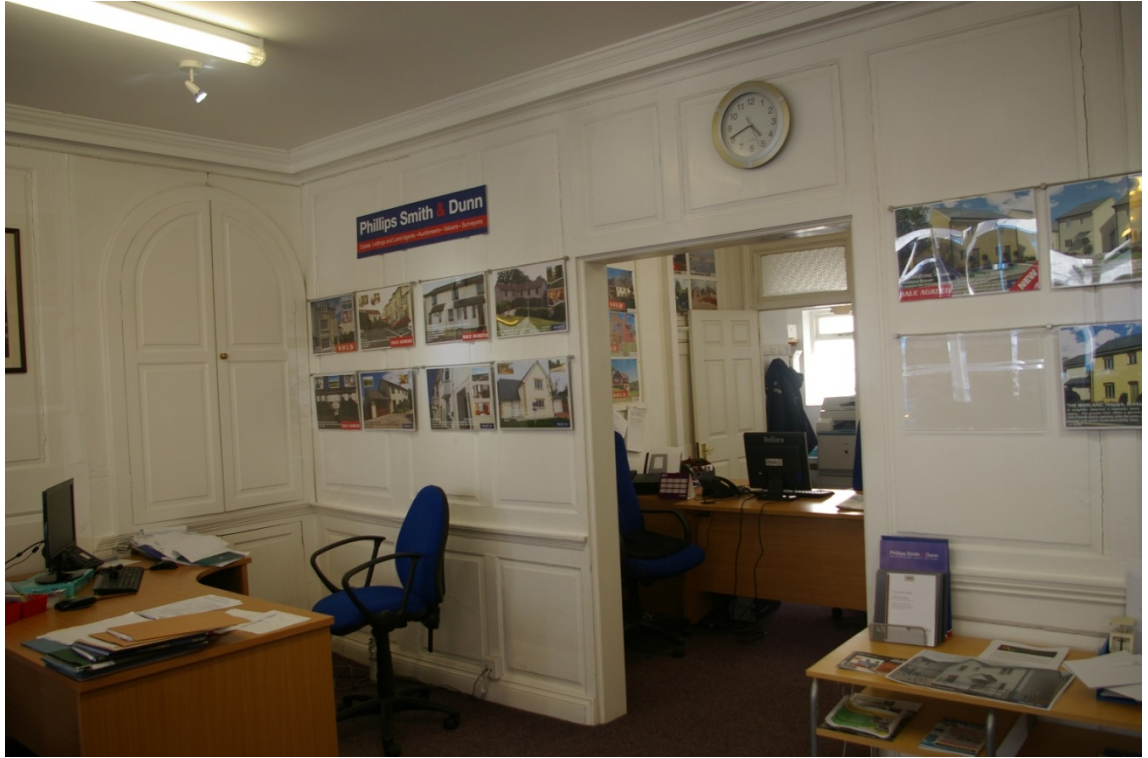
View of the 17th century panelling and alcove cupboard and cornice within the ground floor front reception room to the east, now a retail unit; from the north-west.

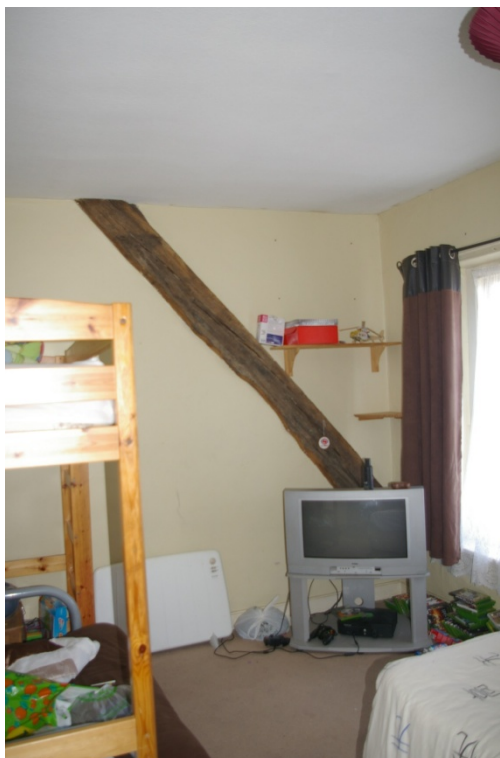
View of one of the 17th century truss blades, now within an internal partition, showing how the roof to the north side has been raised; from the south-east.

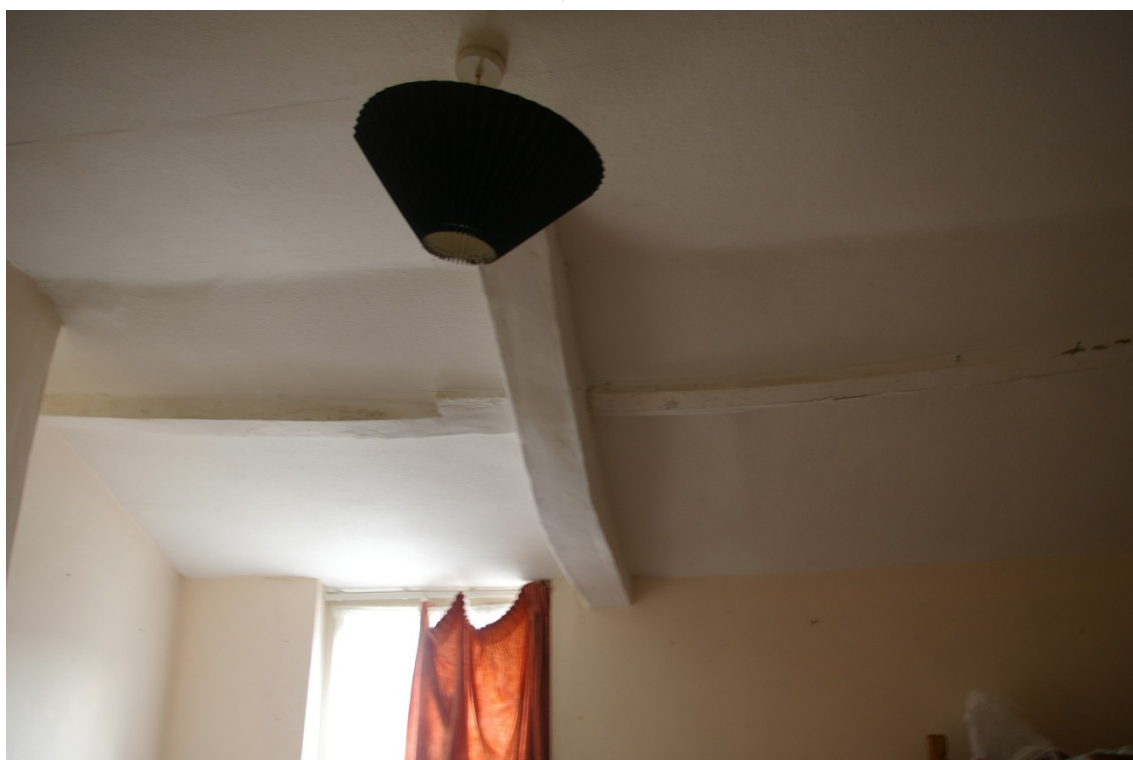
View of part of one of the 17th century trusses and purlins within the second floor; from the north-west.

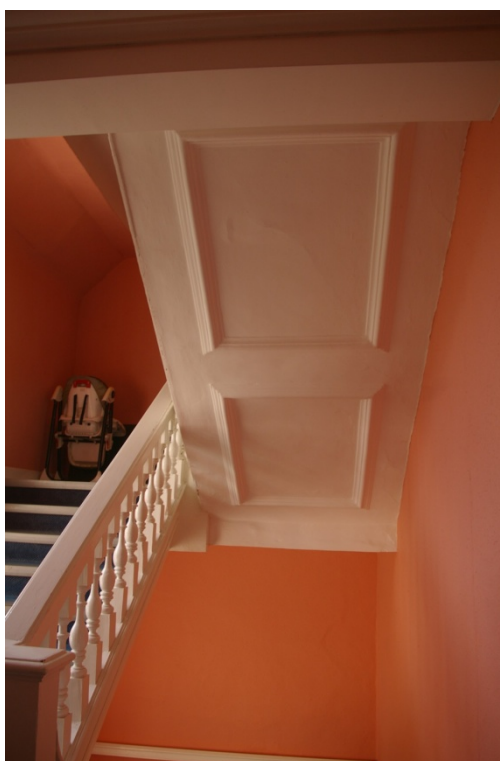
View of the moulded plaster panels on the cantilevered sections of the stair, visible from the first floor landing; from the east.

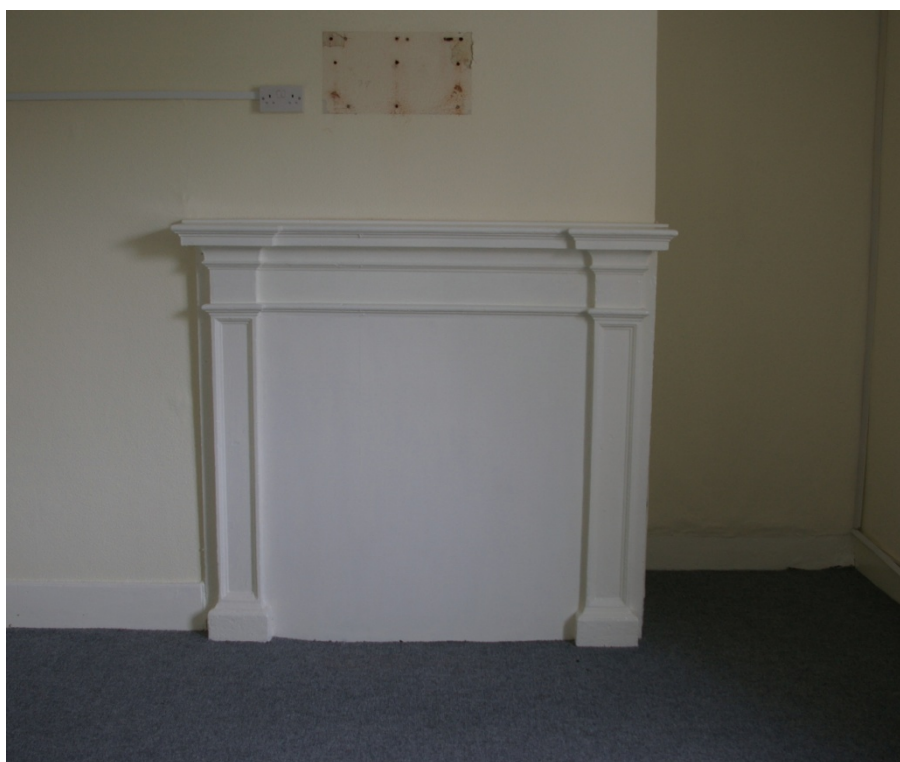
The fireplace in room 5, where it can be seen to project slightly away to the south from the south side of the chimney stack; from the west.

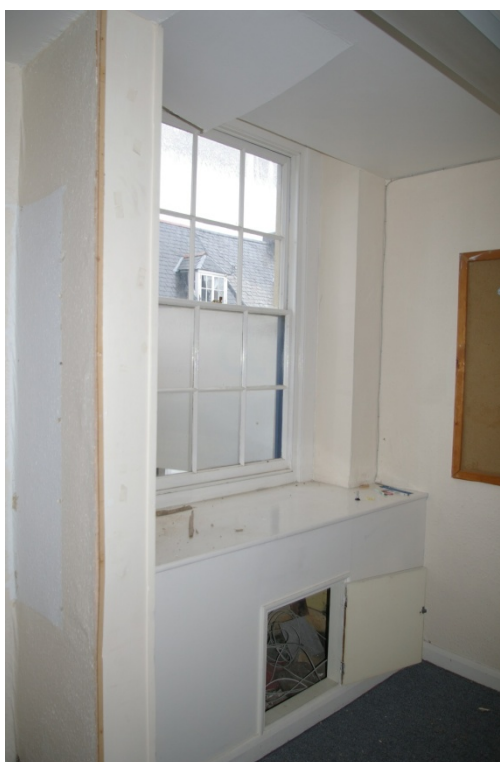
Room 1A, the stub of the historic wall of the lobby and the reuse of the 17th century window opening, now with a 19th century sash; from the south-west.

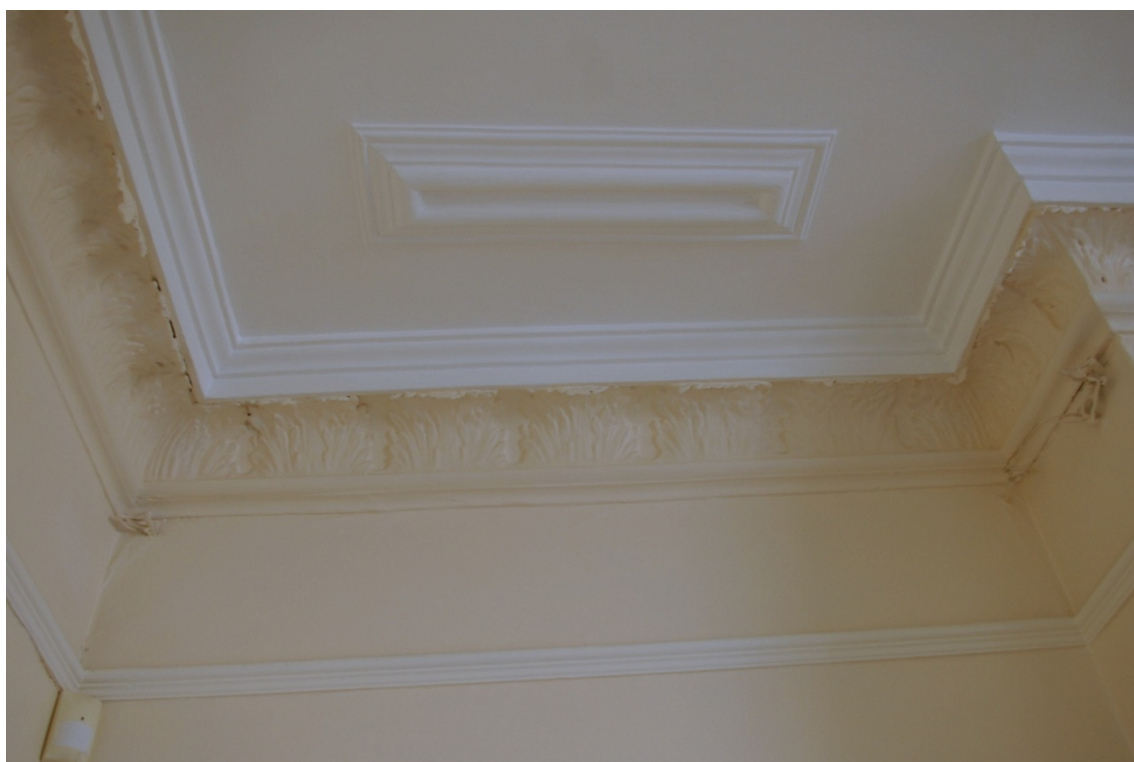
Room 2, the detail of one of the small ceiling panels in the southern alcove and the small bell pulls which survive, also showing the later 19th century addition of the acanthus leaves to the cornice; from the east.

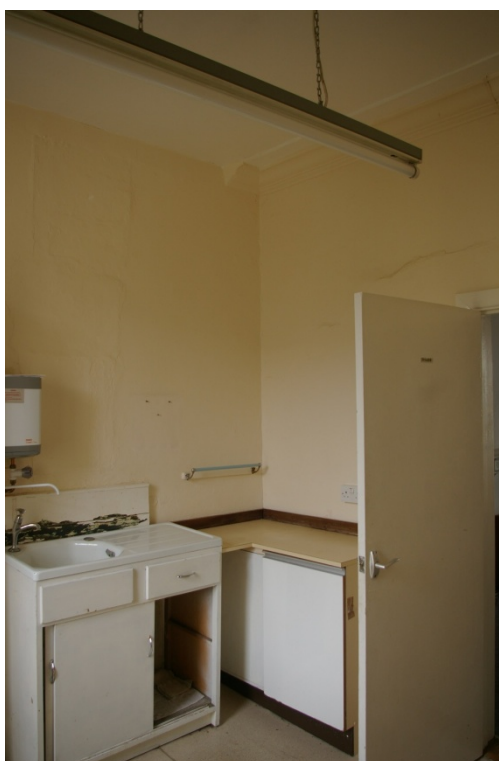
Room 3, showing modern kitchen fitments; from the south-east.
