# KNOWSTONE MILL KNOWSTONE DEVON

Results a Desk-Based Assessment,  
Historic Building Recording & Archaeological Monitoring

Report No.: 110727  
Date: 27.07.11  
Authors: S. Walls  
J. Freeman  
D. Laing-Trengove  
T. Green

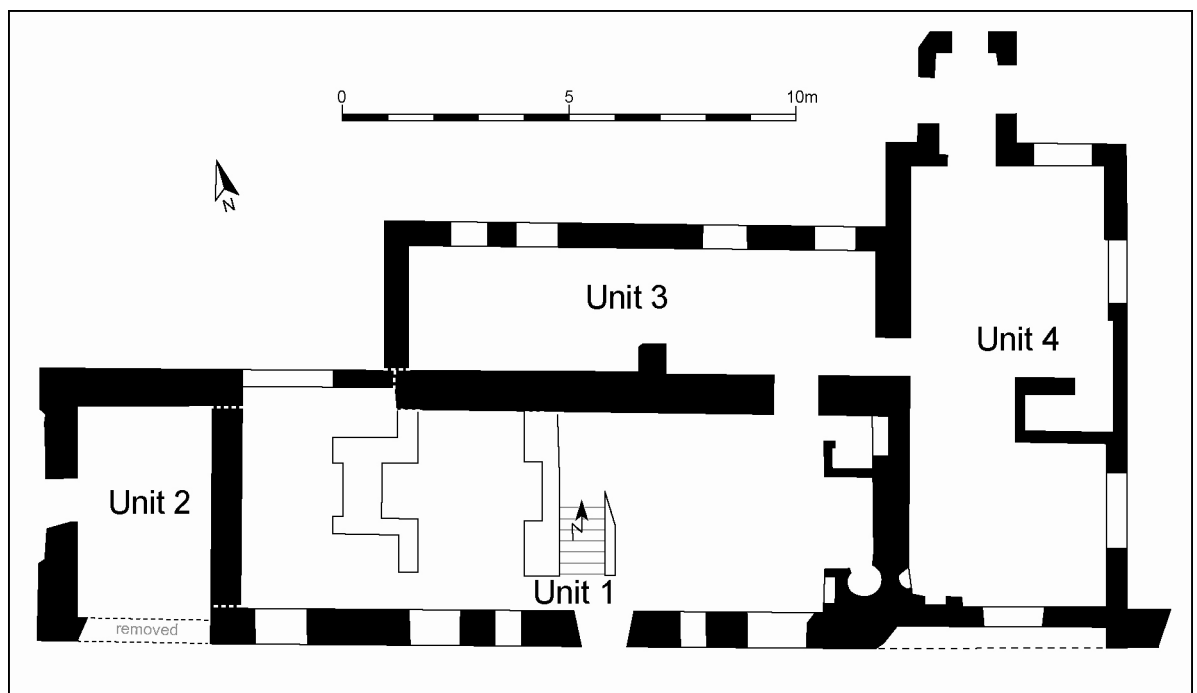
Figure 2: Ground floor plan of the surviving structures at Knowstone Mill.

The building can be divided into four main units (Figure 2).

Unit 1; the core of the building, formed by a rectangular block of two storeys 16m in length east-west, and 6m north-south. This unit had been thatched and was the part of the building that had been most badly damaged by fire.

Unit 2; presently a single storey pent-roofed lean-to extending 4m from the western end of unit 1.

Unit 3; a lean-to extension against the eastern end of the north wall of Unit 1, 3.5m north-south by 11.5m east-west.

Unit 4; an extension of two stories at the eastern end of unit 1, 11.5m north-south and 5.5m east-west.

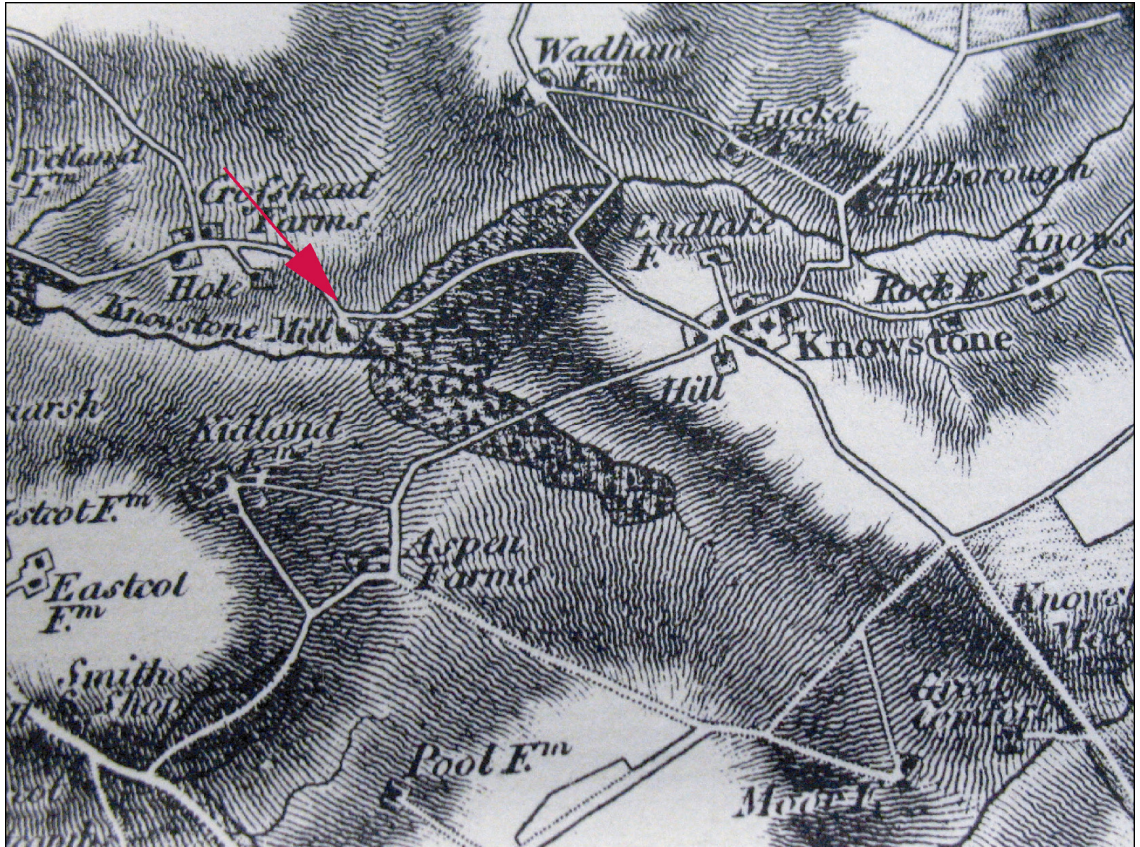
Figure 4: Extract from the Old Series Ordnance Survey at one inch to the mile: published version of the 1804-5 survey, 1809 (WCSL).

The earliest cartographic record available is the Ordnance Surveyor's Draft of 1804-5 (Figure 3), on which the one inch to the mile map published in 1809 is based (Figure 4). This appears to be of doubtful accuracy, since it places Knowstone Mill on the wrong side of the Crooked Oak Stream.

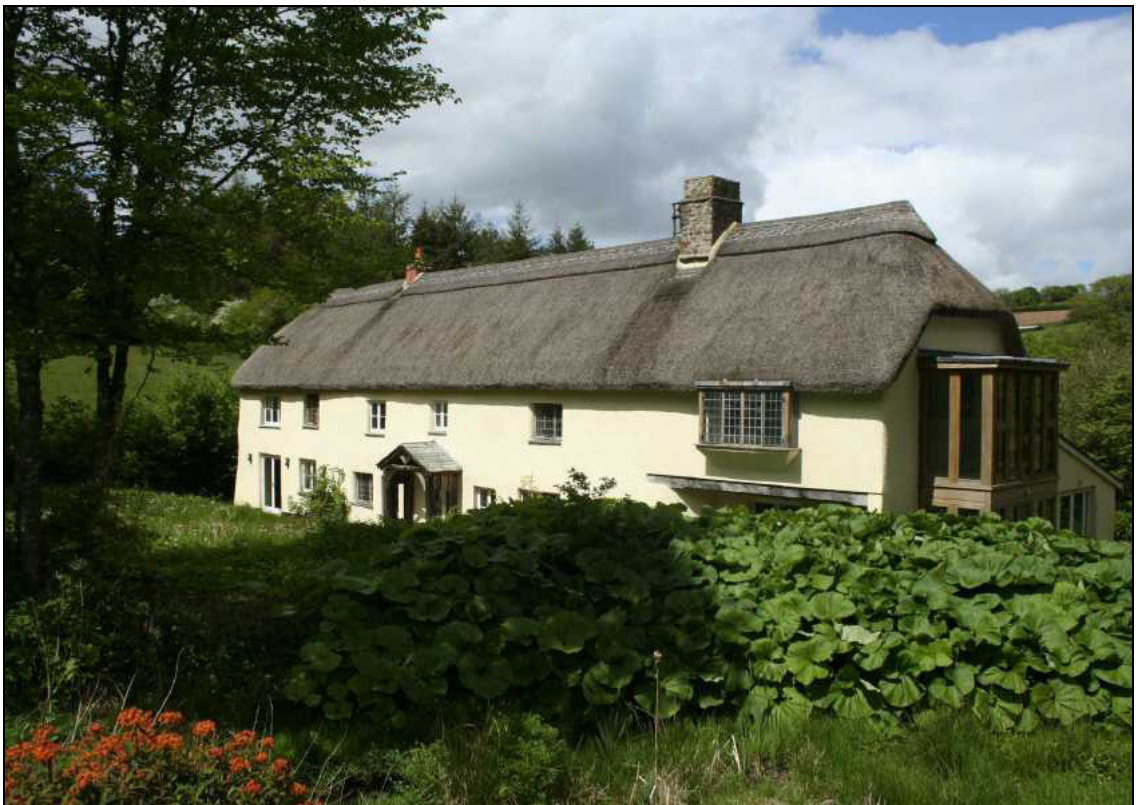
Figure 10: The renovated south elevation of Knowstone Mill, viewed from the south.

The window openings were variable but typically 19th century in appearance (see Figure 10). Two windows on either side of the modern front door were atypical, being only 0.5m wide, and with internal openings that extended to a full 1.84m in height.

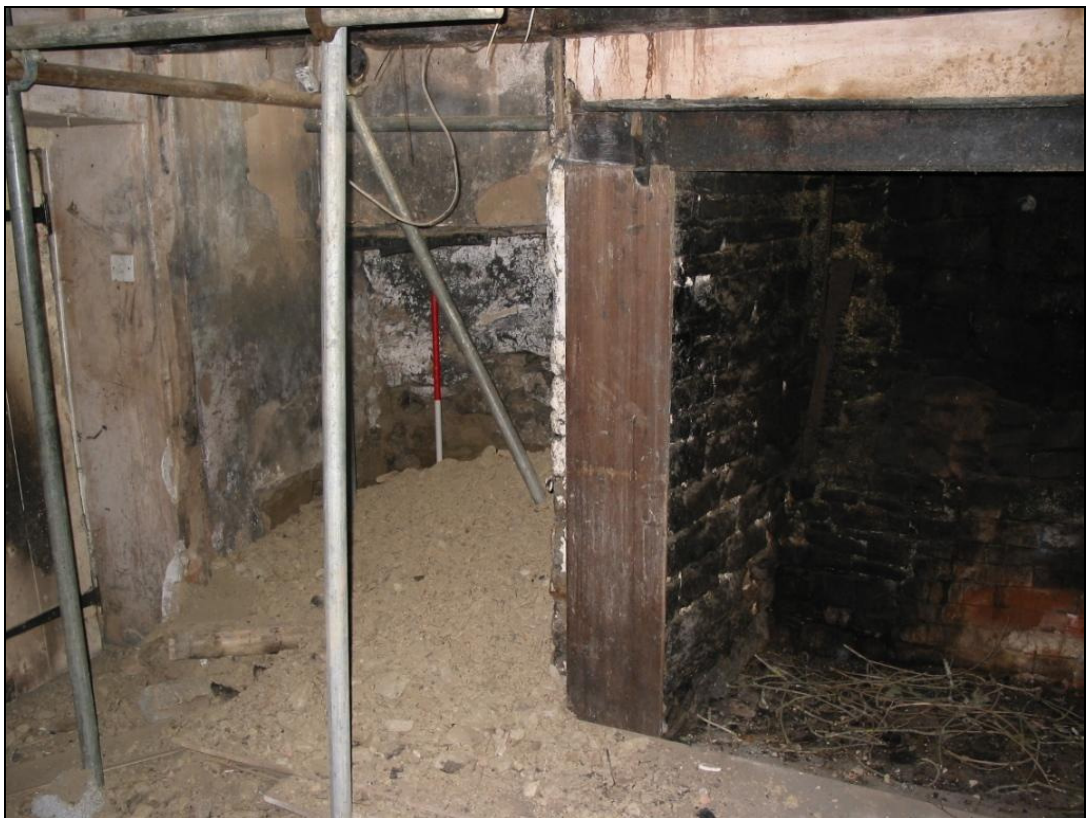
A wide fireplace (1.8m wide and 1.7m in height), with a bread oven with iron door inset in the rear south corner, is located in the centre of the eastern wall of Unit 1 (Figure 11). There was no evidence that this feature had been a later insertion. The alcove (1.3m north-south and 1m east-west) adjacent to the fireplace in the north-east corner, had latterly housed a winder stair, but was revealed to have a blocked doorway 0.9m wide, predating the stair, which had formerly penetrated the eastern wall of Unit 1.

Figure 11: The fireplace in the eastern room of Unit 1 and the blocked opening in the northern alcove, viewed from the southwest (1m scale).

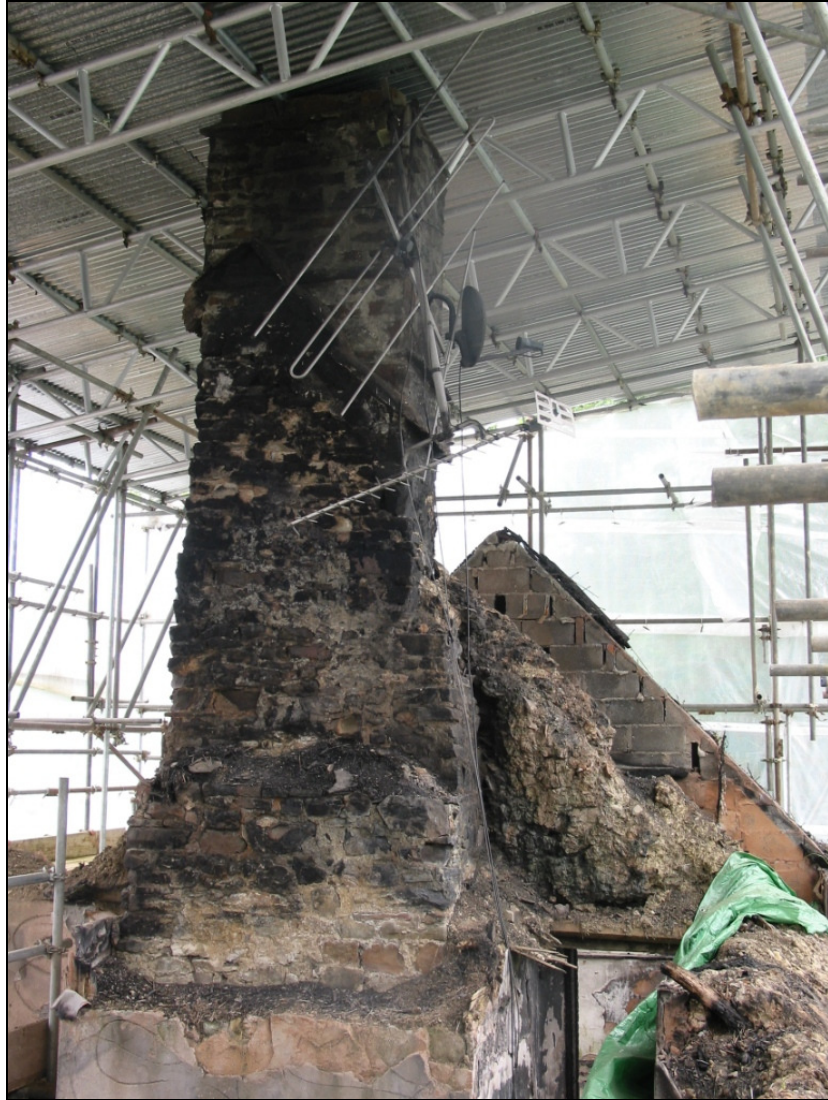
Figure 12: The eastern stack with surviving flashing, viewed from the west.

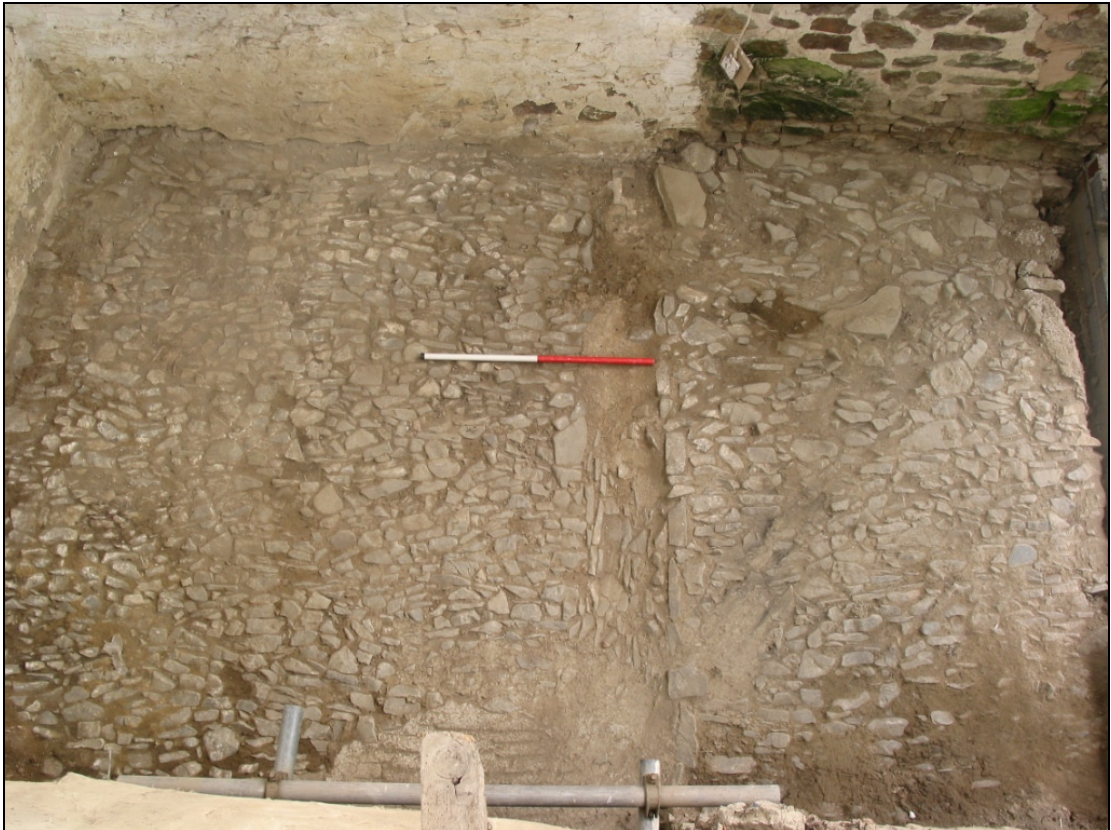
Archaeological monitoring was undertaken during various stages of the renovation work, and any details relating to the historic fabric of the building are included within the descriptions above. The only archaeological deposits which were disturbed by the renovations were during the removal of the cobbled floor (101) within Unit 2 (Figure 13).

Figure 13: Cobbled floor (101) viewed from the south (1m scale).

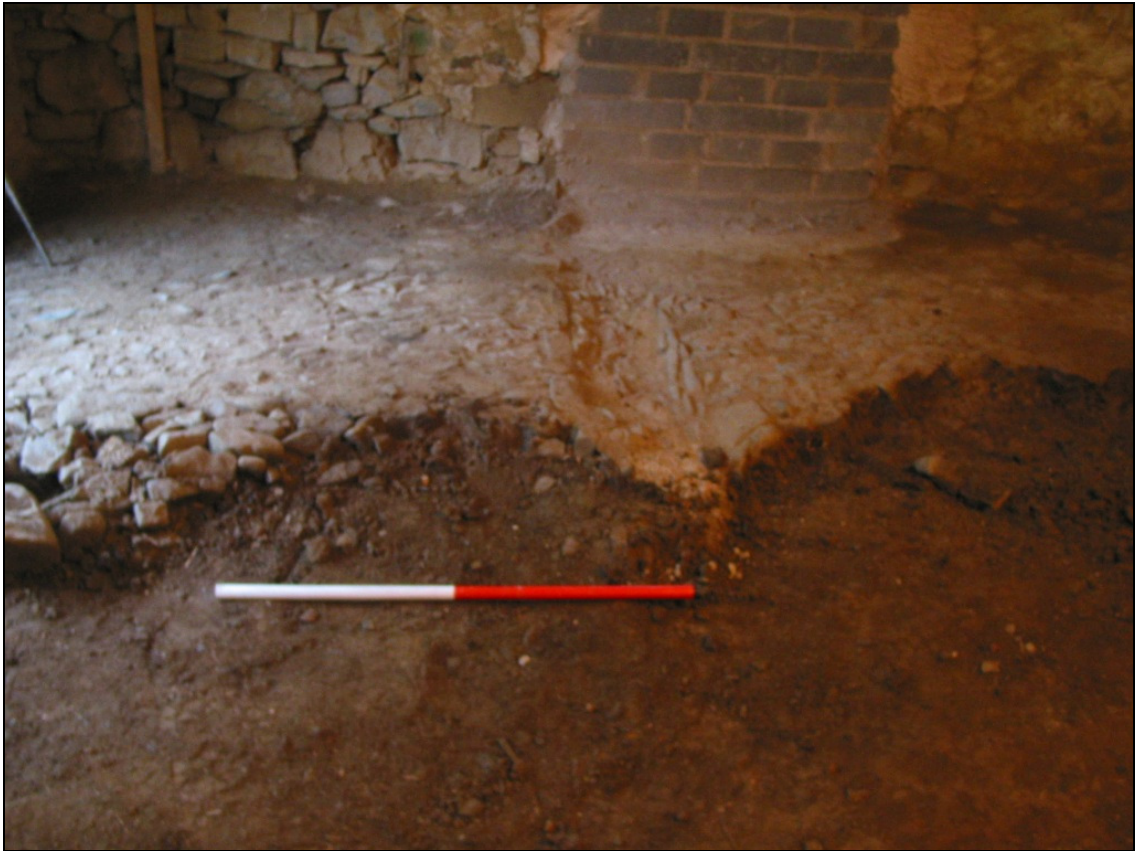
The cobbles (101) themselves were set to between 80 and 150mm depth (Figure 14). They were mostly sub-rectangular and were set along their long axis. Prior to removal, the cobbles in the southwest corner appeared to be of a slightly different pattern, set in a beige clay. However the underlying part of the layer (102) was fairly consistent throughout and it may be that this part of the floor suggests more than one person involved in setting, rather than a residual part of an earlier floor.

Figure 14: Cobbles (101) and drain in Unit 2, viewed from the east (1m scale).
