DEWEYMEADS ST. NEOT CORNWALL

Desk-based Assessment &
Historic Building Record

Report No.: 140909
Date: 09.09.2014
Author: E. Wapshott
S. Walls
V. Hosegood

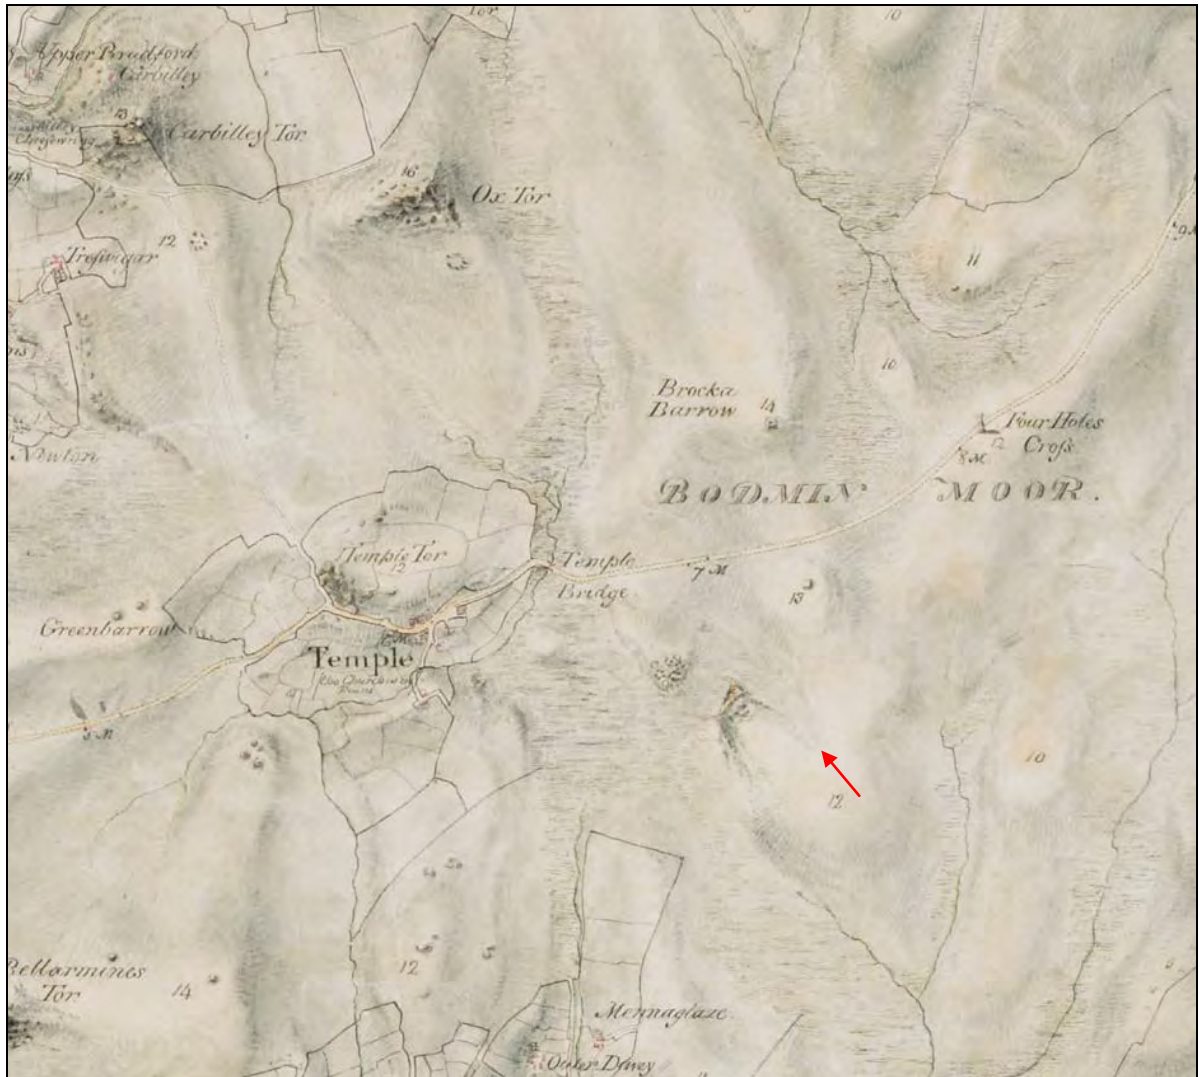
Figure 3: Extract from the 1805 Robert Dawson map of Bodmin Moor.

The next available source is the Robert Dawson Map of Bodmin Moor from 1805. This map does not provide any detail about the landholdings at Deweymeads, rather, it depicts the approximate location of Deweymeads, i.e. the area east of temple to the south of the road, as a vast, uncultivated and unenclosed landscape. We know because of the earlier Lanhydrock estate map, that this was probably not the case, but this map may give some indication of the way that the landscape in general was largely un-enclosed at this time.

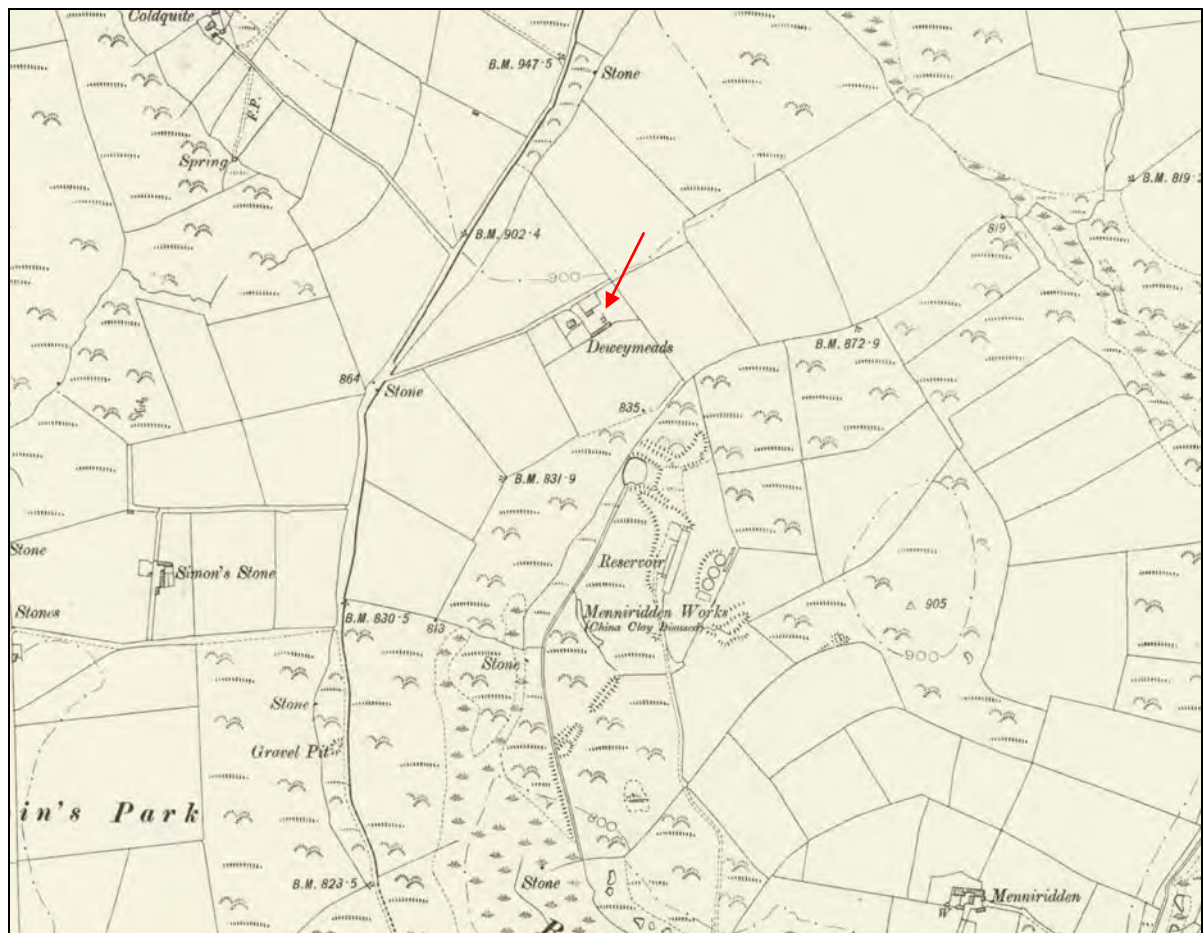
Figure 8: Extract from the c.1907 Ordnance Survey Second Edition 6 inch map (CRO).

There is little alteration in terms of the way that the land has been divided between the first and second edition OS maps. In the second edition of 1907 a number of the larger fields, particularly towards the north east of the site, have been subdivided and fewer fields appear to have been depicted as rough grazing. There is the addition of a number of buildings at Deweymeads in the period between the first and second edition OS maps. A long rectangular building to the south east of the farmhouse and a smaller but wider building to the east of the farmhouse are clearly constructed between these dates. The long building appears to have replaced, and may have partially incorporated the earlier outbuildings shown on the 1st Edition Map.

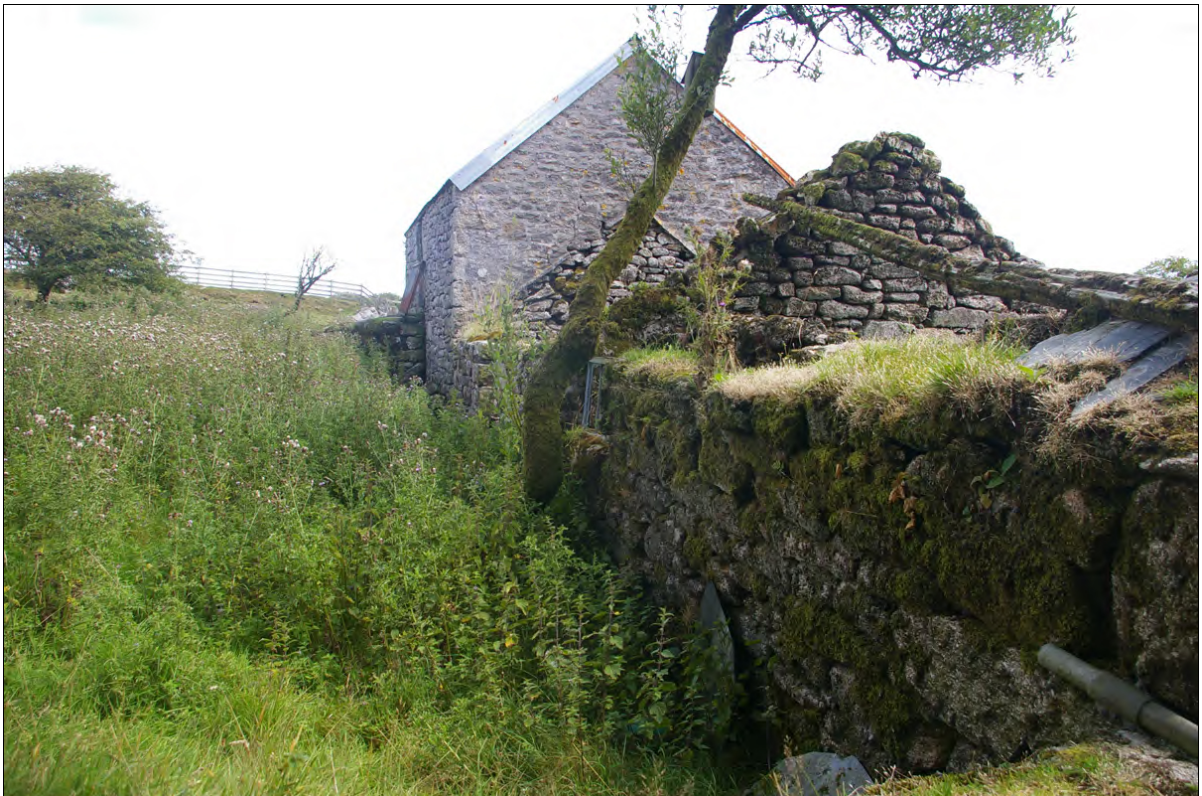
Figure 10: Shot along the north elevations of Building 1b (foreground) and Building 1a (with roof); viewed from the west.

Building 1 (B1) is formed of two elements along the north side of the courtyard, comprising a former barn (B1a) and attached animal sheds (B1b). Building 1a is situated in the north-east corner of the yard adjoining the western wall of Building B1b (Figure 10). These buildings are constructed of rubble stone granite, with roughly dressed granite quoins. A feature of this construction is the use of slate levelling courses in the stone quoins on the corners of the structures. B1a has various phases of repointing and repair within its stonework and retains a corrugated sheeting roof on modern timber trusses. Although seemingly cohesive with B1a, B1b does not appear, at first, to be of the same quality of construction as the barn, but this may merely be due to its poor state of repair. B1a is the only standing building on the site, with B1b in a largely ruinous state with no roof but some standing walls and gables. B1a has undergone several phases of alteration, with the blocking of the opening in its south elevation, the forcing of the small window opening in its west elevation and the removal of the floor. B1b has undergone little alteration other than the updating

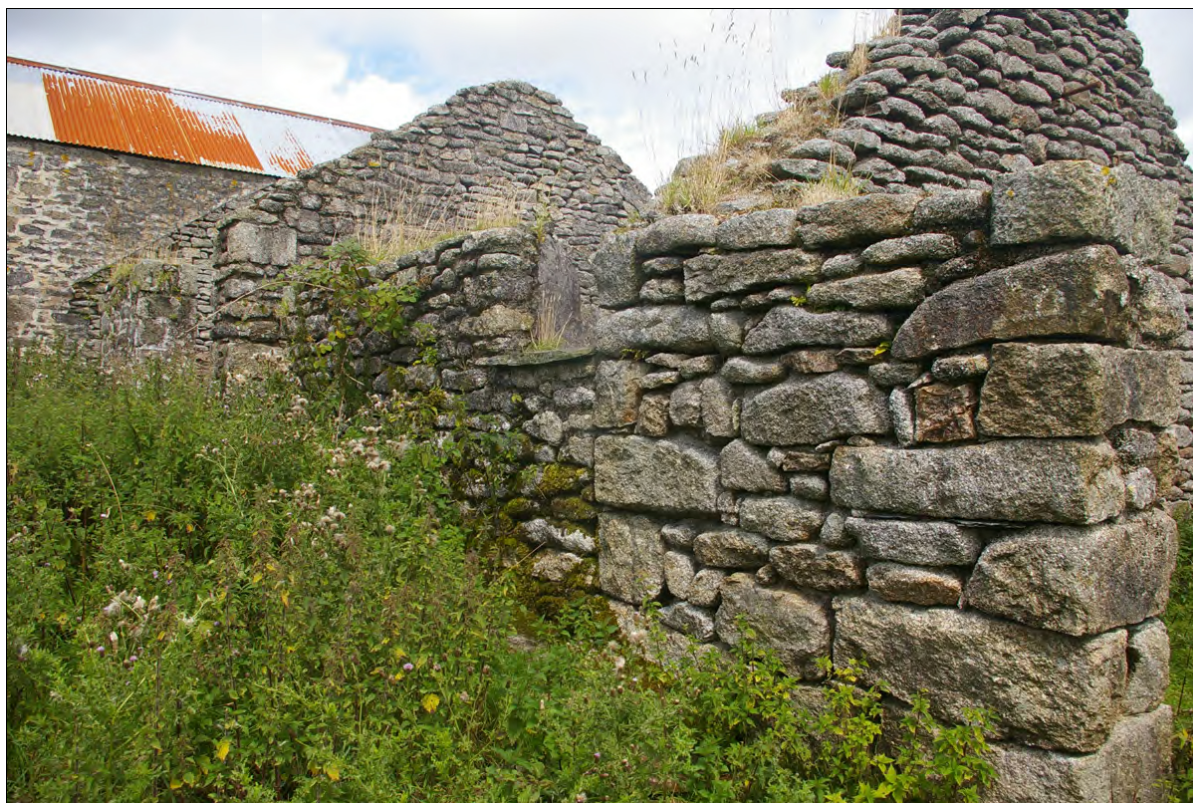
Figure 11: Shot of the west wall of Building 2b, showing how it is built up against the north gable of Building 2a; viewed from the south-west.

The middle structure, Building 2b (B2b), was built onto the north gable of B2a (Figure 11). It consists of an east wall and a north gable wall. This structure is also of rubble construction but is more loosely packed and not of the same quality as B2a. B2b appears to have originally been an open-fronted building. A later alteration comprising a short section of wall built up against the north gable of B2a has enclosed the west side of B2b. This section of wall contains a window and ends in a doorway of roughly dressed quoins. The style of stonework for this section of wall is similar to that in the west wall of Building 2c (B2c). B2b has undergone 20th century alteration to its internal space, converting it to provide cattle pens, with rendered walls and metal partitions.

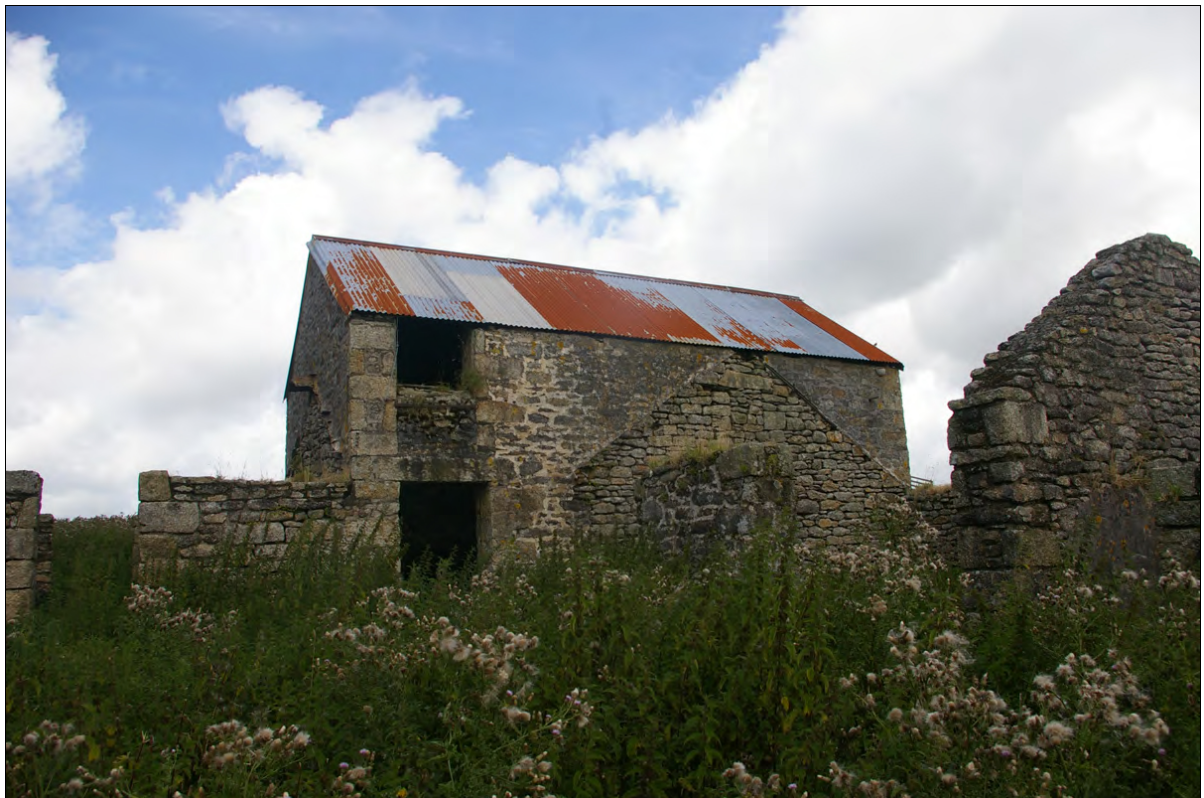
Figure 12: South elevation of Building 1, showing the roofline scar of Building 2c; viewed from the south-west.

The northern building within this range Building 2c (B2c) abuts B1 and B2b (see Figure 12). This consists of a section of wall built to the east between the (raised) north gable of B2b and the south elevation of B1a. A further short section of wall, with dressed quoins to each end, was built in the open space to the west, again between B1a and B2b. It was at this point, when the open space between B1a and B2b appears to have been in-filled, and that the small first floor window in the south elevation of B1a was blocked, enclosing it within the roofline of the new building. No internal fittings survive to indicate the function of B2c.

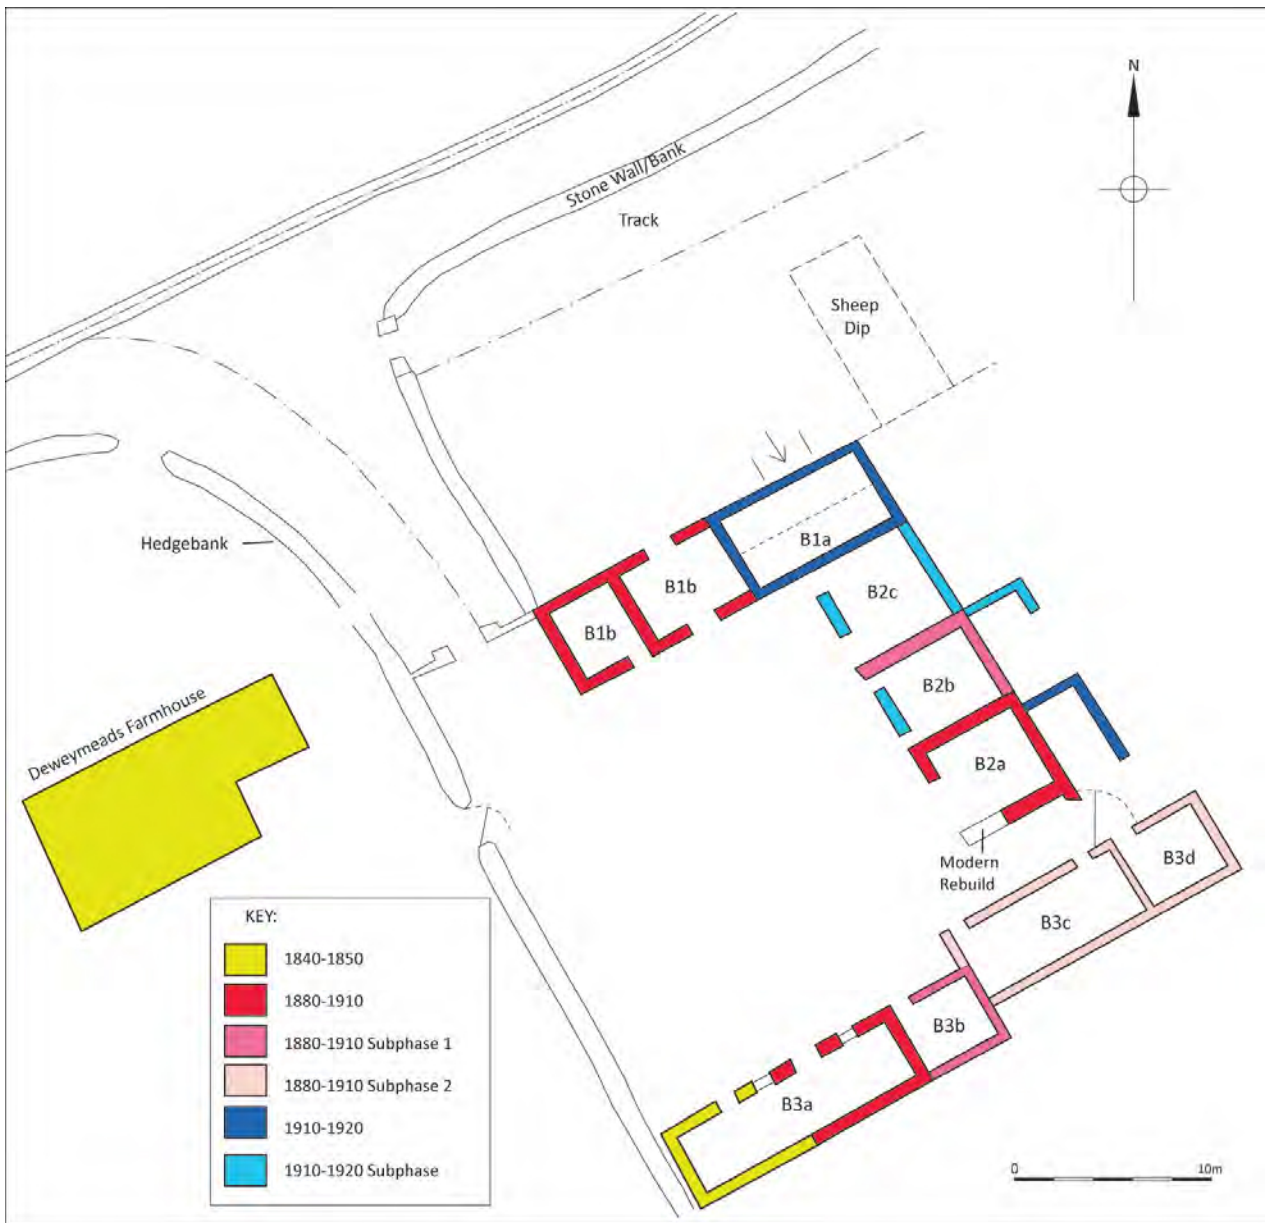
Figure 15: Phased plan, showing building numbers (based on plan provided by Mark Dyson Chartered Surveyors).

The earliest phase of structures is probably represented solely by the farmhouse, and potentially the western end of B3a (see Figure 15). The large pre-1700 enclosure shown in the Lanhydrock Atlas had been sub-divided and the farm positioned with a spine access road, running between the fields, leading to two enclosures, one for the farmhouse the other the farmyard. These enclosures were set on a slight south-facing slope, off the peak of the hill, in an attempt to protect them from the weather. An L-shaped farm building is shown on the 1st Edition Ordnance Survey Map, but most (if not all) of this structure had been demolished by 1907, with only the western end of Building 3a possibly representing a survival.

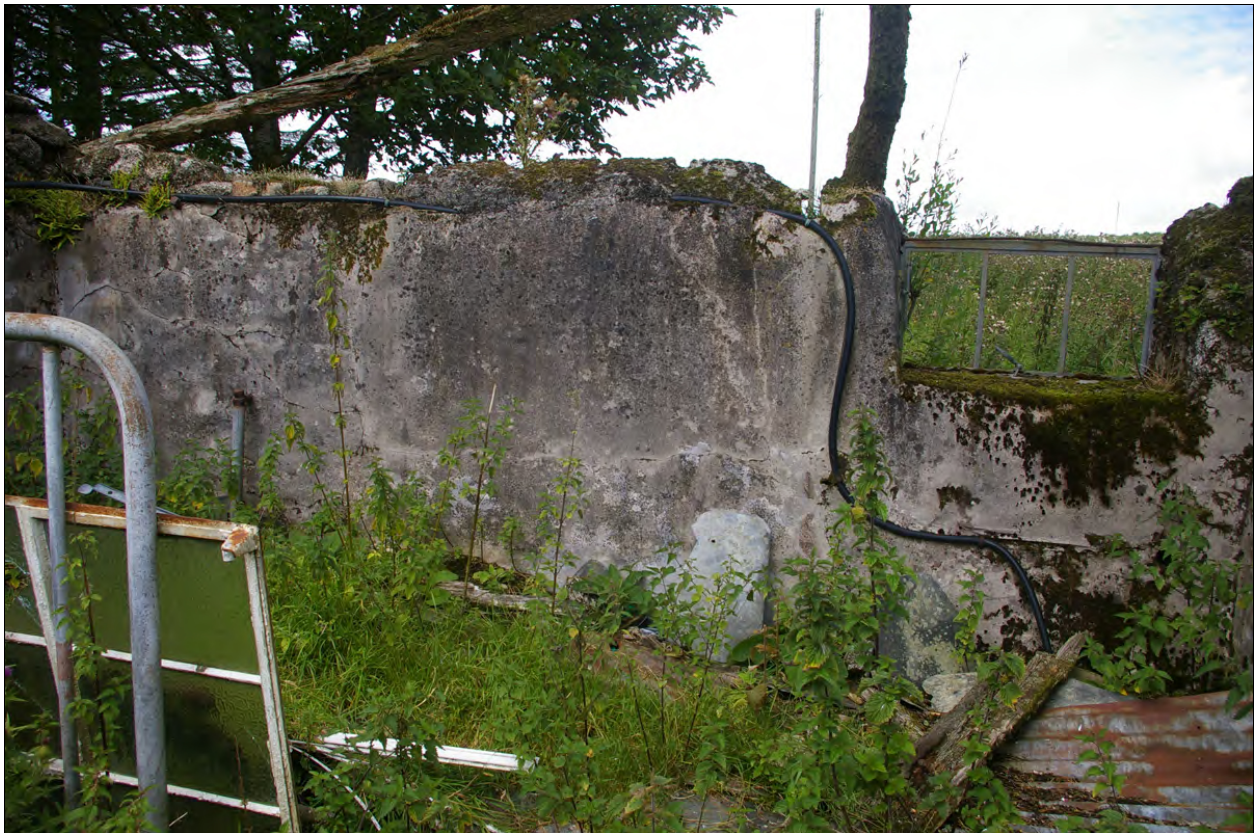
The north wall within the western compartment in Building 1a, with window with surviving metal frame; from the south-east.

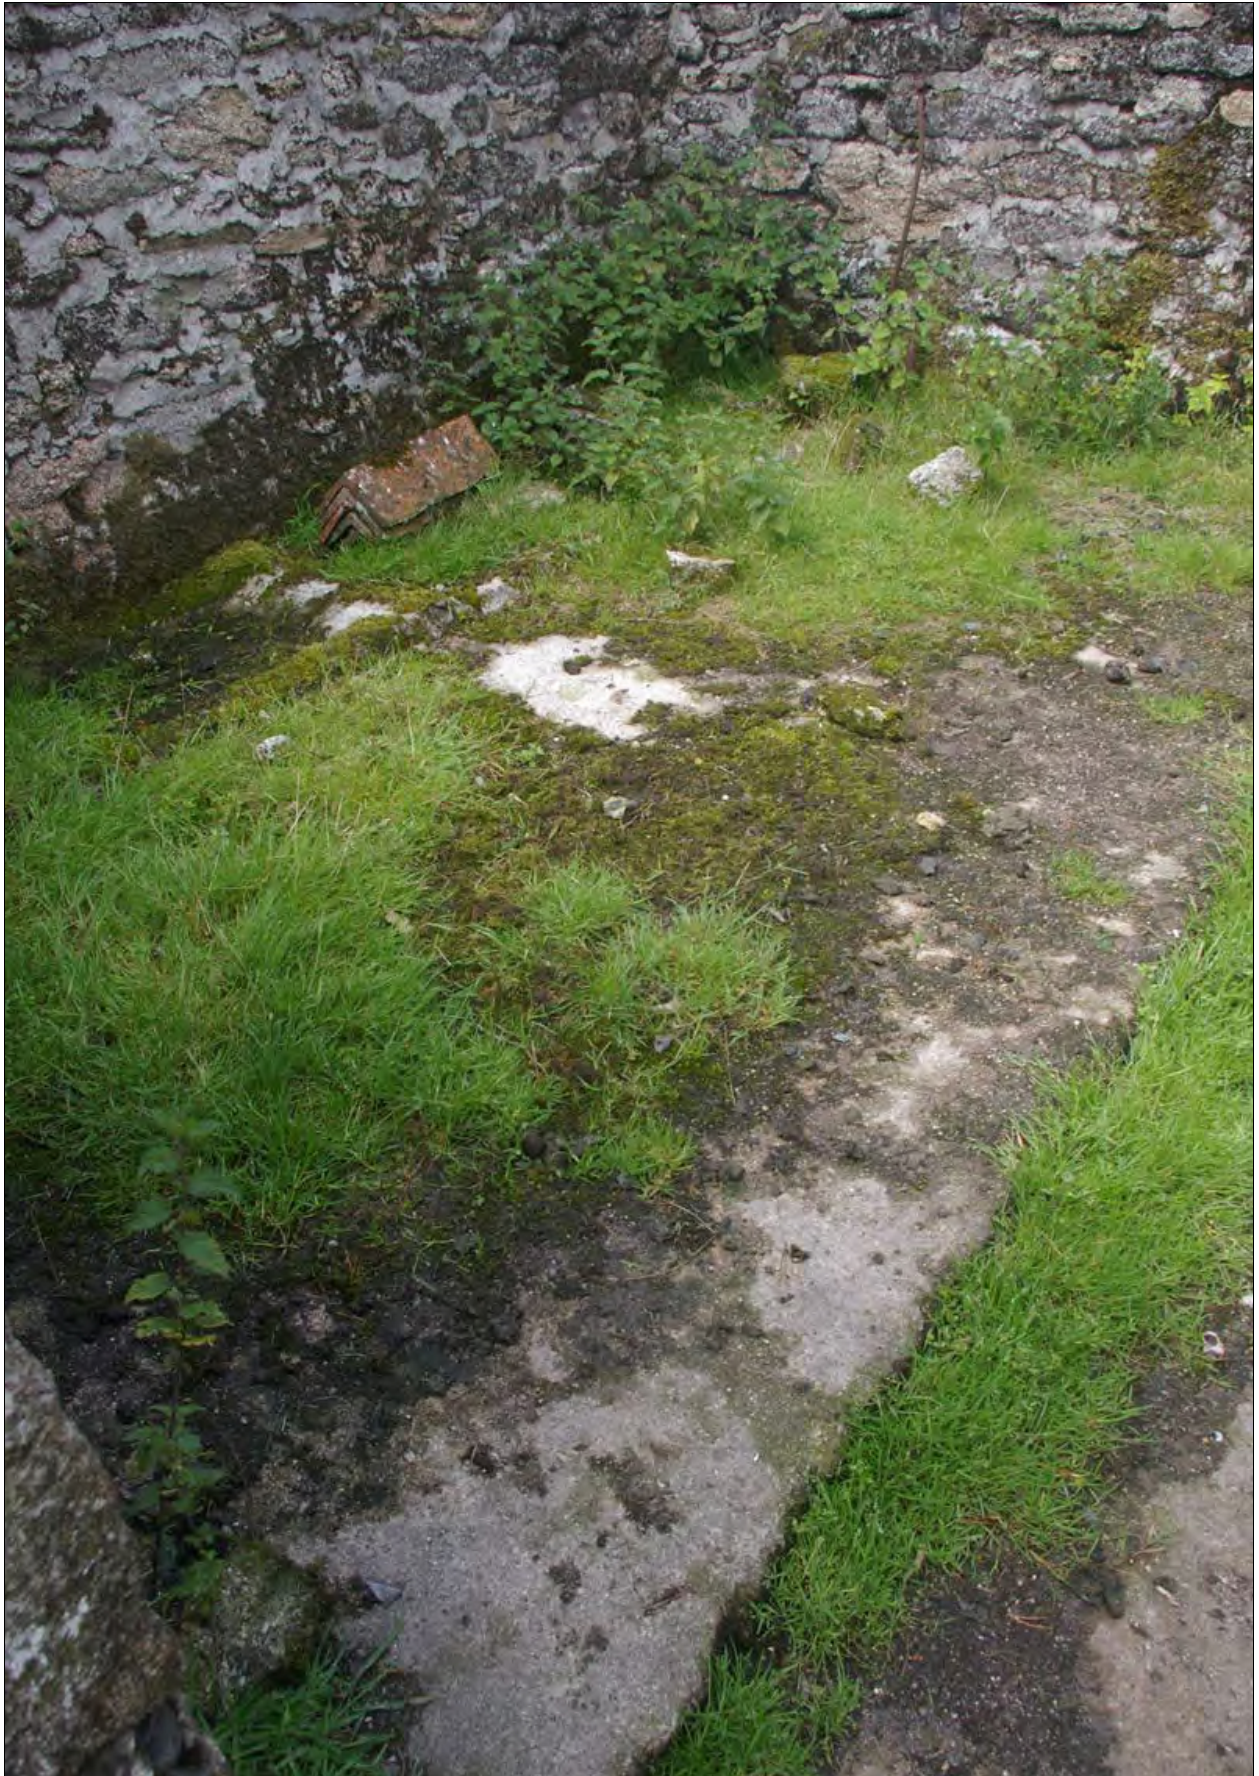
The remains of shallow concrete pens in the eastern compartment of Building 1a; from the south-east.

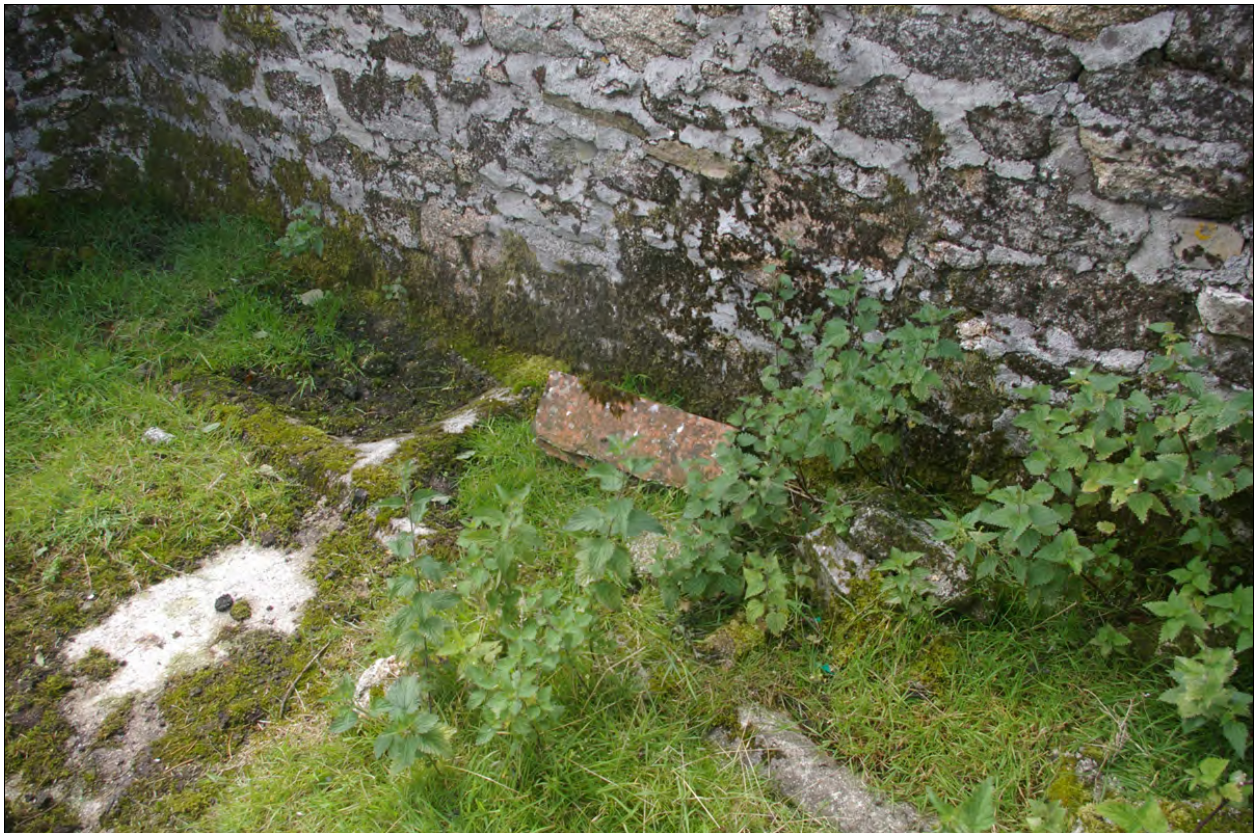
The remains of the former concrete pens, within the eastern compartment in Building 1a; from the north-east.

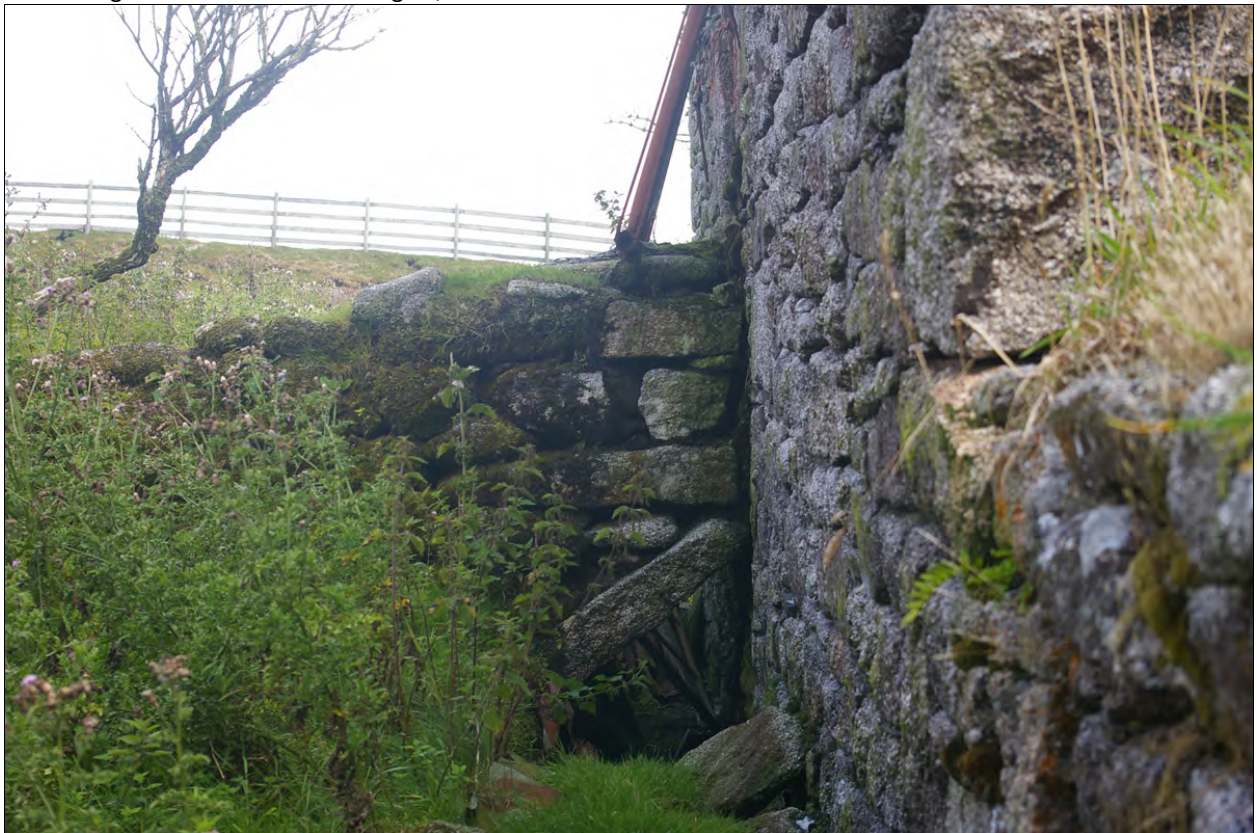
View of the granite slab 'bridge' across to the loading door in the north elevation of Building 1; from the west.

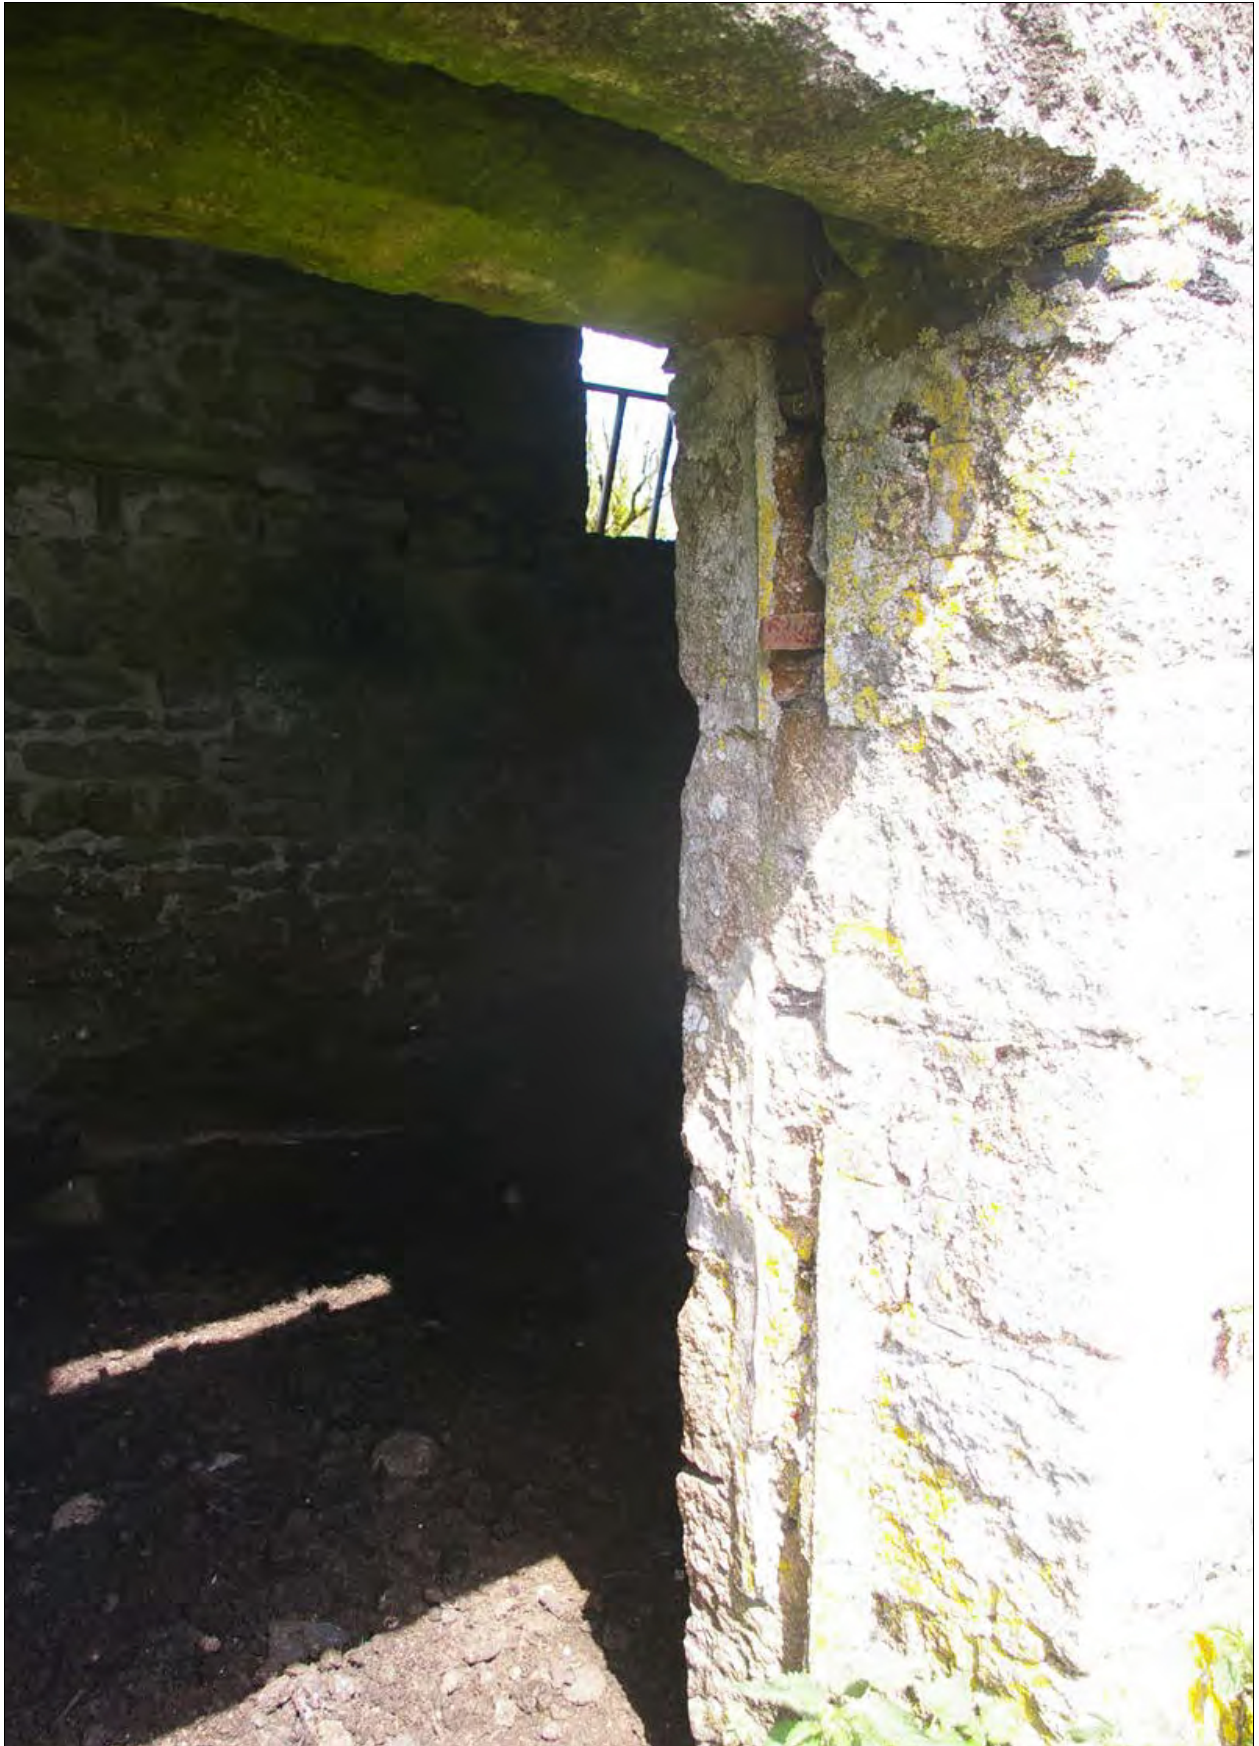
The entrance to the barn, on the south elevation, on the ground floor, showing the granite slabs which form the doorway; from the south-west.

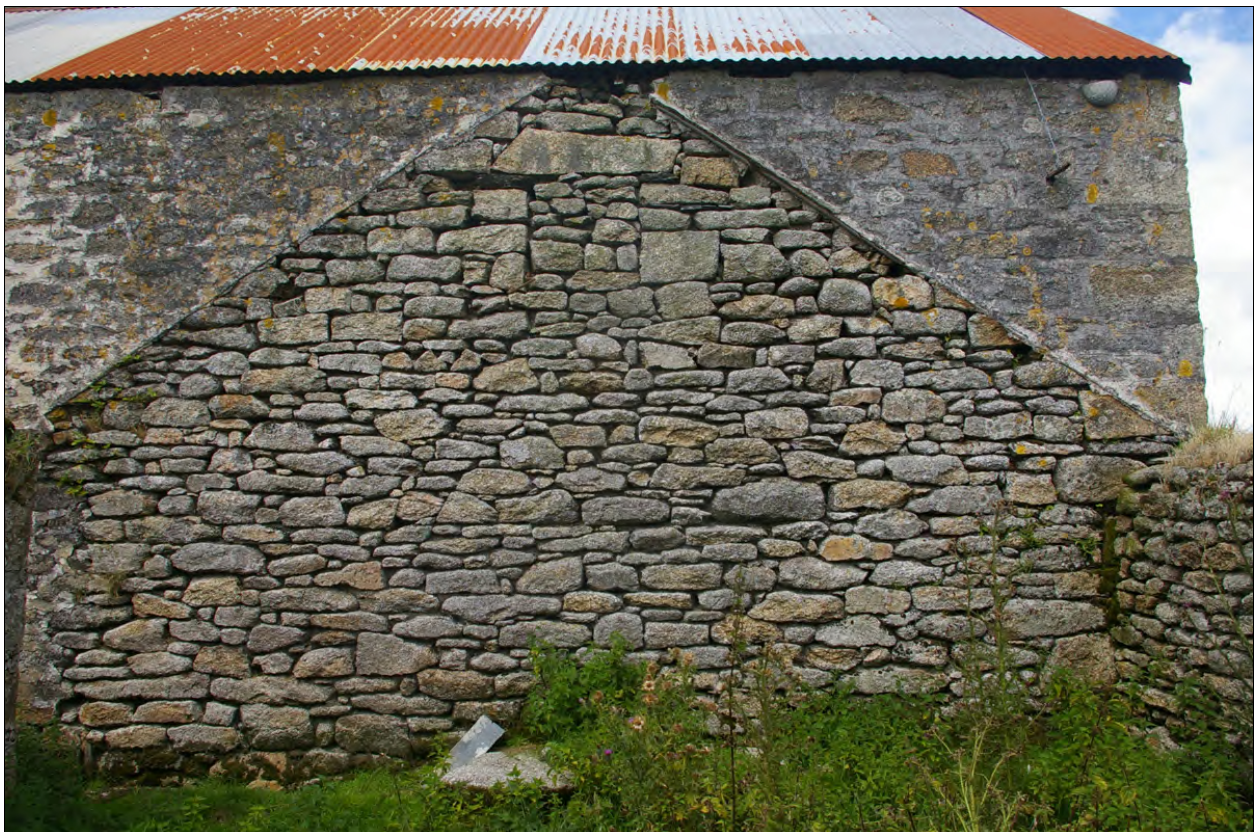
The roofline scar and sockets for timbers within the south elevation of Building 1, for the roof over building 2c, to the south; from the south.

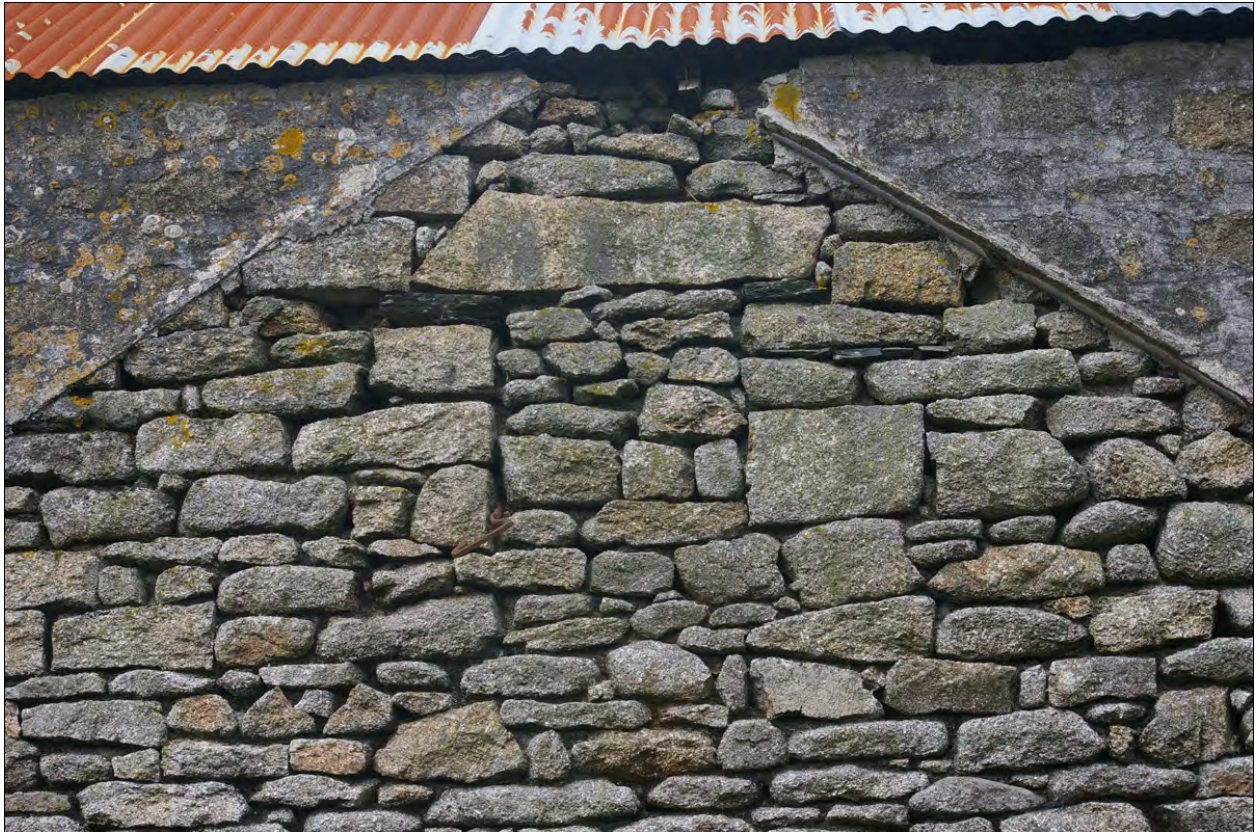
Detailed view of the blocked opening in the south elevation of Building 1; from the south.

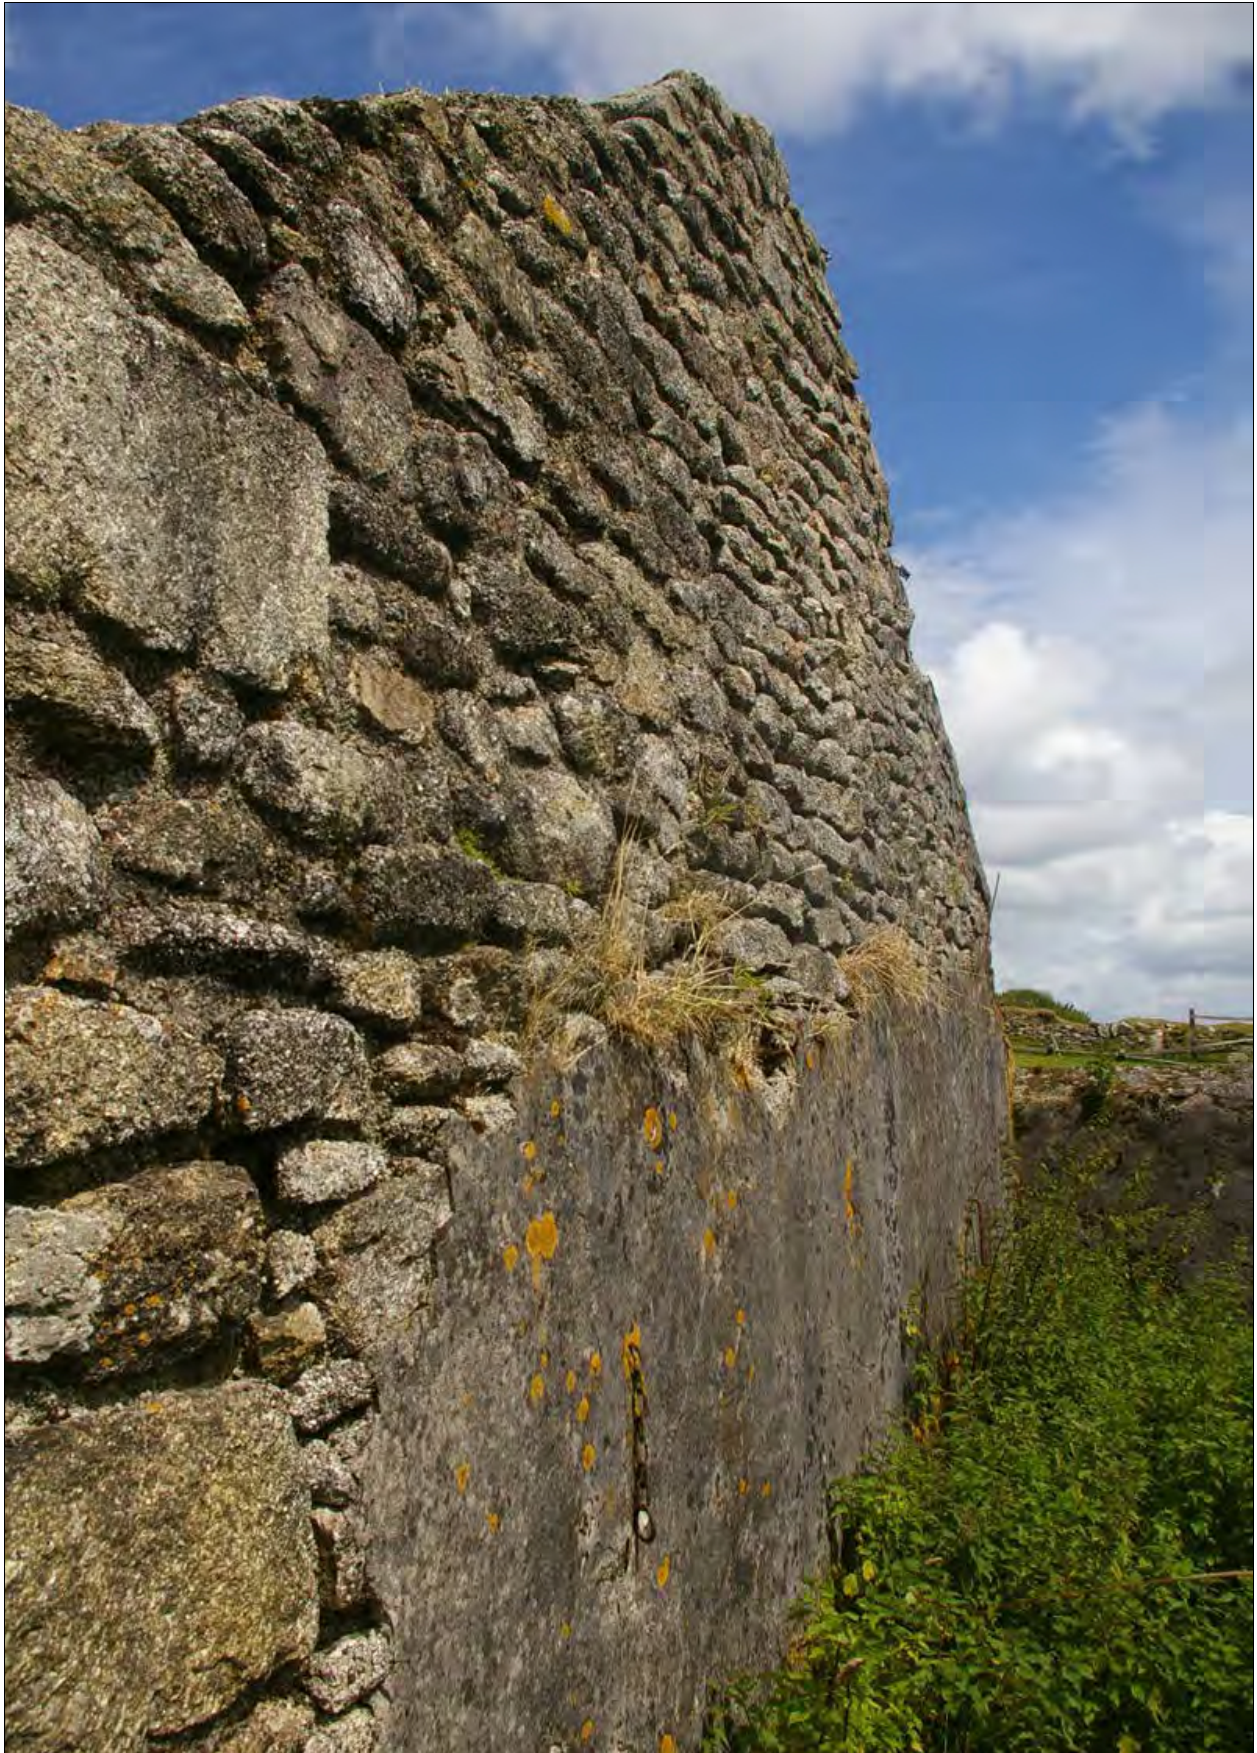
View along the north gable wall of Building 2b, showing the later cement render; from the west.

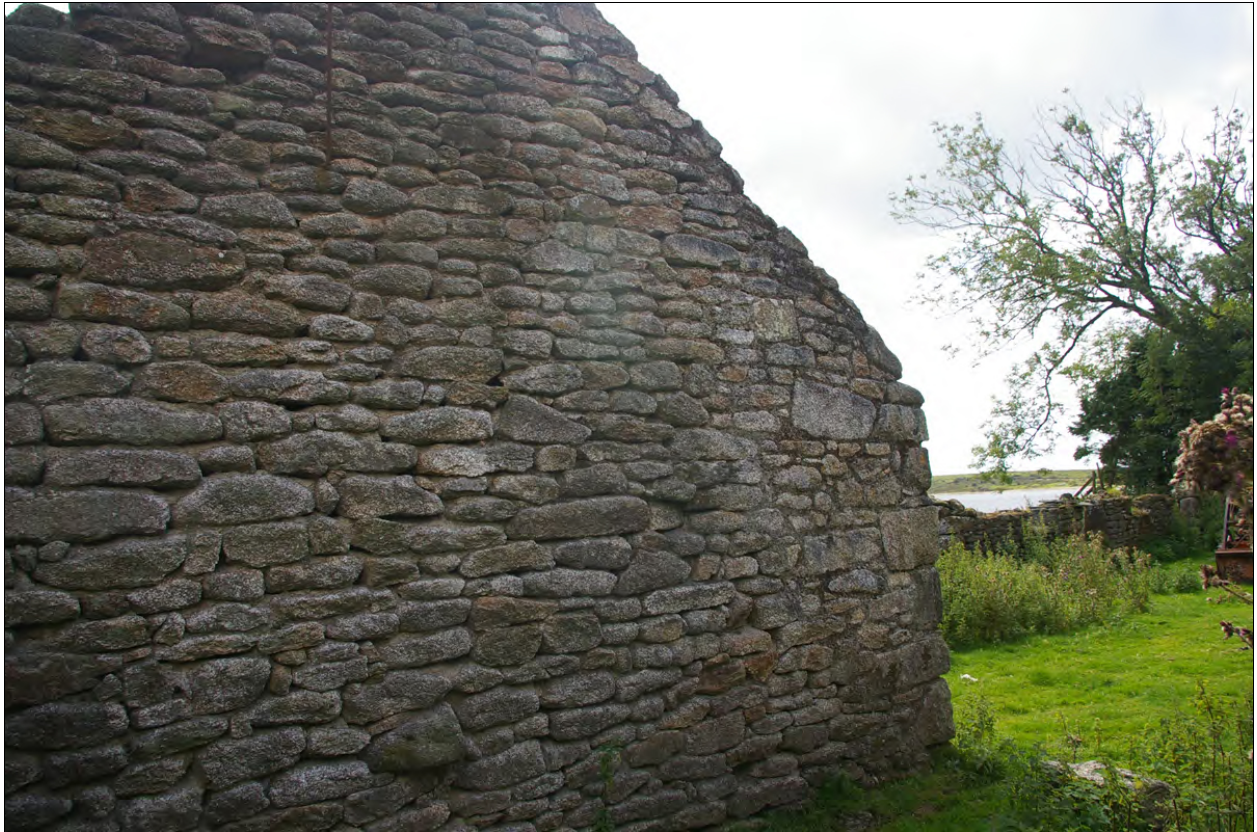
The south gable wall of Building 2a, showing the potentially rebuilt section; from the north-east.

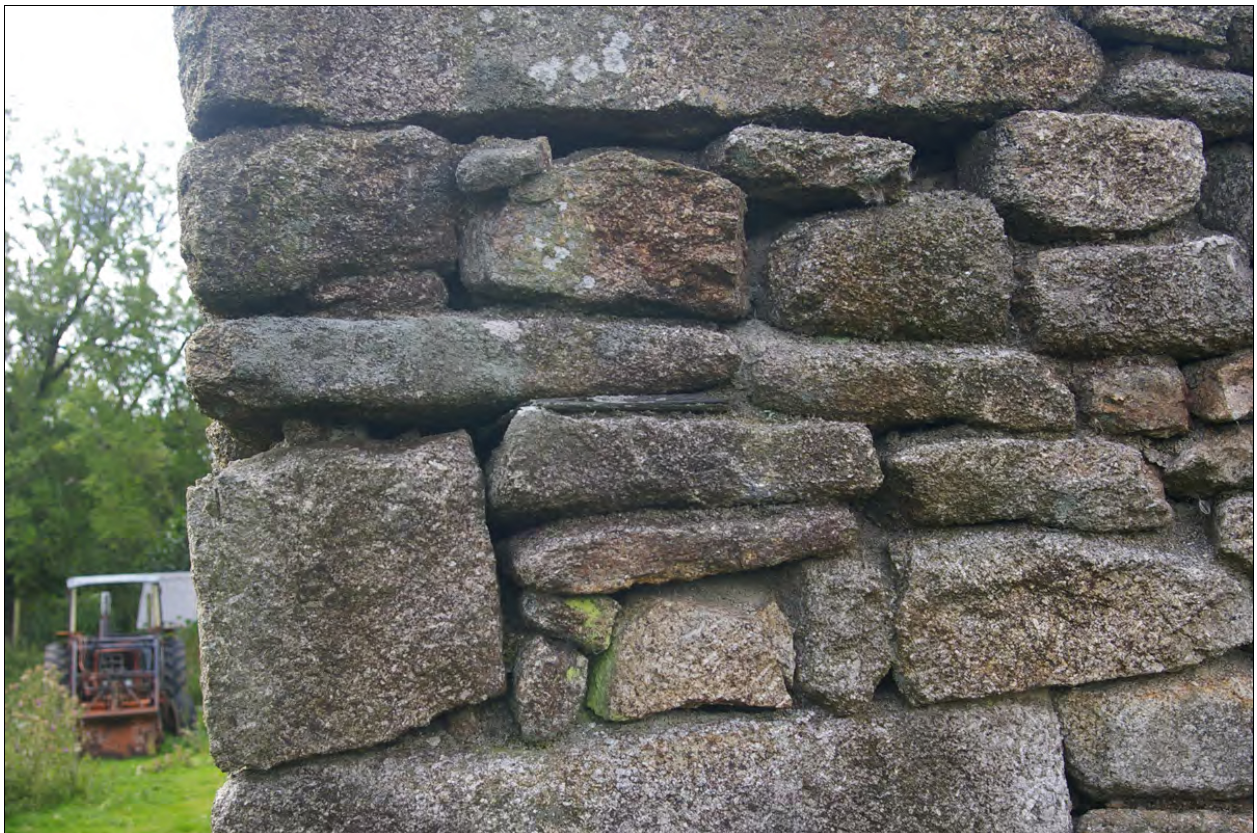
Detail showing the slate levelling courses between the granite block quoins of Building 2a; from the east.
