DEWEYMEADS ST. NEOT CORNWALL

Desk-based Assessment &
Historic Building Record

Report No.: 140909
Date: 09.09.2014
Author: E. Wapshott
S. Walls
V. Hosegood

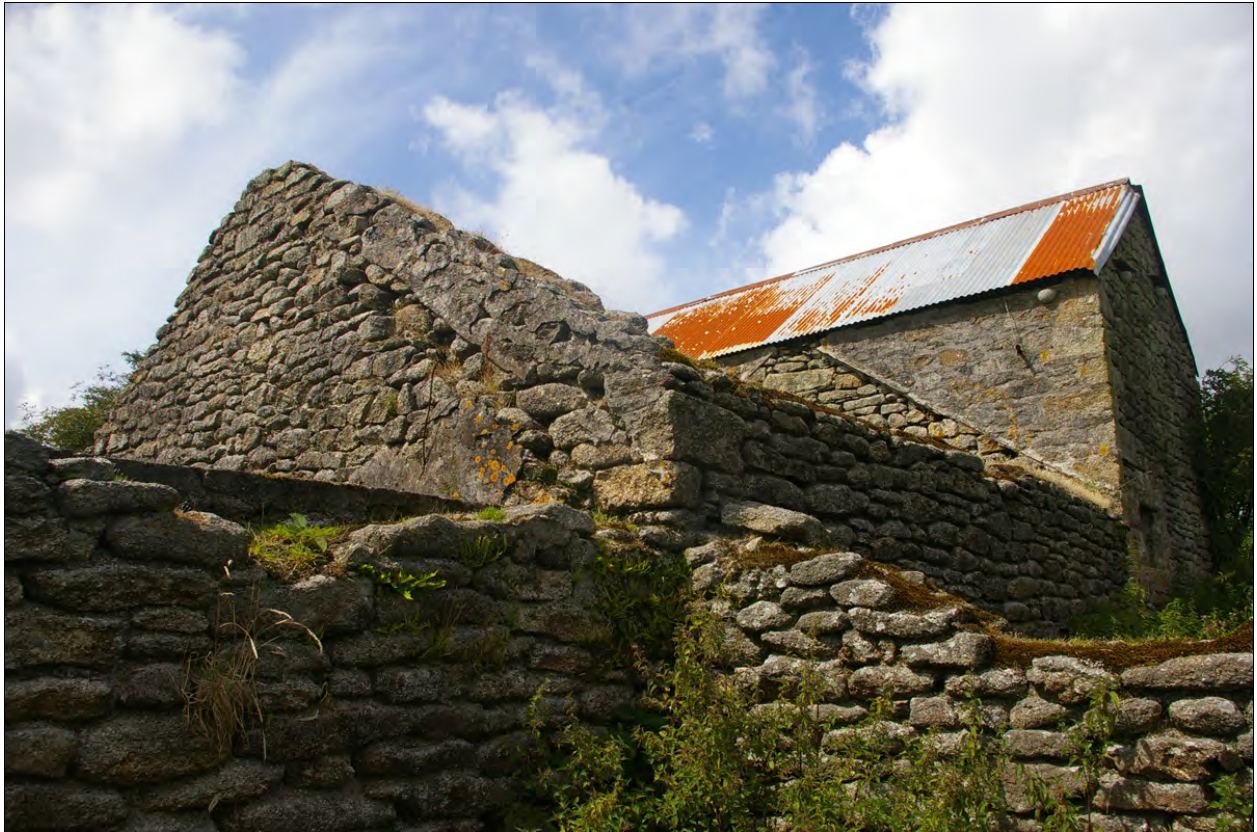
View of the north gable of Building 2b, showing how it has been raised, to allow for the new wall to Building 2c, to the north; from the south-east.

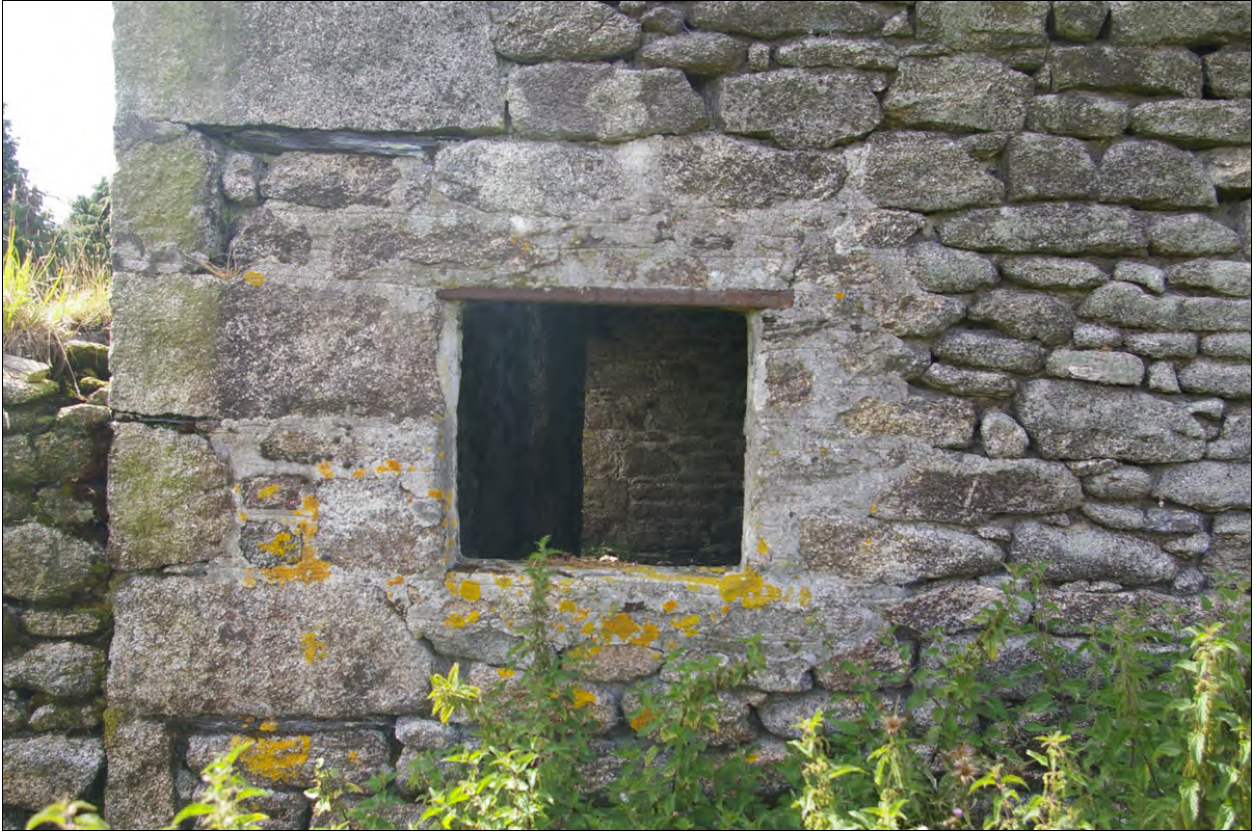
The opening in the east wall of Building 1, showing the disturbance around the opening, which appears to have been forced into the stonework; from the west.

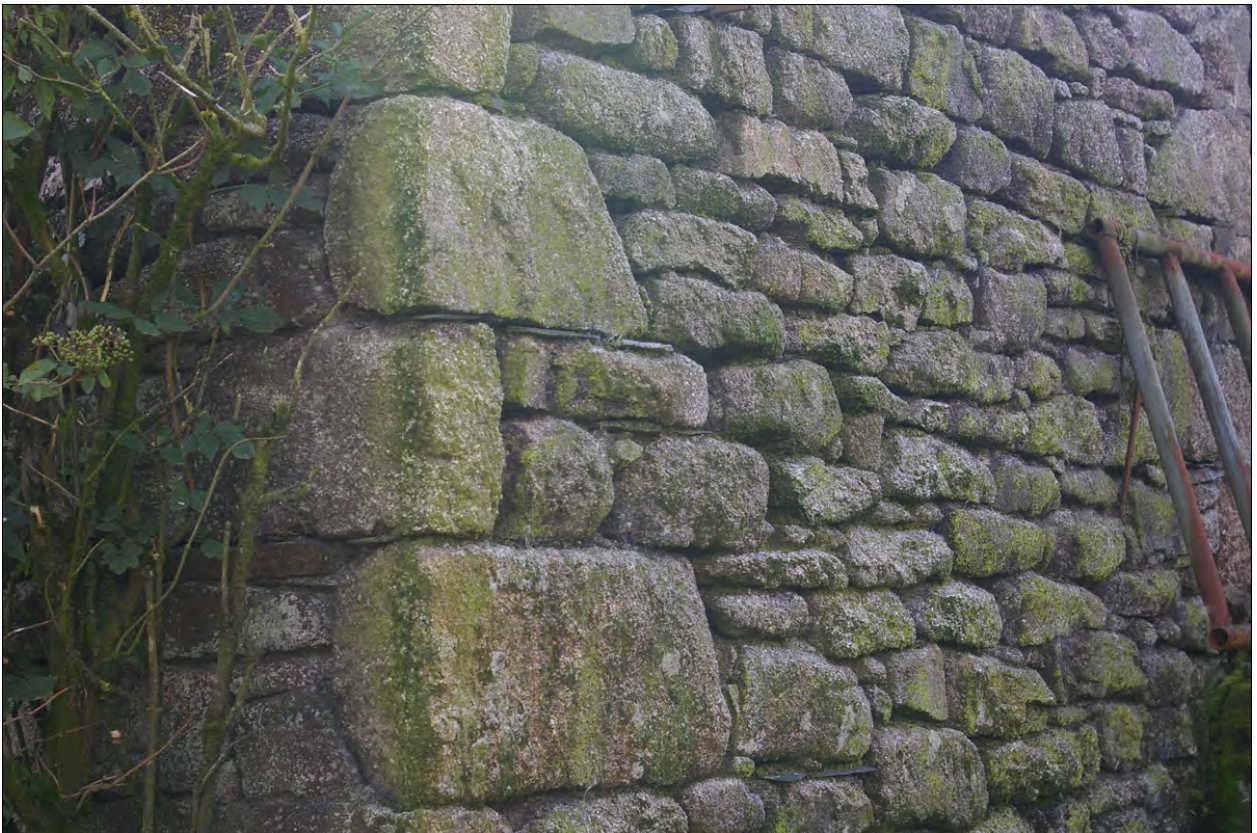
The quoins on the north-east of Building 1, showing the use of slate levelling courses; from the north-east.

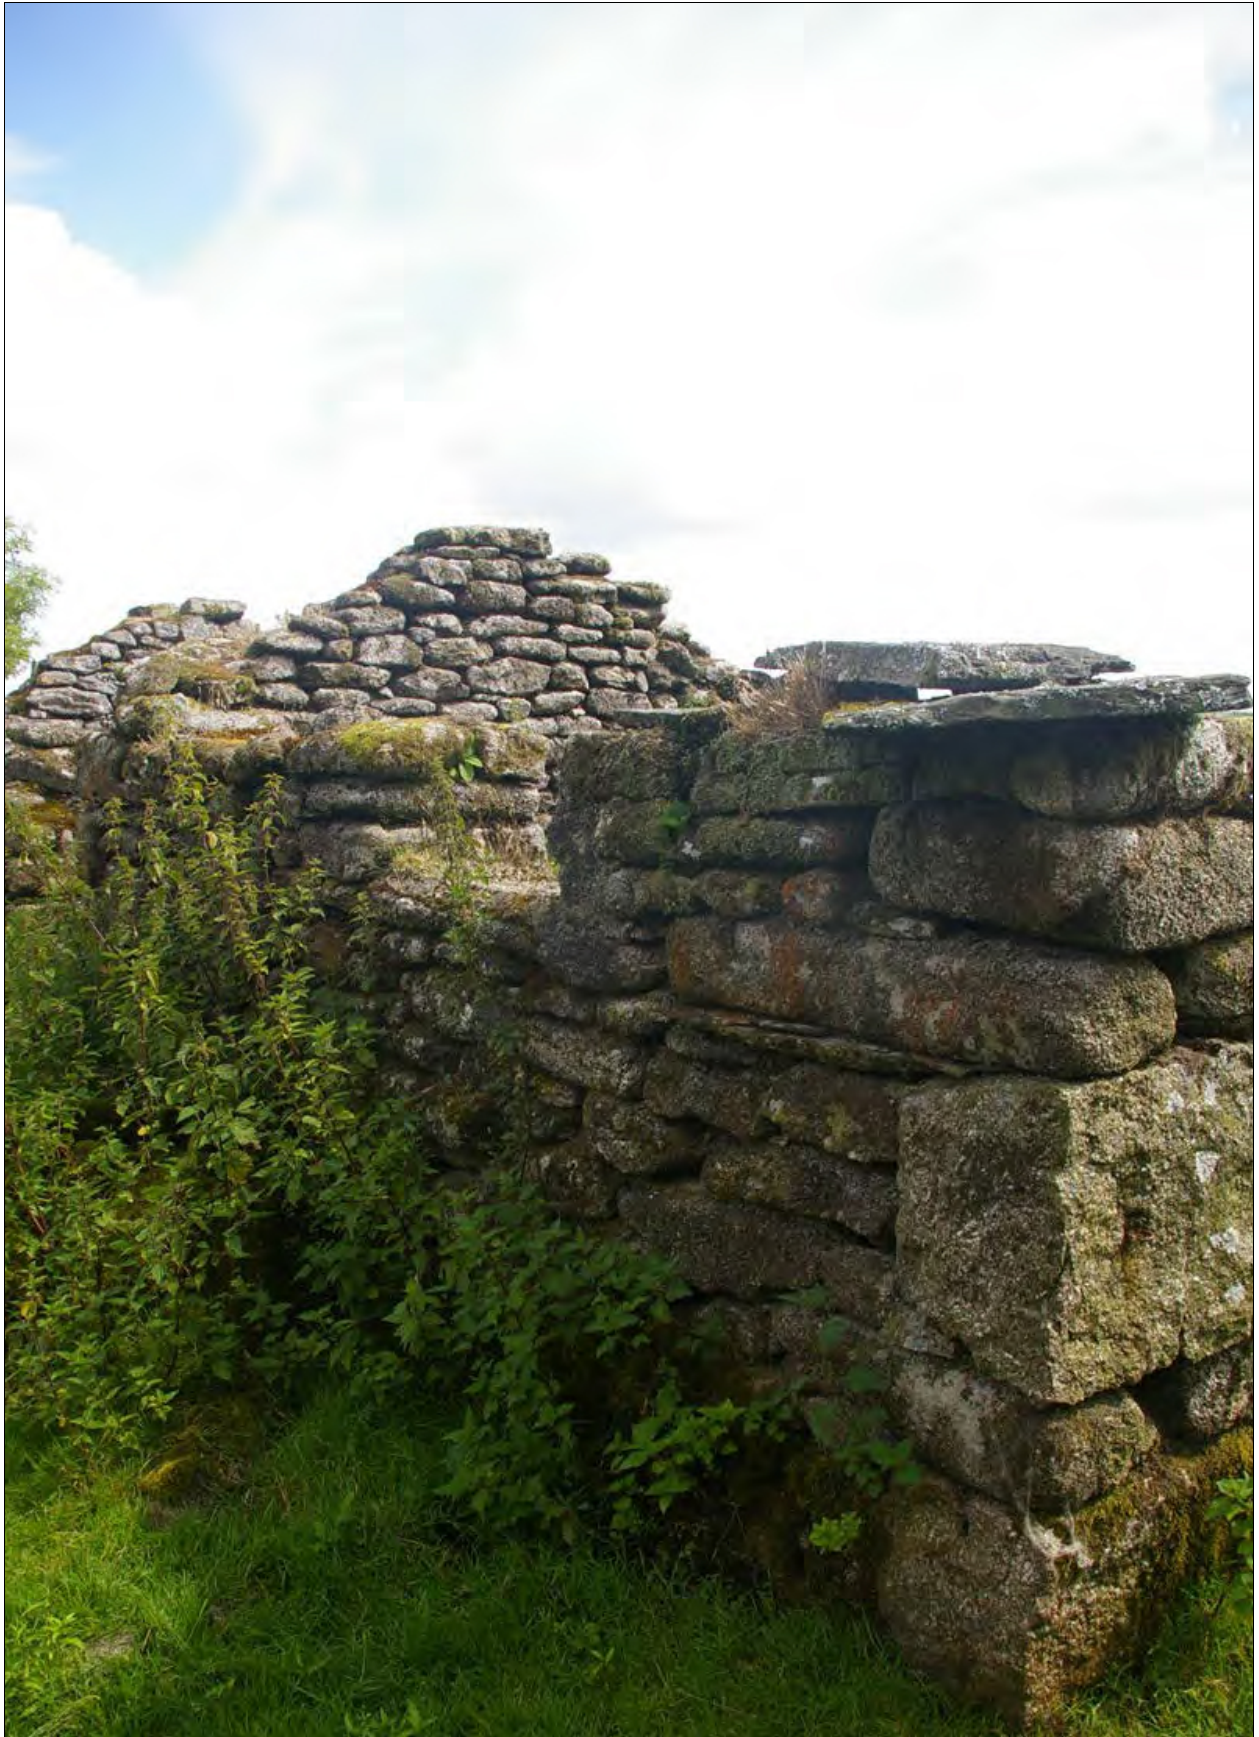
View of the north elevation of Building 3a, the eastern end, the earliest structure within the building range, showing the use of stone quoins, with slate levelling courses; from the west, north-west.

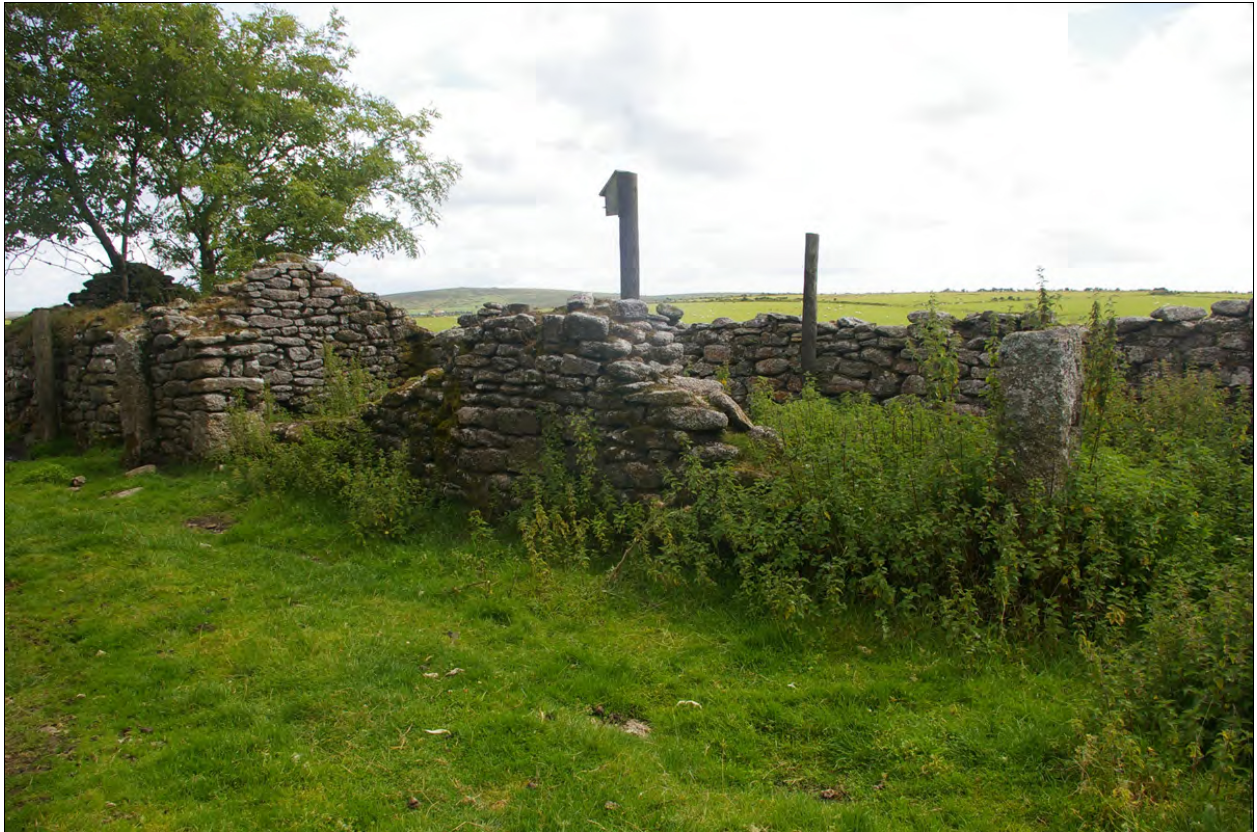
The north elevation of Building 3c, showing the ruinous status of the building; from the north-west.

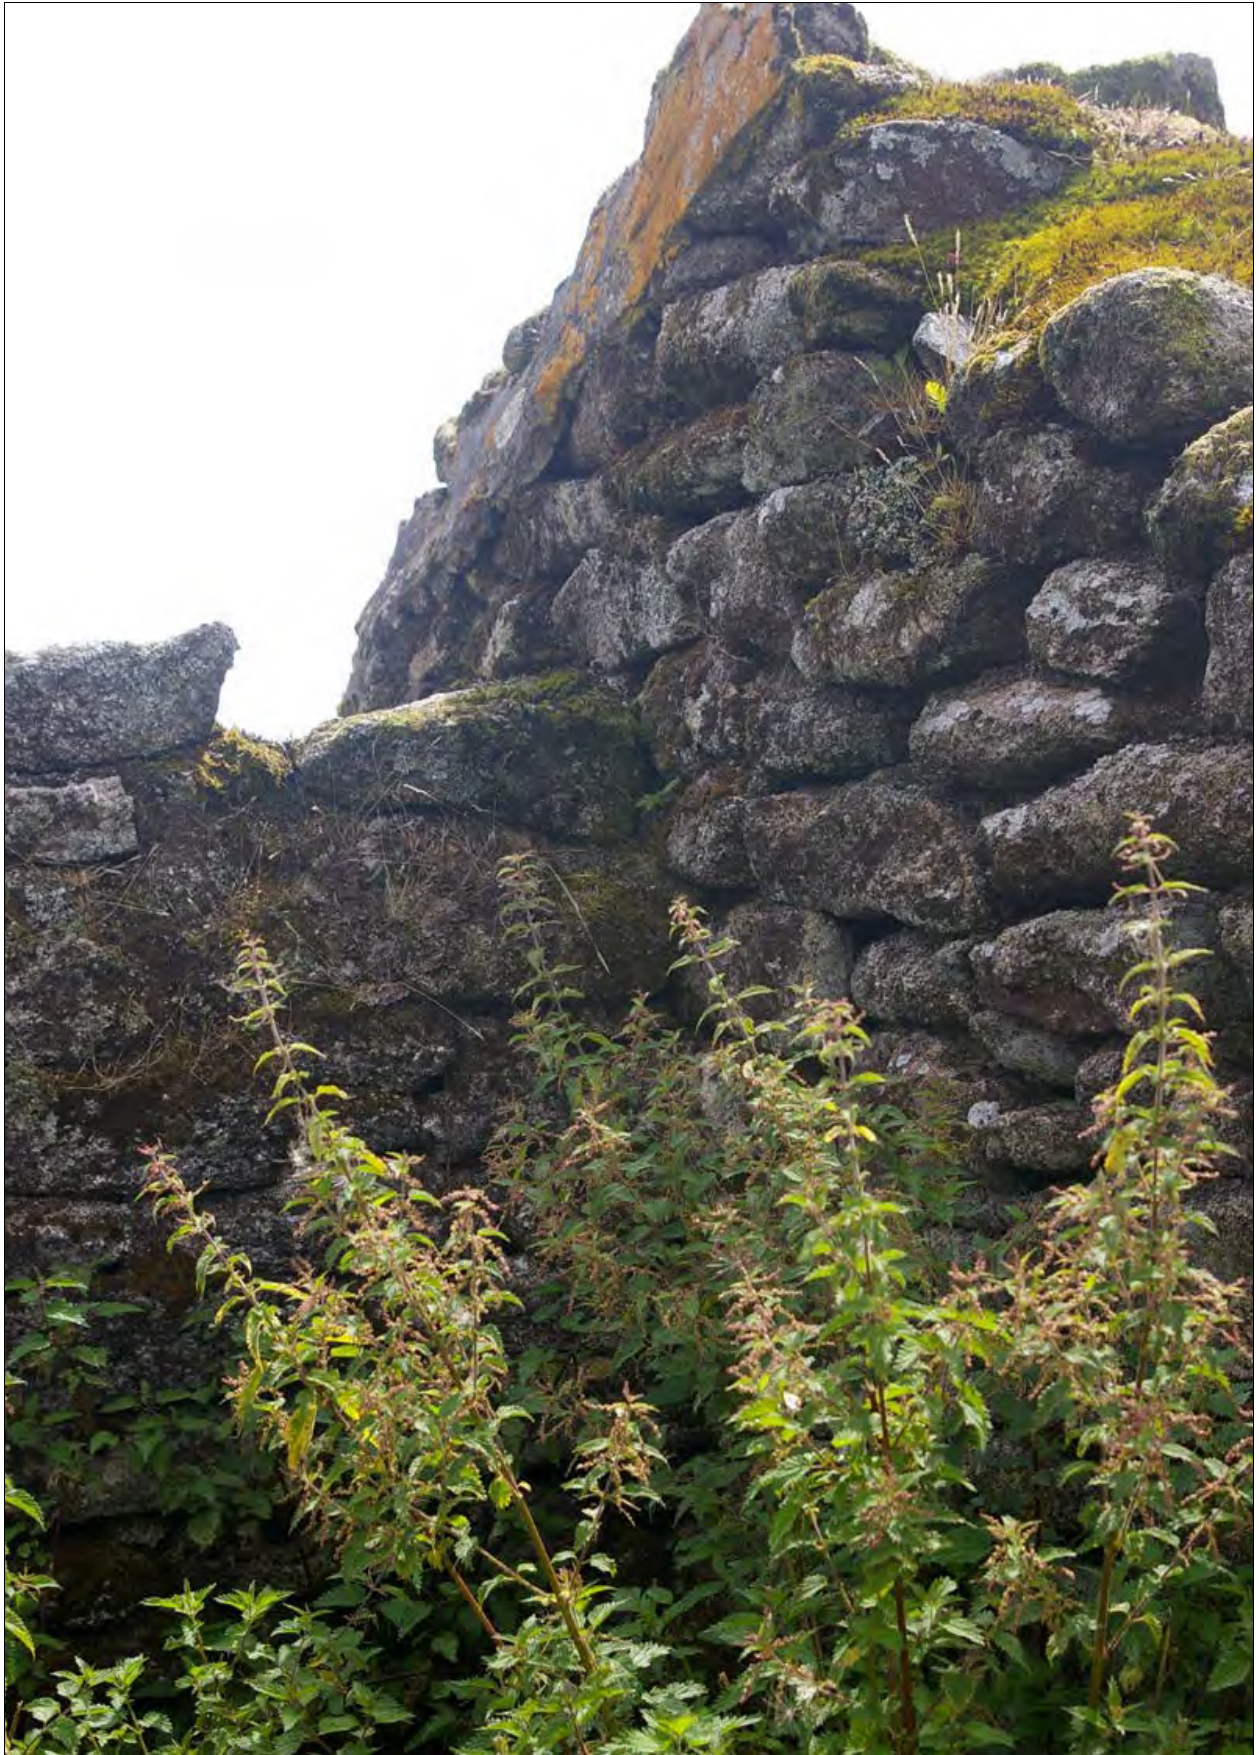
Detailed view of where Building 3c abuts the east wall of the earlier building, Building 3b; from the north, north-east.
