LAND at TRECORME BARTON QUETHIOCK CORNWALL

Results of a
Historic Visual Impact Assessment

Report No.: 140912
Date: 12.09.14
Author: B. Morris

This report presents the results of a visual impact assessment carried out by South West Archaeology Ltd. (SWARCH) on land at Trecorme Barton, Quethiock, Cornwall, in advance of the construction of two 18m (25m tip) wind turbines.

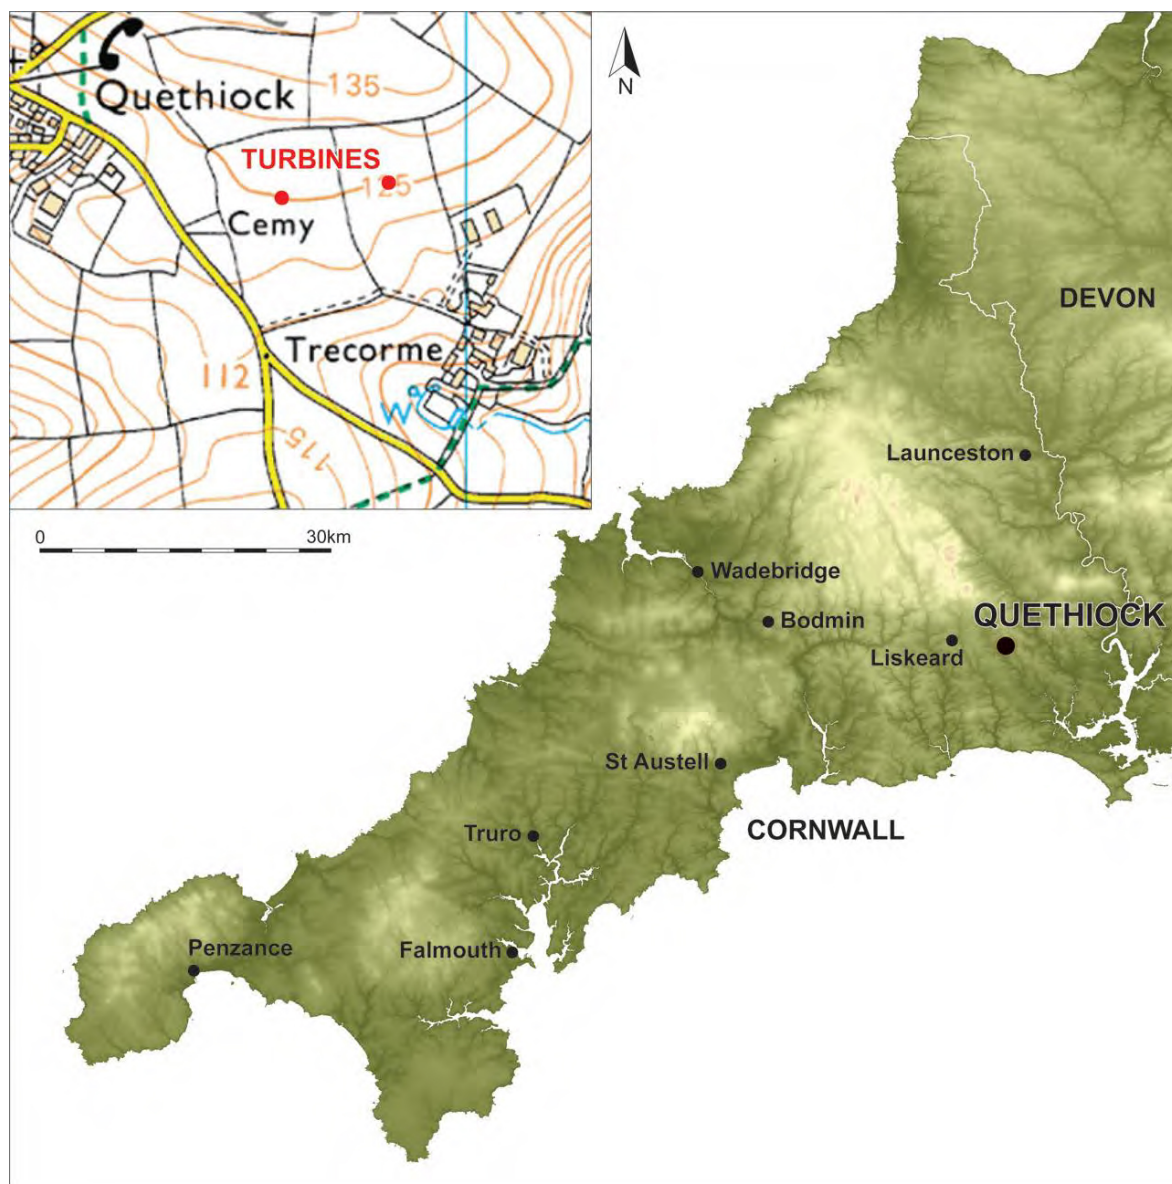
Figure 1: Site location (the approximate location of the proposed turbines are indicated).

This report presents the results of a historic visual impact assessment carried out by South West Archaeology Ltd. (SWARCH) at Trecorme Barton, Quethiock, Cornwall (Figure 1). The work was commissioned by Lucy Bolton of Mosscliff Environmental in order to identify any heritage assets that might be affected by the installation of two 18m wind turbines (25m to tip).

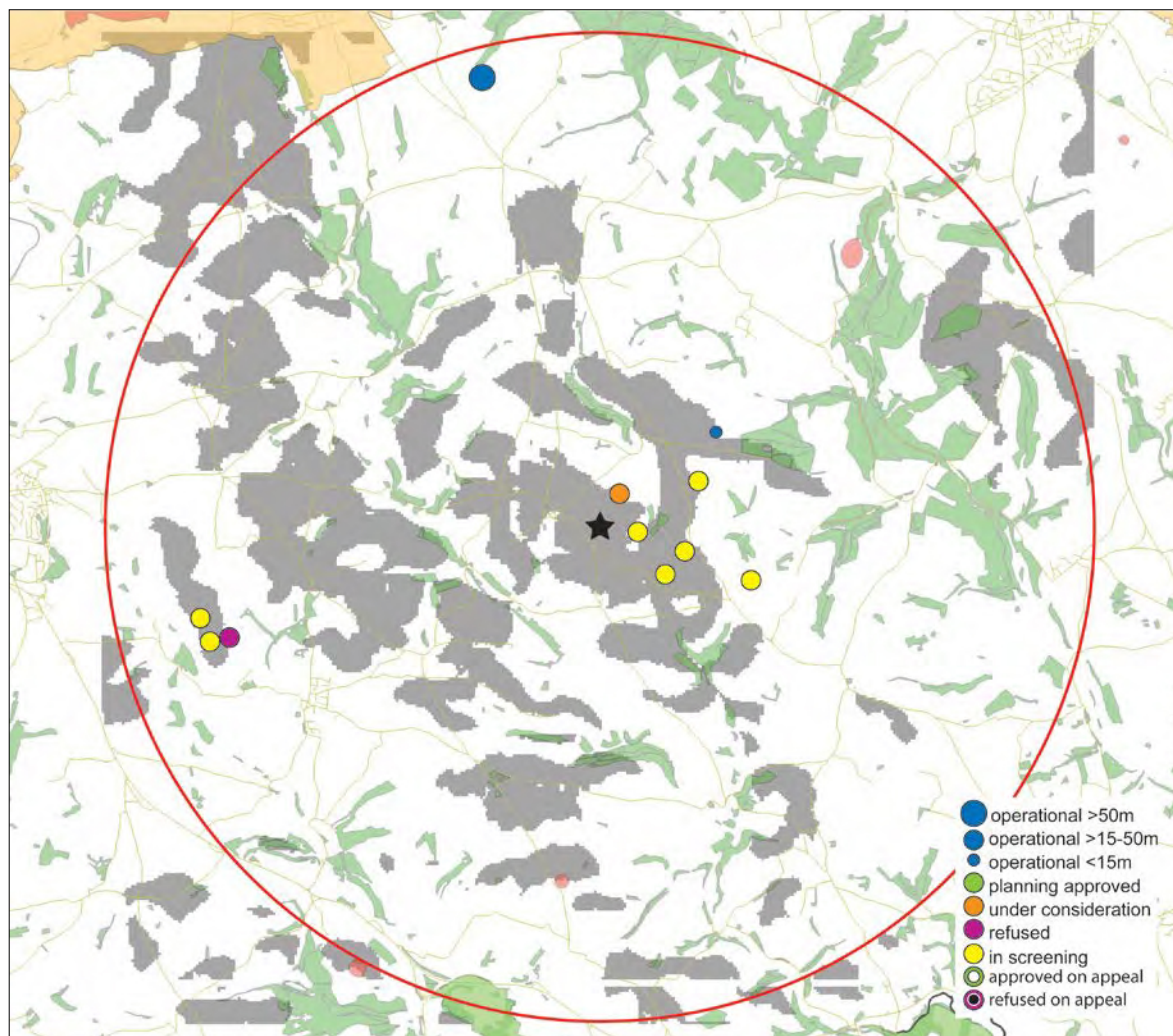
Figure 3: Cumulative impact: distribution of operational and proposed turbines (based on a ZTV generated by SWARCH and data from Cornwall Council, as of 29.08.14).

In terms of cumulative impact in this landscape, a cluster of wind turbines are proposed for the area to the east of Quethiock (see Figure 3); otherwise there are very few operational or proposed turbines within 5km. Dependant on the nature of the proposed developments – and whether they receive planning permission – cumulative impact might constitute an issue; at this current time it is not.

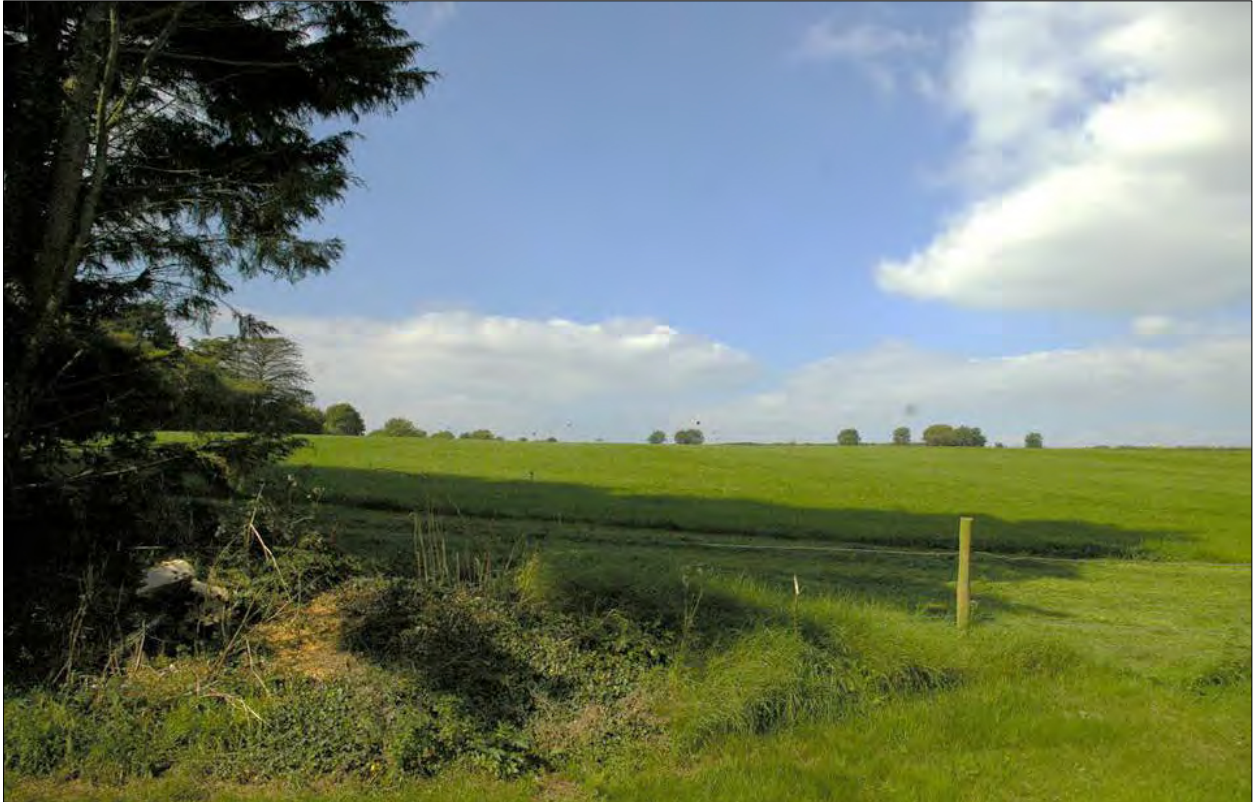
View across the proposed turbine site; western field, viewed from the south-west corner, looking north-north-west.

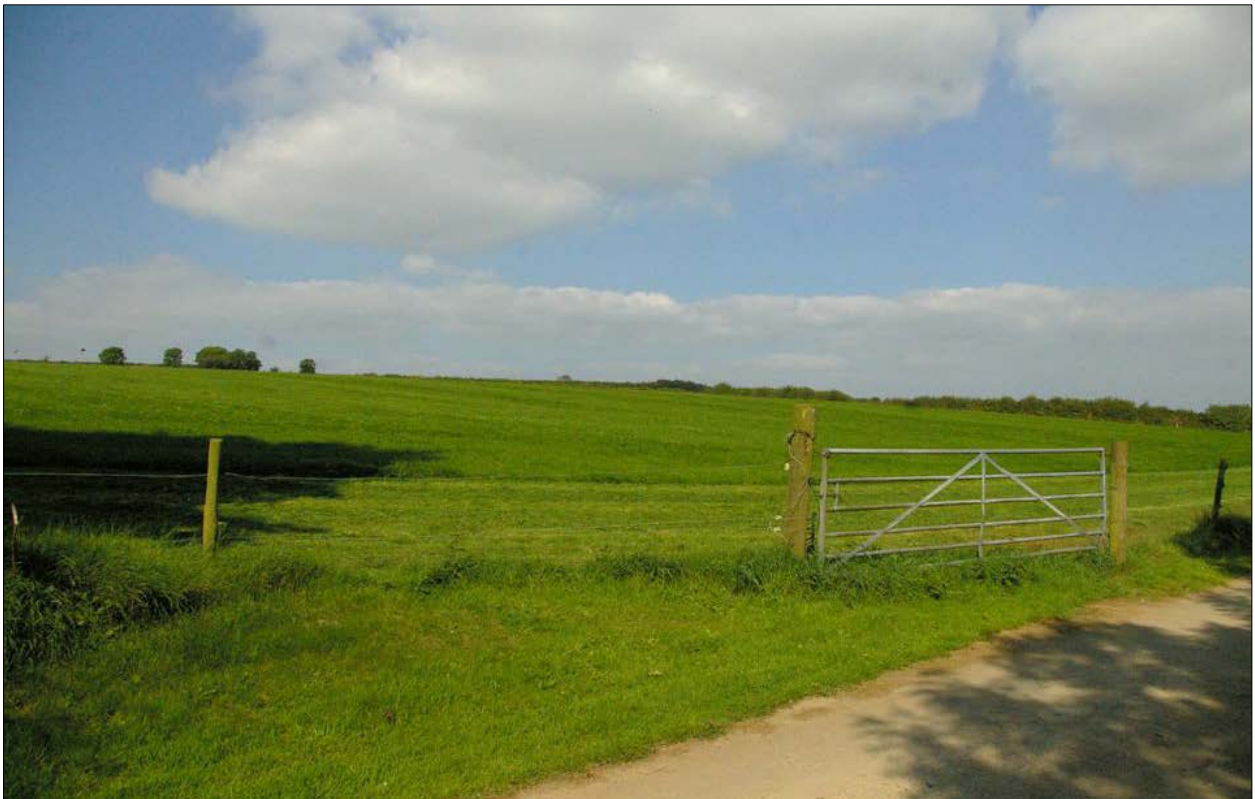
As above, looking north-north-east.

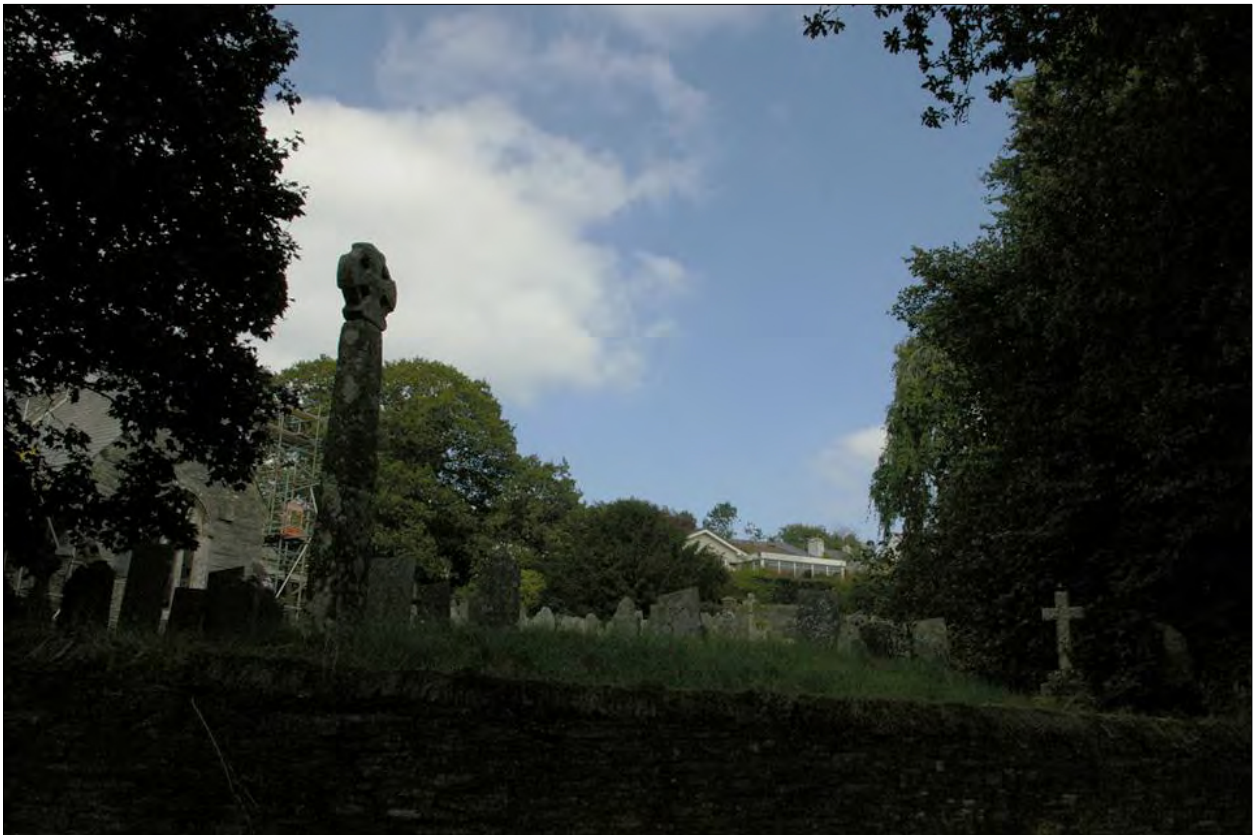
Quethiock: Listed GII*/Scheduled cross in the churchyard at Quethiock; viewed from the south-west, looking north-east.

- Church of St. Hugh of Lincoln, Quethiock; high significance Grade I Listed; condition: fair, currently being renovated. Distance to turbine: c.0.6km. Also, medieval cross; high significance, Grade II* and SAM; condition: good. 'Of more than usual interest for both its pre-C15 features and its later C19 embellishment' (Beacham & Pevsner 2014, 463-4). 14th century church and unusually thin west tower; good interior restoration in later 19th century by Rev. William Willmott. Located within the settlement of Quethiock, in an oval churchyard, probably a *lann*. The more historic properties in Quethiock are to the west (see above); the buildings to the east are 18th and 19th century additions. The churchyard contains numerous deciduous trees, a general feature of the wider settlement. The proposed turbines would be located to the south-east, around the shoulder of the hill; the body of the church falls outside the ZTV, but views from the top of the tower could technically be possible. However, this part of Quethiock is very enclosed, by both buildings and mature deciduous trees. Views from the churchyard are very restricted; they are only open to the north-east, and even then there is local blocking from trees and buildings further up the slope. Meaningful views to the settlement as a whole are possible from the south, and those views would include the proposed turbines. However, the most visible elements of Quethiock are the more recent buildings (painted white) on the eastern side of the village, and the church, despite the tower, is not visible on a landscape scale. On balance, given the evidential and spiritual value of the asset, the introspective character of the asset and the lack of a wider landscape presence, an impact assessment of **negative/minor** is appropriate. The setting of the medieval cross is restricted to the churchyard, and these would be affected; impact: **neutral**.

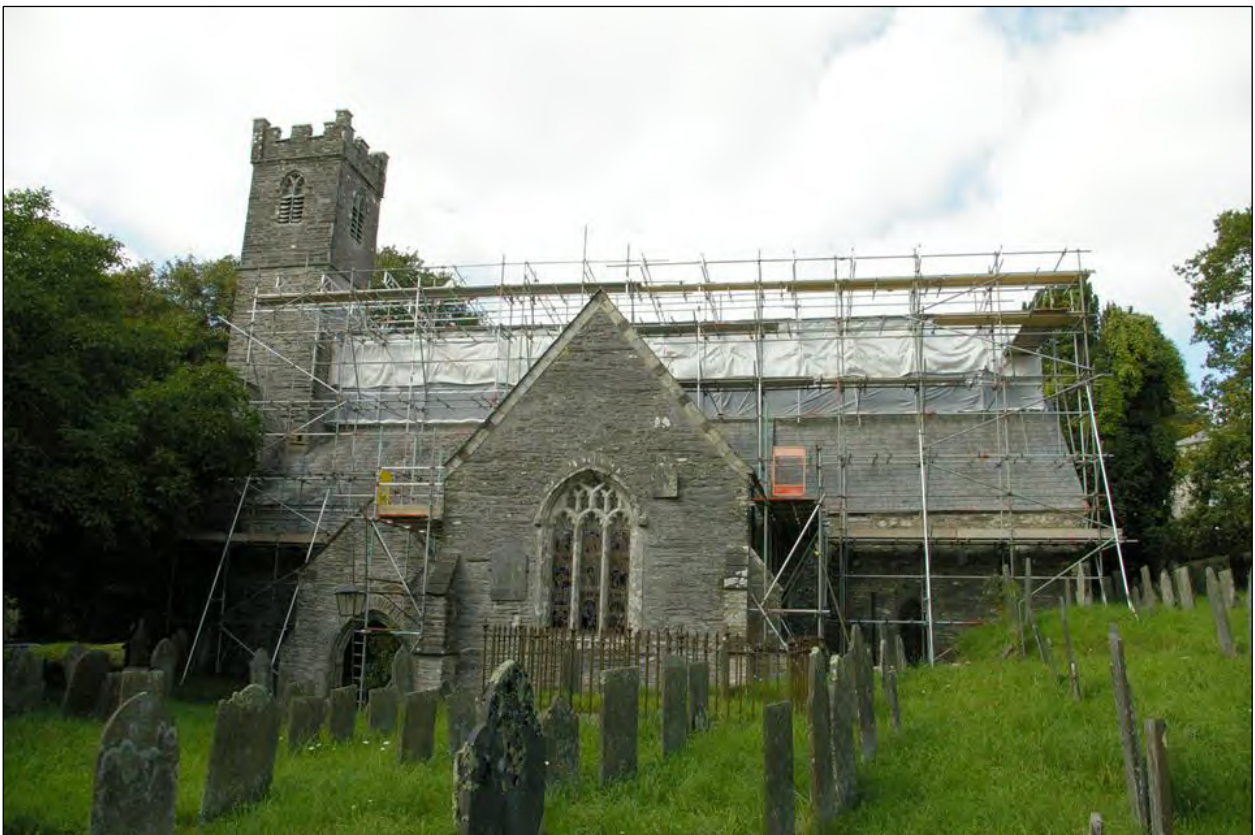
Quethiock: the church, viewed from the south.

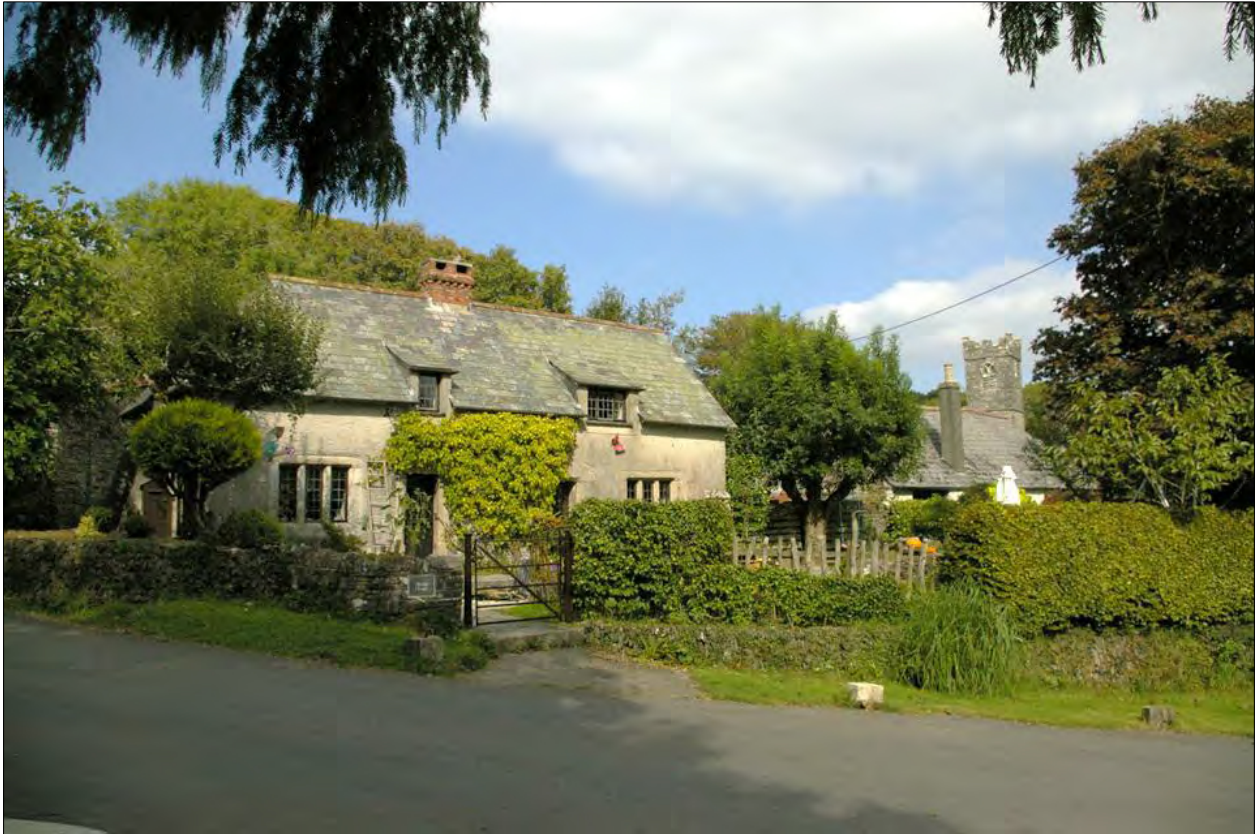
Quethiock: The Maids House, with the church in the background; viewed from the south-west, looking north-east.

- *Quethiock*, including: Maids House, Great West Farmhouse, Old Pound Cottage, Well Cottage and Well House; all medium significance, Grade II Listed; condition: fair to good. Distance to turbine: c.0.6km. Maids House, formerly four almshouses, built c.1640. Great West Farmhouse, mid 18th century, converted. Old Pound Cottage, early 17th century house, now two cottages. Well Cottage, late 17th century house, now two cottages. Well House, mid 19th century. A cluster of 17th-18th century buildings located west of the church on rising ground. All in stone rubble, painted or slate-hung, with a pleasing rustic aesthetic. This knot of historic buildings is located within the modern settlement of Quethiock, and presumably represents the historic core of the village. The settlement is located at the head of a narrow combe that runs down to the River Tiddy, on a south/south-east facing slope. The proposed turbines would be located to the south-east, around the shoulder of the hill but technically visible from these buildings. However, this part of Quethiock is very enclosed, by both buildings and mature deciduous trees around the buildings, and within the village to the south and east. Views out are very restricted, and meaningful views to the assets as a whole are only really possible from the south-south-west. Those views would include the proposed turbines, but the most visible elements of Quethiock are the more recent buildings (painted white) on the eastern side of the village. On balance, given the introspective character of these assets and the lack of a wider landscape presence, a collective impact assessment of **negative/minor** is appropriate.

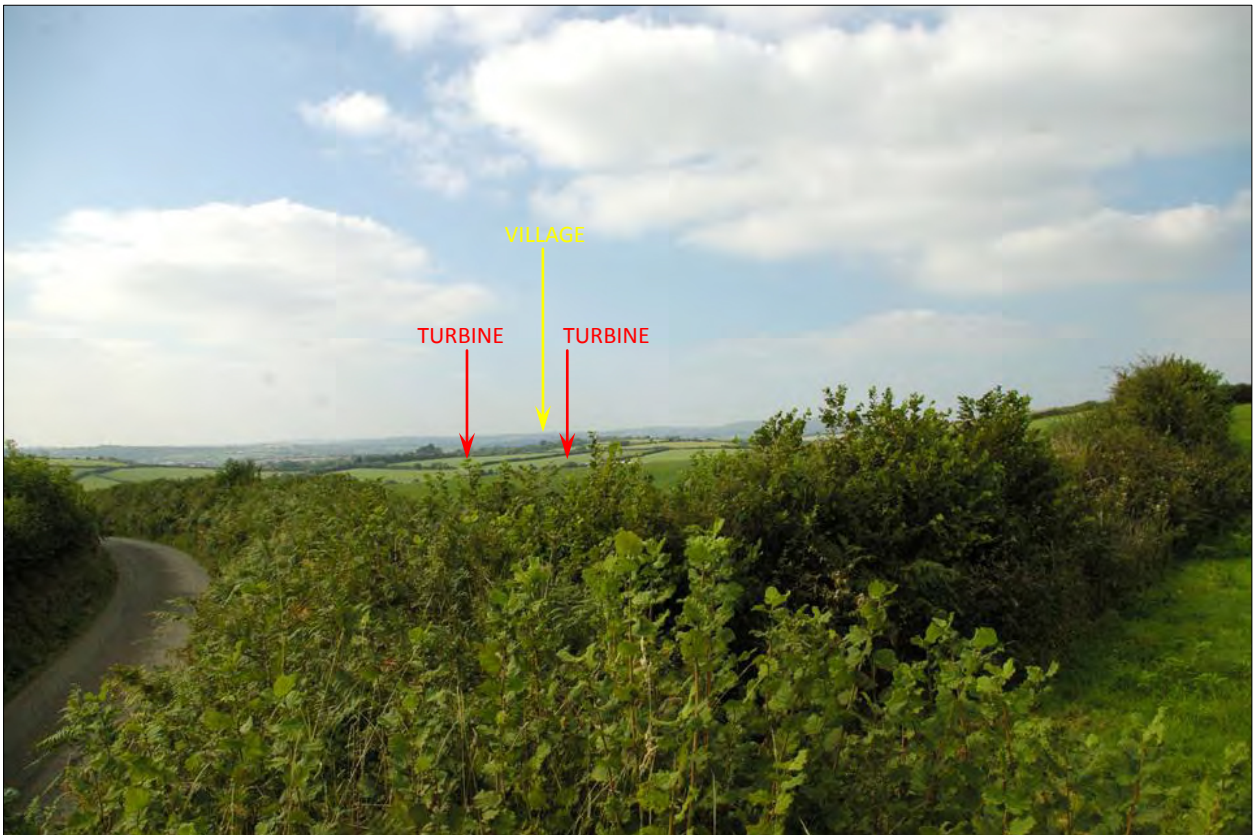
Quethiock: viewed from the south-east near Trewoodgate NGR: SX328639. The location of the proposed turbines is indicated, as is the location of the village.

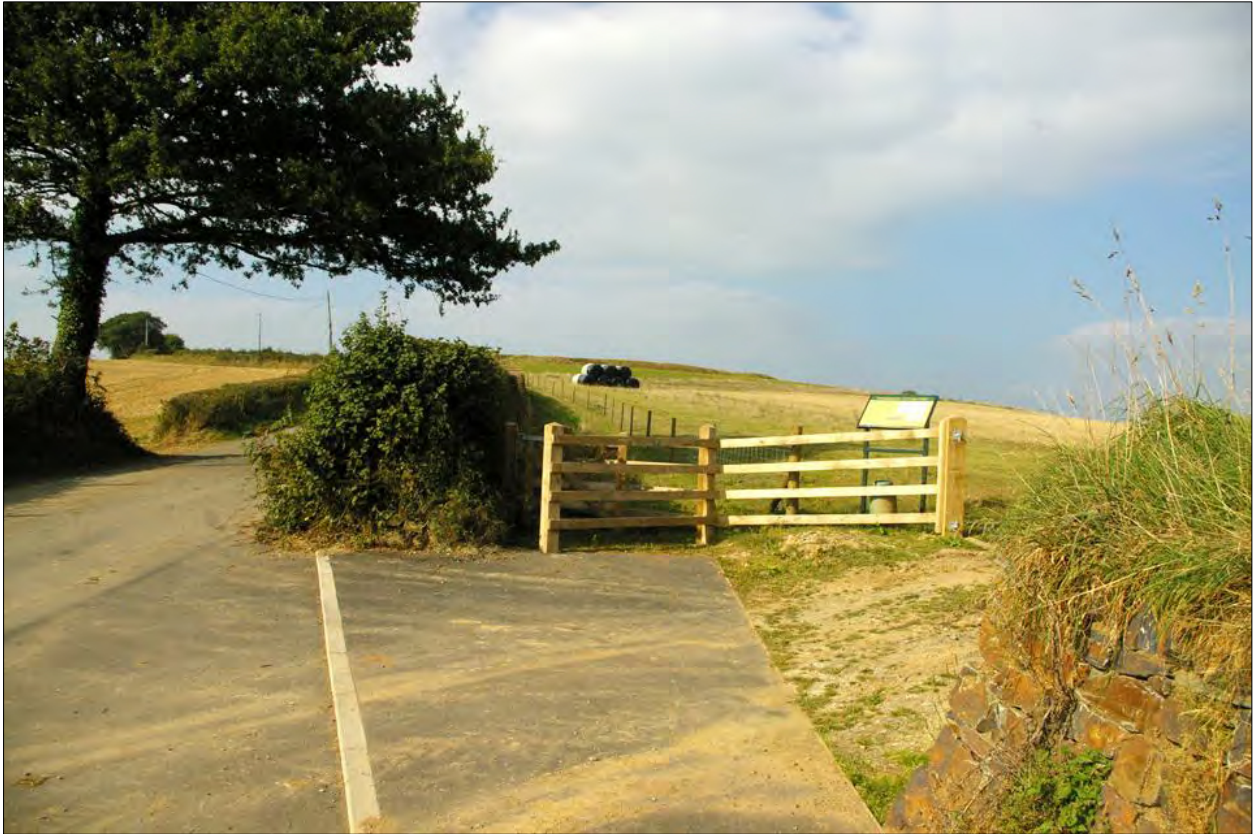
The hillfort at Padderbury Top; viewed from the south, looking north.

- Iron Age defended settlement at Padderbury Top, St Germans; high significance, Scheduled Monument; condition: good. Distance to turbine: c.3.6km. A strongly-defended hilltop with up to four banks and ditches, of which the first (inner) bank (more a sculpting of the hilltop than a bank *per se*) and ditch and third bank are visible. Smaller than most rounds, but more strongly-defended than many hillforts, the nature of occupation here remains uncertain. Located on a discrete hilltop south of Quethiock, the choice of location was clearly influenced by visibility, as it enjoys excellent 360° views. The proposed turbines would not be located within the landscape context of this asset, and would have no affect on its immediate setting; nor would they feature in views to the hilltop. The proposed turbines would, however, be visible from this hilltop fortification, at a distance of 3.6km. At this distance the turbines would constitute one component within a wider historic landscape that contains other strong modern vertical elements, principally the lines of electricity pylons that run east-west to both the north and south. On that basis, and the fact that the evidential value of the site is at least as important as its aesthetic value, an overall impact assessment of **negative/minor** is appropriate.

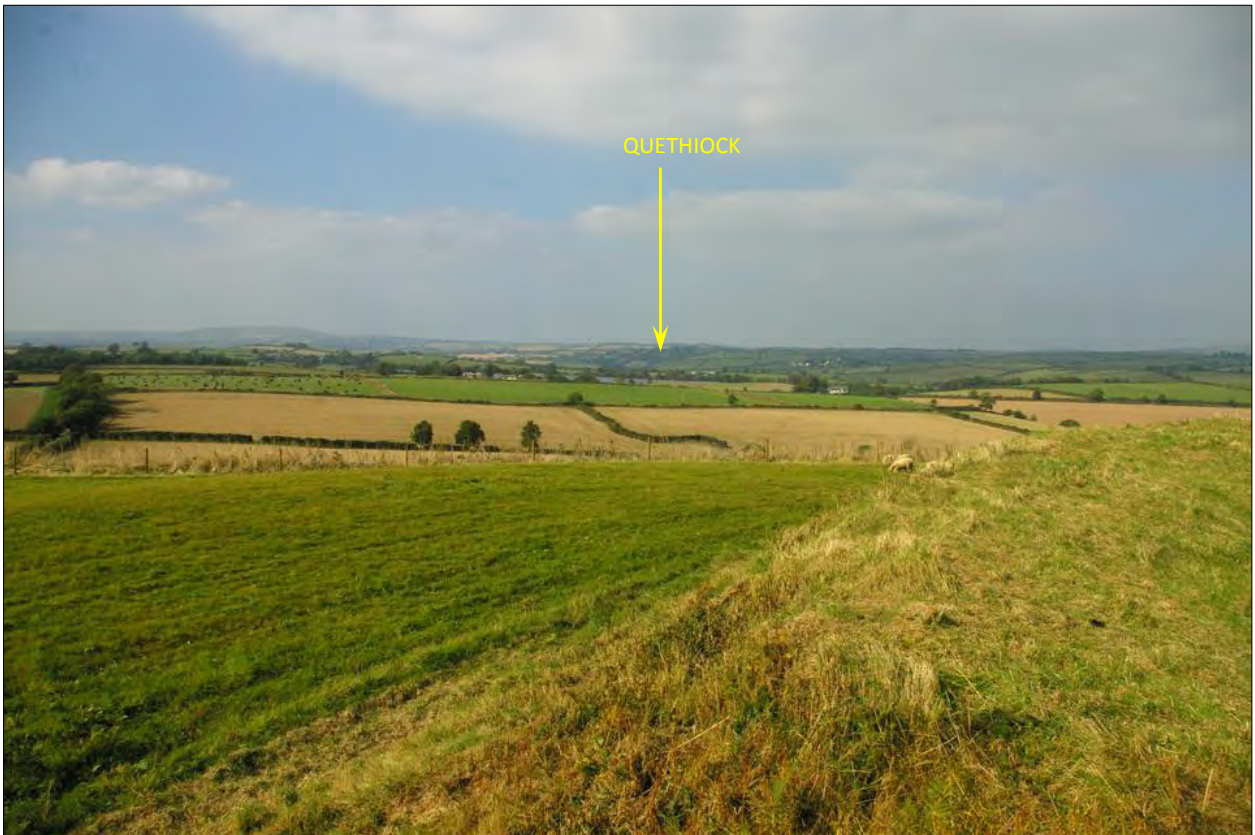
The view from Padderbury Top hillfort; viewed from the south, looking north. The location of Quethiock is indicated.

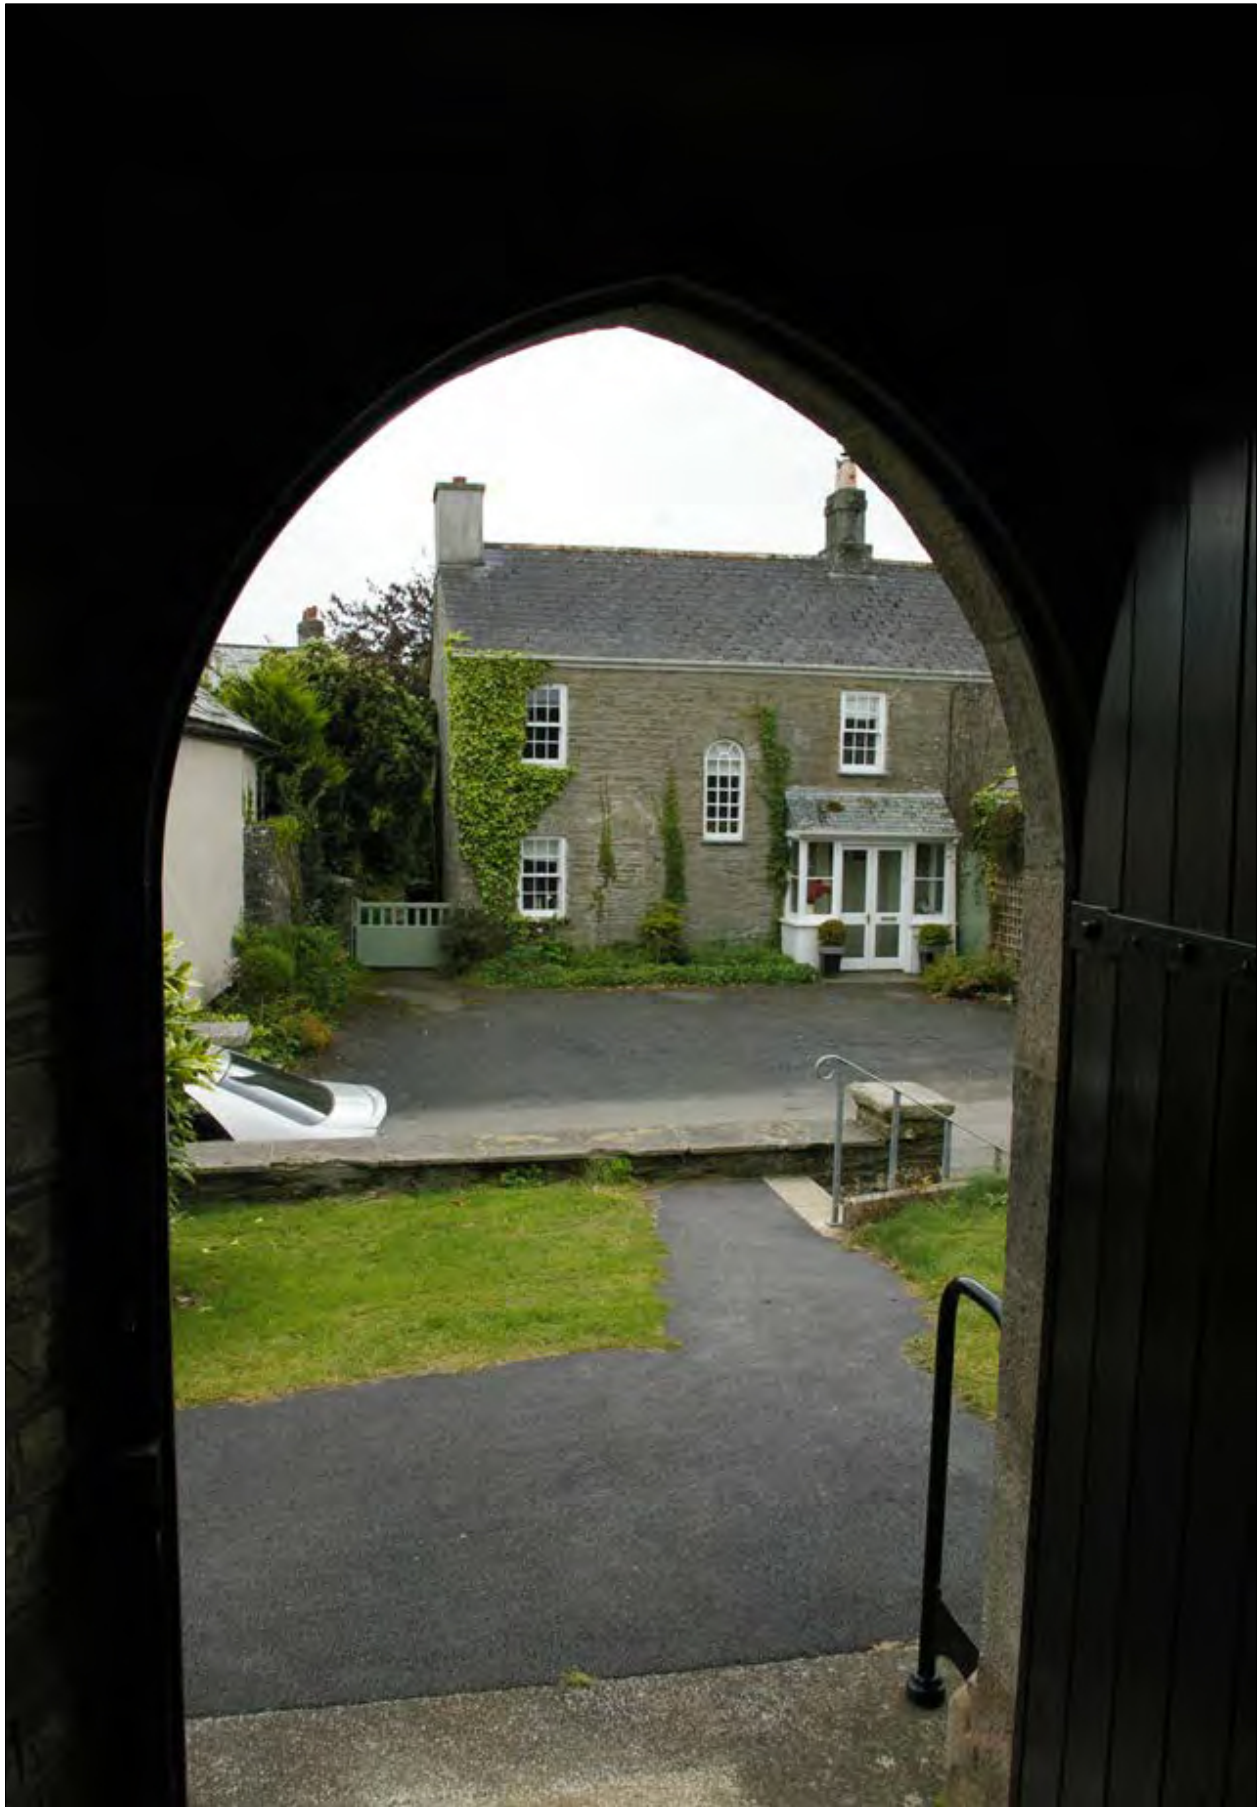
View from the porch of St Mary's Church at Merrymeet across to the north elevation of Merrymeet House; viewed from the north, looking south.

- Merrymeet House, Menheniot; medium significance; Grade II Listed; condition: fair to good. Distance to turbine: c.4.1km. Rubble stone house of c.1840, good period fenestration. Located within the settlement of Merrymeet adjacent to the chapel, set back from the parish road to the north, with a long garden with mature deciduous trees stretching down to the A390 to the south. The settlement is located on a level hilltop, and the ground falls away to valleys to the east and west. The proposed turbines would not be located within the landscape context of this asset. The buildings and garden trees of the settlement provide the setting for this asset, and also comprehensive local blocking. Views from the house are restricted to those along the

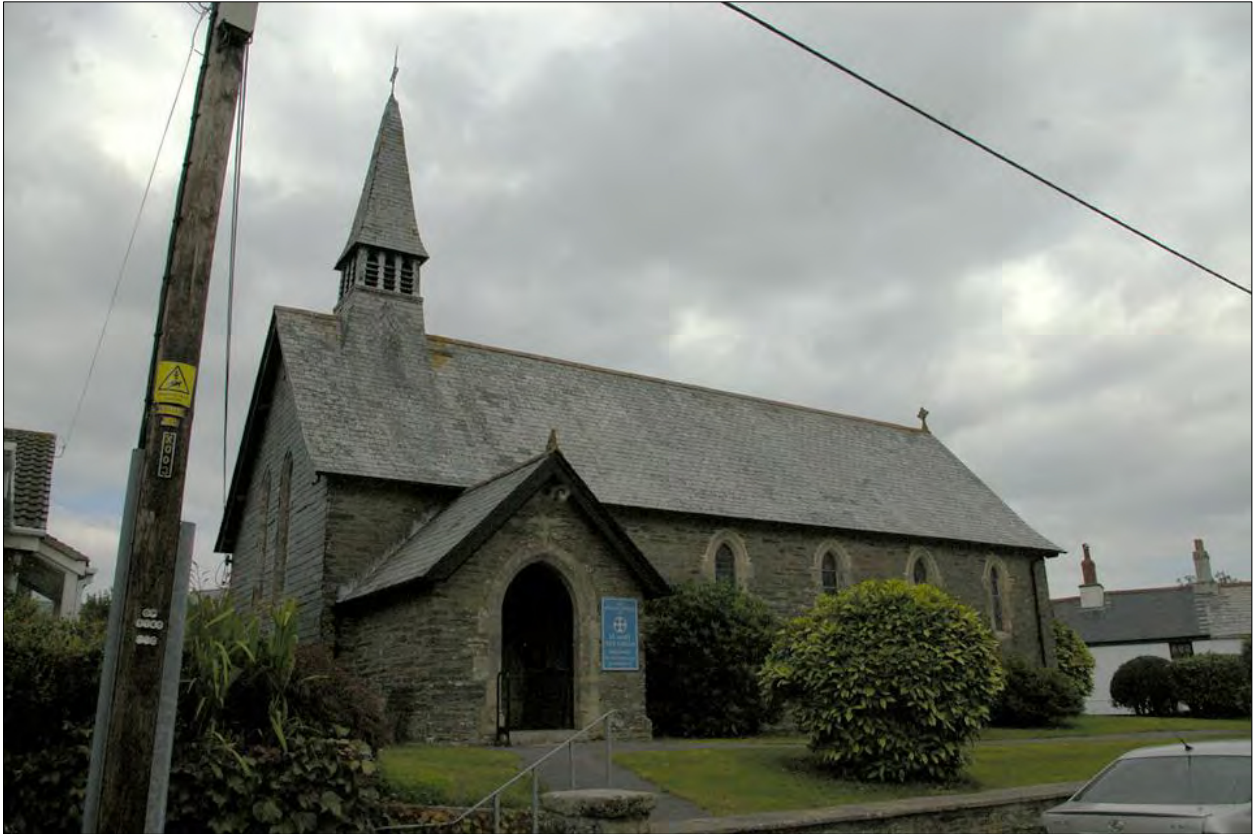
The Church of St Mary at Merrymeet; viewed from the south-south-west, looking north-north-east.

- Church of St. Mary the Virgin, Menheniot; medium significance; Grade II Listed; condition: good. Distance to turbine: c.4.1km. A 1905 chapel-of-ease. Rubble-stone walls, slate roof and small timber belfry with elegant spire rising from the apex of the gabled roof at the west end. Located in the centre of Merrymeet, a settlement located on a level hilltop with the ground falling away to valleys to the east and west. The proposed turbines would not be located within the landscape context of this asset. The buildings and garden trees of the settlement provide the setting for this asset, and also comprehensive local blocking. Views from the chapel are restricted by the buildings to the south, and views back to the asset within its setting are similarly restricted; it has no wider landscape presence, although spire of the belfry is visible above the roofs of the adjacent houses. However, given the setting of the asset would not be affected, and views to and from the site are highly restricted, the impact of the proposed turbines would be **neutral**.

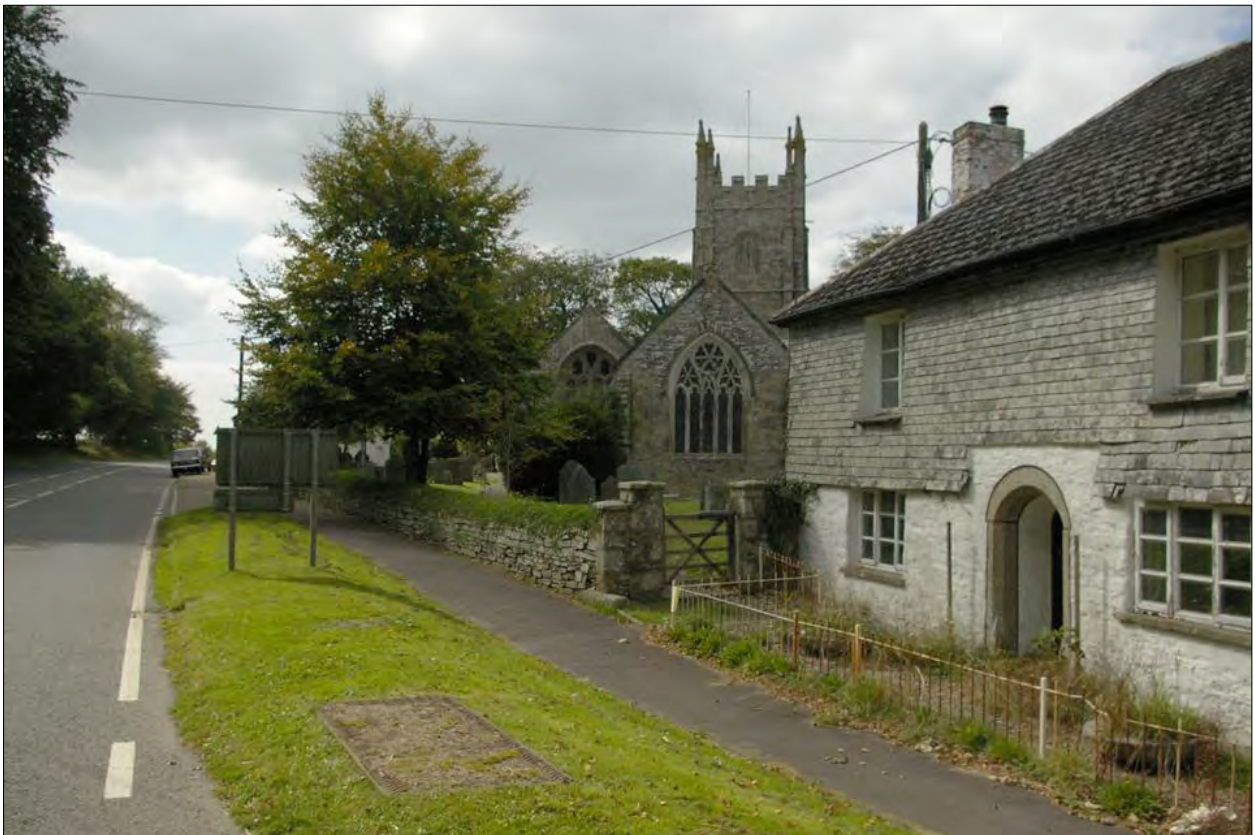
The Church of St Ivo, viewed from the east.

- Church of St. Ivo; various GII Listed tombchests, St Ivo; high significance; Grade I Listed; condition: good. Distance to turbine: c.2.8km. Also, two medieval crosses; high significance, both SAMs; condition: good. 14th century nave, north transept and chancel, 15th century south aisle and 14th-16th century two-stage tower with 12 pinnacles. One of the best Decorated Gothic churches in Cornwall 'and so of unusual importance and interest' (Beacham & Pevsner 2014, 552), with a series of external and internal architectural features (e.g. chancel with stylistic links to St Germans and Exeter Cathedral) of great merit. The church is located on a slight saddle between two hilltops, with the ground falling away to the north-west and south-east. The proposed turbines would not be located within the landscape context of this asset, and it does not fall within the ZTV. The setting of the asset within its small churchtown settlement would not be affected, and views from the church and yard are restricted by the adjacent buildings and trees (e.g. across the A390, for instance). The tower does, however, project a little distance above the trees in the churchyard, and is thus a landmark asset. However, given the location of the tower with respect to the proposed turbines, the impact of

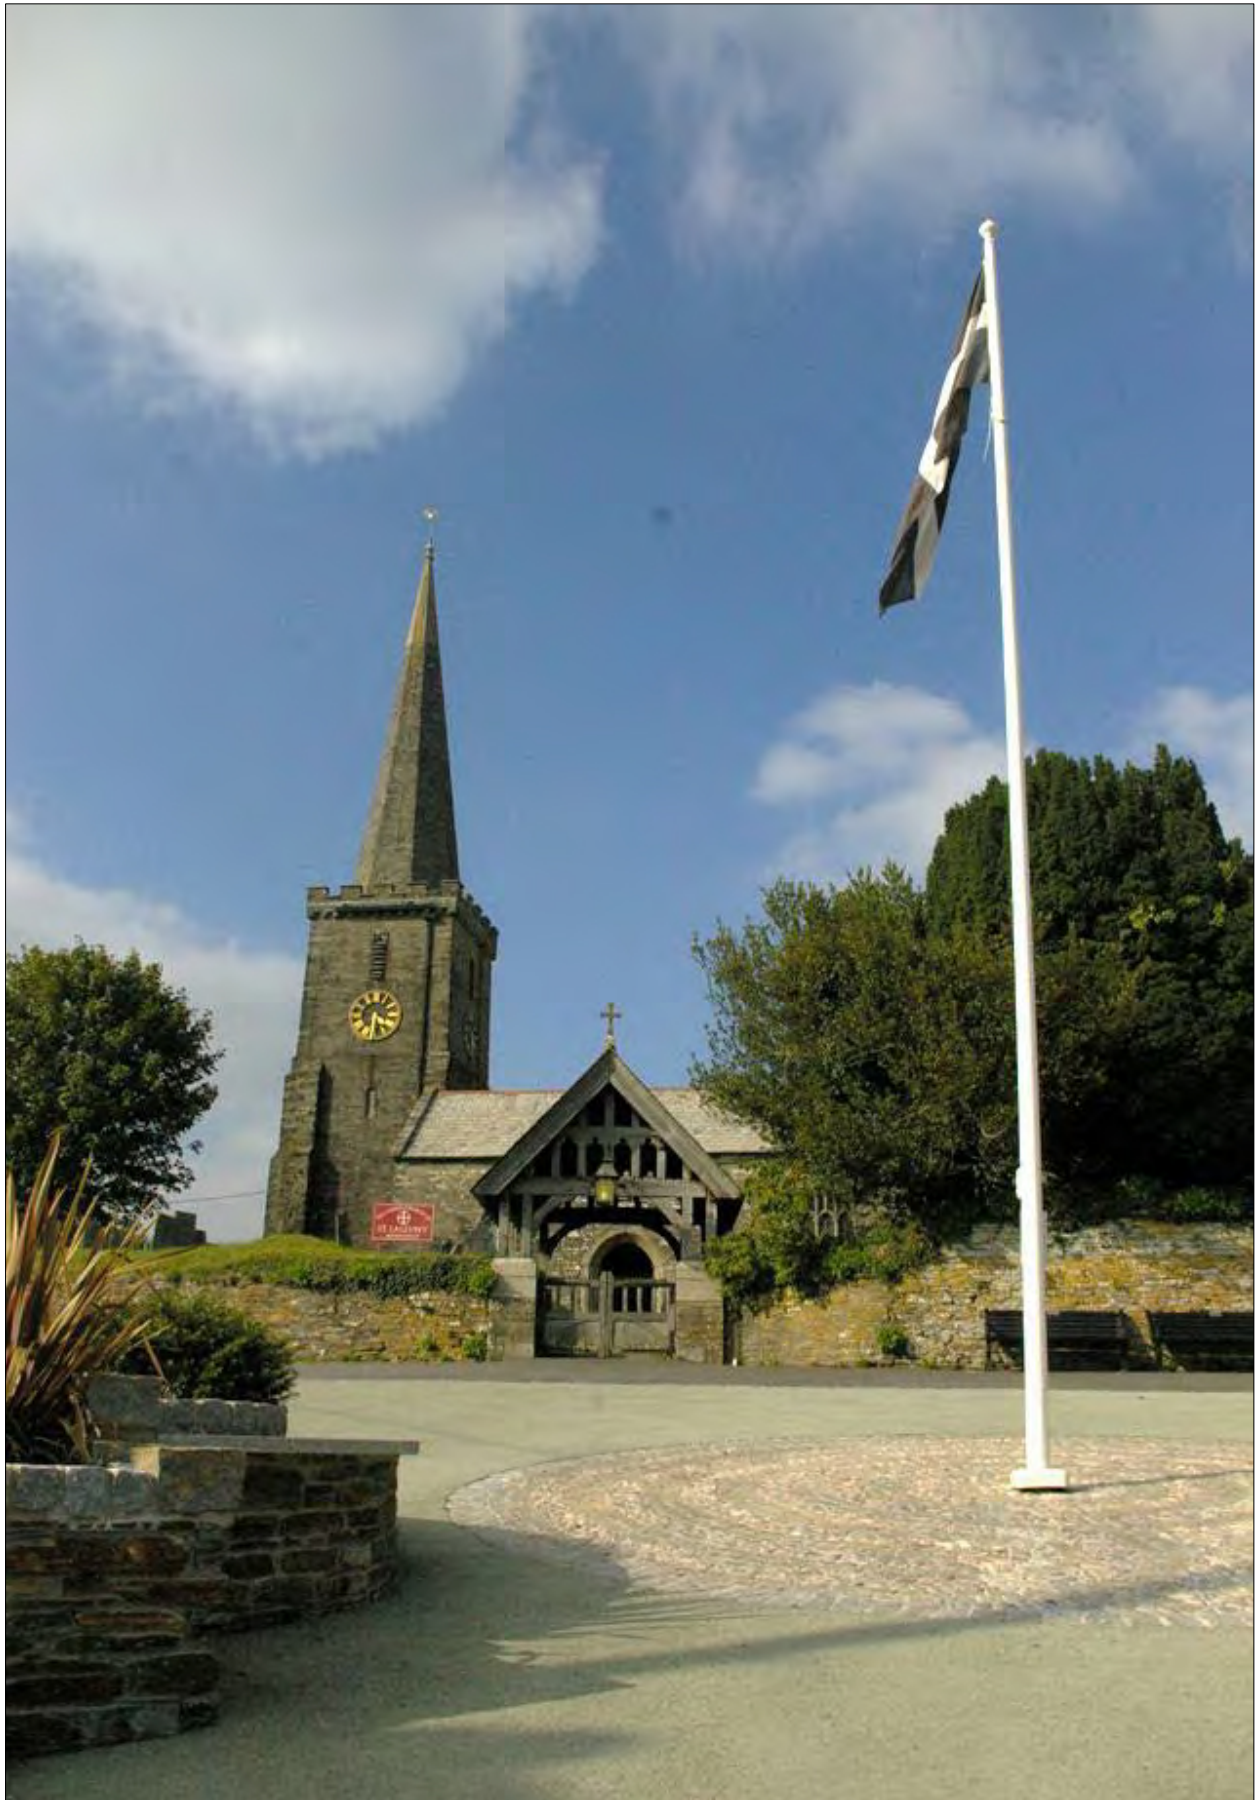
The Church of St Lalluwly at Menheniot; viewed from the south, looking north.

- Church of St. Lalluwly, Menheniot; various GII Listed tombchests; high significance Grade I Listed; condition: good. Distance to turbine: c.3.5km. 15th century church with earlier two-stage tower with tall spire; this is a landmark asset. Good interior features. The church sits within a sub-circular churchyard, with the older part of Menheniot arranged around it. The church is located on the south-facing slopes of a hill, on a level area overlooking a deeply-incised narrow valley to the west, and the confluence of a series of narrow valleys to the south. The proposed turbines would not be located within the landscape context of this asset, and it does not fall within the ZTV. The setting of the asset within its churchtown settlement would not be affected, and views from the church and yard are largely restricted to the south and away from the turbines. The spire is, however, a landmark asset; it is fairly prominent in views from high ground to the south and some of these views (e.g. Padderbury Top, but does not break the skyline from this vantage point) would also include the proposed turbines. On balance, as it is only the landmark character of the church spire from the south and south-west that is an issue, and given that the proposed turbines are fairly small, an impact assessment of **negative/minor** to **negative/moderate** is appropriate.

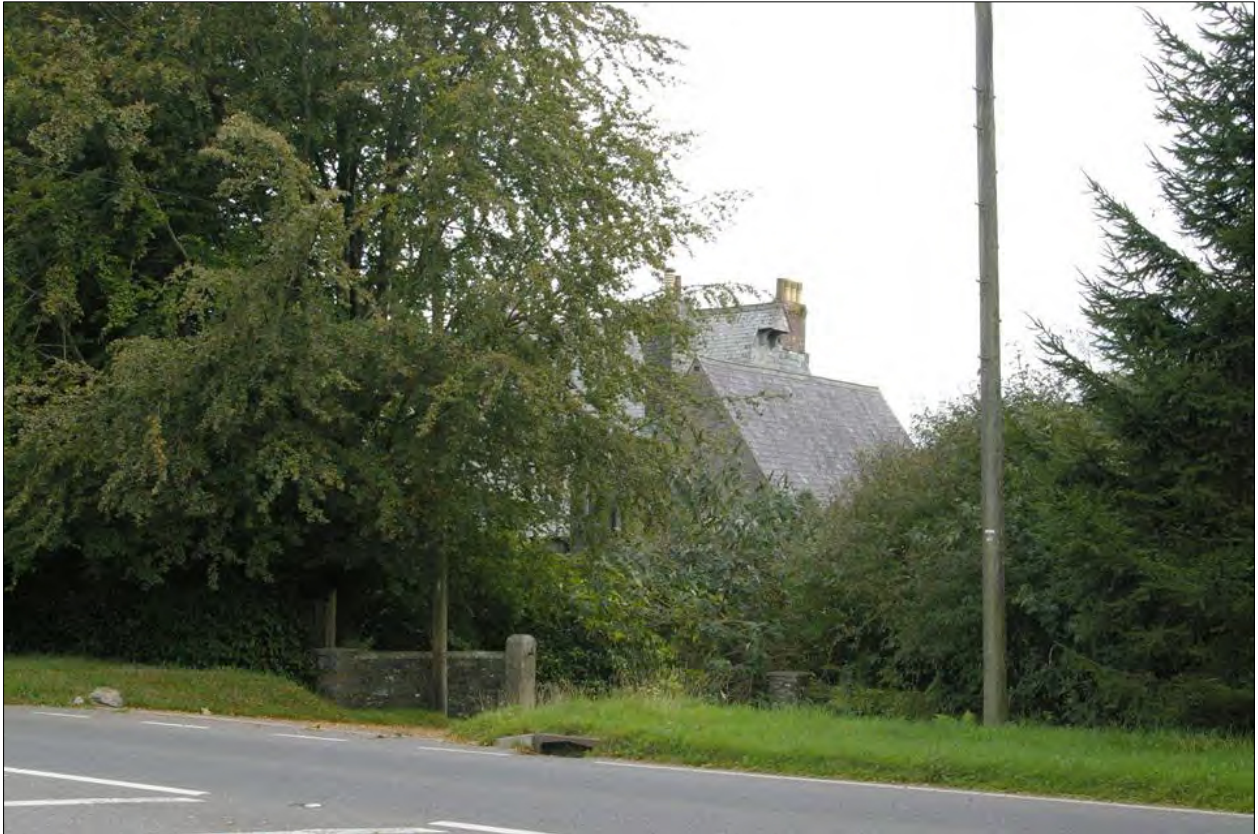
The Chantry at St Ive; viewed from the north-west, looking south-east.

- Chantry, St Ive; high significance; Grade II* Listed; condition: fair to good. Distance to turbine: c.2.6km. Former rectory, built 1852-4 by William White for Canon Reginald Hobhouse. Gothic (fantasy) vernacular style, but not in plan, with separation of ecclesiastical and secular elements; good interior and exterior features, 'boldly massed with striking verticality of outline with very steeply-pitched roofs and irregular elevations full of architectural incident' (Beacham & Pevsner 2014, 554). Reception rooms on the south and east side. Emily Hobhouse (d.1926) has associational links to South Africa and the Boers. Located at the head of a valley, on a south-facing slope, just to the south of the A390 and the Church of St Ivo. The proposed turbines would not be located within the landscape context of this asset, and it does not fall within the ZTV. The garden to the south and east is lined with mature deciduous trees, which lends an enclosed feel to the property, despite the original intention that it be visible from the road. The setting of the asset, within the settlement and close to the church, would not be affected. Views to the property, where they are possible, would be from the south-east and east, and the proposed turbines would not feature in these views. Impact: **neutral**.
