LAND at TRECORME BARTON QUETHIOCK CORNWALL

Results of a
Historic Visual Impact Assessment

Report No.: 140912
Date: 12.09.14
Author: B. Morris

This report presents the results of a visual impact assessment carried out by South West Archaeology Ltd. (SWARCH) on land at Trecorme Barton, Quethiock, Cornwall, in advance of the construction of two 18m (25m tip) wind turbines.

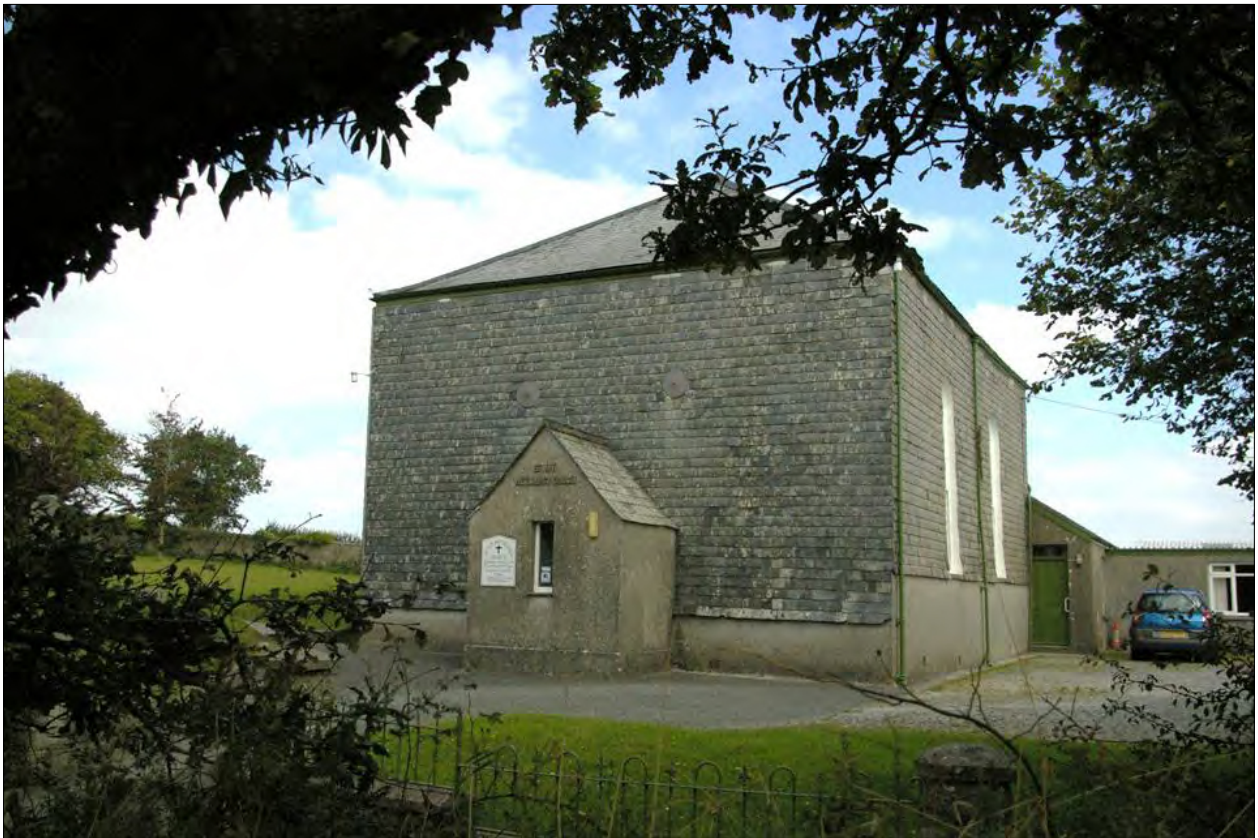
The Methodist Church at St Ive; viewed from the west, looking east.

- Methodist Church, St Ive; medium significance; Grade II Listed; condition: good. Distance to turbine: c.3.6km. c.1860 church with 1926 extension. Rendered and slate-hung rubble stone exterior with simple interior fittings. Located on the eastern side of St Ive, amid what appears to be a small 19th century hamlet. On a south-facing slope between two valleys. The proposed turbines would not be located within the landscape context of this asset, and would have no effect on its immediate setting. The chapel is open to the east, but trees and other buildings lie to the south, providing a measure of local blocking. The spiritual value of the asset outweighs both its evidential and aesthetic value; impact: **neutral**.

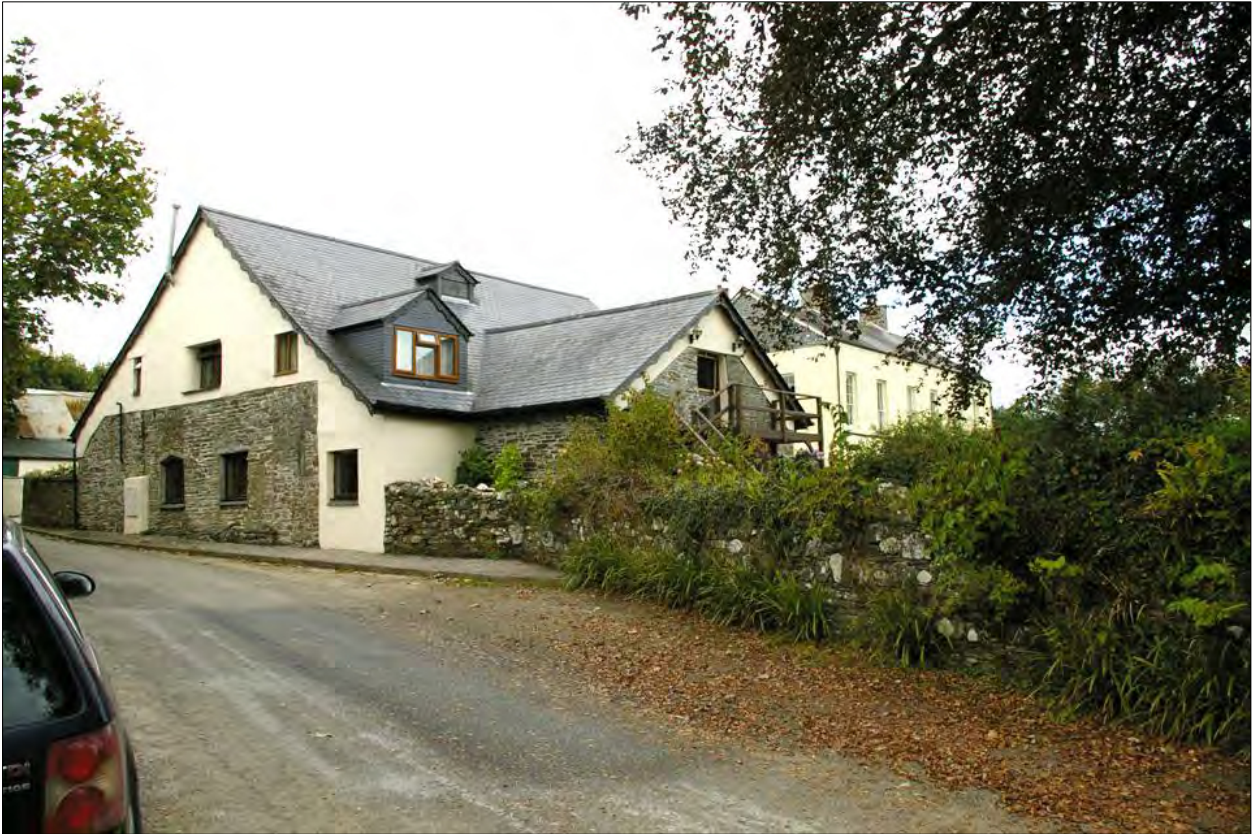
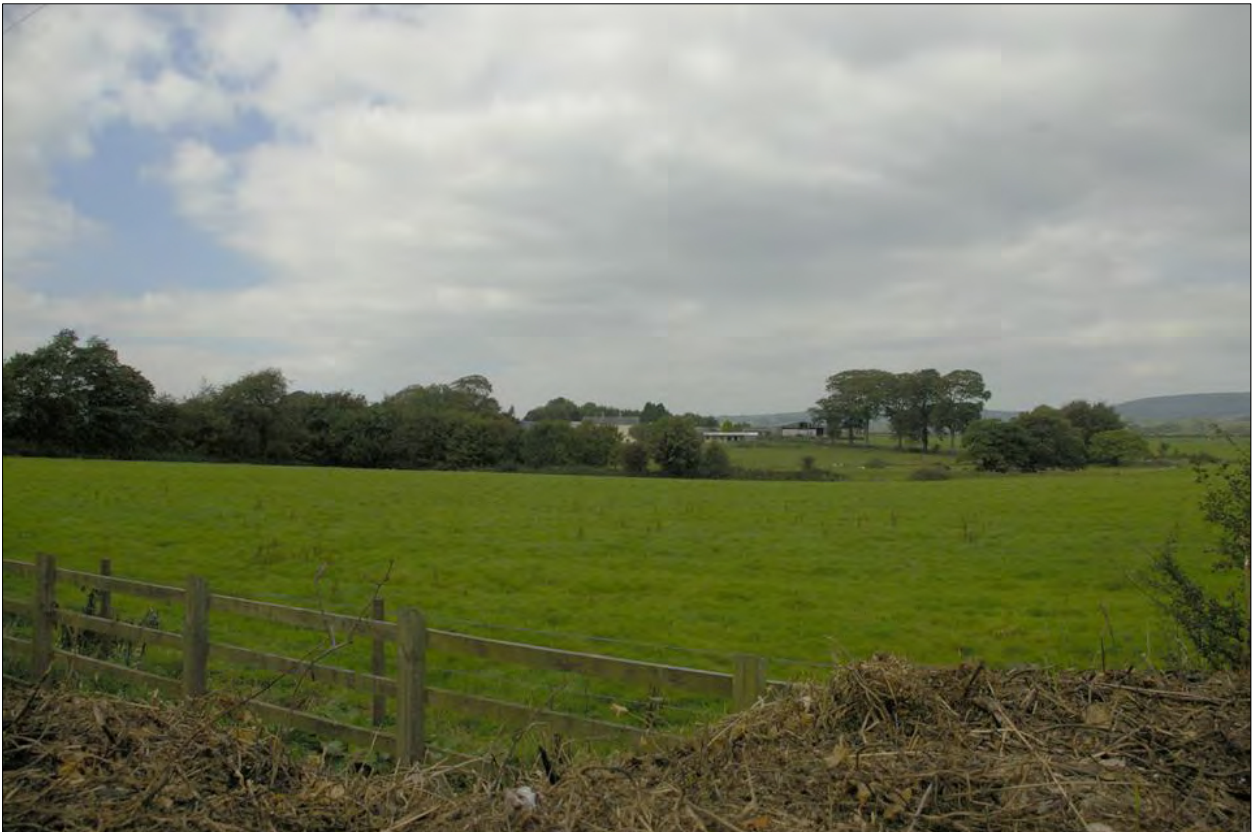
The converted farm building at Trengrove, with the Listed farmhouse in the background; viewed from the south-west, looking north-east.

Trengrove Farmhouse; viewed from the south-south-east, looking north-north-west.

- Trengrove Farmhouse, Menheniot; medium significance, Grade II Listed; condition: good. Distance to turbine: c.4.4km. 17th century farmhouse, substantially rebuilt in 18th century, with 19th century alterations. A range of stone-rubble farmbuildings to rear around a farmyard, some converted to residential use. The presentation elevation of the farmhouse faces south-south-east, across the fields towards Merrymeet. The site is located on the north-east lip of a narrow valley that drops down to the east; Lower Trengrove is located a little further down this valley and outside of the ZTV. The proposed turbines would not be located within the landscape context of this asset. Principal views to and from the farmhouse are from the south-south-east, across the shallow bowl-shaped depression at the head of the valley. Views beyond this landform are blocked by the buildings of Merrymeet. The setting of the farmhouse, with its

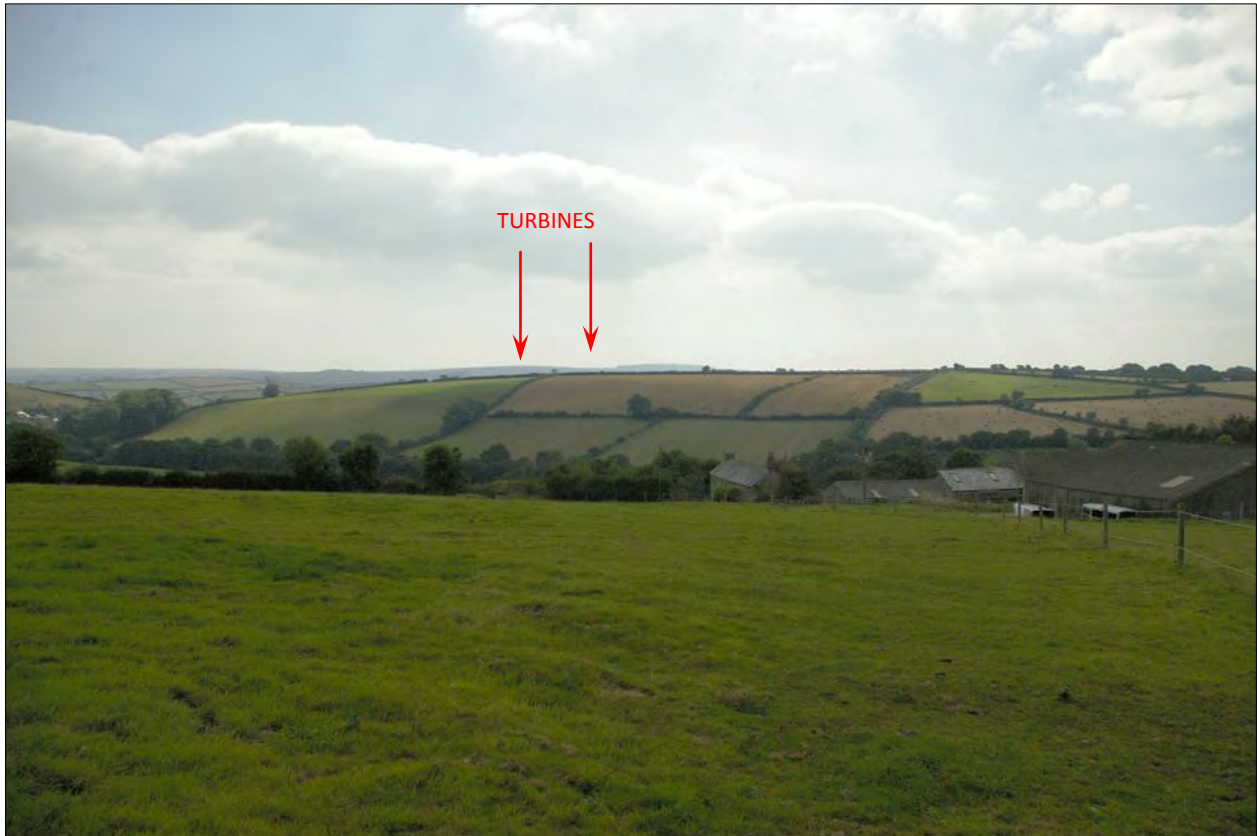
View over the farmstead at Hammett to the location of the proposed turbines (note they would be behind the shoulder of the hill); viewed from the north-east, looking south-west.

- Hammett, Quethiock; medium significance, Grade II Listed; condition: fair. Distance to turbine: c.1.1km. A mid 18th century farmhouse with presentation elevation with large sash windows with brick reveals, as remodelled in mid 19th century. The front of the farmhouse faces along the valley slope to the east. To the rear (west/north-west) there is a collection of undesignated stone-rubble farm buildings around a yard. The farmstead is located on a south/south-west slope perched above the valley to the east of Quethiock, by the side of a parish road. The proposed turbines would be located on the other side of the valley, around the shoulder of the hill to the south-south-west but visible over it. The proposed turbines would not be located within the immediate landscape context of the farmstead, and would not affect the appreciation of its setting. They would be visible from the farmstead, with minimal local blocking, but would not frame views back to the asset. On balance, given the size of the proposed turbines and the fact views are less relevant to the importance of this asset, an impact assessment of **negative/minor** is appropriate.

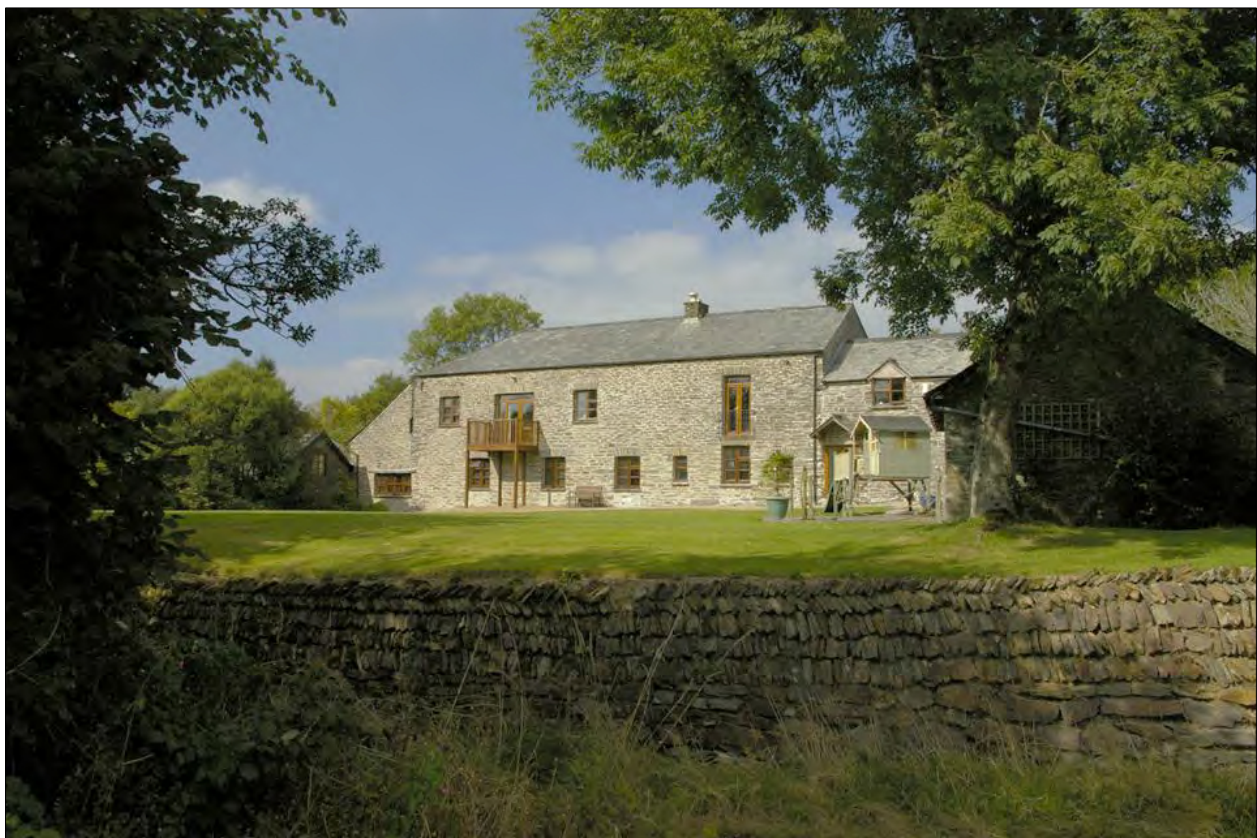
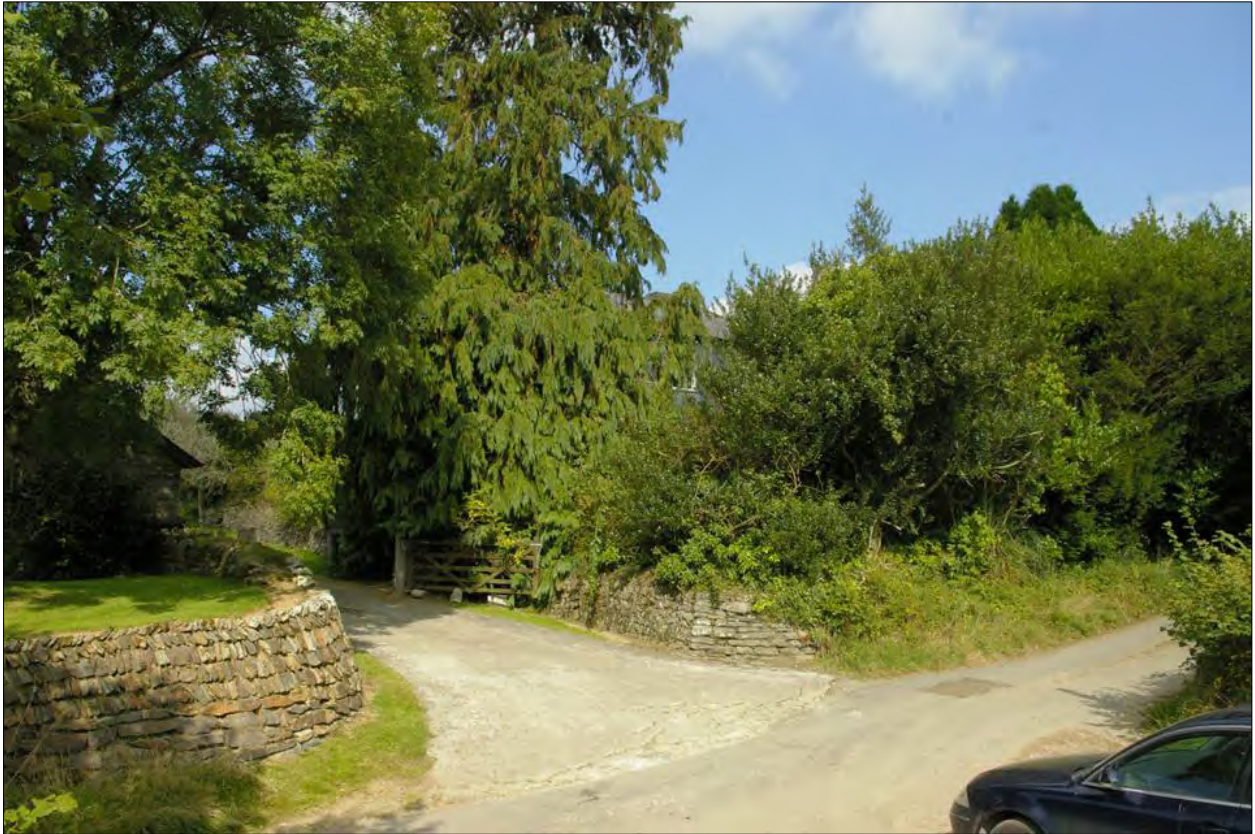
The converted barn at Treweese; viewed from the south.

The farmhouse at Treweese; viewed from the south-west.

- Treweese Farmhouse, Quethiock; medium significance, Grade II Listed; condition: good. Distance to turbine: c.1.4km. A mid 19th century farmhouse with associated (converted) farmbuildings. The farmstead is located within a short narrow combe to the west of Quethiock, on a south-west facing slope. The ground rises to the north, east and south, lending it a very enclosed feel. The proposed turbines would not be located within the landscape context of this asset. Mature deciduous trees and tall hedgebanks topped with mature hedge shrubs provide additional local blocking. The nature of the terrain restricts views to or from the farmstead; the proposed turbines would not be visible from the farmhouse, nor would they frame views to the asset. Impact: **neutral**.

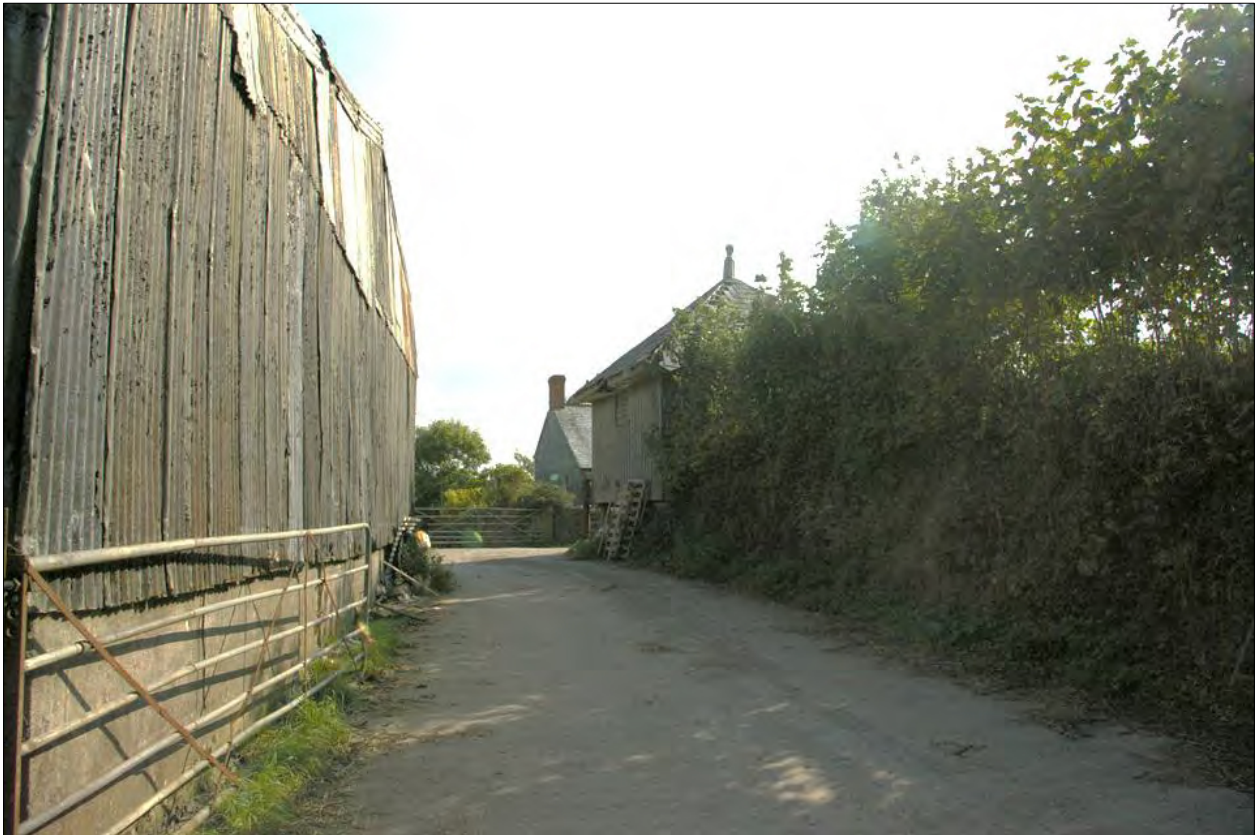
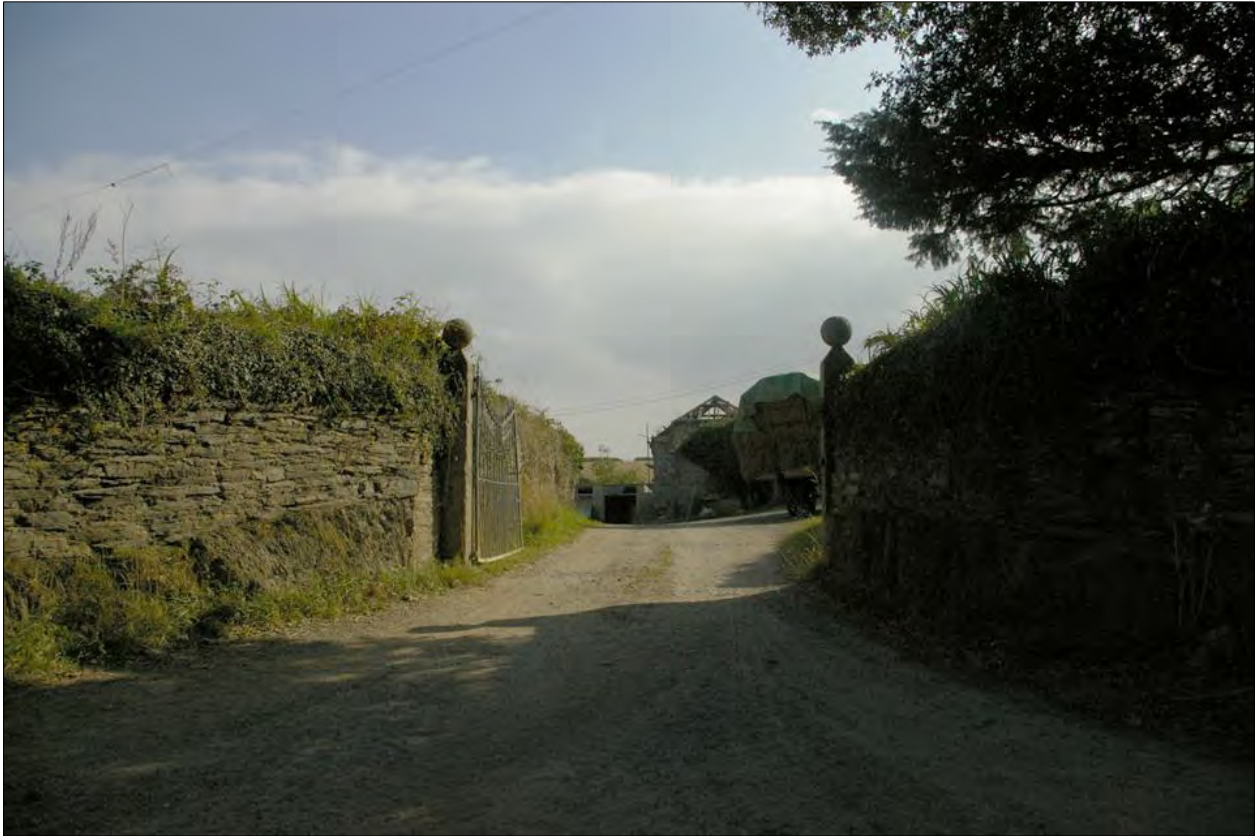
The house and granary at Trehawke, viewed from the public road; from the north, looking south.

The Listed gate piers and barn at Trehawke; viewed from the north, looking south.

- Trehawke, with Granary, Gate piers and Barn, Menheniot; all medium significance, Grade II Listed; condition: fair but deteriorating. Distance to turbine: c.2.7km. Large mid 17th century

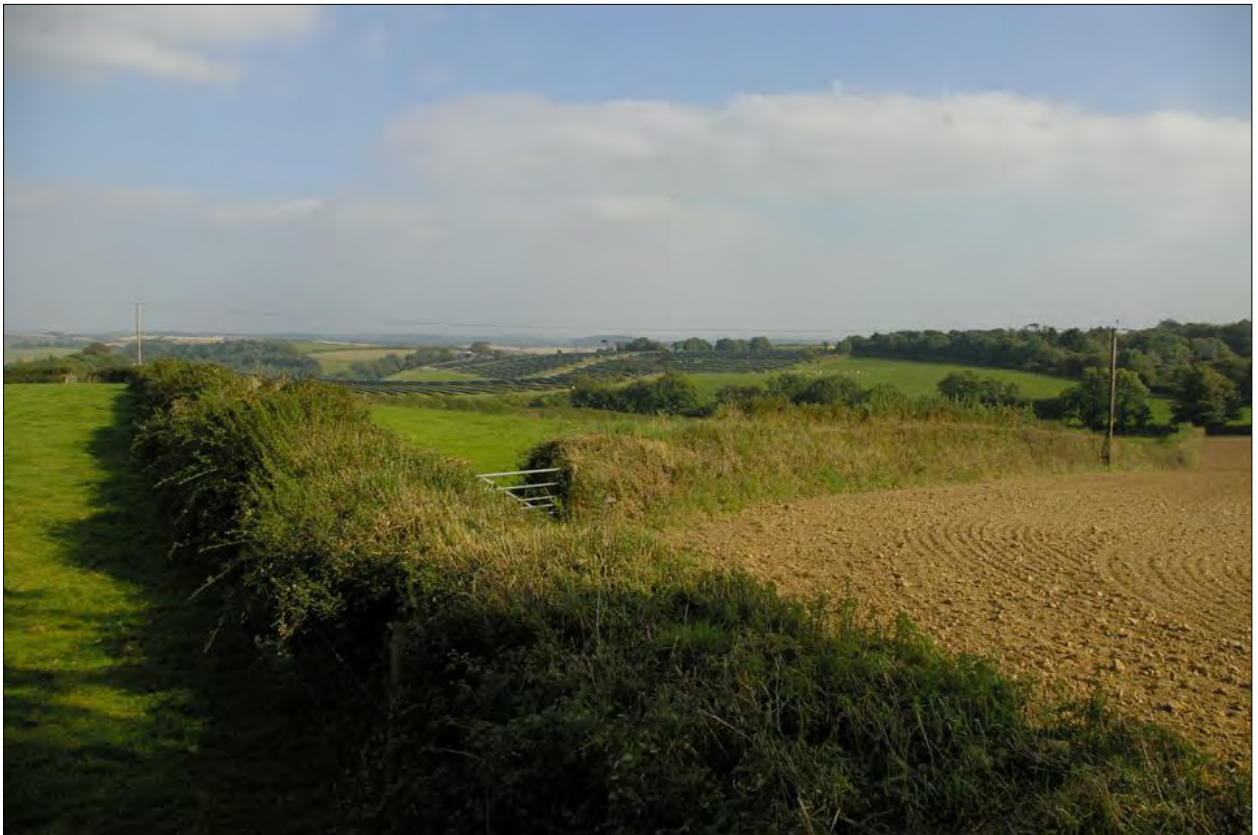
View back to Trehawke from the north-west [NGR: SX304625], showing the solar PV array located immediately to the north of the farm.

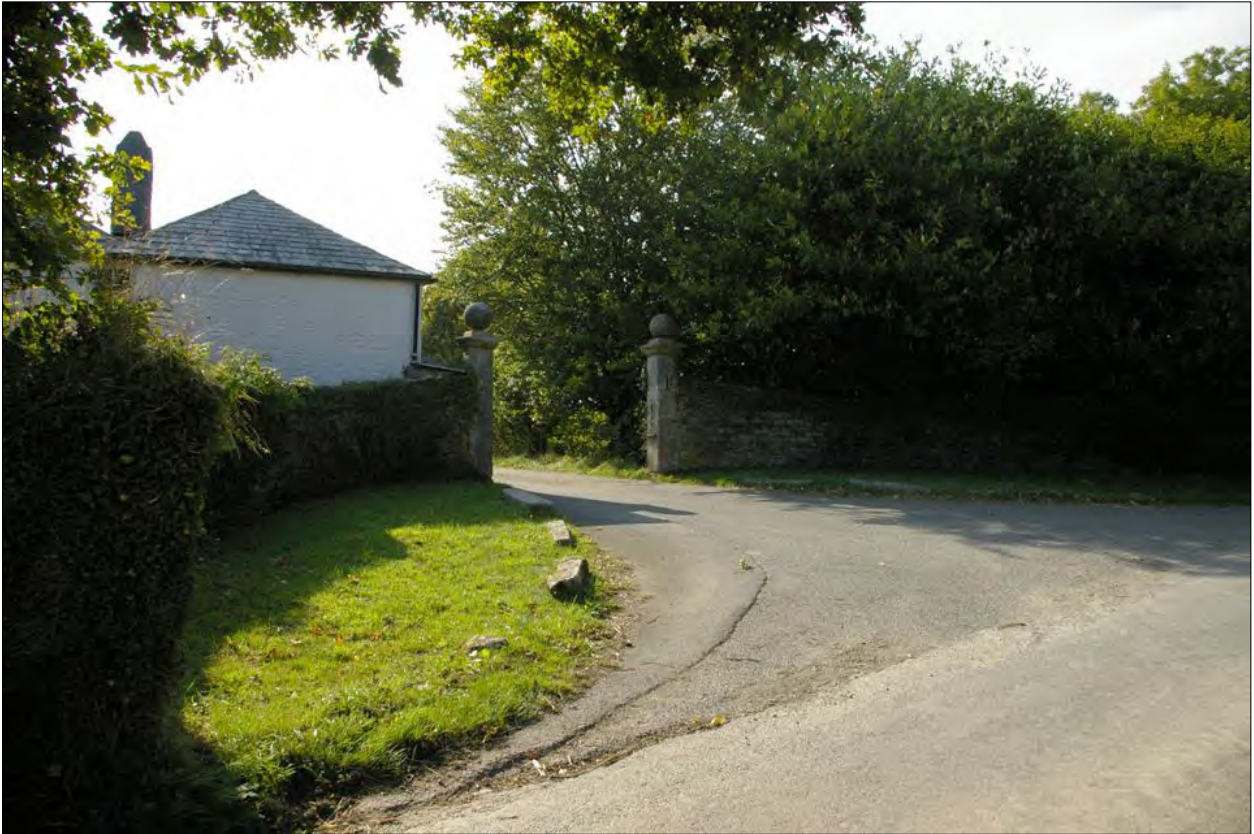
The Listed gate piers at the eastern entrance to Coldrenick; viewed from the south-east, looking north-west.

- Gate piers at east entrance of Little Coldrenick House, Menheniot; medium significance; Grade II Listed; condition; good. Distance to turbine: c.2.8. A pair of early 18th century square-plan piers with moulded cornice and large ball finials. With flanking walls and lodge adjacent, set back from the parish road; the house itself was demolished in c.1950. The gate is located at the top of a hill, with the land falling away gently in all directions. The proposed turbines would not be located within the landscape context of this asset. Despite their location on the top of a hill, the fact that the parish roads are incised and the hedgebanks are built up means views to and from the assets are restricted to the immediate vicinity. The hedgerow shrubs to the north have been allowed to mature, and thus local blocking is comprehensive. Impact: **neutral**.

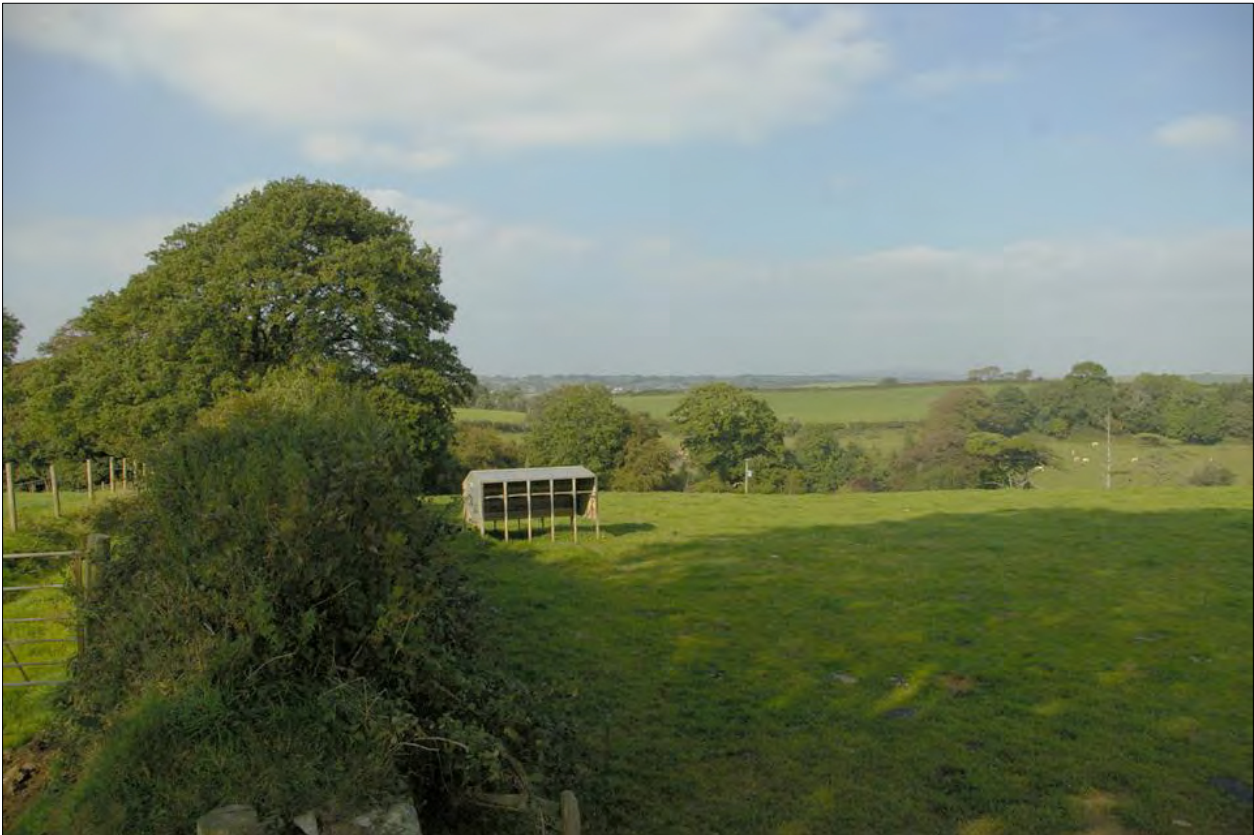
View down onto Trenodden (in the trees) from the south.

- Trenodden farmhouse, and Stables to south, Menheniot; medium significance, Grade II Listed; condition: unknown. Distance to turbine: c.2.4km. A 17th century farmhouse, possible three-room cross-passage type, with 1870s Mine Captain's house built adjoining. 1870s stables, converted to residential use. The house faces down the valley to the east, with hints of polite planning. The farmstead is located at the base of a narrow valley, lending it a very enclosed feel. The proposed turbines would not be located within the landscape context of this farmstead, and the whole farmstead almost certainly falls outside the ZTV. The setting of the farmstead would not be affected, as views to the farm are only possible from higher ground immediately adjacent, and views from the farm are to the east, along the valley. Impact: **neutral**.

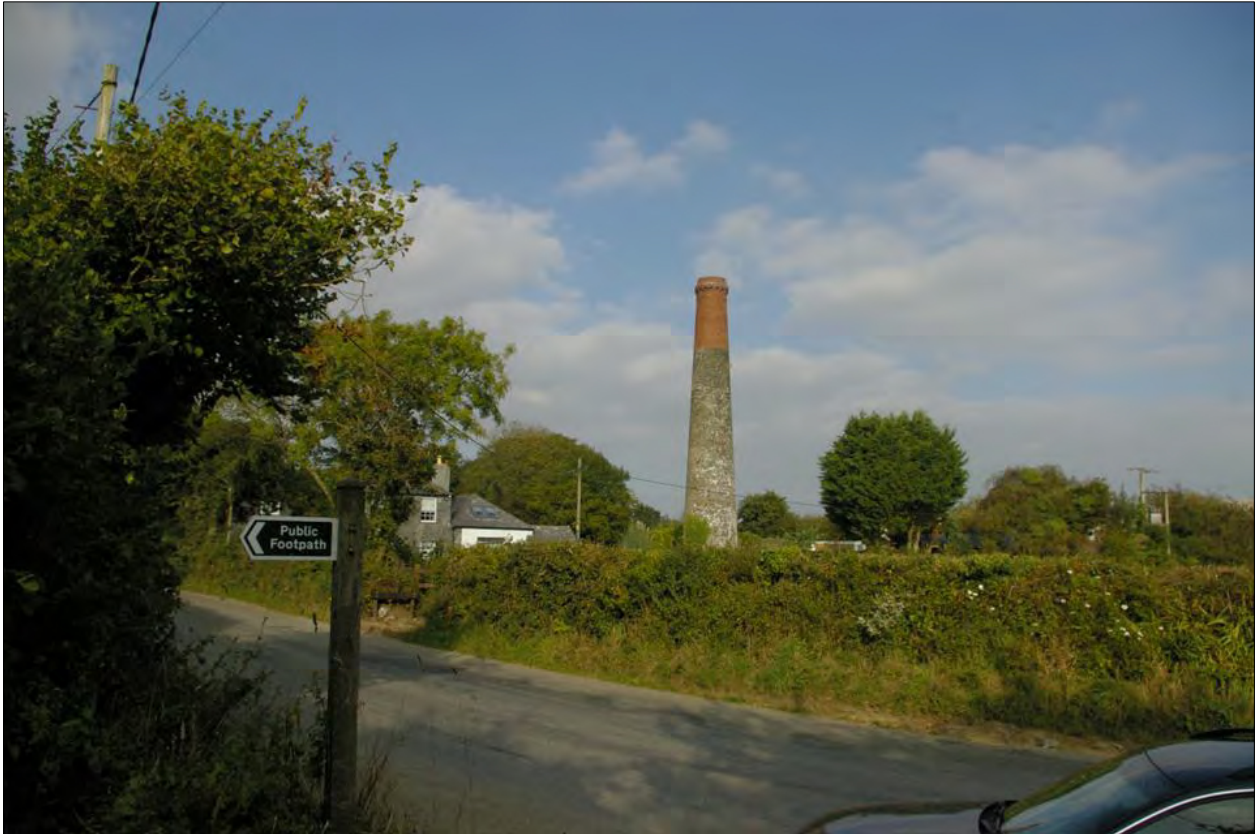
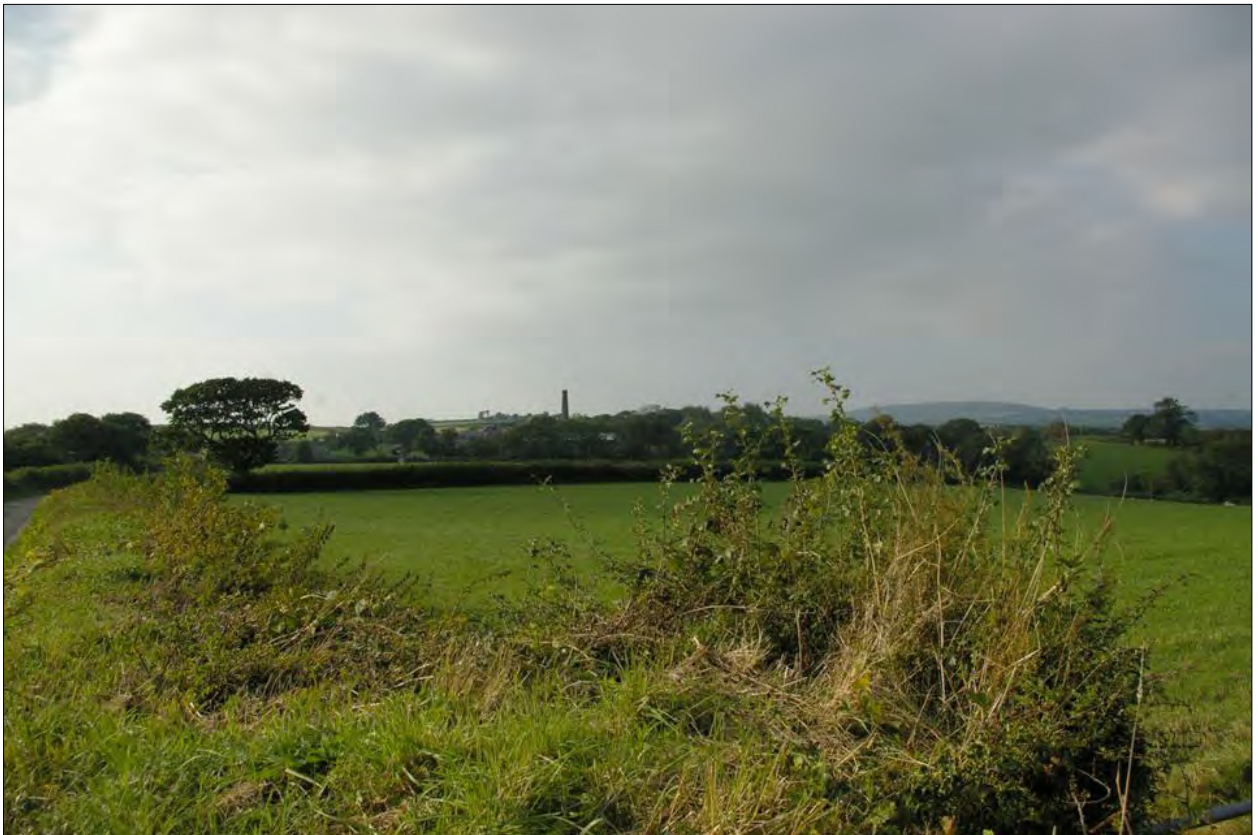
The Listed chimney at Honey Wheel; viewed from the west, looking east.

The chimney at Honey Wheel; viewed from the south-west, looking north-east [NGR: SX291638].

- Wheal Honey Stack, Menheniot; medium significance, Grade II Listed; condition: fair to good. Distance to turbine: c.3km. A tall mine chimney, rubble stone below with brick above, and some good detailing. The mine was operational 1845-1884. This is a landmark asset. The former mine site is located in a saddle between three areas of higher ground, with narrow valleys to the south, east and north; the saddle is fairly level, sloping only slightly to the south-east. Little evidence of the former mine remains; the hedgebanks in the immediate area have been allowed to grow up, presumably to provide screening for the houses and semi-industrial buildings now located at the site. The proposed turbines would not be located within the landscape context of this asset, and views from the asset out to the surrounding countryside are restricted by the buildings and deciduous trees/shrubs in the immediate area. It is, however, a landmark asset, and does break the skyline. Views back to the chimney from the east would not include the turbines, and views from the west would place the proposed turbines even further away. On balance, therefore, given the size of the proposed turbines and their location in respect to the chimney, an impact assessment of **negative/minor** is appropriate.

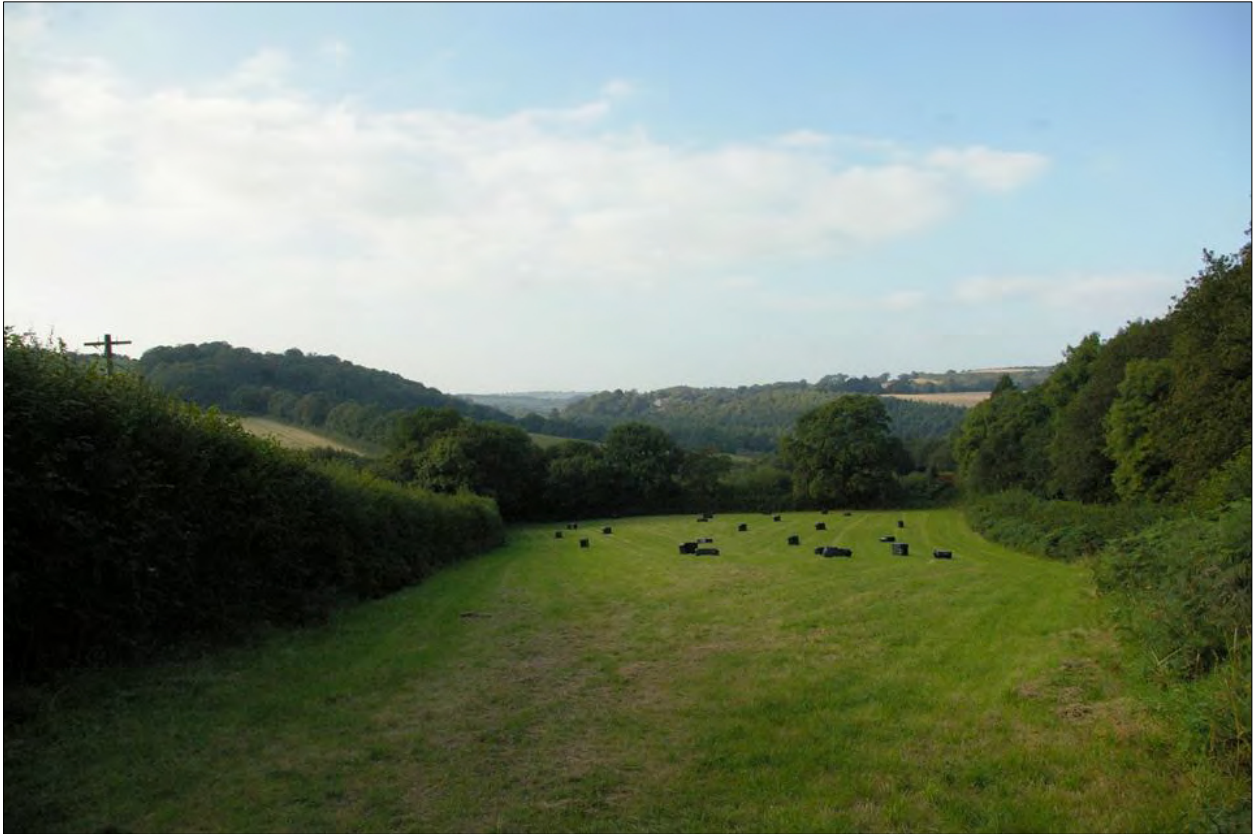
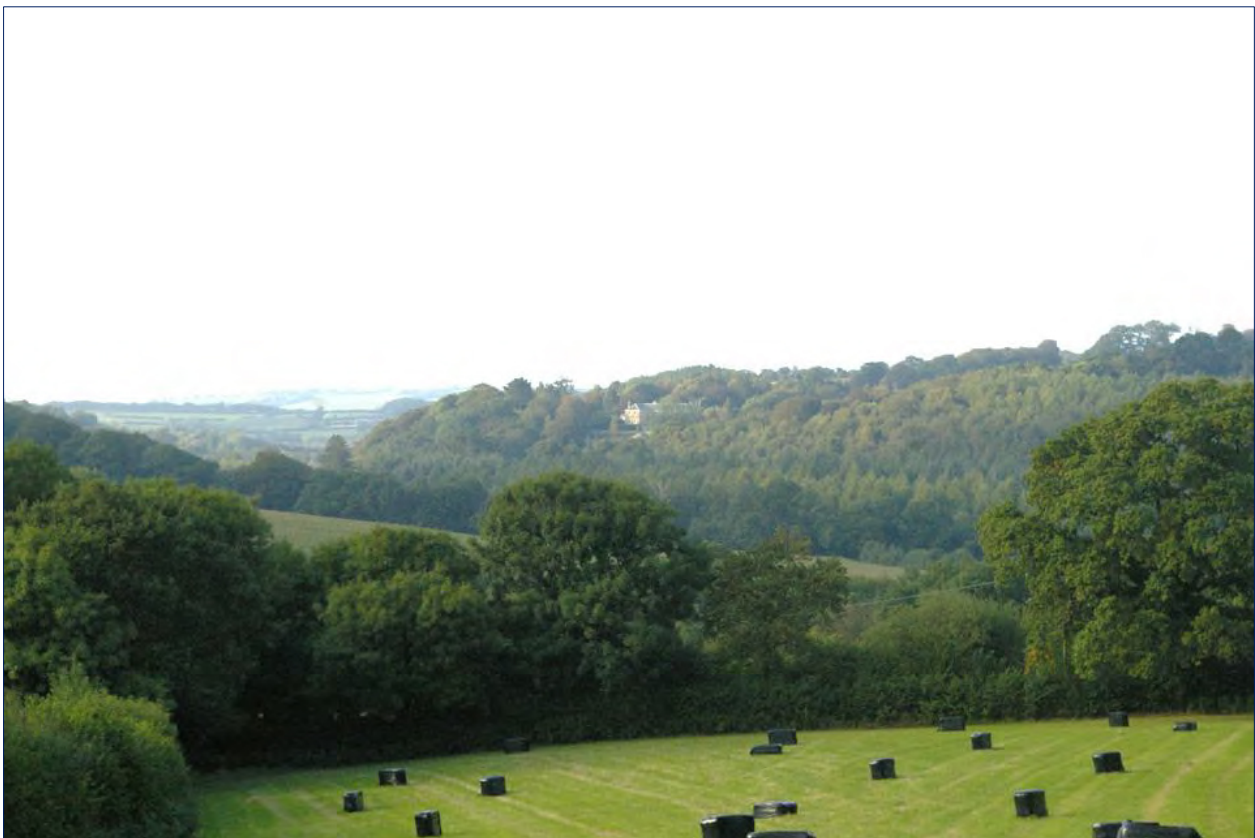
View across the valley of the River Lynher to Newton Ferrers House; viewed from the south-west, looking north-west, from NGR: SX348645.

As above, detail showing the house amid the trees.

- Newton Ferrers House, St Mellion; high significance; Grade I Listed; condition: good. Multiple associated GI assets including: three sets of gate piers, the terrace, and statues on the terrace; GII assets include: bakehouse, barn, store and garage. Distance to turbine: c.3.2km. Large late 17th century gentry house positioned overlooking the valley of the River Lynher; classical design, with two-storey H-plan. The centre and west wing gutted by fire in 1940, only finally restored in the 1990s. To the front, there is a series of 17th century terraces. The complex is located on a narrow spur projecting into the valley of the River Lynher, with the ground dropping away on three sides. The proposed turbines would not be located within the landscape context of this asset, and it does not fall within the ZTV. Principal views to the site in its setting are largely from the south and south-south-east, and would not include the proposed turbines. On that basis, an impact assessment of **neutral** is appropriate.

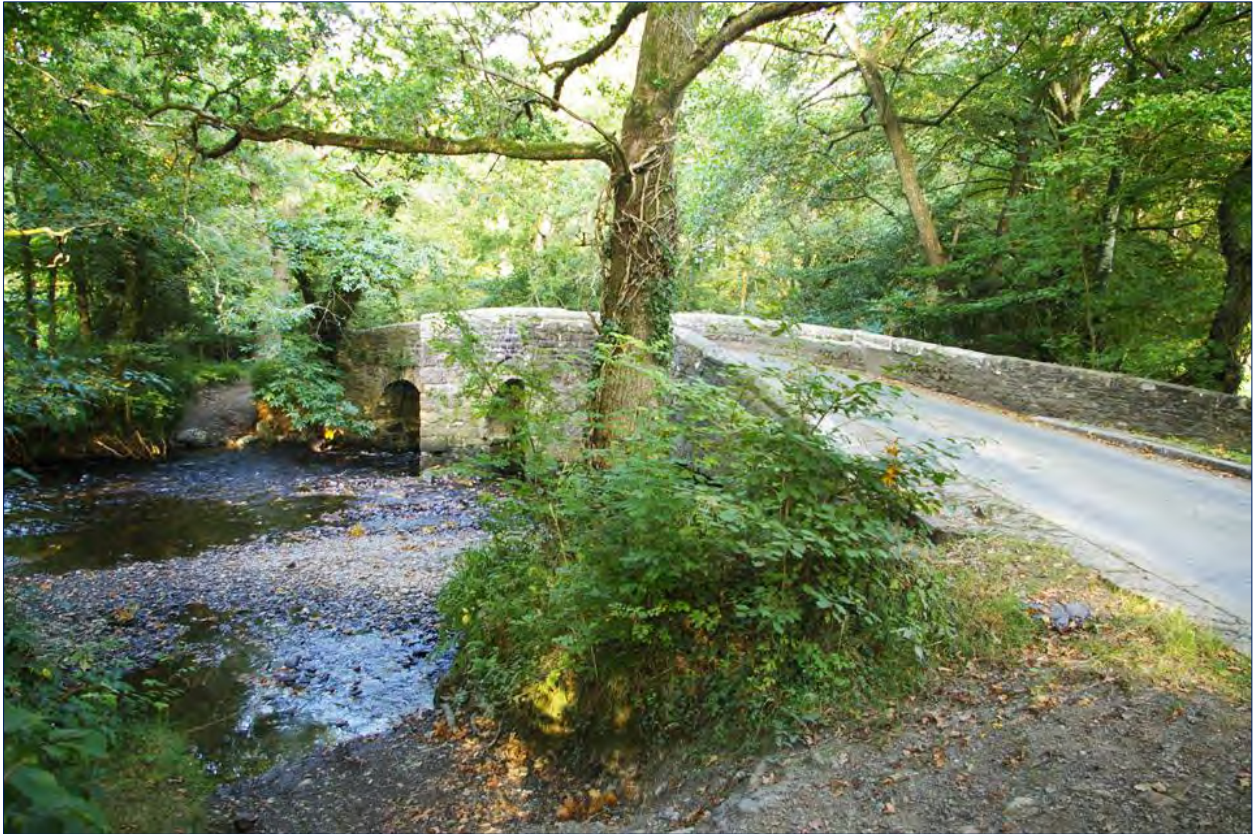
The Clapper Bridge, viewed from the west.

- Clapper Bridge, 520m SSW of Freeres Farm; high significance, Scheduled Monument; condition: good. Distance to turbine: c.3.5km. A partly-rebuilt 16th century bridge of three arches over the River Lynher, replacing an earlier clapper bridge. Mentioned in historical
