LAND at 13 HIGH STREET GREAT TORRINGTON DEVON

Results of a Desk-Based Assessment,
Historic Building Recording &
Archaeological Monitoring & Recording

Report No.: 160614
Date: 14.06.2016
Authors: E. Wapshott
P. Webb

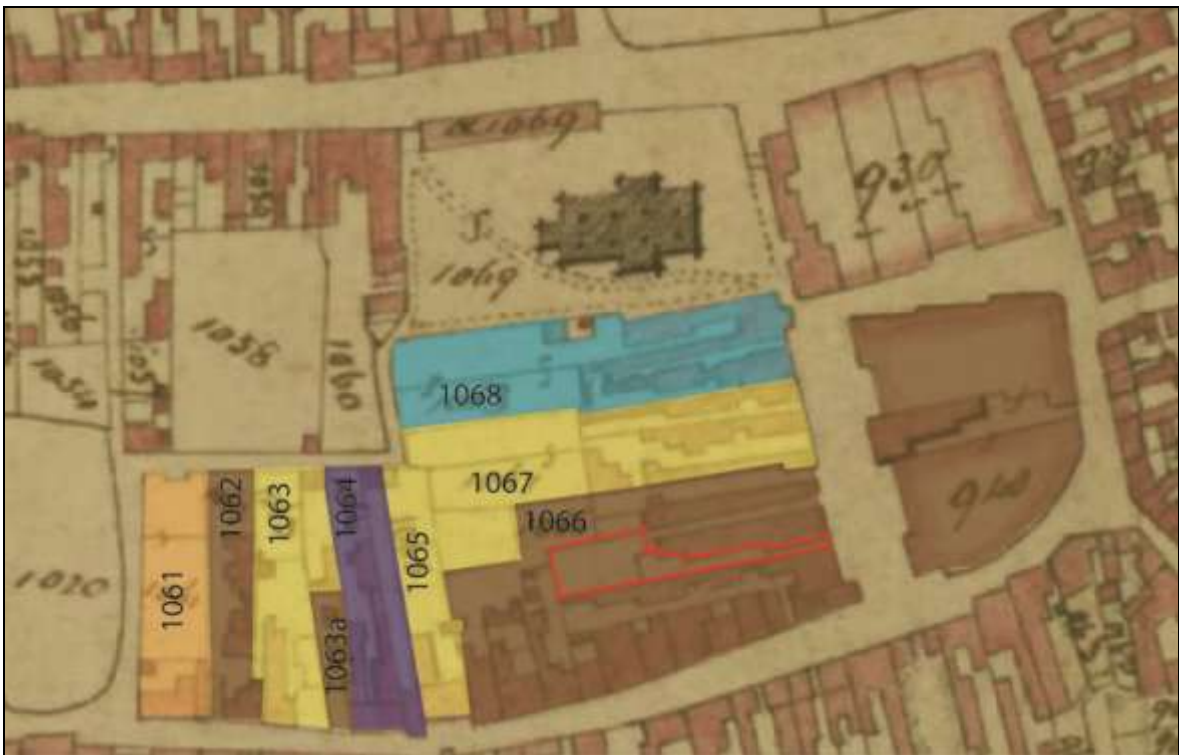
Figure 2: Extract from the 1842 Torrington tithe map (DHC).

The earliest detailed map available to this study is the 1842 tithe map (Figure 2). This depicts the historic core of Torrington to the south of the church, with a series of narrow plots of land with associated domestic dwellings and courtyards. This pattern is consistent with the development of the town following the pattern of medieval burghage plots.

The proposal site (outlined in red), in 1842, is shown as Town Land, to the south of land occupied by Charles Veysey. The site itself consists of buildings and yards or gardens, the same as the surrounding plots. There is also a boundary dividing the site to the west of the buildings, suggesting that the land that is now associated with a single property, may formerly have belonged to different properties.

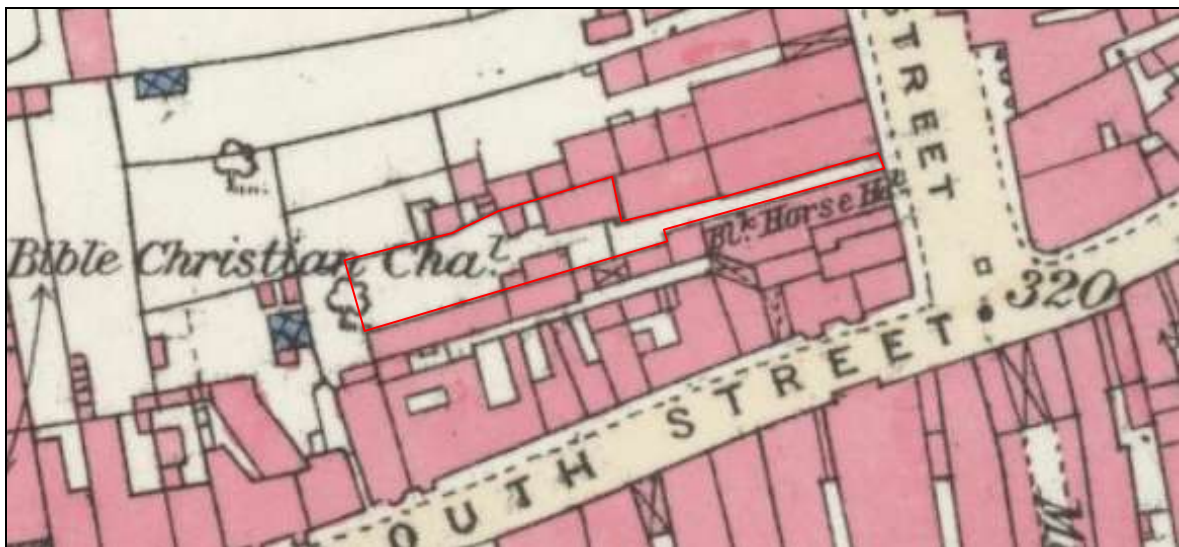
Figure 3: Ordnance Survey 1st Edition, Surveyed 1886, Published 1887, 25 inch series; the site in detail (the site is indicated).

The later OS maps indicate the further development of the town with increased urbanisation within former garden and yard plots (Figure 3). This continues into the 20th century (Figure 4), though around the proposed site, structural development appears to stagnate after 1903 (Figure 5), with garden plots continually shown to the rear of the buildings.

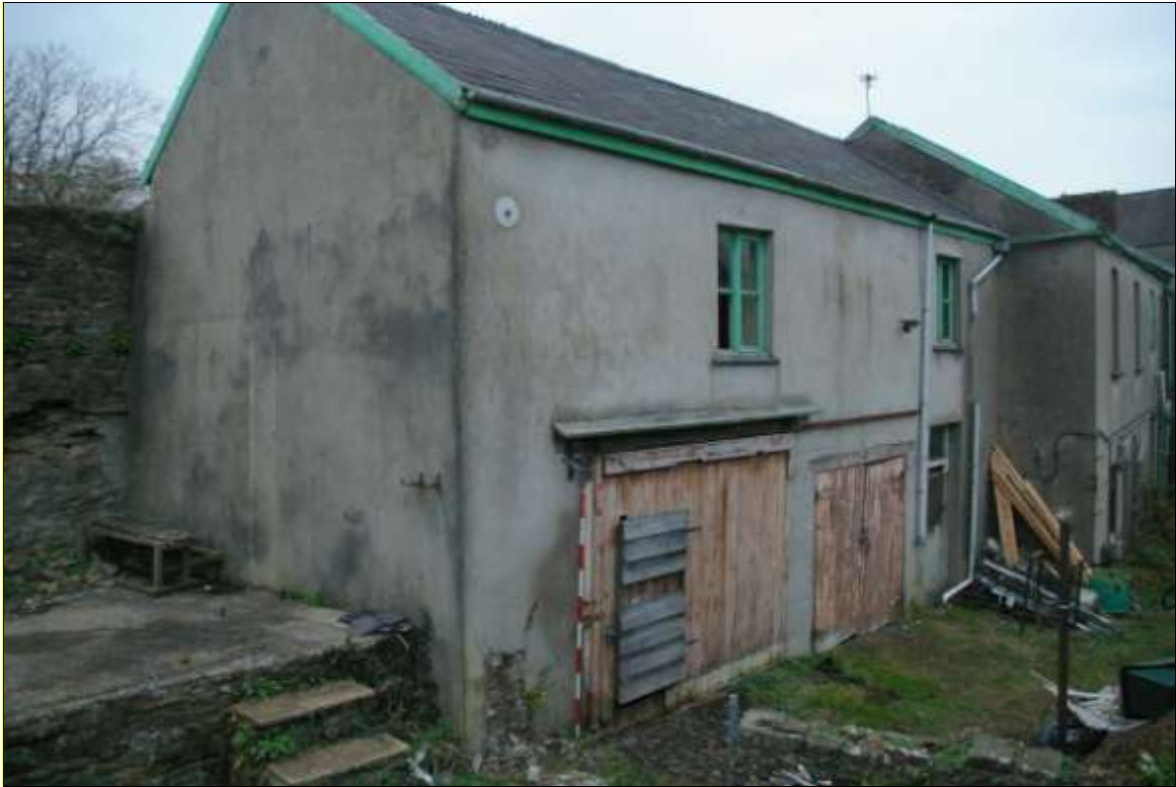
Figure 5: View of the exterior south and west elevations of the outbuilding to 13 High Street; viewed from the south-west (2m scale). Remains of a further building to the west can be seen.

The upstanding outbuilding is built up against the western edge of the main house, is of solid rendered construction under a tar-treated slate roof with terracotta ridge tiles. A detailed building description can be found in Appendix 2. The building shows signs of having been raised to a height of two storeys in the 19th century, formerly having been only one and a half storeys in height. Internally there is a fine king-post roof structure. The first floor has been considerably modernised during the 20th century and incorporated into the accommodation of the adjacent house, with no surviving historic features. The ground floor retains its service function, with numerous surviving features of historic interest, including exposed stone walls, blocked openings and stone cobbled and brick paved floors.

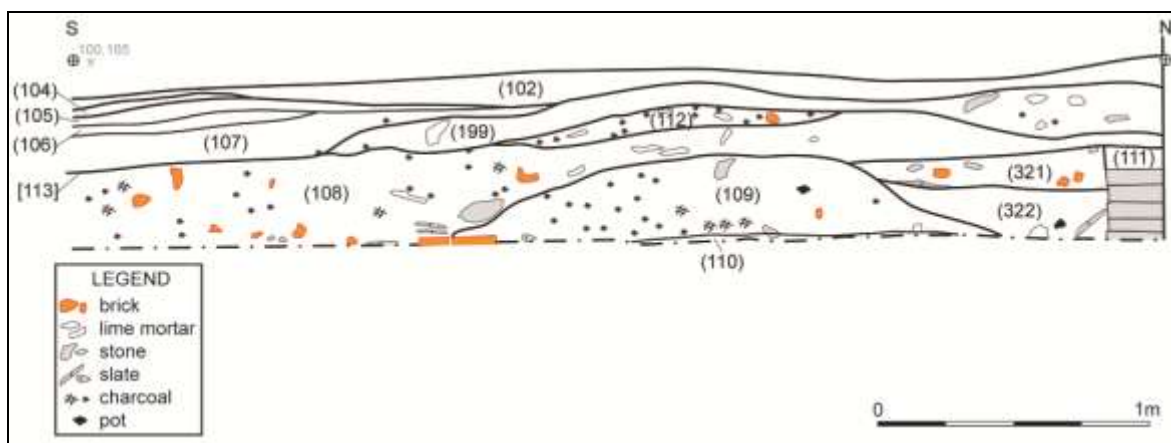
Figure 8: Section of west end of the site, showing the upper stratigraphy.

The site was covered by an upper stratigraphy (Figure 8) comprising imported topsoil (101); black silts, overlying a plastic membrane and subsoils (102) and (103); grey and brown clay-silts. These layers sealed a series of demolition deposits: (104)-(112) up to 0.6m thick, with brick and plaster fragments and which included areas of intense burning. These, in turn overlaid a number of archaeological features:

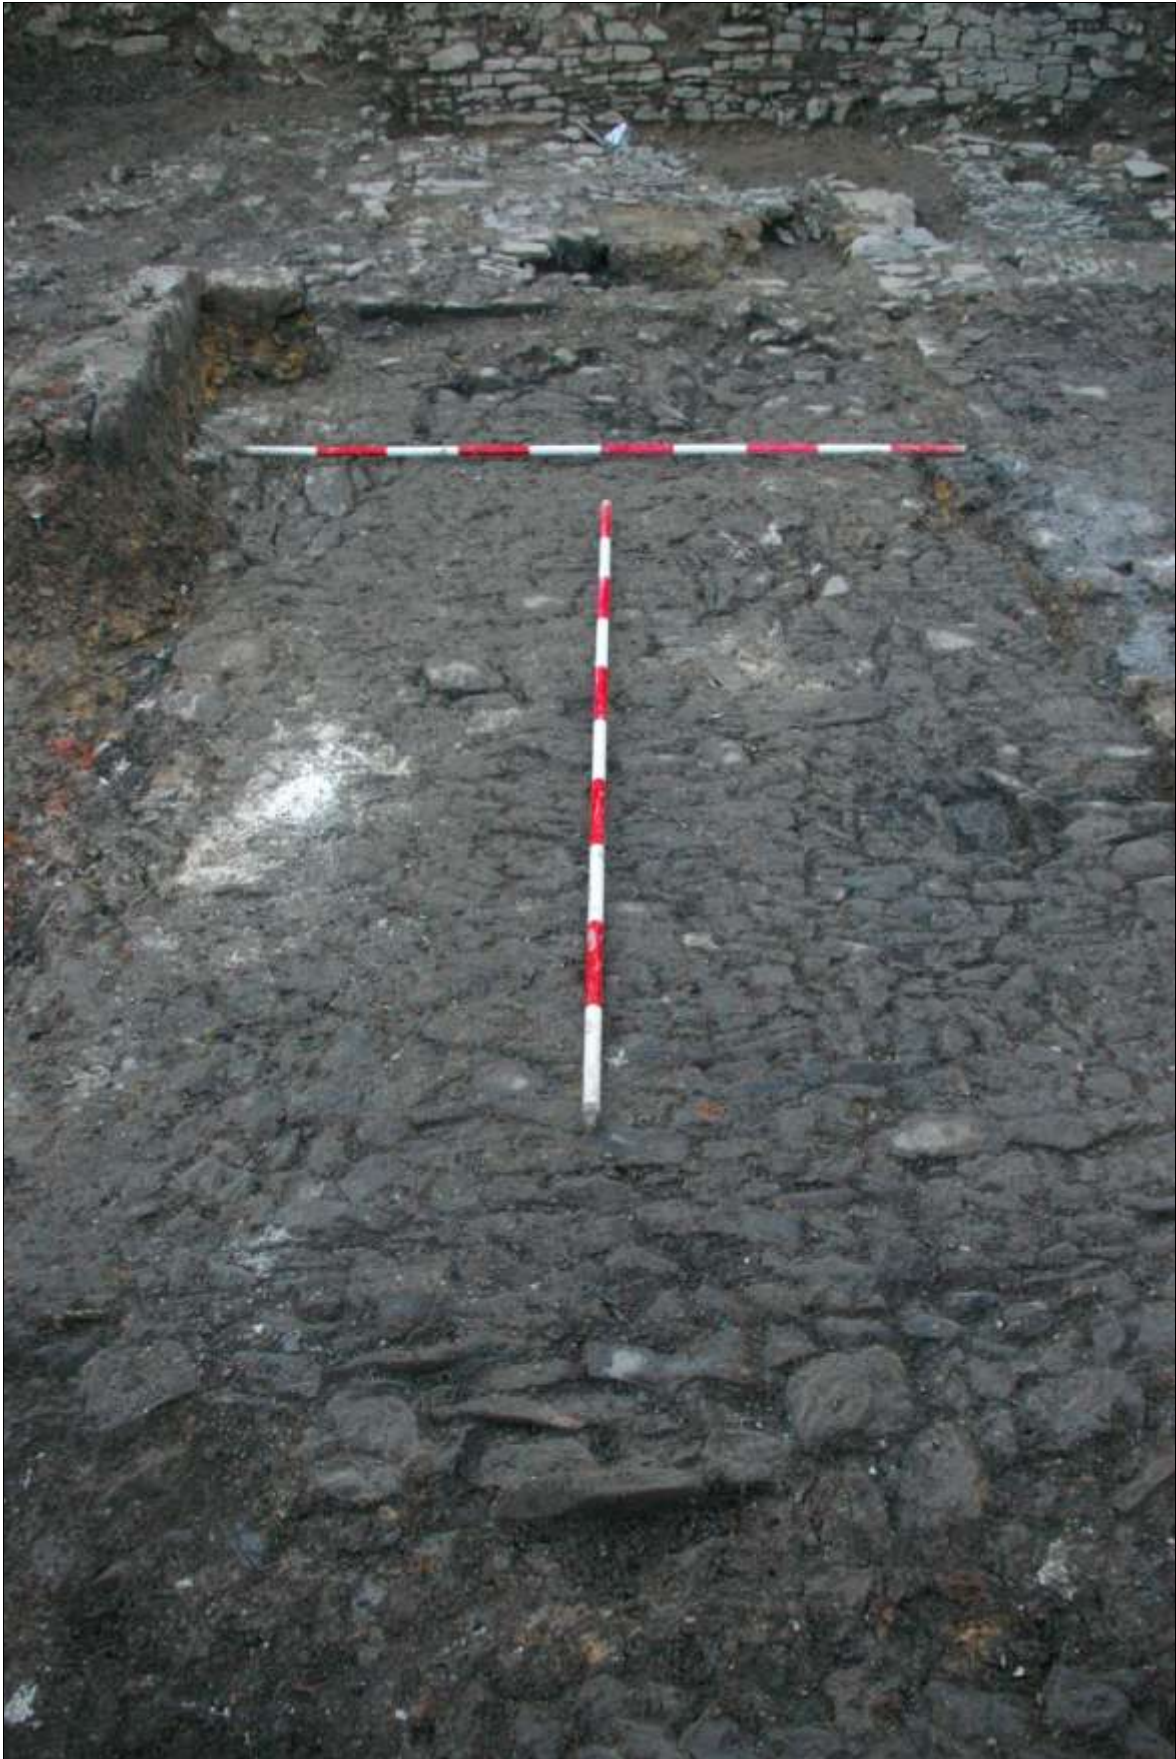
Figure 9: View of cobble surface (129); viewed from the south (2m scales).

To the west of these, extending from the southern site boundary was a rectangular area of cobbles, (129), measuring 5m north to south × 2.4m east to west and comprising shaped large flat slate-stones tightly packed within an earth bond, forming a level surface. This was situated above a layer of crushed slate in friable silt, (149), which formed a base packing layer on which the cobbles were laid. Finds recovered from the cobble surface and its associated base layer included a mix of North Devon coarsewares, scraffito, and plain slipware alongside 17th to 18th century plain delftware and imported stonewares.

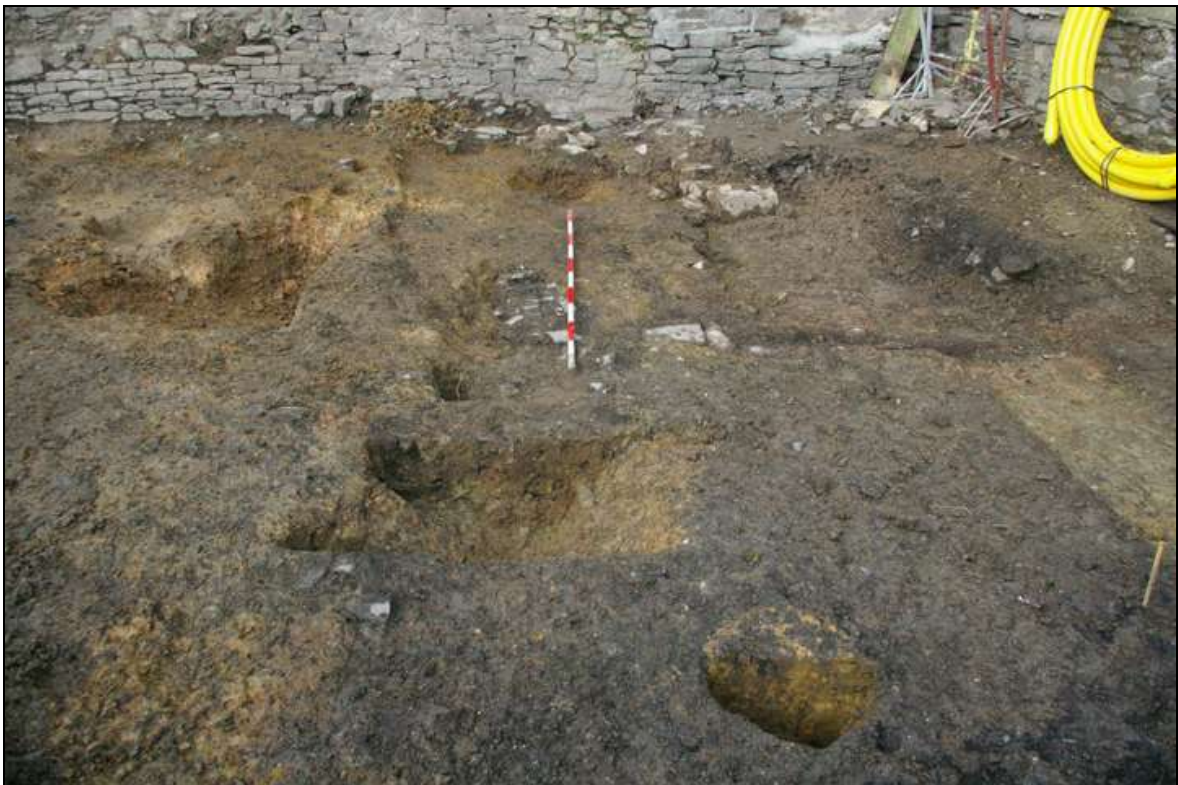
Ditch [353] with Postholes [366], [369] and [373]; looking north (2m scale).
