# LAND at BRADDONS PARK BUCKLAND BREWER DEVON

Results of a  
Historic Visual Impact Assessment

Report No.: 141107  
Date: 07.11.14  
Author: E. Wapshott  
S. Walls  
V. Hosegood

South West Archaeology Ltd. was asked to undertake a historic visual impact assessment on land at Braddons Park, Buckland Brewer, Devon, in advance of a planning application for the construction of a 50kW (25m to hub) wind turbine.

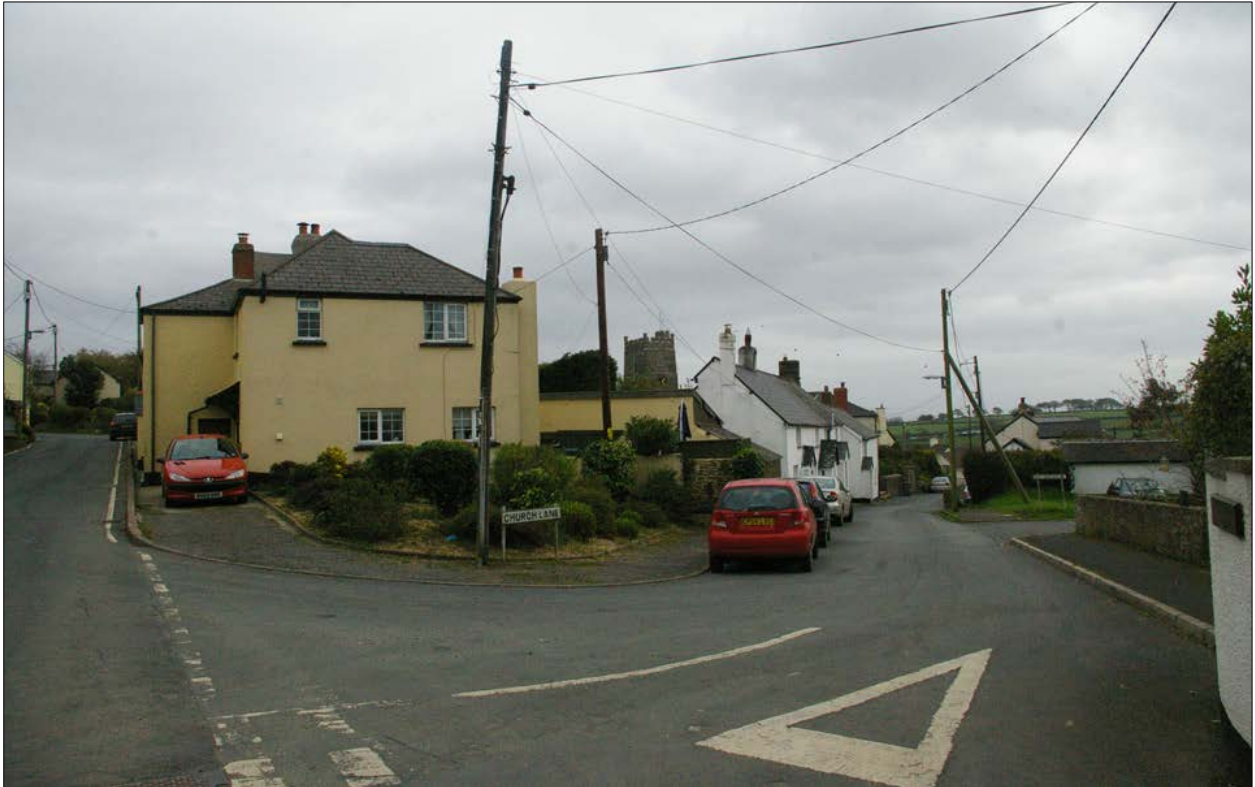
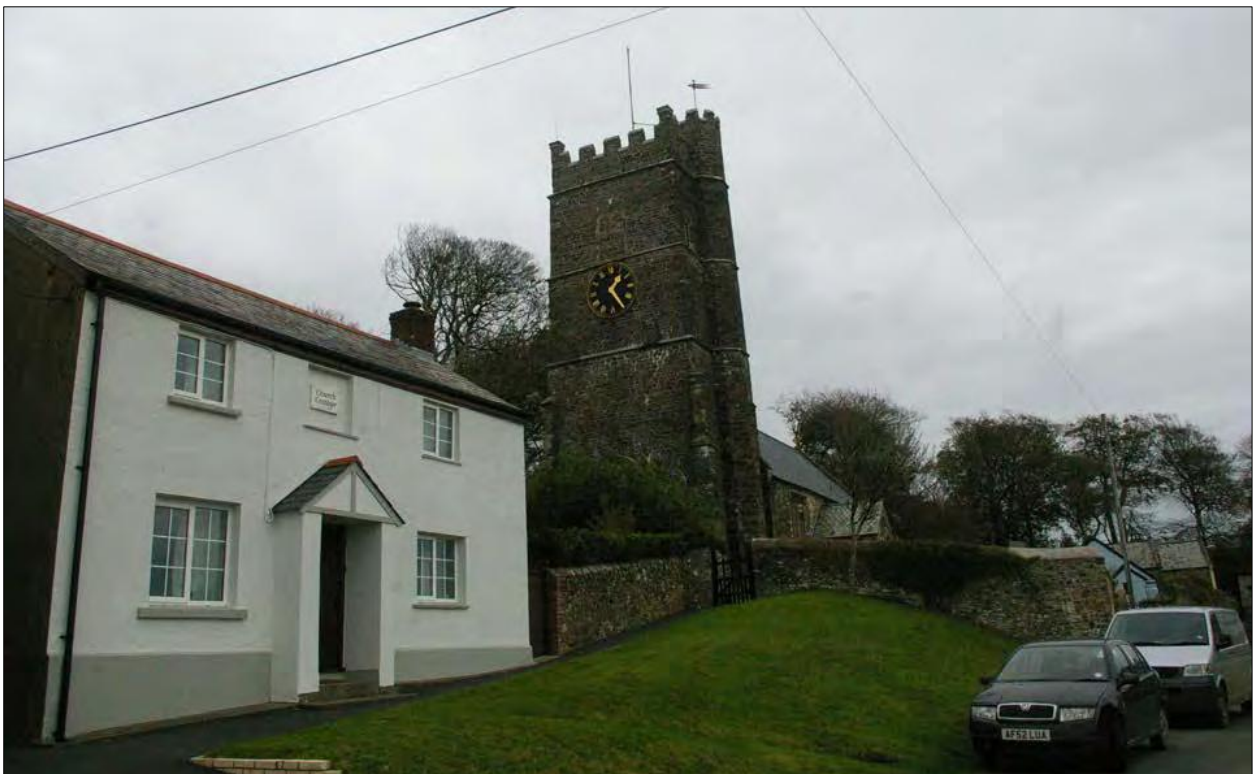
The church in Langtree, within the setting of the village settlement; from the north-west.

Detailed view of Langtree Church; from the west, south-west.

- Langtree Church, Langtree; high significance; Grade II\* Listed; condition: excellent (Churchyard cross in Langtree Churchyard; high significance; Scheduled Monument; condition: fair); distance to turbine c.5-5.25km. A 15<sup>th</sup>/16<sup>th</sup> century parish church, restored in the 1860s. Three staged castellated west tower, with short square pinnacles and corner buttresses. Late medieval waggon roofs survive, fine 17<sup>th</sup> pulpit and some 18<sup>th</sup> century memorials and a royal coat of arms. The church is Listed for the majority survival of a medieval structure and some fine fittings. The church lies on a south-facing slope, on the north side of a combe, above a boggy area called Langtree Lake. The turbine will not stand in the landscape context of this church. The church has significant landscape presence within the valley and the turbine is too distant to compete with this prominence. There are visual links across the landscape to Monkleigh and Buckland Brewer churches, as well as to Great Torrington. The turbine will not affect the setting of the church within the valley or within the village. There will be no views from the churchyard or immediate surroundings of the church, but there will be clear views from the church tower. The turbine may frame some views across to the church from Great Torrington, appearing behind on the skyline, to the north. The turbine will also interrupt views between Buckland Brewer and the church tower. Generally the wider views towards Langtree will not be affected by the proposed turbine; impact: **negative/minor**.

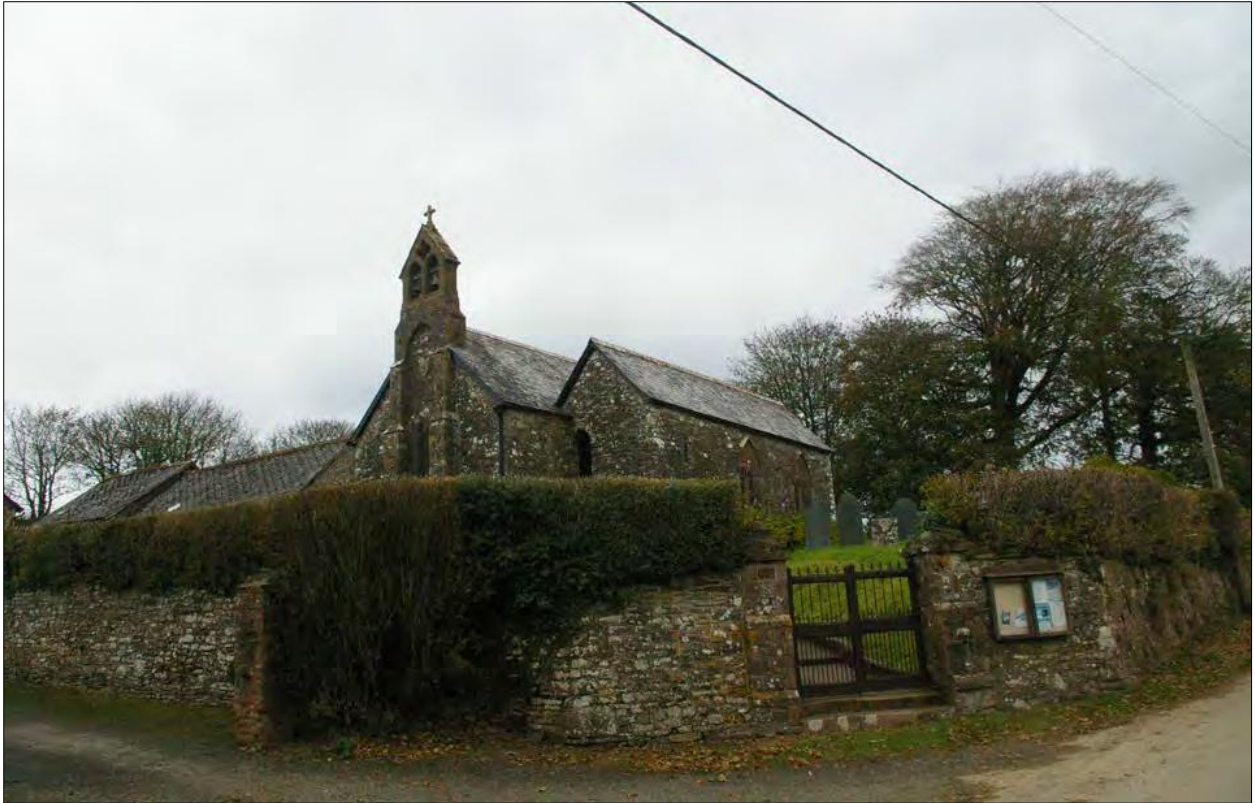
Bulkworthy Church, within its walled churchyard, with the buildings of the adjacent farmyard behind; from the south-west.

- Church of St Michael, Bulkworthy; high significance; Grade II\* Listed; condition: fair to good; distance to turbine c.5.25km. A 15<sup>th</sup> century parish church, restored in the 1870s. Two full-height stepped buttresses carrying relieving arch and gabled bell-cote, to the west end. Restored ceiled barrel vaults, other features and fittings largely 19<sup>th</sup> century. Listed largely for its medieval structure. The church stands in the small farming hamlet of Bulkworthy, on a south and west-facing slope, on the east side of the River Torridge Valley and to the north of a slight combe. The ground rising to the north and north-east. The valley is open and of agricultural character, with generally wide views from the church. The church stands outside of the ZTV and the proposed turbine would not stand within the landscape context of the asset. The turbine will not frame views to the asset. There are four extant wind turbines north-east of the church, on the edge of Thornehillhead Moor, these dominate the local landscape; impact: **neutral**.

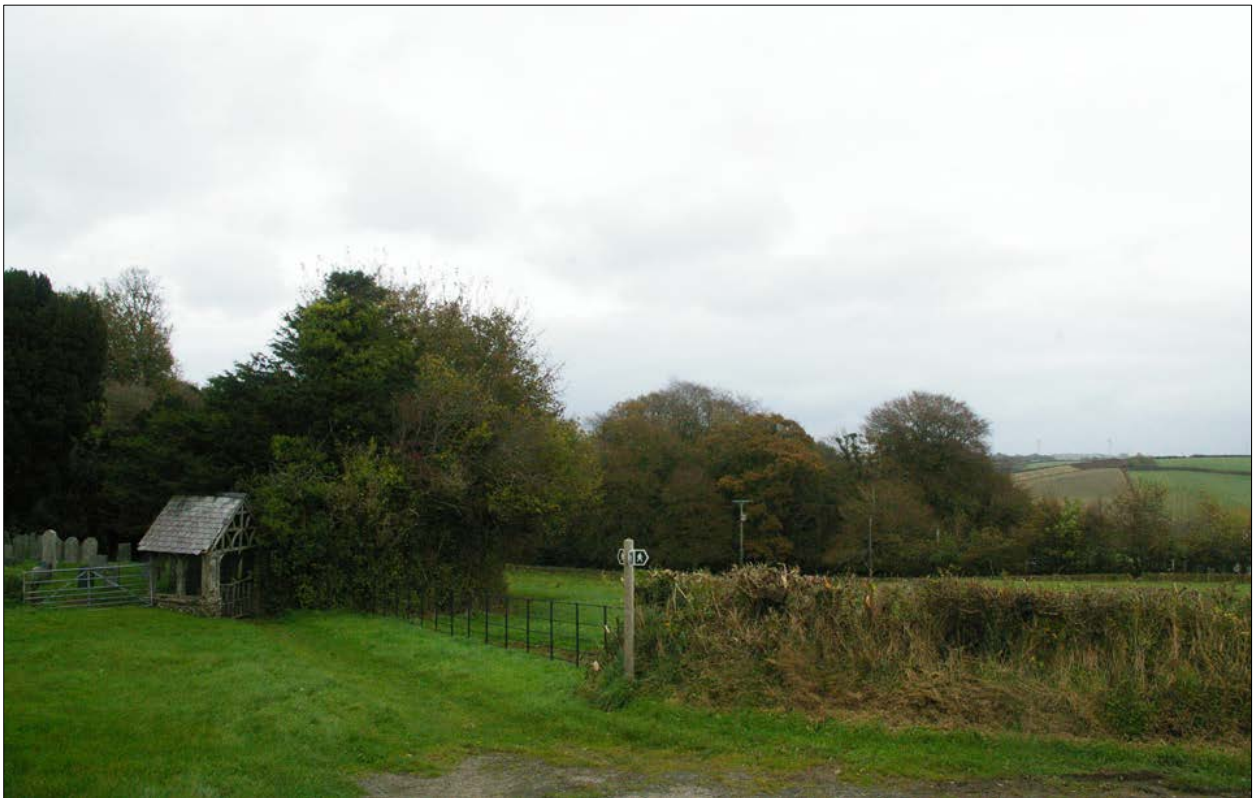
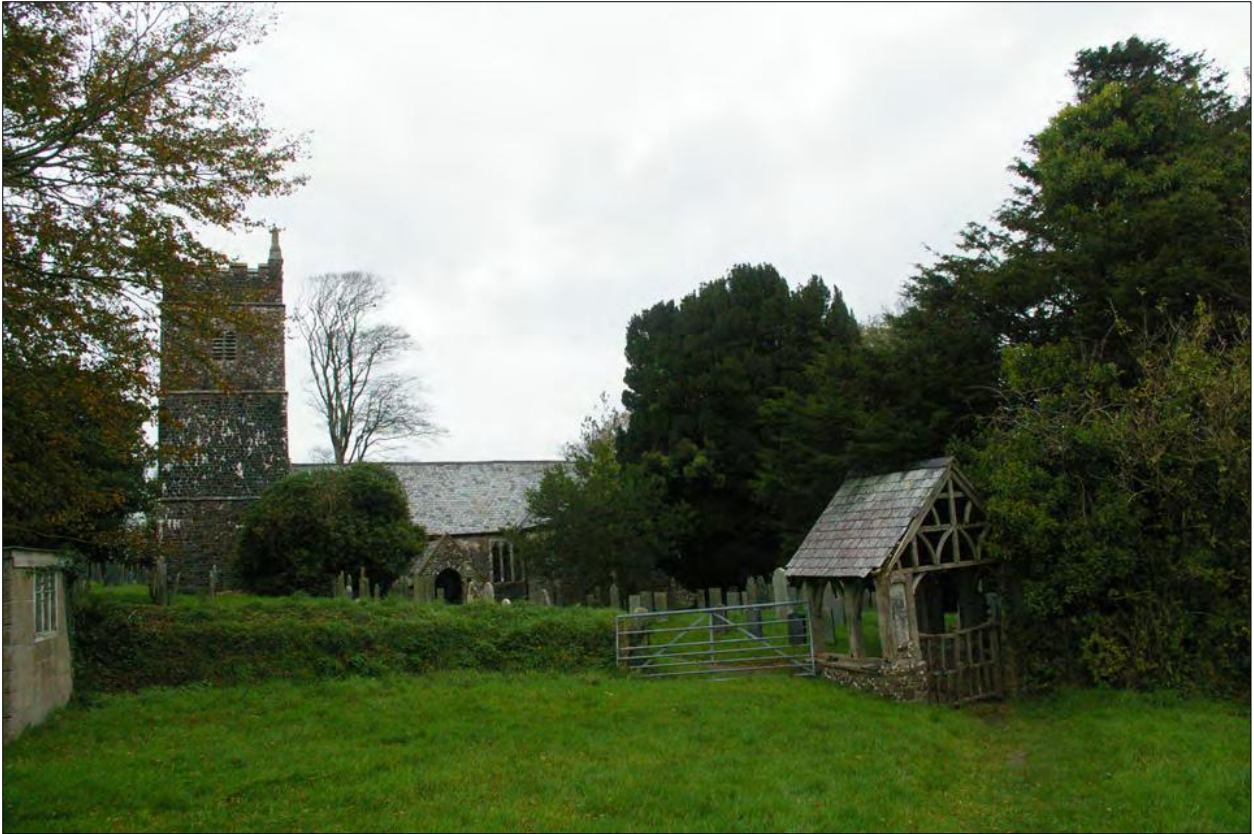
The views towards Buckland Brewer from West Putford Church, showing local blocking from the trees in the grounds of the nearby Manor House; from the west, south-west.

View of St Stephens in West Putford, within its wooded churchyard; from the south-west.

- Church of St Stephen, West Putford; high significance; Grade I Listed; condition: good; distance to turbine c.6.25km. Parish Church of the late 13<sup>th</sup> century/early 14<sup>th</sup> century, with a tower of circa 1400. The west tower may have an upper section dating to circa 1600 and is of three stages, unbuttressed, crenellated, with plain pinnacles, restored and partly rebuilt in 1883. Barrel plastered medieval vaults to the interior, with a 1880s scissor brace roof to the chancel. The 16<sup>th</sup> century encaustic floor tiles are of particular note. The church was again restored in 1929-30, and 1980. The Listing is chiefly for the significant surviving medieval structure of the building and interior 16<sup>th</sup> century details. The church is set on the western side of the wide Torridge valley, to the west of the majority of the village. The church is located on the upper to mid slopes, the ground peaking further to the north-west. The valley is of agricultural character with wet rushy pastures to the base, which is generally scrubby and wooded. The church, and village, fall outside the ZTV; and the proposed turbine would not stand within the landscape context of this asset and would not frame any views to the asset; impact: **neutral**.

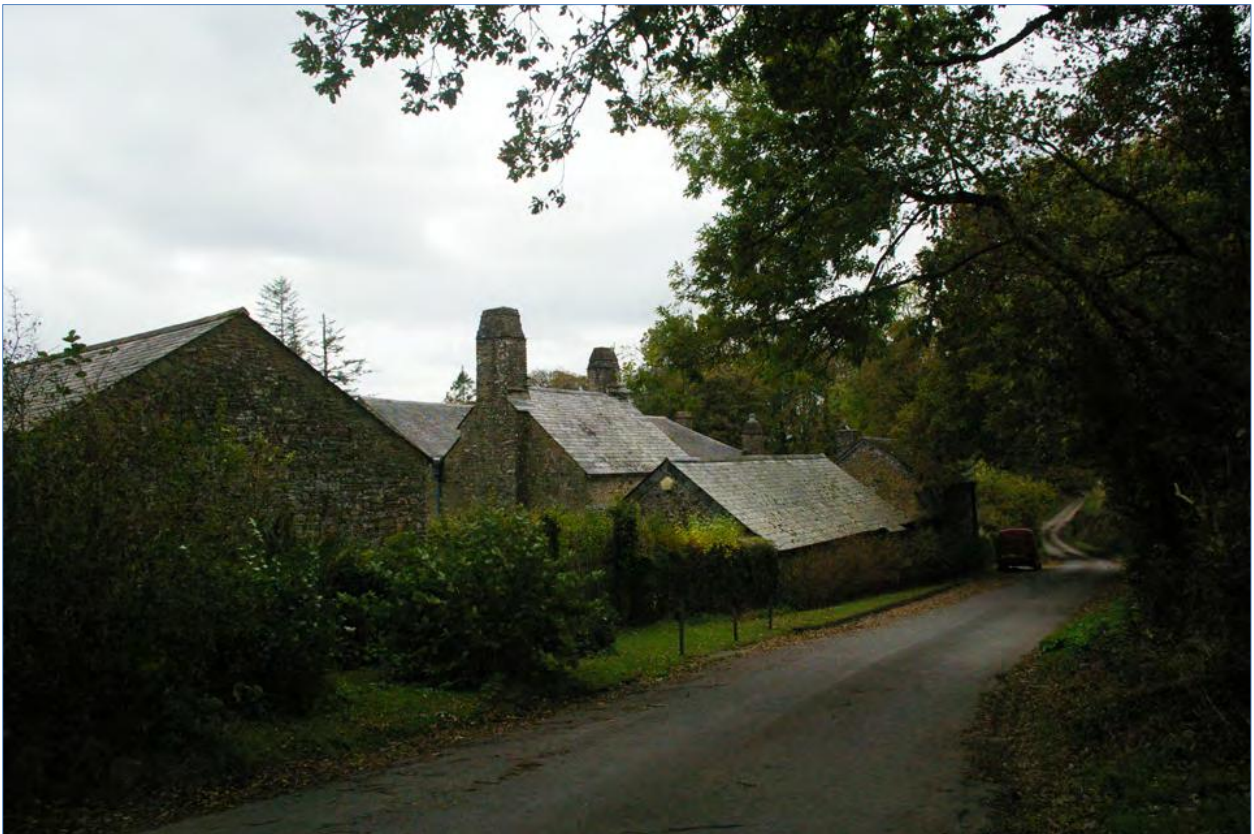
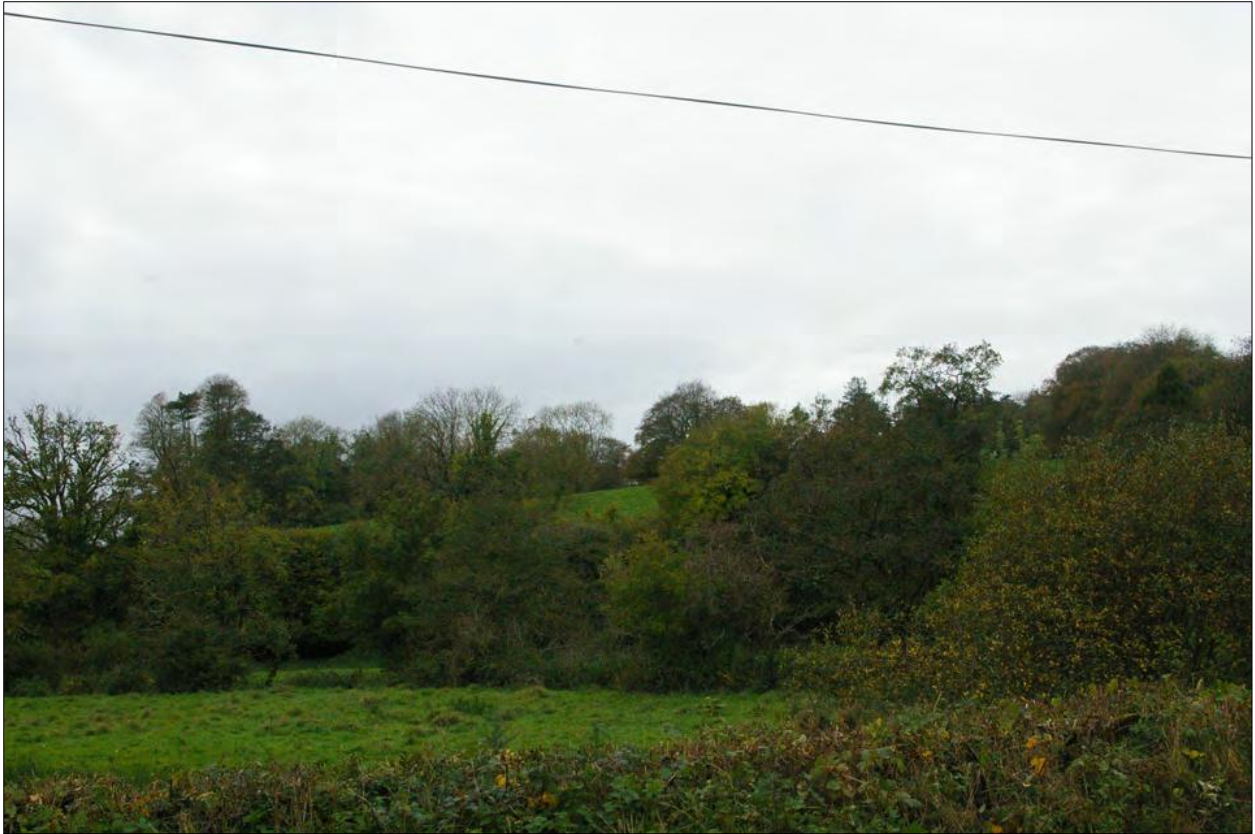
Cory Manor in West Putford; from the west, north-west.

View back up towards Cory Manor from the valley below, showing the local blocking from the wooded landscape grounds; from the north-east.

- Cory Manor, West Putford; high significance; Grade II\* Listed; condition: fair to good. Distance to turbine: c.6km. Late 16<sup>th</sup> to early 17<sup>th</sup> century Manor House. The house was extended in the 19<sup>th</sup> and early 20<sup>th</sup> centuries. The open hall was restored and the ceiling removed in the 1940s. Decorative plaster overmantle to the restored open hall, with some additional 17<sup>th</sup> century panelling. The house is often associated with a member of the Prideaux family. The house is set on the mid slopes, on the western side of the wide Torridge Valley, to the west of the majority of the village, to the east of the Church of St. Stephen. The valley is of agricultural character with wet rushy pastures to the base and is quite scrubby and wooded. The house stands within landscaped grounds with mature parkland and specimen trees. These trees provide additional local blocking to views both outwards and inwards from the building. There are some key views east across the valley, but the turbine lies far to the north-north-east. The village of Putford lies outside the ZTV; and the proposed turbine would not stand within the landscape context of this asset and would not frame views to the asset; impact: **neutral**.

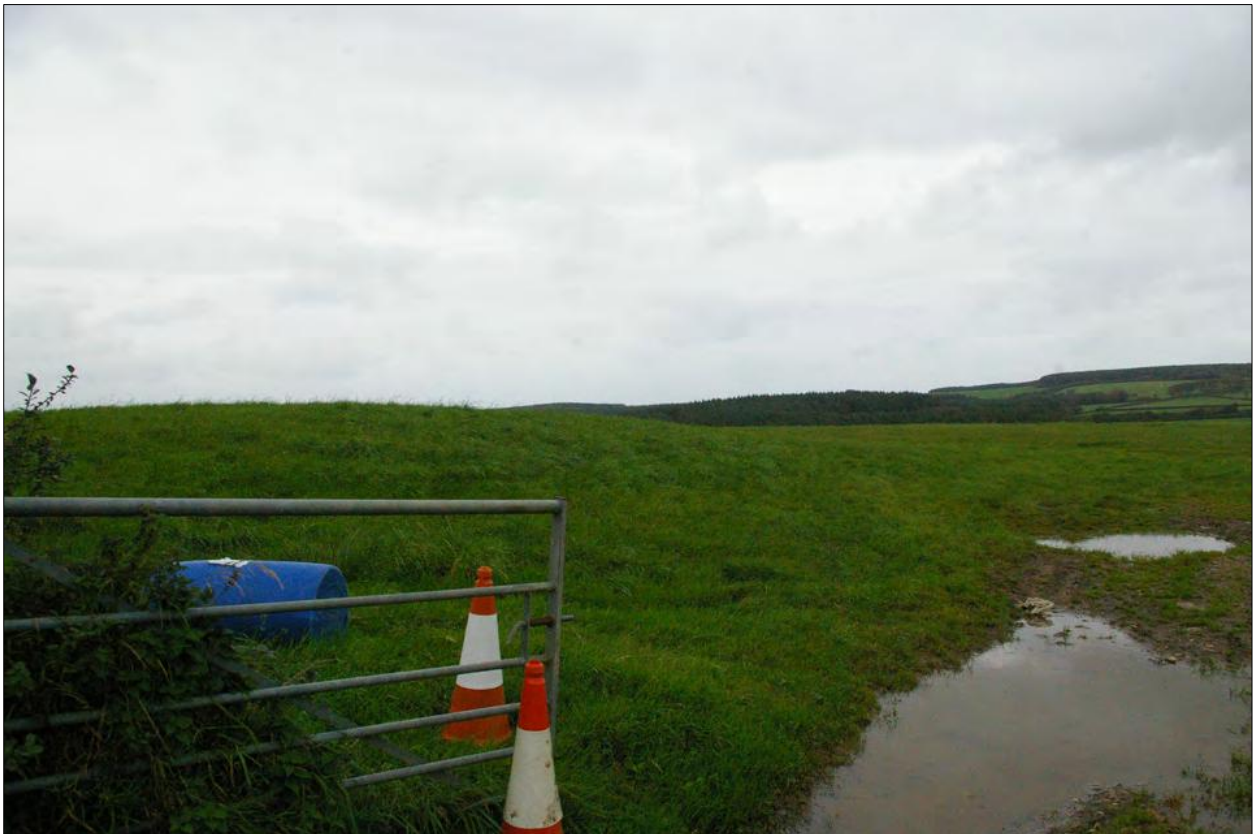
Rush Barrow on the edge of Common Moor; from the south-east.

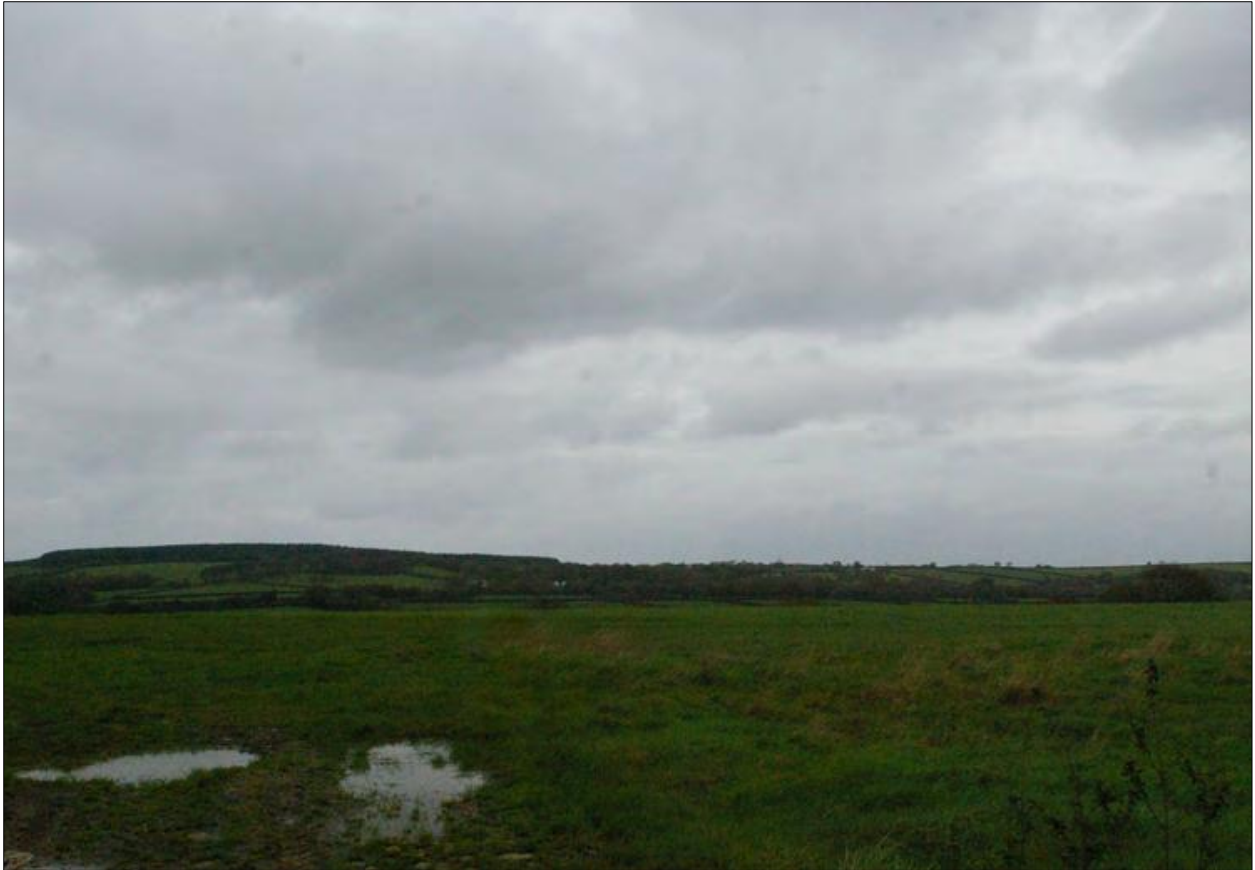
View over Goutisland Farm and Winslade Farms, looking across to Common Moor, with the large extant wind turbine at Babeleigh Barton on the horizon behind; from the south-west.

- Goutisland Farmhouse, Buckland Brewer; medium significance; Grade II Listed; condition: unknown; distance to turbine c.1.5-2km. The farmhouse lies on a working farm, set down a long track, with modern and historic outbuildings visible. The farmyard setting will not be affected by the turbine and the farm lies just over the brow of a hill, on the upper south facing slopes and falls outside of the ZTV of the proposed turbine. Tall hedgebanks line the field and road here and will increase the effect of the topography with local blocking. The landscape context of the farm is the valley; the turbine does stand within the wider landscape setting, being part of the Lydeland Water valley network; impact: **negative/unknown** but neutral expected.

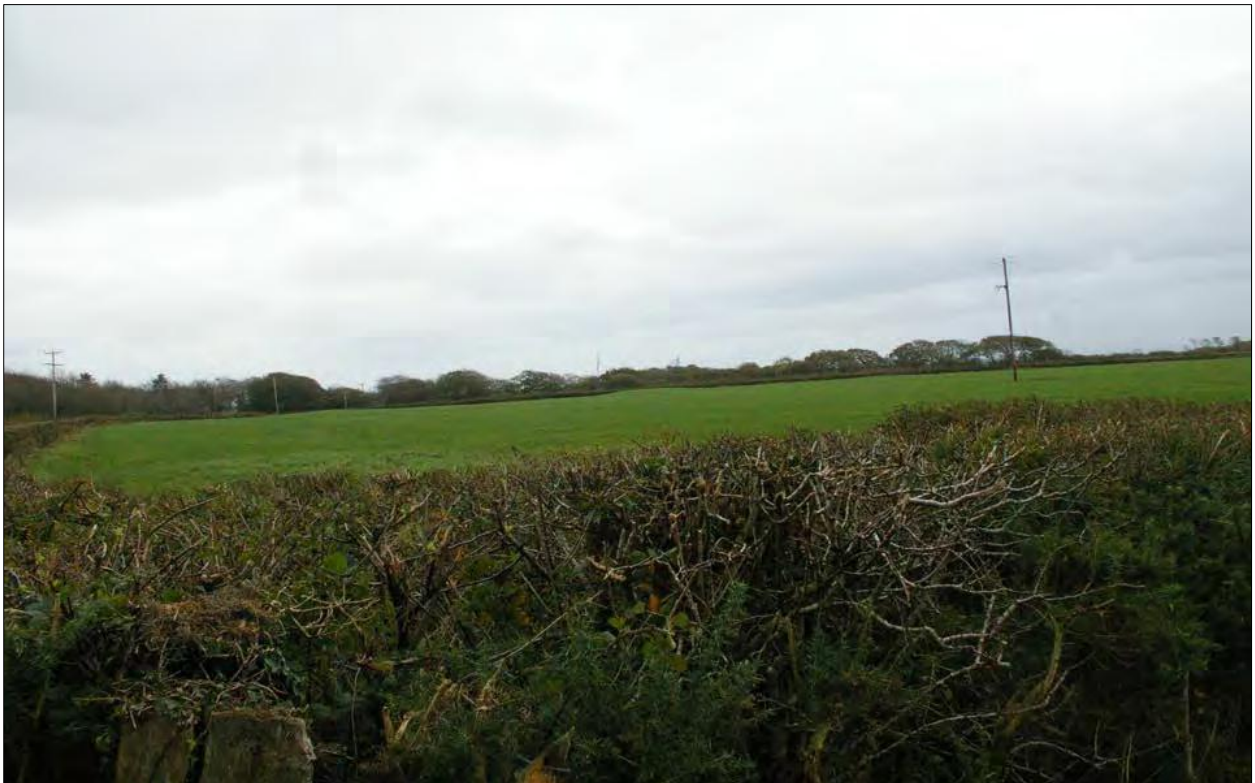
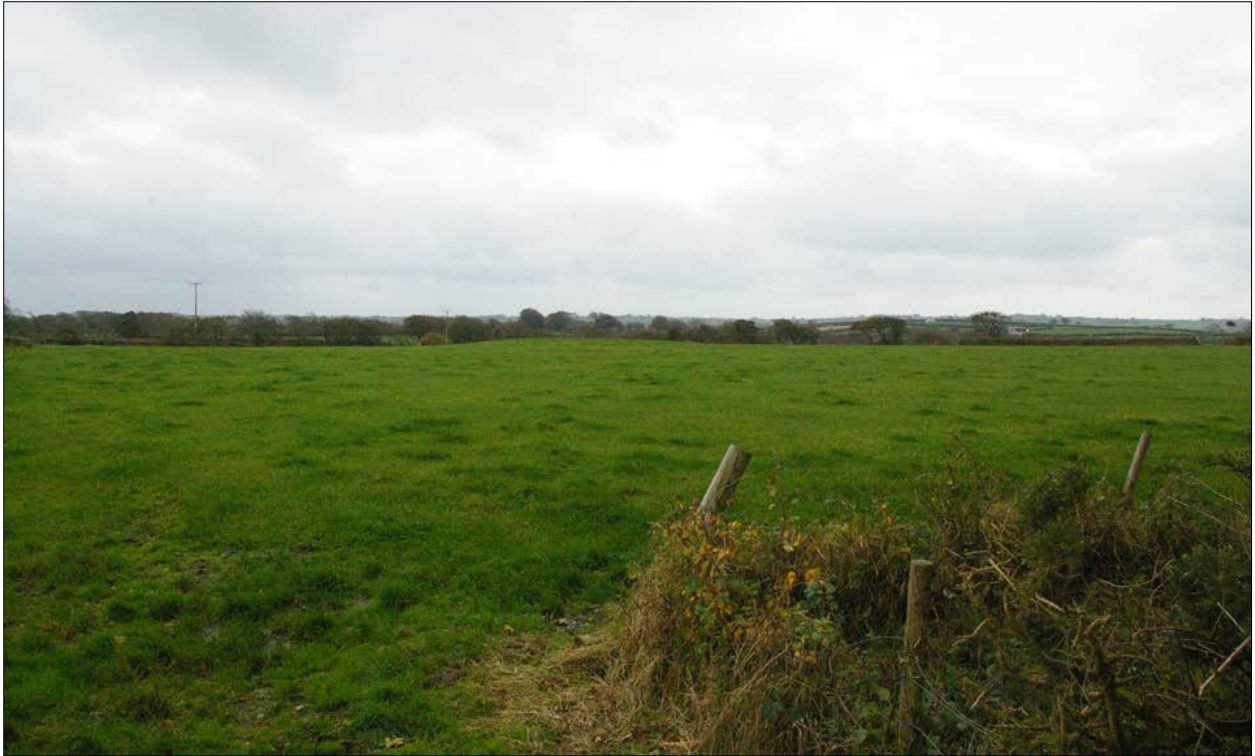
View of some of the barrows within the barrow cemetery north of West Putford, enclosed within fields which provide local blocking to the extant mounds; from the north-west.

One of the further large mounds in the barrow cemetery group near West Putford and East Putford; from the north-east.

- Bowl barrow 130m N of Wrangworthy Cross; Two bowl barrows 600m and 750m west of Wrangworthy Cross; high to very high significance, part of a monument group; Scheduled Monument group; condition: fair to good. Distance to turbine c.3.25-4km. These barrows have landscape presence only within their immediate surroundings however they have wide views out to the landscape to the north and north-east towards the turbine. The turbine does not stand within the landscape context of the barrows. The setting of the barrows is not open ground, as hedgebanks do enclose the large fields, but the effect of the sloping ground and open views gives us the impression of openness and therefore the barrows here are more sensitive to changes in their views. The turbine will appear in views north but will not frame any views towards the assets; impact: **negative/minor**. One of the barrows lies within the small native plantation and is more shielded from views, enclosed by the trees which now provide its landscape context; impact: **neutral**.

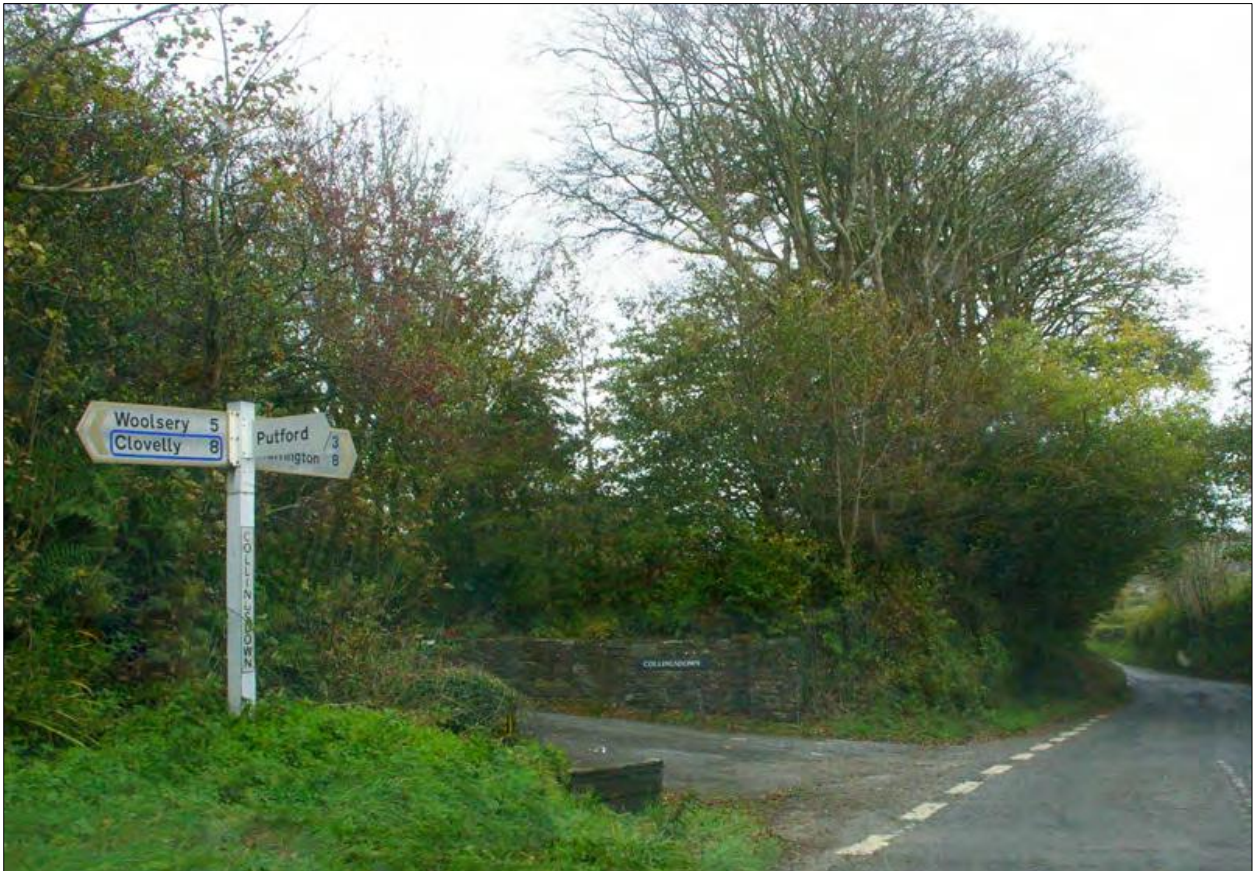
View of the entrance into Collingsdown, showing an overgrown wooded plot with the farm shielded from inward views; from the west, south-west.

- Collingsdown Farmhouse, Buckland Brewer; medium significance; Grade II Listed; condition: unknown. Distance to turbine c.2-2.5km. This farm is set in a wooded enclosure down a private drive and is not visible from the road. The asset seems to be set on a working farm, and some farm buildings are visible however which appear in very poor condition. The farmhouse is set in a farmyard, and it is unlikely this setting of the asset will be affected. There is local blocking from the trees and mature hedgebanks and the other farm buildings; impact: **negative/unknown**, but expected neutral or negligible.

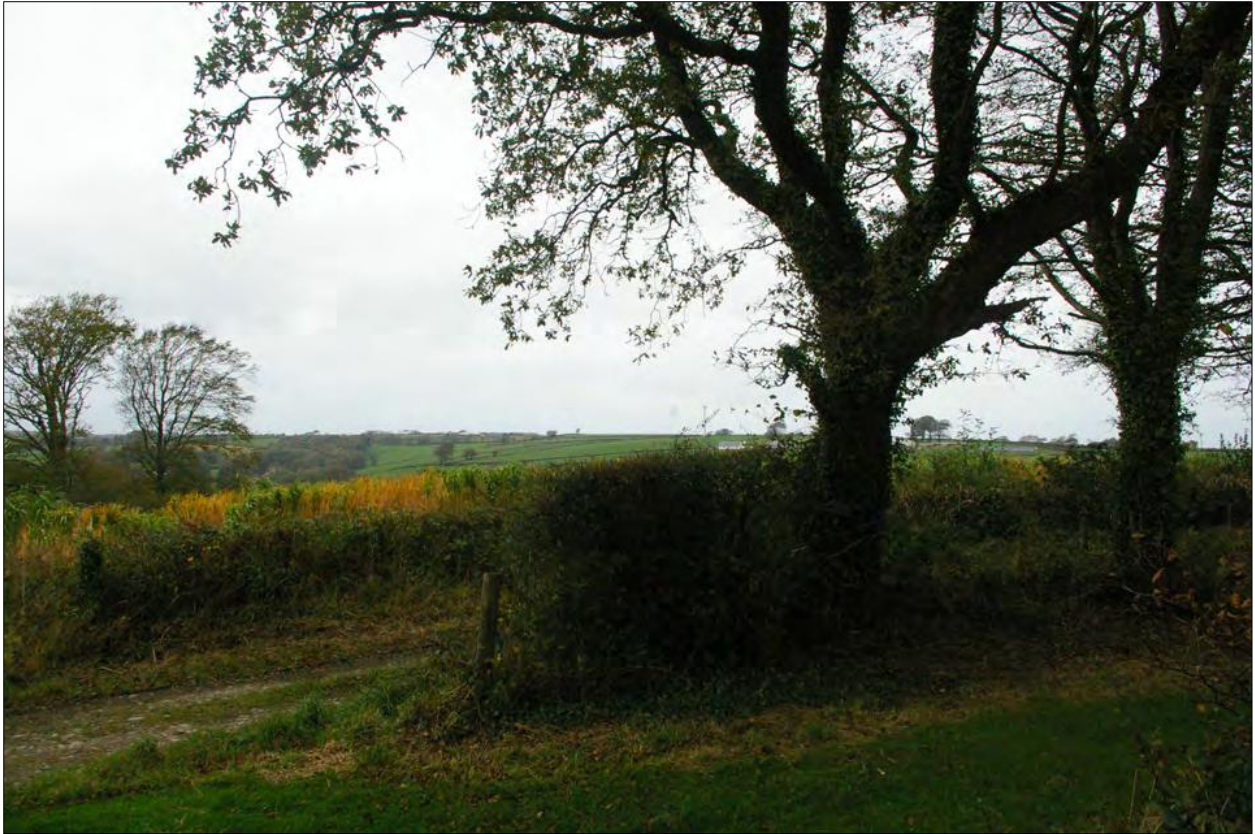
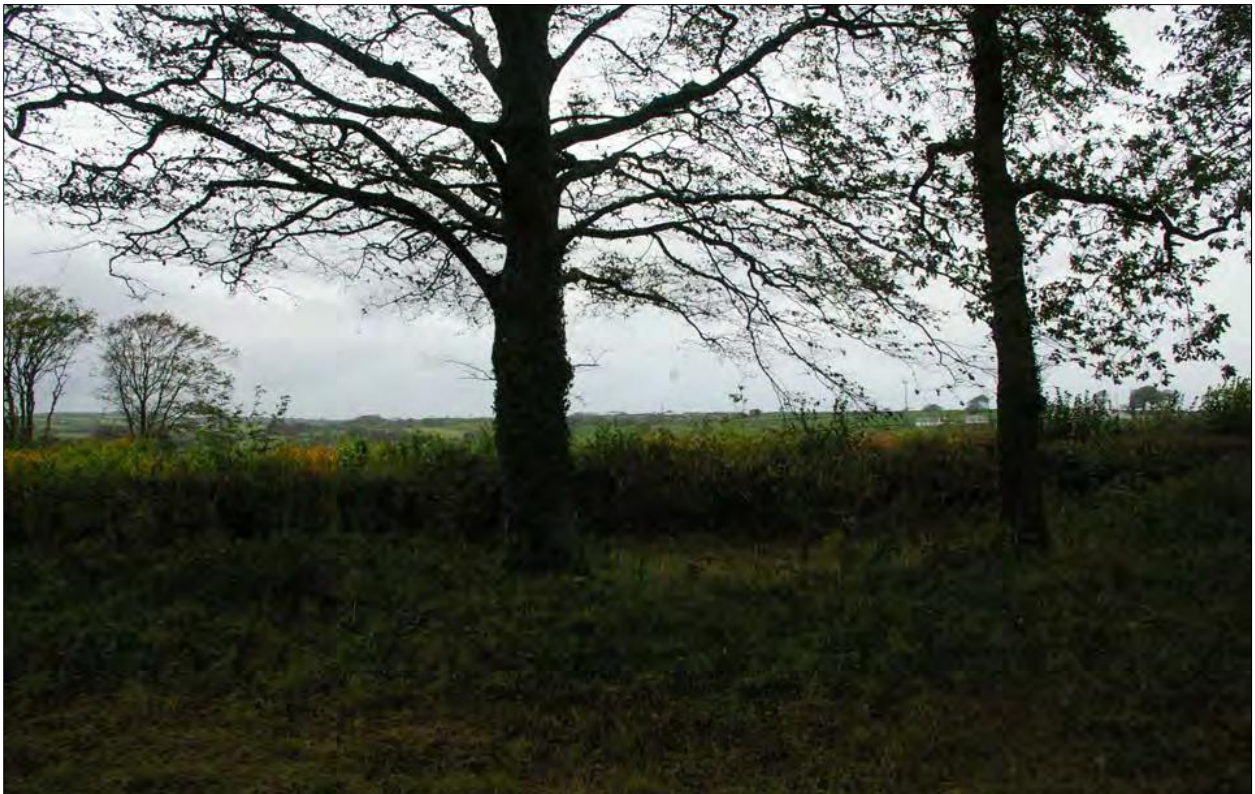
View towards the proposed turbine location on the far horizon from Hembury Castle, a large univallate hillfort; from the south-east.

View to the extant turbine at Babeleigh Barton, on the horizon in the distance and the much closer extant turbine at Craneham hill, directly across the valley from the hillfort at Hembury; from the south.

- Hembury Castle, Frithelstock; high significance; Scheduled Monument; condition: fair to good. Distance to turbine c.2km. A univallate enclosure, the bank and ditch survive well to the north, east and partially to the south, having been largely truncated to the west and south-west. Trees line the bank of the monument, planted in the 19<sup>th</sup> century as part of a semi-planned landscape to a hunting lodge/folly built to the side of the monument. The monument occupies a high knoll of ground, to the west of a steep river valley, within a wider network of steep winding valleys, where Lydeland Water and the River Duntz meet. The monument has 360 degree views to the surrounding landscape, with particularly wide views to the east, north and north-west. The proposed turbine does not stand within the landscape context of the monument. An extant turbine stands just north of the monument at Craneham Farm and the turbine at Babeleigh Barton is also visible on the skyline. The four turbines on Thornehillhead Moor are also visible to the south-west on even higher ground on the moor and another small turbine is visible to the east at Frithelstock. Cumulative impact therefore applies to a further turbine. The turbine will not directly frame any views to the asset, but will contribute to the skyline distraction in wider views upon approaching the monument from Frithelstock; impact: **negative/moderate**.

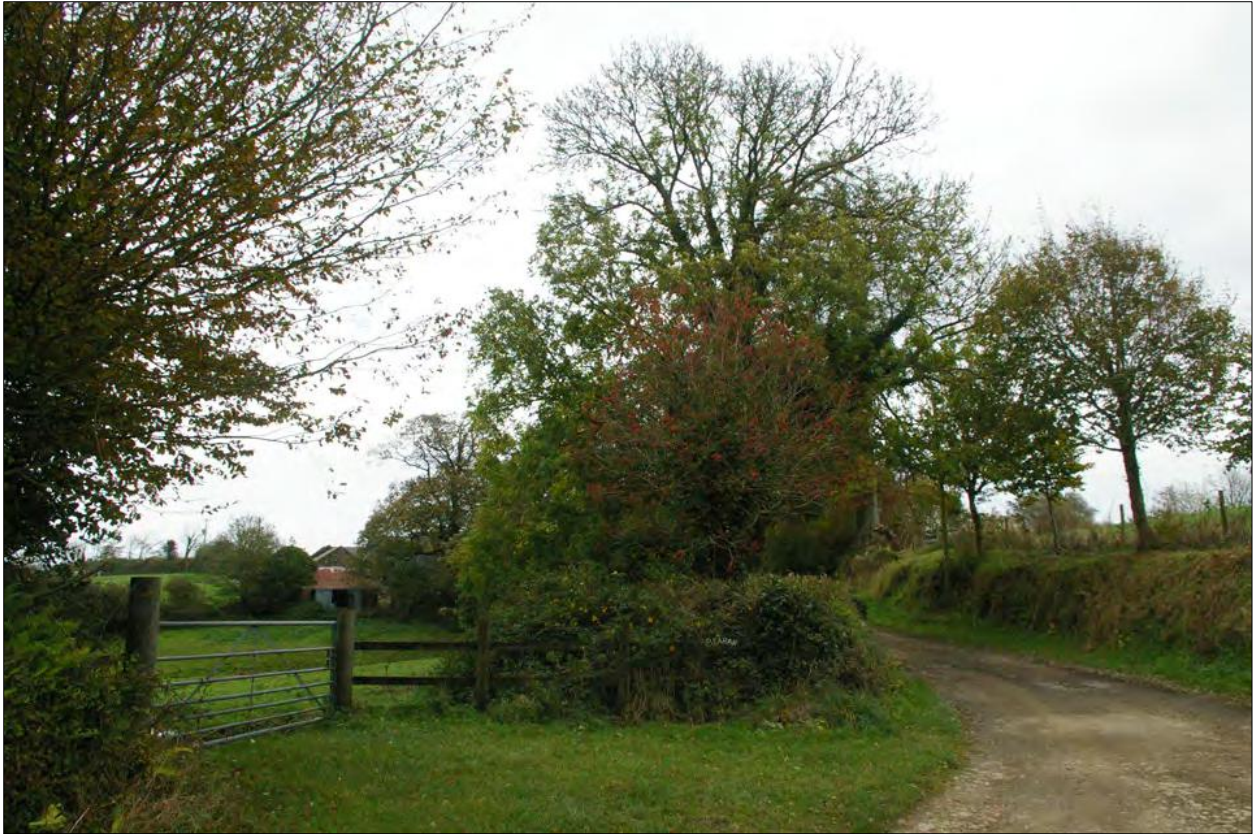
View to Beara Farm, Buckland Brewer, showing the house and barns set in a slight hollow, surrounded by mature beeches; from the west.

- Bearah Farmhouse, Buckland Brewer; medium significance; Grade II Listed; condition: fair to good. Distance to turbine c.1.25km. Set down a short track, on a north-facing slope within a steep valley south-east of Buckland Brewer village. The farmhouse can be viewed on a working farm, set within a large farmyard of historic stone and cob buildings. The house sits within the head of a combe and views are largely focused to the north and north-west, down the valley and across to Buckland Brewer. The proposed turbine will not stand within the landscape context of the farmhouse and its setting will not be affected. The turbine will not frame views to the farmhouse from Buckland Brewer but will appear in views approaching the farmhouse along the road out of Buckland Brewer from some viewpoints. The asset itself is protected from views by extensive local blocking from mature beech trees to the west of the farmyard; impact: **negligible**.

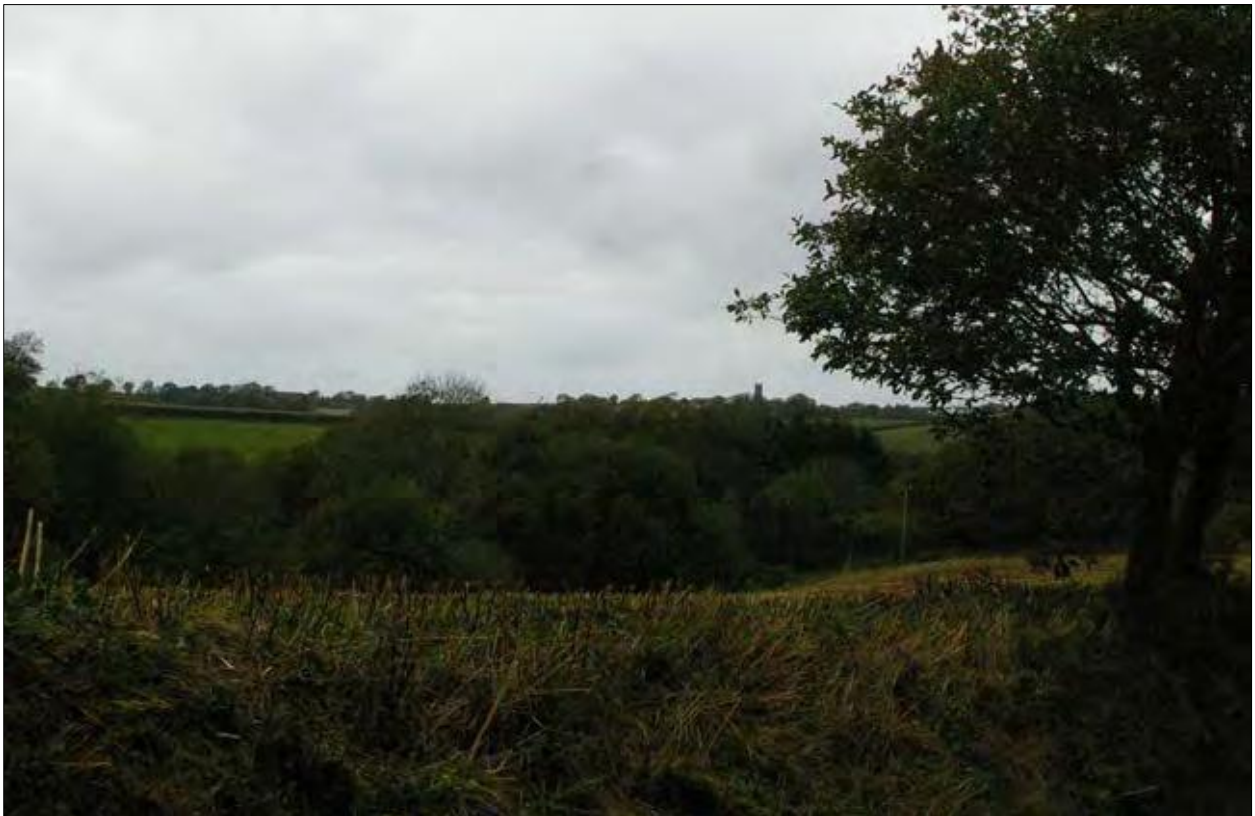
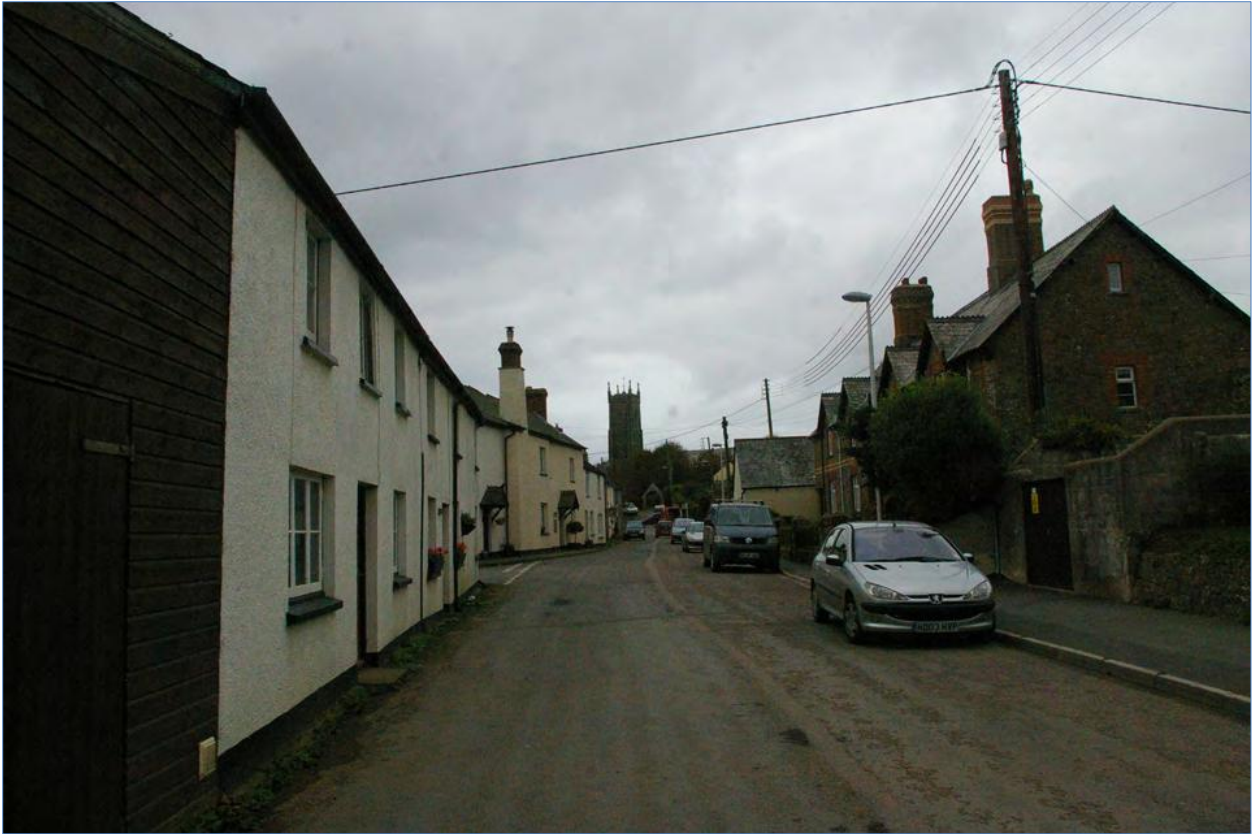
View across the countryside towards Buckland Brewer, showing the landscape dominance of the church, even at a distance; from the south-east.

View of the village setting of the church in Buckland Brewer; from the south.

- Church of St Mary and St Benedict, Buckland Brewer; high significance; Grade II\* Listed; condition: good; distance to the turbine c.2km. A 15<sup>th</sup> century parish church, heavily restored in the 1870s/1880s, by S. Hooper of Hatherleigh. Parish school room of 15<sup>th</sup> century date is attached via a 19<sup>th</sup> century crenellated passage to the east end of the south aisle. A tall three stage tower with full height off-set angle buttresses. Largely valued for its medieval structure and the school room. Located on high ground which peaks further to the north-west the village is on the upper east-facing slopes, on a slight incline, with steep combs and valleys, running away from the village to the north and east and west. The church holds significant landscape primacy within the wider landscape, particularly to the north, north-east and east. The church shares landscape dominance of this area with Monkleigh church, with key visual links between the two buildings. The turbine stands within the wider landscape setting of the church, although not directly within the landscape context. There will be clear views to the turbine from the tower; the setting within the village itself will not be affected. The turbine will frame views to the church, when approaching the village from the south and also from the north and north-east. The proposed turbine will interrupt views to Langtree church tower. There is also an issue of cumulative impact as the proposed turbine will stand on a high ridge south of the village with two extant turbines in close proximity at Babeleigh Barton and Craneham Hill, with another at Frithelstock to the south-east. Further turbines stand on Thornhillhead Moor, and another is under construction just south-west of the village. Views south from the church and views back to the church are dominated by turbines; this interrupts views across the expansive southern parts of the Buckland Brewer parish, removing the church tower as the landscape focus for the parish. The turbine will add to the skyline profile of the extant turbines and will directly compete visually with the church tower; impact: **negative/moderate**.

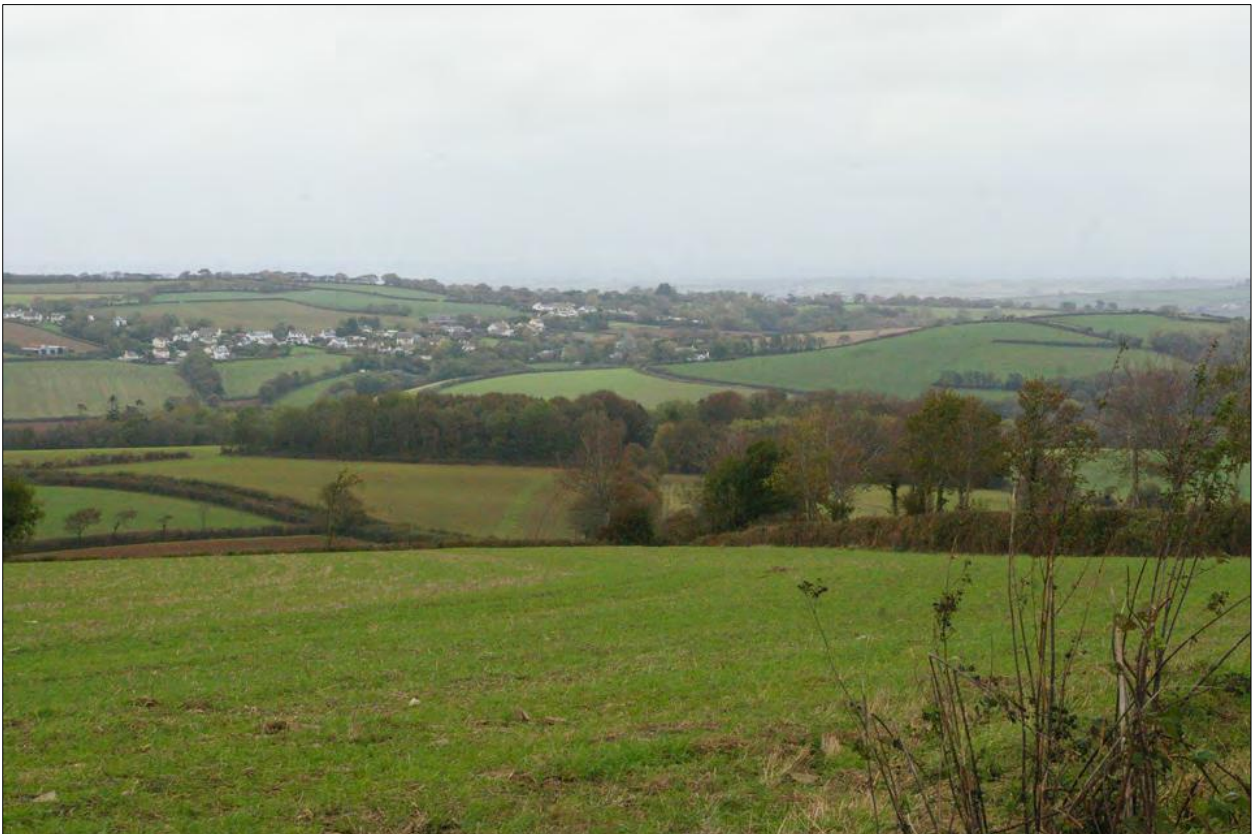
View down and across to Orleigh Court grounds, the house set in the woodland; from the south-west.

- Orleigh Court, Buckland Brewer; high significance; Grade I Listed; condition: good to excellent; distance to turbine: c.4.75. Manor House of various phases, with a 14<sup>th</sup> century open hall, with additional very fine quality 15<sup>th</sup> century hammer beam roof. The building was altered in the 1720s, then again in the 1860s. The whole was converted to flats in the 1980s. The house is of local rubble stone construction, under slate roofs and is of courtyard plan. Listed primarily for the medieval structure and fine interior details, principally the 15<sup>th</sup> century hammer beam roof. The house is set within woods, on a low shallow north facing slope within a wide valley; there are wide views down and across to the Torridge Valley to the east and views north across to Littleham. The ground rises to the south and east, to Buckland Brewer and the house falls outside the ZTV. The proposed turbine would not stand within the landscape context of this asset and would not frame views to the asset; impact: **neutral**.
