# LAND at BRADDONS PARK BUCKLAND BREWER DEVON

Results of a  
Historic Visual Impact Assessment

Report No.: 141107  
Date: 07.11.14  
Author: E. Wapshott  
S. Walls  
V. Hosegood

South West Archaeology Ltd. was asked to undertake a historic visual impact assessment on land at Braddons Park, Buckland Brewer, Devon, in advance of a planning application for the construction of a 50kW (25m to hub) wind turbine.

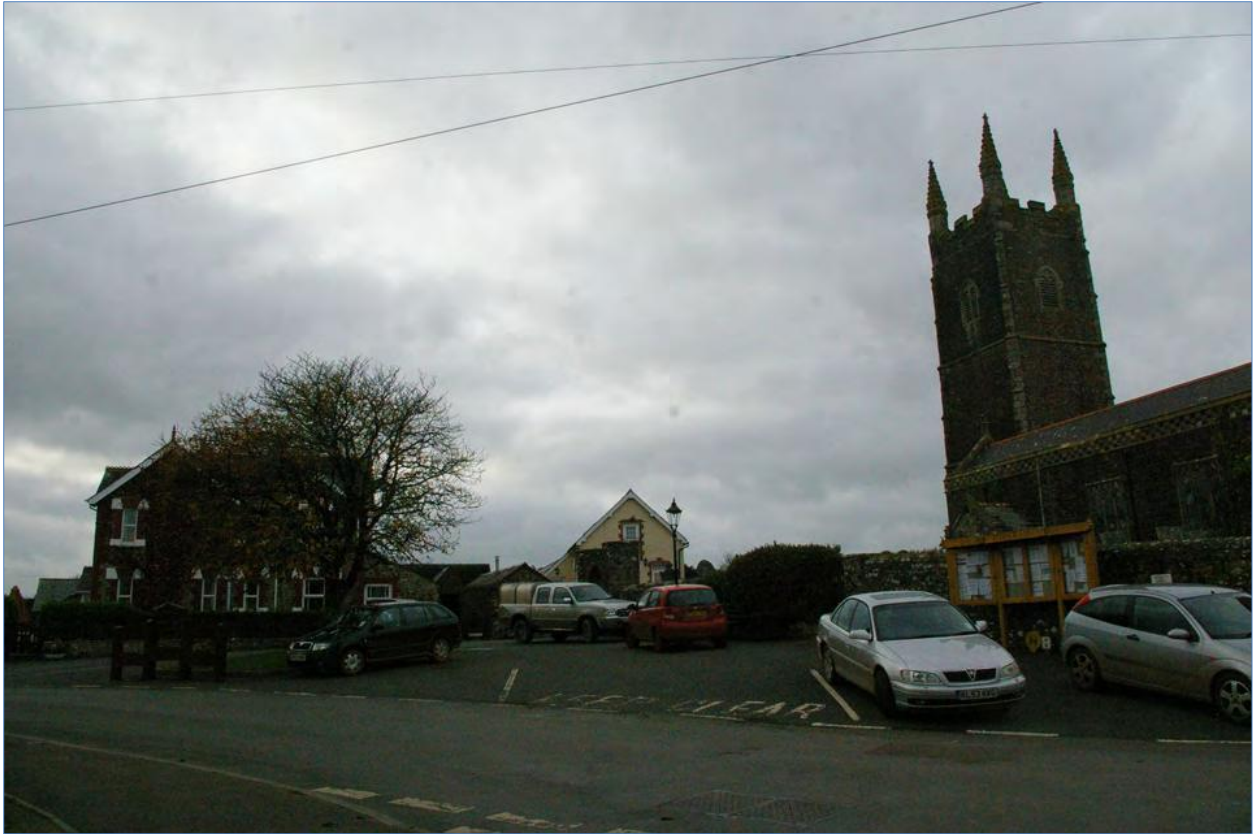
Parkham Church, with tall tower, set in the village square; from the south-east.

- Church of St James, Parkham; high significance; Grade II\* Listed; condition: good; distance to turbine c.3.5km. A 15<sup>th</sup> century parish church, heavily restored in 1875. The west tower is of three stages with full height diagonal corner buttresses. 19<sup>th</sup> century arch-braced roofs throughout and mostly 19<sup>th</sup> century fittings. There is a 12<sup>th</sup> century font with some 15<sup>th</sup> and 16<sup>th</sup> century tiles inset around it, and various 17<sup>th</sup>-19<sup>th</sup> century monuments. Largely valued for its surviving medieval structure. Set high on a north-east slope, just off the peak of a hill, to the west of a steep winding river valley, a tributary of the River Yeo. The church holds distinct landscape primacy to the north-west, north and north-east and less so to the south-east. The proposed turbine will not stand in the landscape context of the asset. The turbine will not affect the setting of the church within the village, framed to the south by the village square, but the turbine will be visible from the church tower. The turbine may frame some views to the church from the north and north-west. The turbine will interrupt (the more limited) views to the south and south-east, (towards Langtree), and there is already an extant turbine just to the south-east; impact: **negative/minor**.

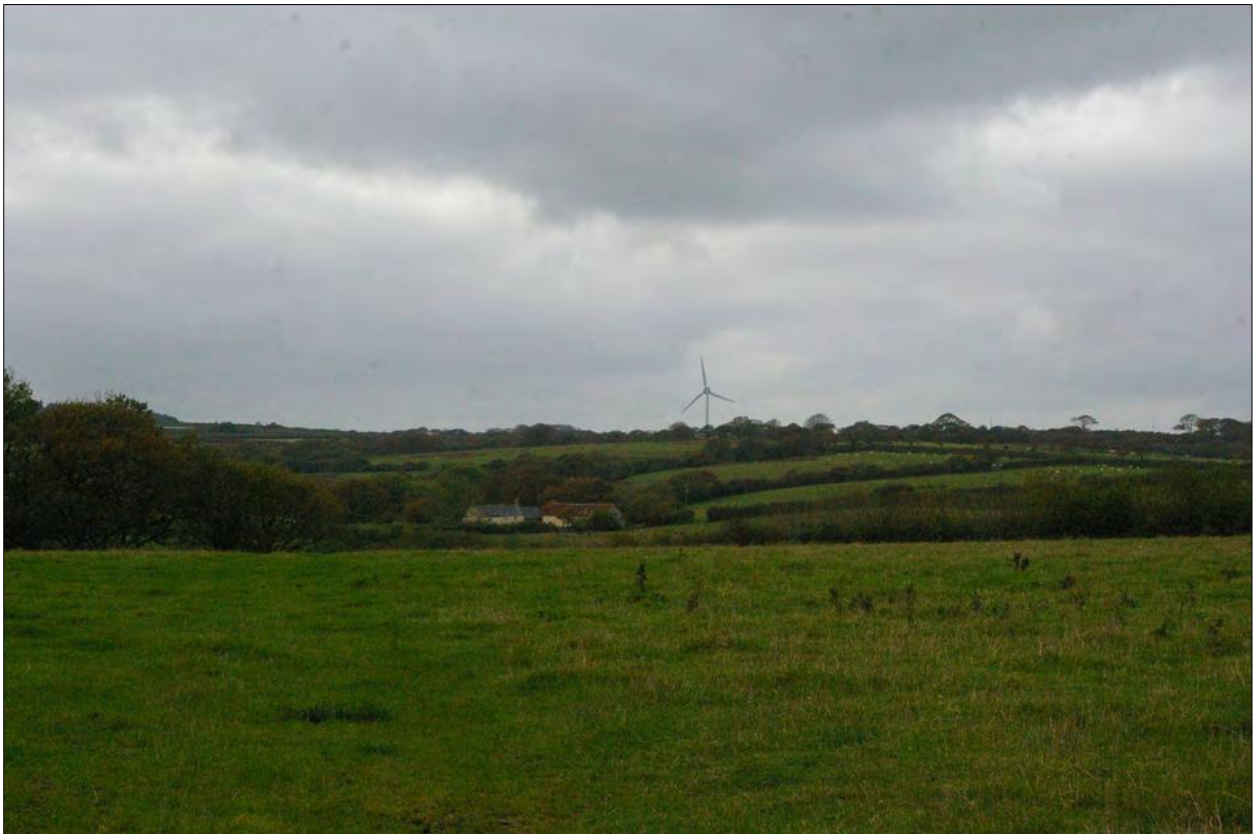
Park Farm, near Buckland Brewer, with the large extant turbine at Babeleigh Barton rising behind on the horizon; from the north-east.

- Park Farmhouse and attached outbuildings, Buckland Brewer; medium significance; Grade II Listed; condition: fair to good. Distance to turbine c.1.25km. Set down a long track but visible

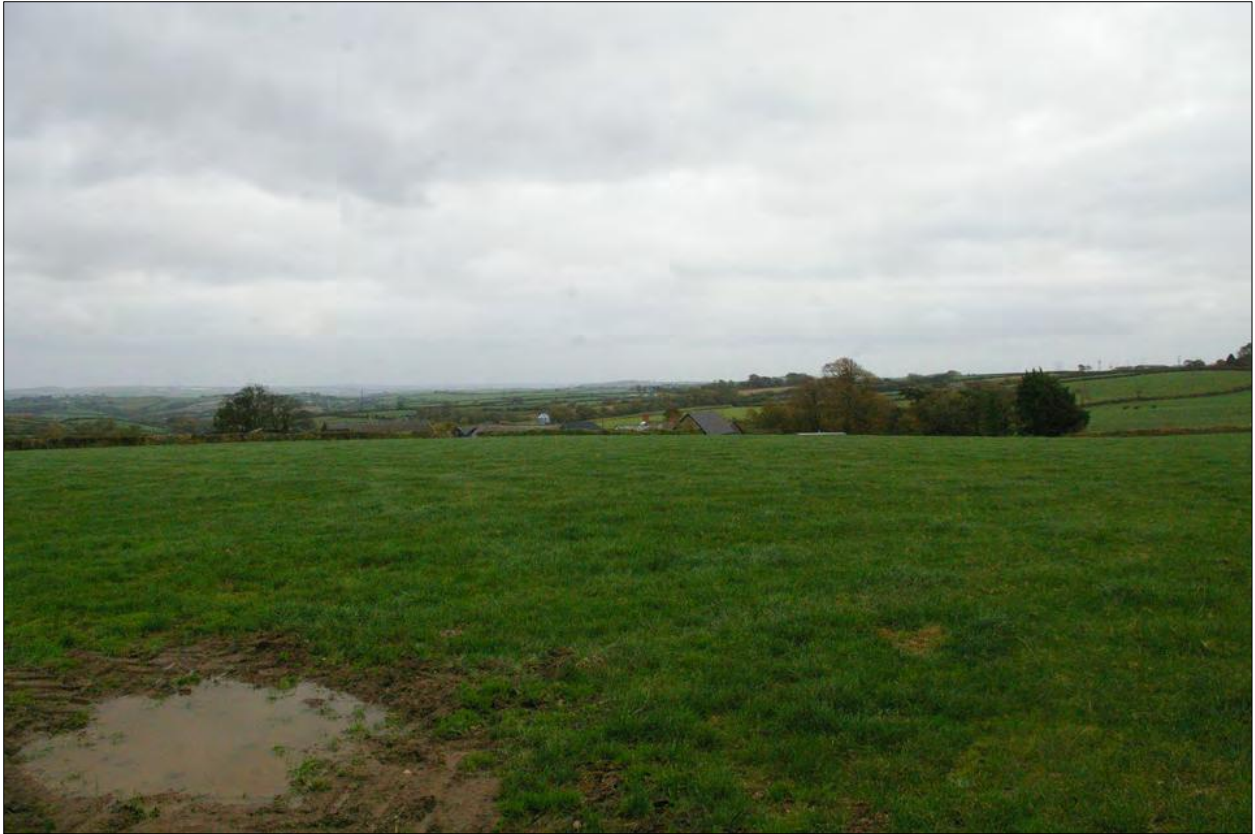
Great Gorwood Farm, set on a north and east facing slope with views across to the wind farm at Torrington and beyond to the wind farm on the edge of Exmoor; from the south-west.

- Barn and Granary at Great Gorwood, Buckland Brewer; medium significance; Grade II Listed; condition: fair to good. Distance to turbine c.1km. Set down a short farm track over the brow of a hill on the upper north and east facing slopes, at the head of a combe, leading down into a shallow valley, to the south of Buckland Brewer. The buildings can be seen from the public road in part over tall hedgebanks, the lane to the farm is also lined by tall hedgebanks and the farm is partly shielded by trees to the south around the entrance to the farmyard. Local blocking will therefore apply, significantly reducing views to the turbine. The barn and granary may be set lower within the farmyard and are not directly visible from the road. The assets are within a working farmstead, on a large farmyard, with extensive modern buildings. Their immediate setting is not affected but the turbine will stand in their landscape context and will affect the character and visual nature of their landscape context. Turbines are already clearly visible in the far distance from the farm, in the wide views north and north-east at Torrington and on the edge of Exmoor; impact: **negative/minor to negative/moderate**.

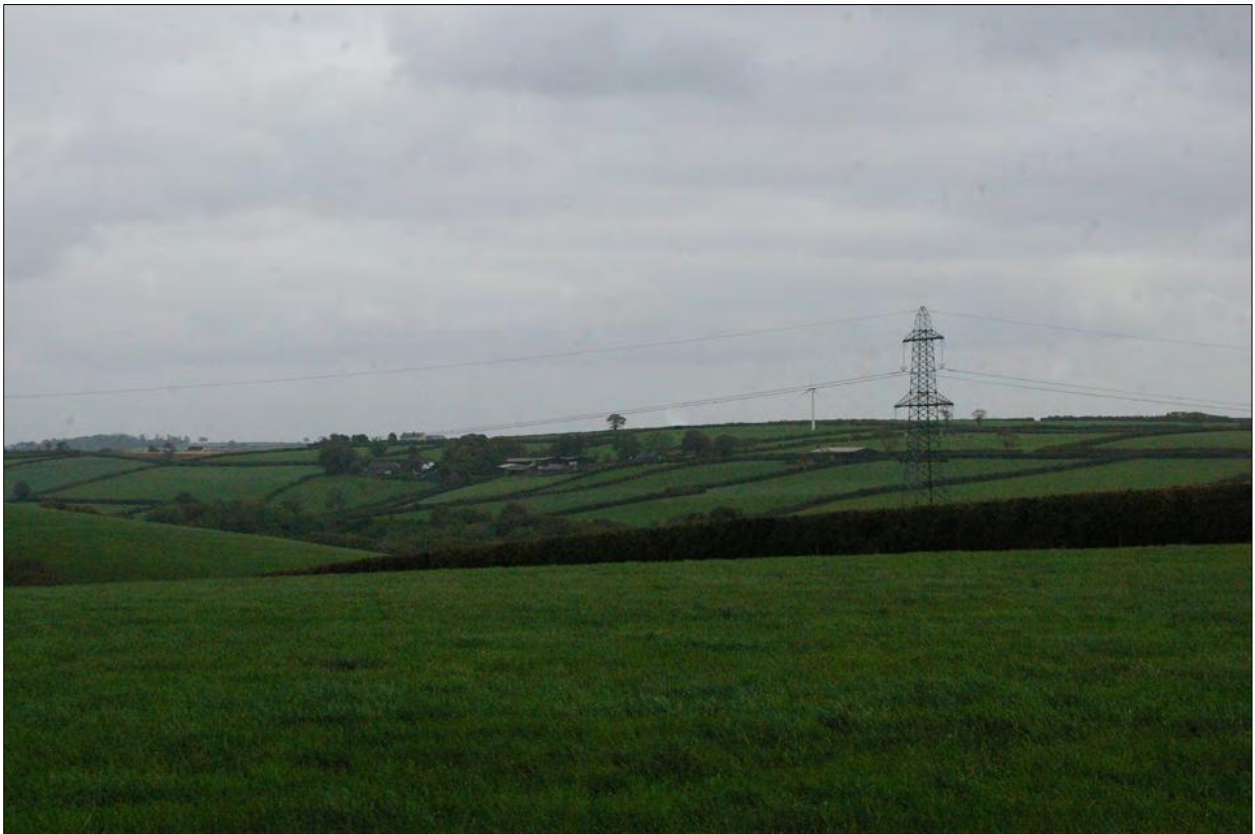
Ash Farm at Frithelstock with the extant turbine in the fields above the farm; from the north-west.

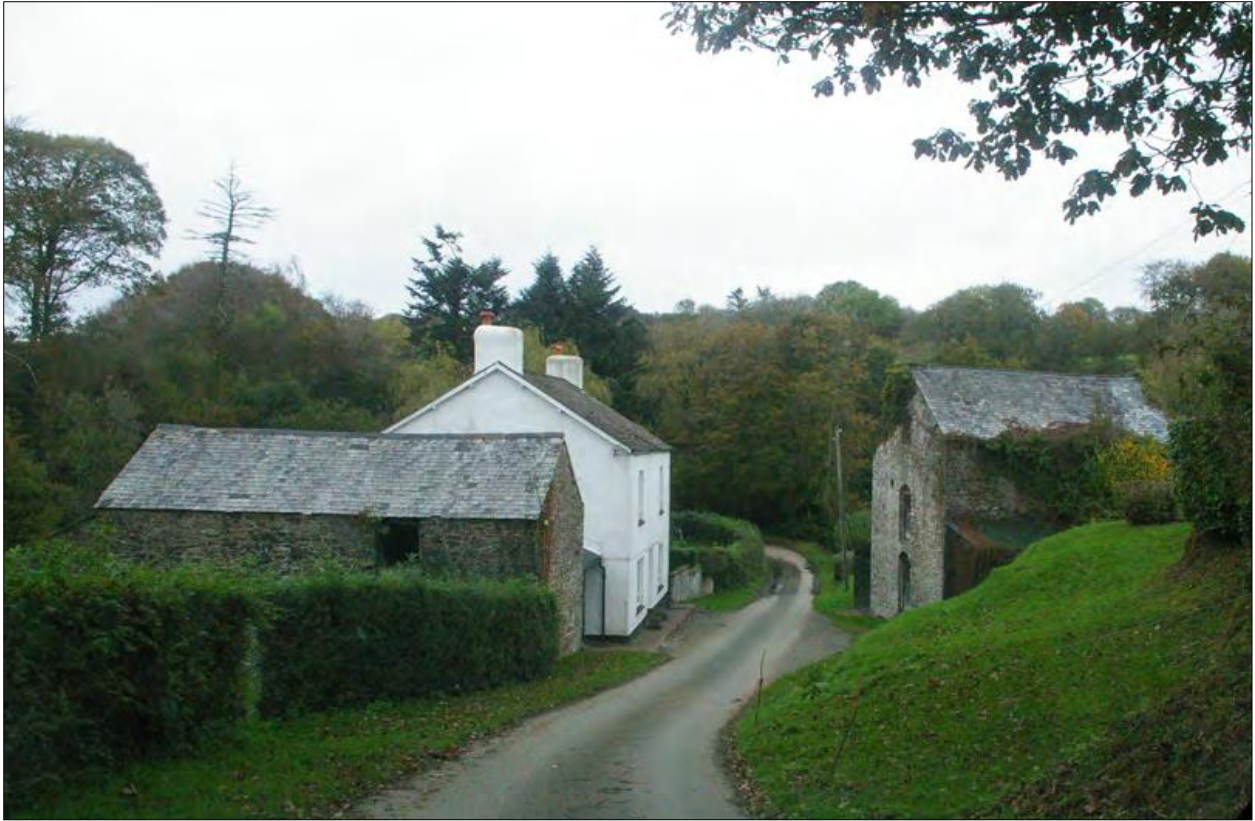
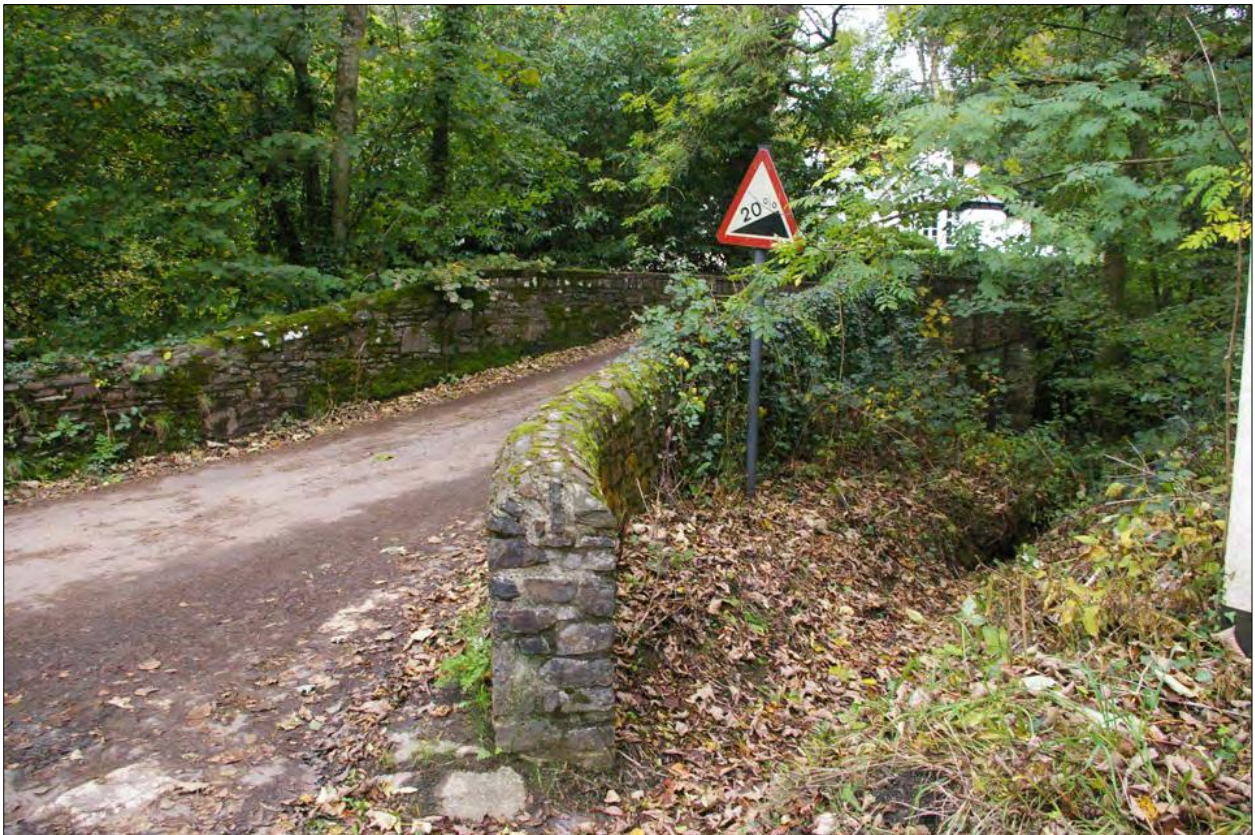
Former Mill at Buckland Brewer, within a steep wooded valley; from the south.

Glen Bridge, in the base of the wooded valley, east and south of Buckland Brewer; from the west.

- Glenn Bridge and Former Millhouse, Buckland Brewer; medium significance; Grade II Listed; conditions: fair to good; distance to turbine c.2.5km. The assets are set at the base of a steep narrow valley, to the east of Buckland Brewer. There is significant local blocking from the setting of the bridge amongst the trees and overgrowth of the banks of the River Duntz. The proposed turbine does not stand within the landscape context of this valley and the assets lie outside of the ZTV. The turbine will be visible on the approach to the valley but not from within it. The setting of the mill by the river and the bridge over the river is not affected; impact: **neutral**.

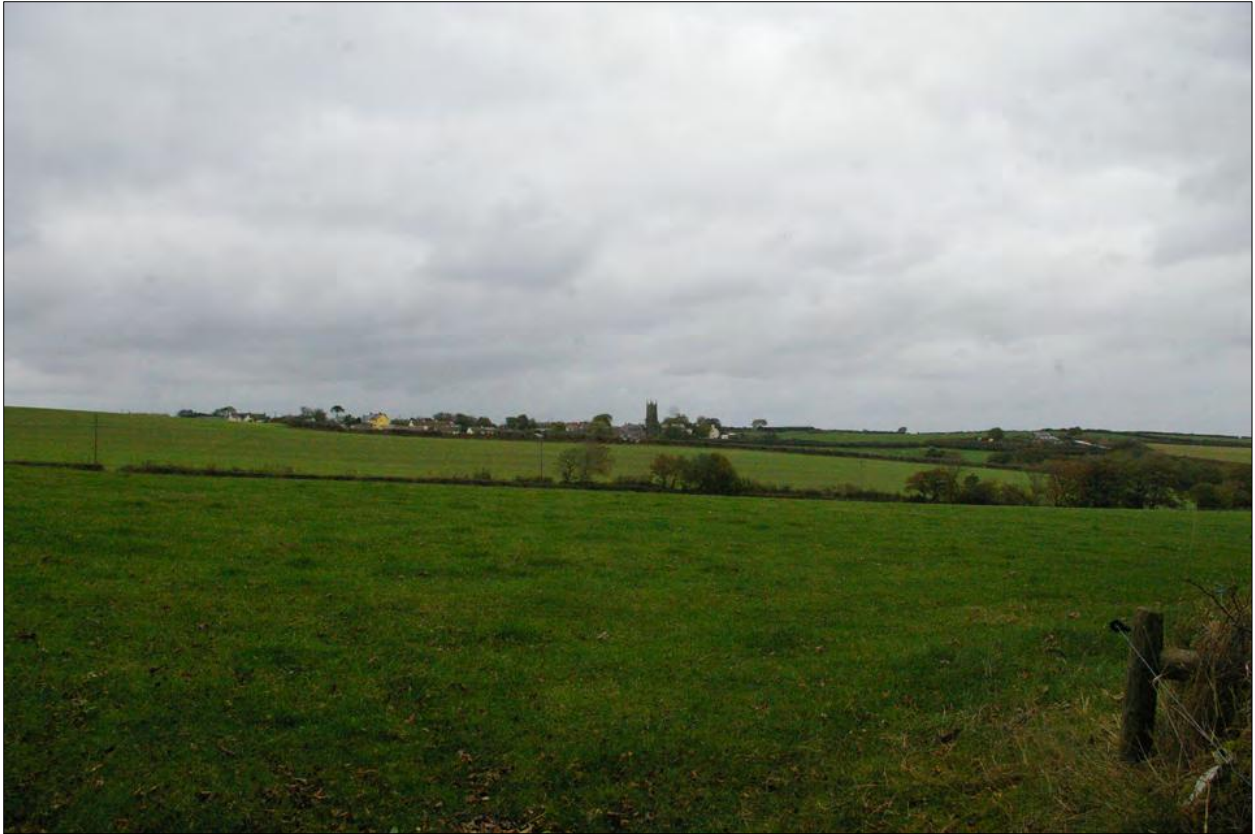
Monkleigh Church, set within the village on the high ridge of ground, with far reaching views and conspicuous landscape primacy; from the south-west.

- Church of St George, Monkleigh: high significance; Grade I Listed; condition: fair to good. Distance to turbine c.4.75km. An early 15<sup>th</sup> century church with addition of later 15<sup>th</sup> century south aisle, heavily restored in the 1860s. Three stage west tower, with offset, setback corner buttresses. The finest feature is the early 16<sup>th</sup> century carved screen in the south Annery Chapel, which is considered one of the finest pieces of Devon screen carving. The church is set on a high ridge of ground, to the west of the River Torridge valley. The village primarily lies to the west of the church. The church holds distinct landscape primacy across the Torridge river valley, south towards Frithelstock and to the west, towards Buckland Brewer and Parkham. The turbine will not affect the setting of the church in the village; however it will be clearly visible from the church tower. The turbine will not stand within the landscape context of the church, but will be a visible skyline feature in the wider landscape. The turbine will frame views towards the church from the north-east and east, such as at Gammaton; it will also appear in views between Monkleigh and Buckland Brewer Church. There will also be issues of cumulative impact as there are now six extant turbines to the south-west; impact: **Negative/minor** to **negative/moderate**.

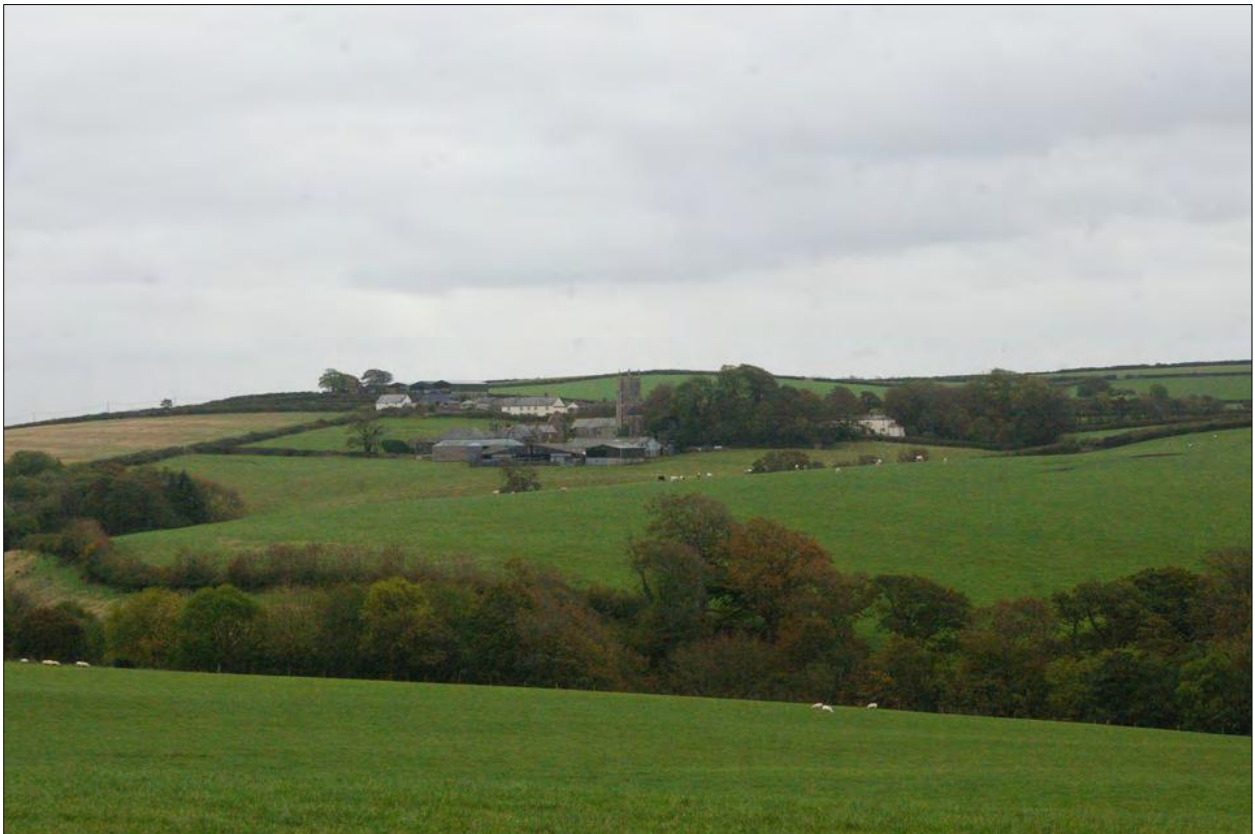
Frithelstock Priory and Church, set within the wide shallow valley; from the north-west.

- Frithelstock Priory, Ruins of Priory Church, Church of St Mary and St Gregory; high significance; Scheduled Ancient Monument and Grade I Listed buildings; conditions: good to excellent for standing church, fair for maintained ruins; distance to turbine c.5km. Ruins of Augustinian Priory church in Early English Style, founded in c.1220 by Robert de Bello Campo, additional Lady Chapel and west tower added in c.1330, built by Bishop Walter de Stapelton. Plan is of chancel and nave with Lady Chapel to the east and foundations of a tower to the south-west; the best preserved surviving remains of a religious house in the district. The church is 13<sup>th</sup> century, with substantial rebuilds in both the 14<sup>th</sup> and 15<sup>th</sup> century, with a 15<sup>th</sup> century west tower. Late 15<sup>th</sup> century waggon roofs to interior, also with 15<sup>th</sup> and 16<sup>th</sup> century choir fittings and bench ends, some fine 17<sup>th</sup> century fittings and Barnstaple floor tiles with some inset medieval tiles. Listed for multitude of important historic fittings, as well as substantial survival of medieval structure. Significant group value with priory ruins. The priory and church lie on the upper south slopes of a valley which runs east down to the Torridge river valley. The church holds some landscape presence within the valley but little out of it. There may be views from the top of the church tower but otherwise the buildings do not lie within the ZTV directly and their primary views are towards Torrington and to Monkleigh. The proposed turbine will not frame any views to the priory, nor frame any outward views or disrupt any visual links to other heritage assets within its landscape context; impact: **neutral** to **negligible** for the tower.
