CHURCH of ST.GILES & ST.NICHOLAS SIDMOUTH DEVON

Results of an Archaeological Monitoring & Recording

Report No.: 151211
Date: 11.12.2015
Authors: J. Bampton
B. Morris

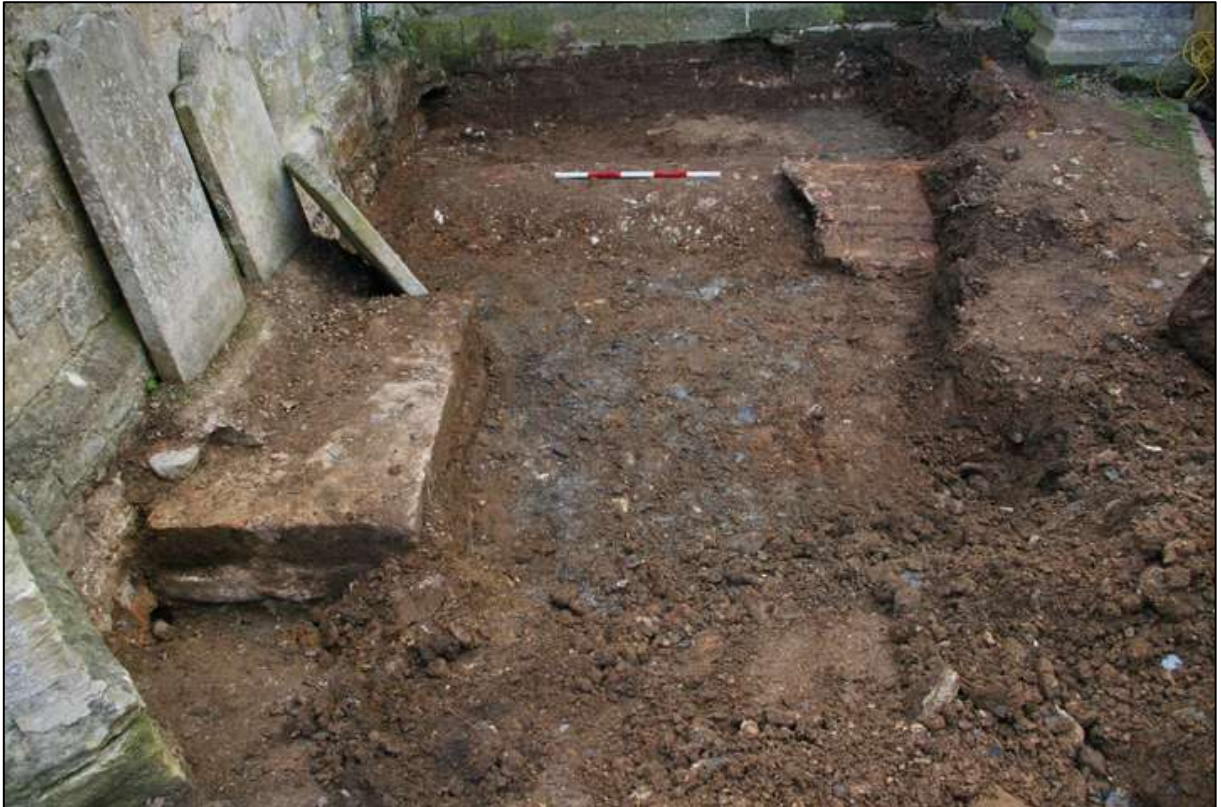
Figure 2: Site shot, mid-excavation showing stone plinth and barrel tombs; viewed from the north (1m scale).

Stone plinth {104} was 0.89m wide, 1.56m long and 0.60m thick (0.20m the fine finished top and 0.40m of a roughly bonded base/foundation). It was bonded together with a light-mid brown buff lime mortar with coal inclusions as in the masonry to the south mentioned above (Surface (102)). It had a relatively rough foundation and a squared upper section forming the plinth. Its eastern section was overlaid with concrete that held the grave stones against the north aisle in place. The top of Stone plinth {104} was 600mm higher than the ground level on the south side of the tower. To the north of Stone plinth {104} was Made-ground (105), 0.30m deep, a mixed brown earth, buff brown slightly silty-sand deposit with frequent flecks of mortar and slate fragments up to 50mm across and occasional animal bone (cattle teeth). Made Ground (105) equates to made-grounds (116) and (117) combined. Made-ground (105) overlaid Made-ground (106), a layer of soft slaty grey sandy-silt with frequent slate meal and moderate mortary fragments. Made-ground (106) abutted the north aisle (Figures 2 and 3).

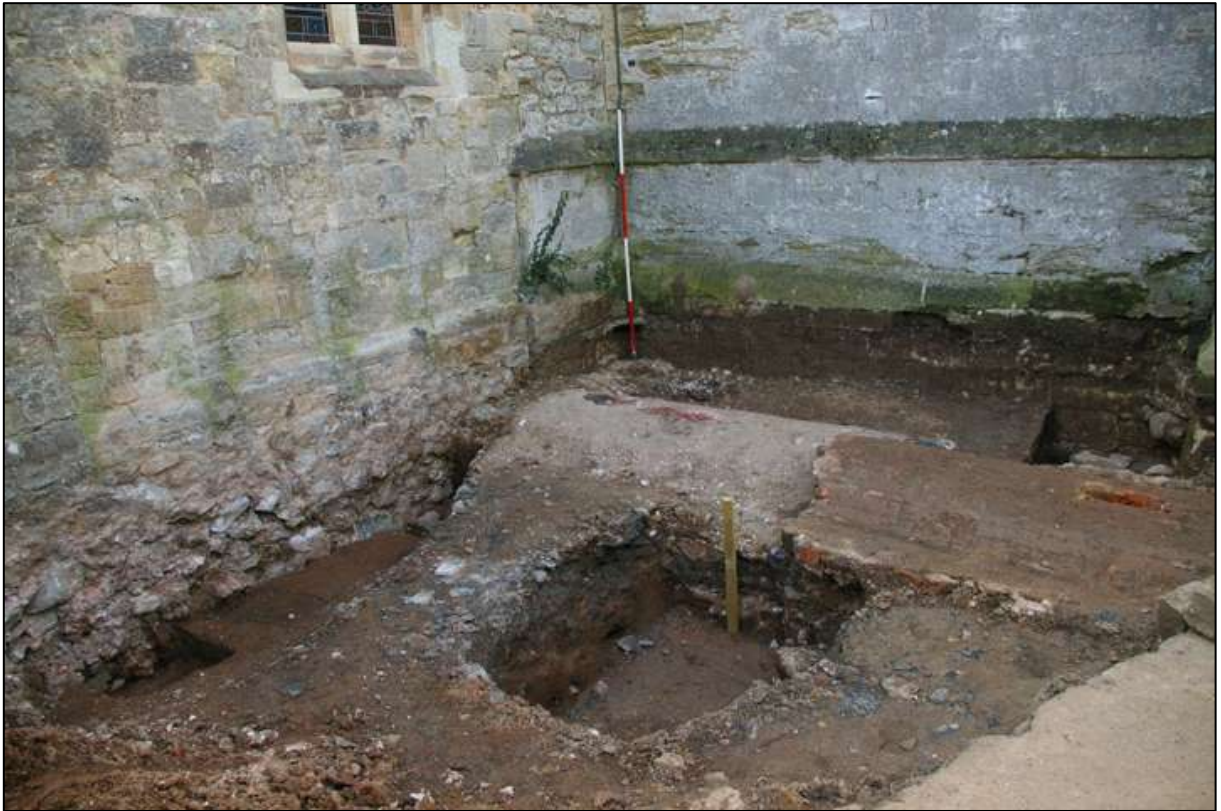
Figure 3: Site shot mid excavation; viewed from the north-west (2m scale).

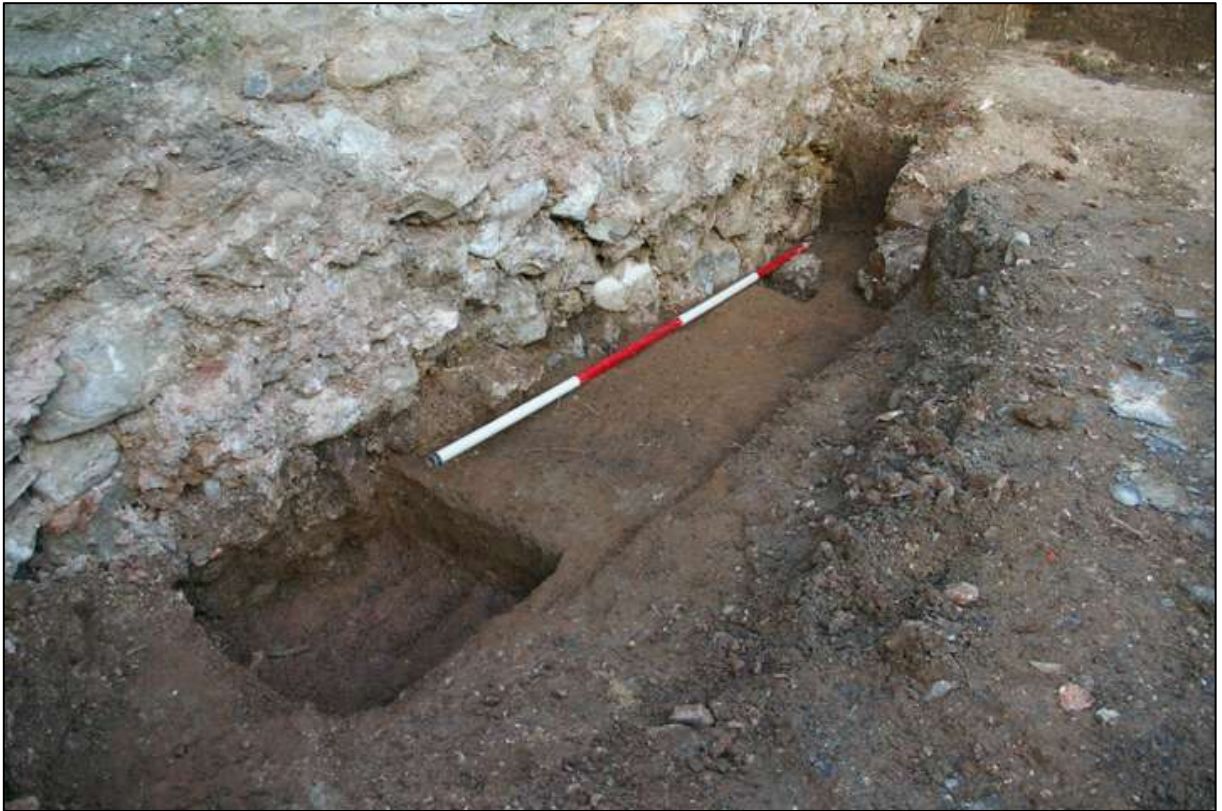
A sondage was excavated into the south-west corner of the area to establish the depth of the footings of the tower. The area between the barrel tombs and the tower had been disturbed. In this area Made-ground (109), which equated to Made-ground (106) overlaid disturbed/redeposited Subsoil (129) and Backfill (130). Backfill (130) appears to be re-deposited soil from previous drainage works that overlaid the top of the tower Foundations {137}. It contained a concentrated deposit of infant bones that indicates a disturbed/truncated infant burial. Subsoil (129), which may equate to Subsoil (120), overlaid Grave Fill (133), natural and the towers north-west buttress Foundations {136}. The north aisle foundations are shallower than the tower foundations and less well consolidated with a crumbly lime based mortar. The tower foundations generally have larger stone and are more densely packed in place with very little in the way of a buff sandy bond (see Figures 4 and 5).

Figure 4: Southern foundations of north aisle and grave cuts; viewed from the north-west (2m scale).

The tower was built in the 15th century and has clearly different and more substantial foundations than those revealed from the 12th-14th phases during interior church ground works (see Brown 2009). The north aisle clearly abuts the buttress of the tower, therefore was constructed

sometime later in or after the 15th century. However, the foundations of the north aisle, which included Salcombe stone and large pebbles and lime mortar, are similar in form, style and construction to the earlier phases of the church. Based on photographs in Brown's 2009 report the 13th century foundations are the most similar. It may be that the 14th century north aisle was longer than originally interpreted from the evidence within the church or that the foundations were simply re-used in the later 15th century north aisle that abuts the tower. In either case it appears probable that the 19th century renovations re-used the existing footings. This re-use may explain the relatively poor consolidation of the foundations of the north aisle.

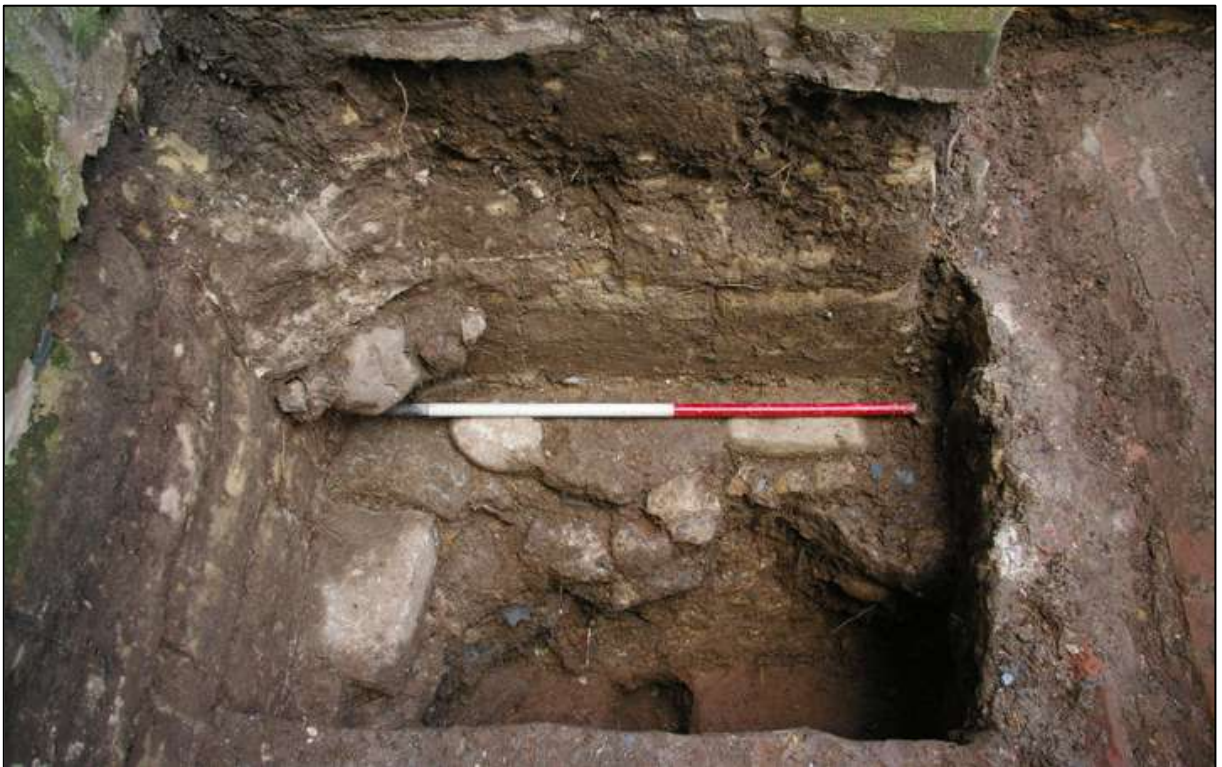
Figure 5: Foundations of north-western buttress to the tower; viewed from the east (1m scale).

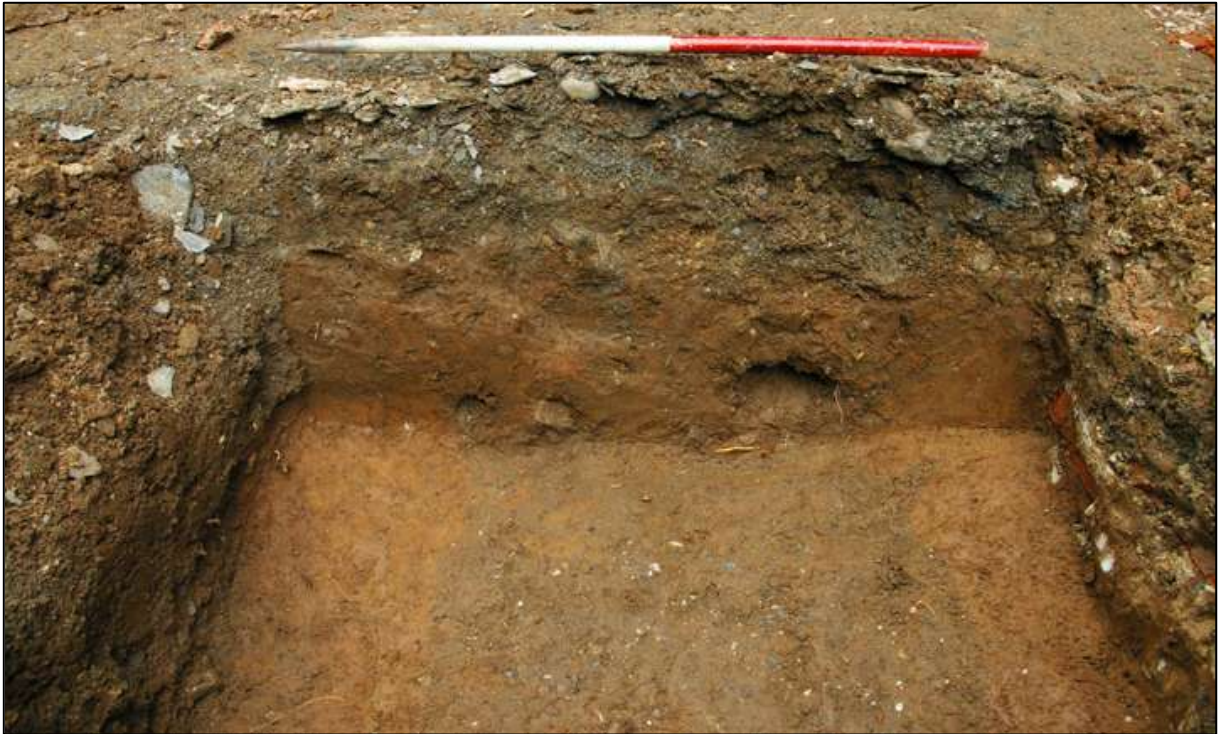
When reduced to formation level nine graves were visible in the church extension area; [121], [123], [125], [127], [132], [139], [141], [143] and [145]. Some of these had been truncated by later groundworks and features including barrel tombs {107} and {108}. At formation level the grave cuts had been partially truncated to a level above the skeletal remains (e.g. Figure 6). In the footing trenches the graves were truncated to a greater depth, although some of these had already been disturbed by other grave cuts or later groundworks.

Figure 6: Grave Cut [121] and west facing section in central test pit; viewed from the west (1m scale).

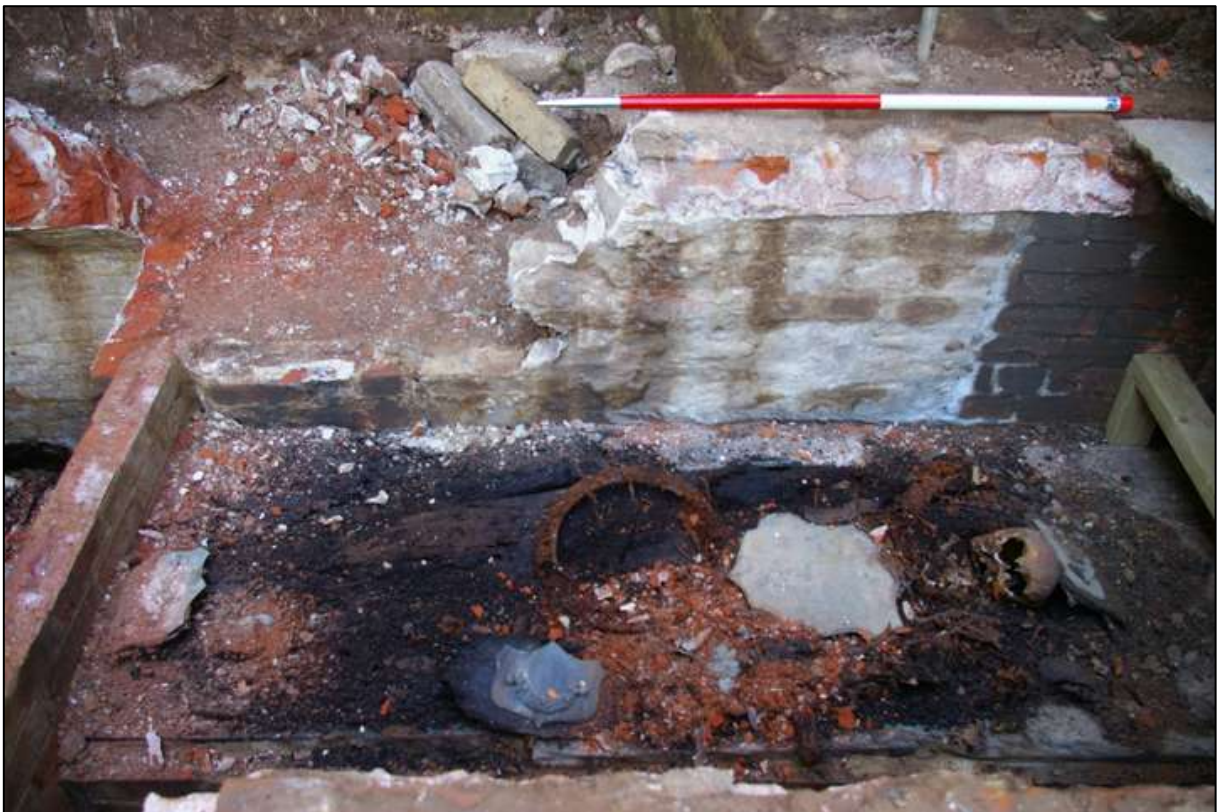
Barrel Tomb {107} abutted Barrel Tomb {108} and the foundations of the north-west buttress of the tower. It was 1.10m deep, 1.18m wide and 2.8m long. The west wall of the tomb uses the end of Barrel Tomb {108} and uses frogged bricks bonded in a harder pink-grey mortar to seal the entrance to Barrel Tomb {108}. The entrance in the western end of the tomb was blocked from the floor level with brick then a large stone slab above. The floor of the tomb appeared to be concrete, although most of the footprint was obscured as a brick built tomb with mortared slate lid, which supported a coffin, took up most of the footprint. The coffin was mostly decayed and had included copper alloy fittings and shield. Four iron rings for flower arranging were also visible. The skull was visible and coffin handles that had fallen to the side of the tomb. The walls of the tomb were lightly white-washed. The top of the extreme west end of the tomb had been removed and flat slate slabs overlaid during the construction of the church path (See Figures 7 to 12).

Figure 8: Barrel tomb {107}, opened; viewed from the north (1m scale).

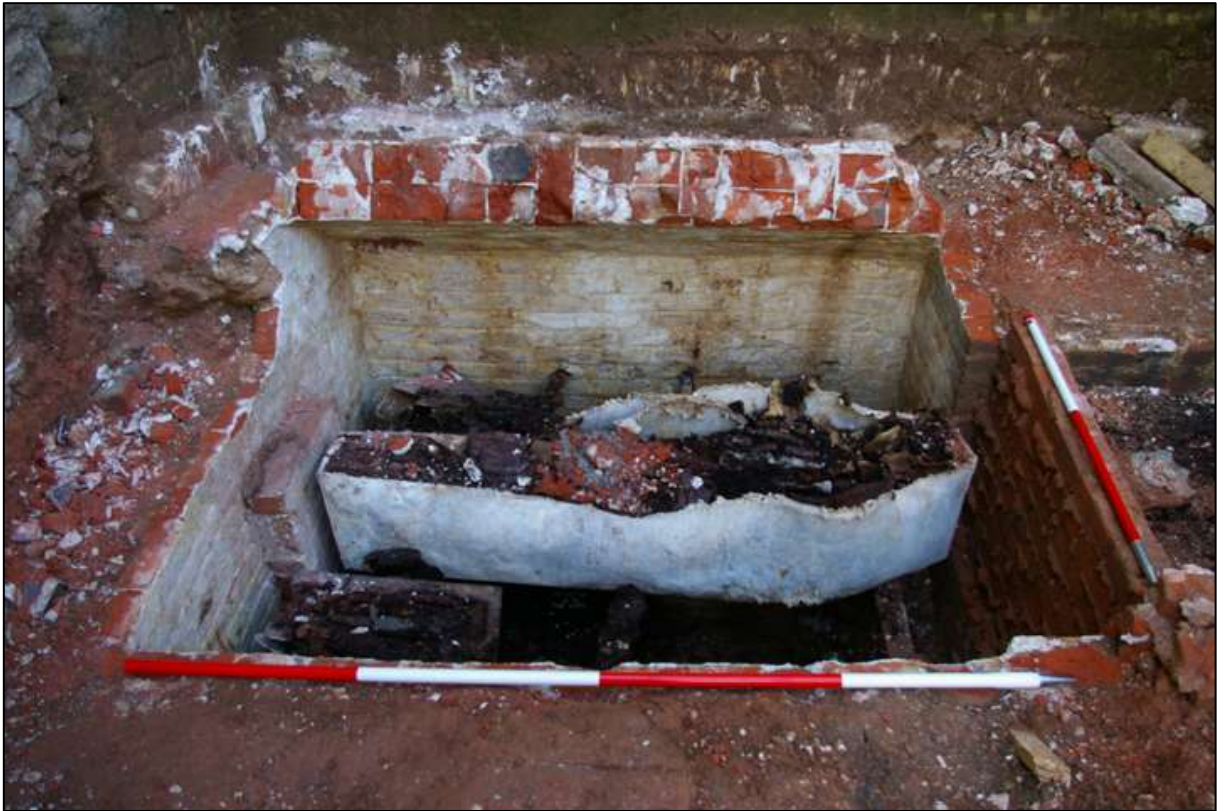
Barrel Tomb {108} abutted the footings of the north-east buttress of the tower. These footings had been rendered over. The tomb was 1m deep to floor level with an additional 0.40m above within the arch of the 'barrel' vault roof and 2.15m by 1.86m wide. The entrance to the tomb was in the north end of its west wall. This had been bricked-up during the use of Barrel Tomb {107}. The internal walls of Barrel Tomb {108} had been lightly plastered or heavily white-washed. A short wall, one brick wide and bowing out to the north (coffin-shaped) spanned the floor of the tomb from east to west. From this, six flat iron bars ran to the north and south walls of the tomb (three on each side). The southern bars were c.0.05m wide and the northern bars were c.0.08m wide and c.0.12m thick. They did not run parallel/perpendicular to the tomb structure. These bars supported a lead coffin in the middle of the chamber. The lead coffin was relatively plain with hatched scoring on its north side. A wooden coffin appears to have been placed above the lead coffin, which may have warped (depressed) the lead coffin beneath and broken its lid. The wooden coffin is now represented by a number of rivets, iron coffin handles and degraded wood fragments. There appeared to be some pale leather on these upper coffins that may have been an interior trim. A roof slate was on the iron bar in the north-west corner on which the footprint of a small child's coffin could be seen. A similar slate overlaid with decayed wood and possible textile could be seen in the south-east corner. Below the iron bars on either side of the bowed wall were the remains of wooden coffins, including rivets and a cranium on the south side of the wall. North of the bowed wall a burial chamber had been excavated into the base of the tomb, which was spanned by three iron bars and had soil overlaying it and infilling it along with coffin wood. Bricks were also noted to the side of this chamber that may have raised an overlying coffin. A copper alloy 'goblet', c.0.08m×0.15m, was observed at the western end of the chamber and left undisturbed, in situ. The chamber walls were built of a single line (stretcher bond) of soft, but well prepared hand-made brick. The arch was two bricks thick in a Flemish bond, although was thinner near the entrance. They had been bonded in a hard brittle light grey mortar.

Figure 9: Barrel tomb {108}, opened; viewed from the north (1m & 2m scale).

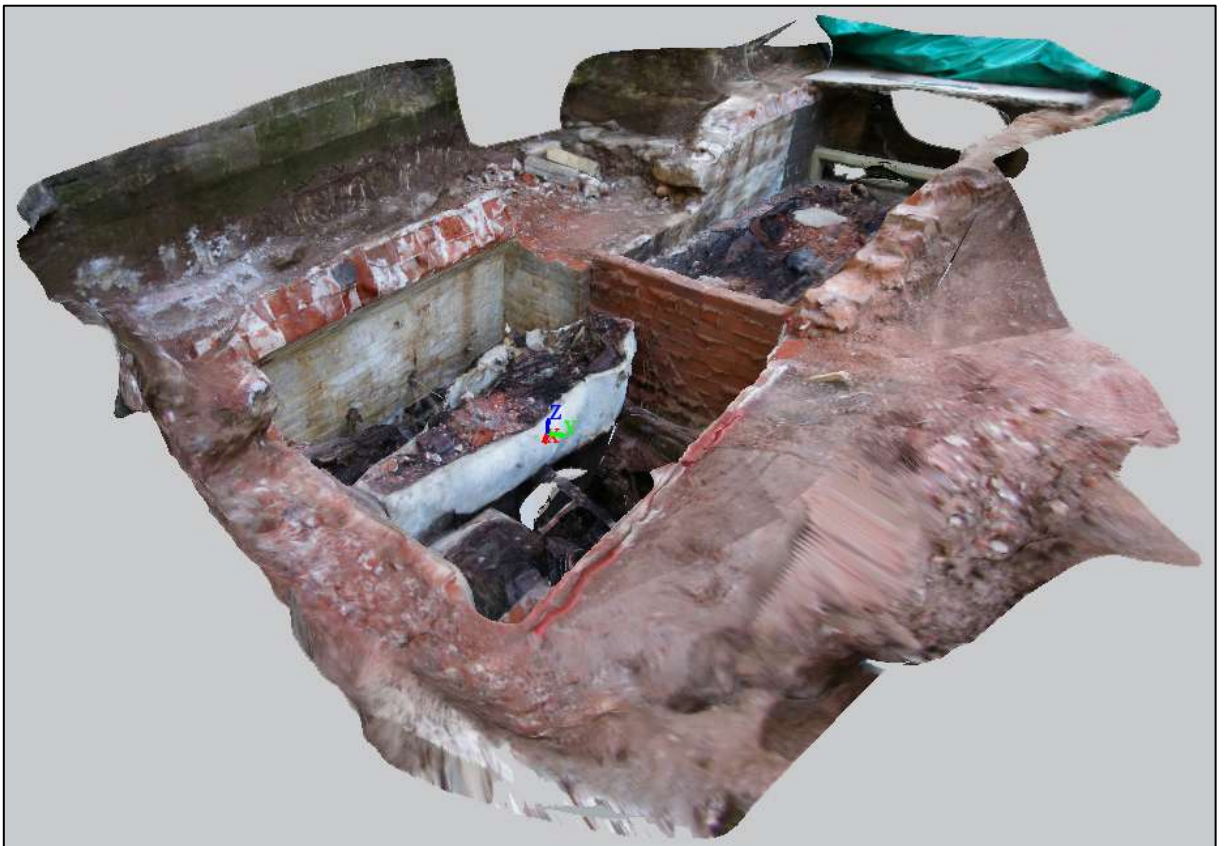
Figure 10: 3D Composite Photograph of Barrel tombs {107} and {108}, opened; viewed from the north-east (2m scale).

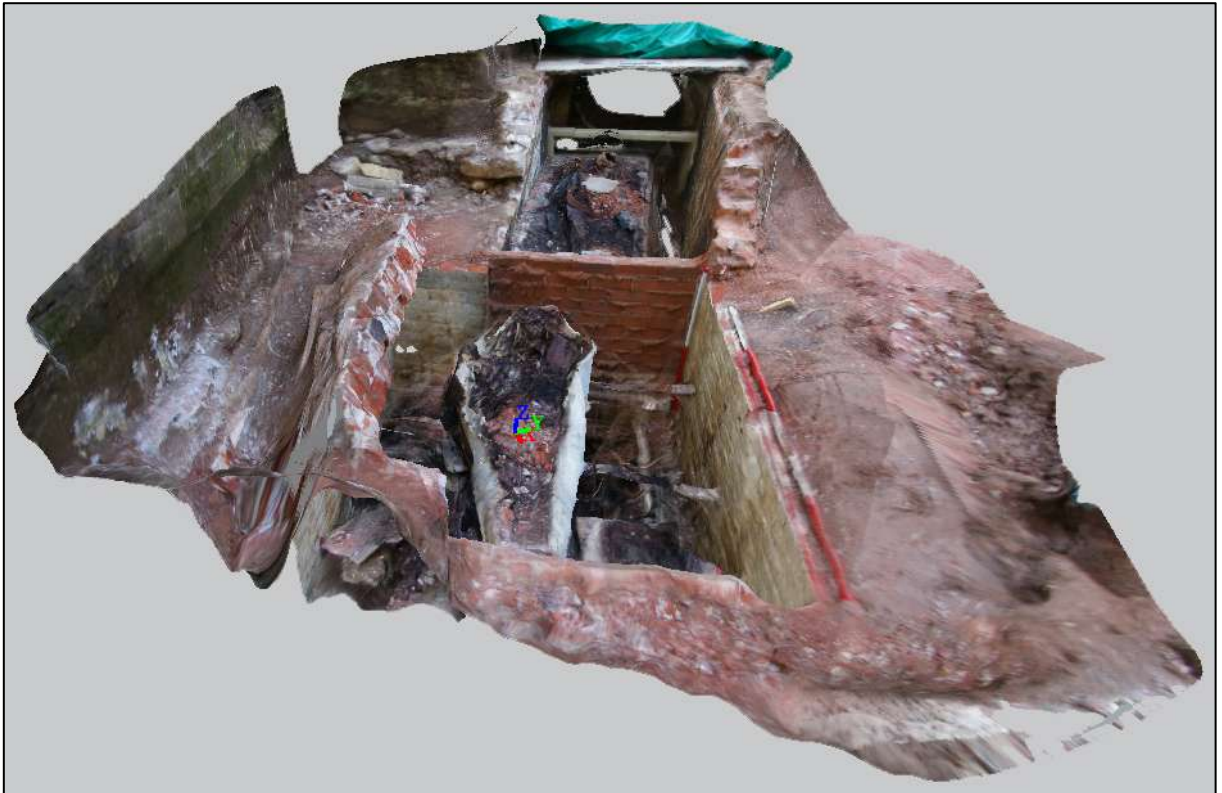
Figure 11: 3D Composite Photograph of Barrel tombs {107} and {108}, opened; viewed from the east (1m & 2m scale).

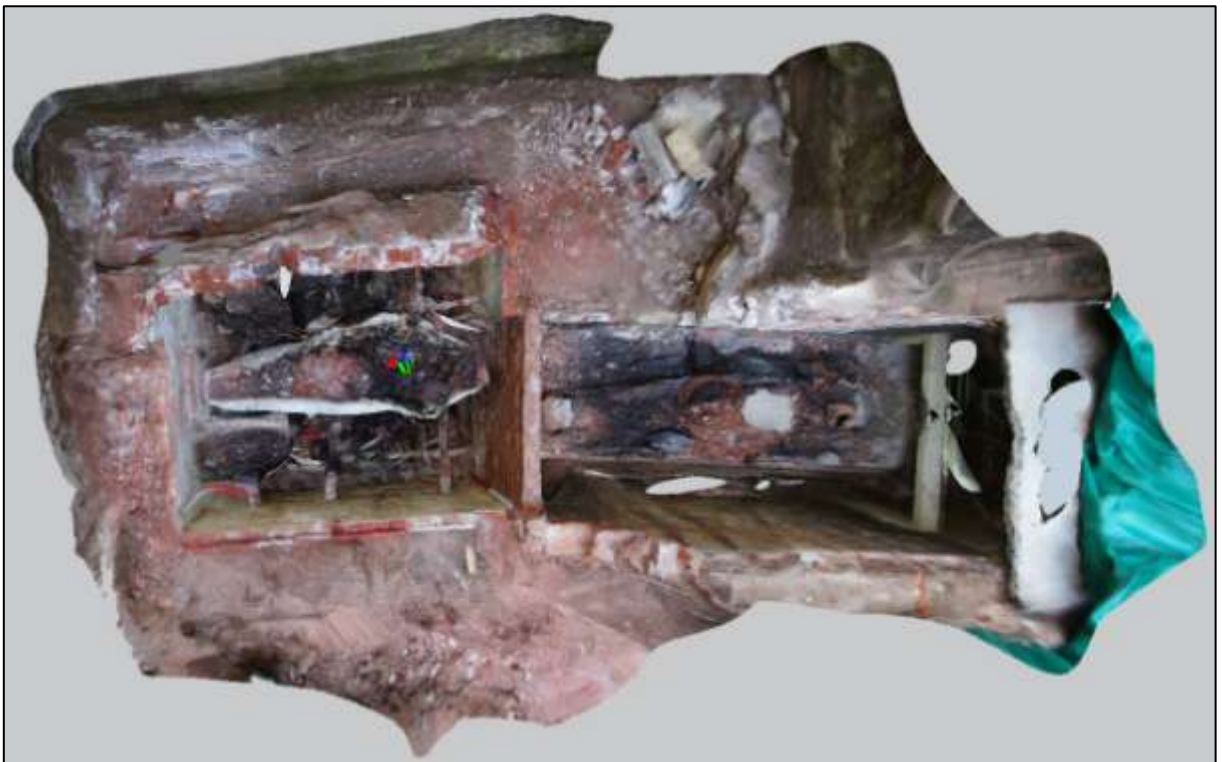
Figure 12: 3D Composite Photograph of Barrel tombs {107} and {108}, opened; viewed from above and the north (1m & 2m scale).
