LAND at CHURCHTOWN FARM, SALTASH, CORNWALL

Results of a Desk-Based Assessment,
Walkover Survey & Impact Assessment

Report No.: 140606
Date: 06.06.2014
Authors: S. Walls
V. Hosegood

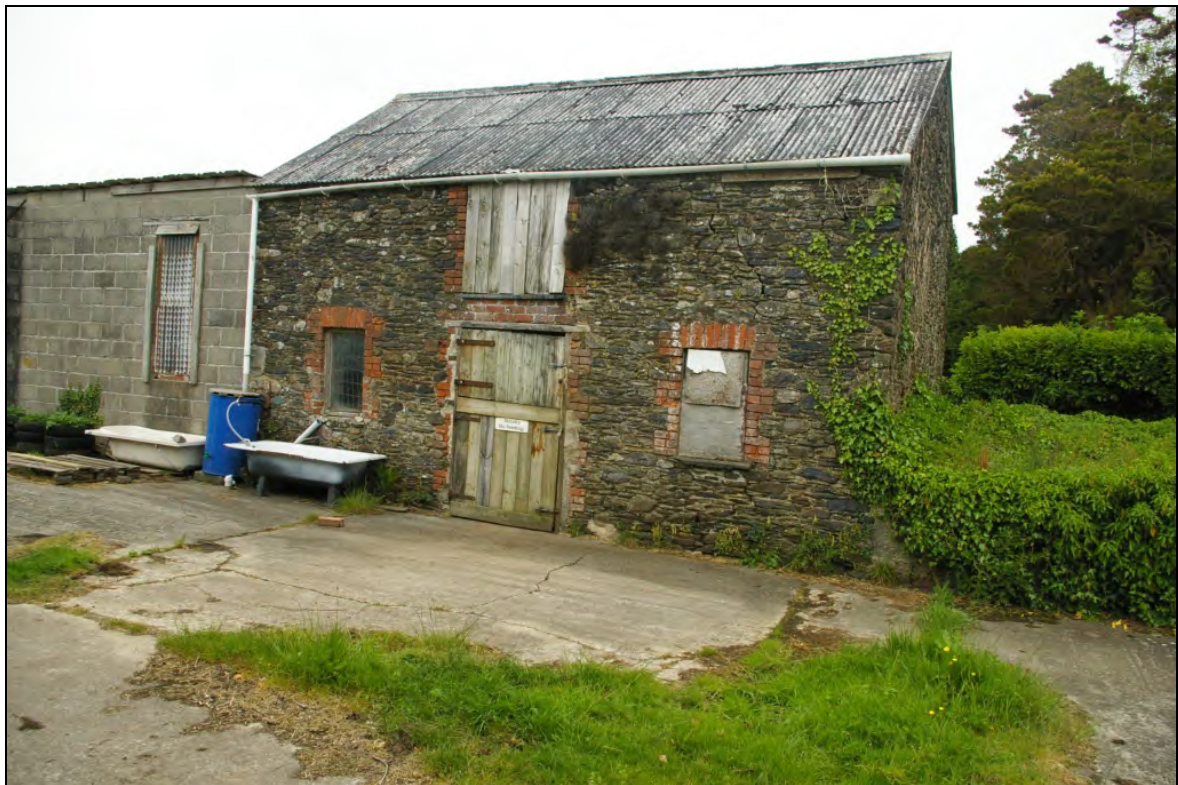
Other than the various modern (largely post-1972) farm buildings on the site there are two 19th century buildings. The most northern of these has been most recently/currently used as a stable, but its original use is unclear (Figure 6). It is a roughly coursed stone built one and a half floor structure with a central (widened) door in the south elevation with a loading door above and two ground floor windows. All of the openings have brick reveals. A large concrete block (machine?) store has been added to the western end of this building.

Figure 6: Shot of stable on the northern edge of the development site, viewed from the south.

Neither of the historic buildings were accessible during the survey, and the preservation of any internal detail is unknown. However the two buildings do form a cohesive small group of some local merit and are worthy of retention, particularly if the various 20th century additions abutting them are demolished. Further recording of the two structures would be of merit, particularly if they were to be demolished.

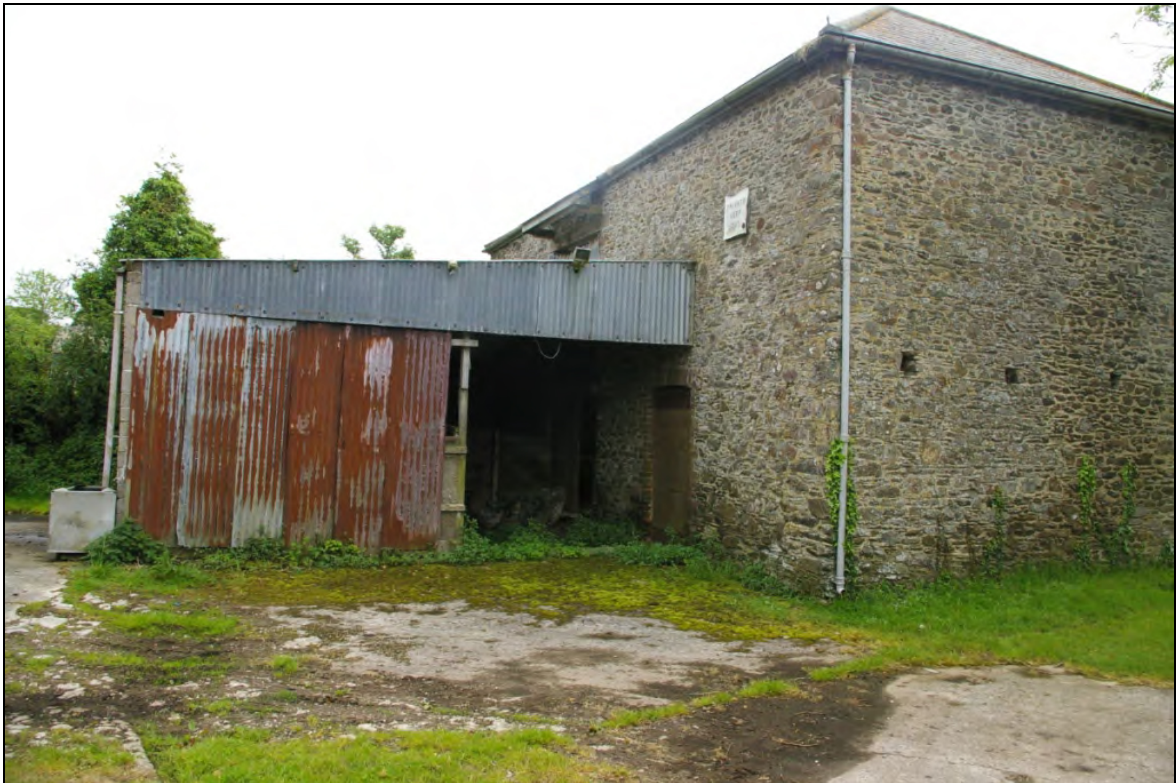
The other building is a large and quite fine two-storey barn of roughly coursed stone with brick reveals to the openings (Figure 7). There are centrally positioned 1st floor loading doors in both the eastern and western elevations, with three ground floor openings in the east elevation. There is a 20th century timber and galvanised steel lean-to standing against the eastern elevation and an open fronted barn set against the southern part of the western elevation. It appears that there are remnants of cobbled surfaces to both the east and west of this barn, although these have been partially overlain and destroyed by concrete and mud.

Figure 7: Shot of the barn, viewed from the north.

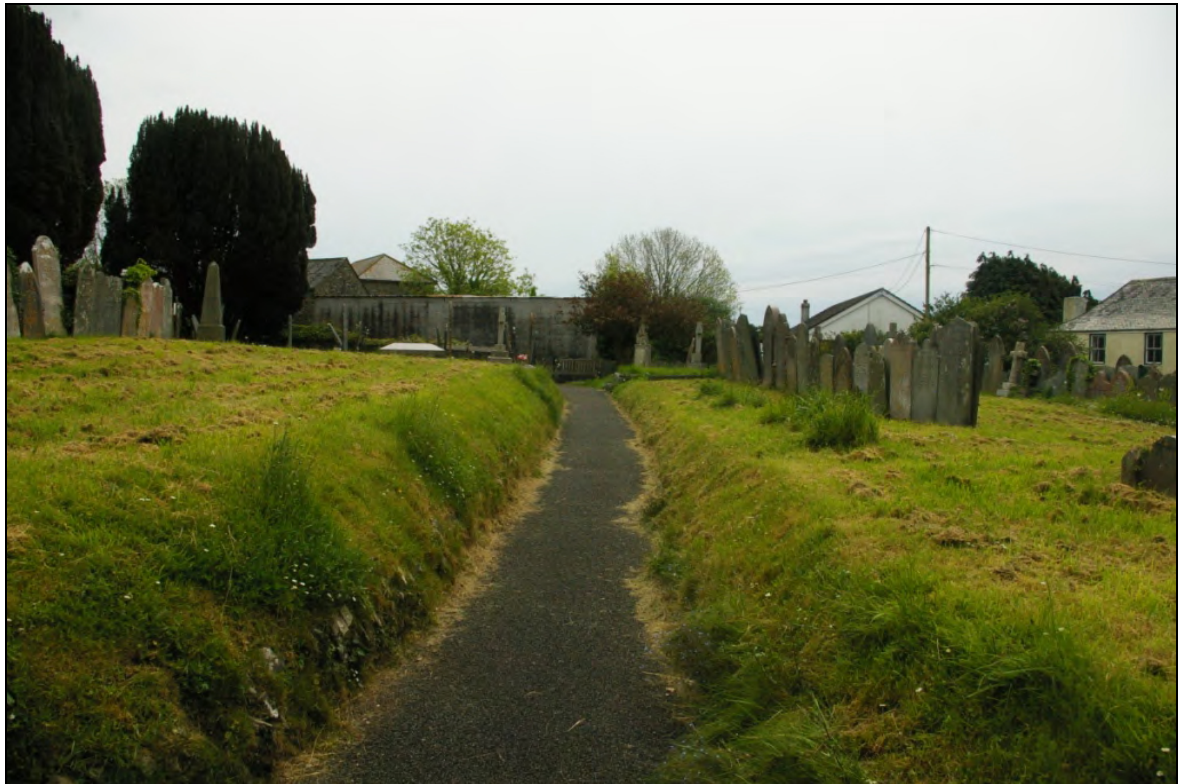
demolition of the concrete block structure will enhance the setting of the church and the experience of the church and churchyard. Any new development will be clearly visible from the body of the church and old churchyard, although with sympathetic design it is unlikely to intrude on the setting of the church and churchyard to the extent of the derelict concrete block barns. Impact on the body of the church and churchyard: **negative/minor to negligible**.

Figure 9: View from the porch of the church towards the proposal site. The view is currently blocked by an ugly and unsympathetic concrete block structure, viewed from the north.

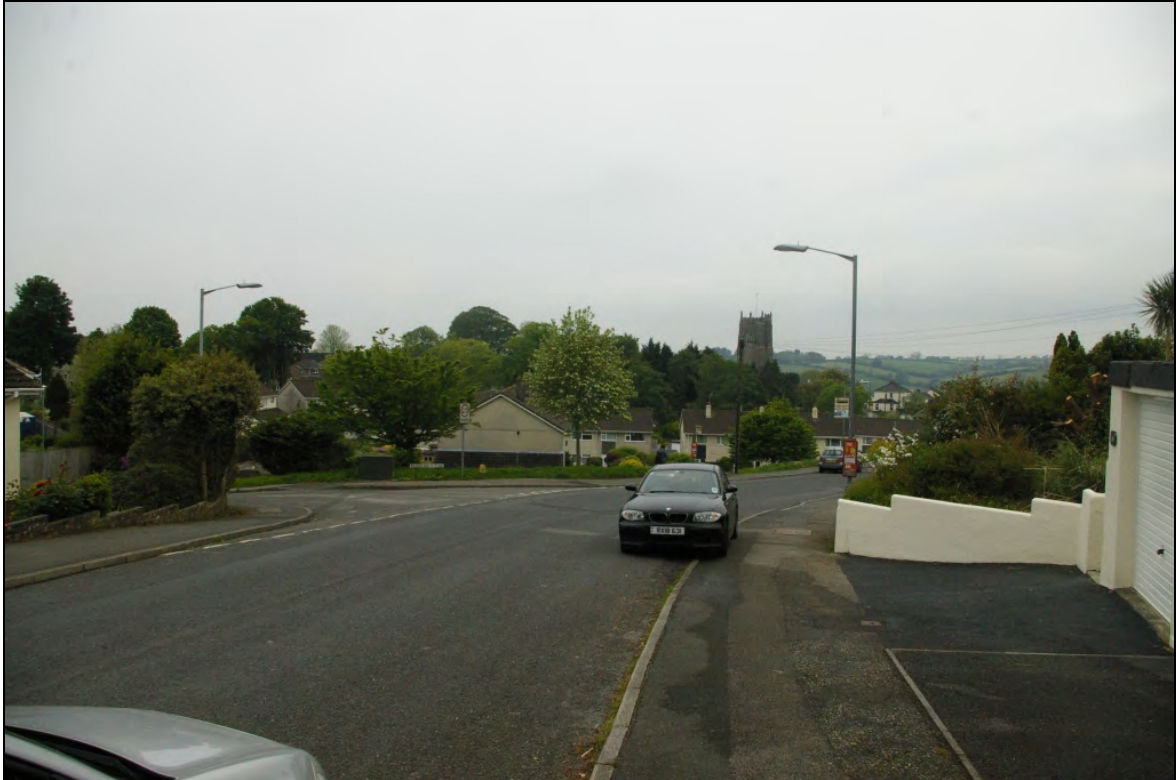
St. Stephen's church tower is certainly a prominent landmark (see Figure 10), but the undulating topography with deep valleys means that this prominence is surprisingly restricted, especially from the north and east where local blocking from the growth of Saltash applies. The majority of the assets which fall within the ZVI do however have views of the Church tower. The proposed development is unlikely to intrude upon its visual dominance or block many views. Most importantly the proposed development will not interrupt the views between the church tower and its former manorial centre (and owner) Trematon Castle, although it will appear within these views it will not be within the direct line of sight, and will have less of an impact than the extant housing estate along Castle View, which already sits (directly) between these assets. The development will certainly not intrude upon the visual dominance of either of these key assets (i.e. Trematon and the Church tower); impact: **negligible**.

Figure 10: Shot of the tower of St. Stephen's Church, demonstrating its landscape primacy within the immediate locale, viewed from the north-east (View 2 from Figure 8).

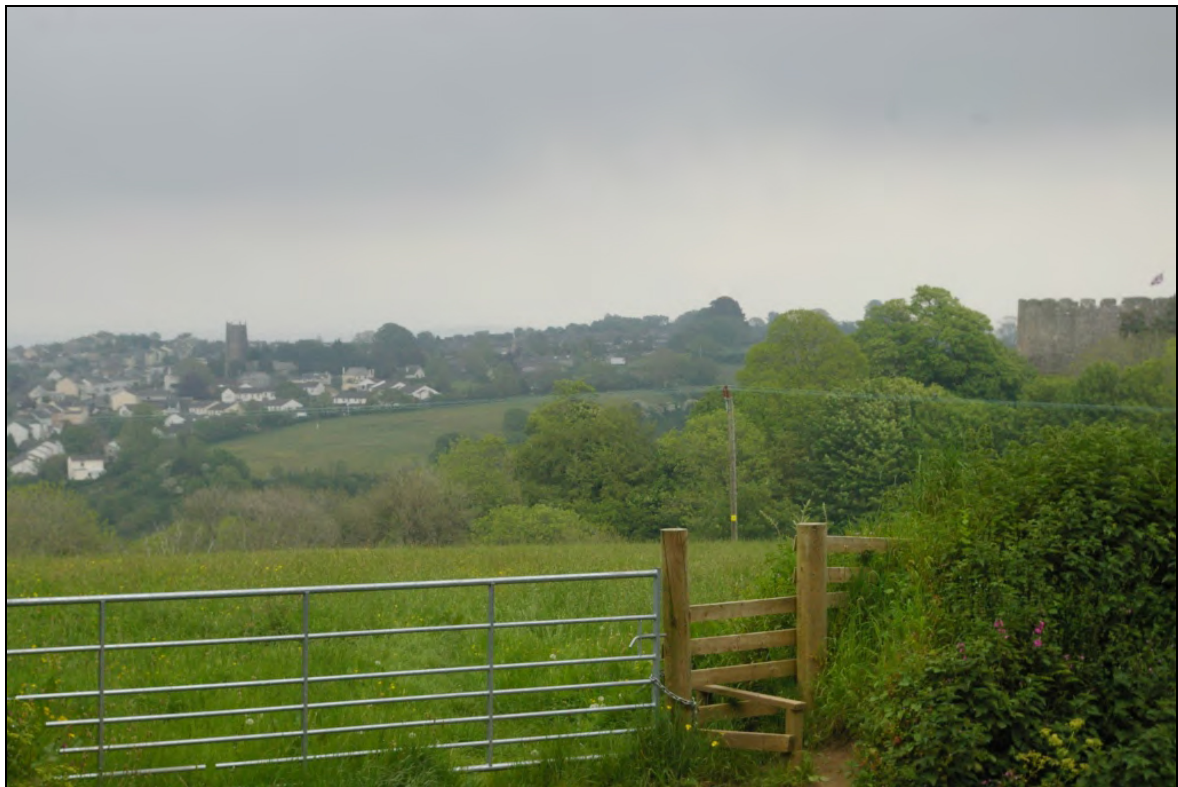
- Trematon Castle; high significance; Scheduled Monument; condition: good. Distance from development: c.0.7km. Viewed from public footpath to the north and public road to the west (see Figure 11), the castle is located on a spur overlooking Forder Lake and the Lynher River beyond. It has a commanding landscape presence with views of St. Stephens Church tower and the roof of the church clearly visible from the general area. The proposed development will appear in views east from the Castle, although local blocking will apply to some extent from within the Castle itself. Local (seasonal) blocking is also created by the eastern boundary of the new allotments, which contains a number of young trees. Despite the local prominence of the castle, and the fact that the development will fall within this zone, it will not compete in terms of visual prominence; and its location is too distant to dramatically impact upon the setting and significance of the asset. Also as much of the proposal site is already occupied by extant buildings the impact of these being replaced by a more thoughtful development will partially mitigate the impacts. The development is located as such that it will simply form a southern extension to the historic and 20th century housing along St. Stephens Hill, Castle View and Farm Lane, and not extend over the break of slope to the east, which would certainly encroach upon the setting of the Castle and have a more detrimental impact. Additional screening through tree planting, particularly along the eastern limits of the site, and the proposed boarding to the 1st floors will soften the impact of new housing, and will further mitigate any impact; impact: **Negative/minor to Negligible**.

Figure 11: View from public footpath at Higher Castle Farm, with Trematon Castle and the Church Tower of St. Stephen's (View 1 from Figure 8).

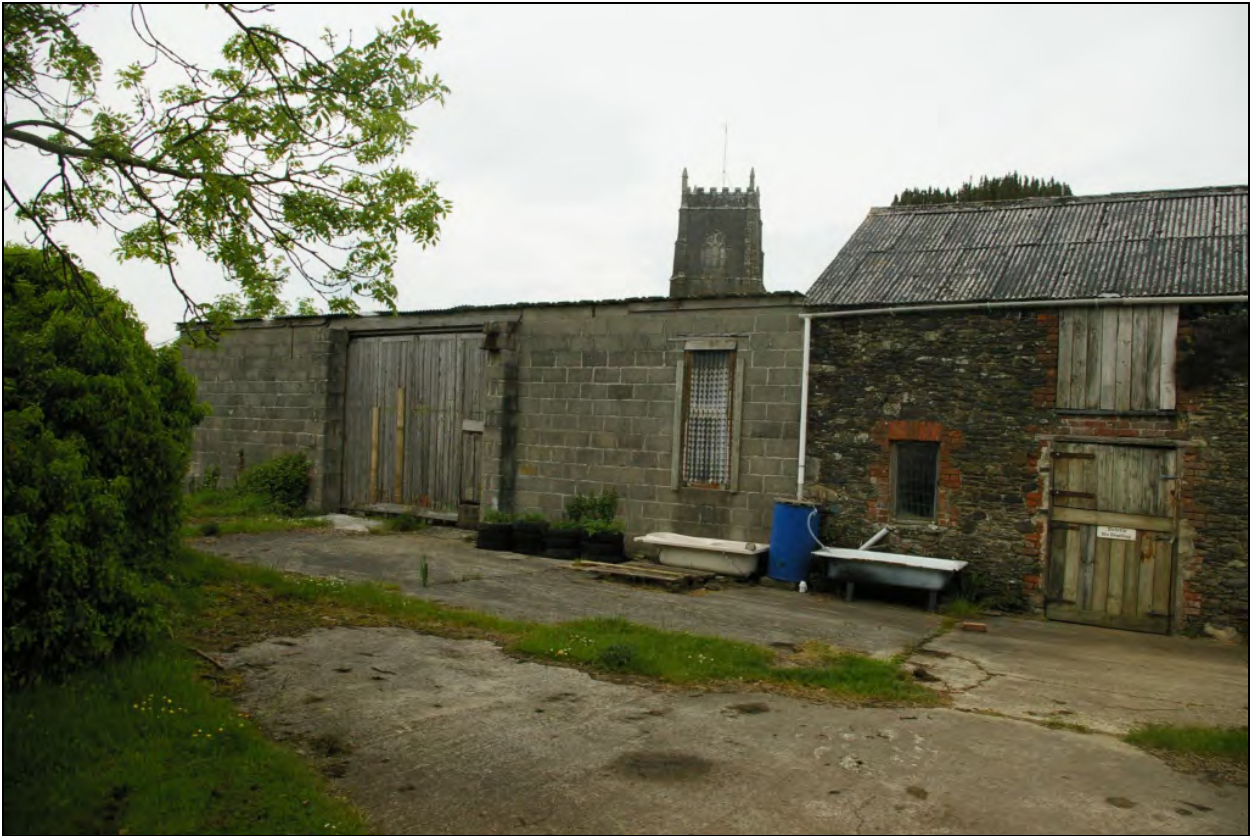
Shot of 20th century extension to the historic 'stable', viewed from the north.

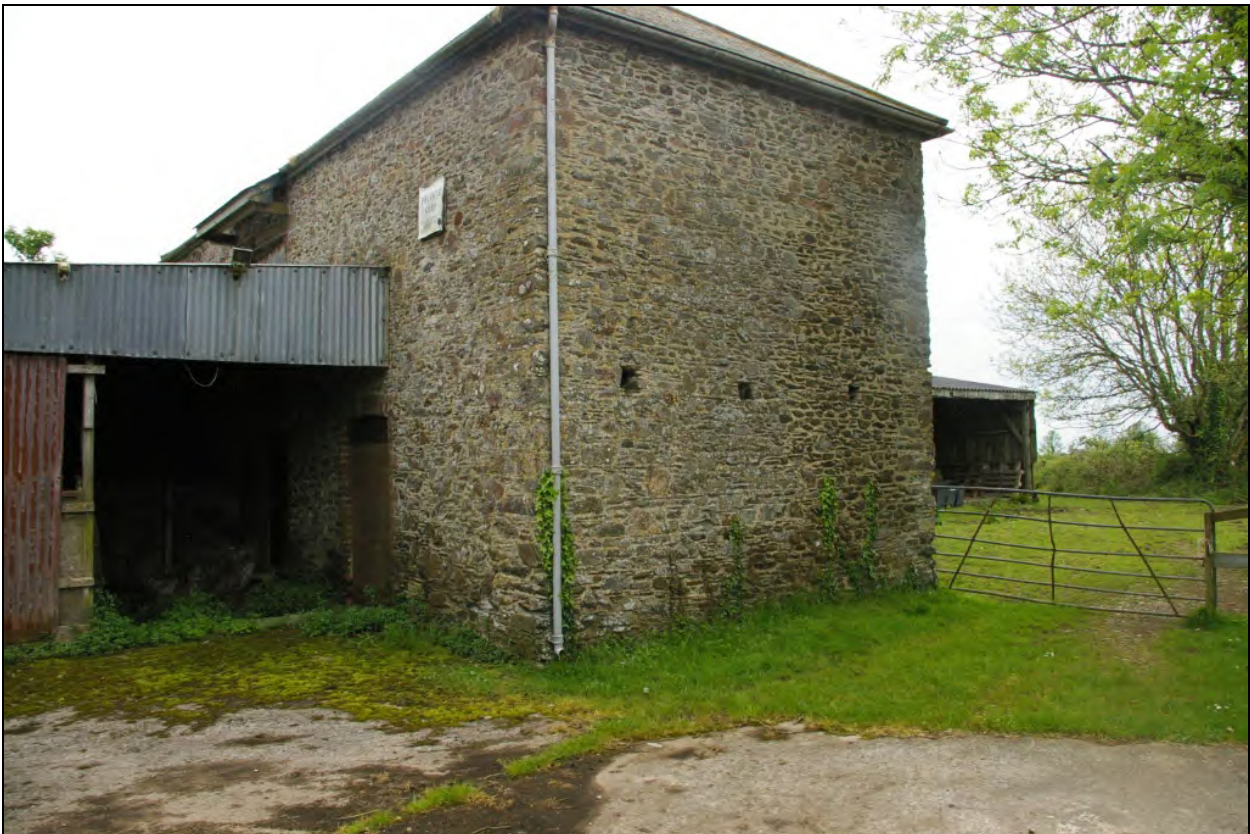
The historic barn within the proposal site, viewed from the north-east.

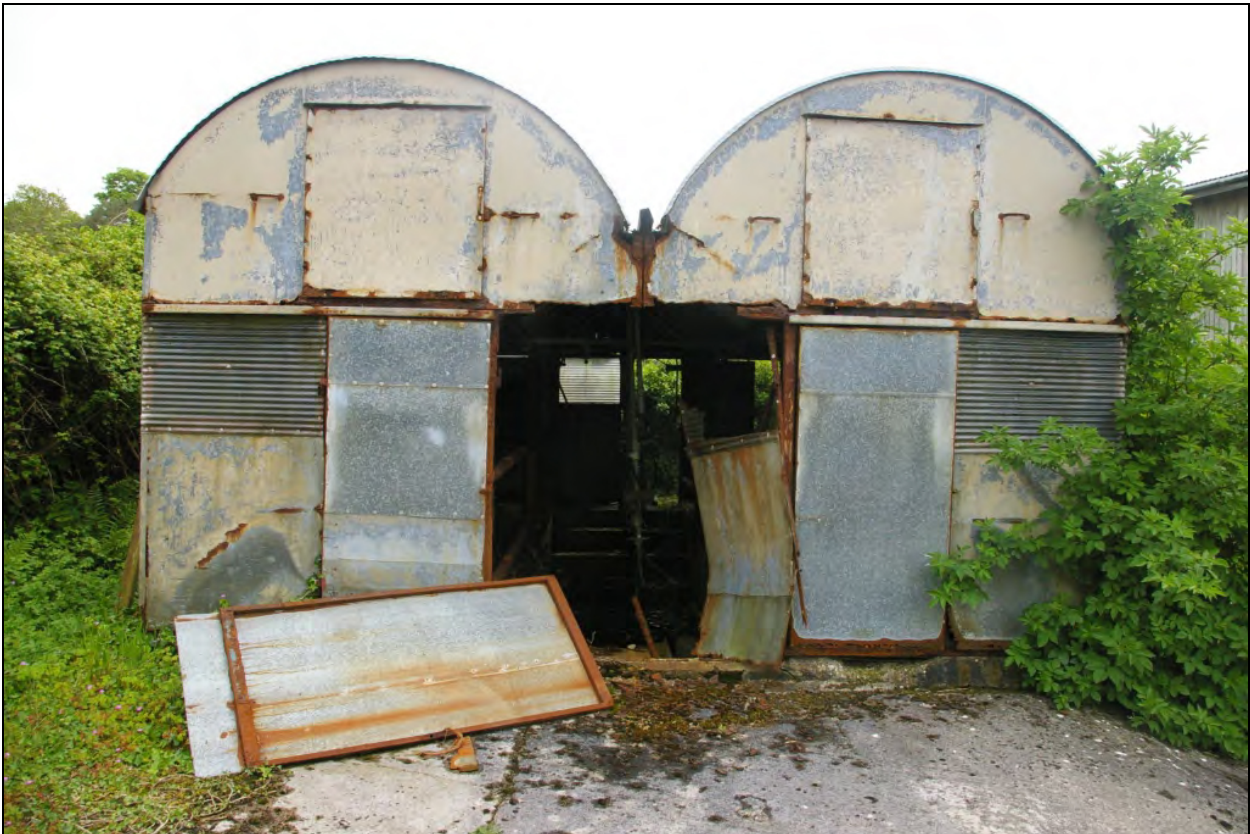
Shot of former milking parlour against eastern boundary to the proposal site, viewed from the north.

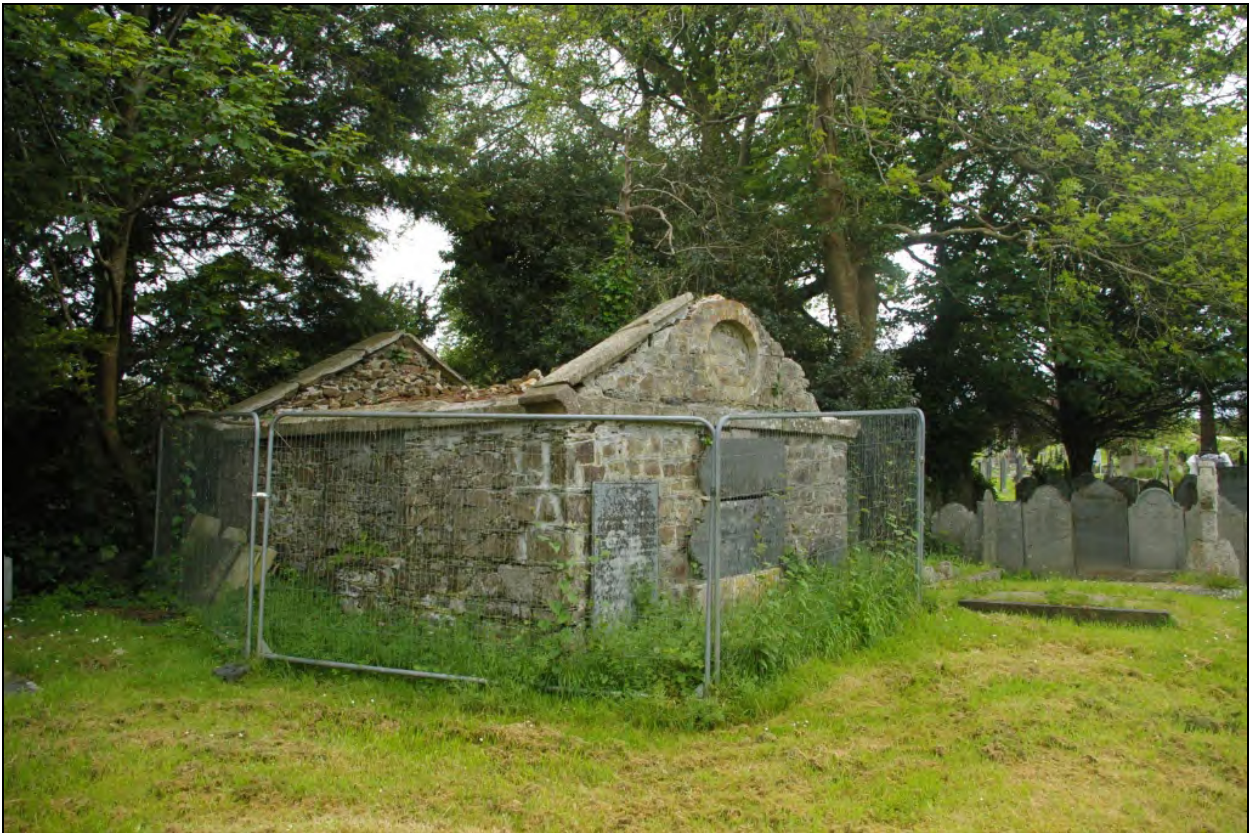
Shot of the Grade II Listed family vault in south-east of the churchyard, viewed from the north-west.

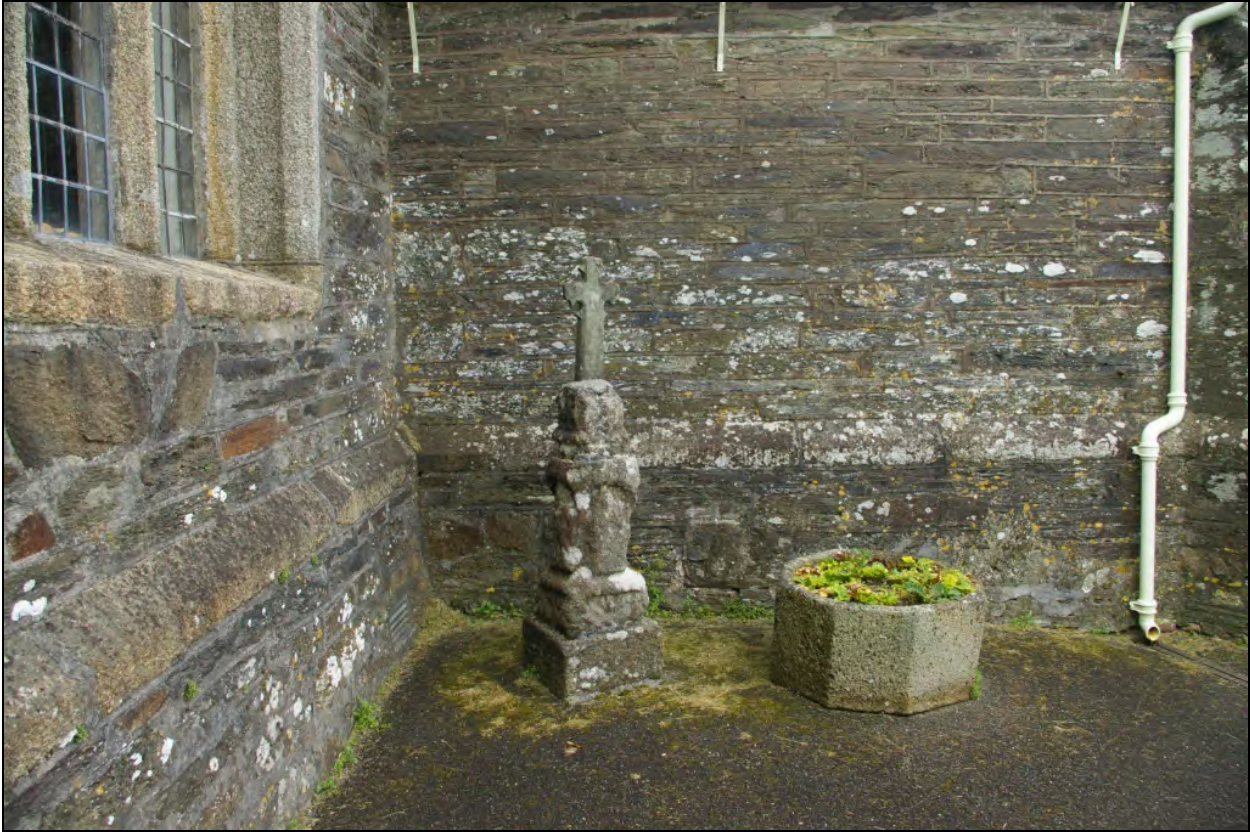
Shot of the Grade II* Listed Cross and Grade II font by the porch of St. Stephens Church, viewed from the west.
