PHASE 5 DEVELOPMENT PLYMOUTH SCIENCE PARK PLYMOUTH, DEVON

Results of a Desk-Based Assessment
&
Walkover Survey

Report No.: 150123
Date: 23.01.15
Authors: S. Walls

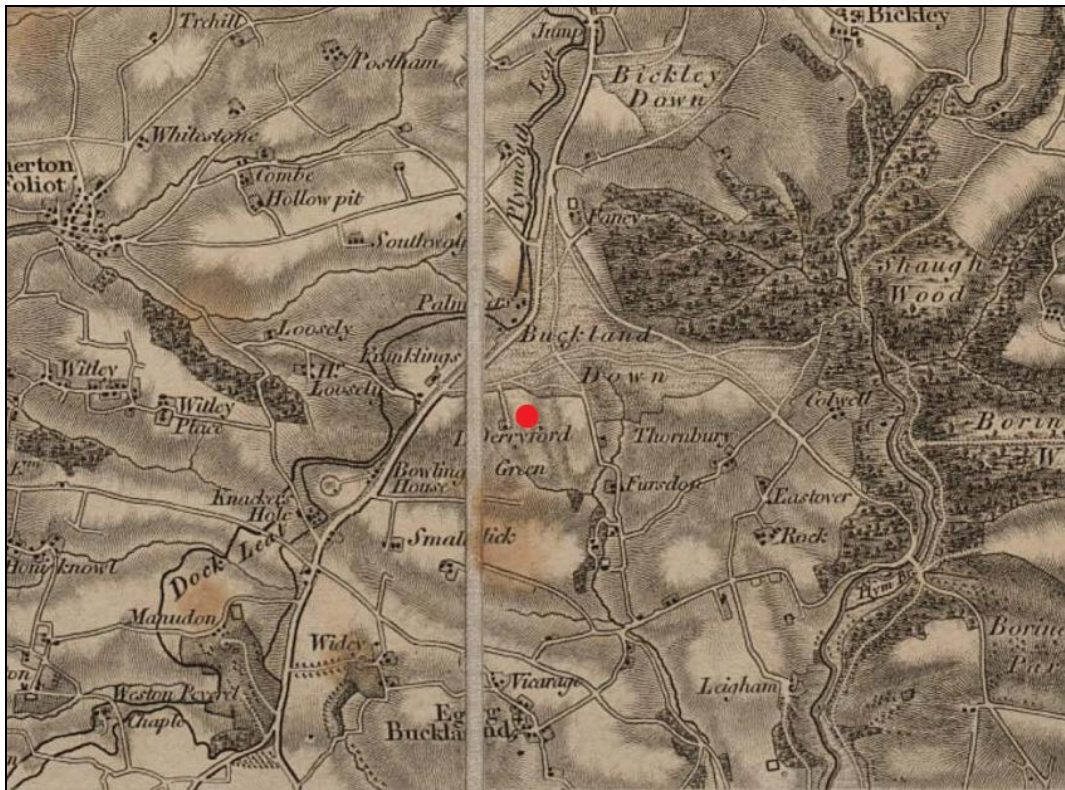
Figure 4: Extract from the First Series Ordnance Survey map of 1809, the approximate site location is indicated.

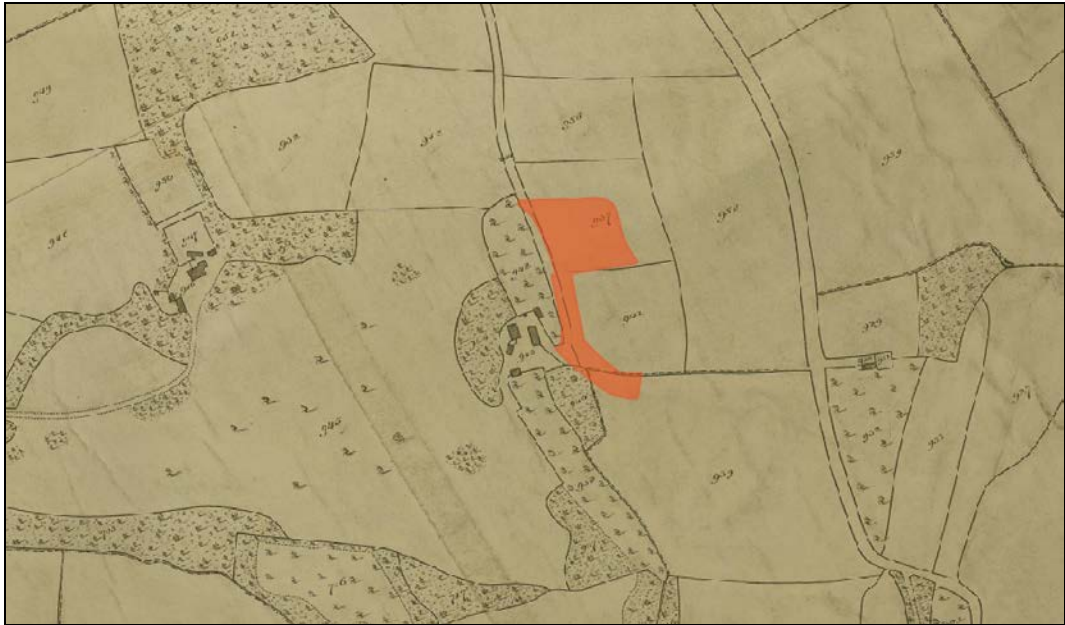
Figure 5: Extract from 1839 tithe map, the approximate site location is highlighted.

The 1839 Tithe map of Egg Buckland shows the Derriford holdings in detail, suggesting the presence of a farmhouse and several farm buildings arranged around a farmyard (Figure 5), with Derriford House and parkland to the west. The trackway leading to Derriford Barton does have a gentle reverse s-curve, which may suggest that there was once an open medieval strip field-system centred on the Barton, but that most of the traces of which had been lost by the 19th century. Most of the fields are large and relatively regular suggesting that they are not particularly early. A small number of gently curving field boundaries are shown, particularly surrounding the areas of woodland which may point to some elements of earlier boundaries from an older medieval field system. The c-shaped plantation of trees to the west of the Barton may also suggest that the Barton (of probable medieval origins) had been located inside an even earlier 'round' prehistoric enclosure. The topographic location, i.e. a south facing slope with a nearby spring would support this. This plantation is probably most likely a 19th century landscape feature created to screen the farm from Derriford House, but an earlier origin should be considered possible.

The proposed site partially covers three fields (numbers 939, 942 and 957) and a trackway (number indecipherable) which was the access road for the Barton. The accompanying tithe apportionment shows that Field number 939 is owned by Thomas Buggs Esq. of Fursdon and leased to a Richard Lemon. The remainder is held by Sir Ralph Lopes and John Butten (Representatives of the late John Clark Langmead and William Clark Langmead) and let to a William Spurrell. The 1841 census suggests that William and his family lived at Fullaford(?), and that a merchant named William Foy lived at Derriford, with a small number of servants.

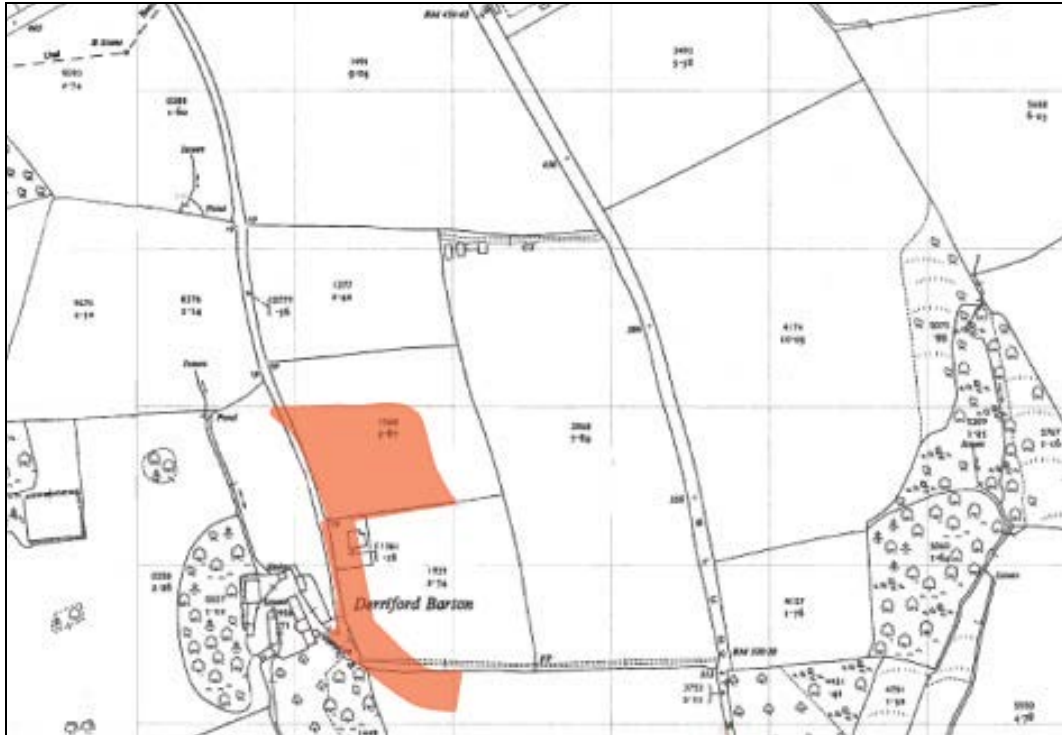
Figure 8: Extract from Ordnance Survey 1:2500 Map of 1957 map (the site is highlighted).

Changes to the farmland to the north of Plymouth does not begin at pace until after the Second World War. It is of note that the Derriford Estate including the House, Barton and all the land was sold in 1946 (PWDRO 1096/567). The first detailed (1:2500) OS map, of the area, suggests that this sale appears to brought about little in the way of changes in the immediate surroundings of the proposal site. The exception is that within the proposal site the small structure shown on the 1st and 2nd edition OS maps had been replaced by a large building (a new farmhouse judging by later maps), which suggests

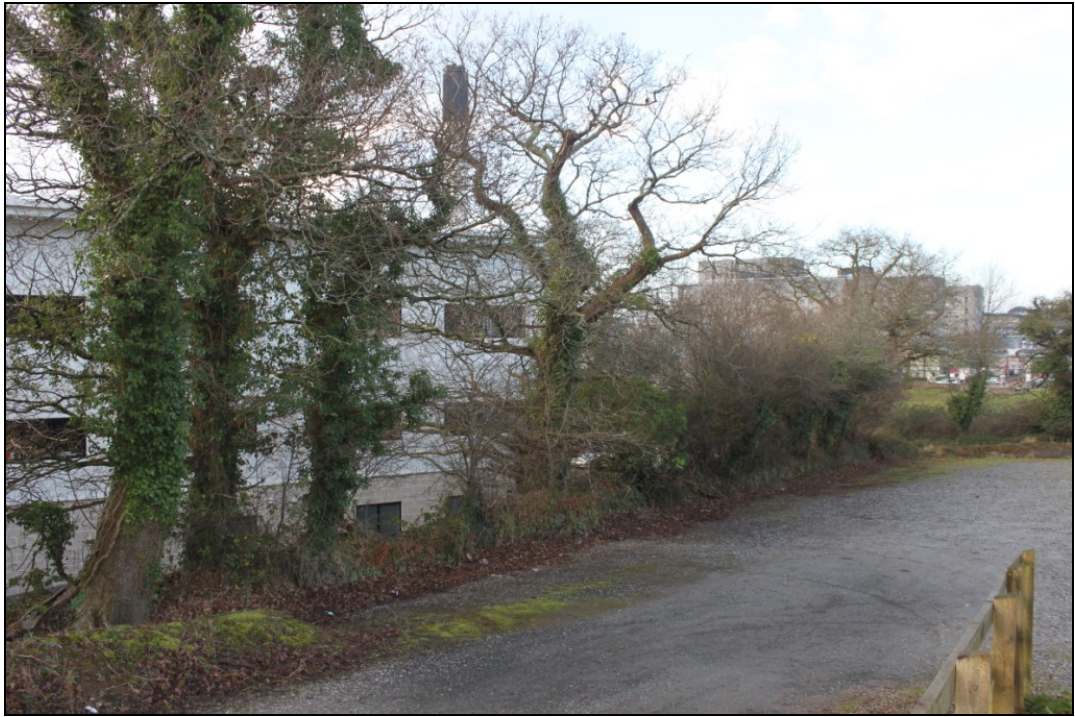
The southern boundary is comprised of a 0.7-1.0m high earth bank, faced with local slate stone set vertically, and the bank topped with a mixture of mature deciduous trees and shrubs (see Figure 10). The western end of the boundary has been rebuilt in blockier stone laid horizontally; this is abutted by a modern earthen bank (a rebuild) of the southern end of the western boundary, which is approximately 16m long and presumably associated with the levelling for the gravelled car park. Towards the eastern end of the hedgebank the top two courses of stones had been repaired (historically), in the locations of some of the larger trees, with the stones being laid horizontally and typically again much blockier in appearance.

Figure 10: Shot of the southern boundary, viewed from the east-north-east (no scale).

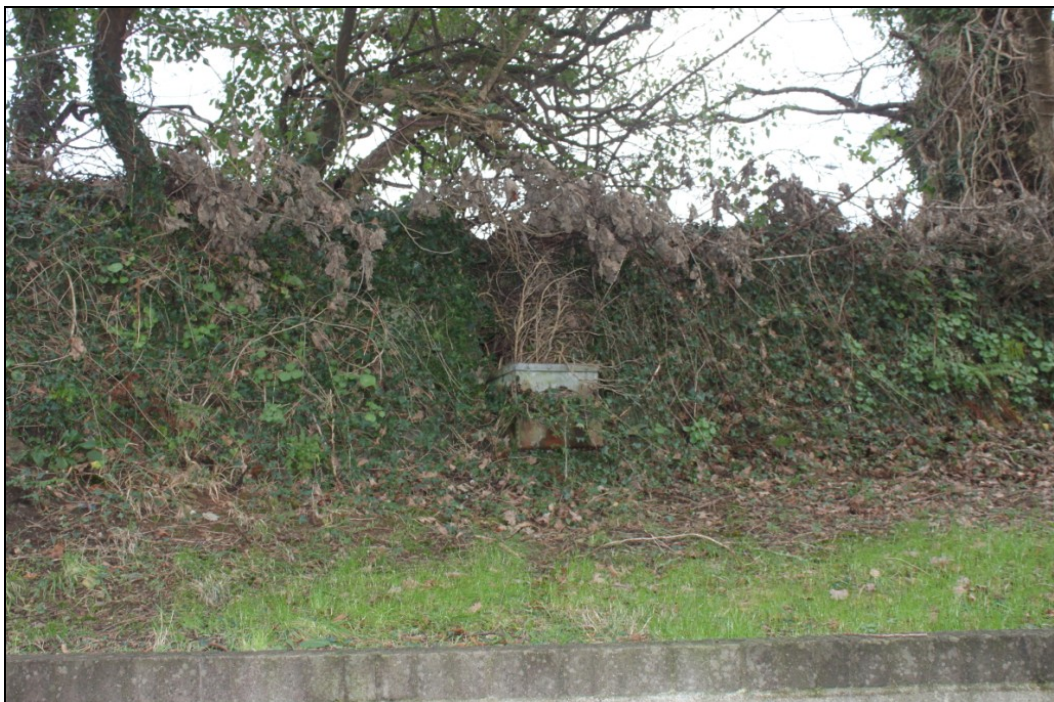
The southern face of the south hedgebank was also faced in vertically laid stone, but it was notably blockier suggesting different phasing. Approximately half way along the southern boundary was a c.0.8m wide gap in the hedgebank, which was very overgrown, but appeared to have been neatly faced (to the east) in rough blocks of granite. There were metal bars running across the gap (stock proofing), and the remnant of a trough projecting to the south of the boundary (see Figure 11). Presumably formerly this trough provided water for both fields.

Figure 11: Shot of the remnant of the water trough projecting from the south boundary into the adjacent field, viewed from the south (no scale).

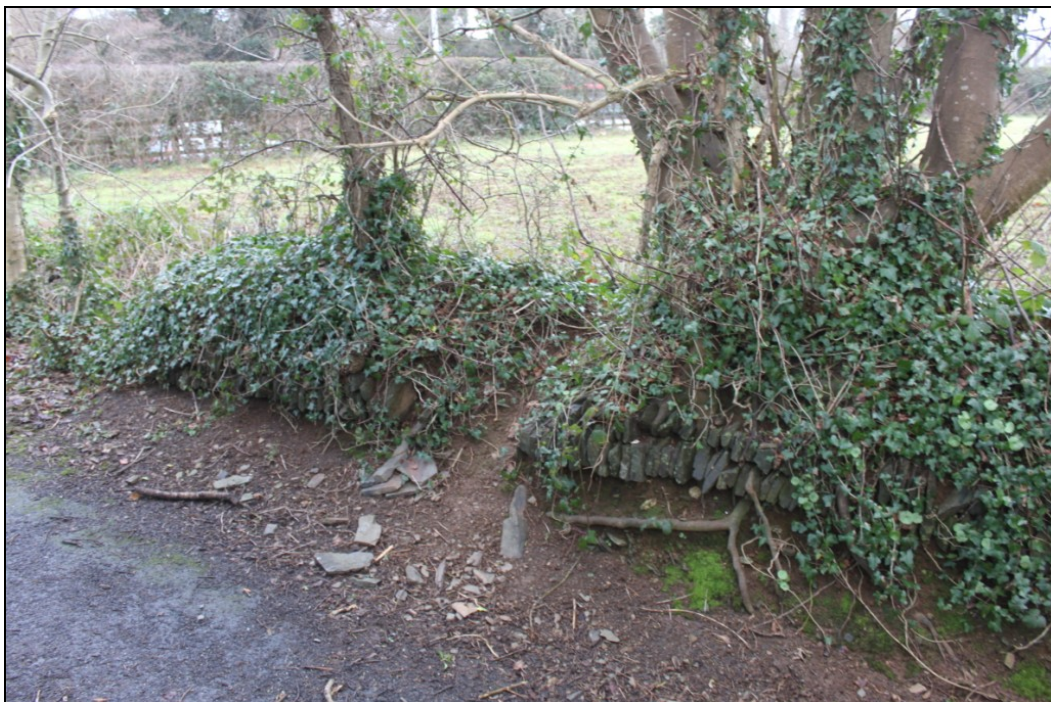
The western boundary was an earthen bank c.0.3m high and topped with mature trees. The boundary had been truncated to both the south (discussed above) and with a further c.8m wide truncation at its northern end. The northern truncation was paralleled in the field to the west, which suggests that it probably occurred when Derriford Road was constructed. The footpath to the west of this boundary is set c.0.7m lower than the field, and so the hedgebank, stands approximately 1m high in the lane. There is almost no stone facing, except for a small portion of stones set on edge at the northern end of the boundary just before the truncated section (see Figure 12). It is of note that the lower c.0.1-0.2m of the hedgebank visible from the footpath is clearly natural subsoil, which means this footpath is slightly sunken and gives some indication of topsoil depth within the proposal site, suggesting that it deepens towards the south, to a maximum depth of c.0.5-0.6m, the northern part of the site is in contrast likely to be very shallow, and damaged when Derriford Road went through in the 1970s (see Figure 13).

Figure 12: The only stone facing surviving in the western boundary, viewed from west (no scale).

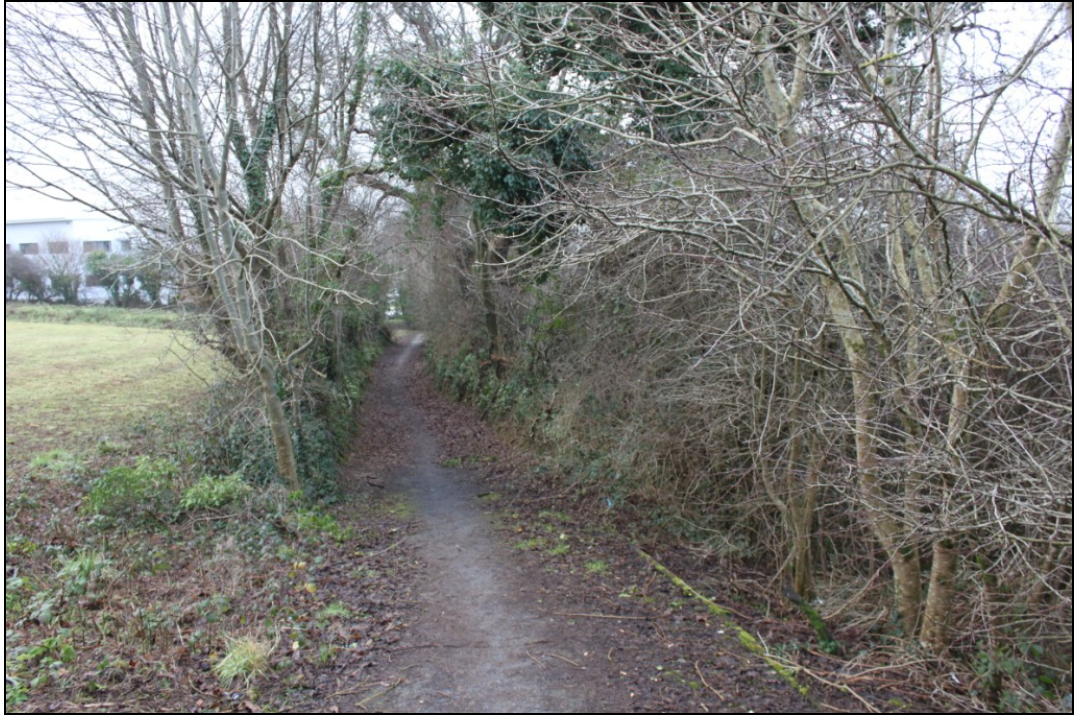
Figure 13: View along the pedestrian lane to the west of the proposal site, viewed from the northern end (no scale).

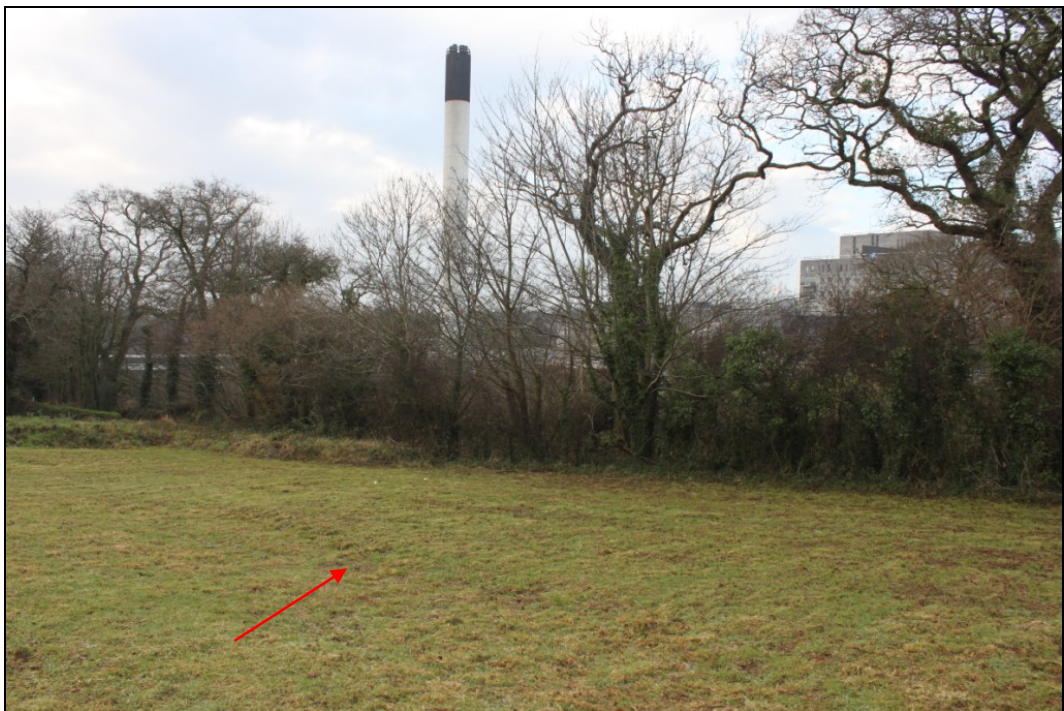
There were the traces of some subtle earthworks within the field. These took the form of an irregular ditch or linear arrangement of intercutting pits towards the western side of the site (Figure 14). The earthwork was orientated north-north-east to south-south-west, directly towards the south-west corner of the site, and so could relate to heavy machinery used during recent development works nearby, or perhaps to some sort of quarrying, given its prevalence in the vicinity of Derriford.

Figure 14: Shot of the subtle earthwork (indicated for clarity), viewed from the north-east (no scale).

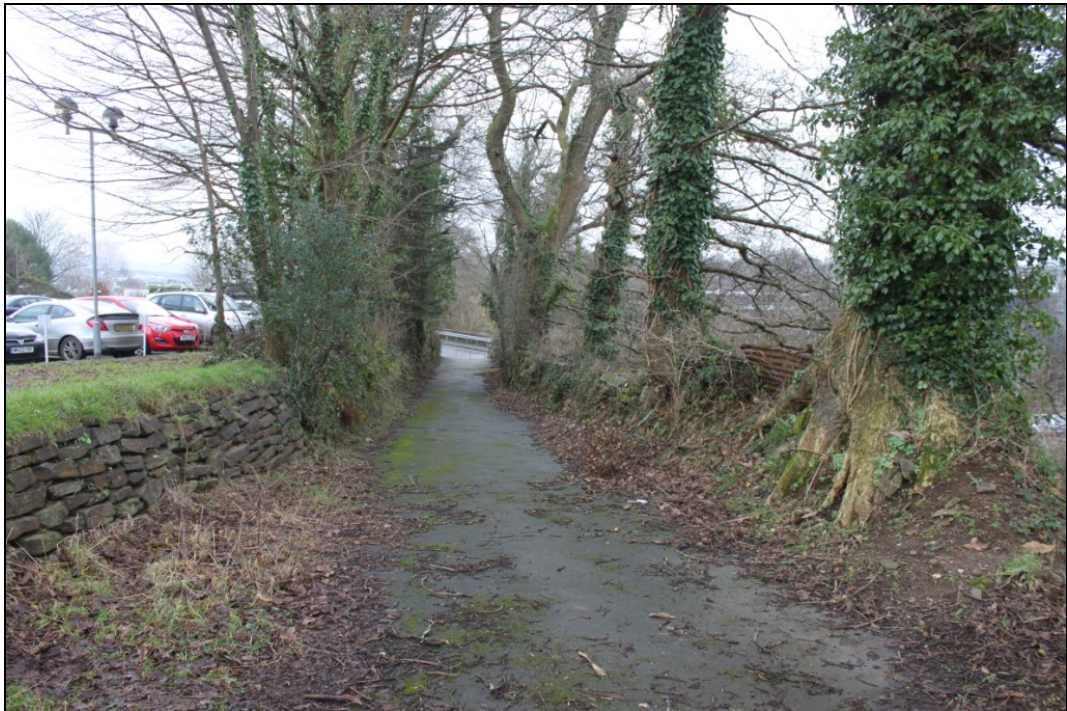
The drainage access to the proposal site, will enter the field in the south-west corner, where all of the hedge boundaries have recently been rebuilt (visible in Figure 15). The proposed drainage route encompasses the southern part of the surviving historic track (now public footpath), and part of the adjacent field, the grass verges around the carparking for the Hyperbaric Medical Centre and the Express Diagnostics and Treatment Centre.

Figure 15: The southern part of the footpath, viewed from the north (no scale).

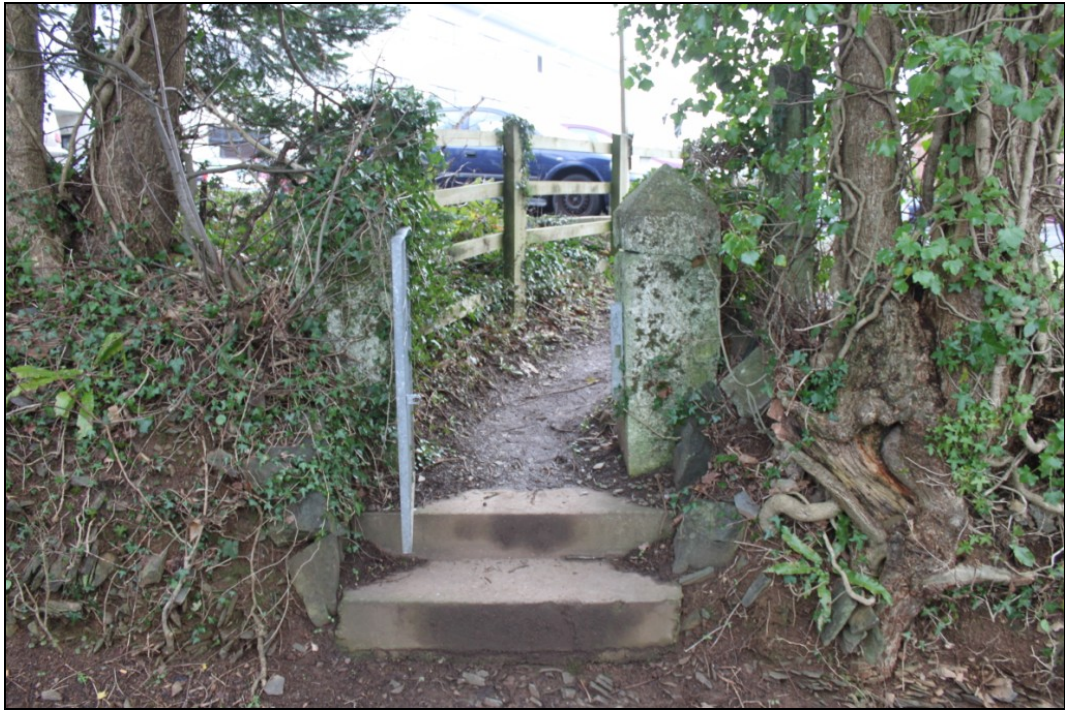
The eastern hedgebank to the footpath is a c.1m high earth bank faced with blocky vertically laid stone, and topped with a mixture of largely young deciduous trees. The hedge stands to c.0.2m high within the car park. The northern portion has been recently rebuilt in stone laid horizontally, and the southern end has been truncated and abutted by a modern stone faced retaining wall. There have been several holes cut through the hedgebank, including two narrow gaps for drainage, and a wider gap with steps and flanked by concrete posts for a pedestrian access (see Figure 16). This gate presumably relates to the 1950s farmhouse, which had been constructed to the east of this hedge.

Figure 16: Gateway and steps forced into the eastern hedgebank of the footpath, viewed from the west (no scale).

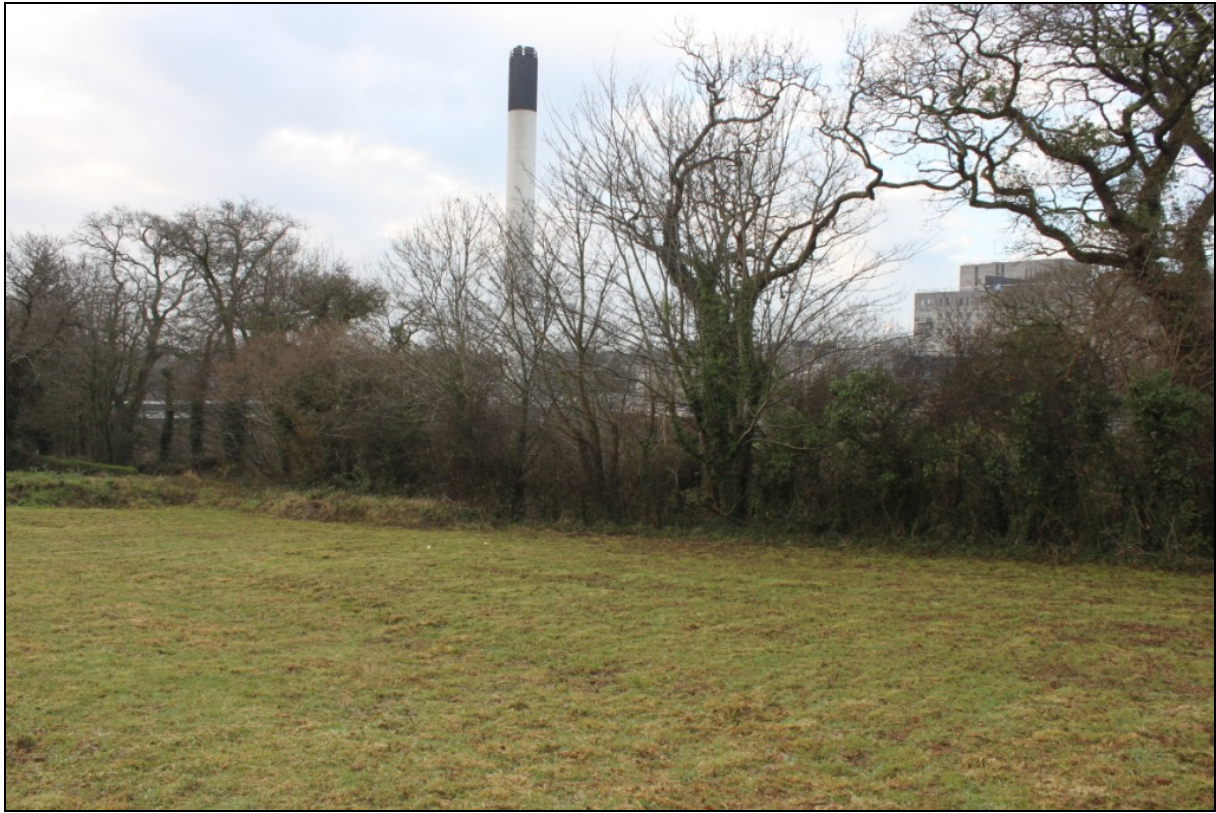
The western boundary, viewed from the north-east (no scale).

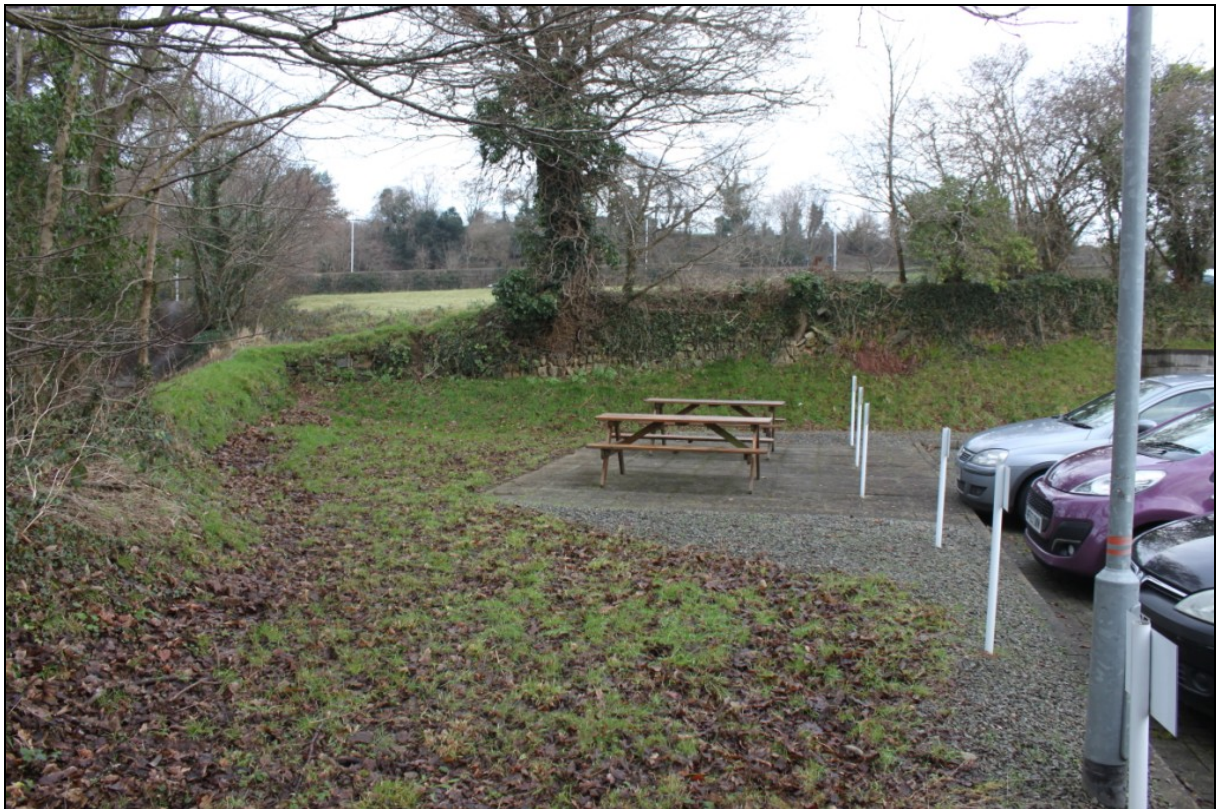
The south-west corner of the southern boundary, where the drainage will enter, viewed from the south.

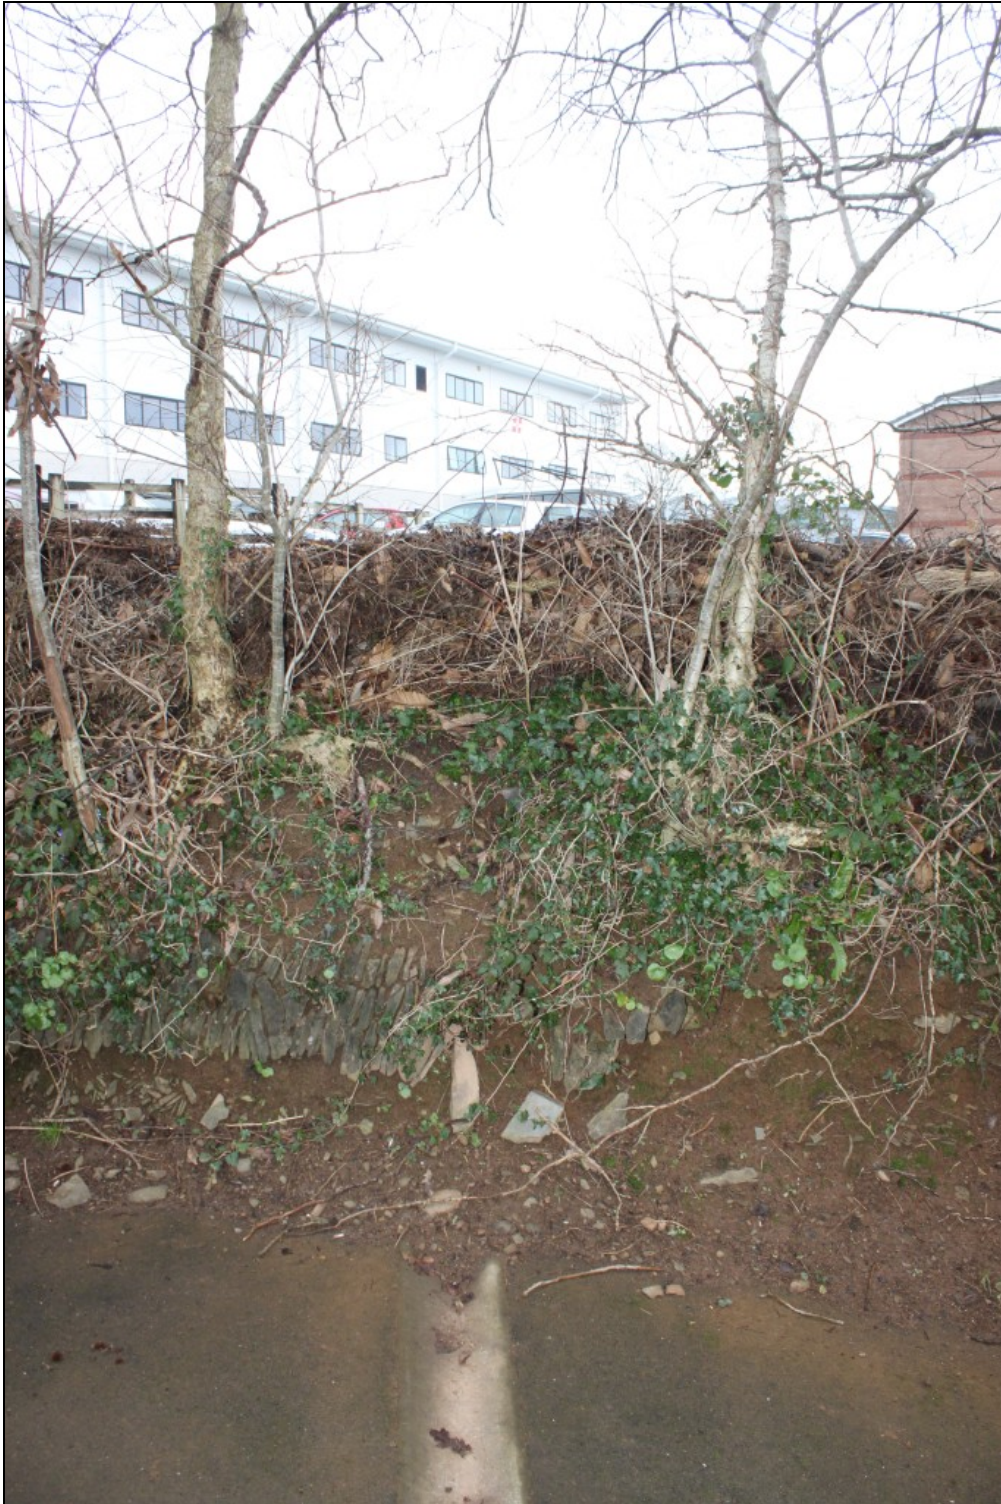
Detail of drain, cut through historic boundary within the drainage route, viewed from the west (no scale).

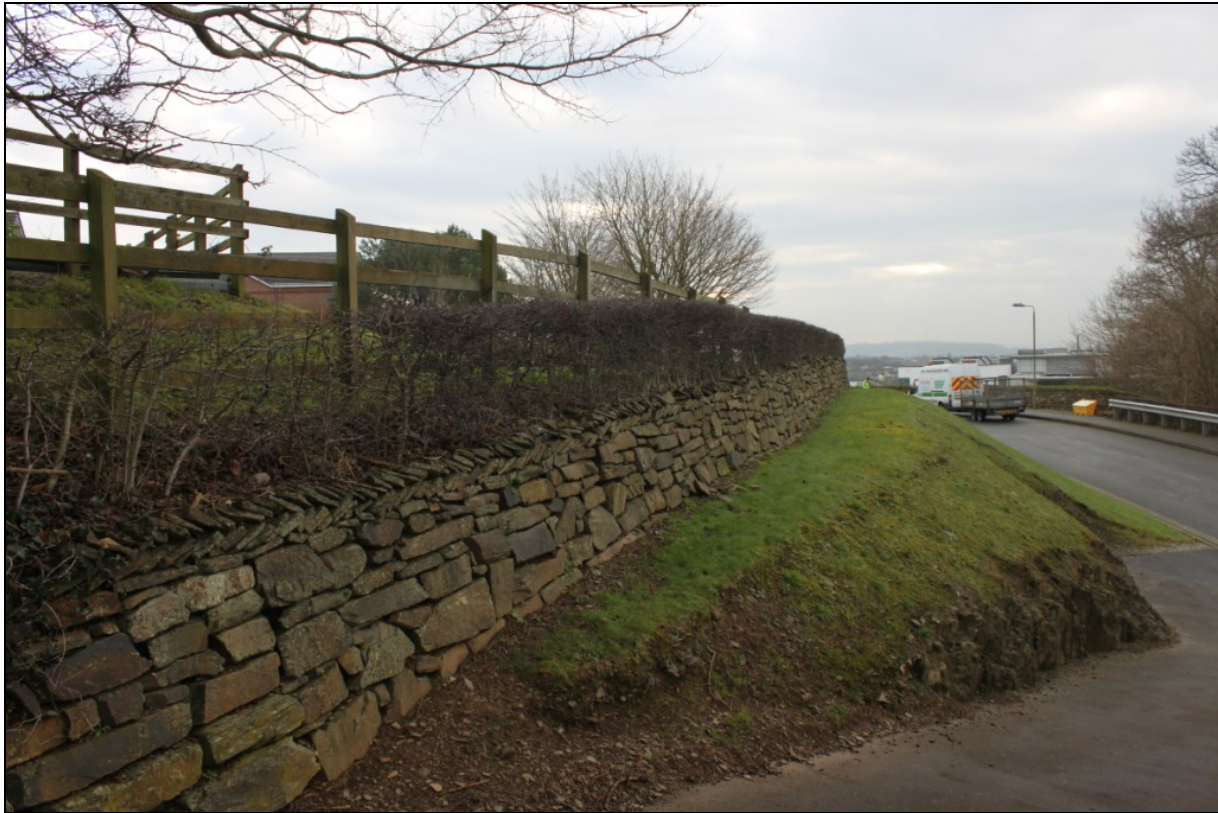
The new wall to the south of the proposed drainage access, viewed from the west (no scale).
