# NORRINGTON SOLAR PV BROUGHTON GIFFORD WILTSHIRE

Results of a  
Historic Visual Impact Assessment

Report No.: 140818  
Date: 18.08.14  
Authors: S. Walls

*This report presents the results of a historic visual impact assessment carried out by South West Archaeology Ltd. (SWARCH) on Norrington Solar PV, Broughton Gifford, Wiltshire in support of a minor amendment application for the inclusion of a CCTV system for a permitted solar farm.*

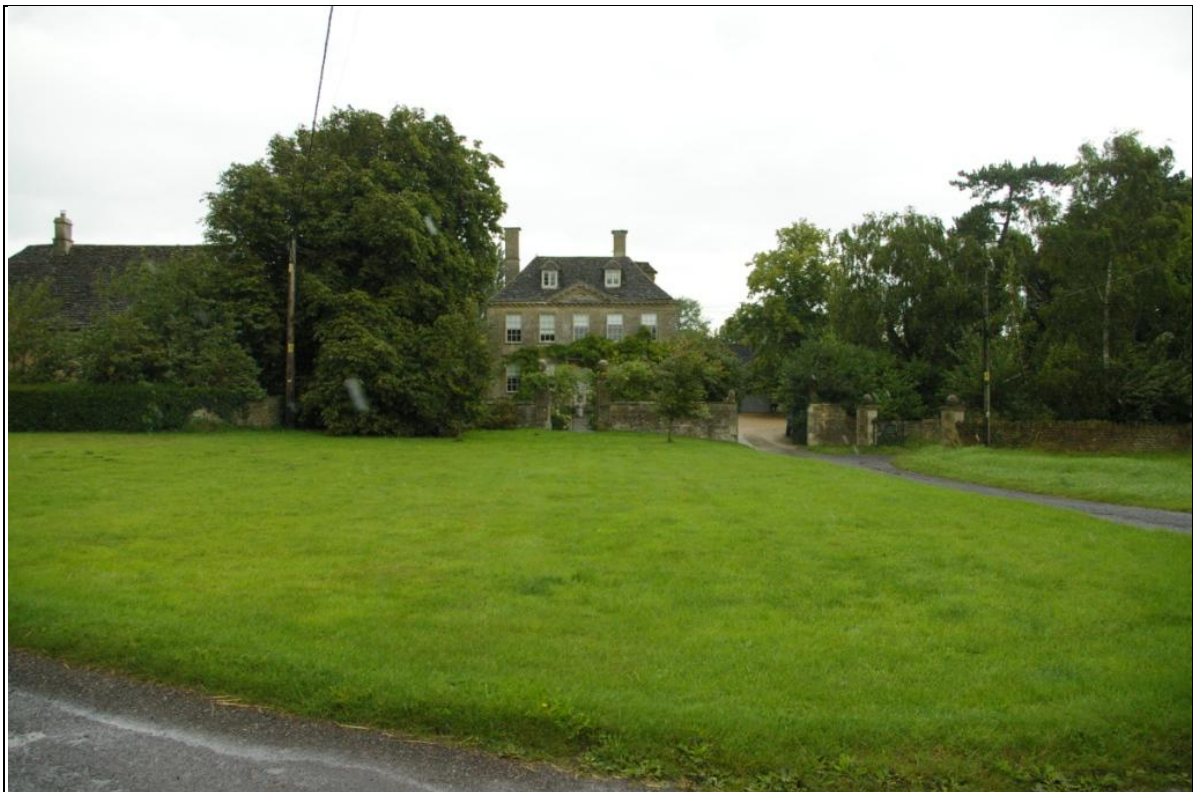
- Gifford Hall; High Significance; Grade II\* Listed; Condition: Excellent. This little altered early 18<sup>th</sup> century House is a tall two-storey and attic structure, which retains many of its original features and has large 12 pane sash windows and two prominent chimneys, which are visible projecting above the ridgeline of the roof (see Figure 3). The house faces south along the public road which edges the Common, and the Norrington Solar PV site is located behind to the north and north-east, and is therefore not visible from ground level in views of the property, or probably from within the grounds. The trees and hedges provide complete local blocking at ground and probably first floor levels, although views of the extant solar site are certain from the attic, and probably (largely seasonally) the first floor. Gifford Hall is located to the south-east of several buildings and structures associated with a working farm, many of which have a negative impact upon the immediate setting of the house, and on the conservation area. The experience of Gifford Hall from within the Common and Conservation Area of Broughton Gifford is unaffected by the existing Solar PV site, and the addition of CCTV cameras will have no further impact. The impact of the proposed CCTV cameras will have no additional impact to that already in existence, will be largely screened by the extant fencing to the site, and not impinge any further upon the asset; impact: **negligible**.

Figure 3: The primary, southern, elevation of Gifford Hall, viewed from the south.

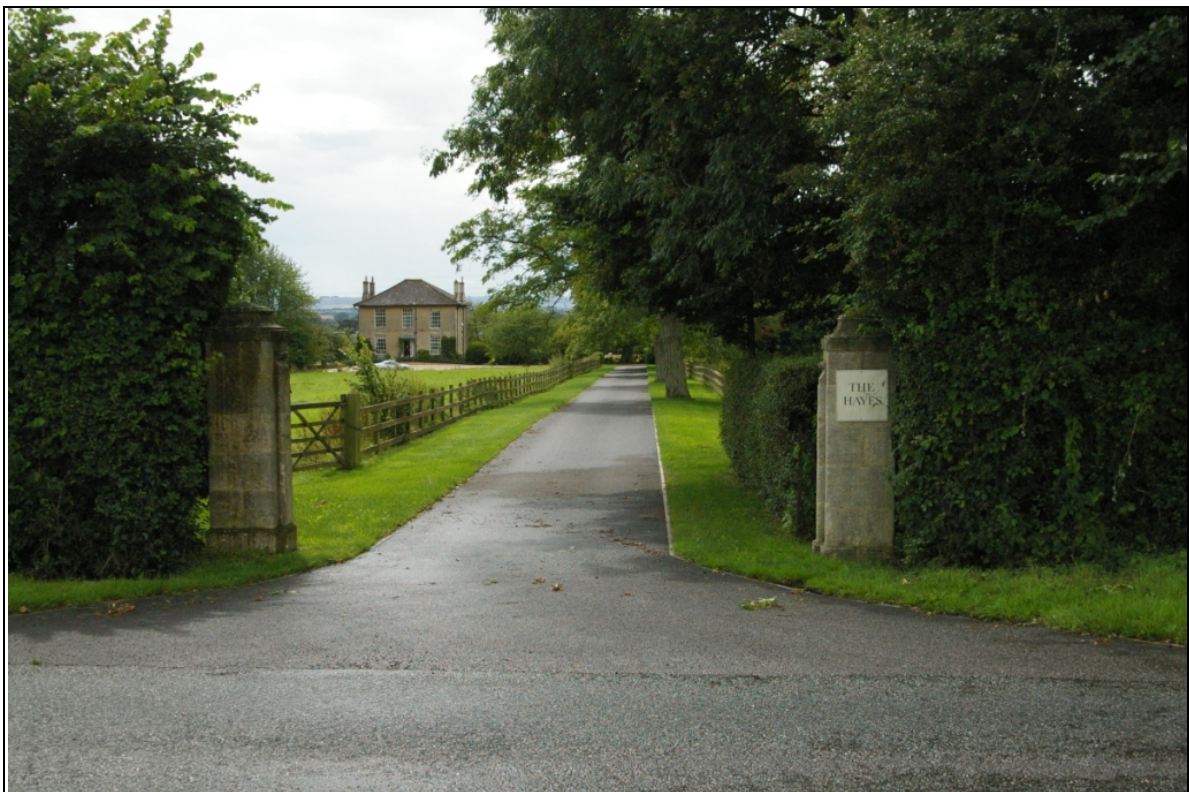
- The Hayes; medium significance; Grade II Listed; condition: good. A fine Regency style farmhouse, now detached house with views over the extant solar array site (Figure 5-6). The slightly higher status of this farmhouse, and its relative isolation, with all of its associated farm buildings and cottages set to the west, means that modern visual intrusions will have a greater impact upon this asset over others of its type. In relation to this specific proposal there is unlikely to be any further impact upon the setting of the Hayes than that already experienced; impact: **neutral**.

Figure 5: The Hayes, viewed from the north

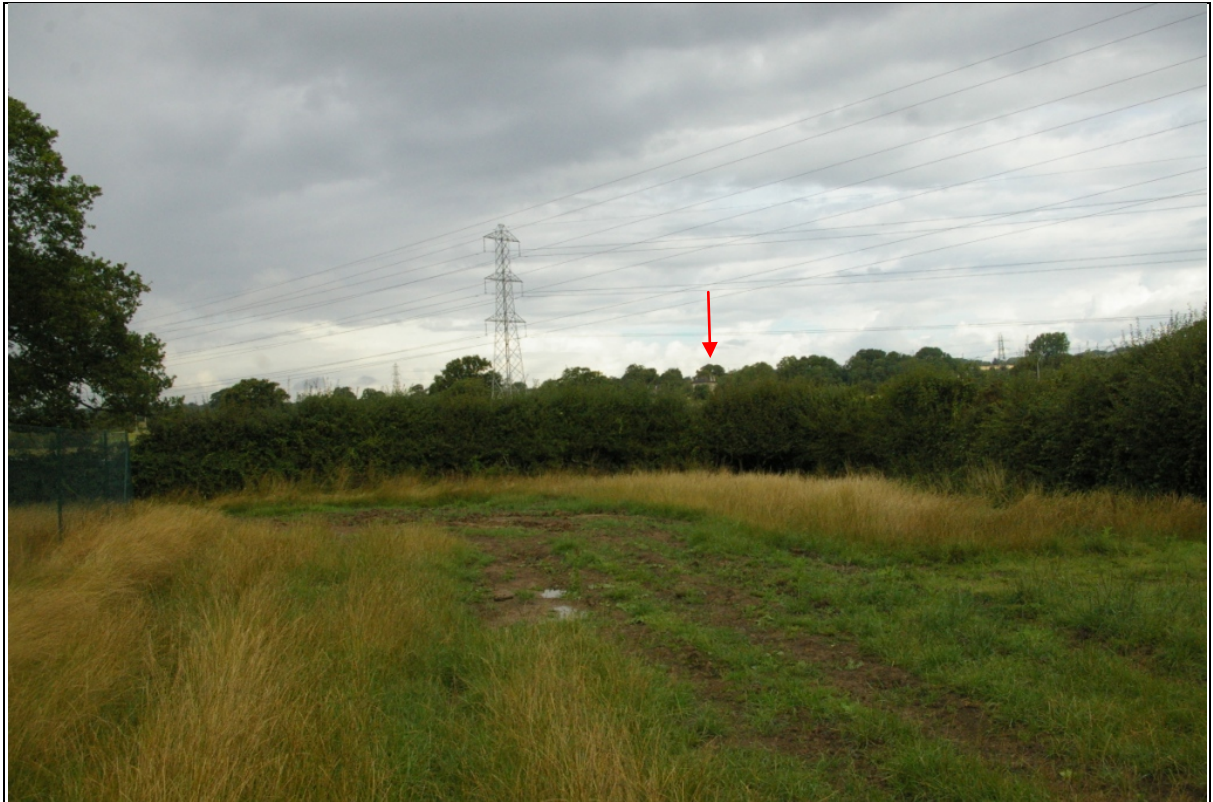
Figure 6: View of the Hayes from the northern edge of the Norrington Solar PV site, viewed from the south-east.
