# LAND at TRUDE FARM GOODLEIGH DEVON

Results of a  
Historic Visual Impact Assessment

## Land at Trude Farm Goodleigh, Devon

### Results of a Desk-Based Assessment, Walkover Survey & Historic Visual Impact Assessment

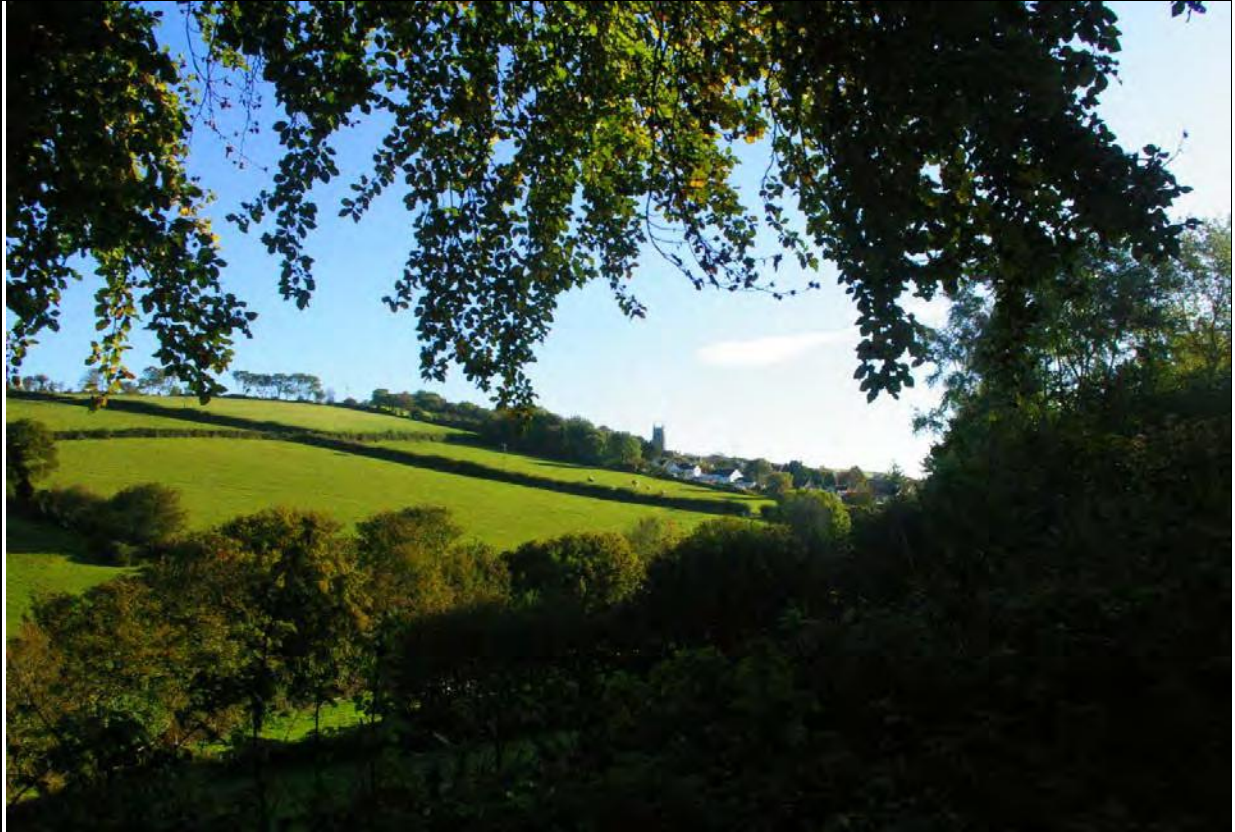
View towards Goodleigh, from the Goodleigh Road from Barnstaple, showing the dominance of the church tower within the valley; from the west, south-west.

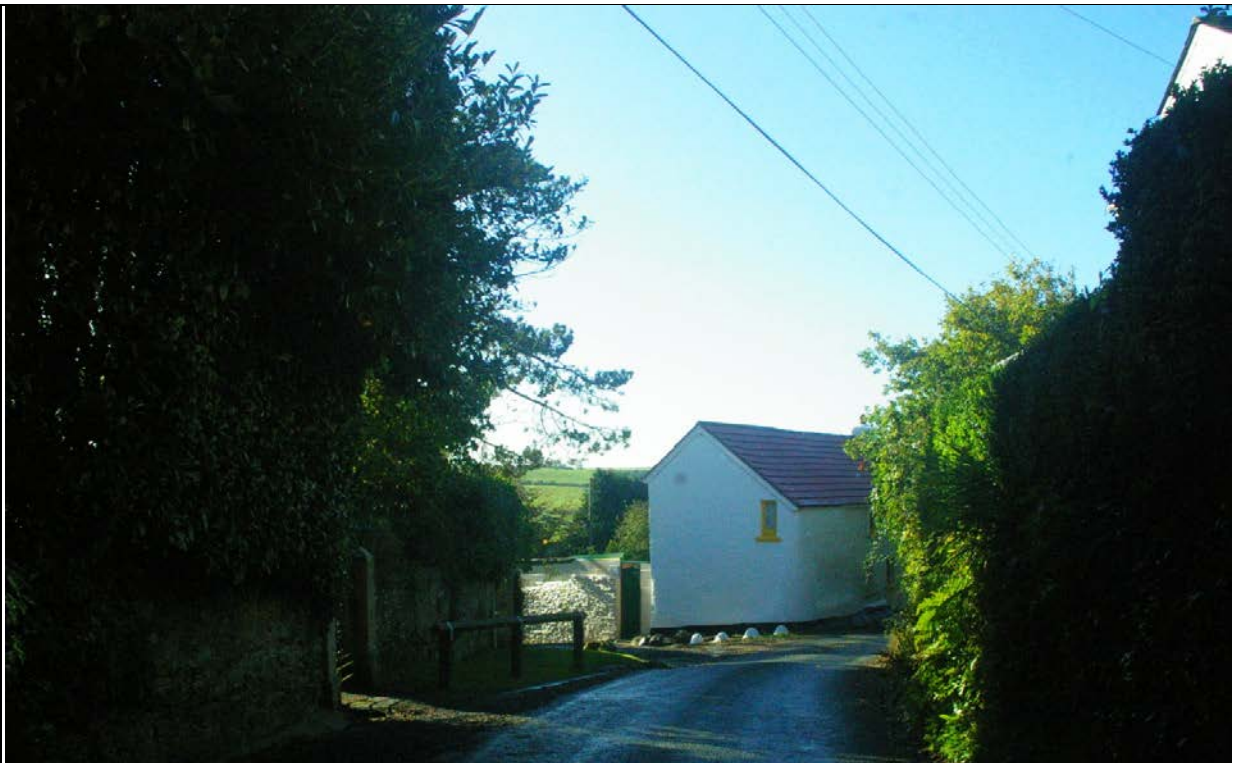
View down into Goodleigh village and the conservation area, from the Northleigh Road, showing limited views across the valley between the hedgebanks and roofs of houses; from the north, north-east.

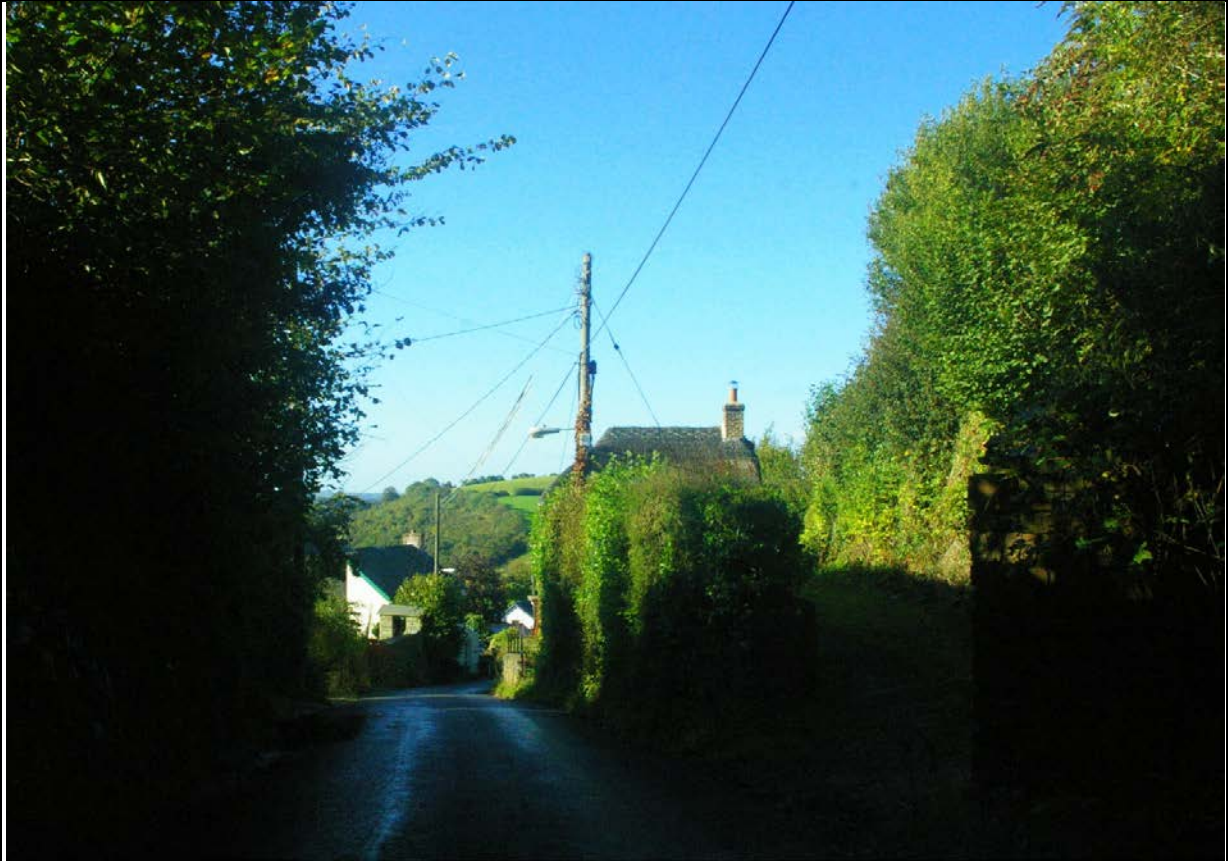
View down towards the street which rises to the road to Northleigh, within Goodleigh village and conservation area, showing the enclosed nature of the steep lanes and hedges between the cottages and houses of the settlement; from the north-east.

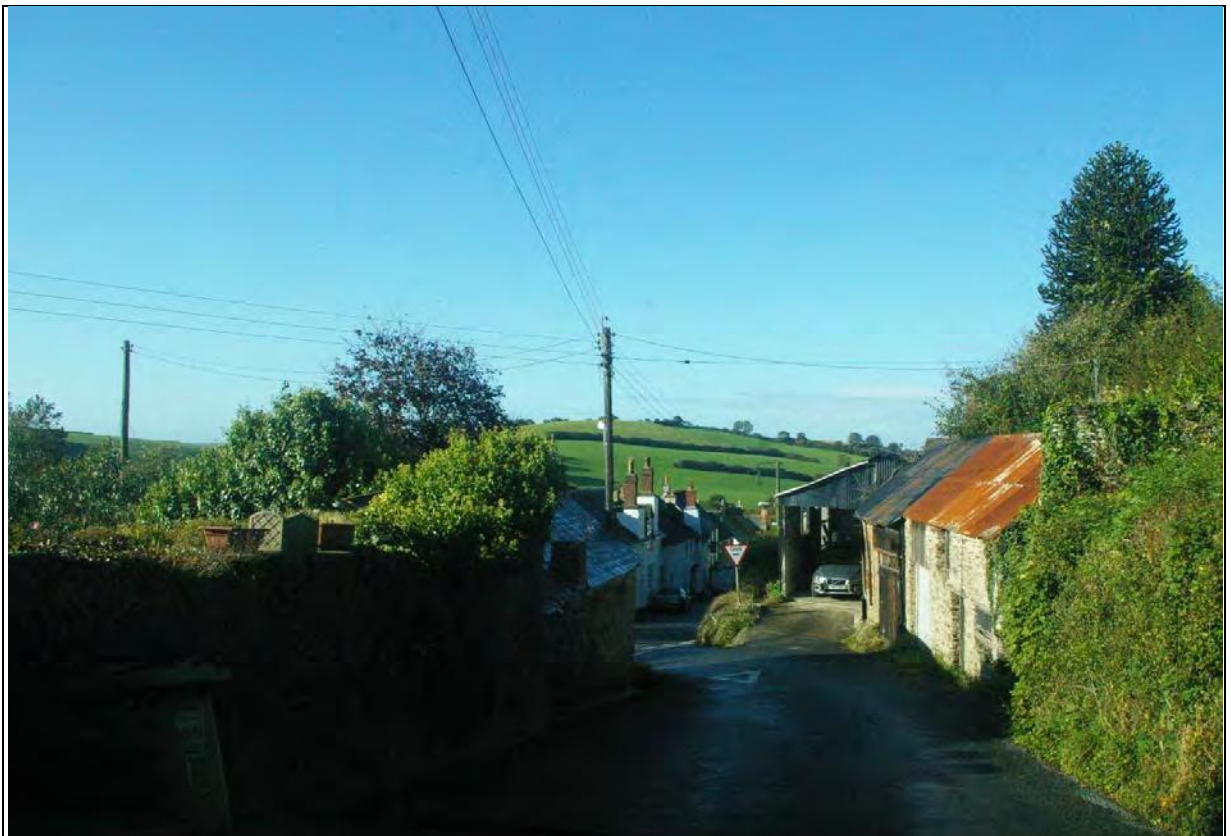
View across Goodleigh from the east, showing the position of the village on the lower slopes of the south-facing slope, on the north side of the valley.

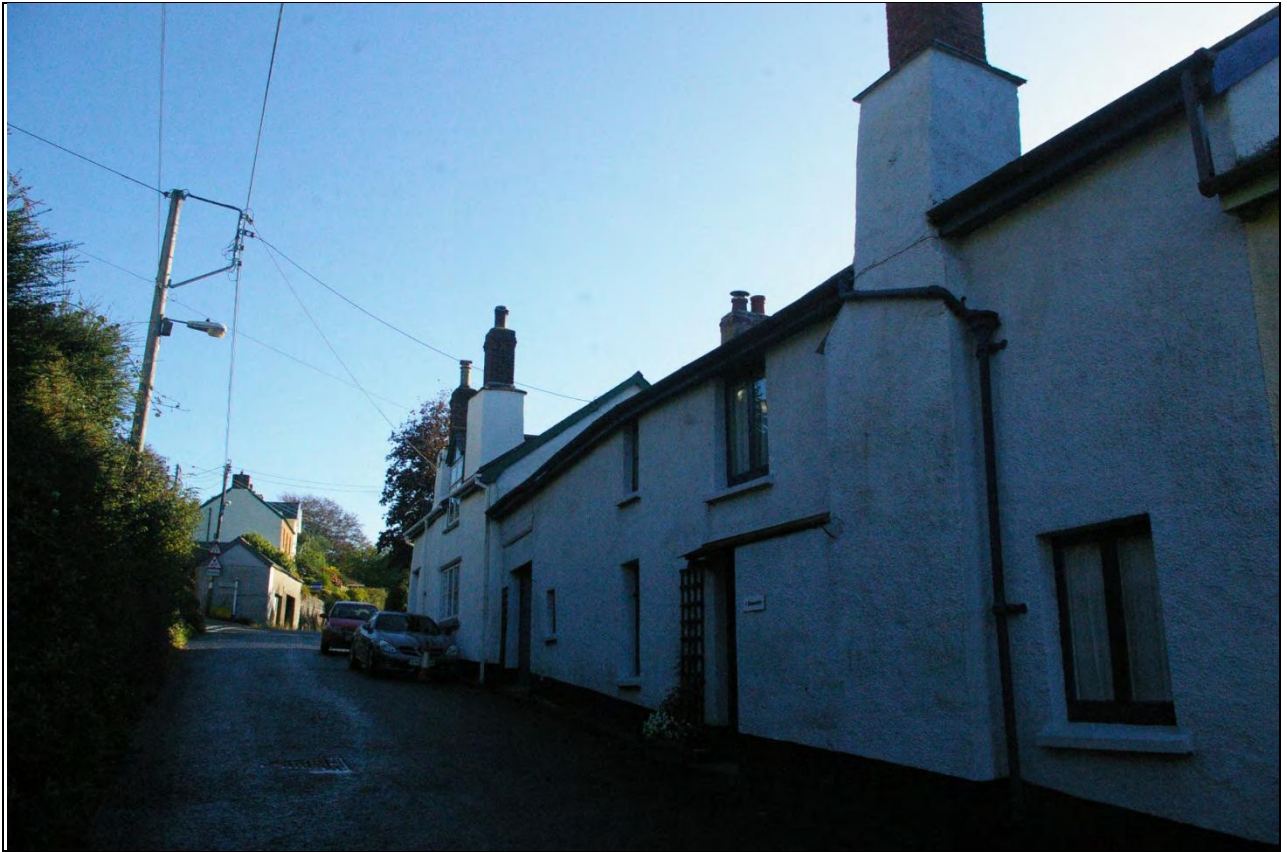
View of medieval or late medieval cob cottages, with later lateral stacks alongside the road, within the main street of Goodleigh, of a typical local North Devon vernacular, a character of the conservation area; from the west-north-west.

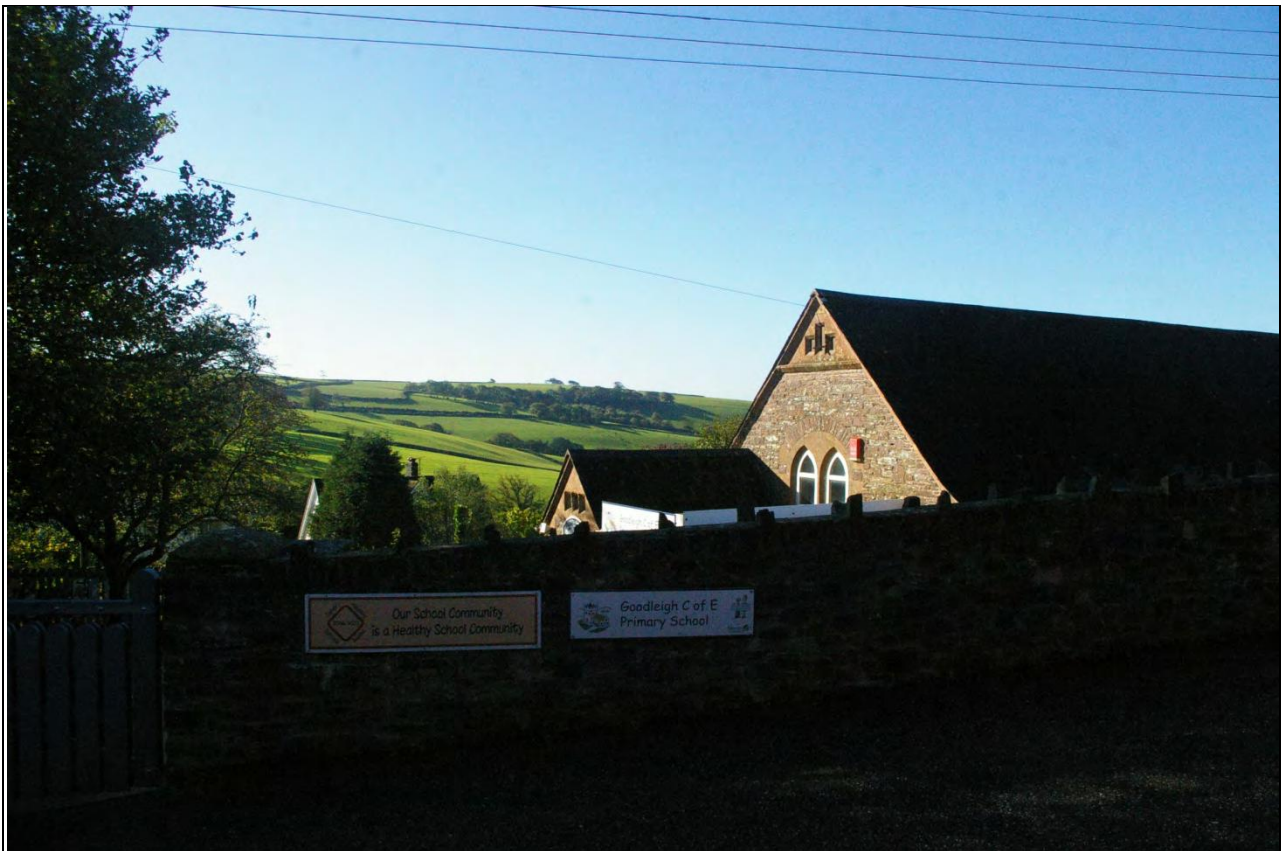
The historic stone primary school building, just south of the church within the heart of the conservation area, showing some views out to the south side of the valley over the roofs of the houses; from the north.

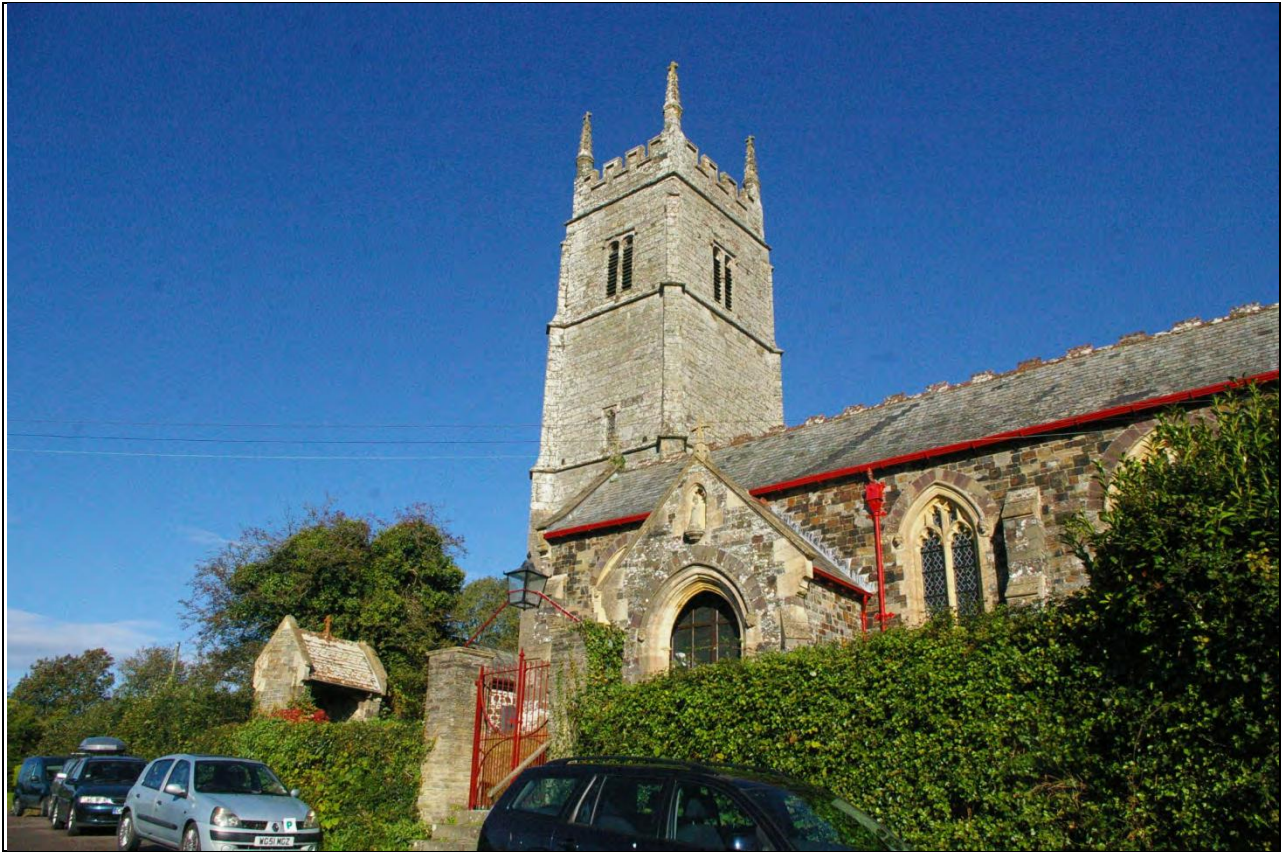
The church in Goodleigh, with tall stone tower, with wide views across and along the valley, from its position on the north slopes of the valley, facing south; from the south-east.

- Church of St Gregory, Goodleigh; high significance; Grade II\* Listed; condition: good to excellent; distance to turbine c.1.1km. Parish Church of late 15<sup>th</sup> century construction, with an early 16<sup>th</sup> century west tower. The building was significantly restored and rebuilt in the 19<sup>th</sup> century, by
