LAND at RIDGECOMBE FARM LIFTON DEVON

Results of a Geophysical Survey, Walkover Survey, Archaeological Evaluation
& Historic Visual Impact Assessment

Report No.: 140523
Date: 23/05/2014
Authors: S.H. Walls
E. Wapshott
J. Bampton
D. Laing-Trengove

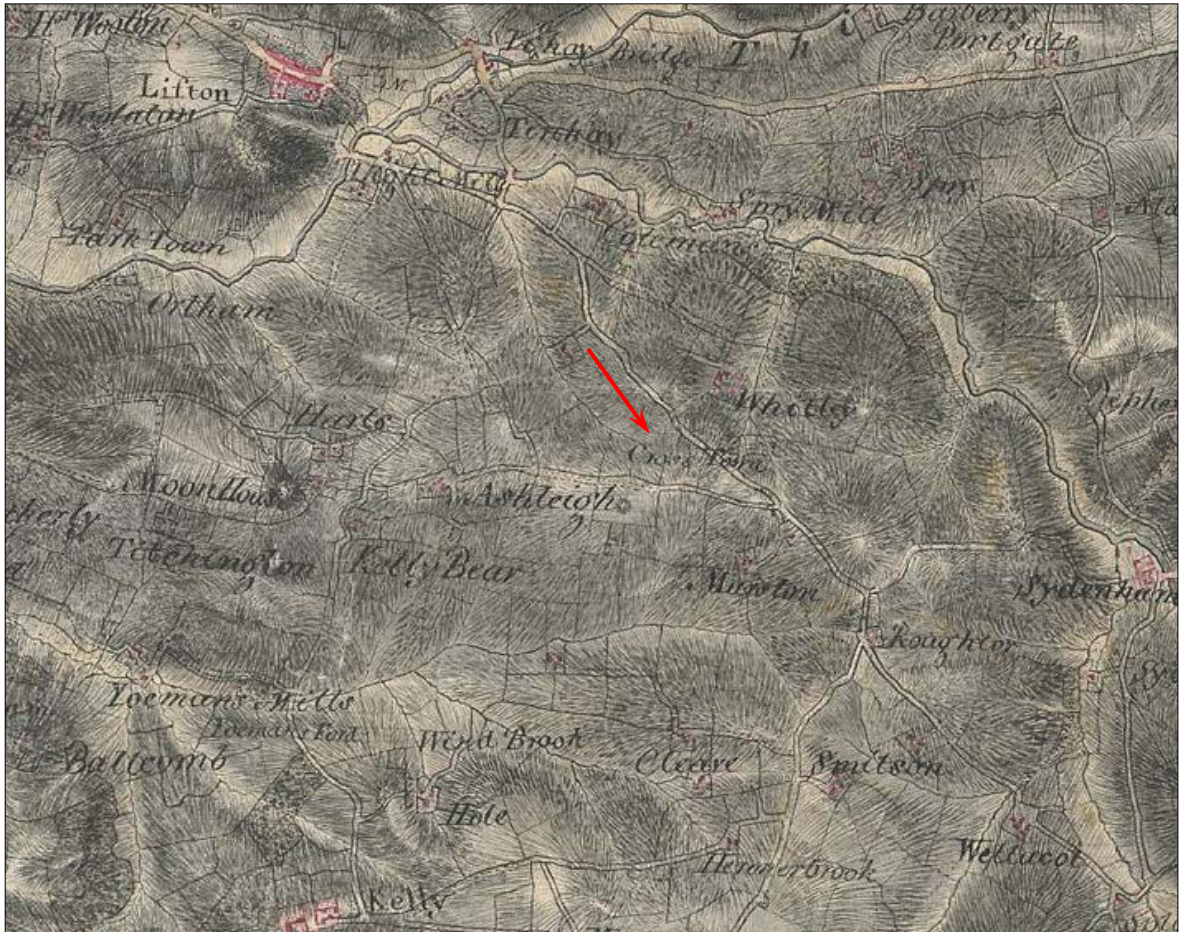
Figure 2: The 1806 Ordnance Survey surveyor's draft map (the approximate location of the site it indicated).

The Surveyor's Draft Map of 1806 does not give a detailed depiction of the area, but there is enough detail to locate the site. Inhabited areas are coloured red/pink and major features such as roads and rivers are clearly marked, allowing an approximate site location to be inferred. The farms of *Cross Town* to the south-east of the site and *Whitley* to the east are named, and *Ridgecombe*, although not specifically named, is indicated as a pale red mark within a rectilinear enclosure at the western end of a lane leading off the main road to the east. A field pattern is suggested but this cannot be accepted as a reliable depiction of the actual layout of the fields at this time.

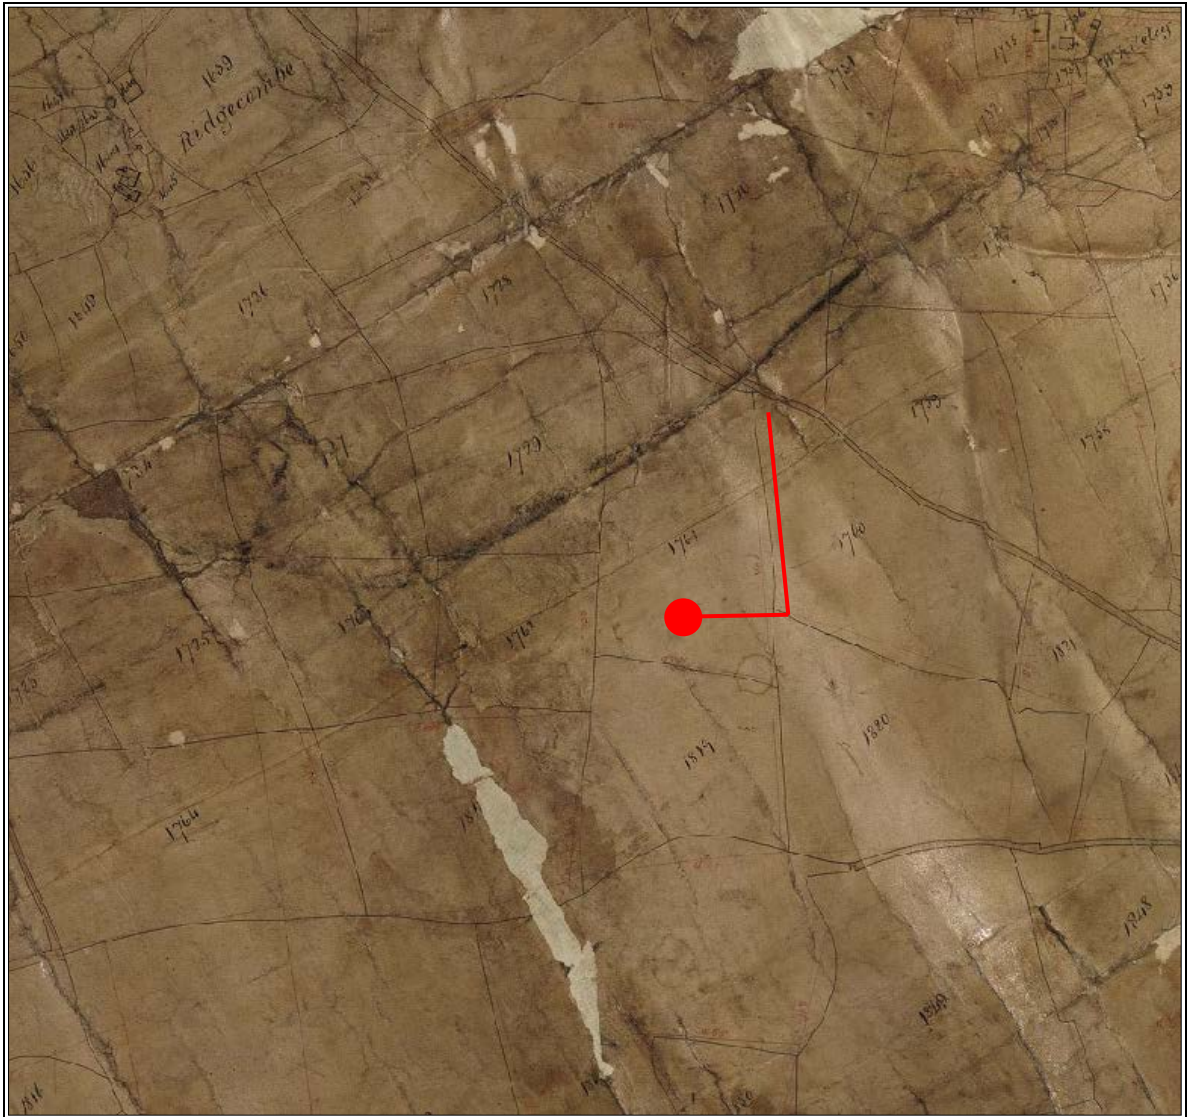
Figure 3: Extract from the 1840 Lifton tithe map (the approximate location of the proposed turbine is indicated).

The Tithe map for Lifton is rather damaged but it is still complete enough to locate Ridgcombe Farm and the proposed turbine field and access track (Figure 3). The field in which the turbine is to be located is divided into two separate enclosures at this date numbered 1761 (*Lower Dennis Field*) and 1819 (*Higher Down Field*). These two enclosures were part of the Whately holding at this date, which was owned by Reverend William Rayer and leased to a William Mason. These fields formed part of the western and southern boundary to the holding at this date. With the holding of Lowley (owned by William Arundell and leased to Roger Jackman to the south and parts of Ashley (largely owned by Samuel Trehawke Kekewich) and Ridgcombe (owned by William Arundell and leased to John Hall) to the west.

The tithe map seems to indicate that the road now running along the southern edge of the site, was in 1840 a droveway from the primarily large (late) enclosures which formed the holding of Lowley. This may suggest that this area was formerly a small open common, and some of the field names reflect this including –down placename elements. The field to the immediate south of the proposal area which adjoins the droveway (number 1851) *Lowley Beacon* has extremely curved boundaries suggestive of an earlier (possibly prehistoric) feature which has been respected by the subsequent field systems.

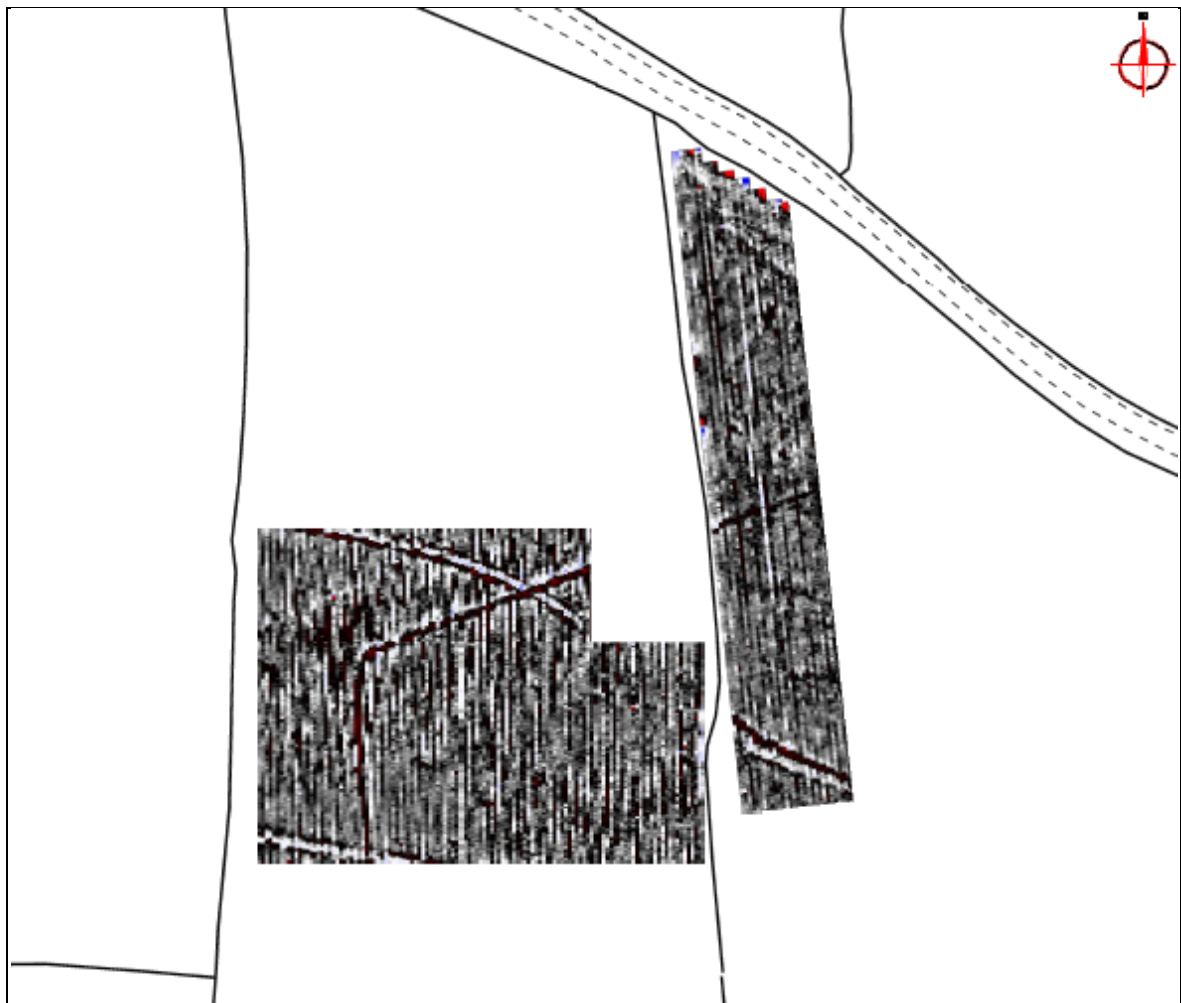
Figure 6: Colour plot of the gradiometer data (From: Stratascan Report No. J6517: Figure 3).

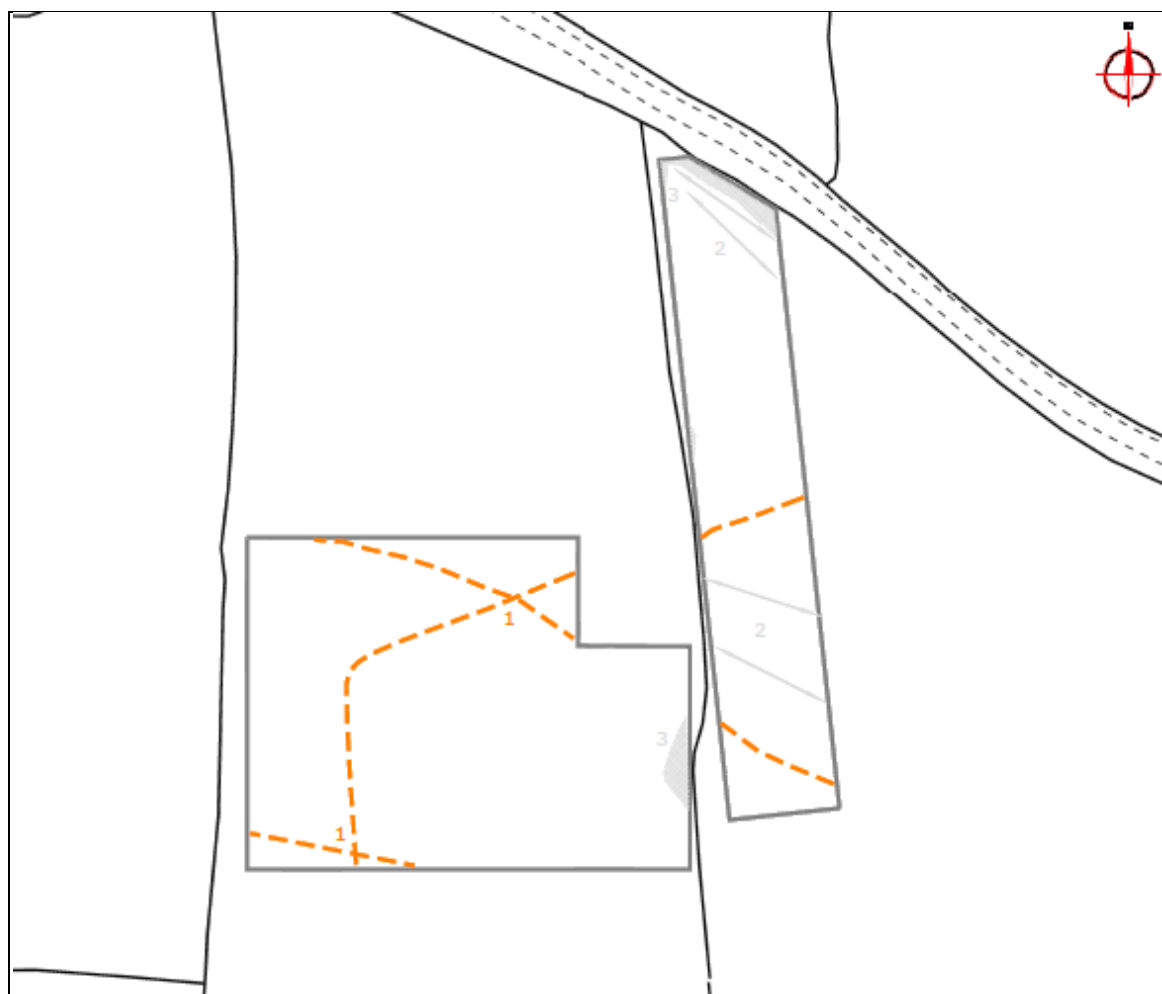
- 1 Strong, positive curvilinear anomalies relating to historic former field boundaries. These are not visible on available historic mapping (from 1840 onwards) so are thought to be of an earlier origin.
- 2 Closely spaced parallel linear anomalies most likely related to ploughing.
- 3 Area of magnetic disturbance as the result of nearby ferrous object/service pipe along the hedge.

Figure 7: Interpretation plot (From: Stratascan Report No. J6517: Figure 5).

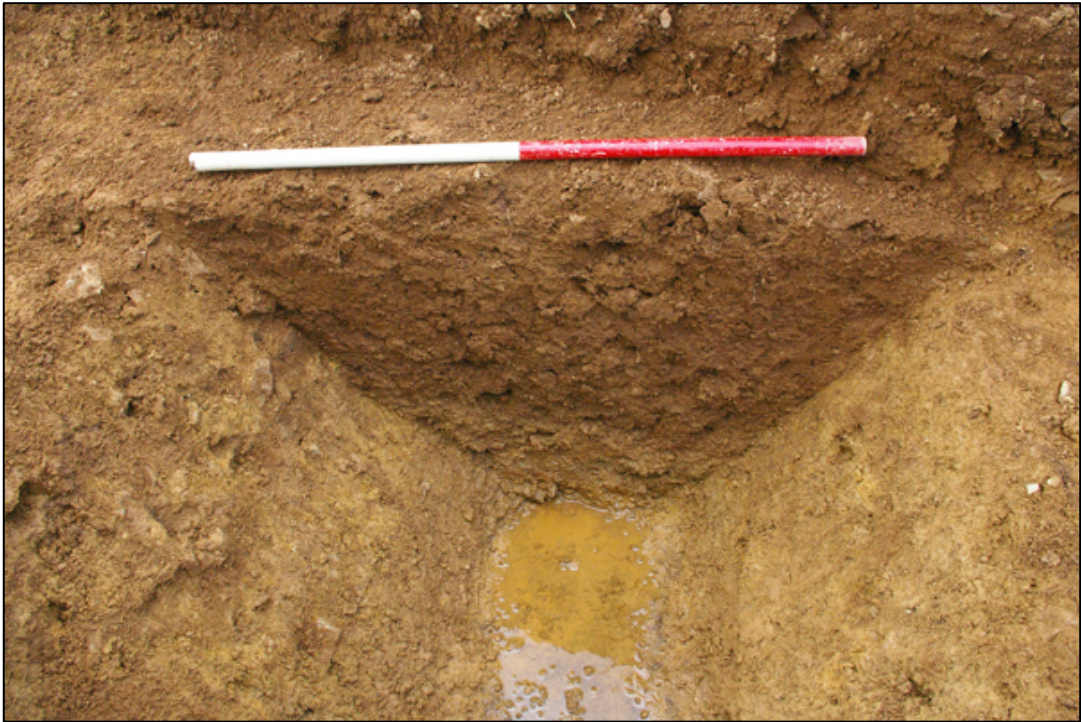
Figure 8: Ditch [104], viewed from south-west (1m scale).

The topsoil and subsoil from Trench 1 represent the upper and lower plough soils from the access track field (Figures 9, 10, 17). Thirteen meters from the north end of Trench 1 was Ditch [104] (Figures 8, 17), a linear feature (1.40m wide, 0.72m deep) aligned WSW-ENE, it had steep sides, a sharp break of slope and a flat base. It cut 2nd Subsoil (102). It contained two fills; (105) and (106), lower and upper respectively, neither of which produced any finds. Fill (105) was a light yellow-brown, soft silt-clay with frequent grit and medium angular stones. This fill was a combination of tumble and wash-in when the ditch was active. Fill (106) was a mid yellow-brown, soft-friable clay-silt with occasional to moderate medium and large angular stones and very occasional charcoal flecks. It represents the backfilling event of the ditch. It was overlaid by Subsoil (101). 2nd Subsoil (102) (10m wide, up to 0.26m deep) (Figures 11, 12, 17) was a layer overlaying the natural and cut by Ditch [102]. It was a light yellow-brown, soft silt-clay with frequent small to medium and occasional large angular stones and very occasional charcoal flecks along root disturbance. It occupied a dip in the relative plateau in the slope on the down-slope side of Ditch [104].

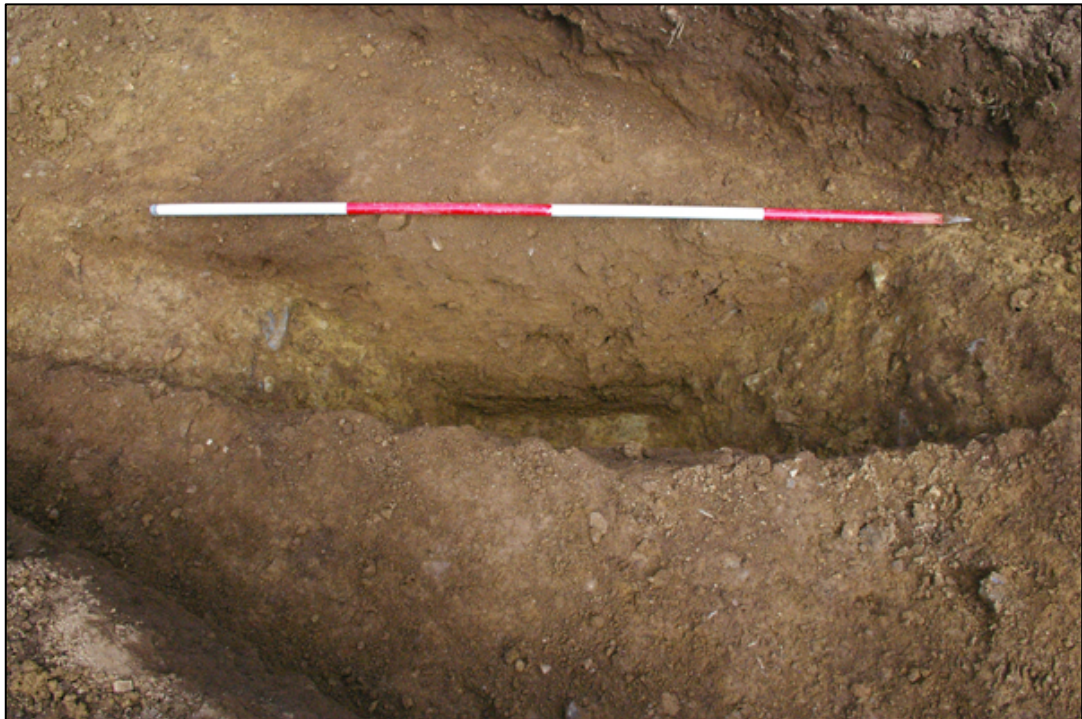
Figure 13: Ditch [204], viewed from south (2m scale).

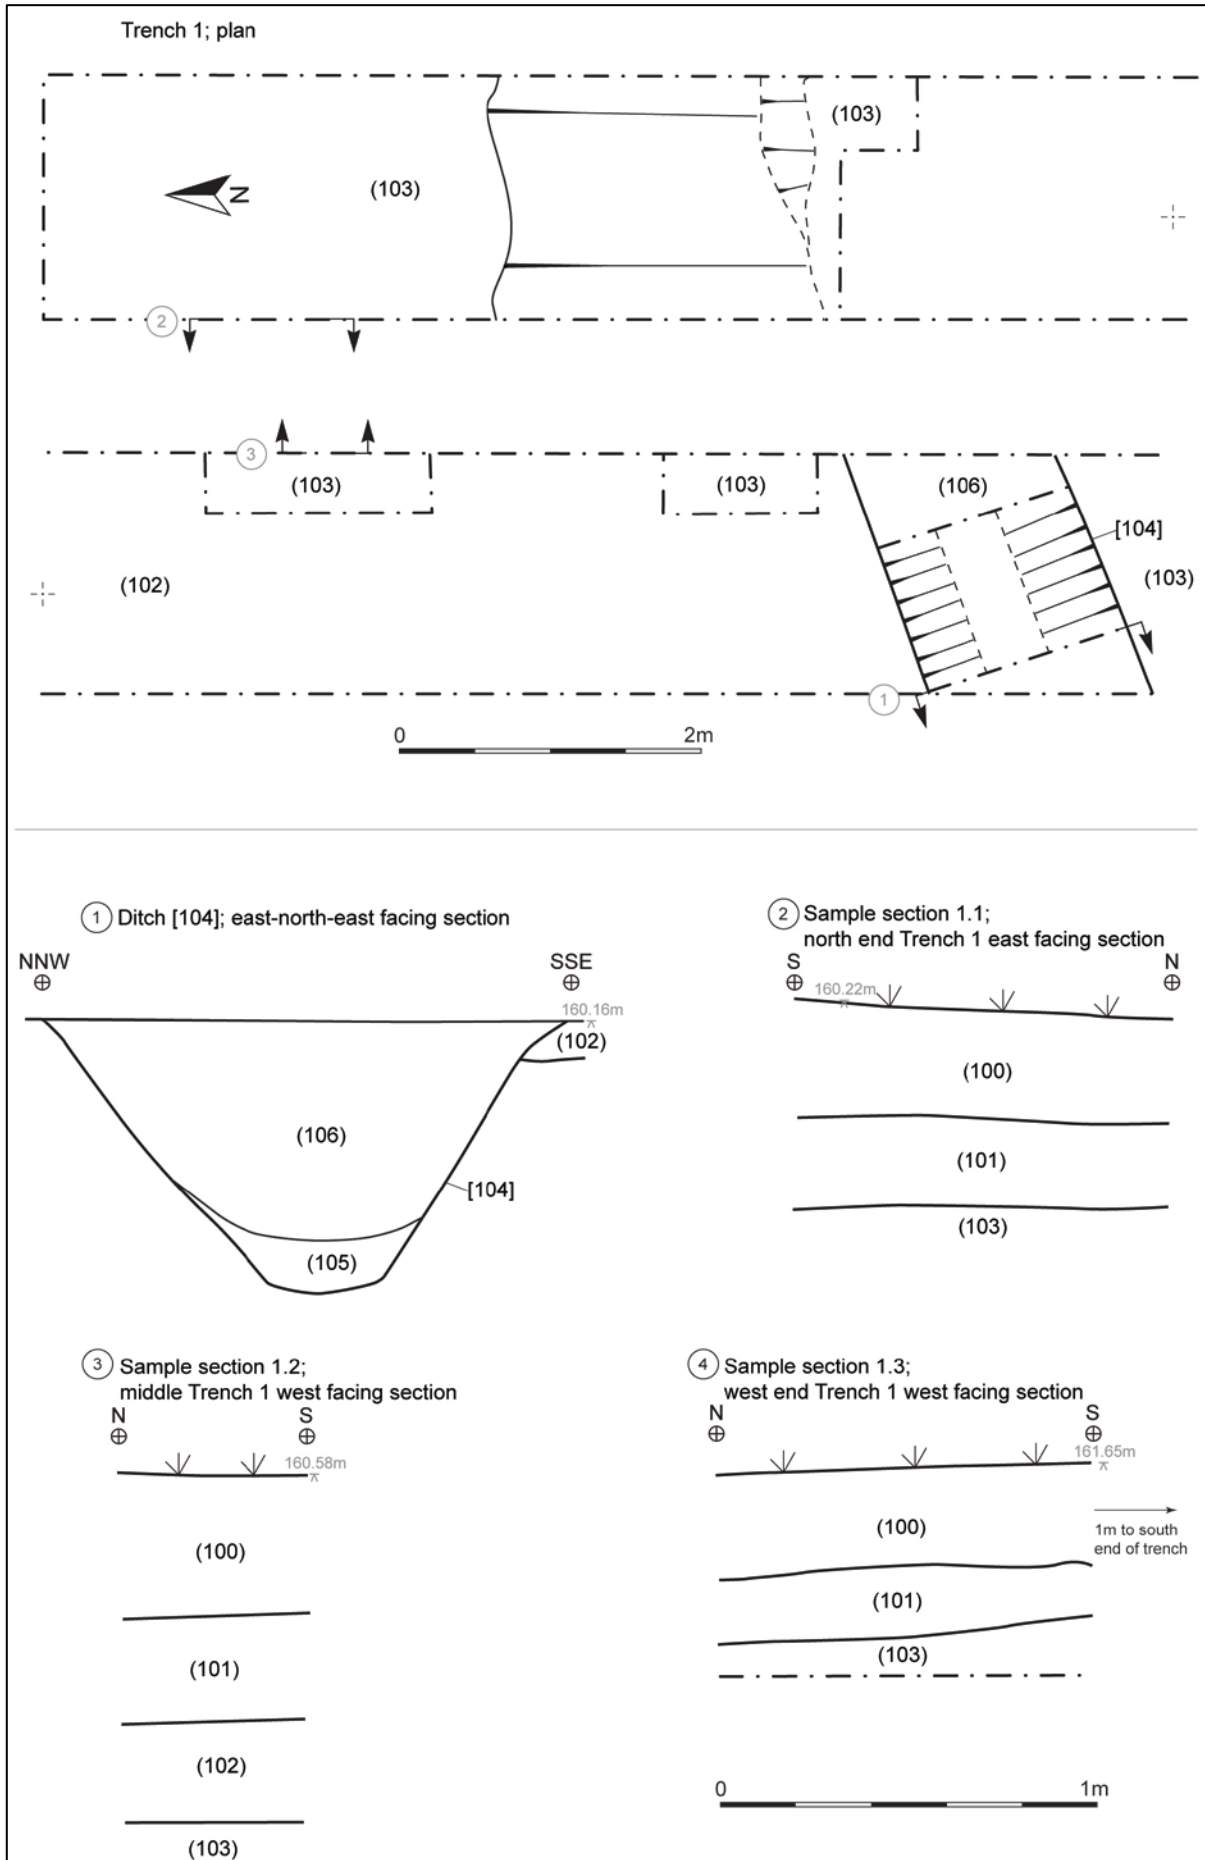
Figure 17: Plan and section drawings of Trench 1 (section numbers equate to greyscale numbers on plan).

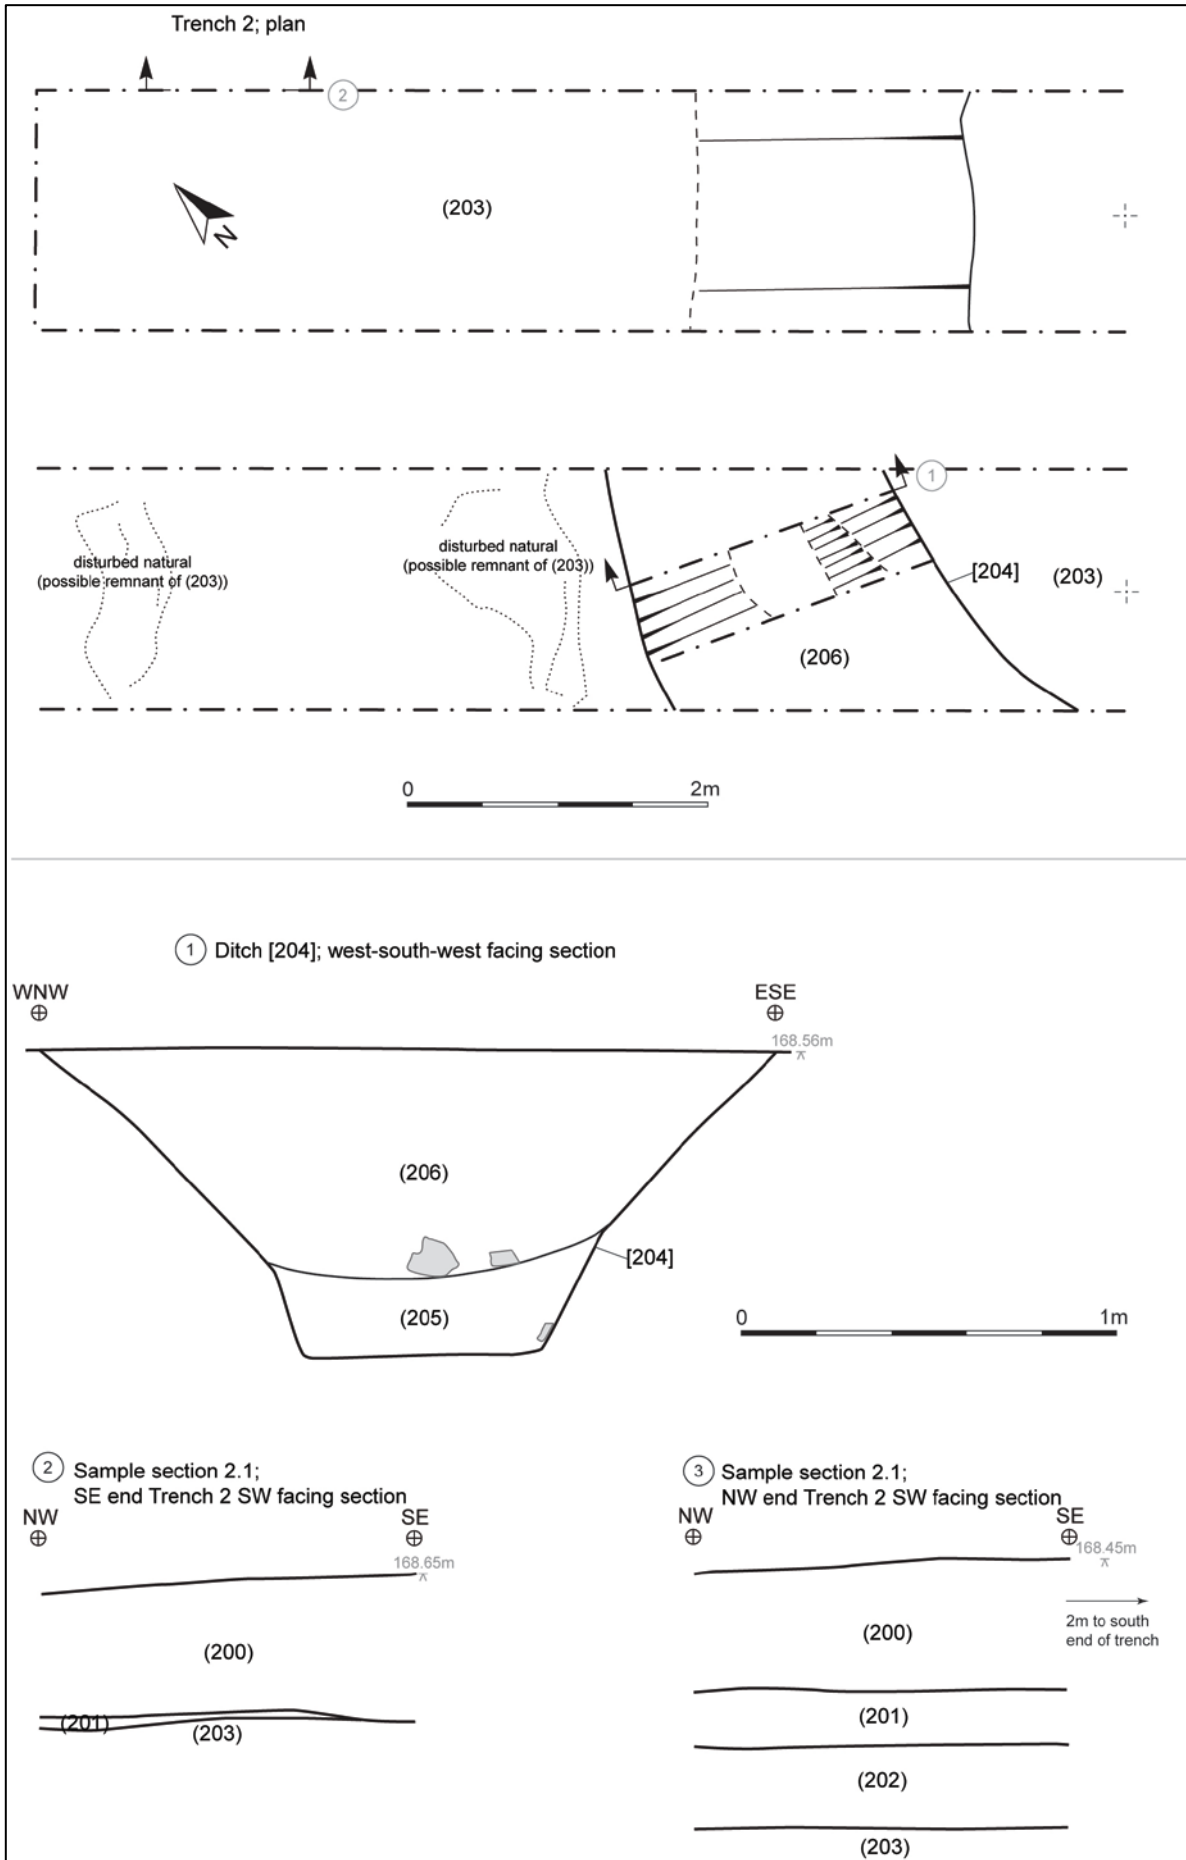
Figure 18: Plan and section drawings of Trench 2 (section numbers equate to greyscale numbers on plan).

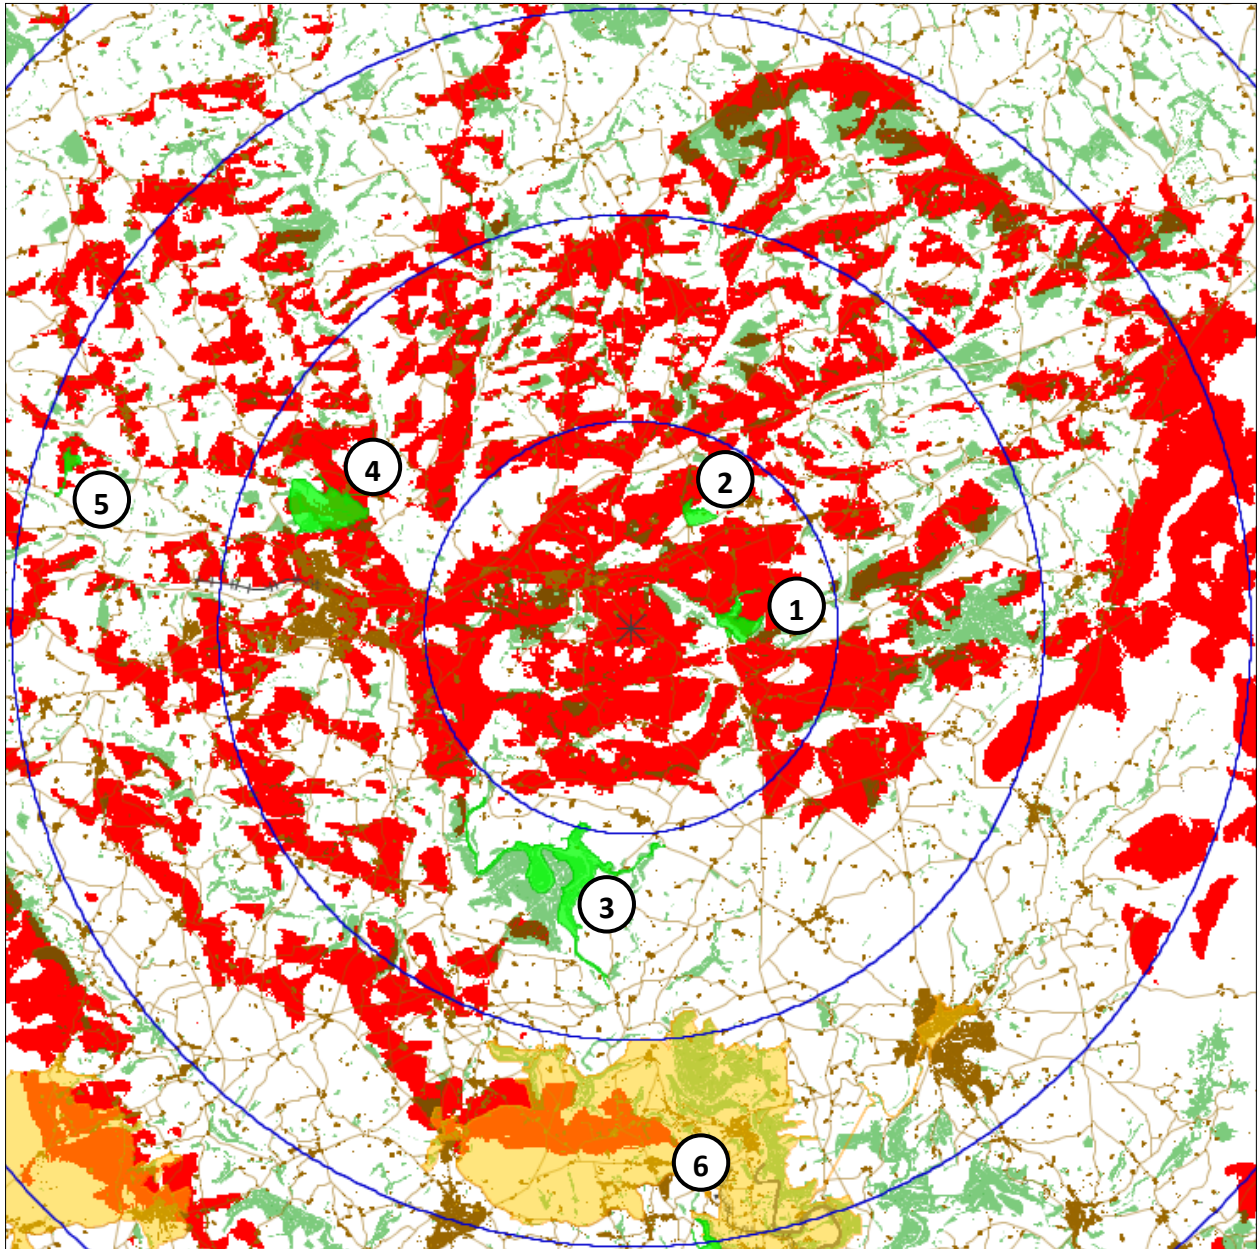
Figure 21: Distribution of protected landscapes within the ZTV (to tip) of the proposed turbine, out to 15km; ZTV to tip (67m) shown in red (based on a ZTV supplied by Aardvark Environment Matters). The Registered Parks and Gardens are: 1. Sydenham House (GII); 2. Hayne Manor (GII); 3. Endsleigh (GI); 4. Werrington Park (GII); 5. Penheale Manor (GI). The World Heritage Site: Cornwall and West Devon Mining Landscape: Tamar Valley Mining District with Tavistock; 6. Data © English Heritage 2014; contains Ordnance Survey data © Crown copyright and database right 2014.

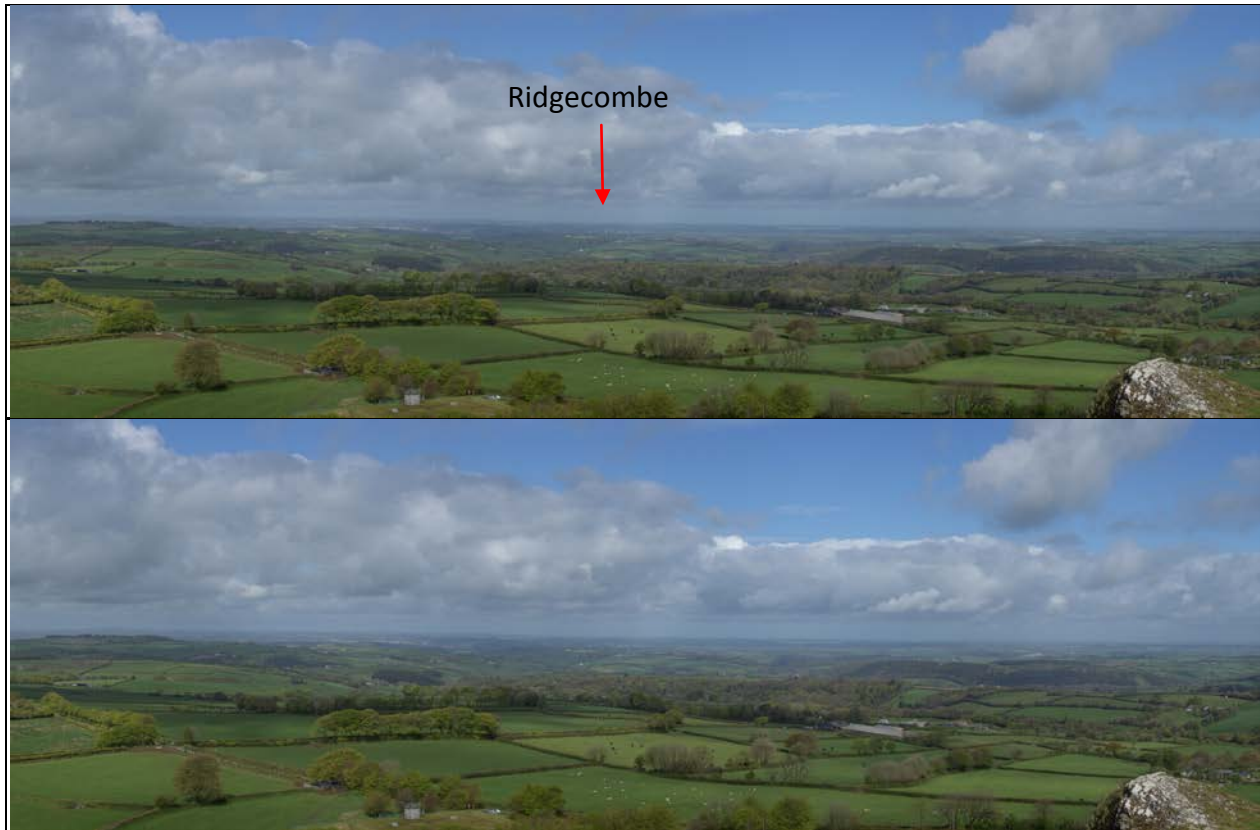
Figure 22: Photomontage and existing view from Brent Tor (supplied by Landscape Visual Ltd.).

designed to light the church, not for views. So far reaching is the viewshed from this asset that multiple wind turbines can already be seen from it. This has not damaged our appreciation of the asset, as none are close enough or large enough to compete for primacy. At 8km away the turbine near Lifton also cannot impact the church to any great extent; impact: **negative/minor** to **neutral**.

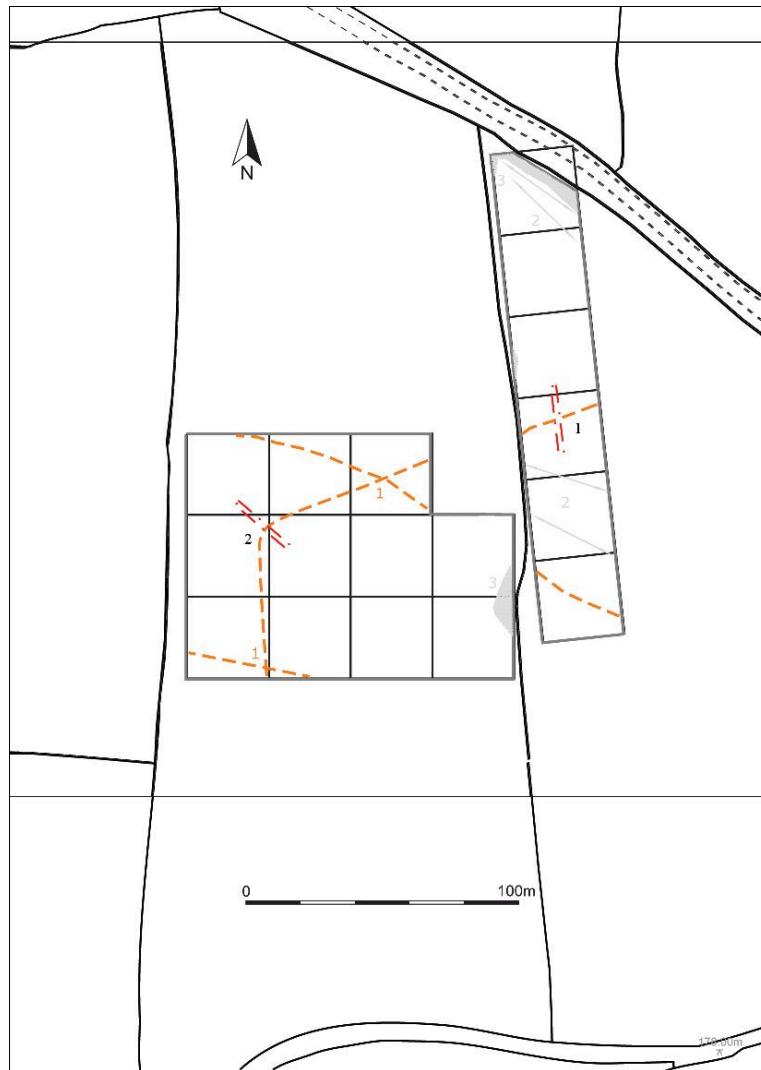
Figure 1: Trench plan showing the planned trenches and the geophysics results.

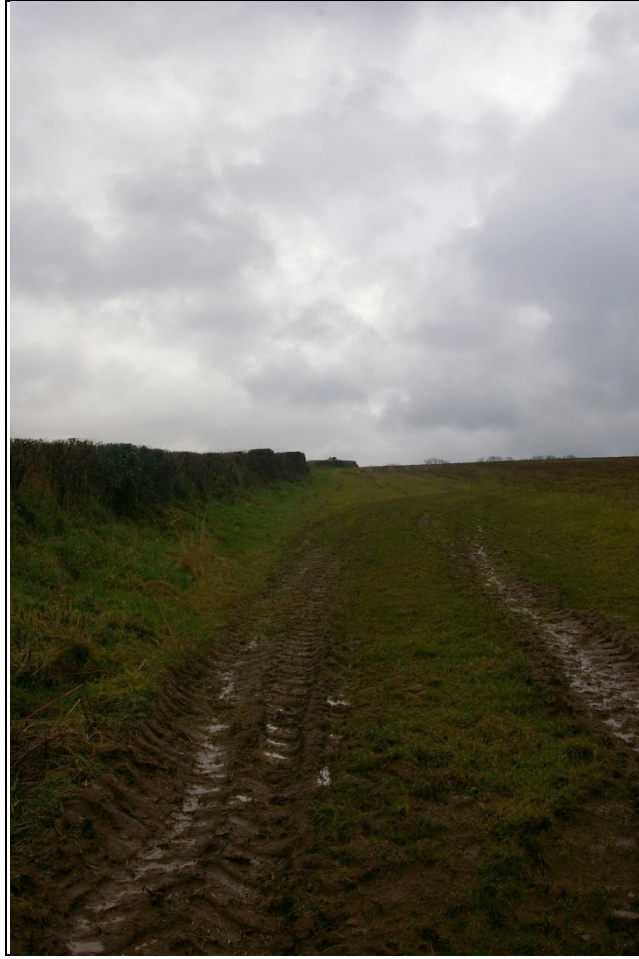
View up the long eastern boundary, from the base of the slope; from the north.

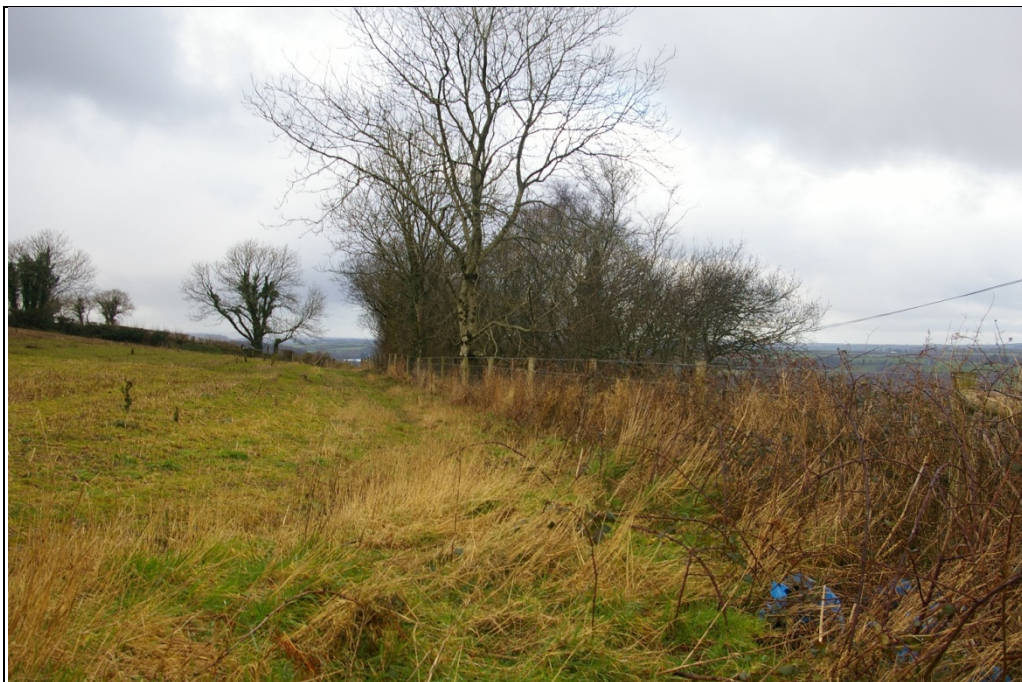
View along the northern boundary, against the road; from the east.

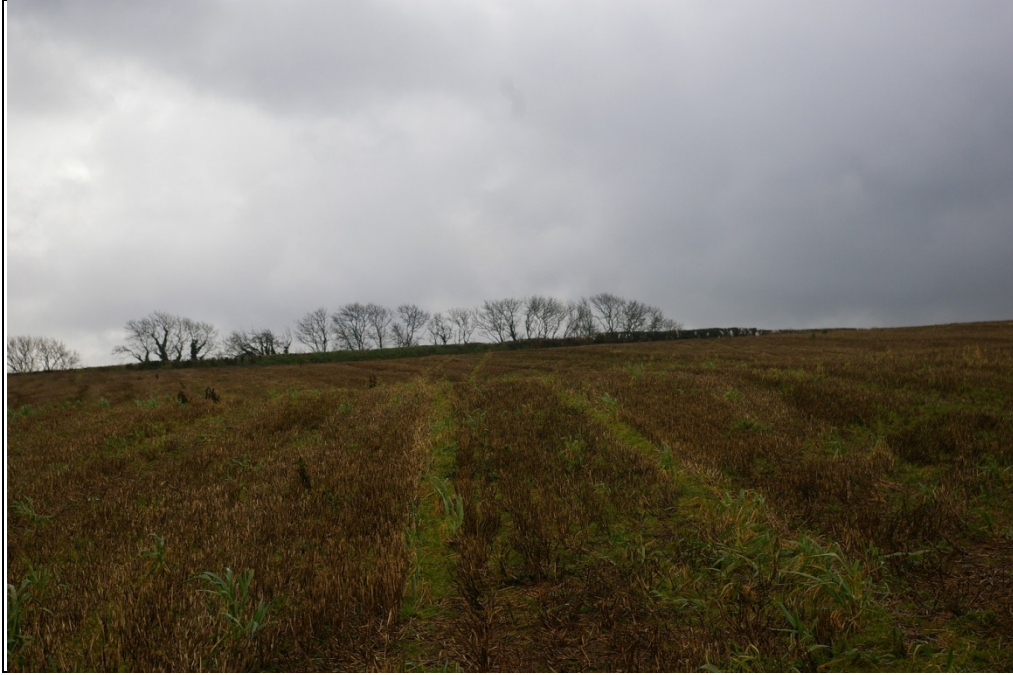
View up to the curving southern boundary, showing the central section where it has a pronounced rounded curved section, a solid earthen bank, not topped with a hedge as the rest of the hedge-bank; from the north.

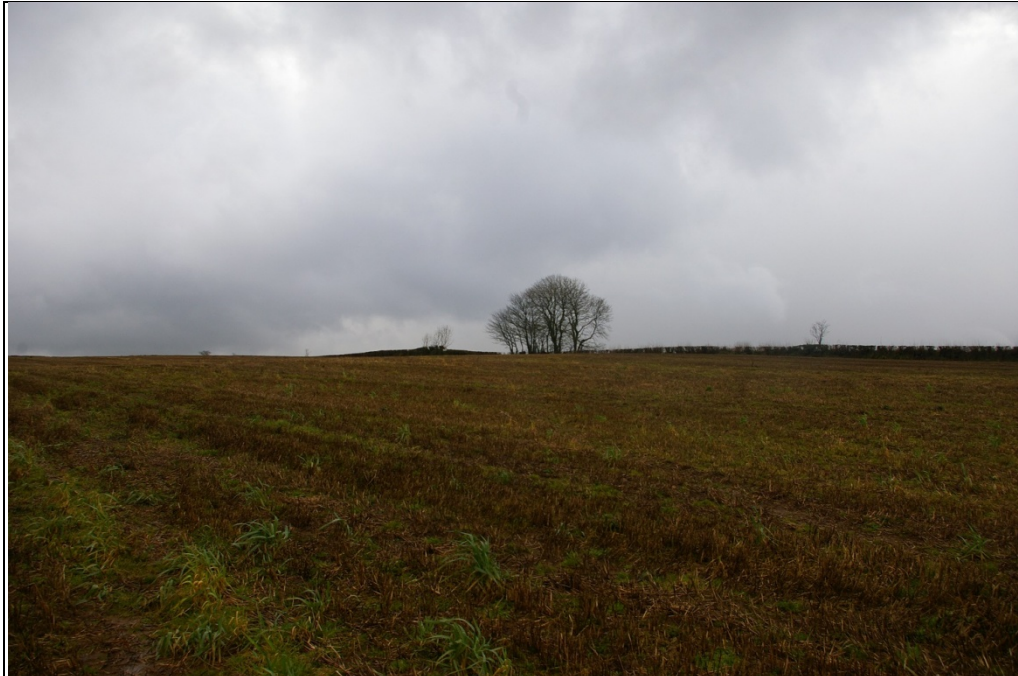
View up to the clump of trees on the western hedge-bank boundary of the field; from the north-east.

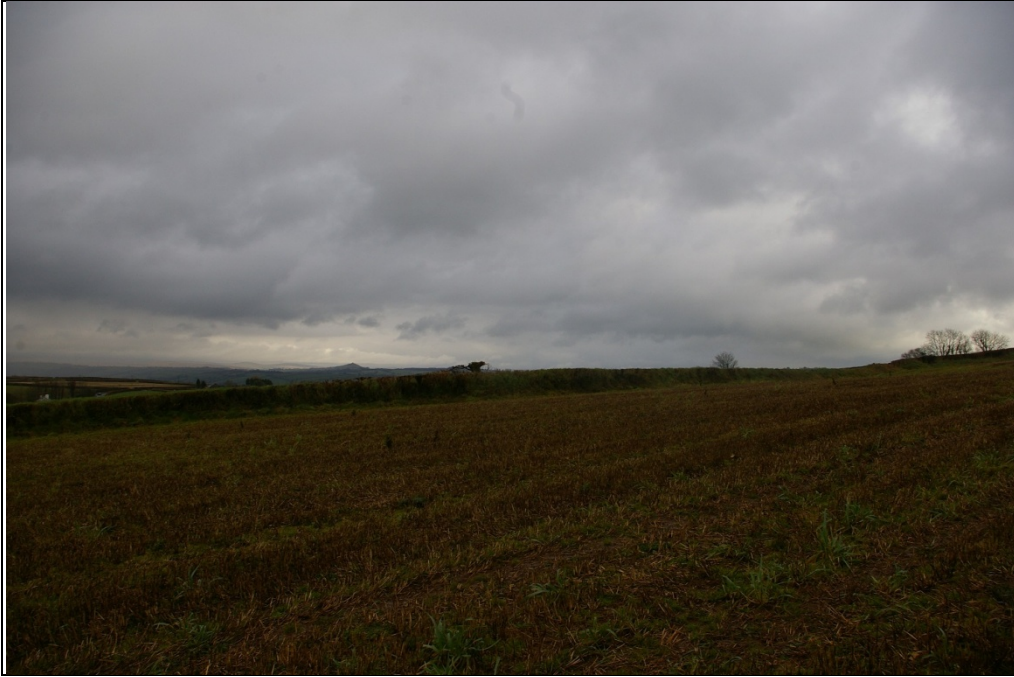
View to the eastern hedge-bank boundary, where it 'kinks' and changes direction, this section of the boundary appears to be of a solid earthen bank, similar to the section of the northern boundary; from the north-west.

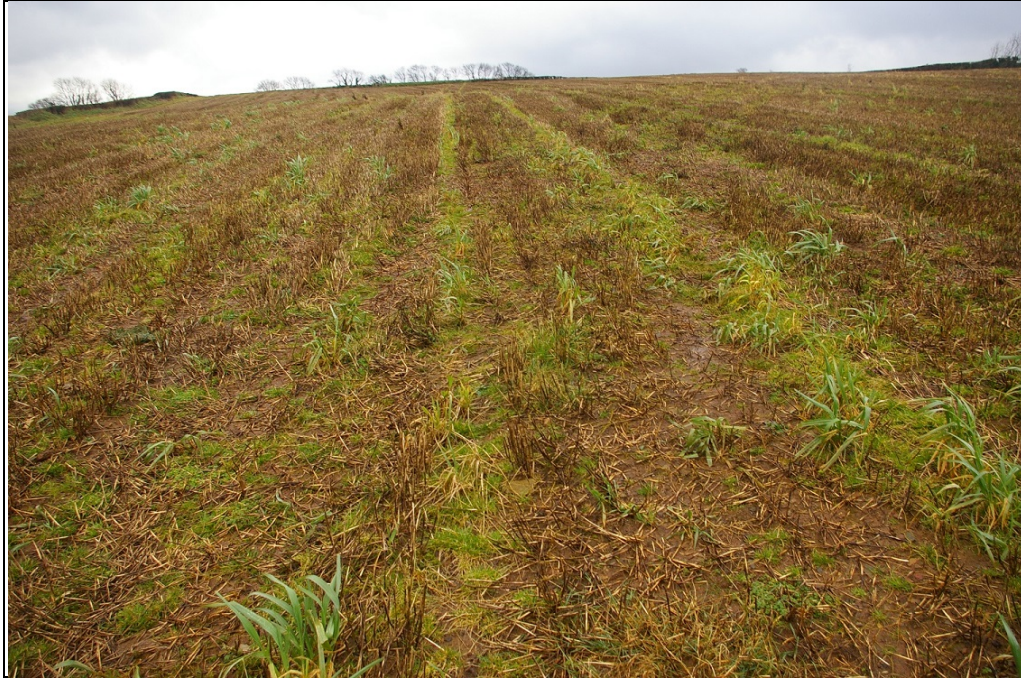
View up the field, showing the natural undulations up the slope, as it rises to the south and the west; from the north.

The field in which the turbine is to be located is long and narrow, of fairly regular shape, with straight-sided boundaries to the east and west, a diagonal boundary to the north where the road slightly truncates the field, and with a curved boundary to the south. The field runs down a north-east facing slope, with the highest point in the south-west corner. The field boundaries are stone-faced banks, topped with hedges; against the roadside the boundary is overgrown with brambles and the bank appears to have become worn down and a timber fence put in place. In the north-west corner several hedgerow plants have become semi-mature shrubby trees where the hedge-bank partially survives. There is a gate from the road into the field in the north-east corner. The long field boundaries are well kept. Along the western boundary, towards the southern end, a few hedgerow trees have been allowed to grow to maturity. There is a wide entrance into the field to the east halfway up the eastern field boundary. The southern boundary respects the road, which curves sharply at this point, as do the banks of the field boundaries on the opposite side of the road. There appears to be the remains of an enclosure here, in the field on the opposite side of the road, preserved in the field boundaries, which continue to the east in a marked, sub-ovoid pattern. In the potential turbine field there is a slight increase in the angle of the slope in the south-east corner, which may be associated with this enclosure, the area now being bisected by the road and hedge-banks. The southern end of the field will not be disturbed by the construction of the turbine. The rest of the field is fairly level, as it slopes downwards to the north. There are a few undulations which are expected to be natural geological formations forming contours of the slope.

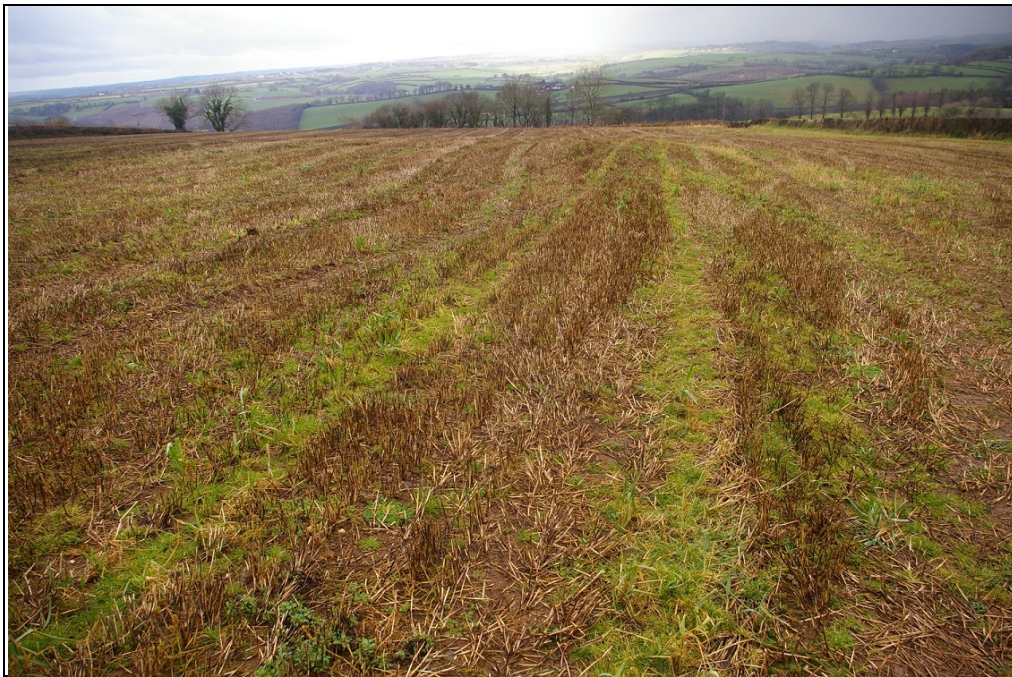
View of the more pronounced although slighter in size undulation which crosses the field, but appears to curve ever so slightly; from the south-east.

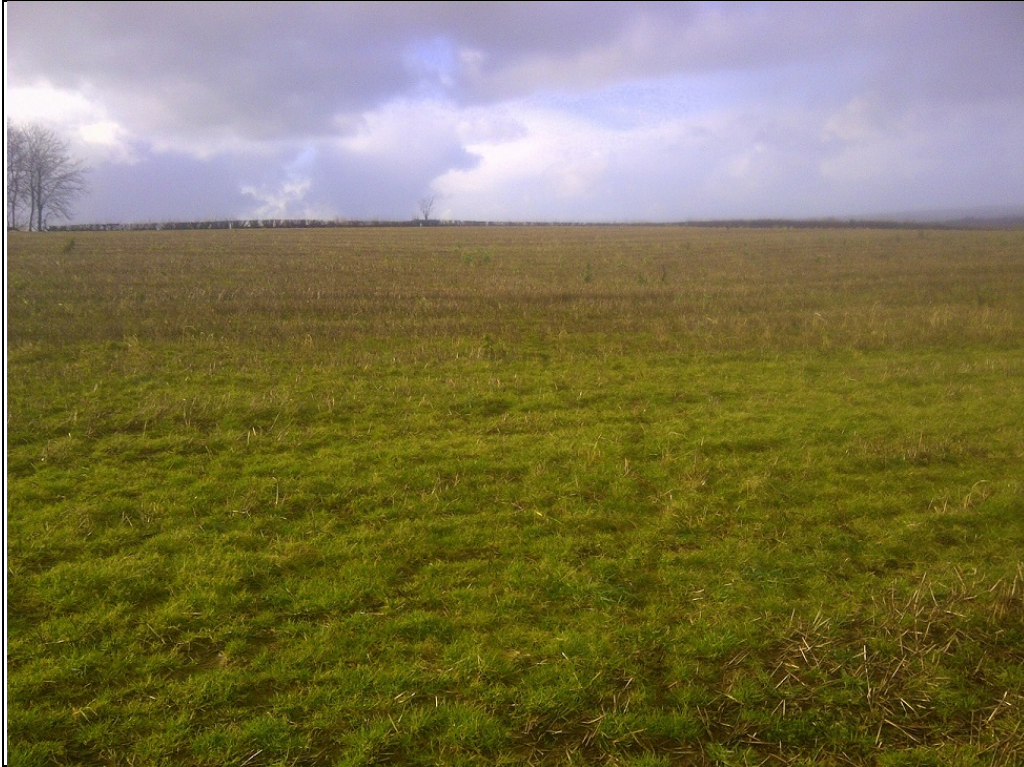
View across the proposed location of the turbine, showing no obvious earthworks, crop marks or evidence of archaeology; from the east.

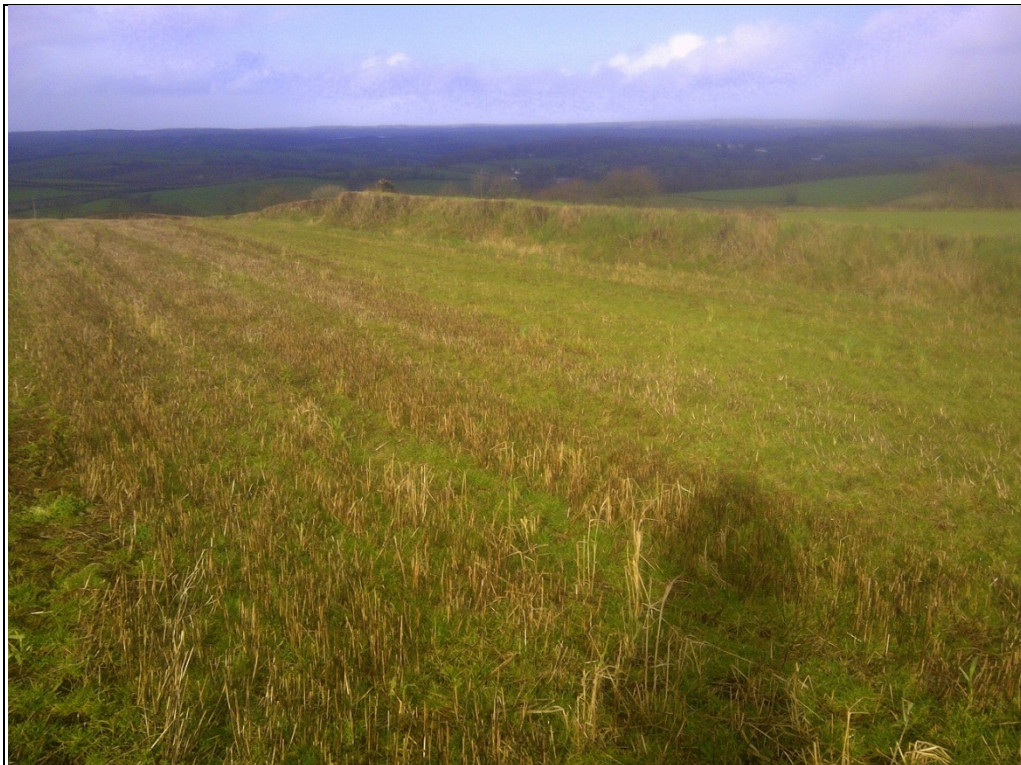
The point at which the field boundary 'kinks' or 'dog-legs'; from the south-west.
