LAND at RIDGECOMBE FARM LIFTON DEVON

Results of a Geophysical Survey, Walkover Survey, Archaeological Evaluation
& Historic Visual Impact Assessment

Report No.: 140523
Date: 23/05/2014
Authors: S.H. Walls
E. Wapshott
J. Bampton
D. Laing-Trengove

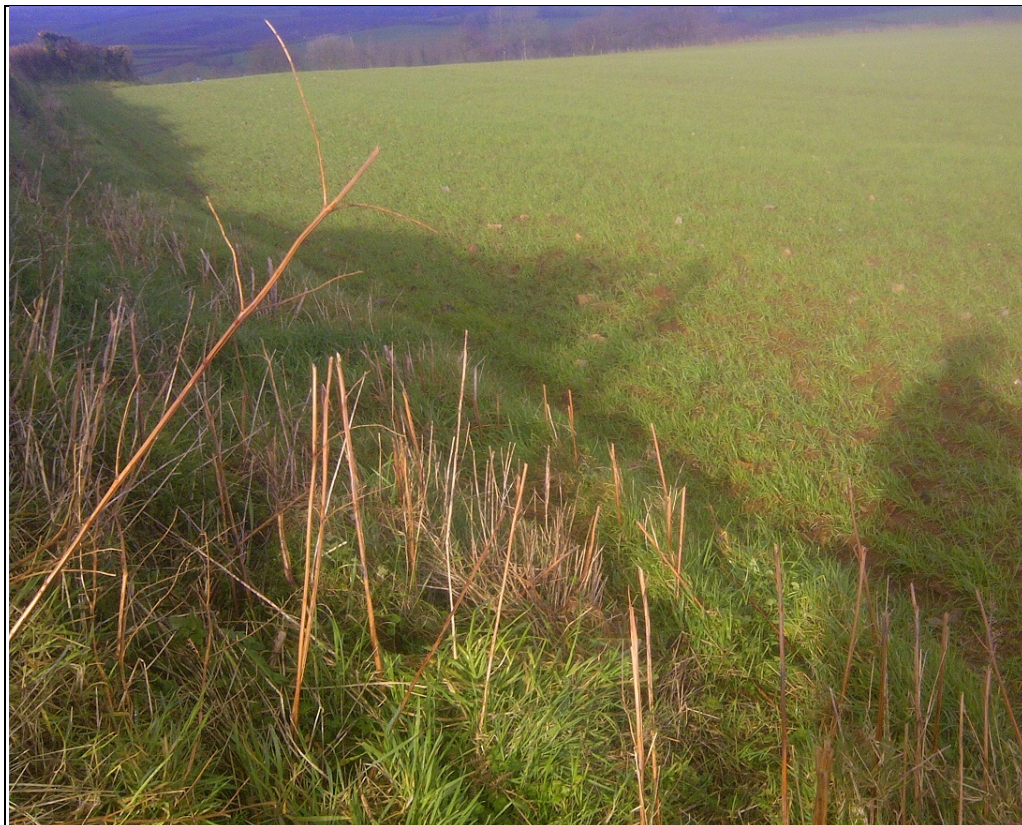
View down the hedge-bank which the two fields share, showing the 'dog-leg' in the boundary and the change in the slope; from the south-west.

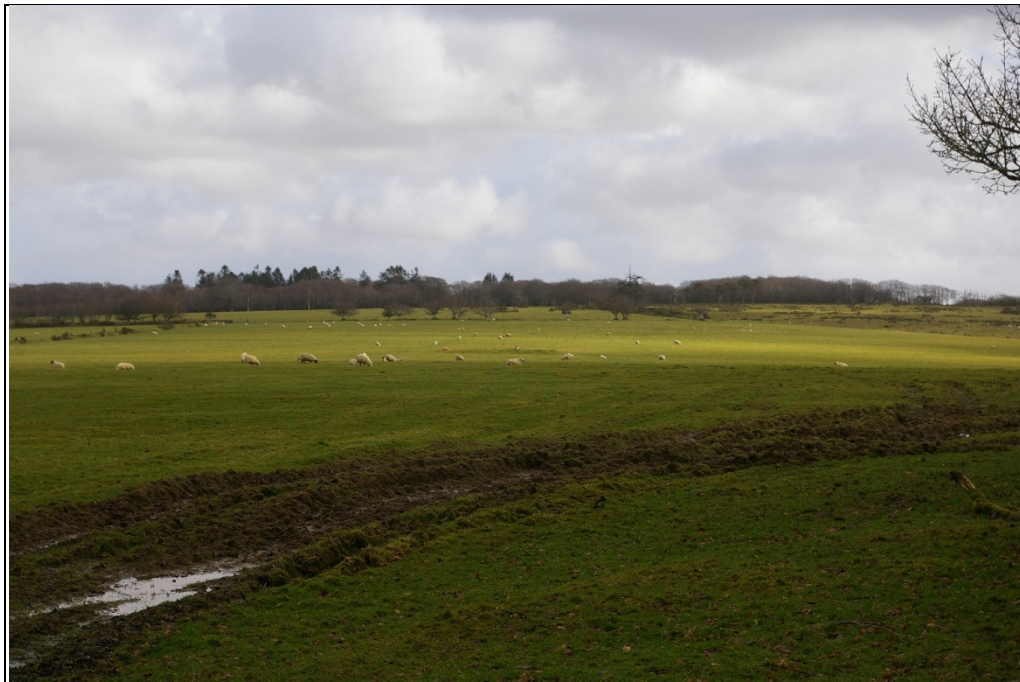
View of the field near Longcross crossroads and Sand Pit, which contains two bowl barrows, visible as the slight earthworks within this pasture field; from the north-west.

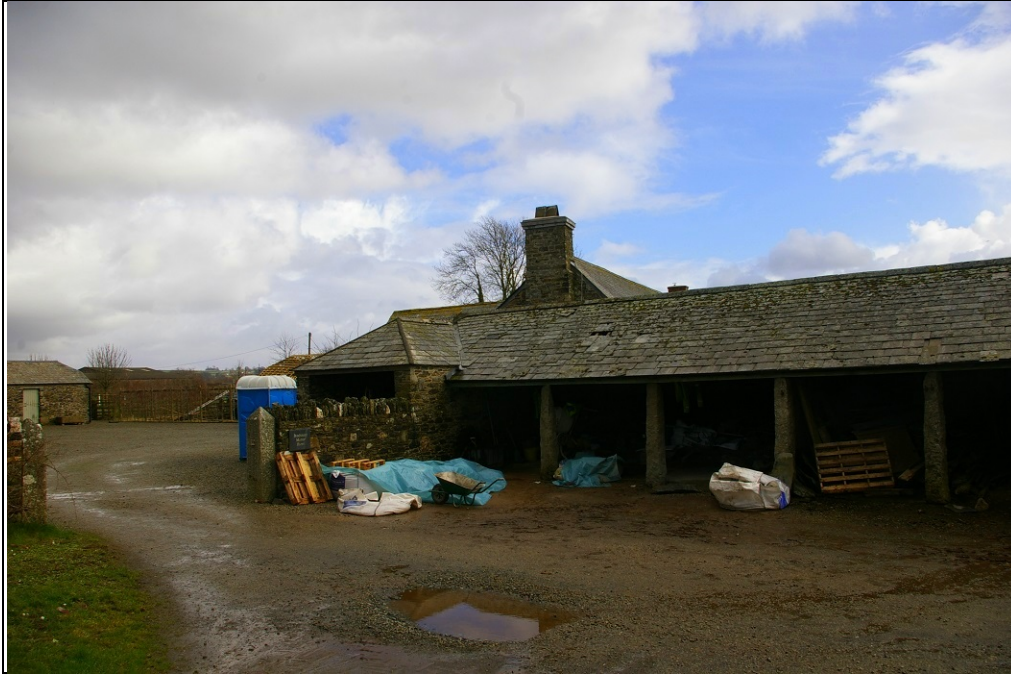
View of Bradstone Manor, showing the north side of the house and the outbuildings which wrap around its north side and the relationship between the house and the large courtyard of barns; from the north-west.

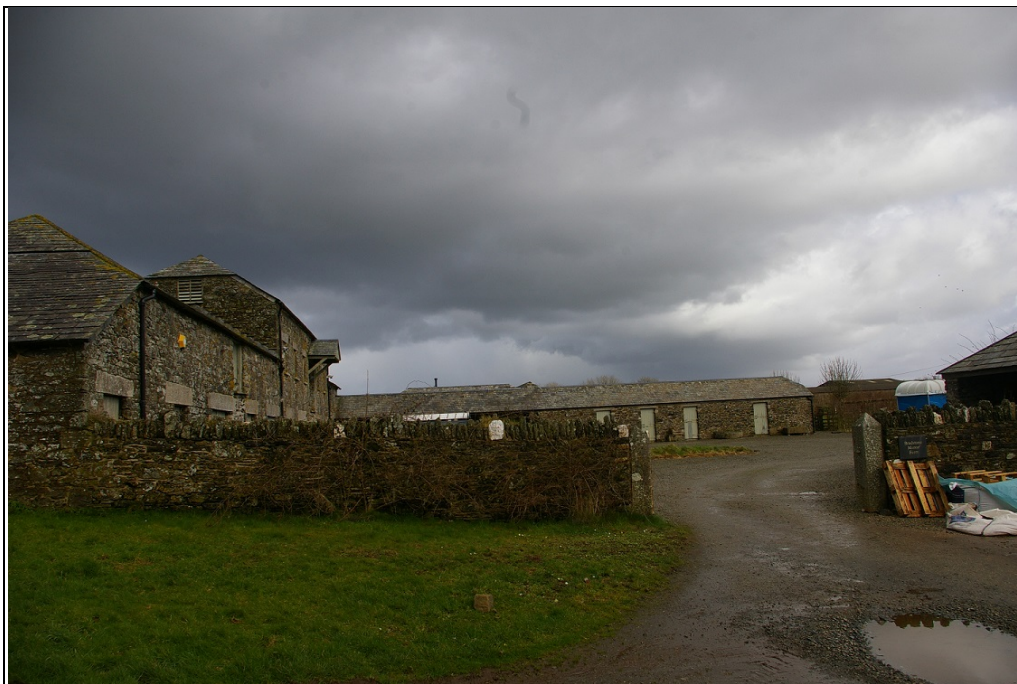
The large courtyard of barns and buildings which sit to the north and north-east of the main house, blocking views to the turbine; from the west.

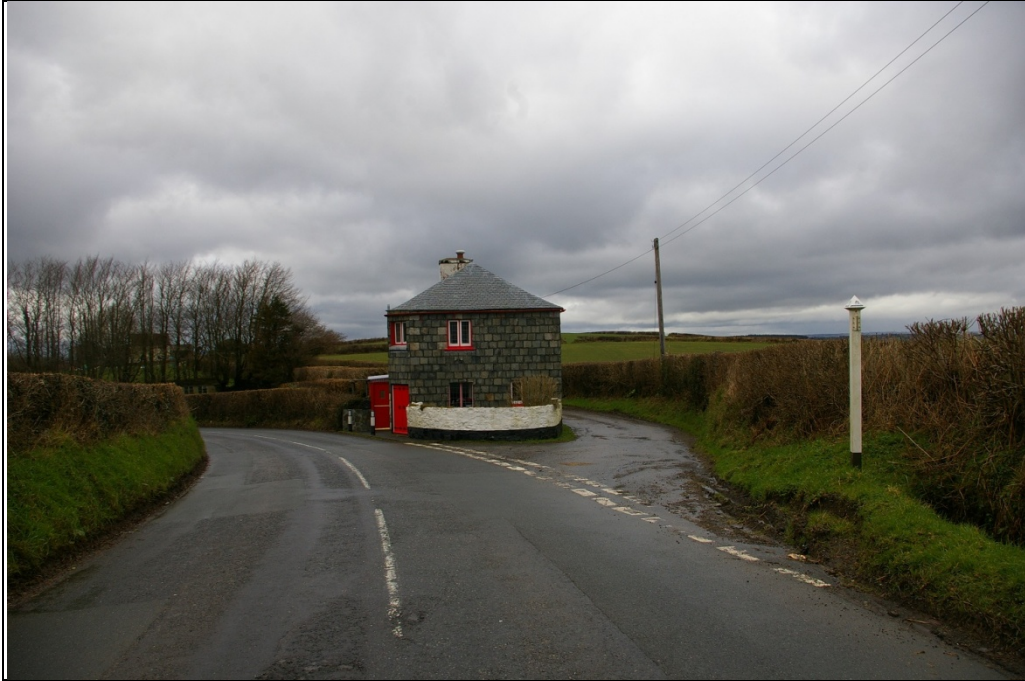
Roundhouse toll house, showing blocking; from the south

- the drive to the house, but not from the asset itself; impact: **neutral**.
- The Round House and garden wall; medium significance; Grade II Listed; condition: excellent. A former toll house, set at a junction of three roads. This building was constructed with views in mind, but these are limited to up and down the routeways which it was in charge of monitoring. The building will have some limited views to the north-west, up the valley, over Chillaton to the turbine. These views are limited by the trees which form the north boundary of the small plot of land on which the house is built, between the two roads. The trees stand higher than the building and block views. There may be some limited views along the western edge of the trees, at 4.5km. The building is defined by its former function as a toll-house and our experience of it will be unaffected and the views limited; impact: **neutral**

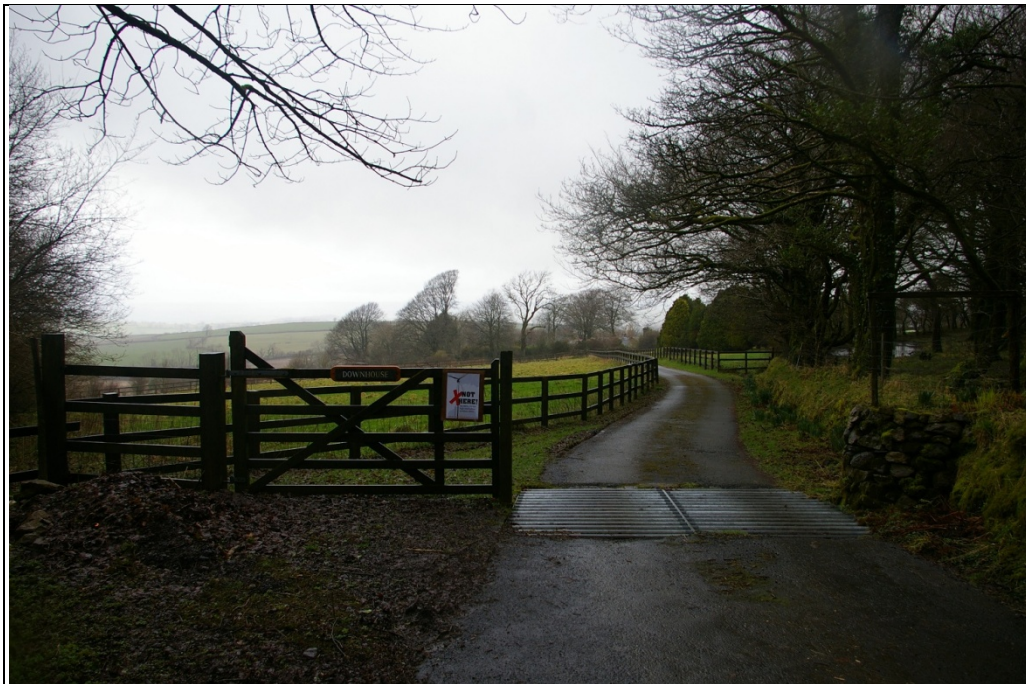
Downhouse, set in wooded grounds, but with views to the north and north-east to the turbine; from the west.

- Downhouse and ranges of outbuilding; medium significance; Grade II Listed; condition: excellent. The large house faces south-east, away from the turbine, the buildings behind to the north appear to form a large courtyard. It sits in gardens and grounds, with numerous mature specimen trees, within several enclosures, lined by hedge-banks. The building is a farmhouse but of a gentleman's residence-type, of slightly higher status and certainly built with its architecture and probably views, if only to its gardens, in mind. The house has views east and south-east, but less views south-west and west where a large wood encloses the farmstead. The house will be blocked from views north by its outbuildings to the rear, which enclose the farmstead. There are far reaching views to the north from the general area and the house is built on an exposed ridge of ground. The focal point of the buildings to the rear are the house and grounds and farmland, the focal point of the house is to the south over the farmland, its wooded gardens and to the buildings which enclose it to the rear. Little to no impact from the turbine, 4km away, it will be visible as one drives down

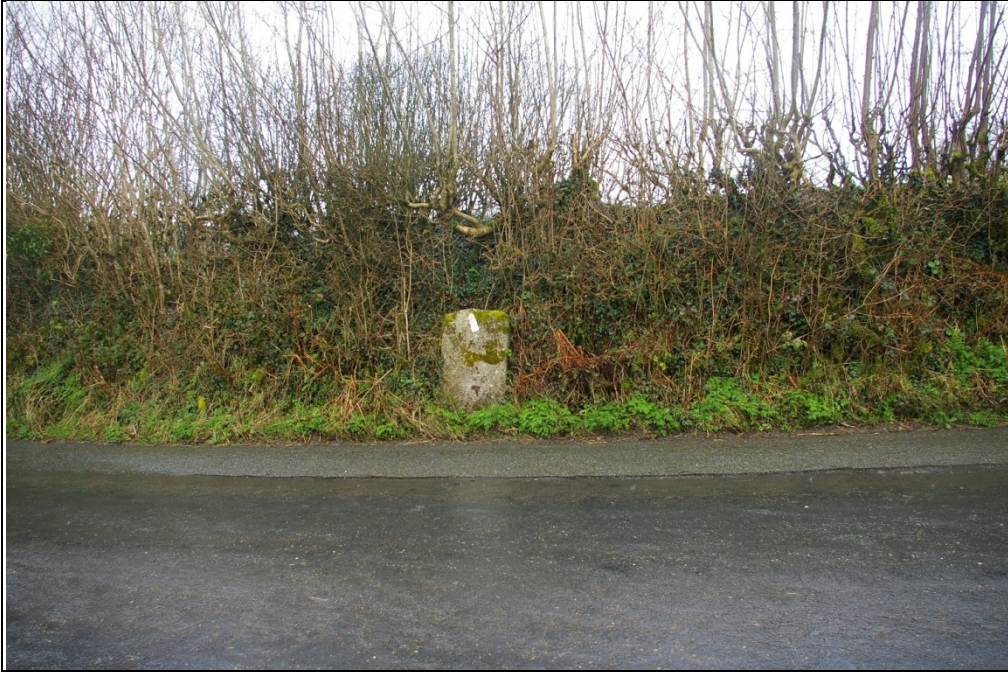
Boundary Stone near Pallastreet, set into a hedge-bank blocking all views; from the south

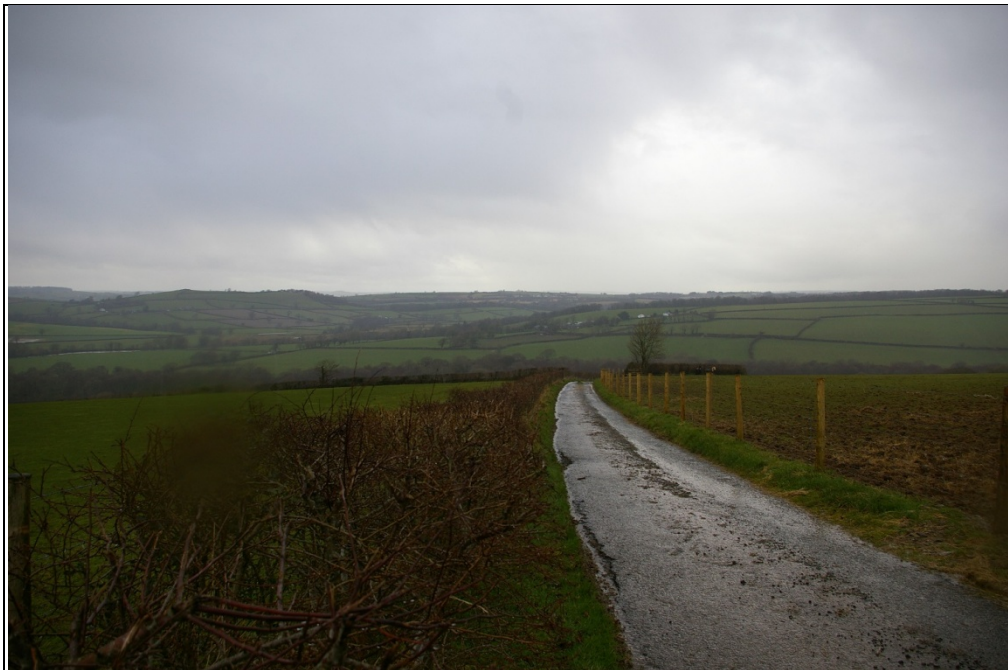
View down private track to Baucombe Farm in the valley below and the turbine on the high ground to the east; from the south.

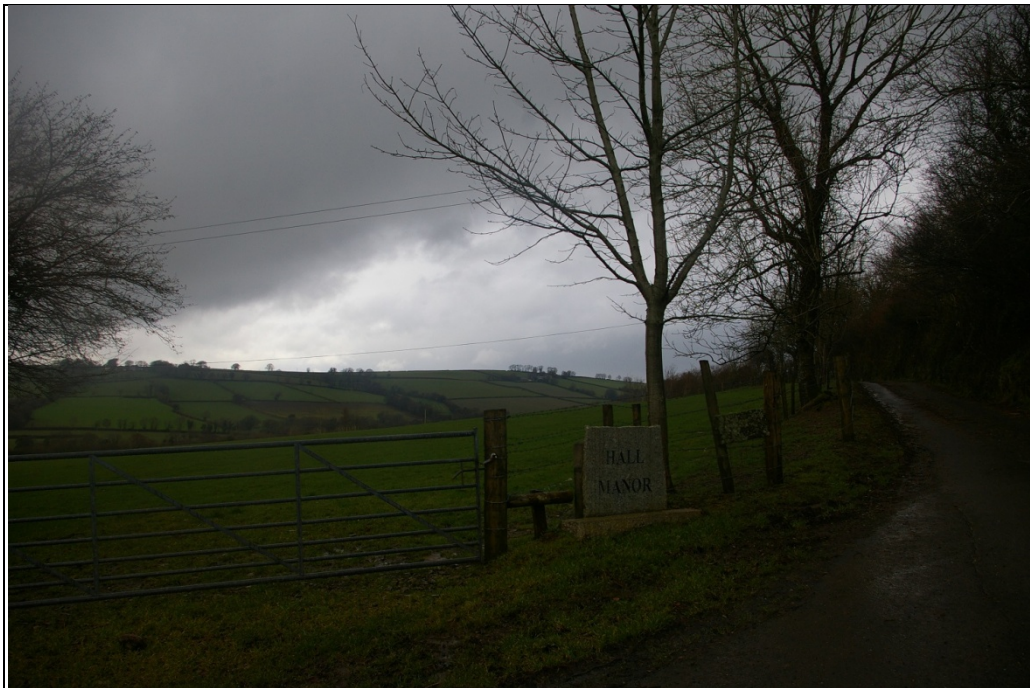
The private drive down to Hall Farm, showing the position of the turbine on the high ground to the north (on the left hand side of the photograph); from the west.

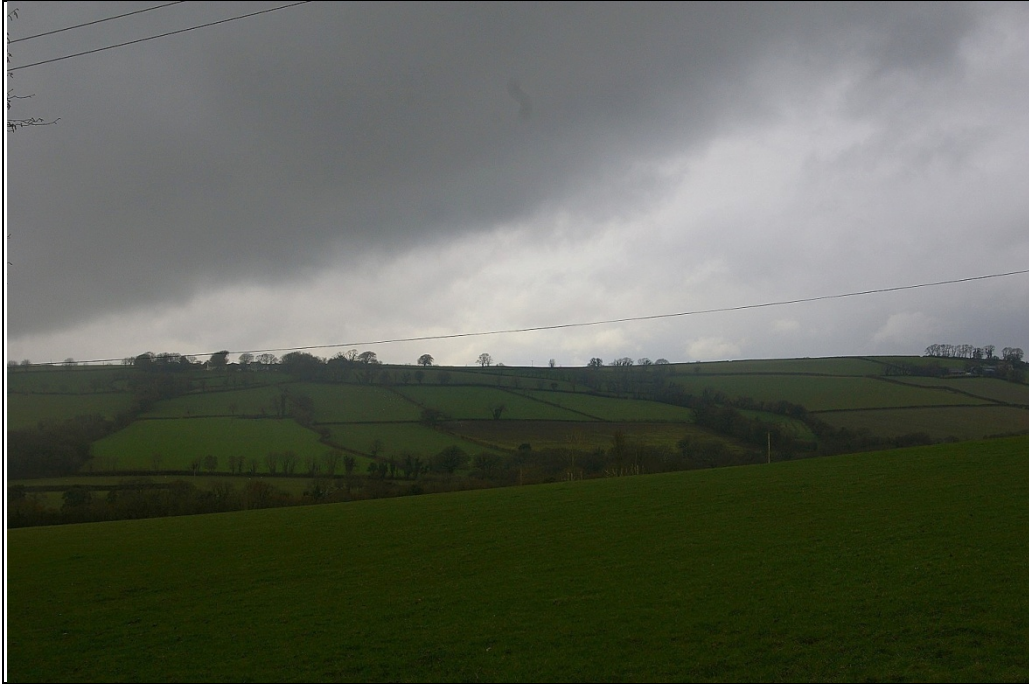
Ashleigh, Lifton, set high on the left hand side of the photograph, with the turbine site visible to the right, on the high ground.

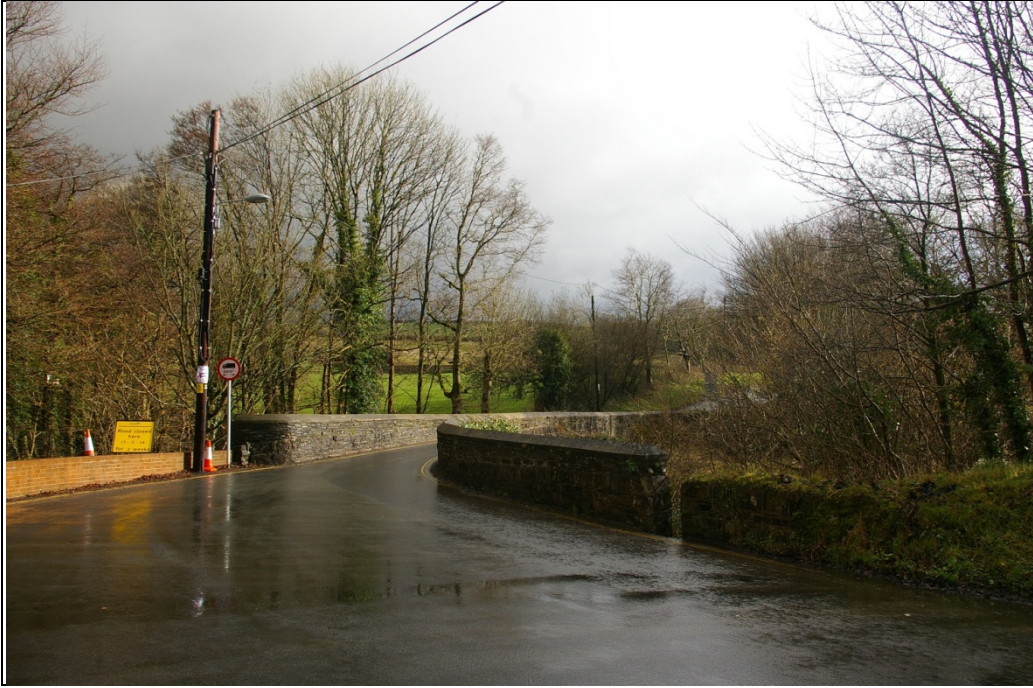
View over south bridge in Tinhay, showing local blocking from trees but views beyond and through the trees to the turbine site on the hills opposite; from the north-west.

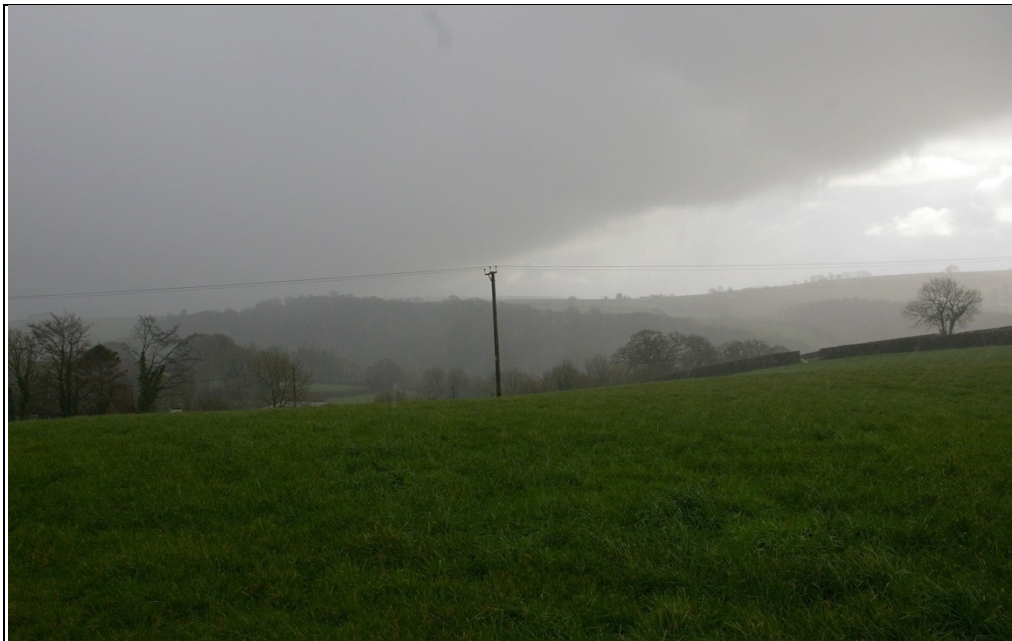
View from Sprytown across to the turbine on the high ground to the south-west; from the north-east.

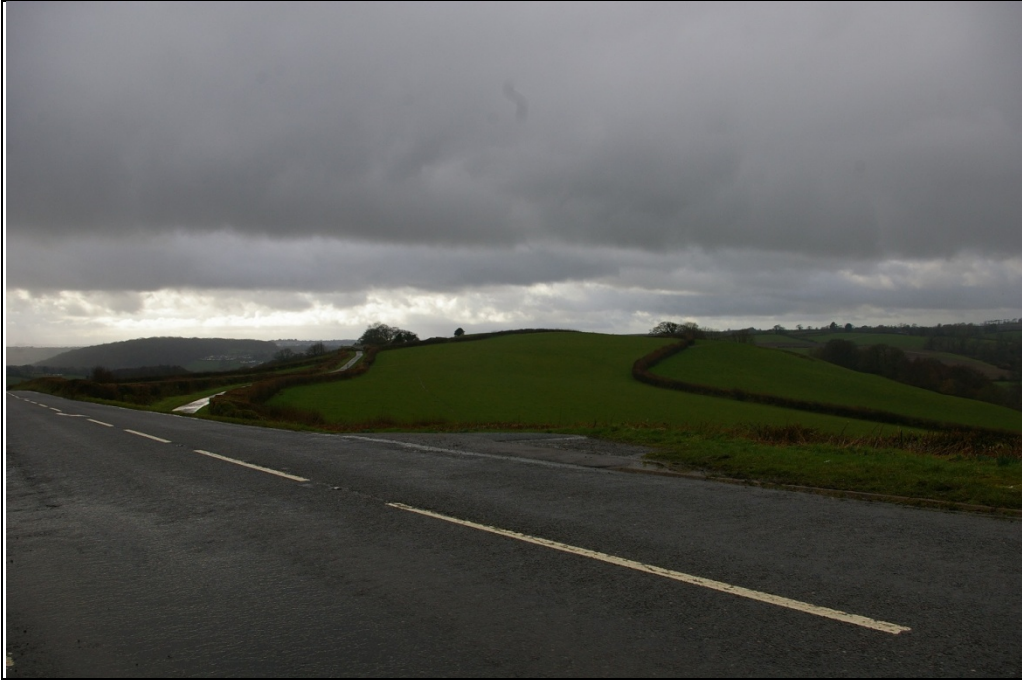
Enclosure at Castle Hill, partially blocked by hedge-banks with better views from the western half of the monument; from the south-east.

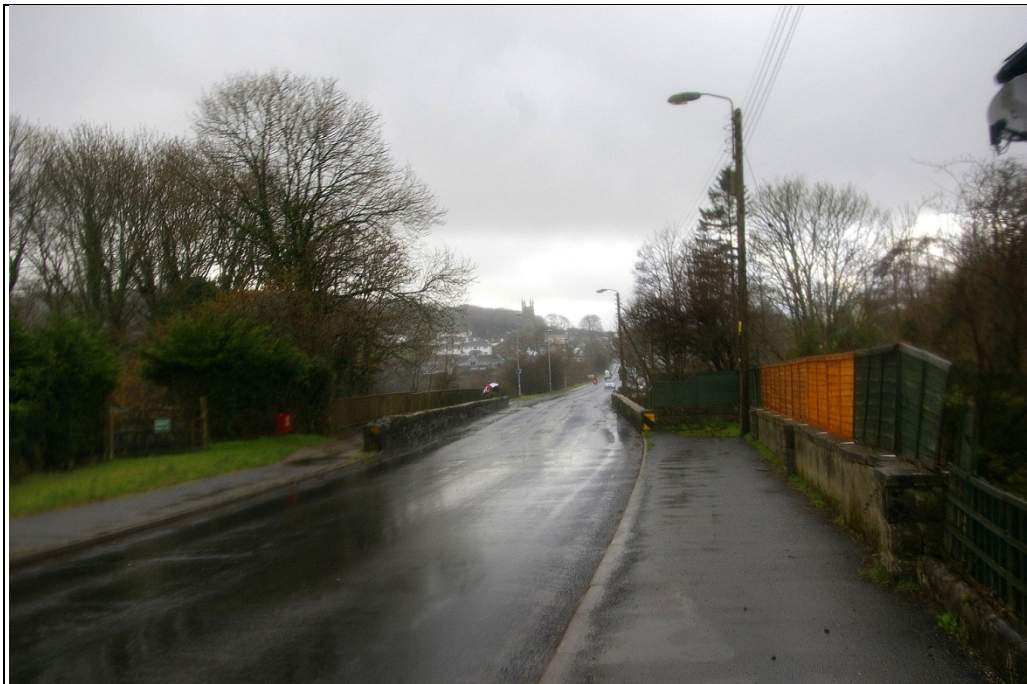
View to Lifton, showing the primacy of the church down the valley. Also showing the high hill immediately south of the village; from the east.

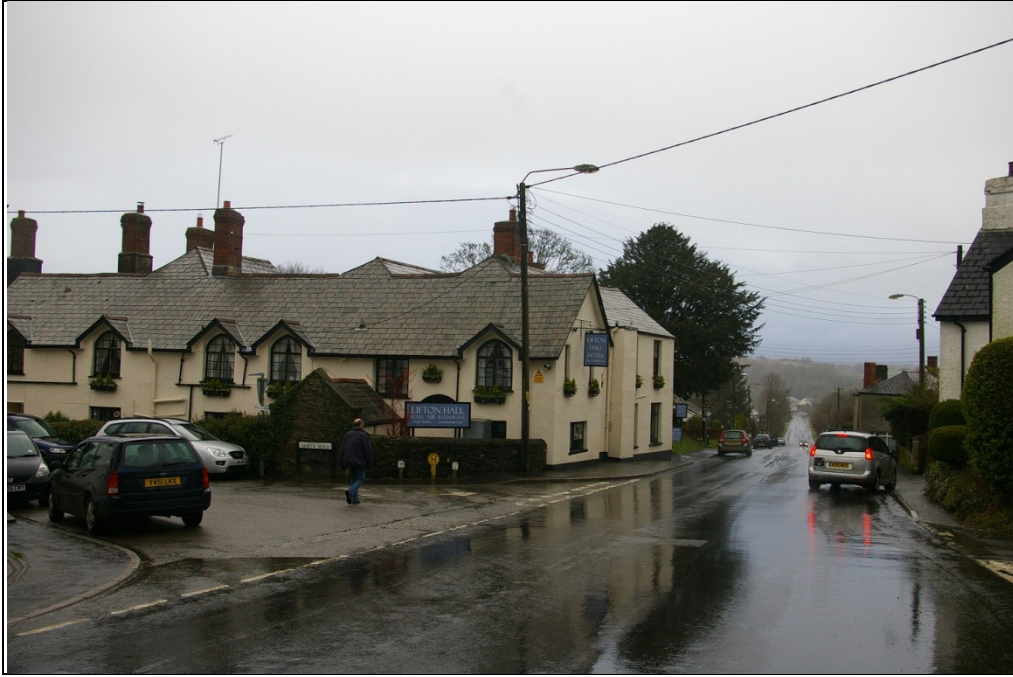
Lifton Hall Hotel, with views to the east, down Fore Street, showing some views across the houses to the south-east; from the south-west.

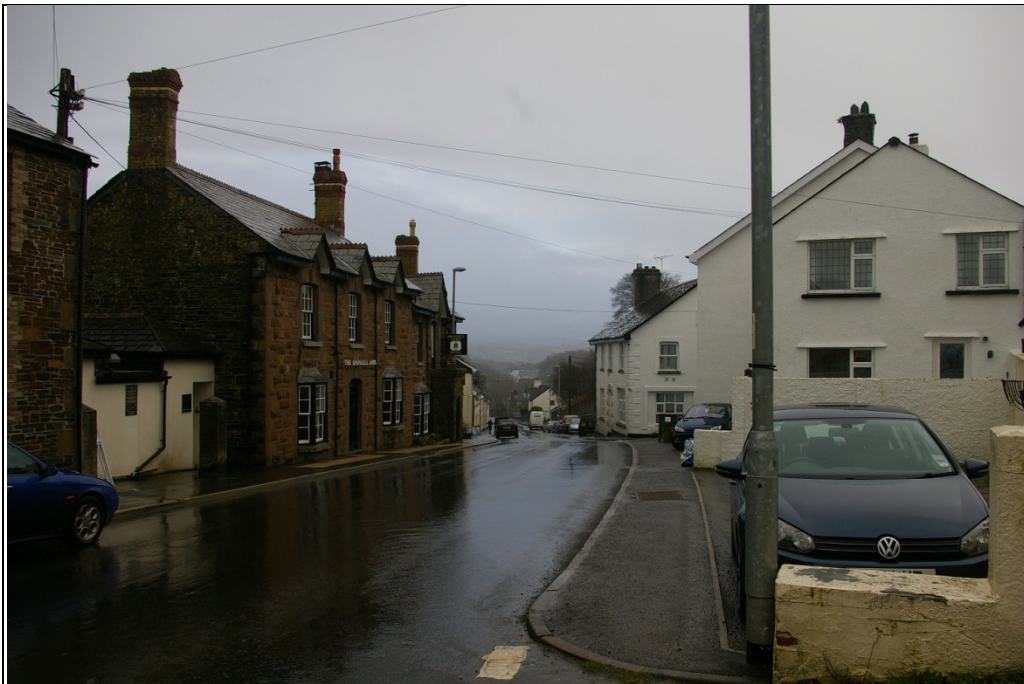
The Arundell Arms hotel and public house, on the main street in Lifton; some views to the east, down the street, but views across the street are blocked; from the south-west.

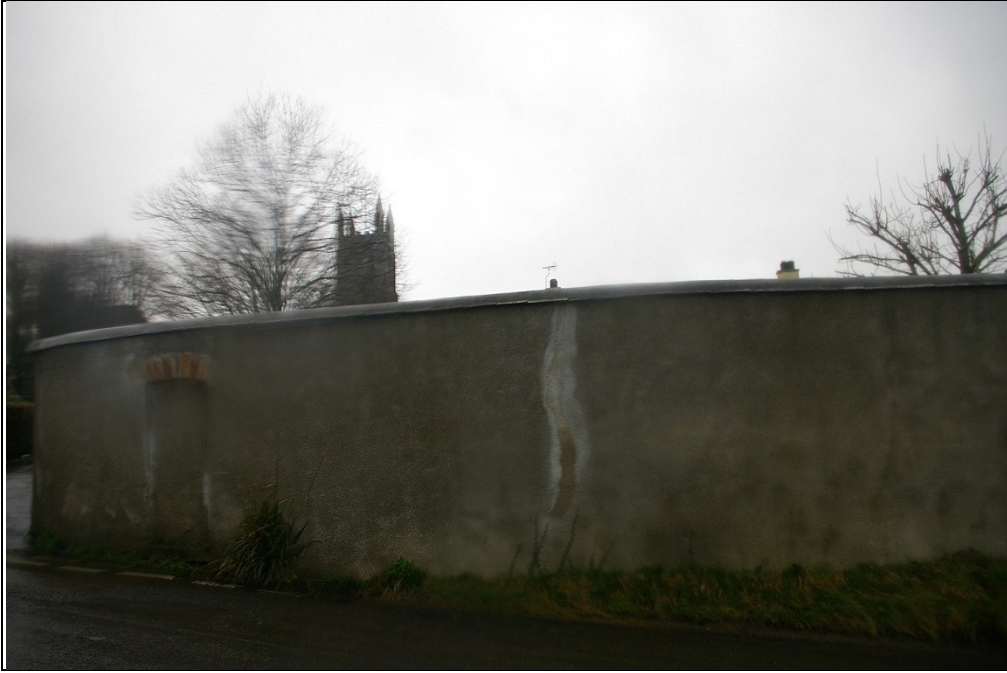
View from the east in Lifton, the walled grounds of the Manor House, showing the local blocking, with views to the church tower over the top.
