LAND at CHERRYFORD MARTINHOE DEVON

Results of a Cartographic Desk-Based Assessment
& Walkover Survey

Report No.: 140801
Date: 01.08.14
Author: J. Bampton

SWARCH project reference: MHC14
National Grid Reference: SS66464760
OS Map copying Licence No: 100044808
Planning application No: 62/43/14/002
Project Director: Colin Humphreys
Project Manager: Samuel Walls
Walk-over Survey: Joe Bampton
Desk-Based Assessment: Joe Bampton
Report: Joe Bampton
Report Editing: Samuel Walls
Graphics: Joe Bampton

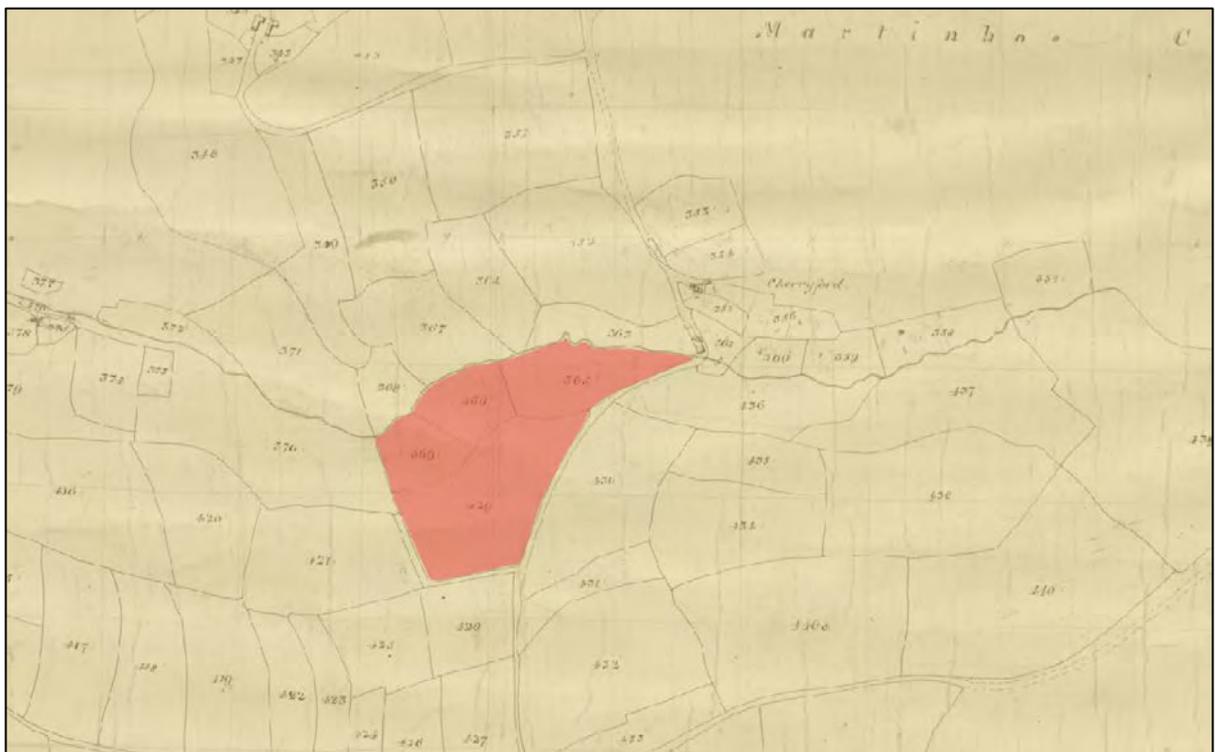
Figure 2: Martinhoe tithe map c.1842 (DHC). The proposal site is indicated.

The earliest detailed cartographic source for the site is the 1840's Tithe map (Figure 2). The tithe map shows the site much as it appears today in the cartographic record; comprised of four fields, three of which occupy the northern half of the site and down slope aspect of the valley and a single larger field that occupies the top of the slope. The dividing boundary between these lower enclosures and the upper roughly follows the contour of the slope. The site is roughly trapezoidal in shape with roads and trackways lining the east, south and southern half of the west boundaries with a watercourse forming the curved northern boundary.

The majority of the fields in the area are post-medieval enclosures, however the topography of the landscape only allows for so many straight boundaries. A number of remnant boundaries based on medieval strip fields can be seen in the south-west corner of the tithe extract (Figure 2). All the field names are prosaic and descriptive (see Table 1) and often take on the name of the local area, probably representing the late practice of intensified farming. The site is part of *Kemacott and Carders* at Kemacott, and owned by Sir Robert George Throckmorton. The land use generally is meadow or pasture, probably due to the impossibility of cultivating most of the slopes. Field no. 369 has been missed off of the apportionment but like much of the area abutting the river was probably wooded and recently enclosed and coppiced; as was the case with field no. 479, just off the western edge of the map.

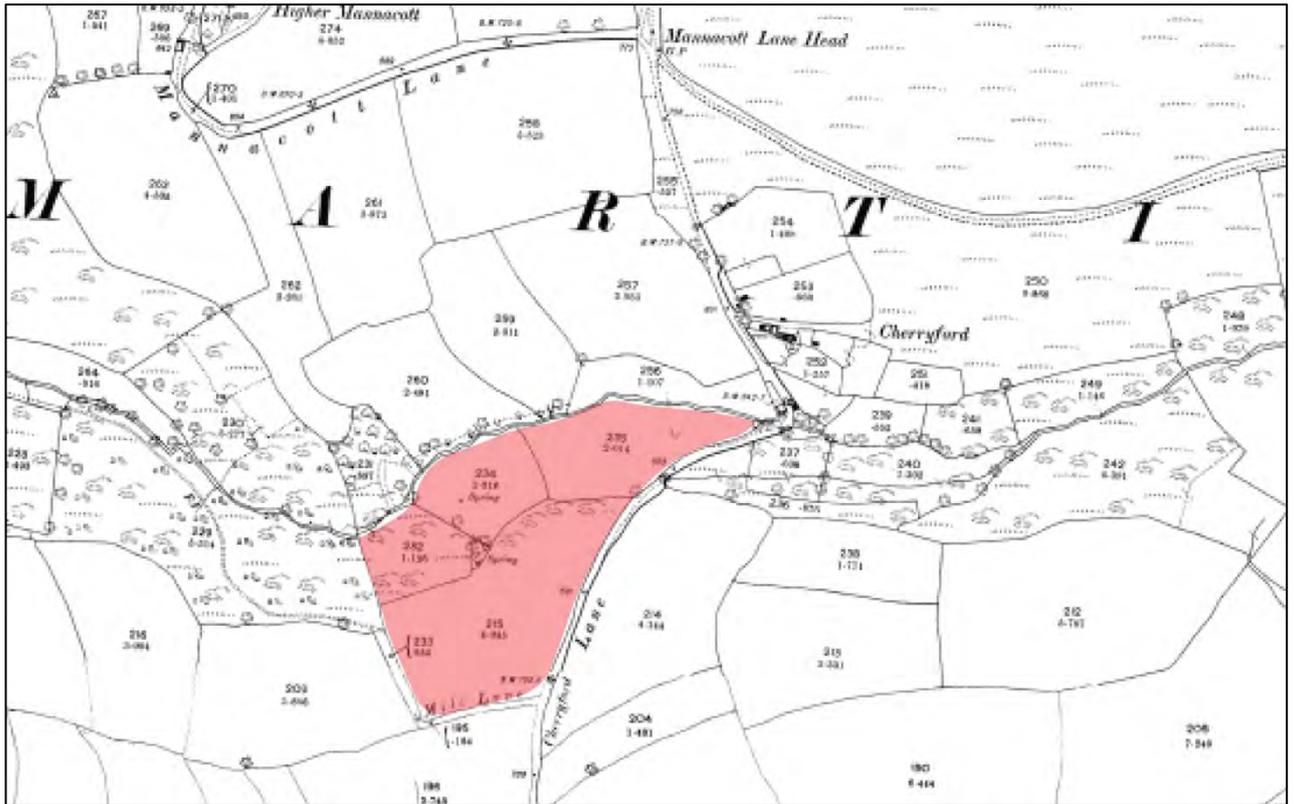
Figure 3: Ordnance Survey 1st Edition map, 1889-90, 1:2,500 (DHC). The proposal site is indicated.

The First and Second Edition Ordnance Survey (OS) Maps of 1889 and 1904 respectively (Figures 3 and 4), show general continuity in the landscape. Field no.369 on the tithe map is evidently part of the wooded scrubland lining the water course, which supports the suggestion that the area was suitable for coppicing. An additional boundary is depicted, which defines a spring in the east corner of field no.369 and the boundary between the southern field at the top of the slope and three northern fields is depicted as scrub, indicative of its non-cultivable nature as it is on such a steep slope. The road along the south boundary is labelled here as Mill Lane. The second edition shows field no.369 and the east-west boundary that divides the upper and lower parts of the site without scrub, suggesting it has been thinned or removed between the two OS maps.

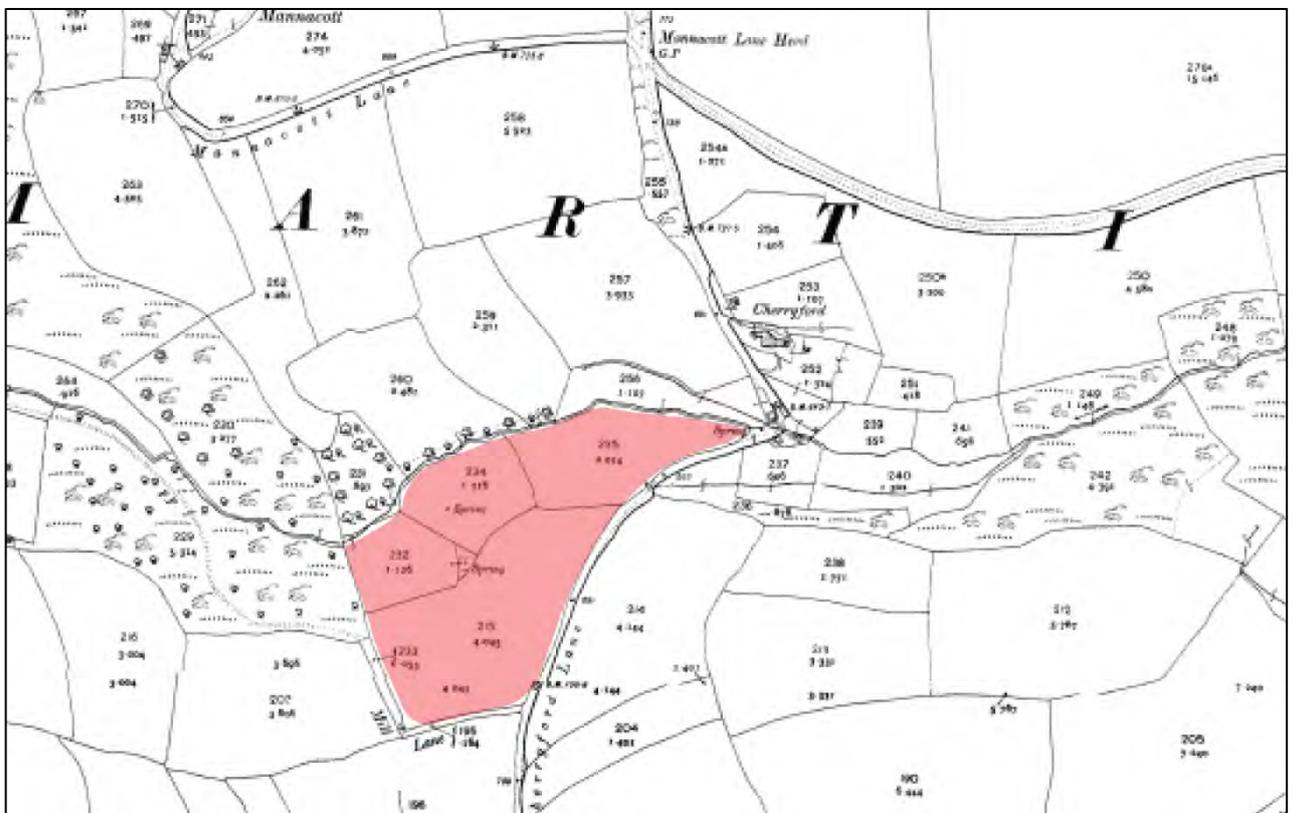
Figure 4: Ordnance Survey 2nd Edition map, 1904, 1:2,500 (DHC). The proposal site is indicated.

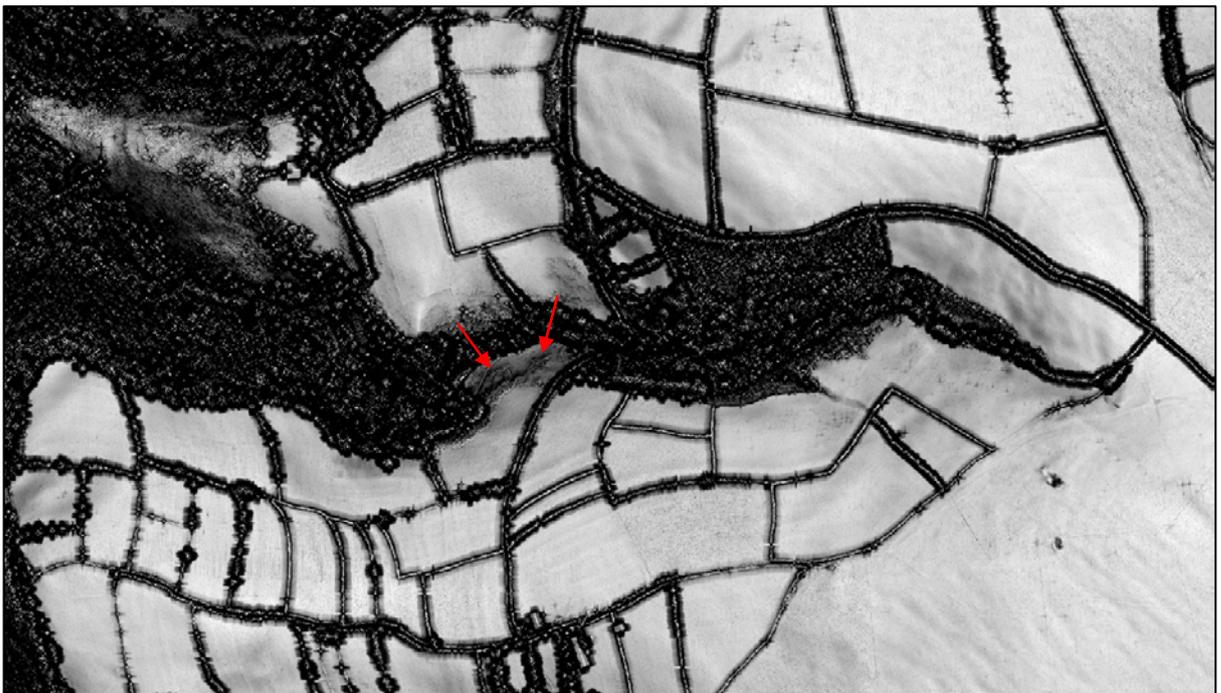
Figure 5: A Digital Terrain Map (DTM) showing the tributary to the River Haddon points of interest are indicated. DTM generated using Skyview version 1.11. Contains freely available LIDAR data supplied by Natural Environment Research Council (Centre for Ecology & Hydrology; British Antarctic Survey; British Geological Survey). ©NERC (Centre for Ecology & Hydrology; British Antarctic Survey; British Geological Survey).

Modern mapping shows further continuity with the second edition Ordnance Survey map, although with further removal of scrub from alongside the watercourse, particularly to the east around the ground south of the Cherryford Cottage Hotel. The Digital Terrain Map (DTM) shows field boundaries and the woodland and difficultly steep terrain across the northern fields that comprise the site, including field no.369, which is clearly still wooded (Figure 5). Although the boundary between field no. 362 and 365 has been removed it is still visible on the DTM (and Google Earth) as a change in tone. Parts of the tracks that have been recently cut through the site are also visible on the DTM image. With the eye of faith one could see a subtle suggestion of the gutters/leats surviving in the eastern extremity of the site and possible terraces east of the track running diagonally across the visible western part of the site.

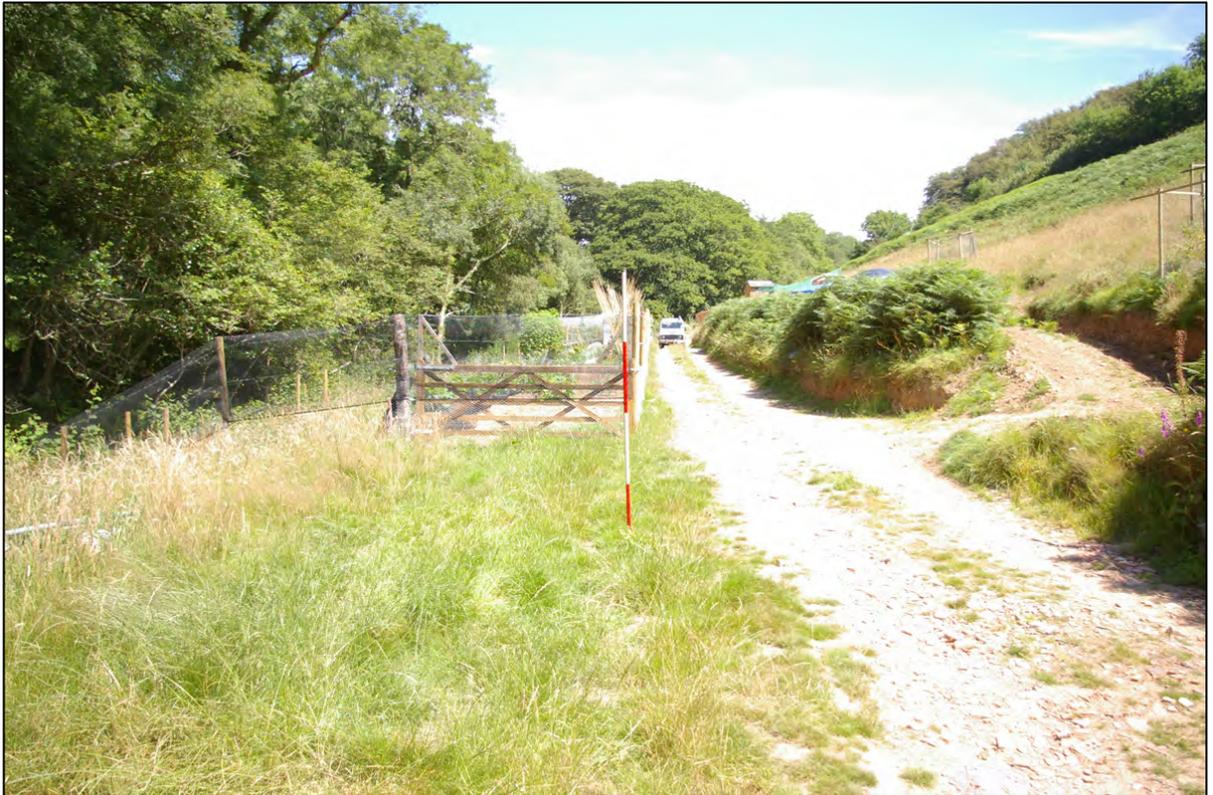
The entrance to the site proper was in the north-east corner of the site on the south side of the water course. A dirt track (Figure 6) had been cut into the site that followed the proposed layout of the site (Figure 12). This had involved some terracing of the land for the track and north of it towards the bank of the watercourse. West of the fork at the western end of the track up to the south east corner of the western most field the site was much more heavily overgrown with wooded scrub and thick bracken (Figures 7 and 10). Trees lined the bank of the watercourse and extant boundaries.

Figure 6: View along track, with the wooded stream valley to the south; viewed from the west (2m scale).

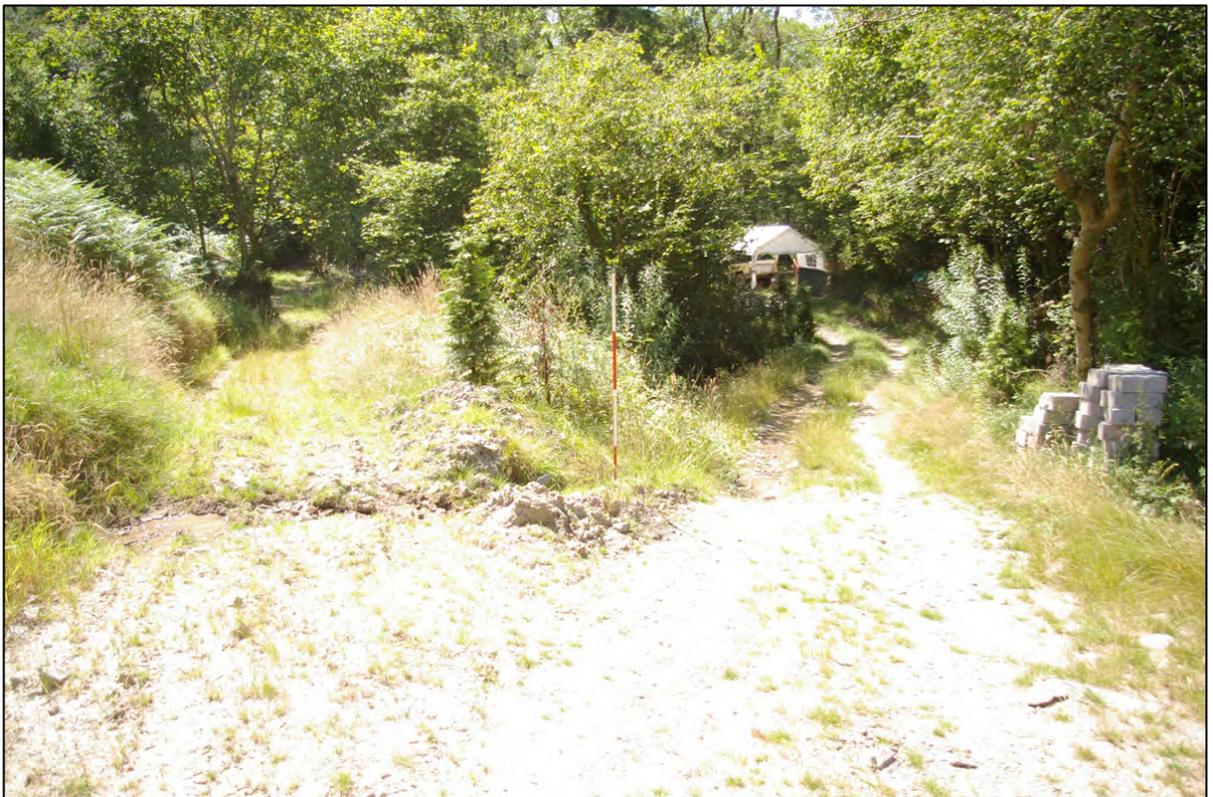
Figure 7: Western fork in track; viewed from the east (2m scale).

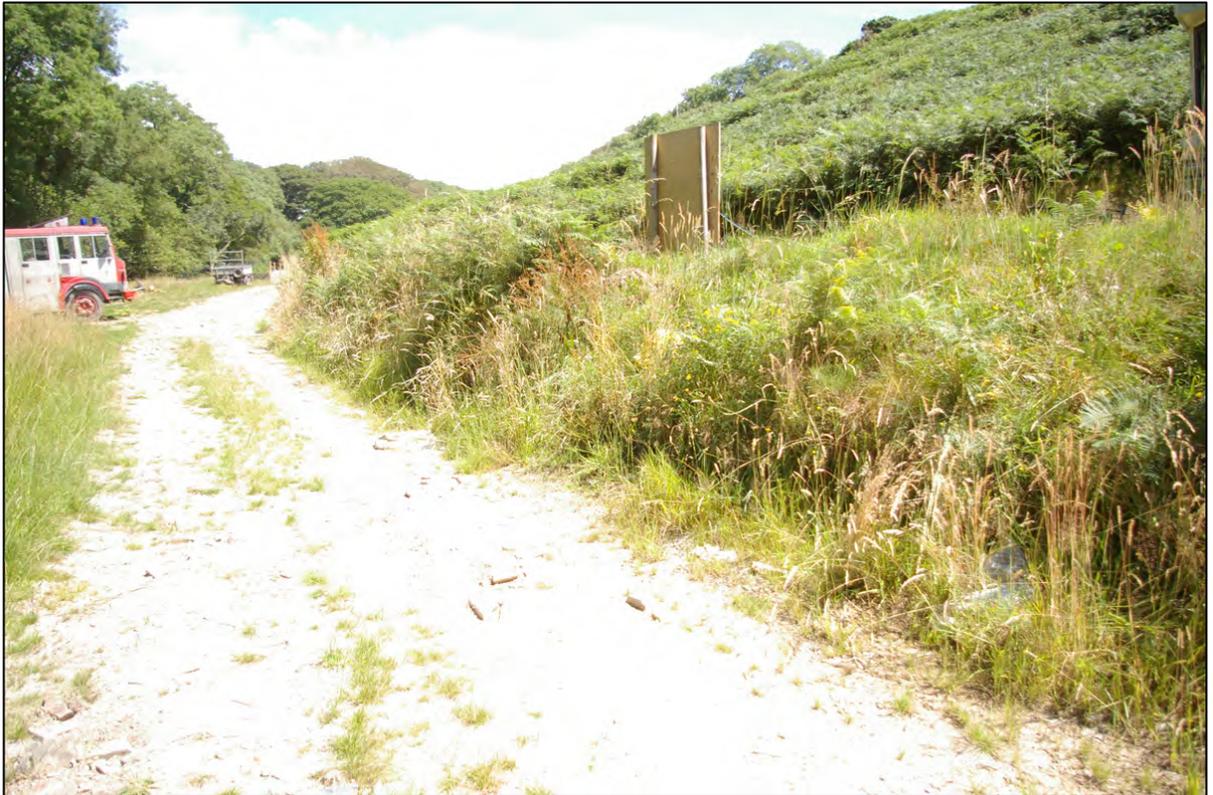
No leats or other features were present in the slope allocated for the proposed barn (Figure 8), which will necessitate the terracing into the slope. This area was very closely scrutinized and no evidence for a leat was seen or felt in the slope.

Figure 8: Location in the slope for the proposed barn; viewed from the west (no scale).

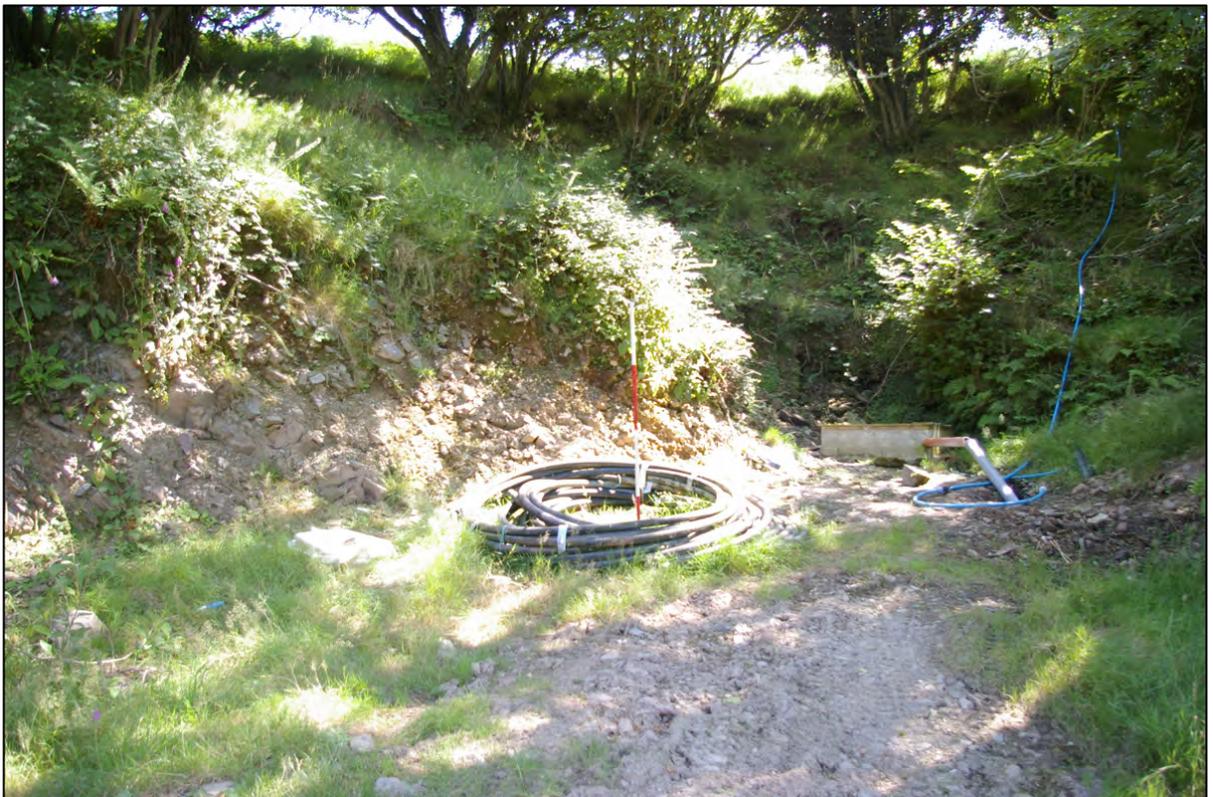
Figure 9: Southern most extent of the proposed development area; viewed from the north (2m scale).

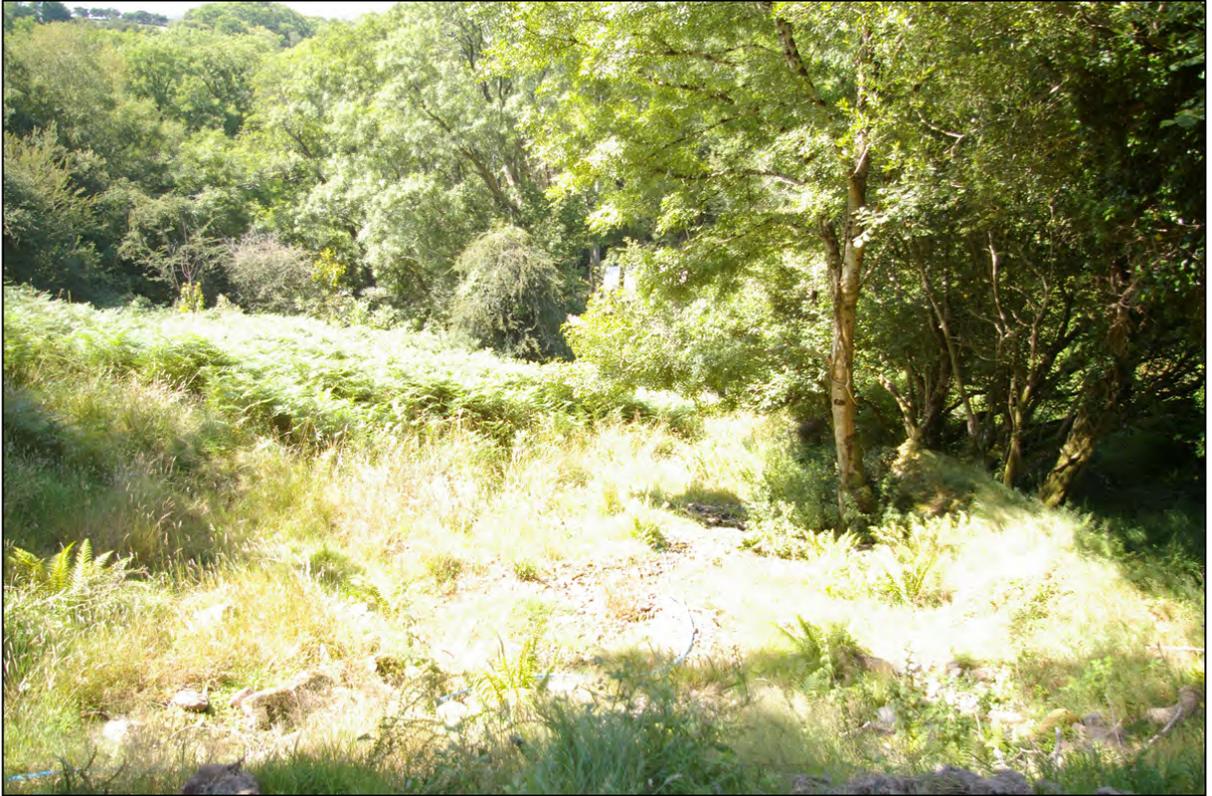
The areas for development had been cleared. The eastern boundary of the western field survived as an earth bank (Figure 10) with trees growing along it up to the point of the onsite spring where a plateau (Figure 9) had been cut. There were no other boundaries visible on the site apart from the natural border to the field to the south, which was an extremely steep overgrown ridge. The steep slope on the south side of the site was totally overgrown with bracken and scrub and no archaeological features visible across the majority of the site.

Figure 10: Extant field boundary (on the right) between the western and central lower fields; showing ground conditions of the western field; viewed from the south (no scale).

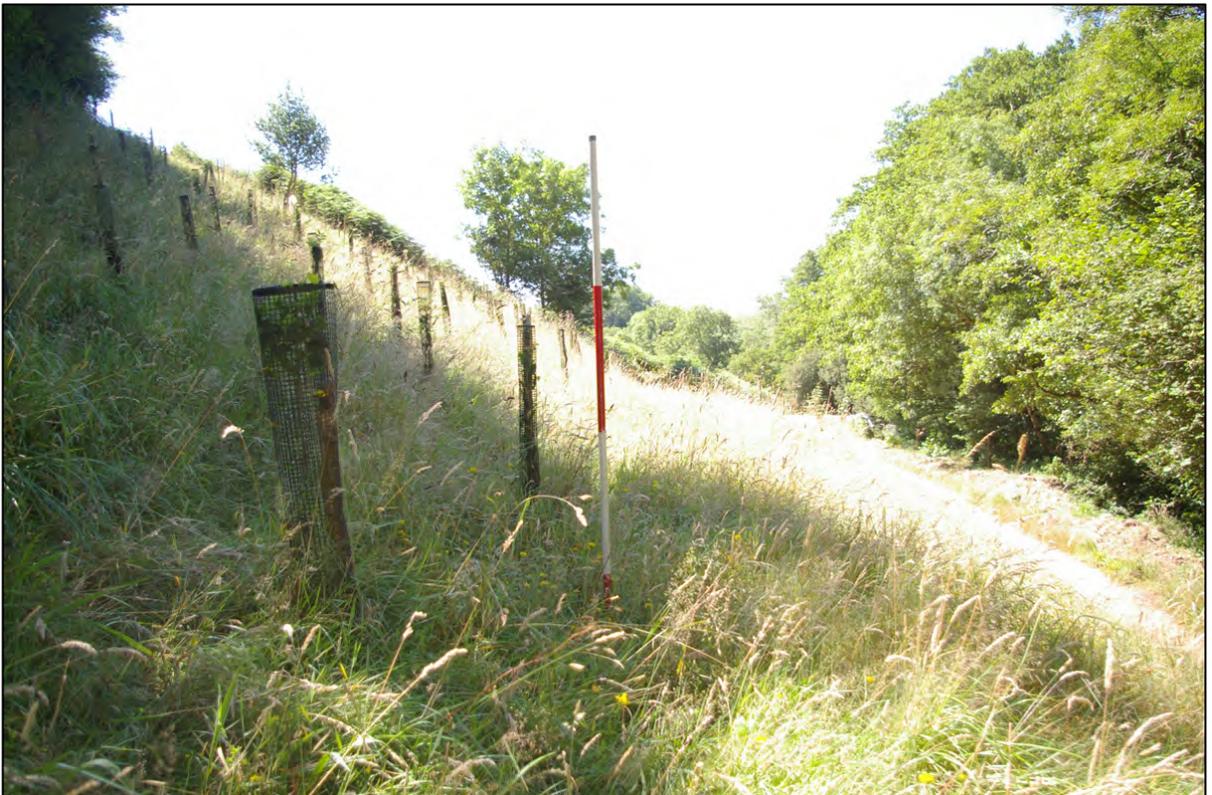
A single terrace (Figure 11) that probably relates to one of the leats described in the HER (MMO1803) was visible just south of the access track near to the entrance. It was visible for about 45m before dissipating or being lost in the overgrowth. It ran parallel with the access track and roughly along the contour of the slope. It is hypothesised that the access track most likely runs along the course of a further leat.

Figure 11: Leat parallel with track near to site entrance, viewed from the east (2m scale).

Due to the overgrown scrub that covers the slopes of the northern fields it was impossible to discern specific features apart from a single visible surviving leat of the water-catchment system (MMO1803) (see Figure 12). It has probably been utilized as an animal track and worn down. It did not appear to survive as far as the proposed development and may have been restricted to within the eastern field of the three enclosures present on the cartographic record. Perhaps the spring and its own watercourse at the western end of the middle field may have provided ample drainage and irrigation to the other fields on the site. The HER records the water catchment system as centring on the site but describes it as being on the east of Cherryford Lane, however this appears to be an error as the polygons that depict the extent of the features show them wholly on to the west of the lane and the fields to the east are shown as scrub in 1889 on the historic maps and in also in 1946-8 on aerial photography (historical aerial photography can be seen by appointment at the Exmoor National Park HER). There does not appear to be a likely location for them on this side of the lane. It is possible that the leats would not reach into the western field as it may have historically been scrub and woodland based on the 1889-90 mapping and would not need the regulated water flow; also its extant eastern boundary would form a logical limit of extent for the leats. However, in aerial photography (1946-8) the western most field is shown as pasture and has subsequently been overgrown with scrub, particularly bracken so it is possible the leats serviced this part of the field system as the area may have intermittently been used as pasture, especially as its slope is slightly less steep in general than the fields to the east. It is possible that the present access track is located over one of the other contour leats.

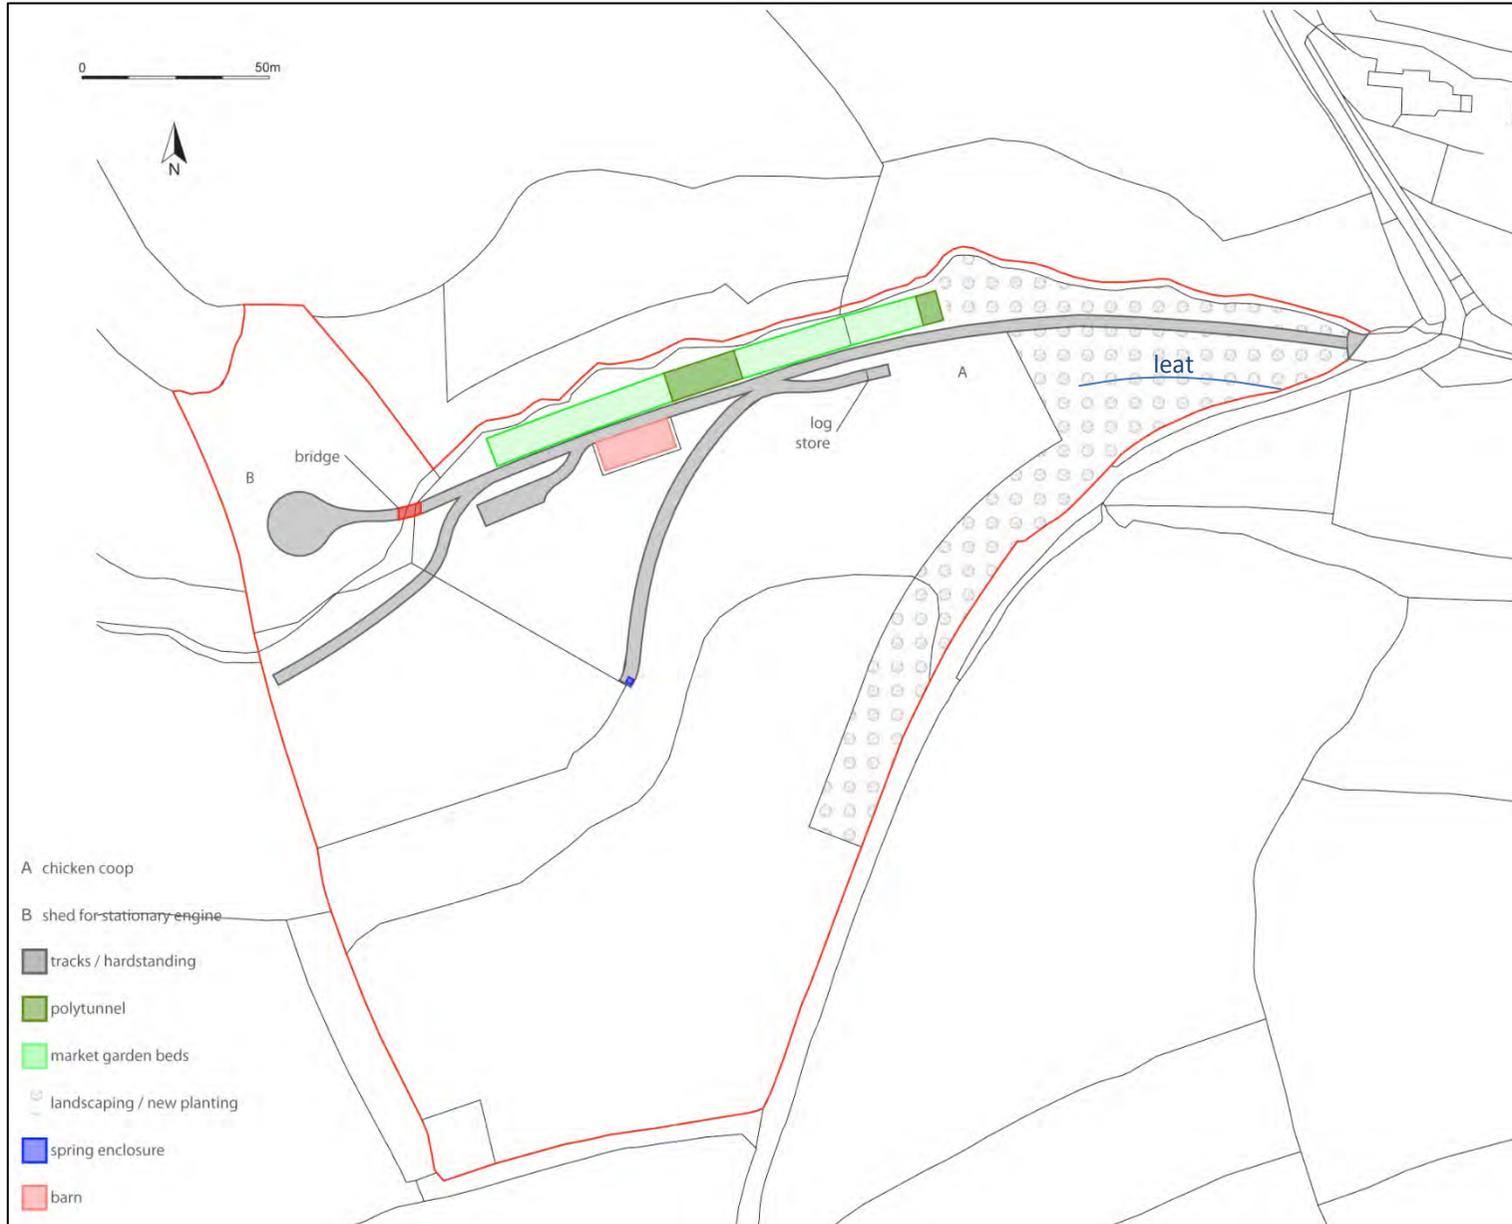
Figure 12: Existing and proposed site plan; the location for the barn is yet to be landscaped (after: Geo & Co Ltd.).

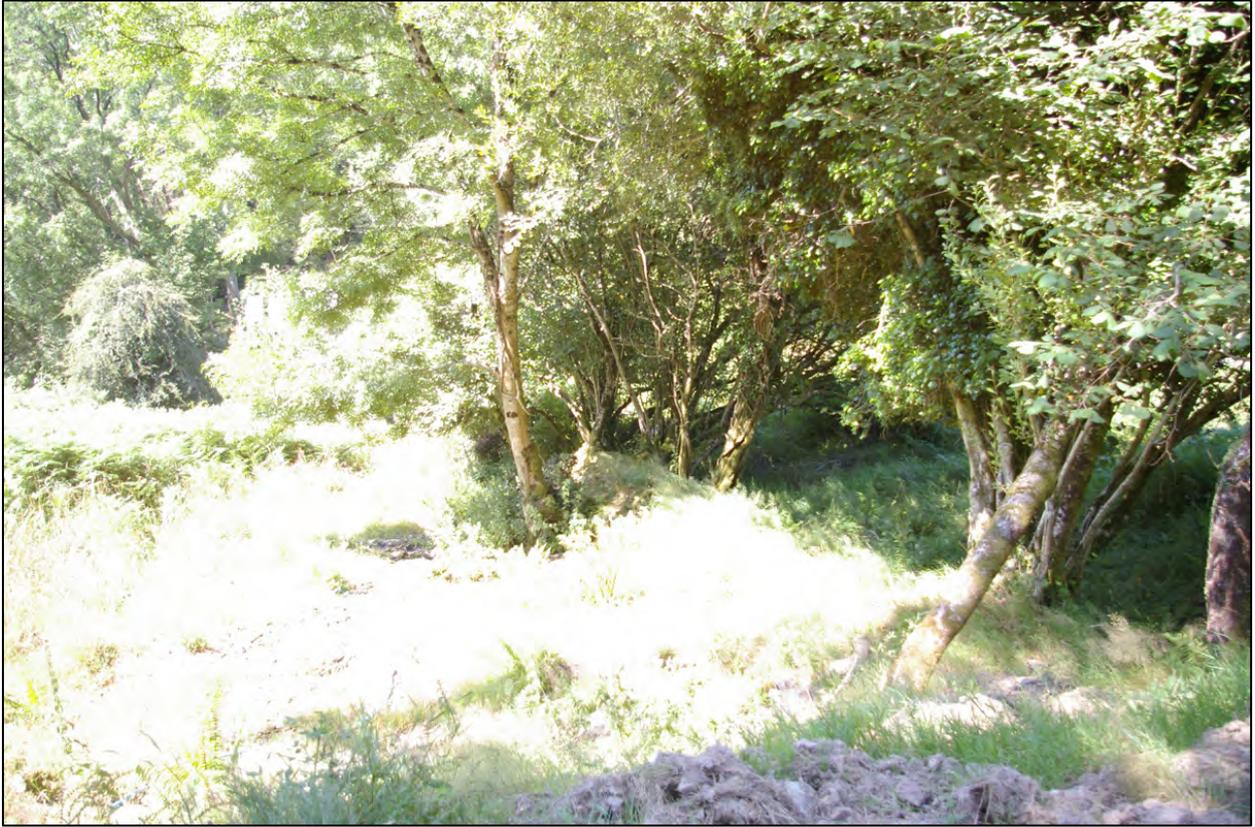
Figure 16: Field boundary running north-west between western and middle northern fields; viewed from the south.
