THE MALT SCOOP MERTON DEVON

Statement of Significance

Report No.: 141118
Date: 18/11/2014
Authors: E. Wapshott

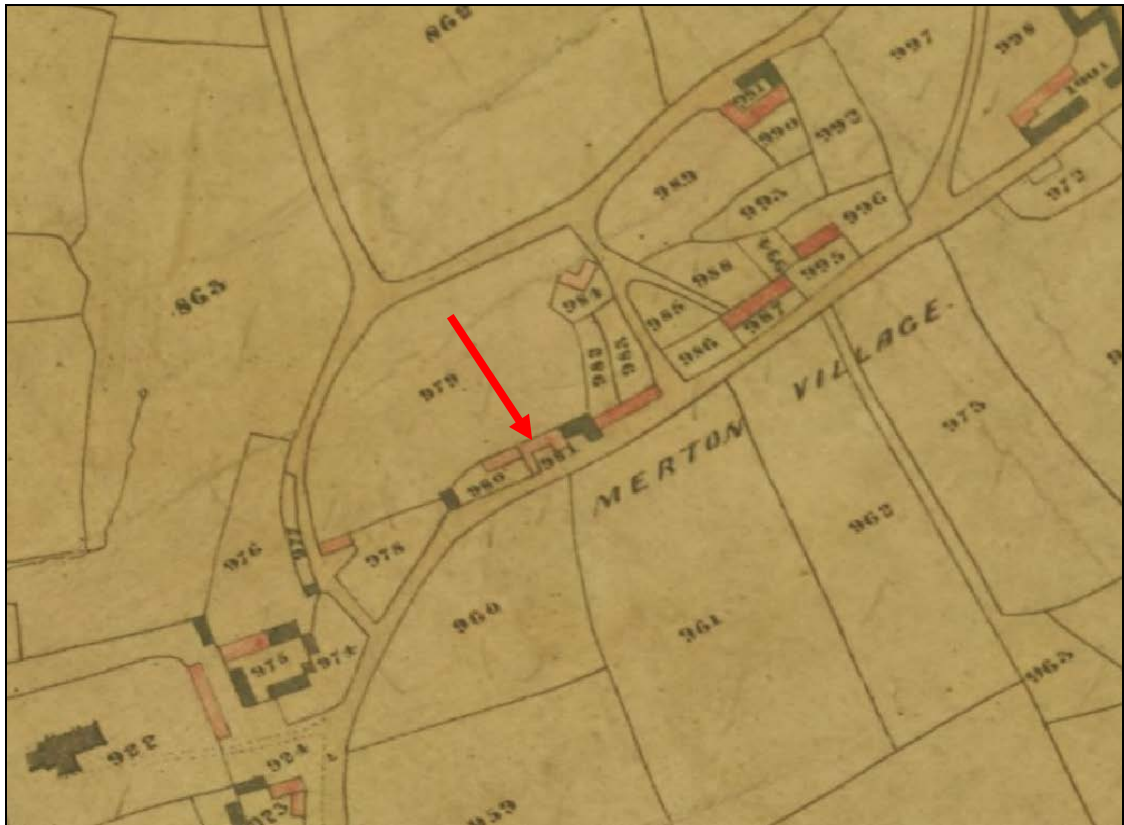
Figure 1: Extract from the Merton Tithe Map c.1842, the Malt Scoop Inn (number 981) is indicated.

The Merton tithe map appears to show the building by then known as the Malt Scoop as a u-shaped building, which indicates that the extension to the west was already in place at this stage, along with an extension to the east (where the modern toilet block now stands). The pink shading indicates that the building was residential, described in the accompanying apportionment as *house and outhouses*. The wall between the main house and the western extension had likely already been forced between the two, with the stack visible in the extension suggesting it may have originally been built as a separate cottage in the later 18th century.

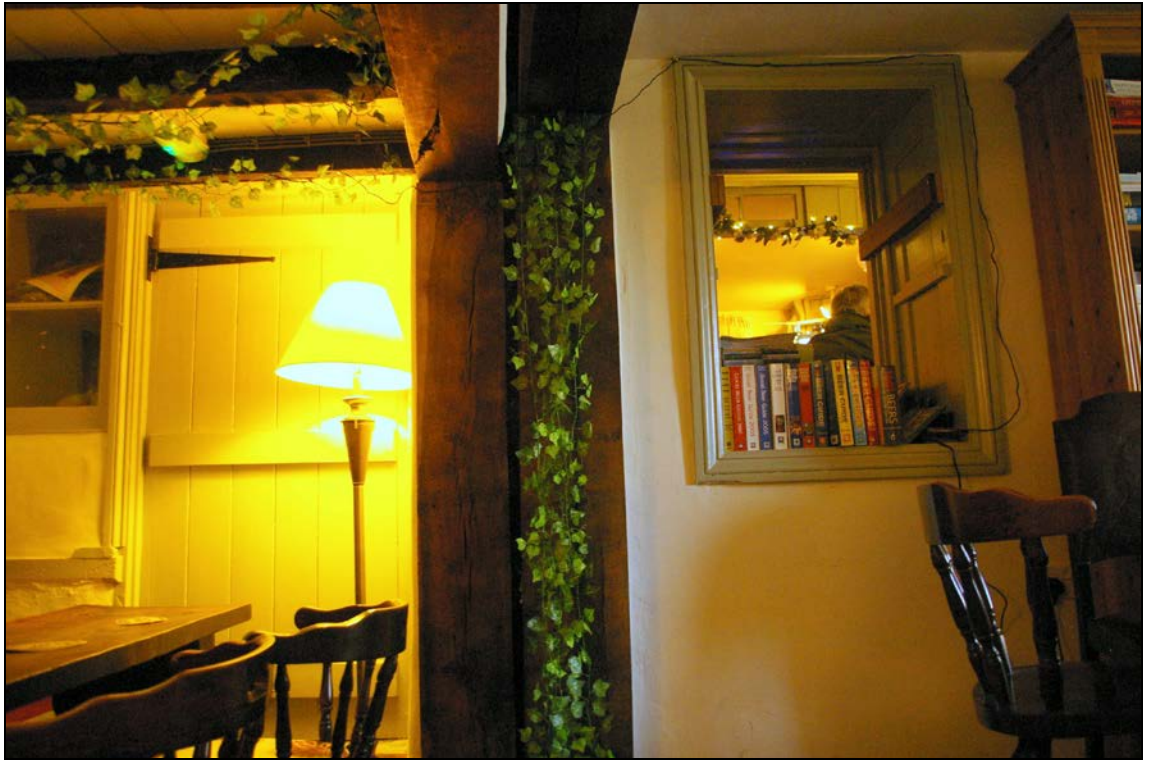
The former front exterior elevation including door and window openings, viewed from within the secondary bar area to the south.

The wall in question was viewed beneath the raised floor and appears to be of solid, stone construction. The wall is plastered and painted and has been heavily altered, a door and a window forced through. The door is likely to have been forced in order to join two formerly separate buildings in the 19th century at the time the building first became a public house. The window opening in contrast probably dates prior to the late 18th century construction of the western wing of the Inn, when the wall was still an external wall.

The window has plain panelled wooden shutters which are currently fixed shut; the opening set with modern shelves. The sash box is visible on the north side of the wall, the former internal face. A modern moulded door architrave frames the forced doorway linking the main bar space with the late 18th century extension which abuts the wall. Late 19th century style boarded panelling with raised dado rail is attached to the north (internal) face of the wall, within the main bar. A modern raised timber floor abuts the wall on the south side, to the north is a fine slate slab floor reset in cement. The slate (internal) floor is set slightly lower
