# LAND at NEWTON FARM STOKE LACY, BROMYARD HEREFORDSHIRE

Results of a Desk-Based Assessment &  
Historic Visual Impact Assessment

Report No.: 150522  
Date: 22.05.2015  
Author: B. Morris

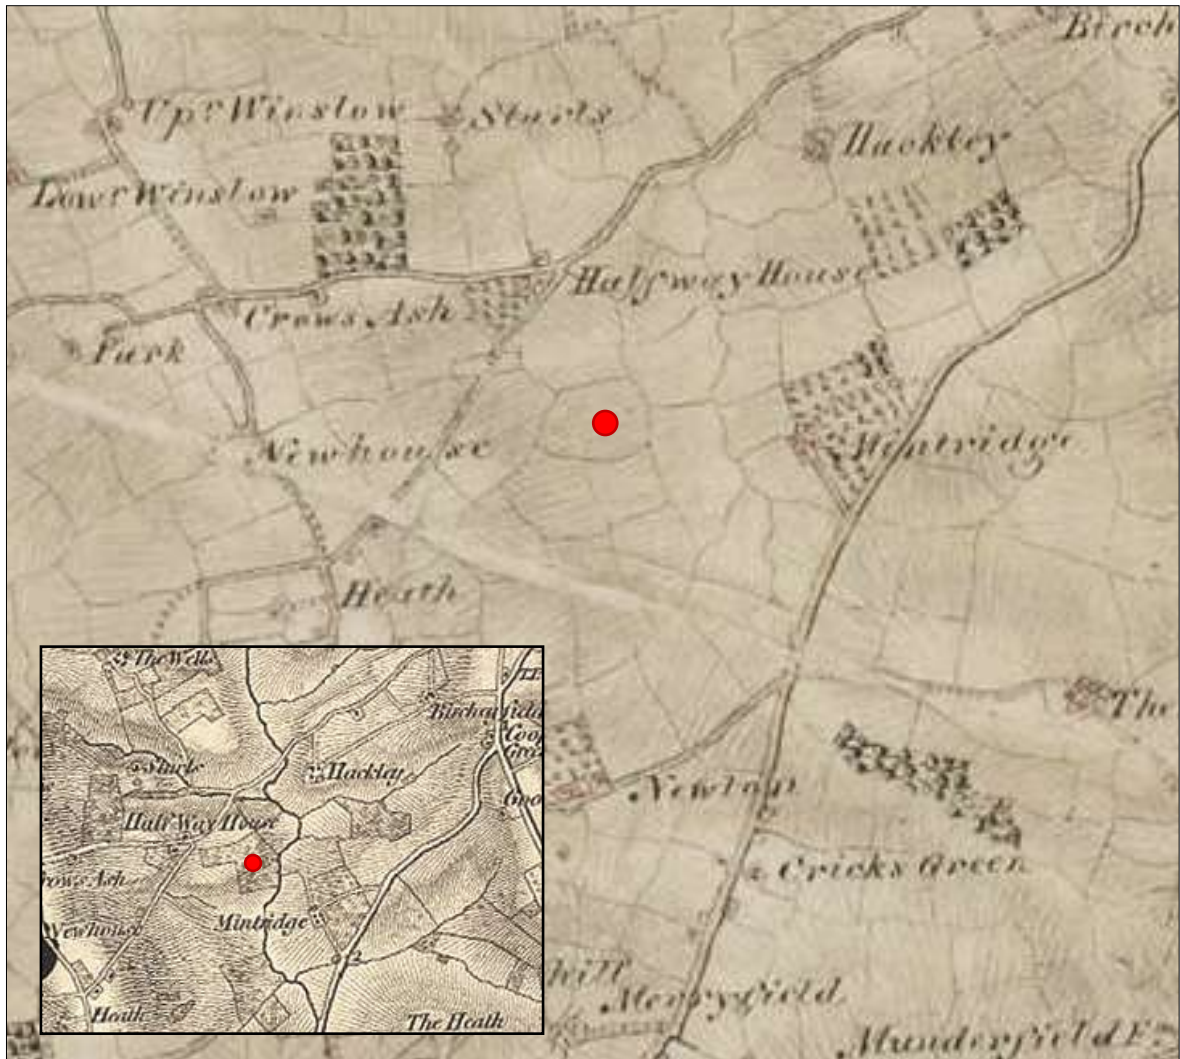
Figure 2: Extract from the OS Surveyor's draft map of 1816, with an inset from the 1832 1" 'Old Series' map for the area (the approximate location of the site is indicated).

The next map is the Ordnance Survey draft map of 1816. The depiction of settlements and roads on these draft maps is usually reliable, but the field boundaries shown are representative rather than accurate; the 1" 'Old Series' maps, which were based on the surveyor's drawings, show these fields with a stipple, and it is unclear whether this represents woodland, orchard or rough ground.

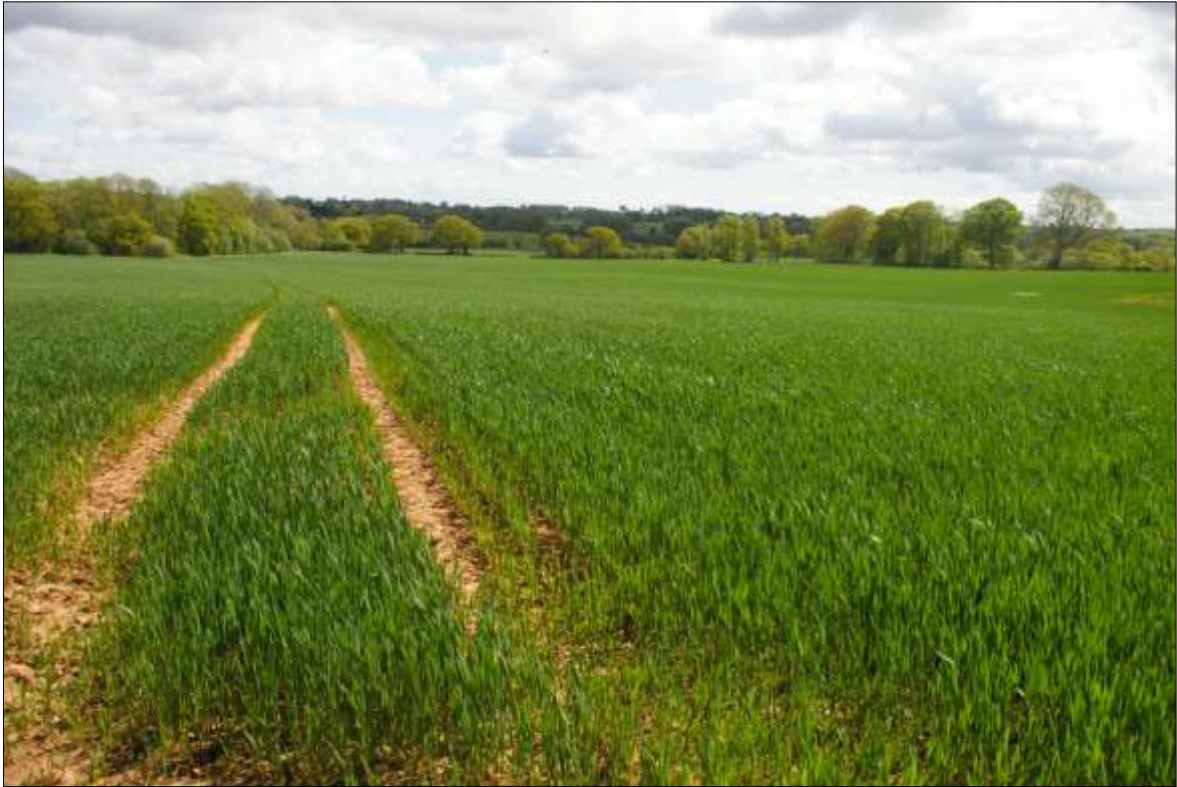
Figure 7: View across the field toward the location of the proposed turbine; viewed from the north.

The field was under an established winter cereal crop, with minimal exposure of bare earth. The soil is a reddish-brown silty loam, clayey to the east and south where waterlogging was in evidence, with very rare to occasional sub-angular stones and rare rounded stones. Occasional sherds of 19<sup>th</sup> and 20<sup>th</sup> century pottery were observed in the topsoil, and occasional small CBM fragments, probably ceramic land drain fragments, to the south.

No features of archaeological significance were observed during the walkover survey, but proglacial (fluvioglacial) deposits may be exposed during the excavation of the turbine base.
